Report title: August 2022 Site Visit Report for the Nunavut Impact Review Board's Monitoring of Baffinland Iron Mines Corporation's Mary River Project (NIRB File No. 08MN053).

Project: Mary River Project
Project Location: Qikiqtani (North Baffin) Region, Nunavut

Site visit dates: August 23-25, 2022

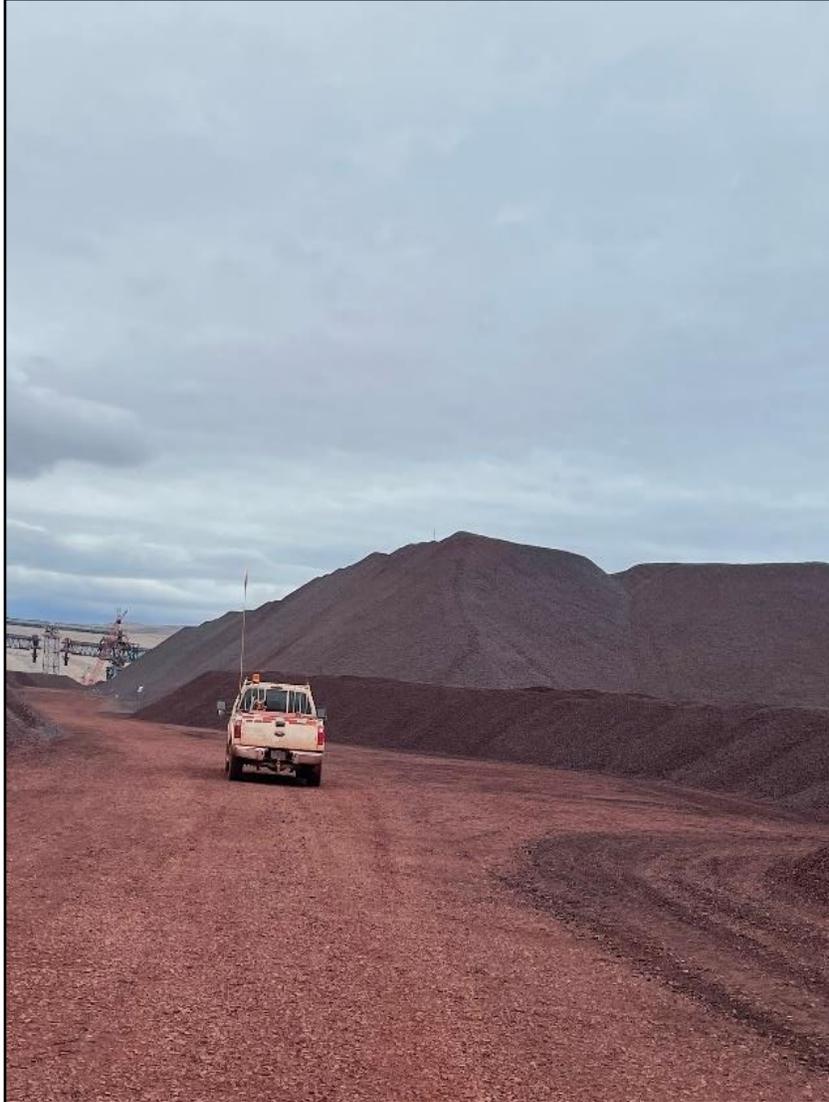
Photo 9: Ore Stockpile

NIRB staff toured the Ore Stockpile (Photo 9) and the Ship Loader Facility (Photo 10 & Photo 11). The Ore Stockpile area was not in full operation and maintenance activities were ongoing at the facility. Baffinland staff had noted that due to a labour dispute affecting their contracted vessels and operators, no ore carriers had been called to Port for seven (7) days at the time of the visit. Therefore, Monitoring Officers were able to climb and make observations from the loaders.

During the visit, due to limited operation no visible dust was observed and Baffinland staff informed the Monitoring Officers that Baffinland still apply the dust suppressant on the stockpile. Baffinland further noted that they had begun investigating options to implement wind fencing along the water side of the Ore Stockpile to help reduce wind-blown dust emission from stockpiling activities.

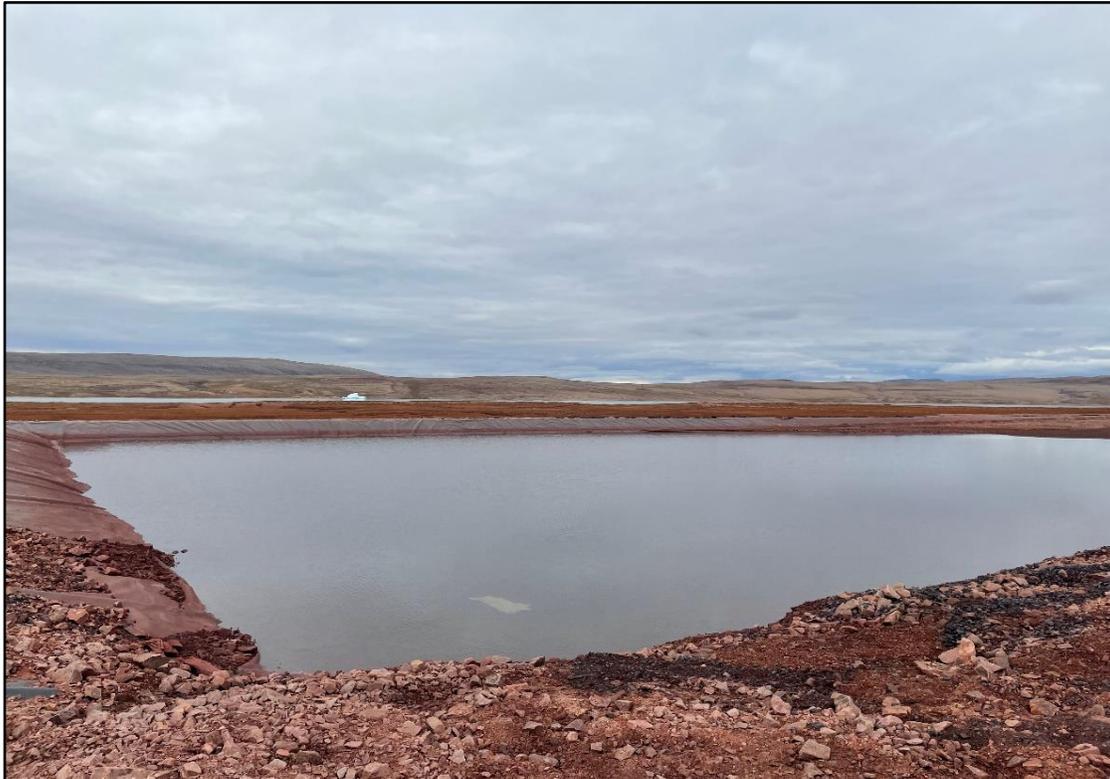
Photo 12: West Sedimentation Pond

As per Term and Condition No. 17 and Baffinland *Surface Water and Aquatic Ecosystem Management Plan*, NIRB staff observed the West Sedimentation Ponds that are adjacent to the Ore Stockpile ([Photo 12](#)) where runoff water is stored allowing any sediment in the ponds to settle before being tested and transferred to another pond to be discharged in Milne Port once water testing results indicate effluent is within discharge limits.

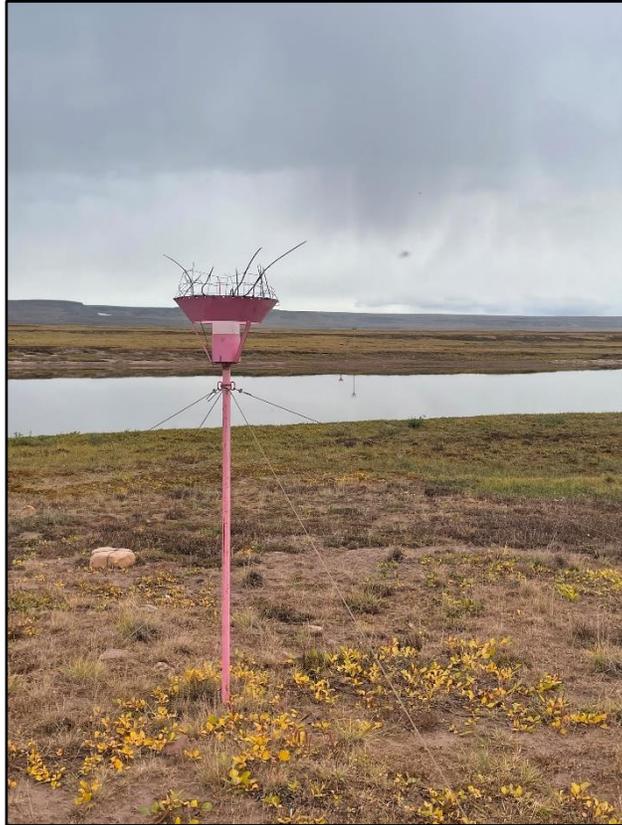
Photo 15: Dust Collector

The NIRB monitoring officers observed dust collectors ([Photo 15](#)) and ongoing dust mitigation measures of water being dispersed on the Tote Road ([Photo 16](#)) as part of Baffinland's fulfillment of the Term and Condition No. 10.

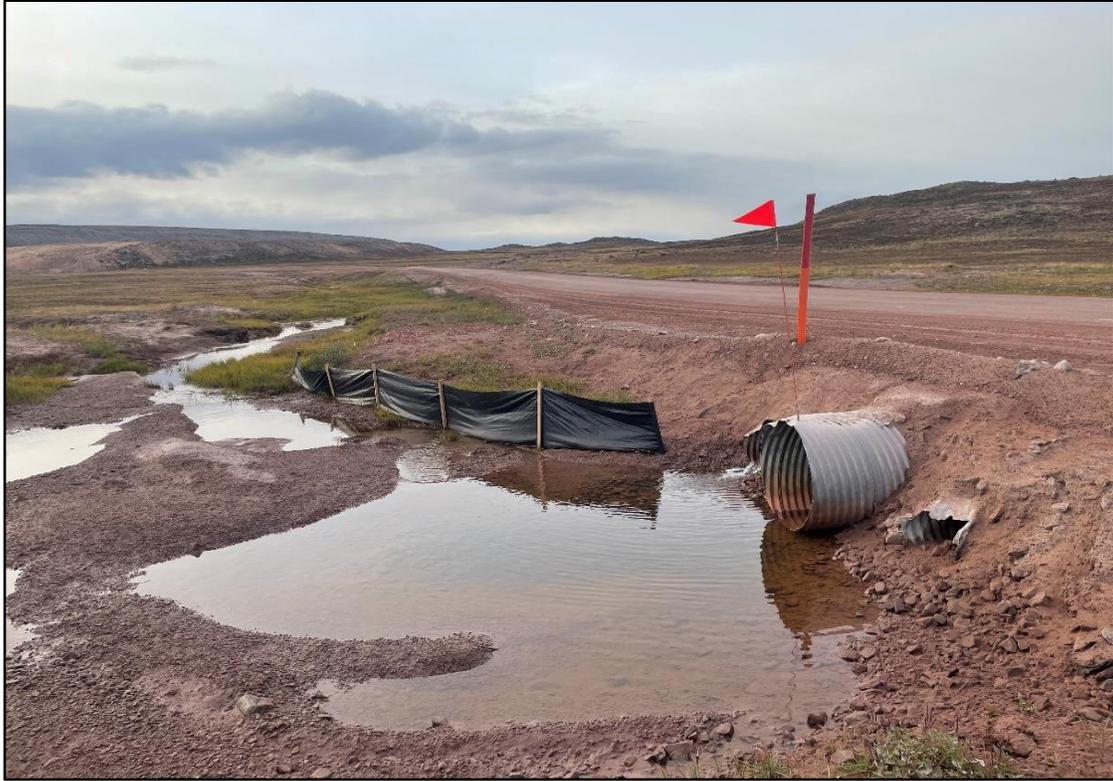
Photo 20: Sedimentation Control Located at KM94.5

As part of Baffinland's *Erosion Management Plan* within the *Surface Water and Aquatic Management Plan*, Baffinland has developed measures to prevent erosion and sediments impact to surface water. Related to Term and Condition No. 22, the Monitoring Officers were able to observe methods used by Baffinland such as silt fencing ([Photo 20](#)) and rip rap ([Photo 21](#)) to control erosion to enter in the nearby surface water.

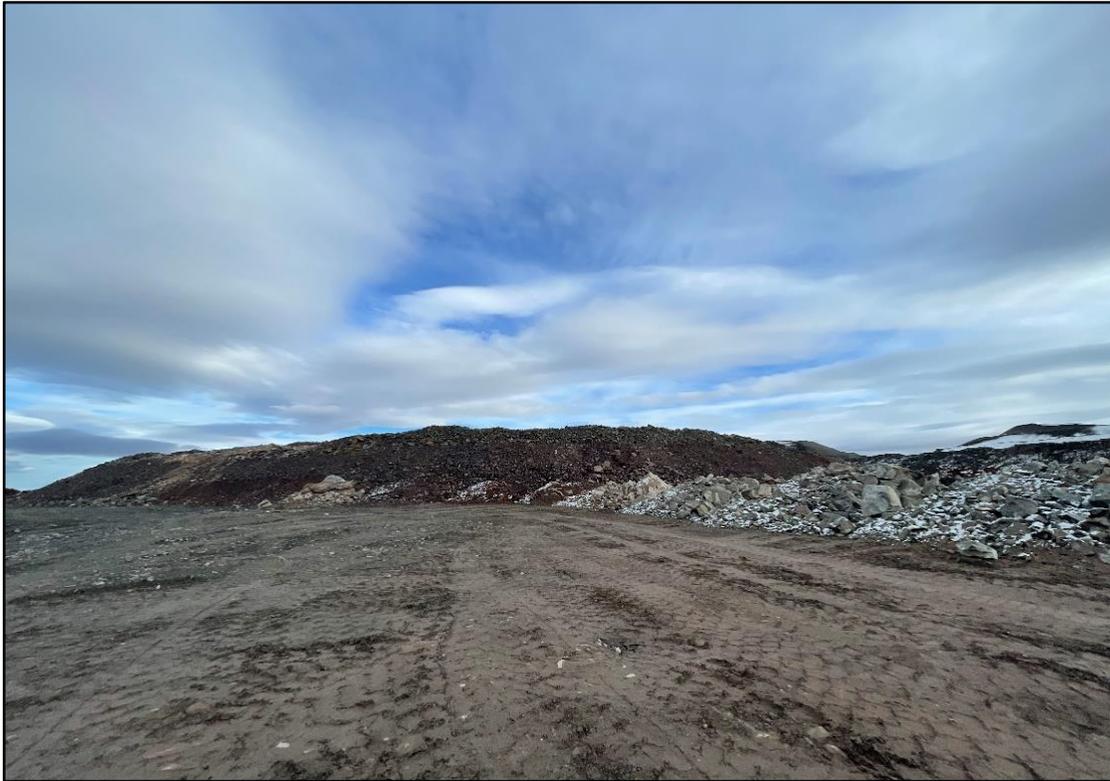
Photo 22: Waste Rock Storage Pile

The waste rock storage facility (WRF) is an open area where potentially acid generating rocks are stored (Photo 22). NIRB staff observed that the WRF was expanding as per the *Waste Rock Management Plan*.

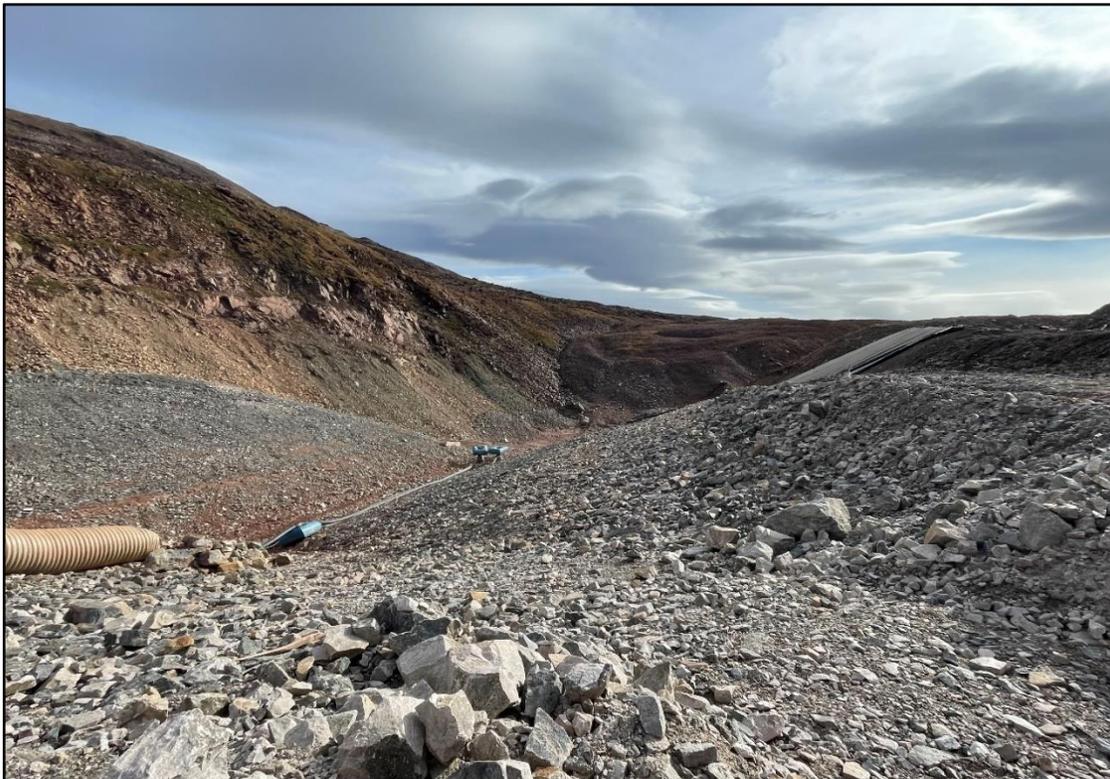
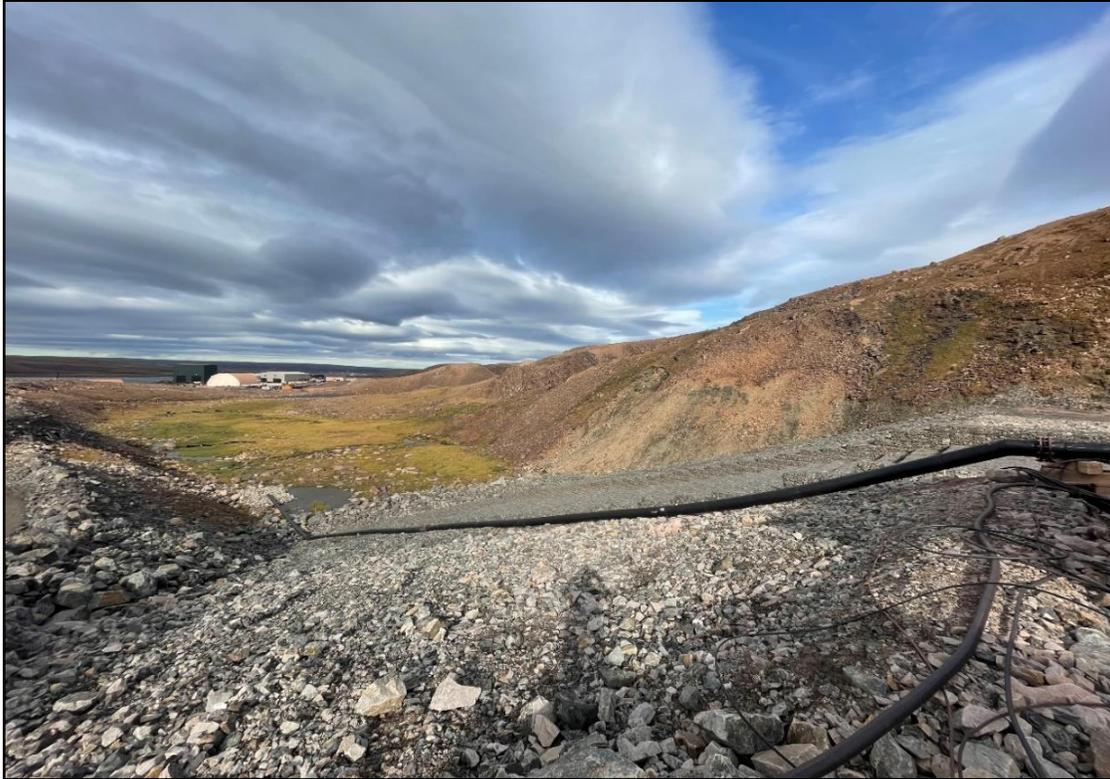
While at Deposit No.1 NIRB staff visited the KM 105 Dam located at the base of the Deposit (Photo 27 & Photo 28). This Dam allows for water running down the deposit to be captured in a sedimentation pond where suspended solids in the water can settle prior to the water being pumped with other effluent, after meeting release requirements, into creeks. The Dam was completed in 2022 to mitigate any potential accumulation of total suspended solids in run-off water which may lead to impacts on the freshwater environment if left untreated. Baffinland explained to NIRB staff, that a seepage was discovered in June and Baffinland is in the process of remediating the situation in working close with the Qikiqtani Inuit Association as the landowner.

Photo 27: Deposit No. 1 Dam Sedimentation Pond

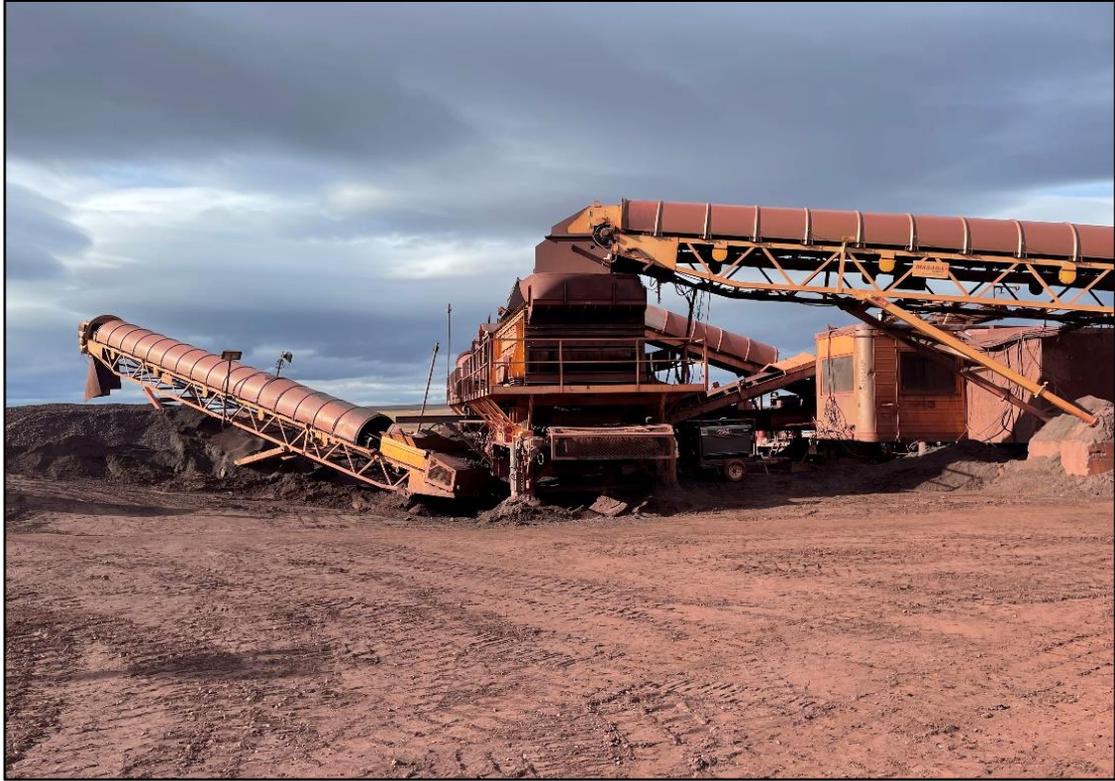
NIRB staff viewed the crusher facility (Photo 29, Photo 30 & Photo 31) by foot. The Monitoring Officers observed the continued dust mitigation applied by Baffinland. On all three (3) crushers facilities hoods, shrouds, and bellows are installed to reduce dust emissions. Baffinland staff also noted the continued maintenance on the crusher equipment generally as well as on the hoods and shrouds. Baffinland stated that due to the need for dust mitigations on the crusher equipment, many of the mitigation designs implemented are constructed on site by repurposing old conveyor belts and other pieces of metal on site.

Photo 29: Example of Hoods Covering the Conveyor Belt

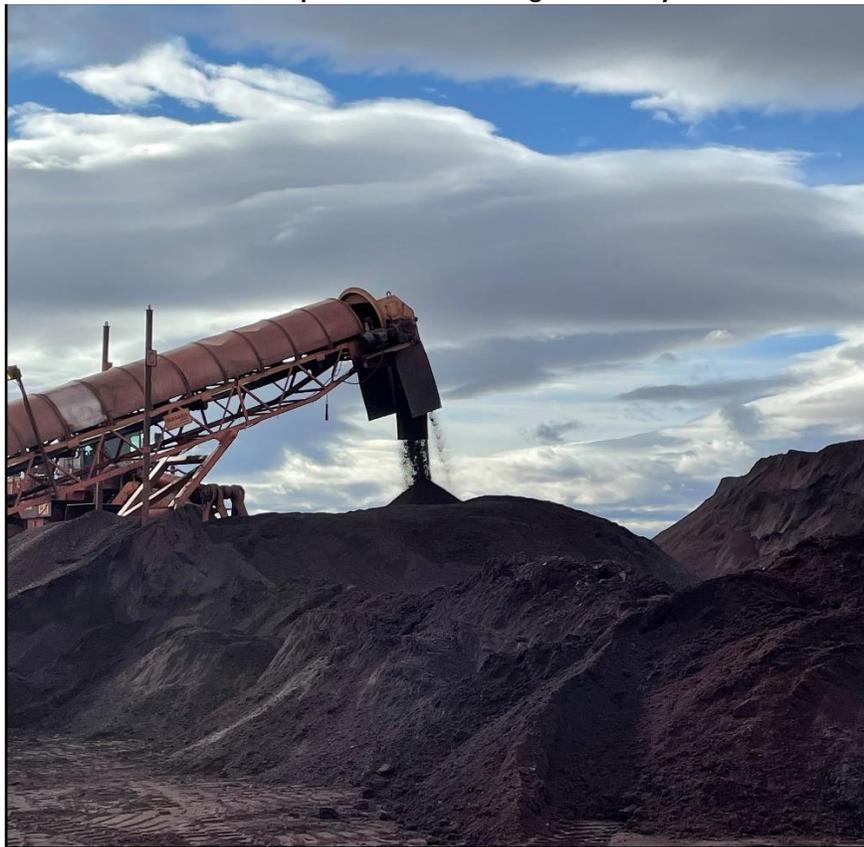
Photo 30: Example of Hood on the Conveyor System and Bellows at the End of a Conveyor Belt

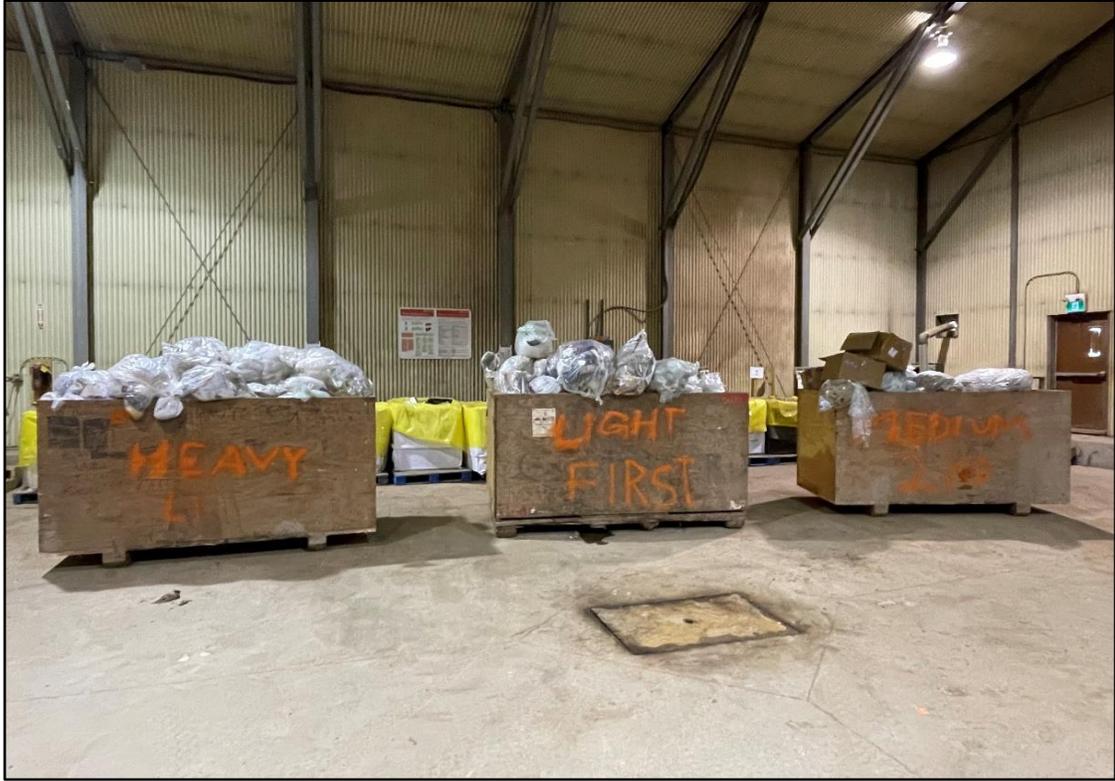
The incinerator facility at the Mary River Mine Site remains in operation. Related to Term and Condition No. 11, Baffinland segregated waste as per their *Incinerator Management Plan*. Non-hazardous material are the only materials incinerated (Photo 36) and hazardous waste is disposed in labelled bins (Photo 37) for backhaul off site.

Photo 36: Waste Prior to Incineration

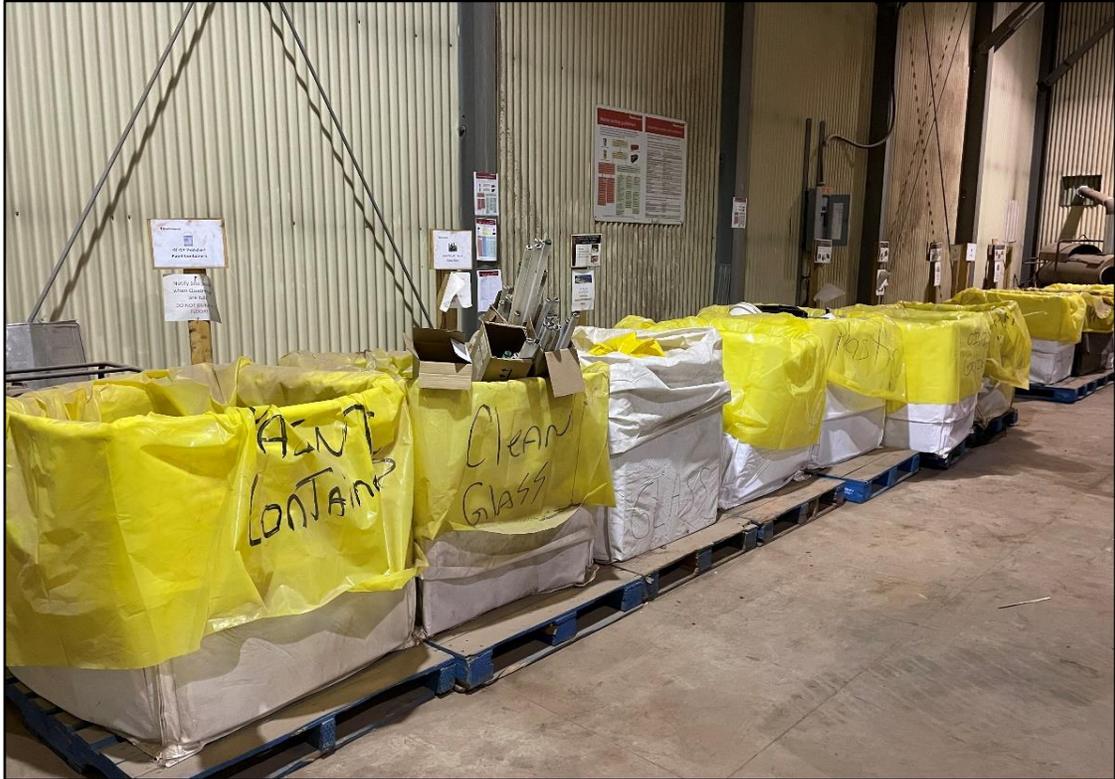
Photo 37: Hazardous Waste Segregation

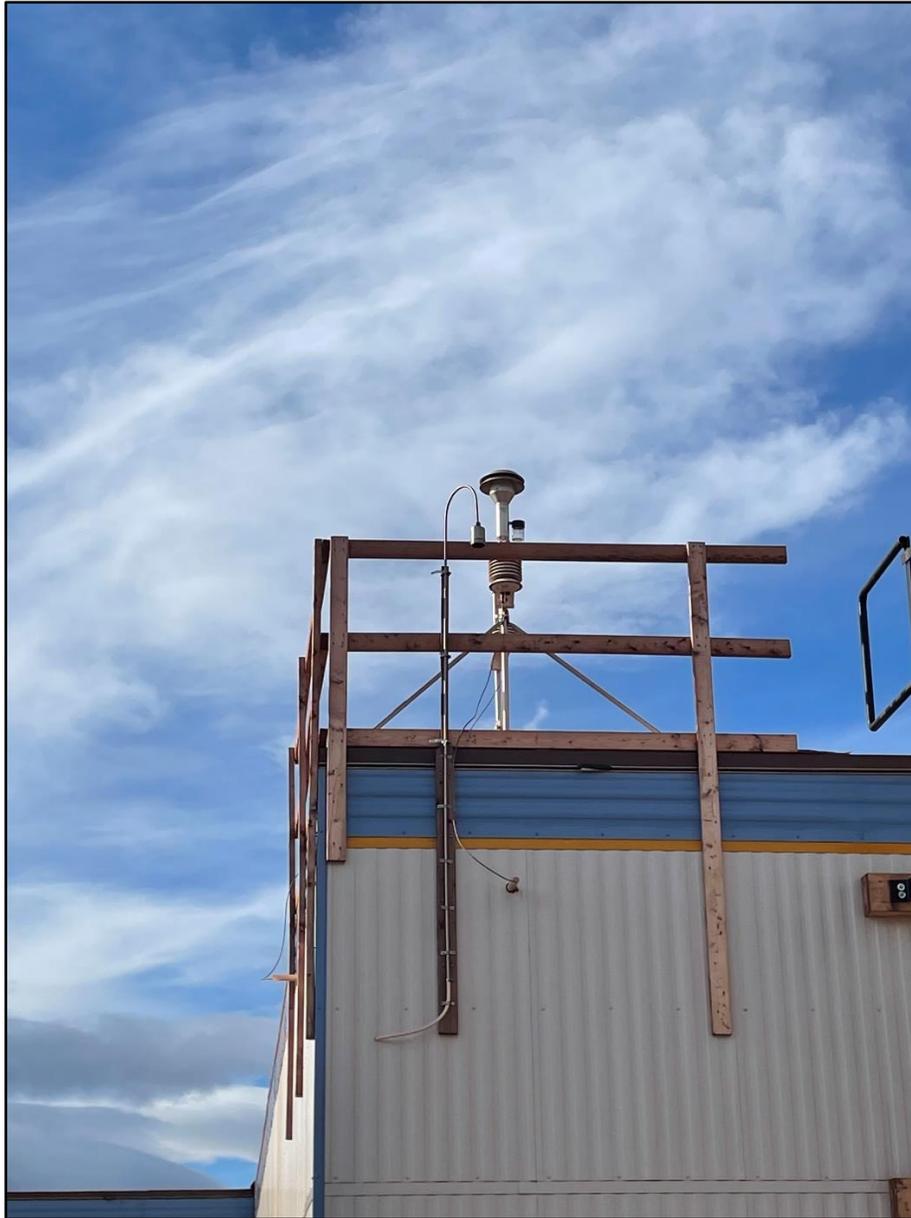
Related the Term and Condition No. 6, Baffinland monitors air quality for SO₂ and NO₂. NIRB staff could observed a continuous air quality monitor (Photo 38) located at Mine Site Complex. Inside the building, real time data SO₂ and NO₂ are collected and recorded to ensure air quality thresholds are not surpassed. (Photo 39).

Photo 38: Real Time Air Quality Monitor

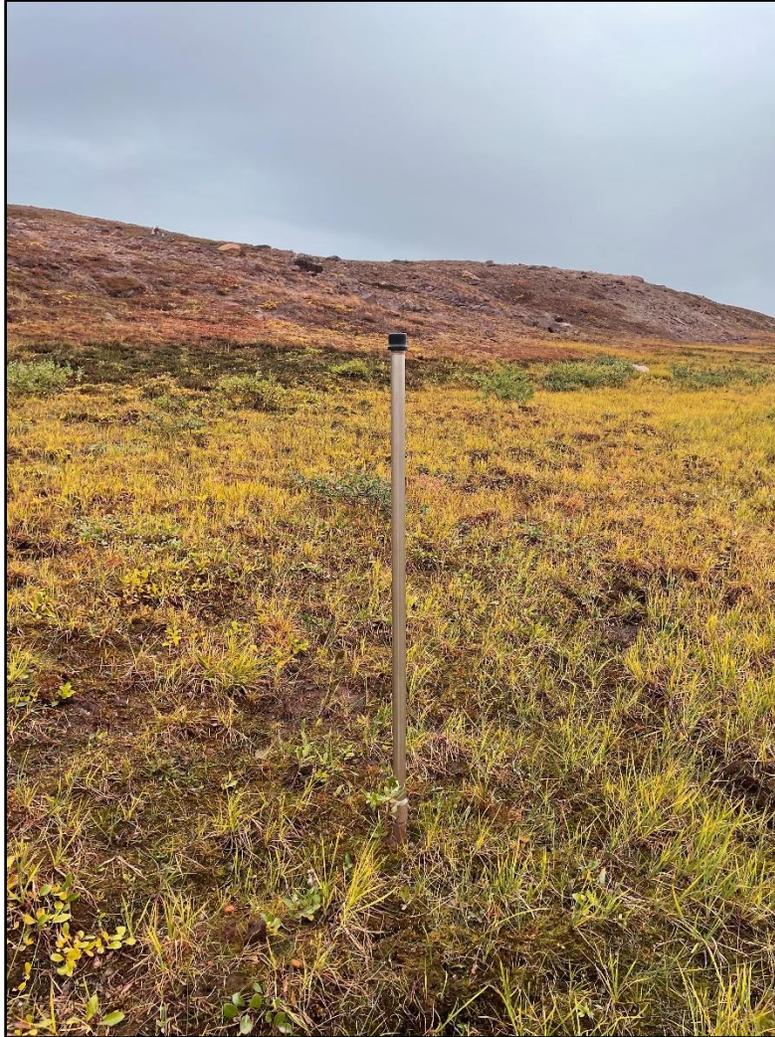
As per Baffinland's *Groundwater Monitoring Program* and related to the Term and Condition No. 23, Baffinland has multiple ongoing groundwater wells around the landfill. NIRB Monitoring Officers observed one (1) located (Photo 40) several meters outside the fence from the landfill.

Photo 40: Groundwater Monitoring Well Next to the Landfill
