# Goose & MLA Project Sites – 2025 Annual Geotechnical Inspection

Back River Project, Nunavut, Canada  
B2Gold Back River Corp.

SRK Consulting (Canada) Inc. ■ CAPR004312 ■ March 2026

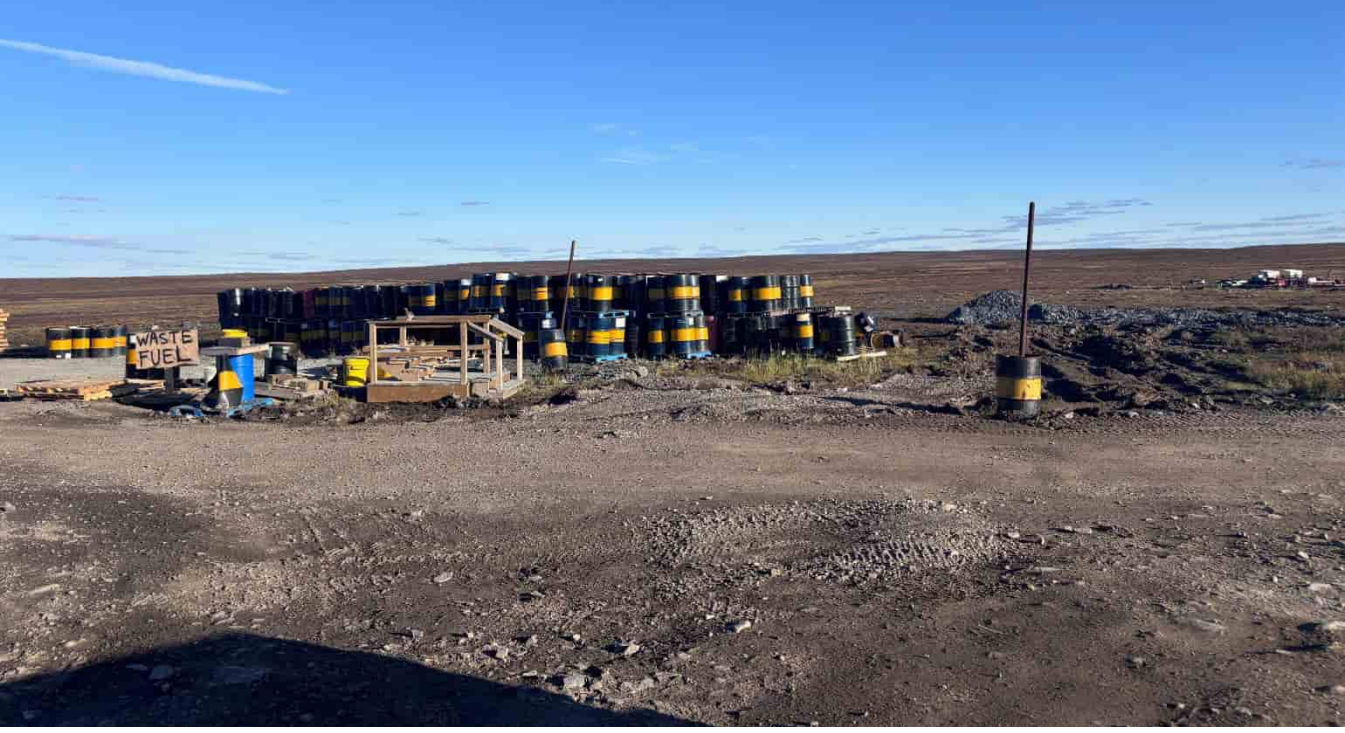
G-6: Temporary fuel storage, looking SE

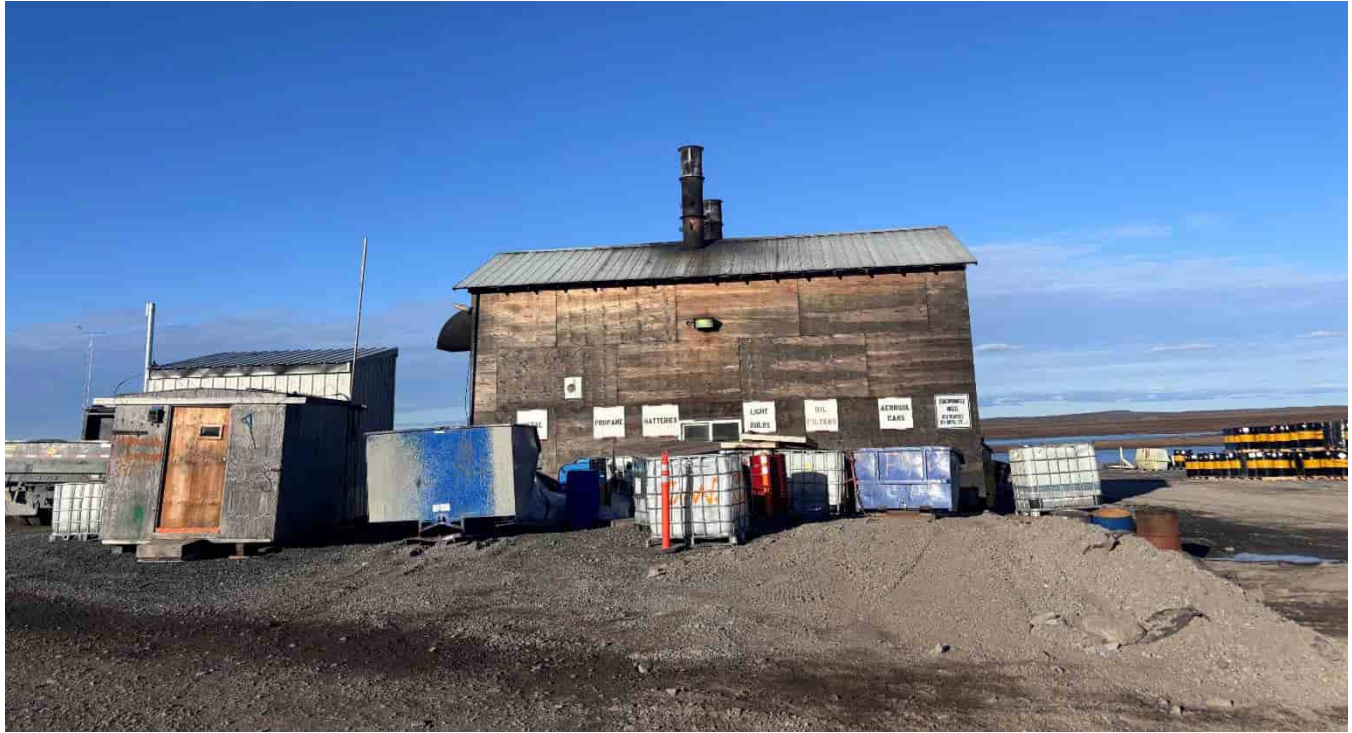
G-7: Incinerator, looking NE

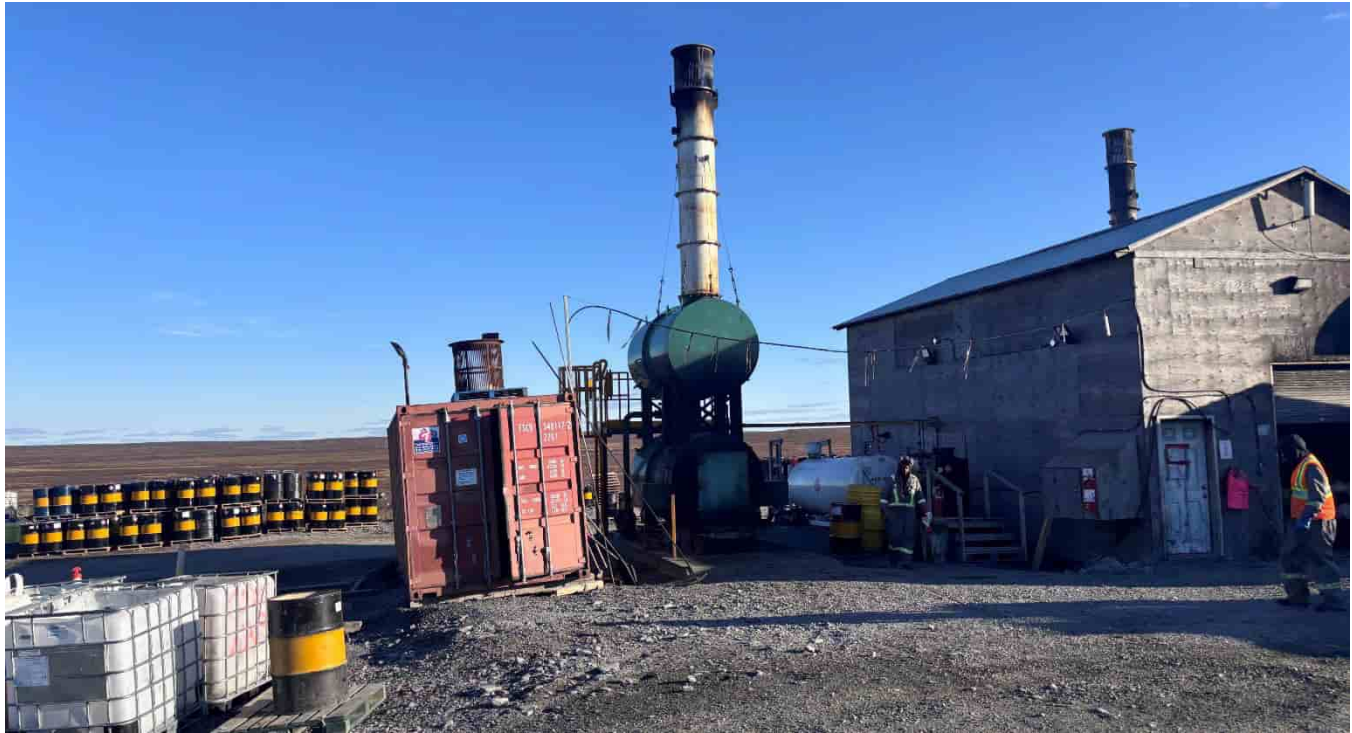
G-9: Temporary fuel storage facility and incinerator, looking S

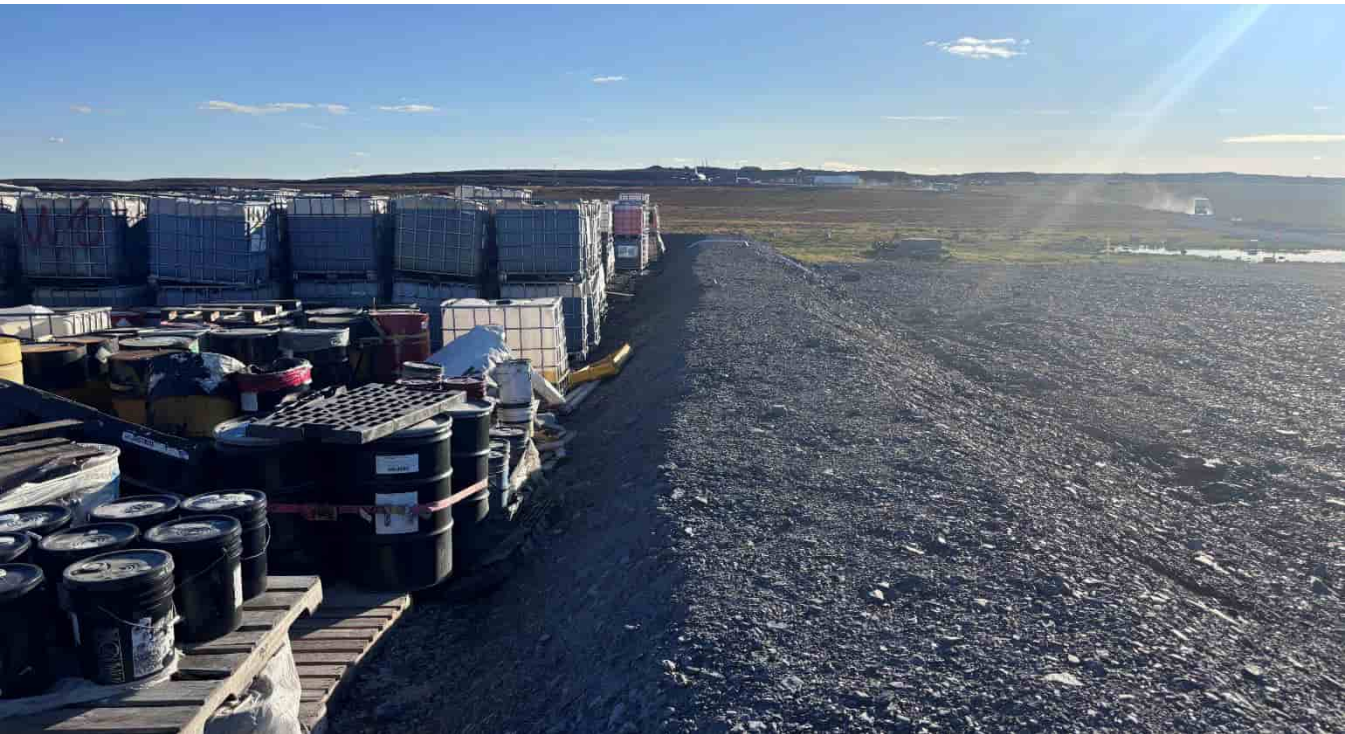
G-12: Exploration camp tote storage and berm

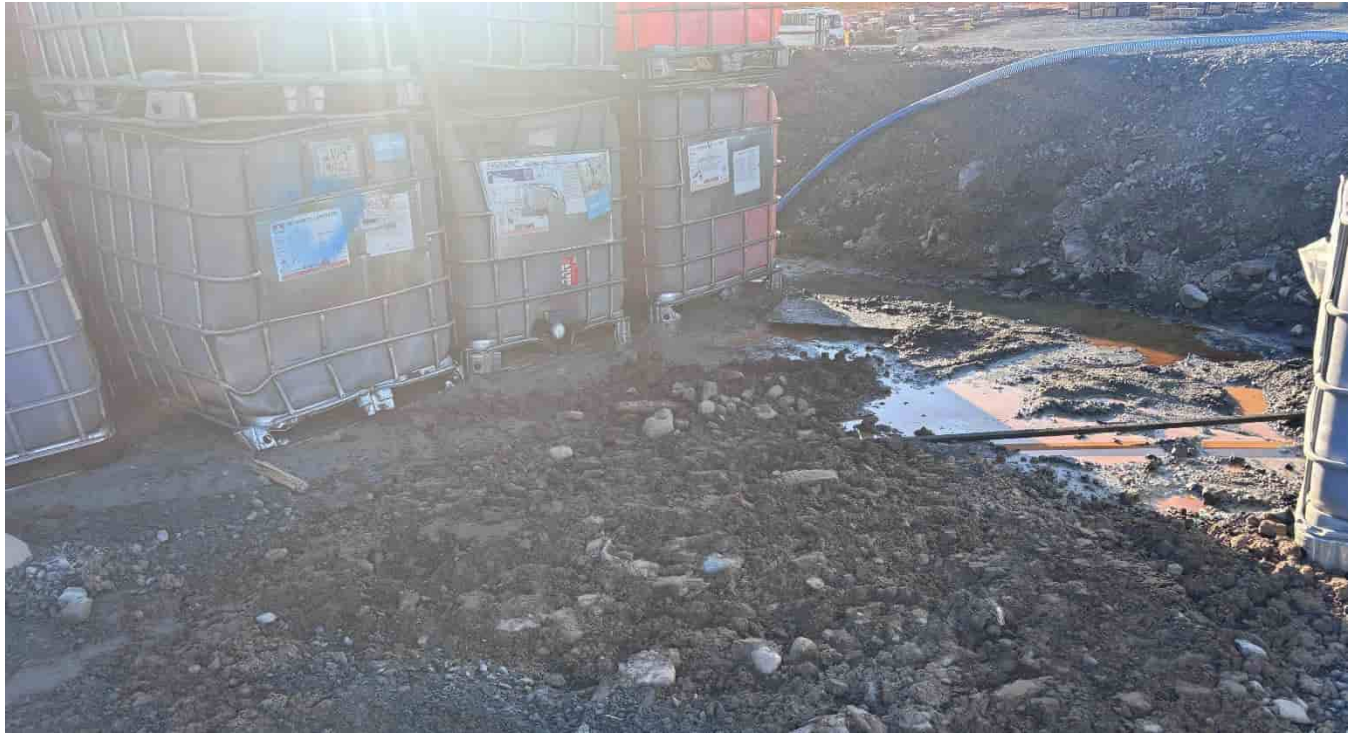
G-13: Tote storage area and berm

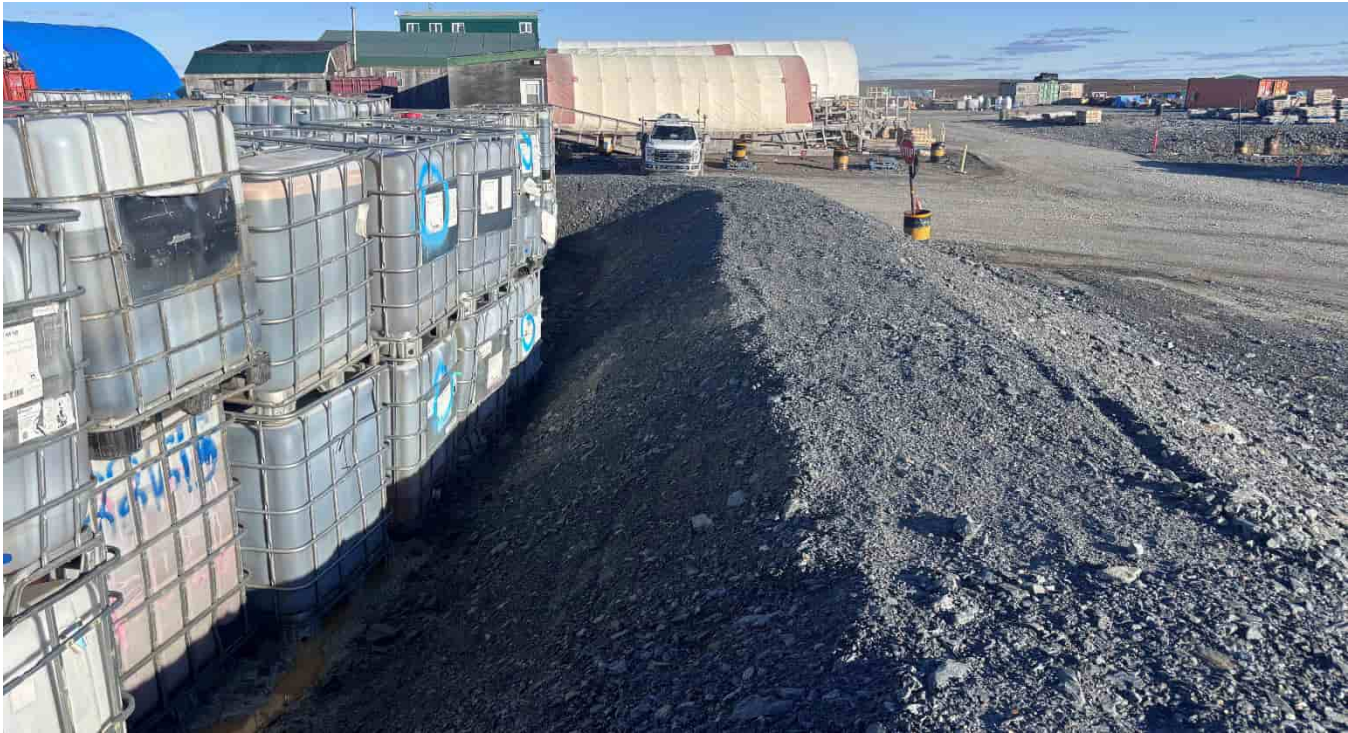
G-14: Tote storage area and berm

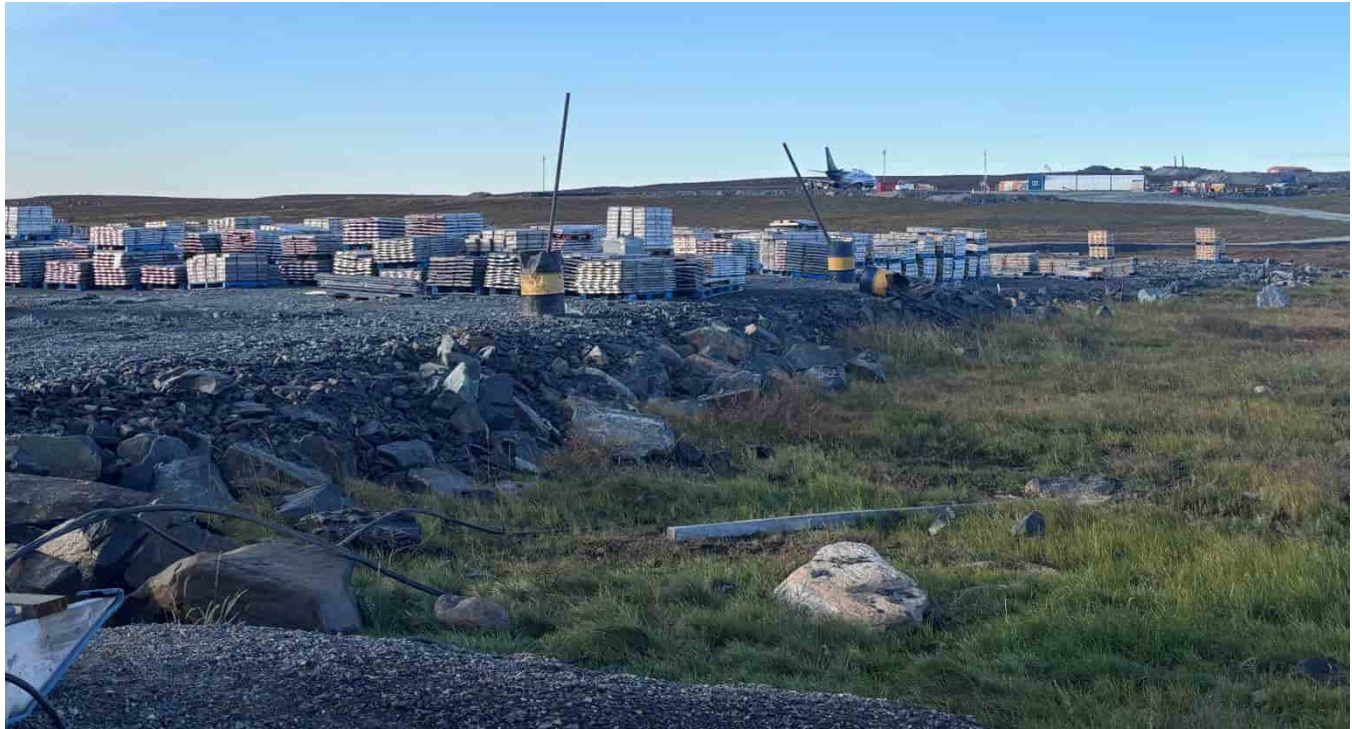
G-17: Laydown, looking S towards airstrip

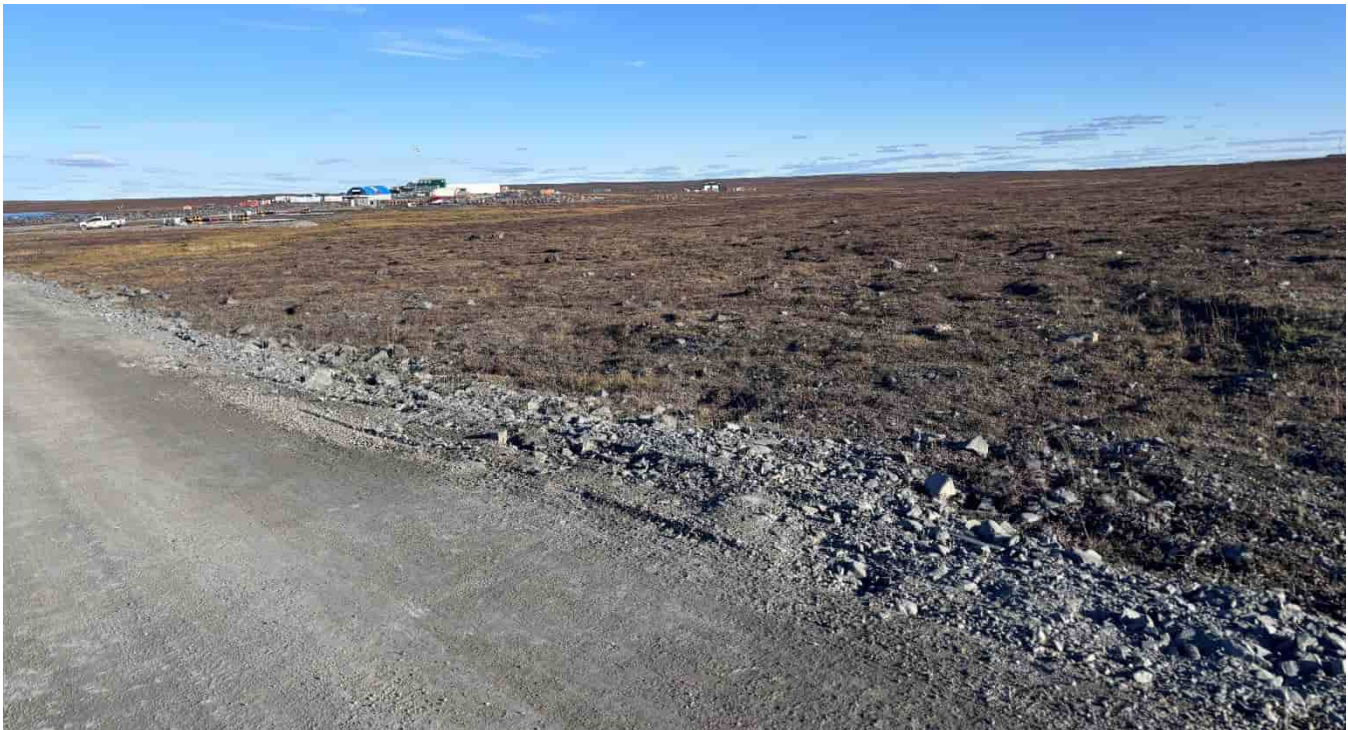
G-20: Exploration camp road, looking E

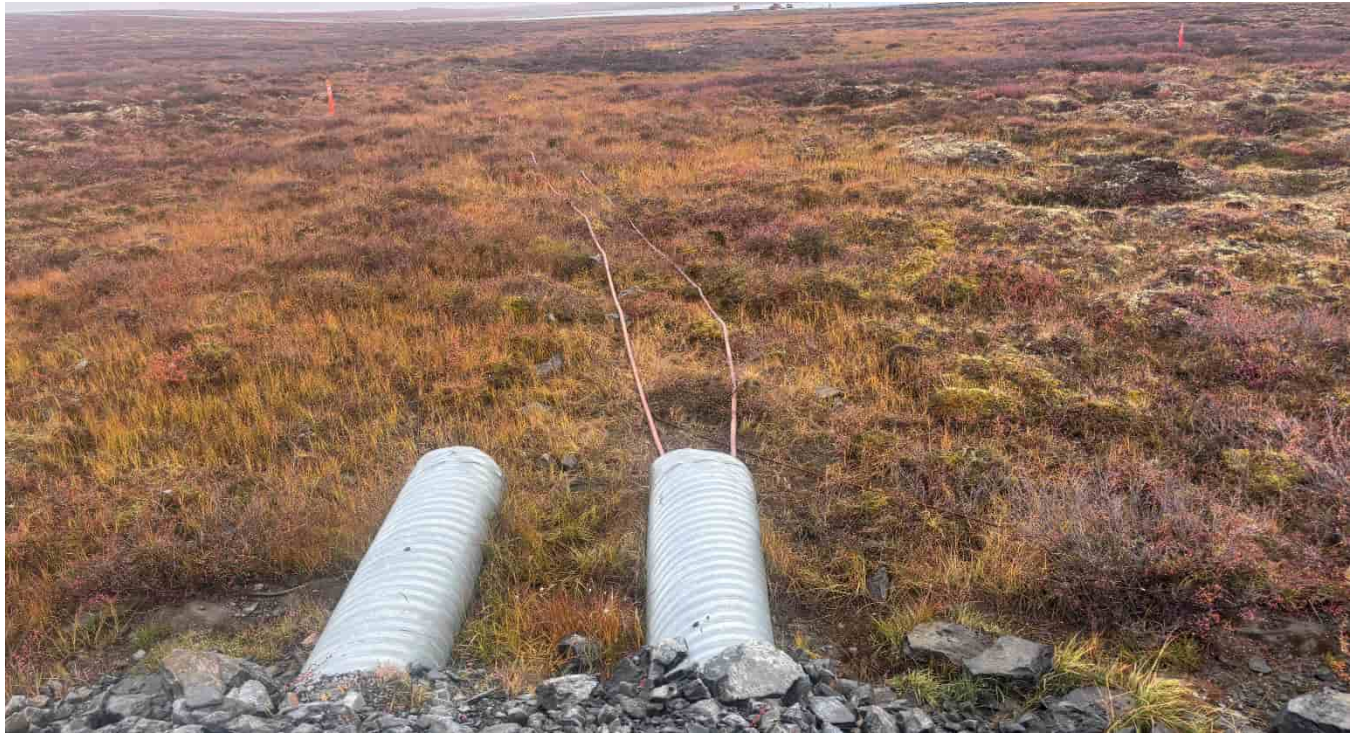
G-21: Culverts under the airstrip access road, looking N

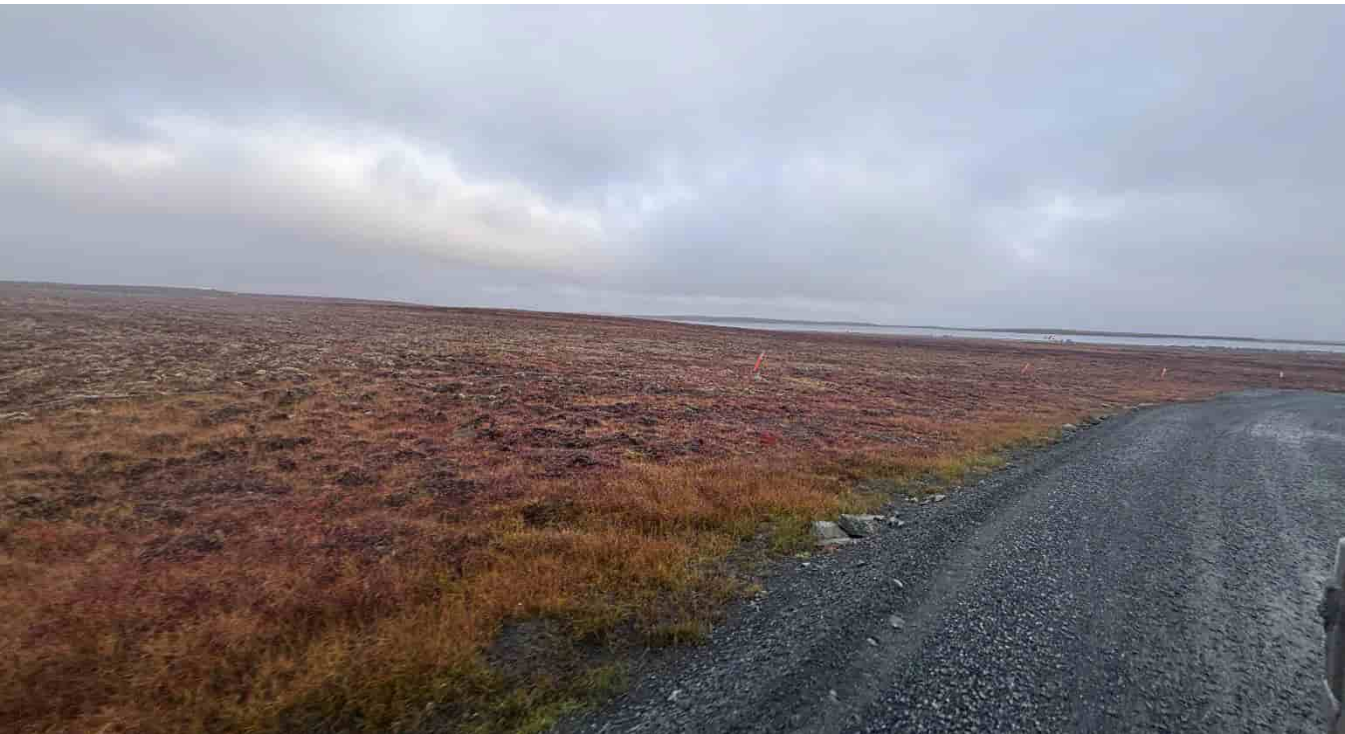
G-24: Tundra N of airstrip access road – Note thickness of road rockfill

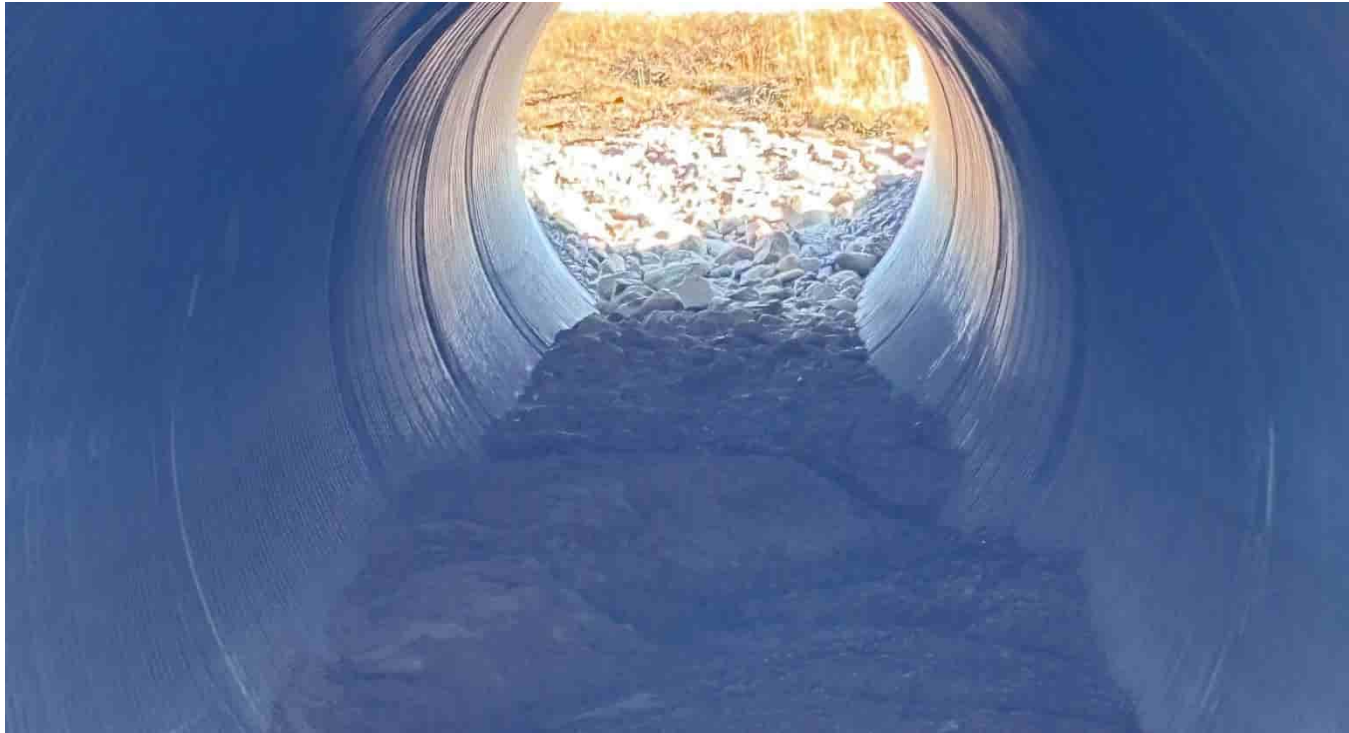
G-28: Interior of eastern culvert, looking upstream

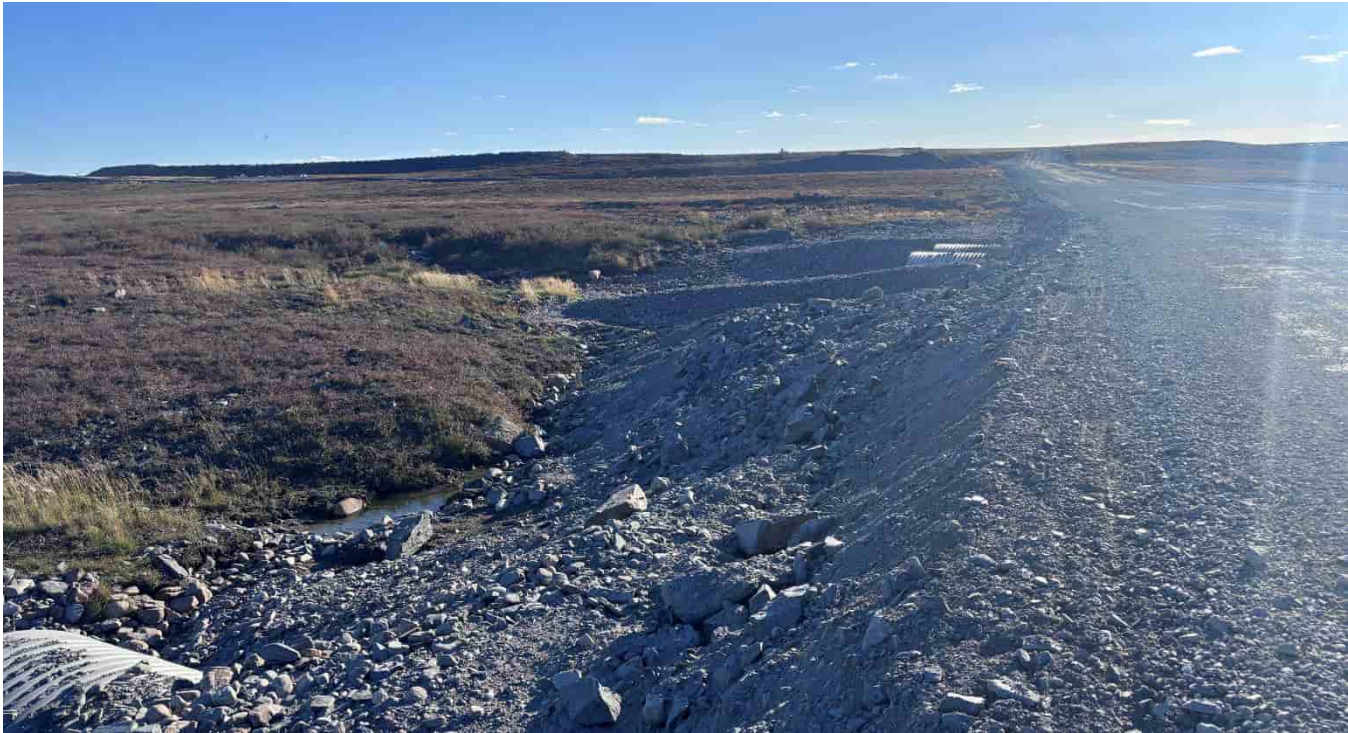
G-29: South side road rockfill, looking SW

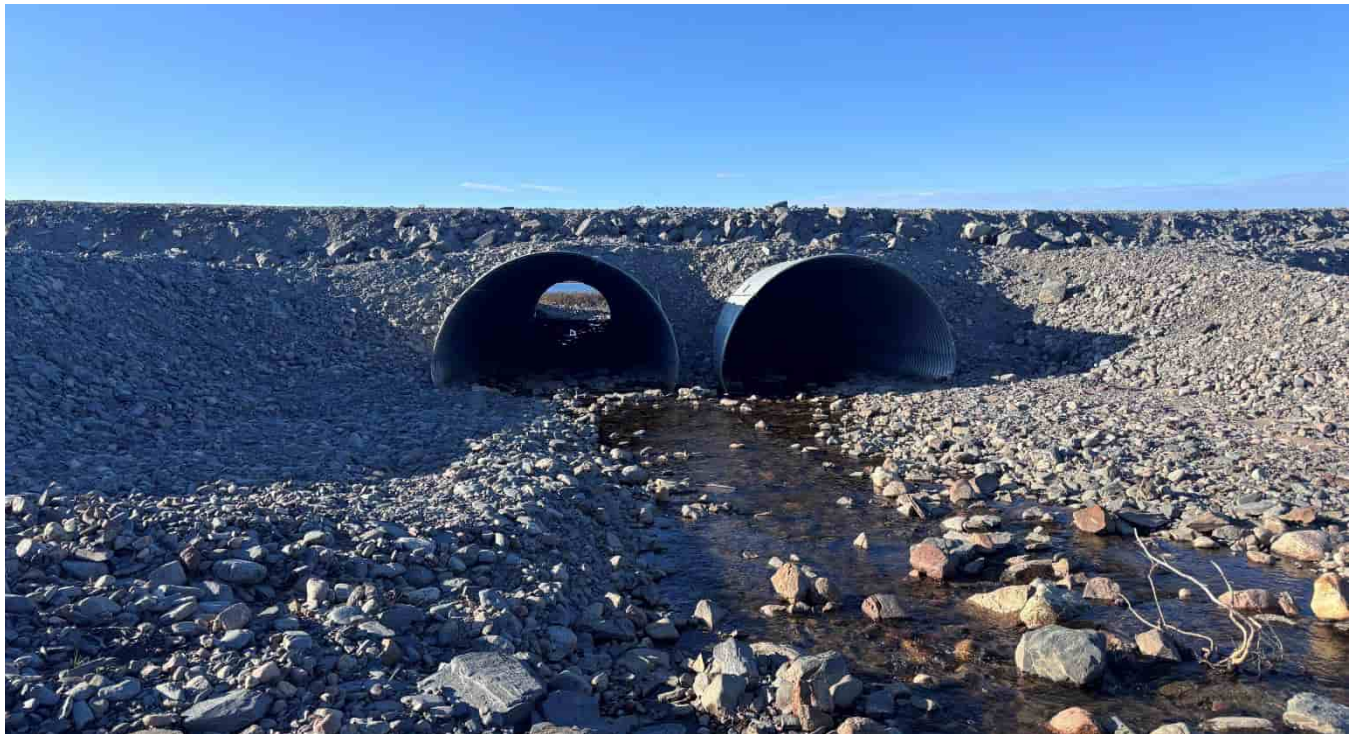
G-30: Upstream (S) side of twin culverts

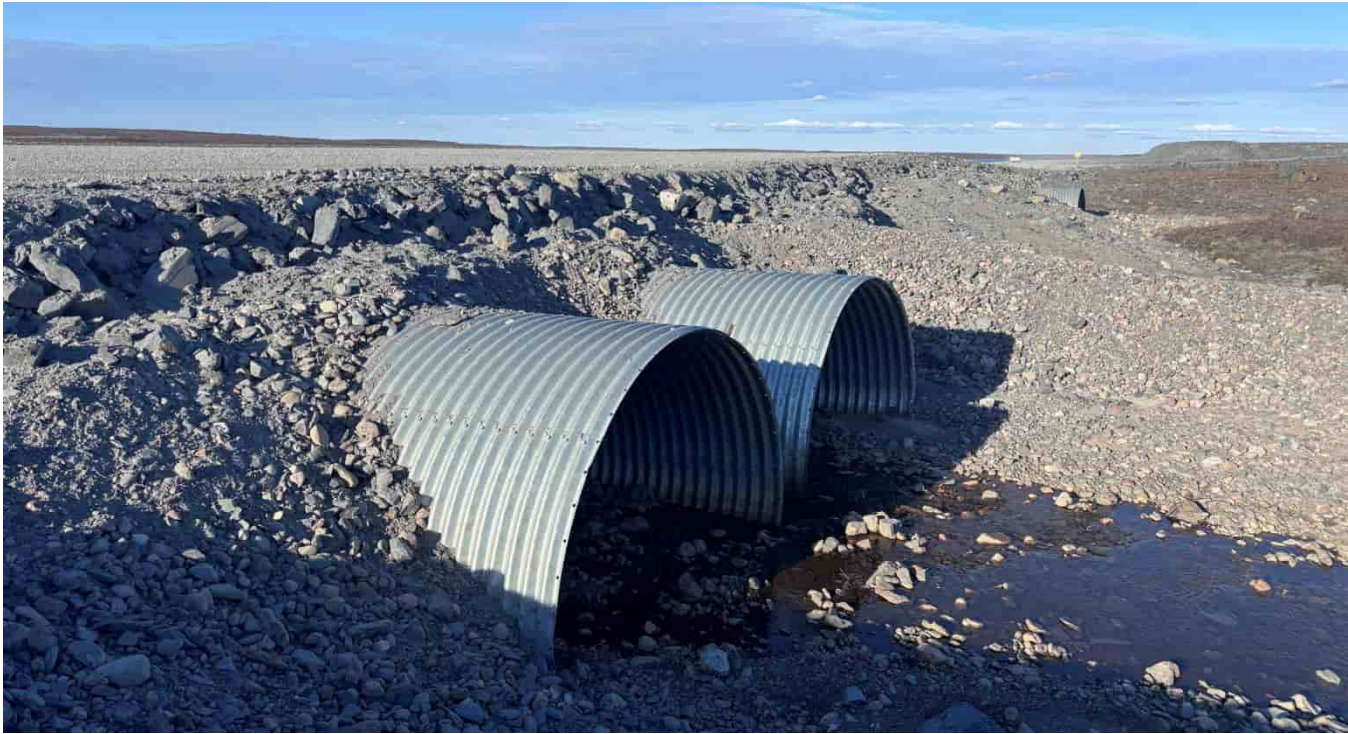
G-31: Upstream (S) side of twin culverts, looking NE

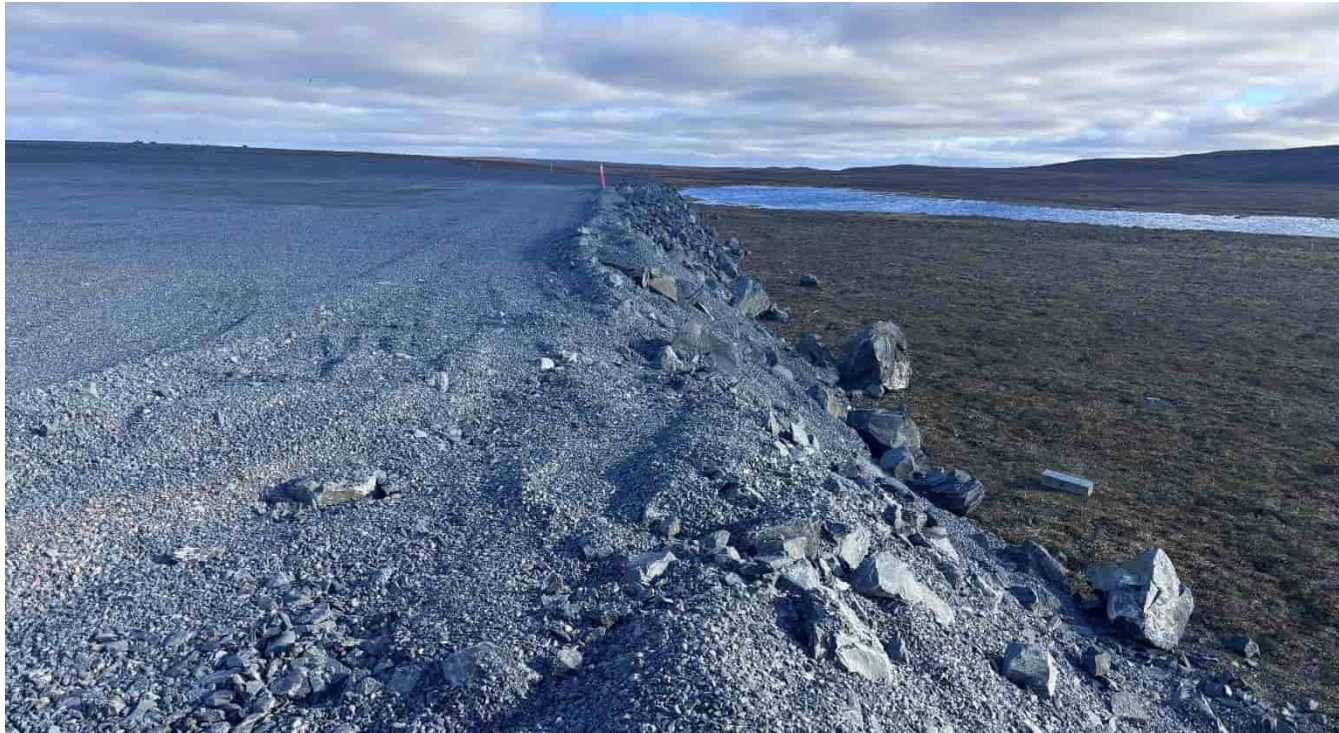
G-32: SW slope of SW airstrip apron, looking SE

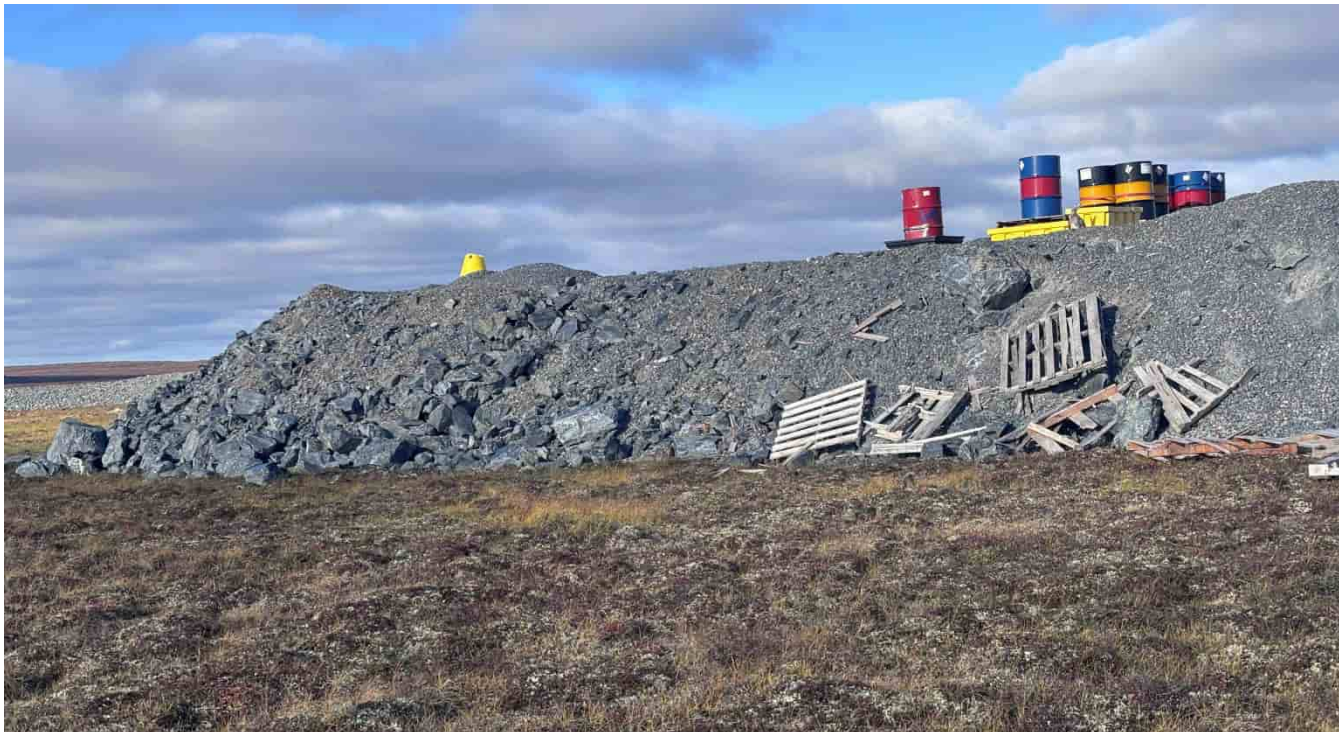
G-34: SW apron at W corner

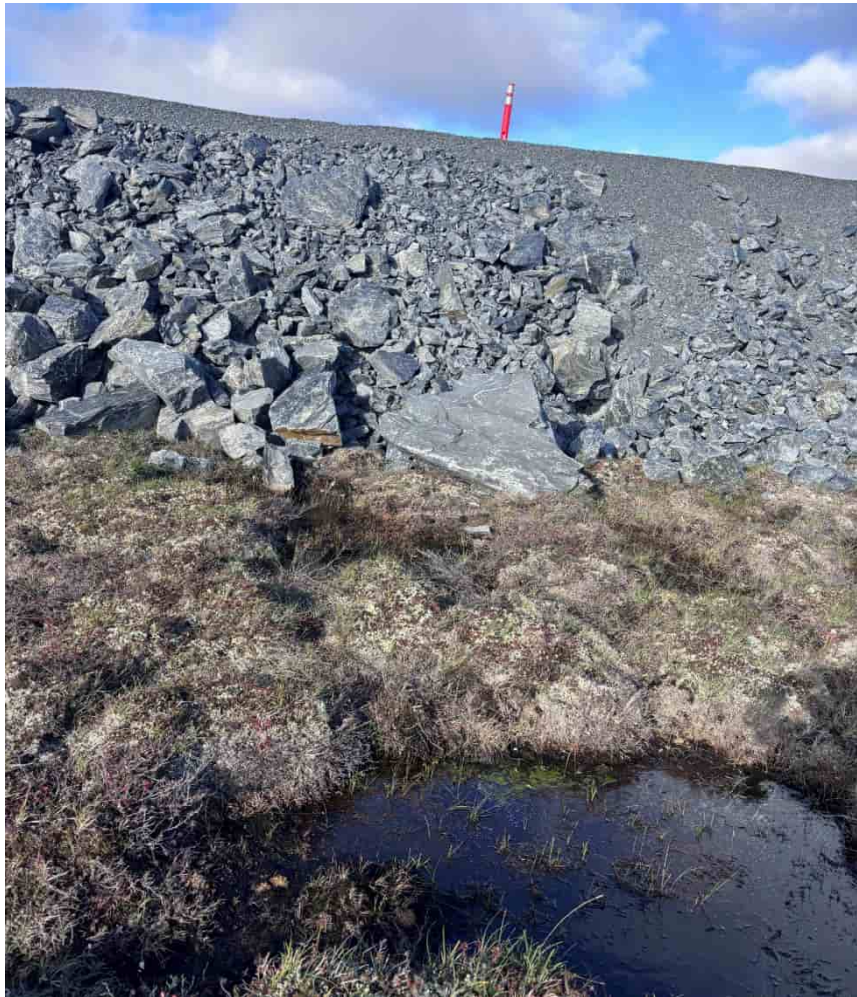
G-36: Below SW apron toe, looking NE

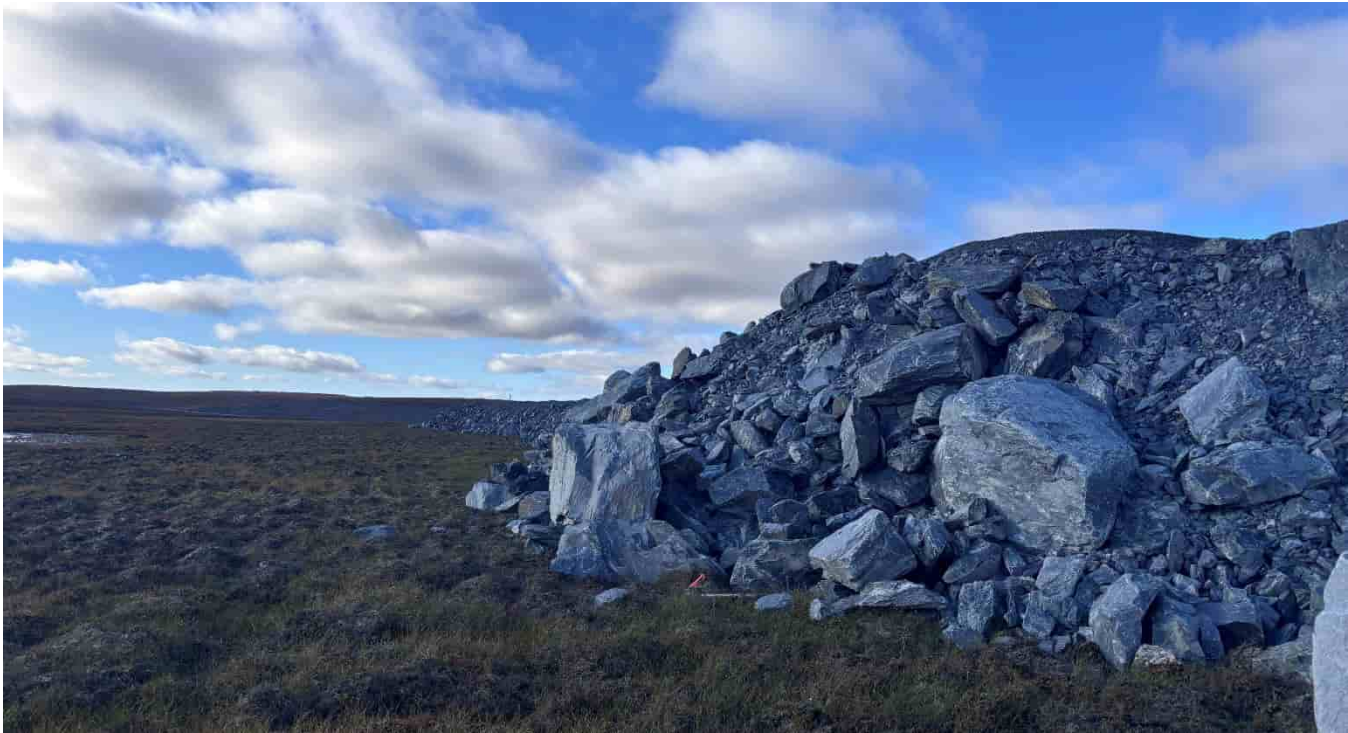
G-37: S corner of SW apron, looking NW

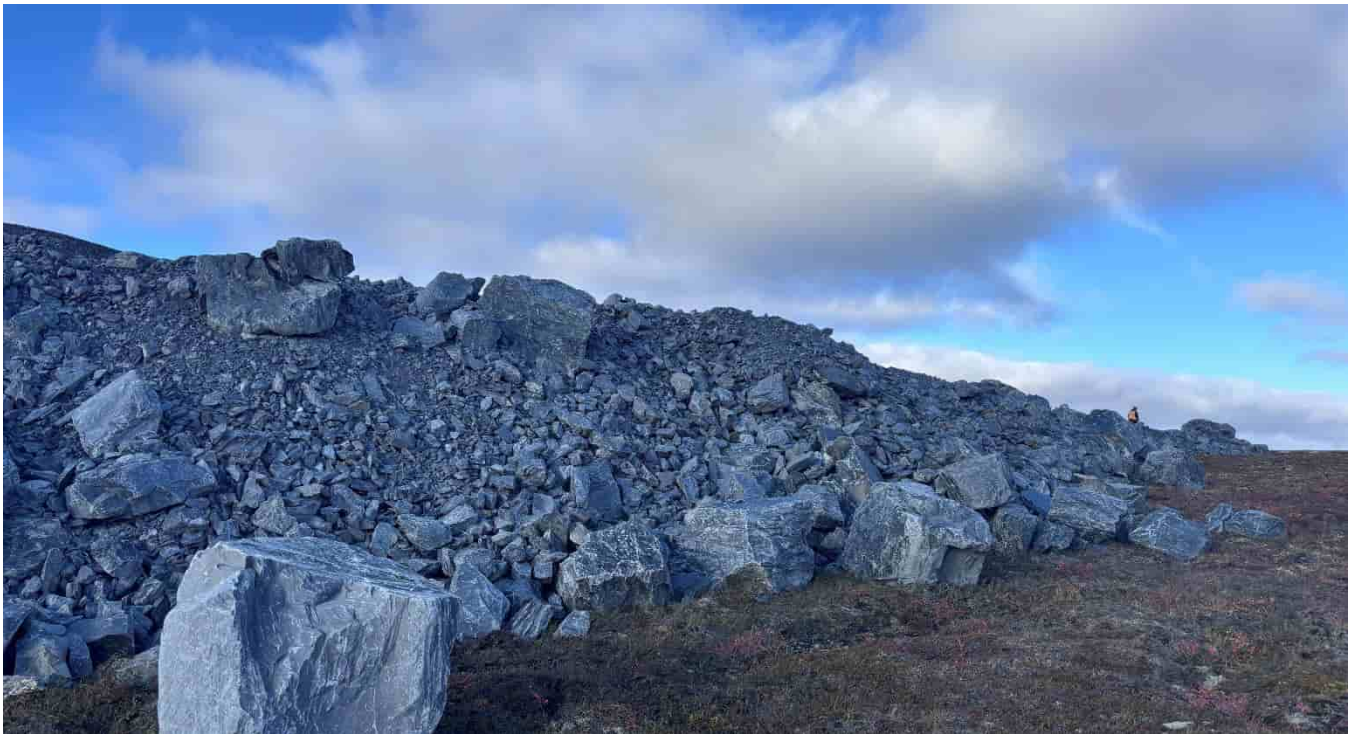
G-38: SW apron, looking NE

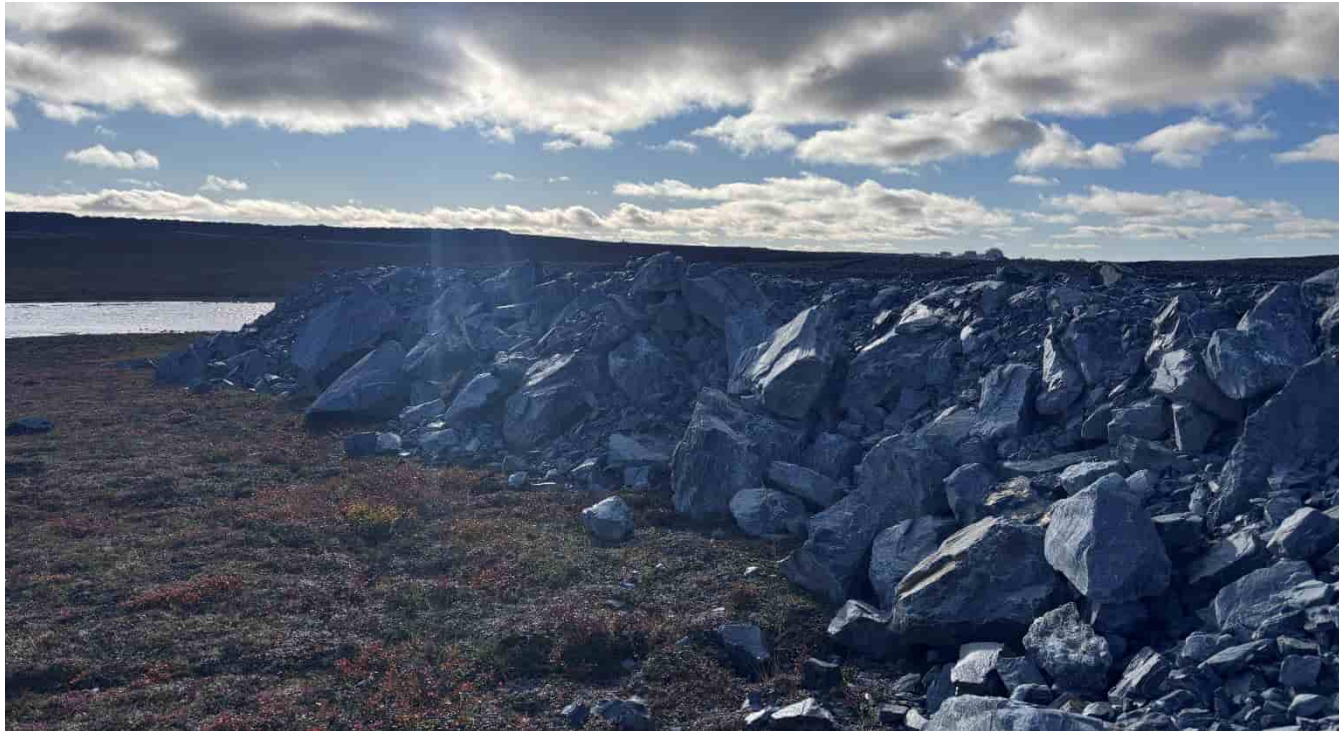
G-39: SE rockfill of SW apron, looking SW – Some larger boulders notes near edges

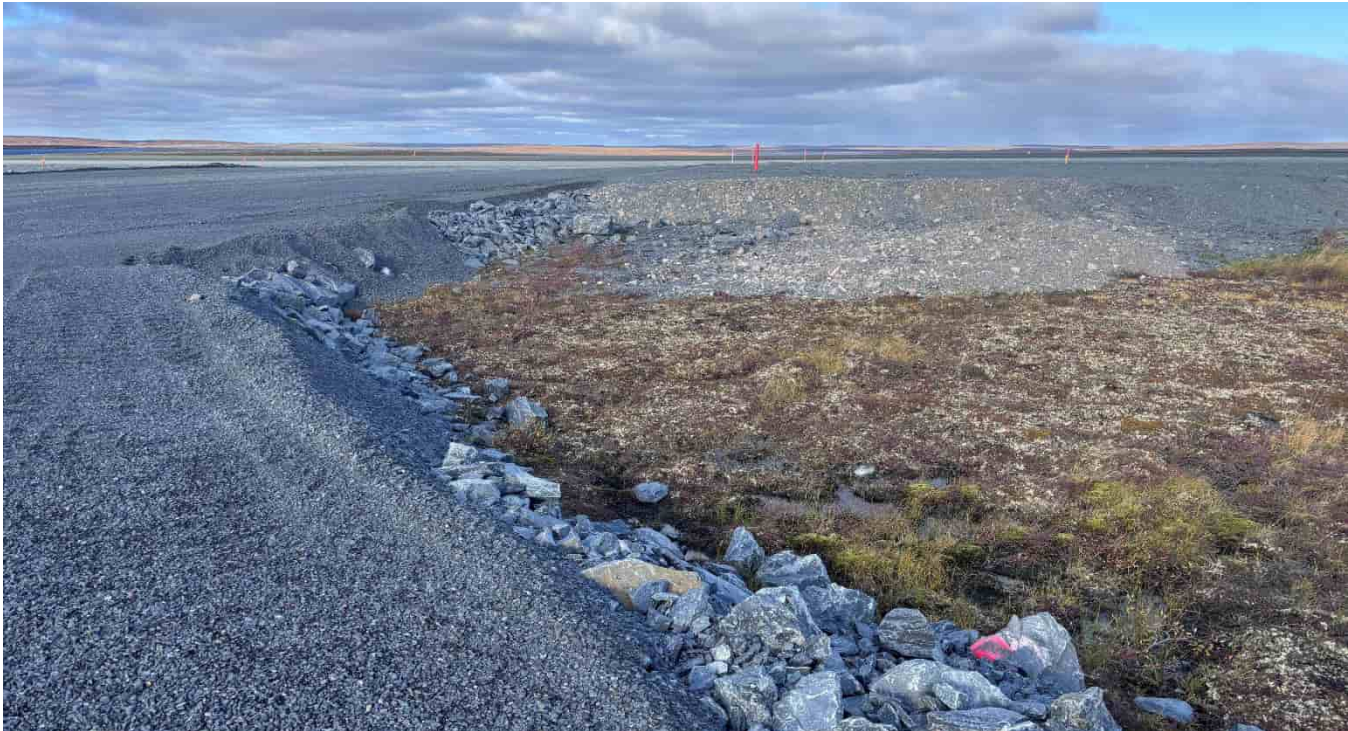
G-40: Looking NE towards runway from SW apron

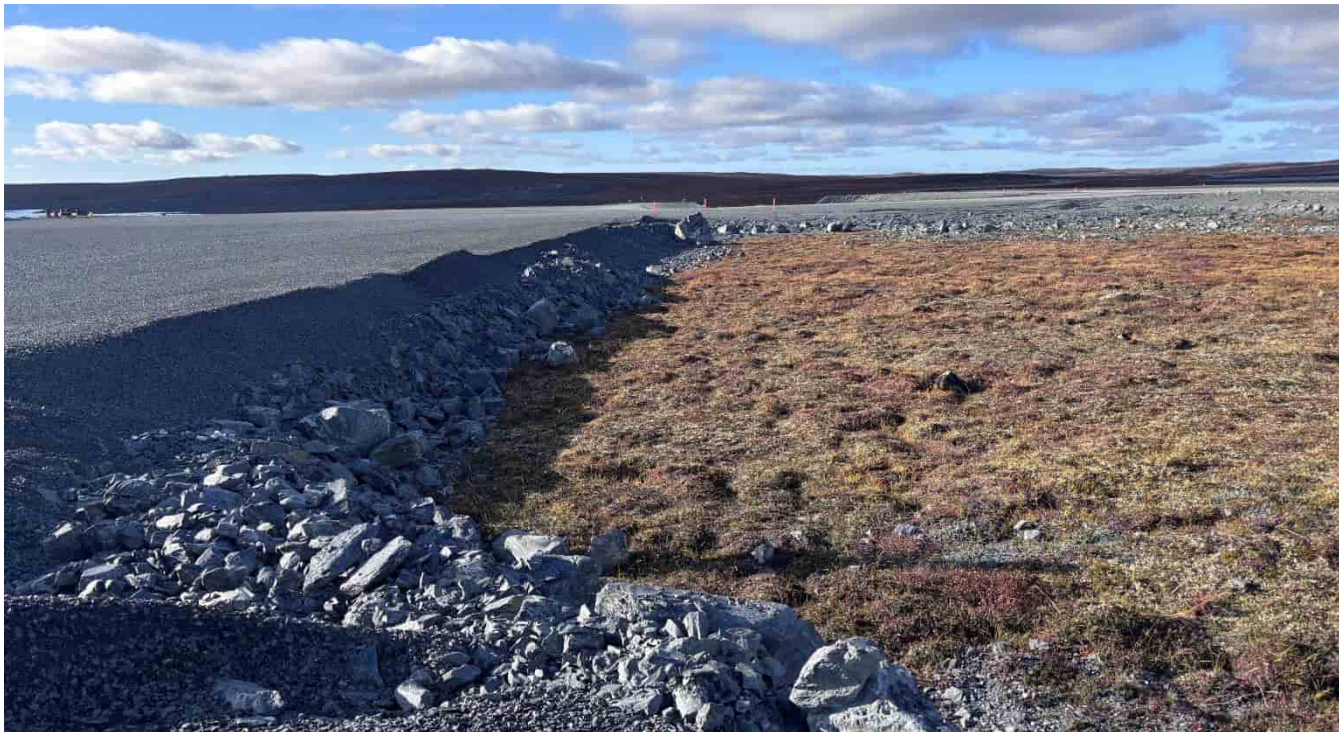
G-41: Airstrip rockfill, looking NW

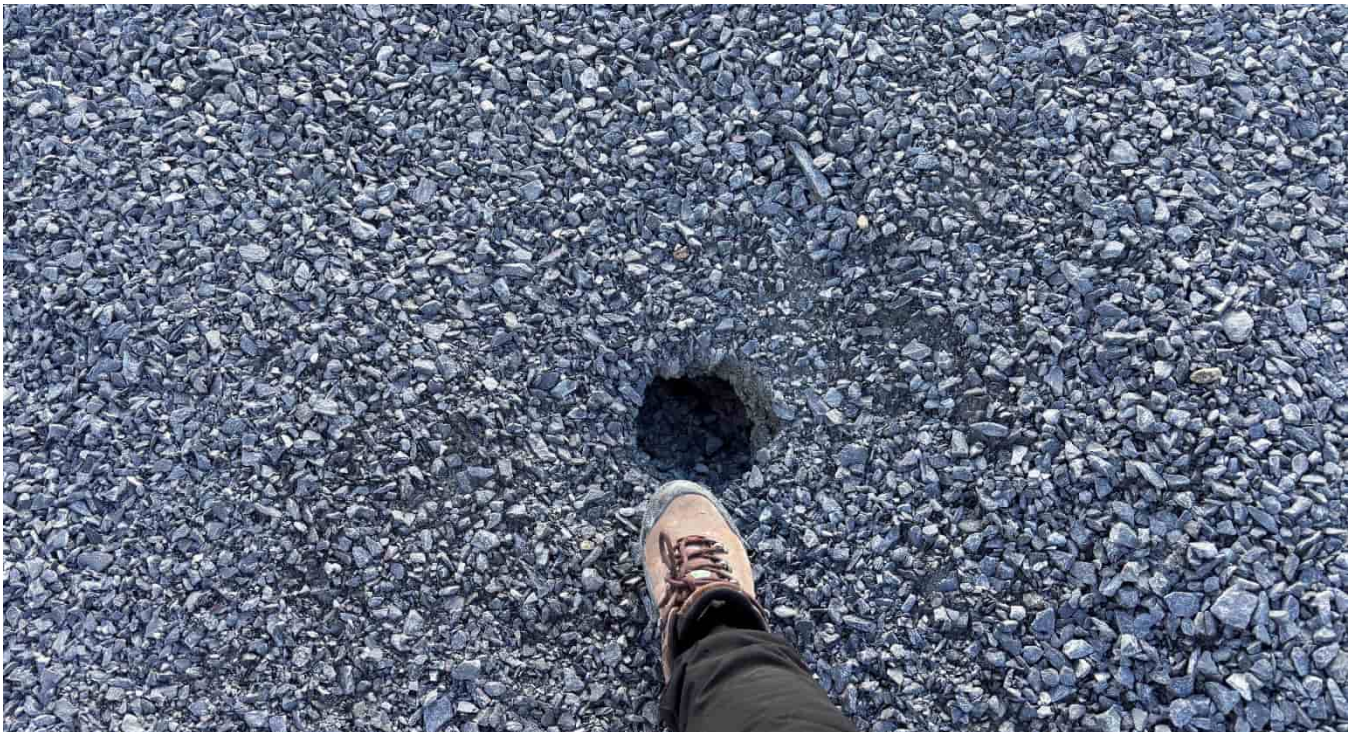
G-42: Smaller sinkhole in SW apron (expected from crush material migration in to voids of larger material)
