# Goose & MLA Project Sites – 2025 Annual Geotechnical Inspection

Back River Project, Nunavut, Canada  
B2Gold Back River Corp.

SRK Consulting (Canada) Inc. ■ CAPR004312 ■ March 2026

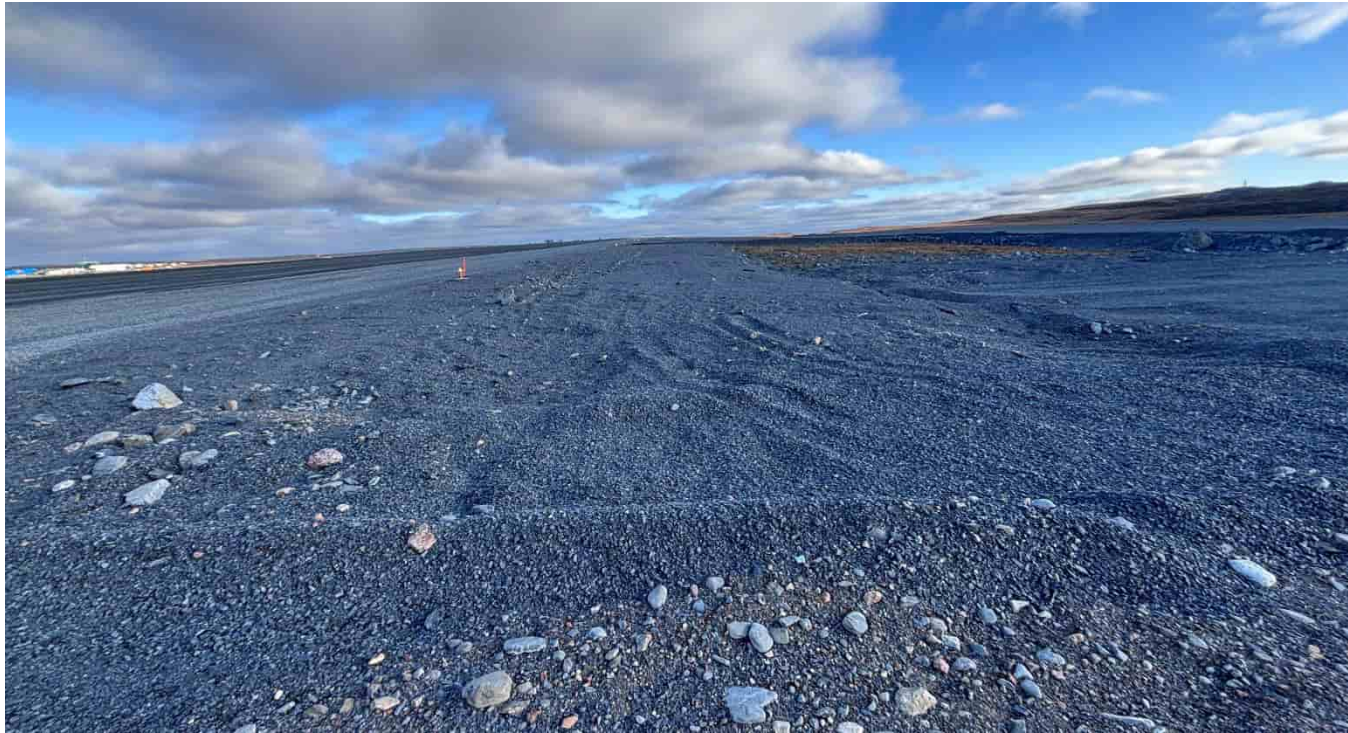
G-43: SW side of runway, looking SE

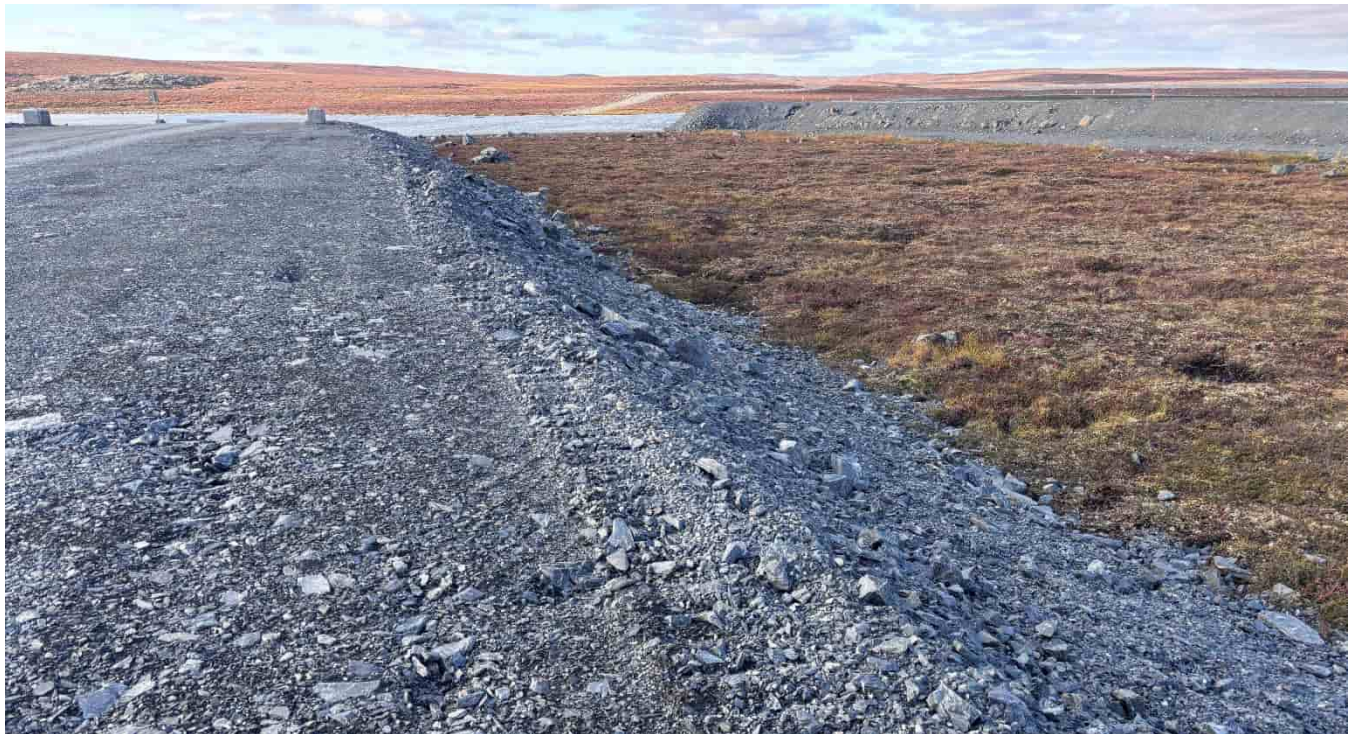
G-45: Airstrip runway access road rockfill, looking NW

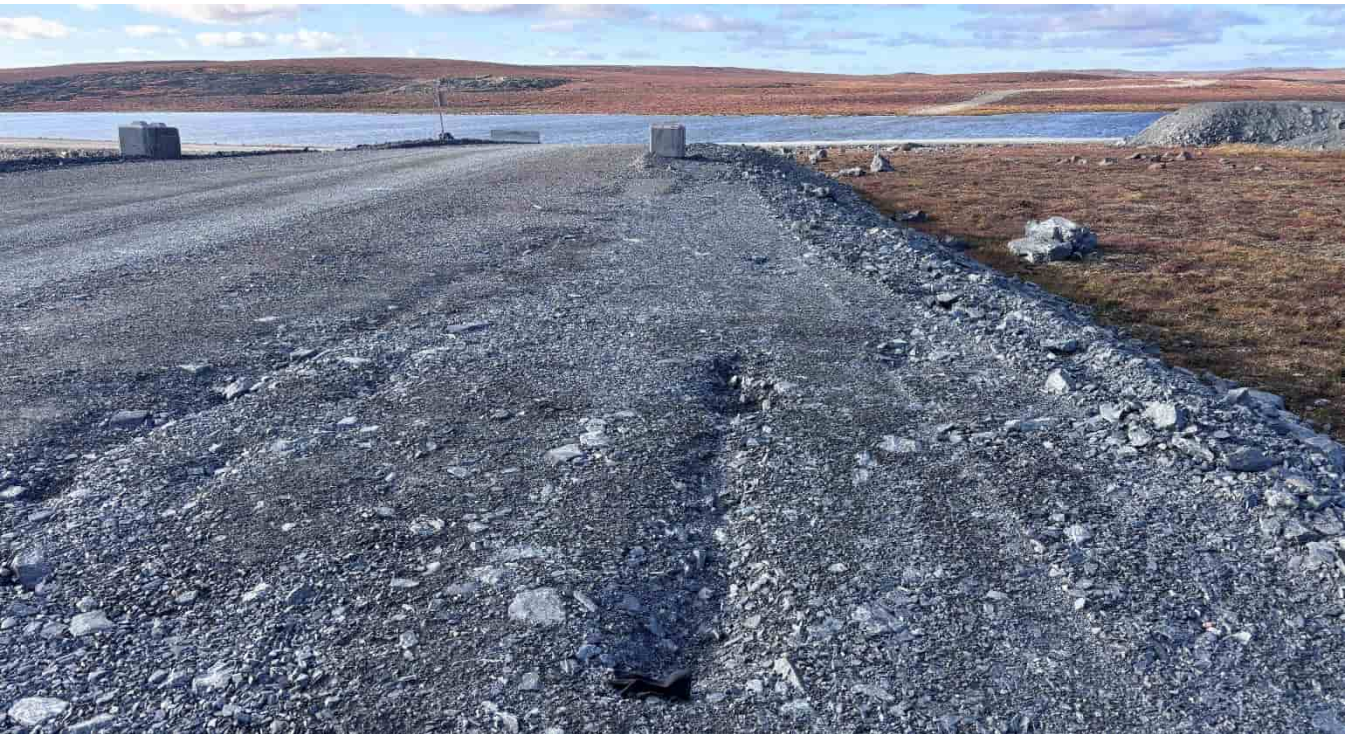
G-46: Airstrip runway access road settlement, looking NW

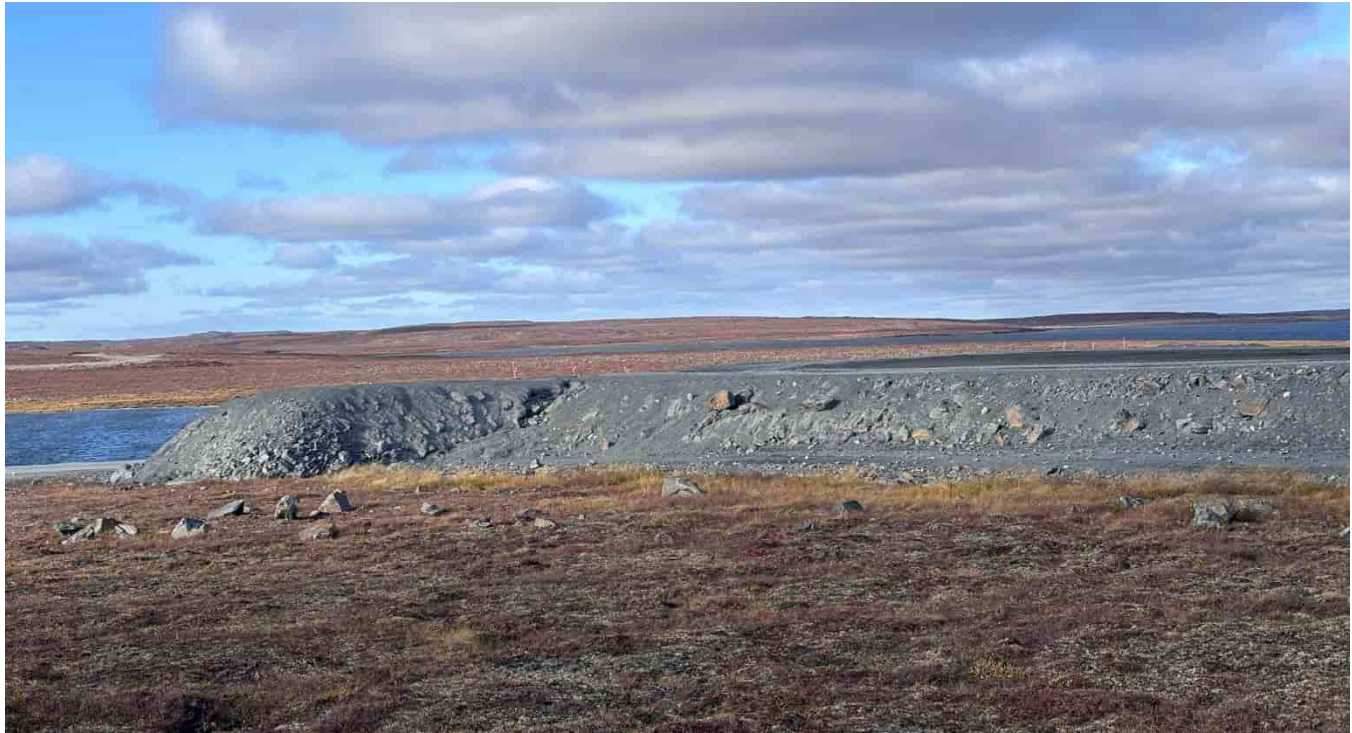
G-47: Airstrip rockfills at NW end of runway

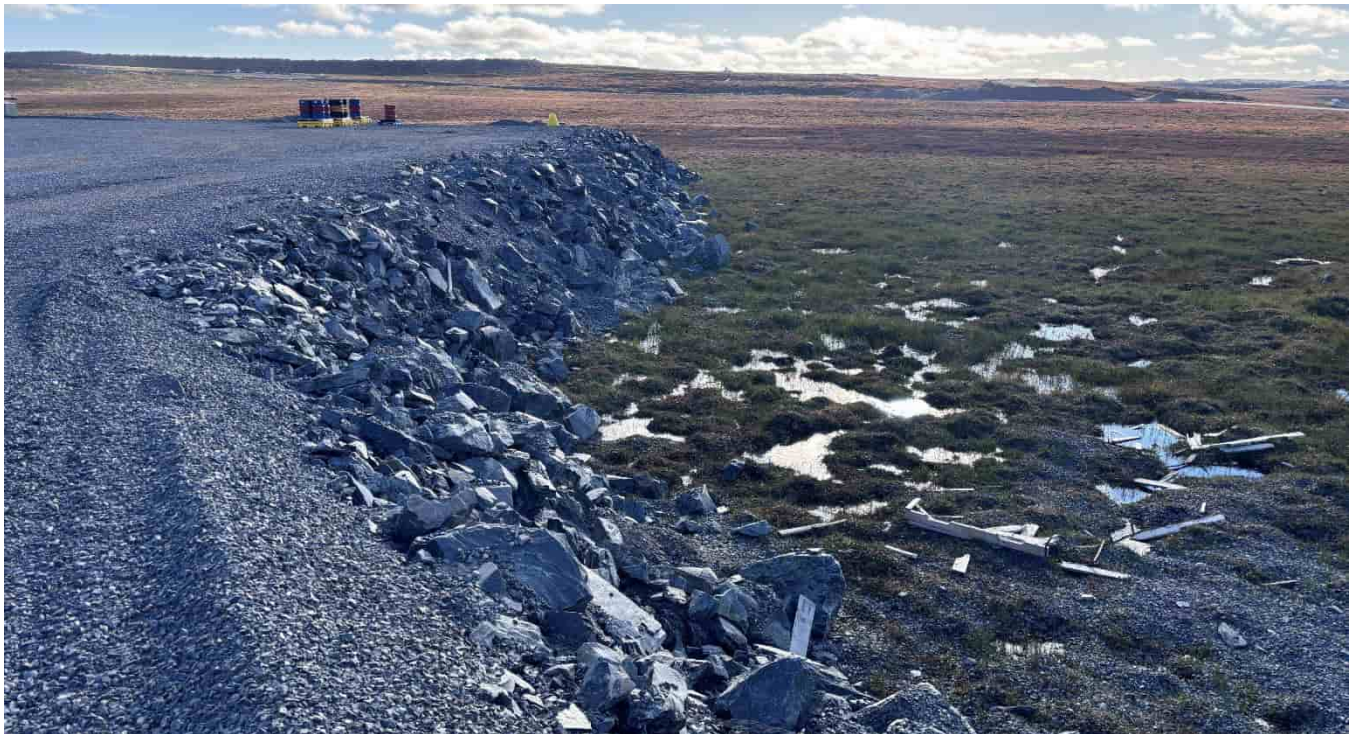
G-49: SW apron, looking SW.

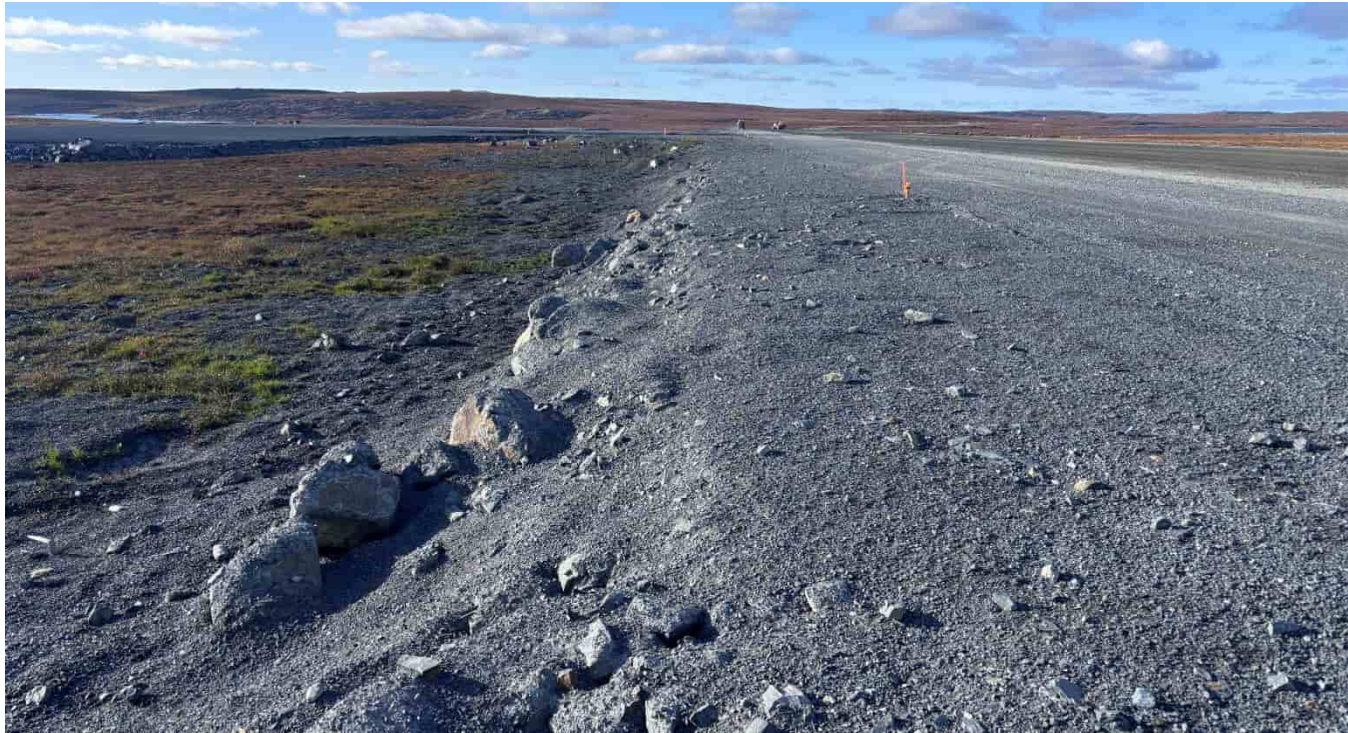
G-51: SW runway rockfill, looking NW

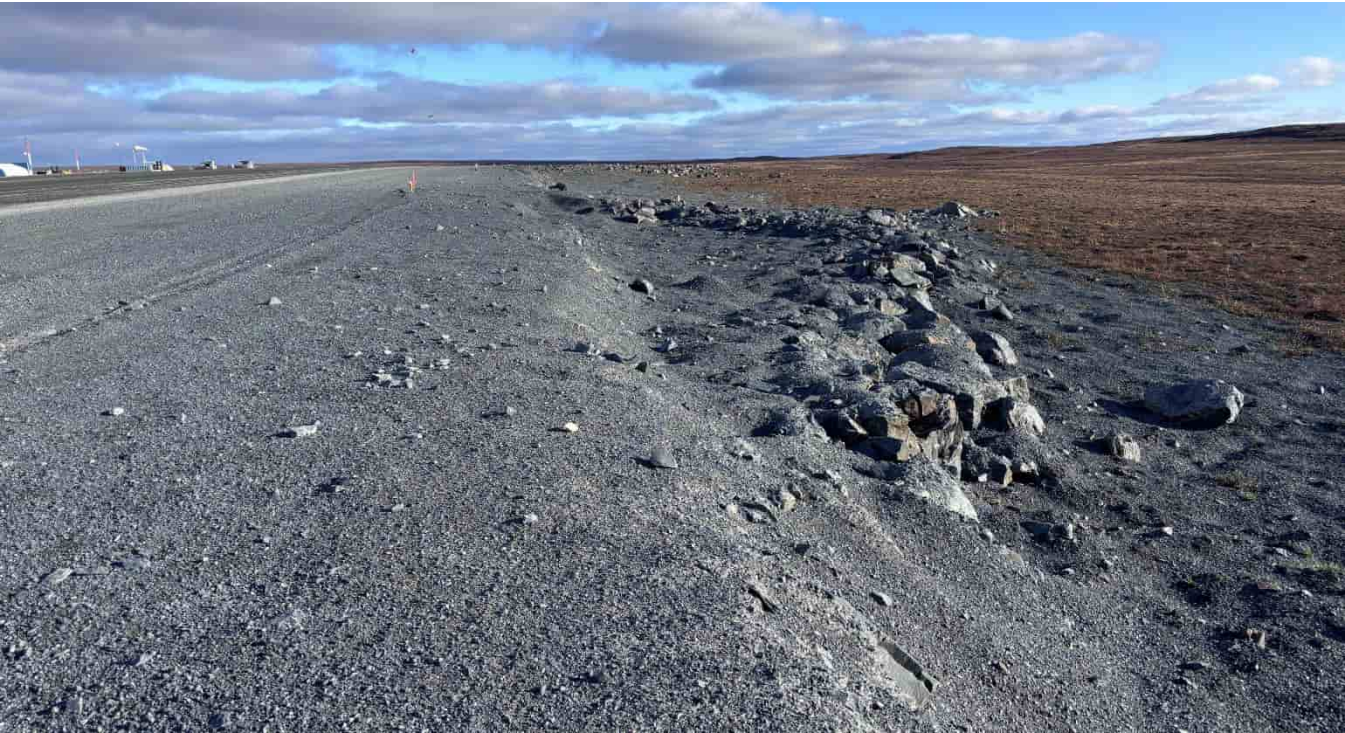
G-52: SW runway rockfill, looking SE – Undefined edge in area

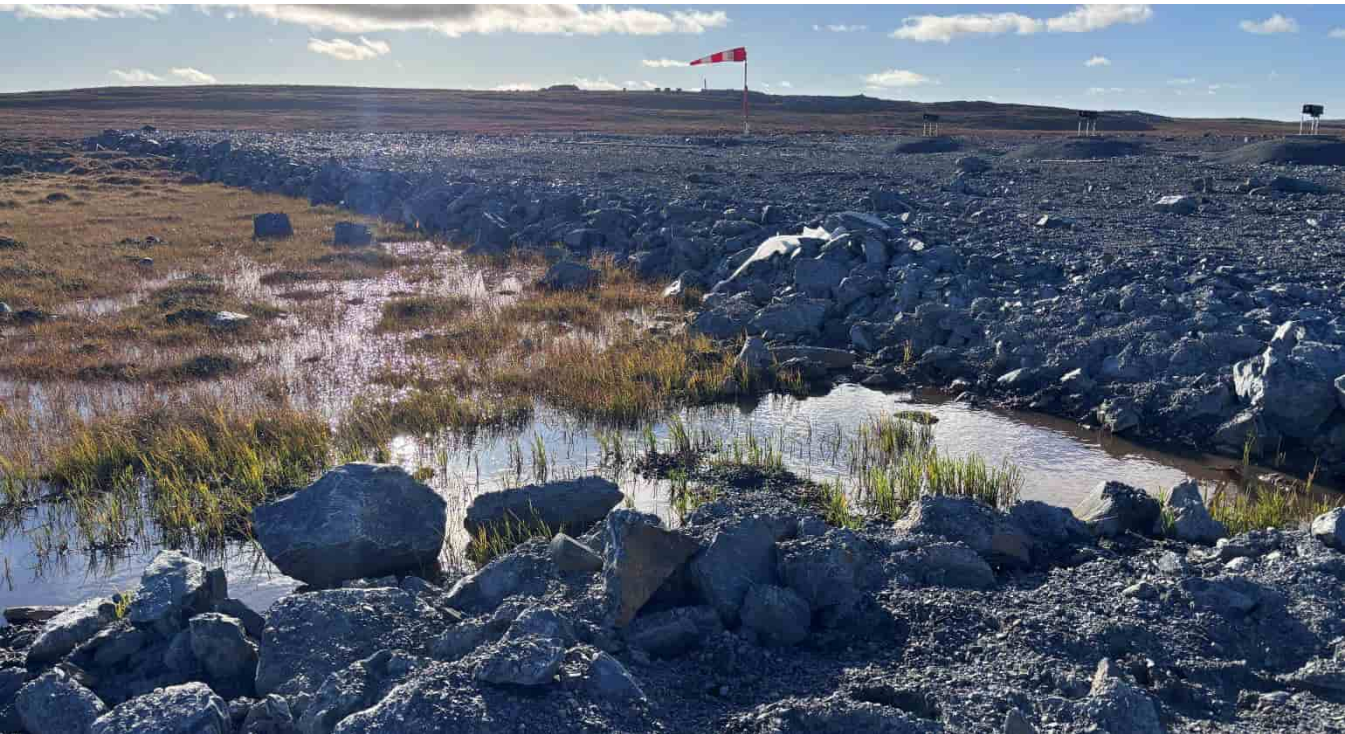
| Infrastructure | Observations | Recommendations and Comments | Recommendation ID |
|---|---|---|---|
| | <ul style="list-style-type: none"> <li>Similar to the 2023 and 2024 inspection observations, ponding water was observed at the airstrip toe. This ponding is most prevalent near the south and southwestern portions (specifically near the edges) of the airstrip. A series of tension cracks along the southwestern crest was observed during the inspection.</li> </ul> | <ul style="list-style-type: none"> <li>Watch these areas (specifically as temperatures annually warm-up at site from winter to spring and to summer conditions). Consideration should be given to redirecting or trying to push any ponding water further away from the toes of the existing MLA airstrip. Pumping down / removal of any ponded water at the toes of the airstrip in the fall (before winter freeze-up) would increase the cold ambient air and ground heat transfer to help slow down permafrost degradation (reduce thawing rates and slow deepening of the active layer). This increased water management may help reduce overall short and long-term maintenance activities.</li> </ul> | <ul style="list-style-type: none"> <li>Carried over from 2024 AGI</li> <li>2024 &amp; 2025-AGI-7</li> </ul> |

G-54: Ponding water at SE end of airstrip

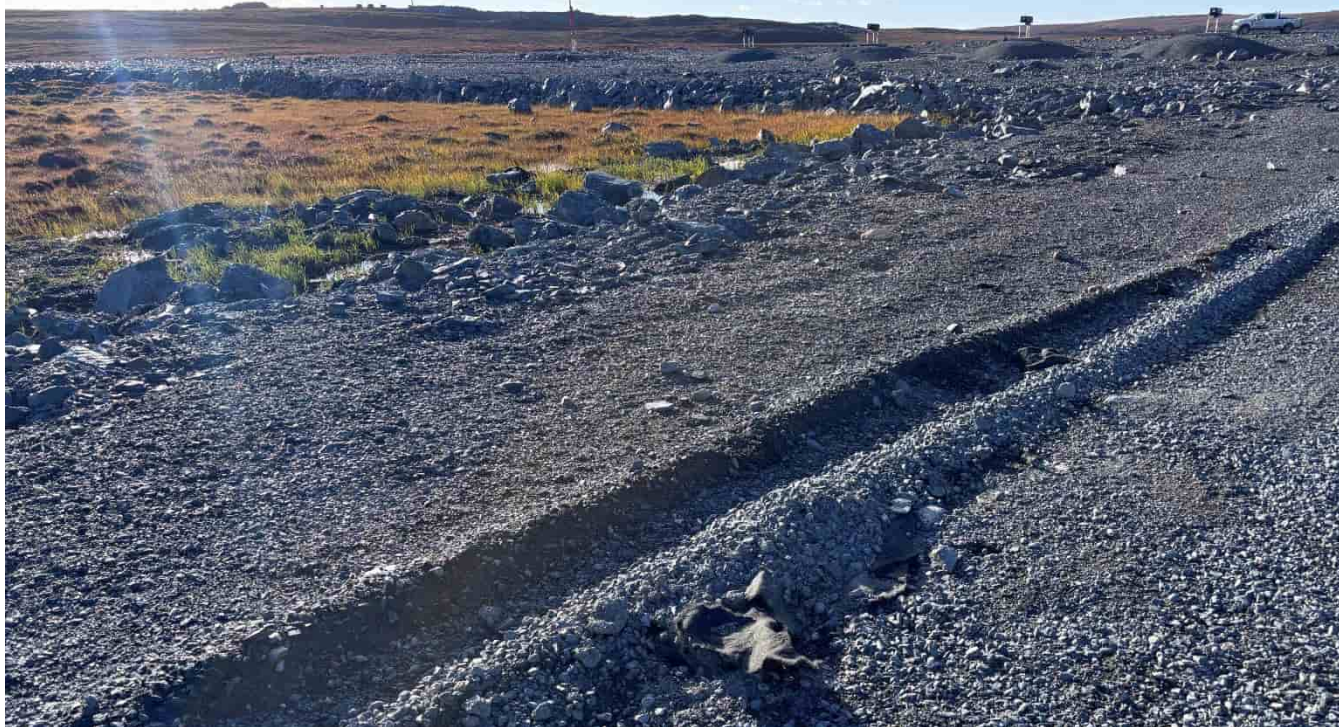
G-55: View towards airstrip lighting apron, looking W – Exposed geotextile visible

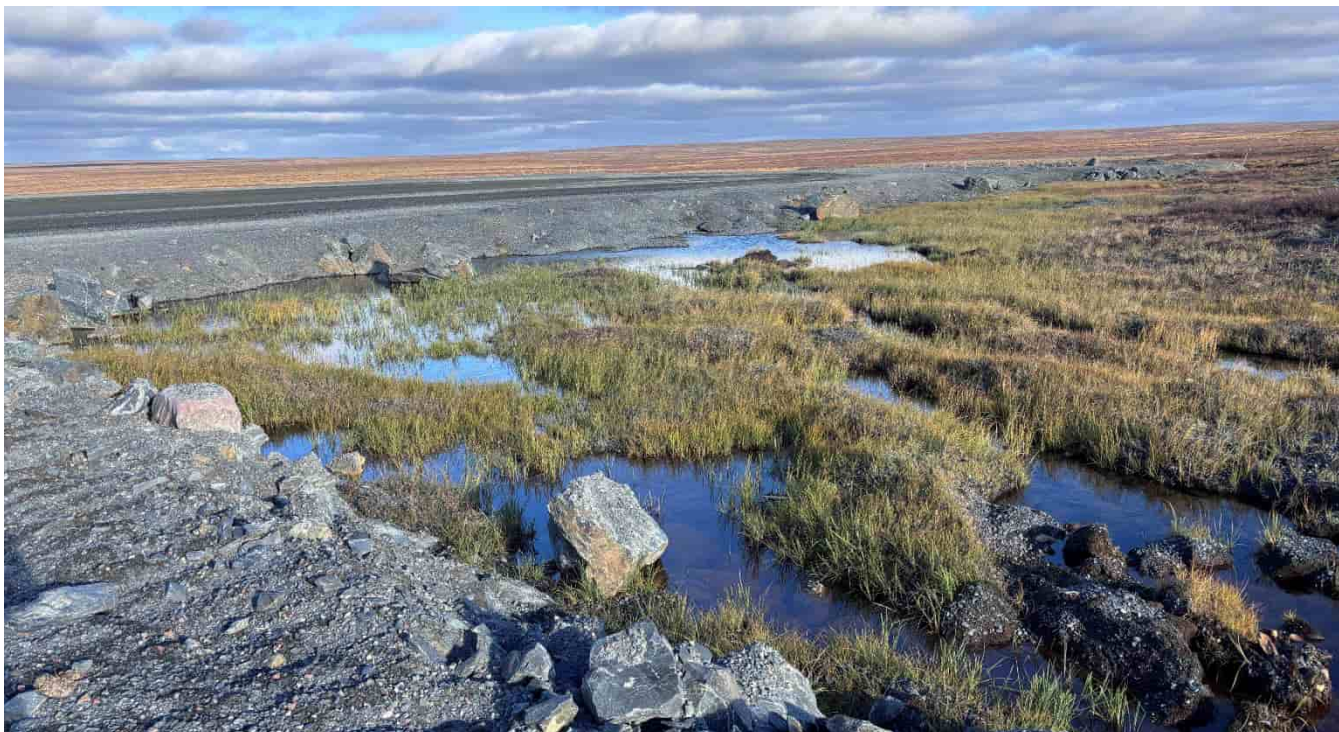
G-57: Ponding at SE end of runway, looking E

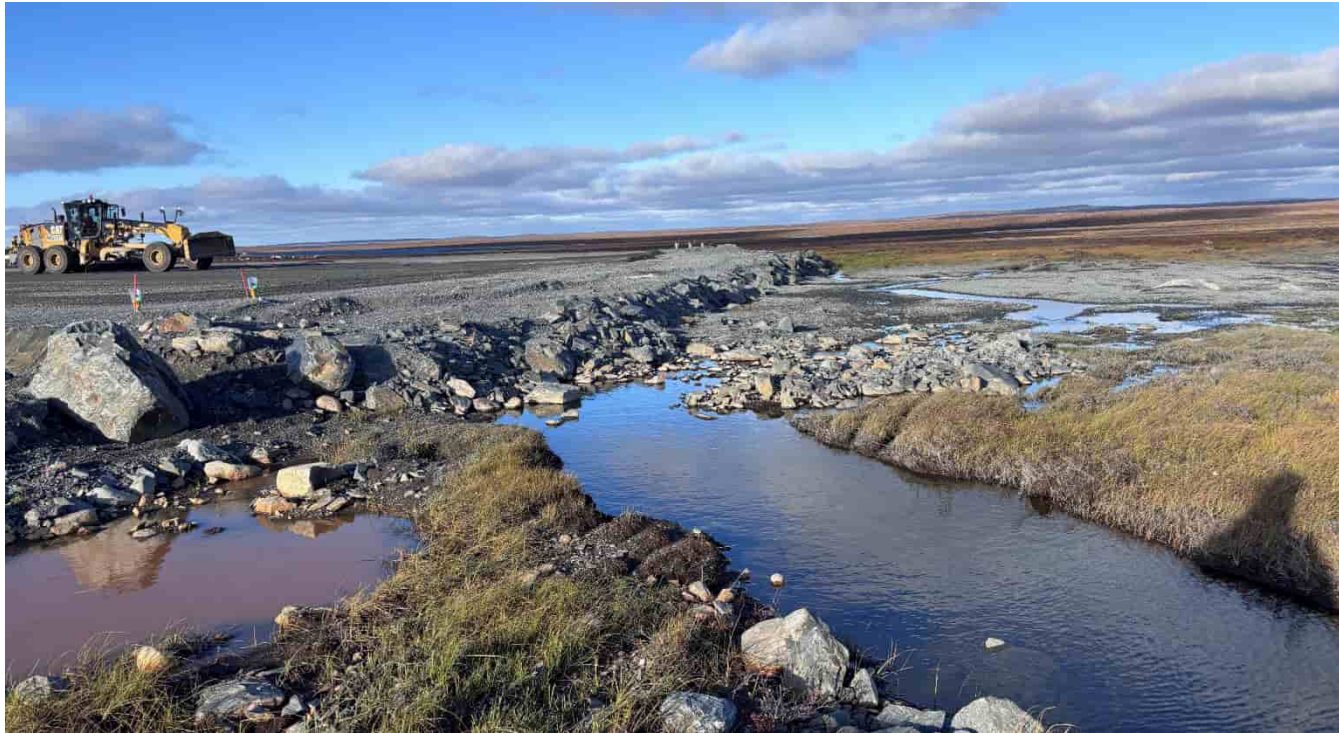
G-59: Stream beside SE end of runway, looking NE – lower pad thickness in area, ongoing settlement

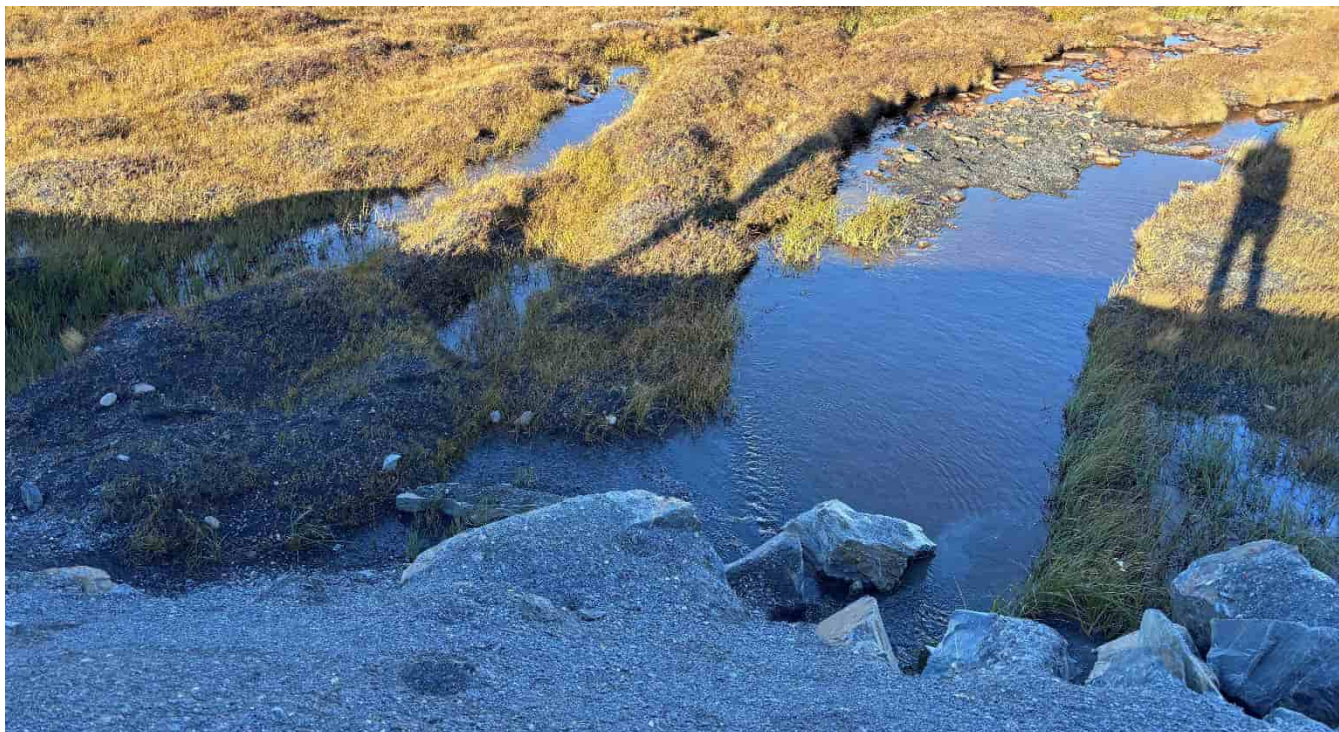
G-61: Culvert under SE end of runway

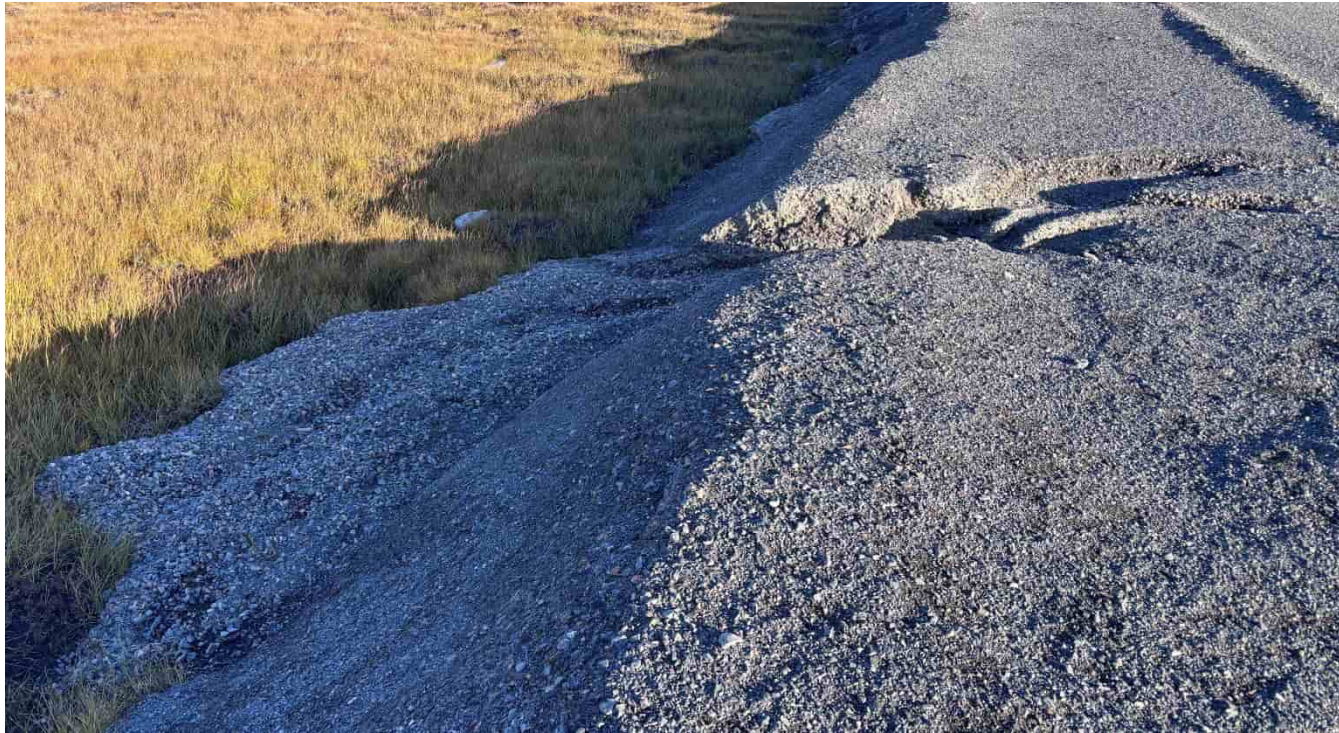
G-63: Erosion pathway on NE side of airstrip – Looking SE

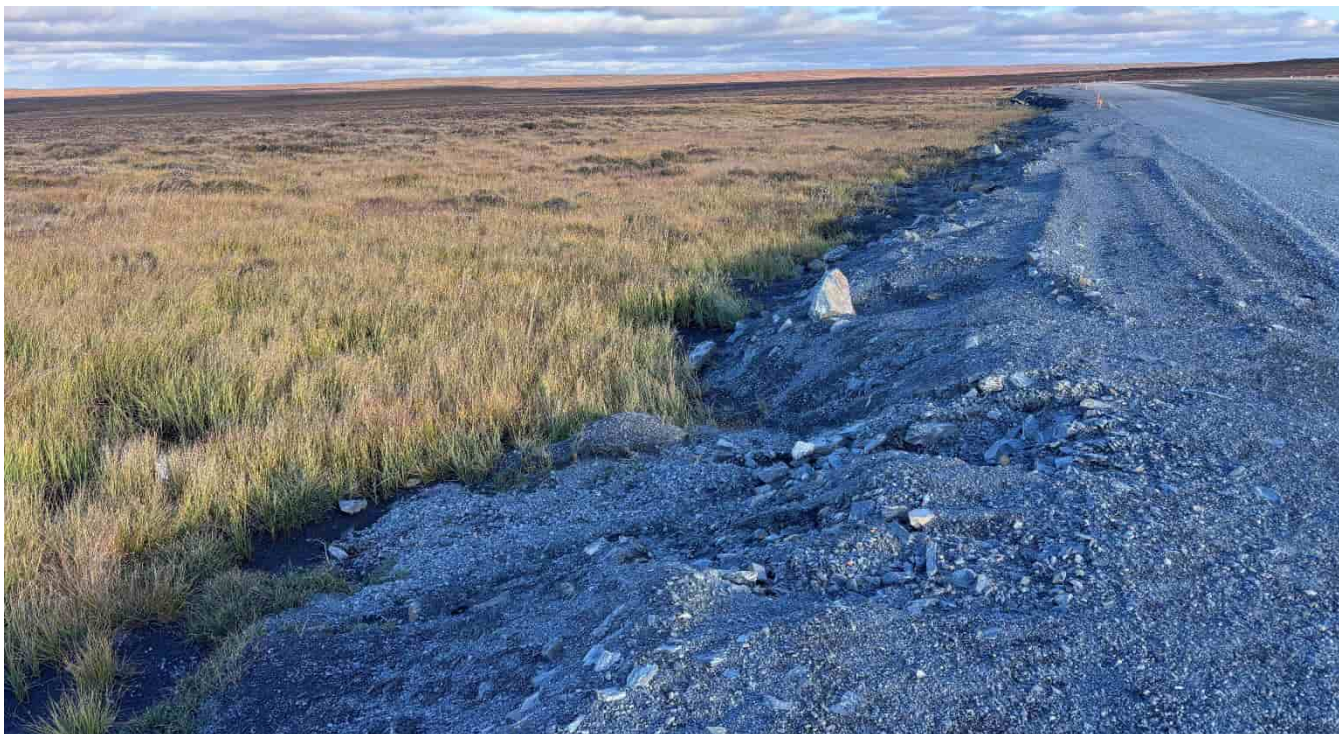
G-65: Erosion pathways on NE side of runway

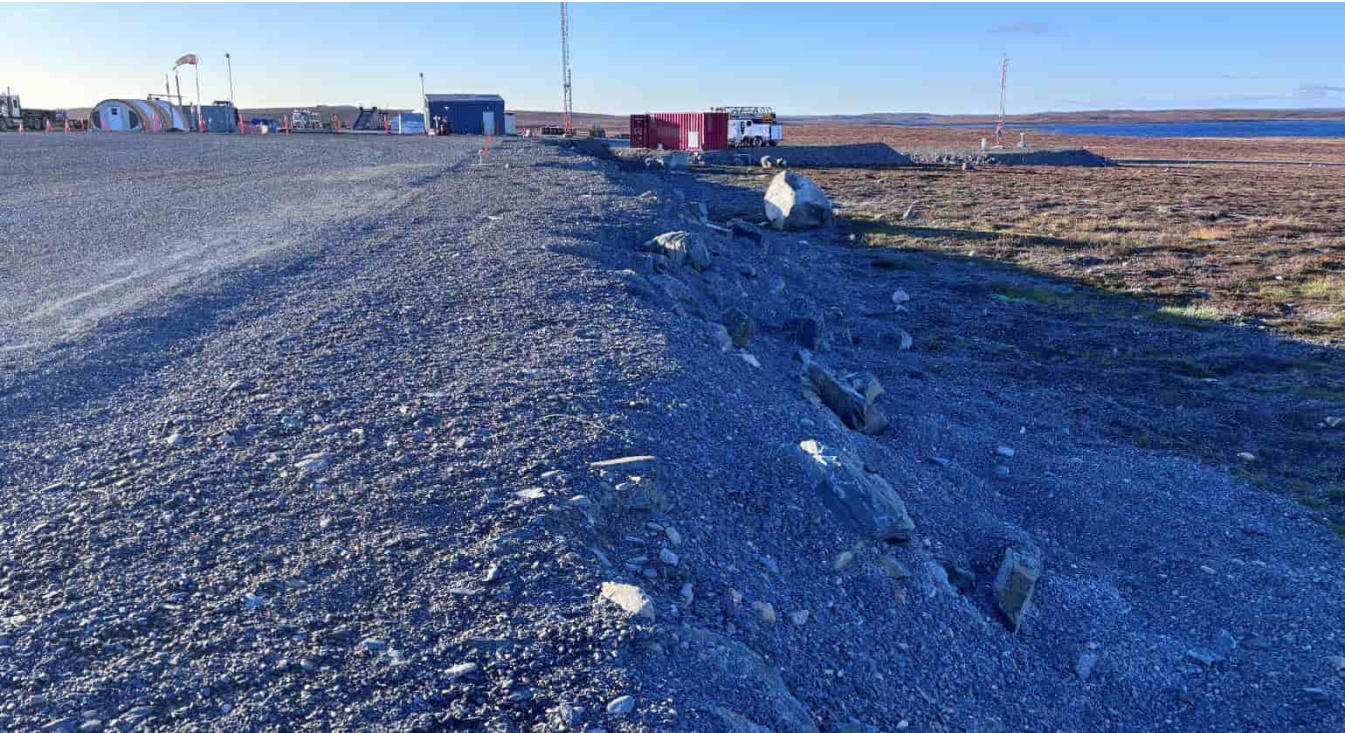
G-68: Slopes of NE apron south of laydown area

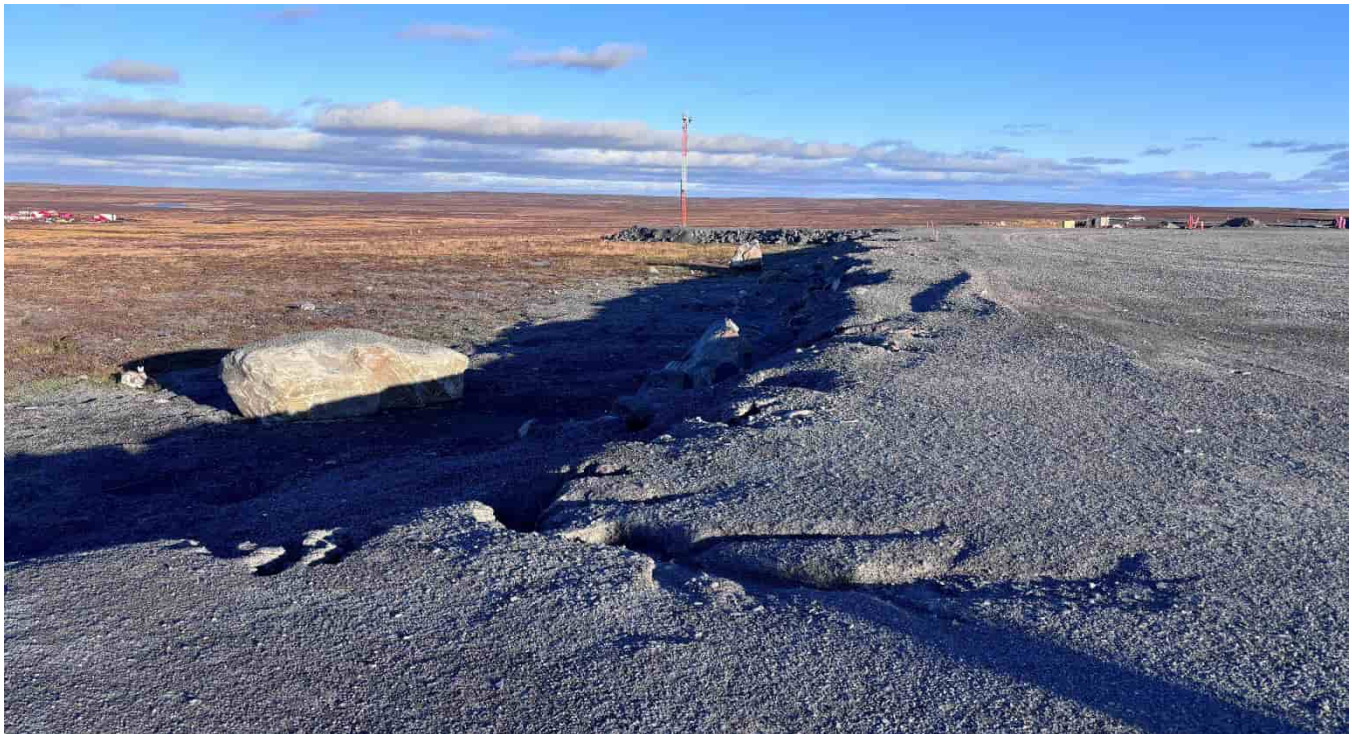
G-69: Erosion on NE apron, looking SE

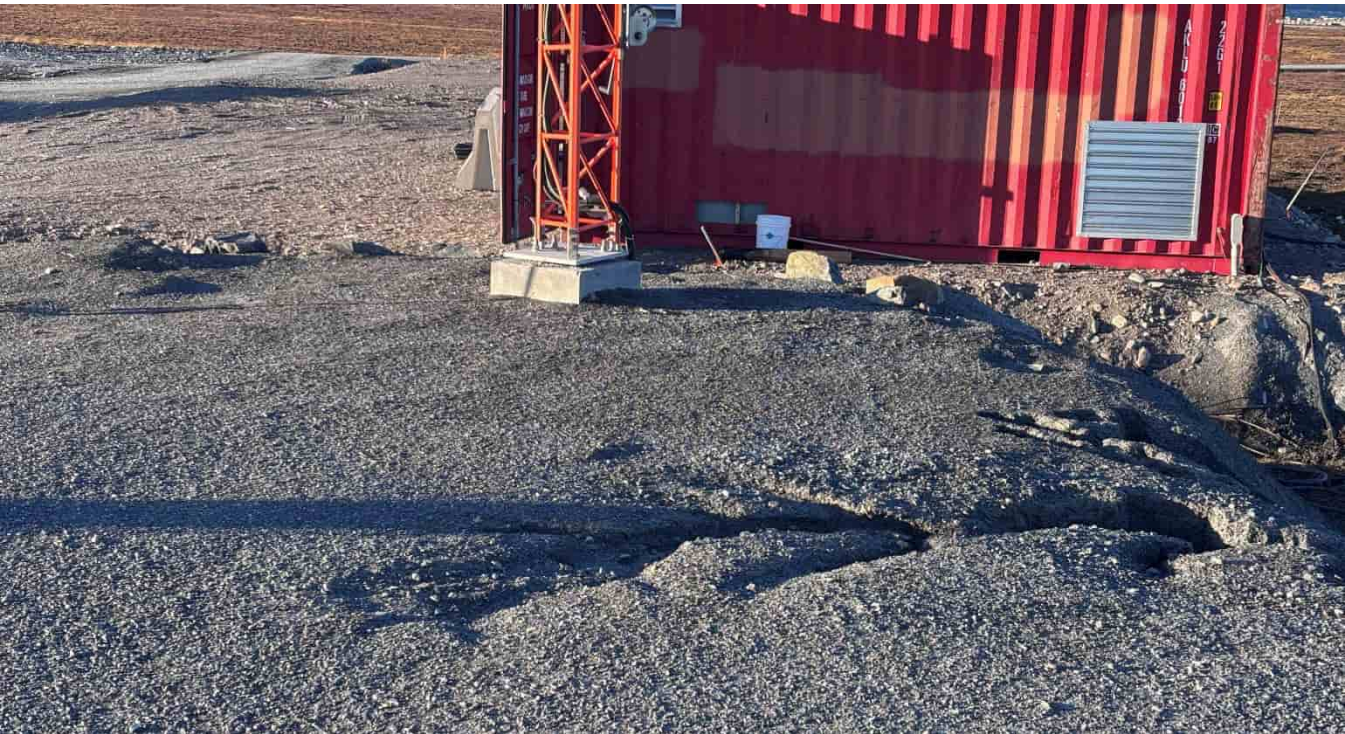
G-70: Erosion NE apron, facing N

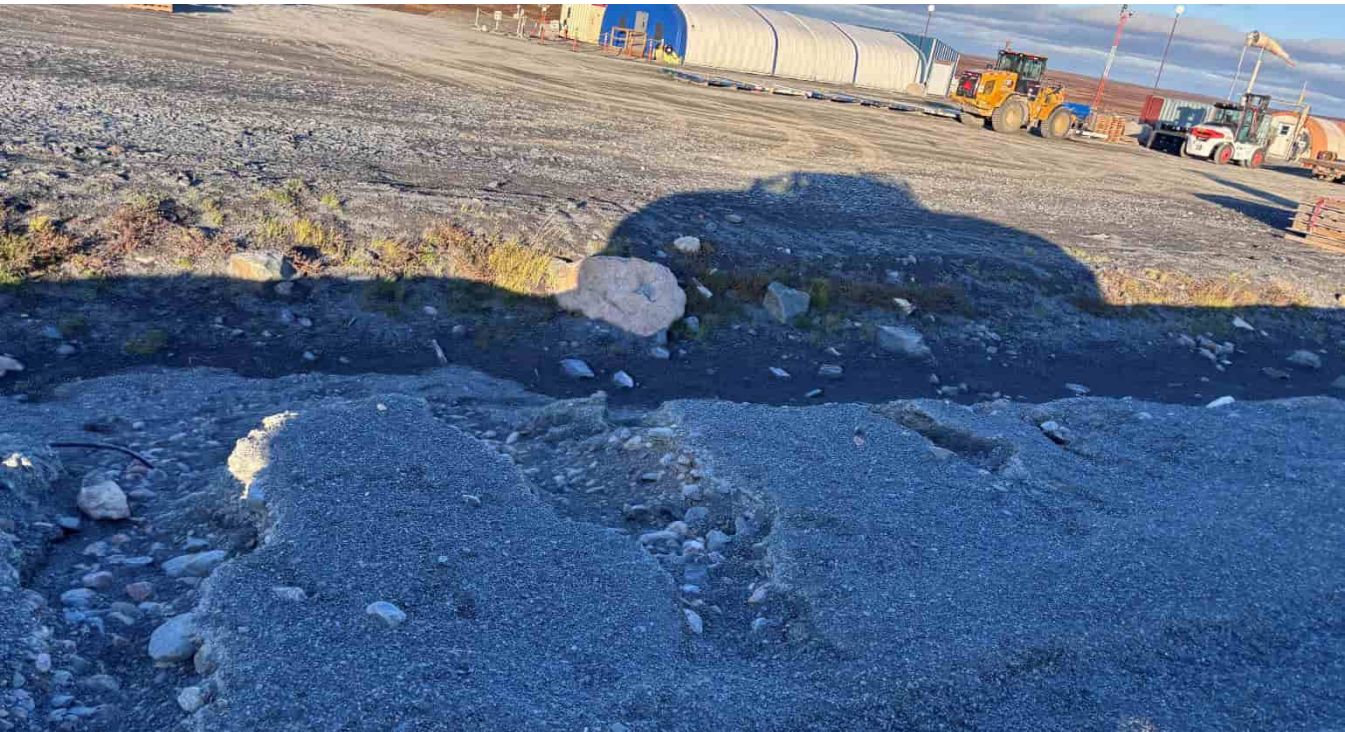
G-74: Erosion beside laydown area

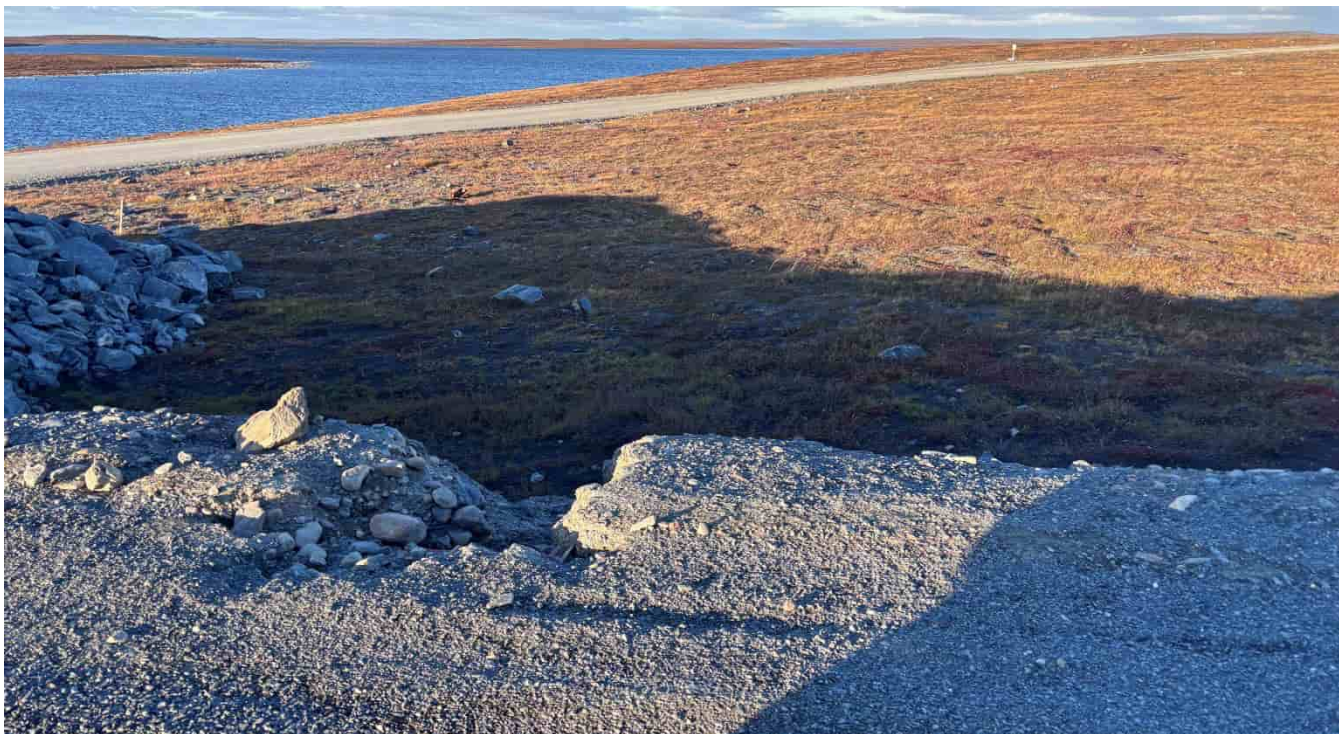
G-77: Erosion pathway at NW end of runway

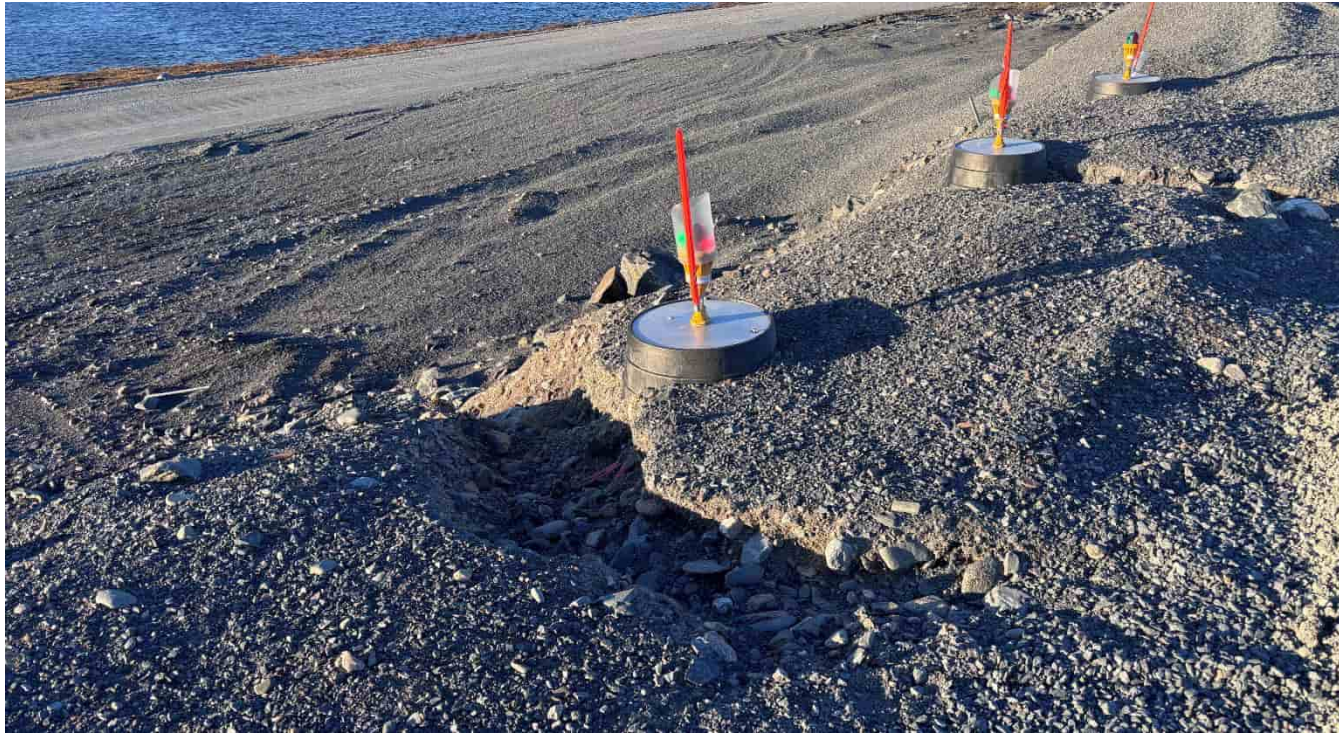
G-79: Erosion at NW end of runway, above All-Weather Road

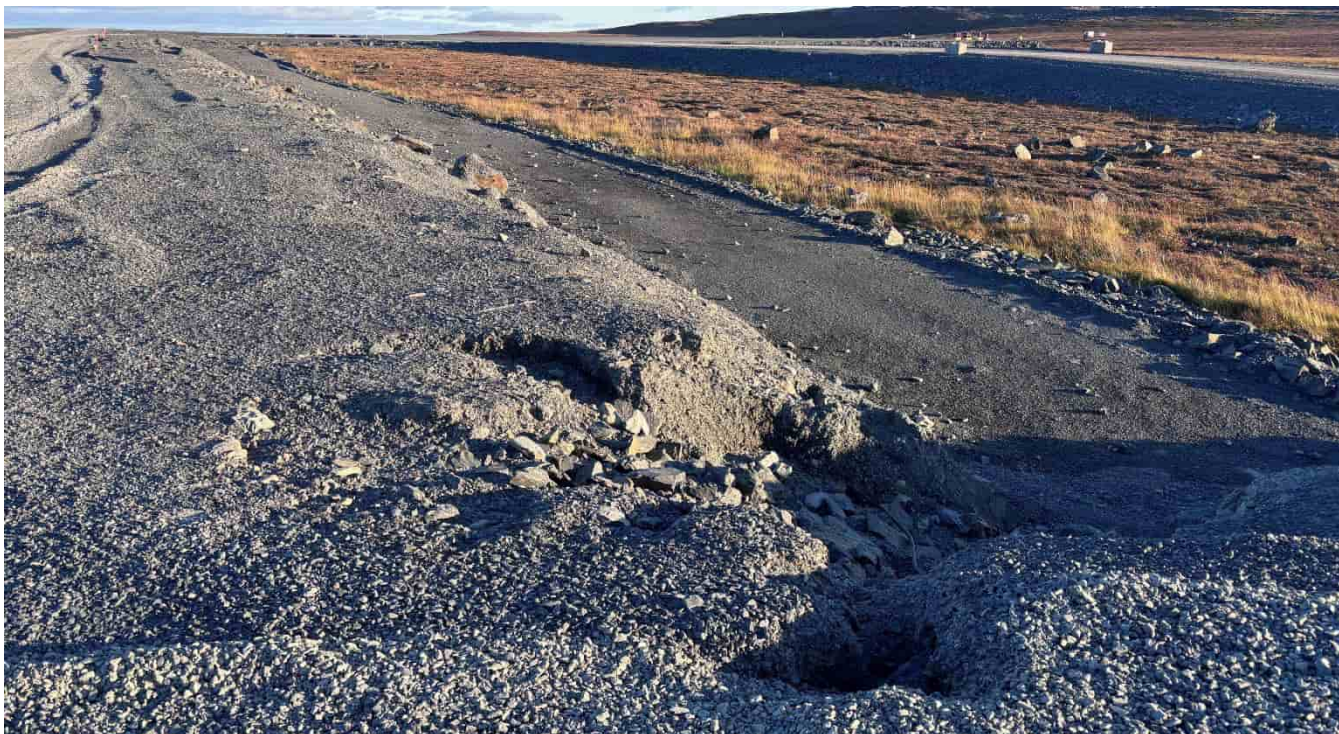
G-81: Erosion pathway at NW end of airstrip

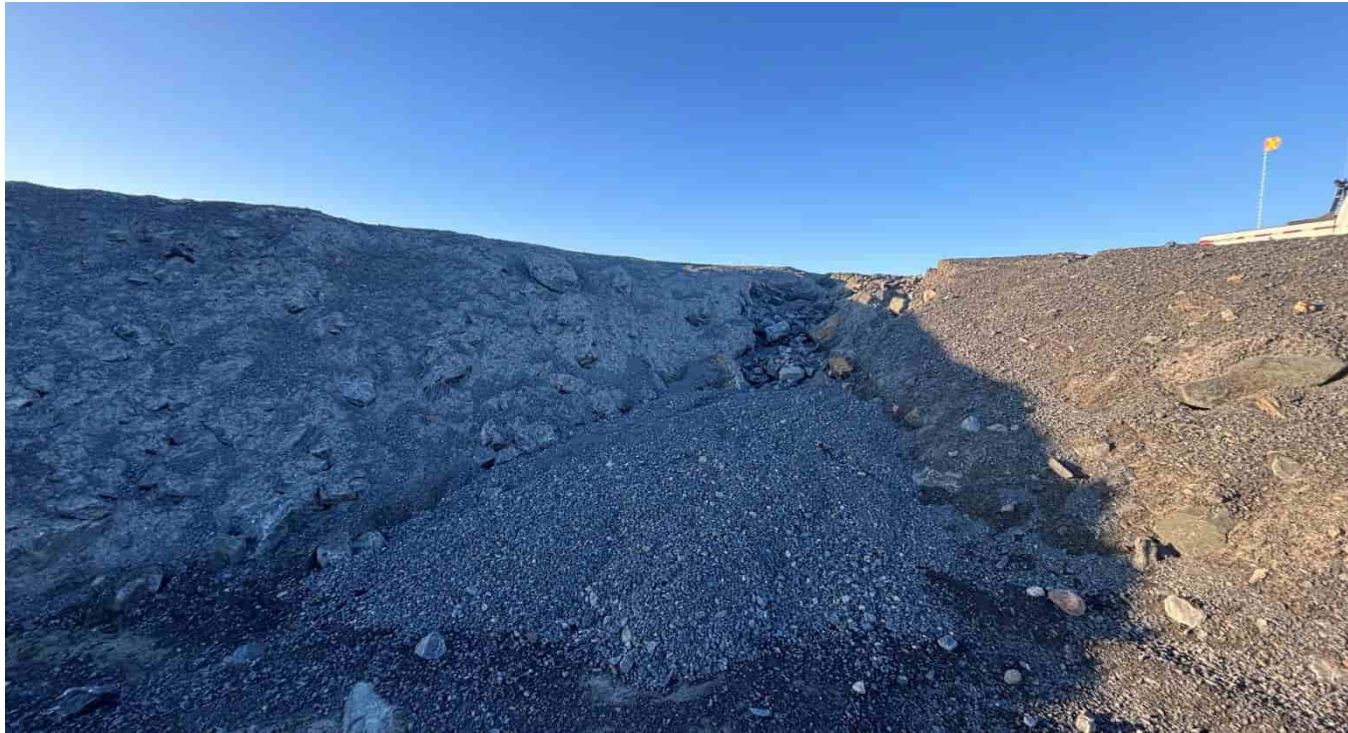
G-83: Erosion at NW end of airstrip

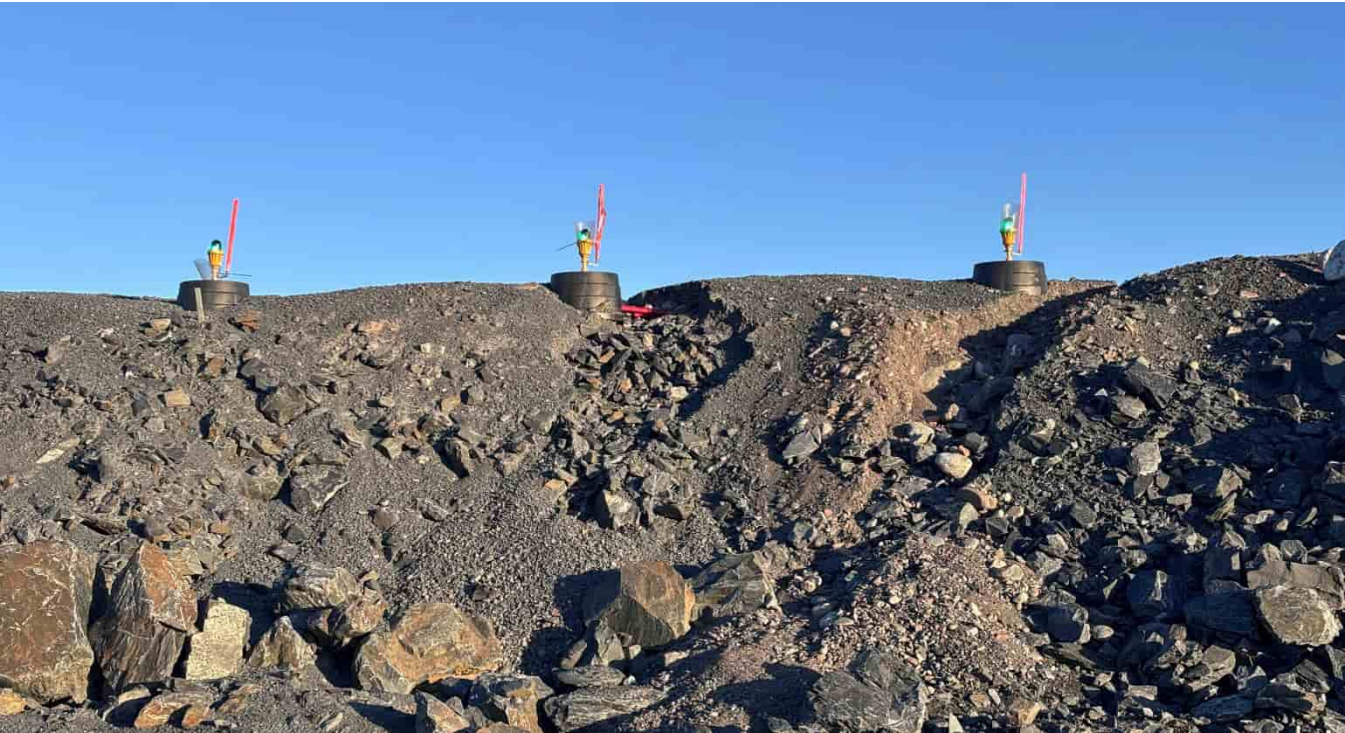
G-84: Erosion pathways at NW end of airstrip beside airstrip lights
