# Goose & MLA Project Sites – 2025 Annual Geotechnical Inspection

Back River Project, Nunavut, Canada  
B2Gold Back River Corp.

SRK Consulting (Canada) Inc. ■ CAPR004312 ■ March 2026

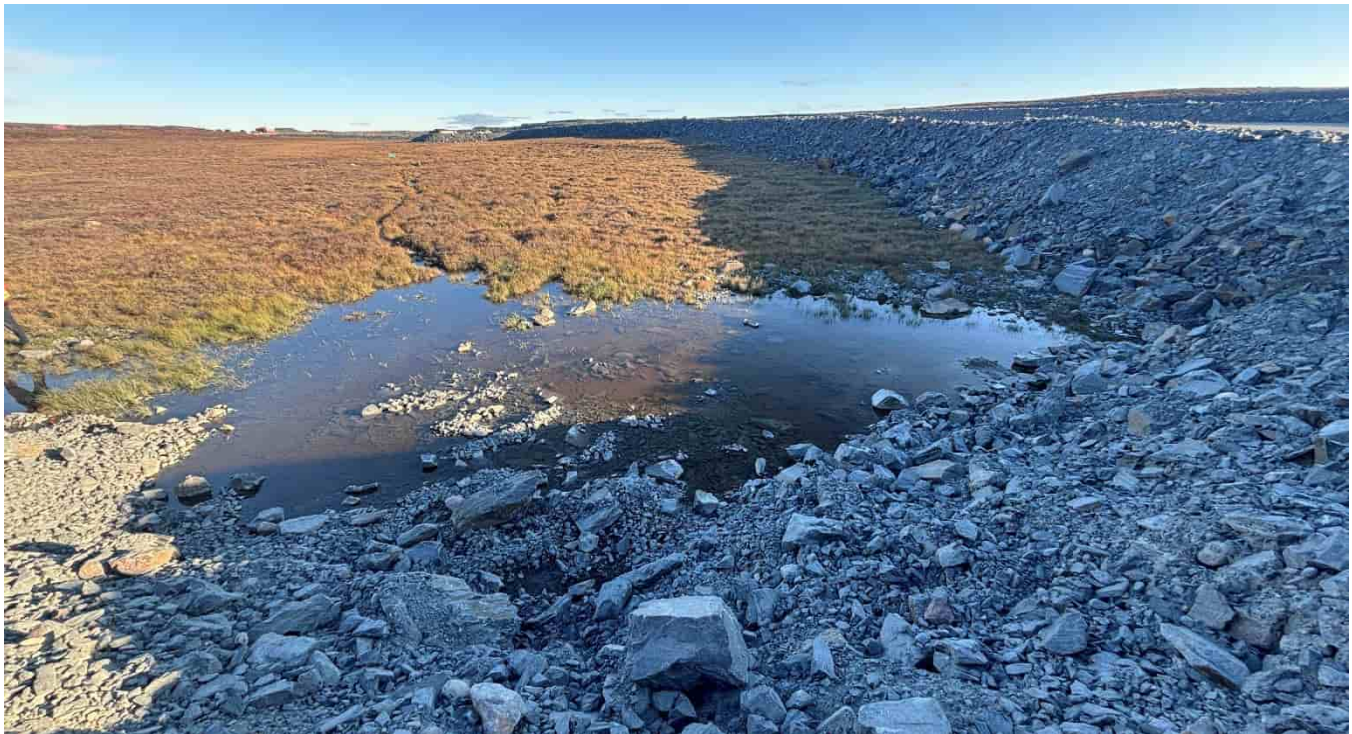
G-94: Ponding on SE corner of junction between the All-Weather Road and Echo Pit Haul Road

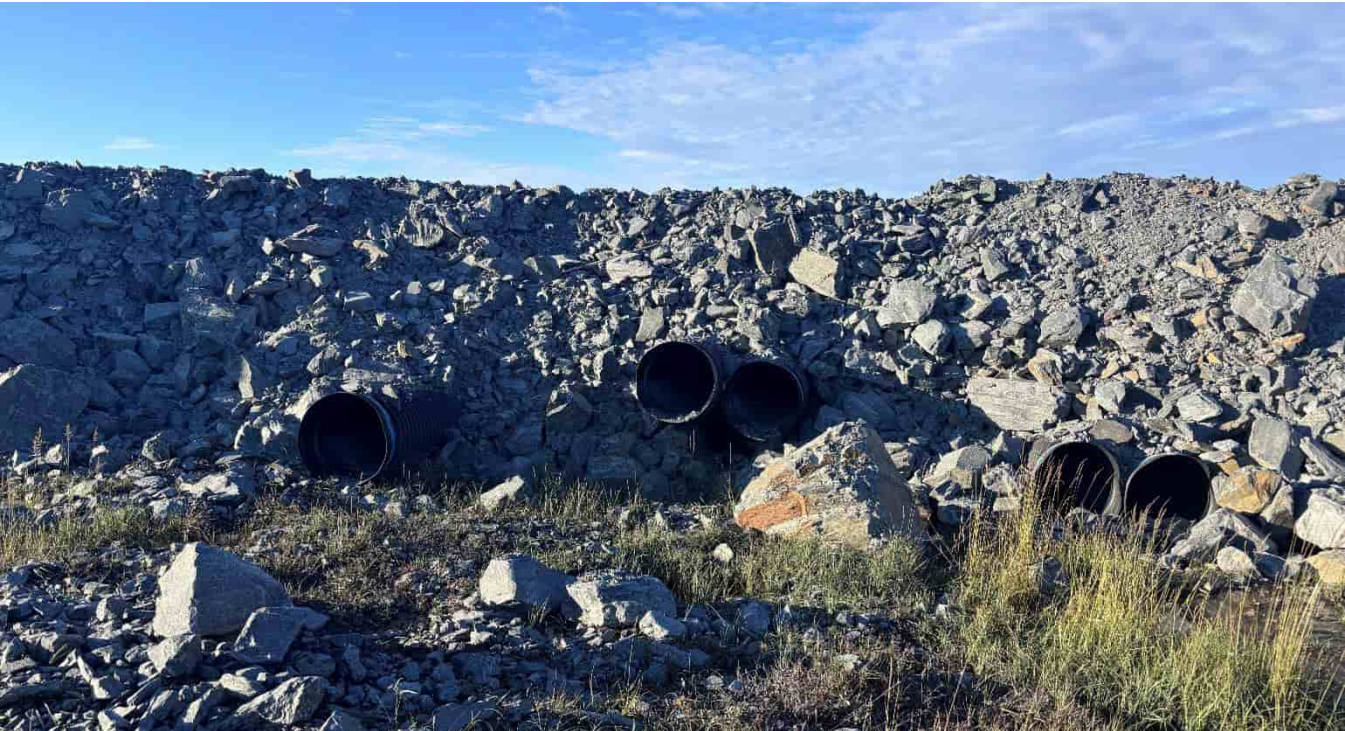
G-97: Upstream (S) side of western culverts – Two culverts raised approximately 0.5m from the toe rockfill

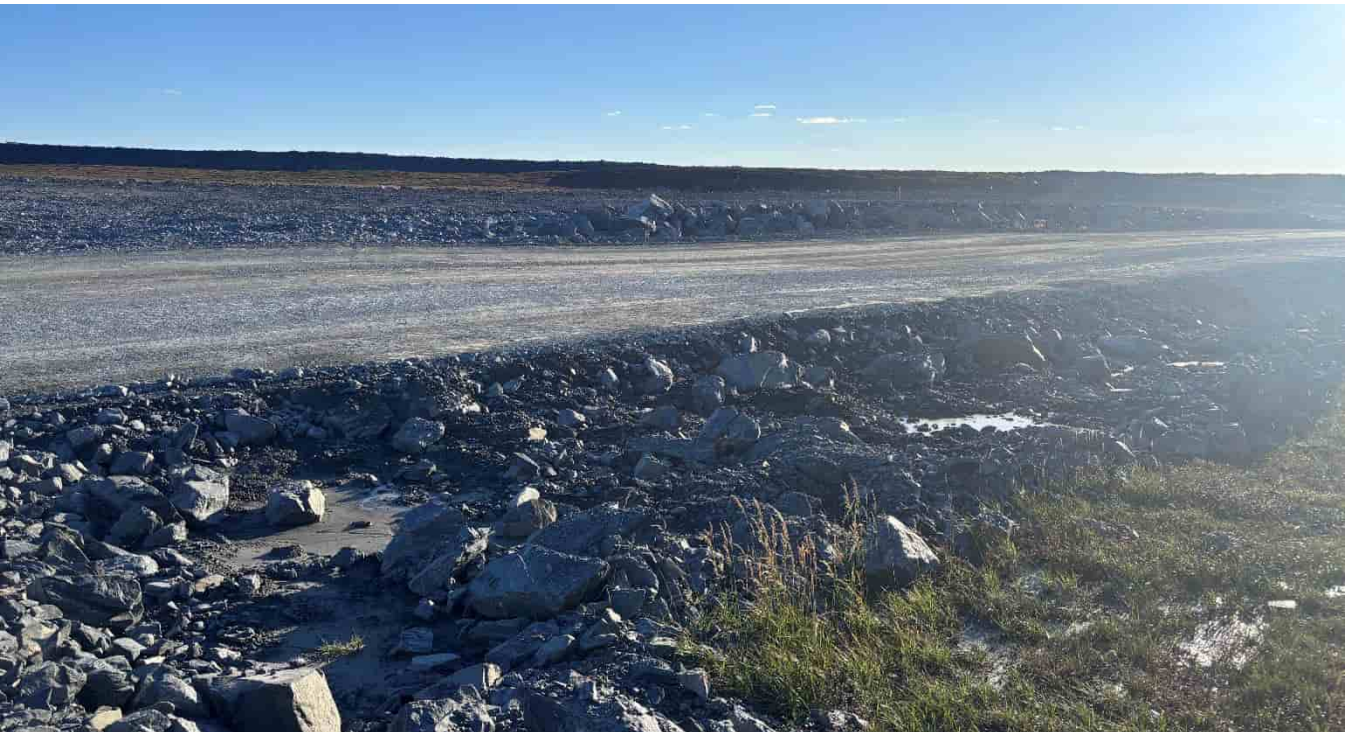
G-99: N side of All-Weather Road – lower road thickness in area

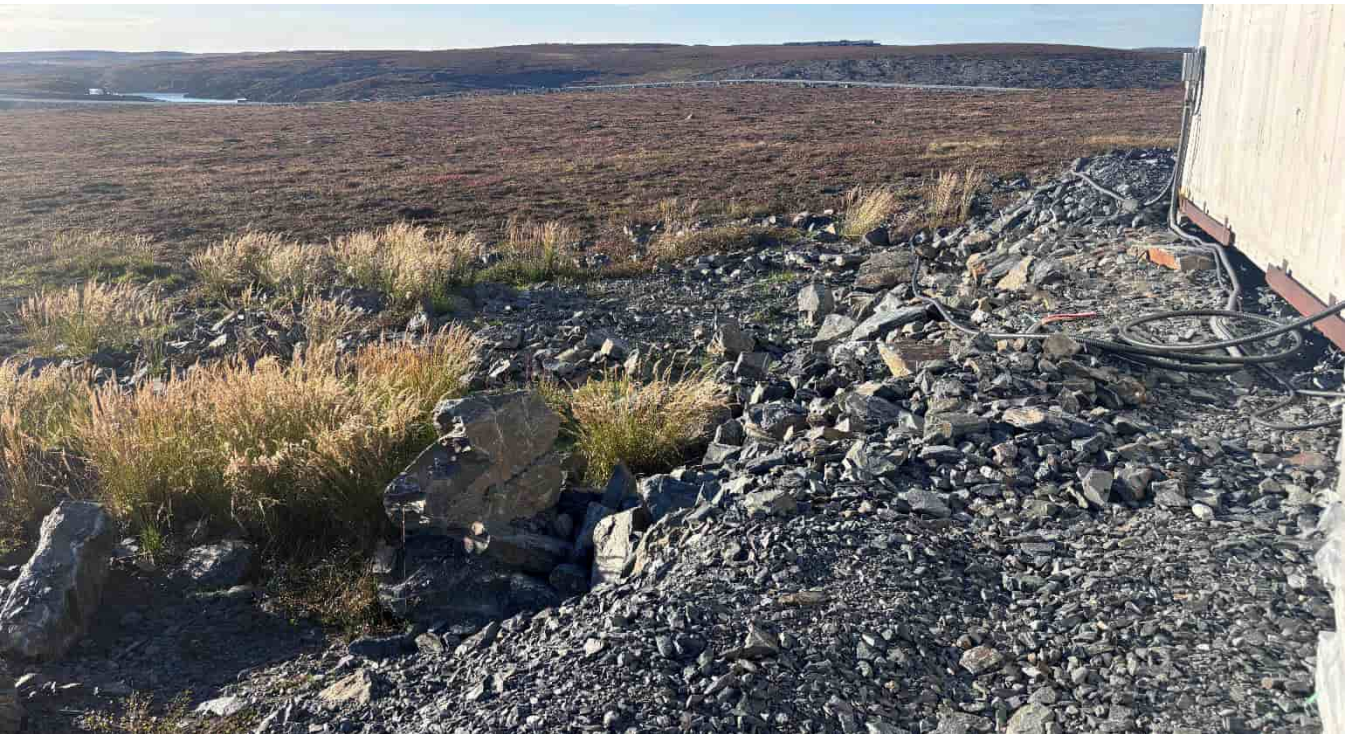
G-104: Pad toe, slope and erosion beside Seacan

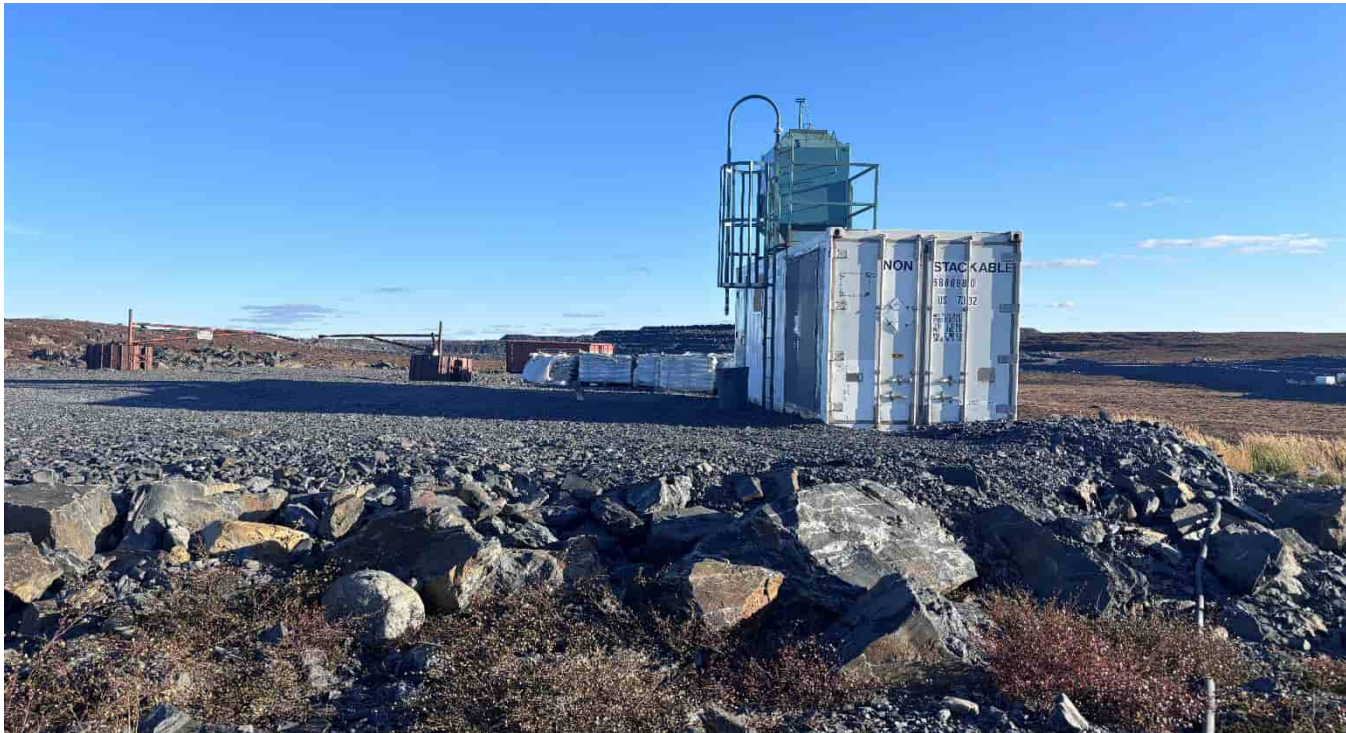
G-106: Old explosive storage pad, looking S

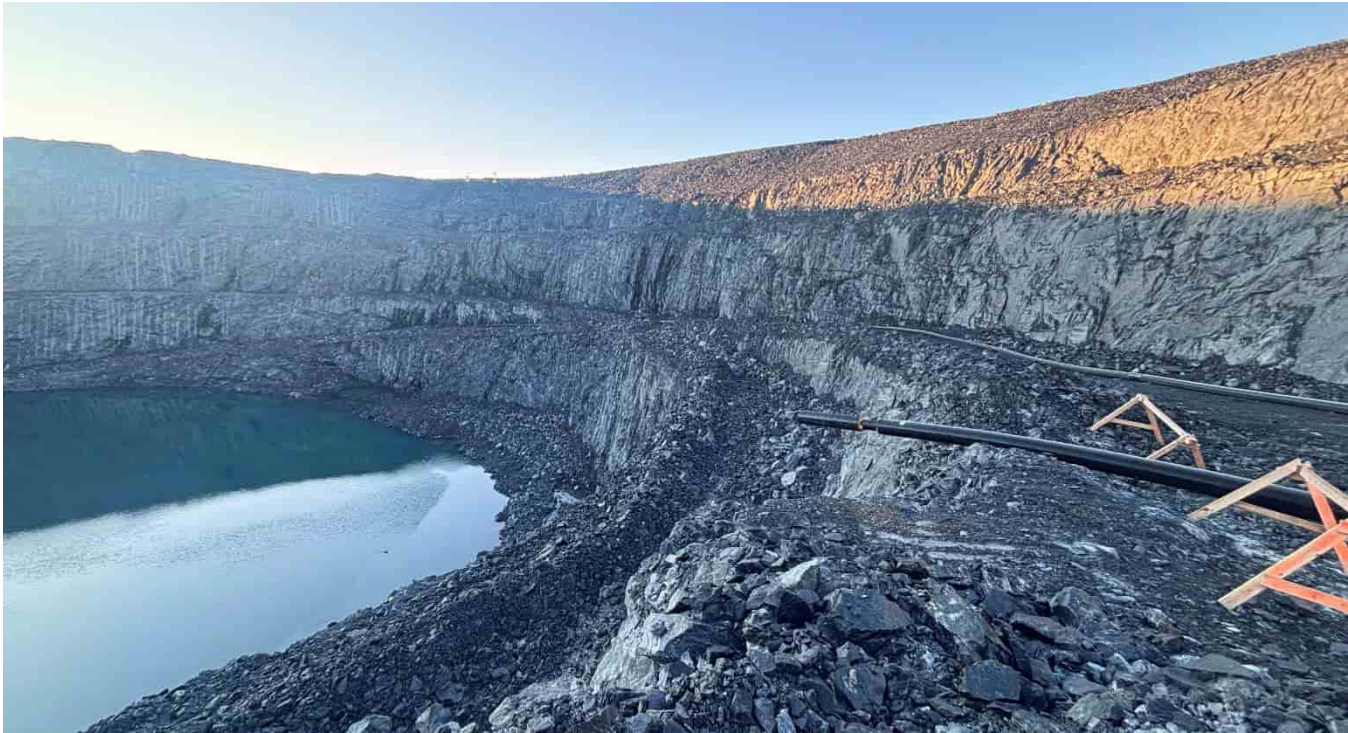
G-112: Western wall, looking S + tailings pipeline in place

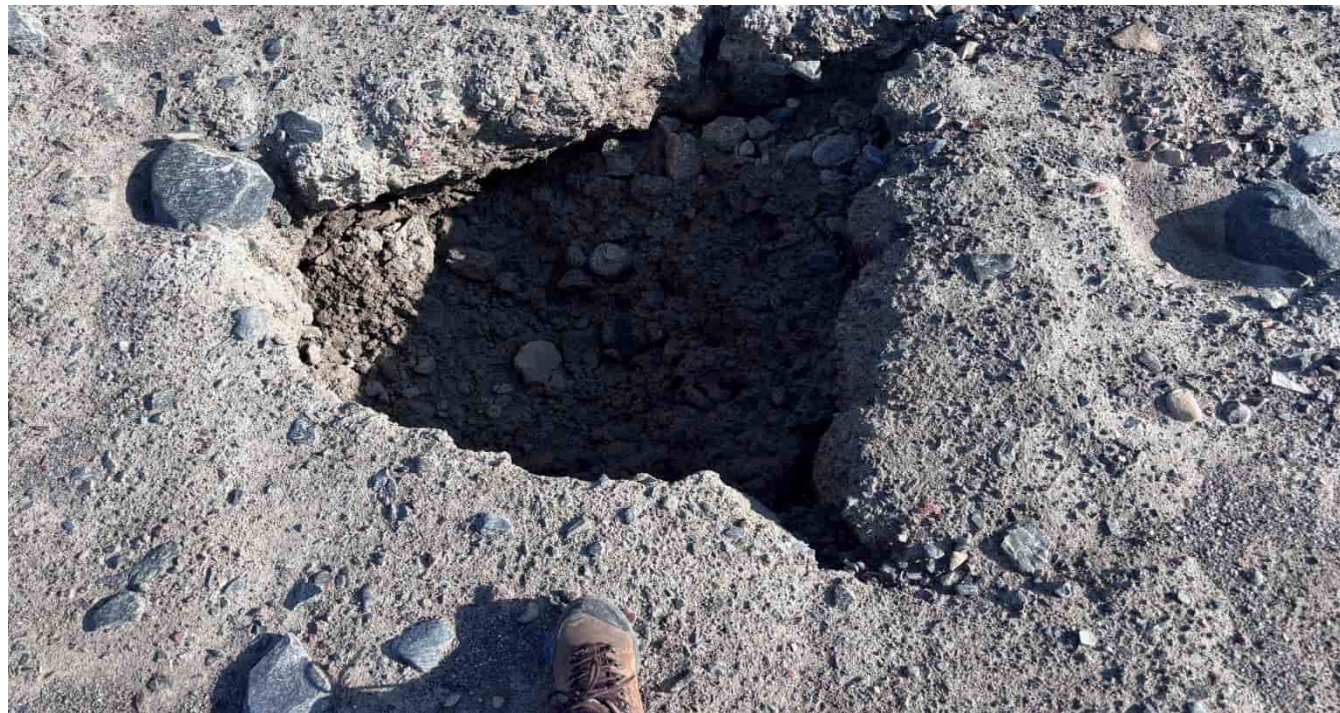
G-132: Example of sinkhole in the eastern side of the stockpile

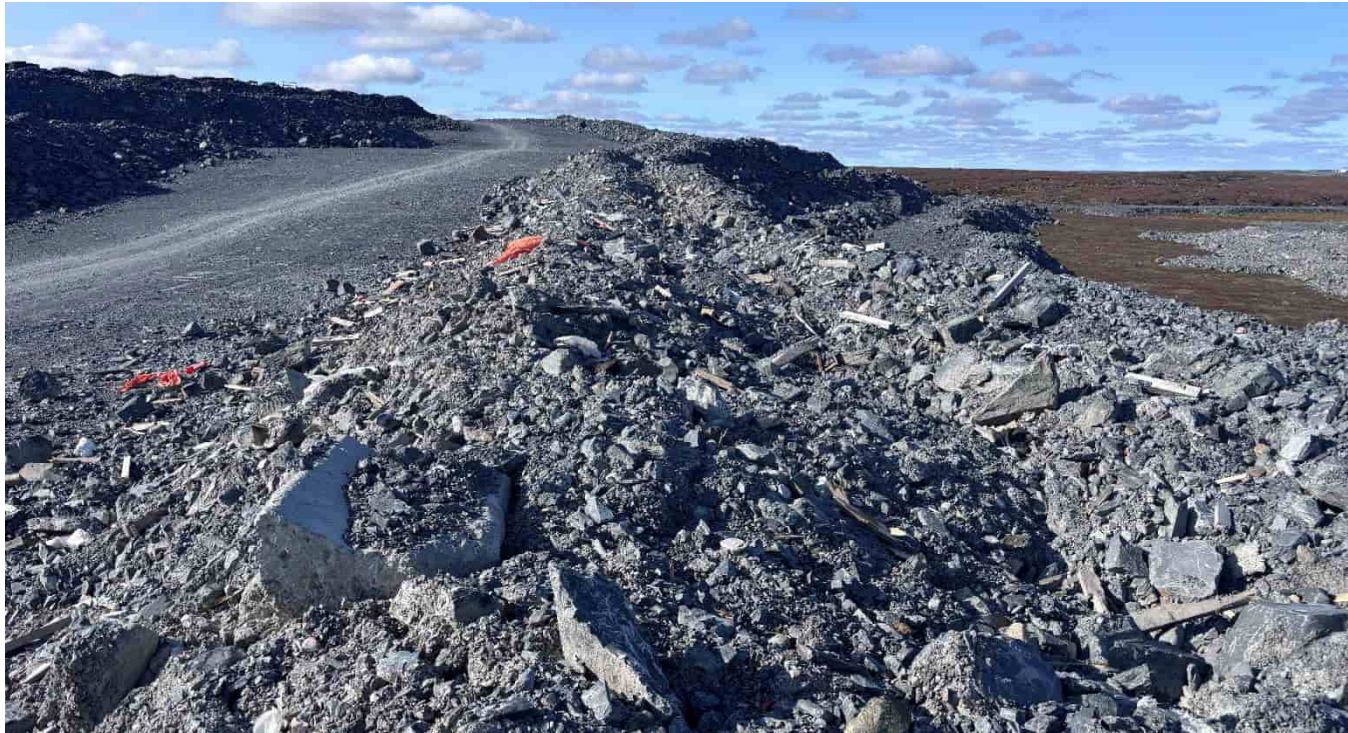
G-134: Entrance road to Echo WRSA, looking SW – Garbage in upper windrow

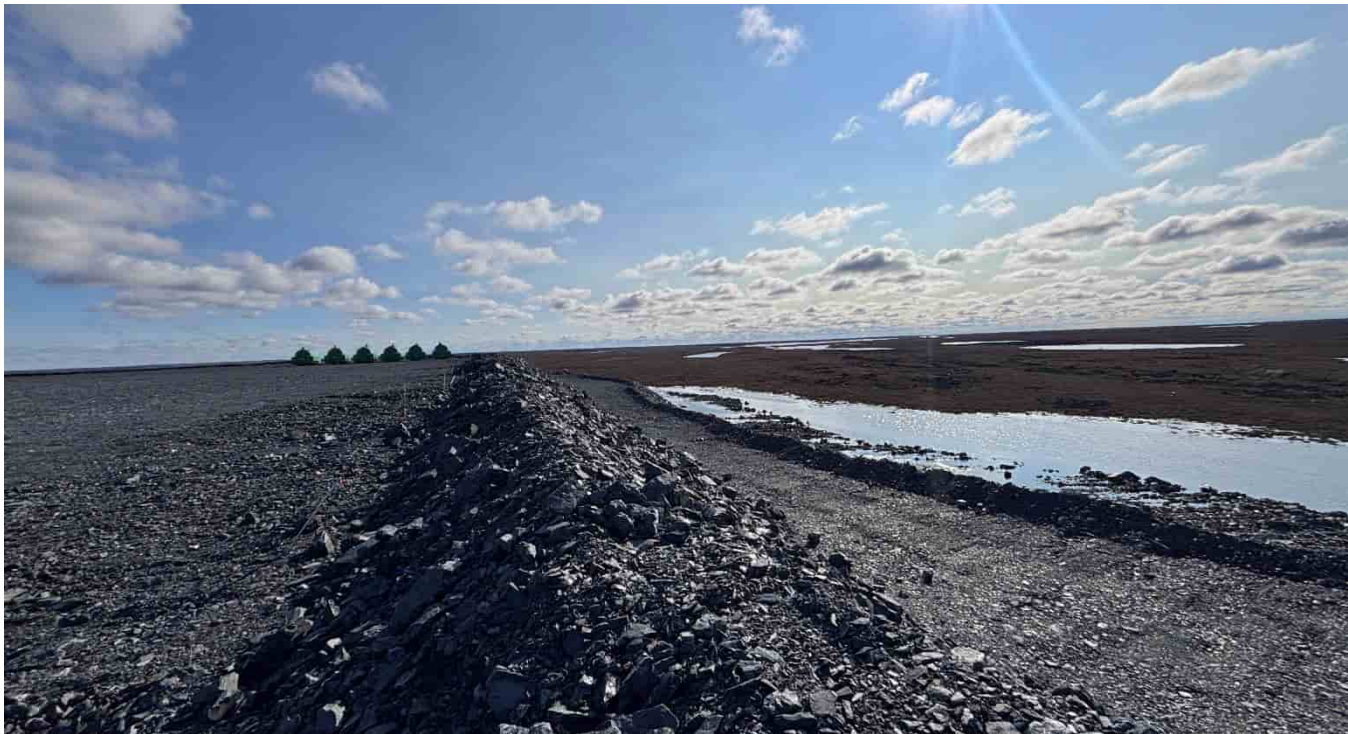
G-136: Top of berm, looking SE – Ponding water beside waste rock area

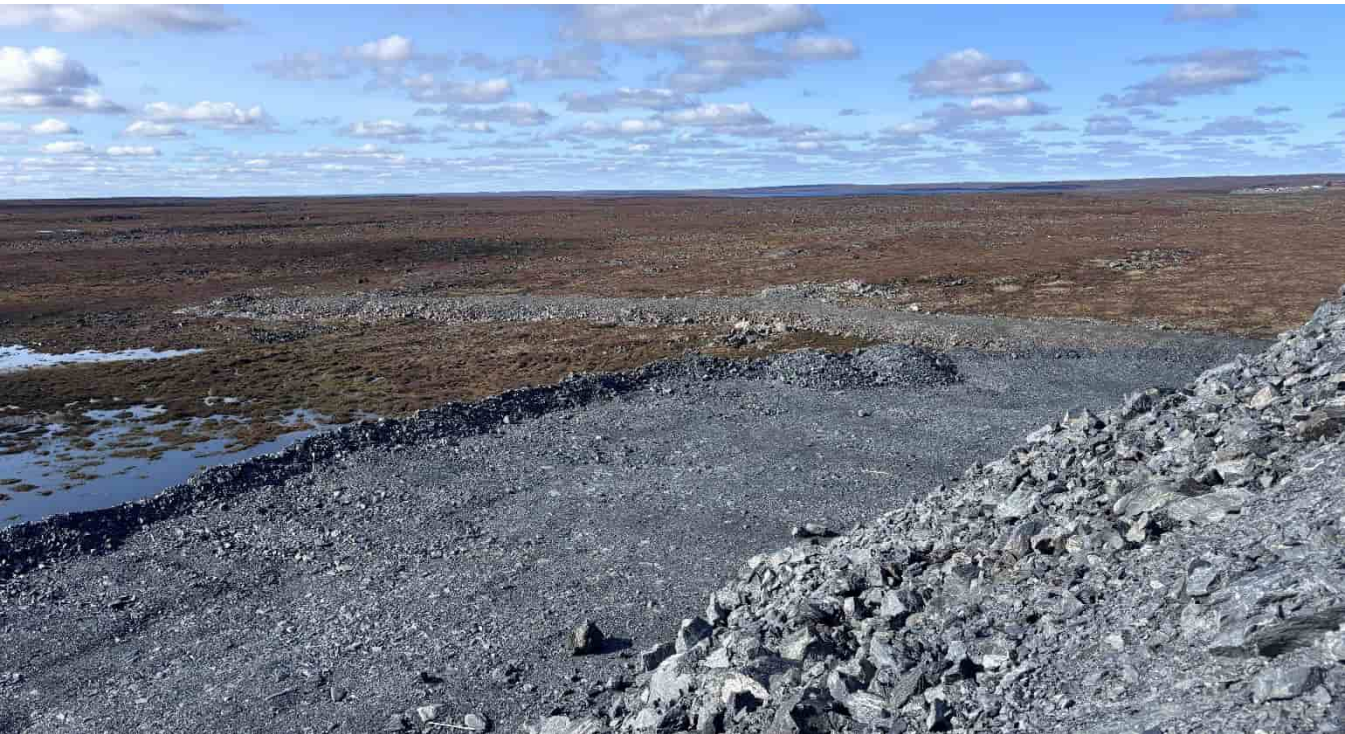
G-137: Looking SW towards Echo Diversion from waste rock storage area - ponding water on SSW end

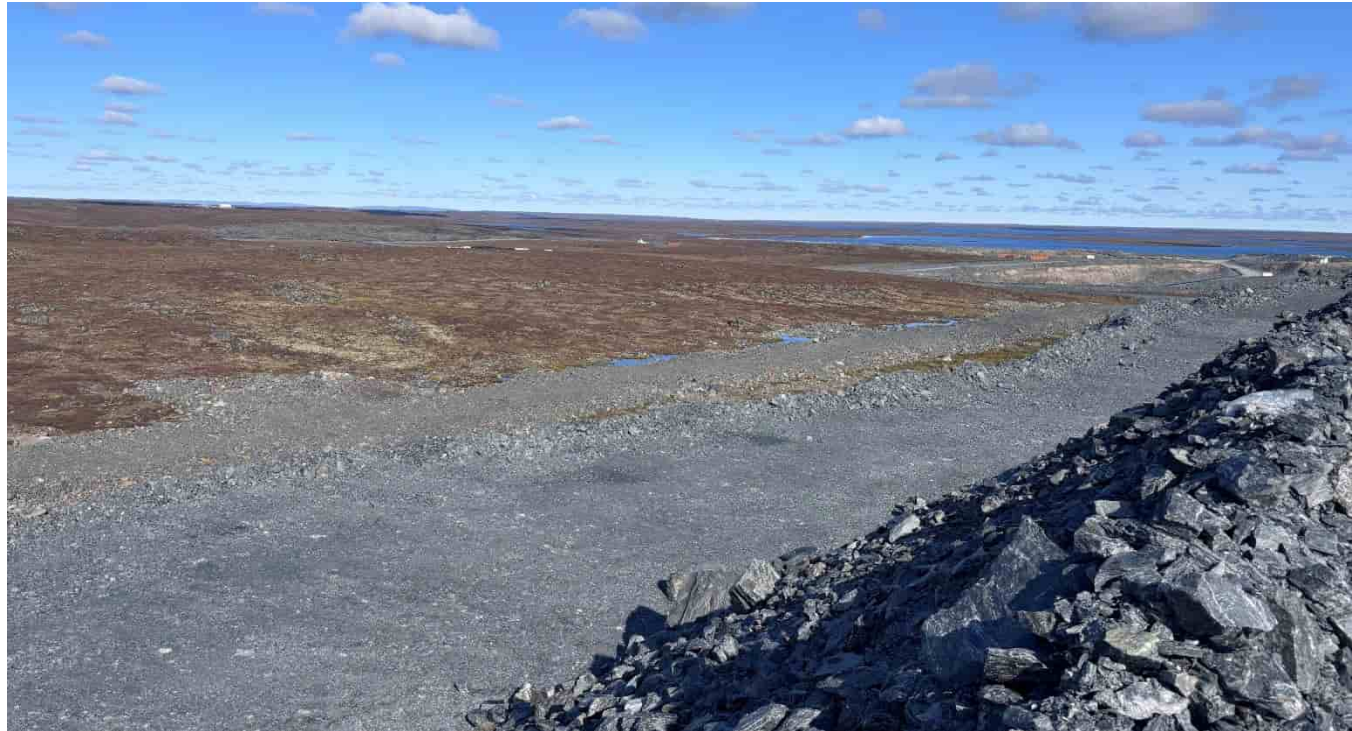
G-138: Looking N towards Echo Diversion from waste rock storage area – ponding water beside diversion and steep slope of waste rock dump

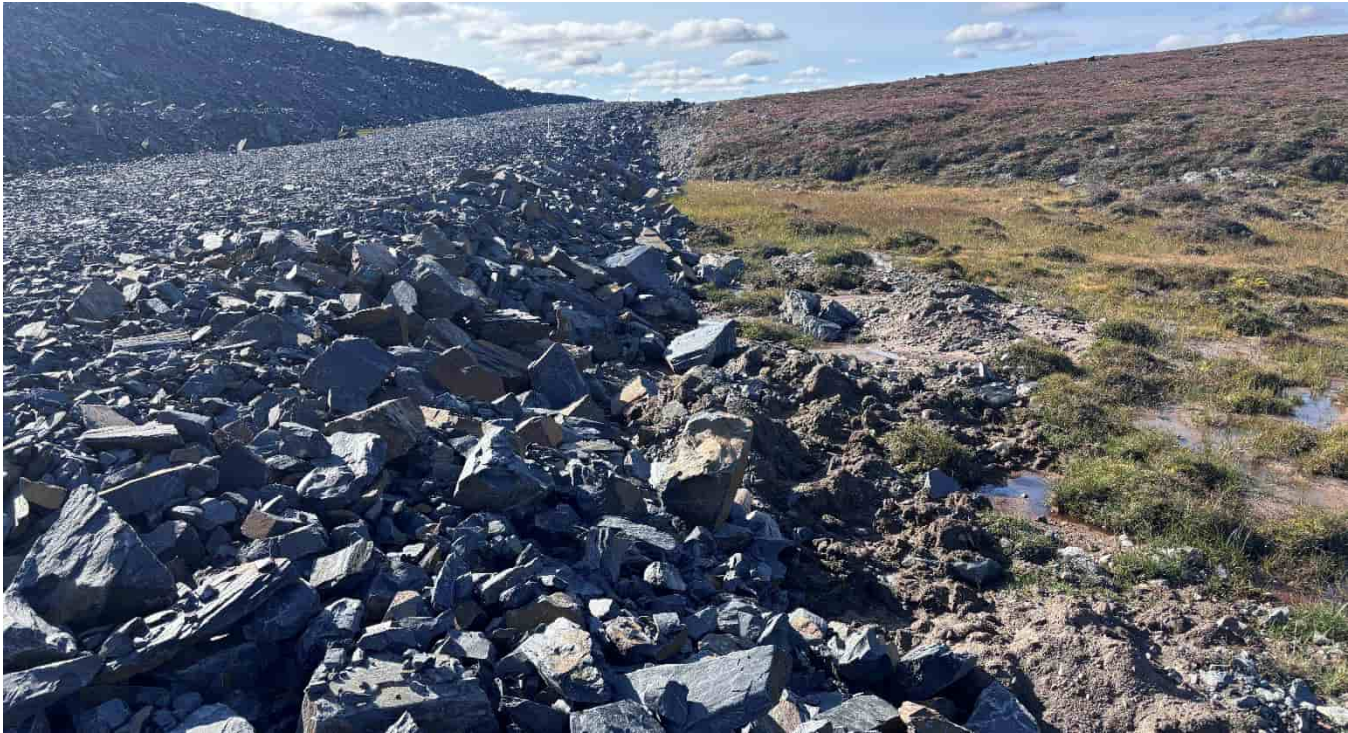
G-139: Beginning of diversion, looking SW – some ponding water

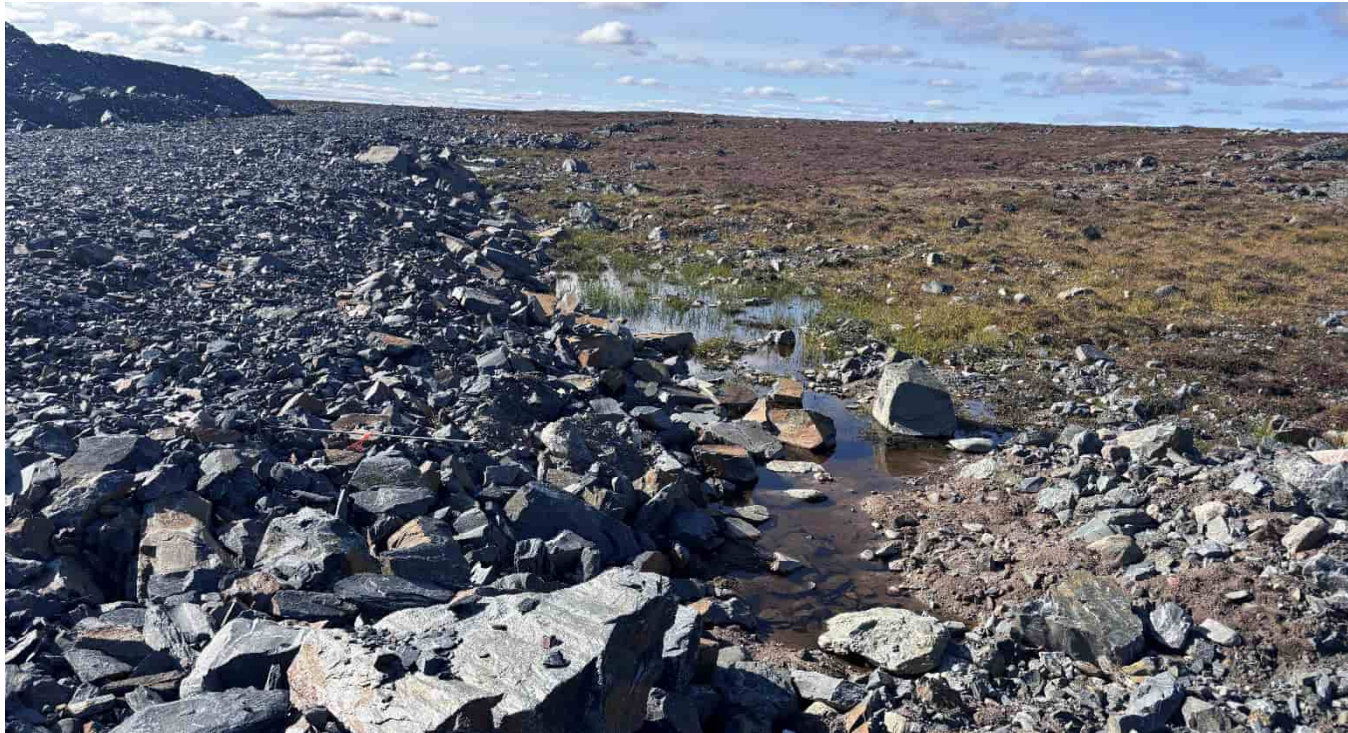
G-142: Ponding water beside diversion, looking SW – thin rockfill placements in area

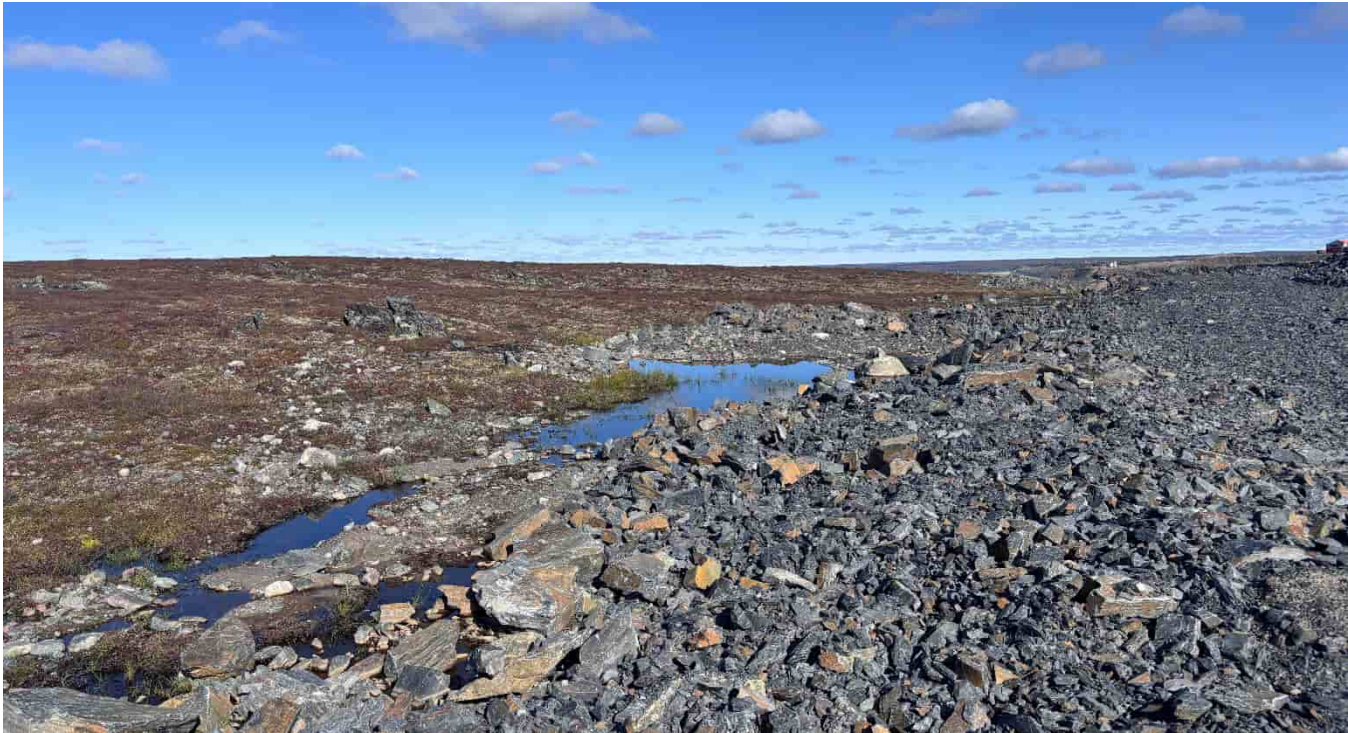
G-143: Ponding water beside diversion, looking N – undefined edge of diversion slope

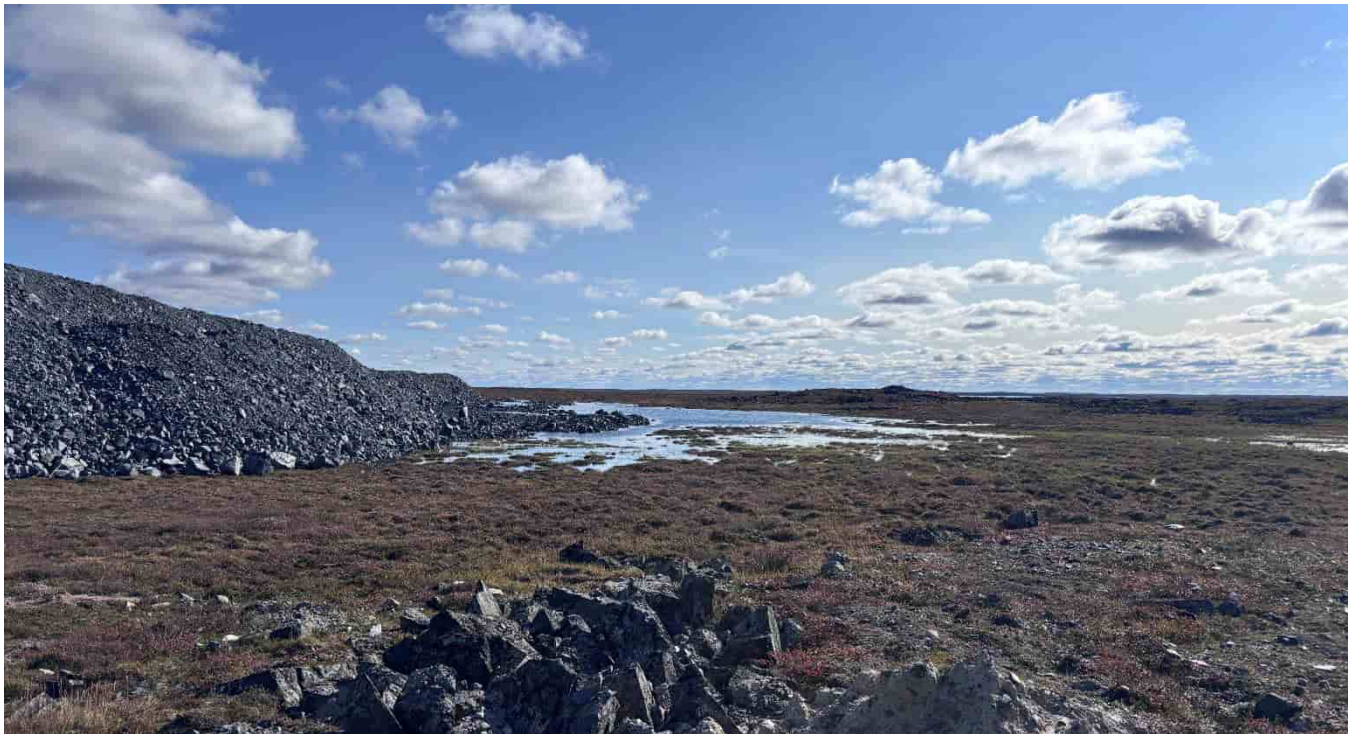
G-144: Waste rock dump in pond, as seen from diversion – Steeper slopes into ponded area

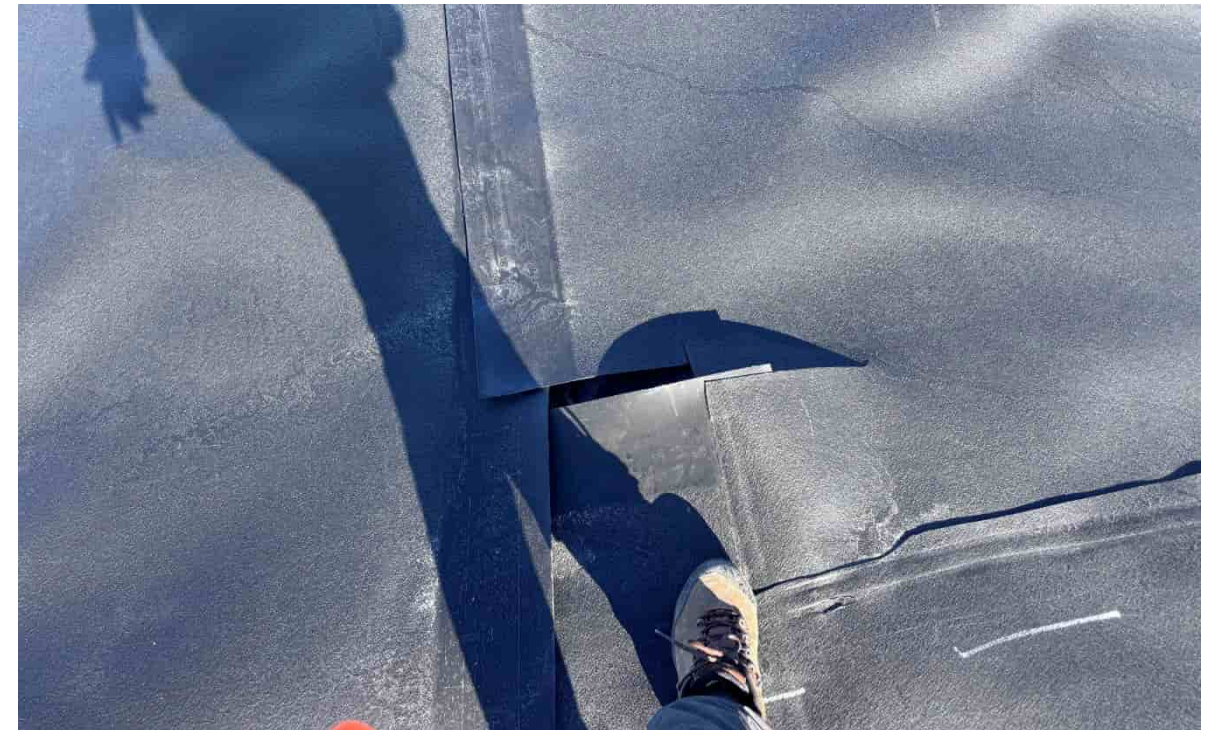
G-149: Gap in treatment pond liner – higher elevation

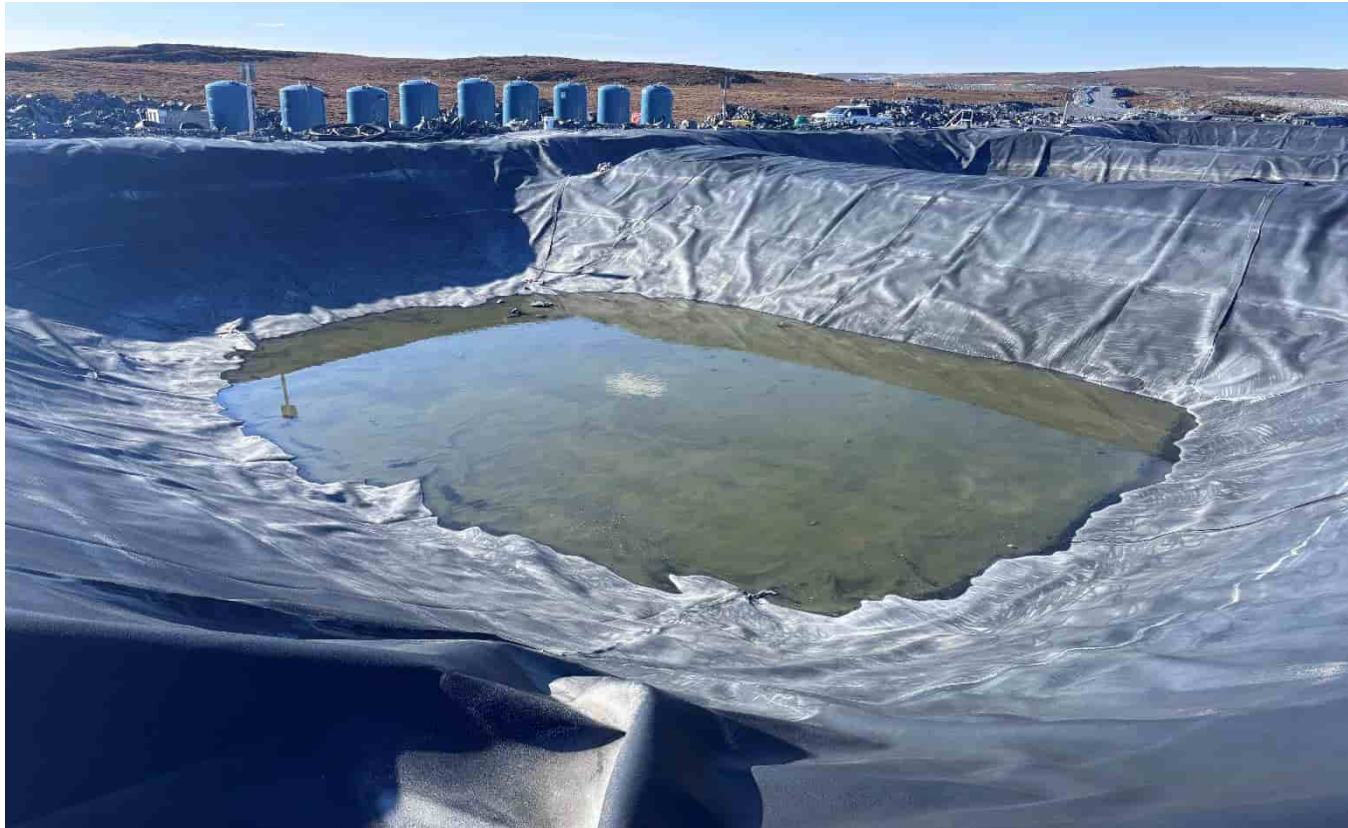
G-150: Treatment pond cell

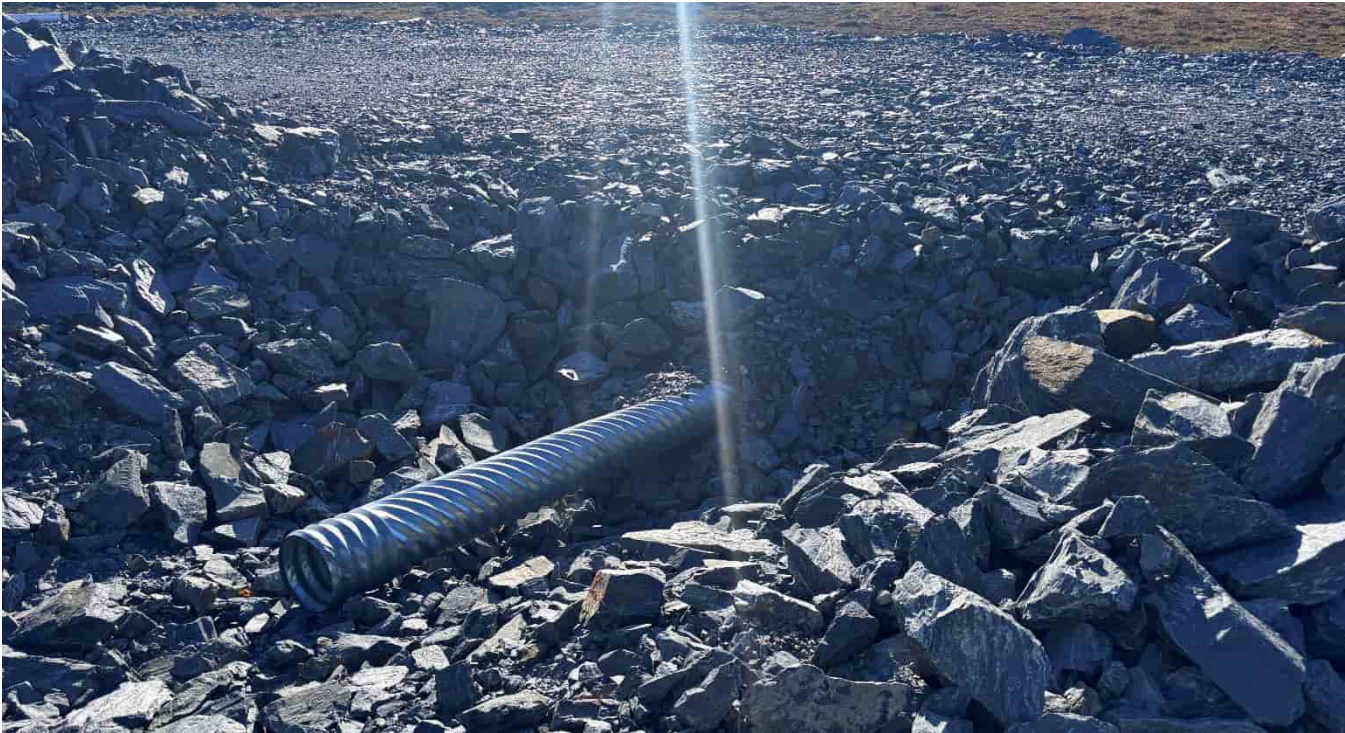
G-157: Culvert underneath pad

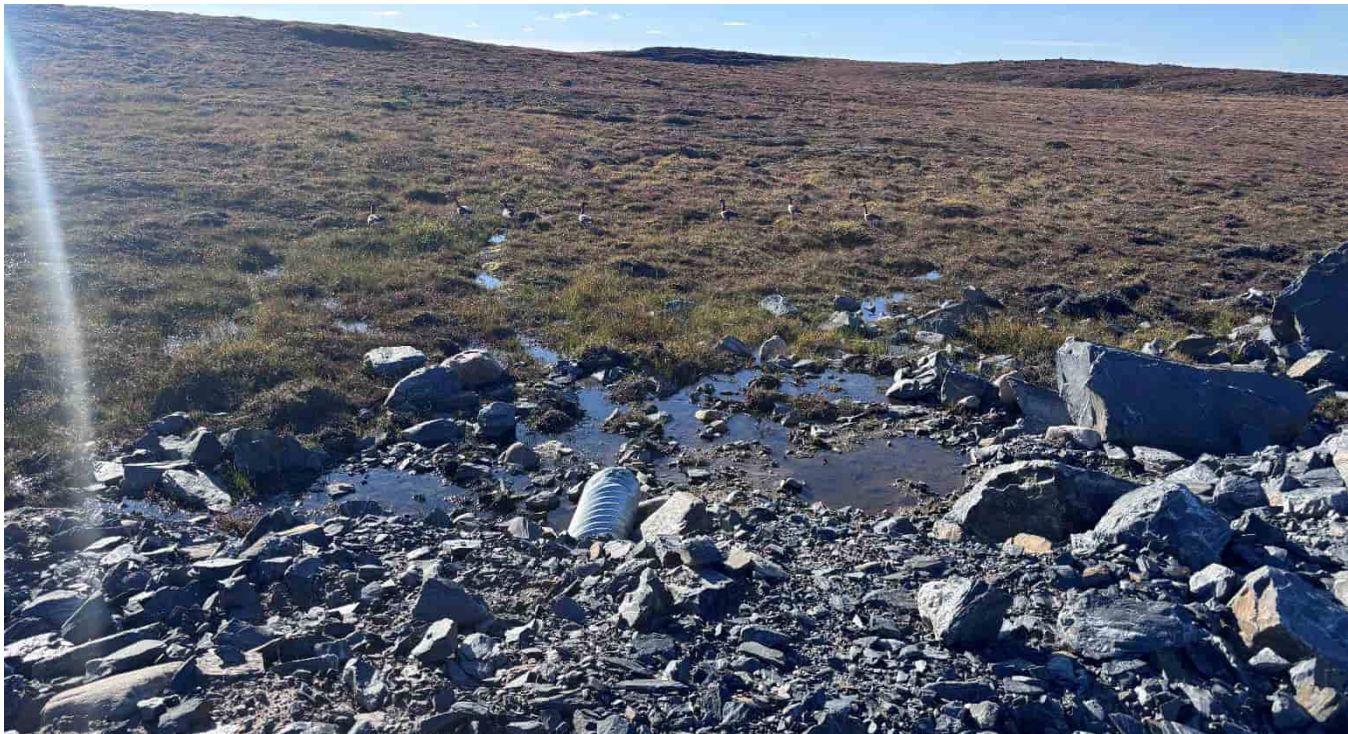
G-158: Downstream of small culvert, looking W

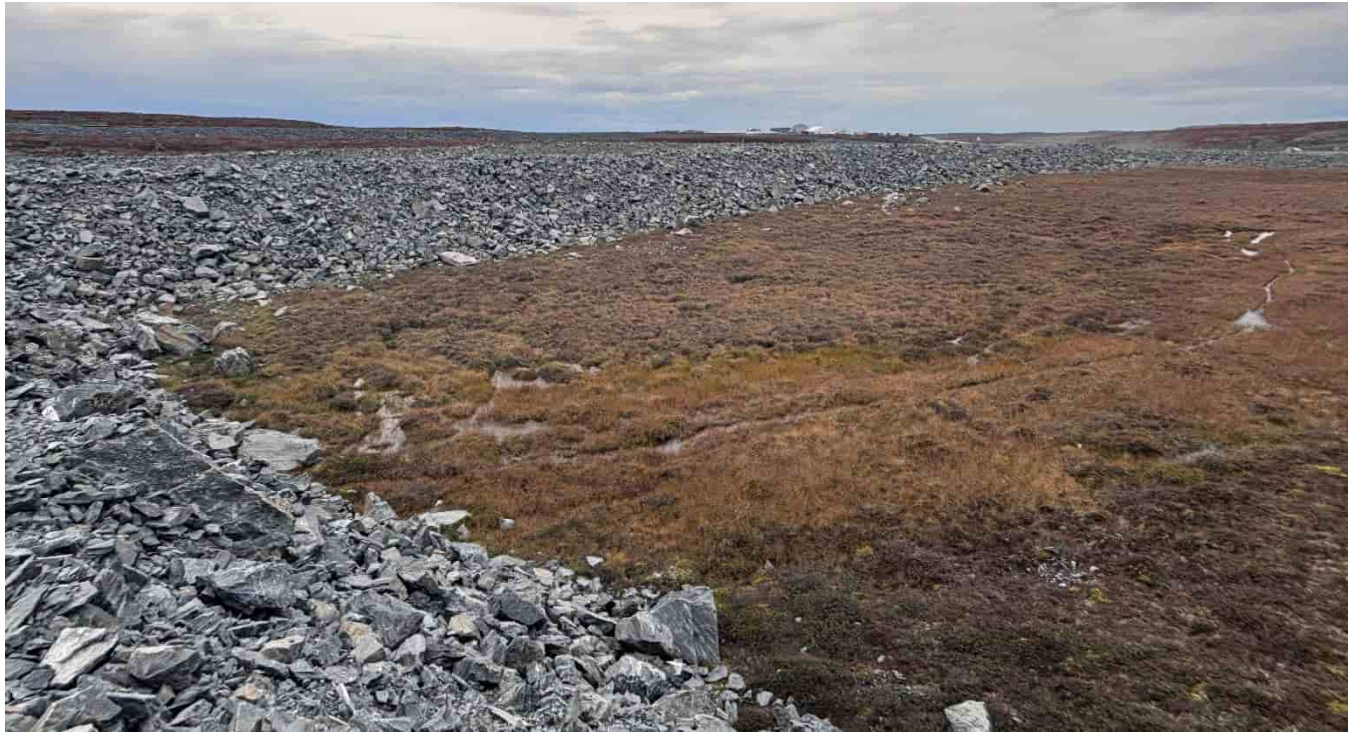
G-172: Tire pad and road rockfill, facing W – minor ephemeral stream flow

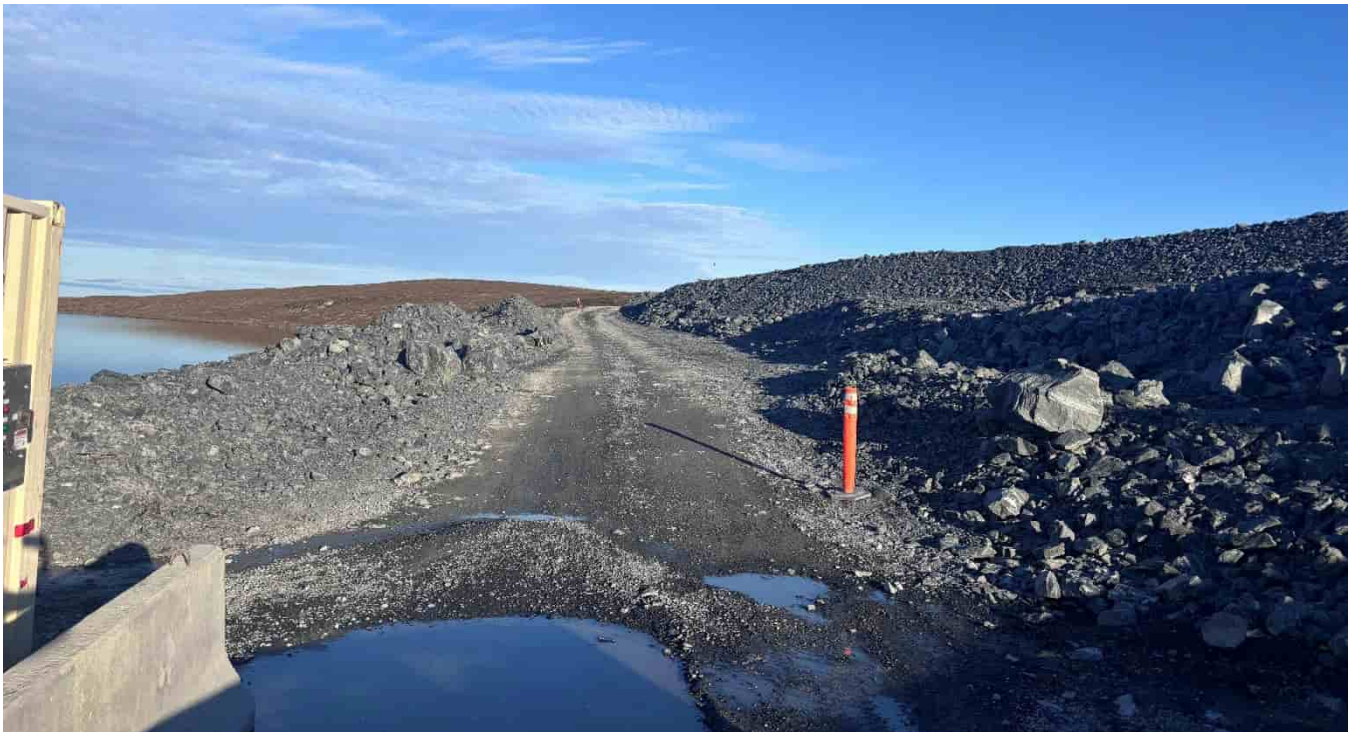
G-177: Barge access road, looking E – Note ponding water

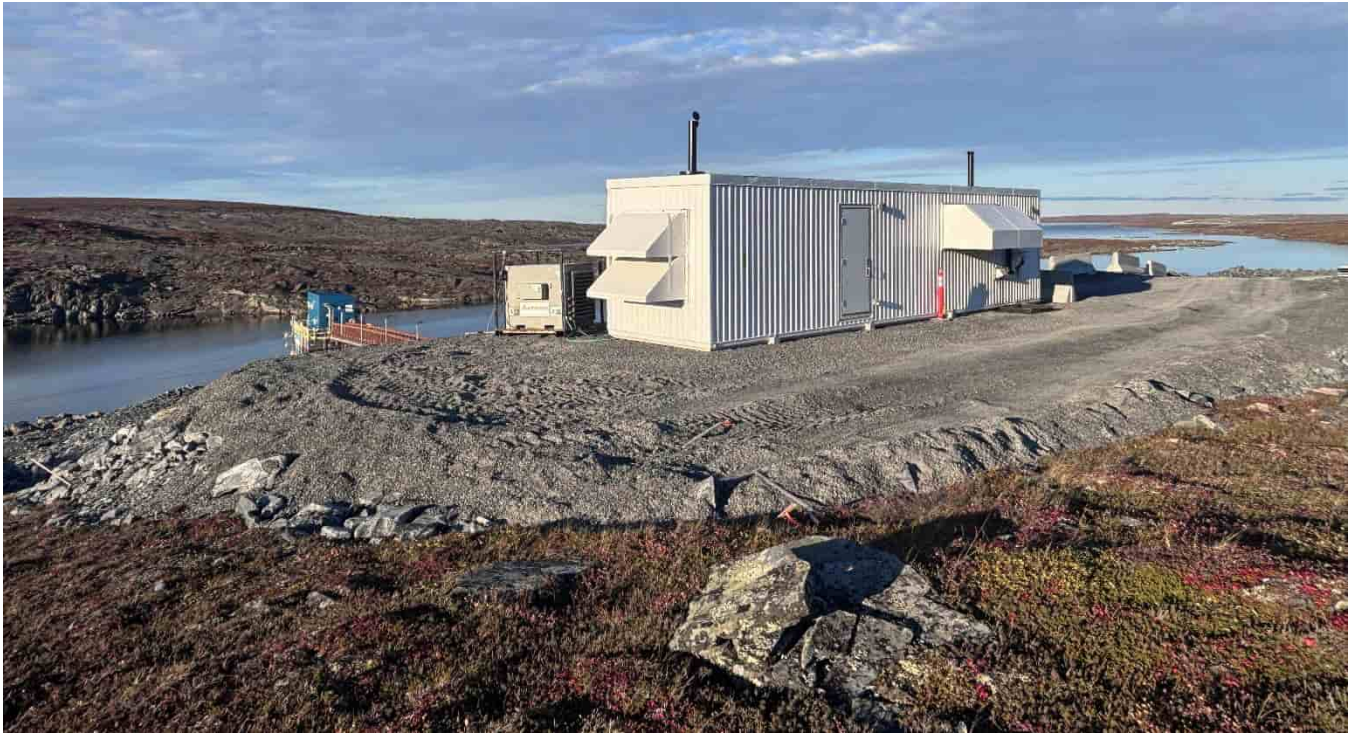
G-179: Highest pad above barge access road – pad approximately daylighting into slope

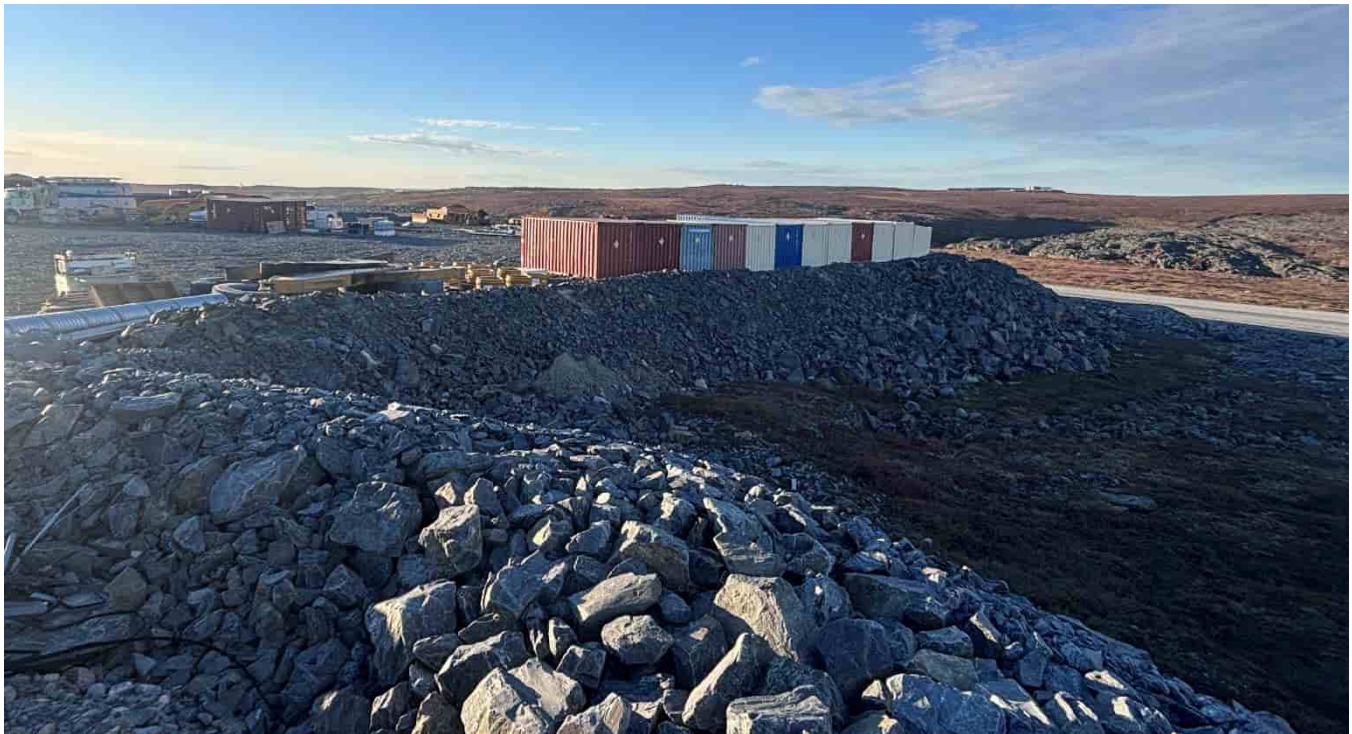
G-193: Laydown area N of Sandvik
