# Goose & MLA Project Sites – 2025 Annual Geotechnical Inspection

Back River Project, Nunavut, Canada  
B2Gold Back River Corp.

SRK Consulting (Canada) Inc. ■ CAPR004312 ■ March 2026

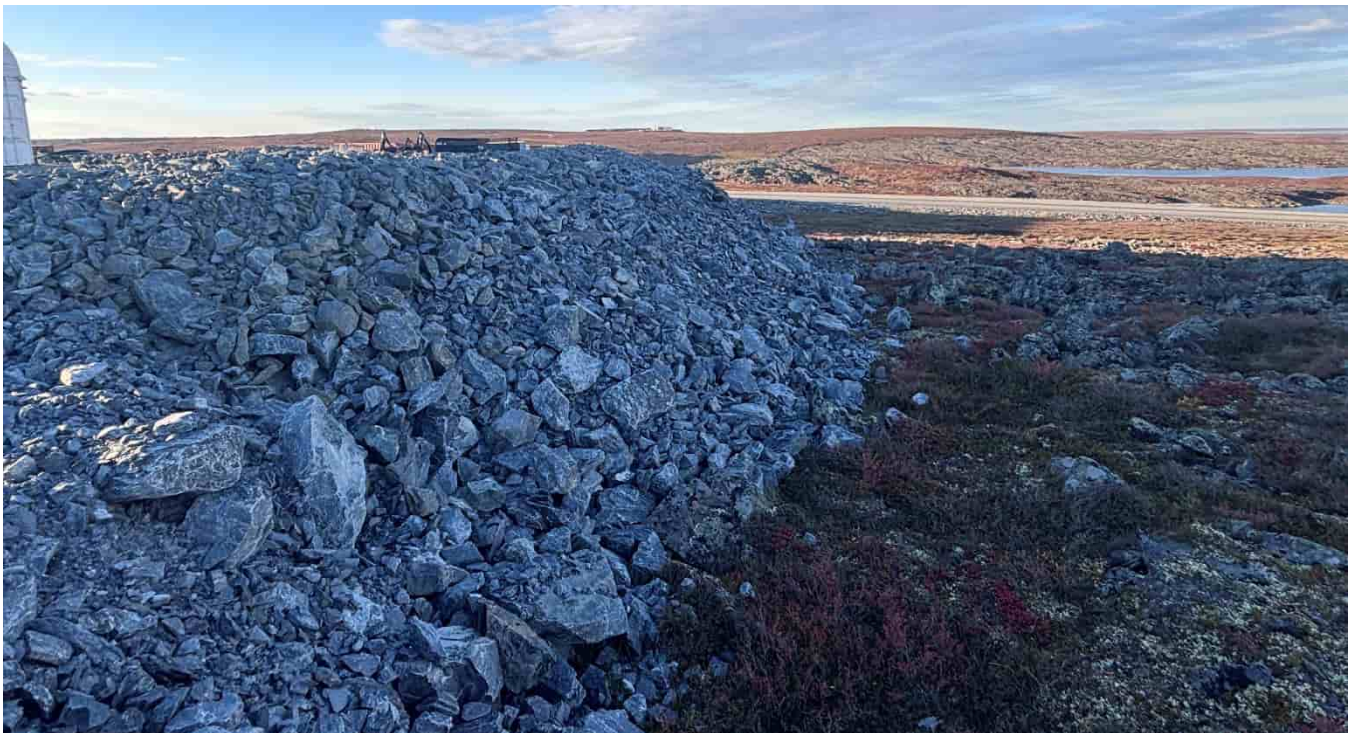
G-194: Laydown area N of Sandvik

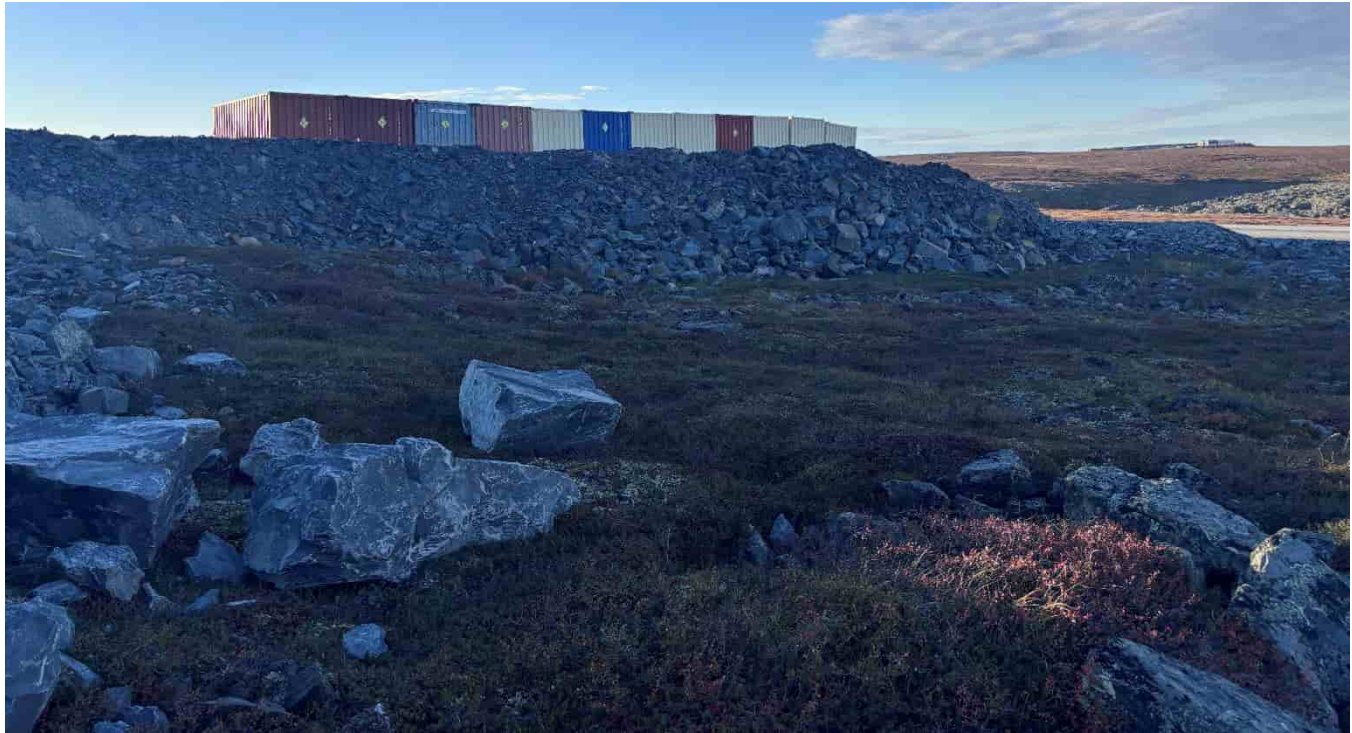
G-195: Pad slope beside Sandvik, looking N

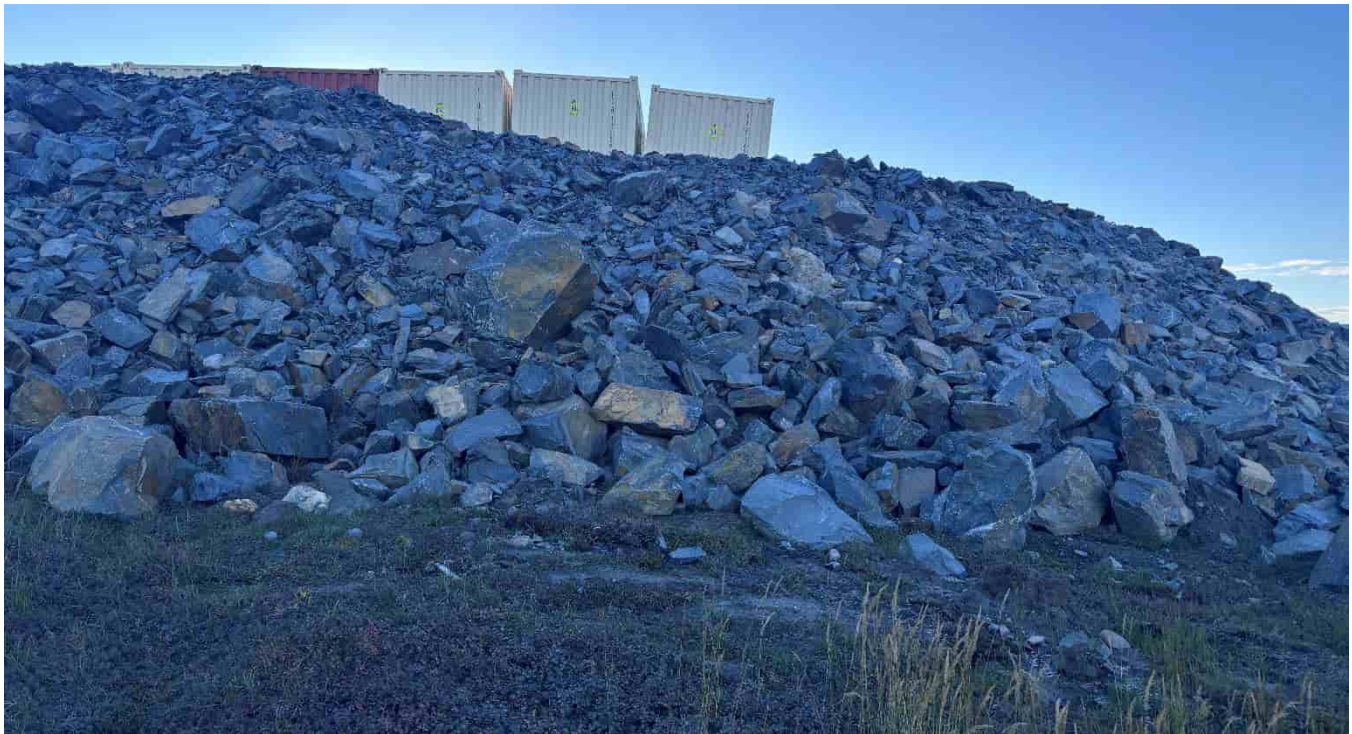
G-197: Slope beside Sandvik, looking SW

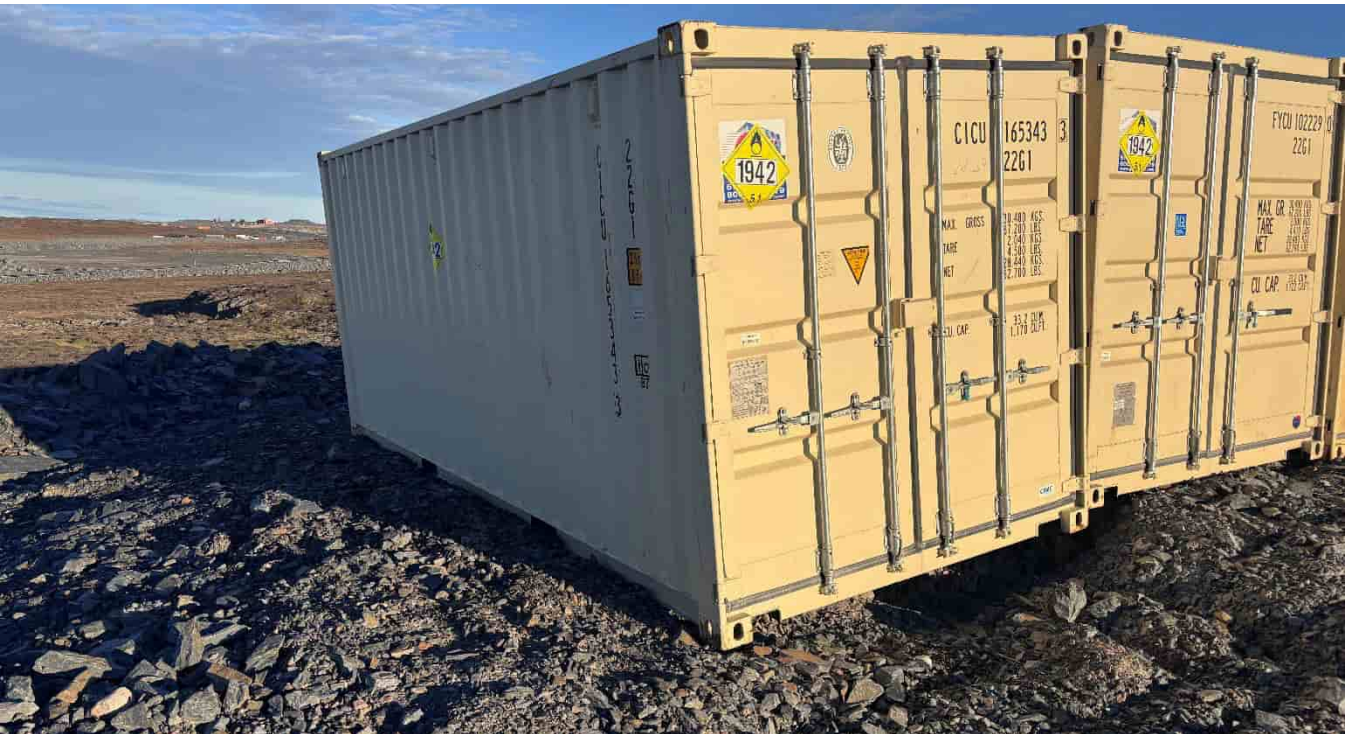
G-198: Slope beside laydown, facing W – Note differential settlement of northernmost seacan

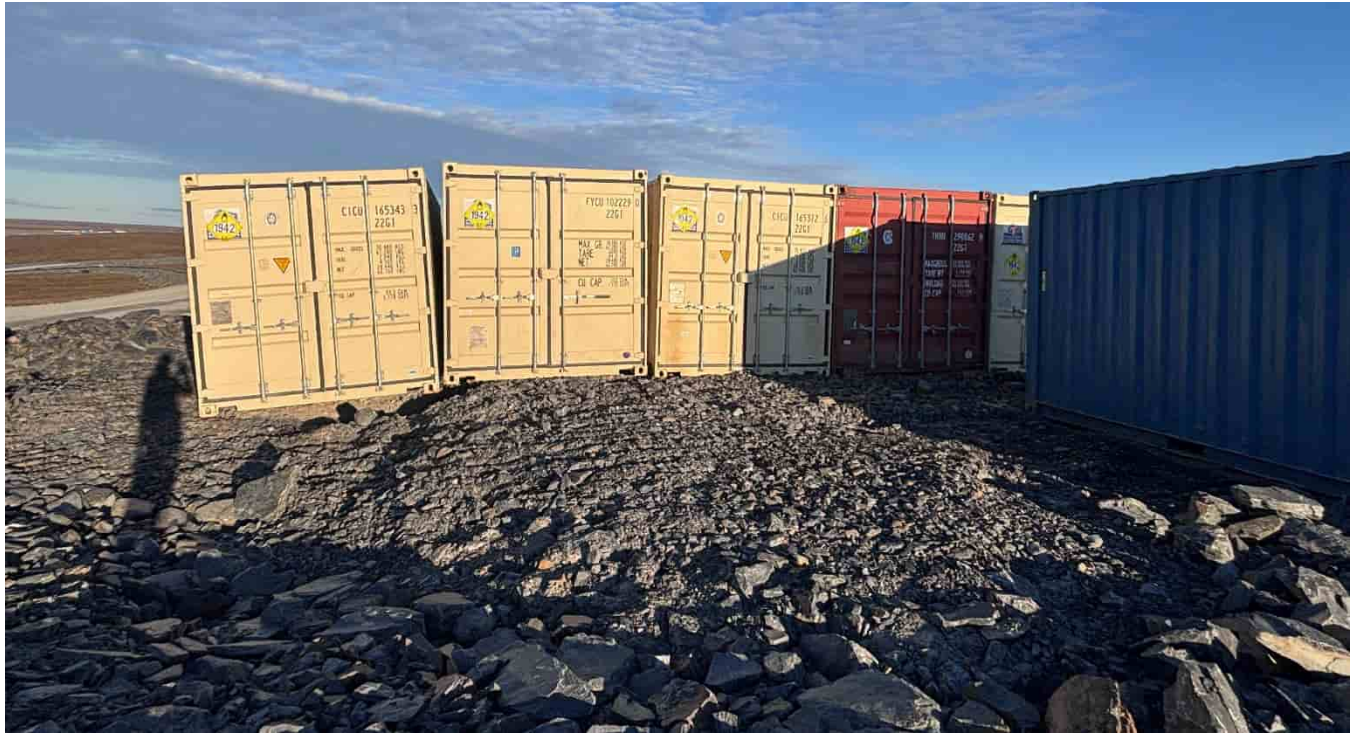
G-199: Differential settlement of northernmost seacan in Sandvik laydown area

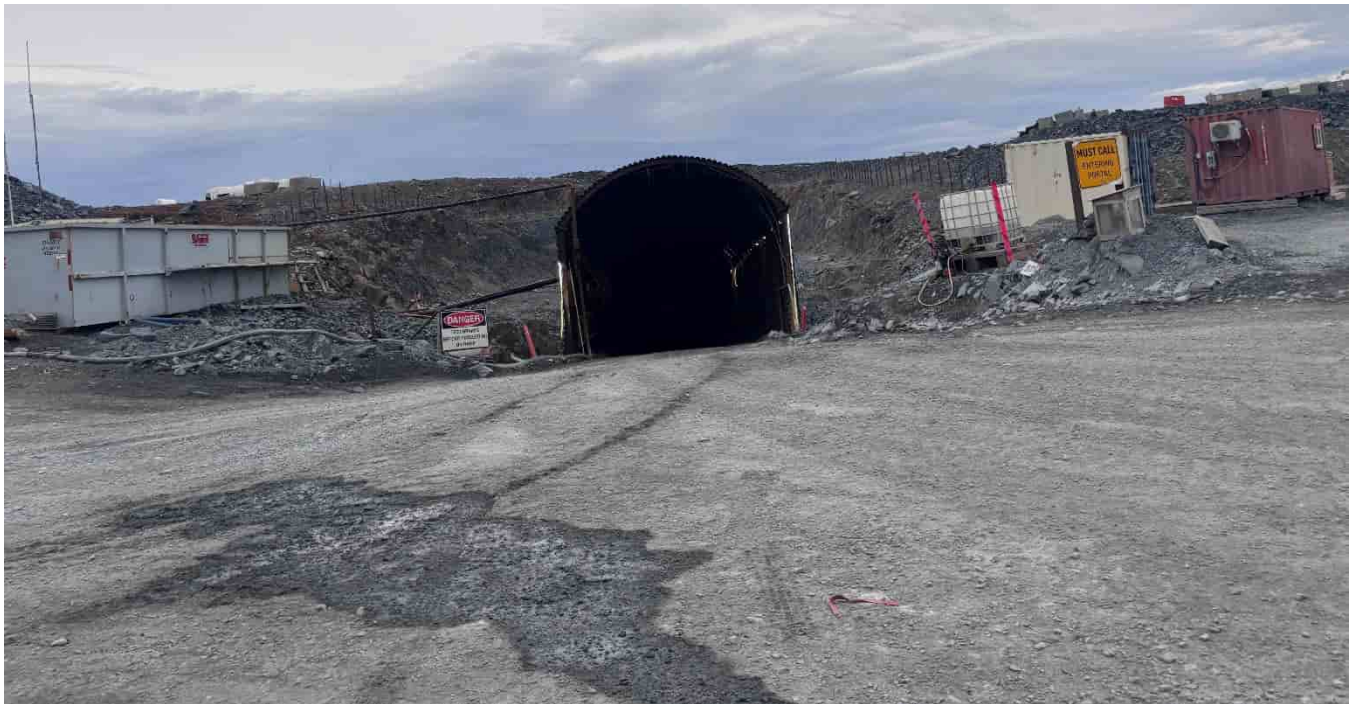
G-201: Maintenance laydown, looking S

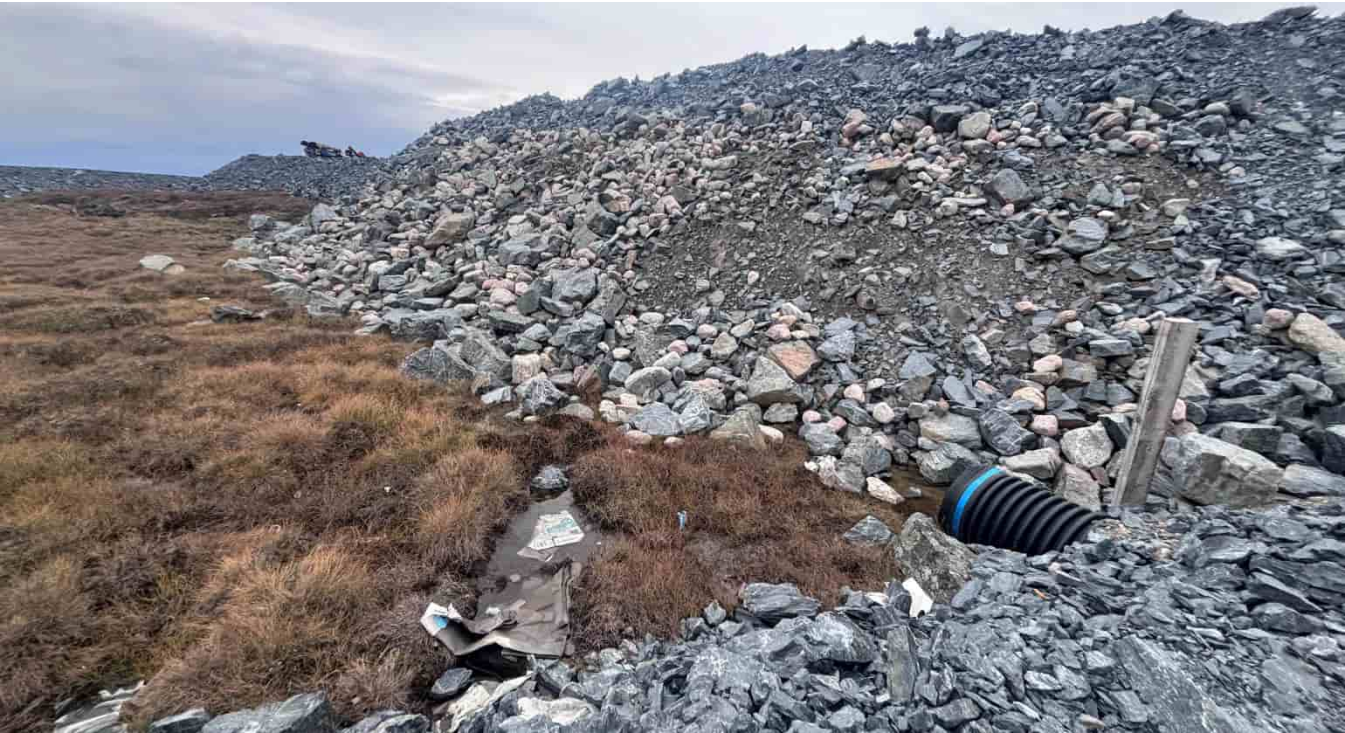
G-204: Access road to cemented rockfill laydown and ROM stockpile

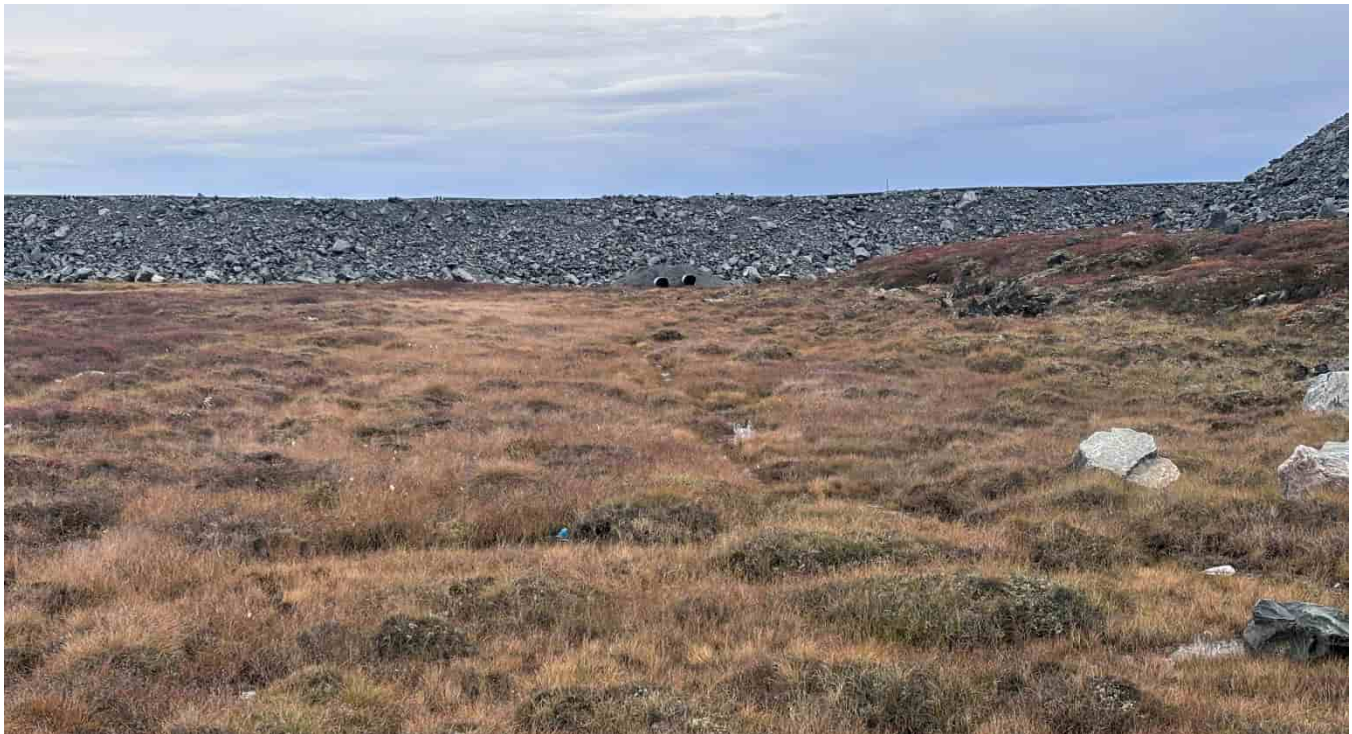
G-205: Road rockfill – culvert inlet behind pad (outlet in pad rockfill)

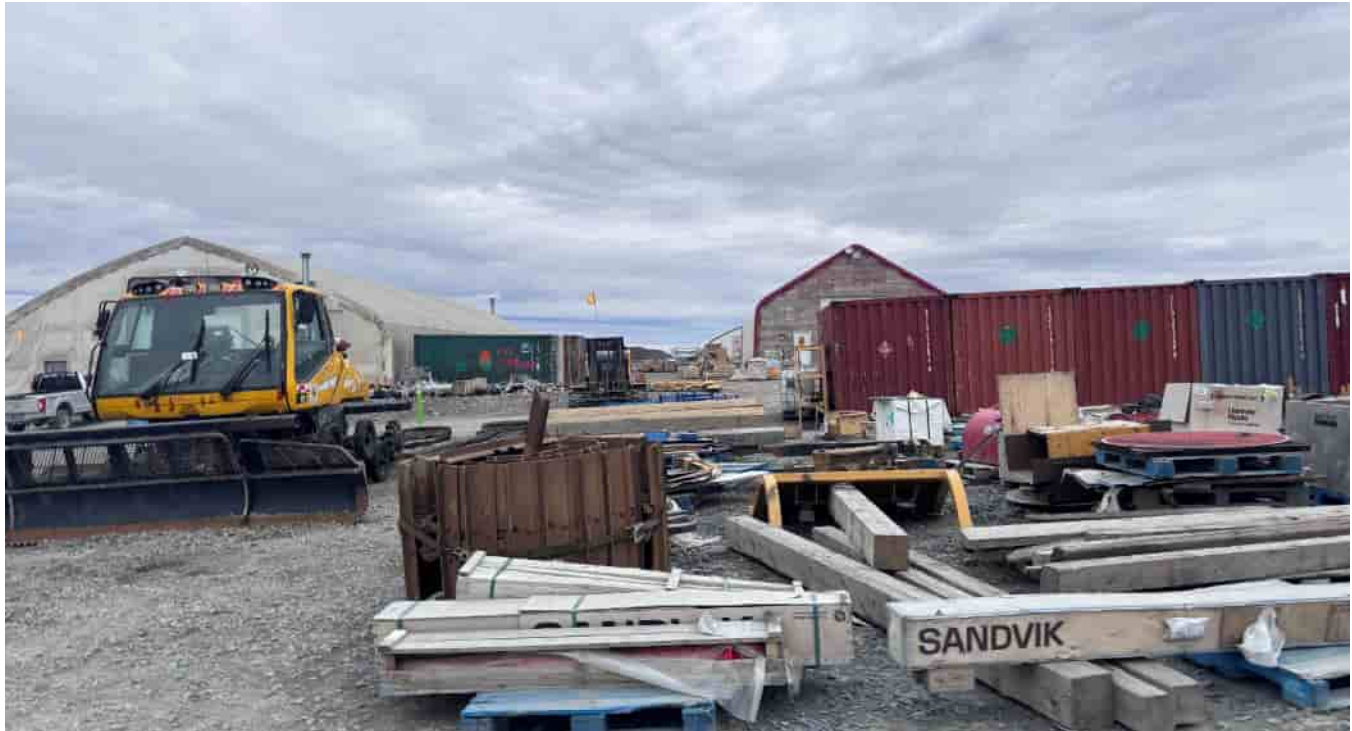
G-208: Maintenance warehouse and laydown

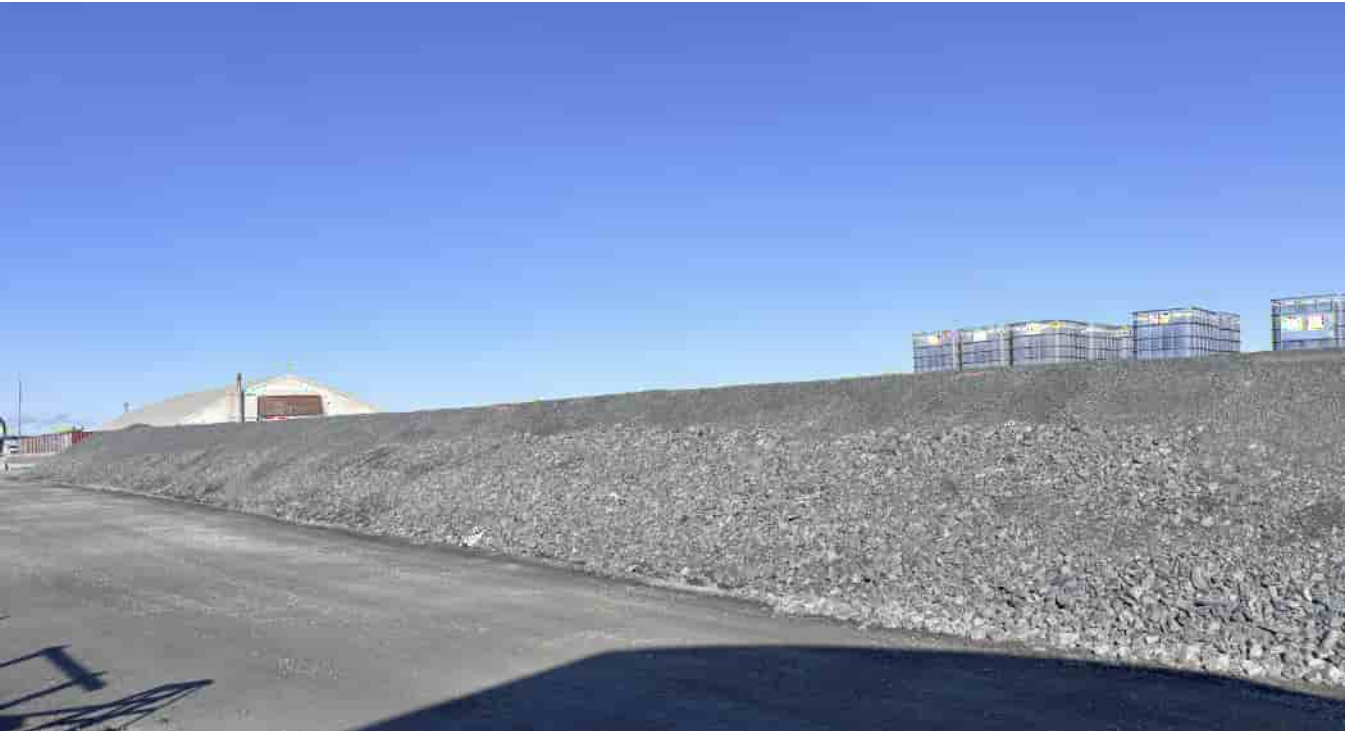
G-209: Tote Storage Facility: Southern berm

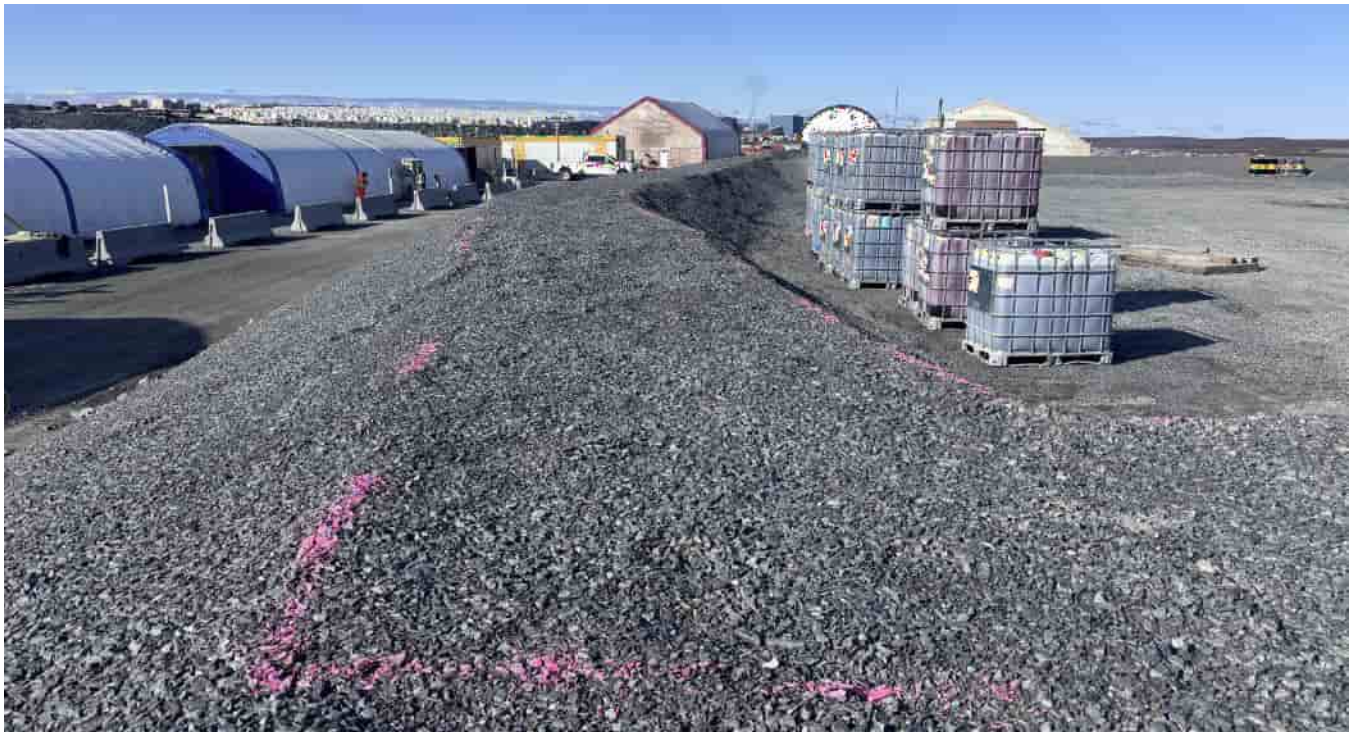
G-210: Tote Storage Facility: Crest of the southern berm, looking NW

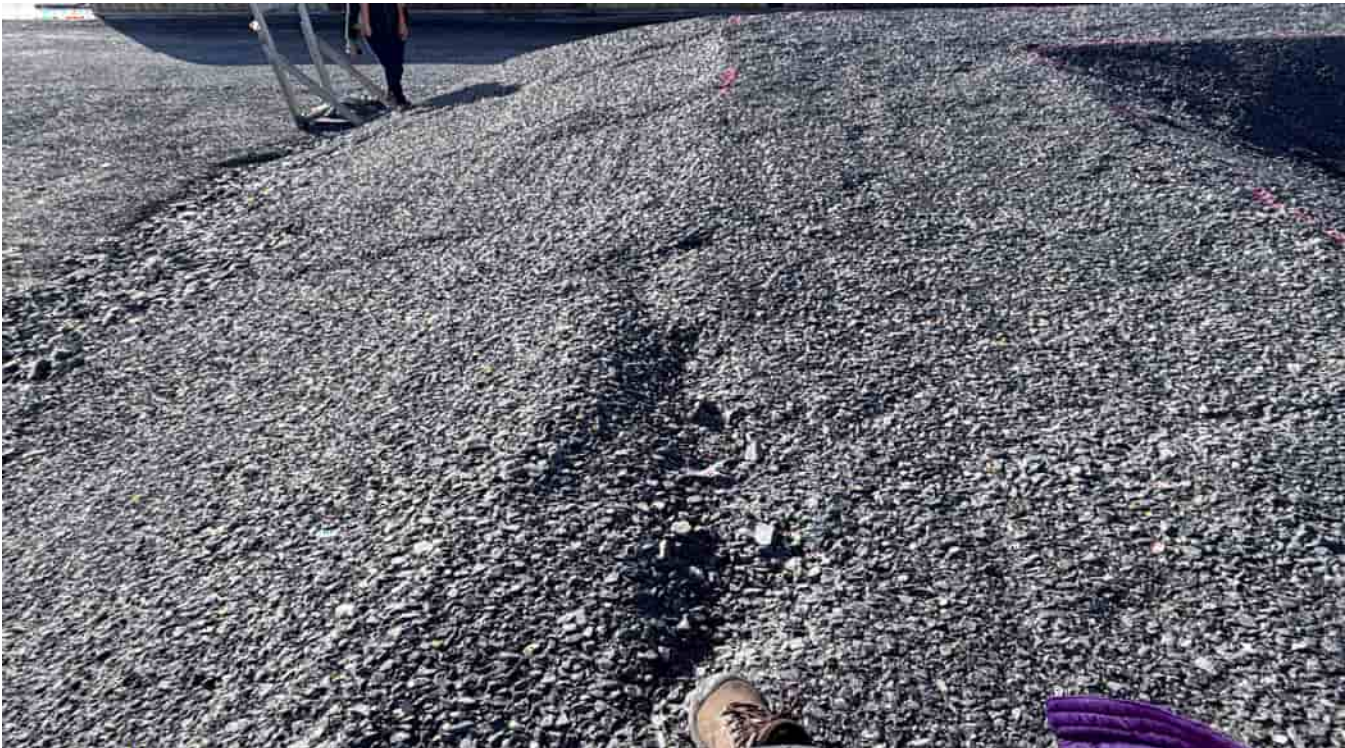
G-211: Tote Storage Facility: SE corner

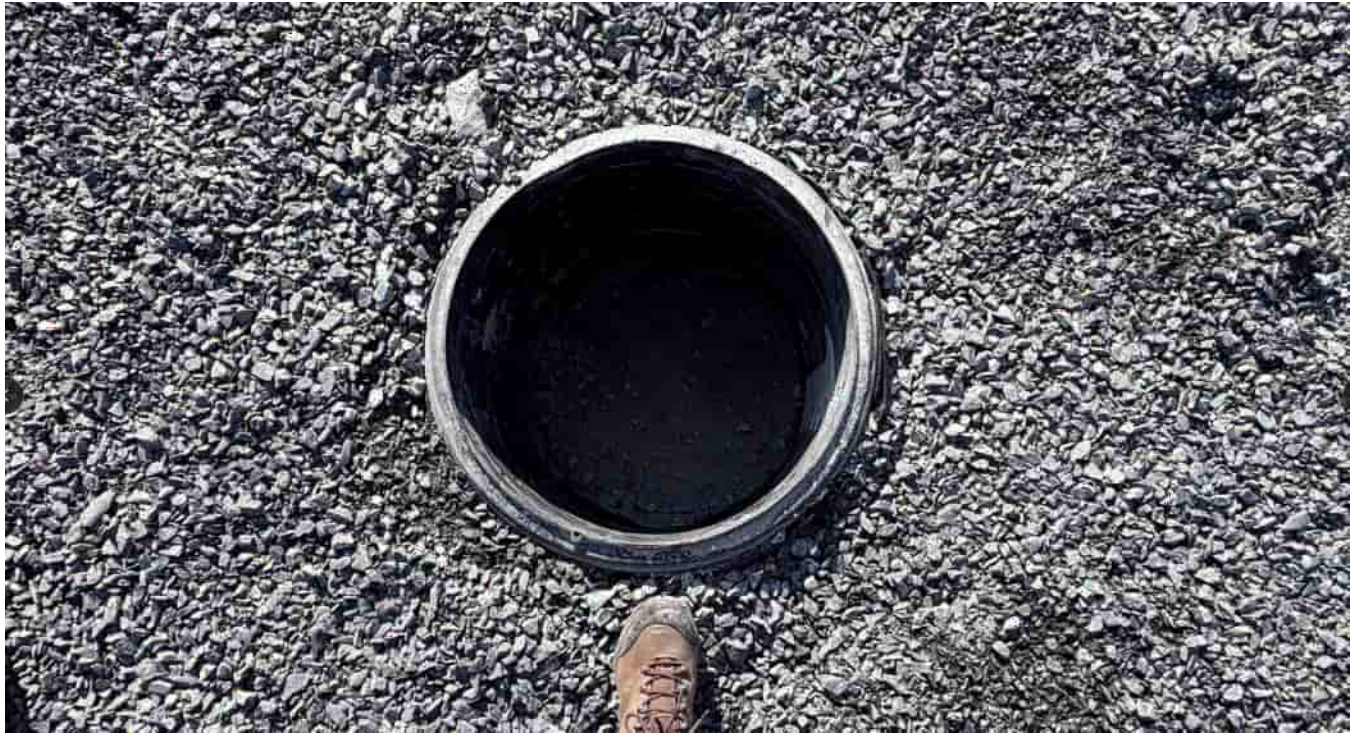
G-212: Tote Storage Facility: sump

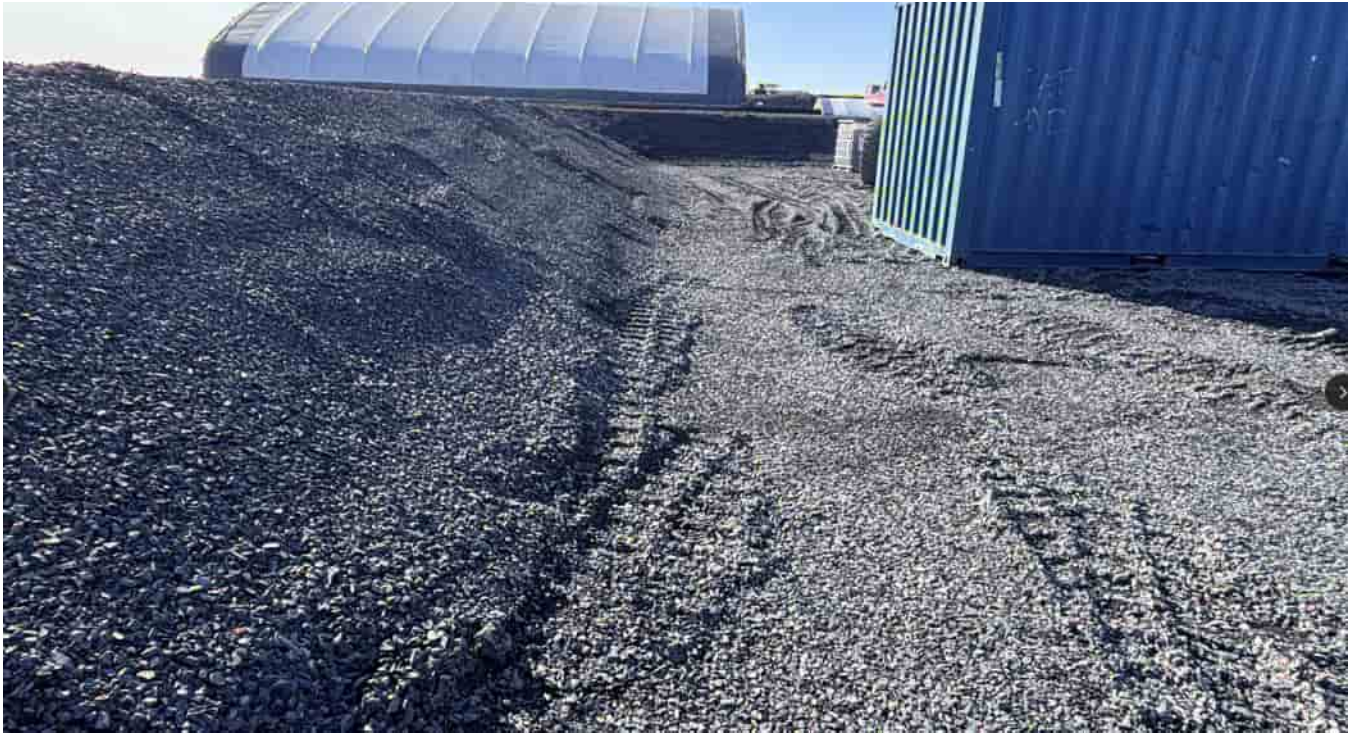
G-213: Tote Storage Facility: Toe of the eastern berm, looking E

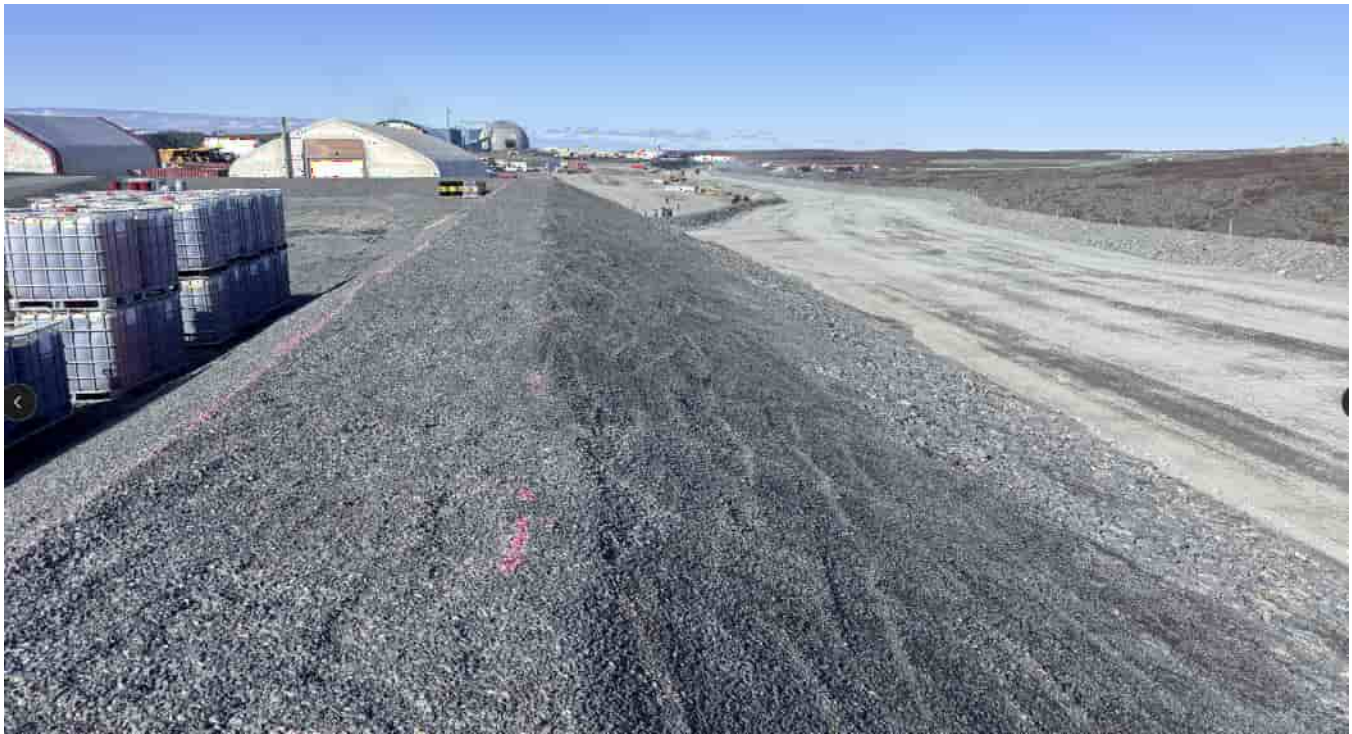
G-214: Tote Storage Facility: Crest and side of the northern berm, looking NW

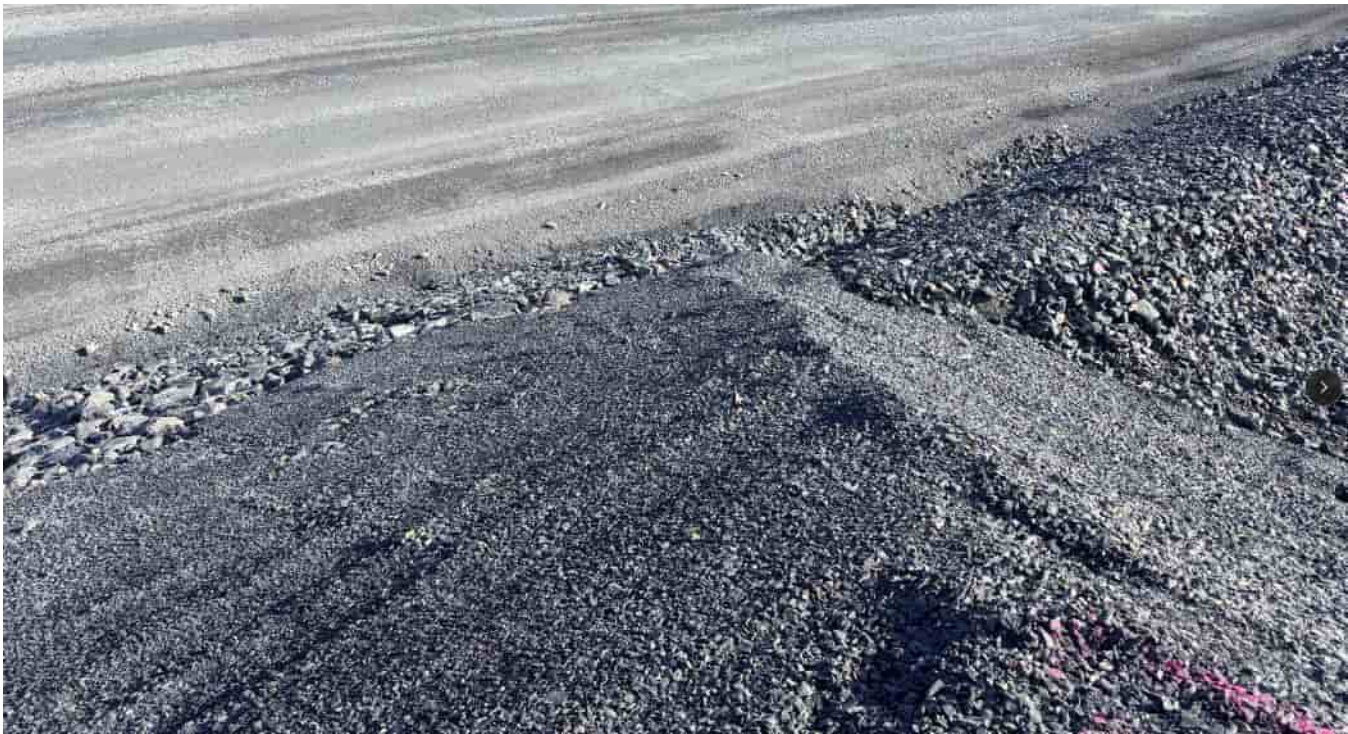
G-215: Tote Storage Facility: Northern berm, looking N form the berm crest

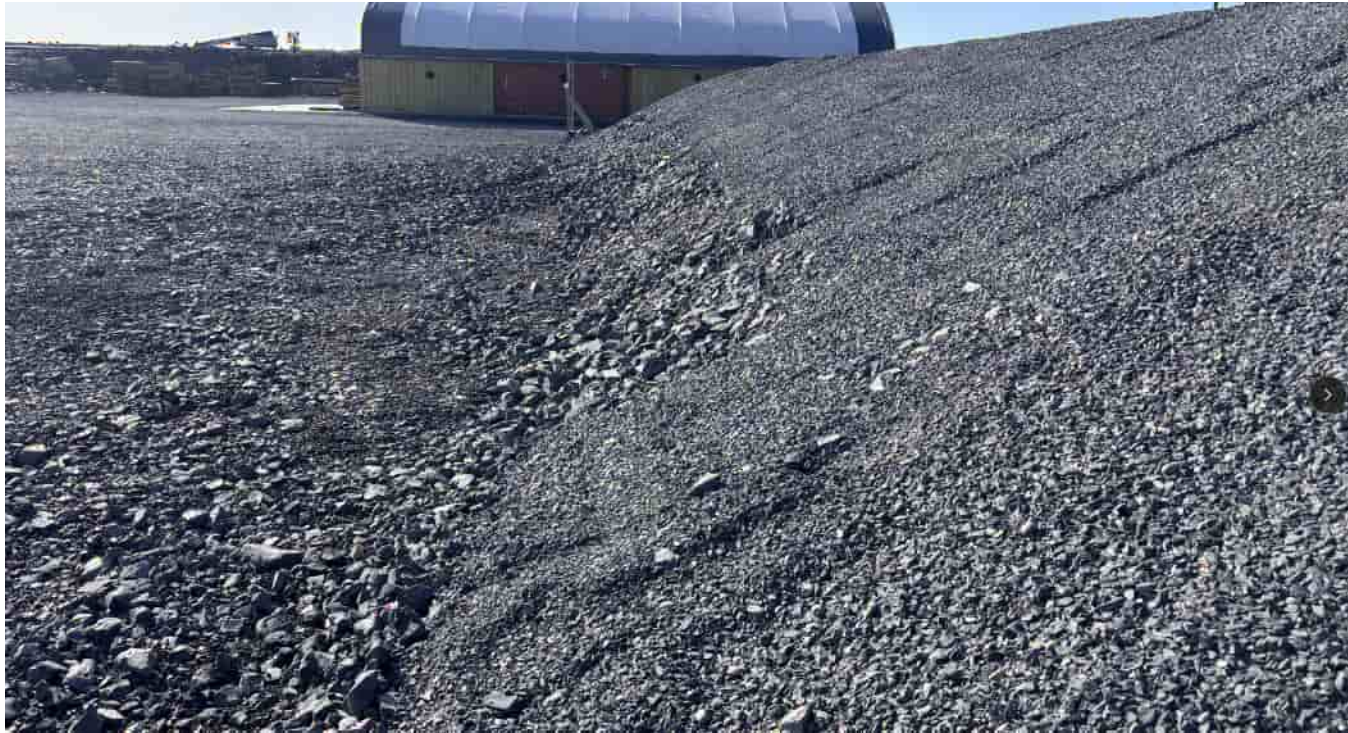
G-216: Tote Storage Facility: Toe of the eastern berm

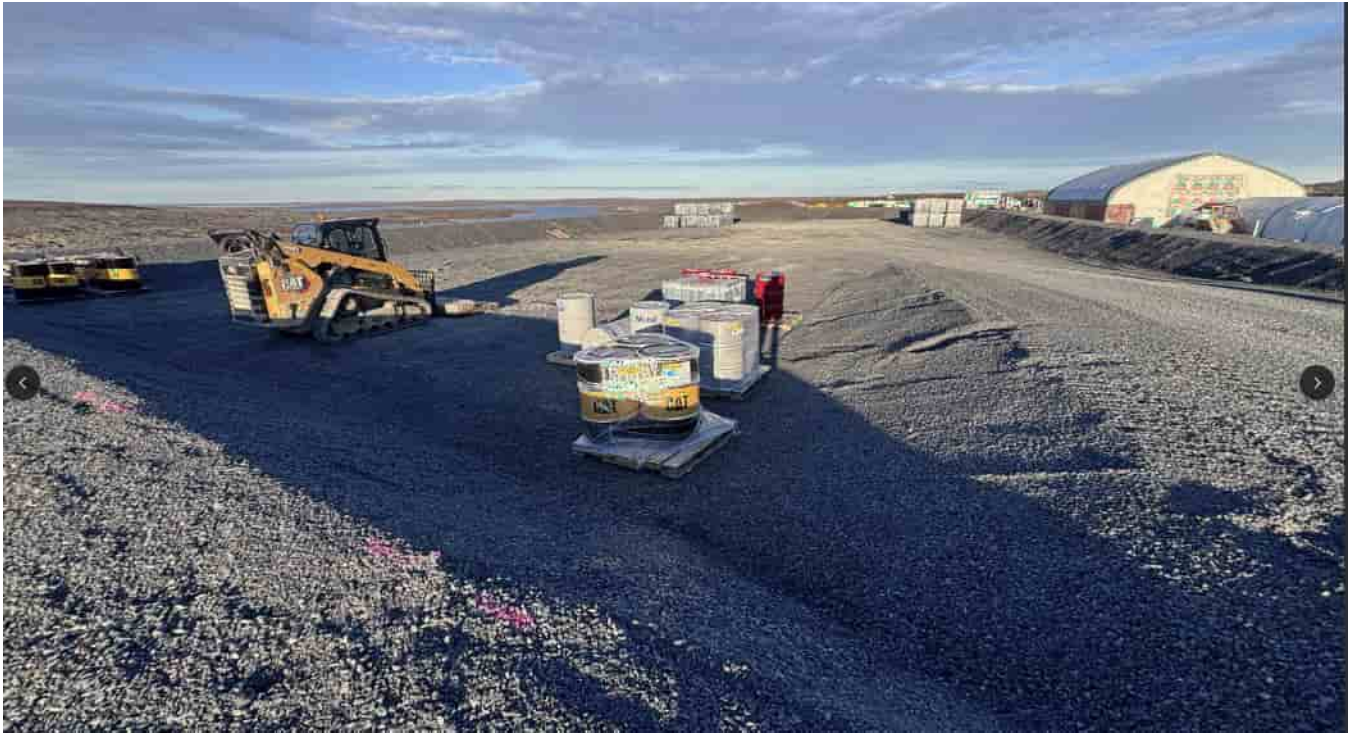
G-217: Tote Storage Facility, looking E

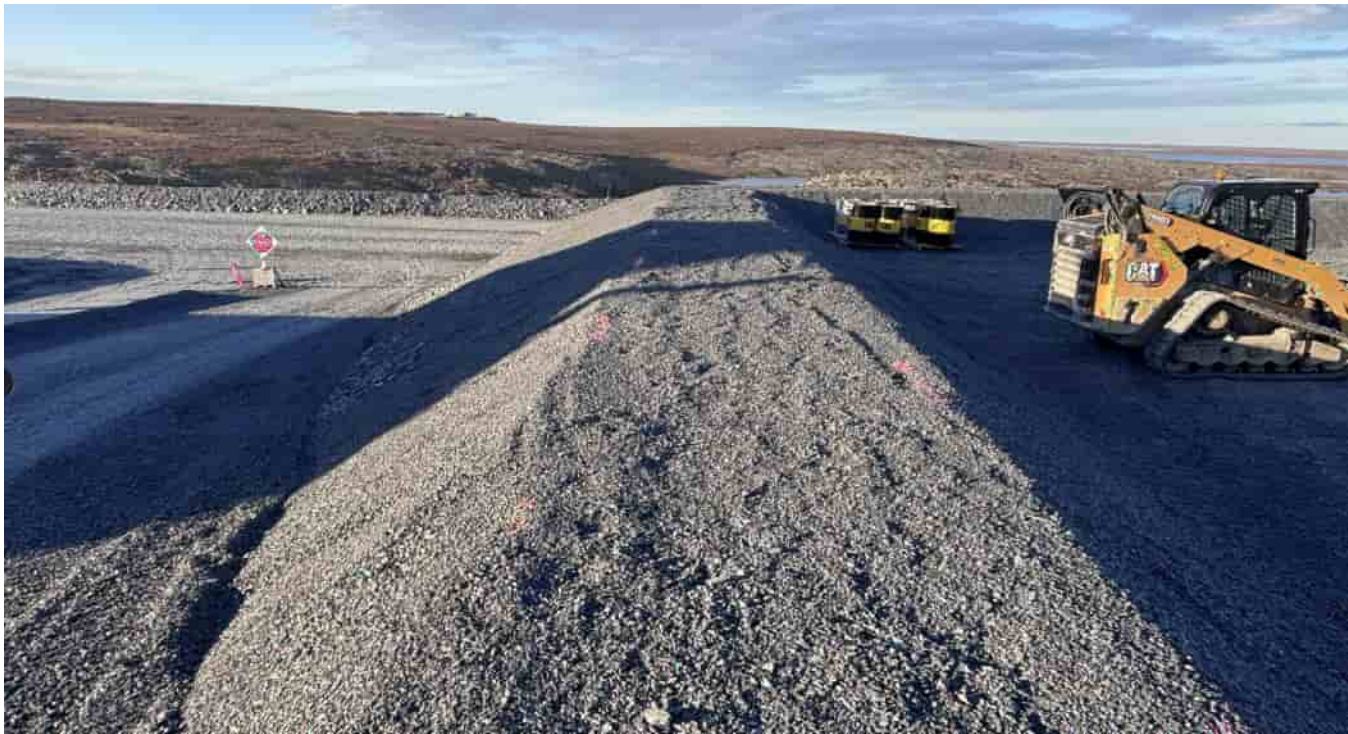
G-218: Tote Storage Facility: Western berm, looking N

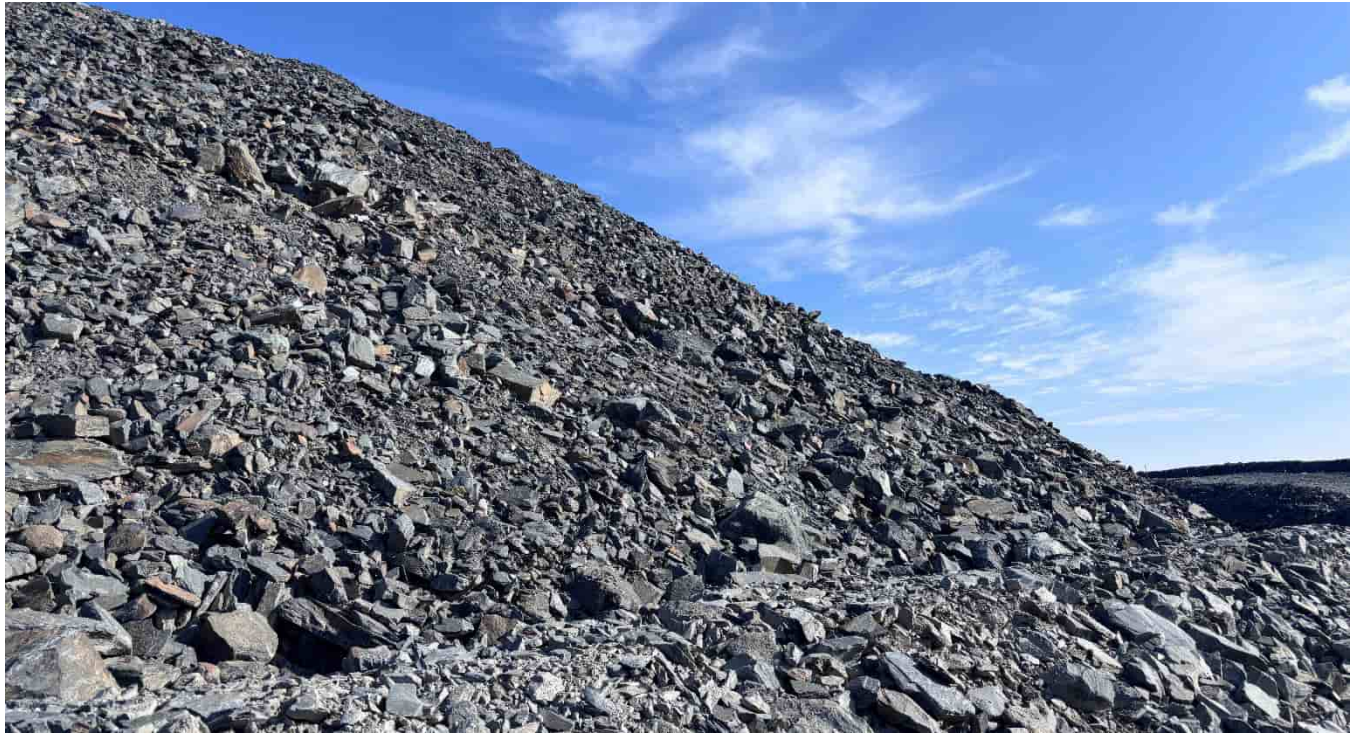
G-219: ROM stockpile typical slope above road

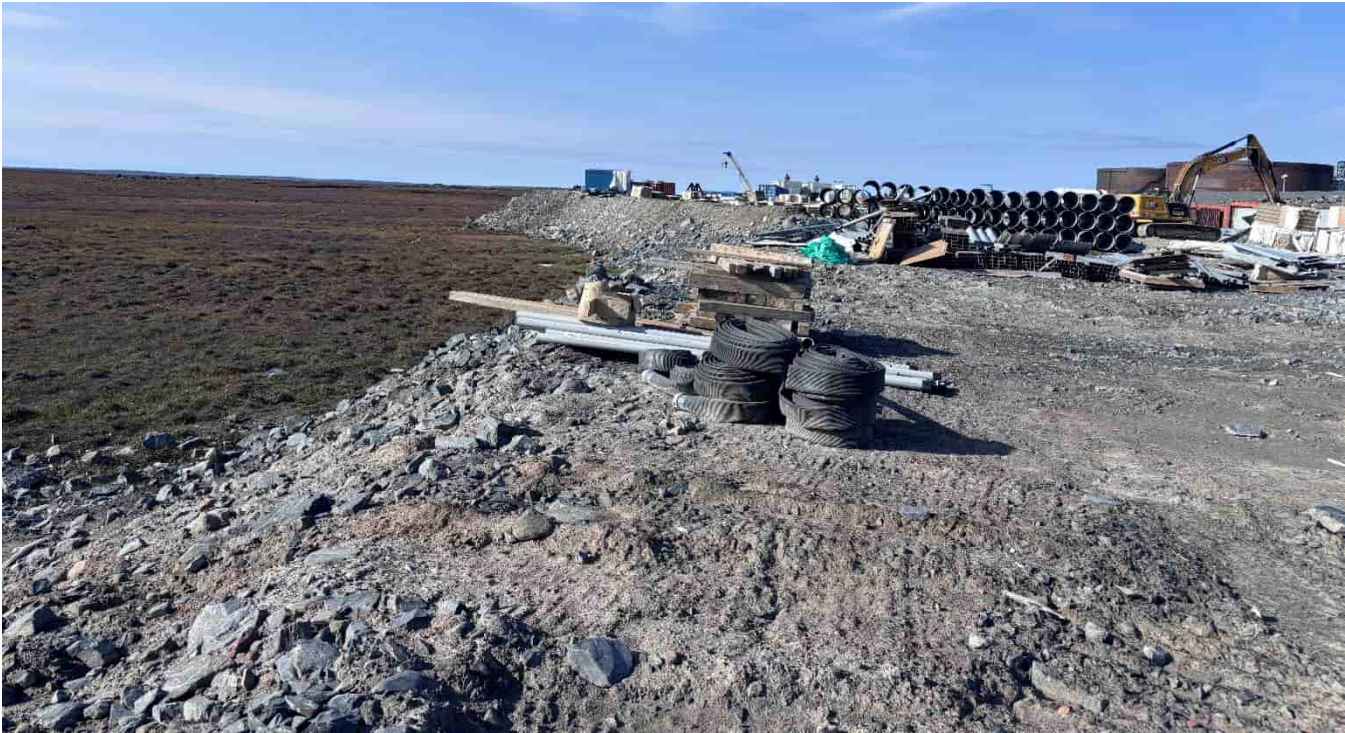
G-220: Edge of ROM area, looking W towards main plant

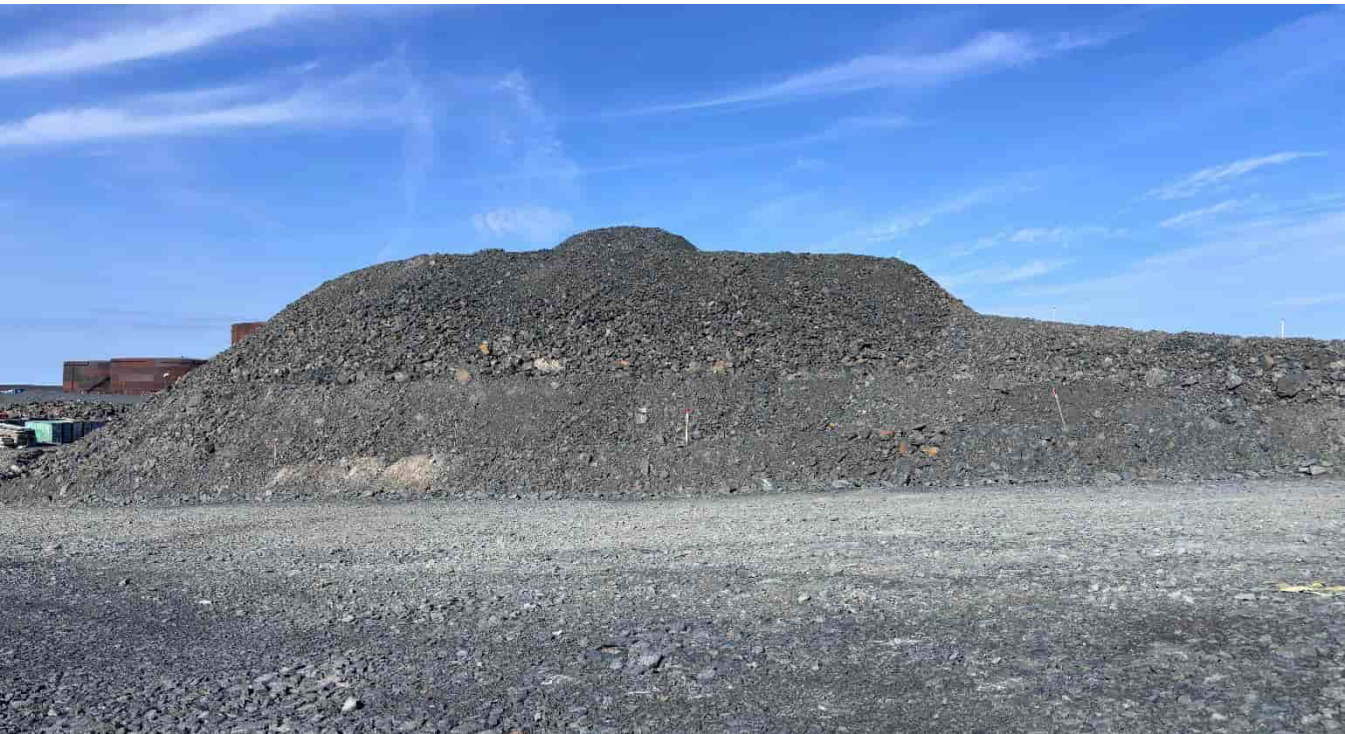
G-222: ROM stockpile slopes

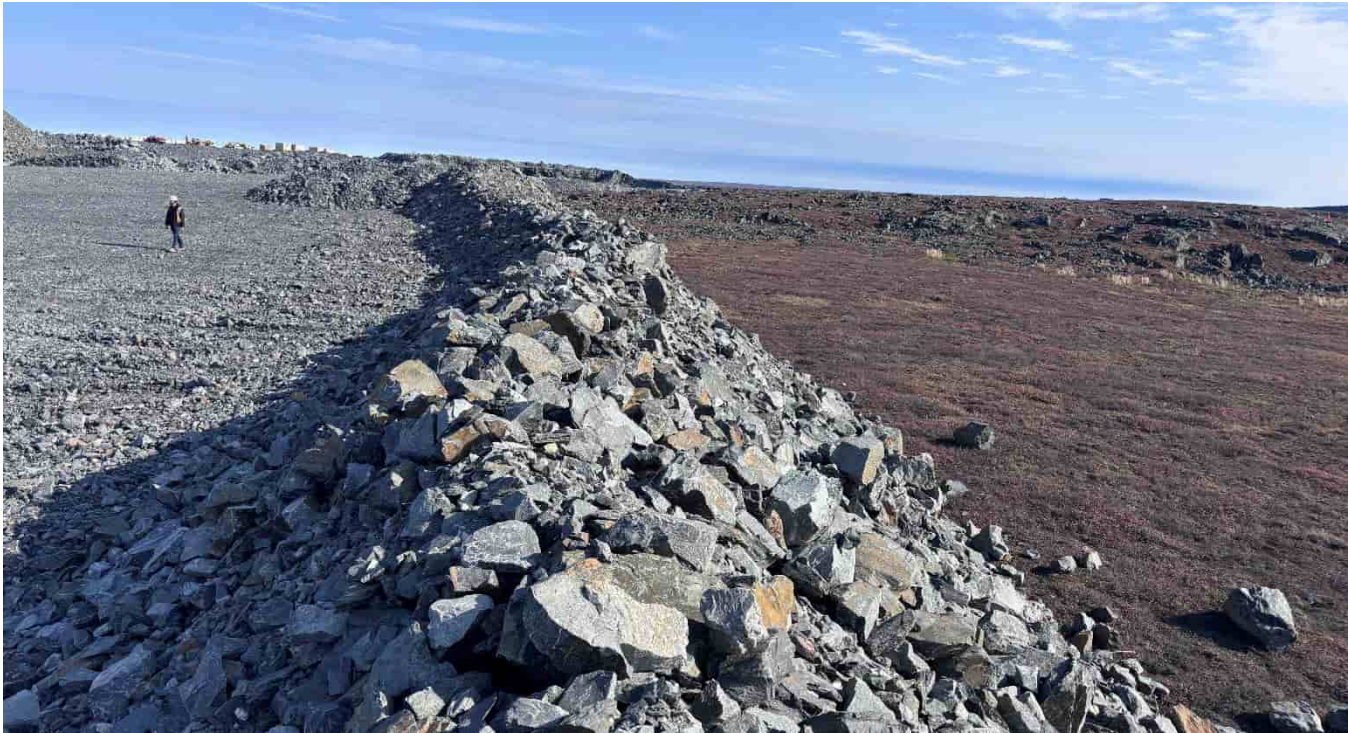
G-224: Edge of S side of pad, looking E
