# Goose & MLA Project Sites – 2025 Annual Geotechnical Inspection

Back River Project, Nunavut, Canada  
B2Gold Back River Corp.

SRK Consulting (Canada) Inc. ■ CAPR004312 ■ March 2026

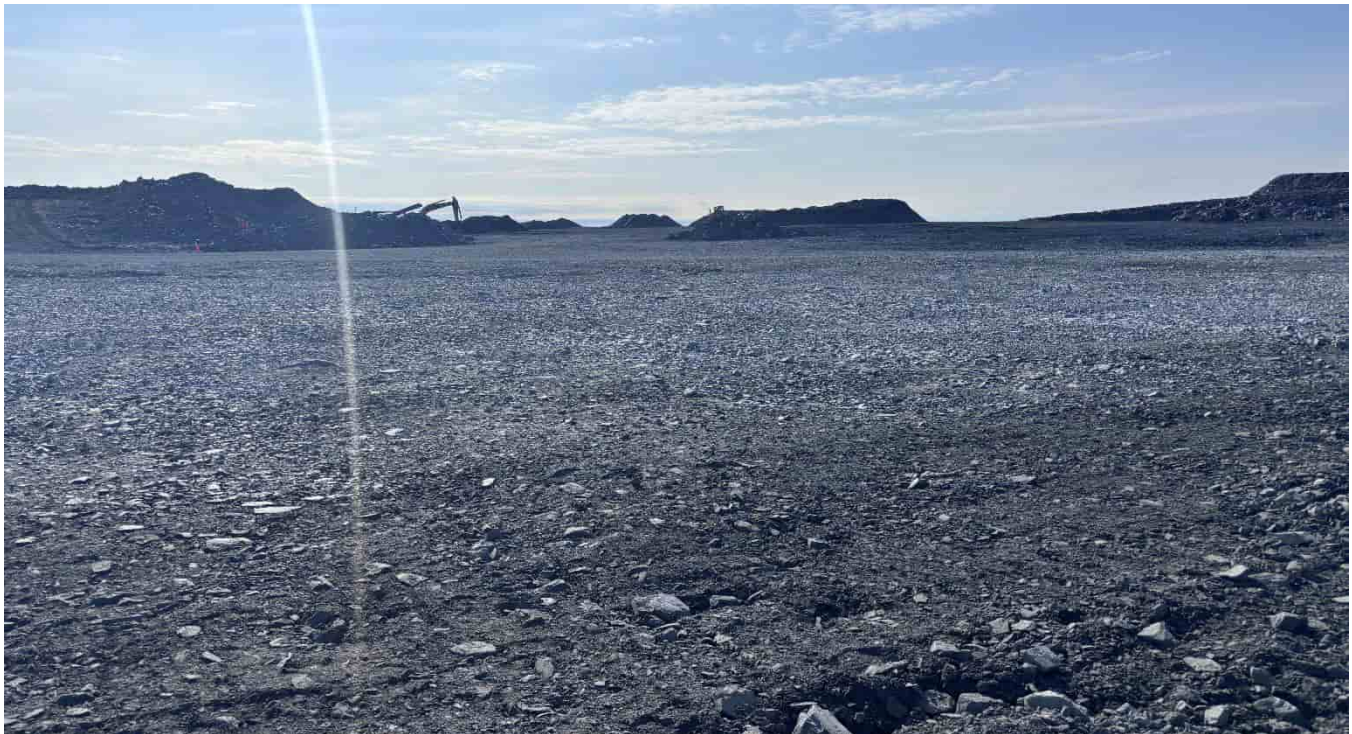
G-225: Typical stockpile pad surface condition

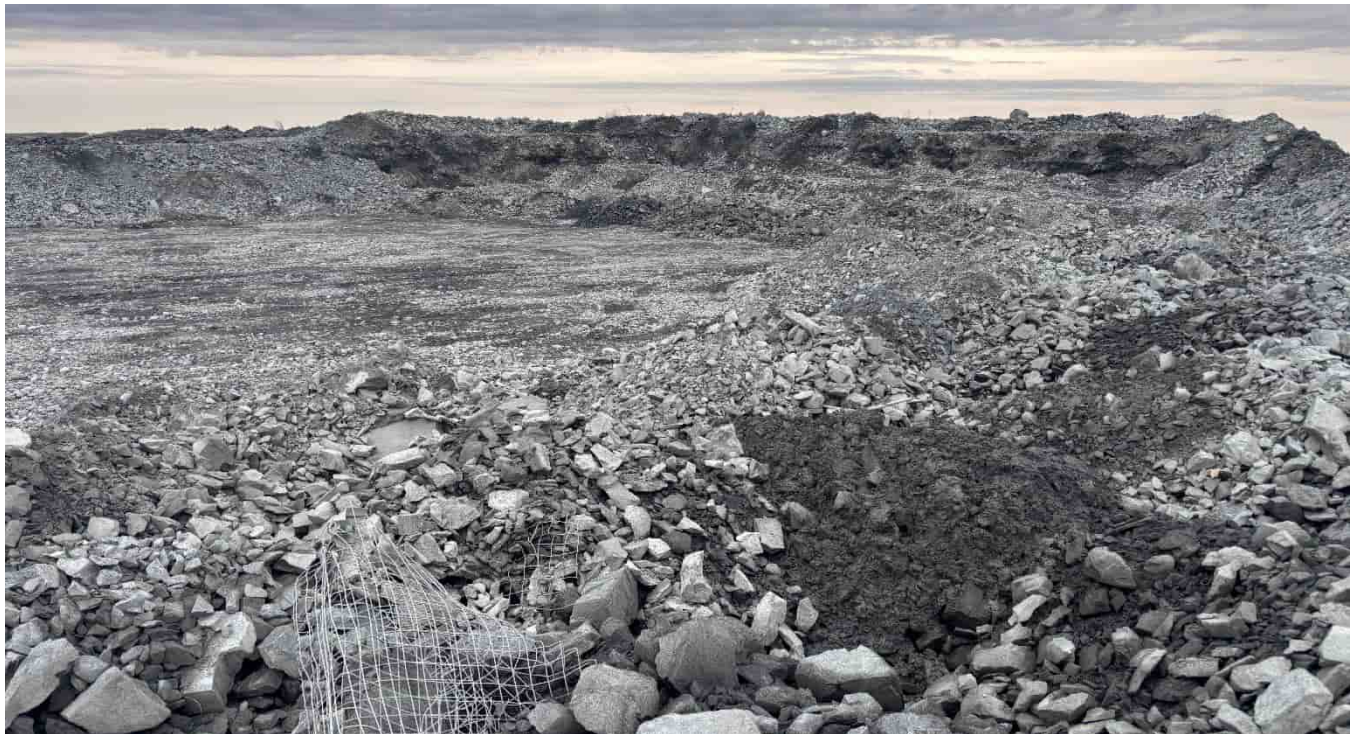
G-227: Typical stockpiles, looking N

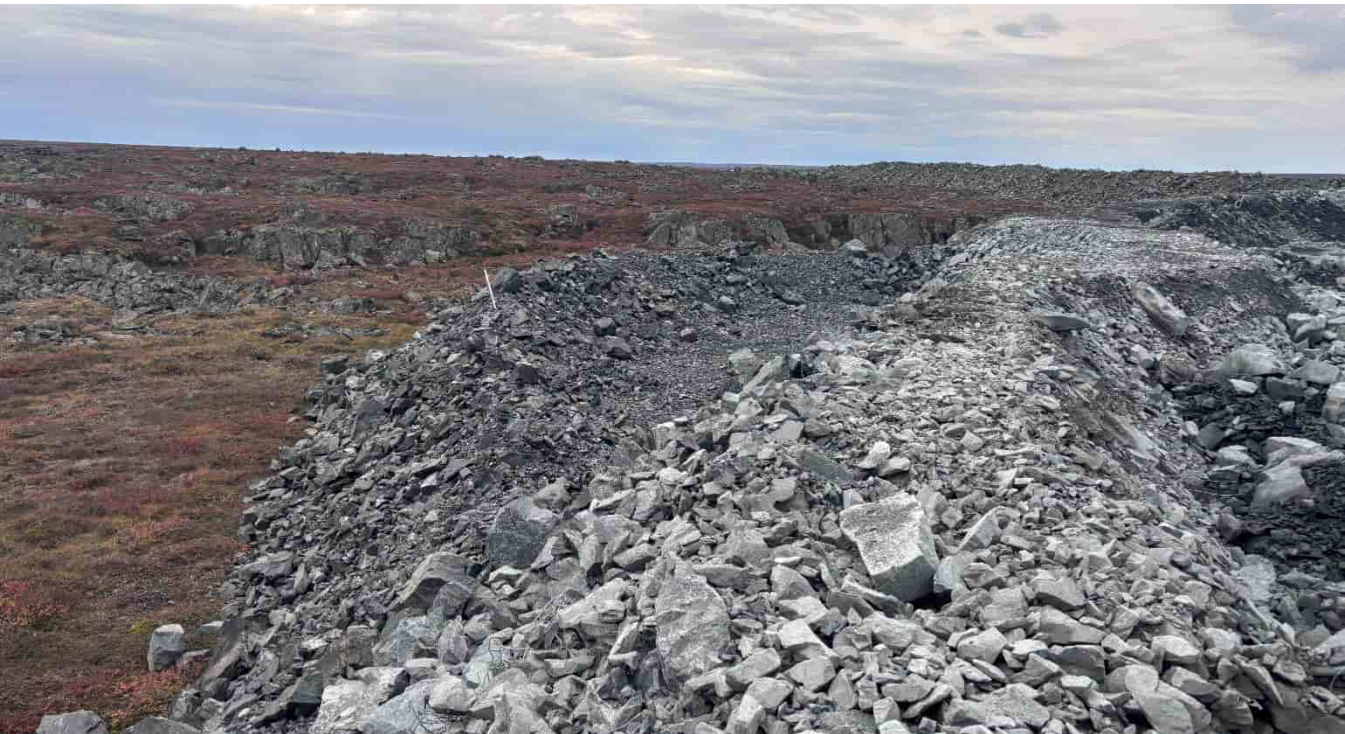
G-228: Stockpiles and berm at S end

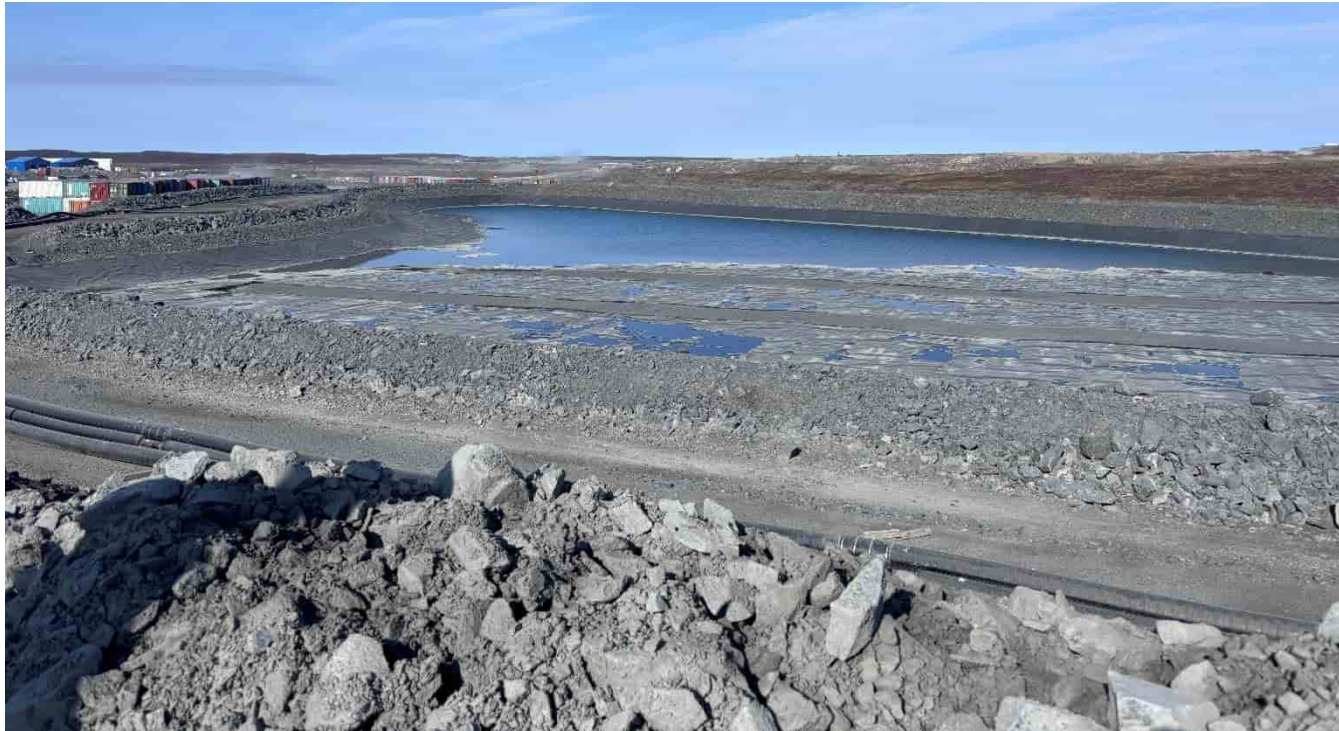
G-229: Contact water pond, looking NW

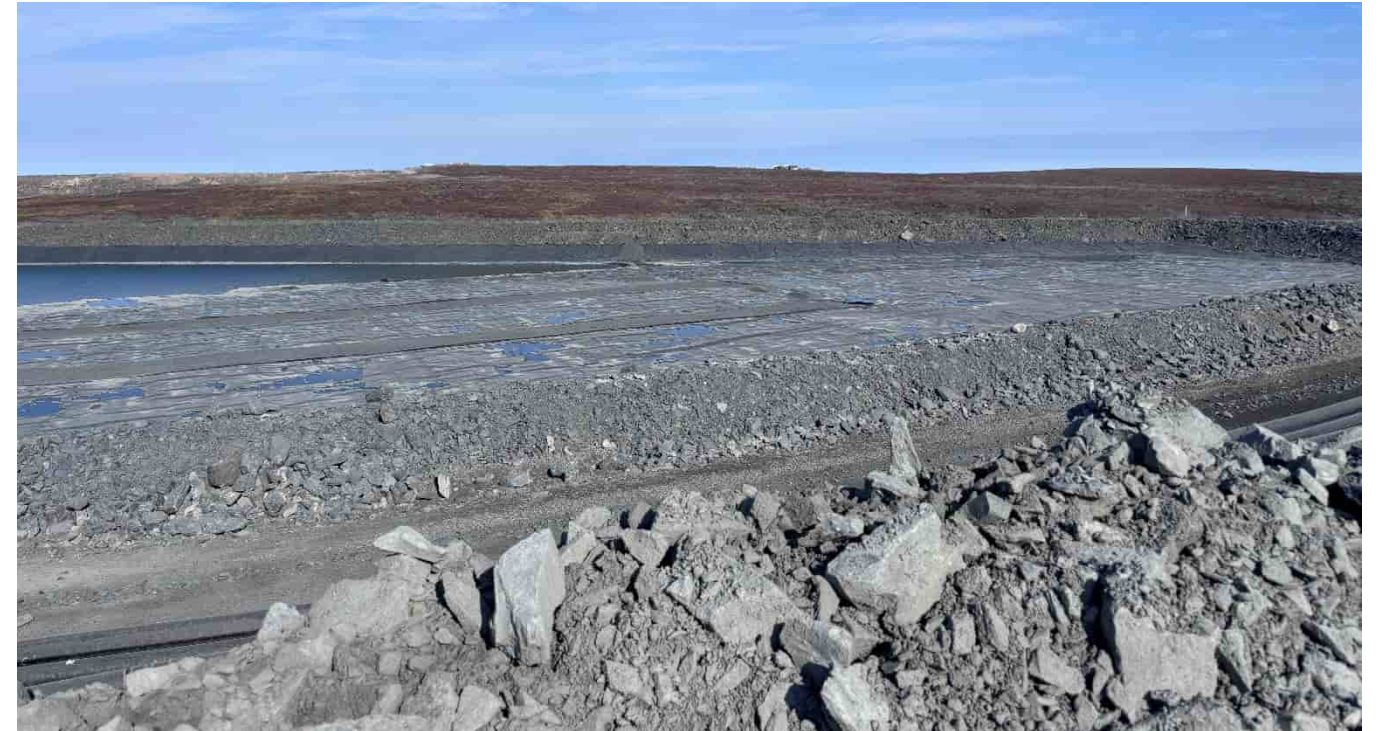
G-230: Contact water pond, looking NE

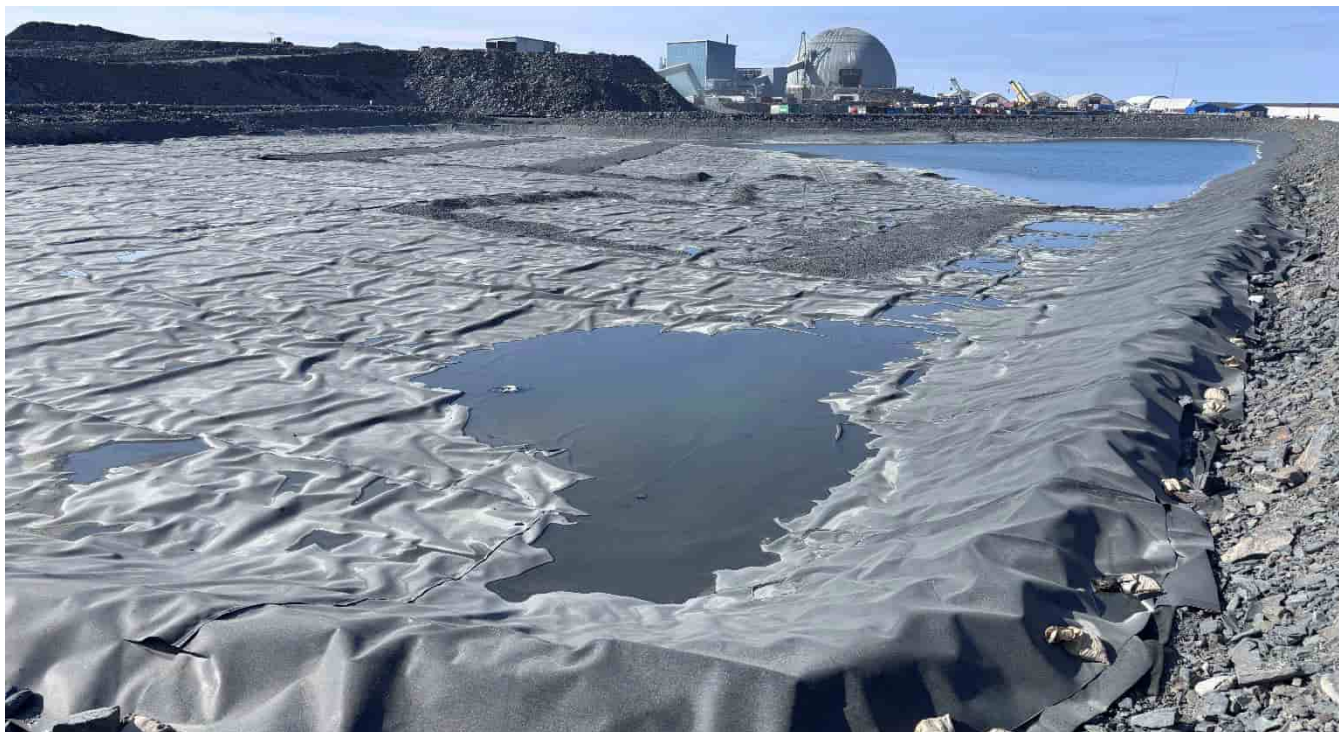
G-231: Looking E along northern edge of pond – minimal tie-in / anchoring

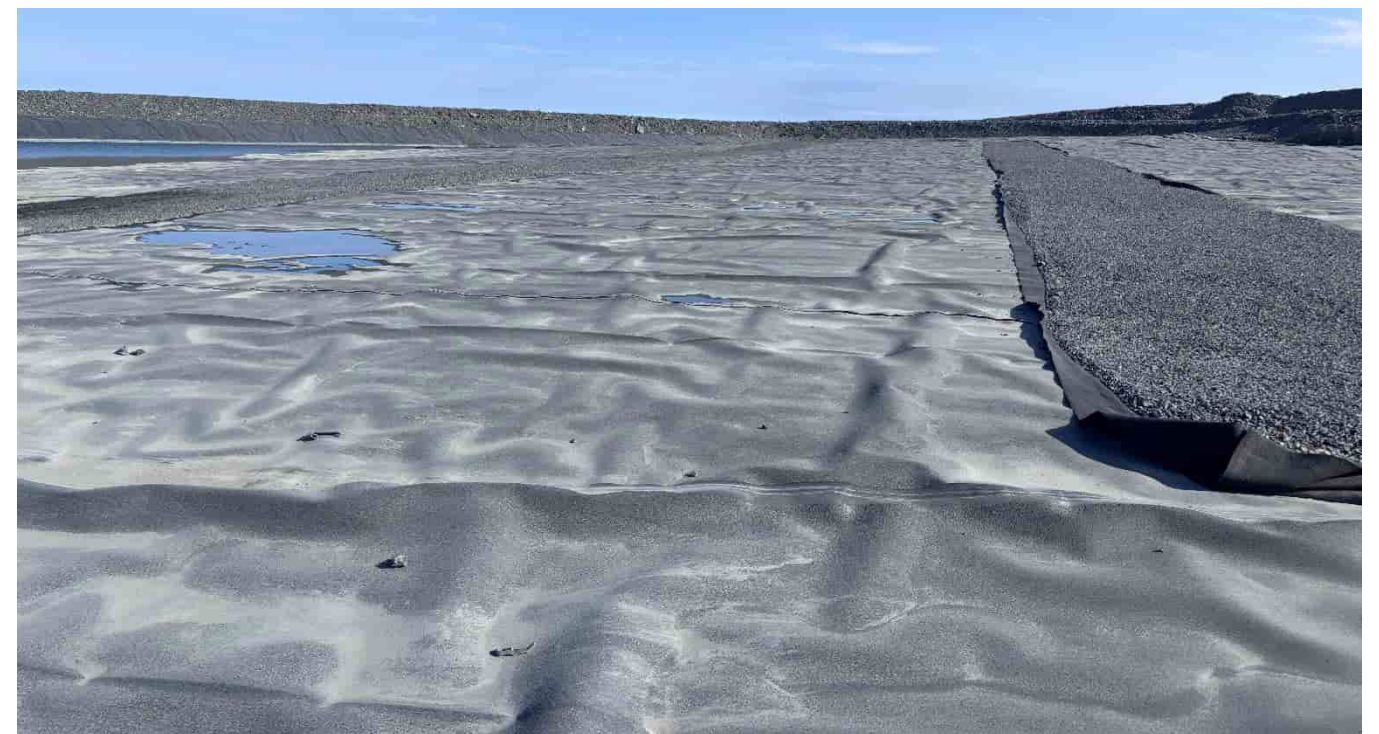
G-235: Typical liner surface conditions, looking NE
