| | | 2025 Annual Geotechnical Inspection | | |
| Job No: CAPR004312<br>Filename: Back River_Goose_2025_AGI_Photoslog.pdf | Back River Project | Date:<br>February 2026 | Approved:<br>JBK | Figure:<br>79 |

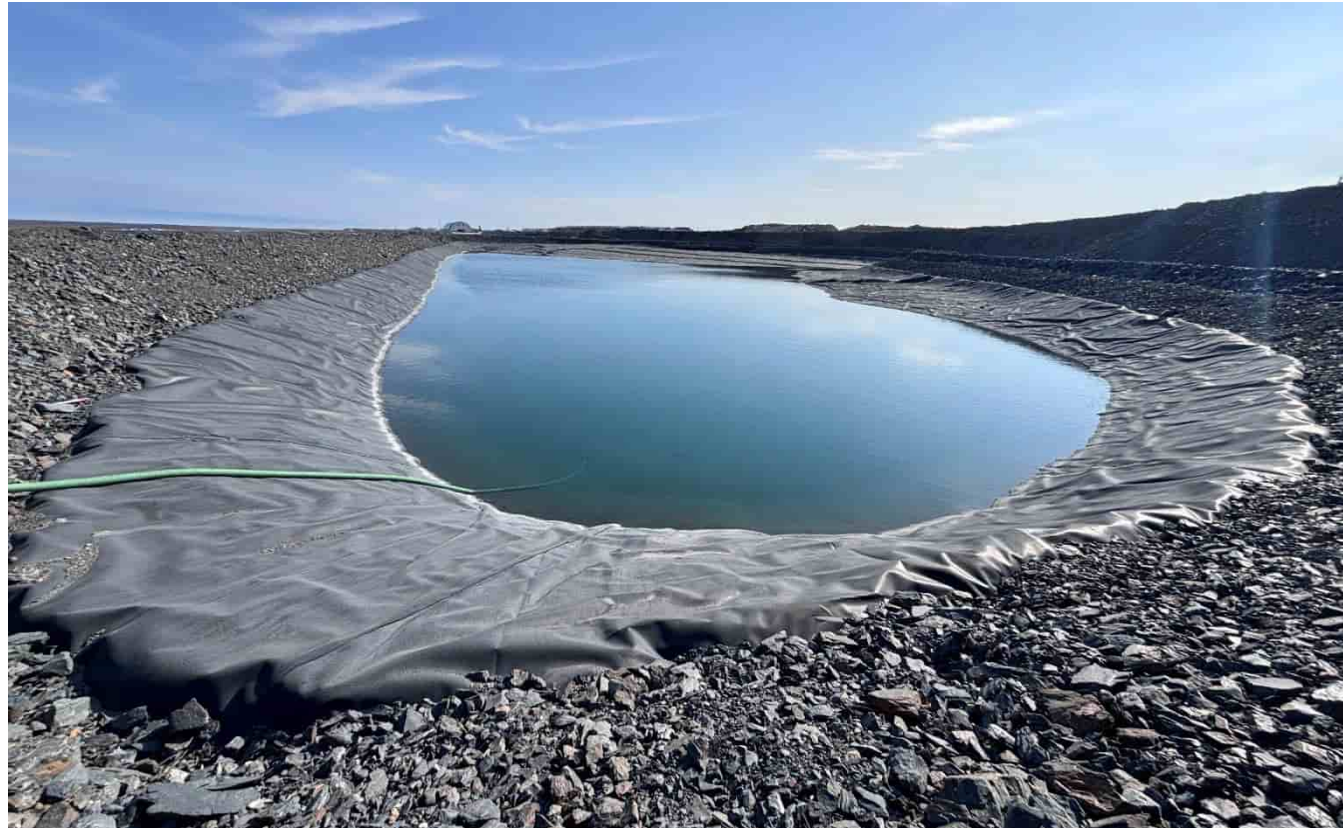
G-239A: Overall pond view from NW corner

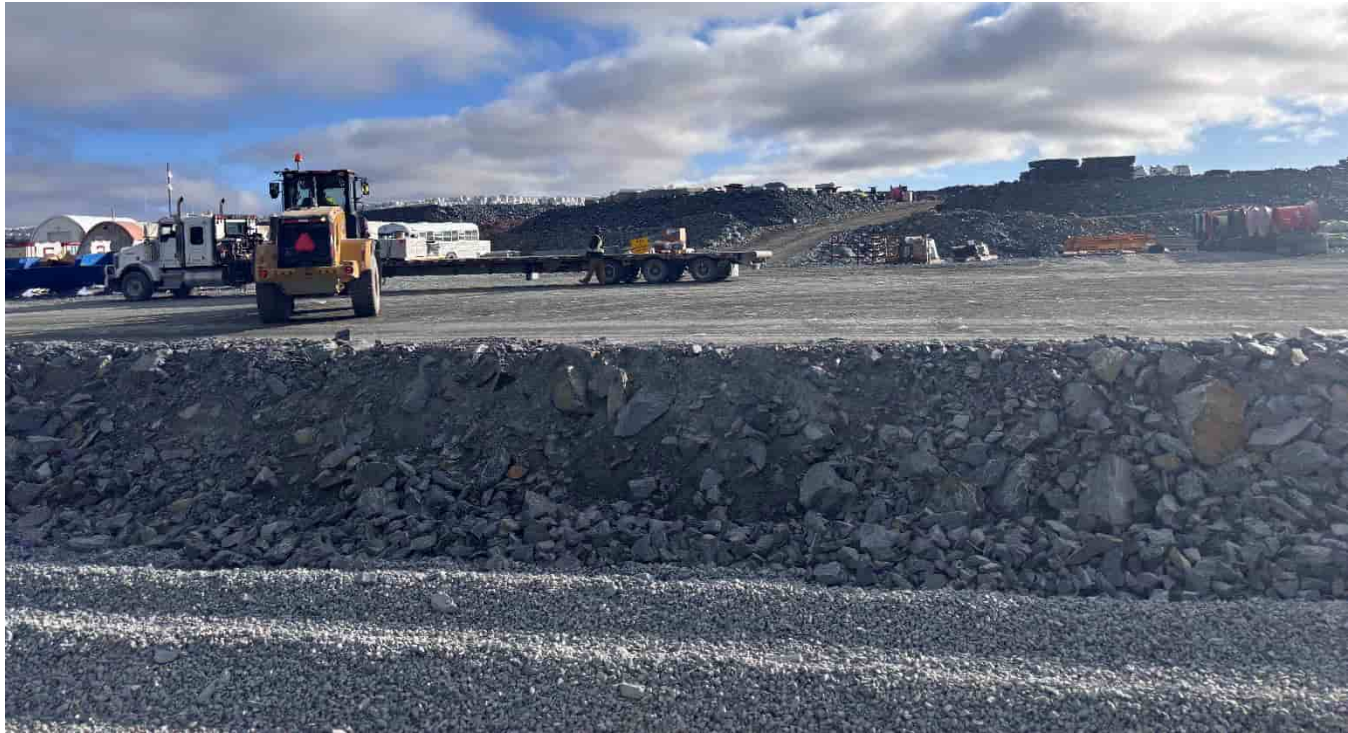
G-240: Underground laydown area as seen from All-Weather Road

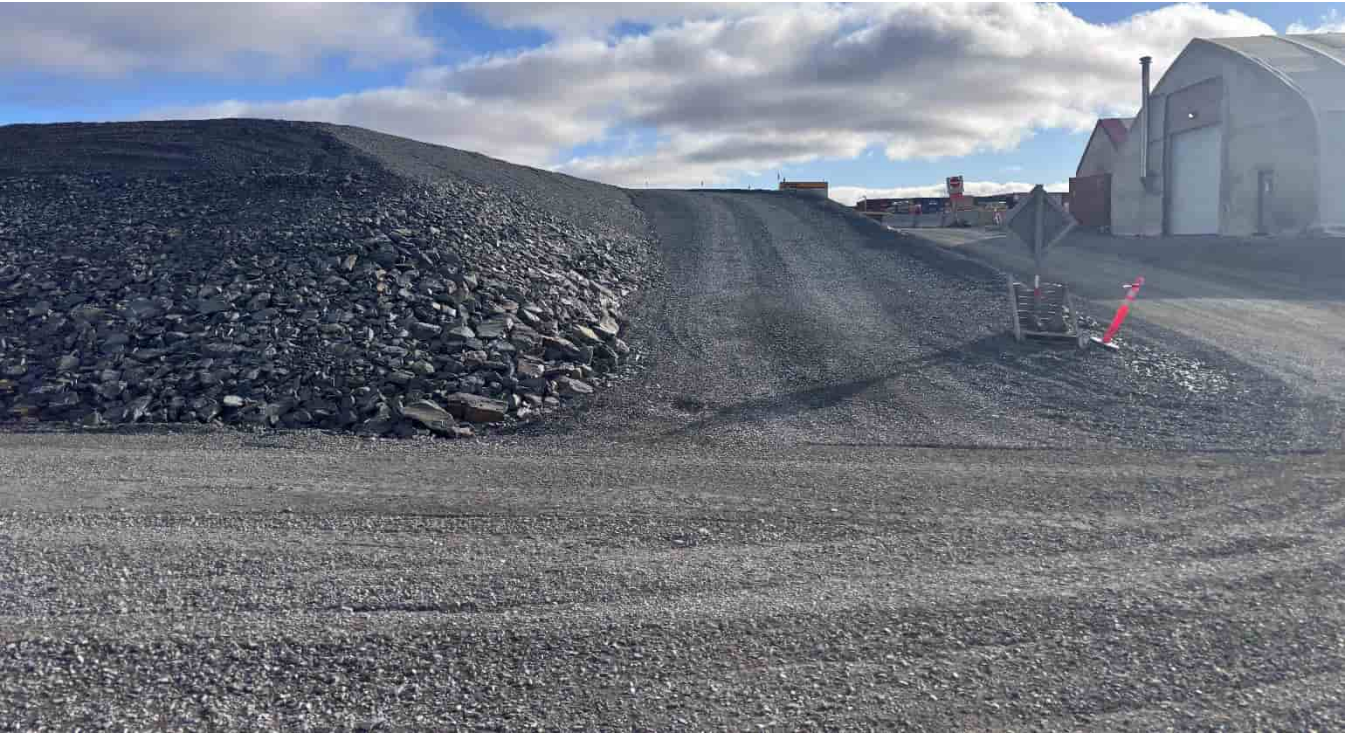
G-241: Entrance to tote storage and operations area – Looking S from All-Weather Road

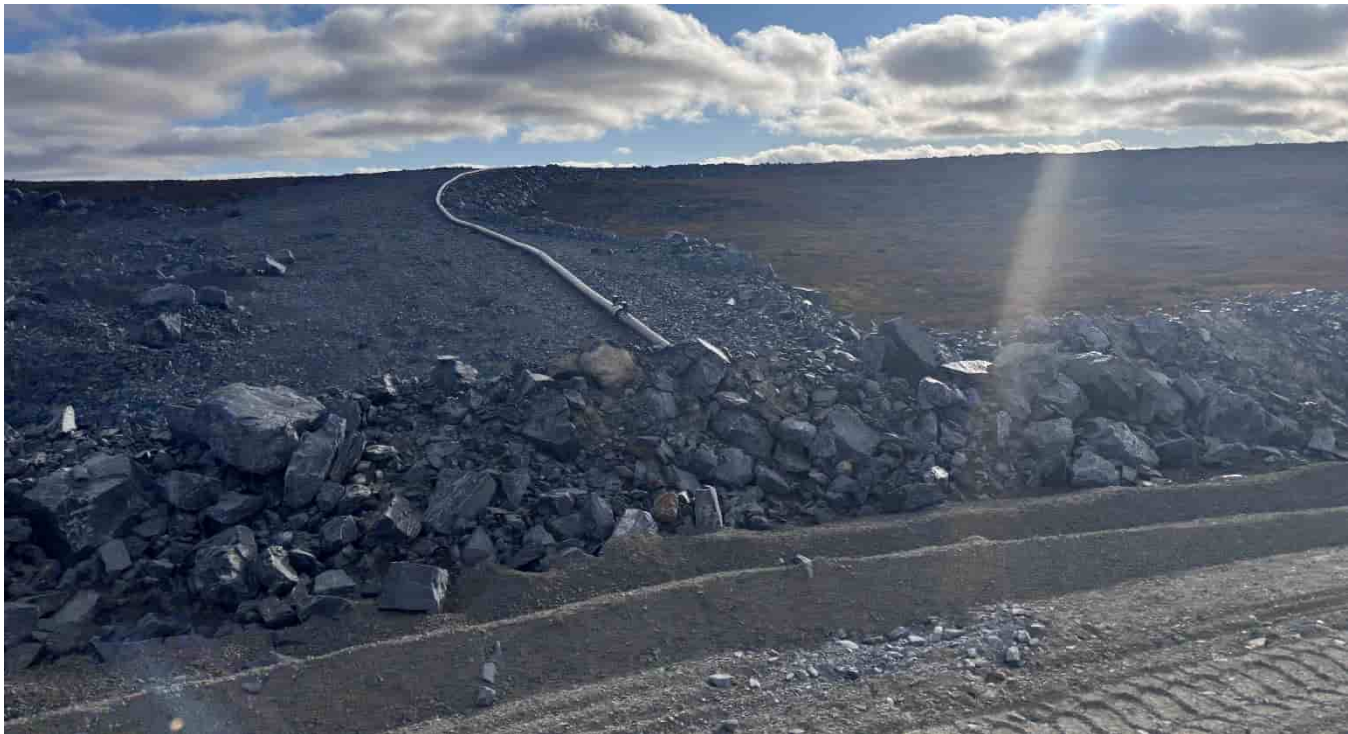
G-242: Pipeline crossing under road, looking S

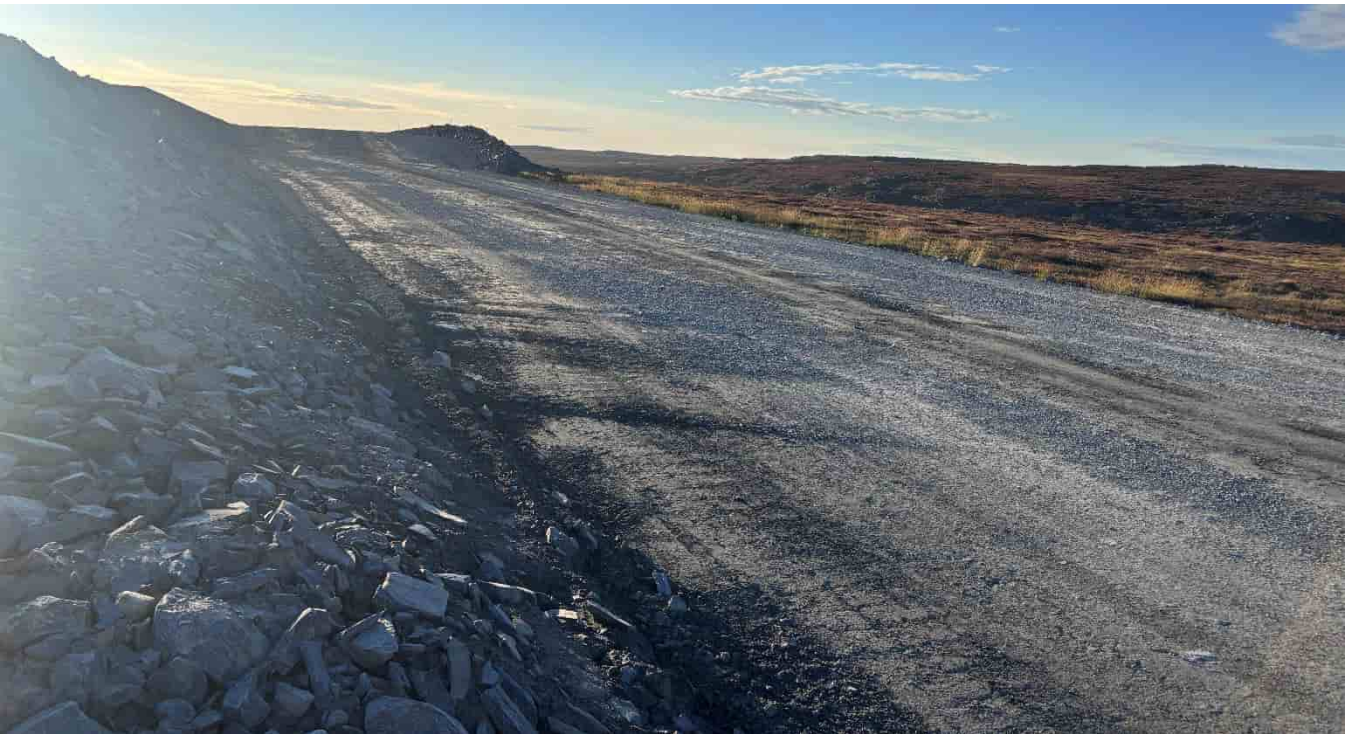
G-243: All-Weather Road slope below Sandvik laydown, looking W

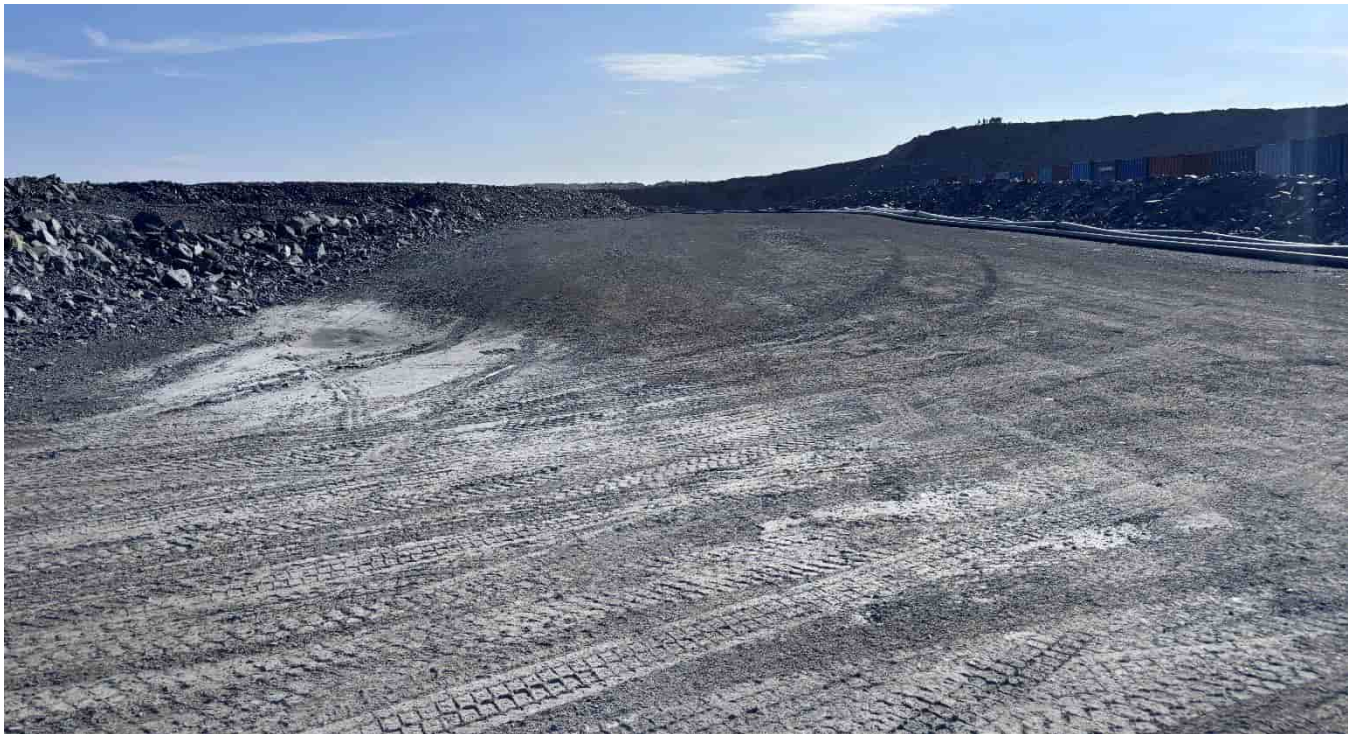
G-246: Laydown area and tailings pipeline W of contact water pond

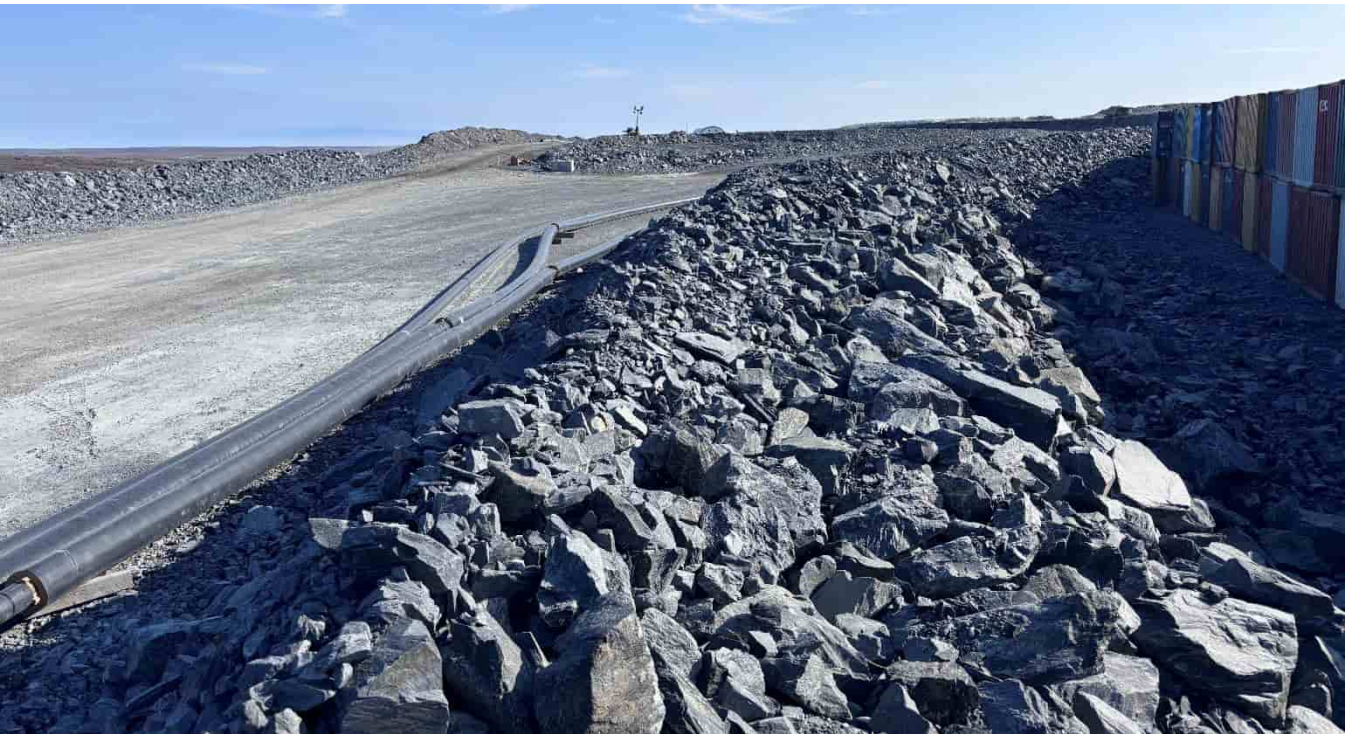
G-247: Berm between tailings pipeline road and seacan laydown area, looking E

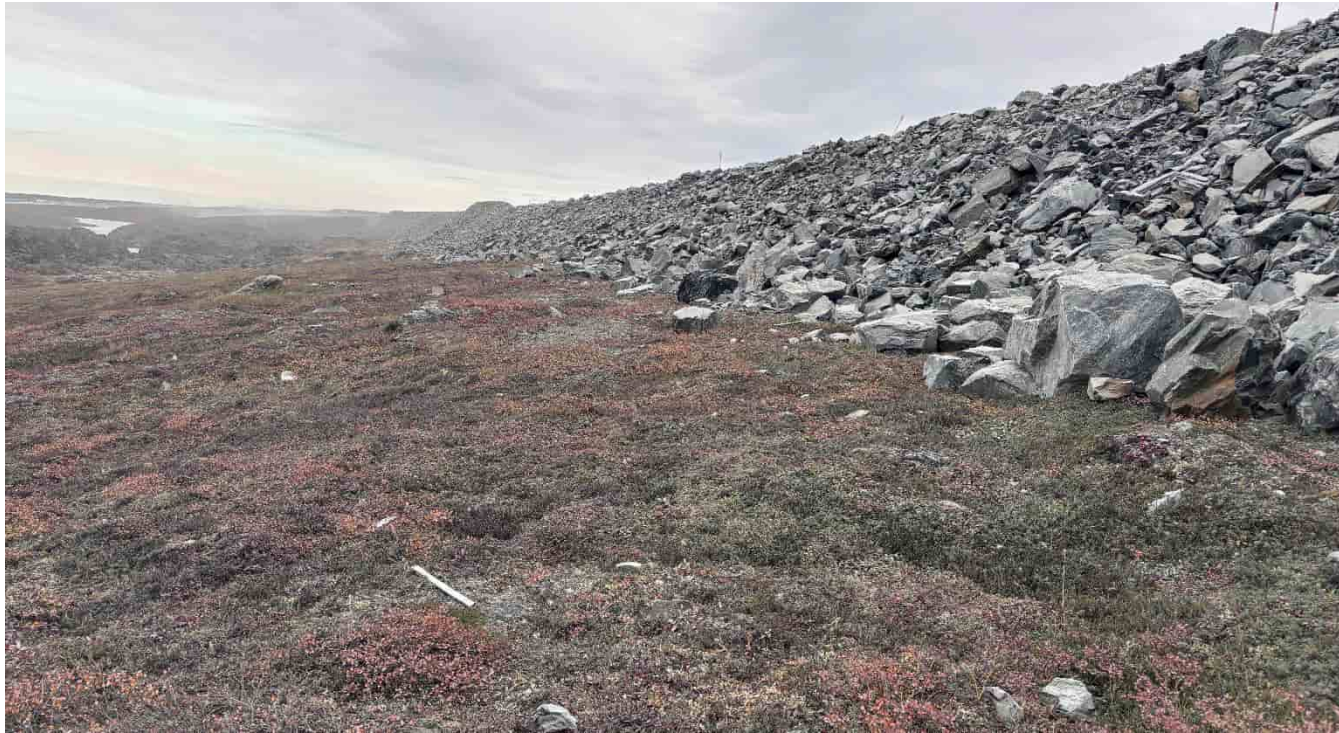
G-248: All-Weather Road N rockfill, looking E

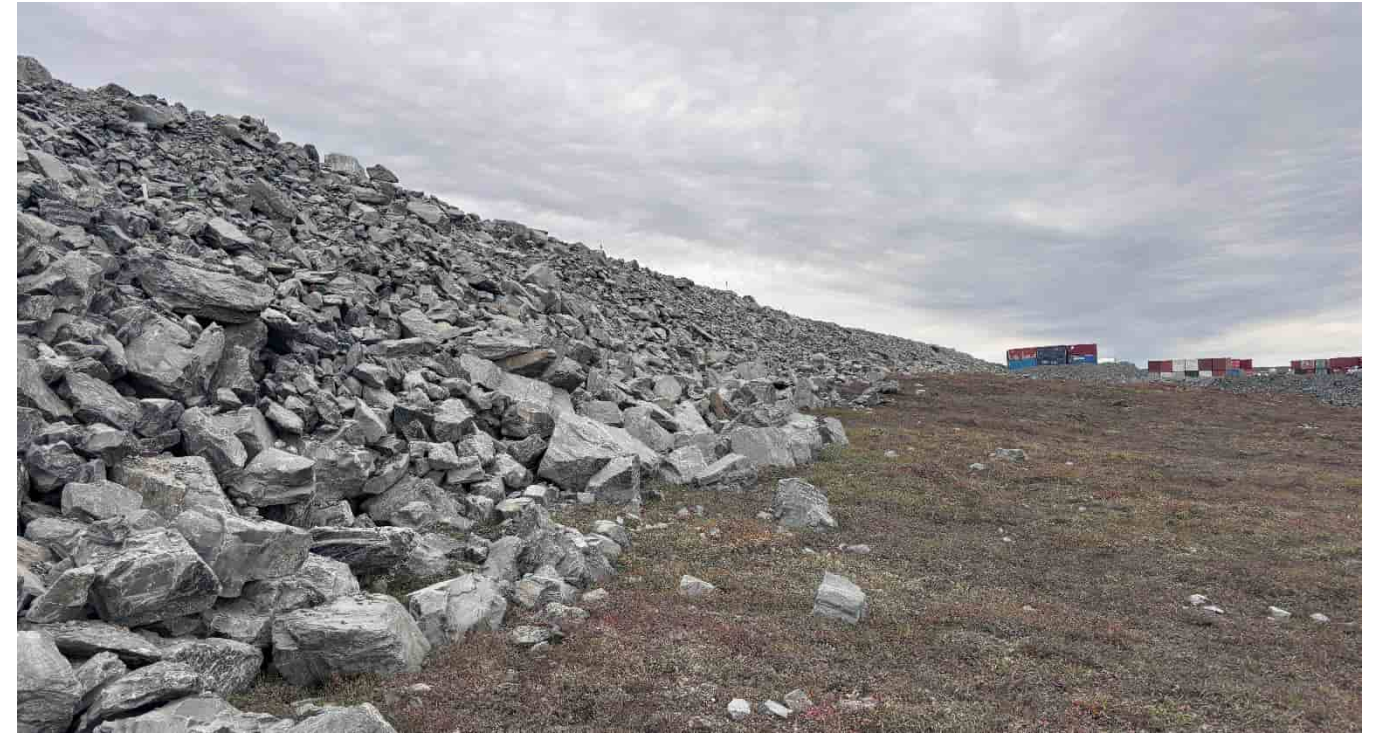
G-249: All-Weather Road N rockfill, looking W

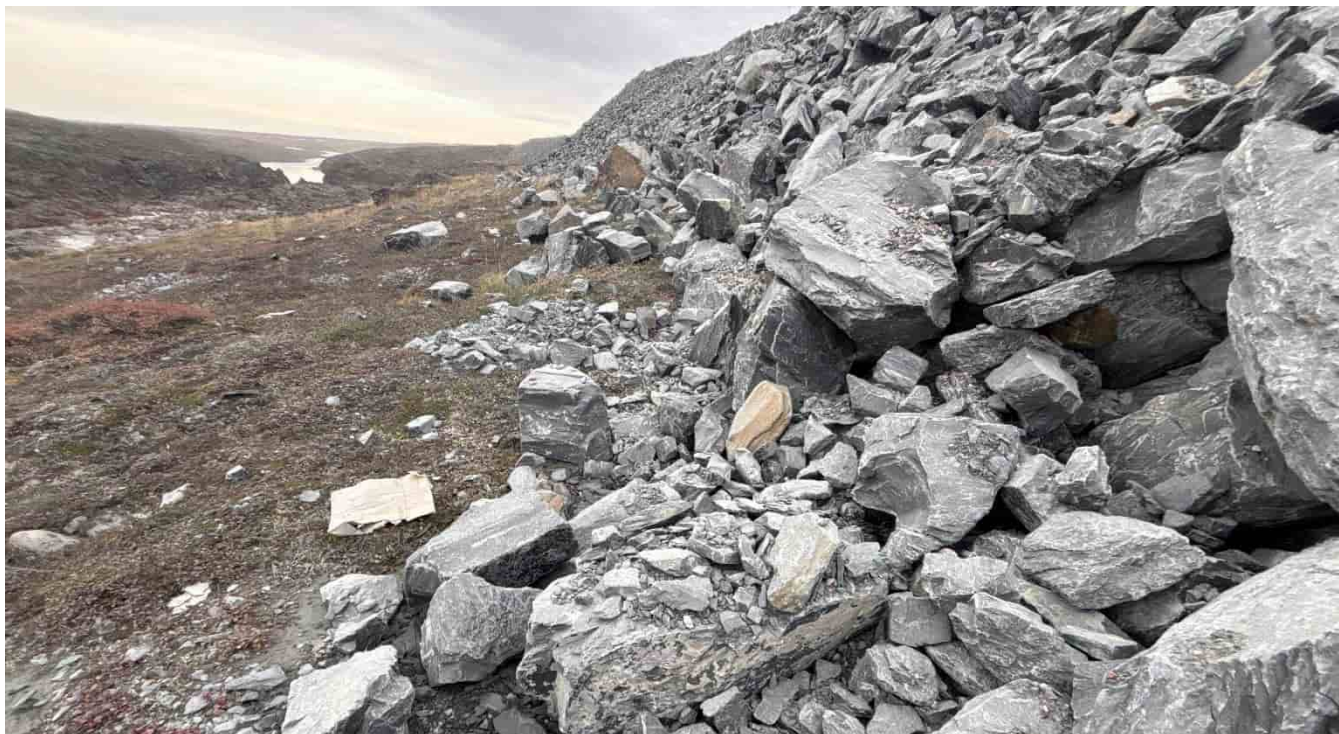
G-250: Downstream slope of All-Weather Road N rockfill

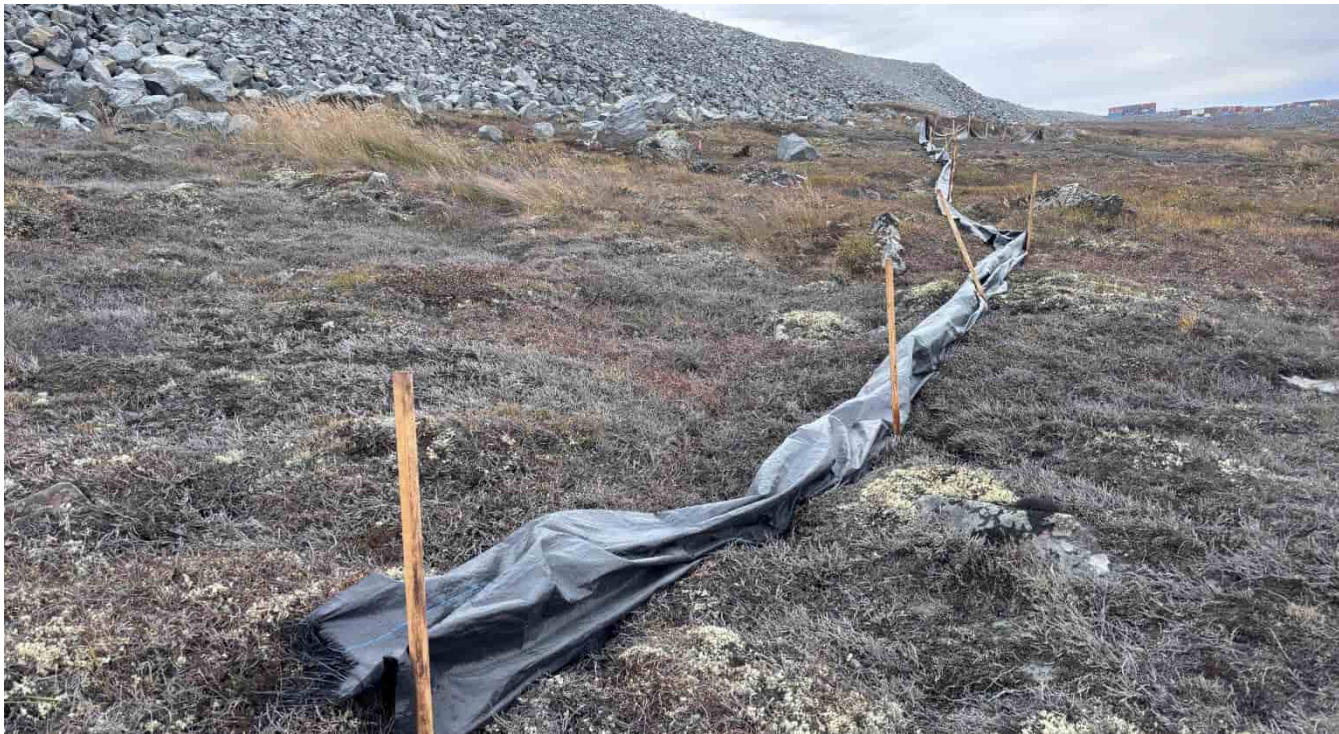
G-254: Silt fencing on N side of road – Looking W

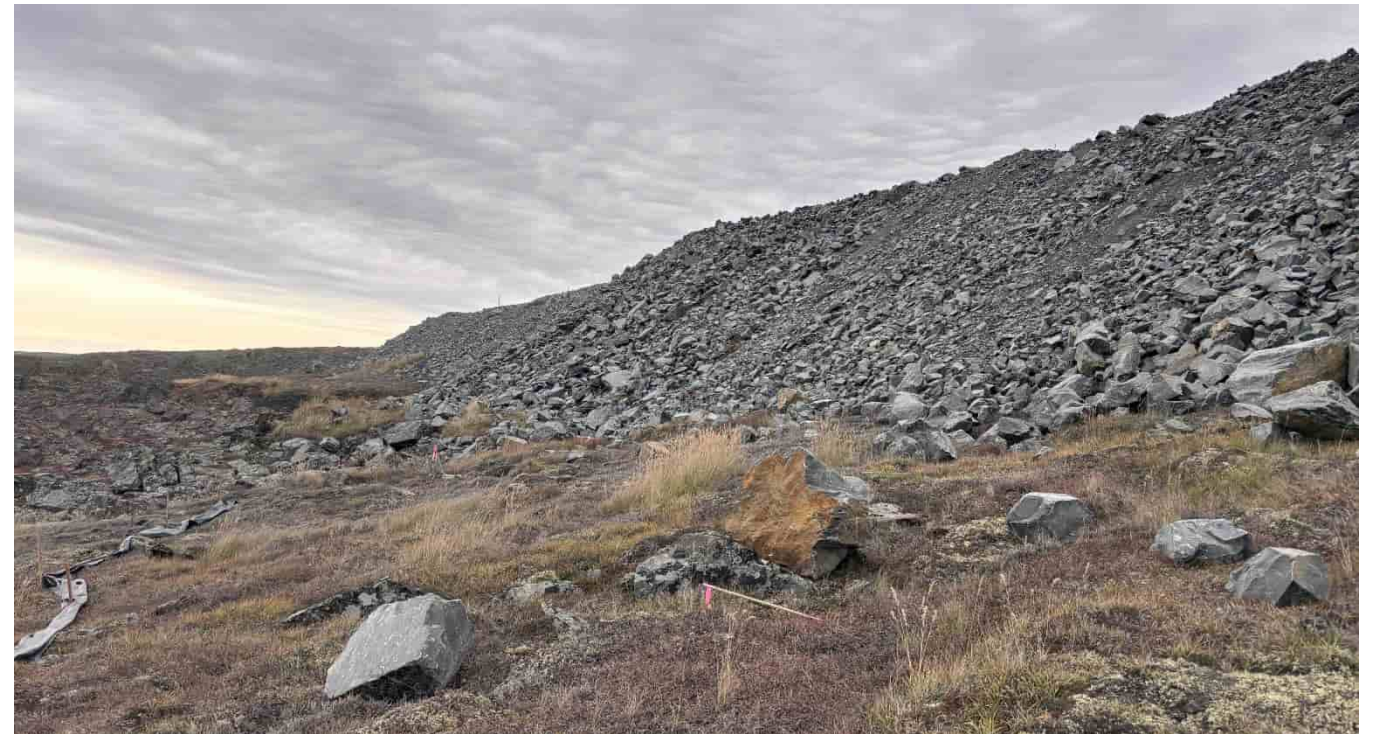
G-255: Road rockfill, looking E – Historic silt fencing at toe

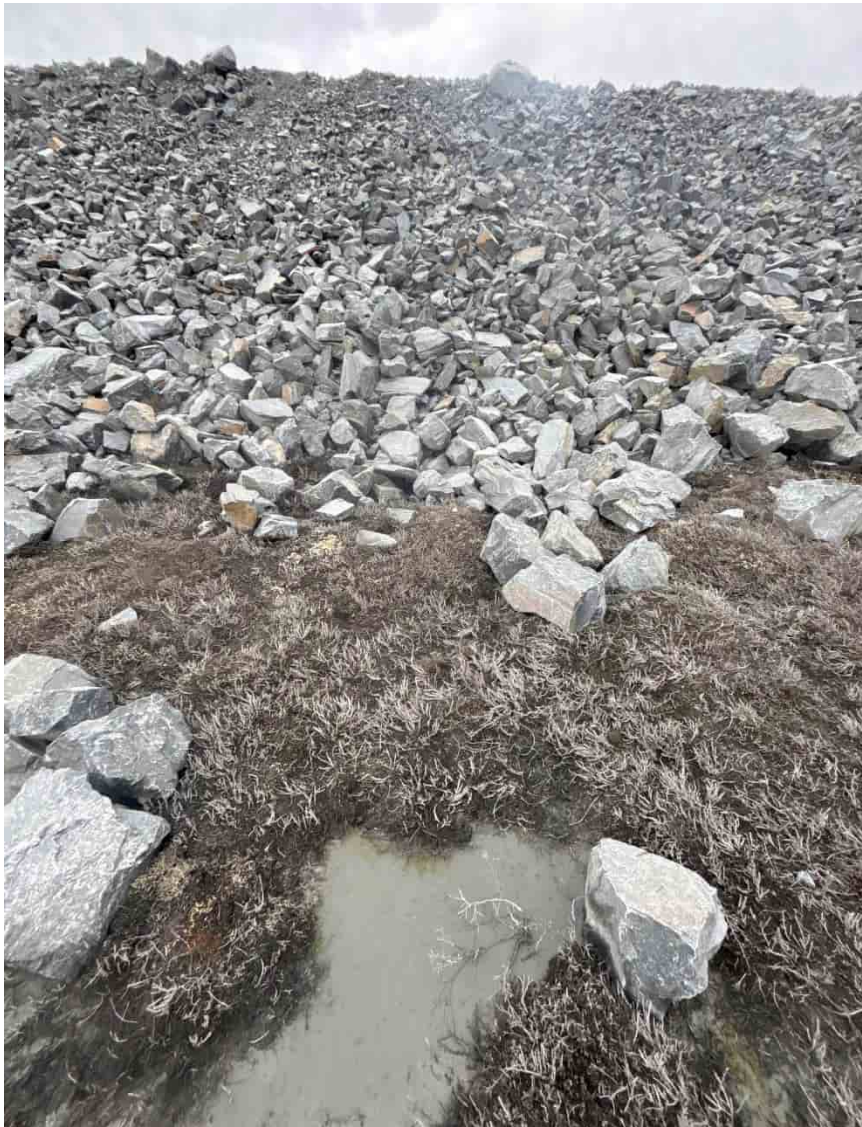
G-256: Water seepage from road rockfill

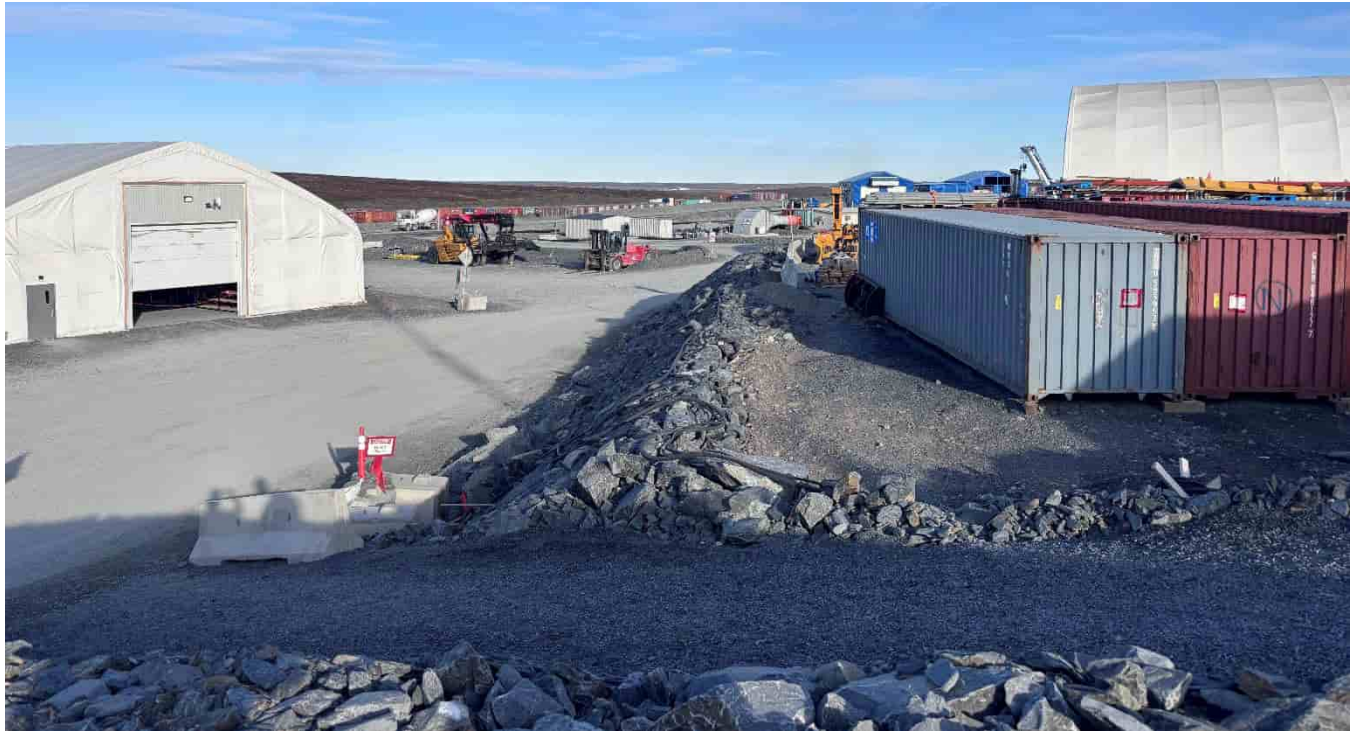
G-258: View towards site services area from camp pad, looking E

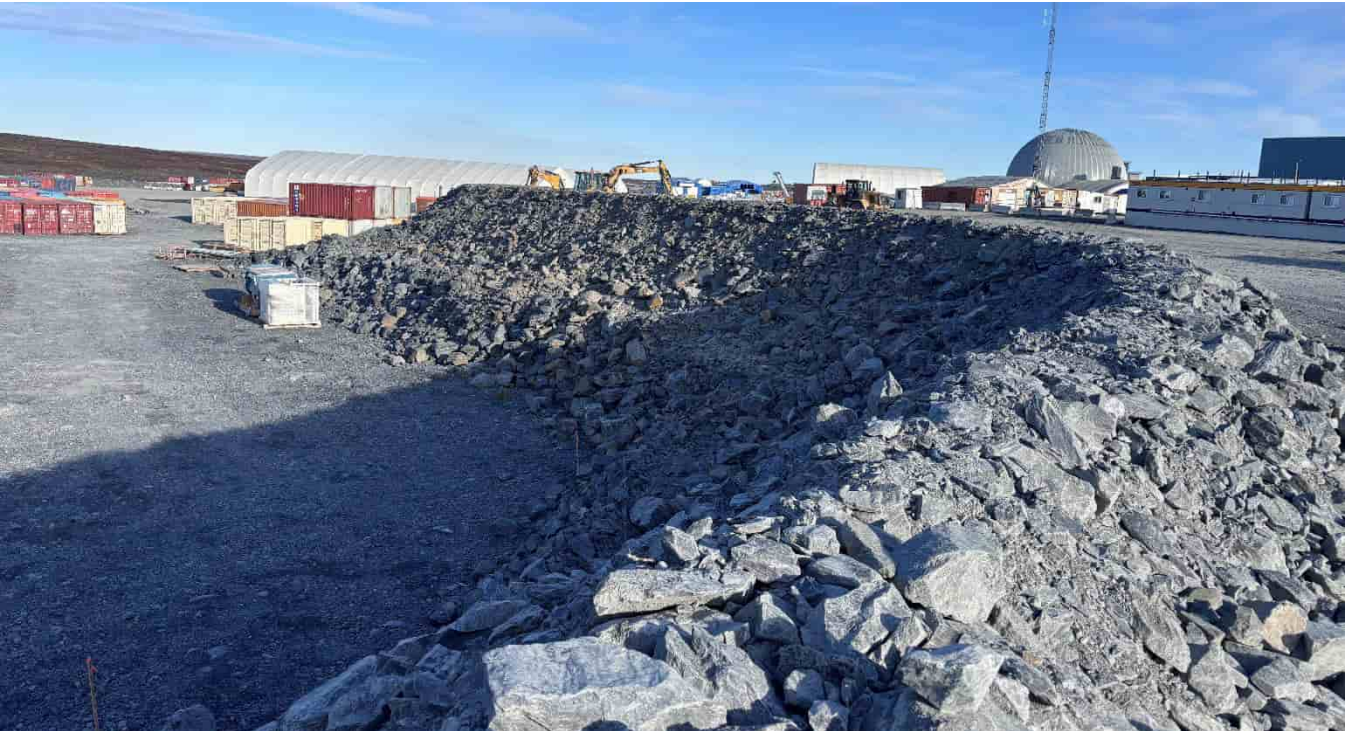
G-259: Berm between main camp and main warehouse

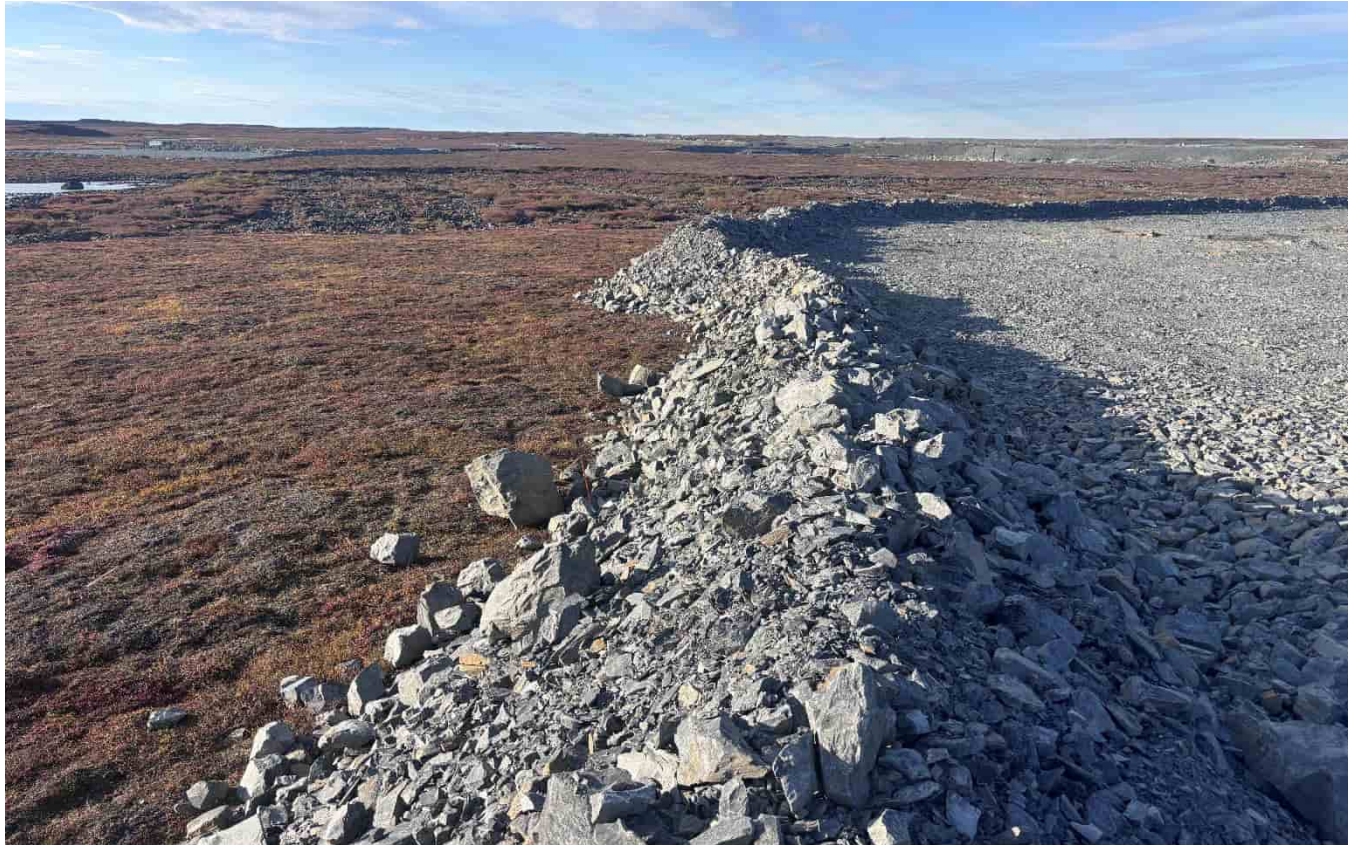
G-262: Camp pad W slope, looking N

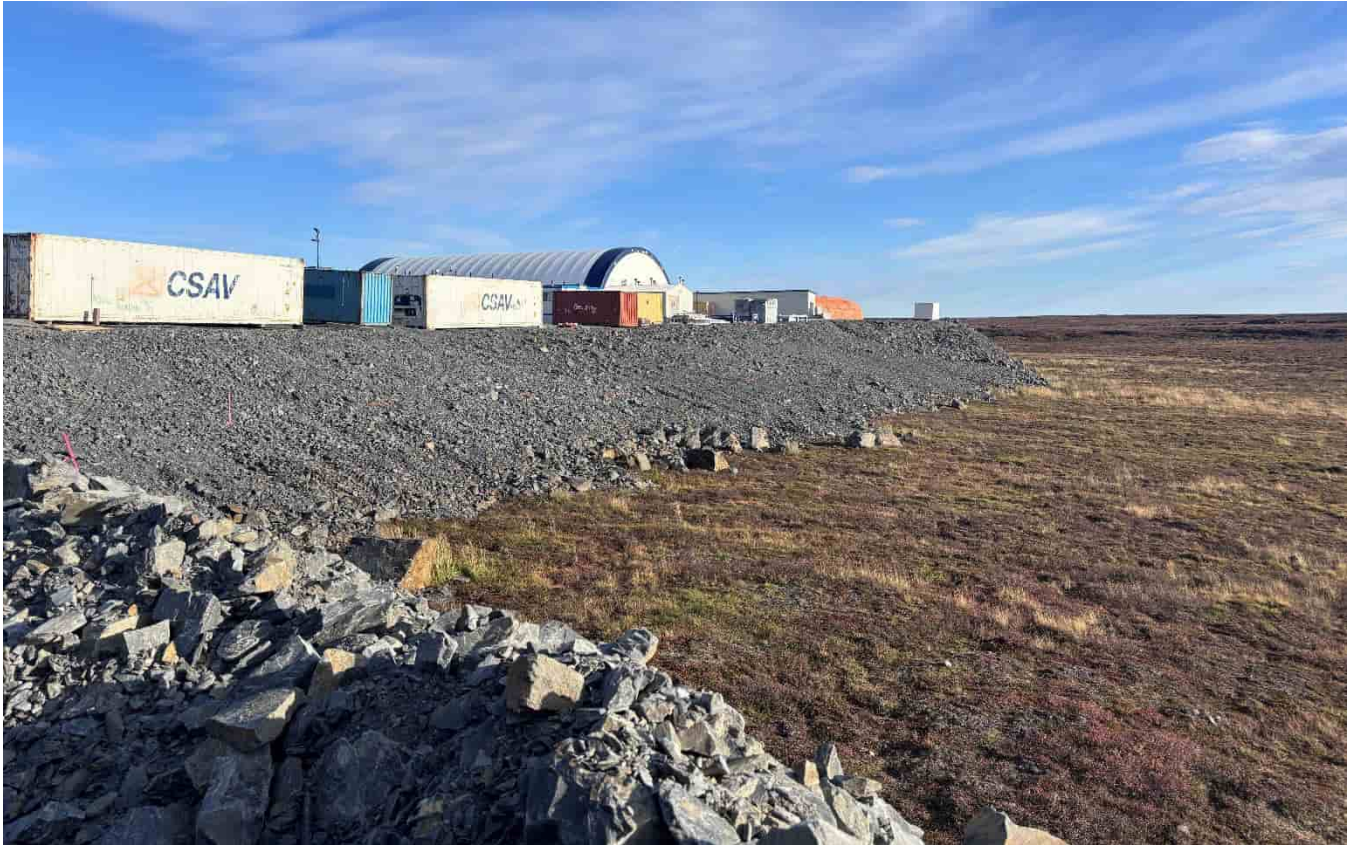
G-263: Camp pad W slope, looking SE

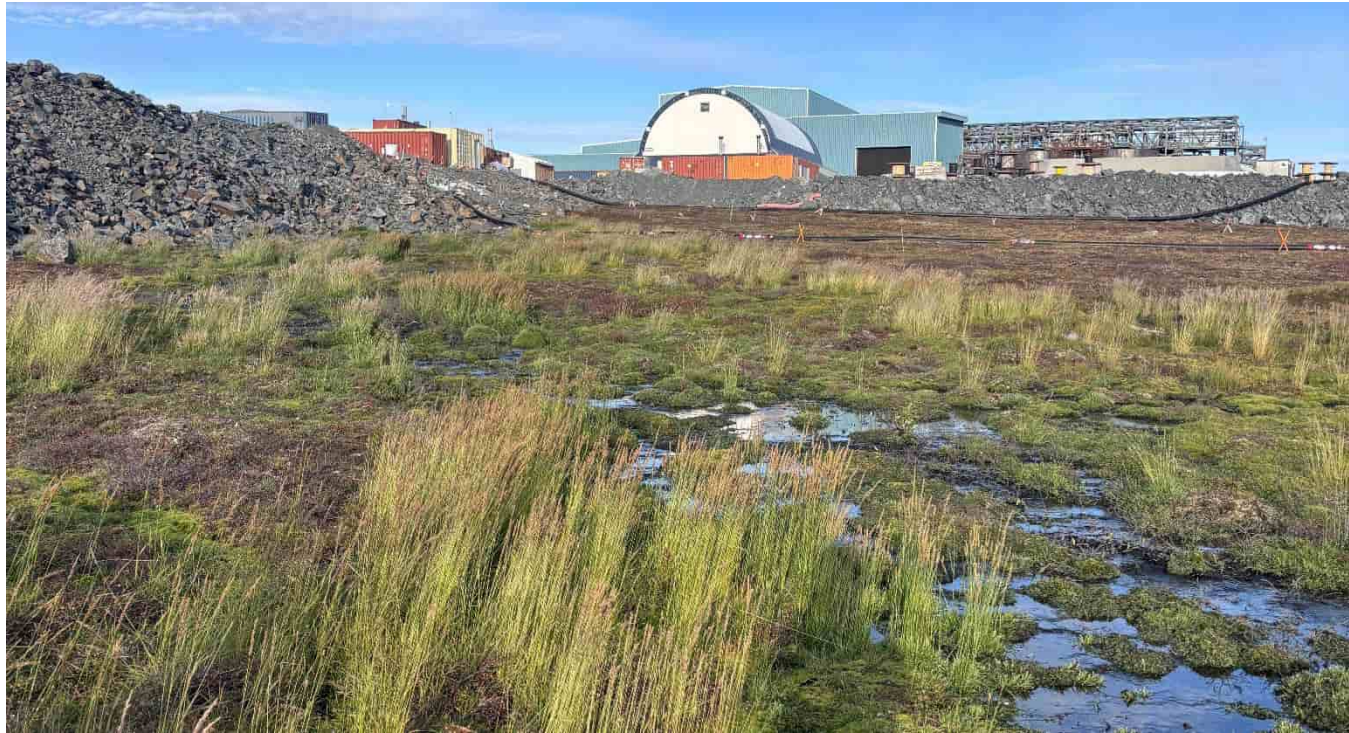
G-265: S edge of camp pad, looking E – downstream of post (grey water) treatment discharge

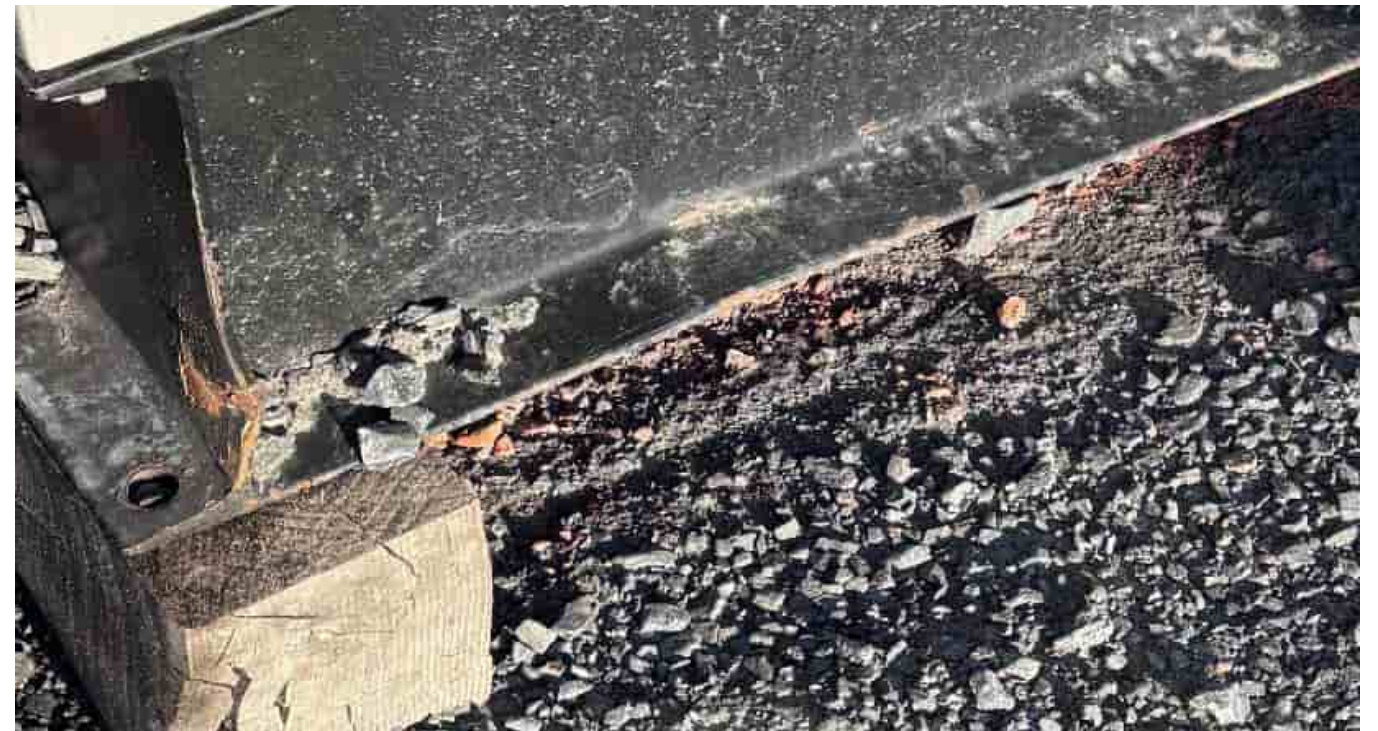
G-268: Camp pad, example support below ancillary structures (beyond main camp trailers / accommodation). Watch for planning maintenance

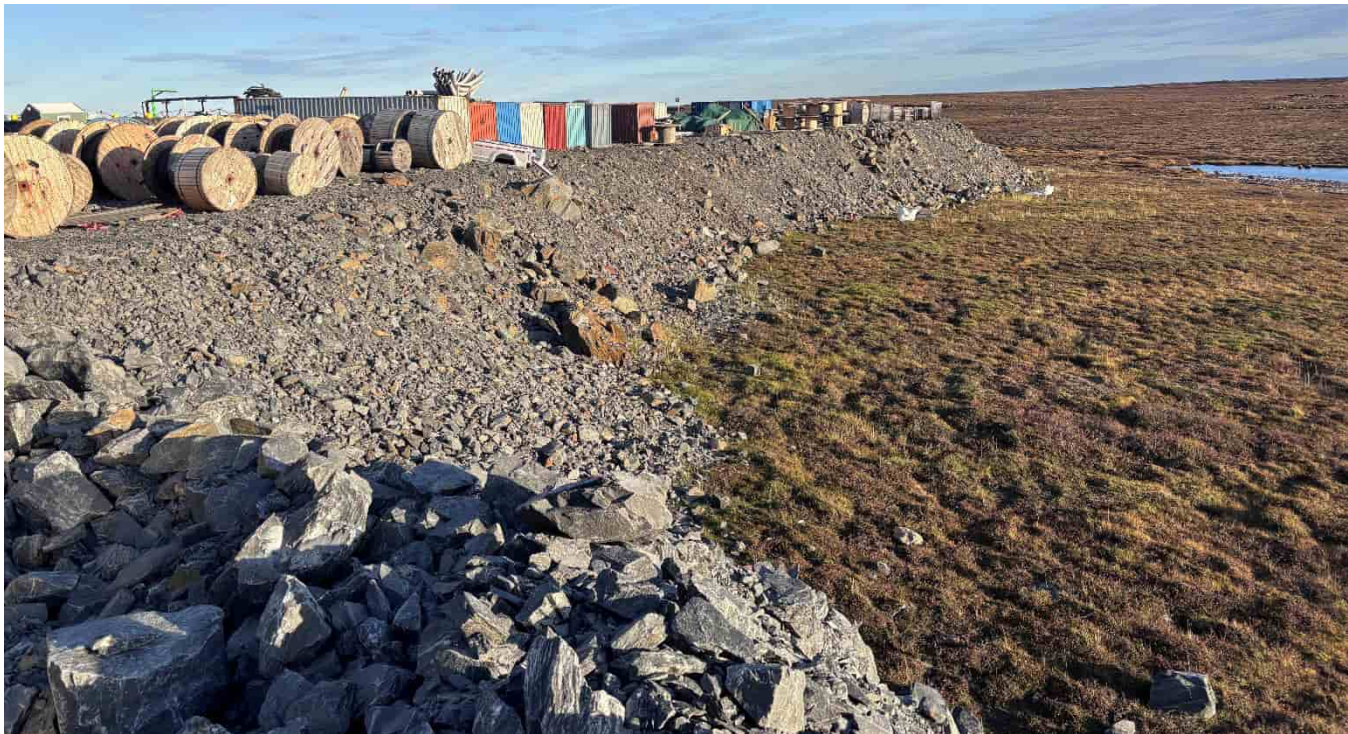
G-278: Pad slope beside laydown on western pad edge

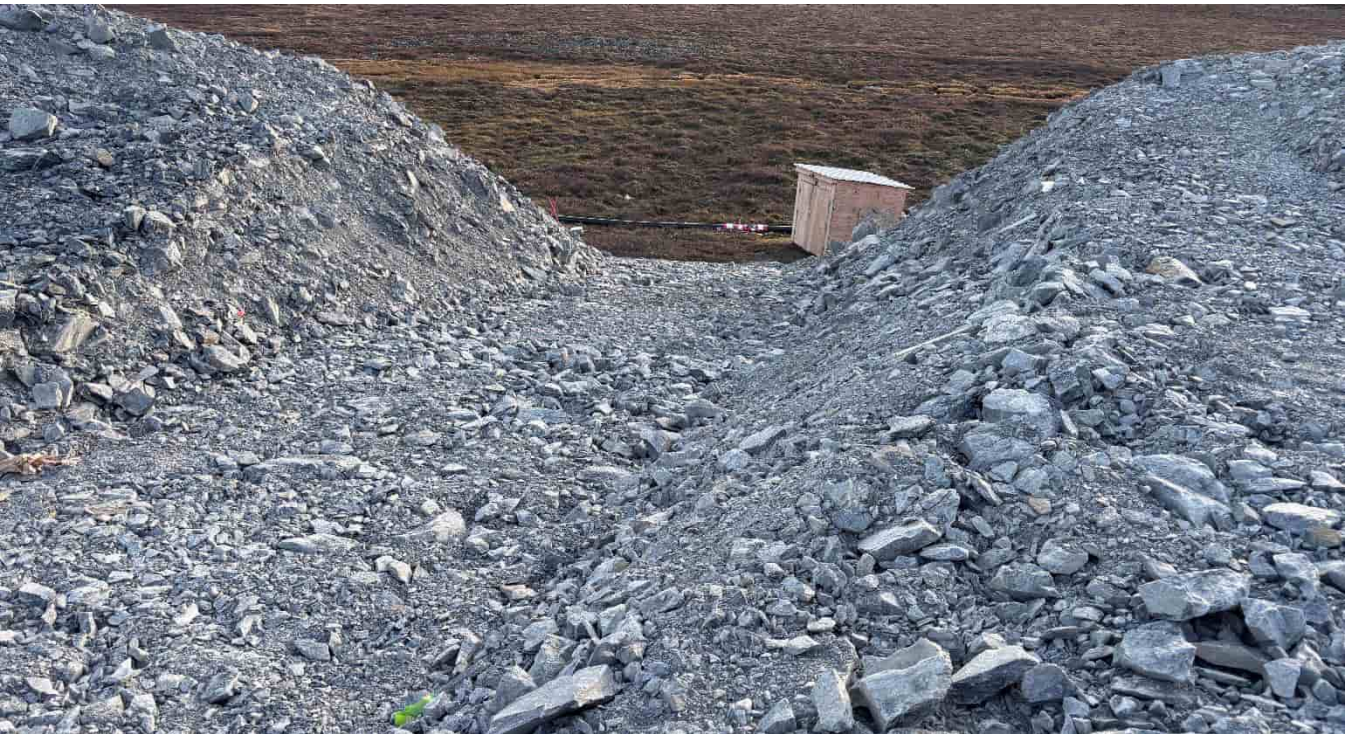
G-279: Ground access from pad, looking SW

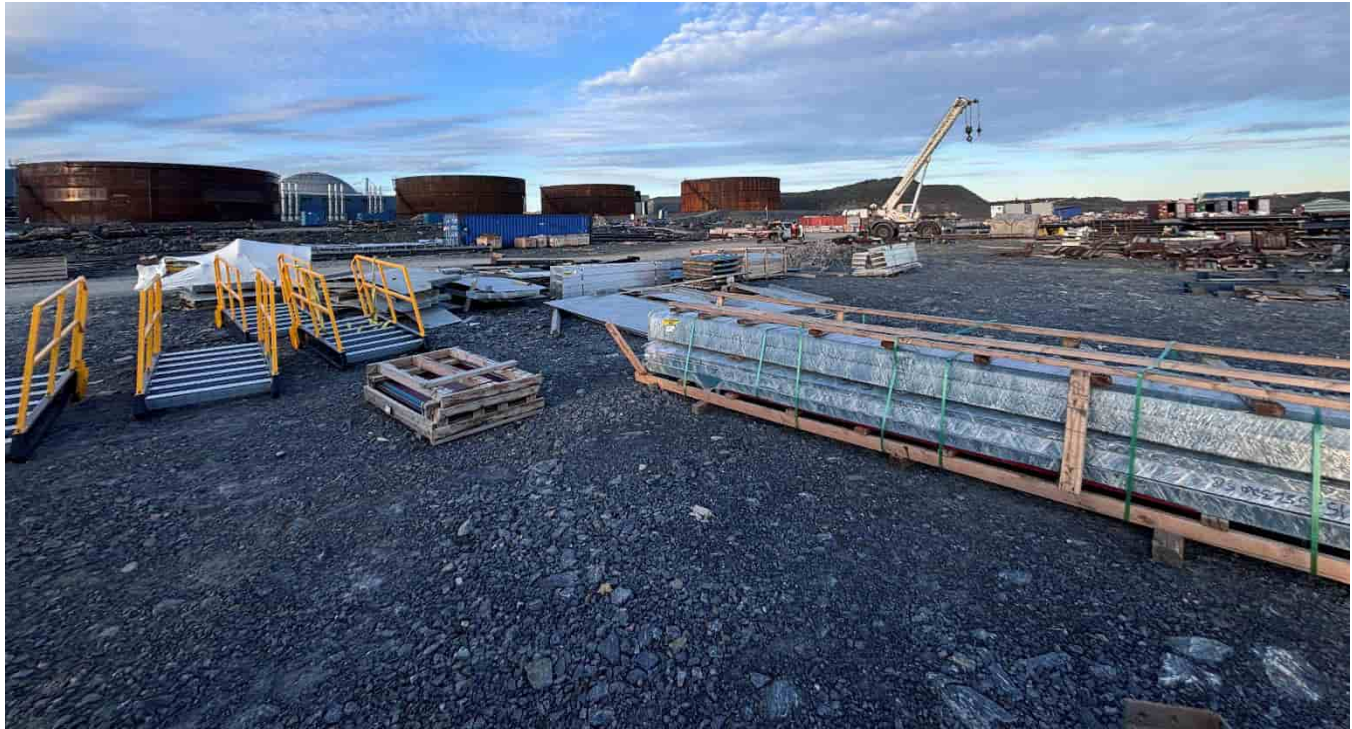
G-280: Laydown S of tank farm, looking NE
