| | | 2025 Annual Geotechnical Inspection | | |
| Job No: CAPR004312<br>Filename: Back River_Goose_2025_AGI_Photoslog.pdf | Back River Project | Date:<br>February 2026 | Approved:<br>JBK | Figure:<br>79 |

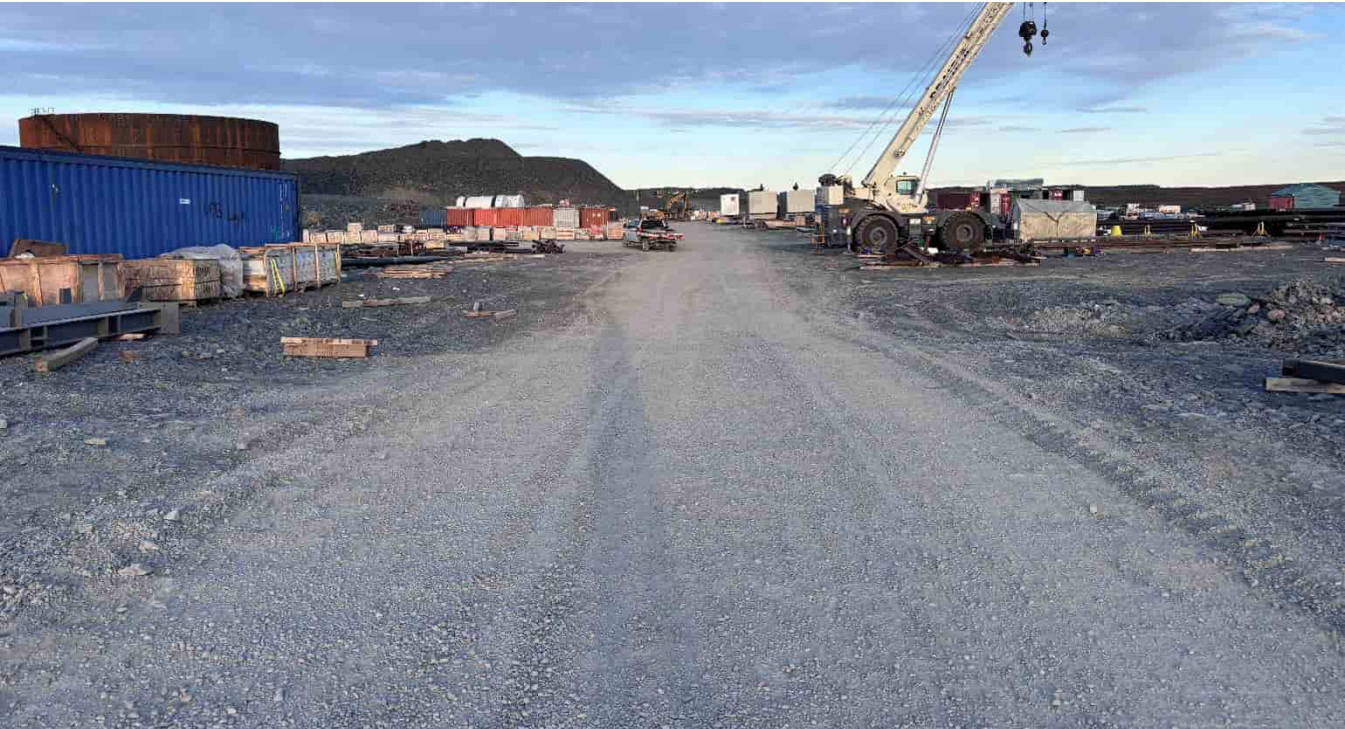
G-281: Laydown area and road S of tank farm, looking E

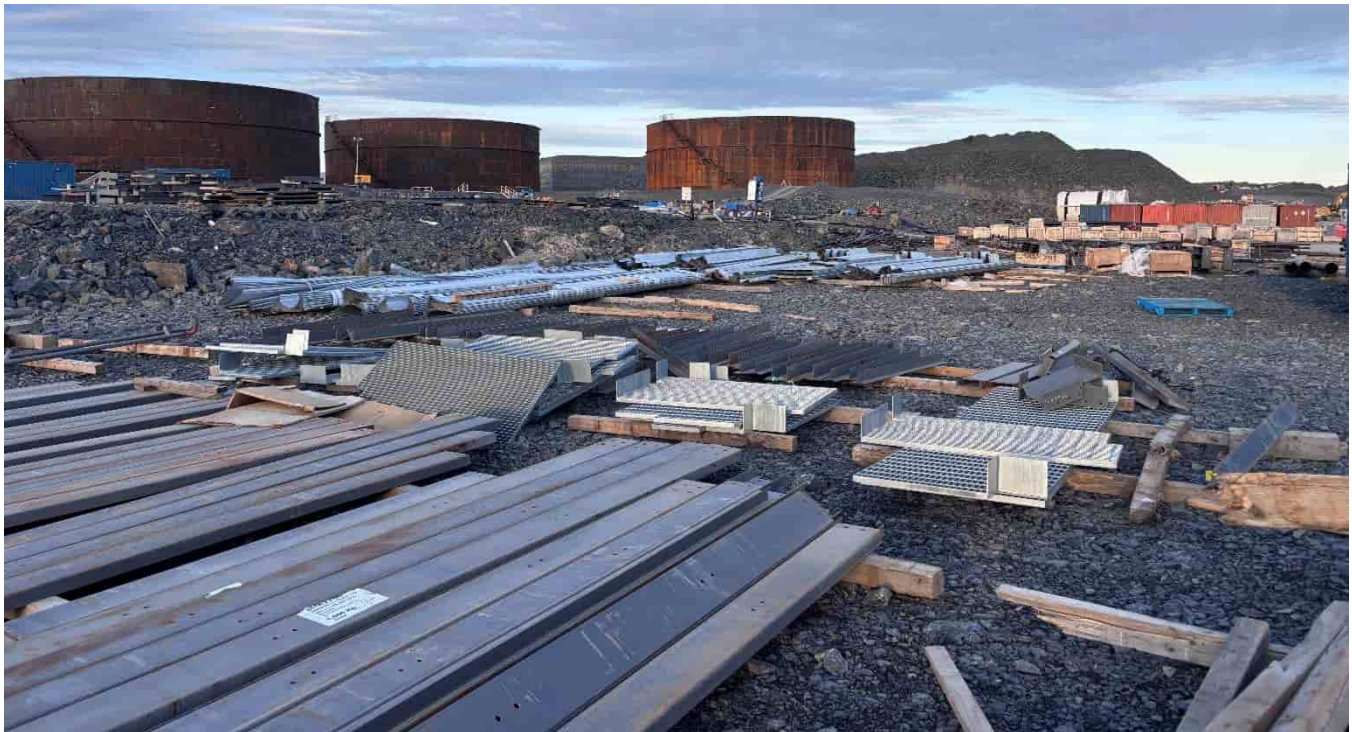
G-282: Laydown area, looking NE

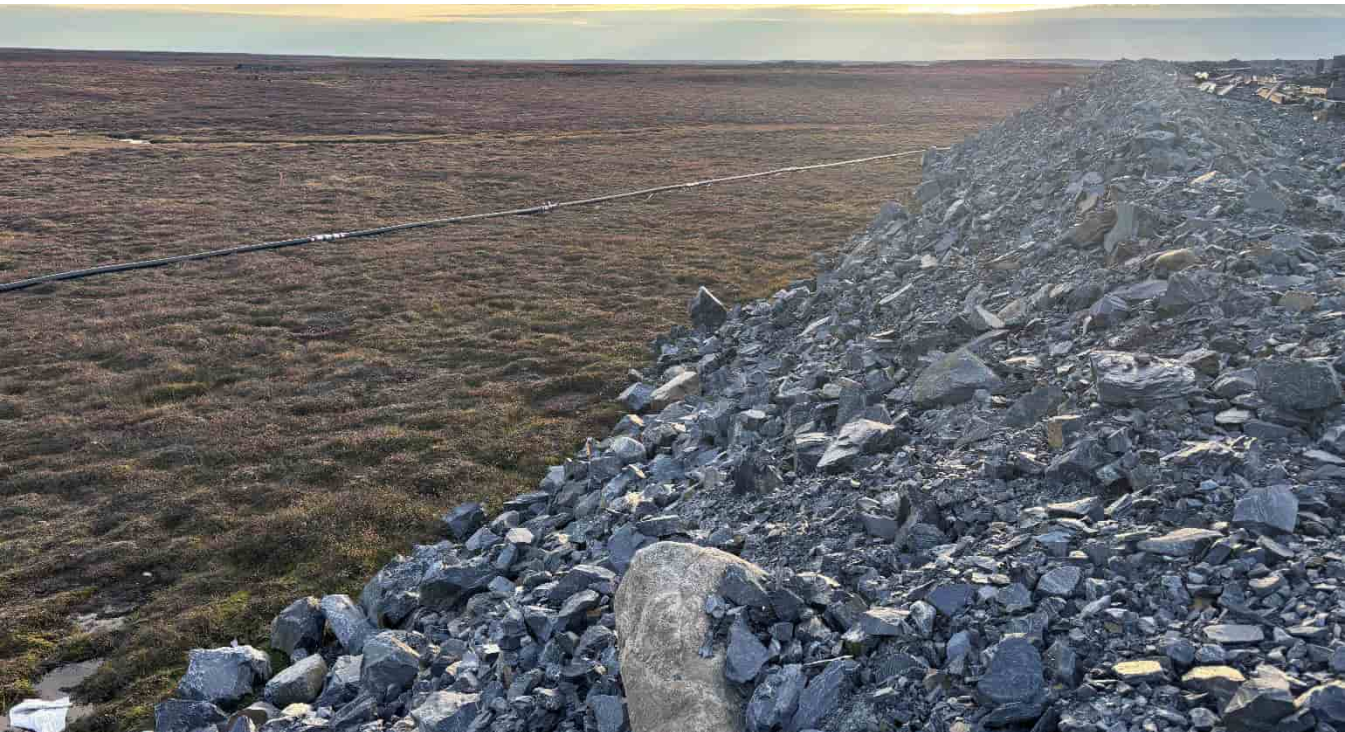
G-283: Southern pad slope, looking W – pipeline on tundra beyond toe

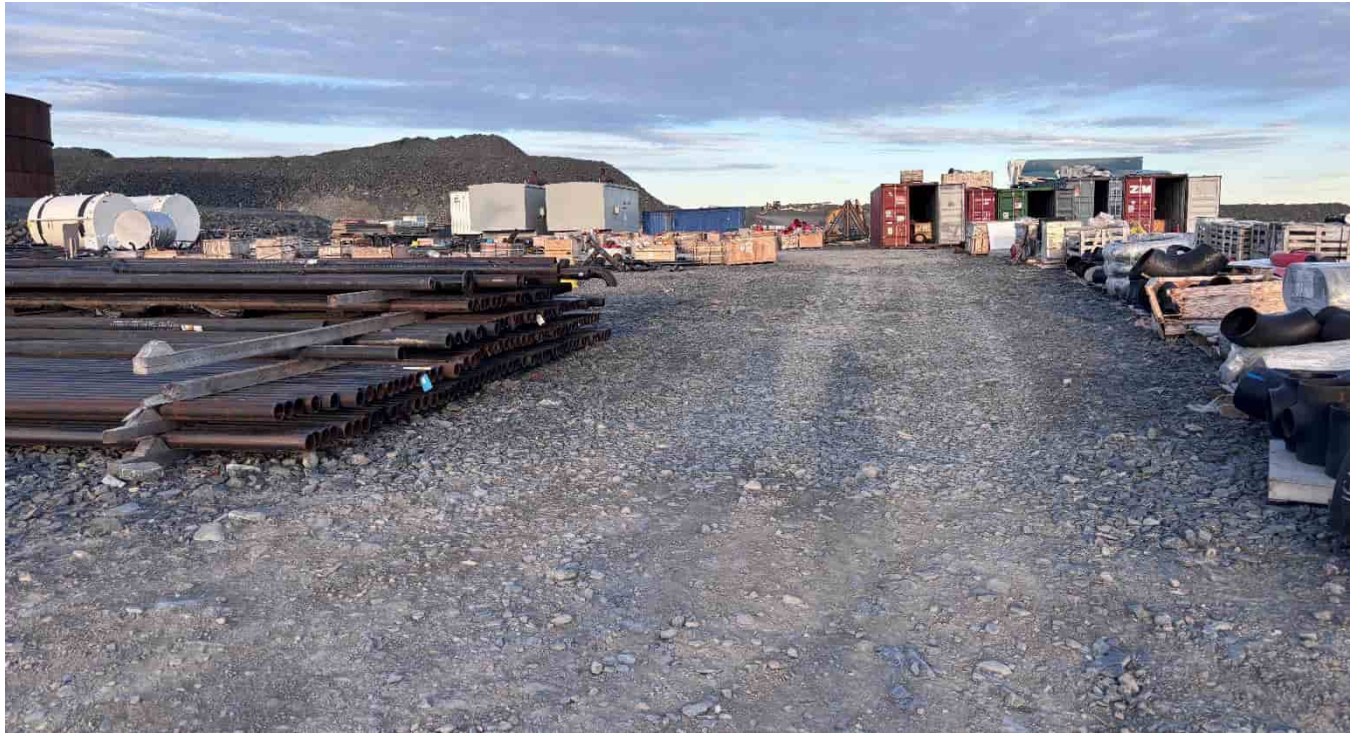
G-284: Laydown, looking E

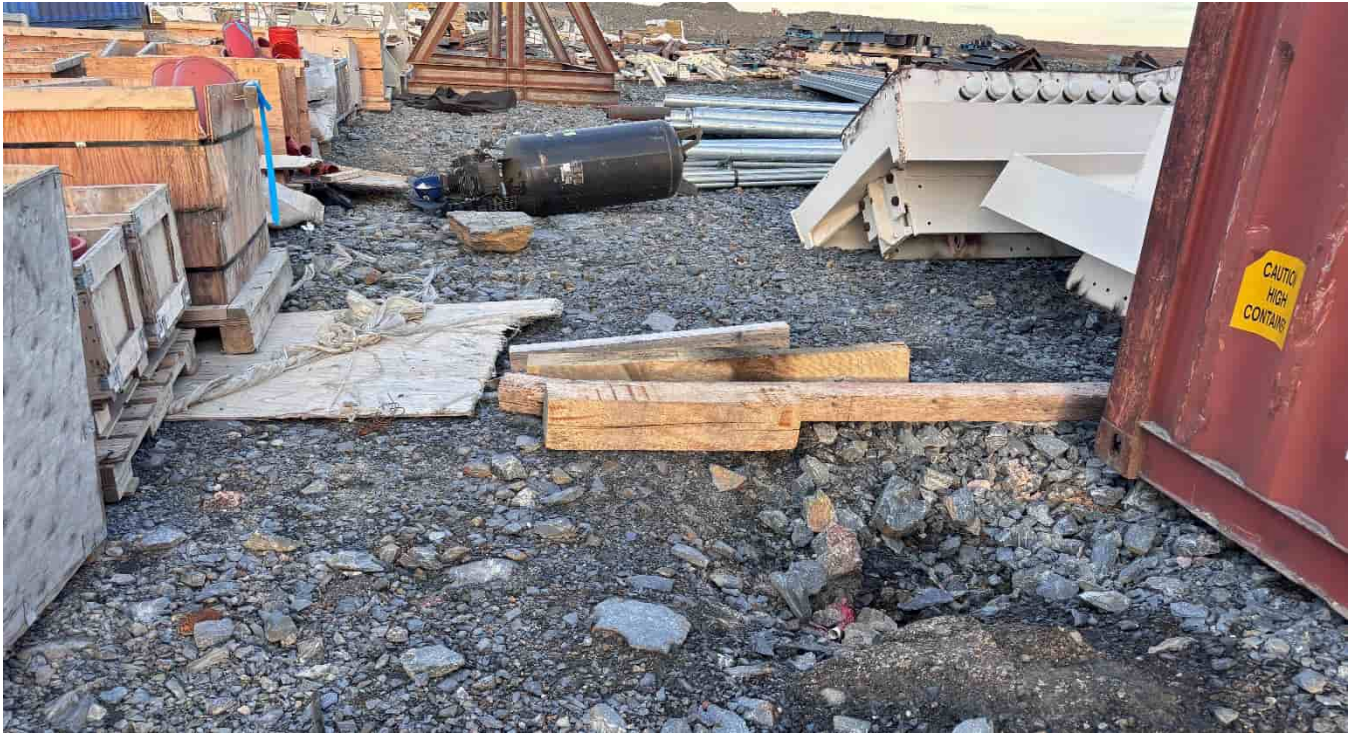
G-285: Settlement of laydown area near edge of seacan

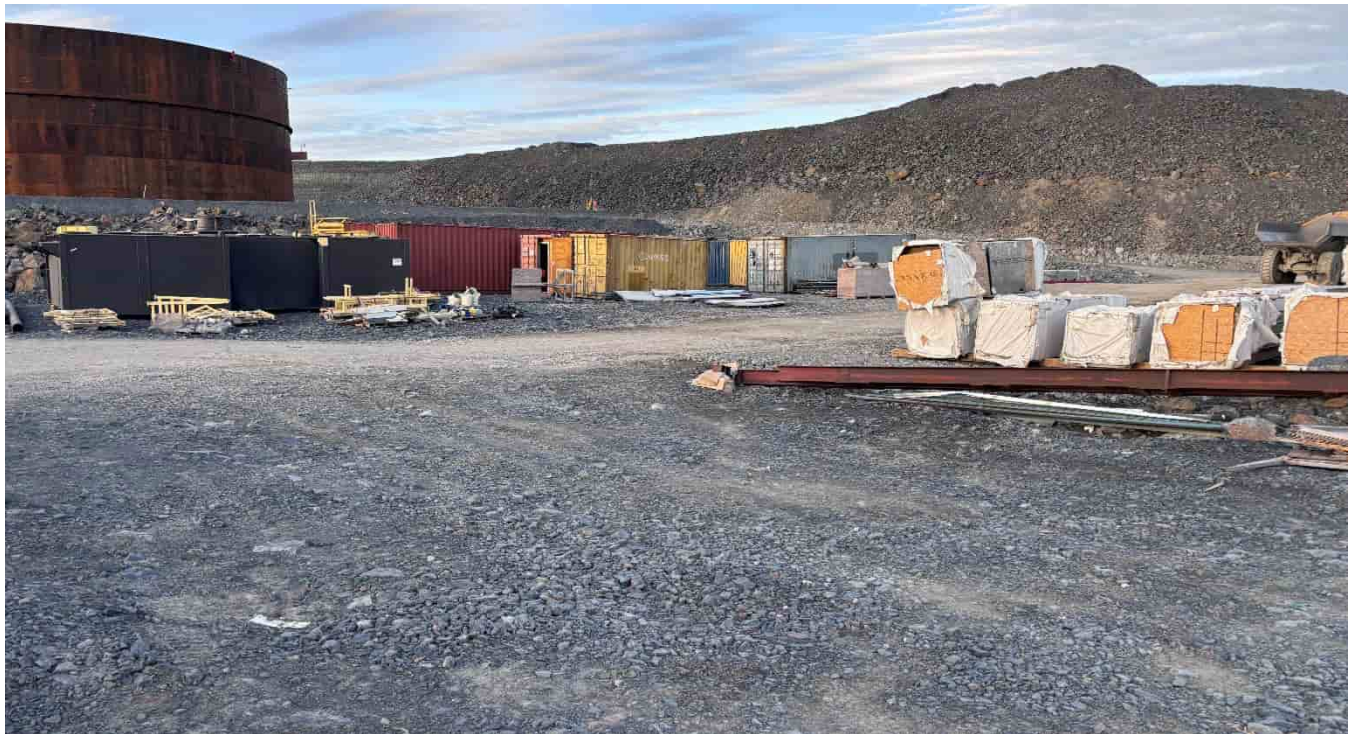
G-286: Looking NE from laydown area towards tank farm and ROM stockpile

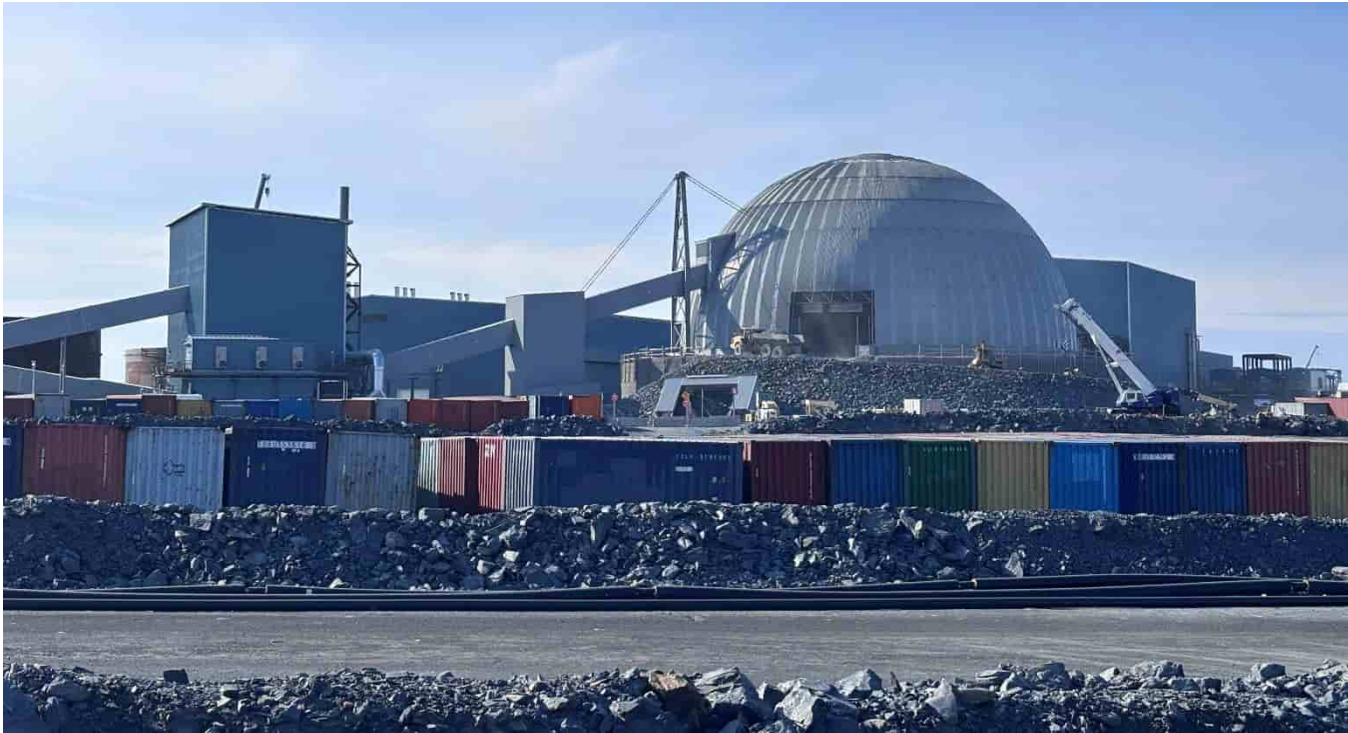
G-289: Overall view towards ore dome and plant area from the berm between the All-Weather Road and contact water pond

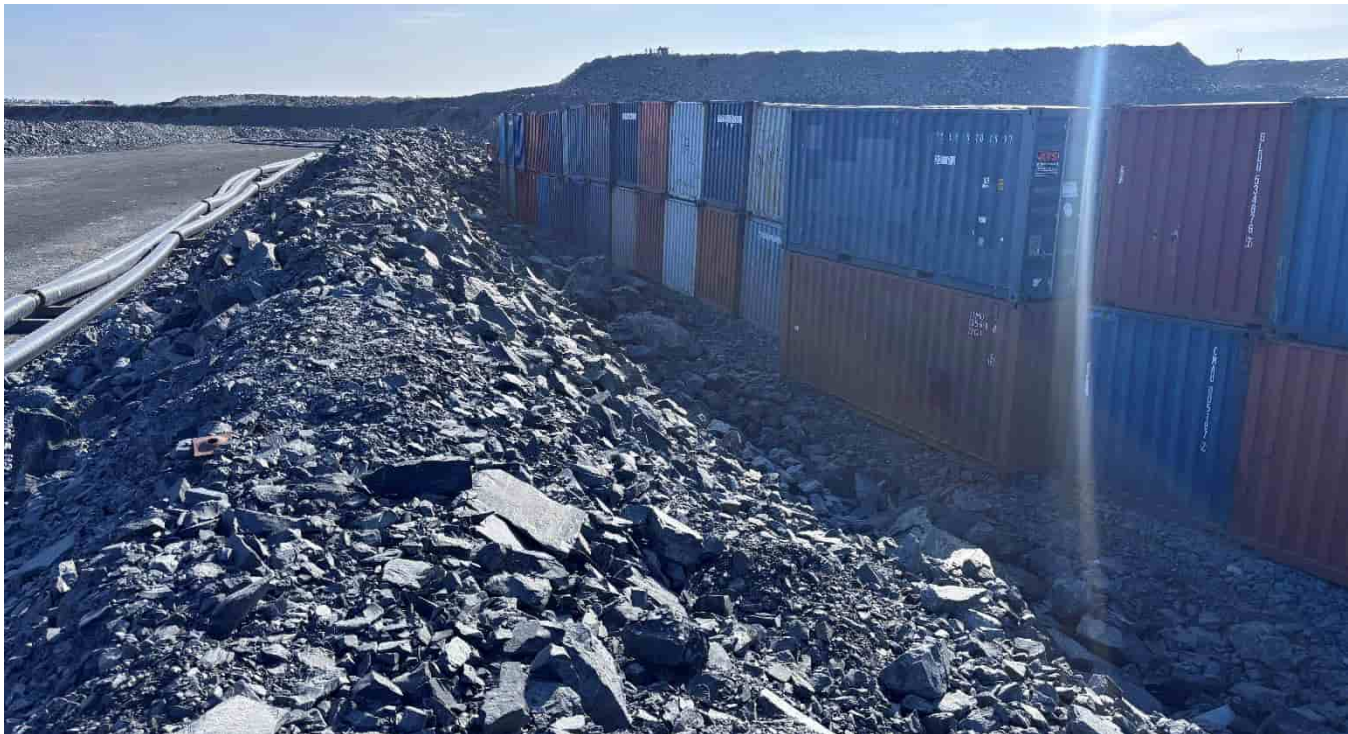
G-290: Berm between tailings pipeline road and seacan laydown area, looking SE

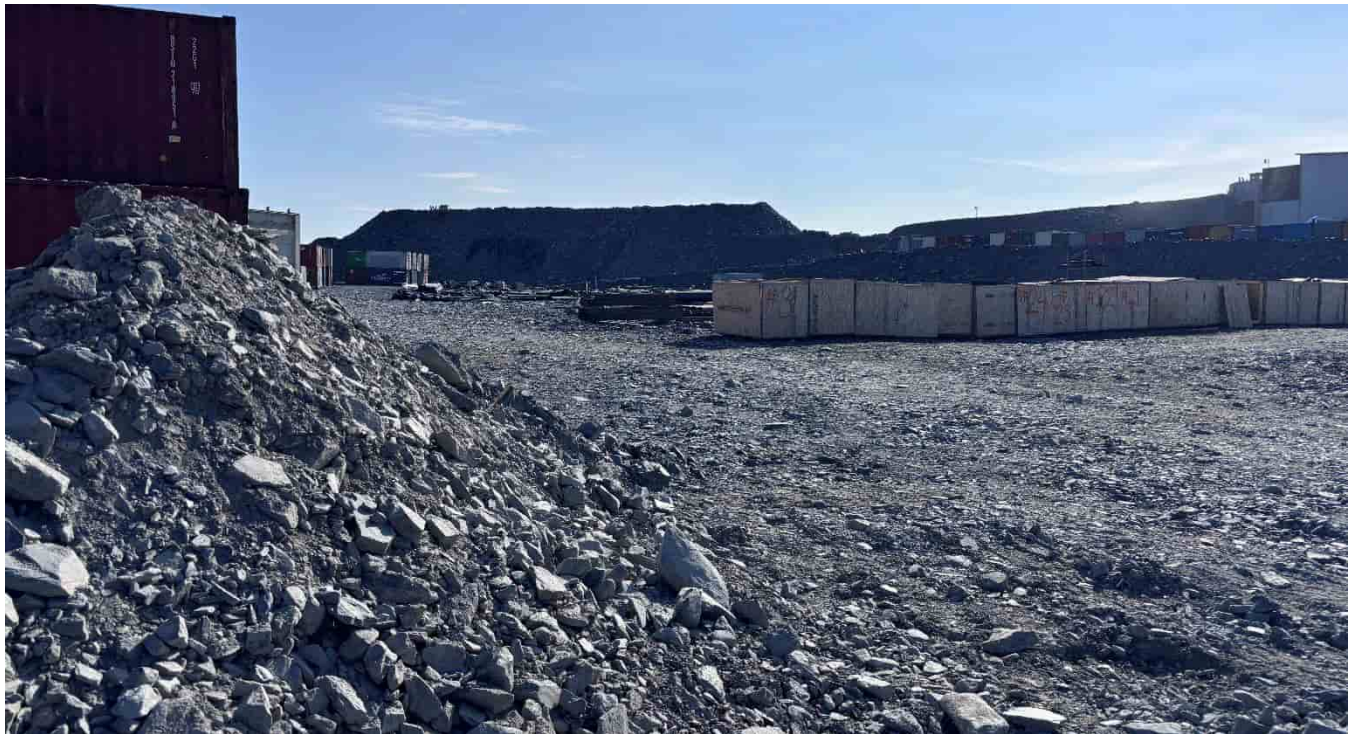
G-291: Seacan laydown area surface conditions, looking S

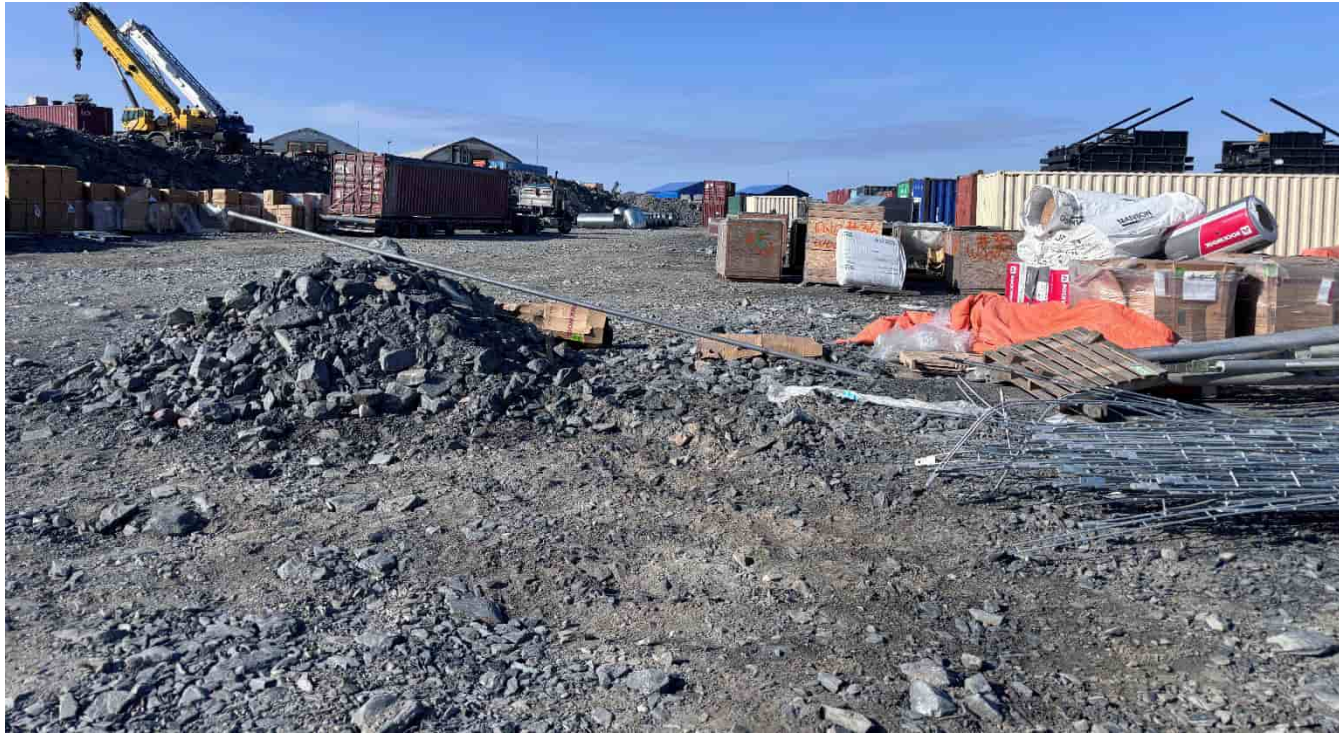
G-292: Laydown area, looking NW

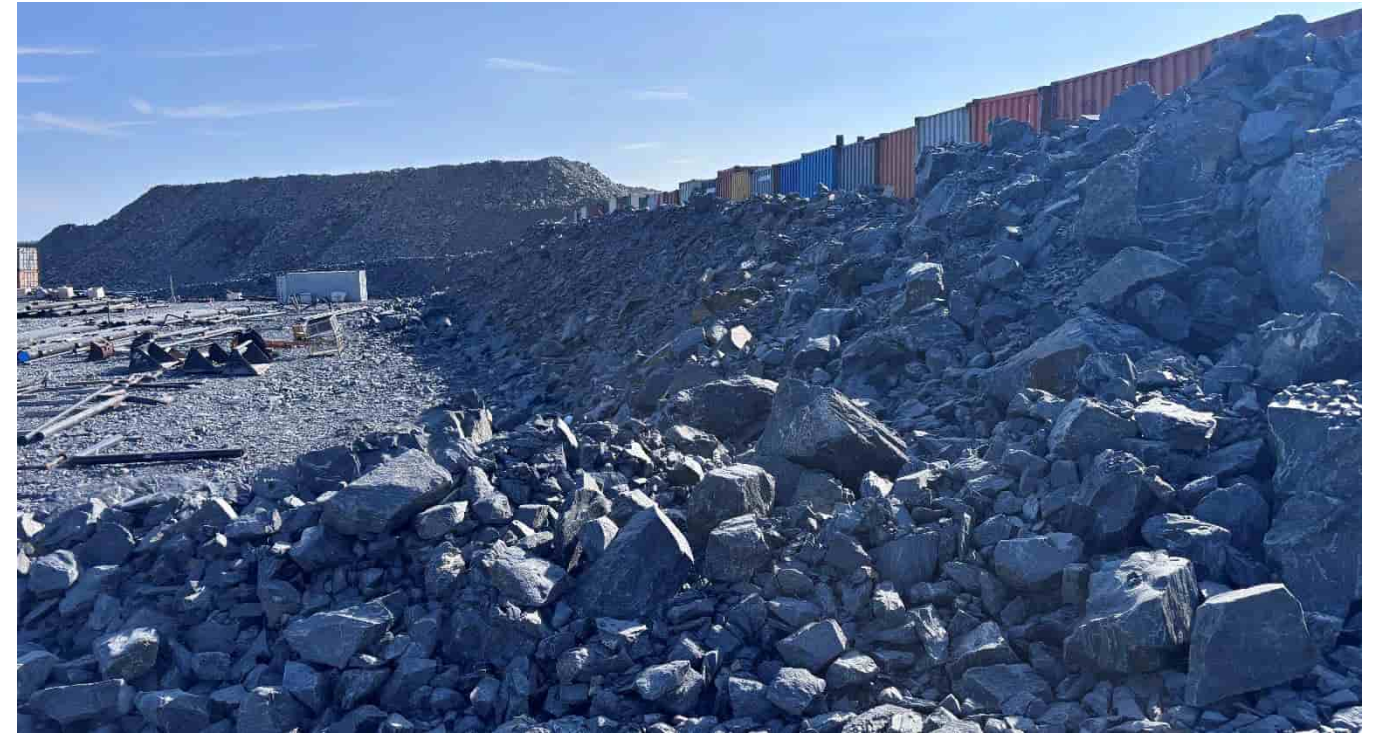
G-293: Laydown area berm, looking SE

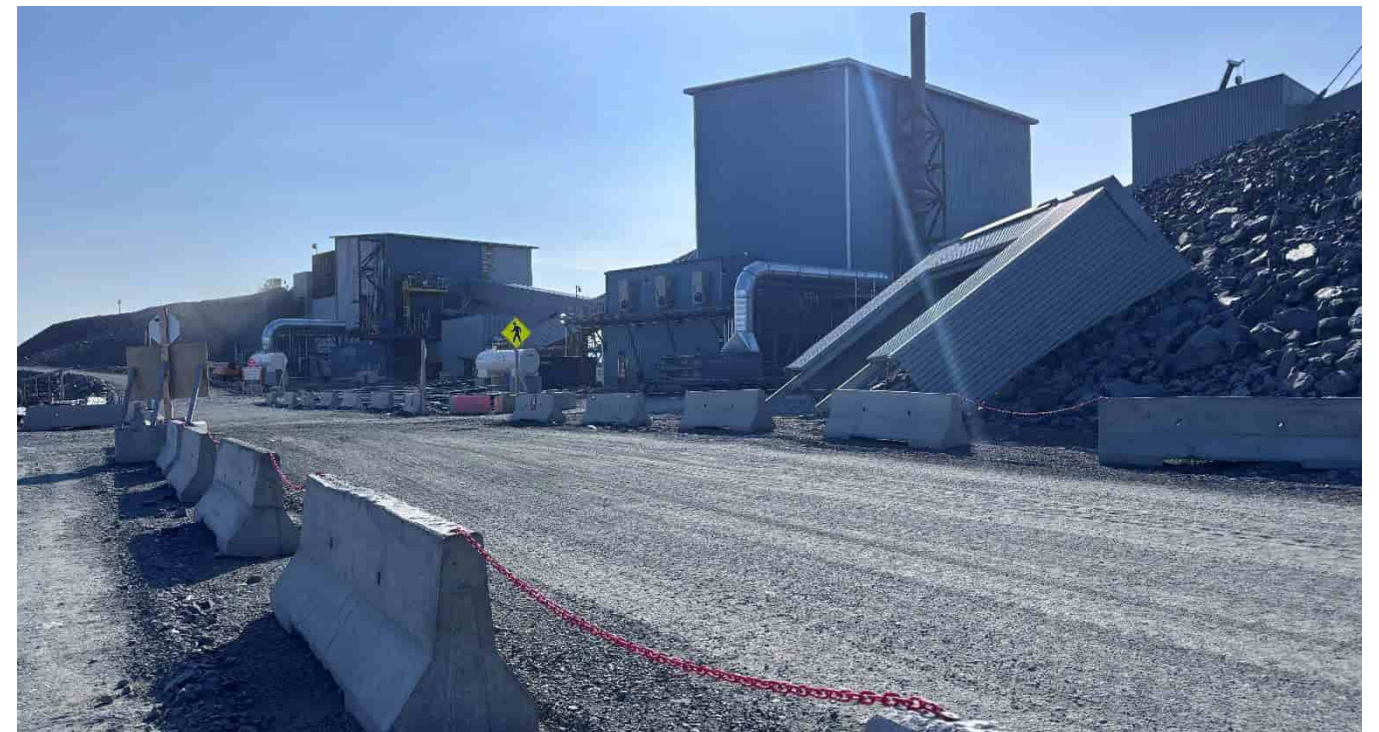
G-295: View towards crusher from road, looking S – area under construction at time of inspection

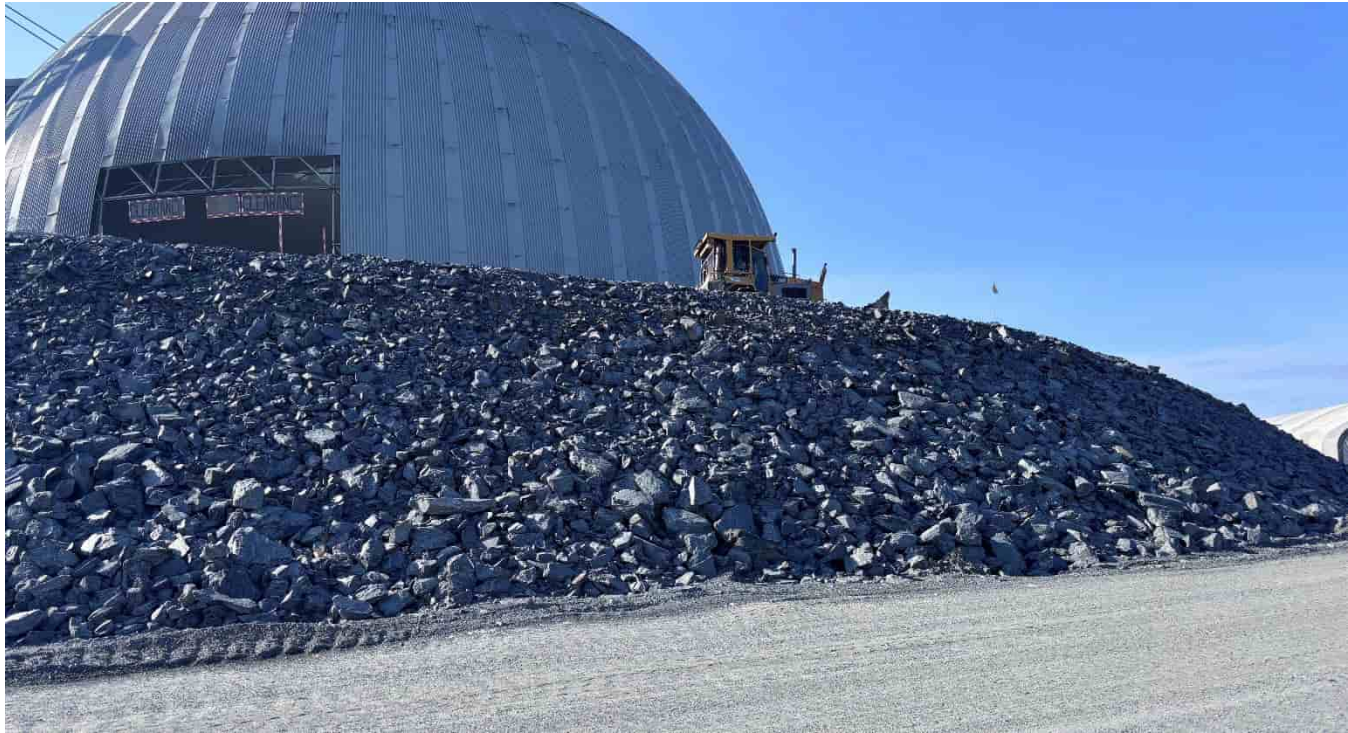
G-296: Typical slope below ore dome

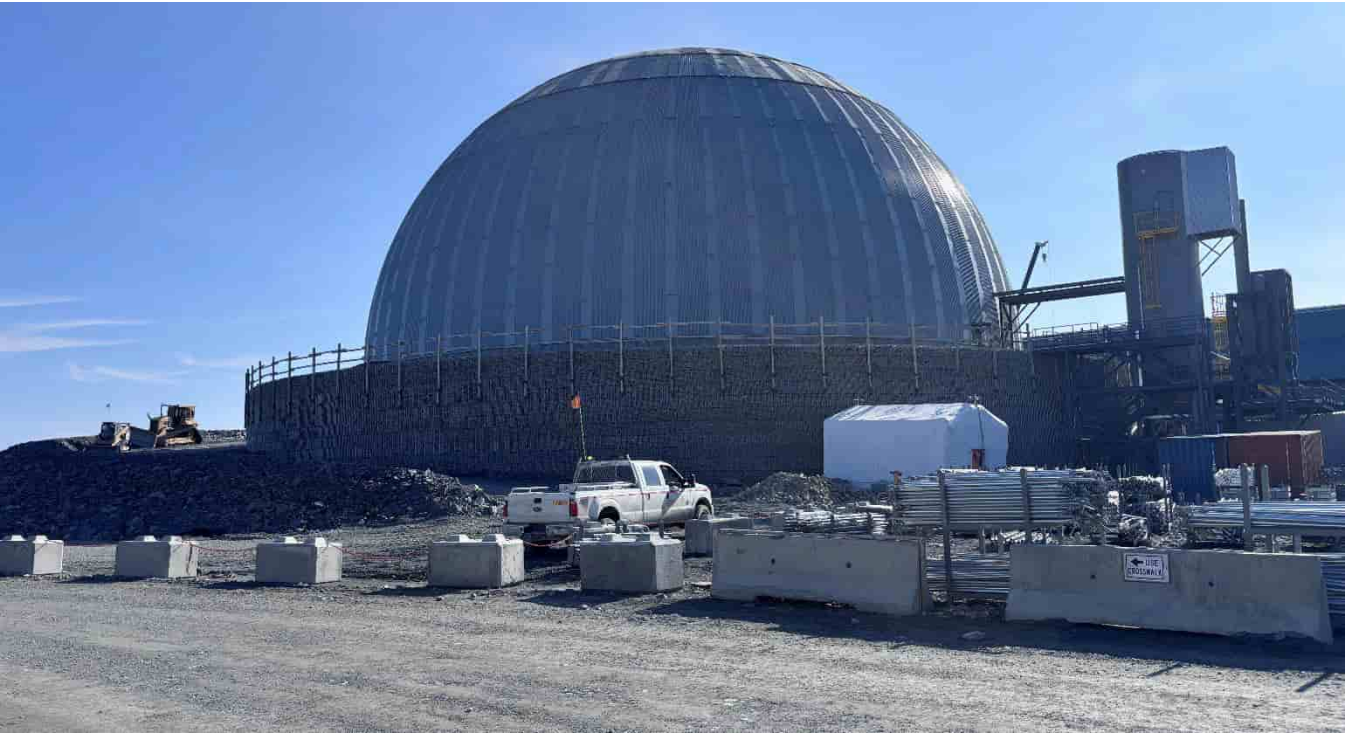
G-297: View towards ore dome from road, looking SE

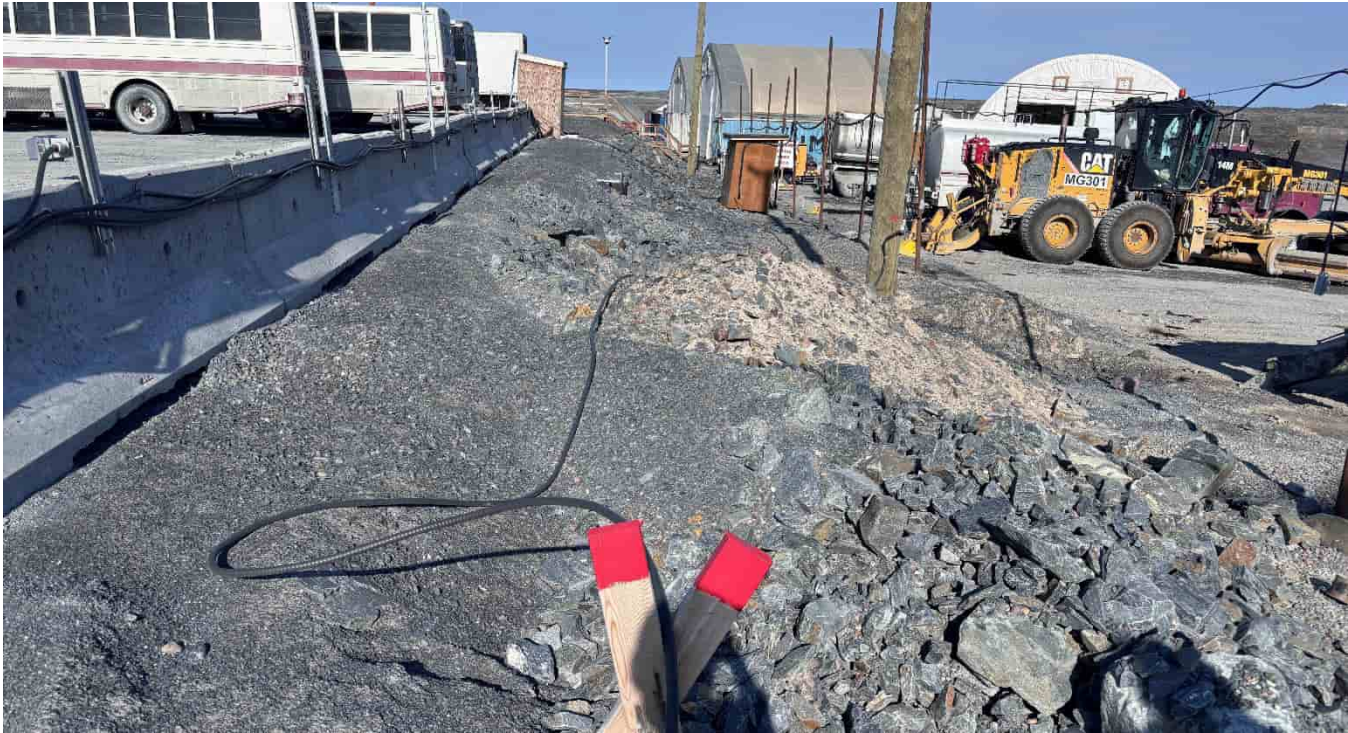
G-301: Laydown area E of main camp, looking S at erosion to slope

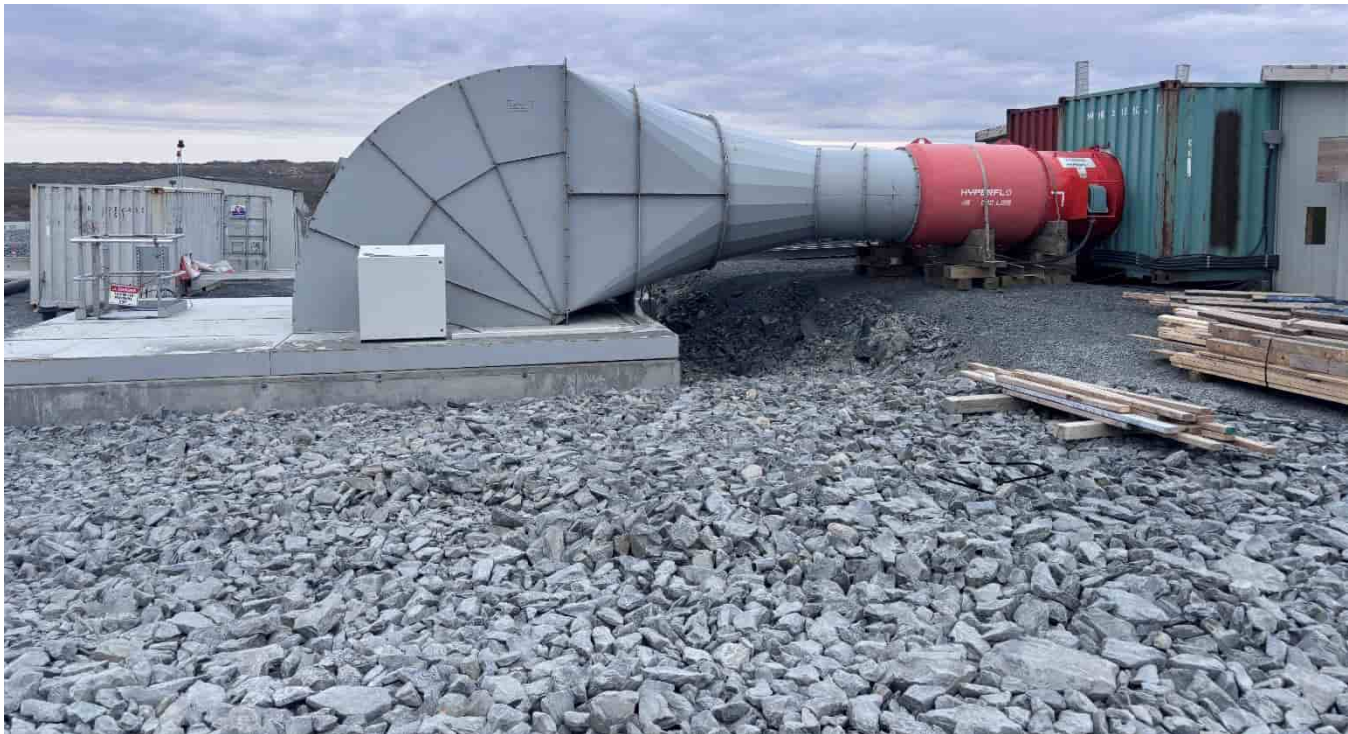
G-302: Vent raise, looking NE

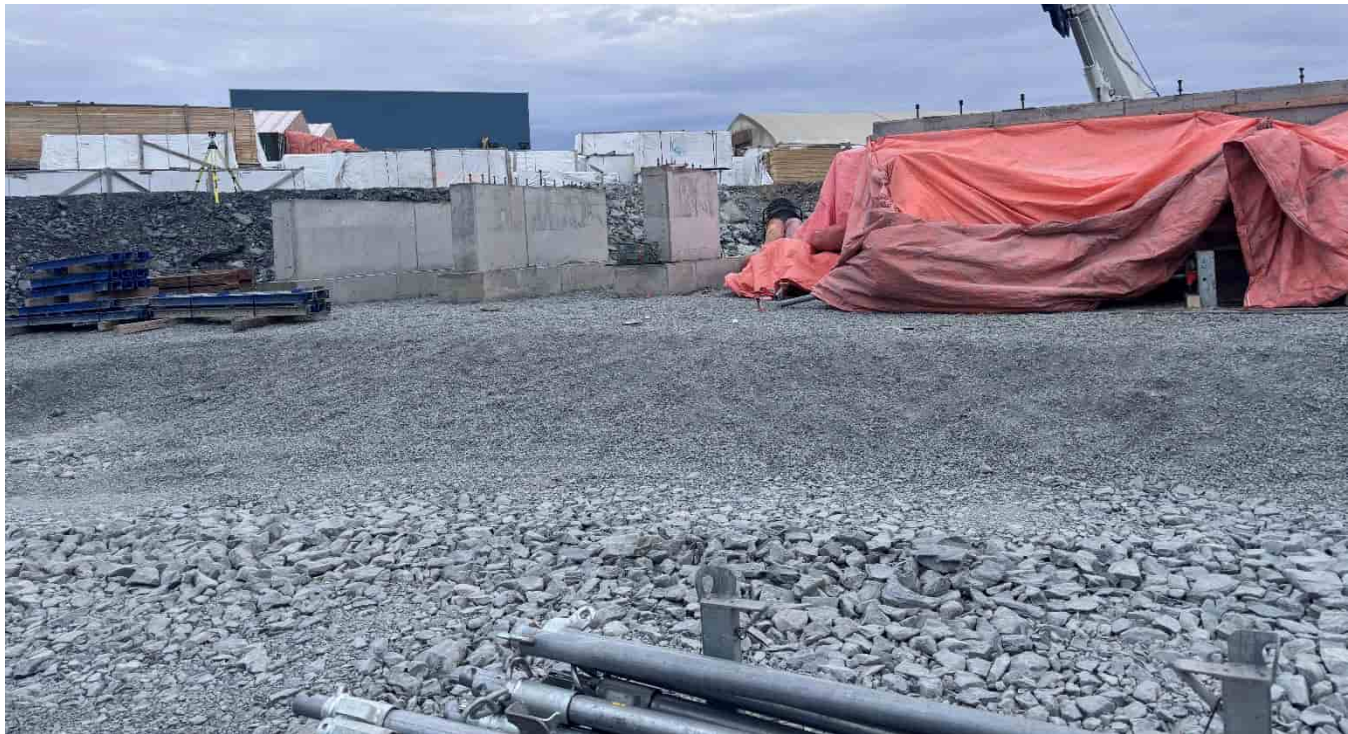
G-303: Laydown area beside vent raise

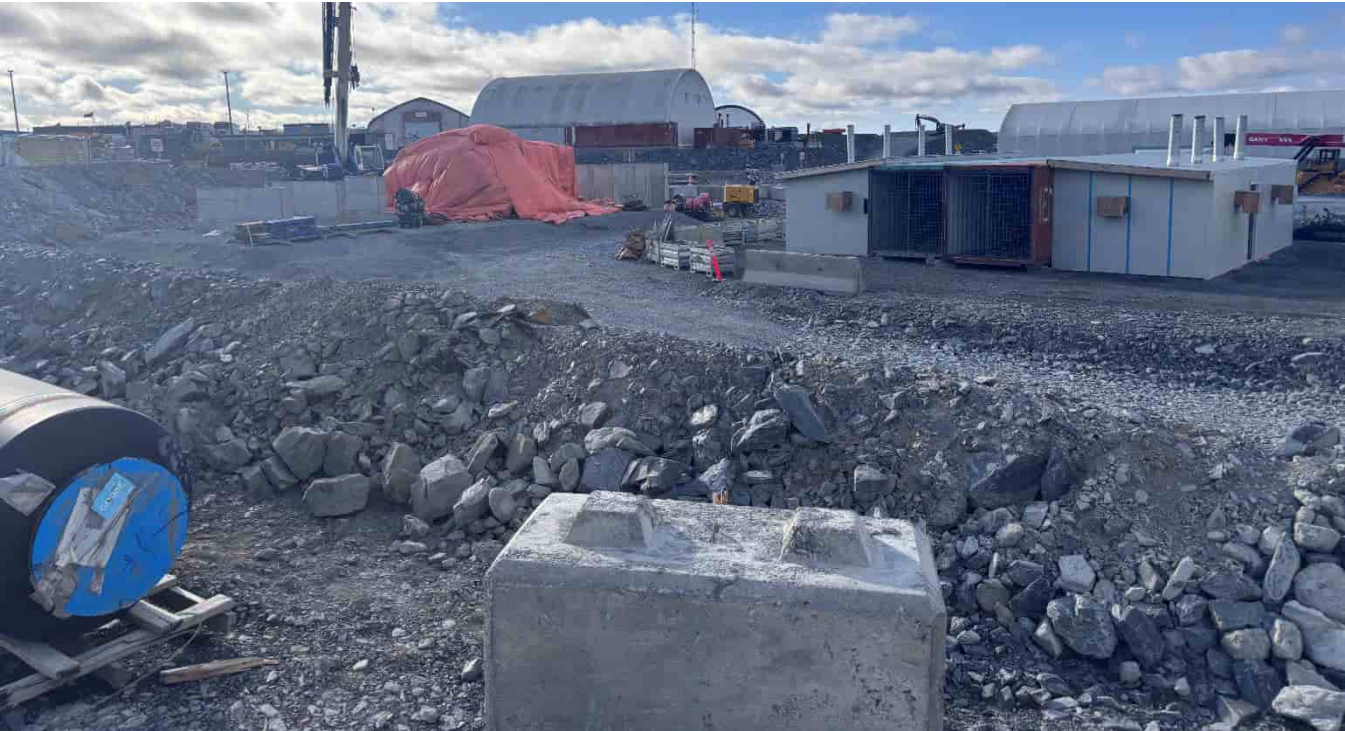
G-305: Looking S towards scaffolders and ironworkers area

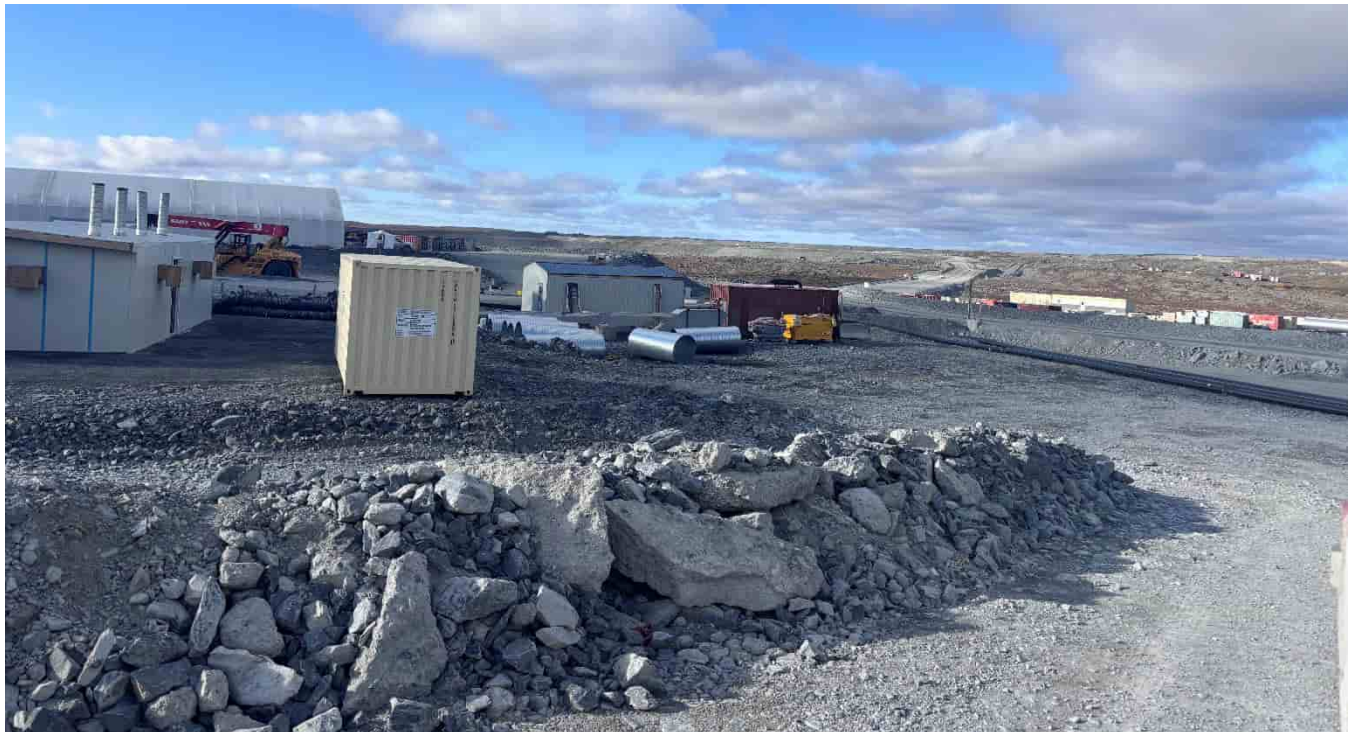
G-306: Looking W towards vent raise, laydown, All-Weather Road, and tailings pipeline

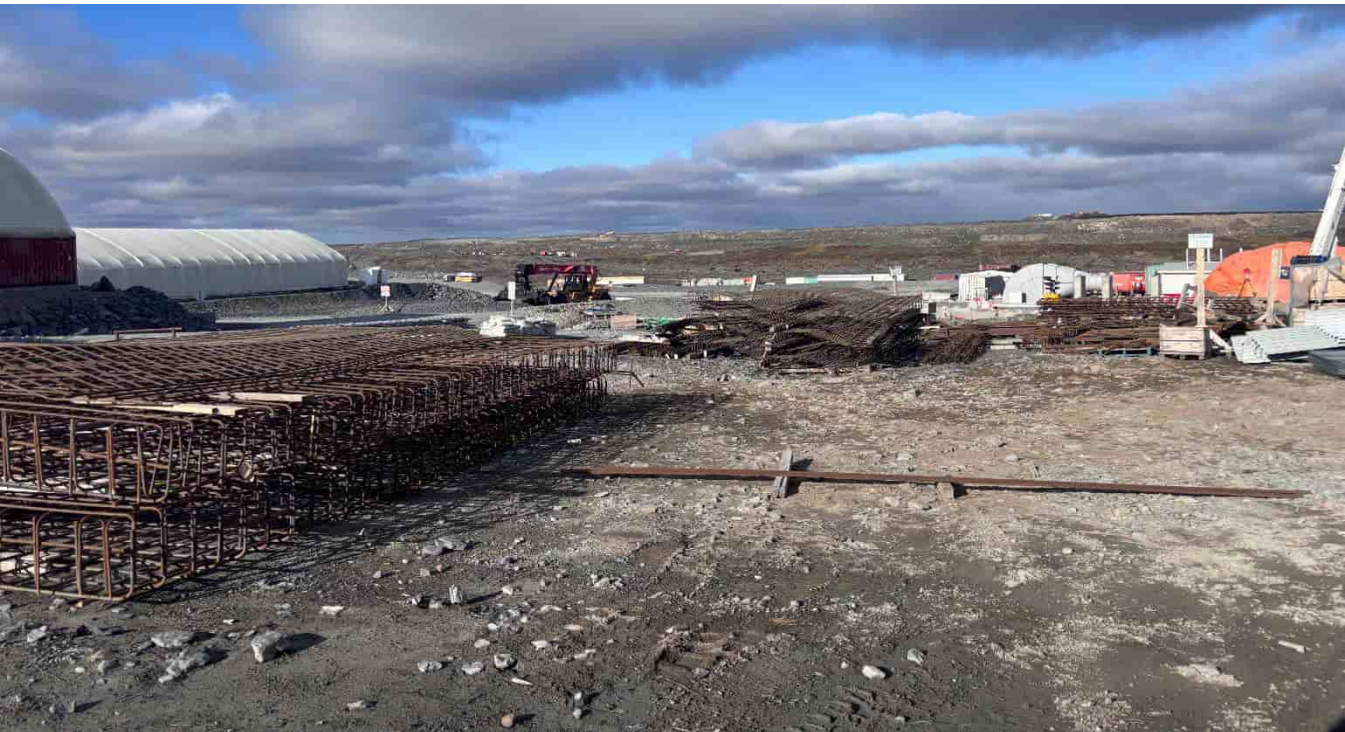
G-307: Rebar laydown N of pipefitters building

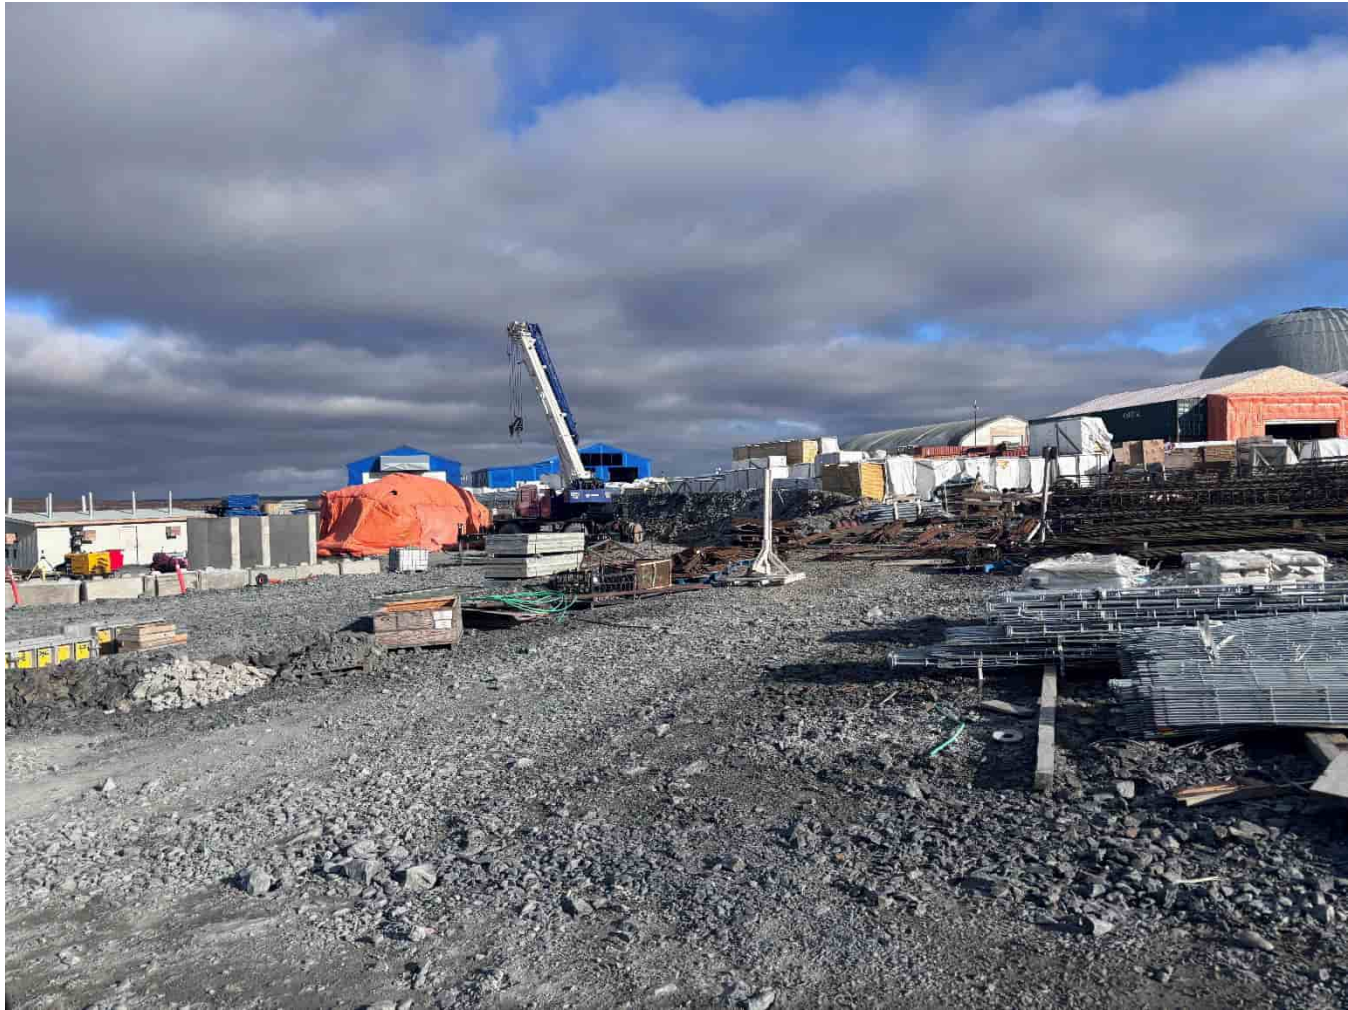
G-308: Laydown area beside site services, looking E

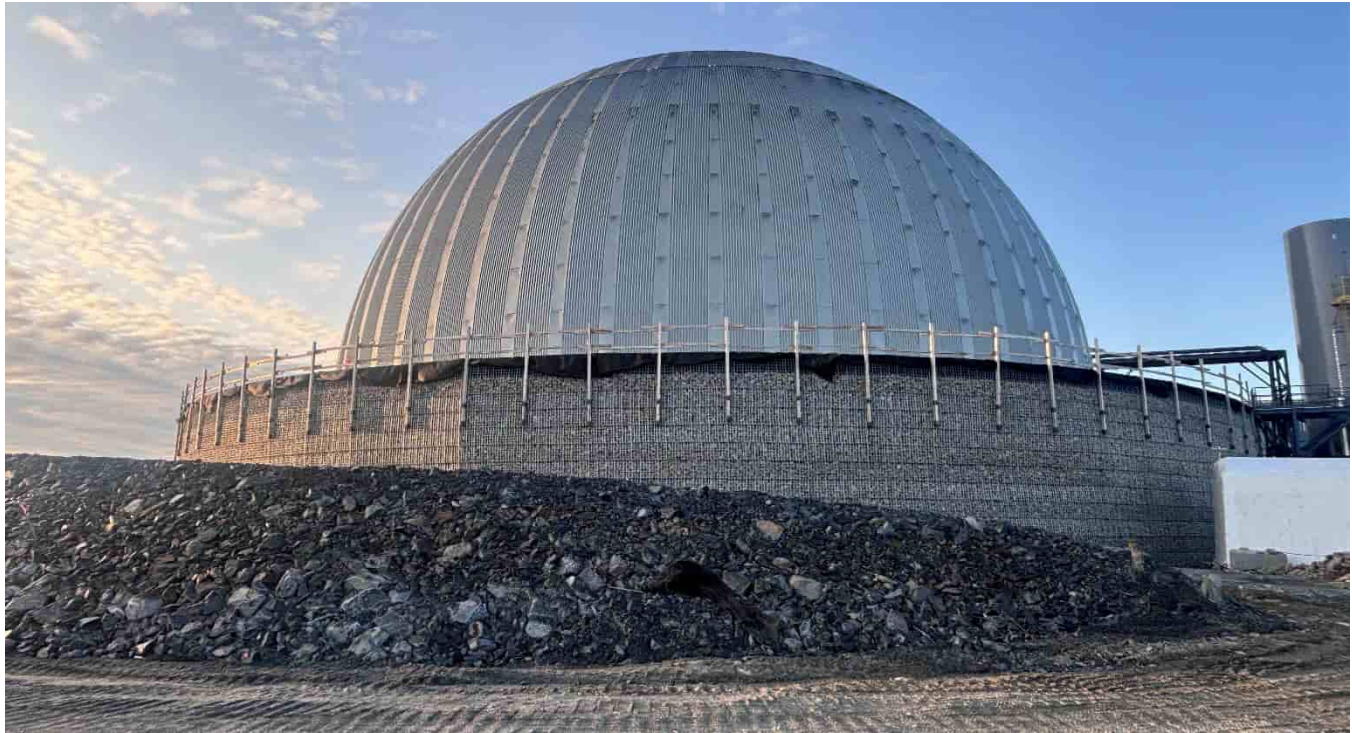
G-310: Ore dome MSE wall, looking S
