| | | 2025 Annual Geotechnical Inspection | | |
| Job No: CAPR004312<br>Filename: Back River_Goose_2025_AGI_Photoslog.pdf | Back River Project | Date:<br>February 2026 | Approved:<br>JBK | Figure:<br>79 |

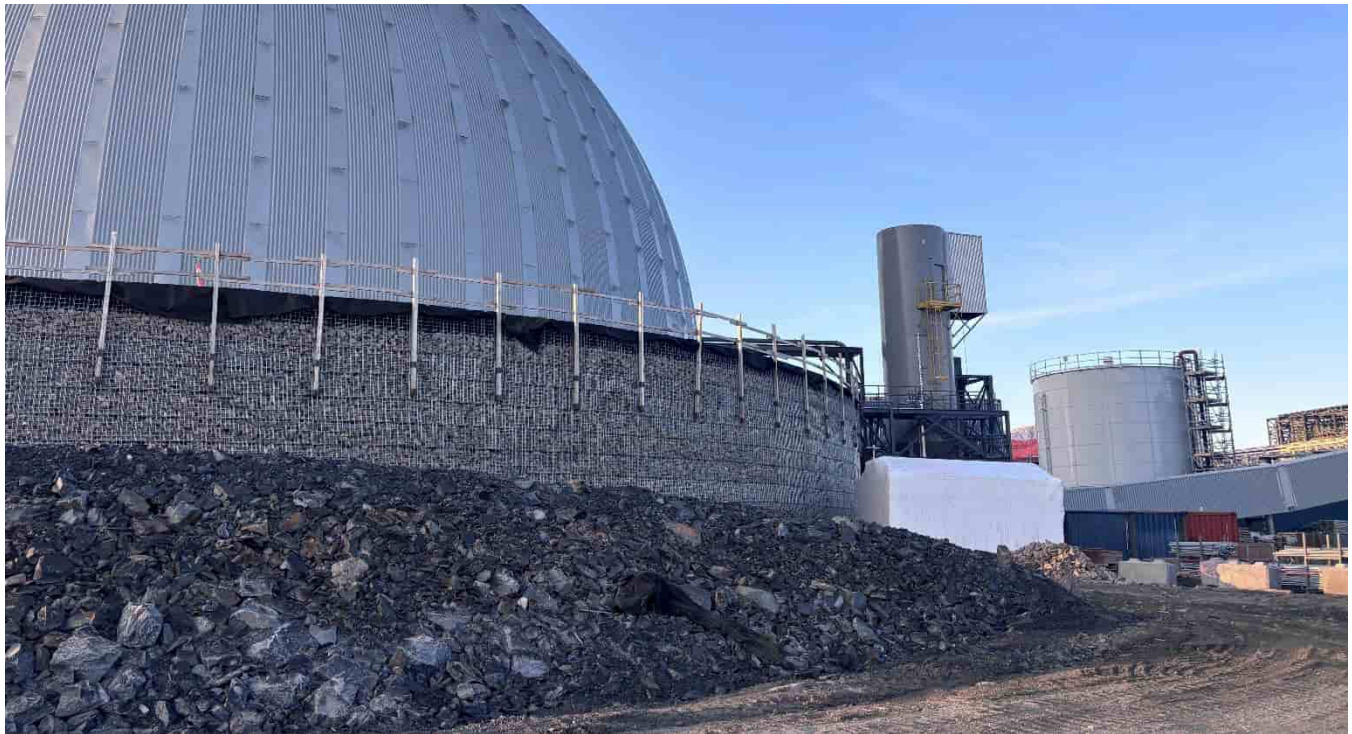
G-311: Ore dome MSE wall, looking SW

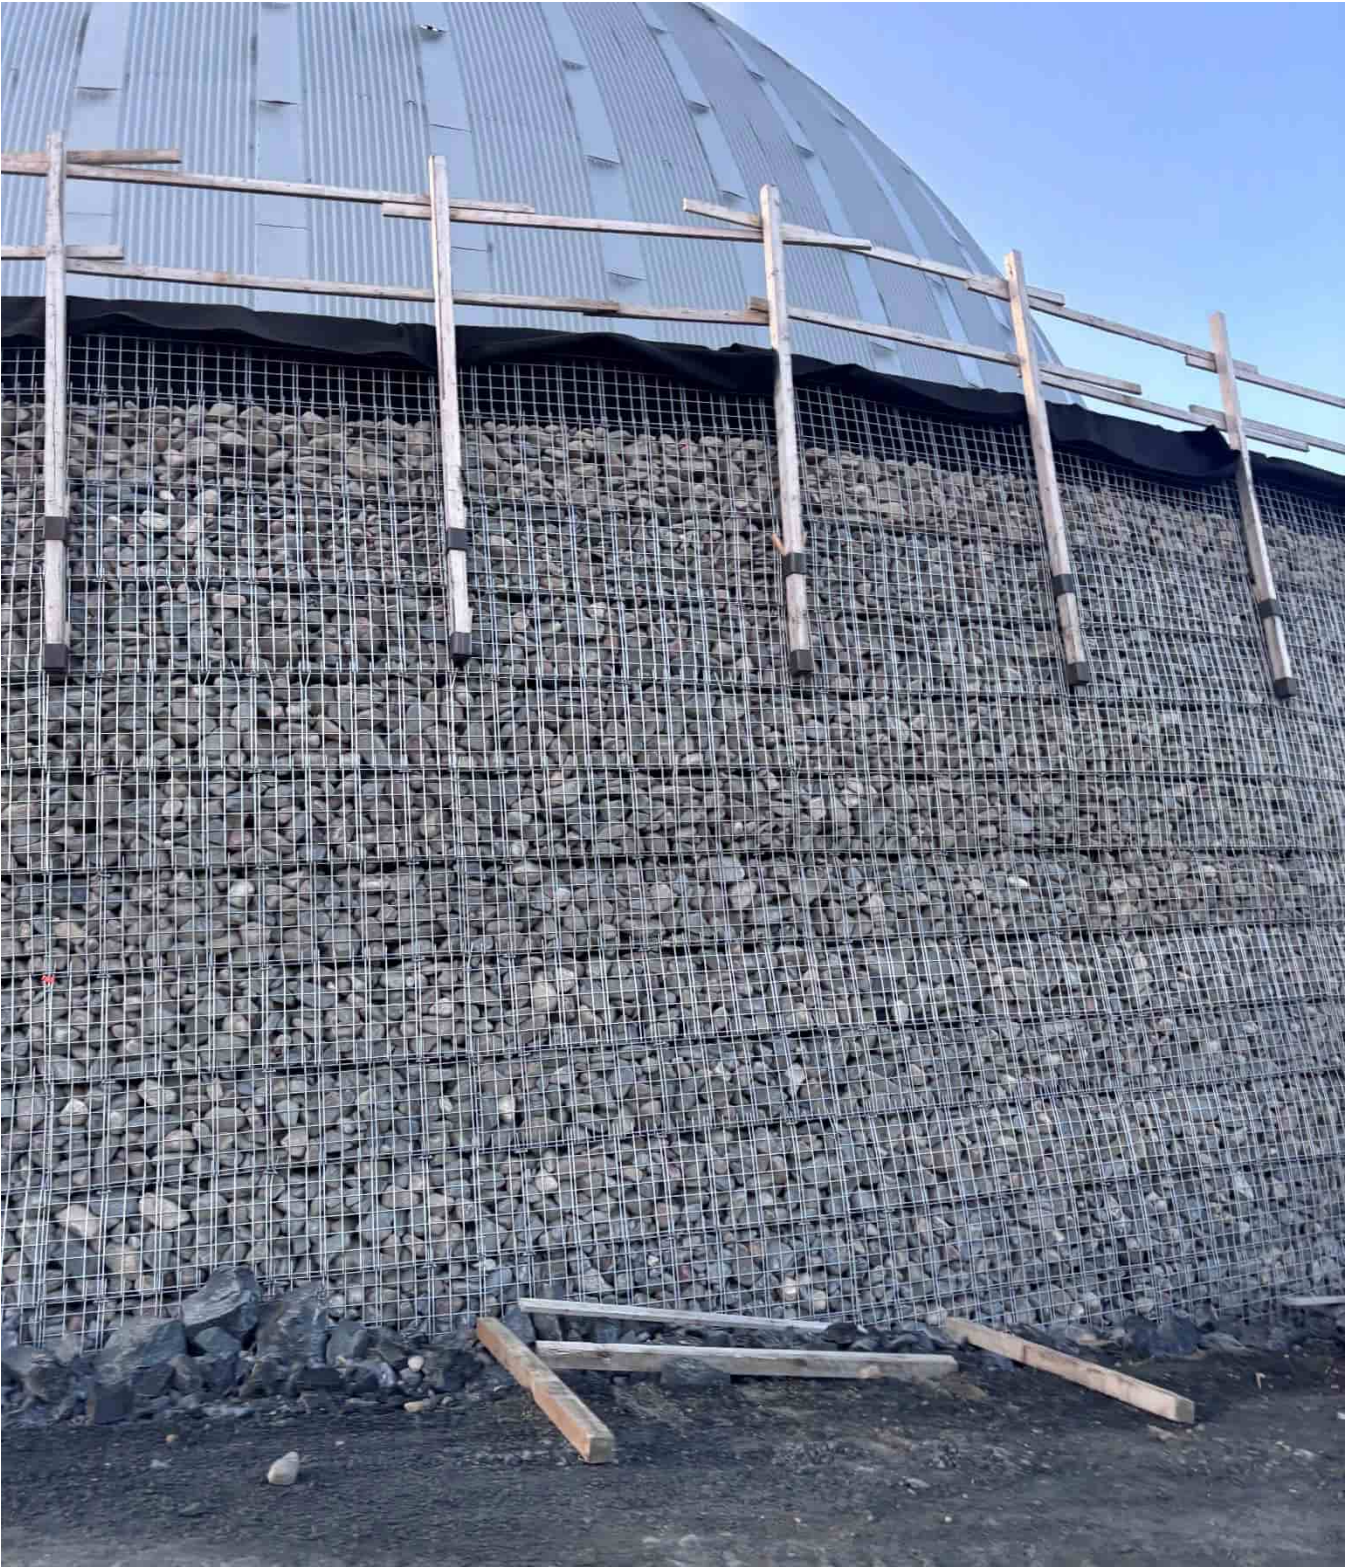
G-312: Typical MSE wall construction

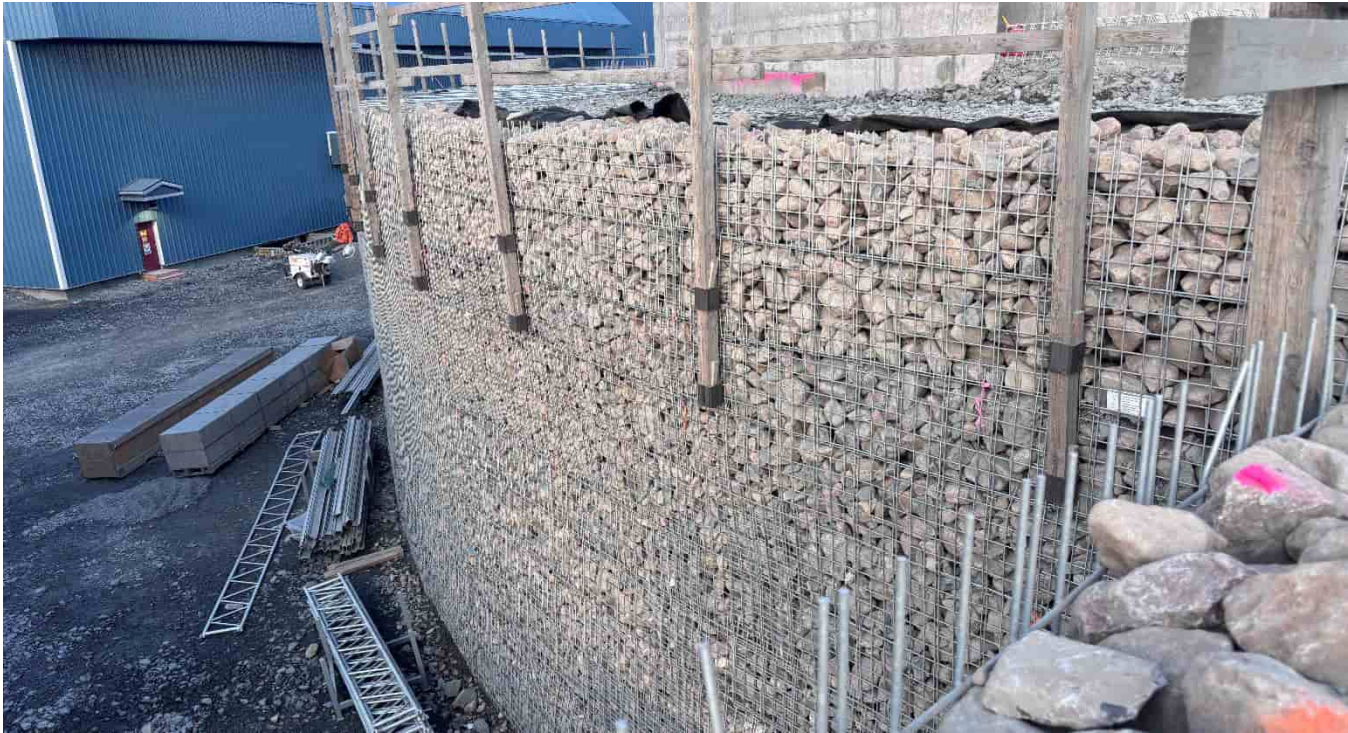
G-314: MSE wall SE side, looking S

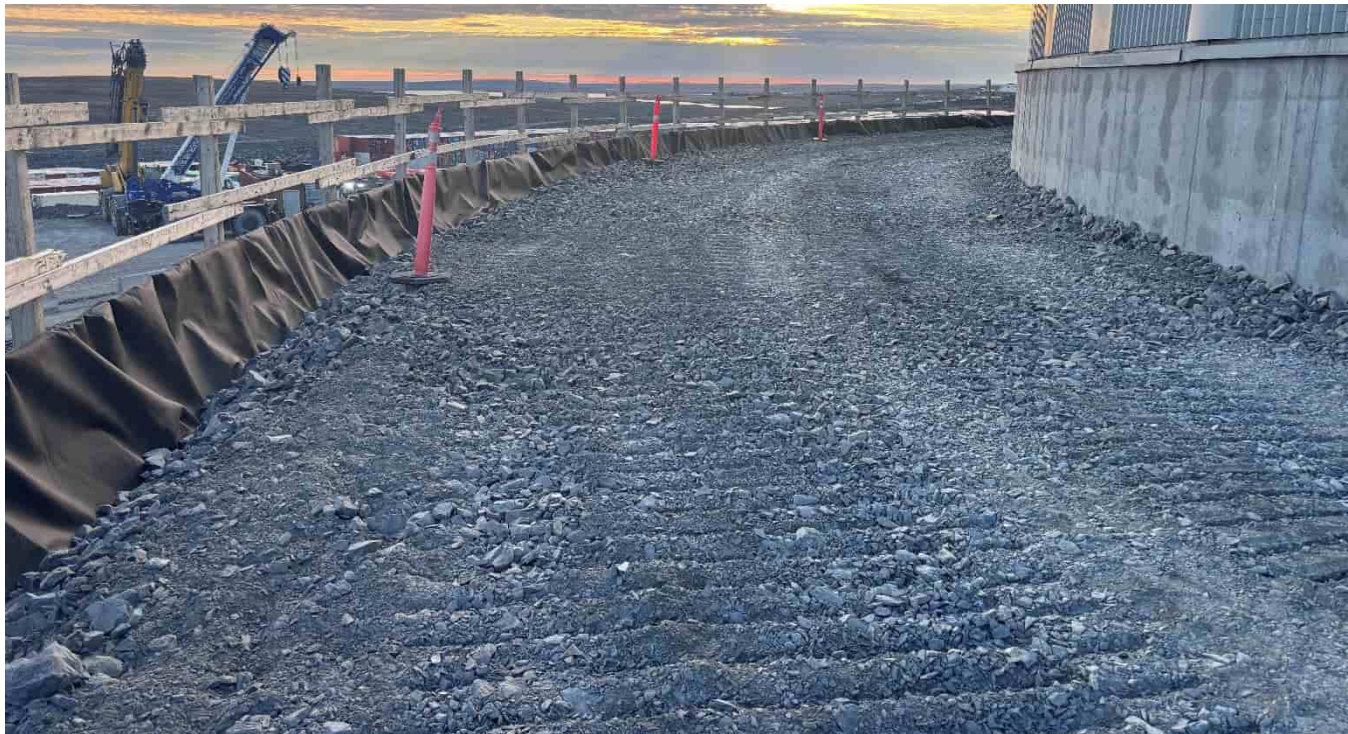
G-315: Typical MSE wall finished construction – construction in progress

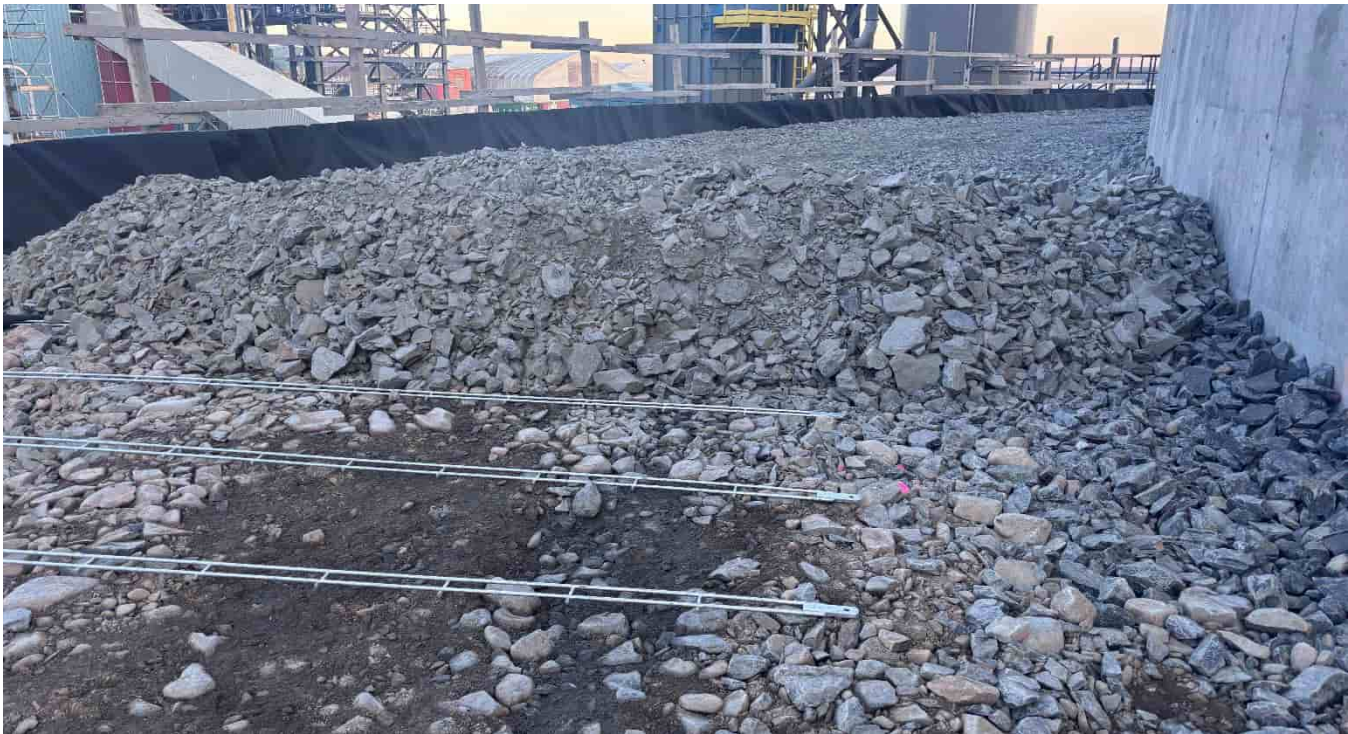
G-316: MSE wall reinforcing example – construction in porogress

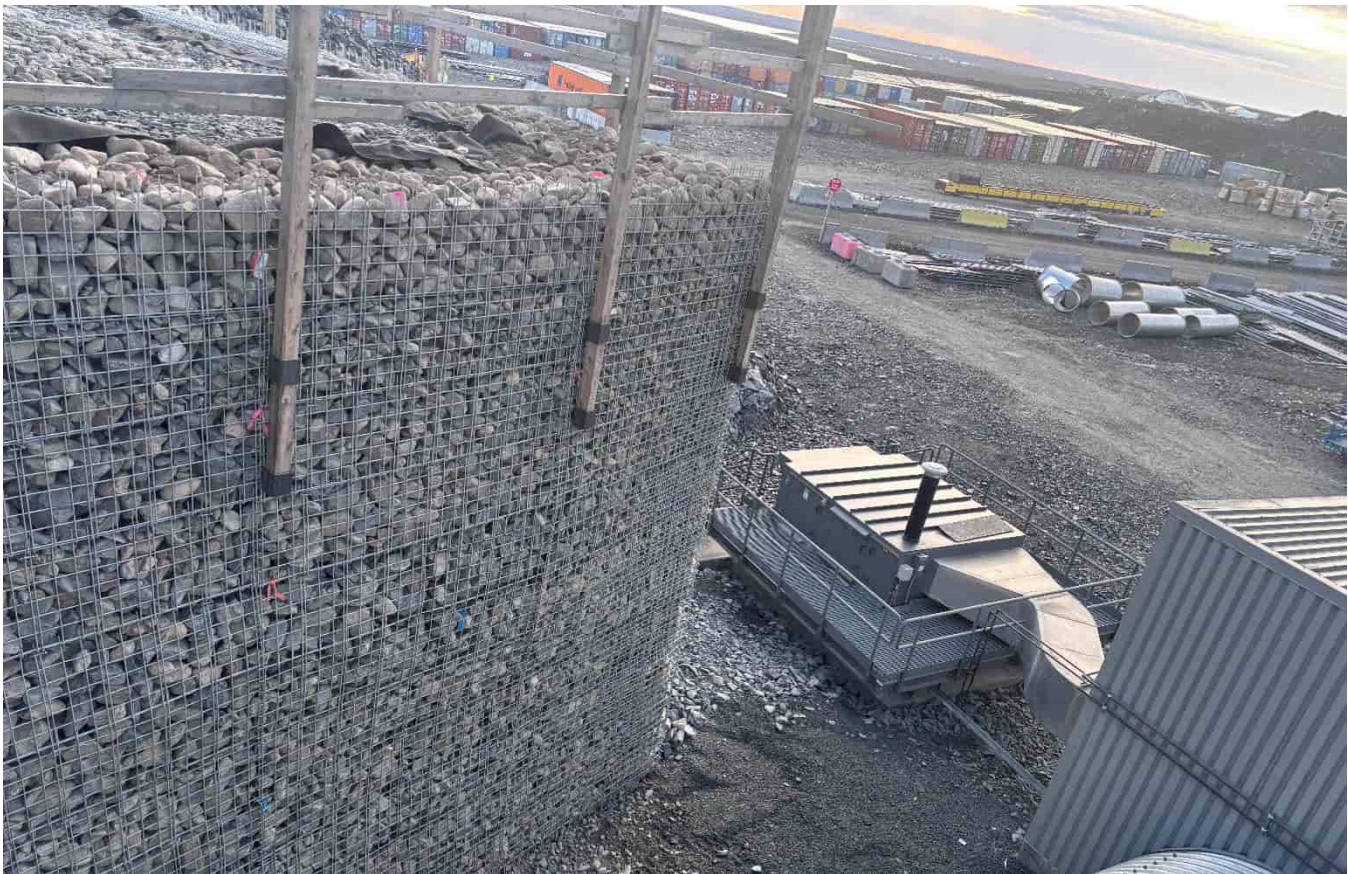
G-318: MSE wall E corner, looking N

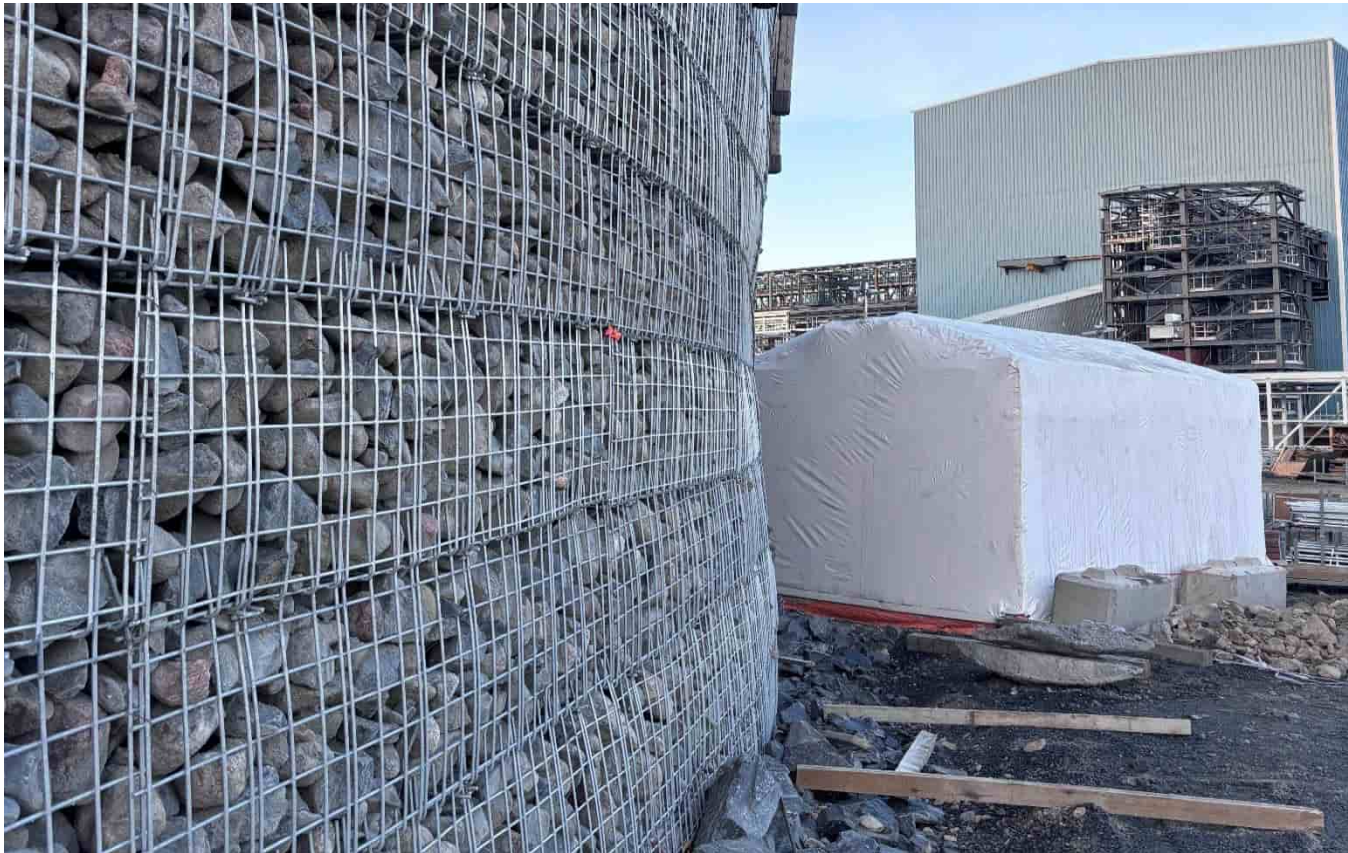
G-320: Typical MSE wall construction

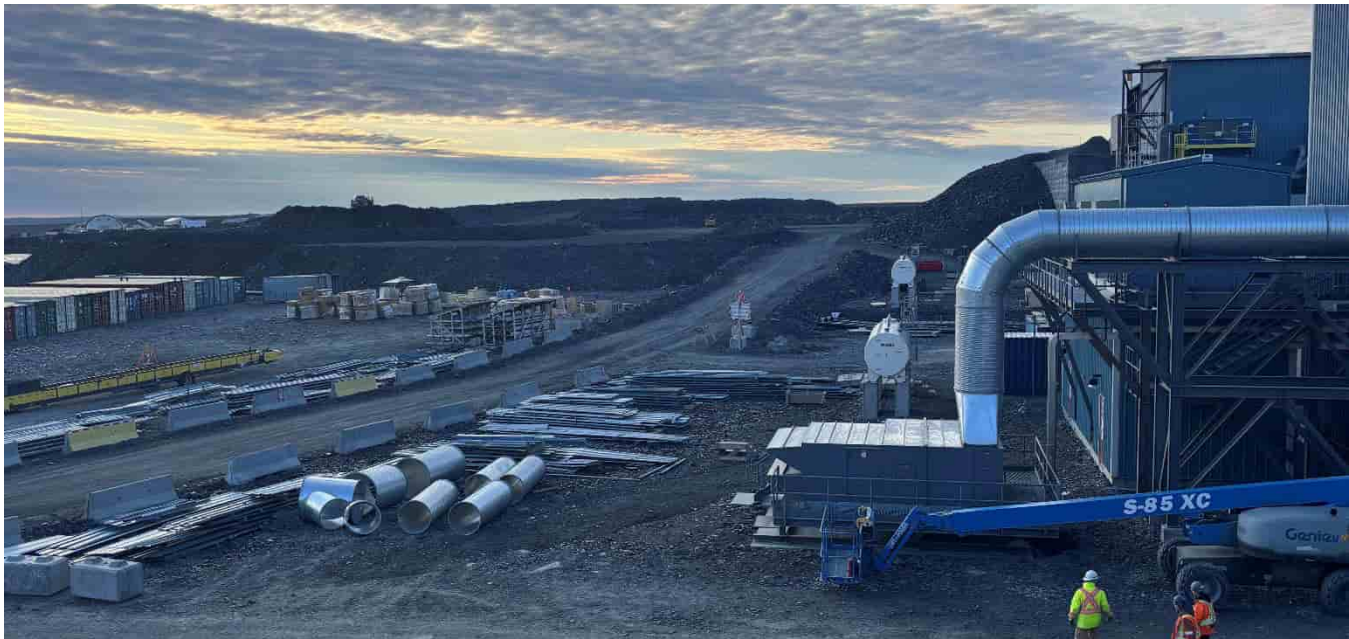
G-319: View SE towards crusher from MSE wall

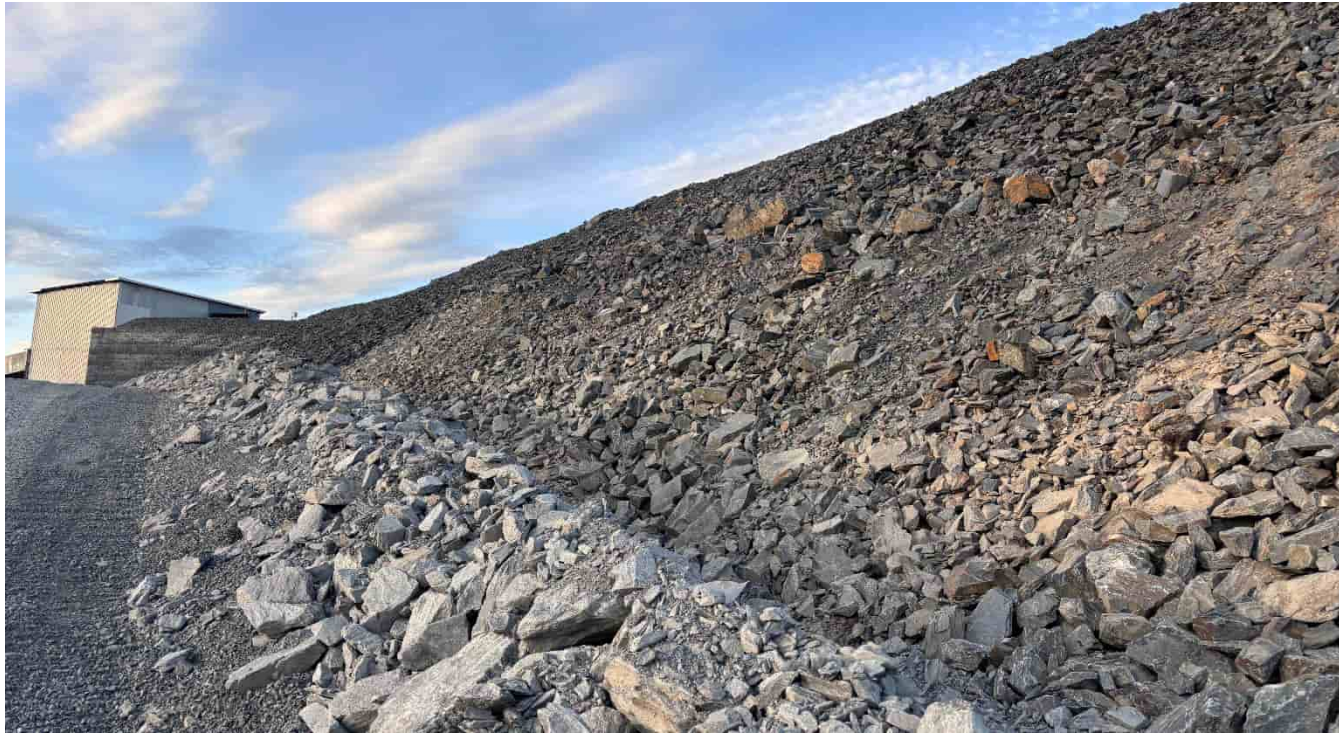
G-321: Slope approaching MSE wall, looking N

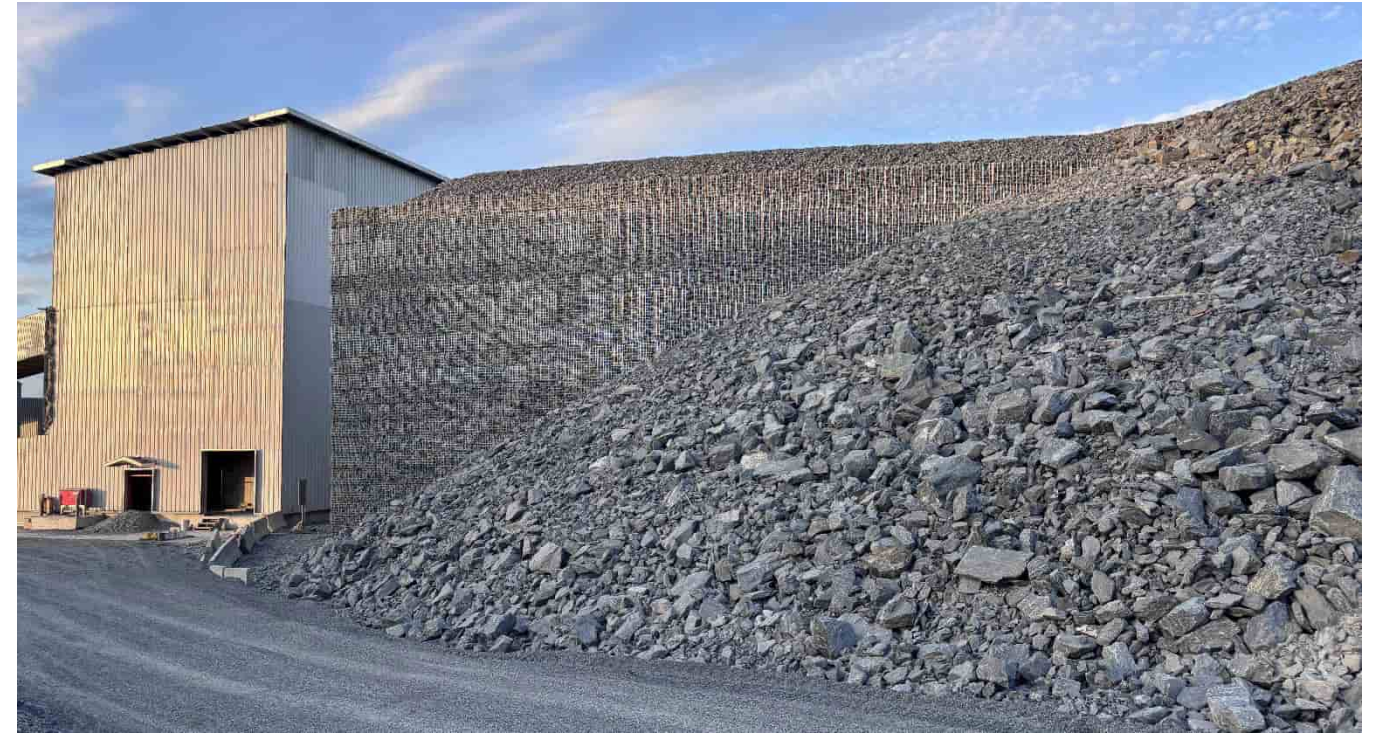
G-322: MSE wall and slope, looking N

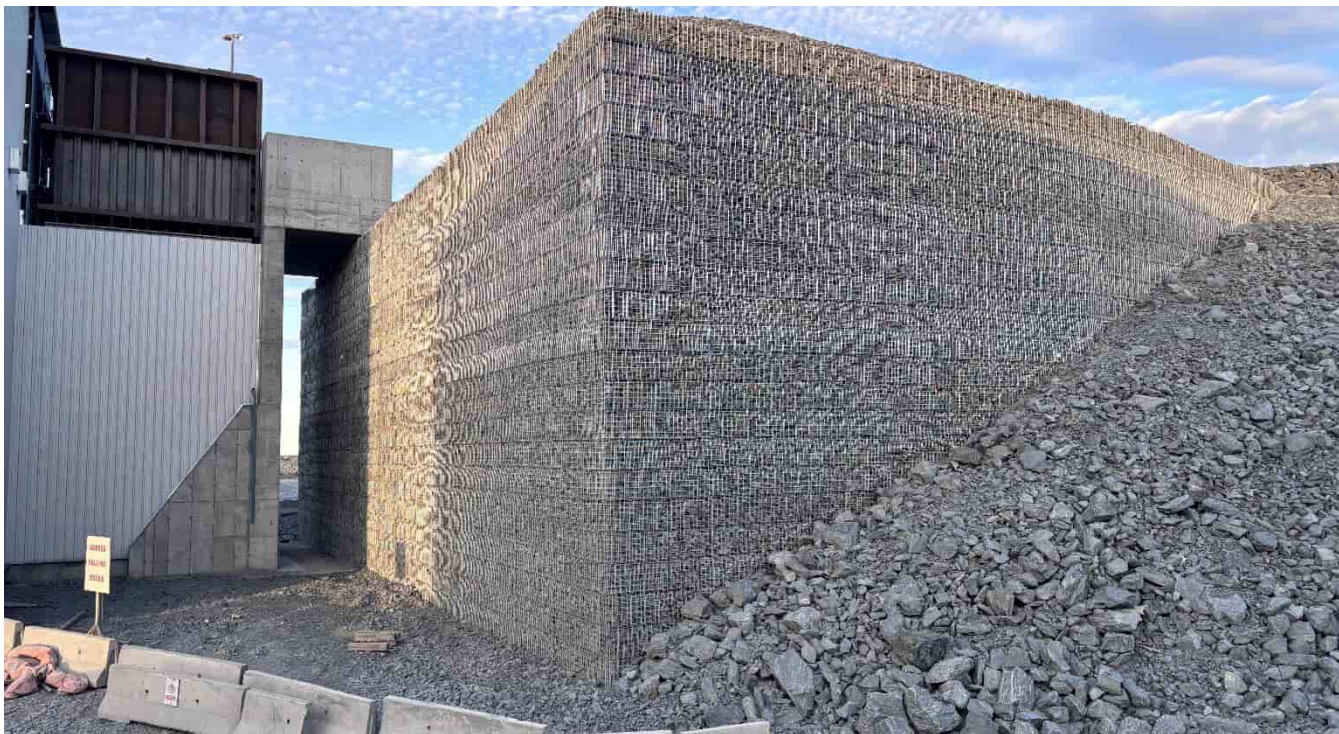
G-323: MSE wall W corner, looking E

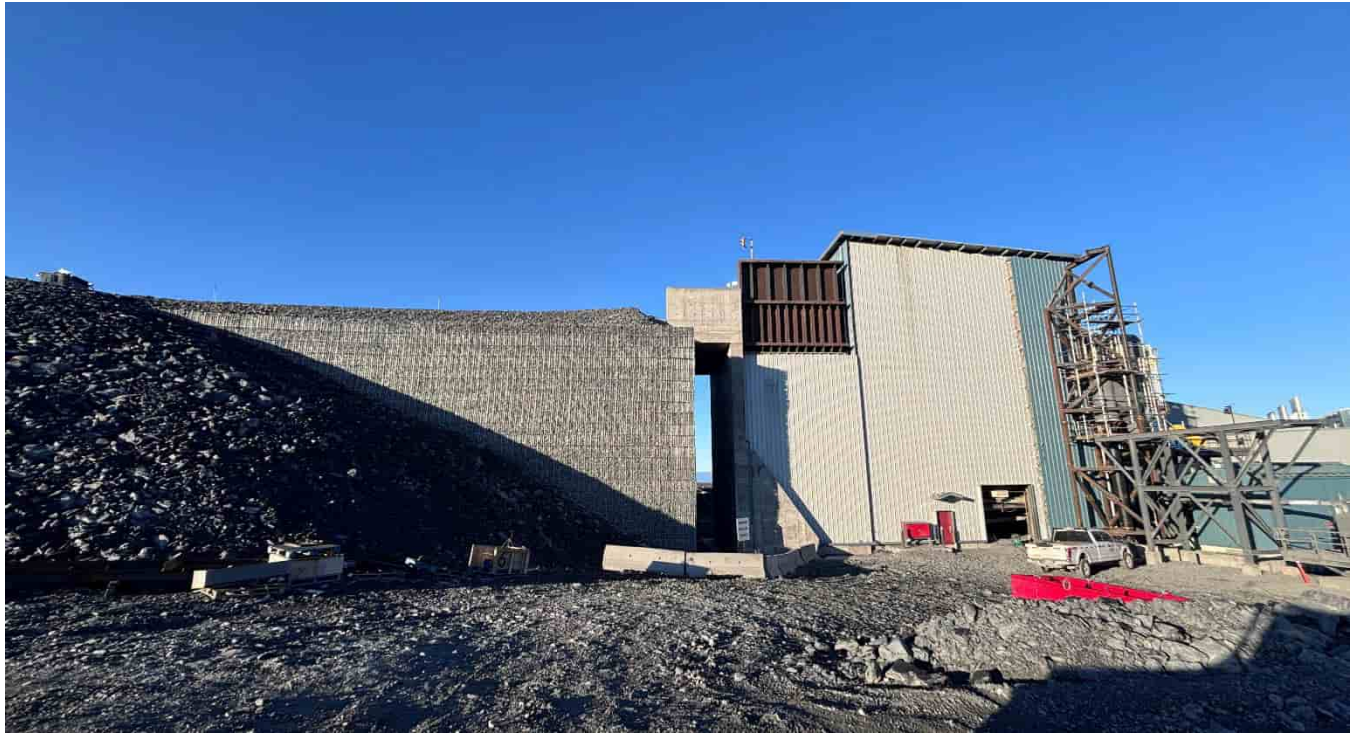
G-325: MSE wall eastern side and crusher, looking W

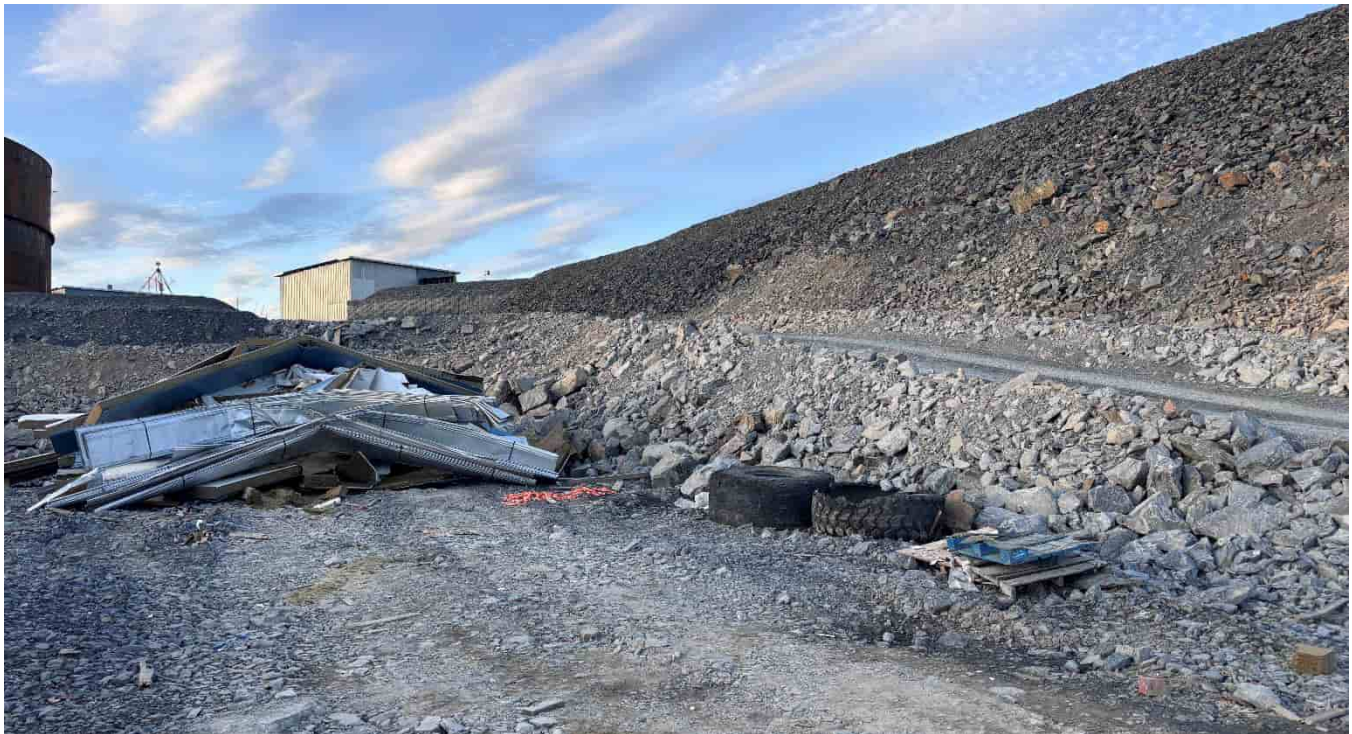
G-329: MSE wall and approach road, looking N from laydown area

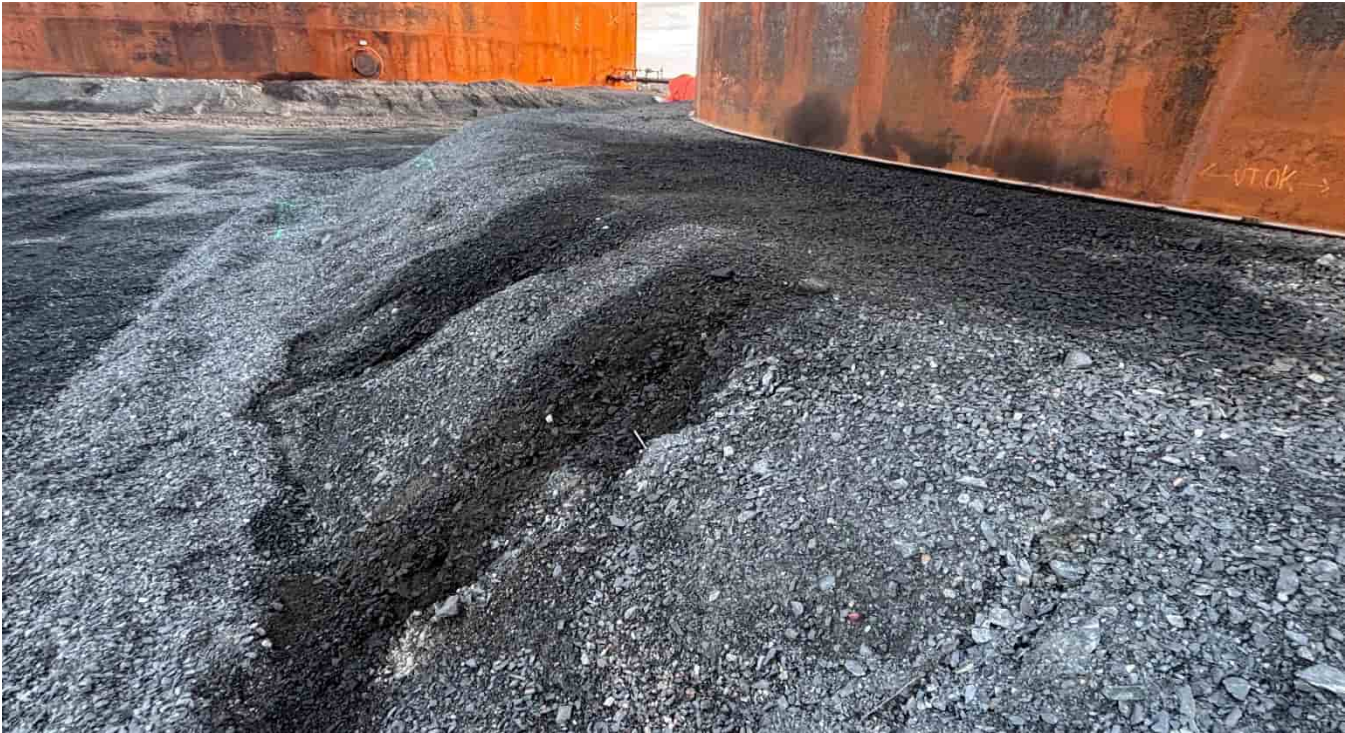
G-331: Tank pedestal slope

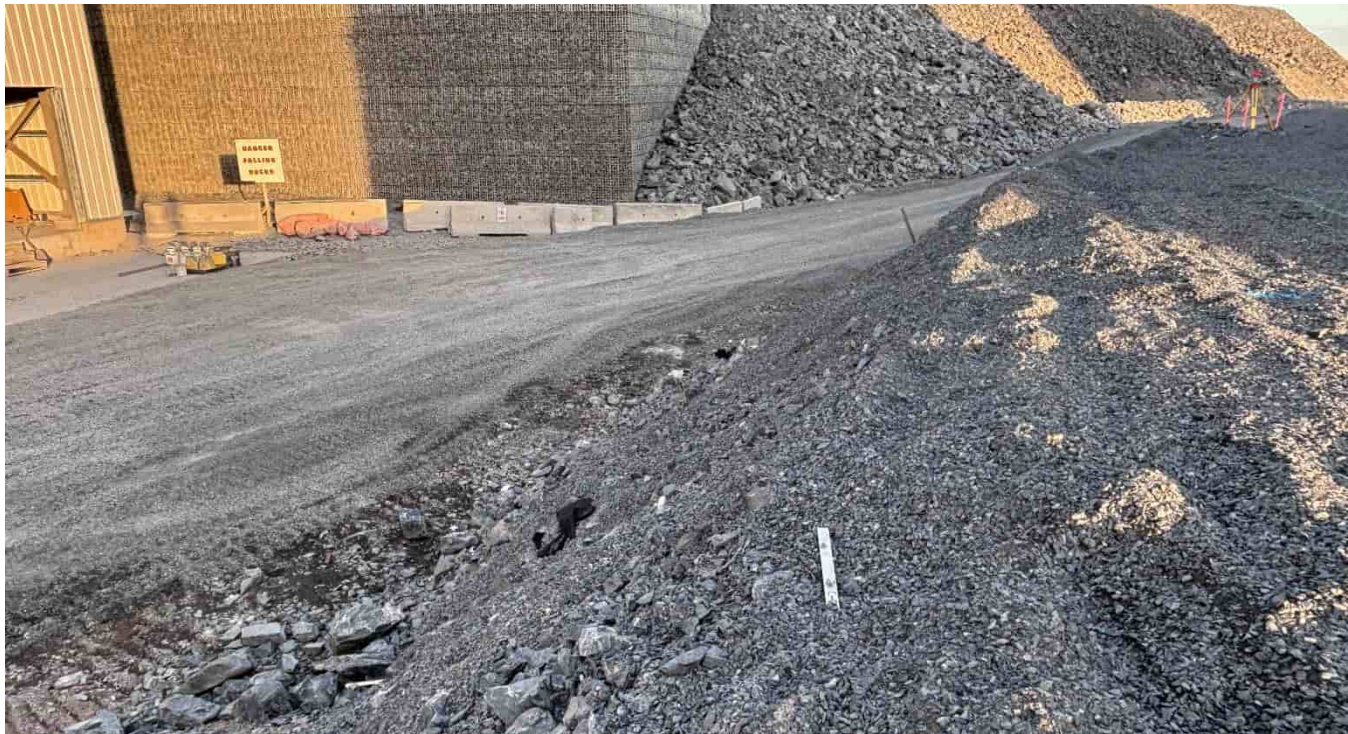
G-332: Slope across from crusher MSE wall

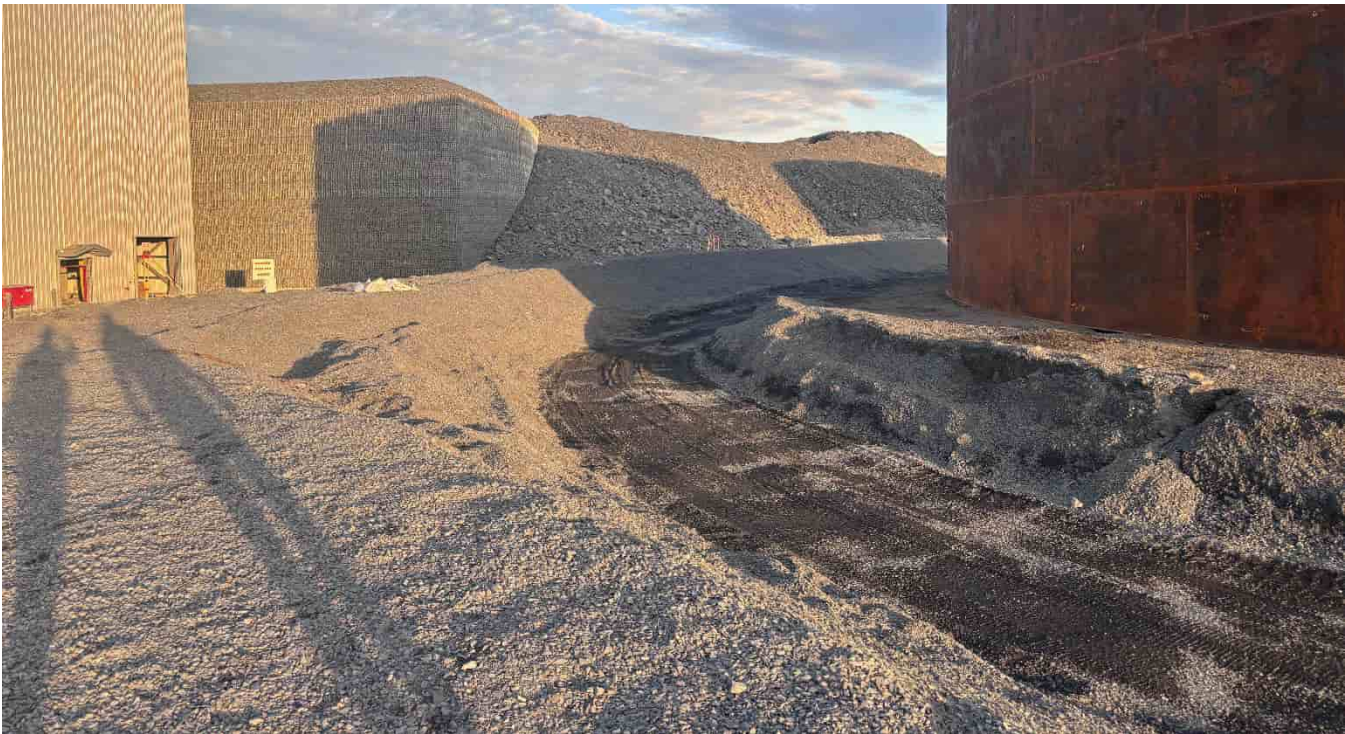
G-333: View E towards crusher MSE wall from tank farm

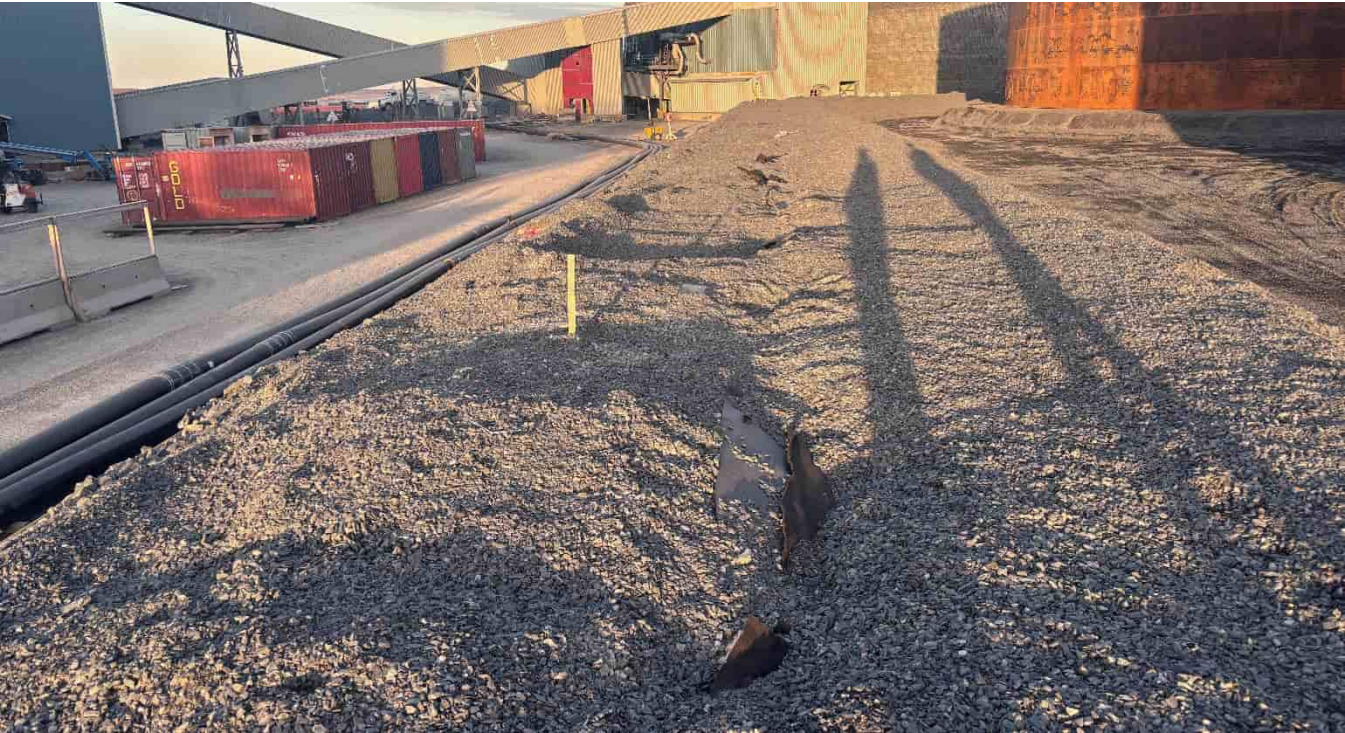
G-339: Exposed liner on northern berm, looking E

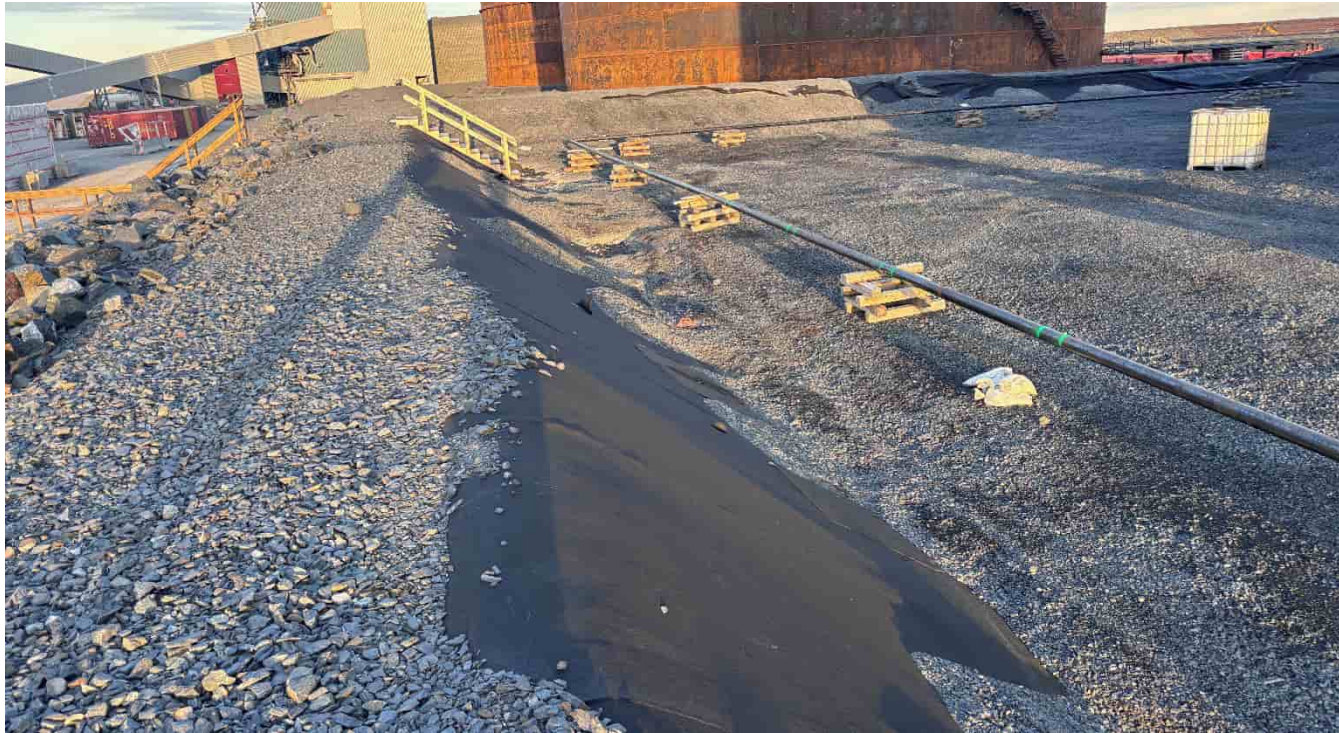
G-342: Exposed liner on tank farm northern berm slope, looking E

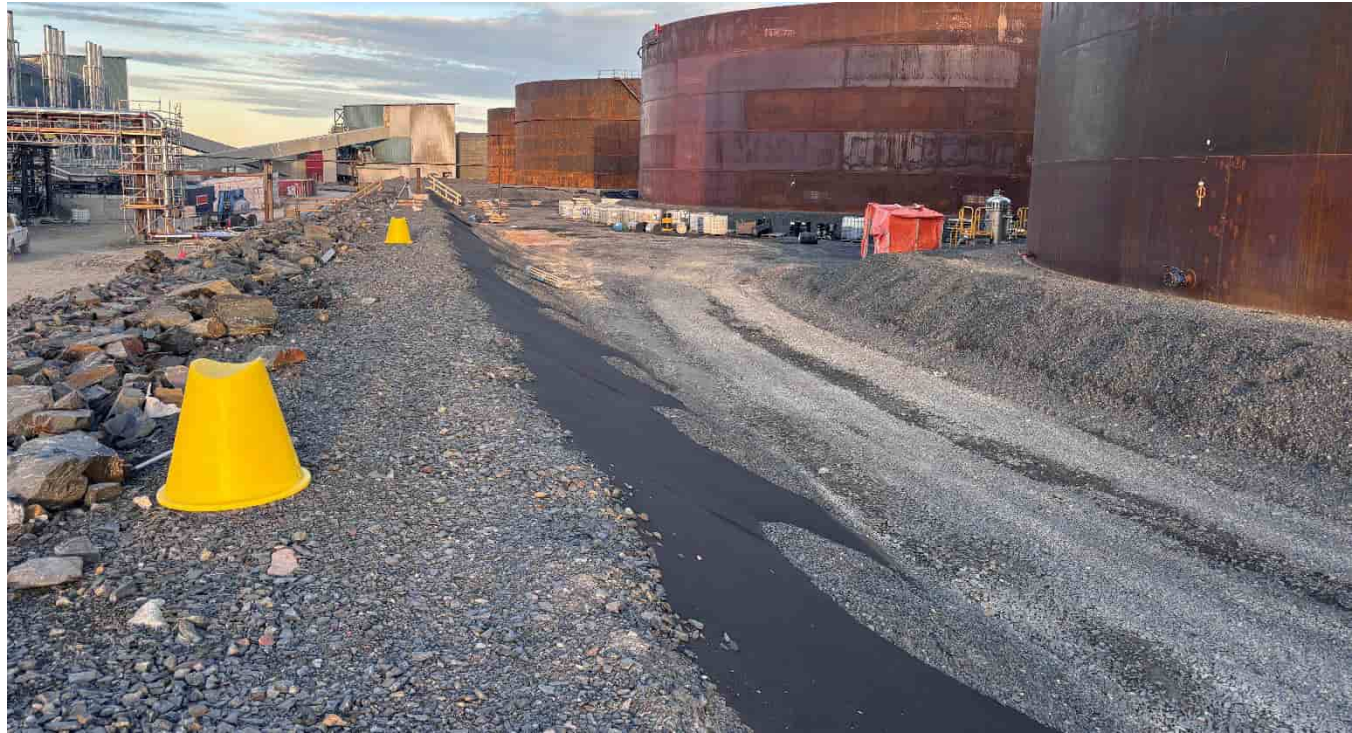
G-343: Exposed liner on tank farm northern berm slope, looking E

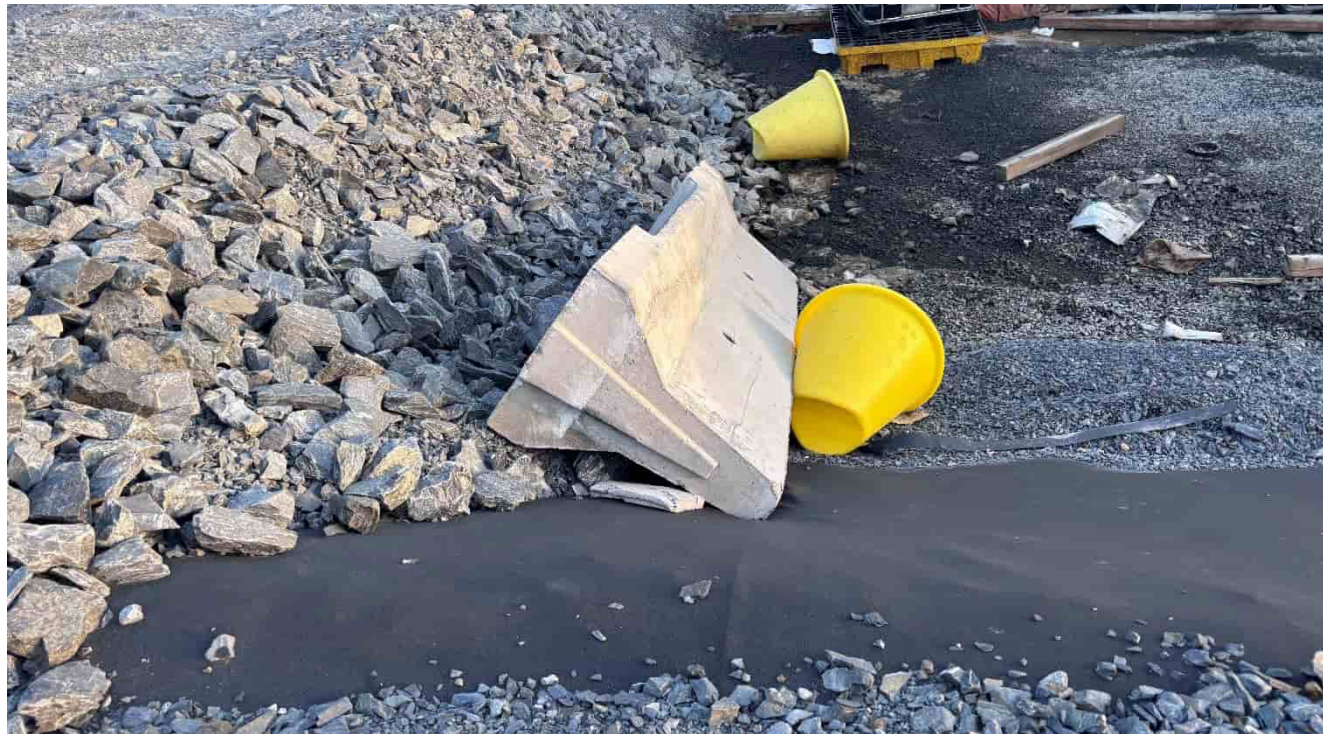
G-344: Fallen barrier on western berm liner, looking E

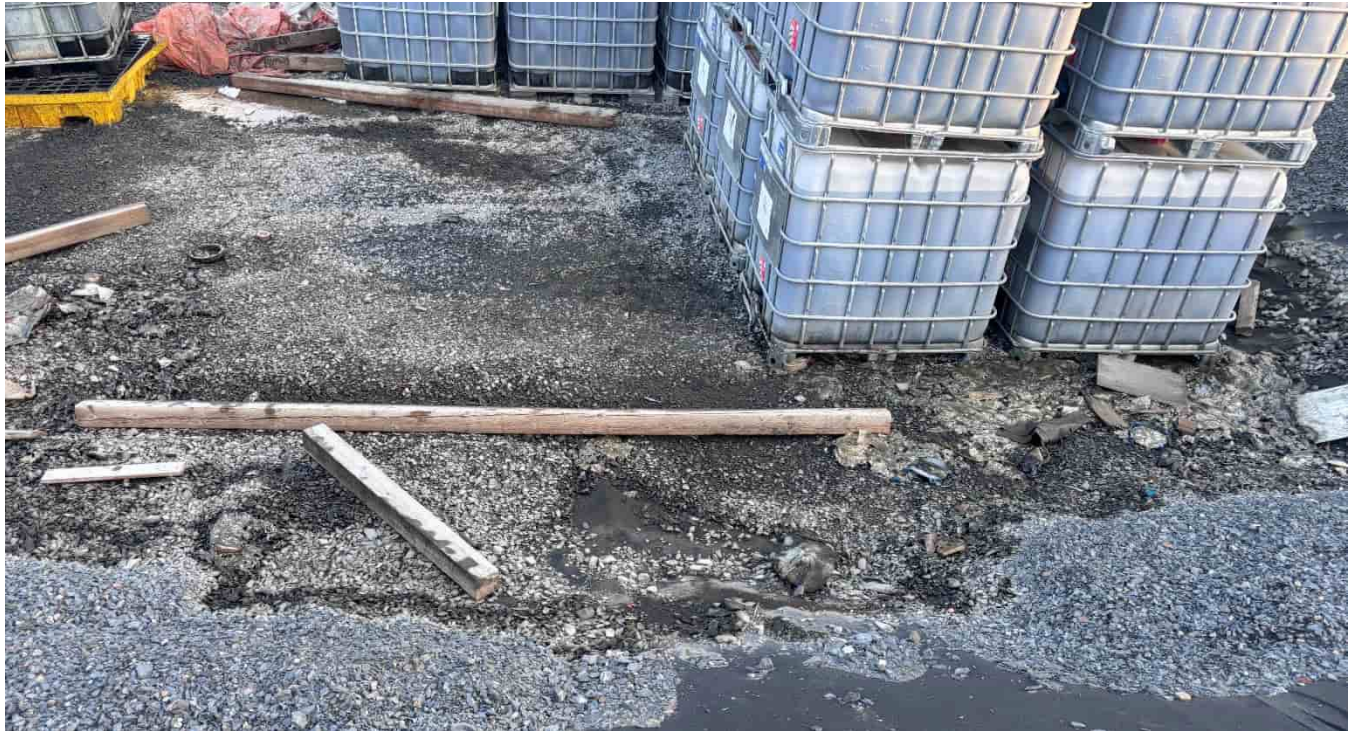
G-346: Tote storage area below northern berm

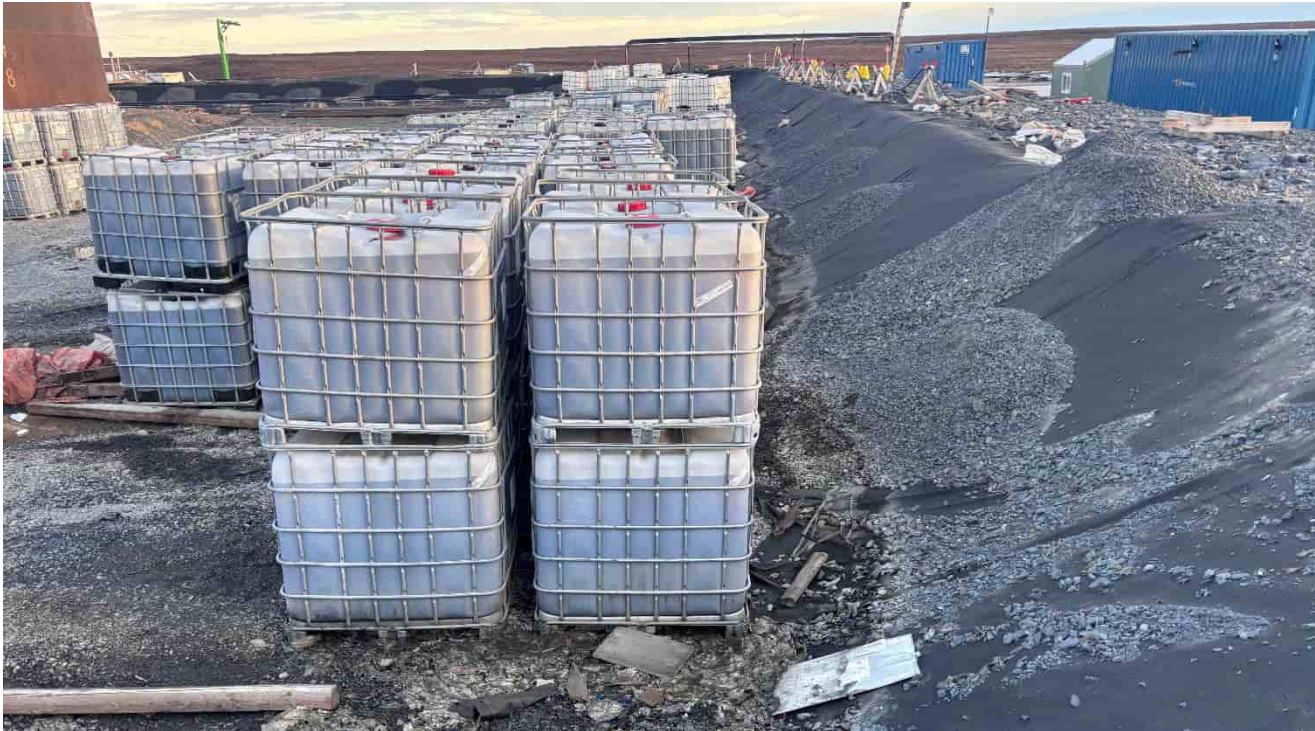
G-347: Tote storage area and western berm, exposed geotextile
