| | | 2025 Annual Geotechnical Inspection | | |
| Job No: CAPR004312<br>Filename: Back River_Goose_2025_AGI_Photoslog.pdf | Back River Project | Date:<br>February 2026 | Approved:<br>JBK | Figure:<br>79 |

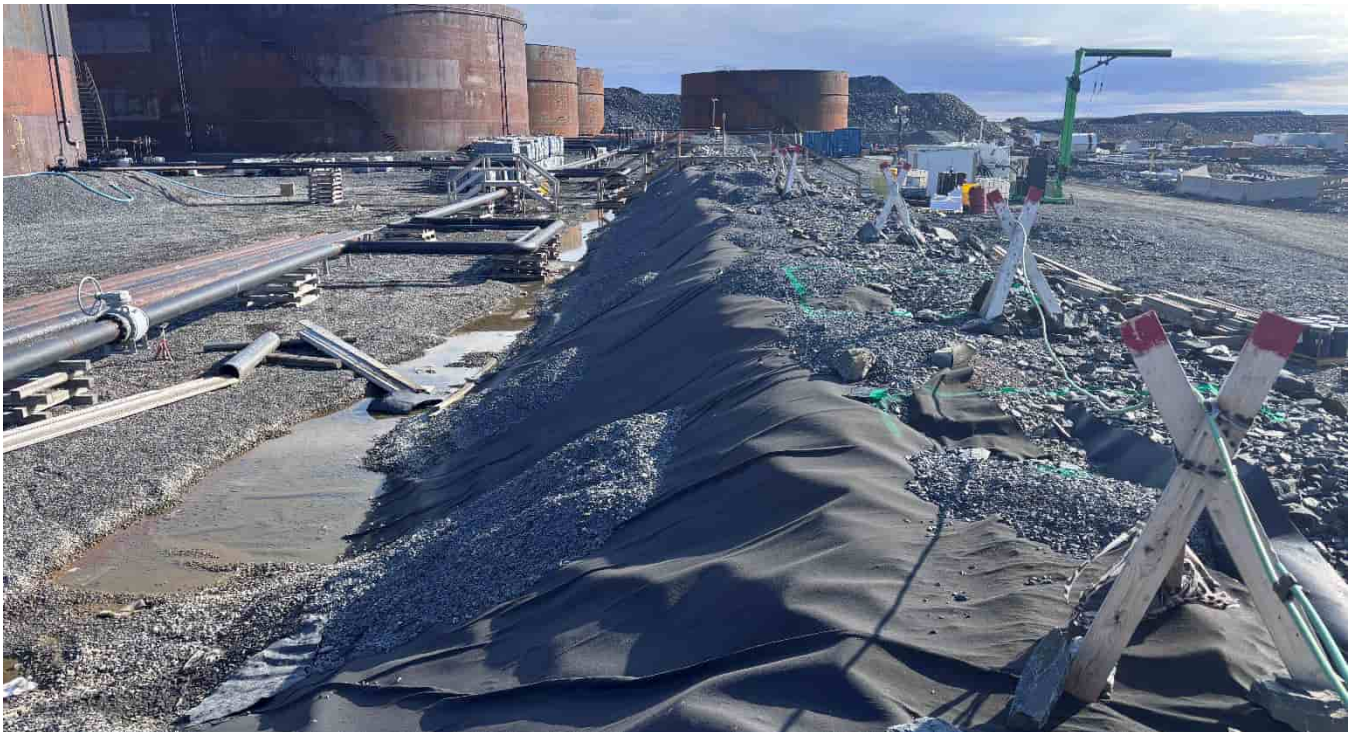
G-349: Exposed geotextile on southern berm – ponding at toe of slope, undulating liner anchoring

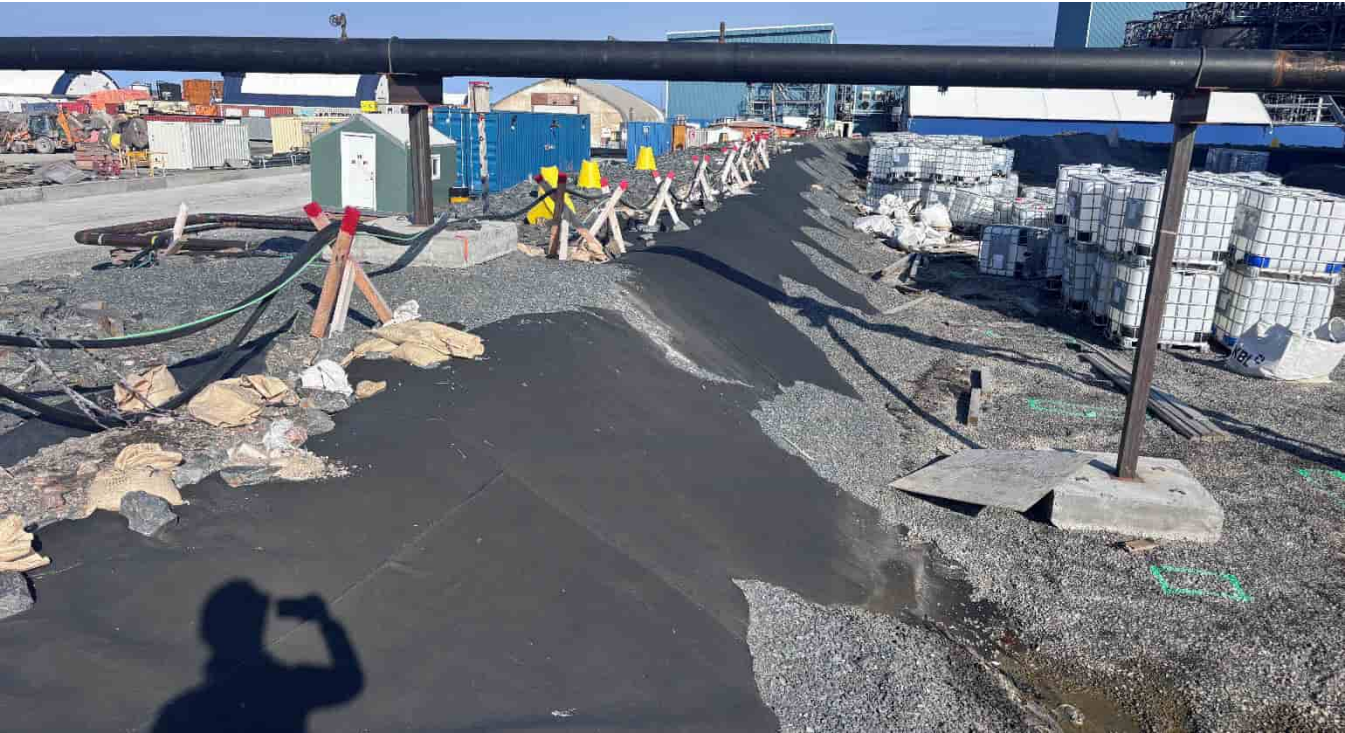
G-351: Western berm, looking N – exposed geotextile and ponding at toe

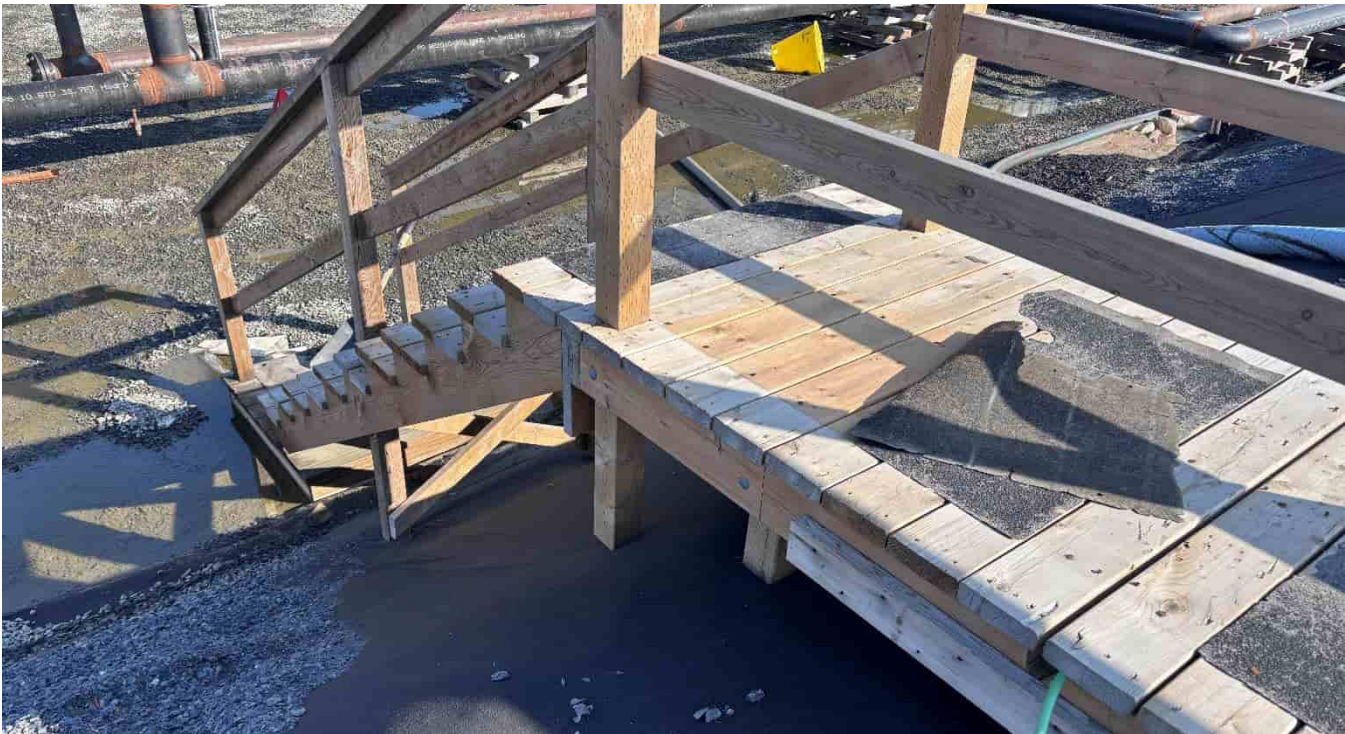
G-353: Stairs over southern berm, looking N. Stairs installed on top of the exposed geotextile.

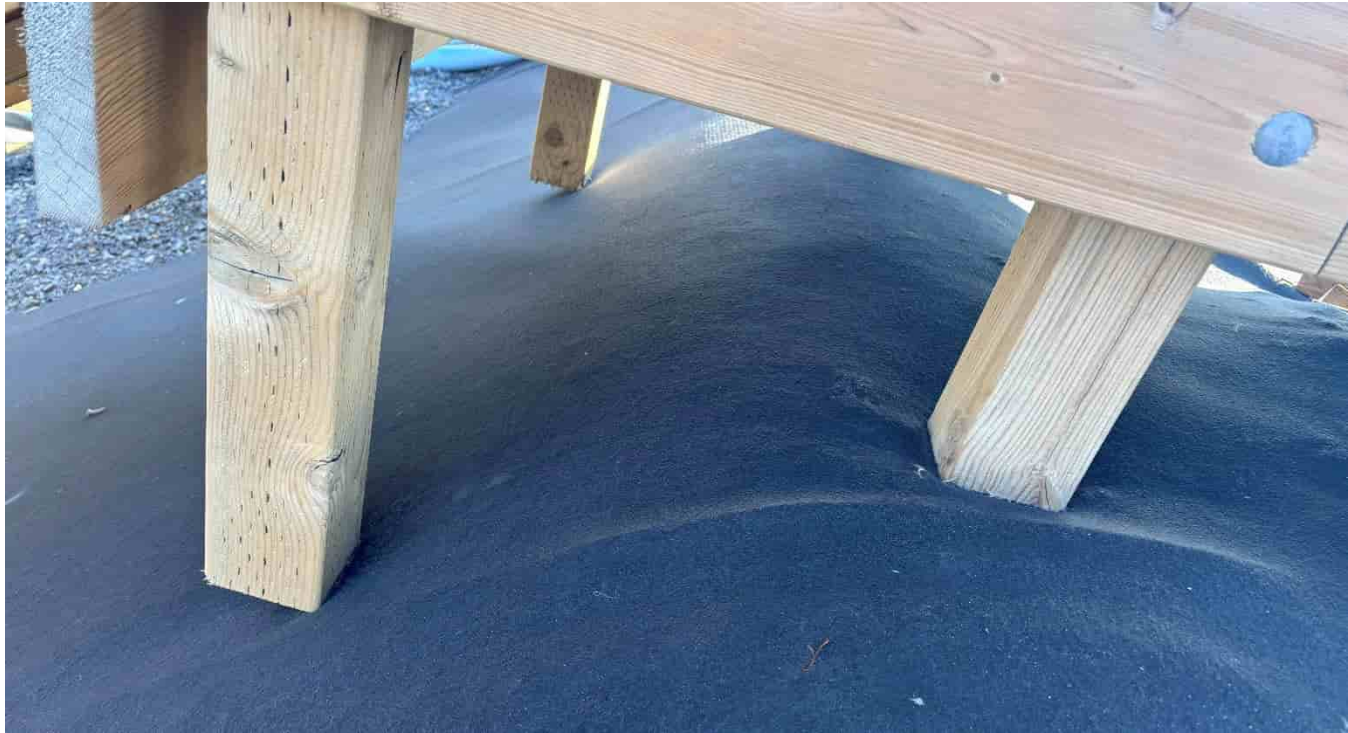
G-354: Wooden stairwell supports on exposed geotextile

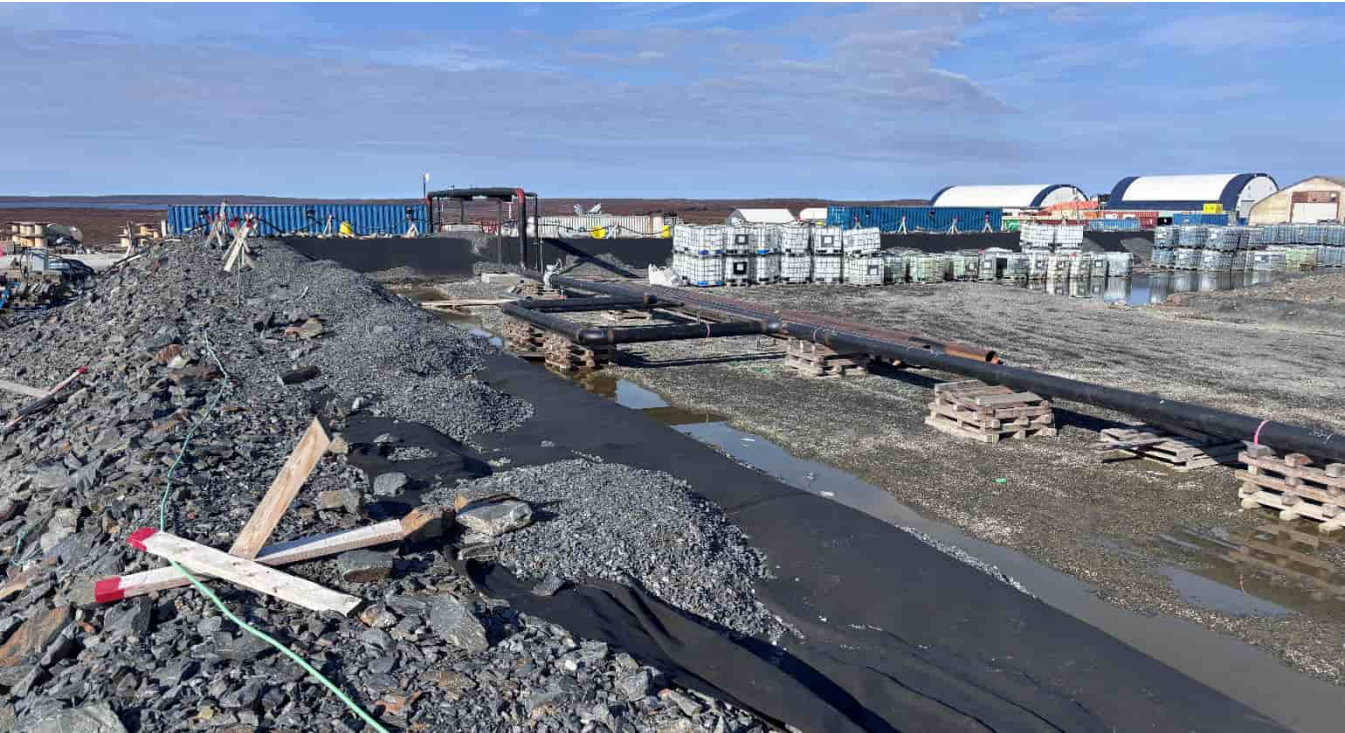
G-355: Southern berm, looking W – exposed liner

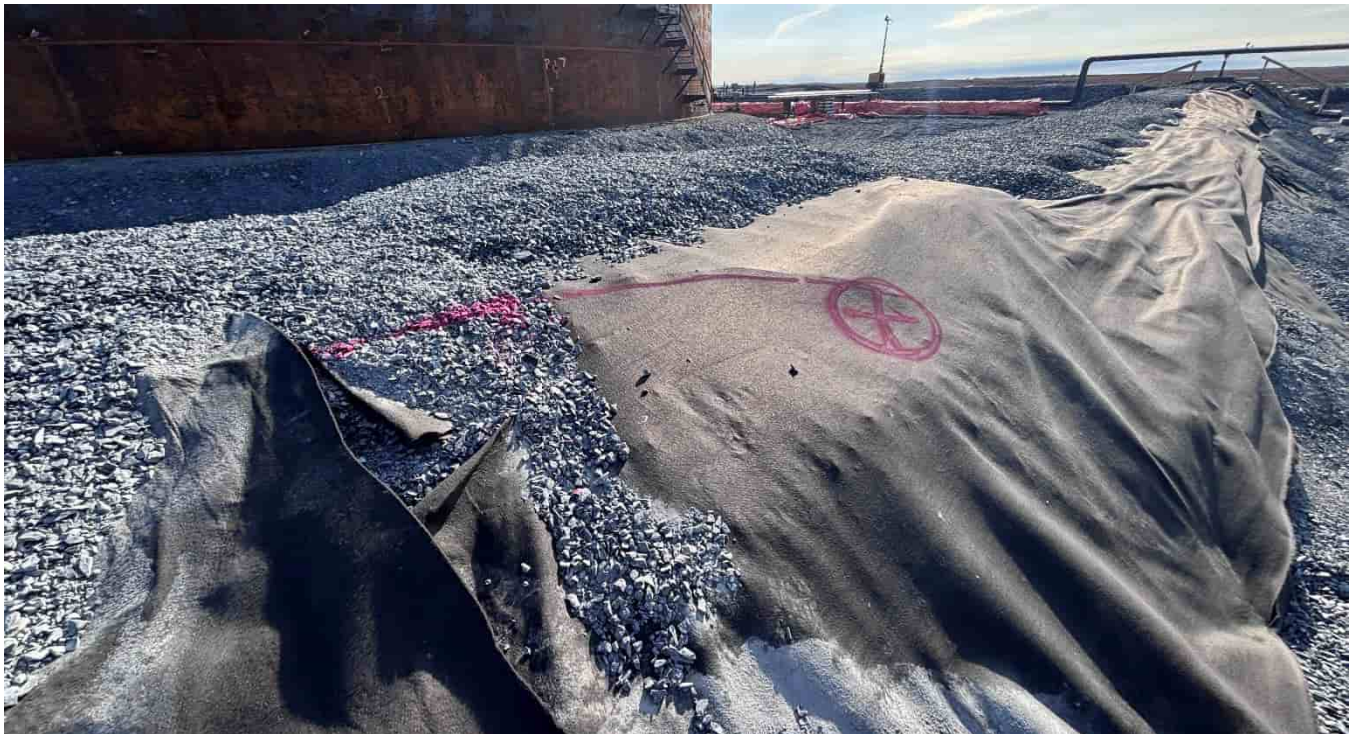
G-360: A berm between central tanks, looking S – the mark indicates the edge of the liner approximately at the elevation governing the containment volume – areas revisited with site staff during visit

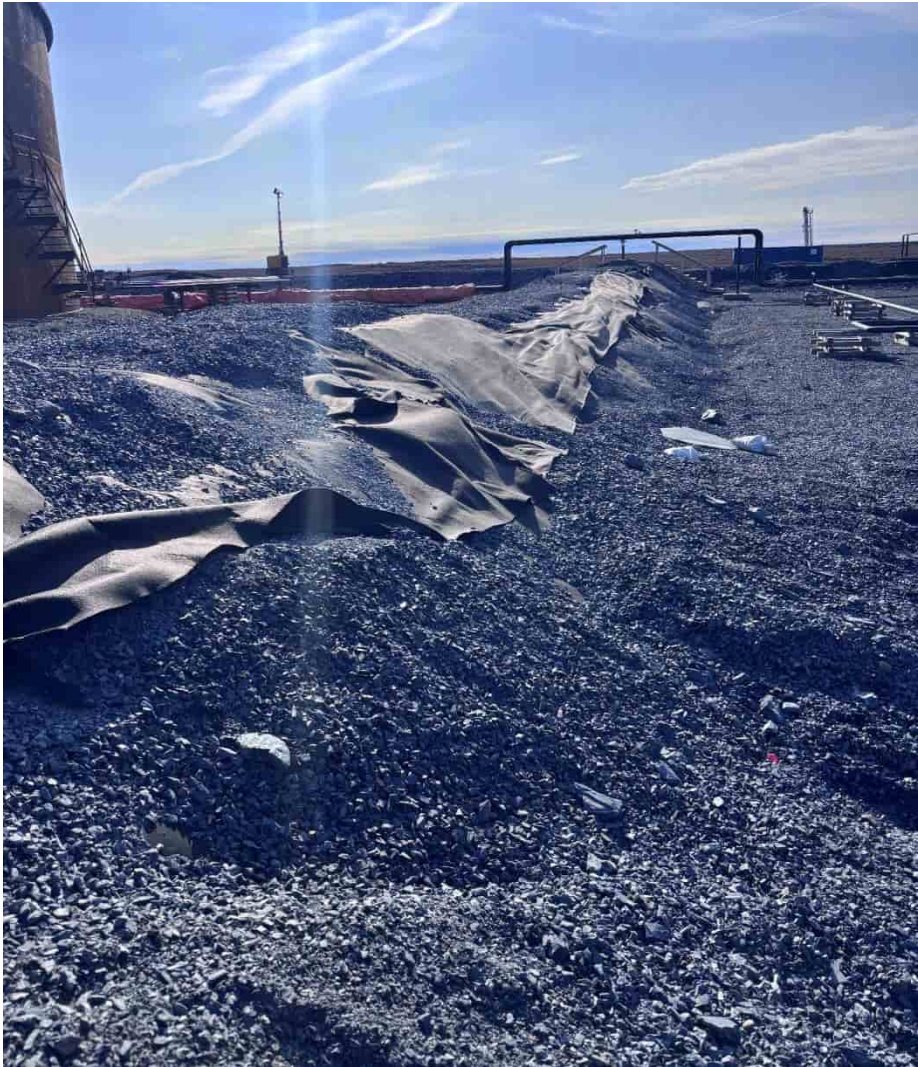
G-359: Exposed geotextile and HDPE liner on slope berm between Tank 2 and Tank 3, looking S

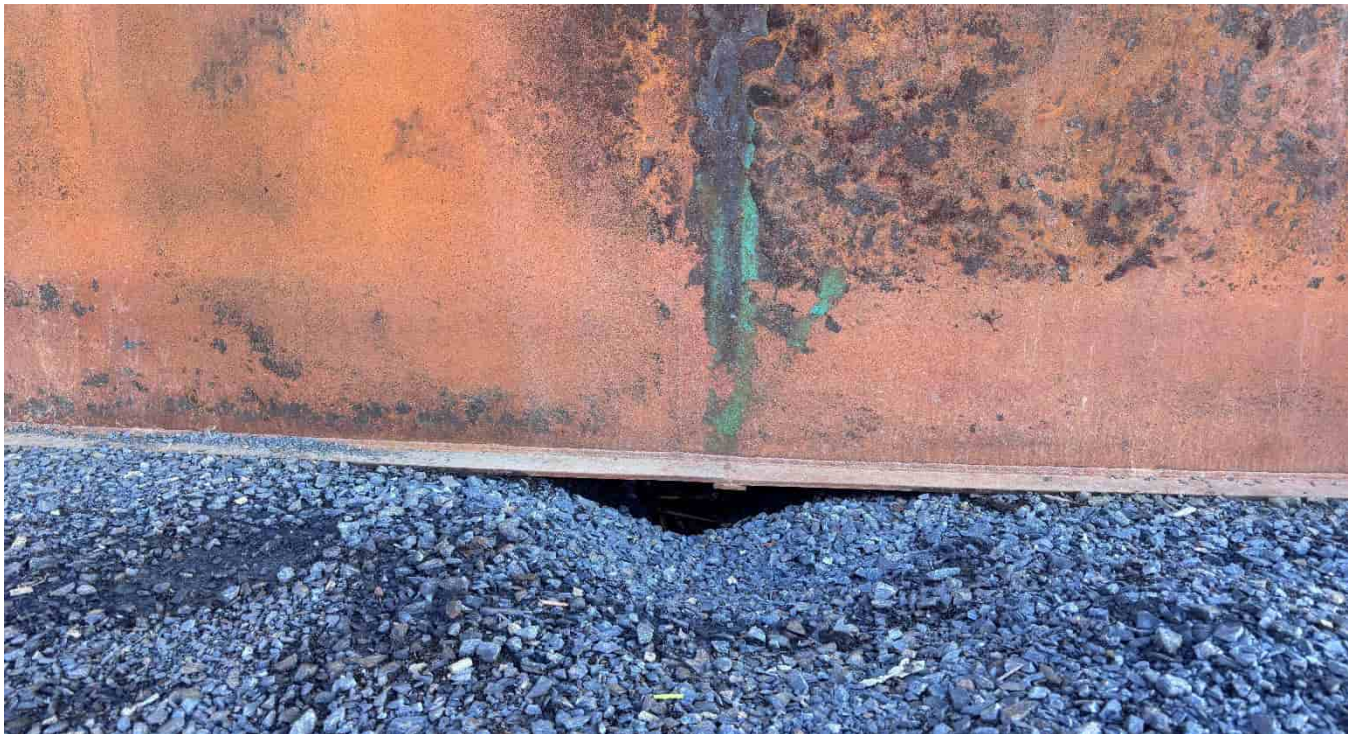
G-363: A gap between pedestal and base of Tank 5 – former installation jack location based on tank marks

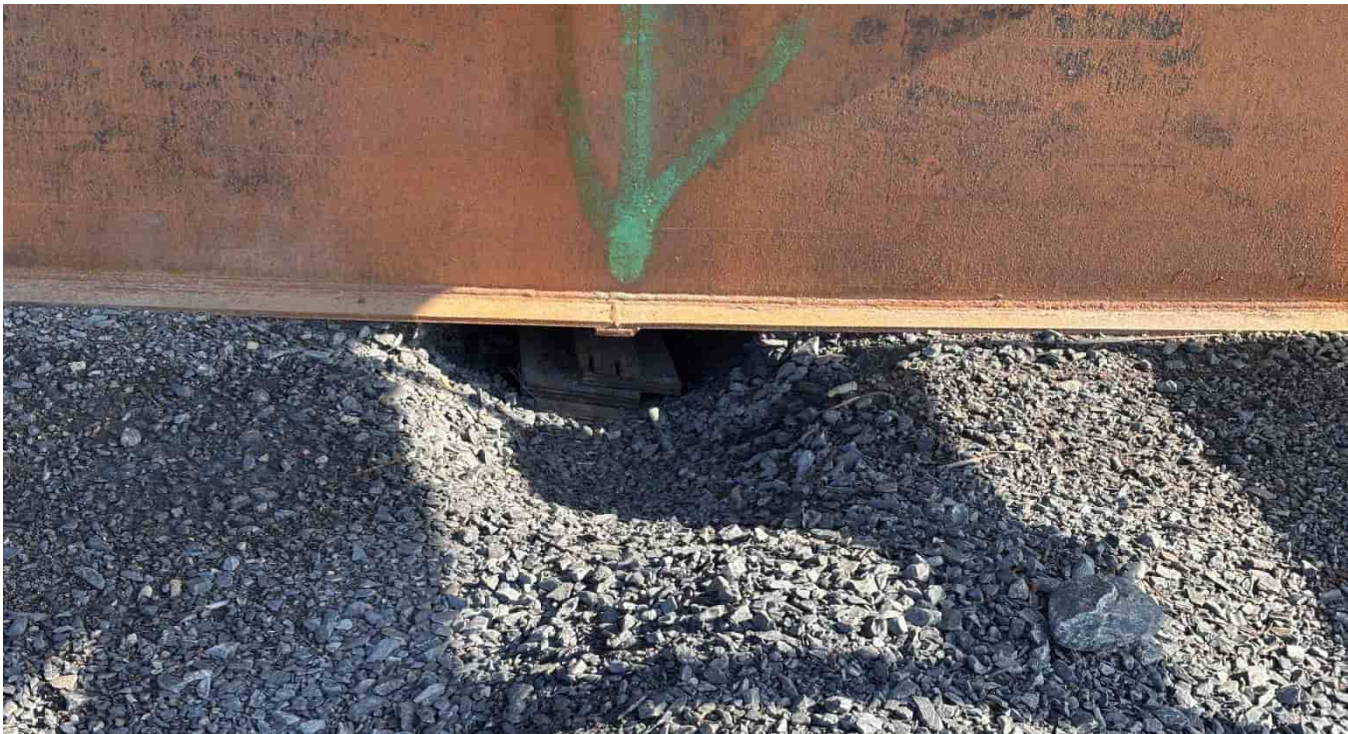
G-364: A gap between pedestal and base of Tank 5

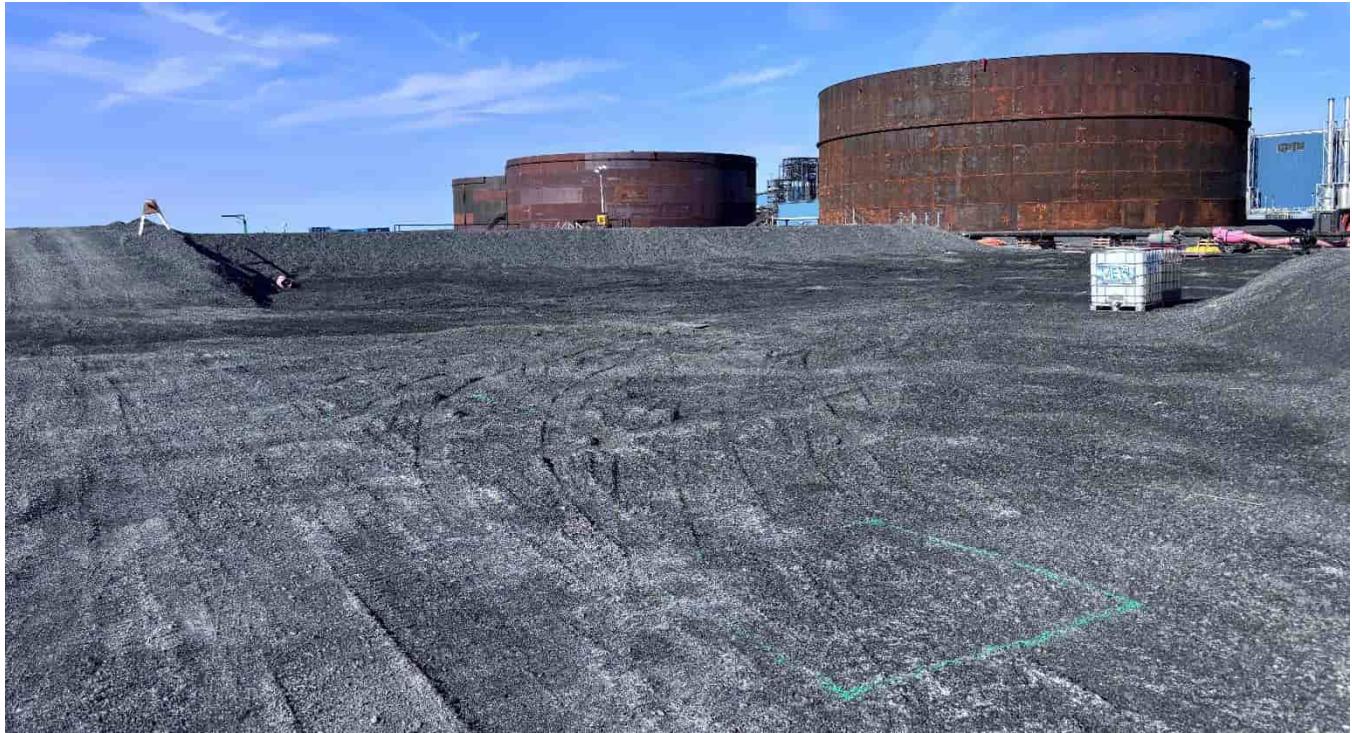
G-365: Tank farm surface conditions at southeastern end, looking NW

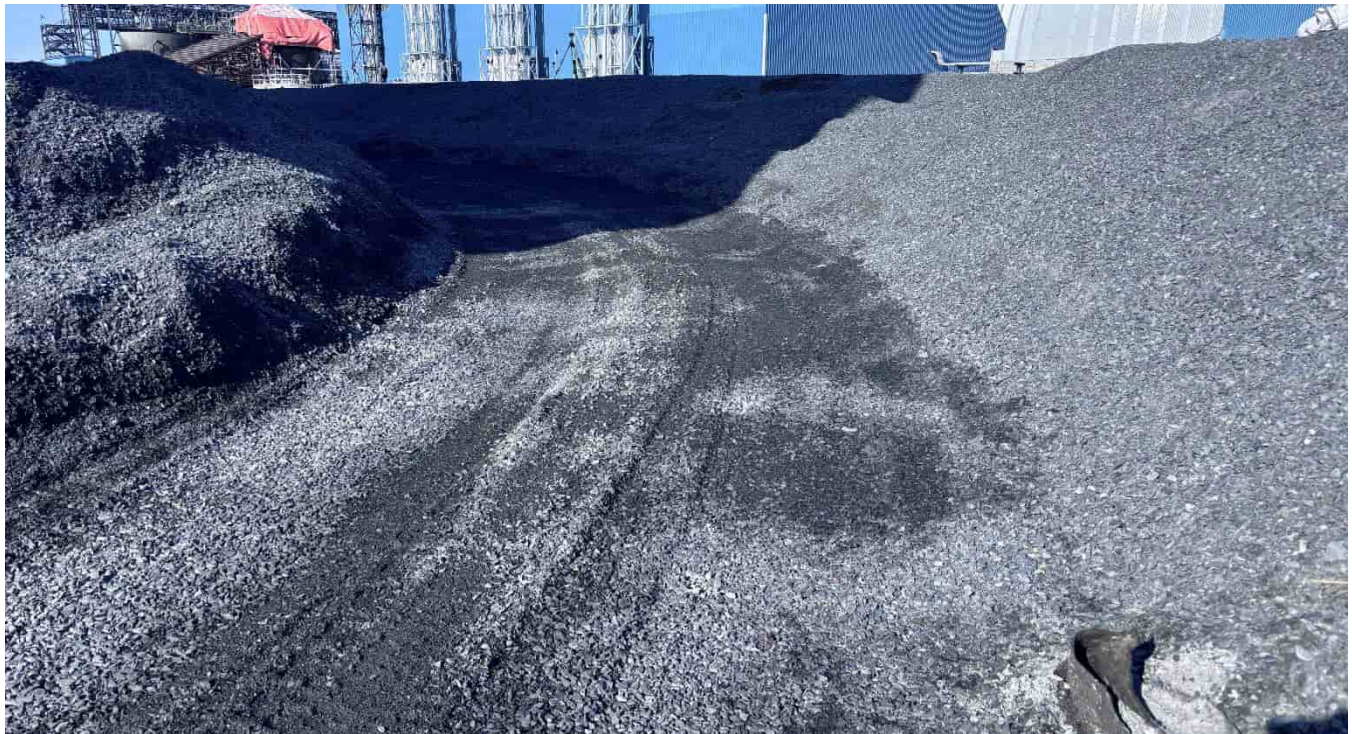
G-367: Tank farm access road, looking NW

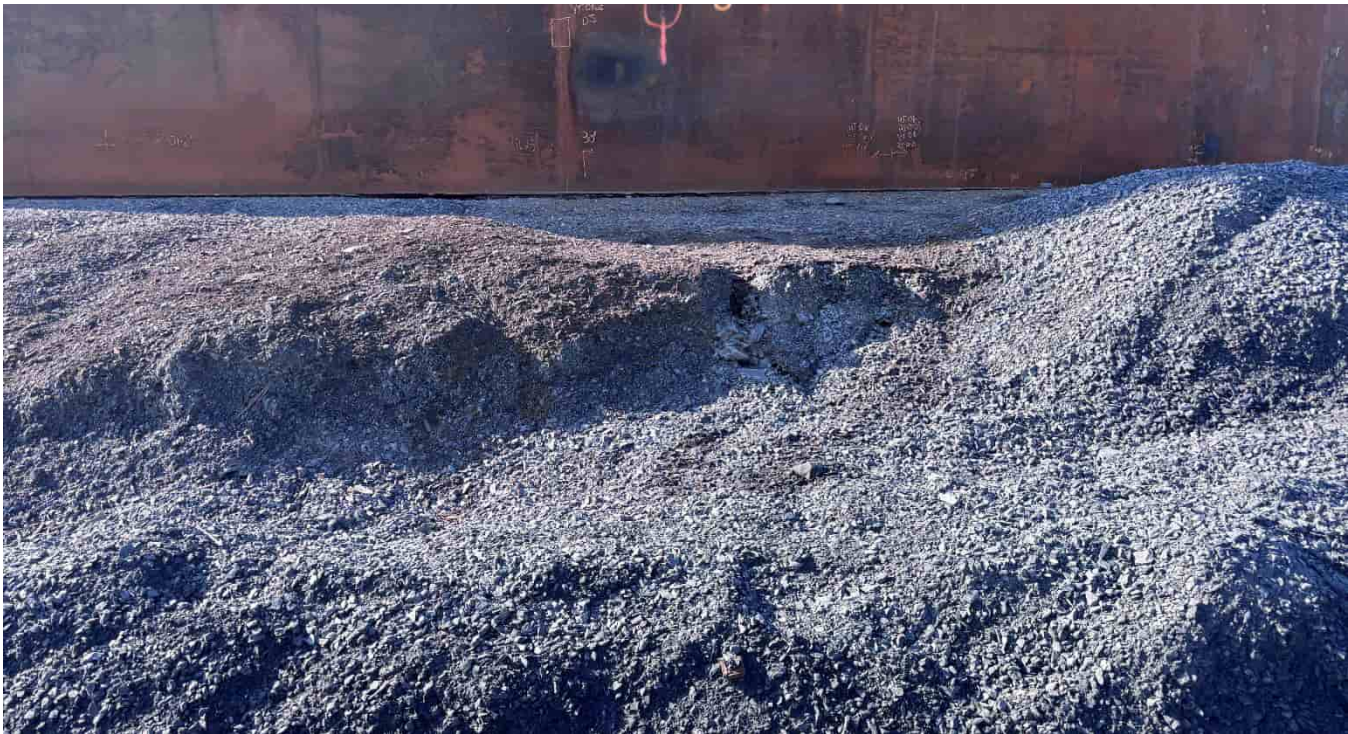
G-368: Northeastern tank slope

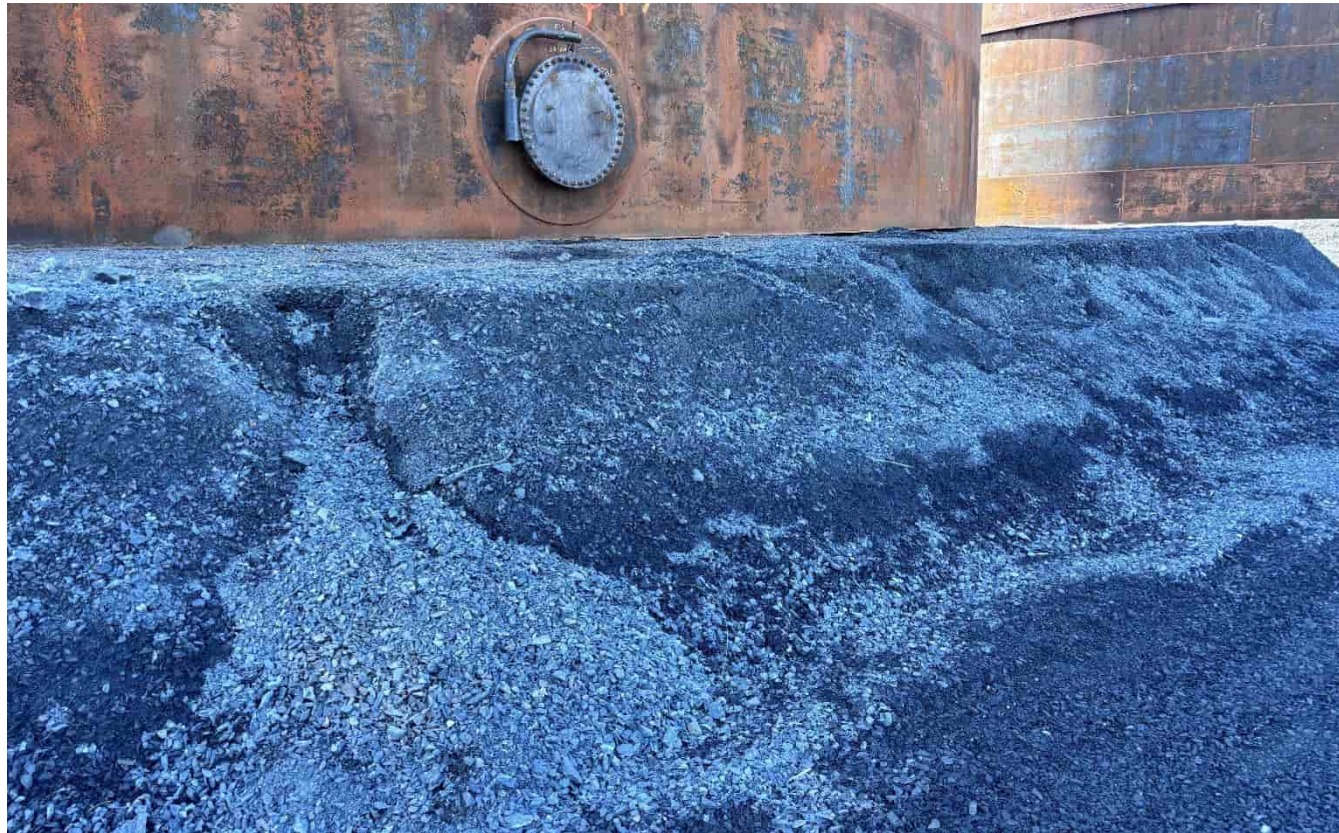
G-369: Pedestal for Tank 1 erosion tracking

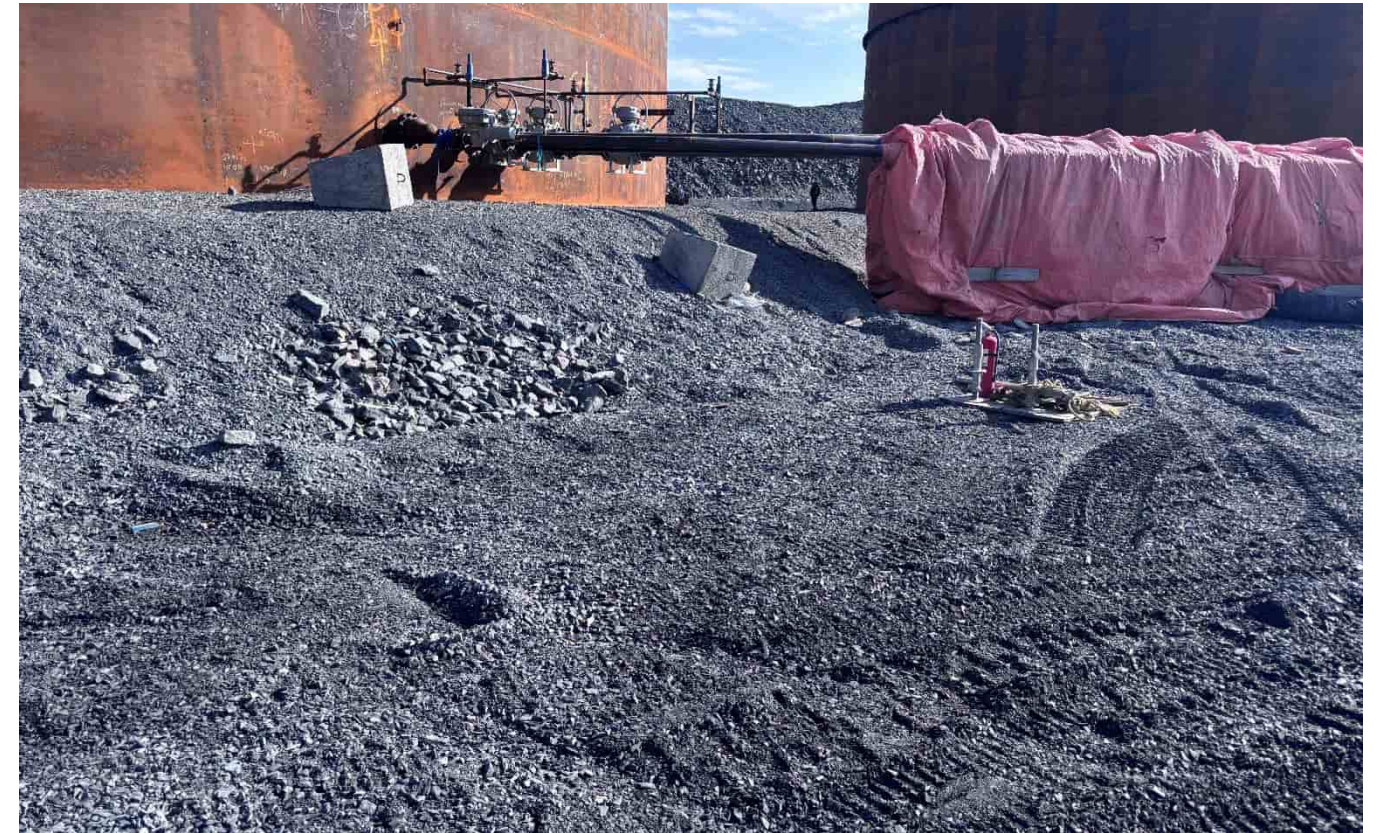
G-370: Slope beside western tanks, looking E

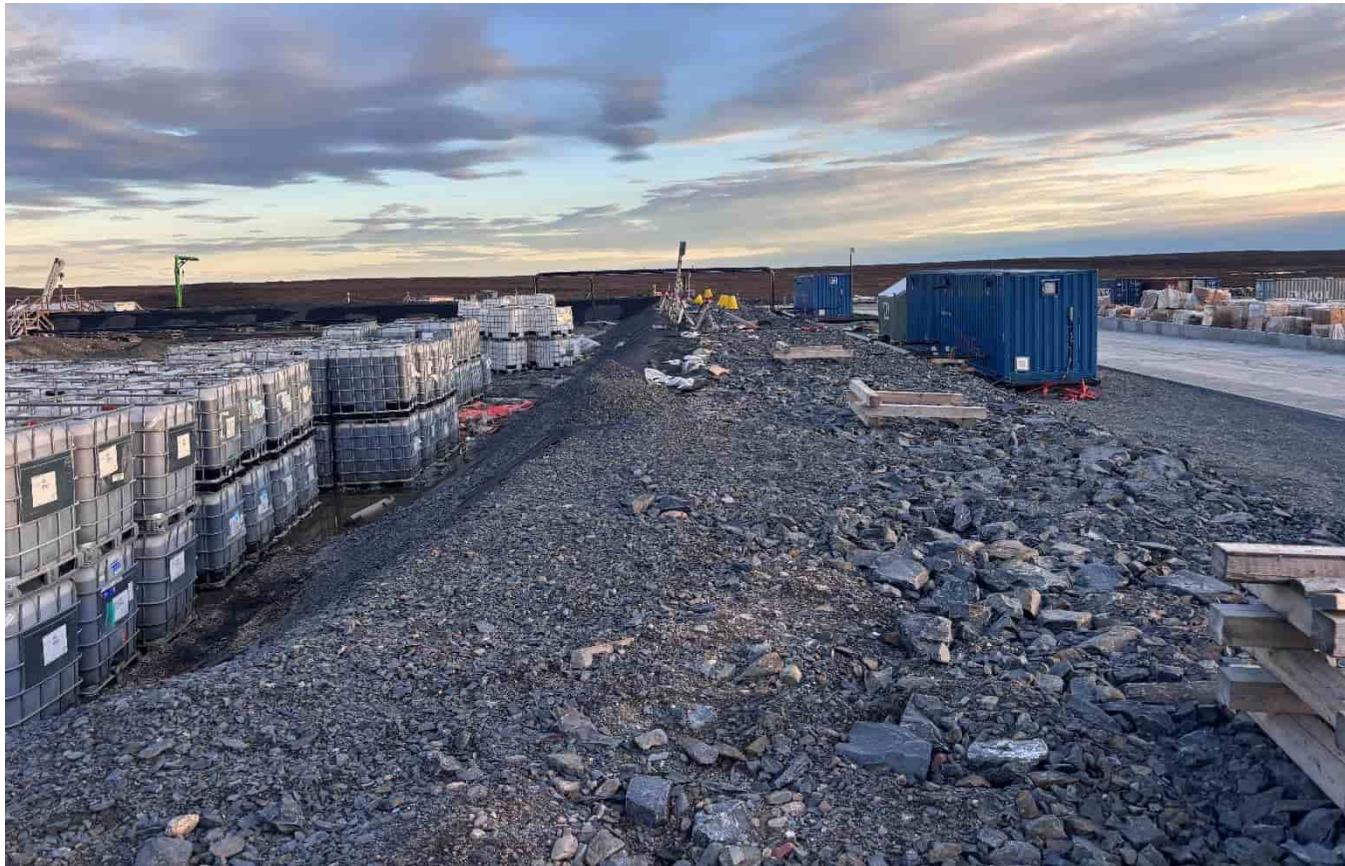
G-374: Berm between fuel transfer / refueling area and tank farm tote storage, looking S

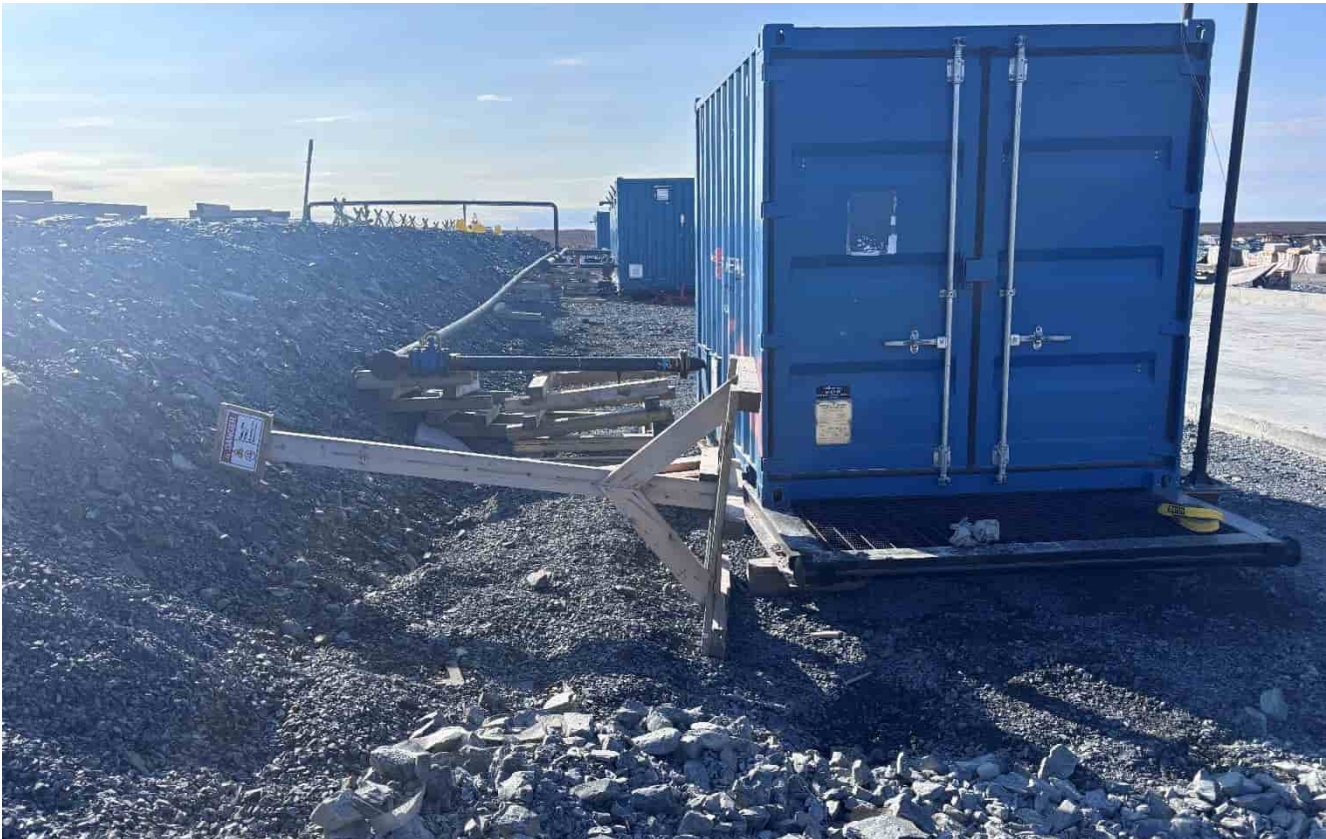
G-376: Looking S along toe of berm between fuel transfer / refueling and tank farm

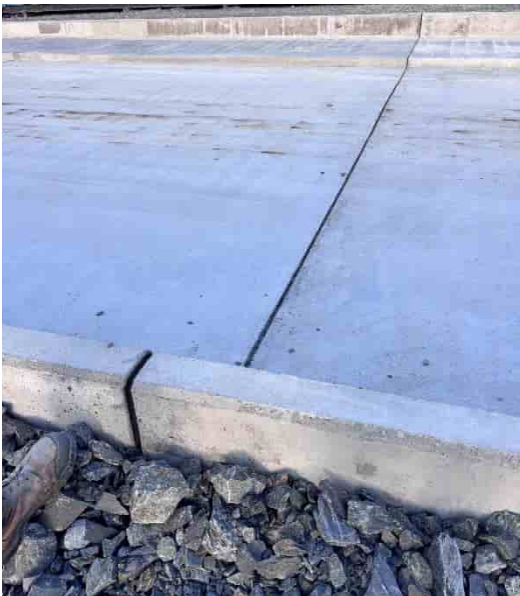
G-372: Fuel transfer / refueling concrete pad Seam

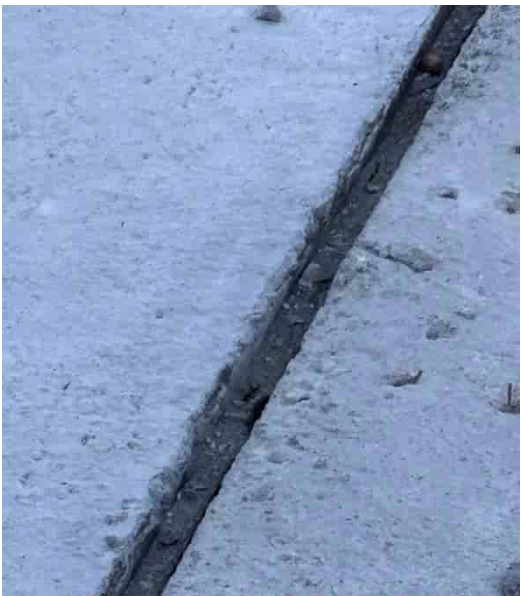
G-373: Close-up view of fuel transfer / refueling concrete pad seam

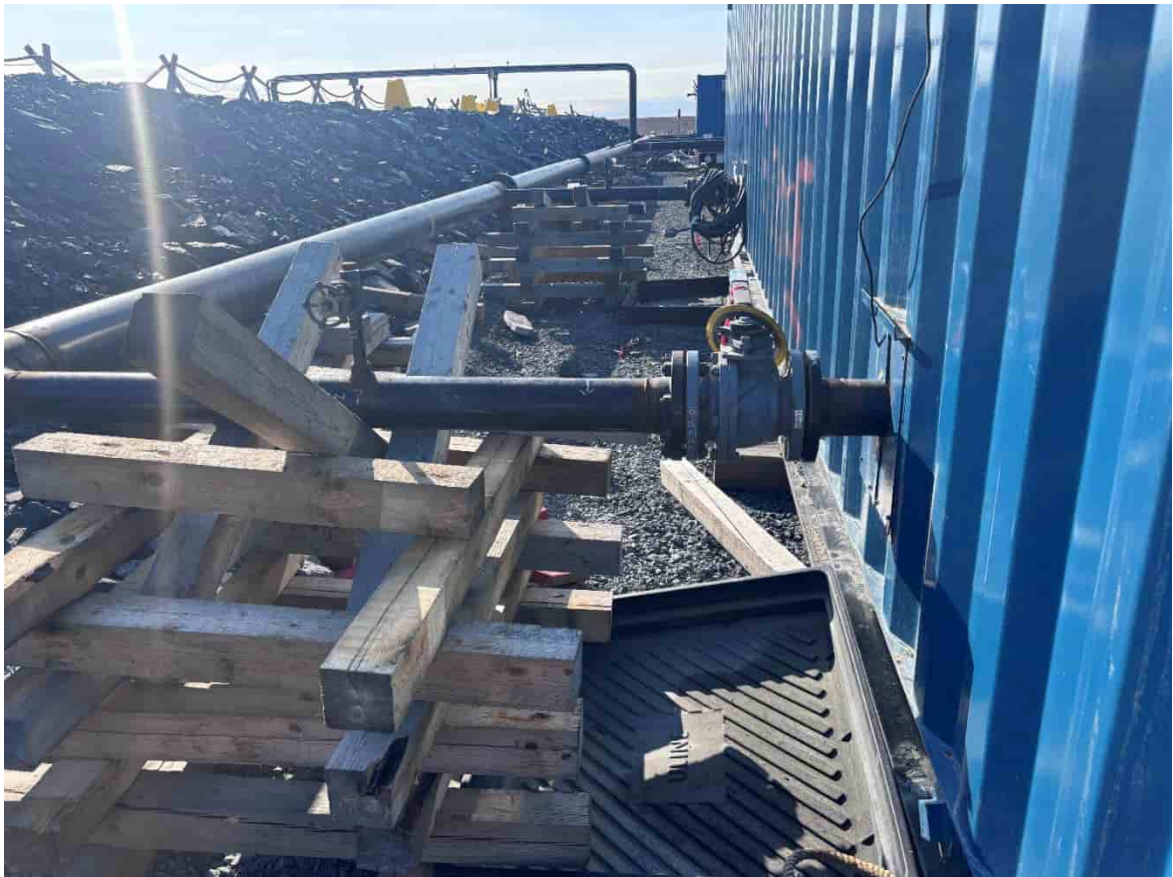
G-378: fuel transfer / refueling pipe connection to seacan

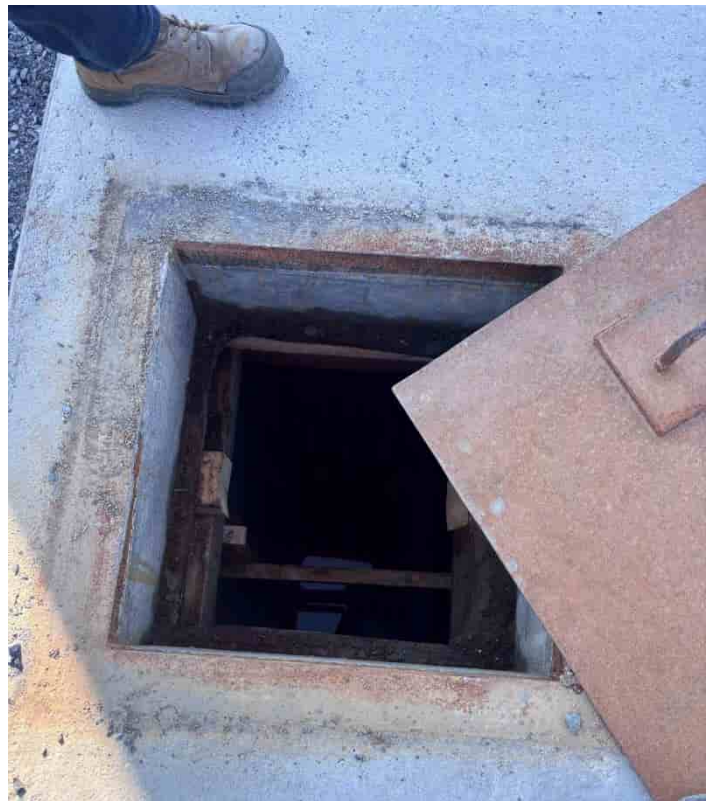
G-380: Fuel transfer / refueling sump access hatch

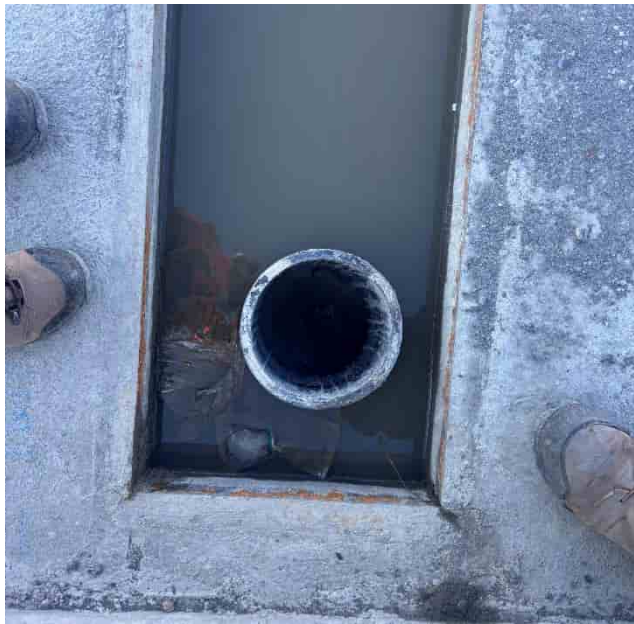
G-379: Fuel transfer / refueling sump

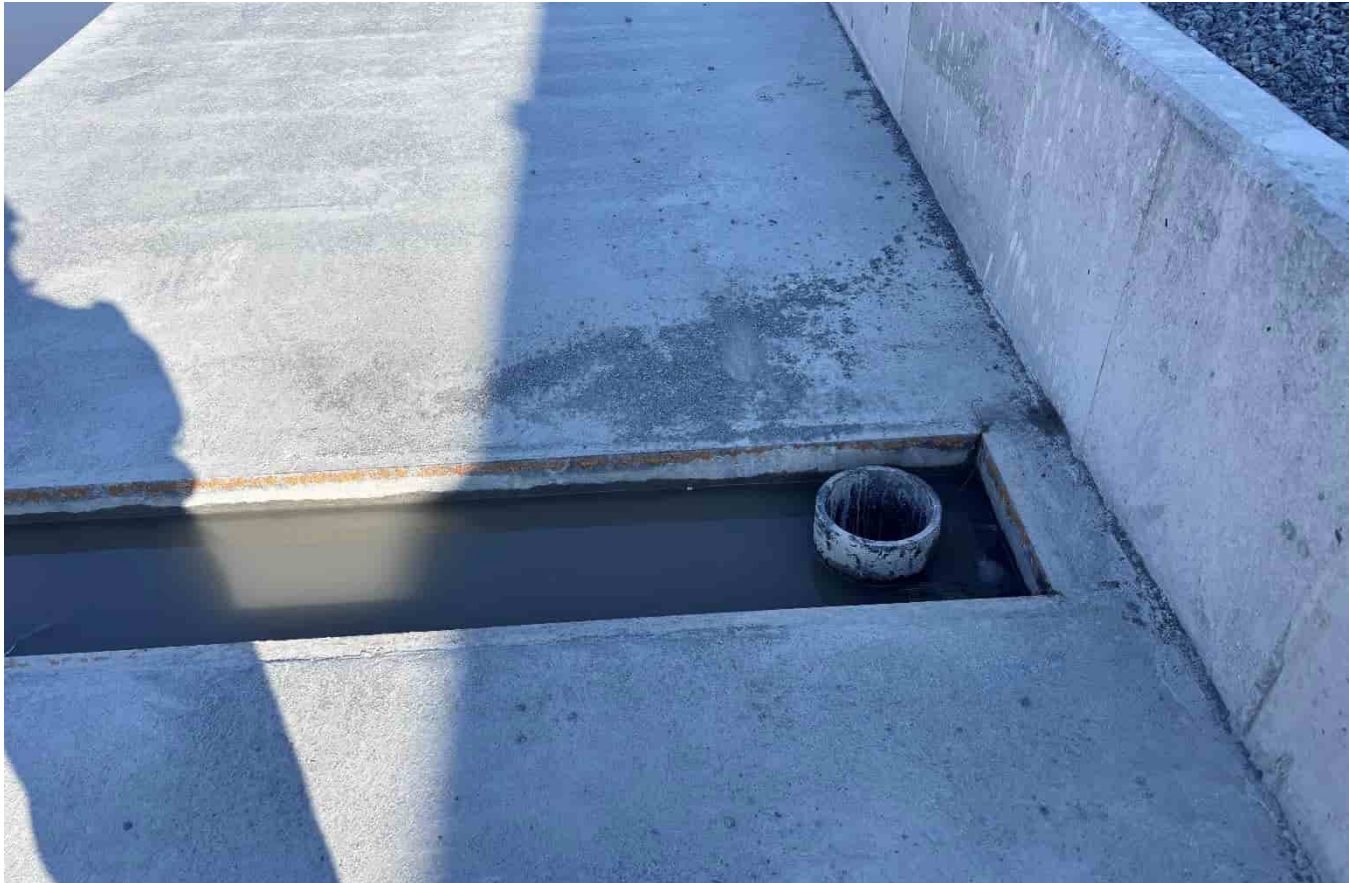
G-381: Fuel transfer / refueling sump, looking N

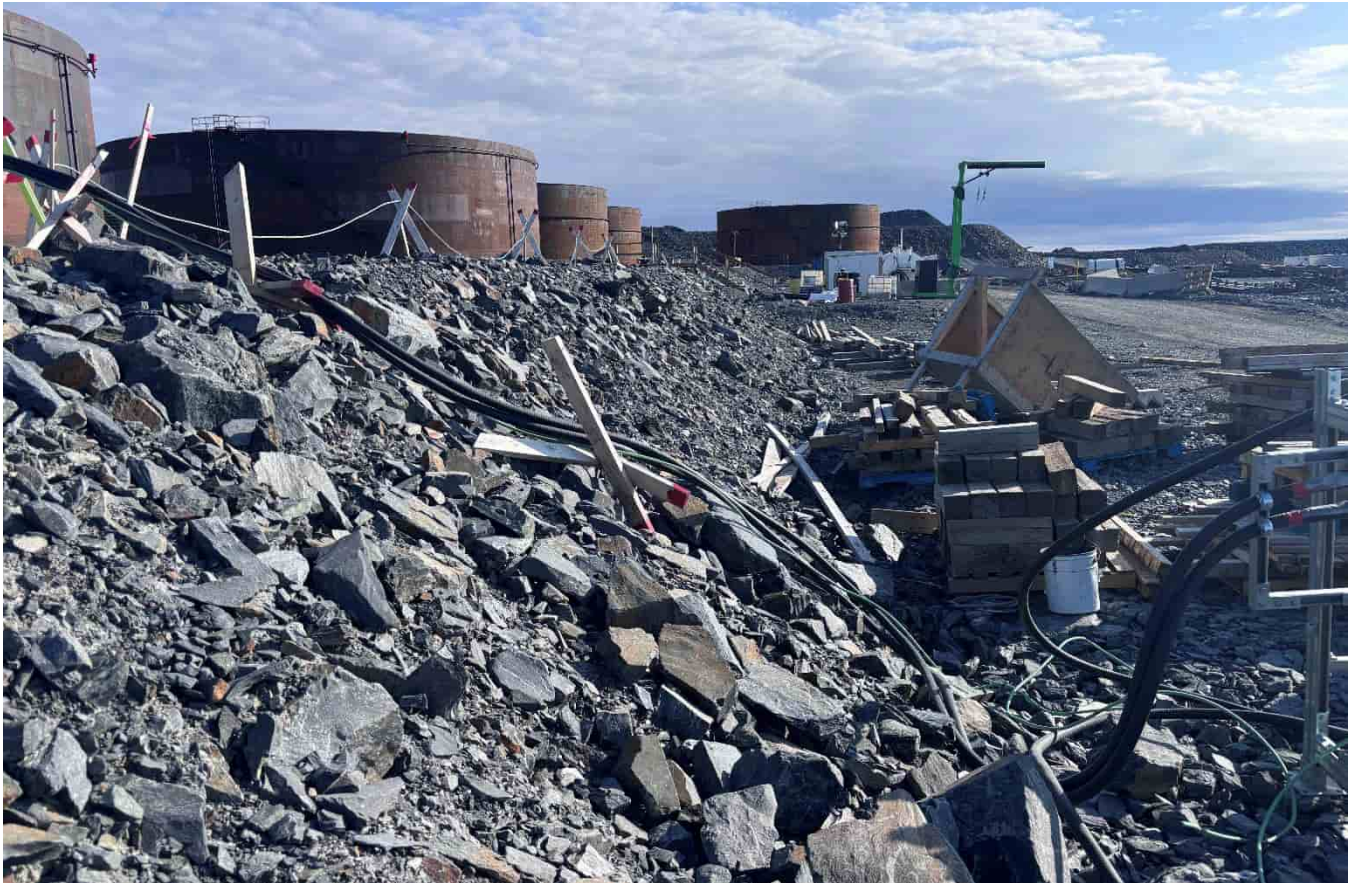
G-382: Laydown area S of tank farm, looking E from fuel transfer / refueling

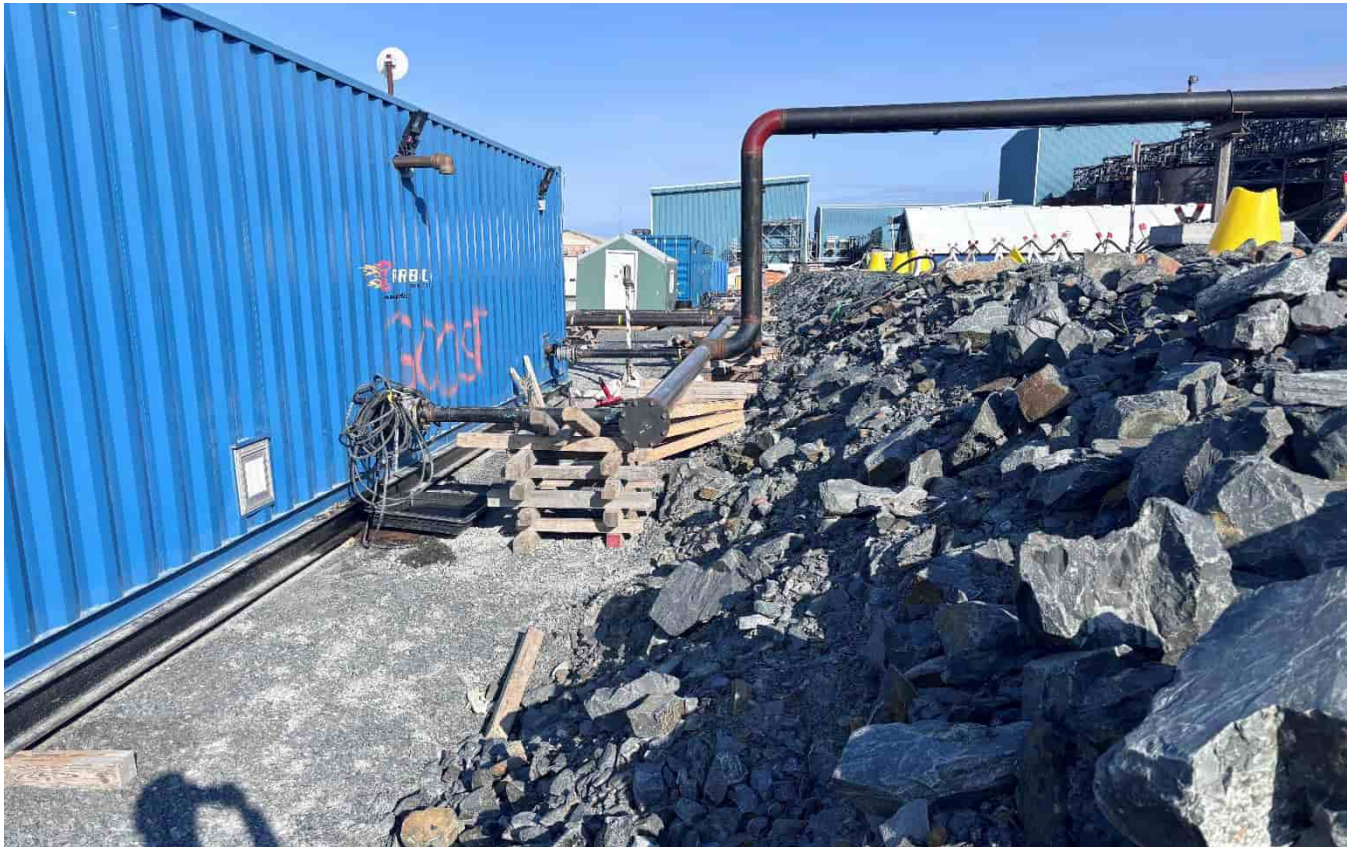
G-383: Looking N along toe of berm between fuel transfer / refueling and tank farm
