| | | 2025 Annual Geotechnical Inspection | | |
| Job No: CAPR004312<br>Filename: Back River_Goose_2025_AGI_Photoslog.pdf | Back River Project | Date:<br>February 2026 | Approved:<br>JBK | Figure:<br>79 |

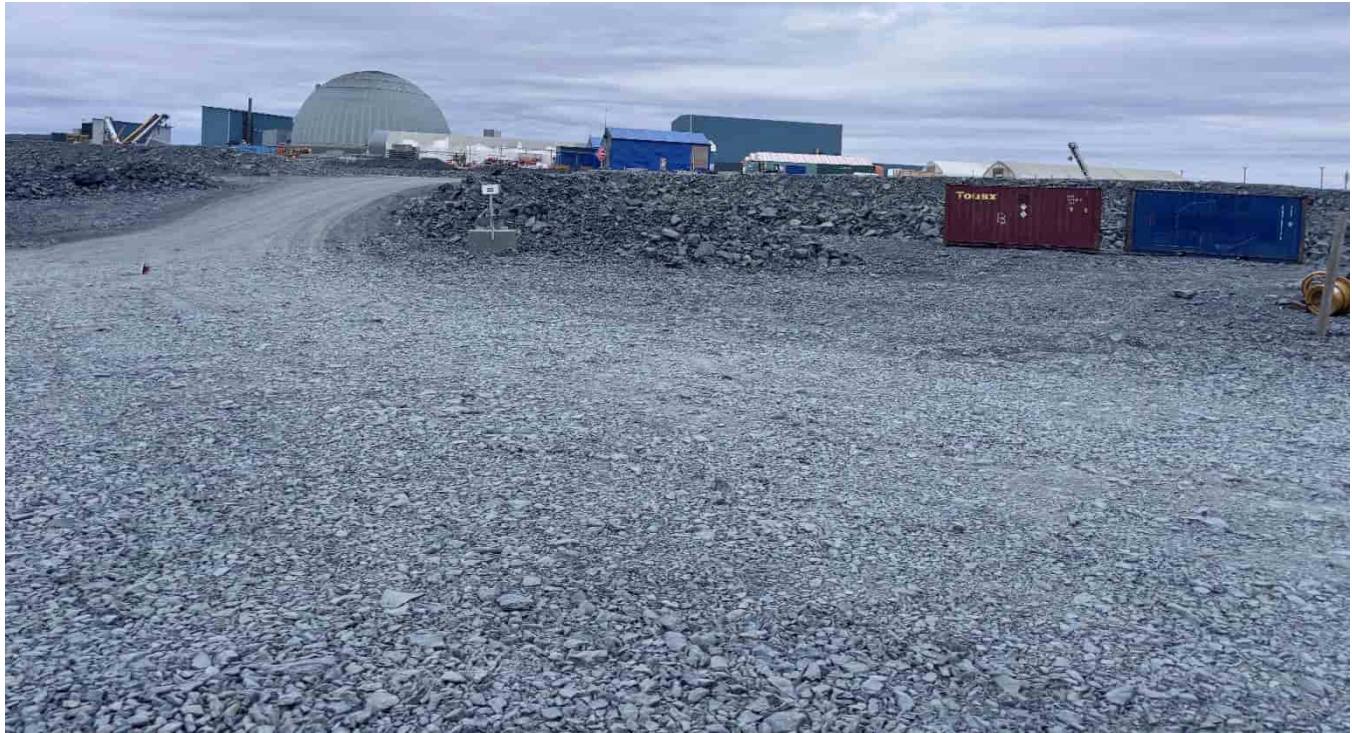
G-384: View towards main plant from laydown area, looking S

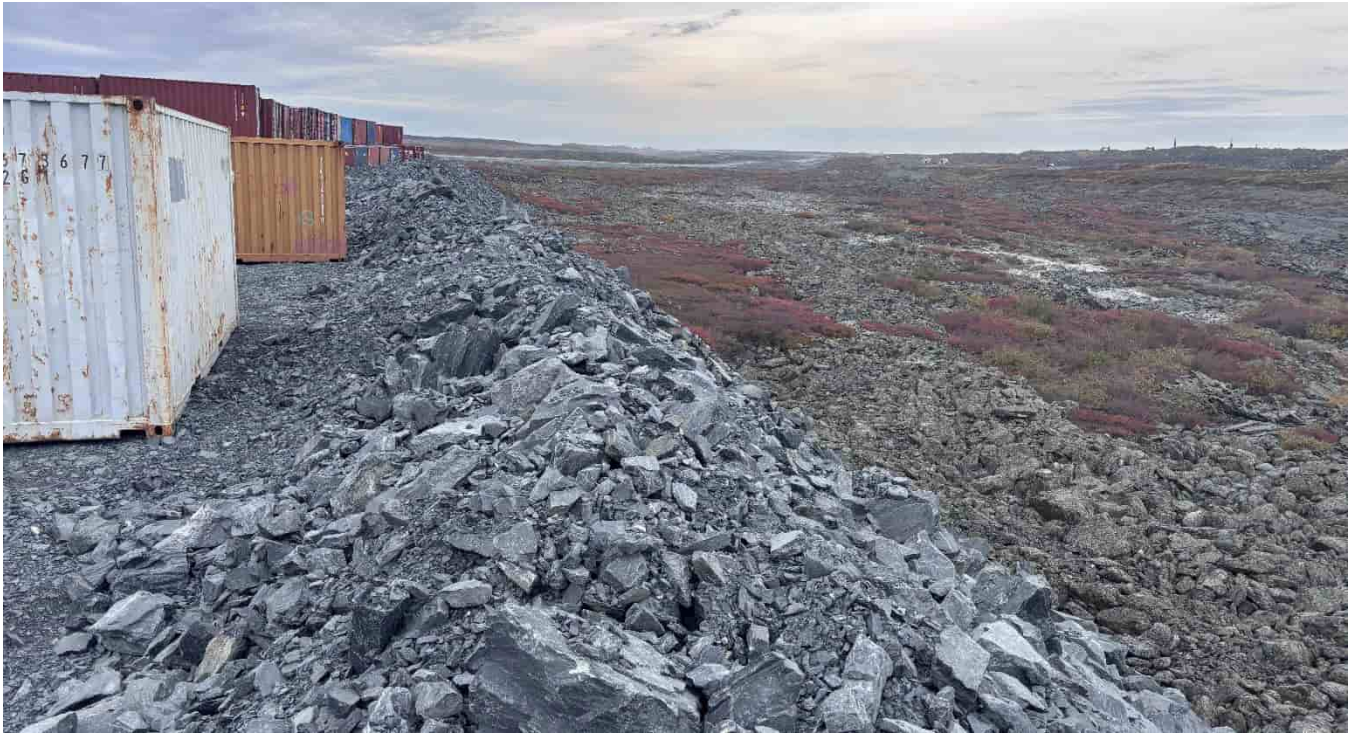
G-385: Laydown area NE pad slope, looking NW

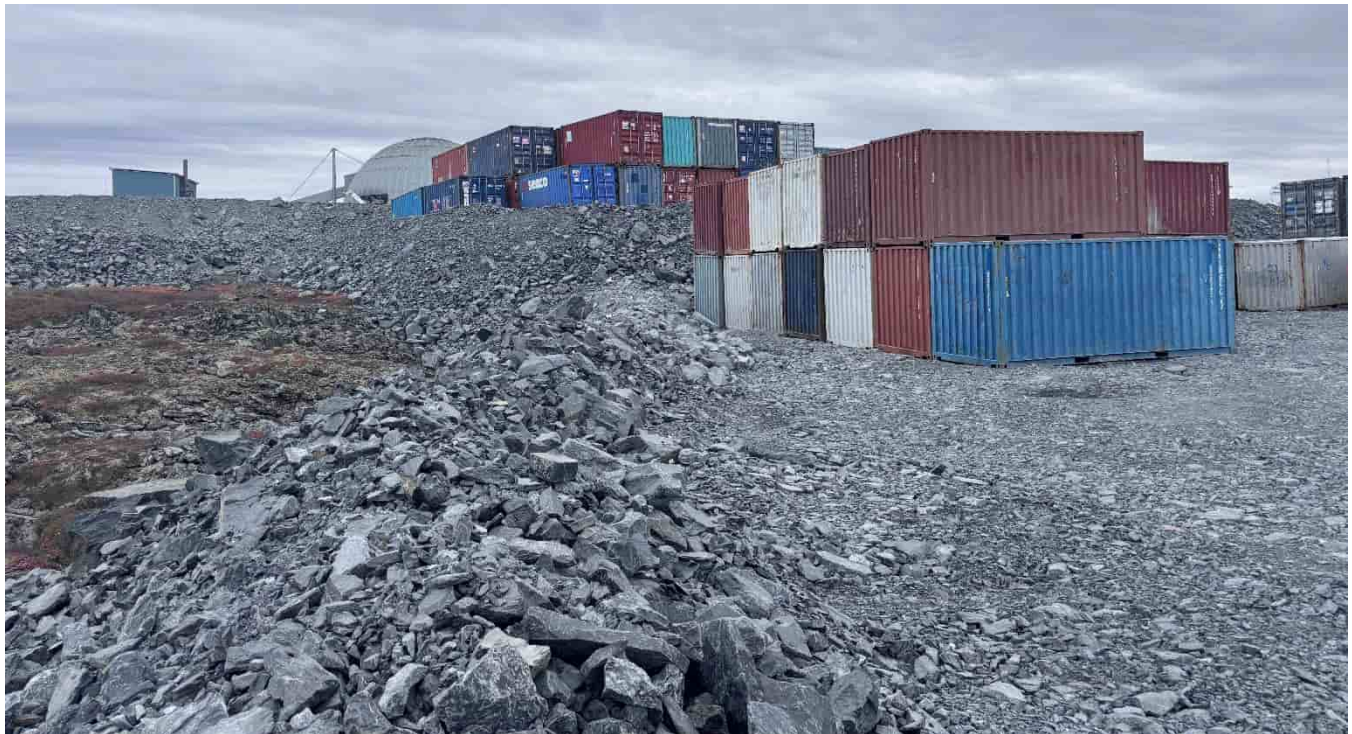
G-386: Laydown area SE pad slope, looking SW

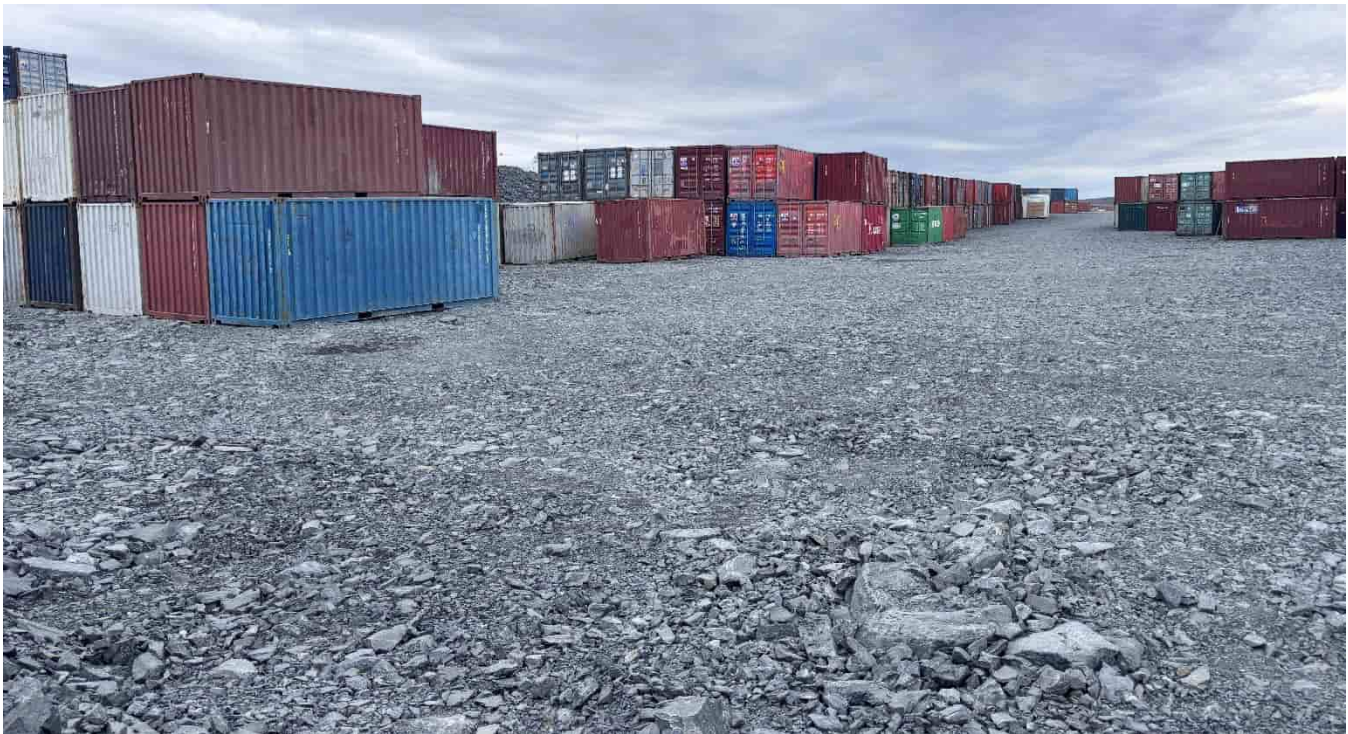
G-387: Laydown area overview, looking W

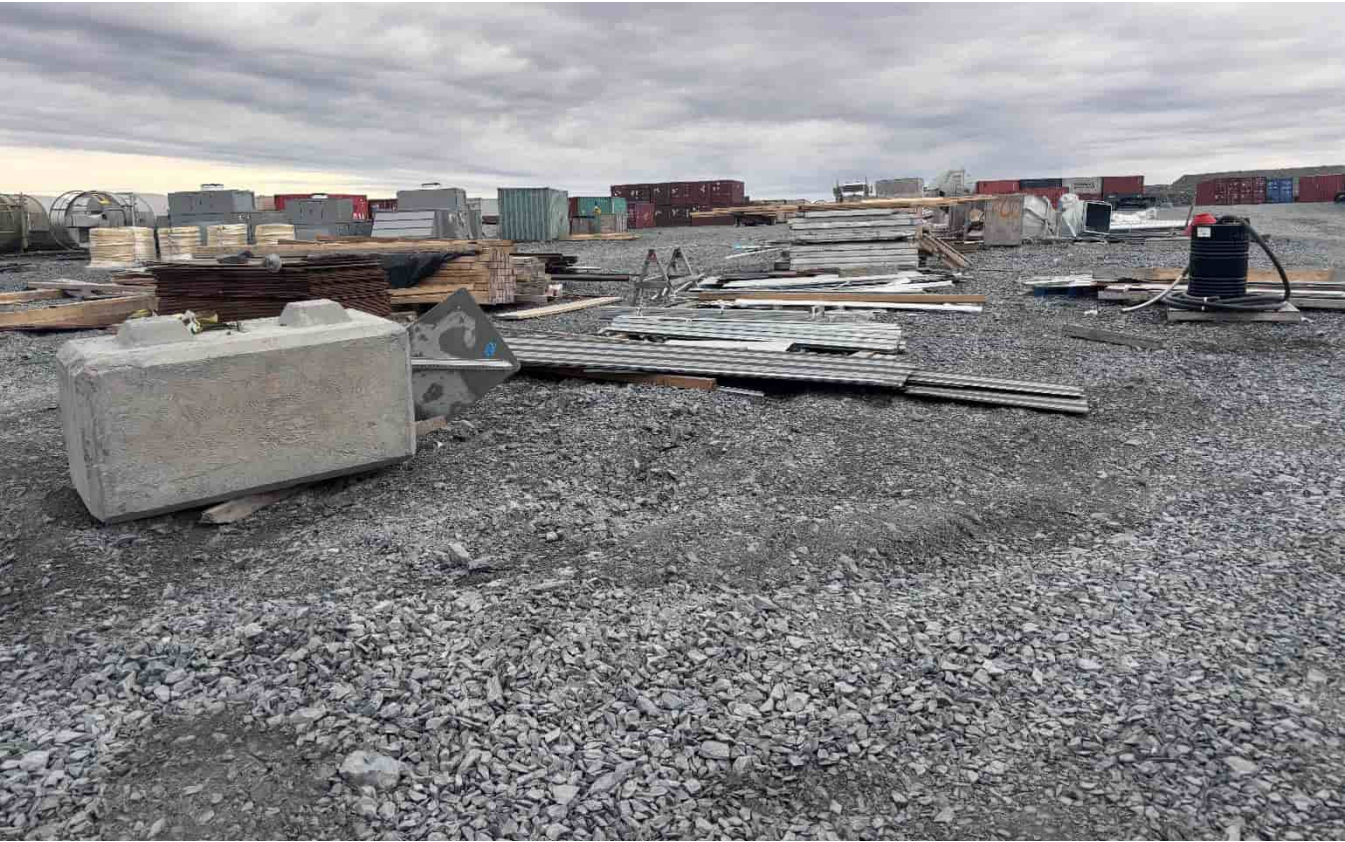
G-389: Laydown area, looking SE

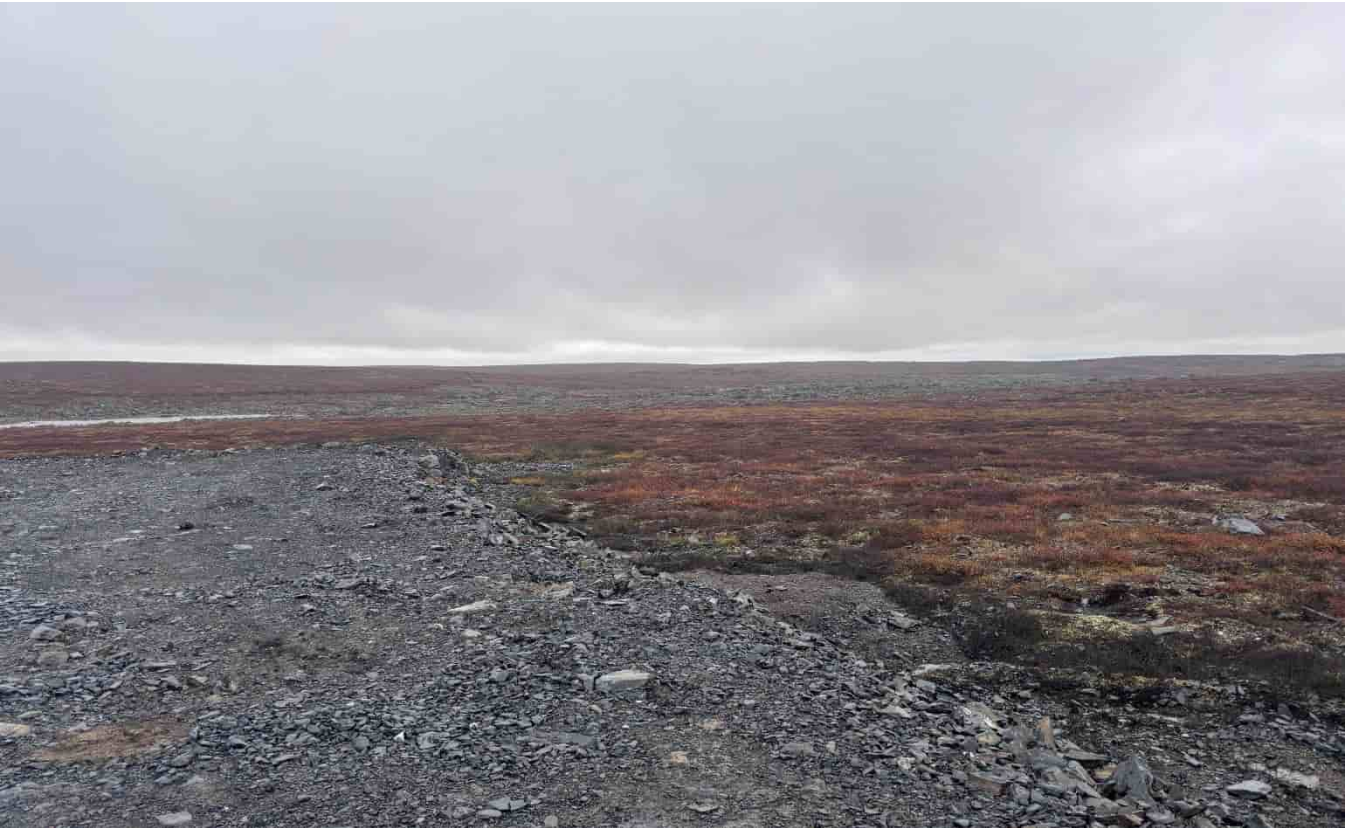
G-390B: Edge of North WIR Laydown pad, looking N

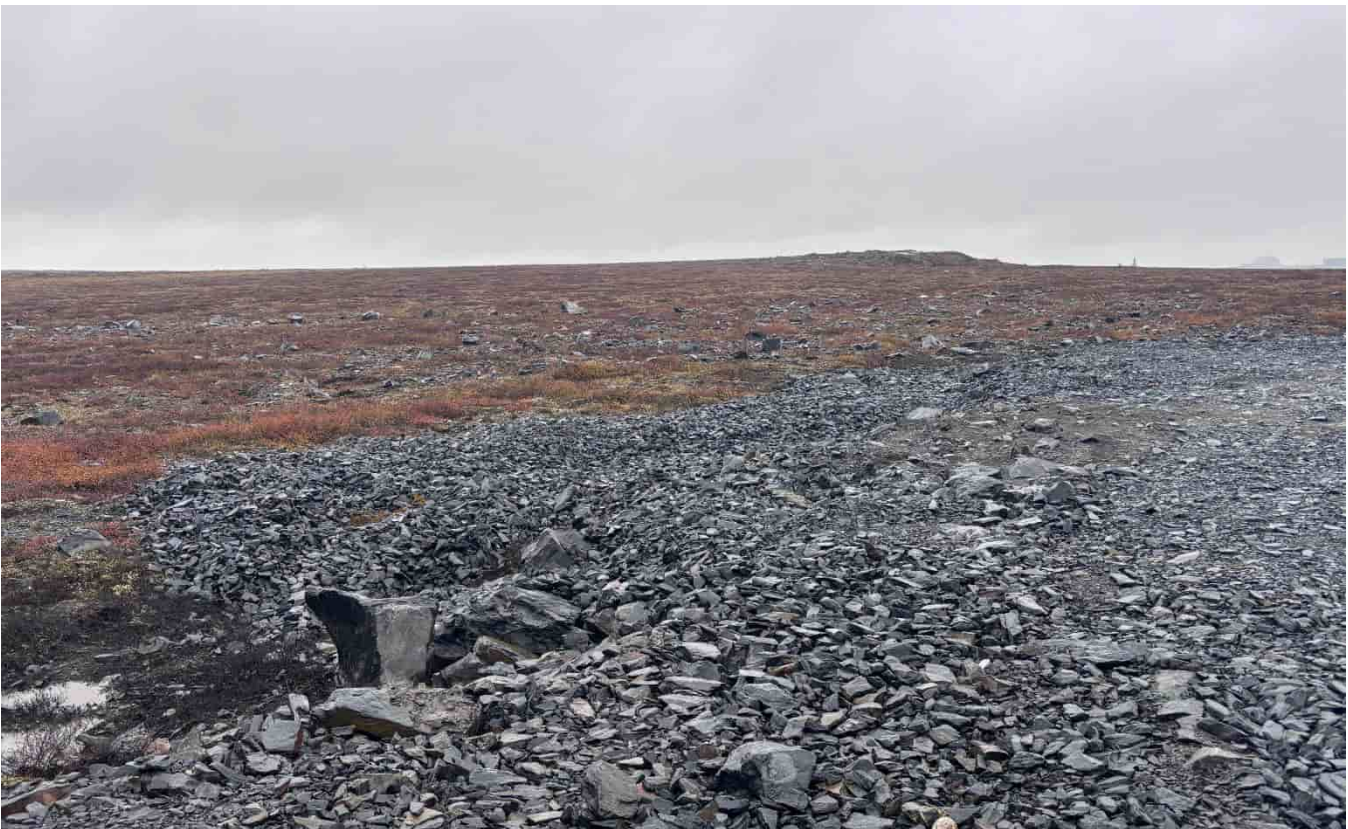
G-390C: Edge of North WIR Laydown pad, looking SE

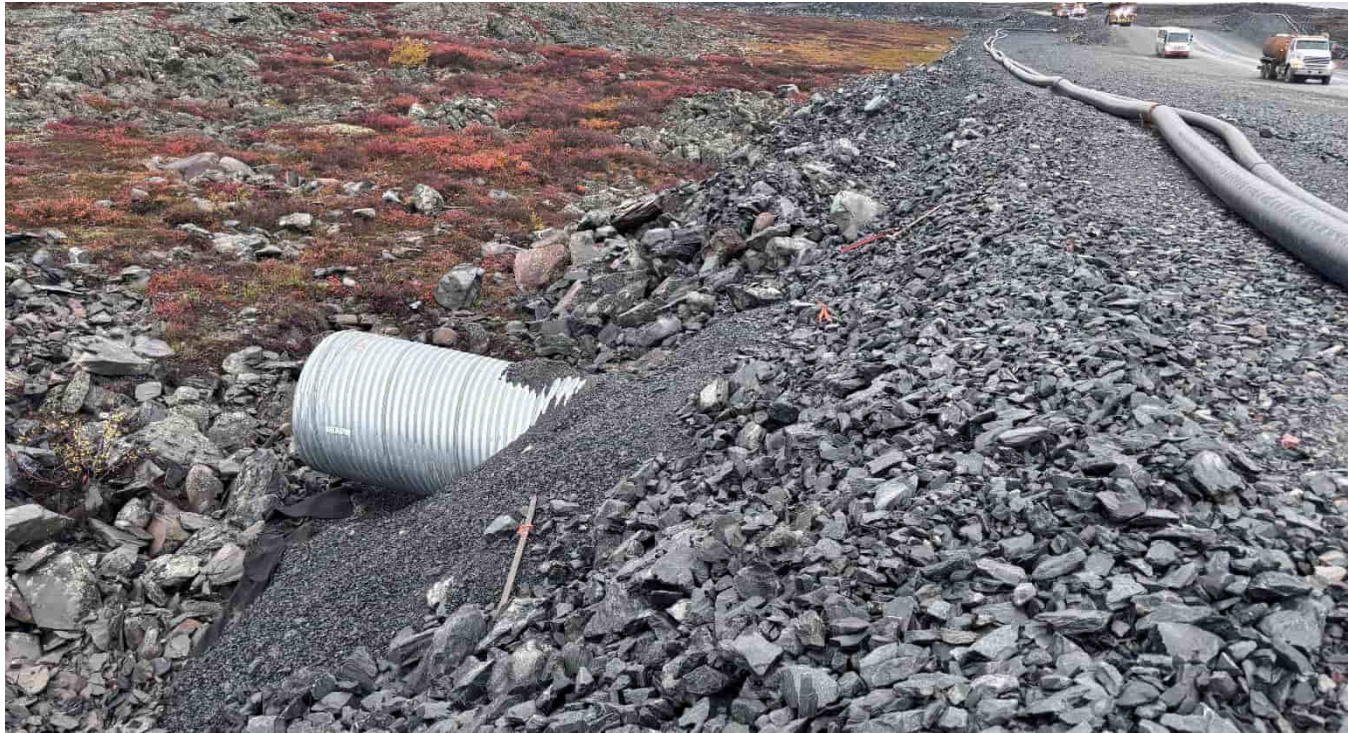
G-391: Northern culvert inlet, facing NW

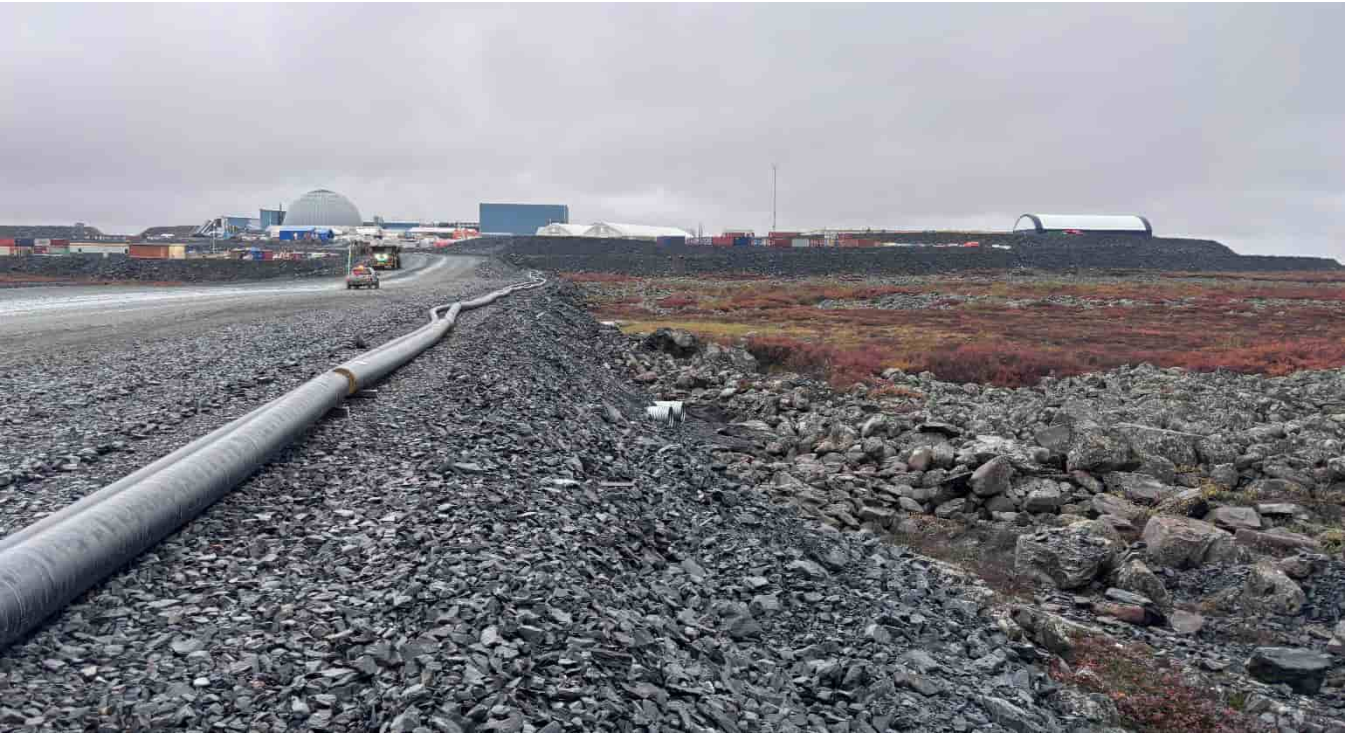
G-392: View towards twin culverts inlet, looking S along road rockfill

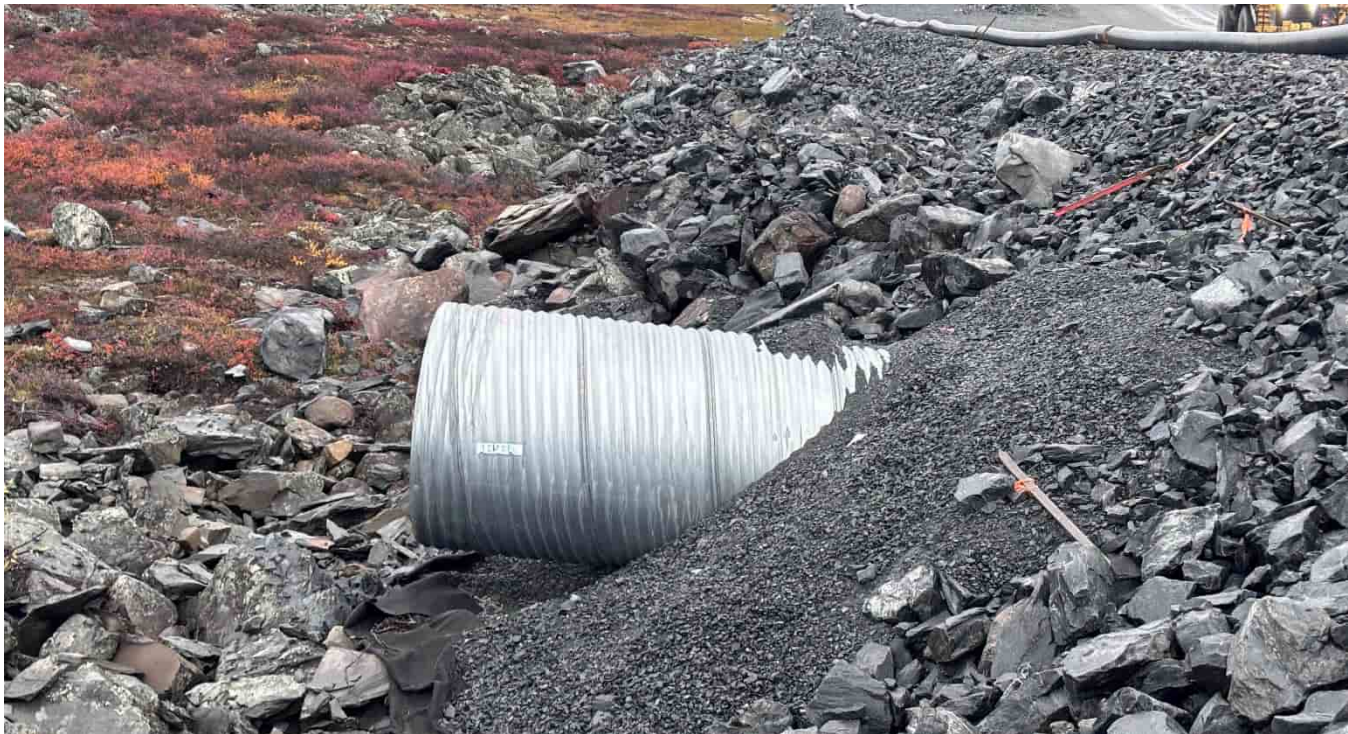
G-393: Northern culvert inlet, looking N

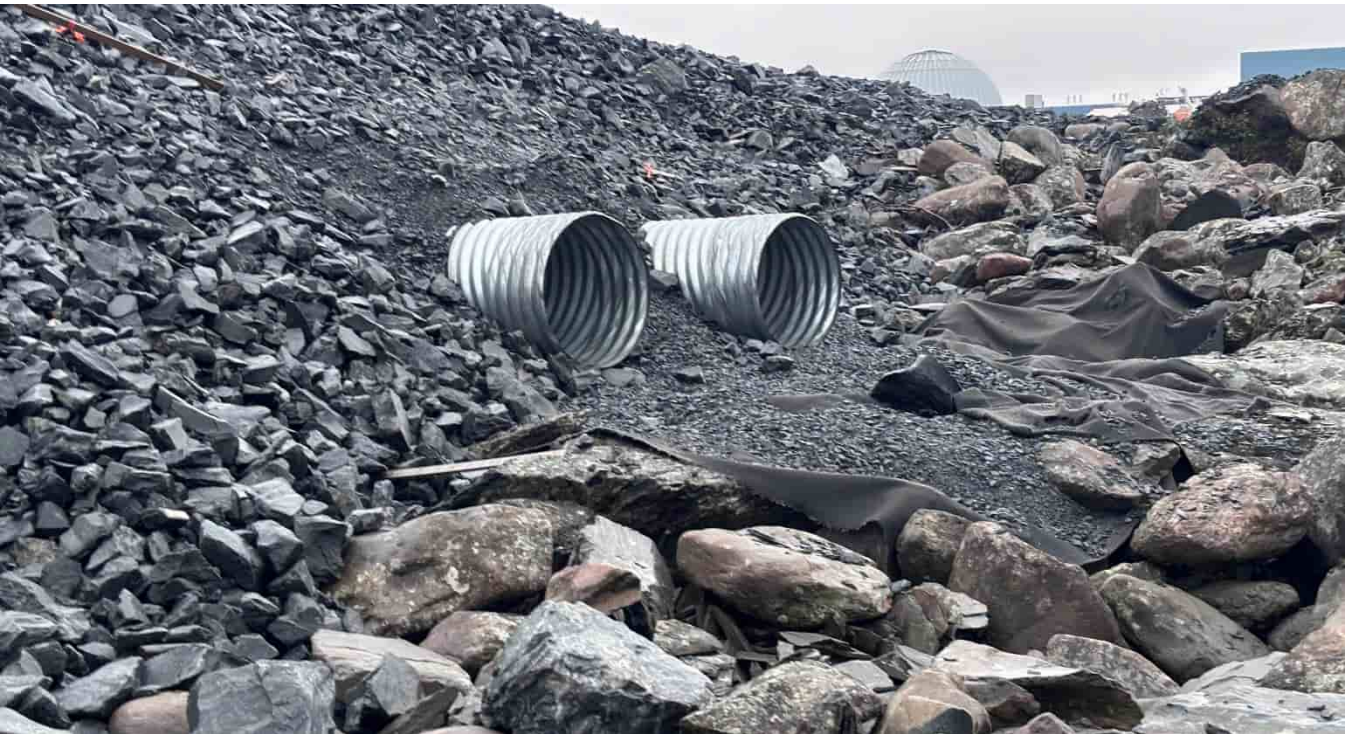
G-394: Twin (southern) culverts inlet

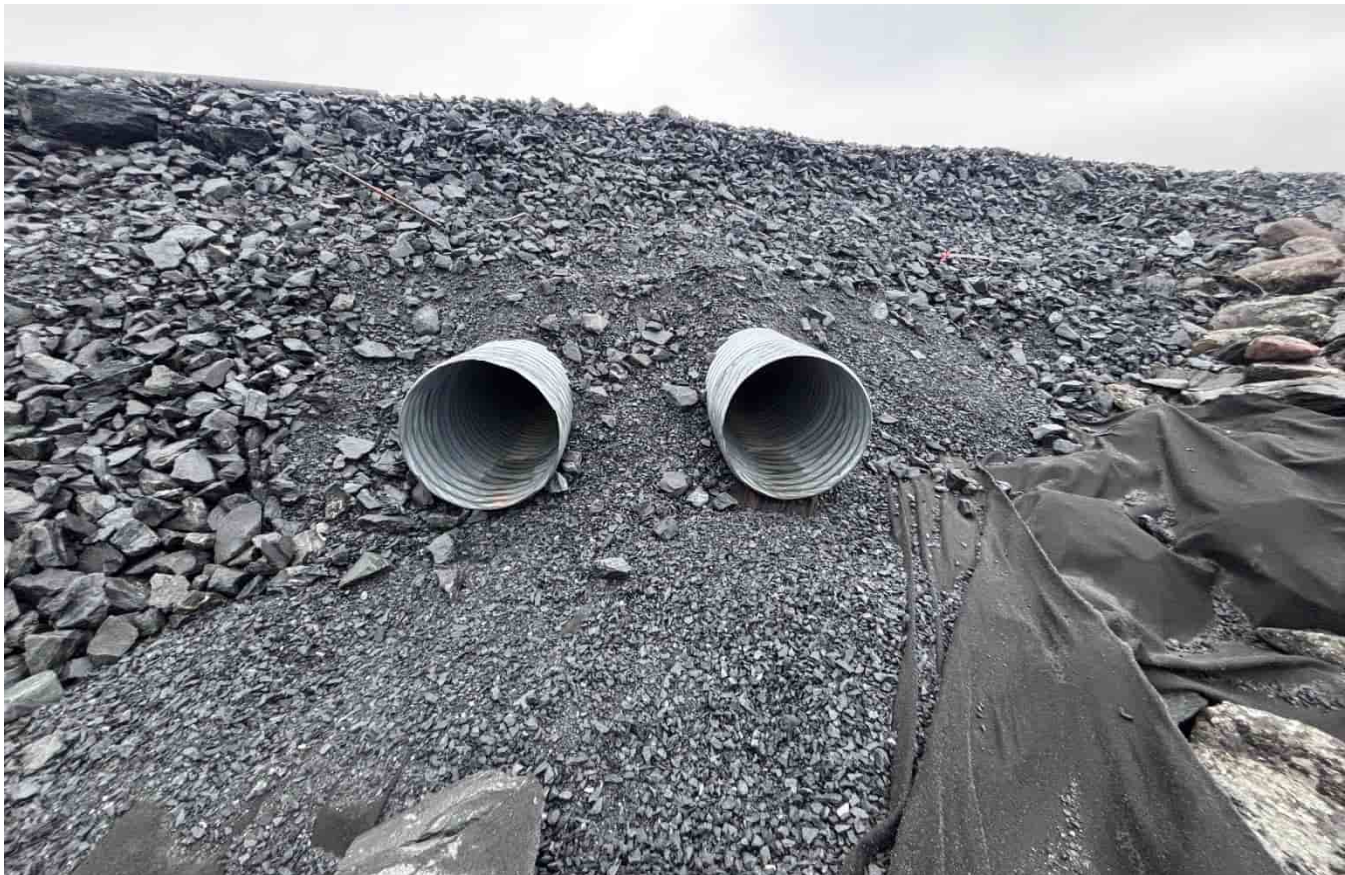
G-395: Twin culverts inlet

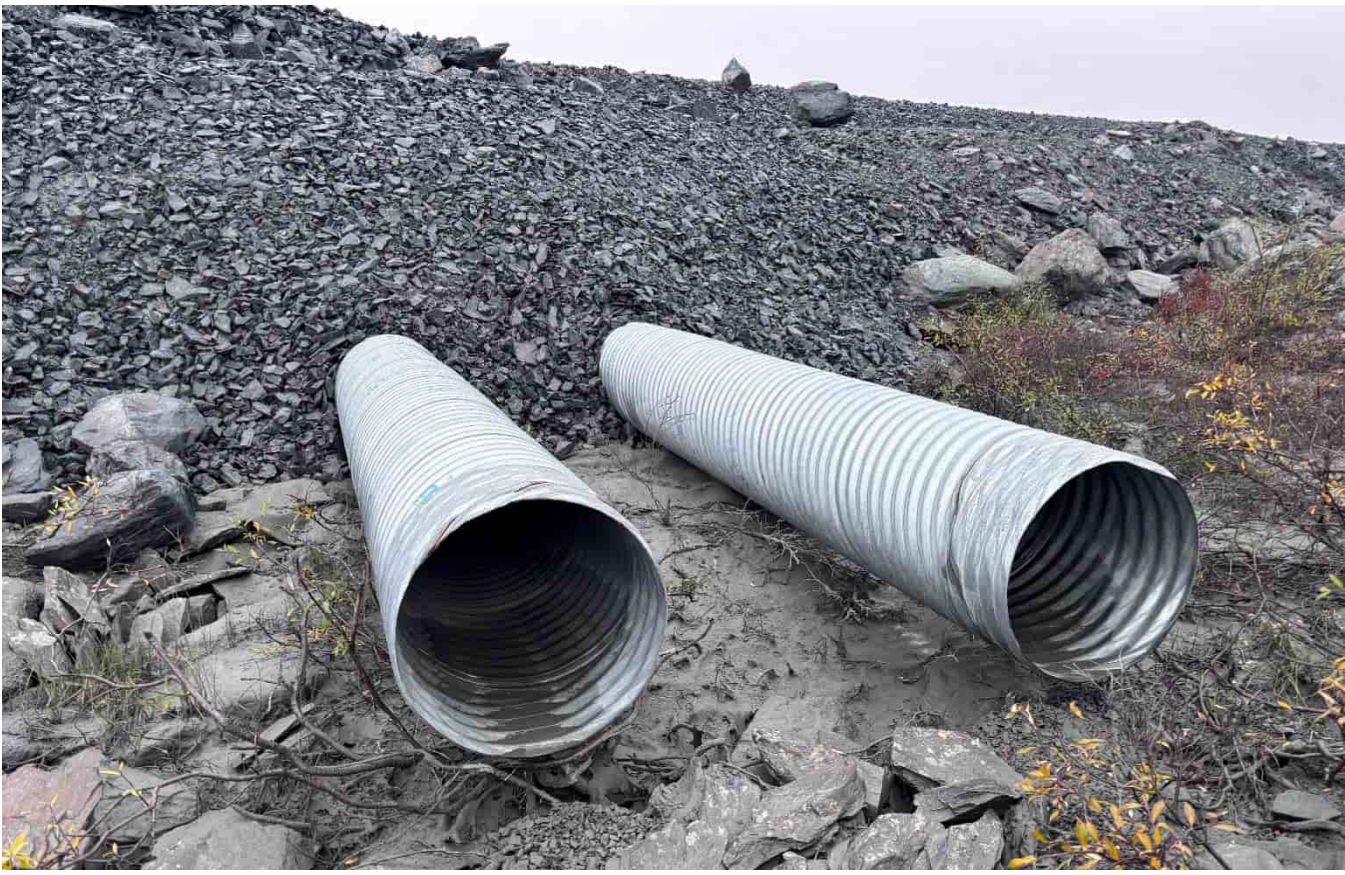
G-396: Twin culverts outlet

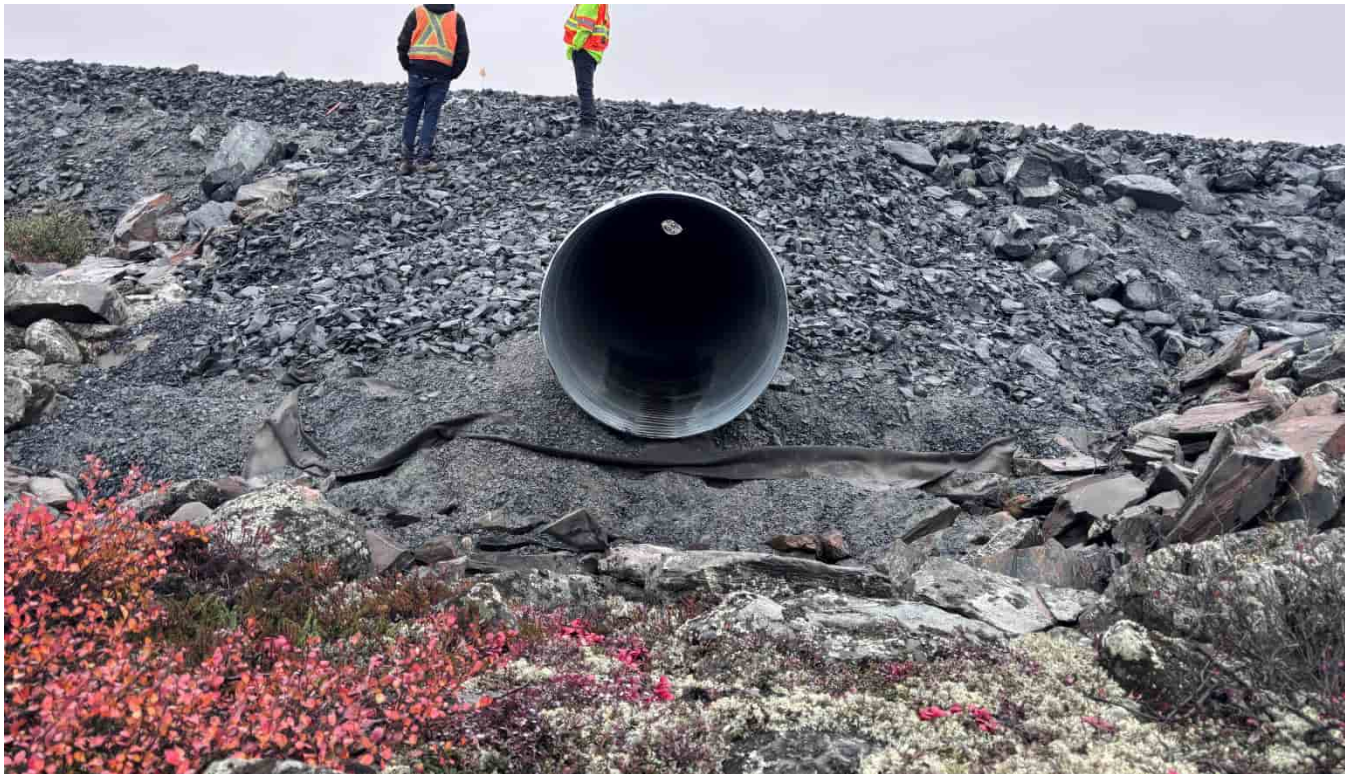
G-397: Northern culvert outlet

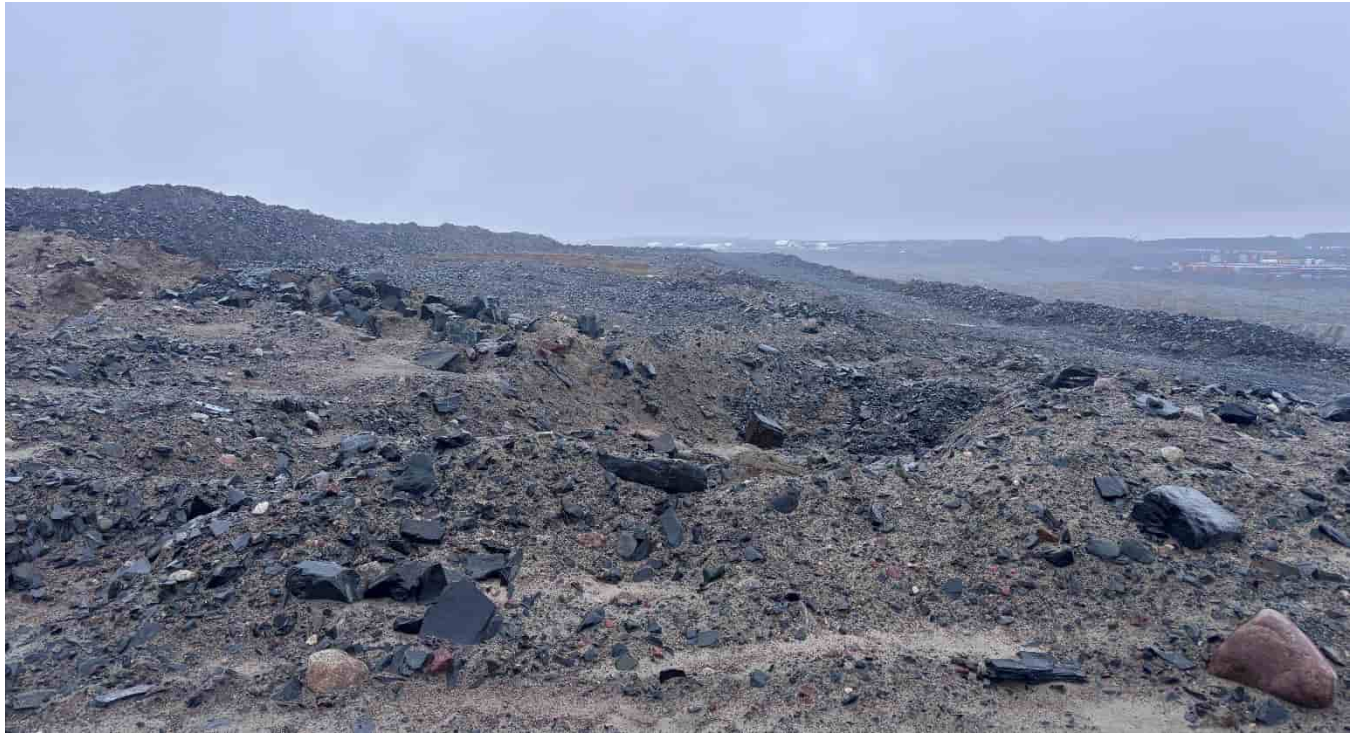
G-398: Typical overburden stockpile surface conditions

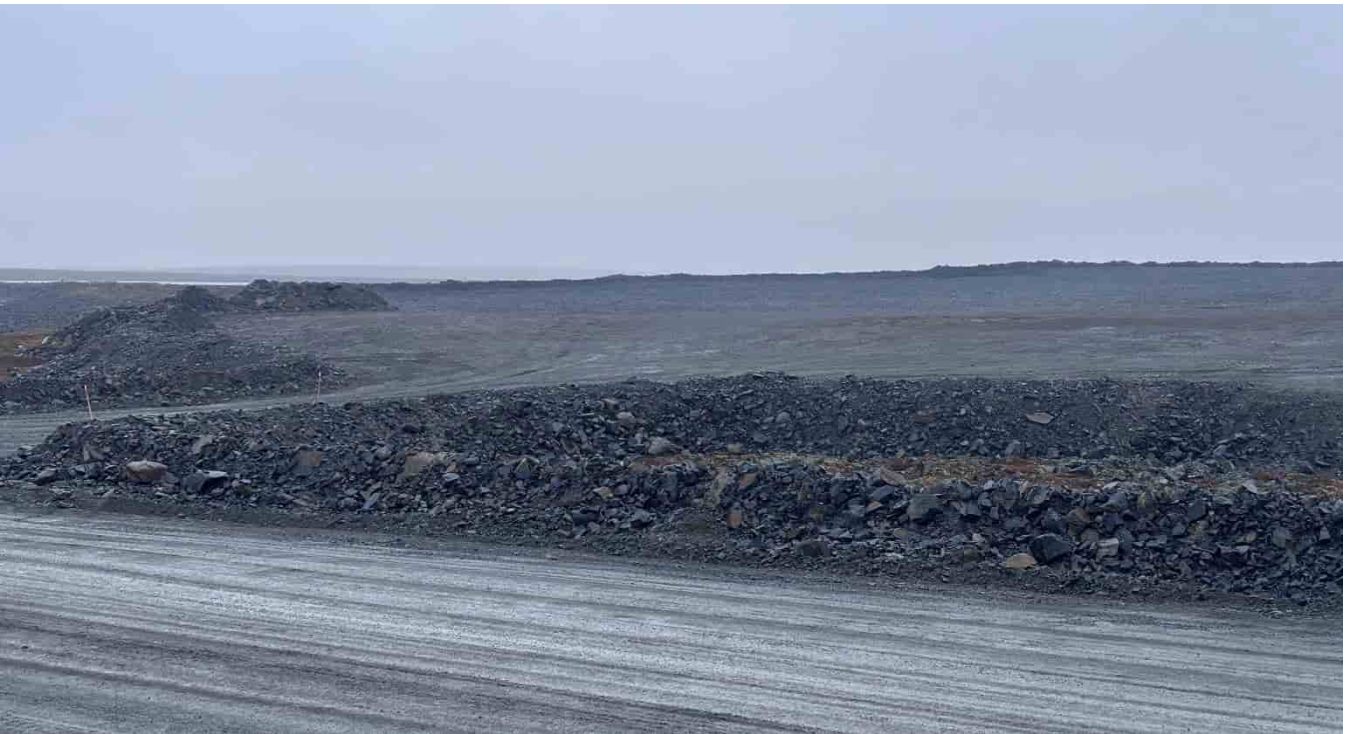
G-401: Umwelt rock storage, looking N from overburden stockpile

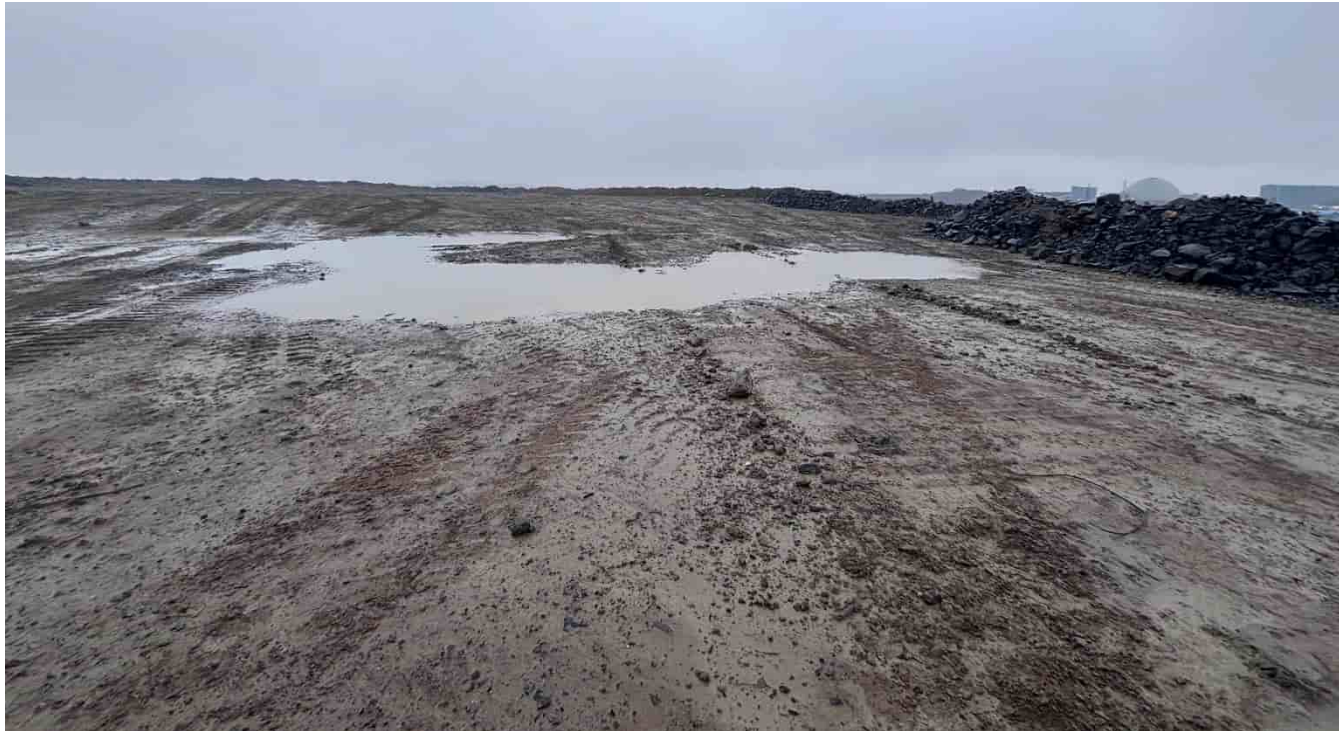
G-402: Ponding on overburden stockpile surface, looking S

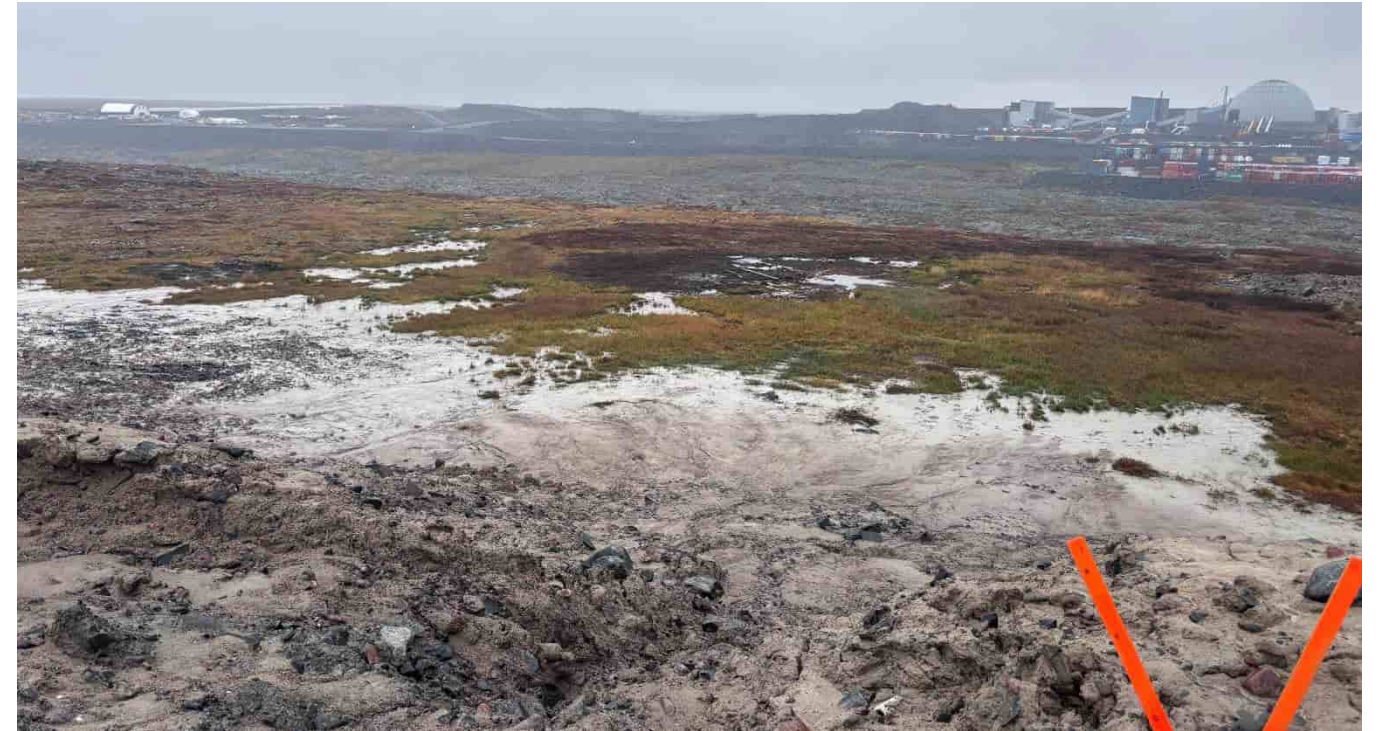
G-403: Looking SE from S corner of stockpile – ponding and water from thaw of stockpiled overburden material

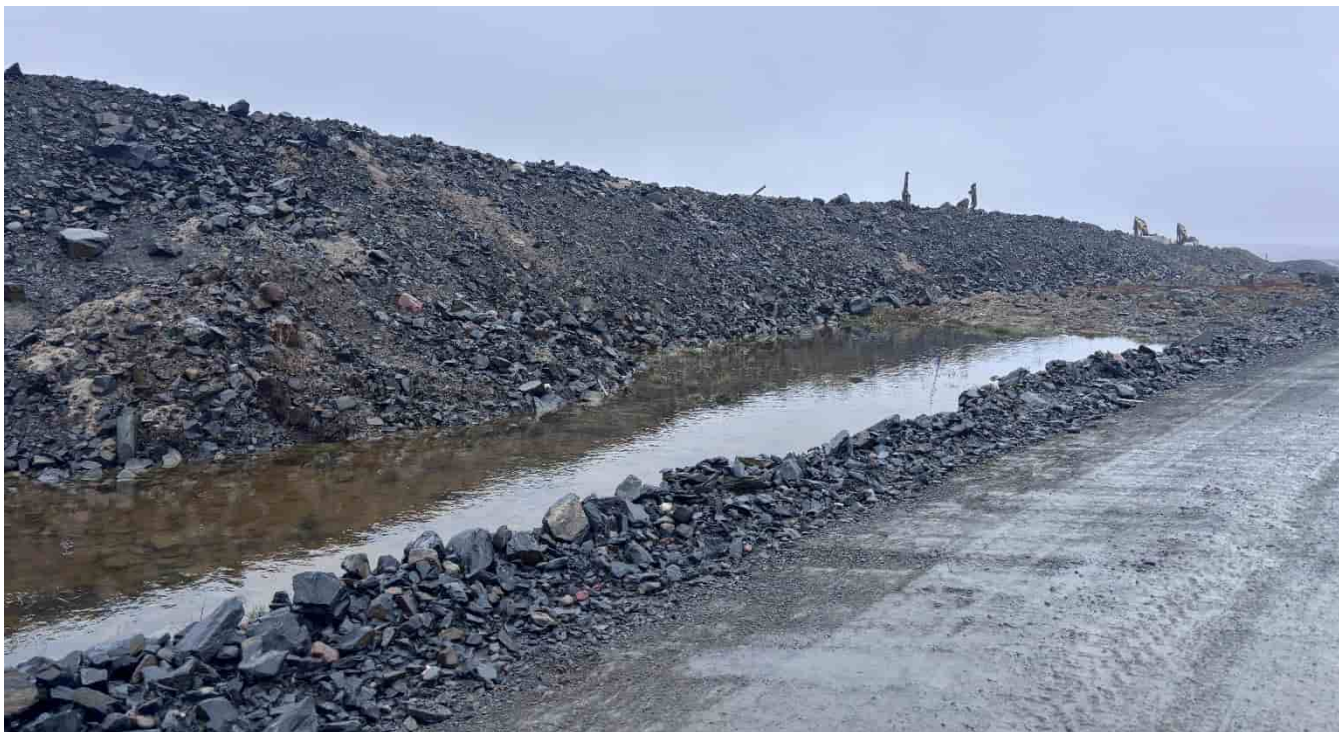
G-404: Ponding between road and N slope of stockpile pad, looking W

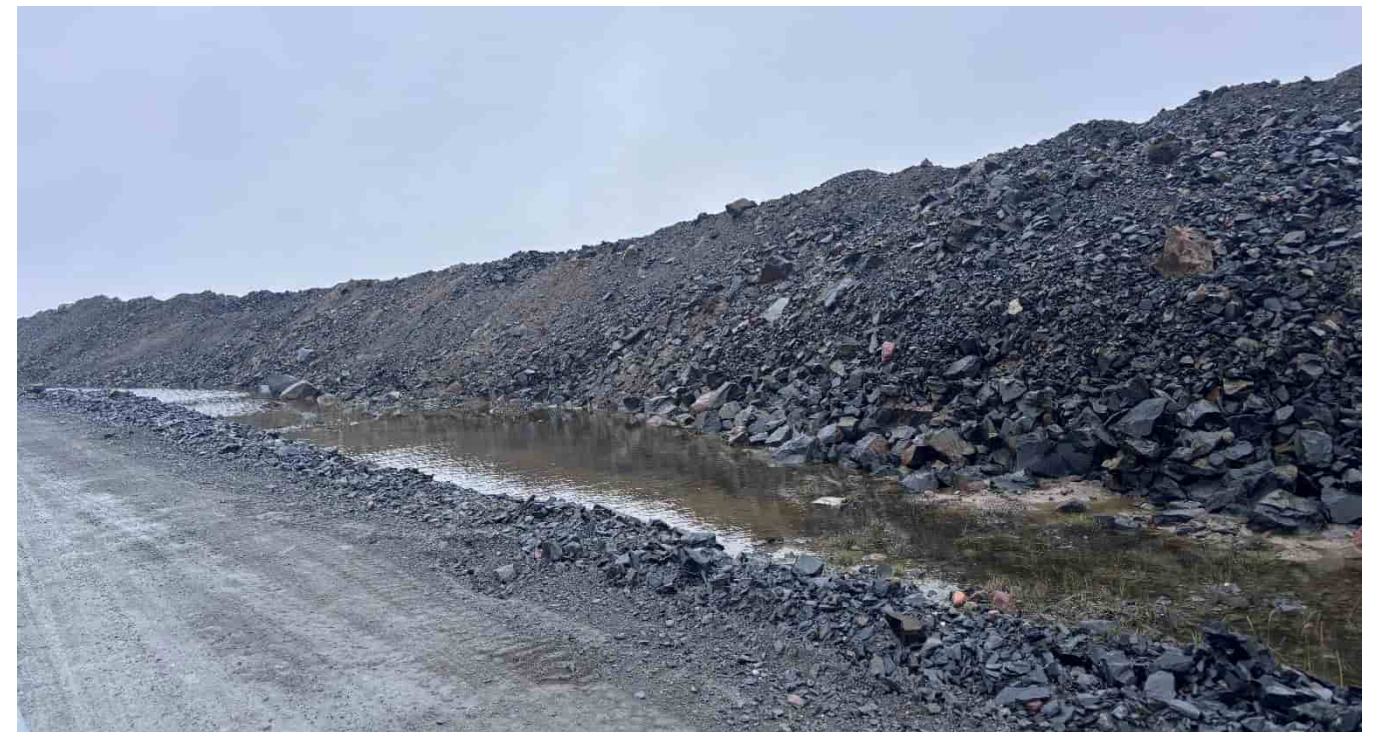
G-405: Ponding between road and N slope of stockpile pad, looking E

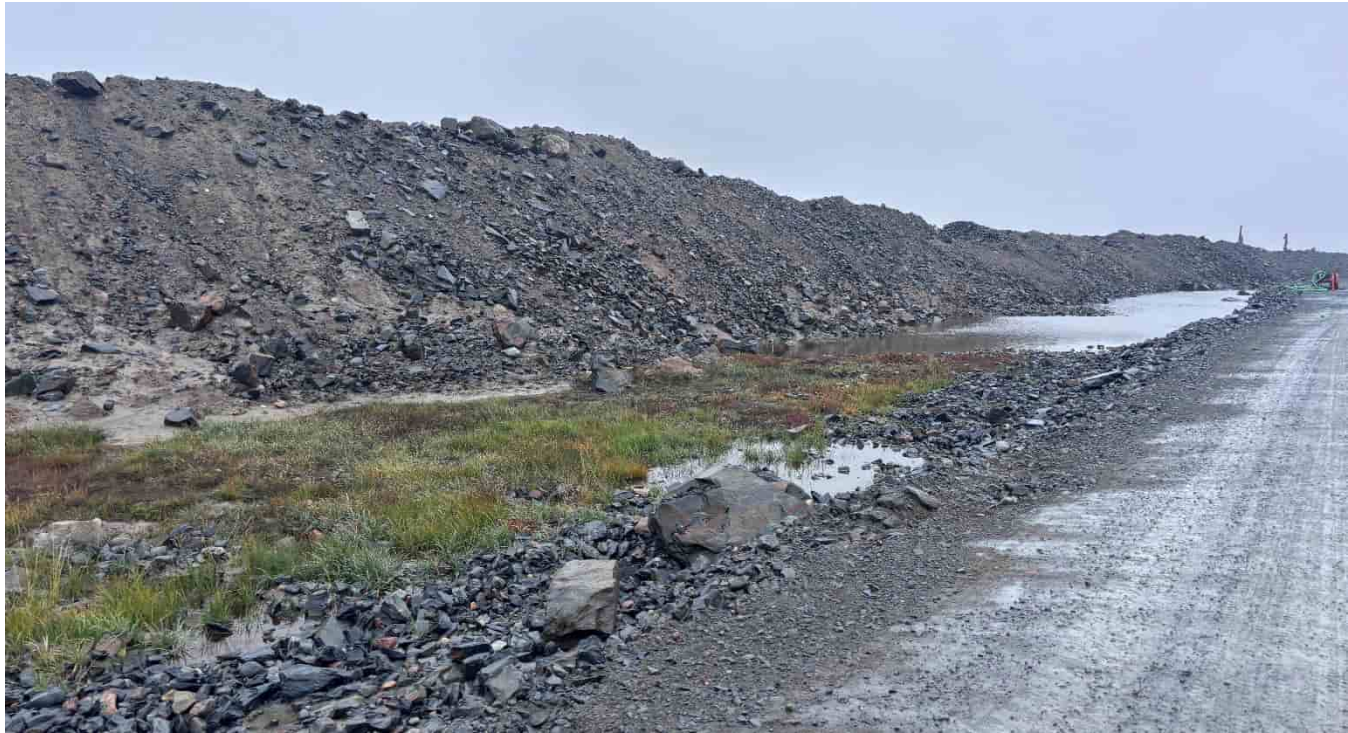
G-406: Ponding between road and N slope of stockpile pad, looking W – thinner rockfill road in area
