| | | 2025 Annual Geotechnical Inspection | | |
| Job No: CAPR004312<br>Filename: Back River_Goose_2025_AGI_Photoslog.pdf | Back River Project | Date:<br>February 2026 | Approved:<br>JBK | Figure:<br>79 |

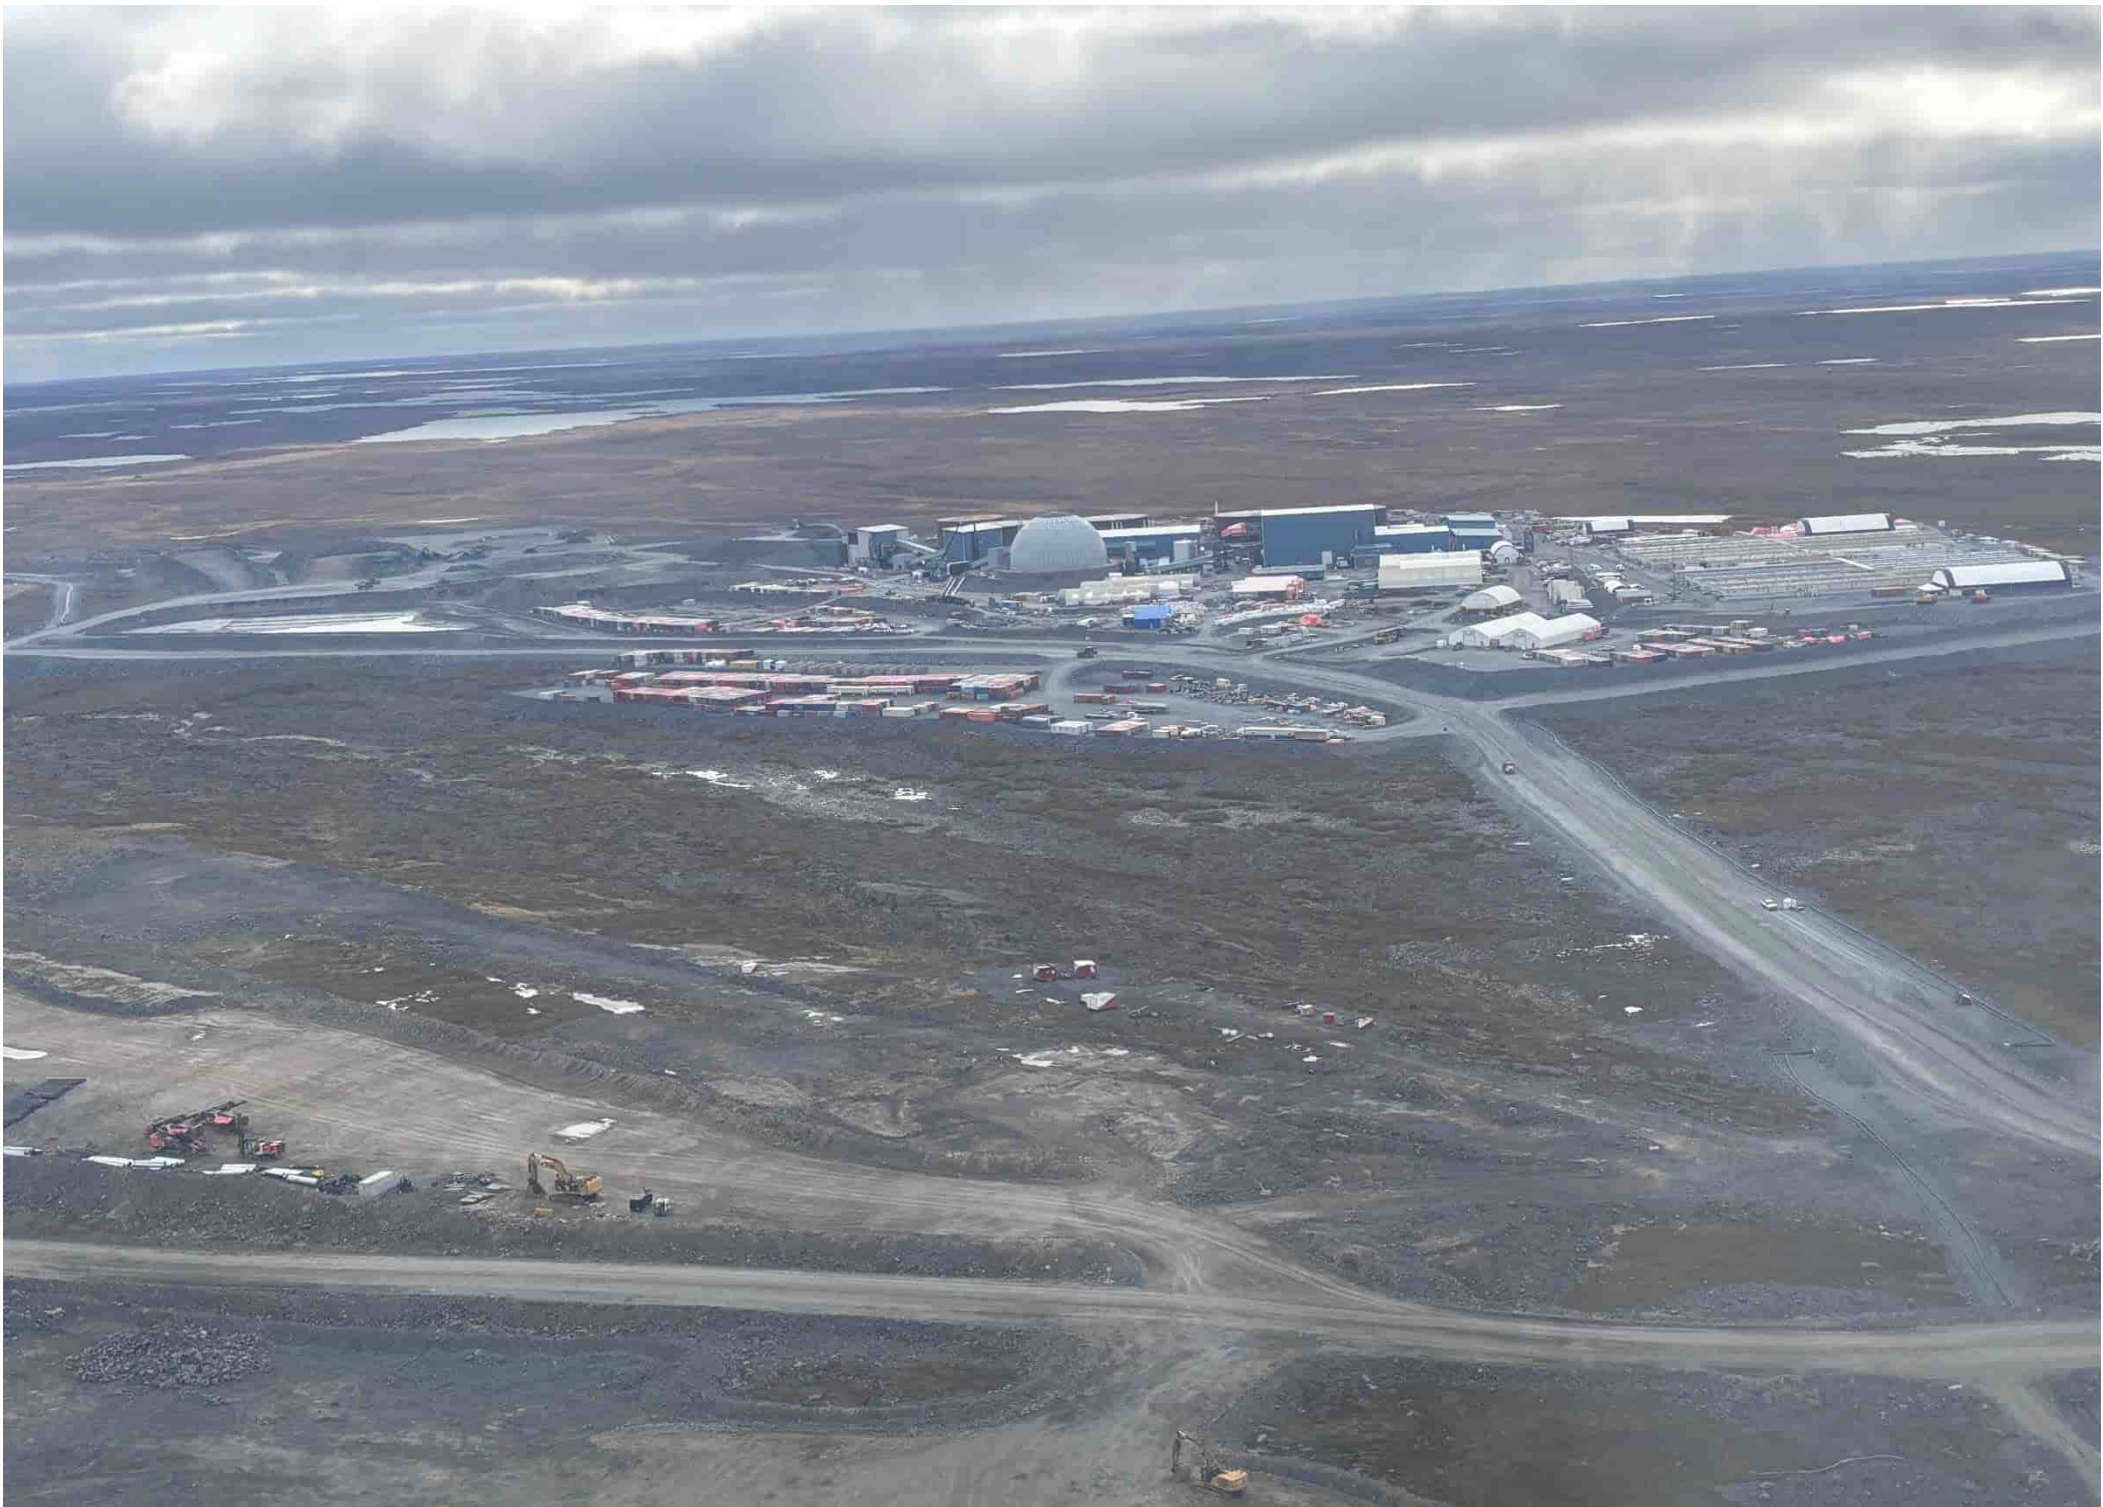
Heli Photo 8: Umwelt overburden stockpile and main plant area, looking S

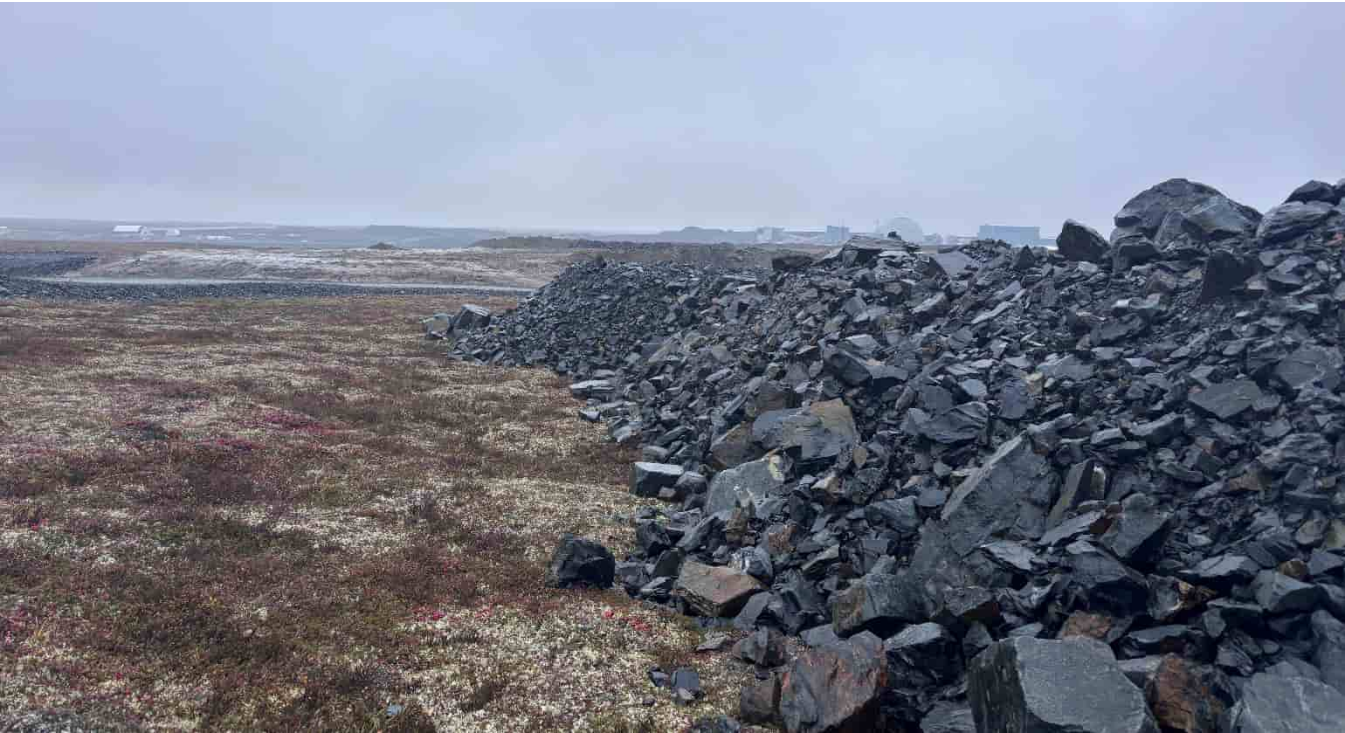
G-411: Eastern pad slope, facing S

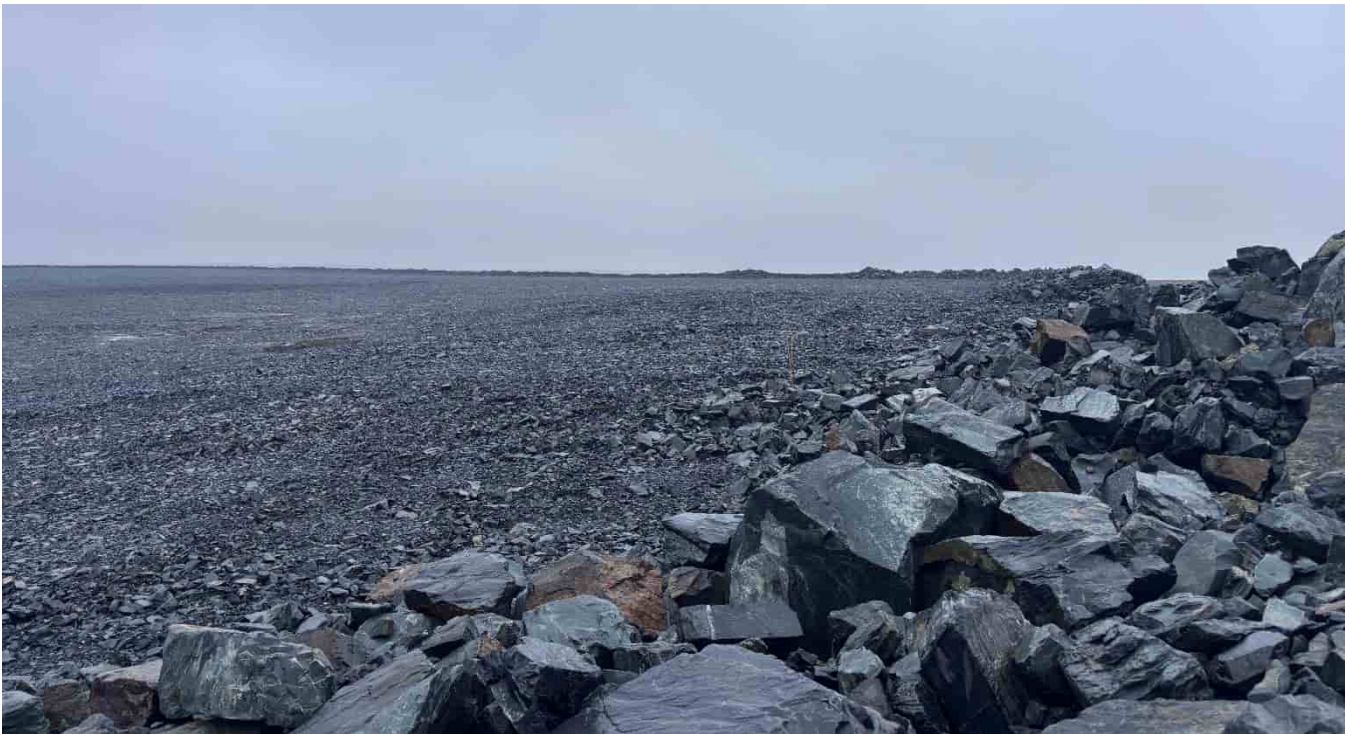
G-413: Rock storage eastern side, looking N

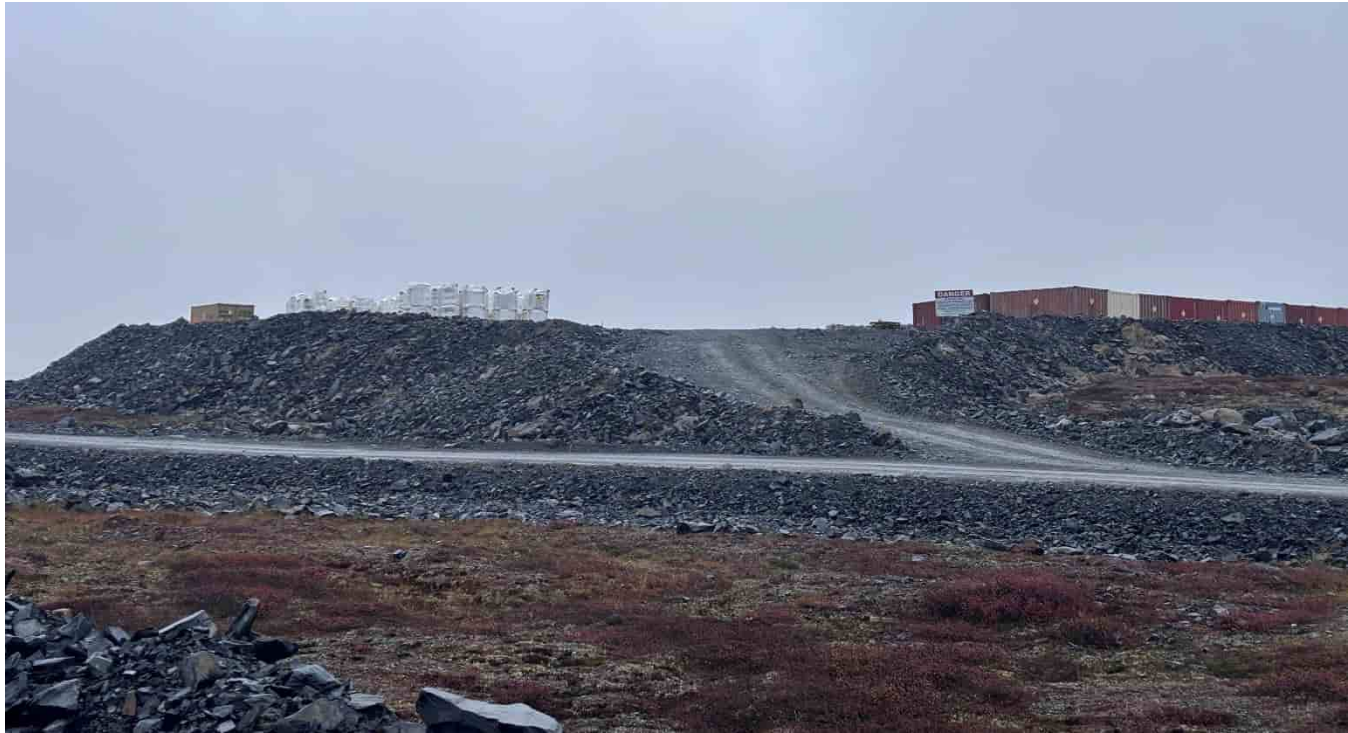
G-410: Explosives storage area, looking NE from rock storage area

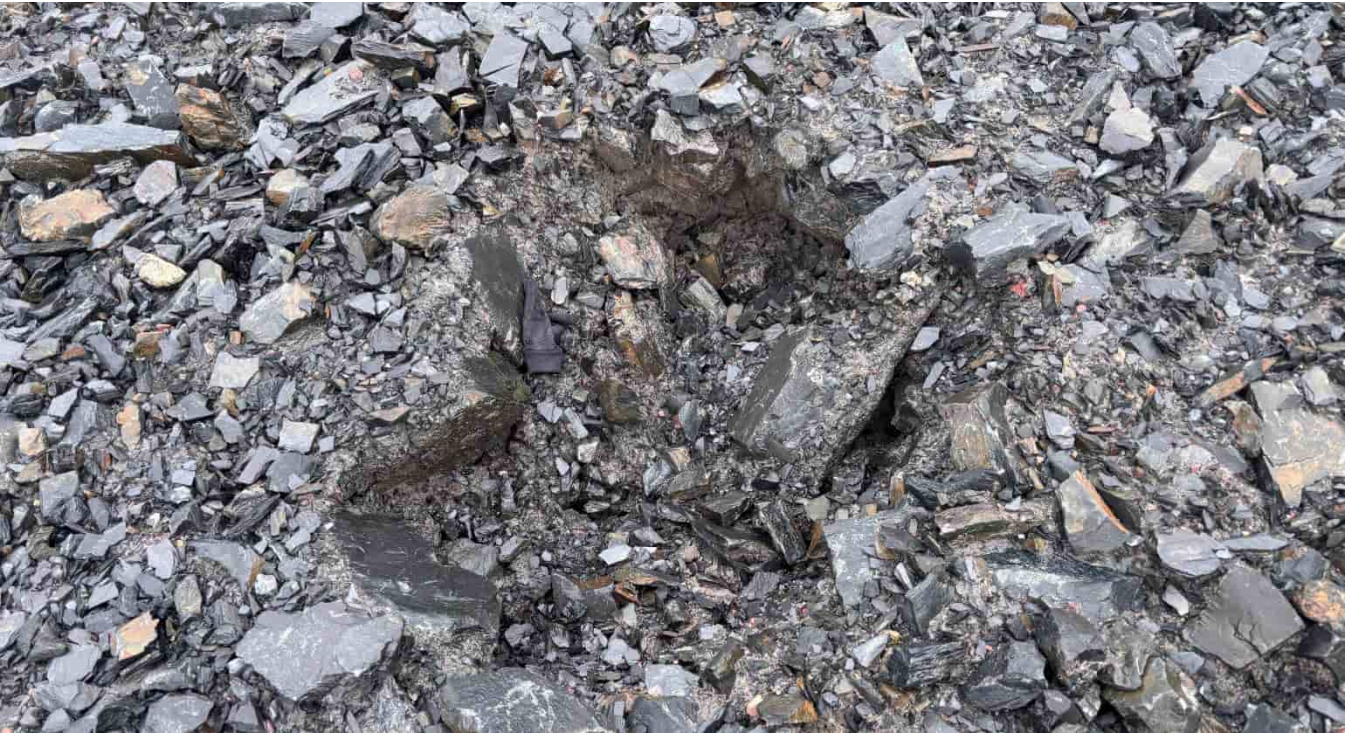
G-411: Sinkhole in storage area pad surface

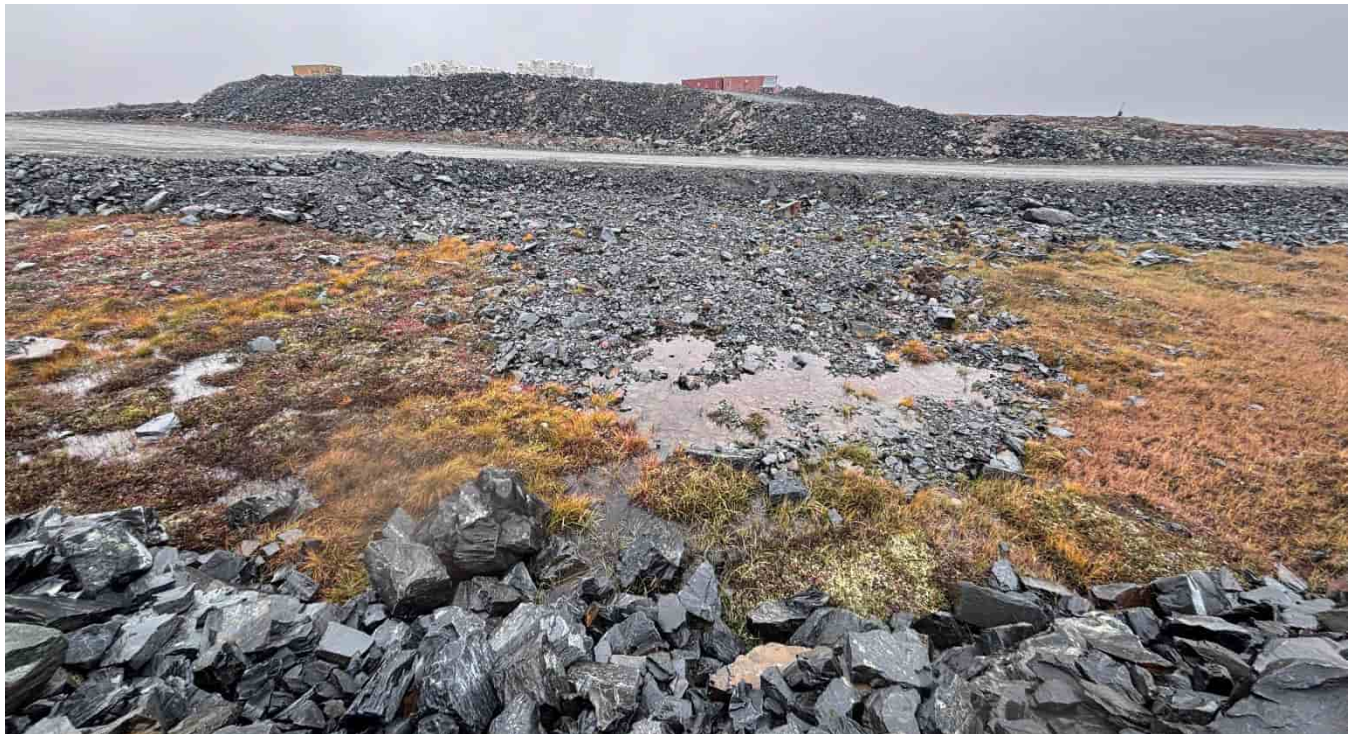
G-412: Toe of rock storage area eastern slope, looking E

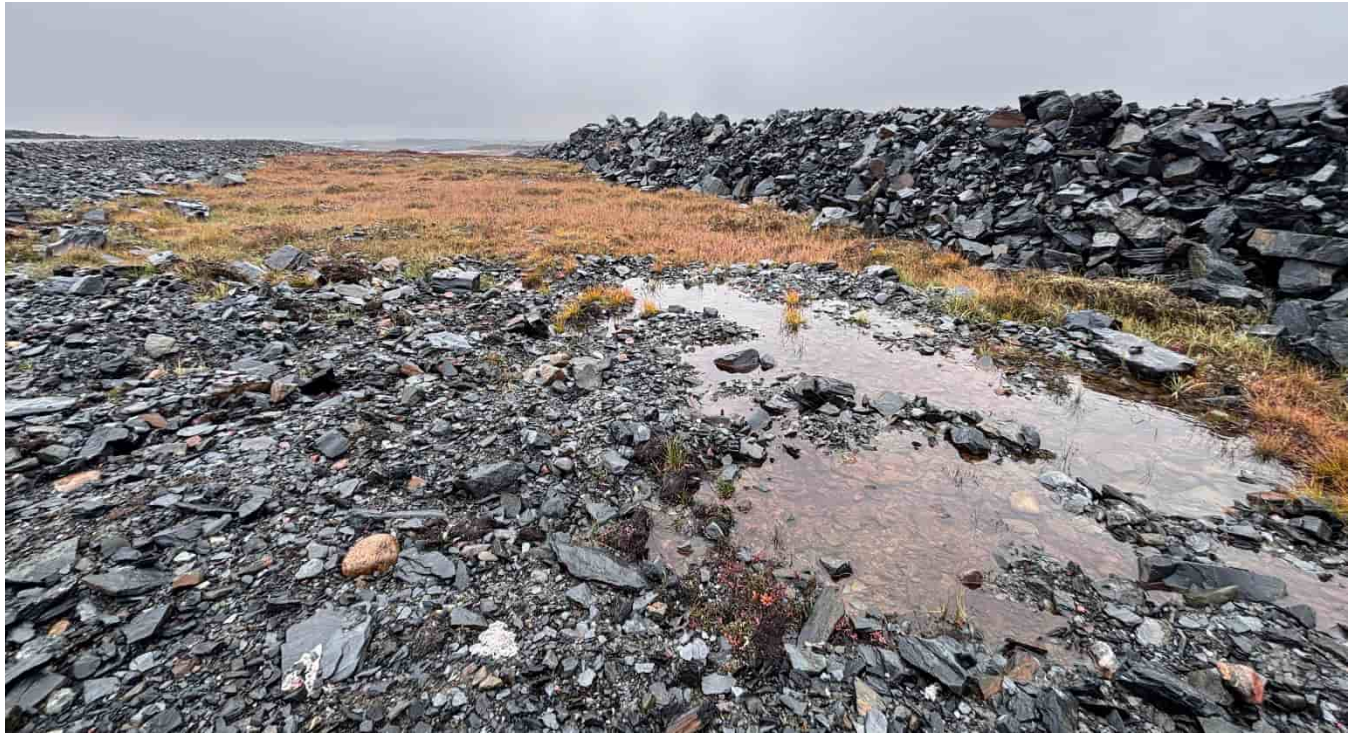
G-418: Toe of rock storage area eastern slope, looking S

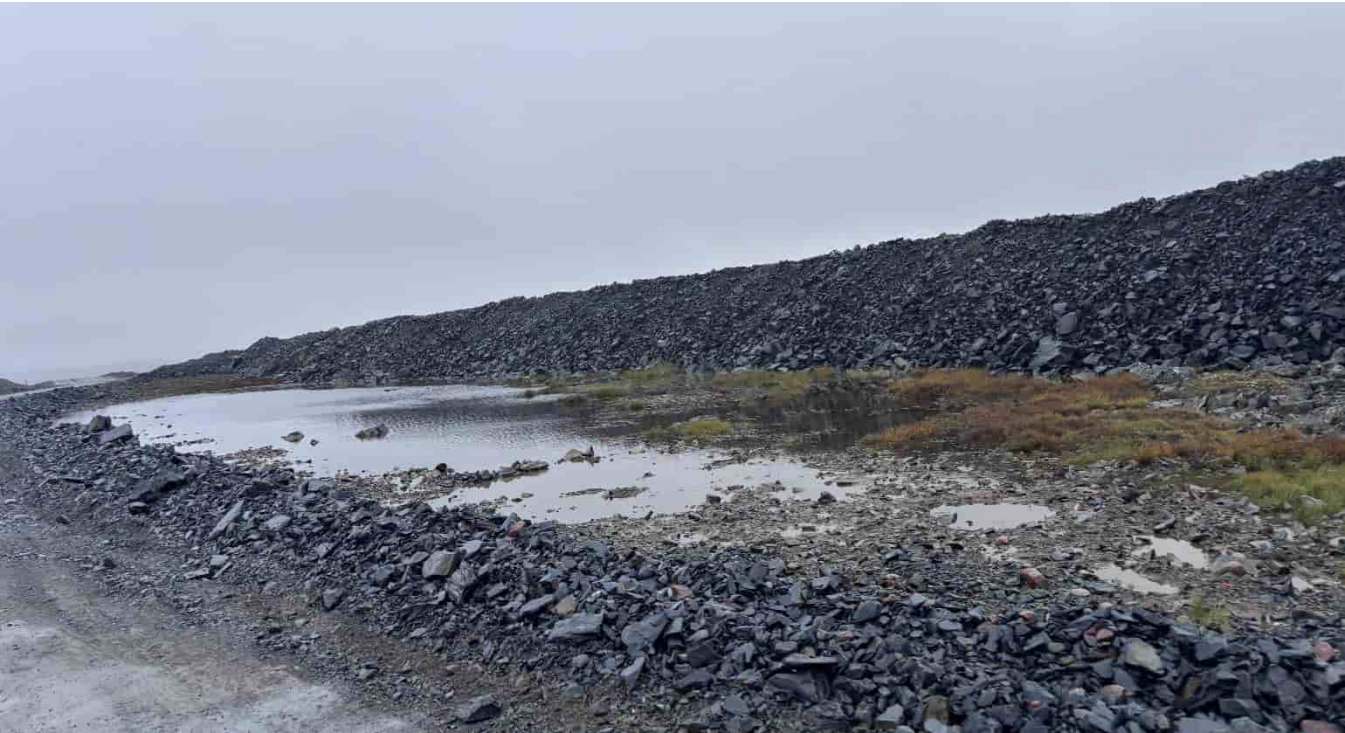
G-419: Ponding at toe of southern pad slope, looking NW

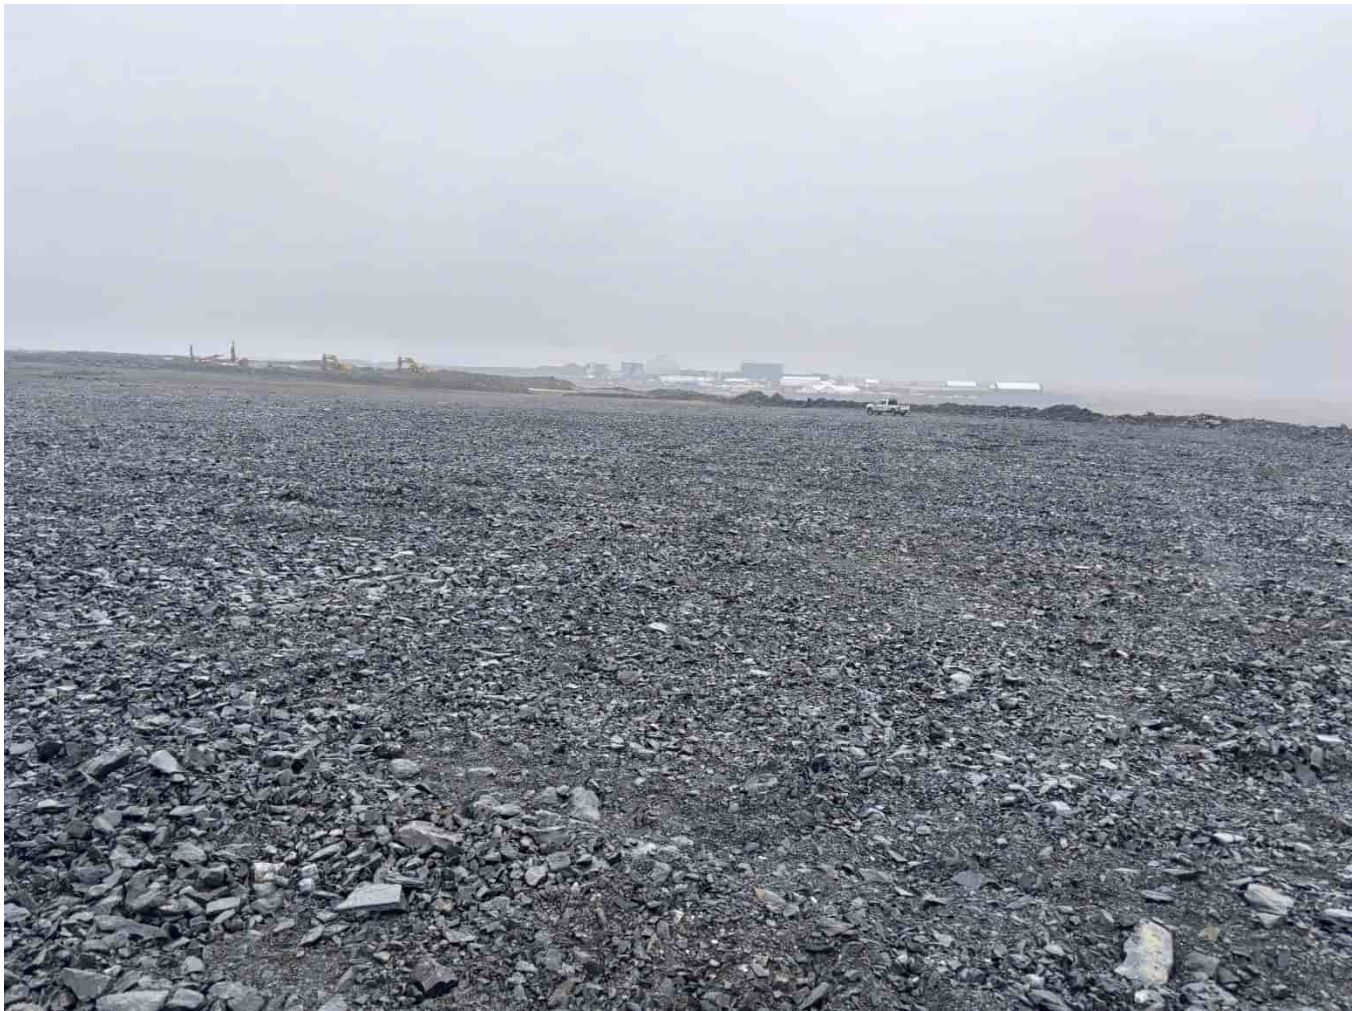
G-422: Typical rock storage area surface conditions, looking S

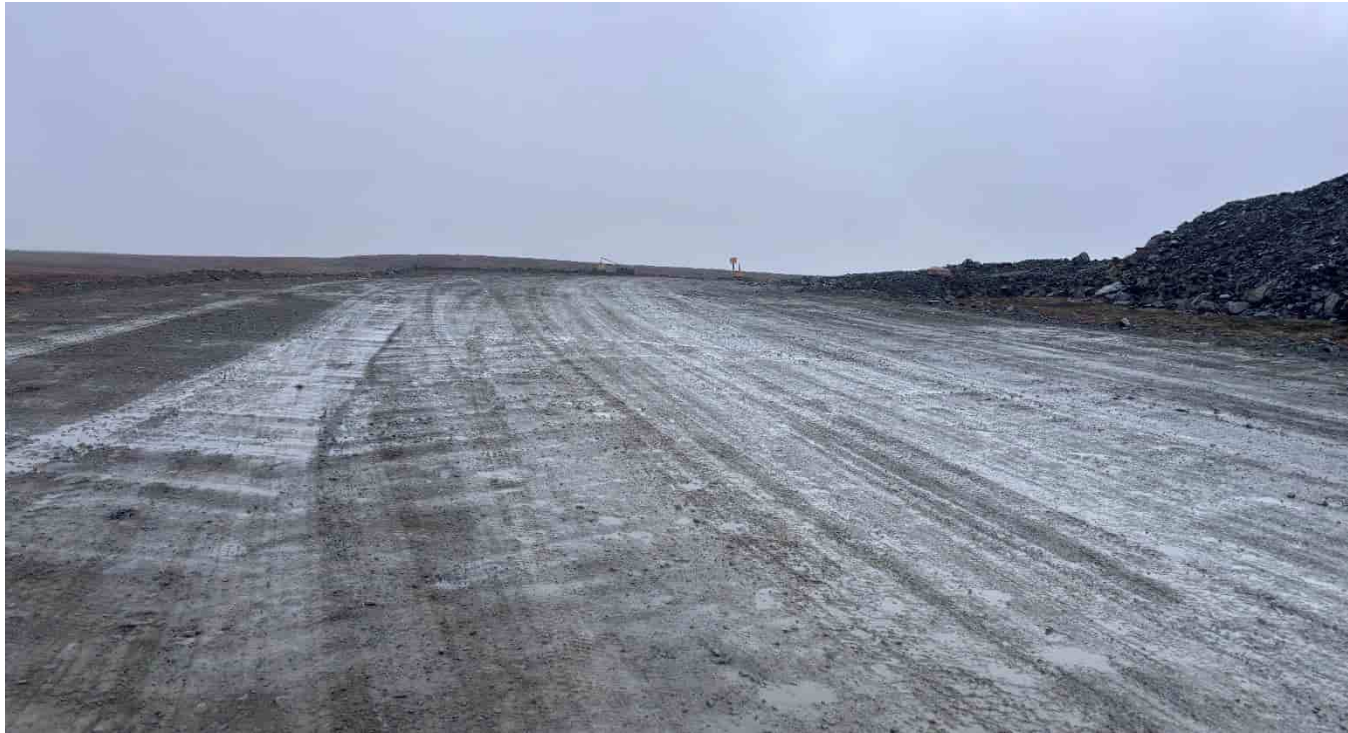
G-423A: Explosives area access road, looking N

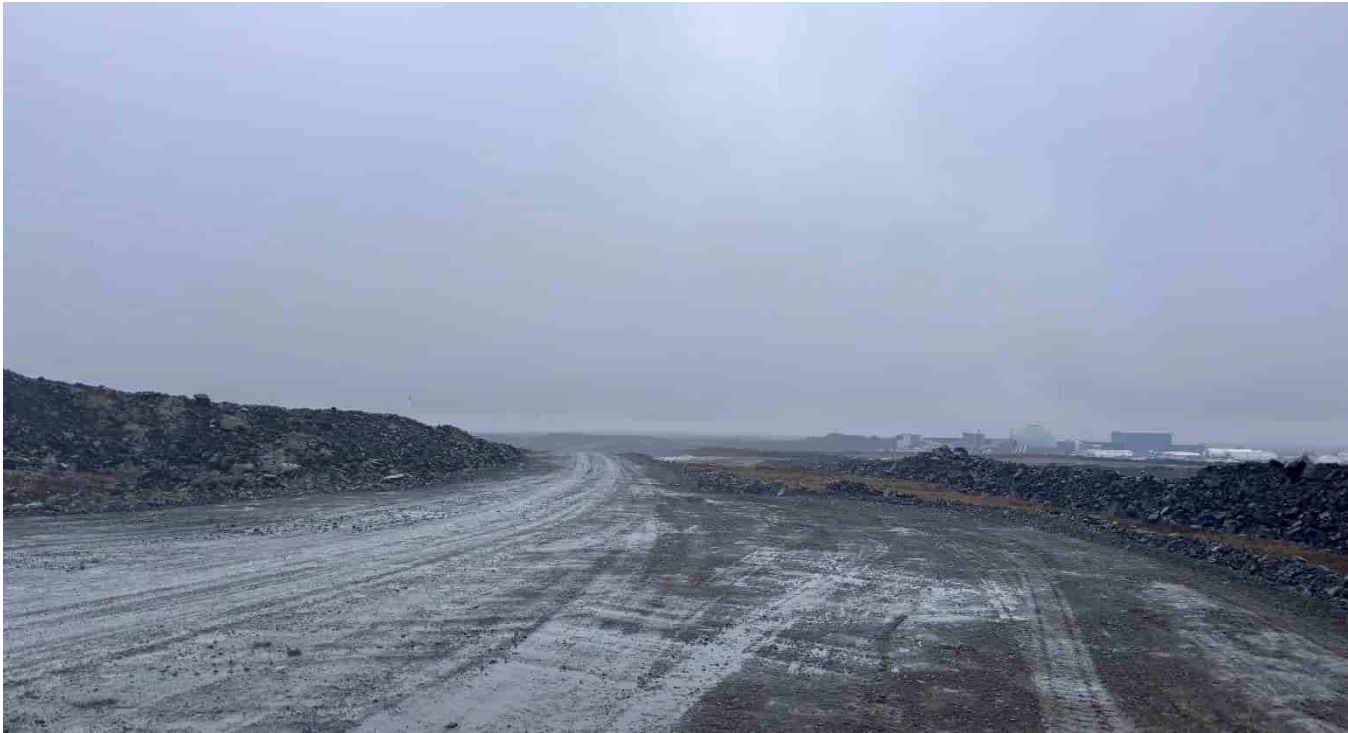
G-423B: Explosives area access road, looking S

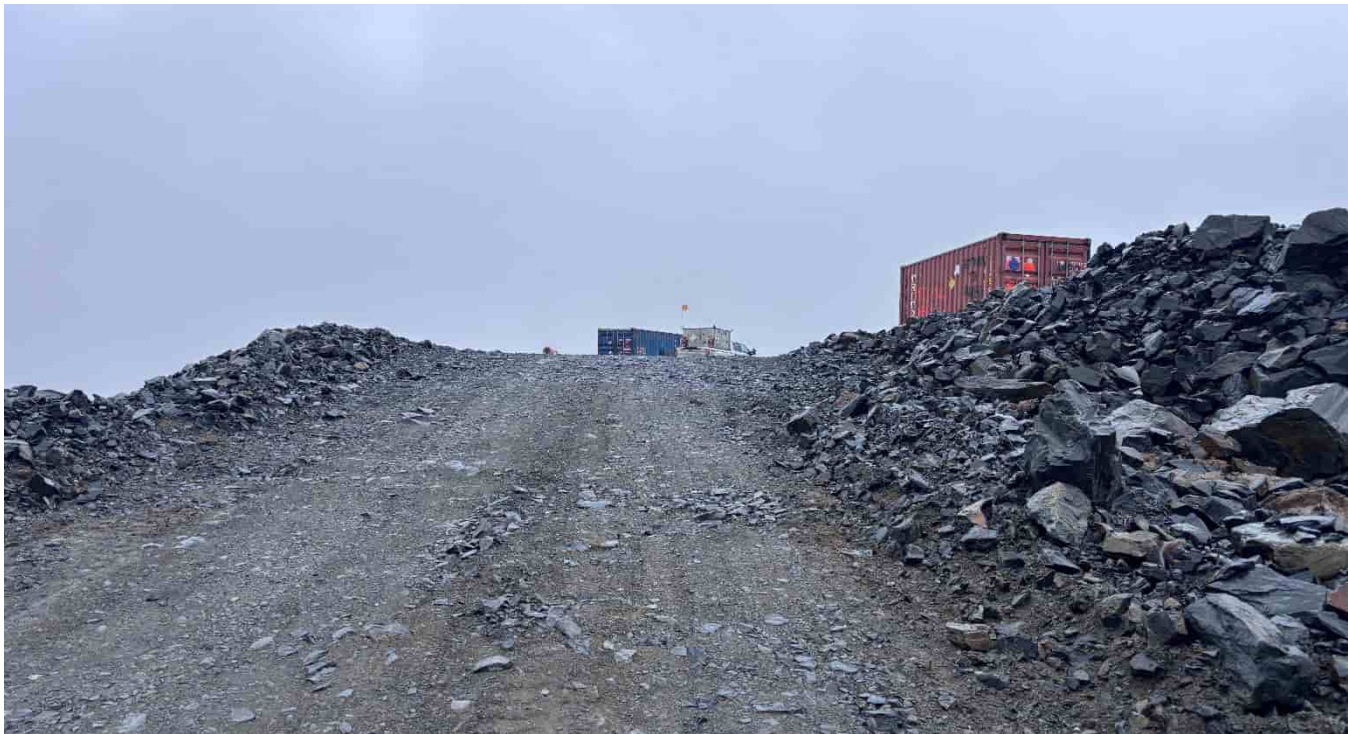
G-424A: Amfo / explosives area access

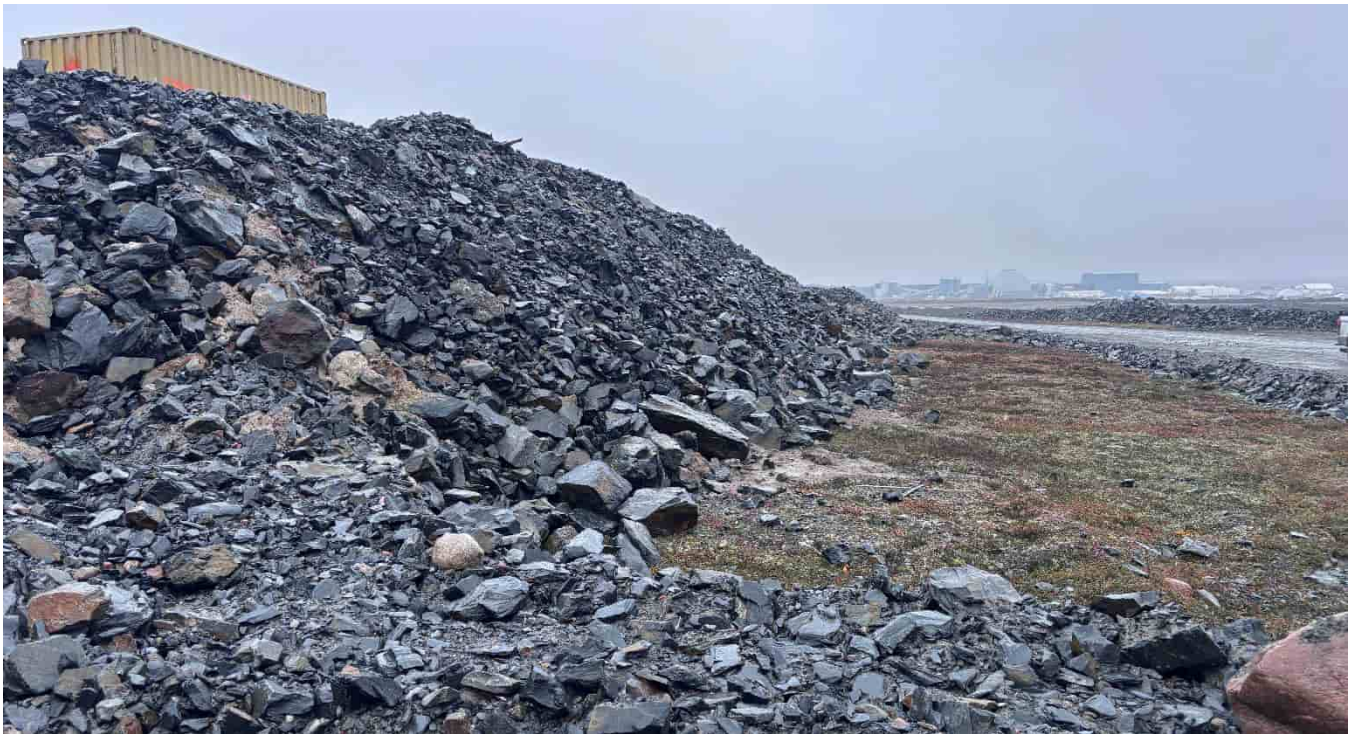
G-424B: Slope below explosives storage area, looking S

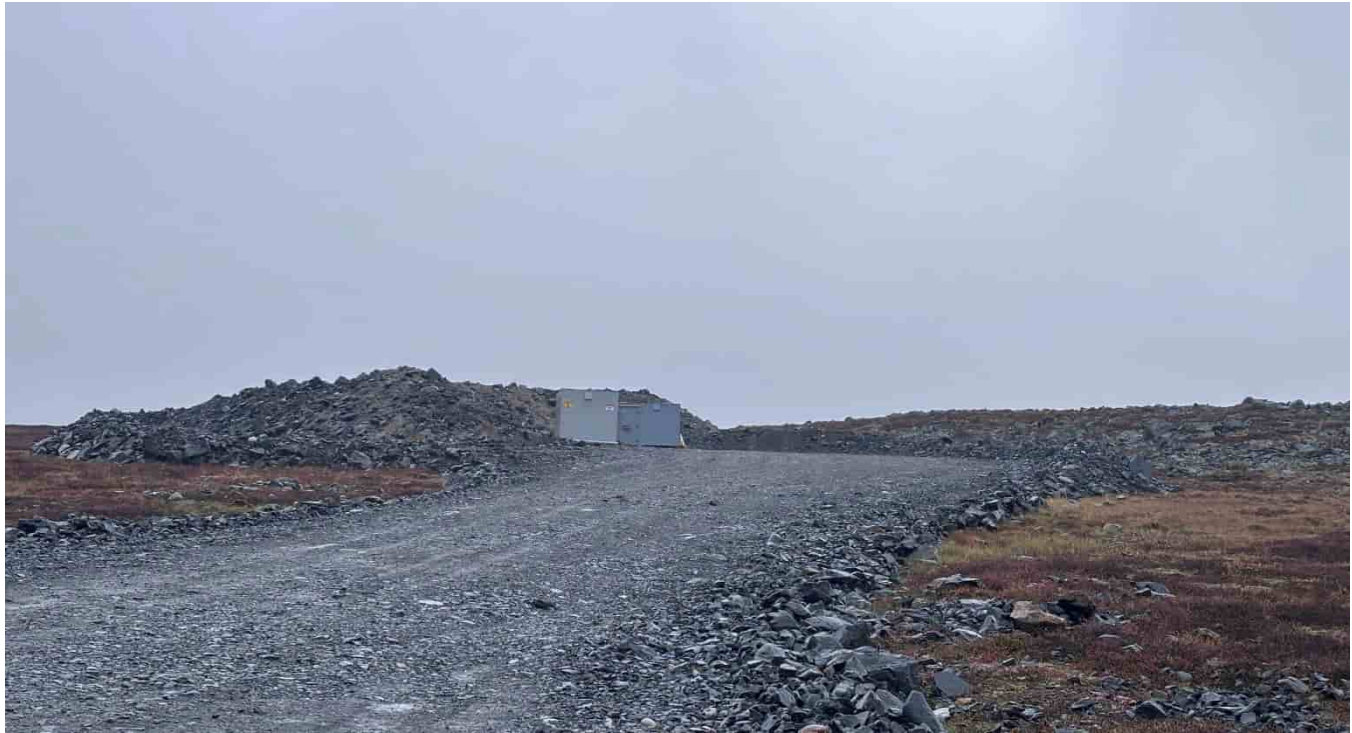
G-425: Access road, looking S

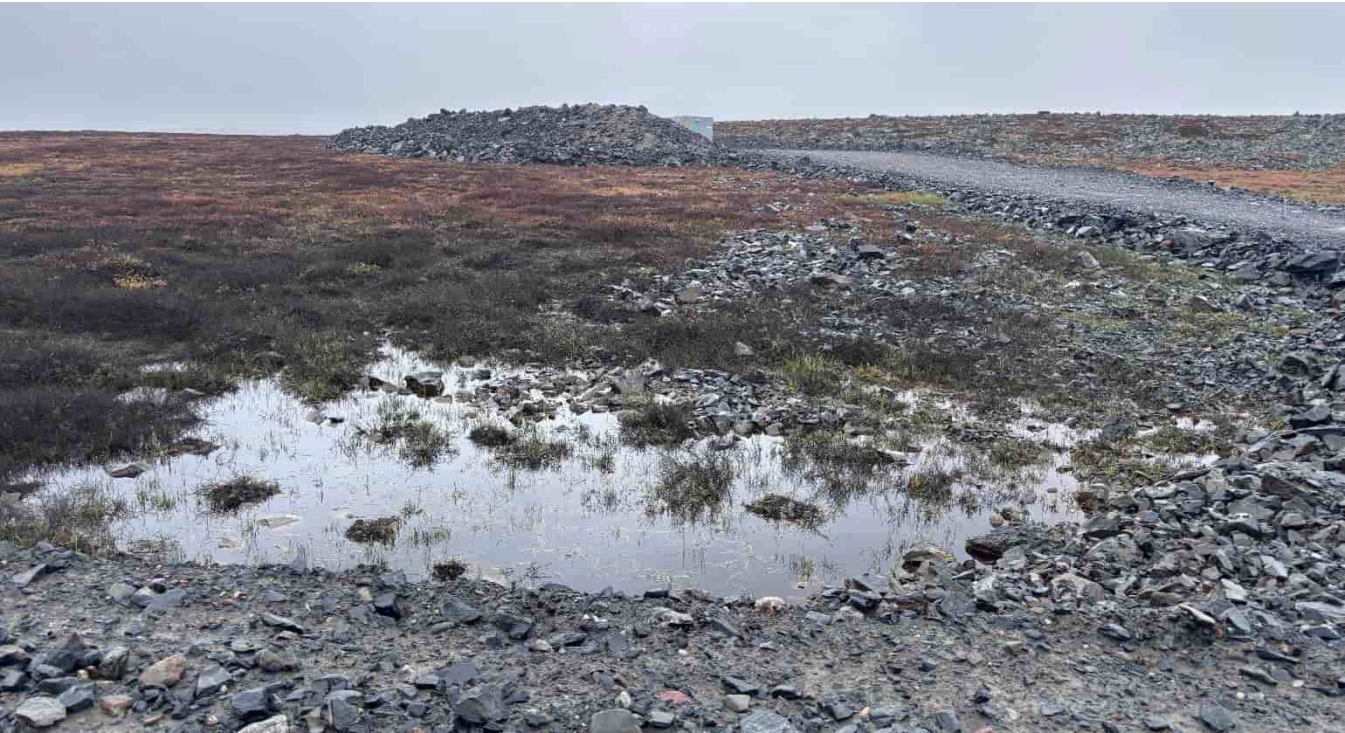
G-426: Emulsion plant access road, looking S

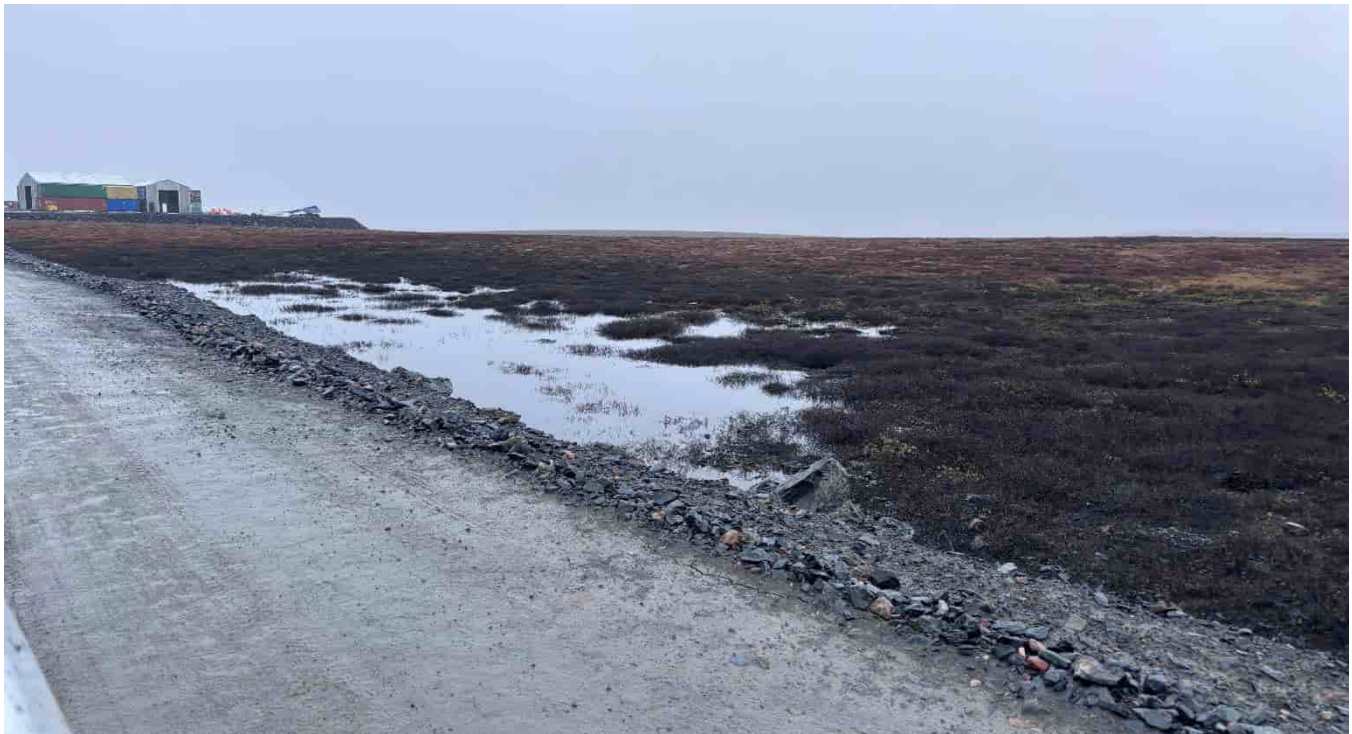
G-427: Ponding beside access road, looking E

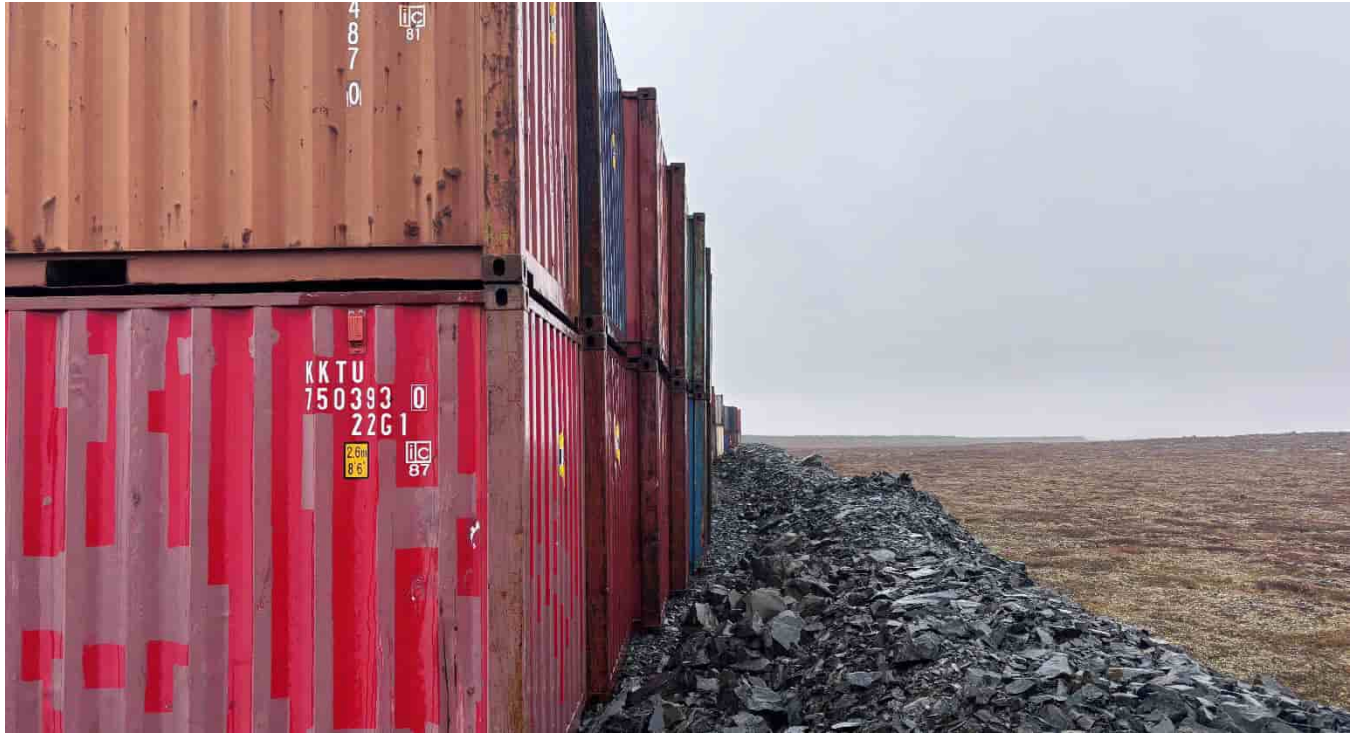
G-429: Northern slope of laydown pad, looking W

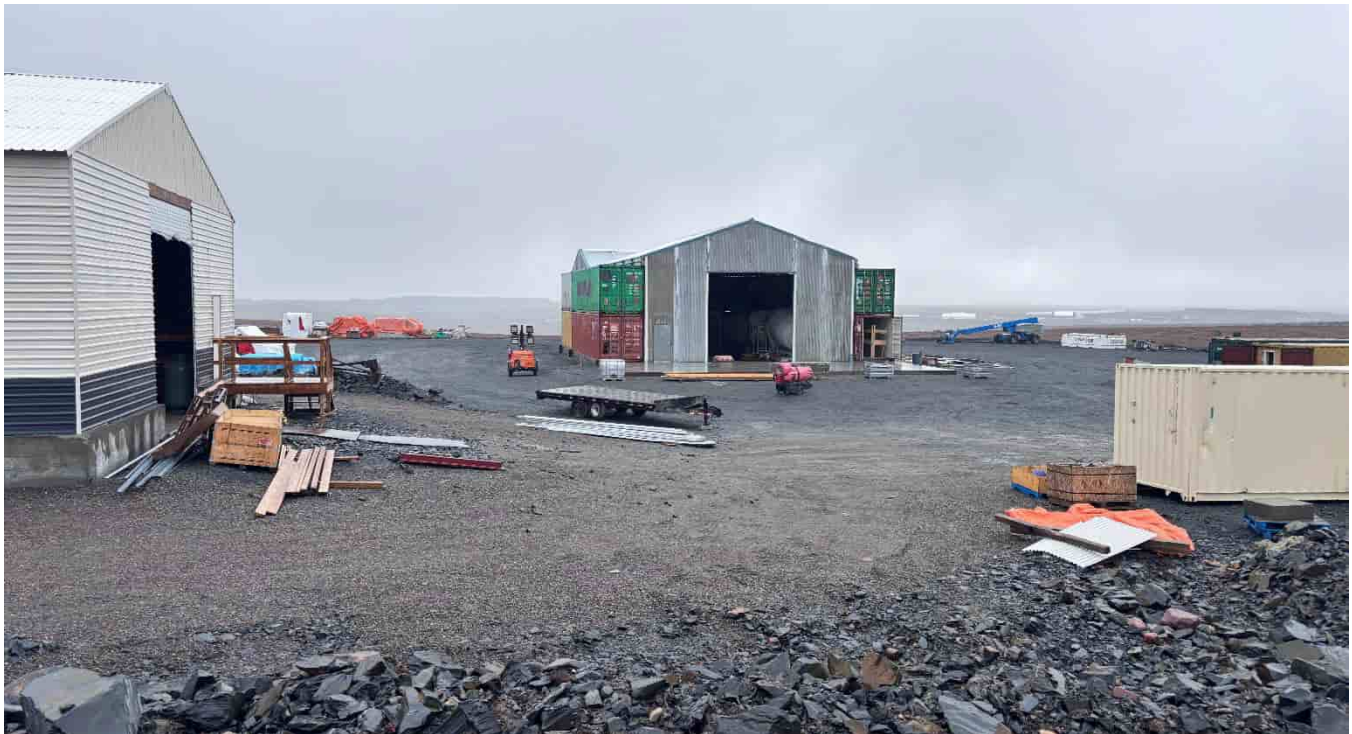
G-431: Emulsion plant general view, looking S

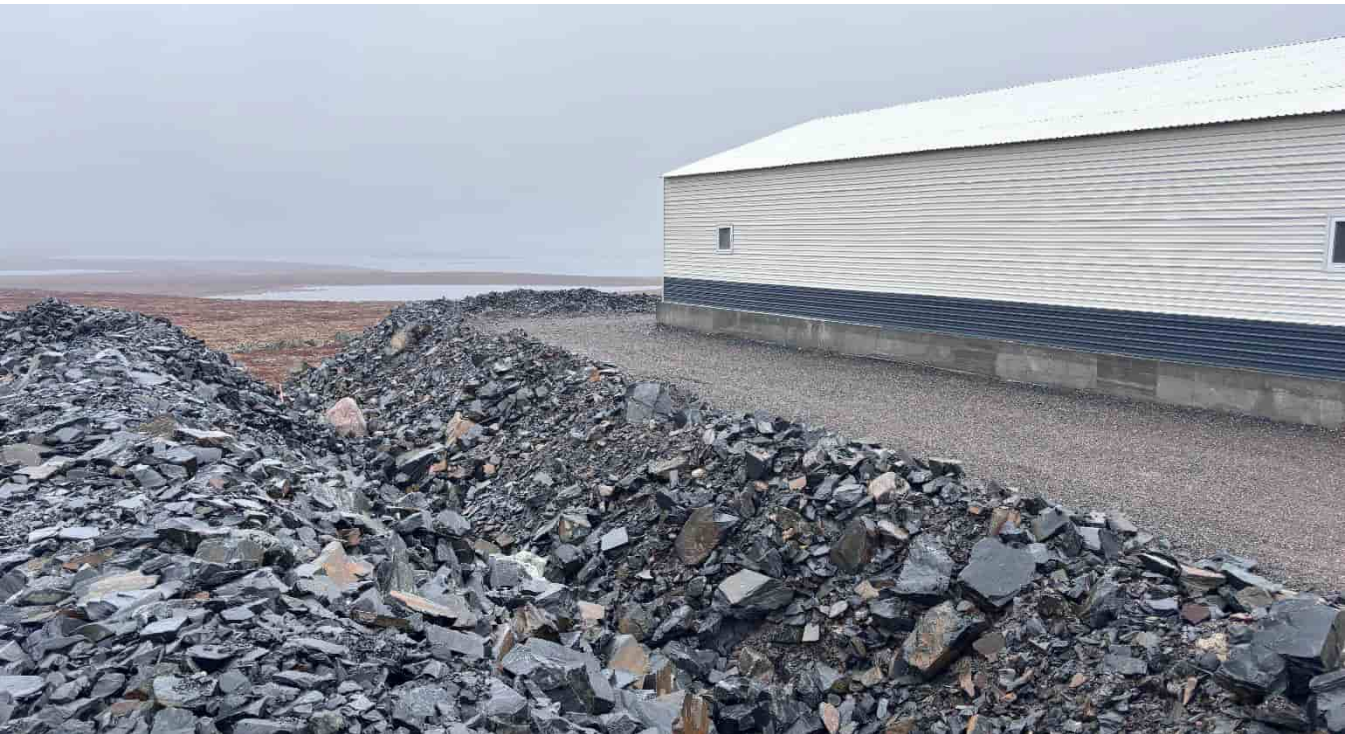
G-432: Berms between emulsion plant and laydown pads, looking E

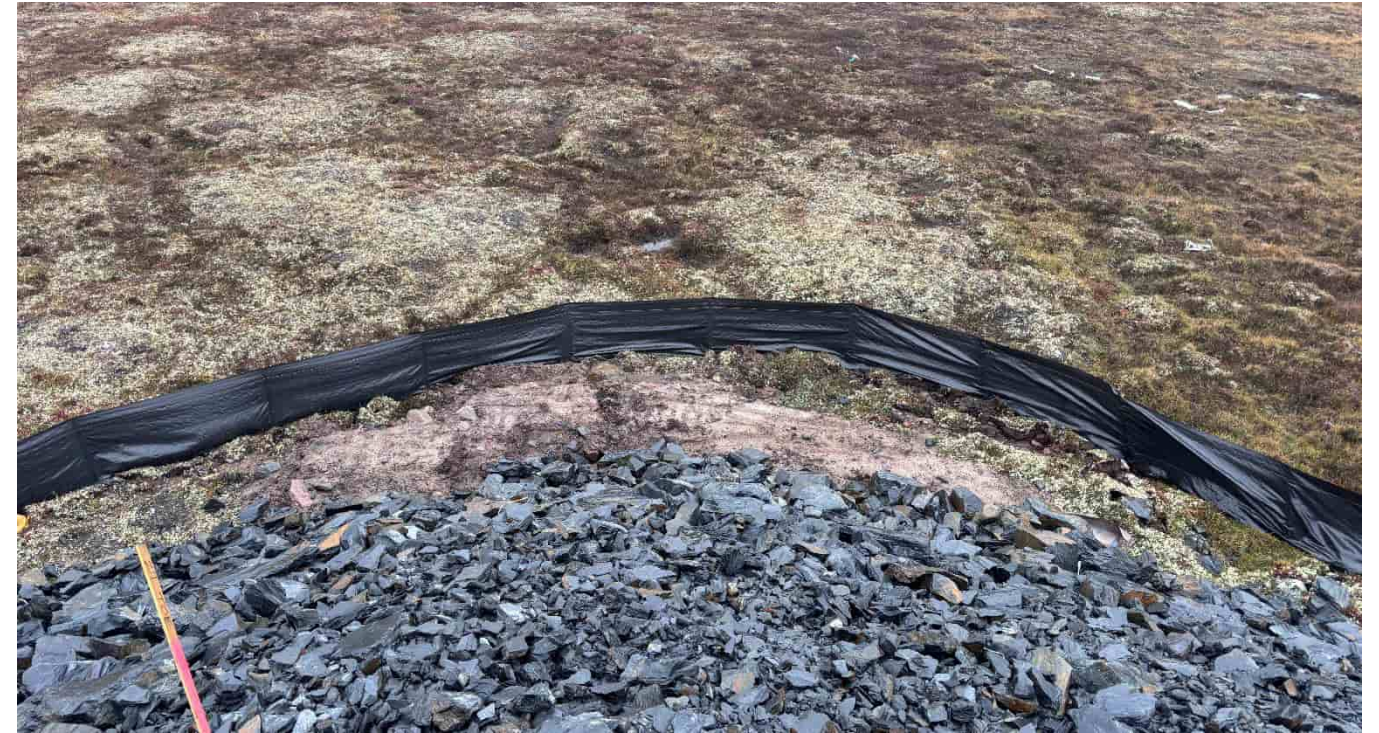
G-434: Silt fencing at SE corner of pad
