| | | 2025 Annual Geotechnical Inspection | | |
| Job No: CAPR004312<br>Filename: Back River_Goose_2025_AGI_Photoslog.pdf | Back River Project | Date:<br>February 2026 | Approved:<br>JBK | Figure:<br>79 |

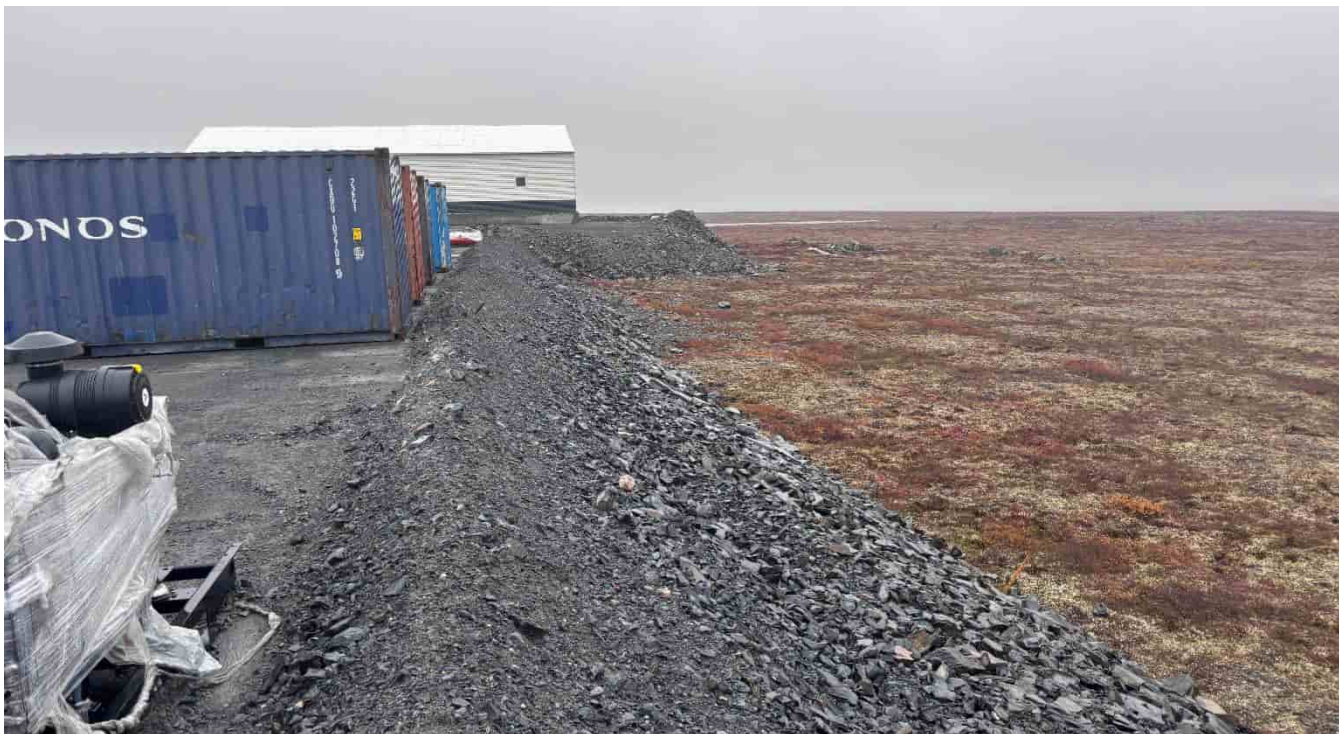
G-435: Eastern pad slope, looking N

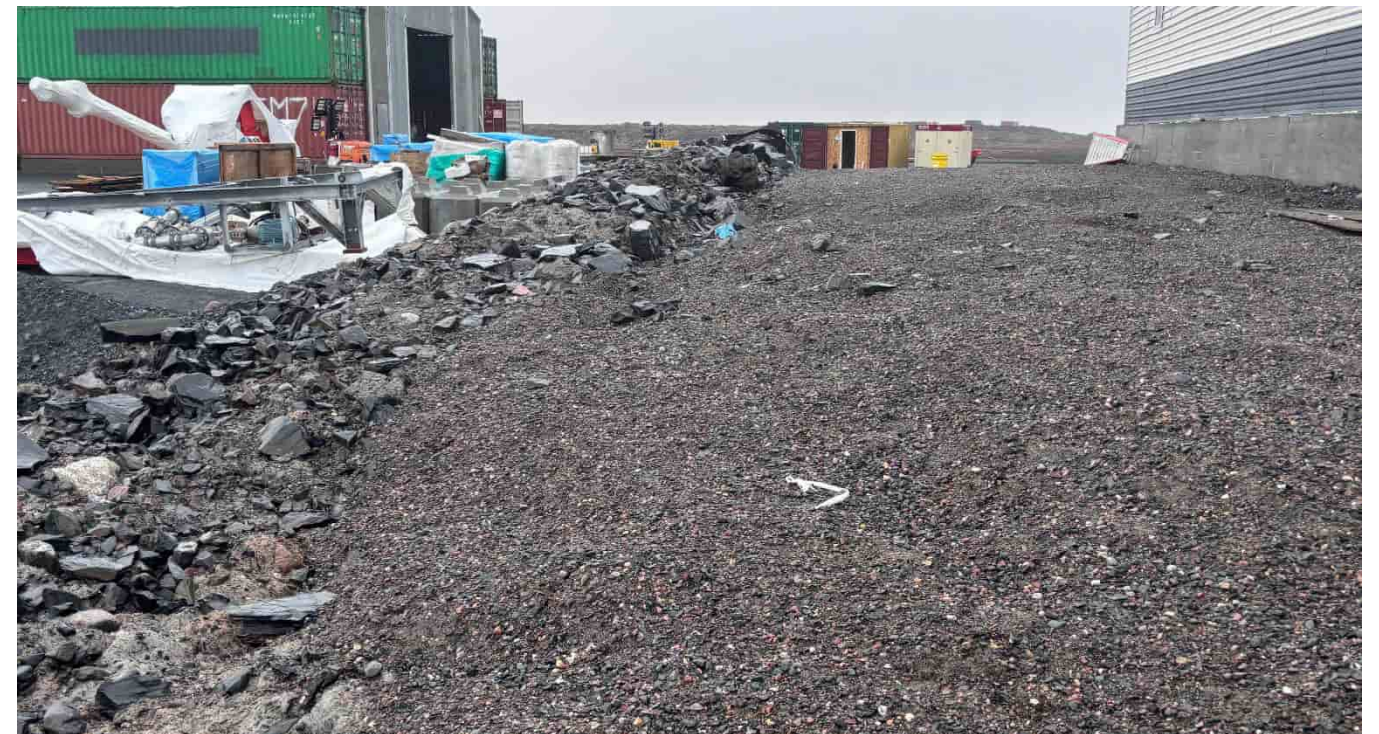
G-436: Emulsion plant berm, looking W

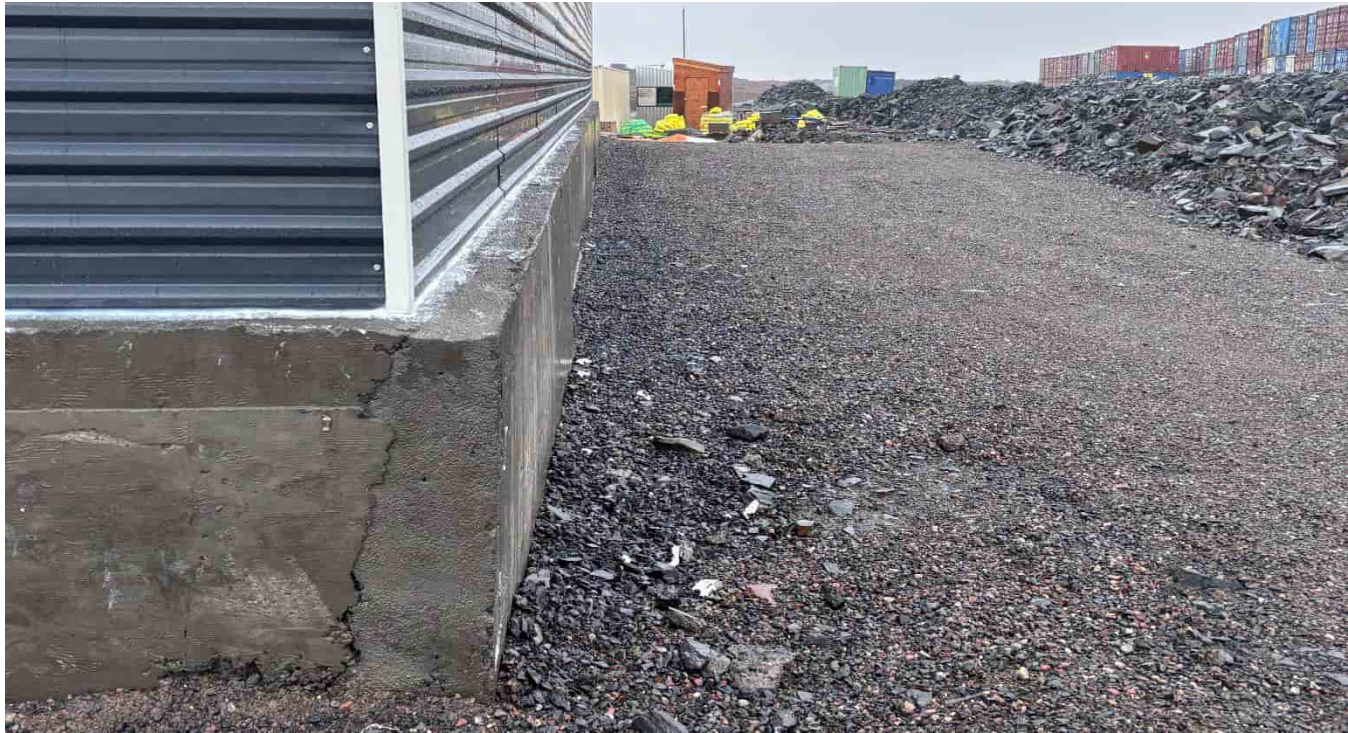
G-437: Building foundation, looking W

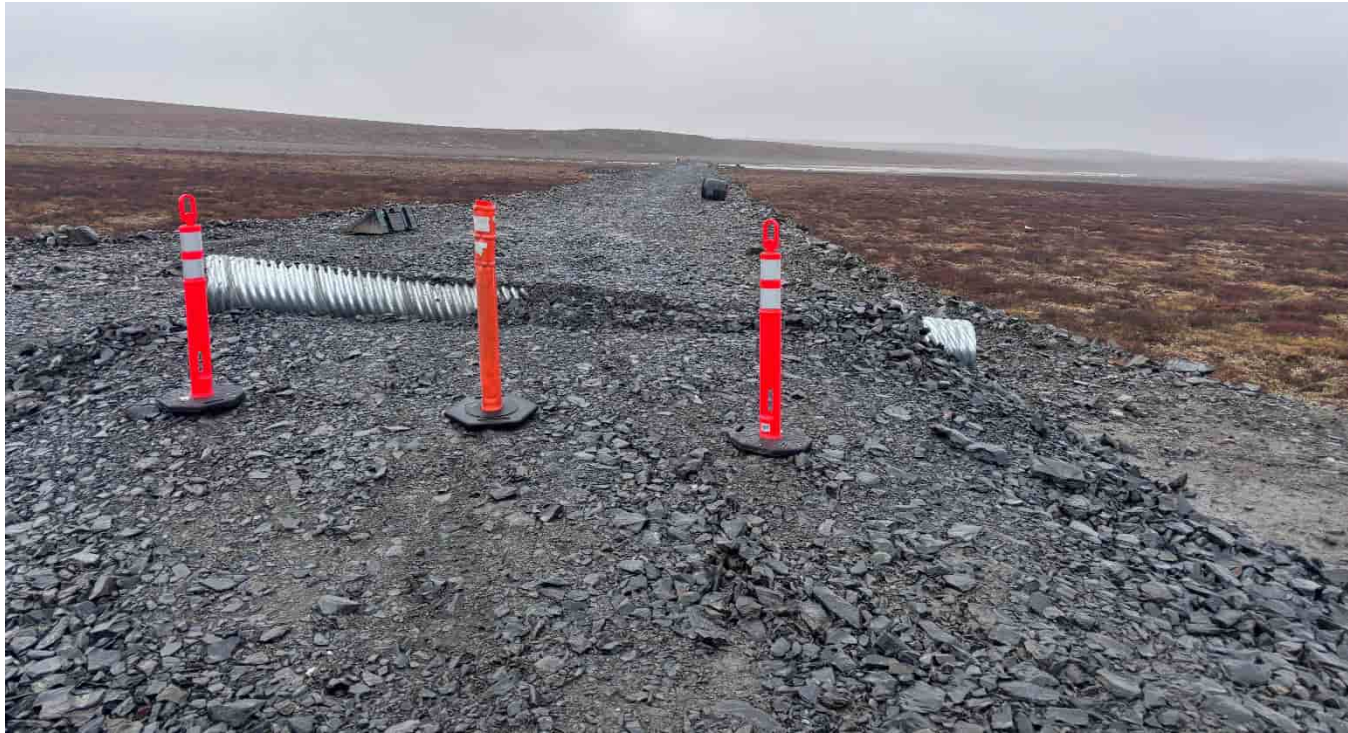
G-440: Exposed culvert on Saline Water Pond Access Road, looking W

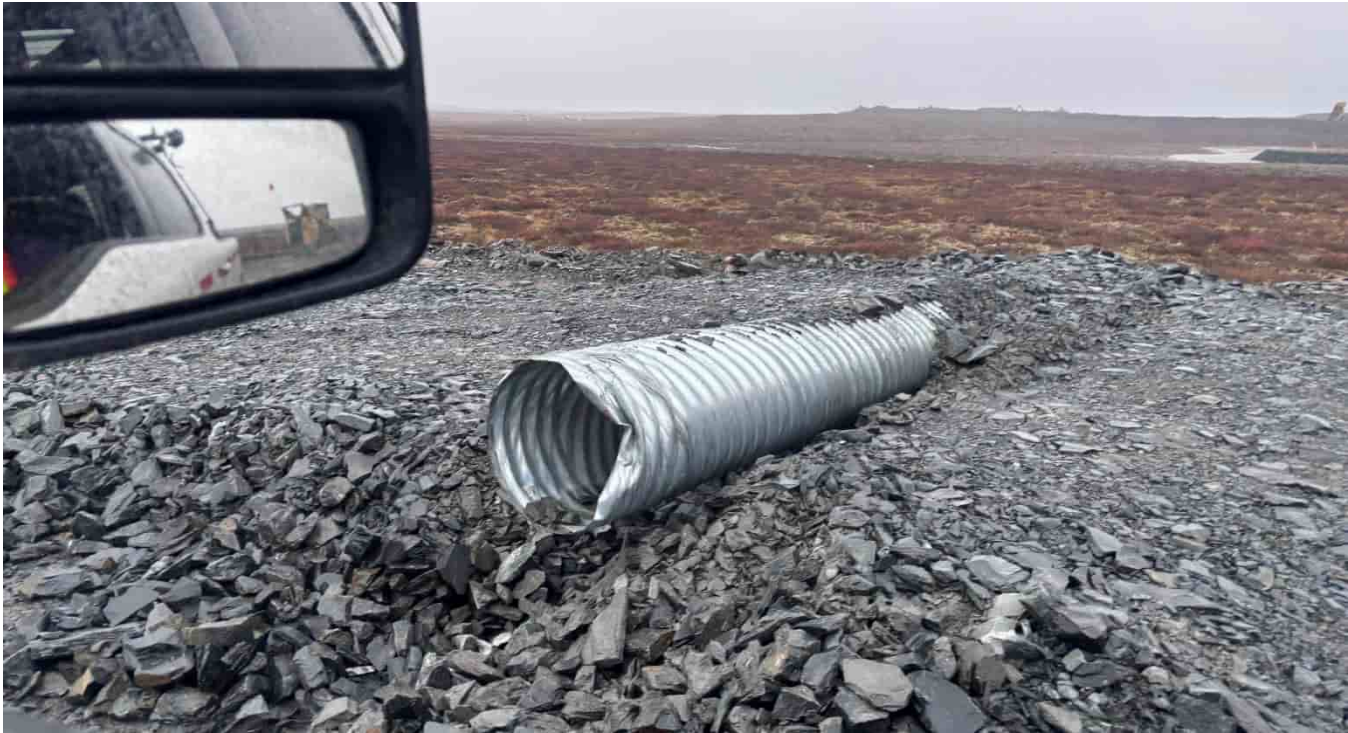
G-441: Exposed culvert, looking N (noting location for consideration when advancing Phase w of SWP)

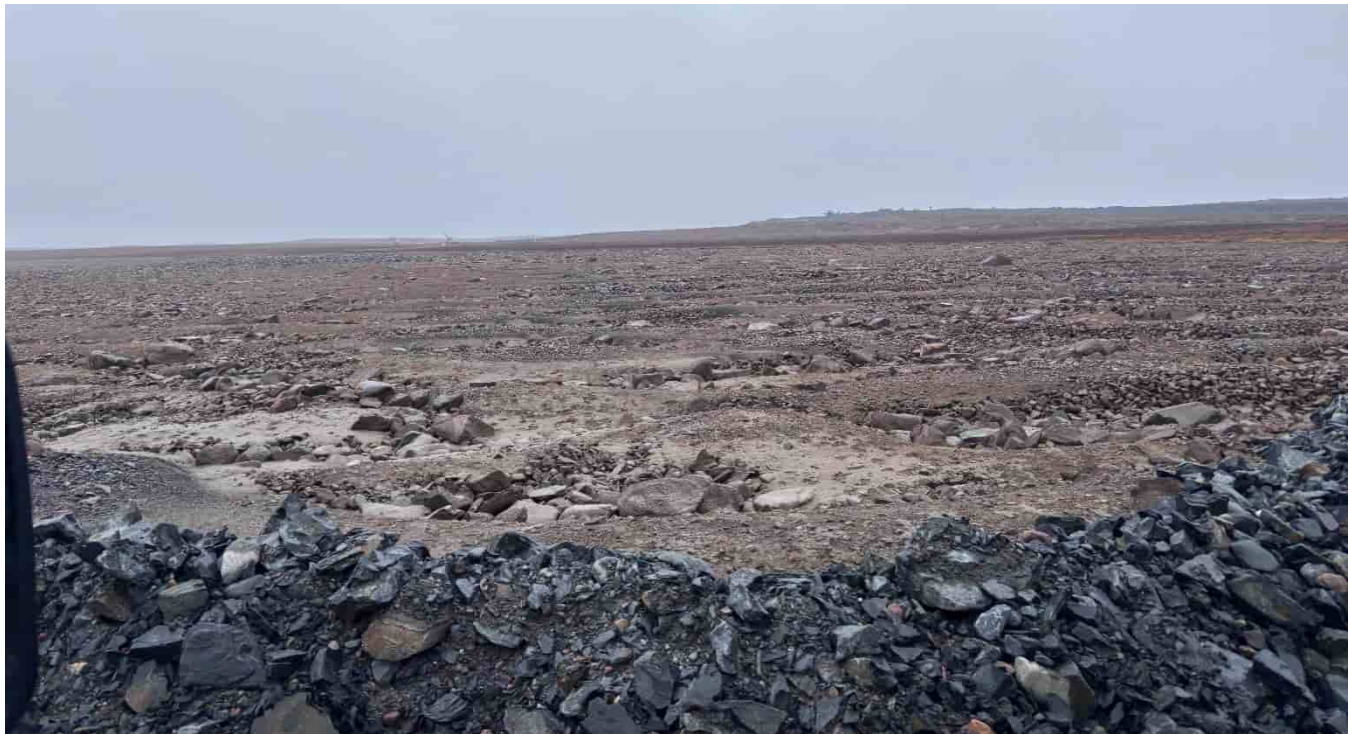
G-442: Typical surface conditions of dewatered SWP area (former Umwelt Lake), looking N

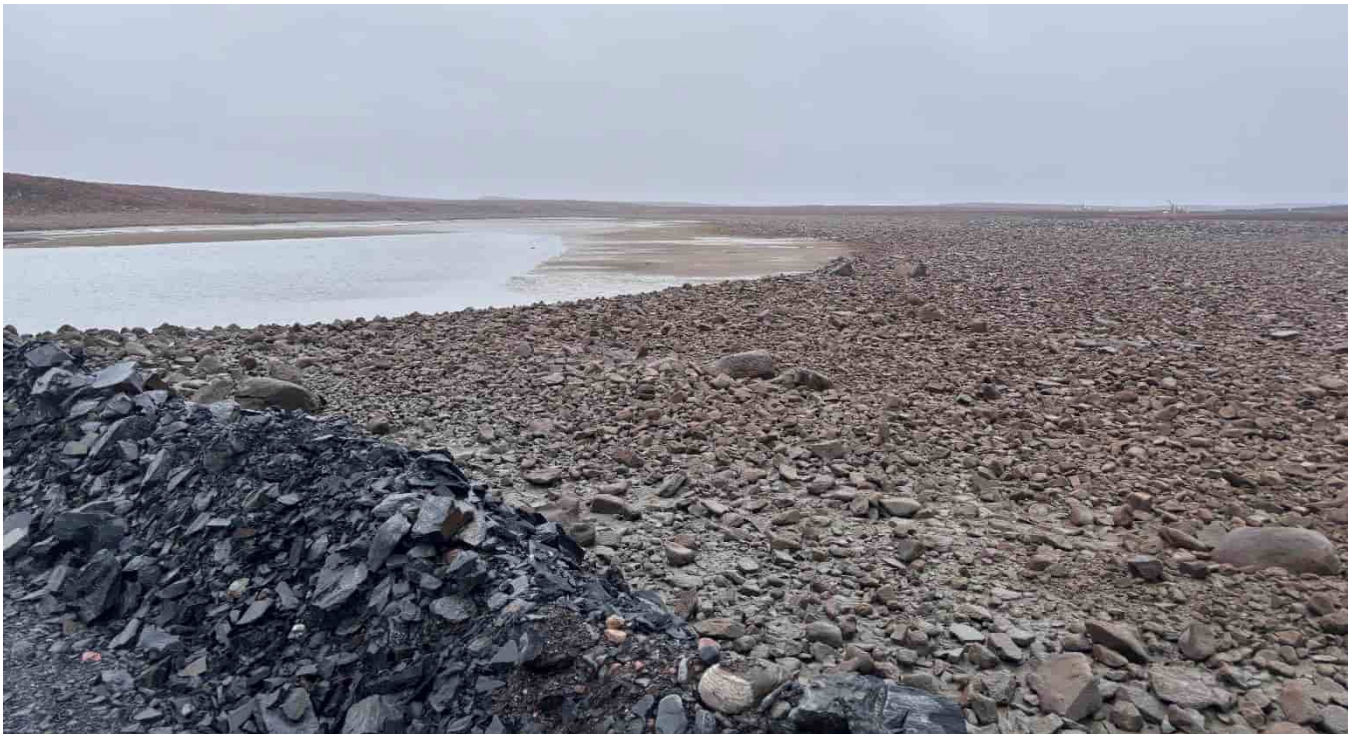
G-443: Typical surface conditions of dewatered SWP area, looking NW (former Umwelt Lake)

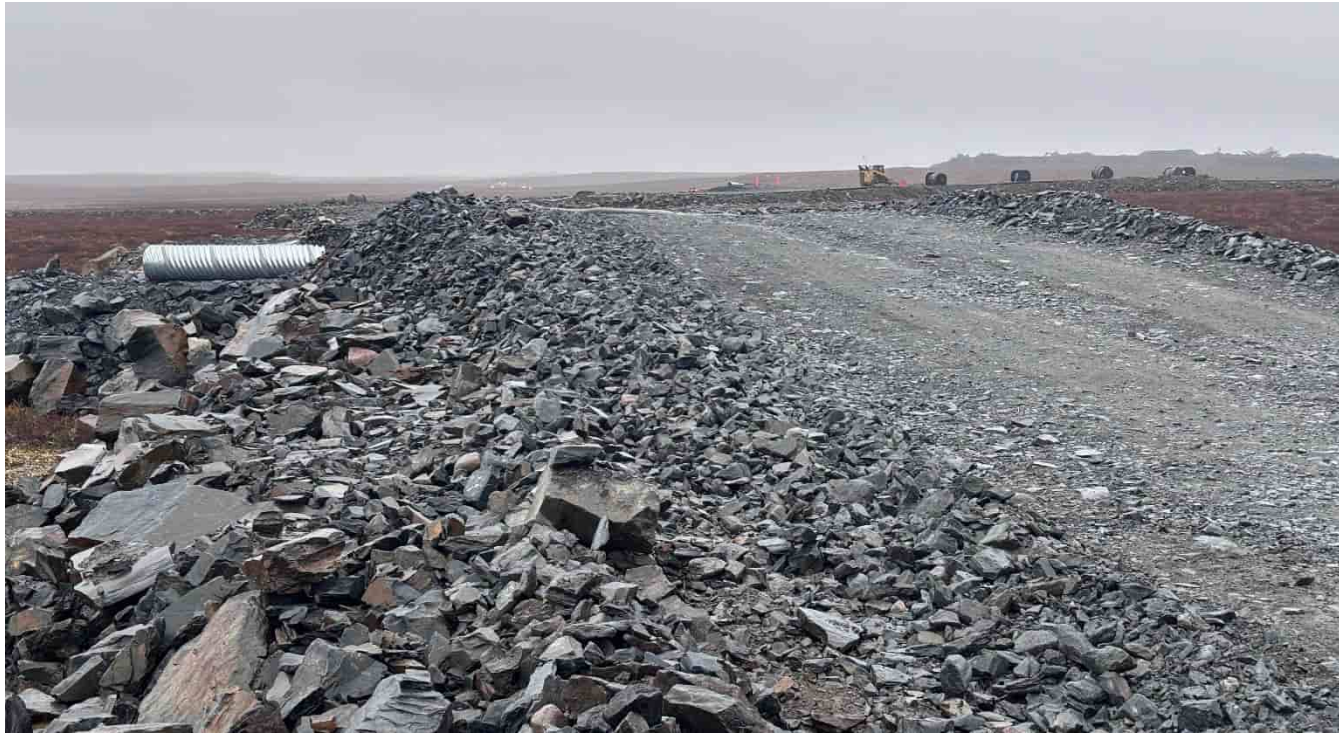
G-444: Culvert under SWP Dam Access Road, looking NW

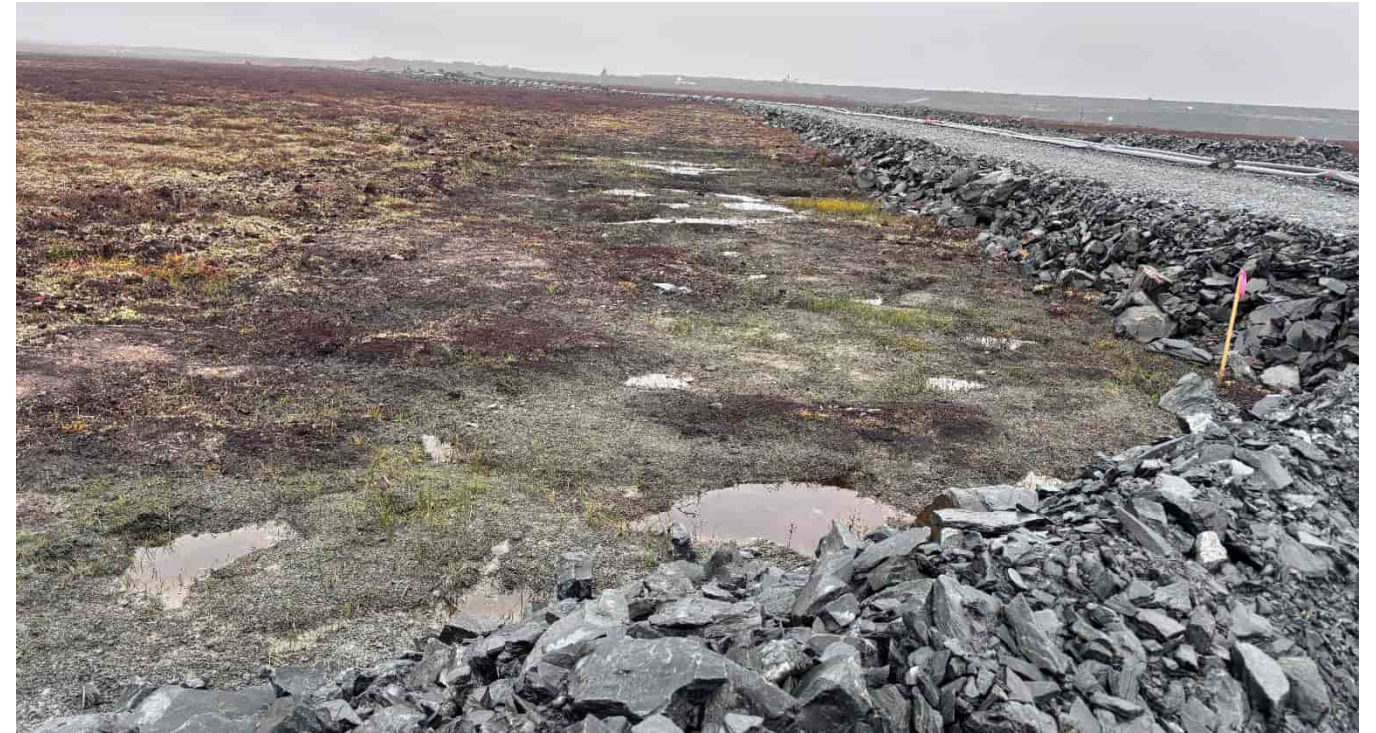
G-445: SWP Dam Access Road

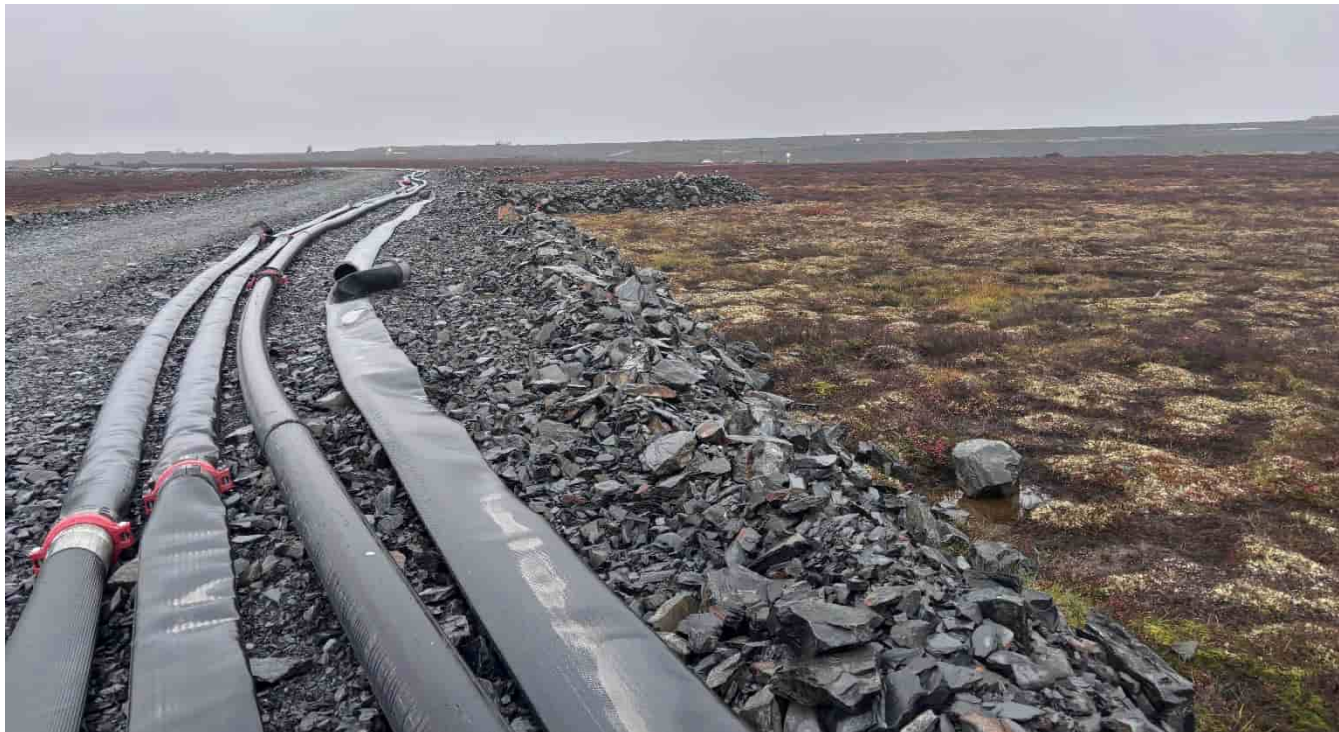
G-446: Unfinished piping along SWP Dam Access Road, looking N

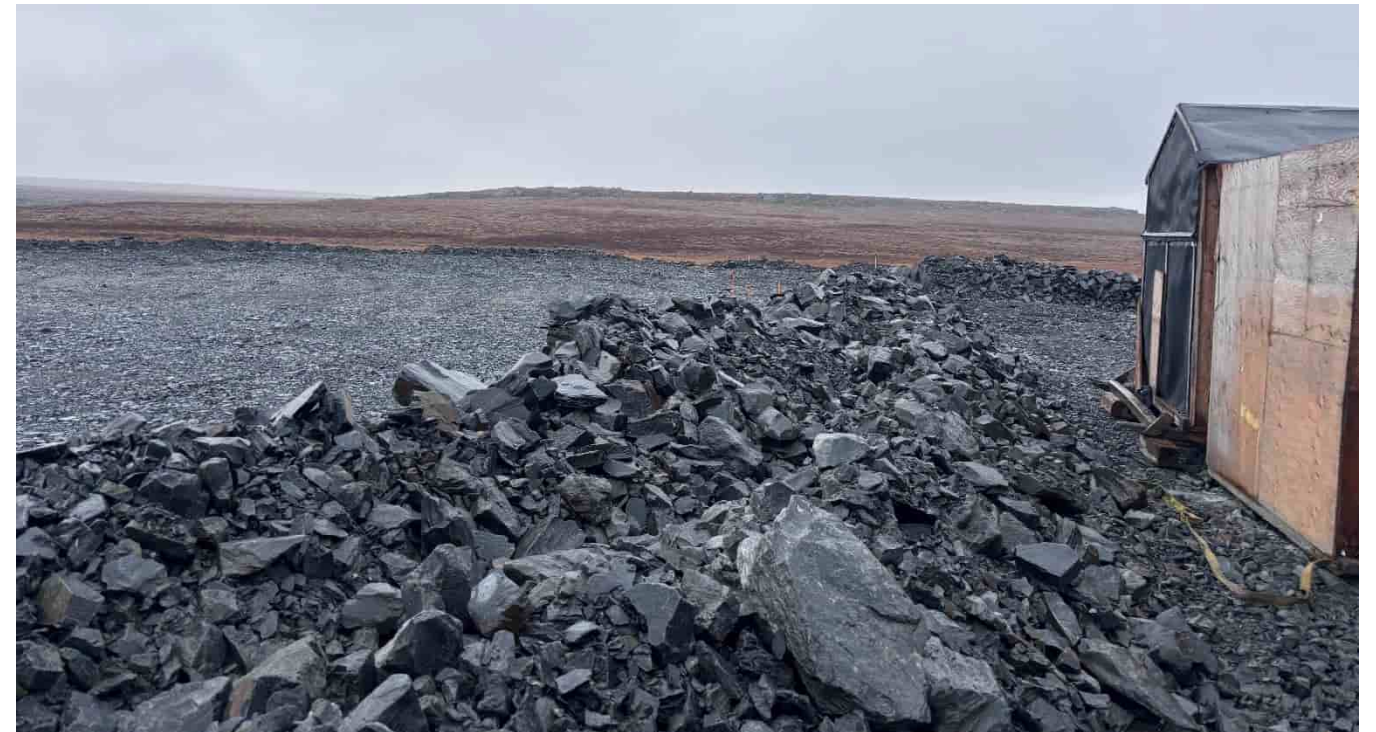
G-447: Pad and berm around future SWP Dam area

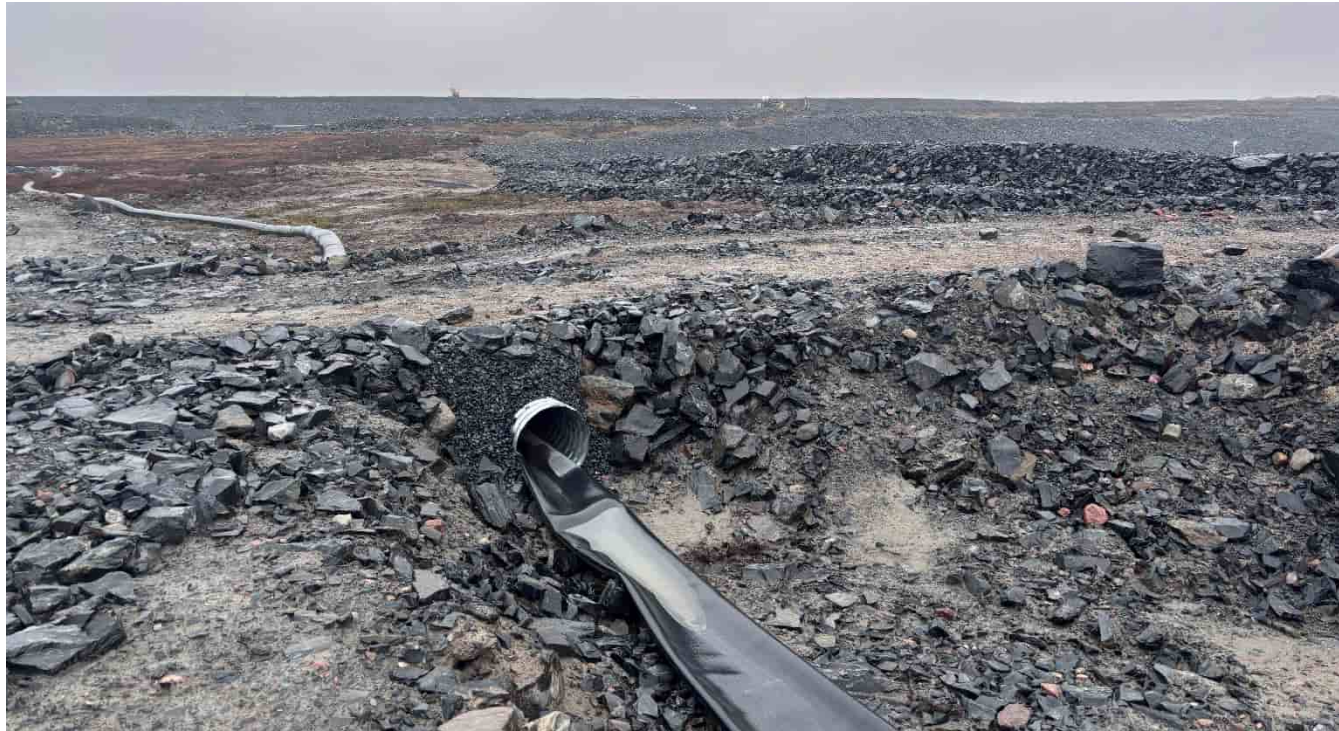
G-448: Culvert under access road to Umwelt Pit from SWP Access Road, looking NE

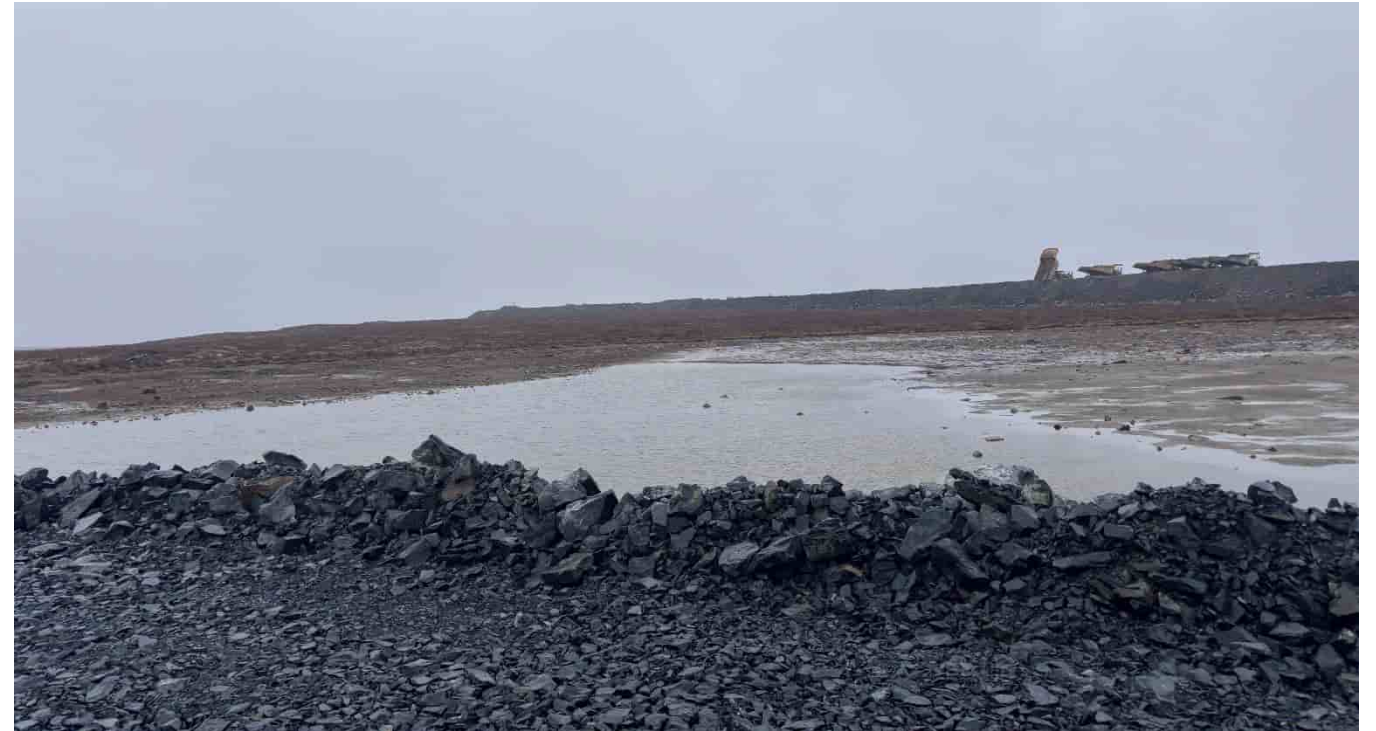
G-449: Northeastern pond (Round Pond) dewatering, looking N

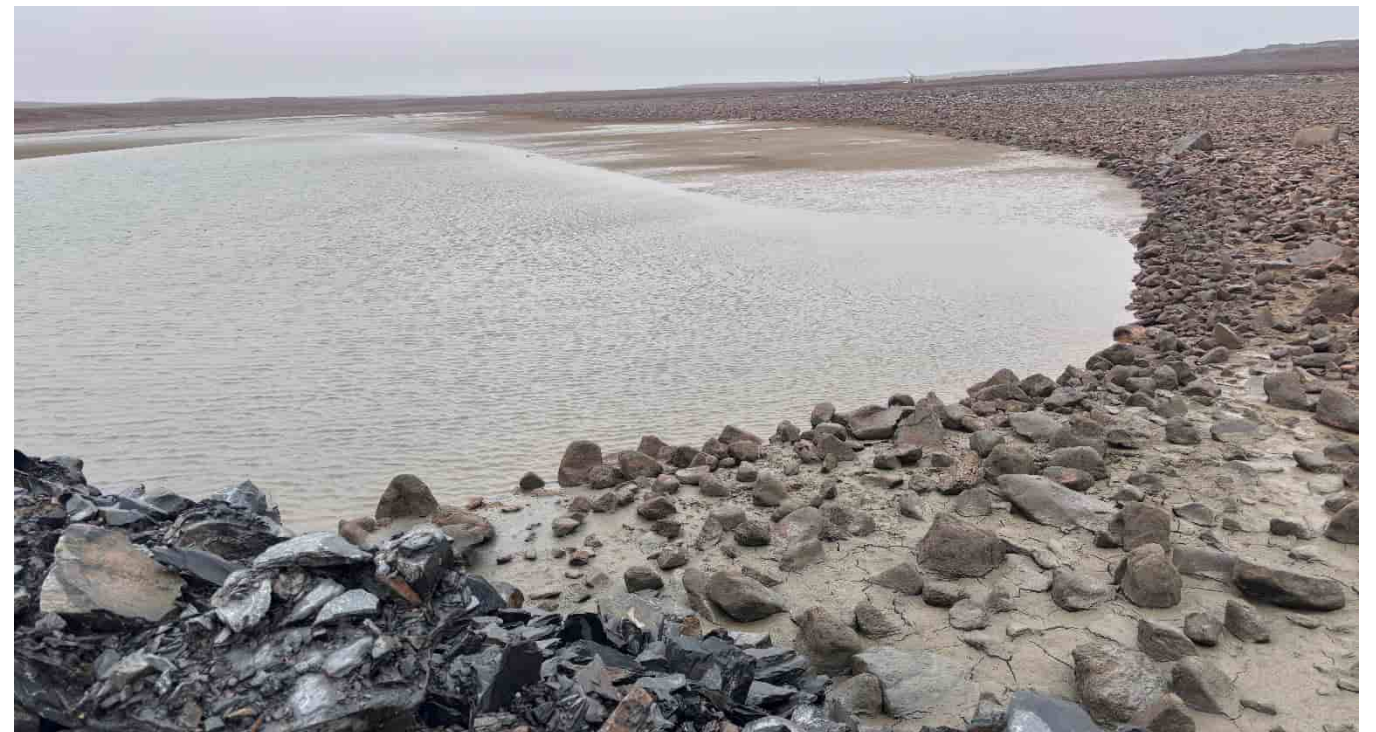
G-451: Pond dewatering waterline, looking NW

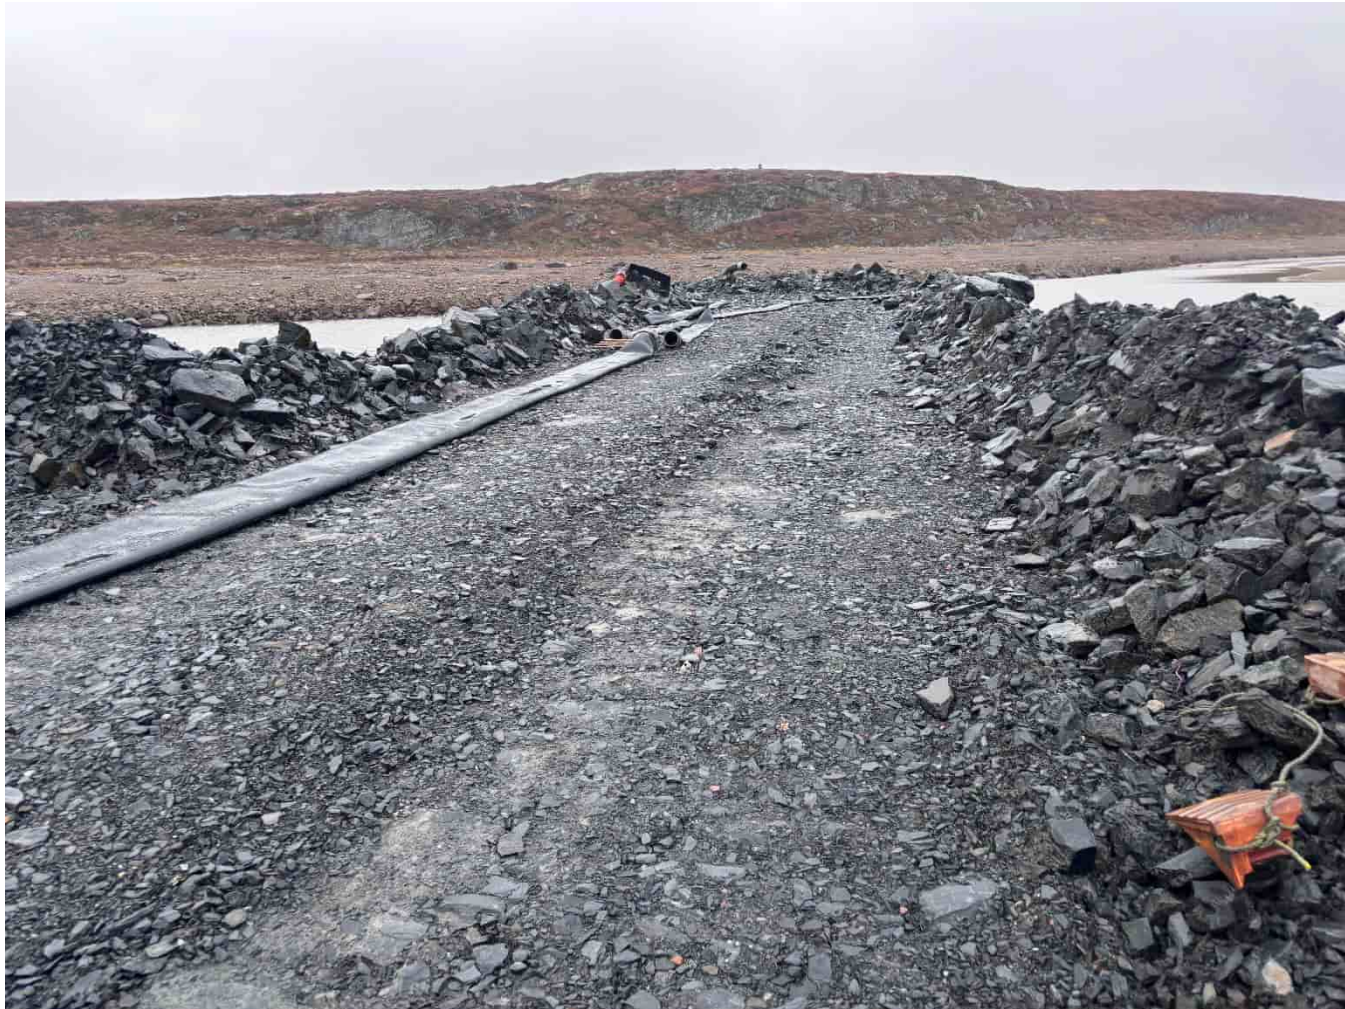
G-452: Northeast pond (Round Pond) access road, looking W

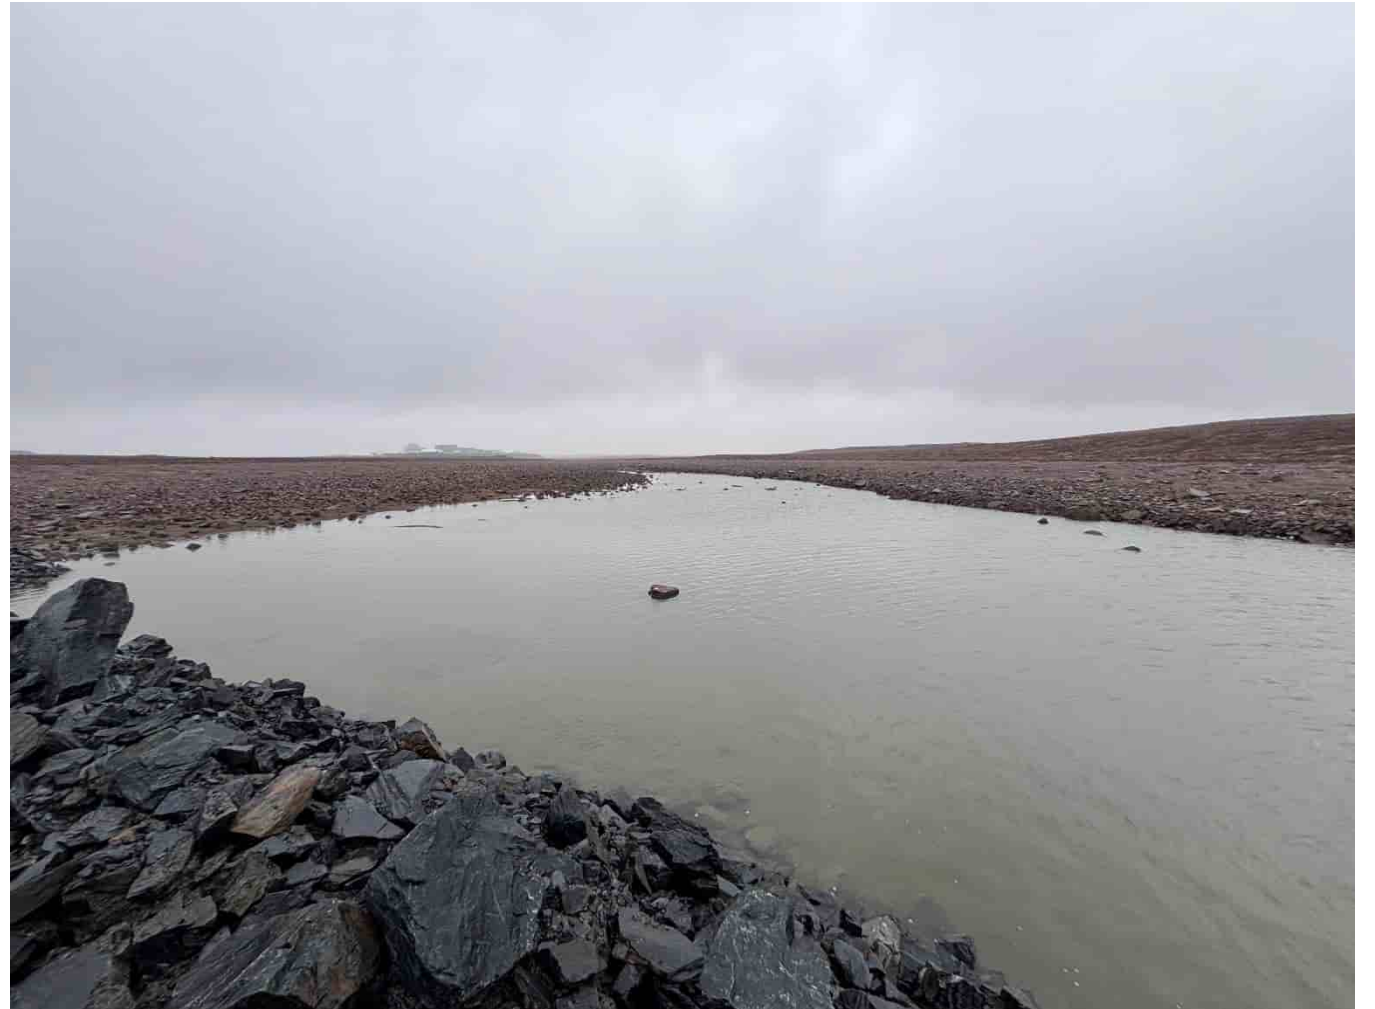
G-453: Mostly dewatered pond (Round Pond), looking SE

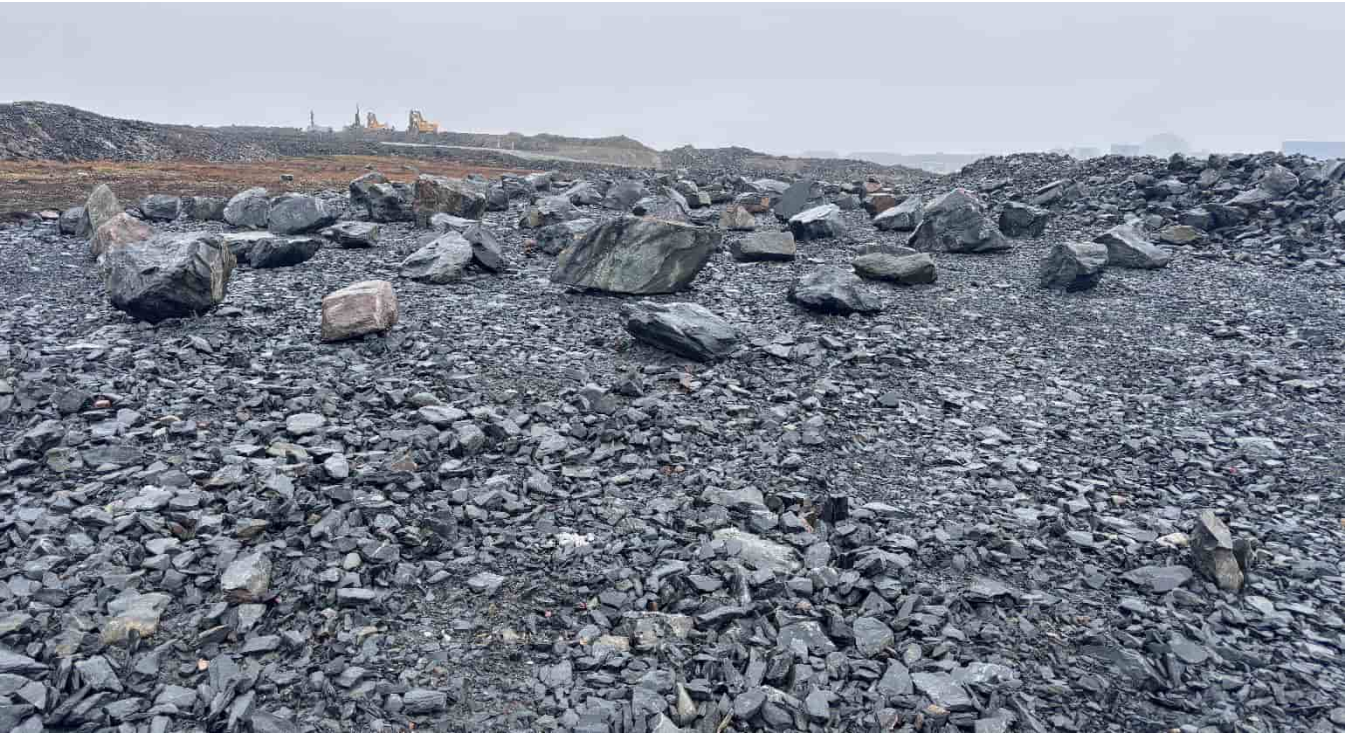
G-455: Large blast rocks at end of spillway, looking S

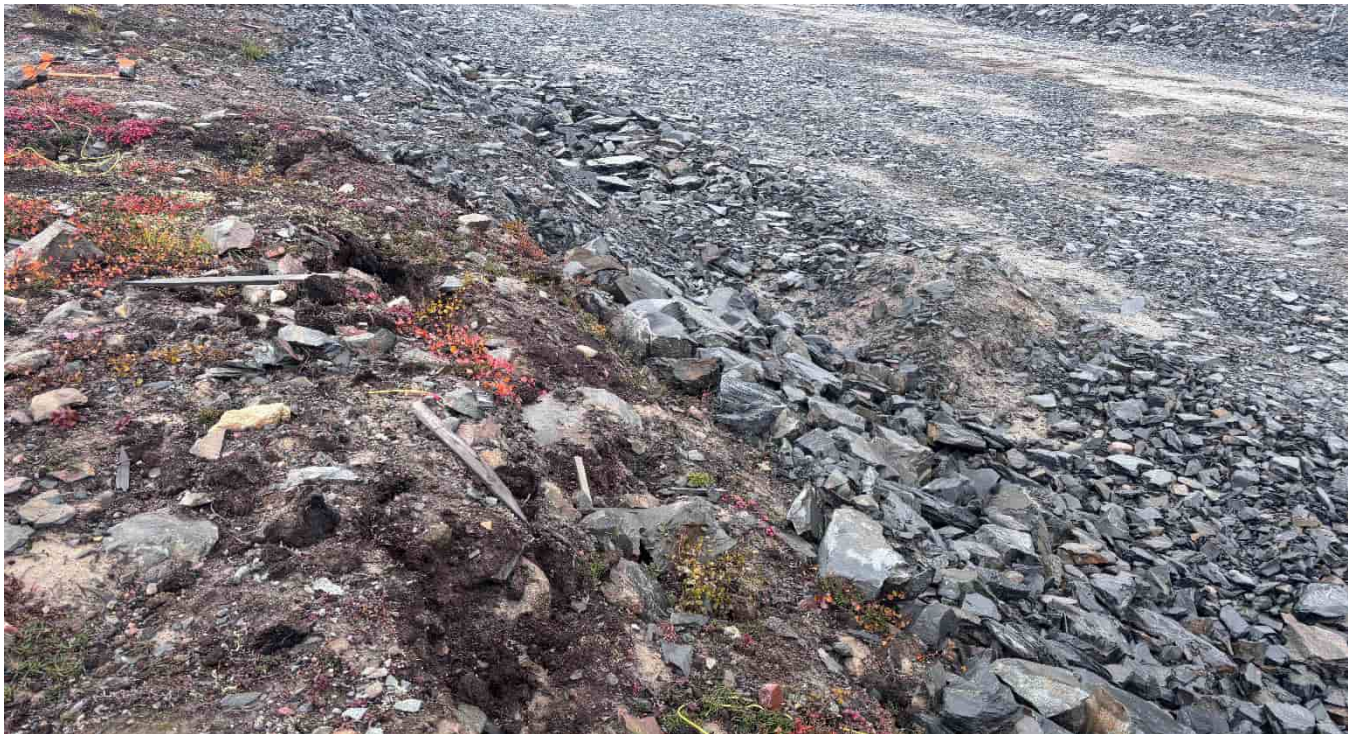
G-456: Southern end of spillway, looking N

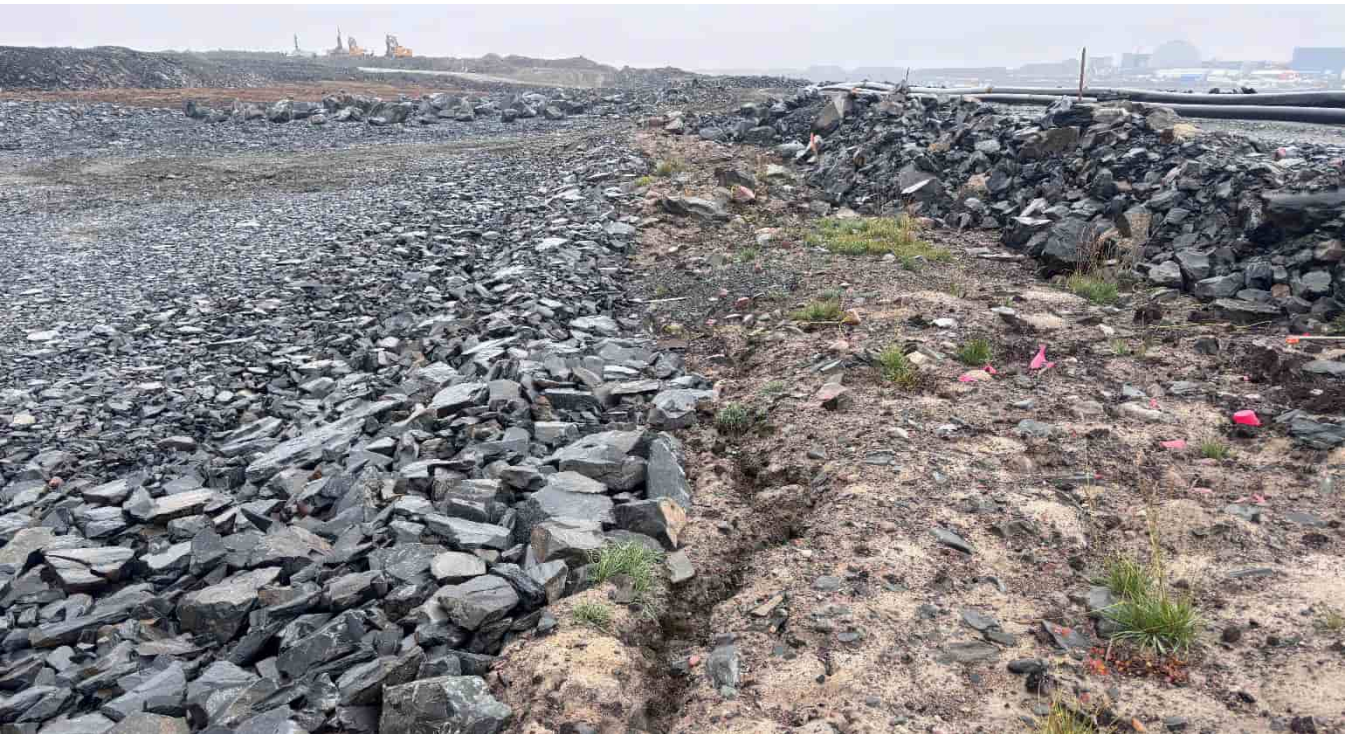
G-457: Spillway: western berm, looking S, thin rock cladding thickness in areas

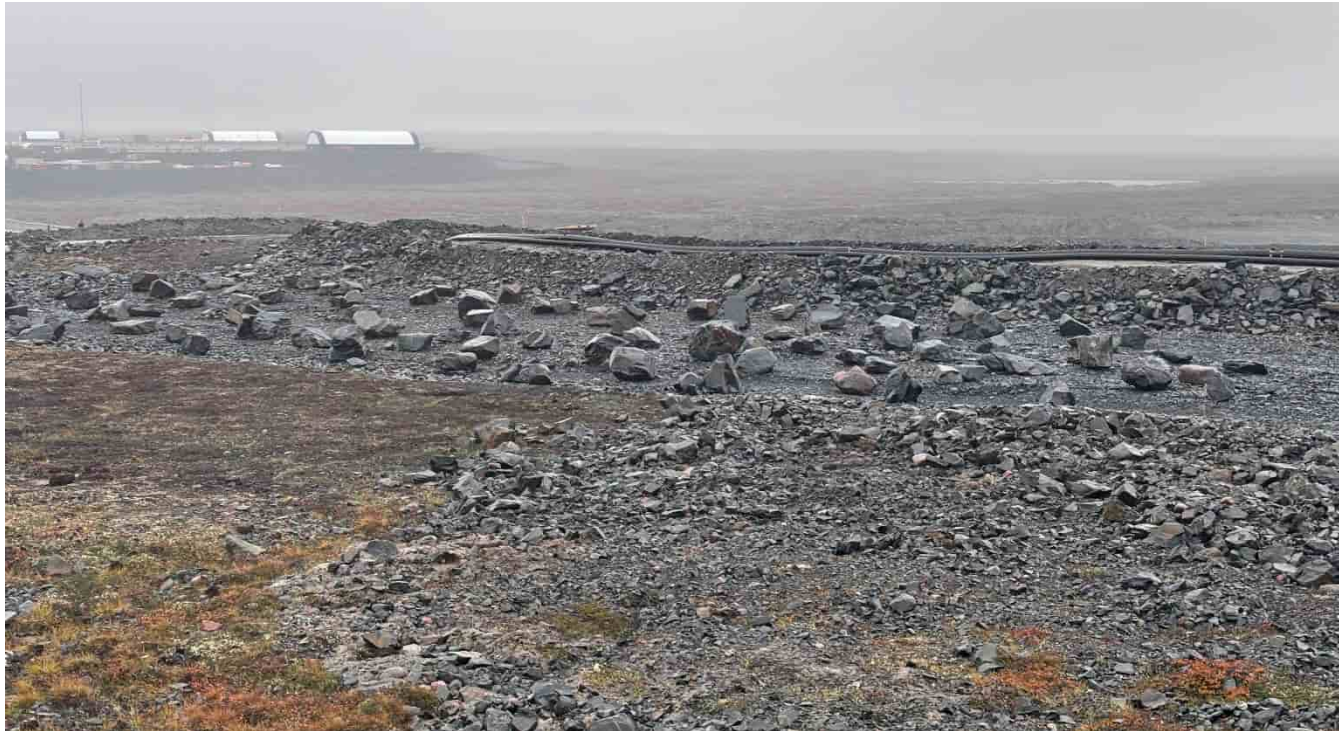
G-458: Looking W towards downstream (SE) end of spillway

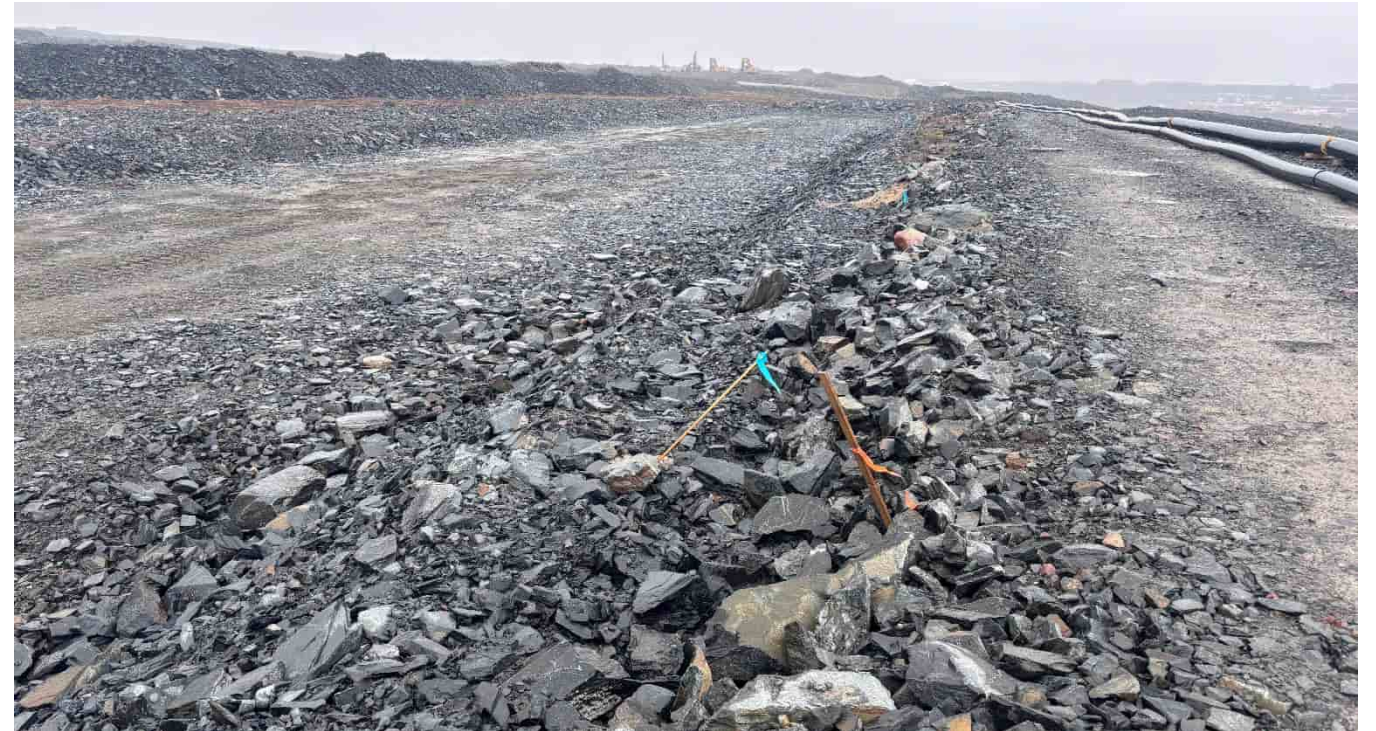
G-459: Western edge of spillway, looking SE

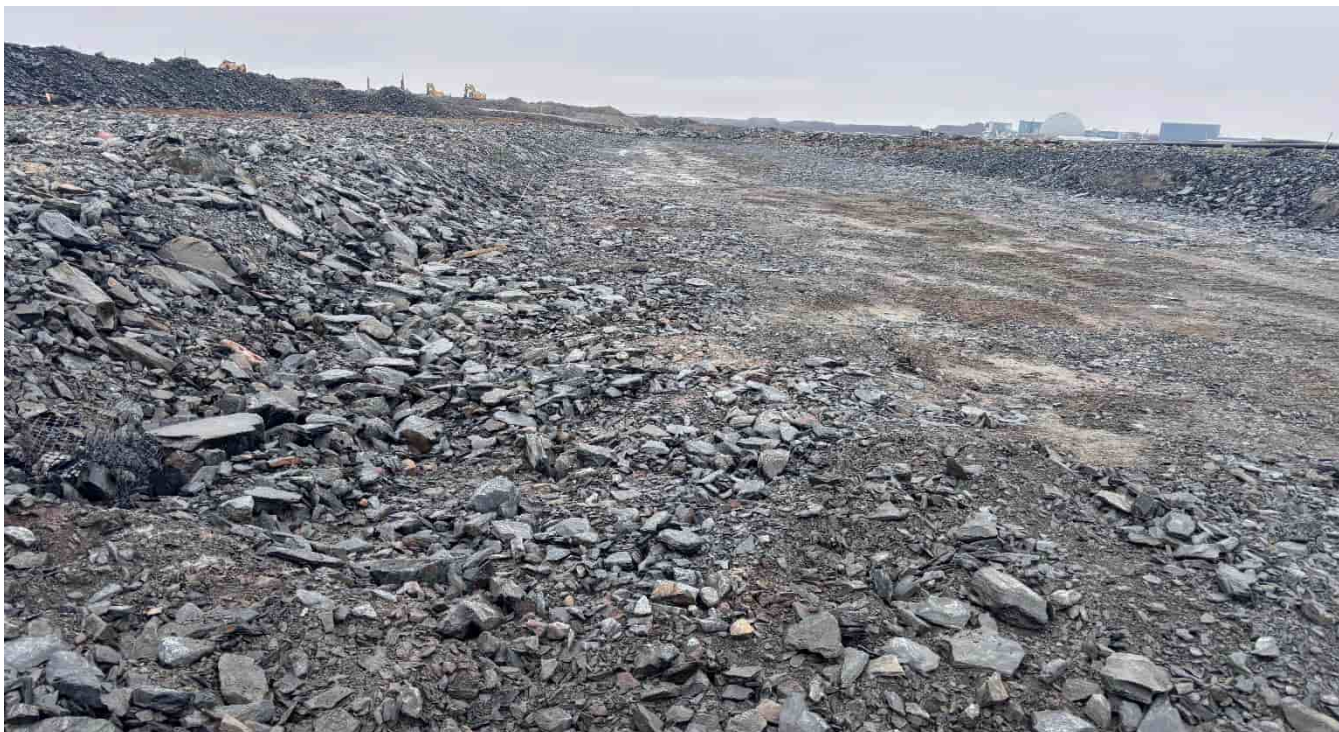
G-460: Spillway, looking SE
