| | | 2025 Annual Geotechnical Inspection | | |
| Job No: CAPR004312<br>Filename: Back River_Goose_2025_AGI_Photoslog.pdf | Back River Project | Date:<br>February 2026 | Approved:<br>JBK | Figure:<br>79 |

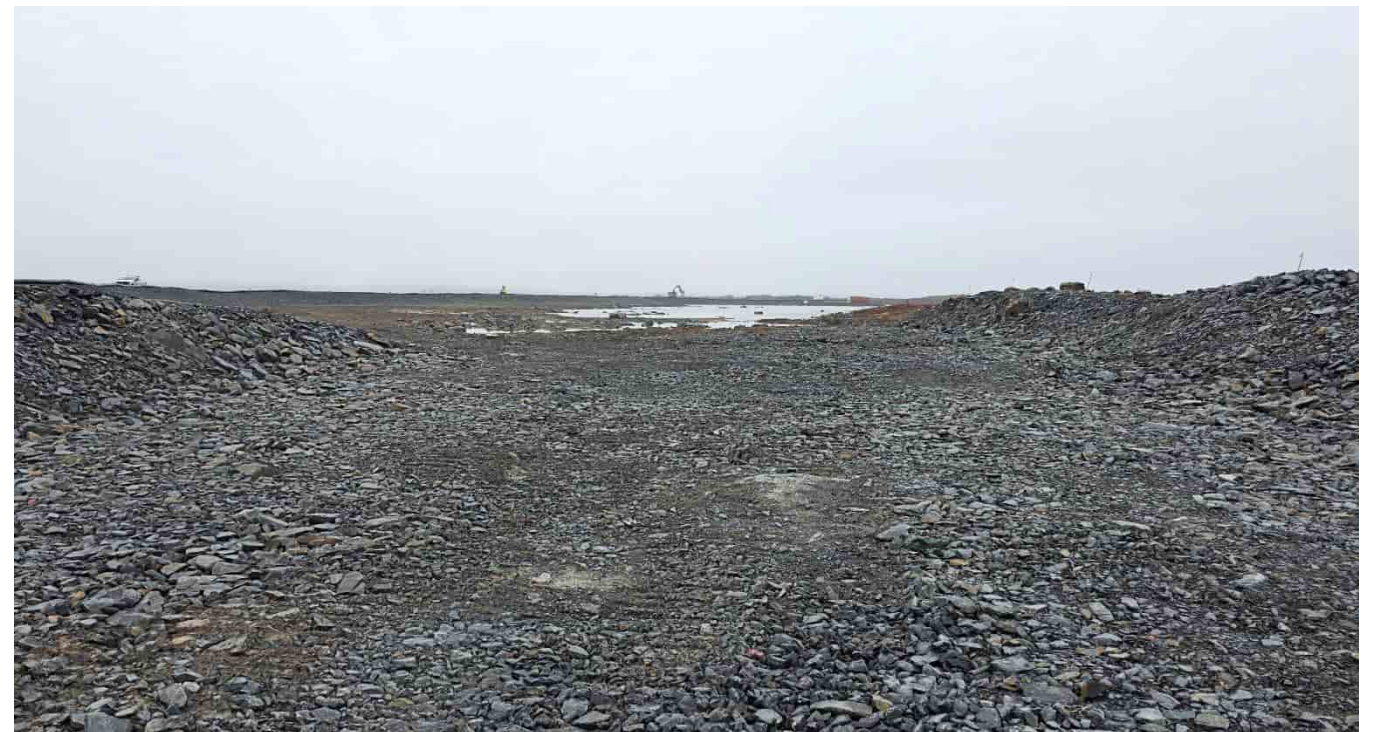
G-461: Upstream (NW) end up spillway, looking NW
