| | | 2025 Annual Geotechnical Inspection | | |
| | | Primary Pond Dam | | |
| Job No: CAPR004312<br>Filename: Back River_Goose_2025_AGI_PhotoLog.pdf | Back River Project | Date:<br>February 2026 | Approved:<br>JBK | Figure:<br>159 |

## **Appendix B      Photolog from 2025 Site Visit – MLA**

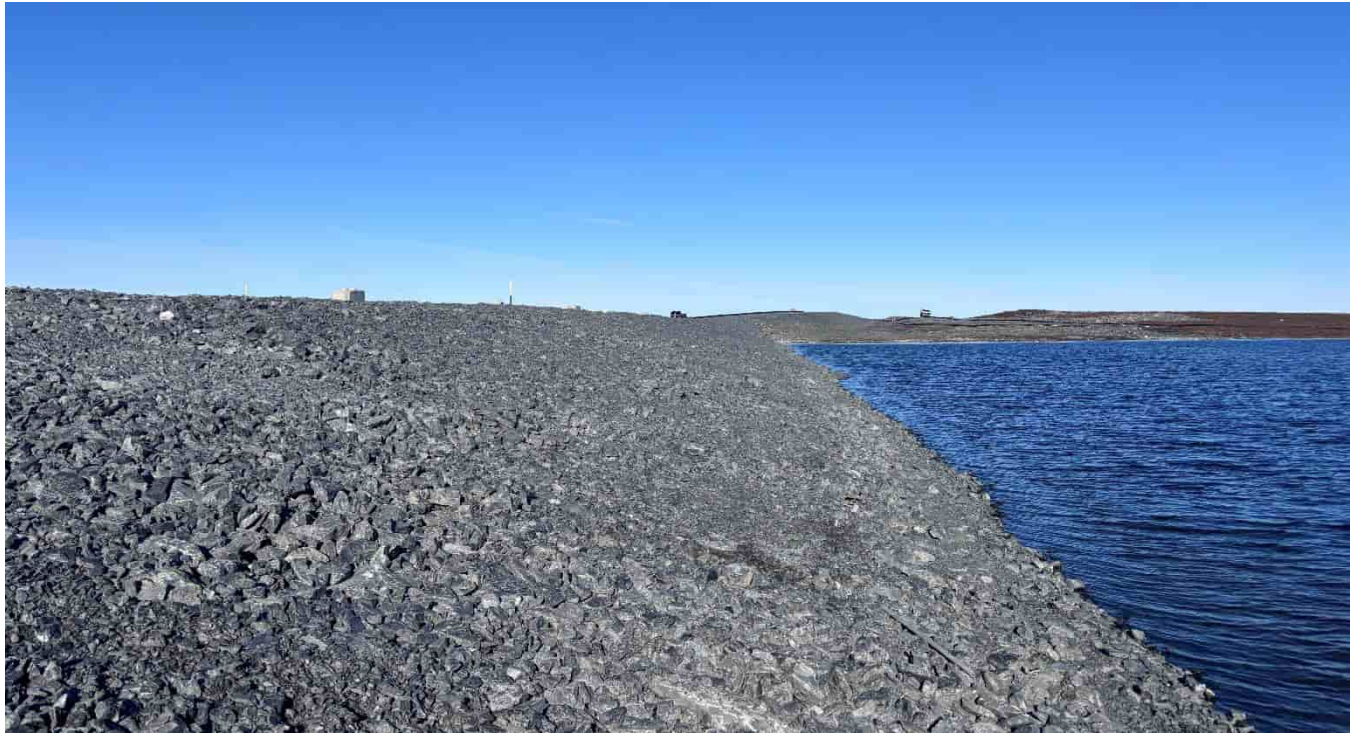
G-466: Upstream side of dam, looking NW

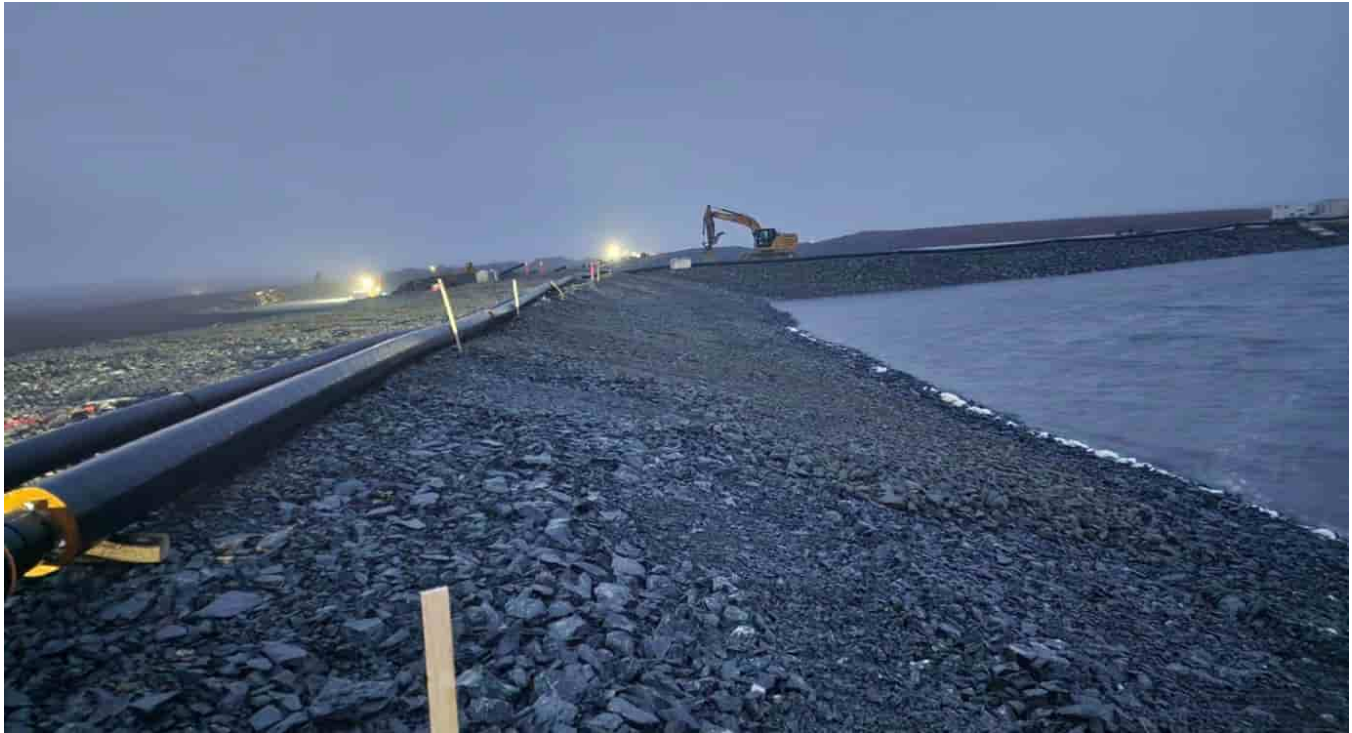
G-468: Upstream crest and upstream slope of the dam, looking NW

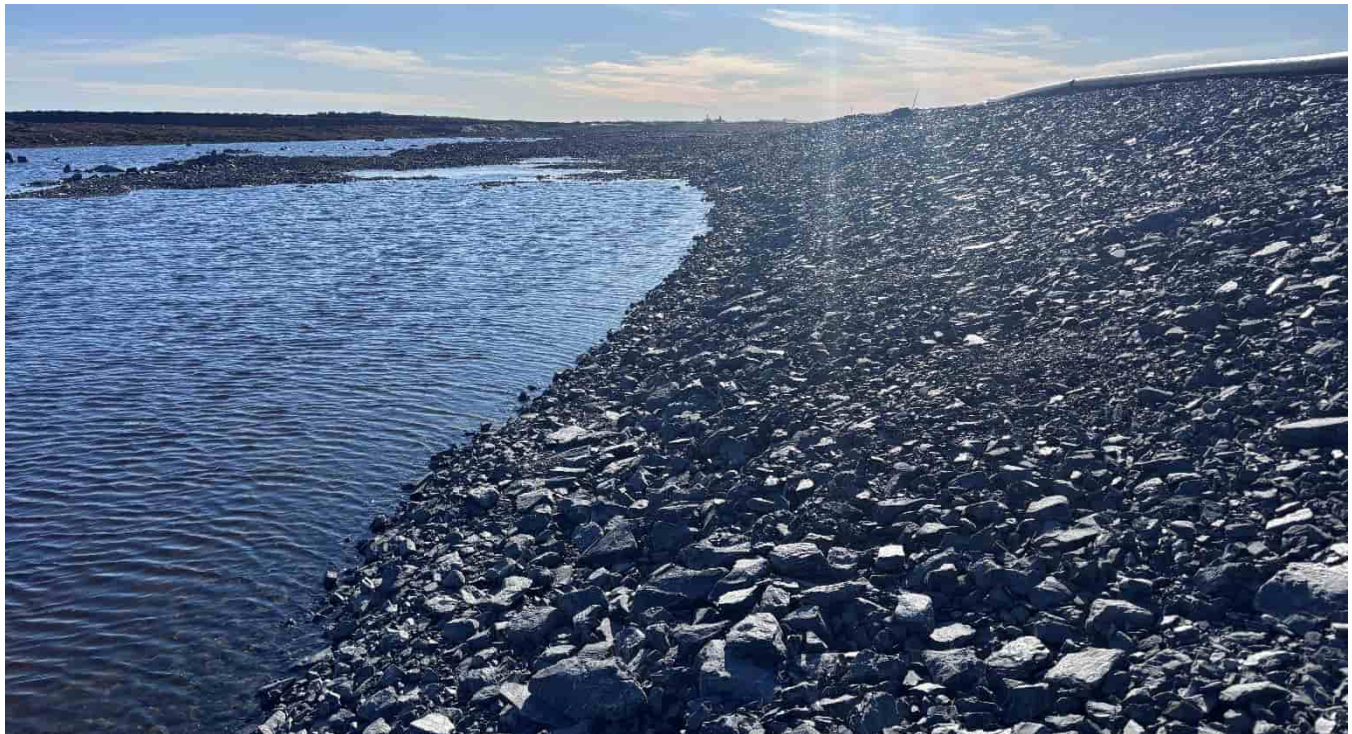
G-467: Upstream side of dam, looking SE

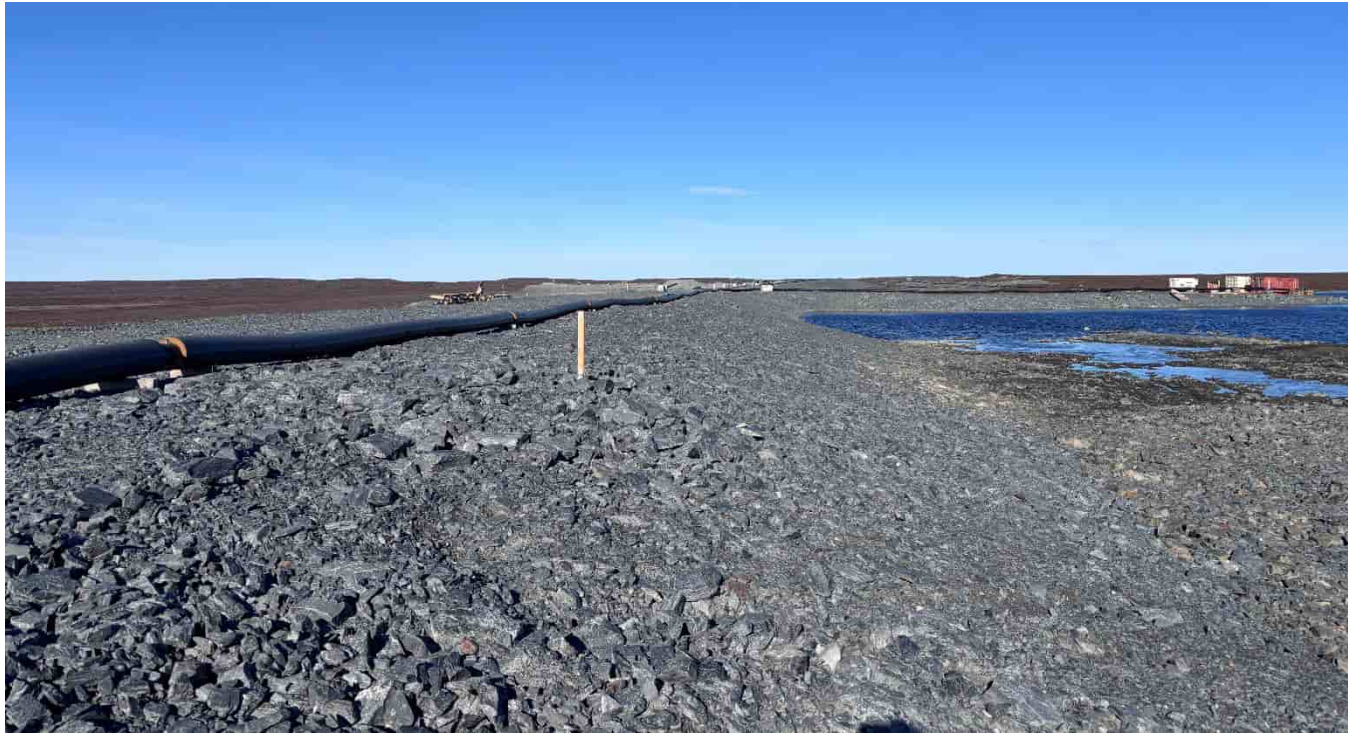
G-469: Crest of dam on upstream side, looking NW

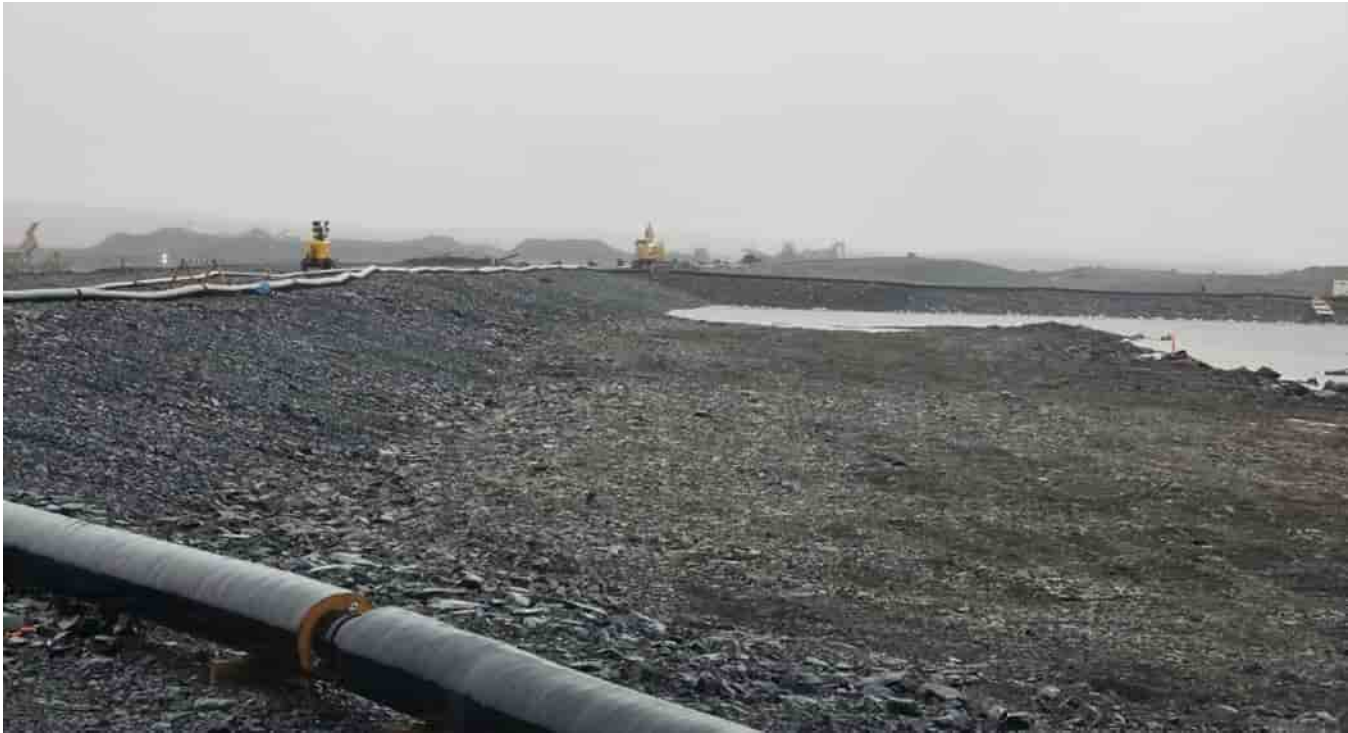
G-470: Upstream thermal protection barrier and upstream slope of the dam: southern end of pond

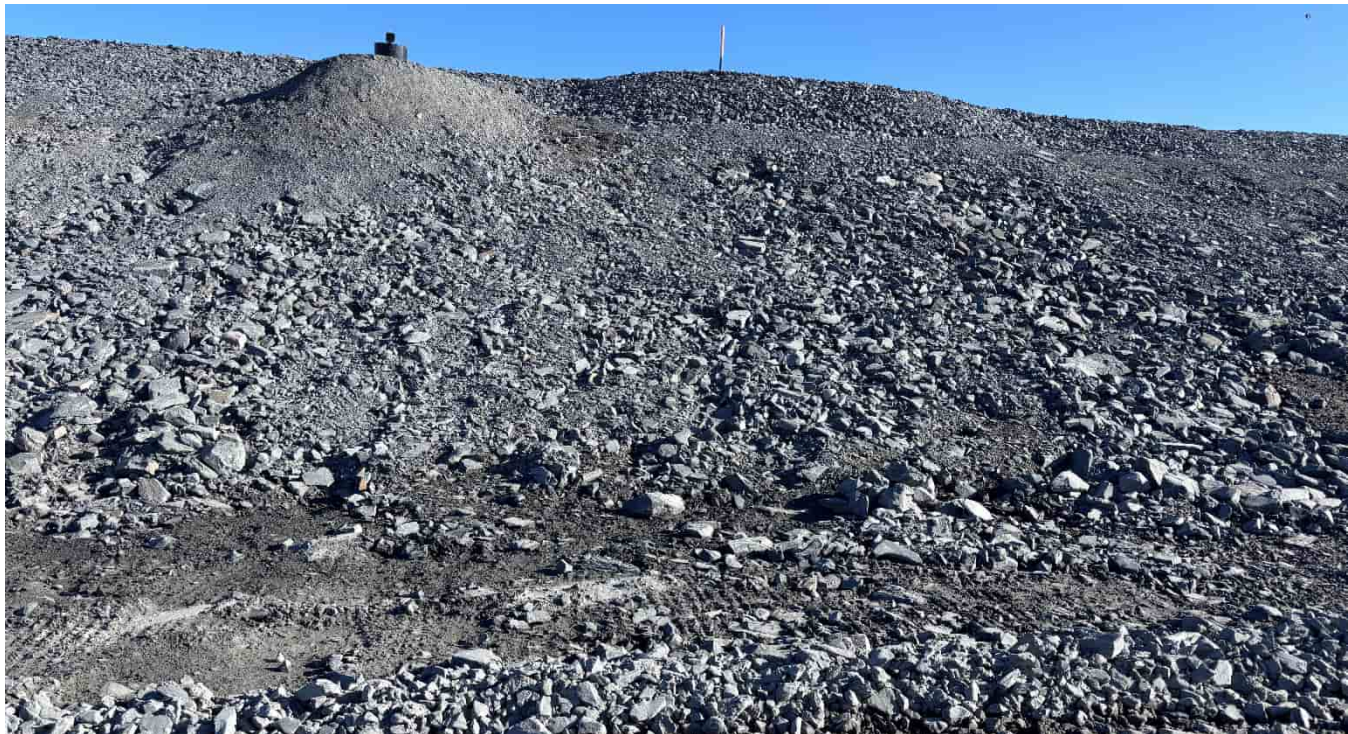
G-471: Downstream side typical dam slope, looking NE from All-Season Road

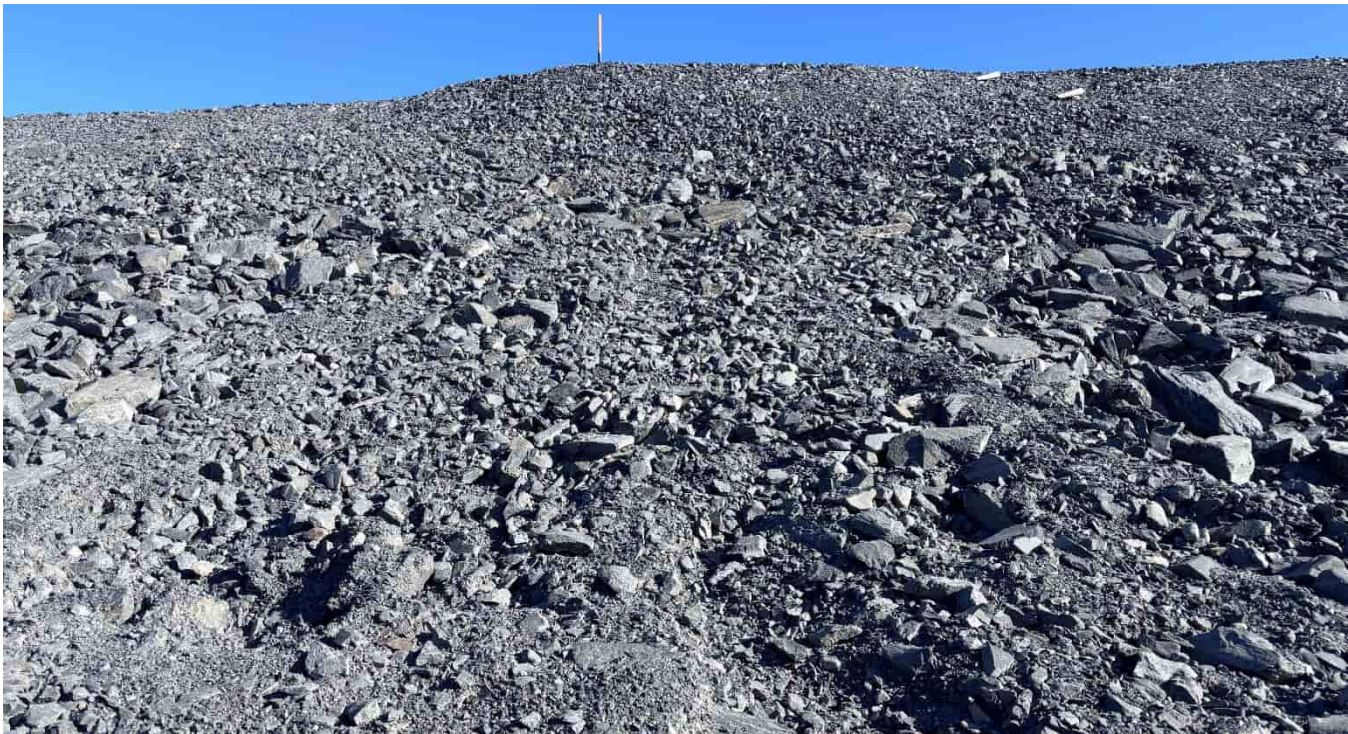
G-472: Downstream dam slope, looking towards crest at Reclaim Pipeline Access Road junction.

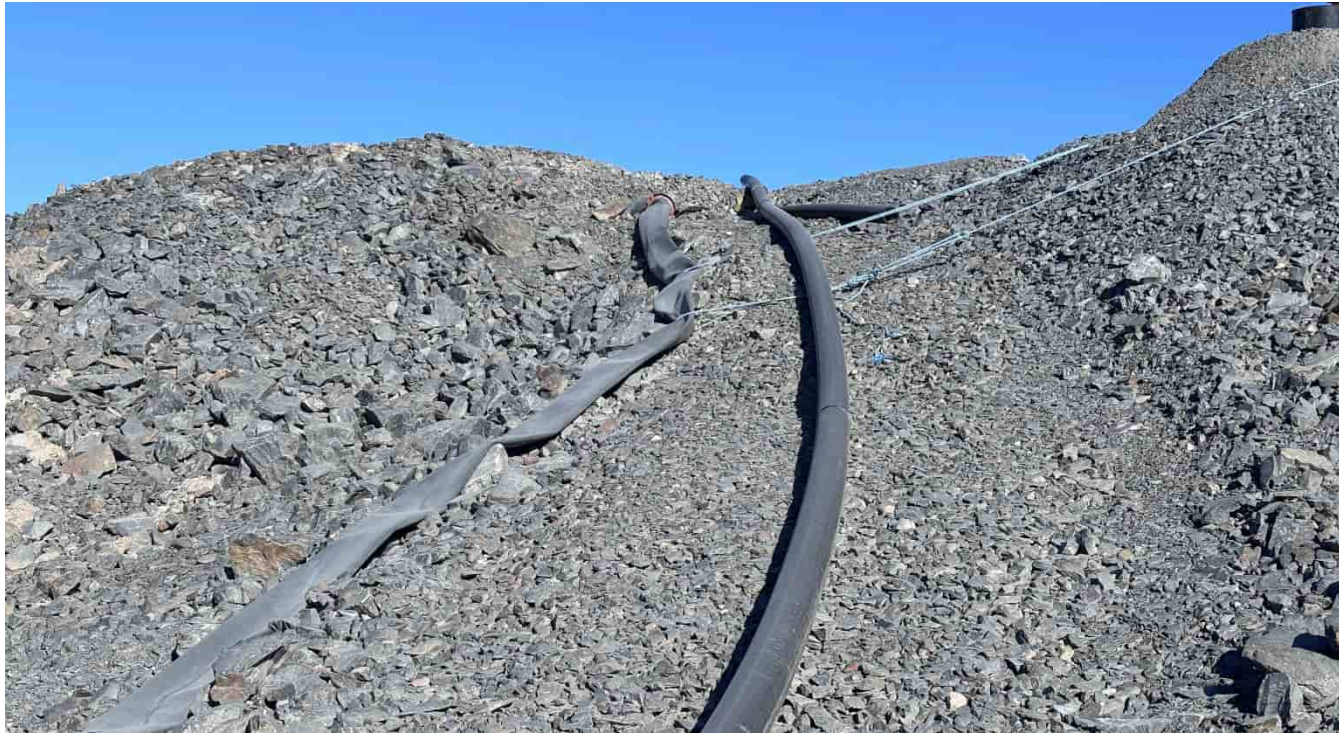
G-473: Unused pipes on downstream slope

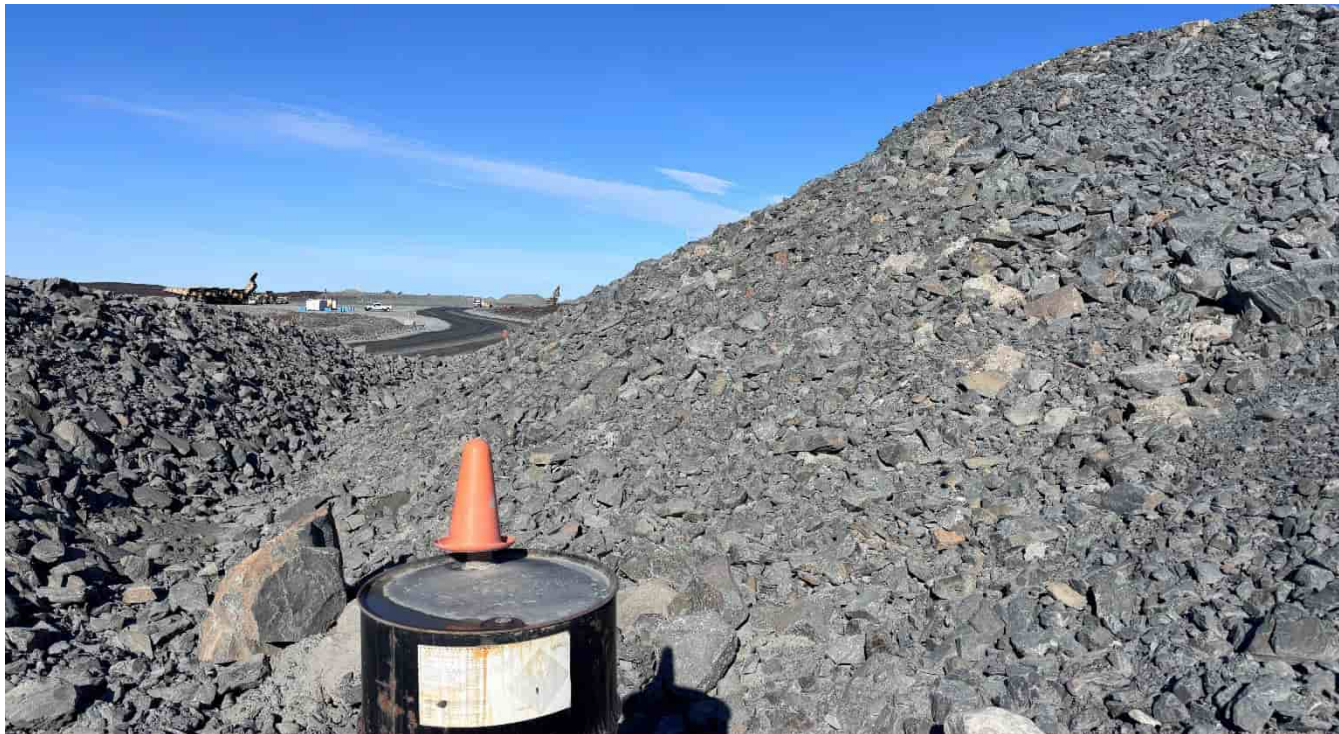
G-474: Downstream slope, looking NW

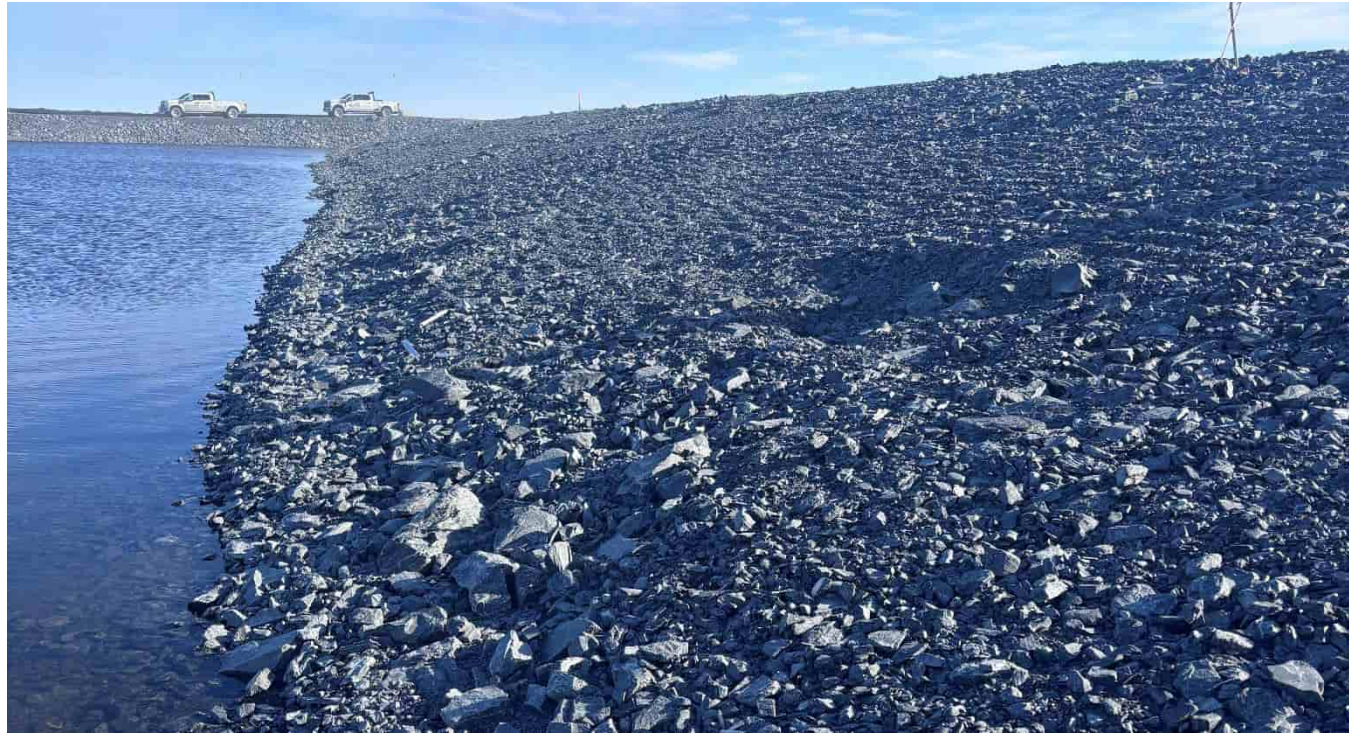
G-475: Upstream dam toe of slope, looking SE towards Reclaim Pipeline Access Road. The “depression” areas were inspected, surveyed and backfilled with the engineering fill.

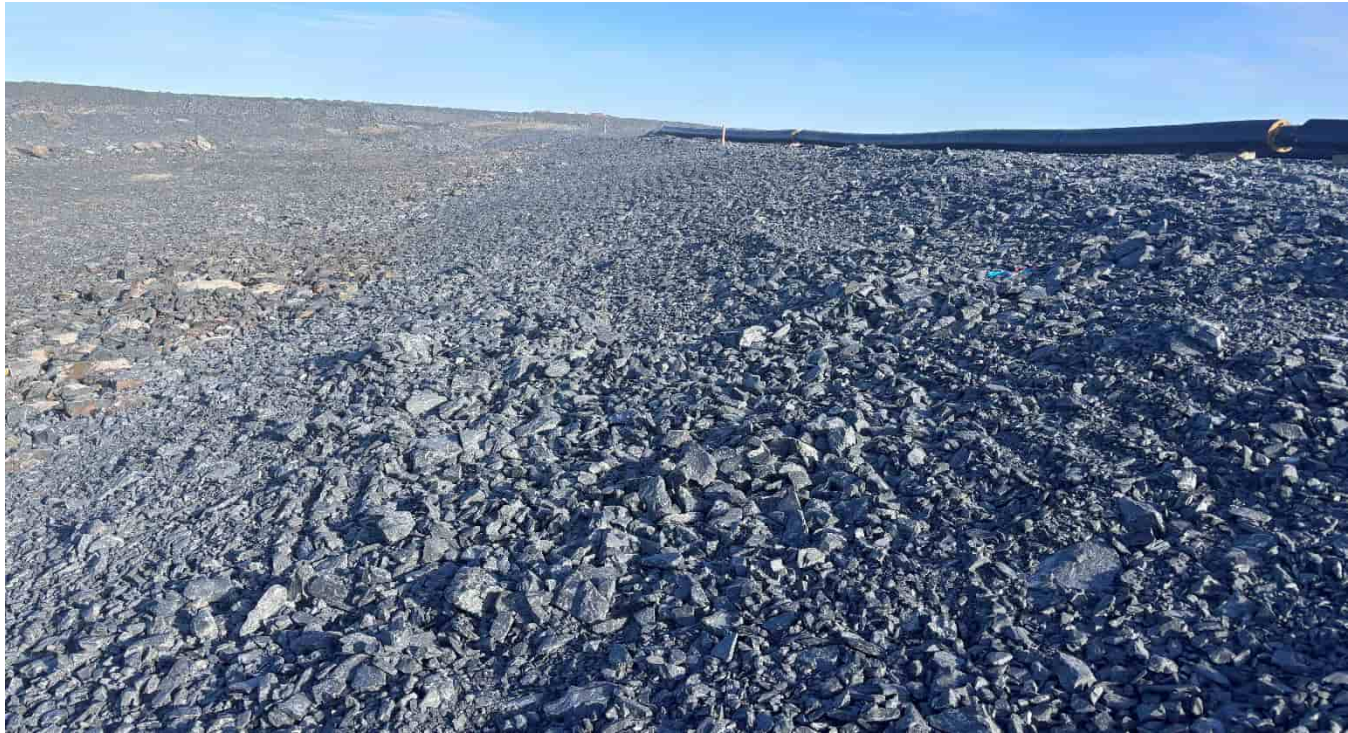
G-476: Upstream dam slope and thermal protection barrier, looking SE from southern end of pond

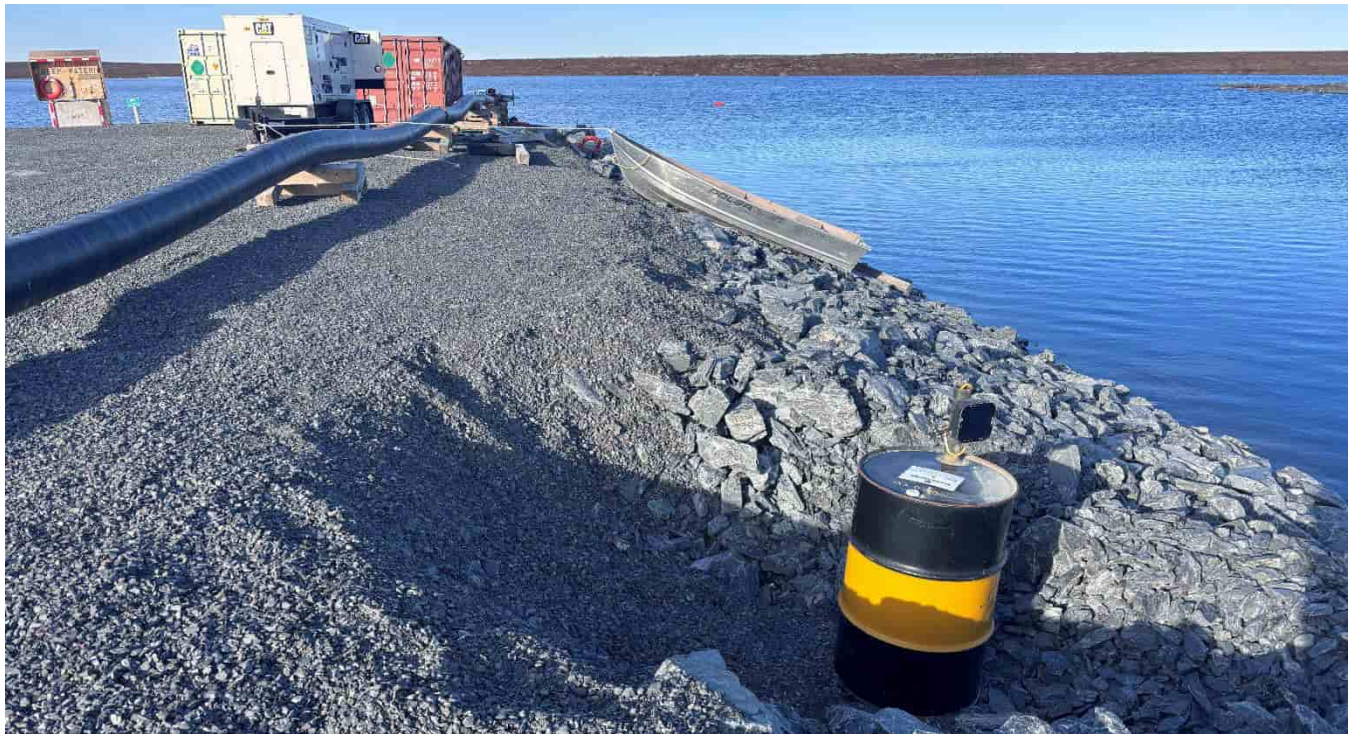
G-477: Reclaim Pipeline access road and pad

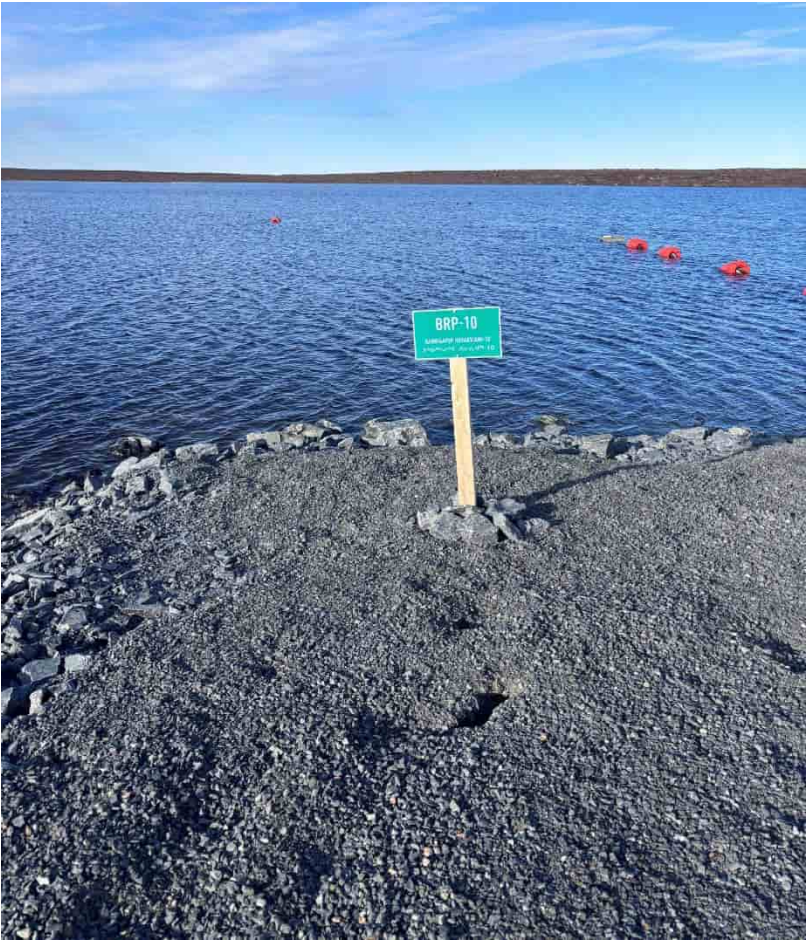
G-478: Sinkholes in the reclaim pipeline access road pad, looking northeast. A series of sinkholes developed due to the placement of surfacing material directly over the ROQ without placement of Transition layer in some areas (ie crush migration into voids in coarser rockfill). Note this area is upstream (not structurally connected) to the main Primary Pond dam structure (so less of a technical concern at this time).

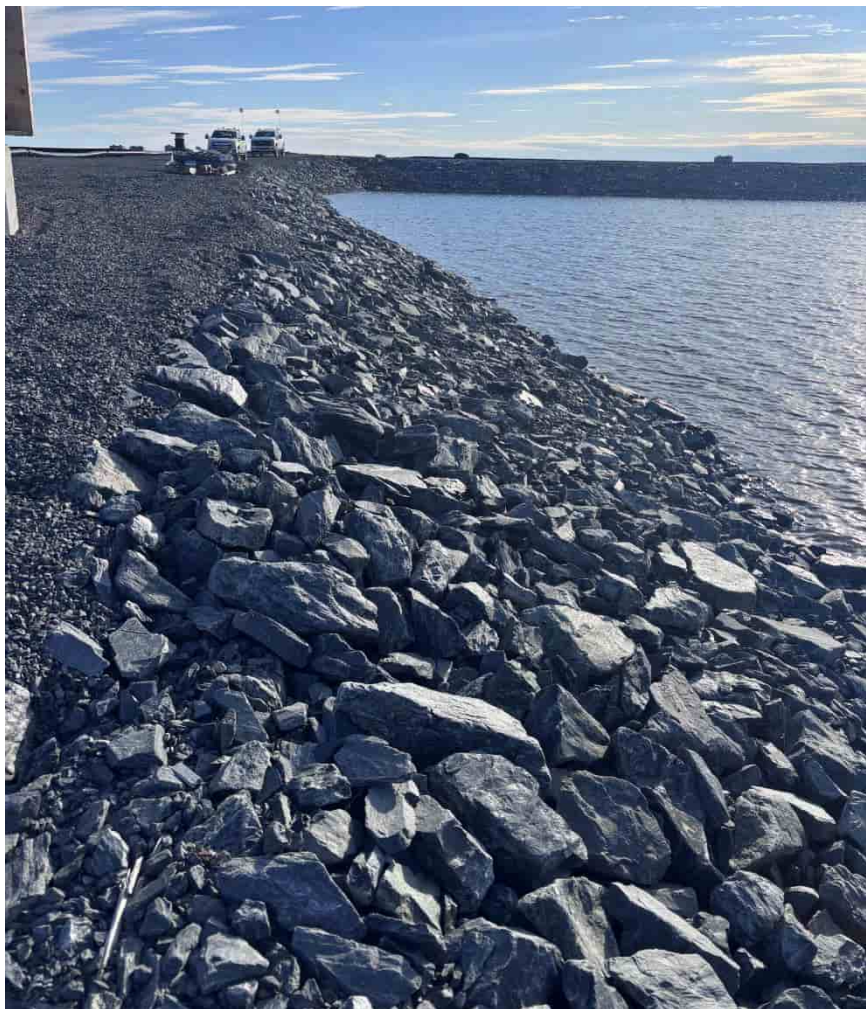
G-479: Reclaim Pipeline Access Road NW slope, looking SW

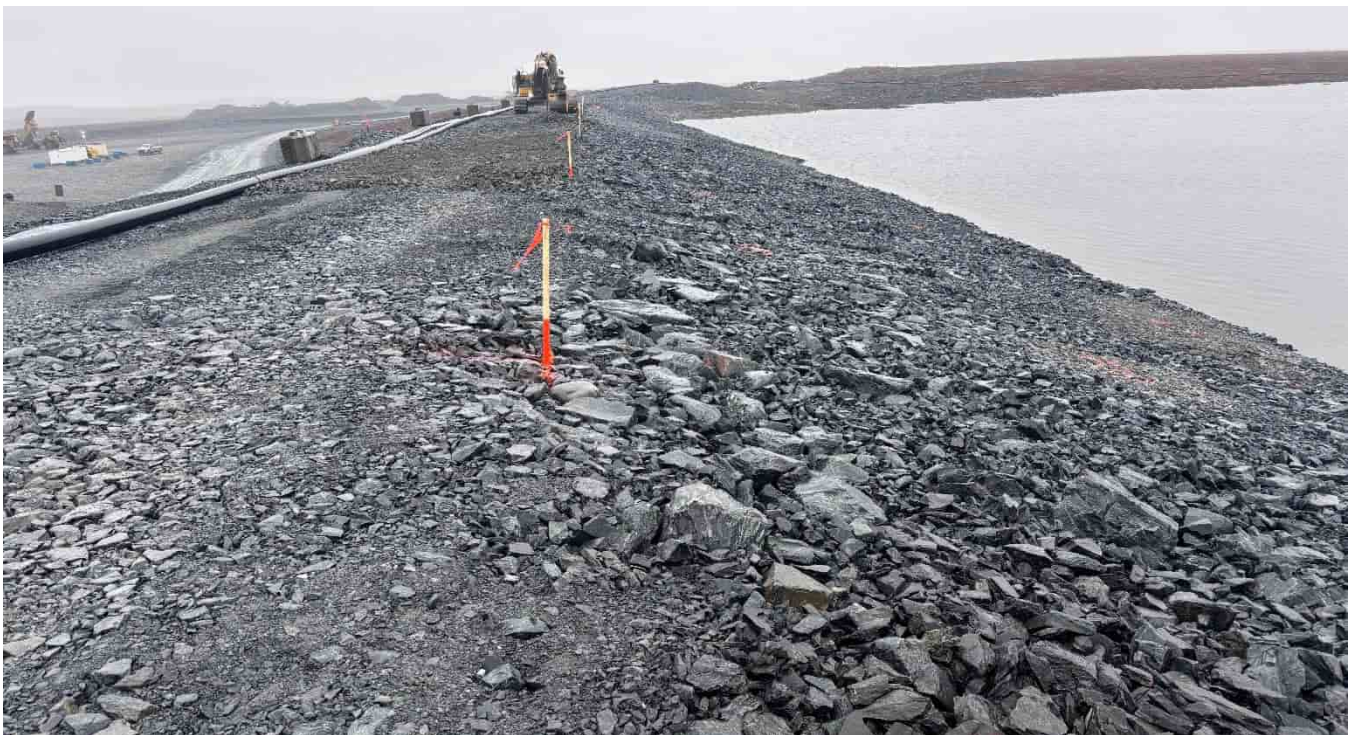
G-480: Upstream crest of dam, looking N

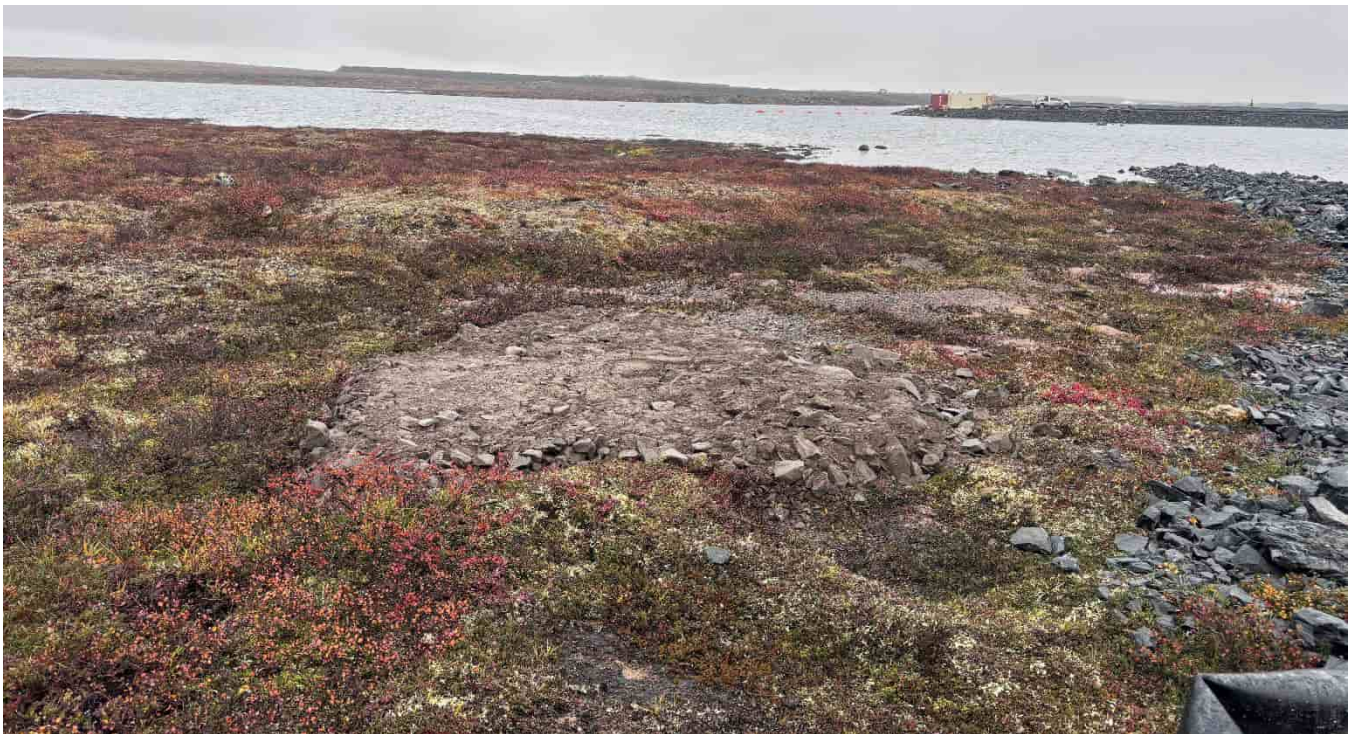
G-481: Discharge point the N of Primary Pond : Note that the disturbed area was backfilled with the low permeability material and the discharge point was moved while SRK was on site.

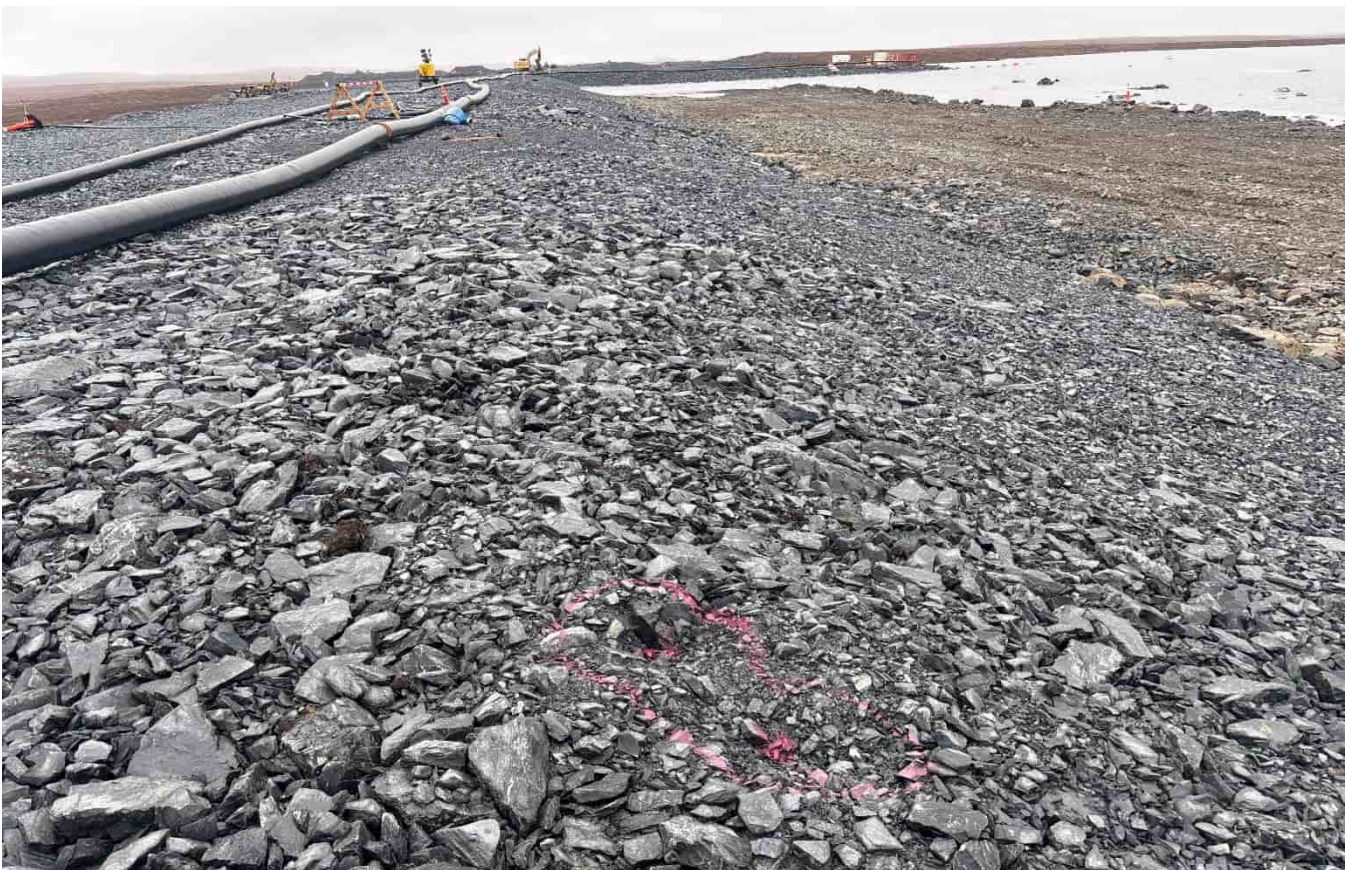
G-483: Dam crest southern end, looking N

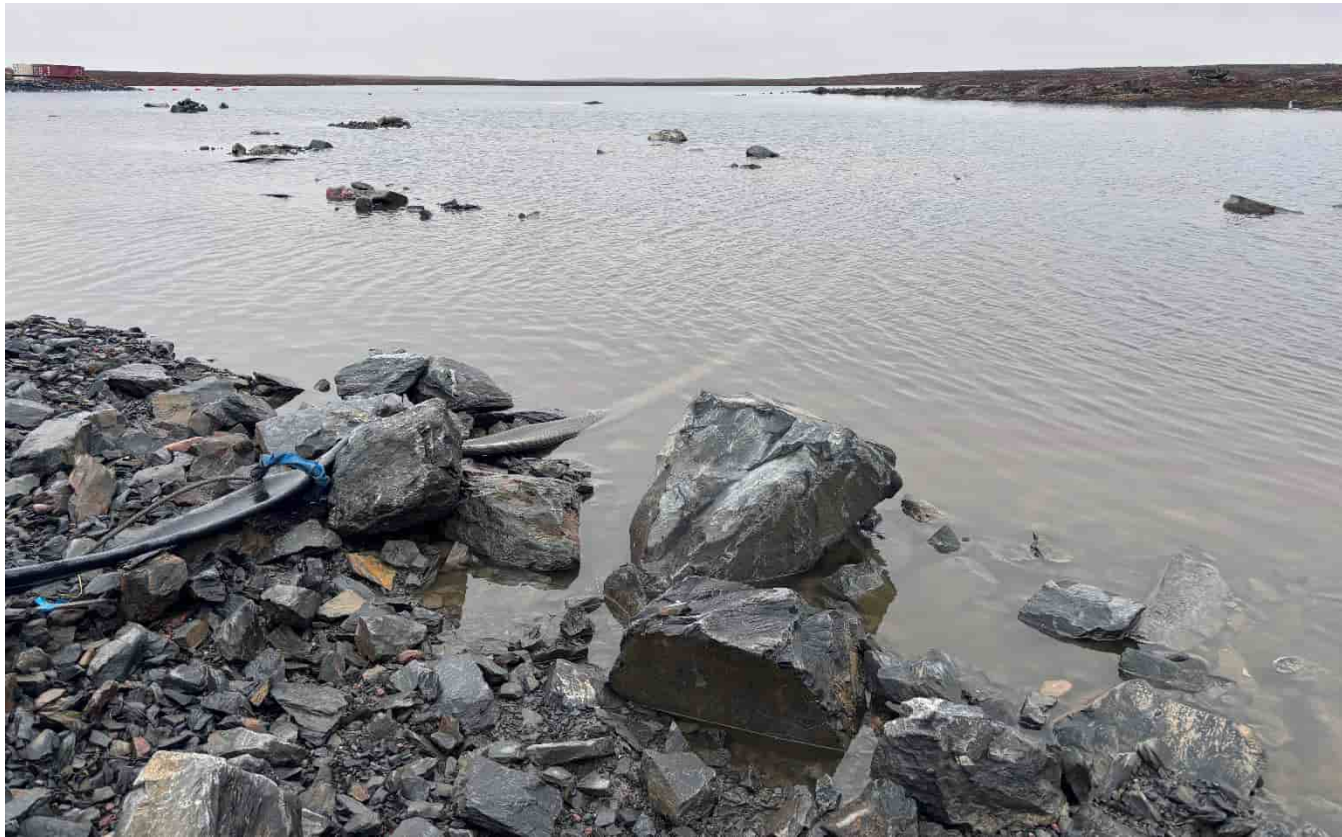
G-484: Pipeline entering water at southern end of pond

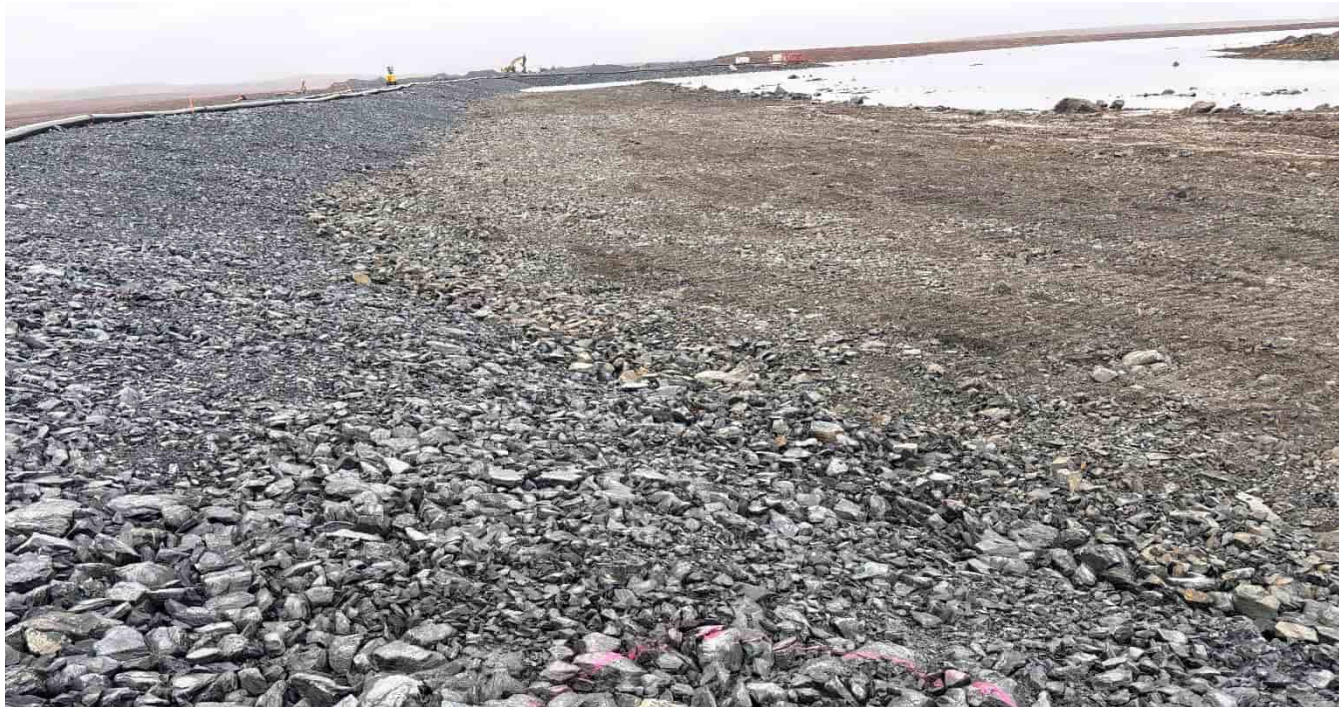
G-485: Southern end of dam and upstream thermal protection barrier, looking NW

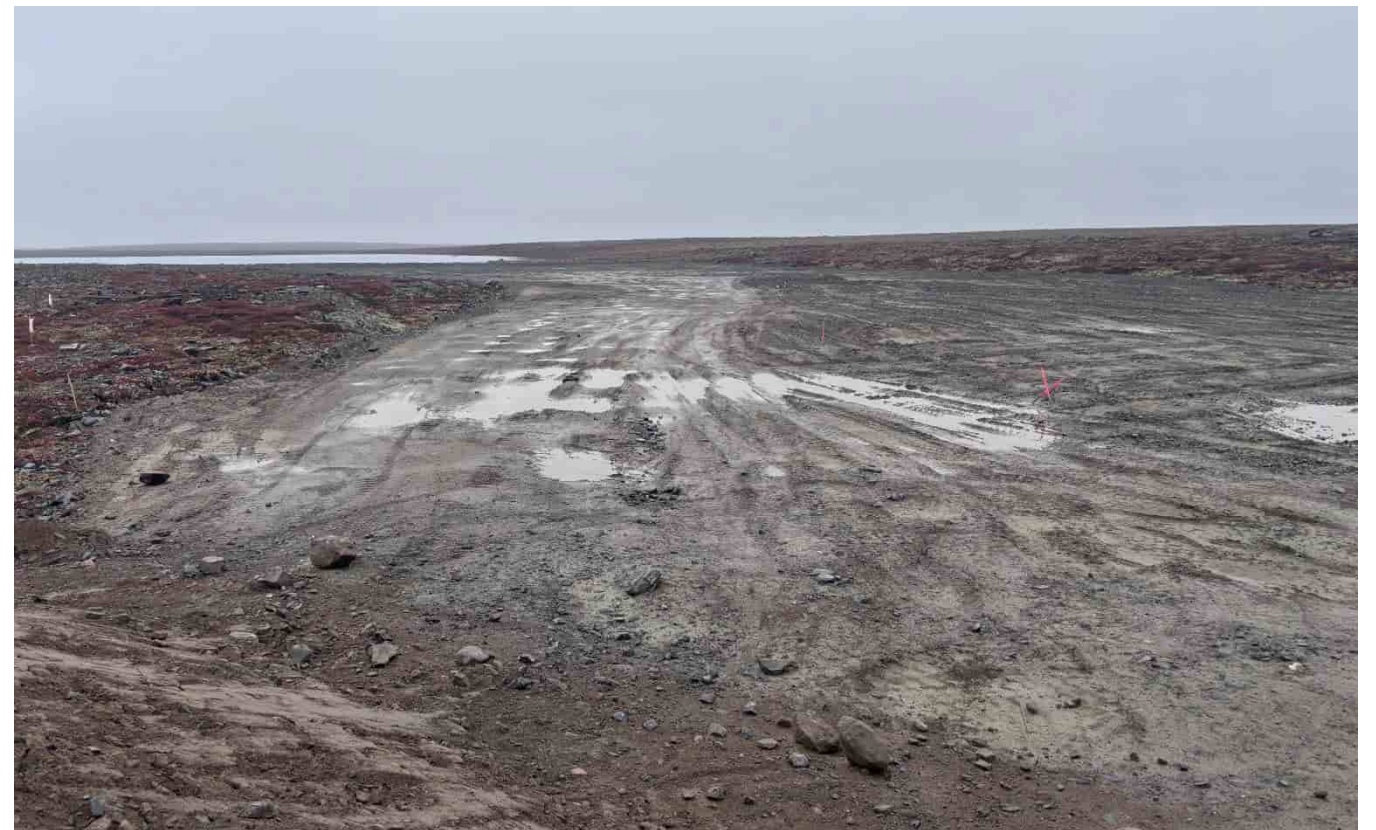
G-486: Overburden fill S of pond, looking N

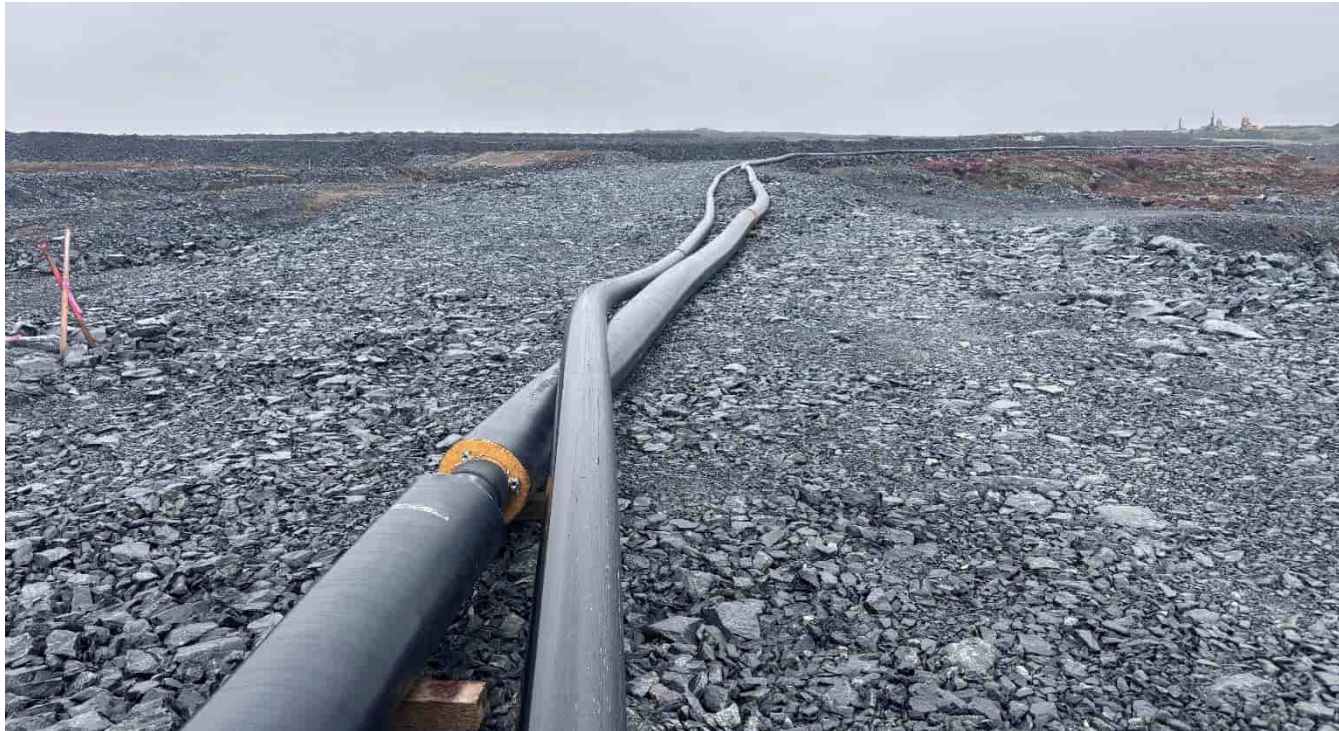
G-488: Typical water reclaim pipeline layout, looking SE

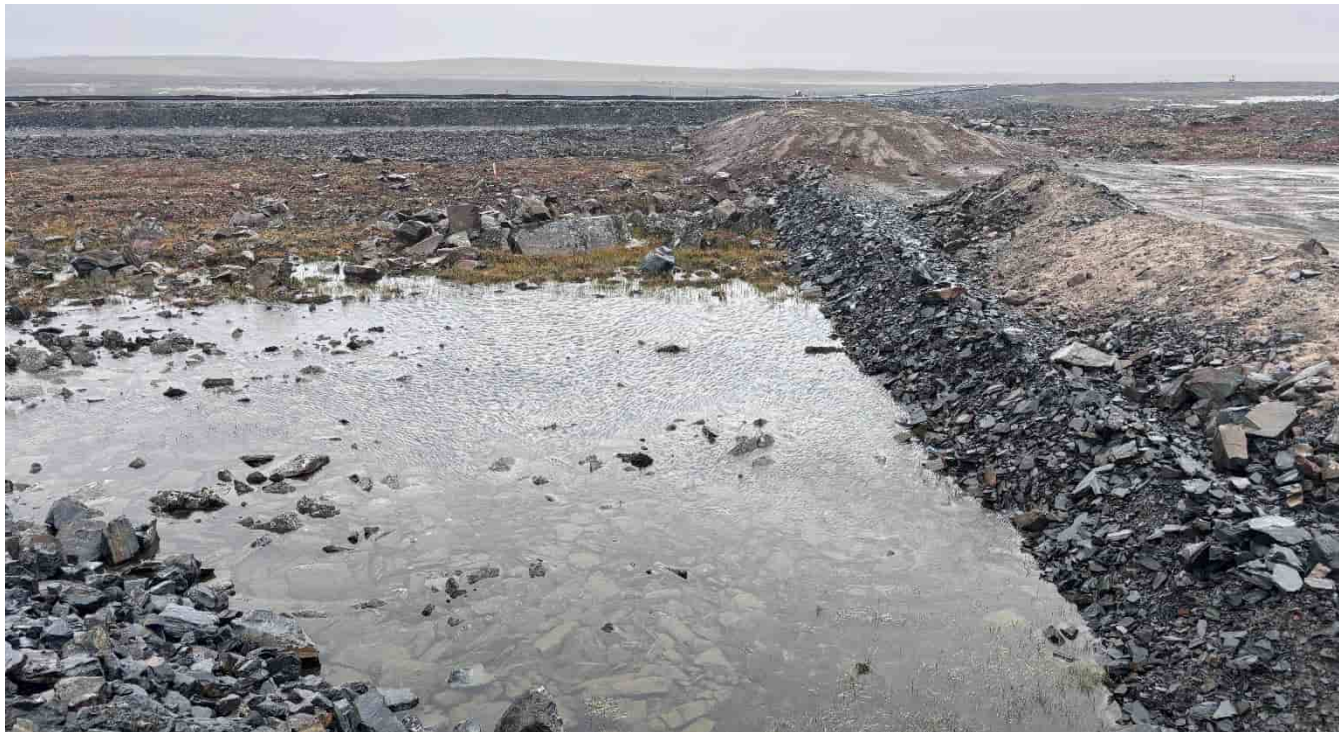
G-490: Ponding south of overburden fill
