| | | 2025 Annual Geotechnical Inspection | | |
| | | Primary Pond Dam | | |
| Job No: CAPR004312<br>Filename: Back River_Goose_2025_AGI_PhotoLog.pdf | Back River Project | Date:<br>February 2026 | Approved:<br>JBK | Figure:<br>159 |

## **Appendix B      Photolog from 2025 Site Visit – MLA**

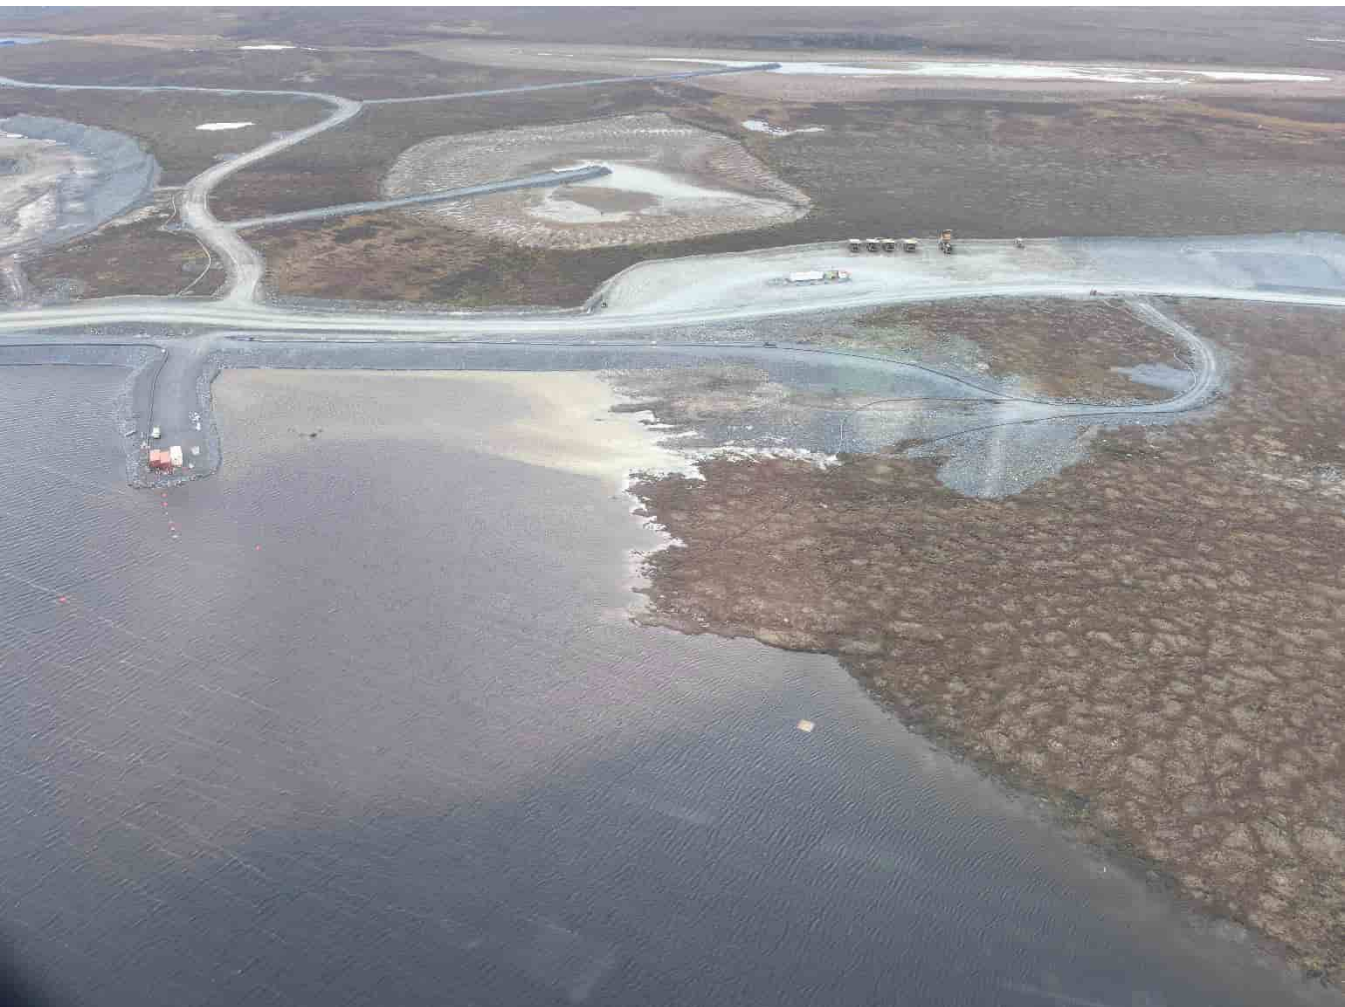
Heli Photo 4: Northern end of dam and pond, looking SW

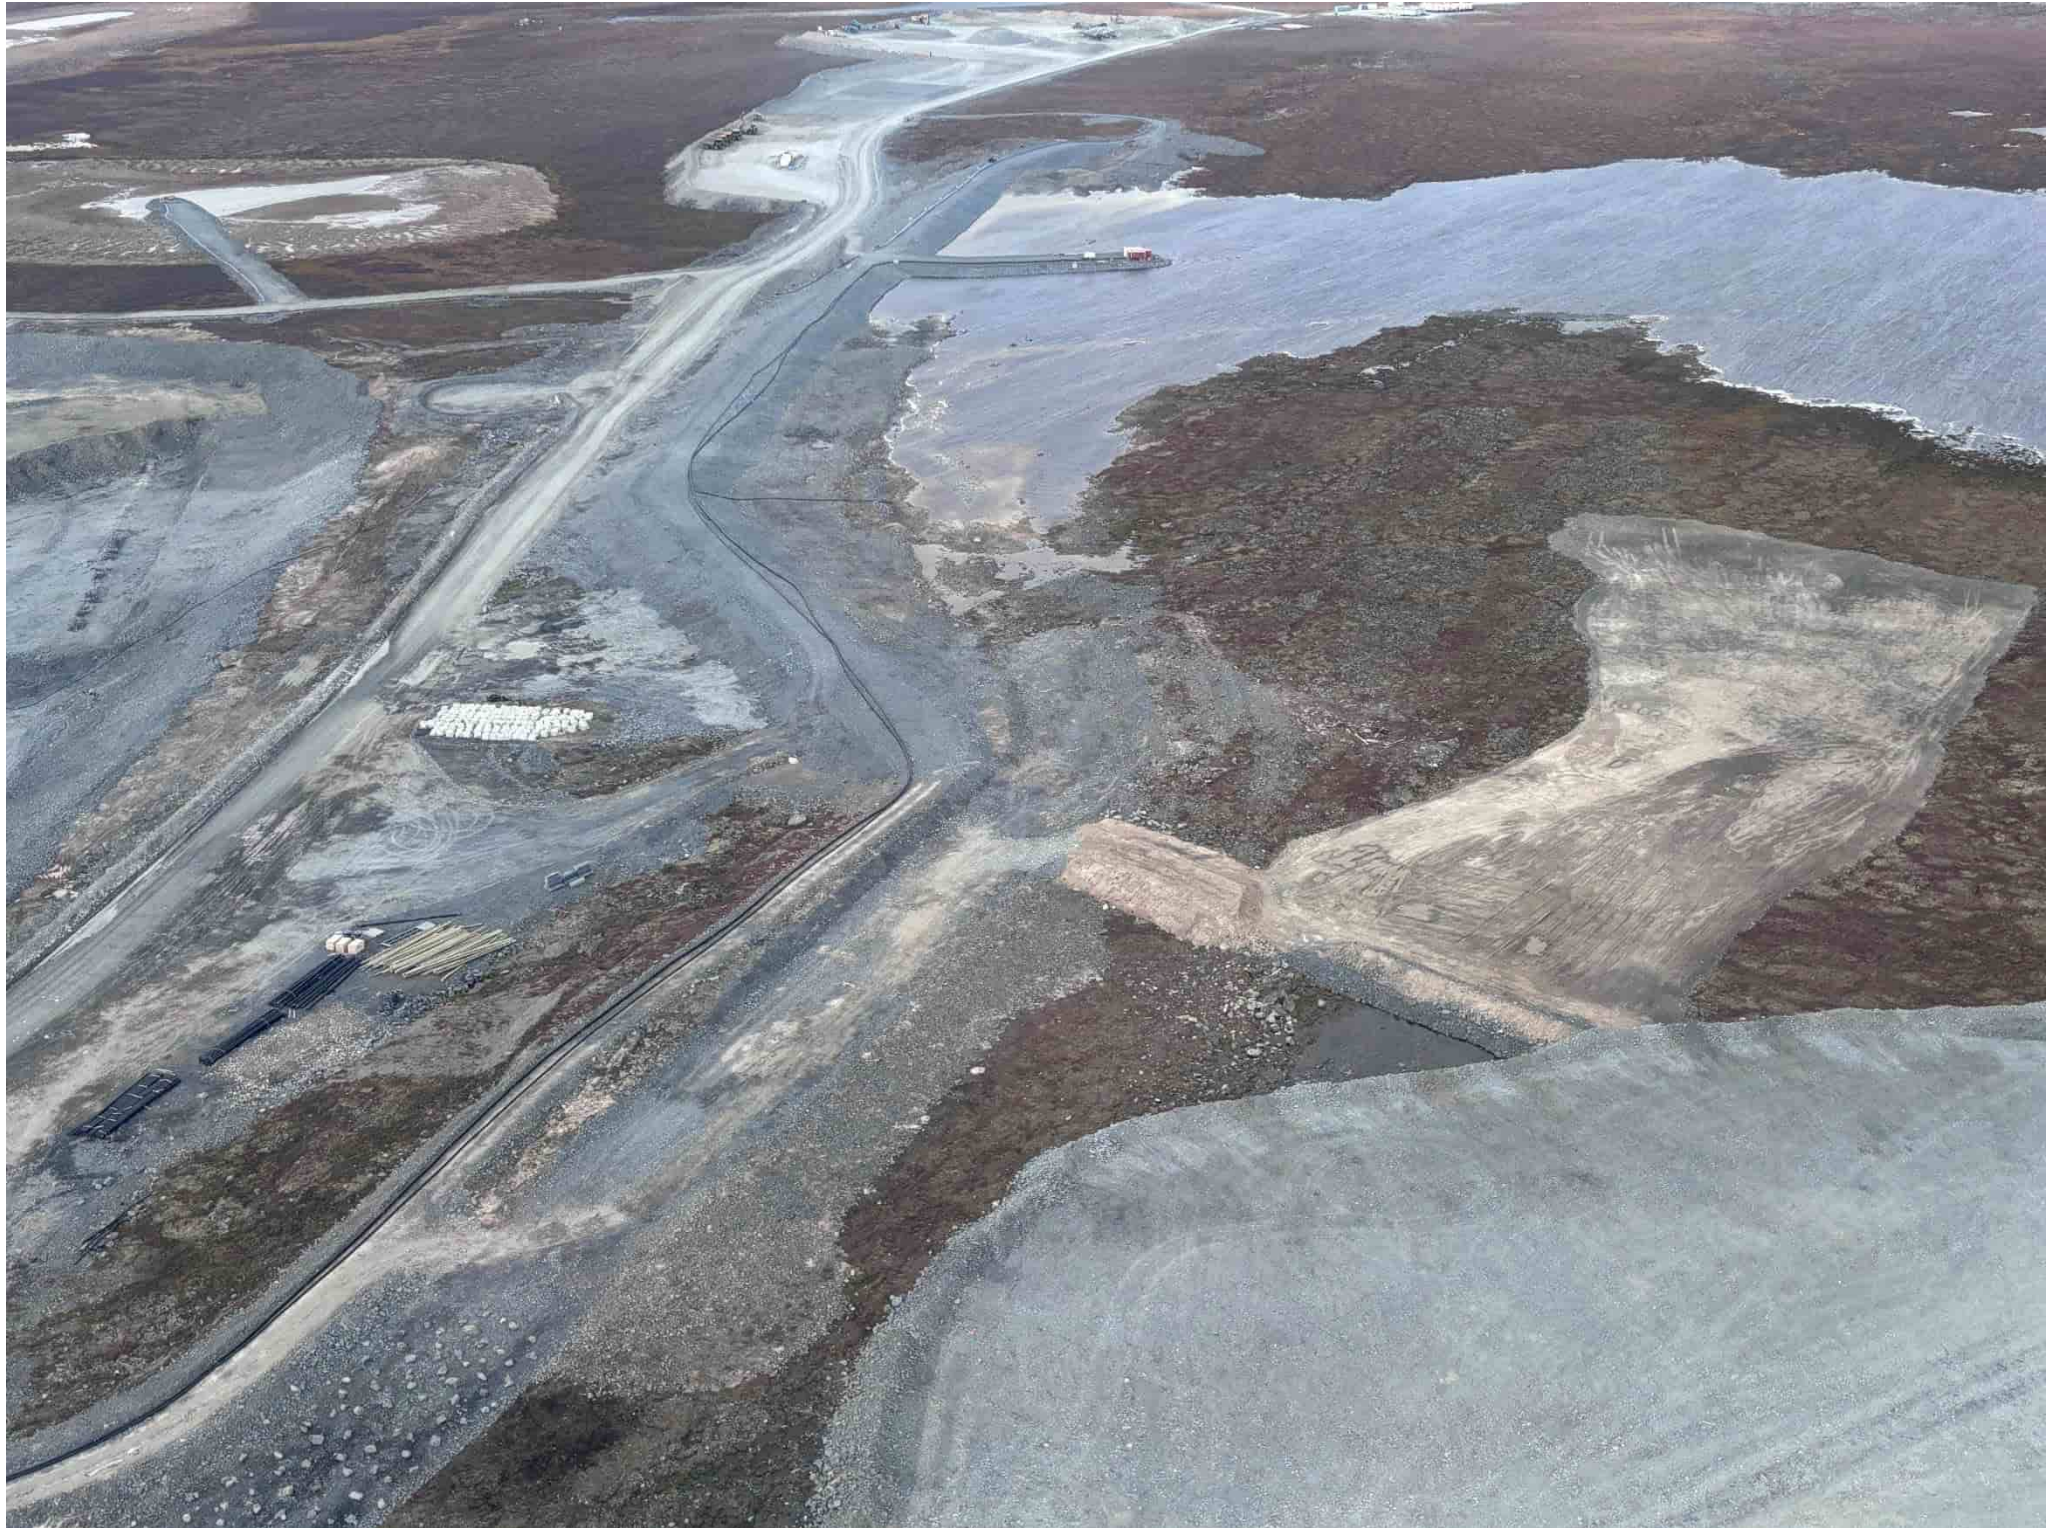
Heli Photo 5: Primary Pond, dam, and spillway, looking NW

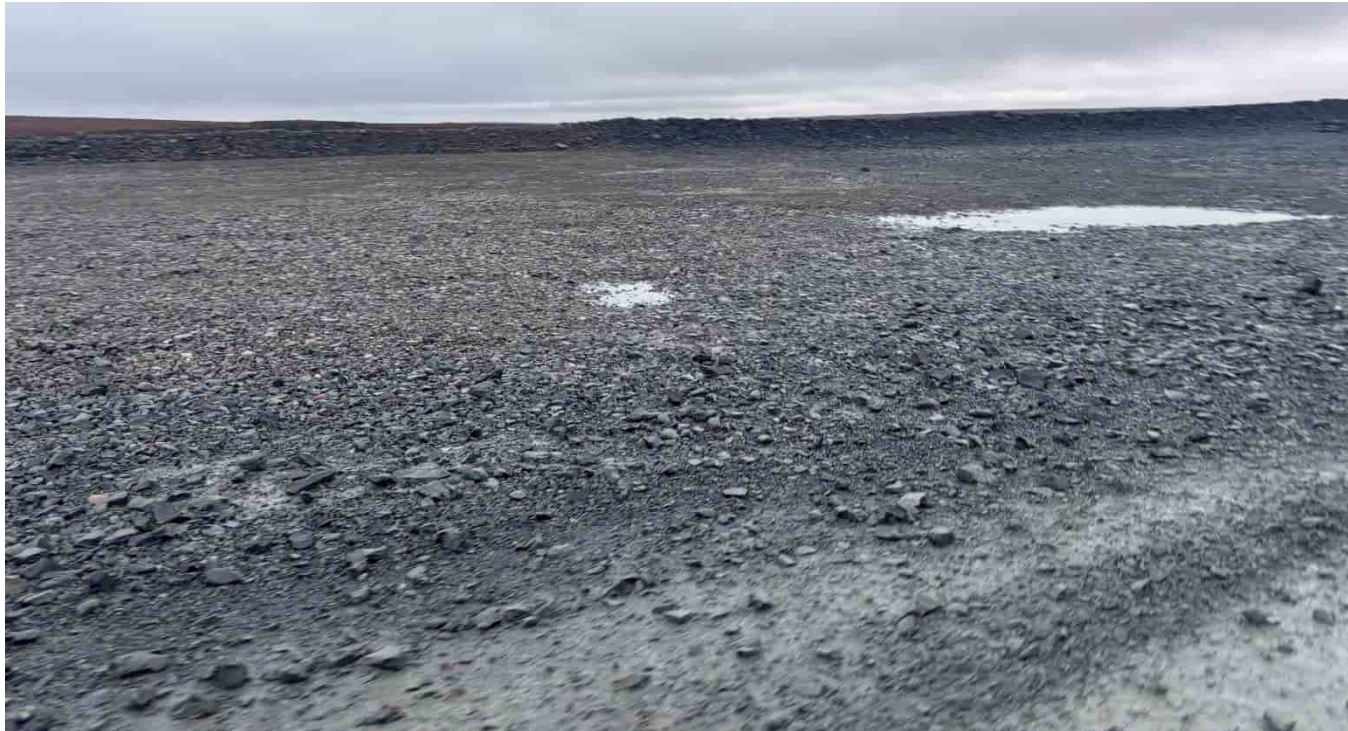
G-492: Truck laydown, looking S

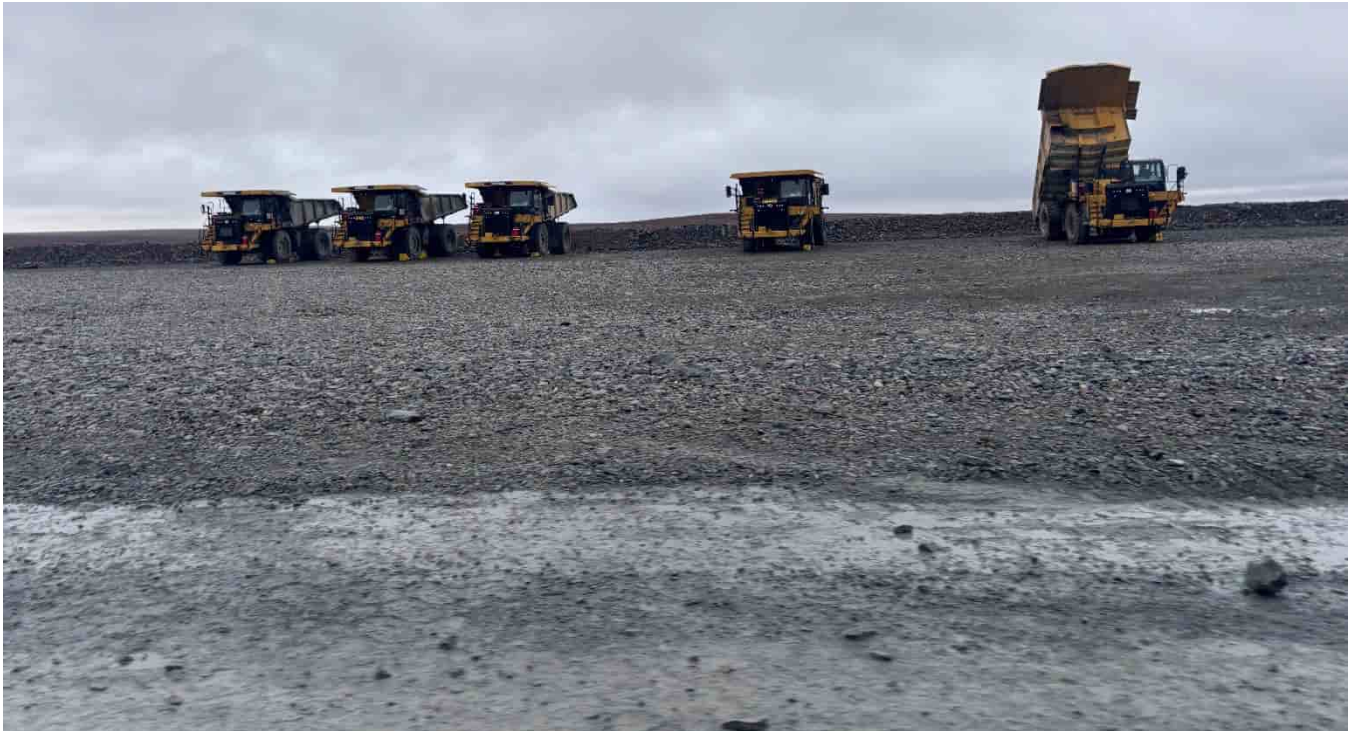
G-493: Trucks in truck laydown

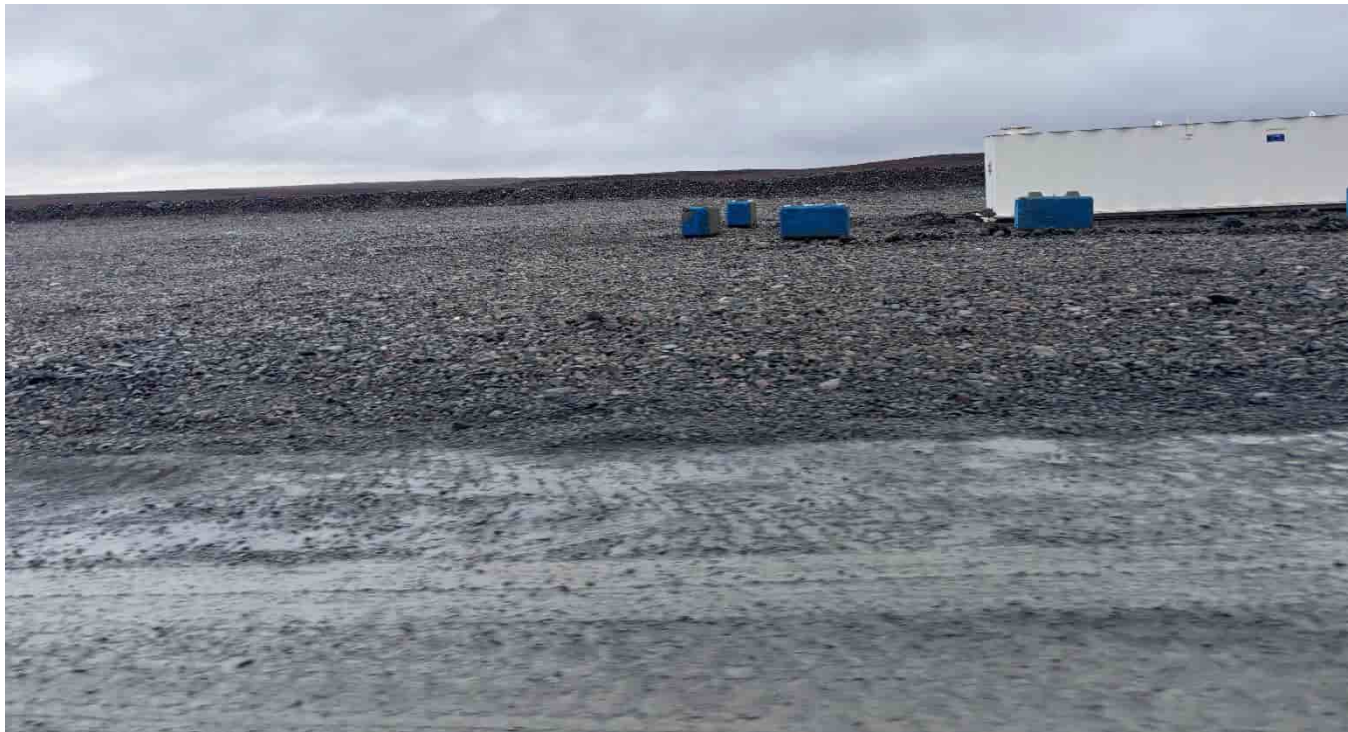
G-494: Laydown trailer, looking SW

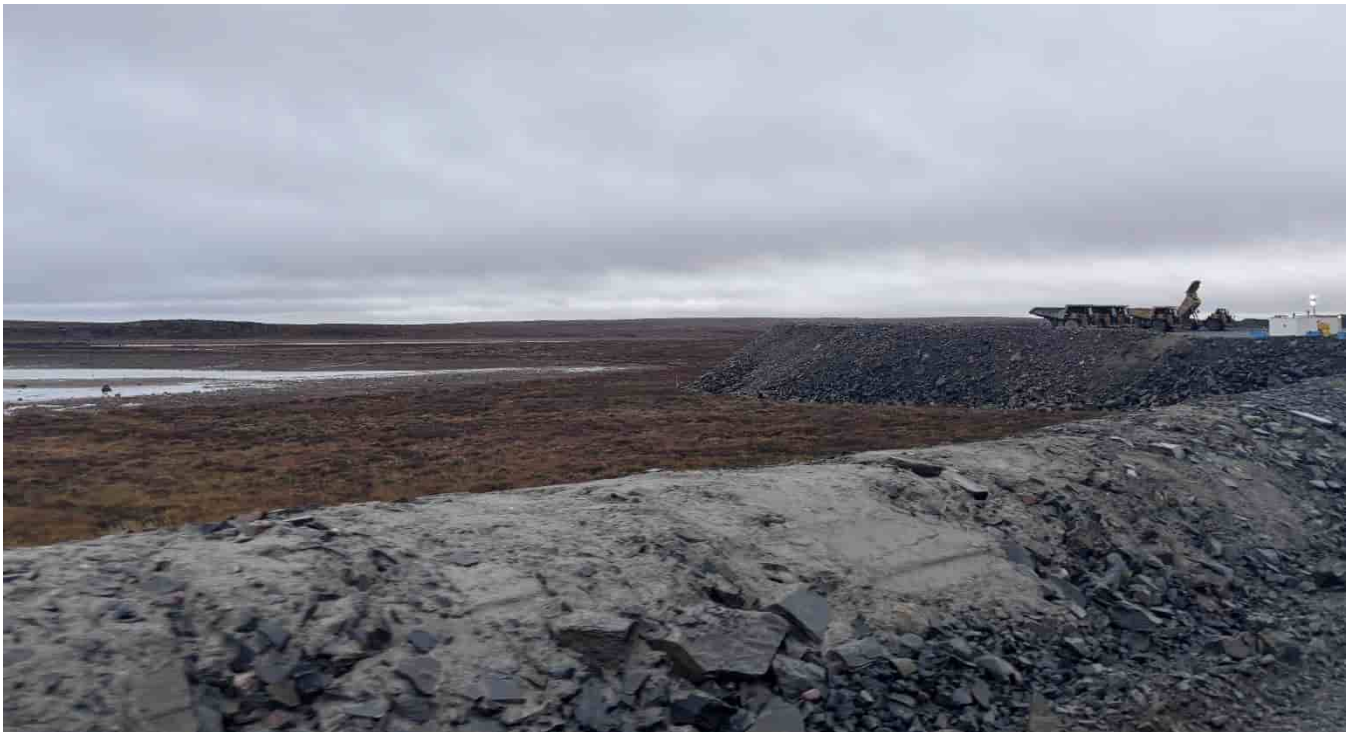
G-495: Truck laydown pad slope, looking W

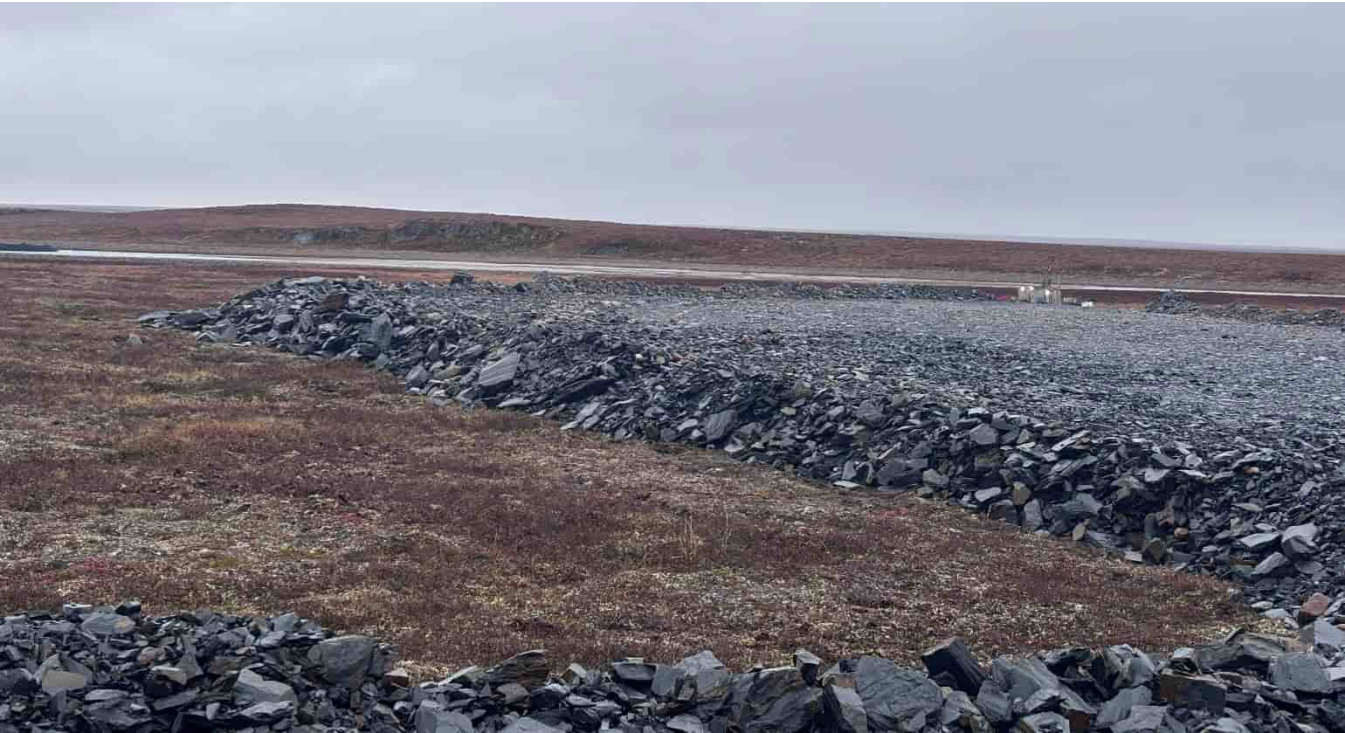
G-497: Pad S of Llama crusher pad, looking SW

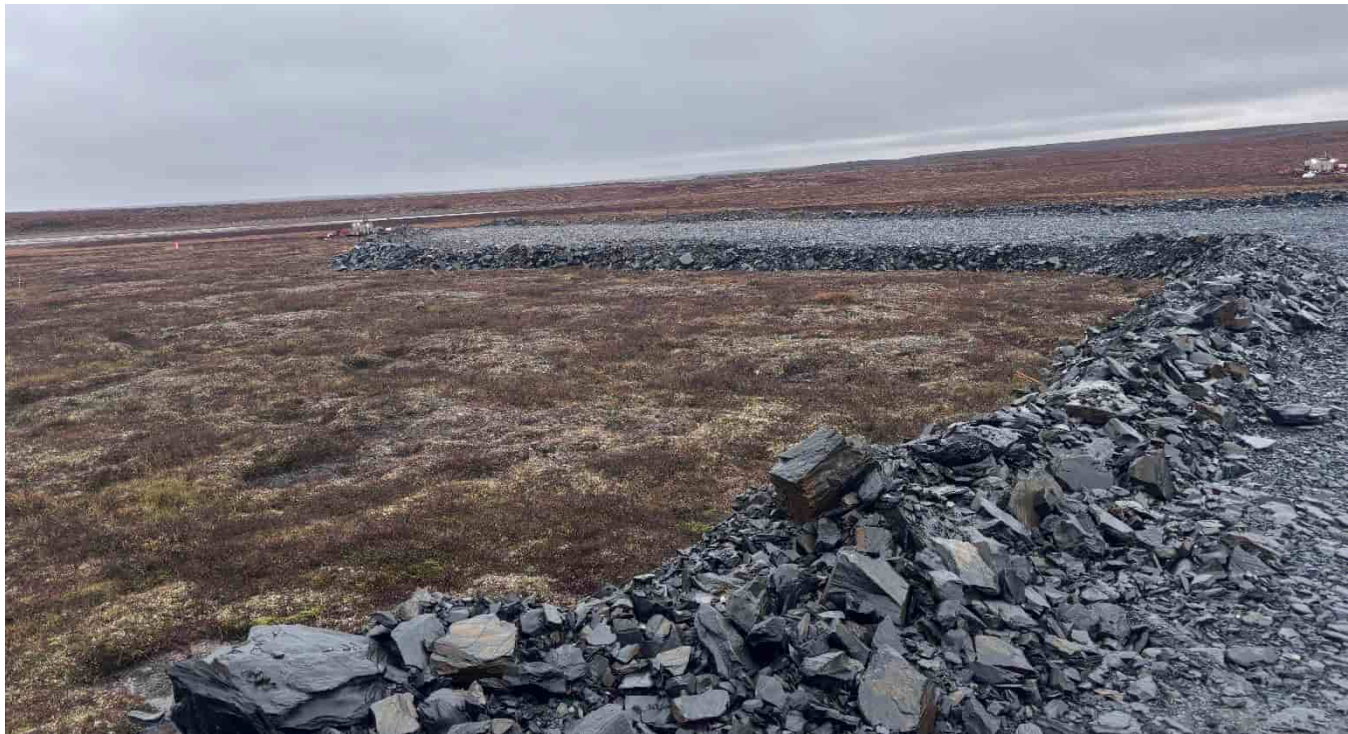
G-498: Access road typical rockfill

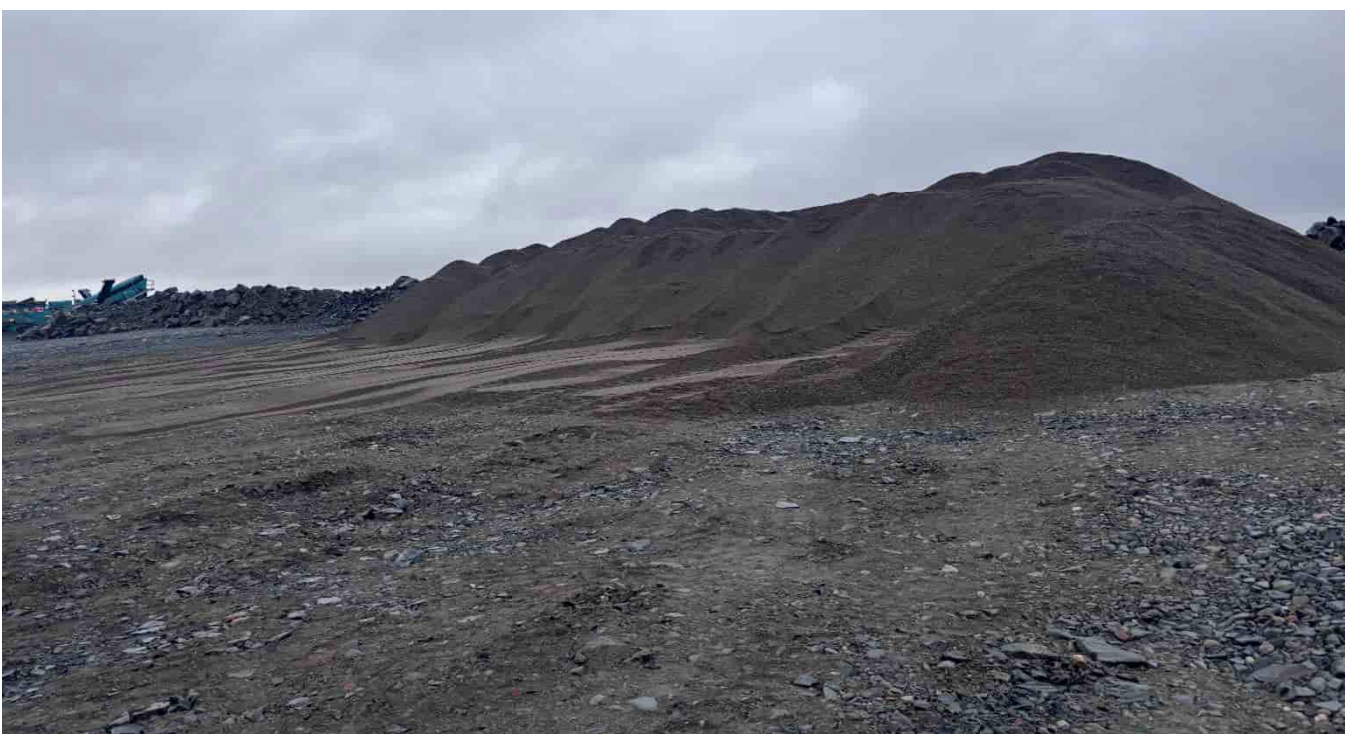
G-499: Overburden stockpile in Llama crusher pad

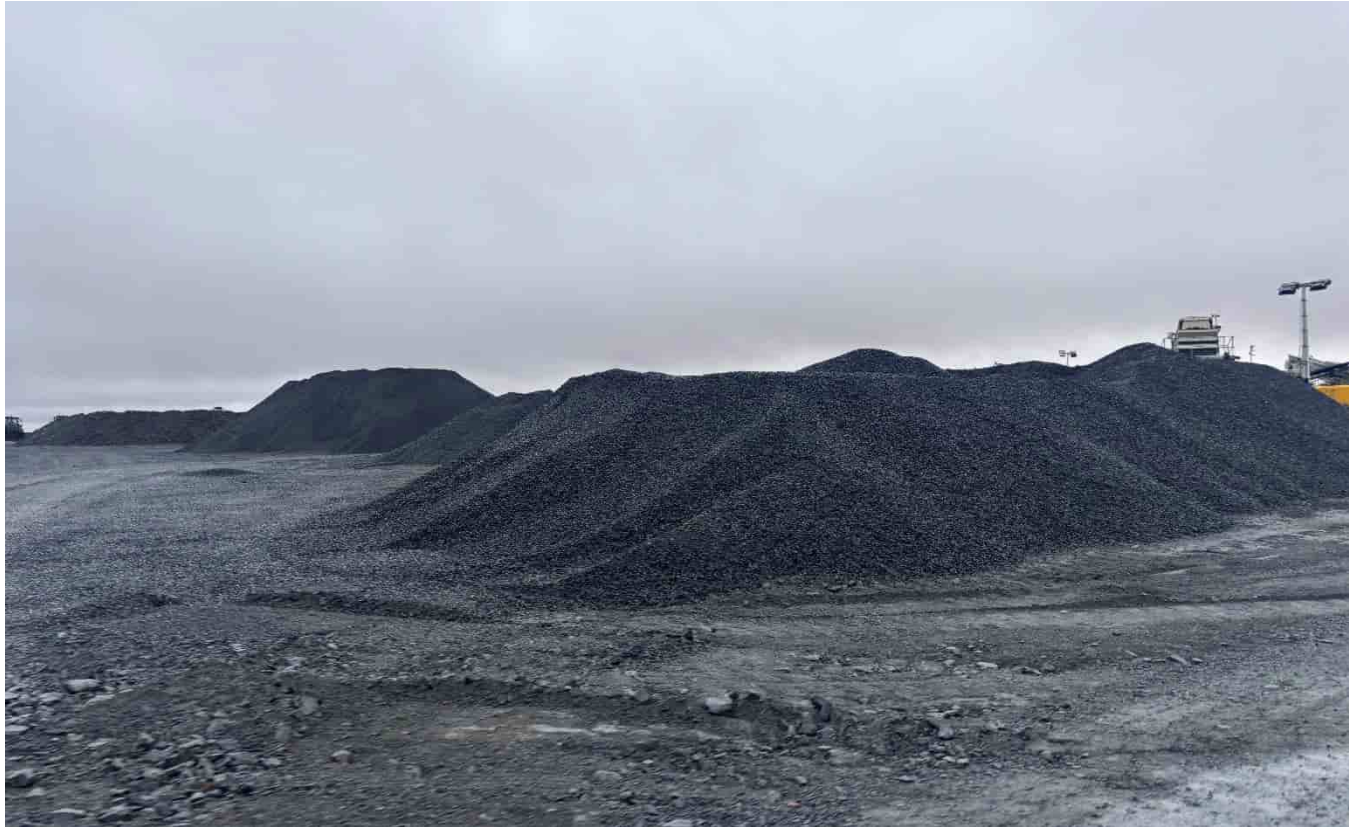
G-500A: Stockpiles on Llama crusher pad, looking SW from the All-Season Road

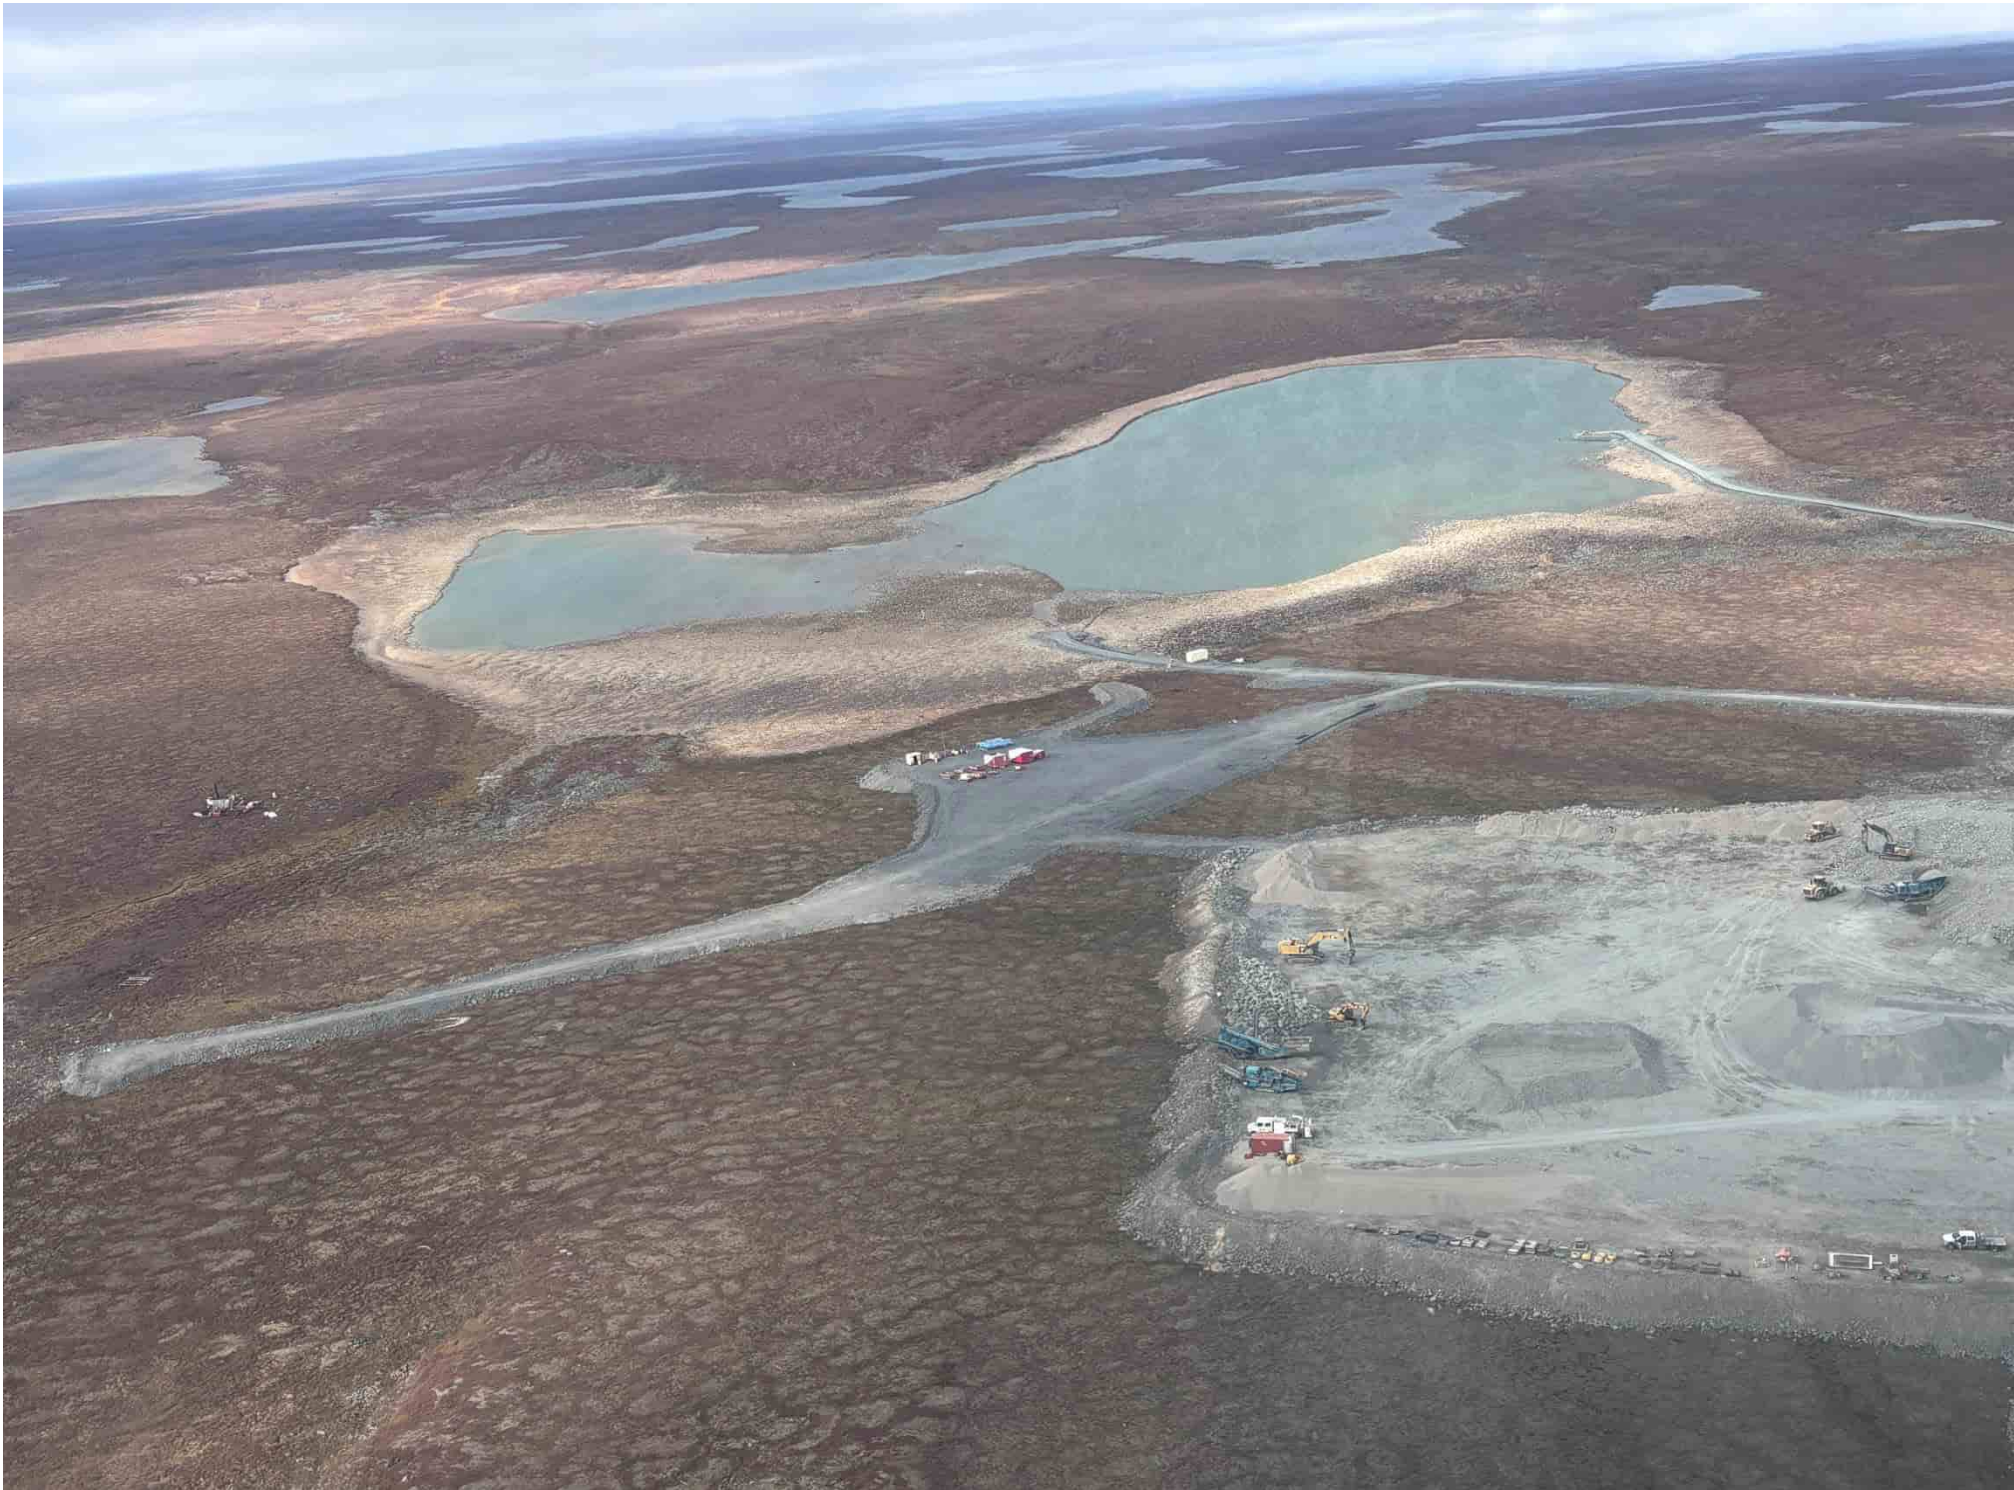
Heli Photo: Llama Lake and crusher pad, looking N – lake dewatering in progress

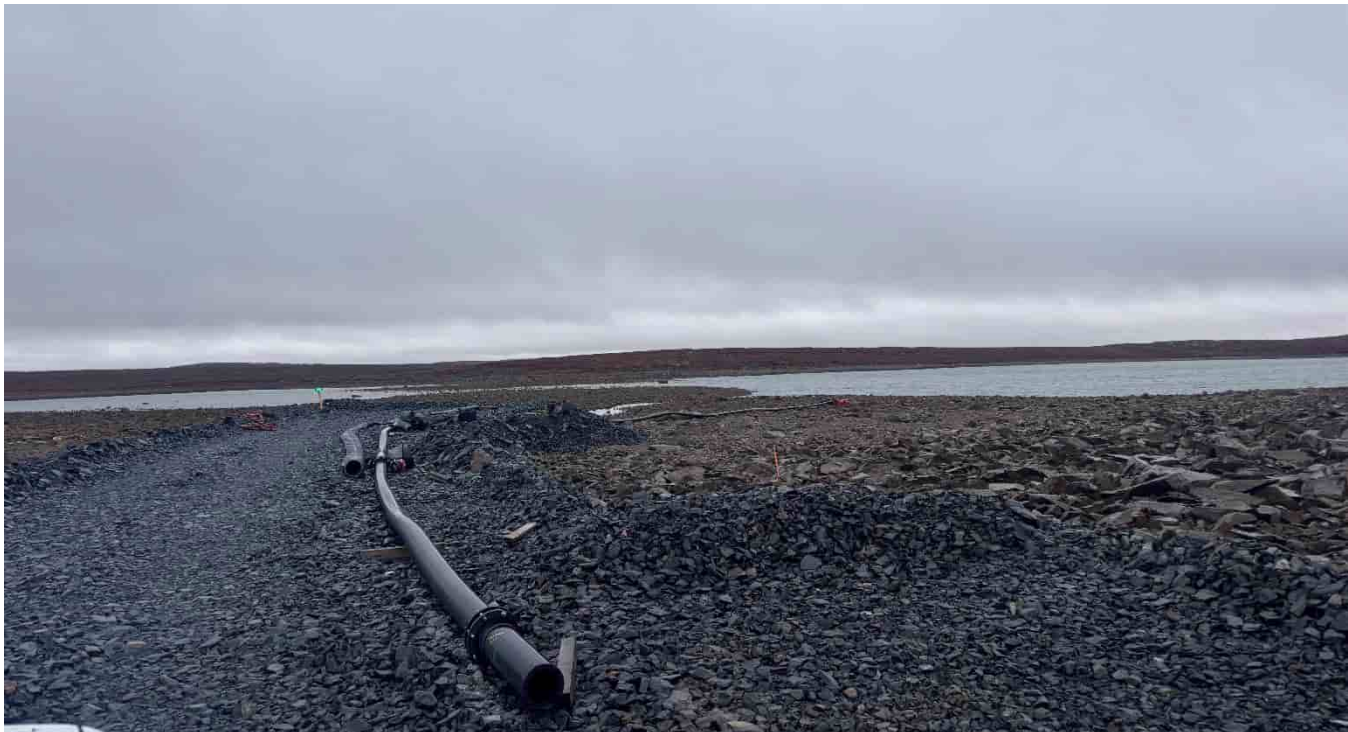
G-502: Unconnected pipeline to Llama Lake, looking W

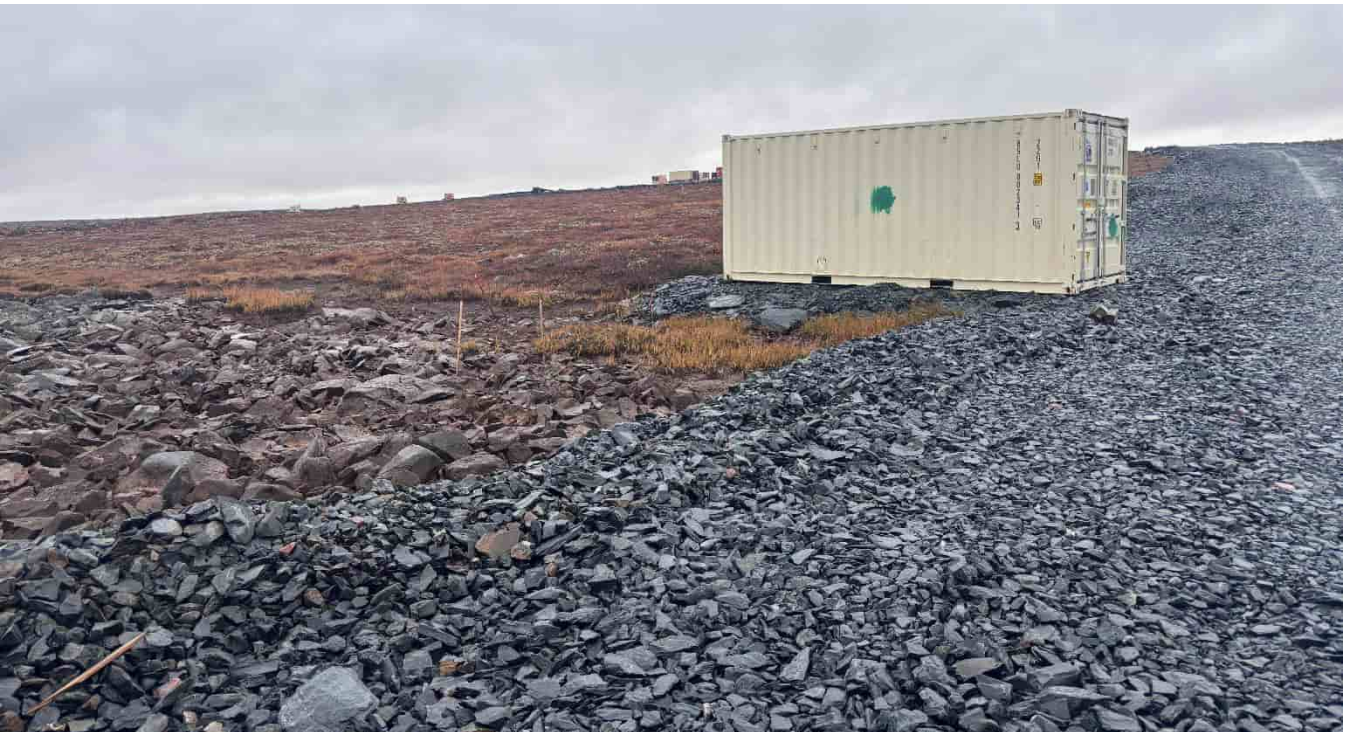
G-503A: Seacan beside access road, looking E

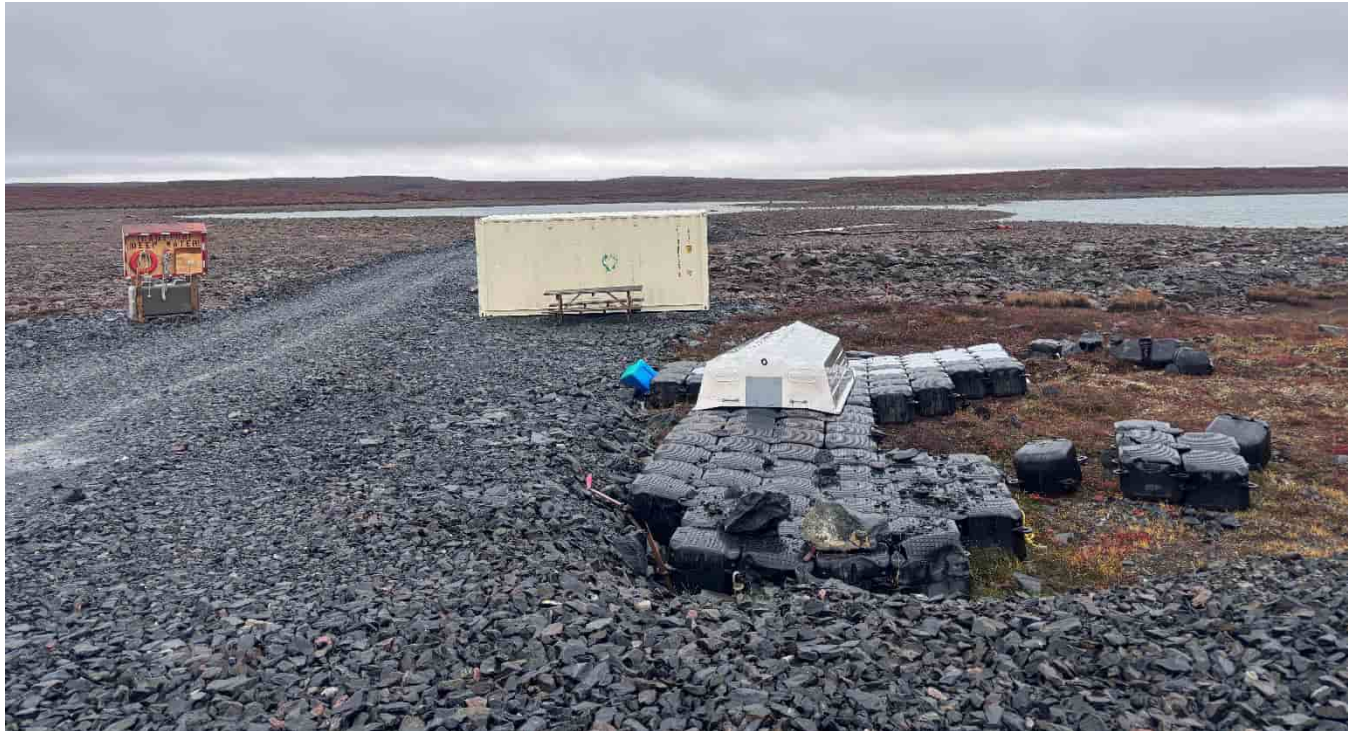
G-503B: Laydown and seacan beside access road, looking W some items directly on tundra

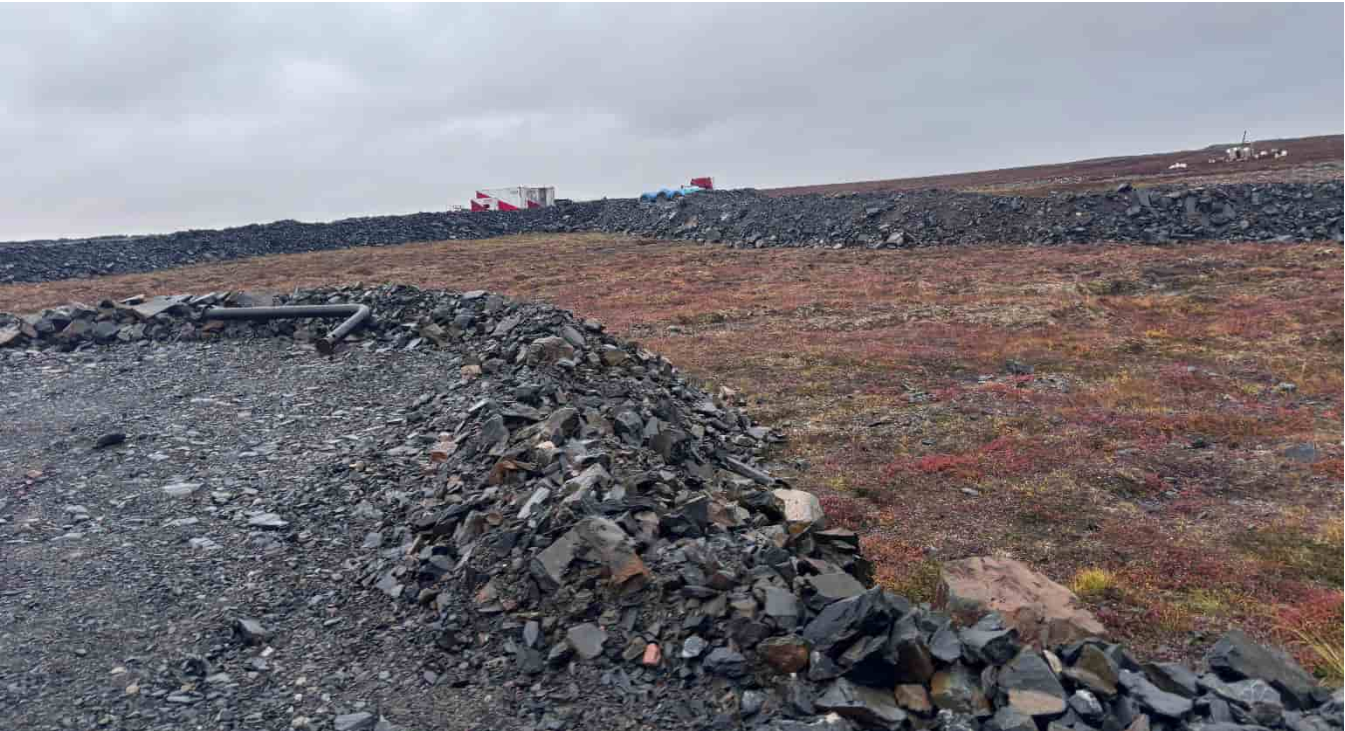
G-504: Pad slopes beside access road, looking S

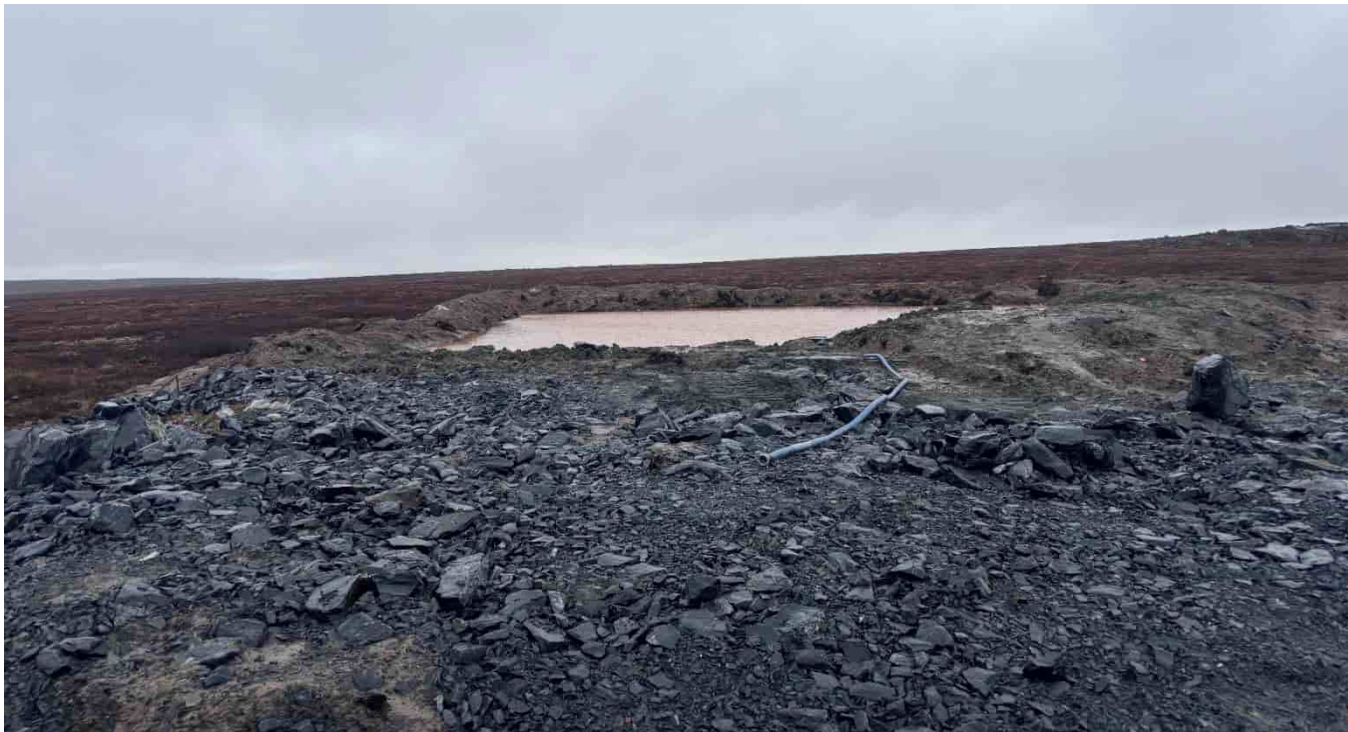
G-505A: Major drilling "pond" (unengineered) as seen from All-Weather Road, looking E

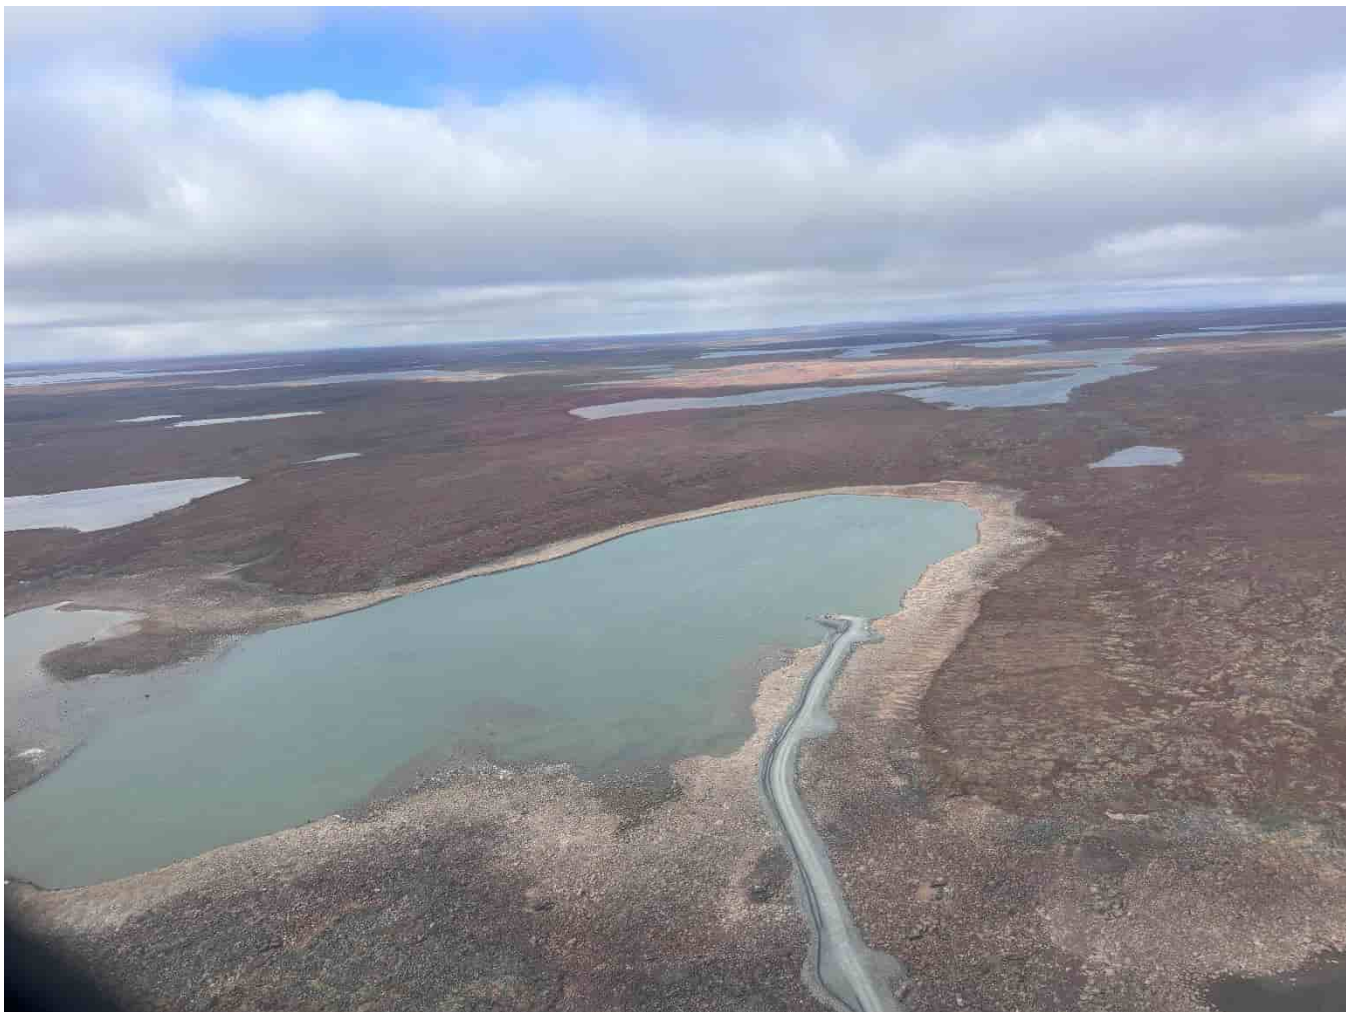
Heli Photo 7: Llama Lake northern access road, looking N

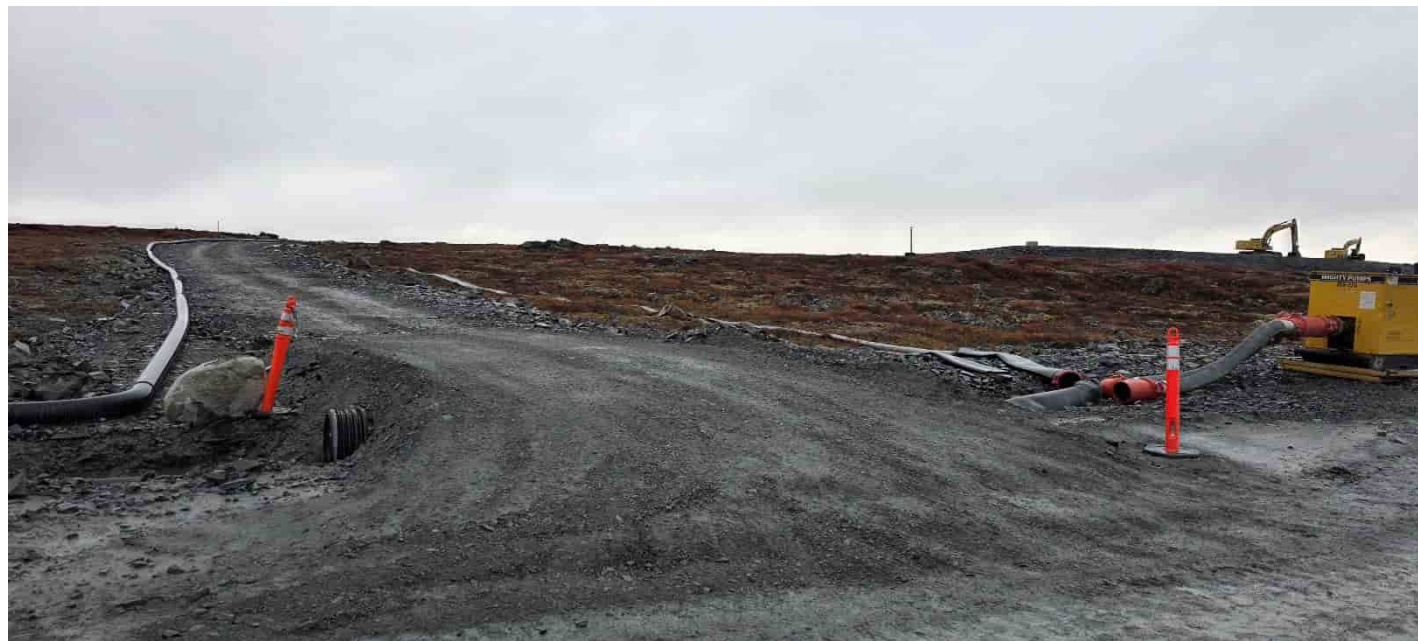
G-506: Culvert under northern access road to Primary Pond, looking E from the All-Season Road
