| | | 2025 Annual Geotechnical Inspection | | |
| | | Primary Pond Dam | | |
| Job No: CAPR004312<br>Filename: Back River_Goose_2025_AGI_PhotoLog.pdf | Back River Project | Date:<br>February 2026 | Approved:<br>JBK | Figure:<br>159 |

## **Appendix B      Photolog from 2025 Site Visit – MLA**

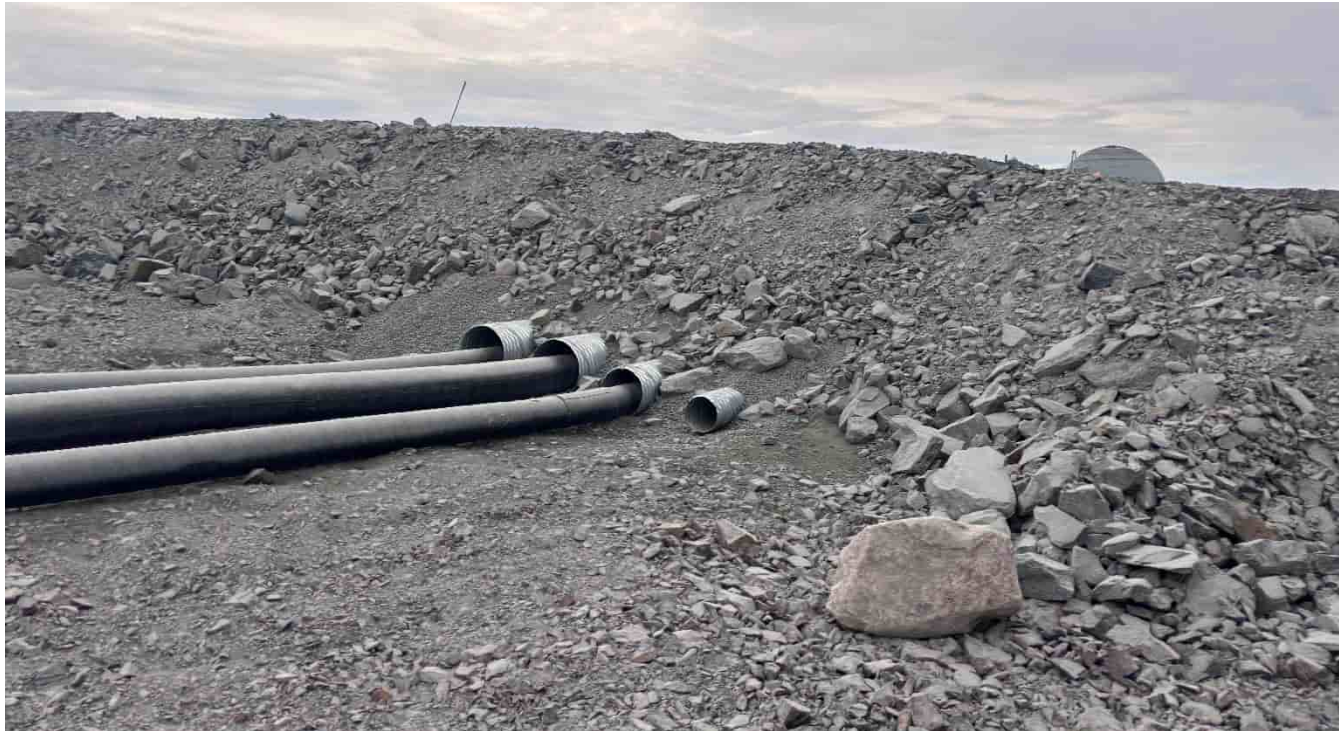
G-507: Tailings pipeline crossing under ROM stockpile western access road, looking SW

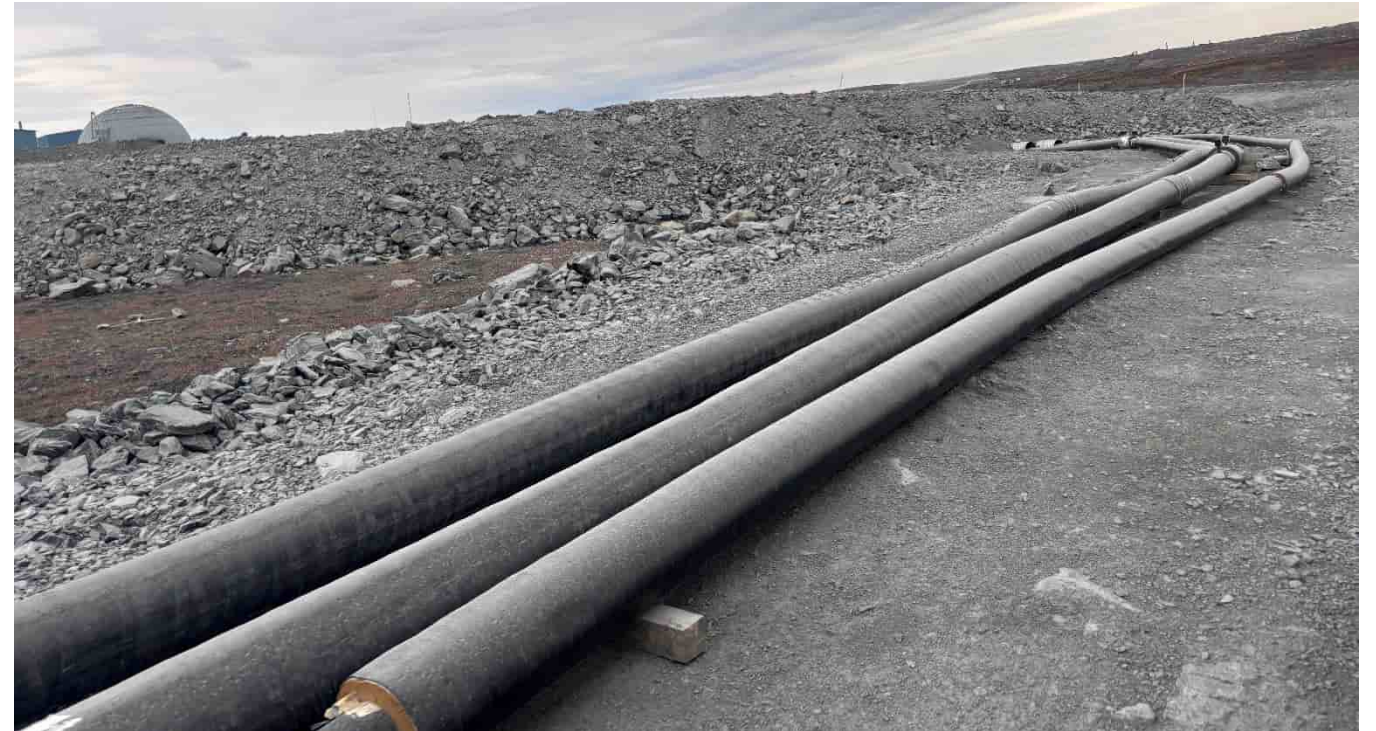
G-508: Tailings pipelines, looking NW

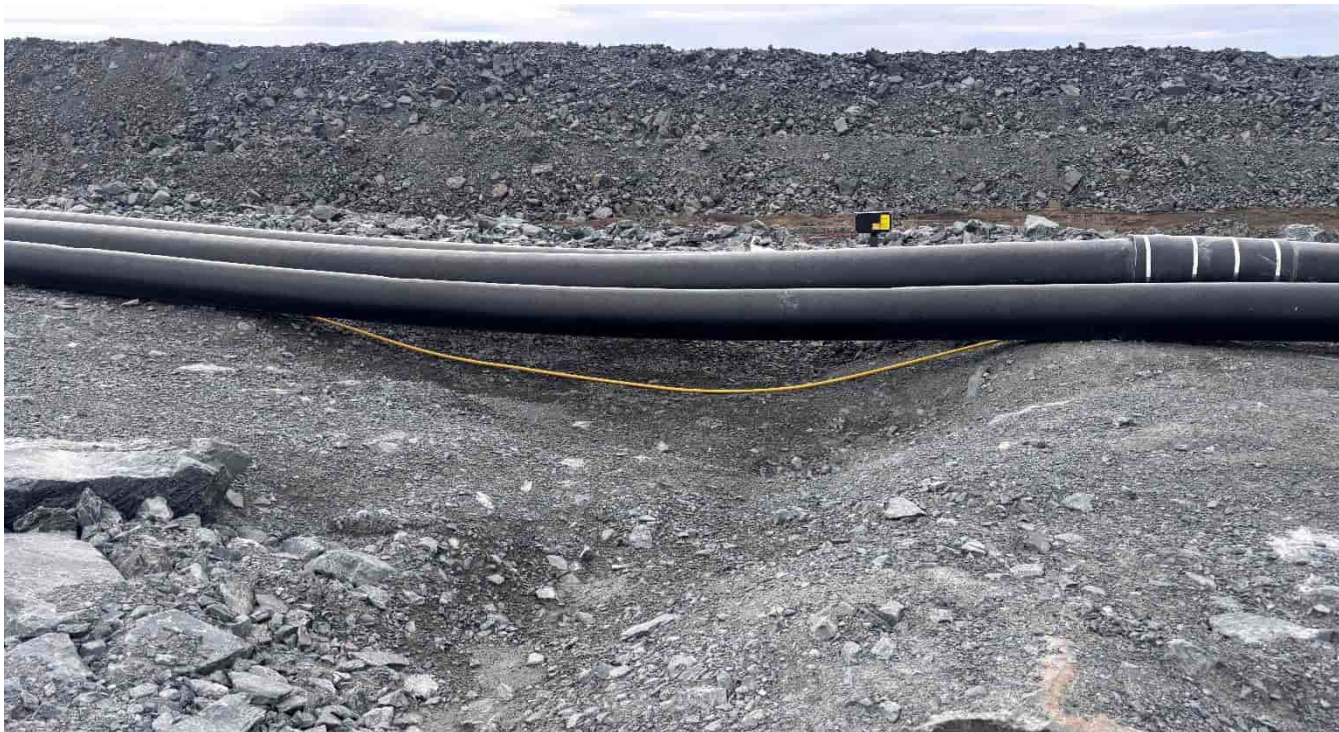
G-509: Depression in tailings pipeline road, piping suspended in smaller sections

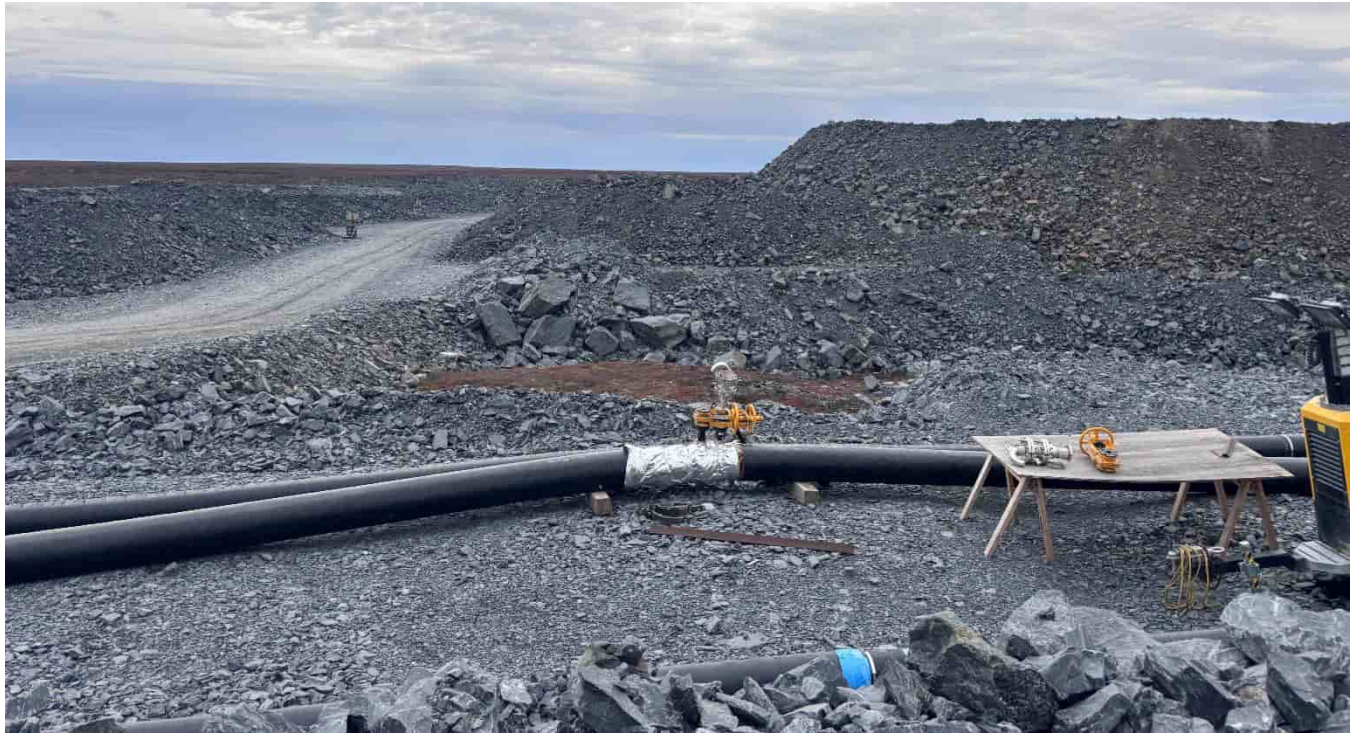
G-511: Tailings pipeline connection, looking SW towards ROM stockpile

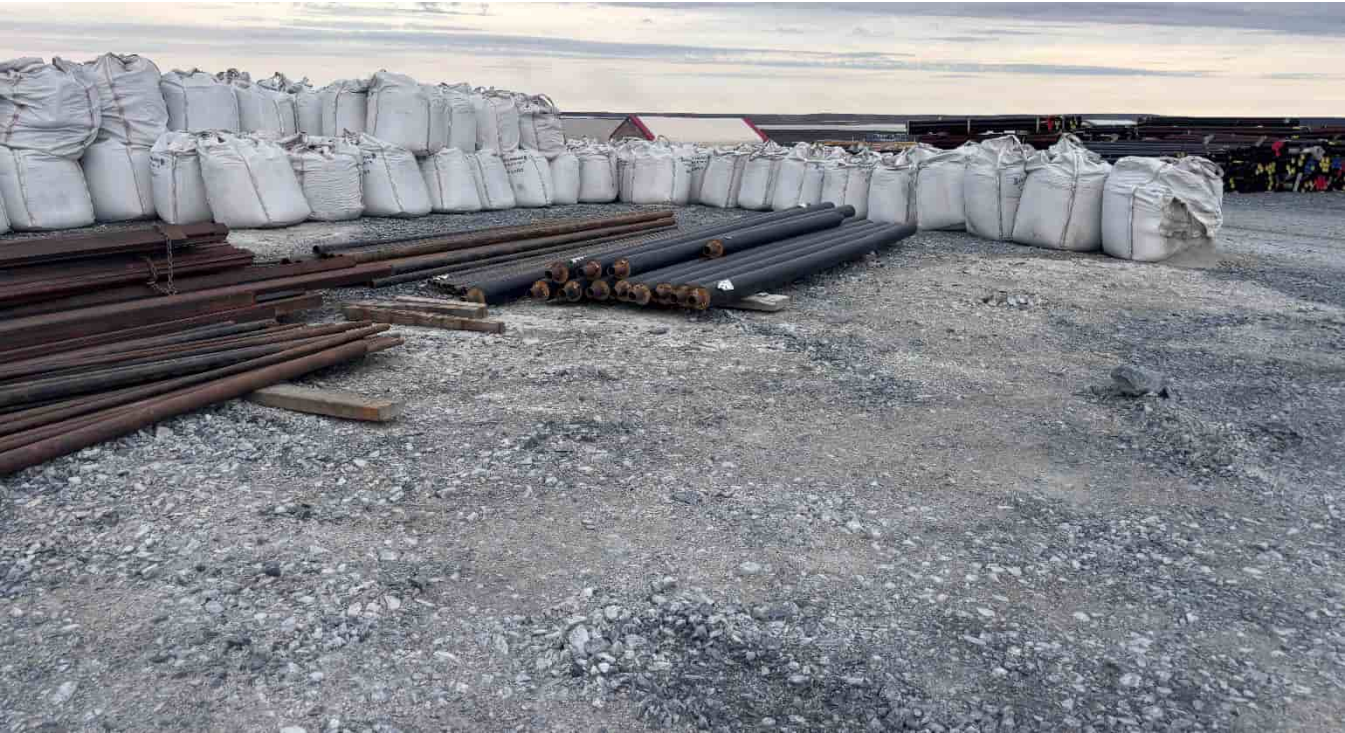
G-512: Cement and pipe laydown

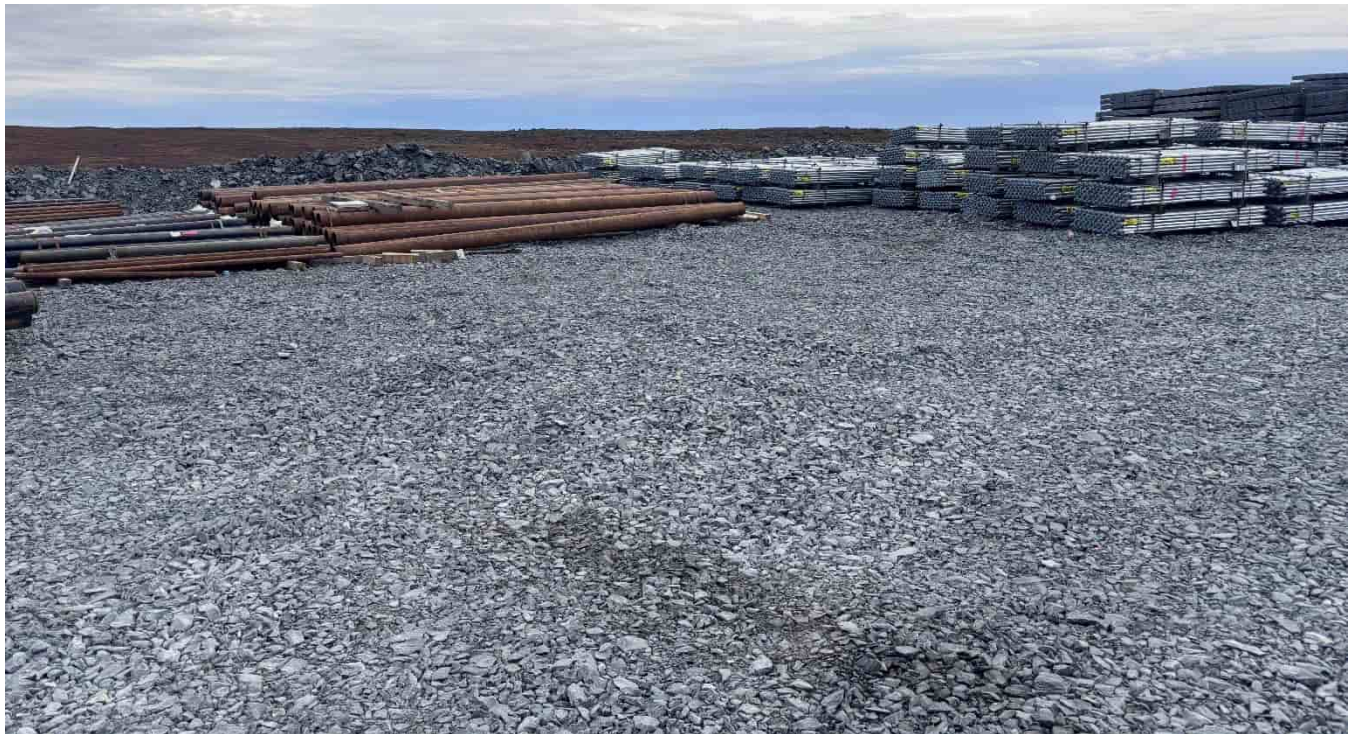
G-513: Pipe laydown beside tailings corridor

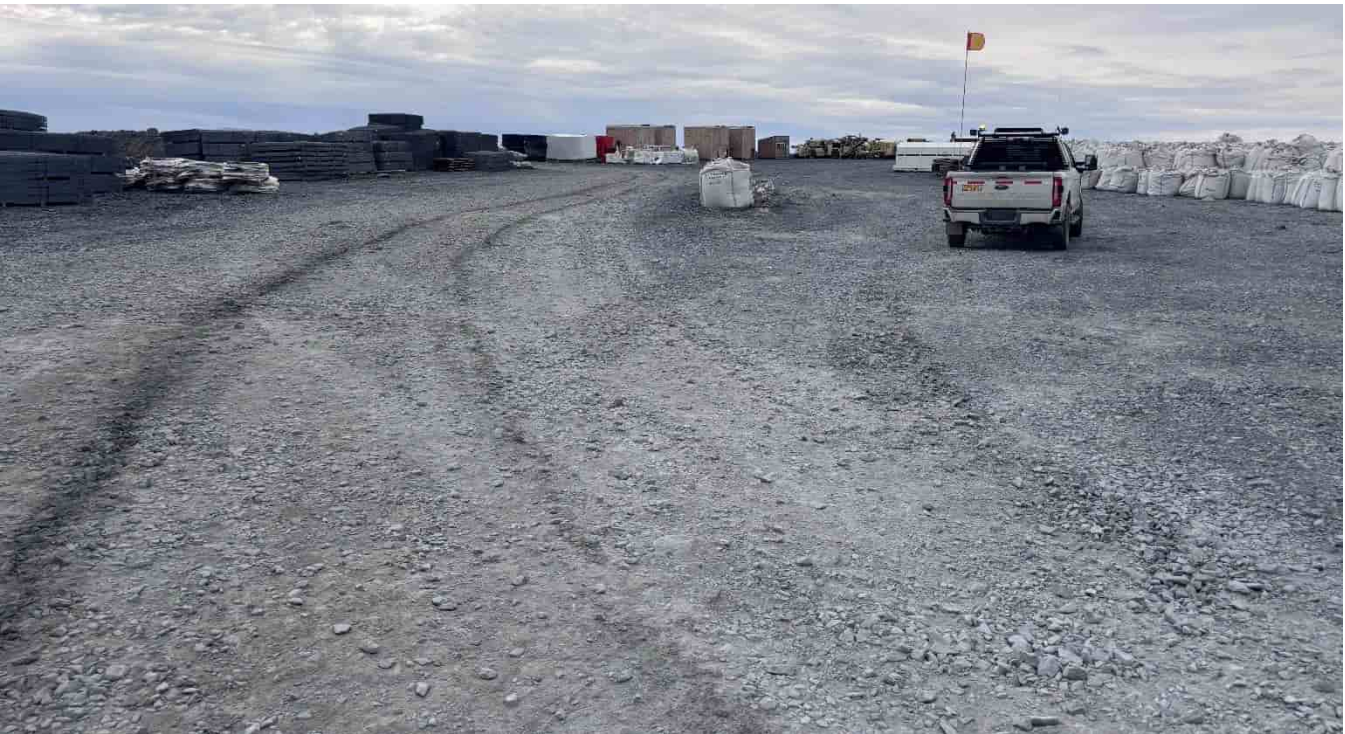
G-514: Cement laydown area access, looking NE

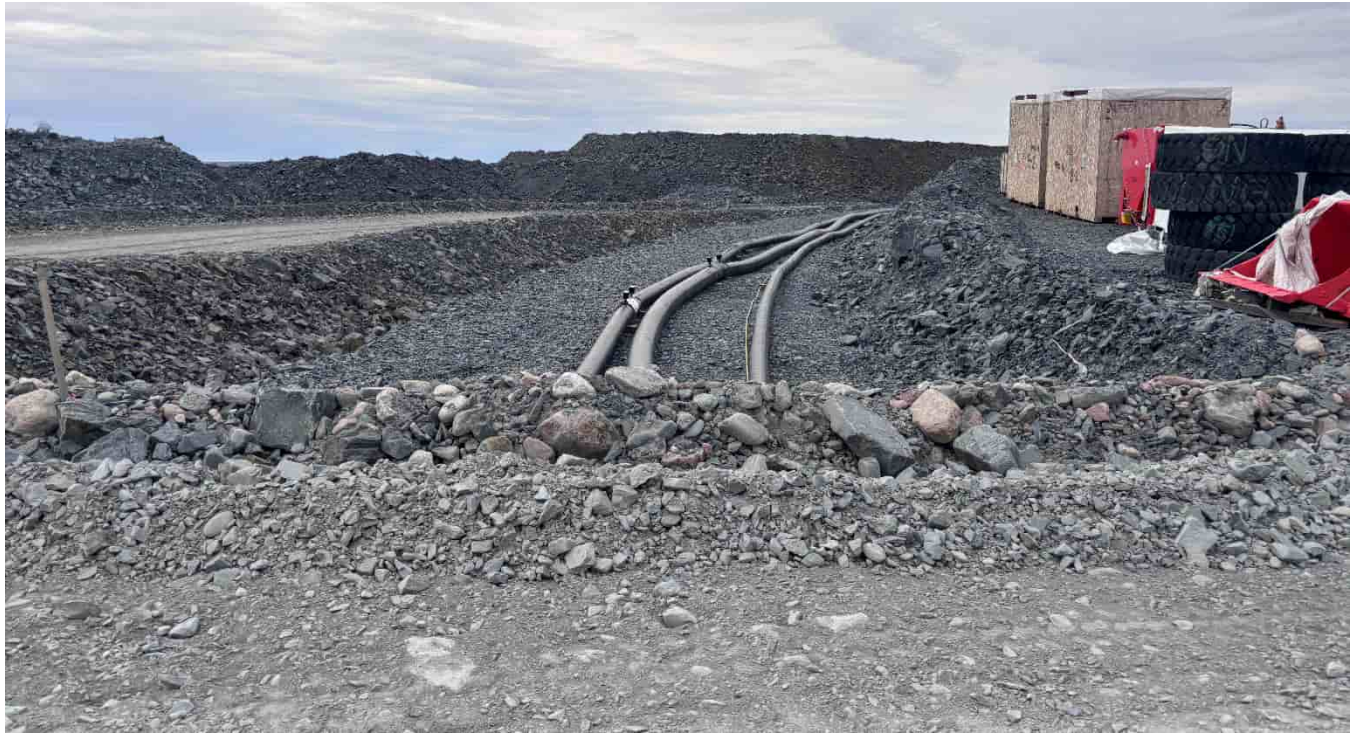
G-515: Tailings pipelines crossing under ROM stockpile eastern access road, looking W

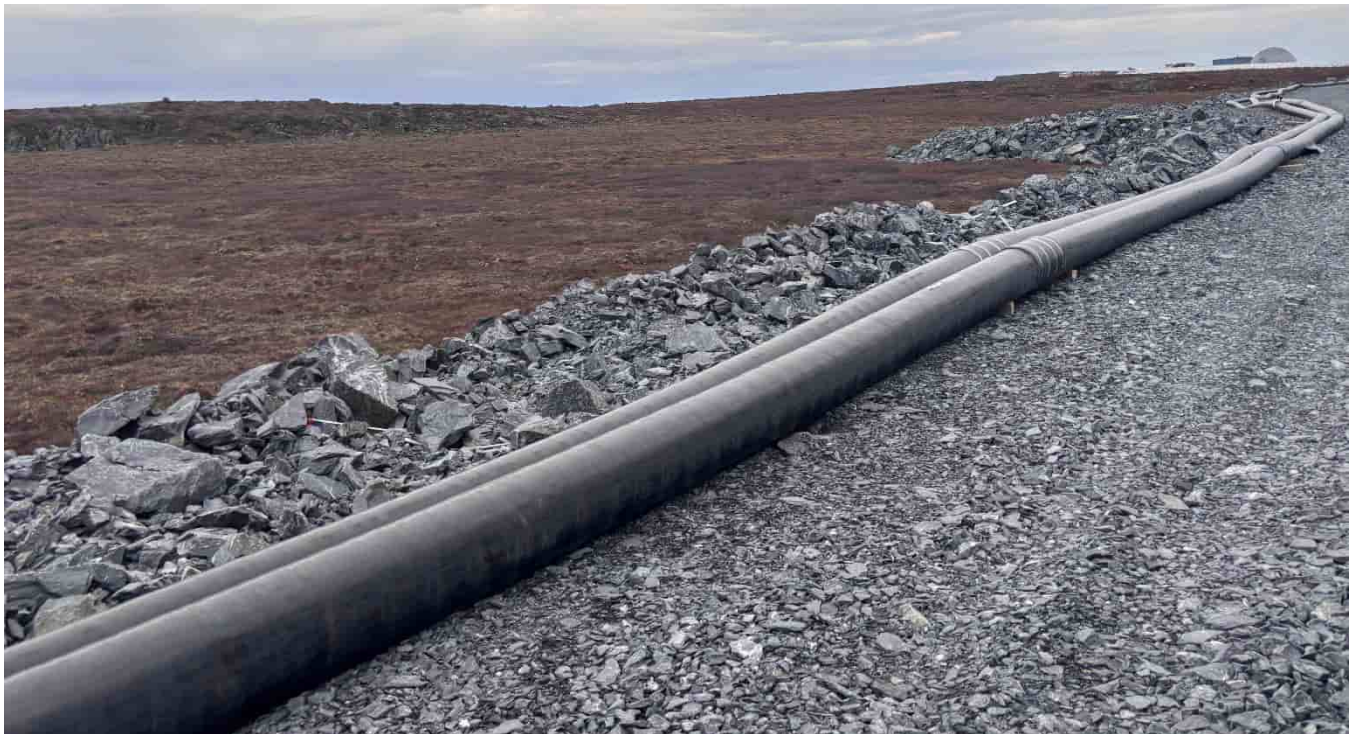
G-517: Tailings pipeline along southern rockfill, looking W

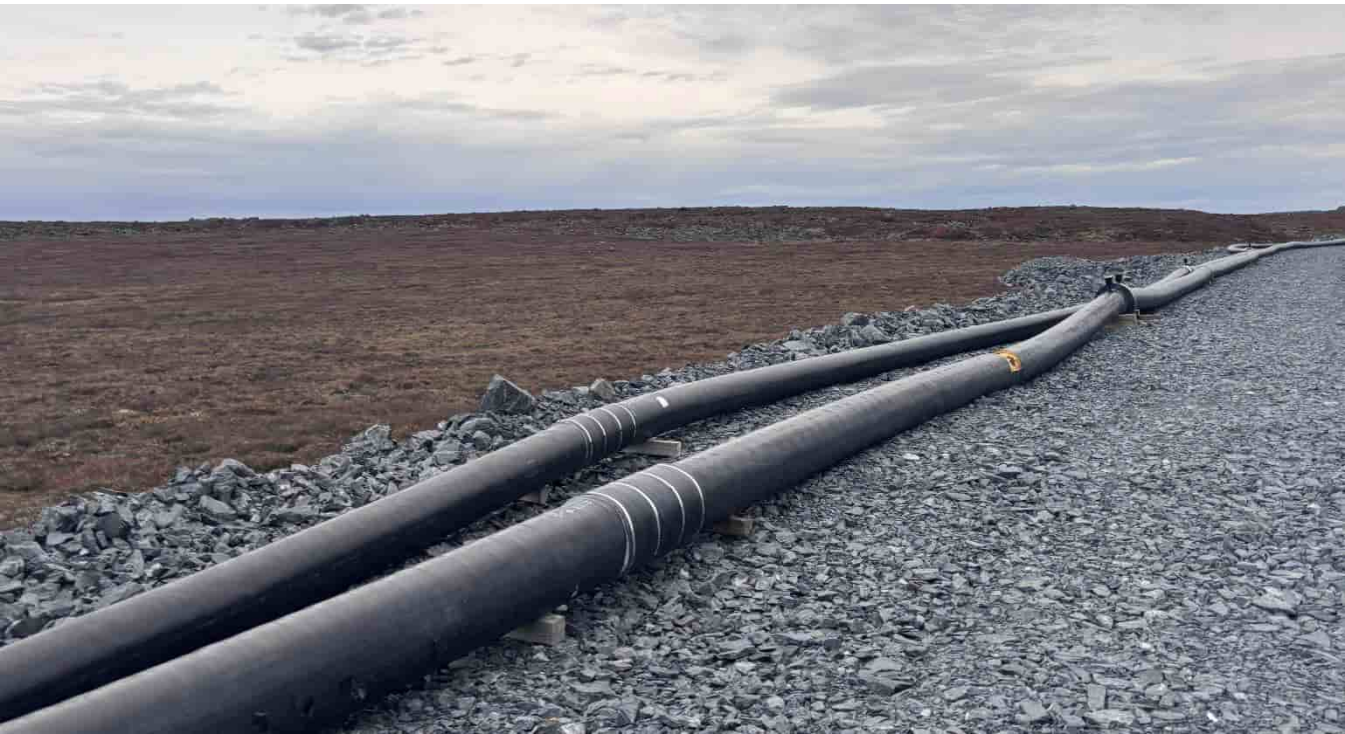
G-518: Tailings pipeline along southern rockfill, looking W

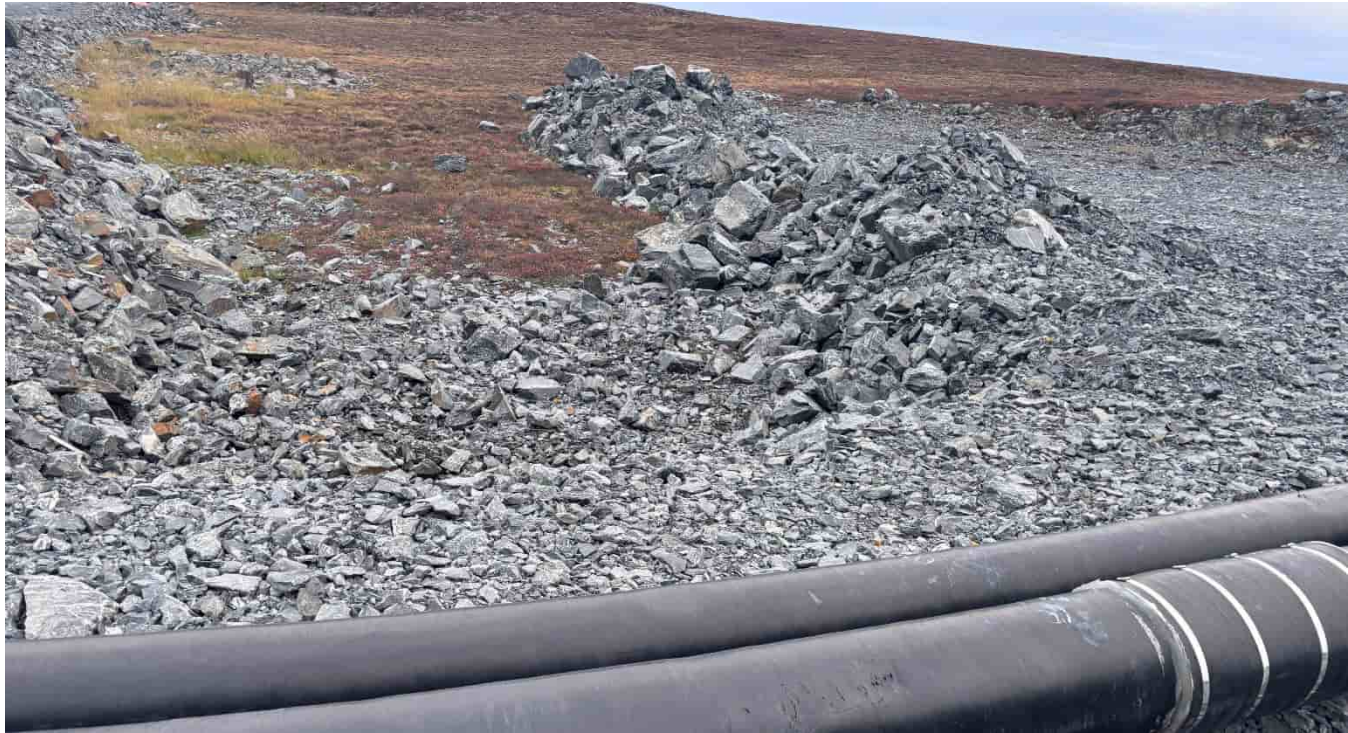
G-519: Pad on S side of tailings pipeline corridor beside Echo Pit Haul Road, looking S

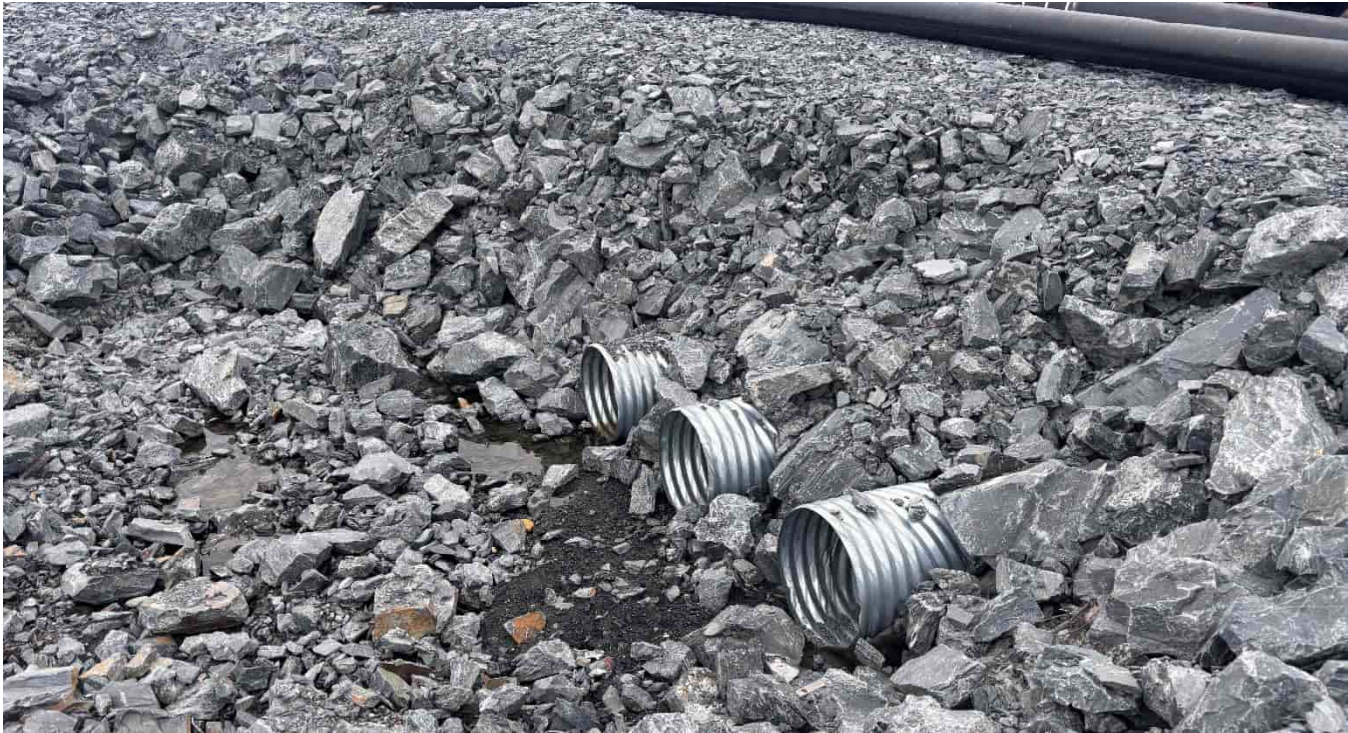
G-520: Culvert inlets (S side) under tailings corridor

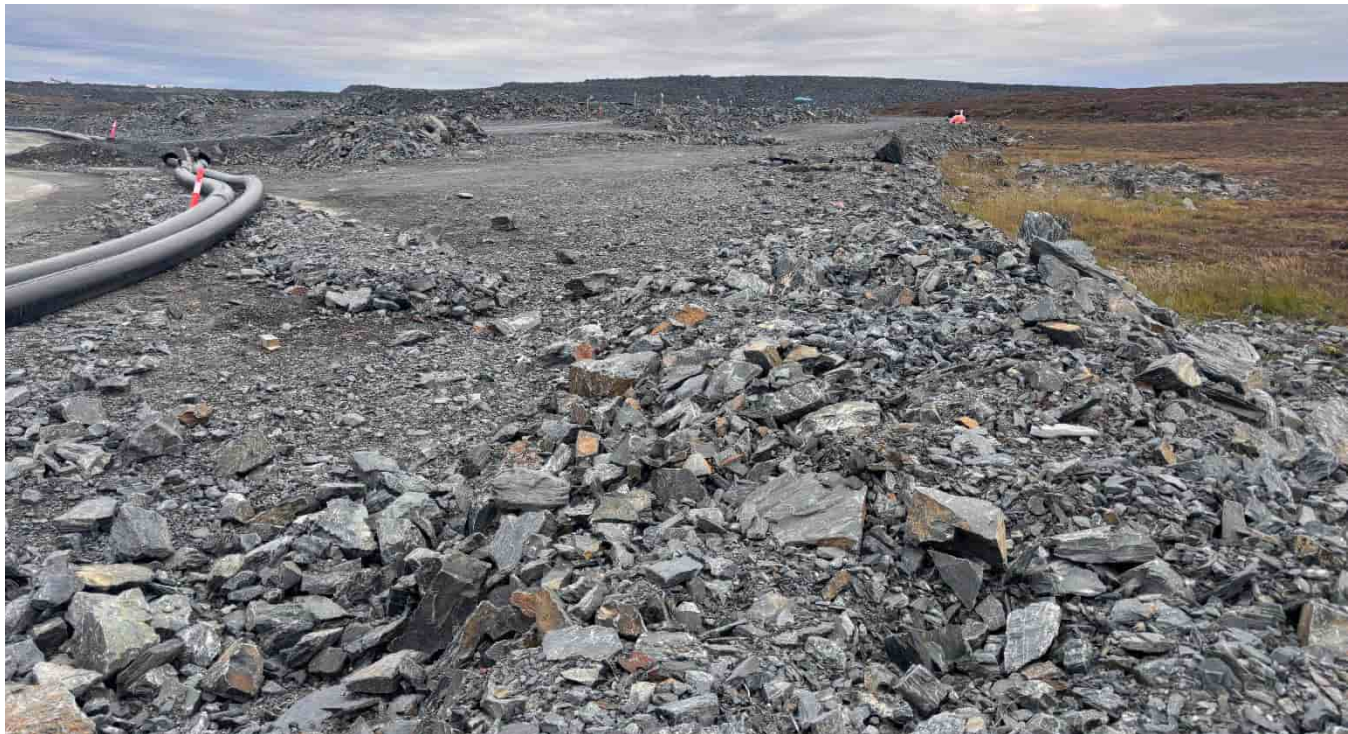
G-521: Tailings pipeline crossing under Water Treatment Plant access road, looking SE

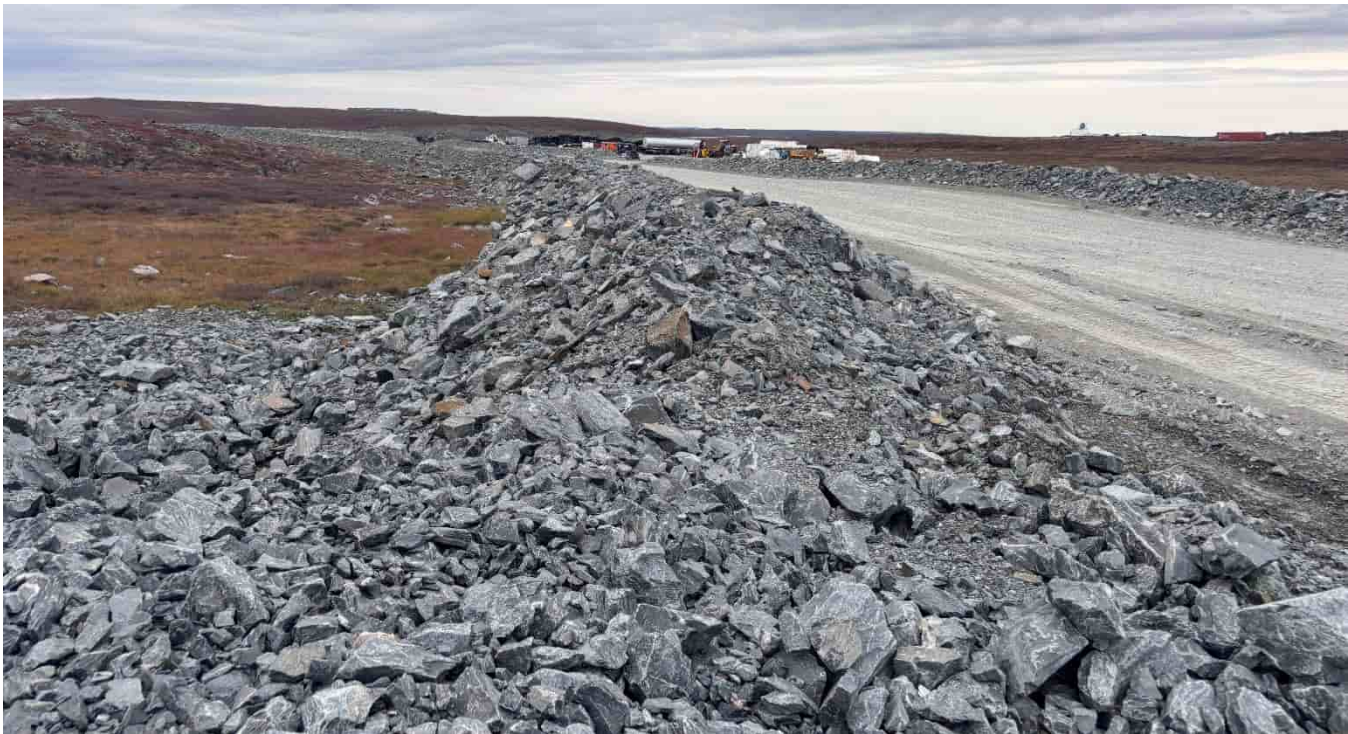
G-522: Echo Pit Haul Road rockfill, looking N from tailings corridor

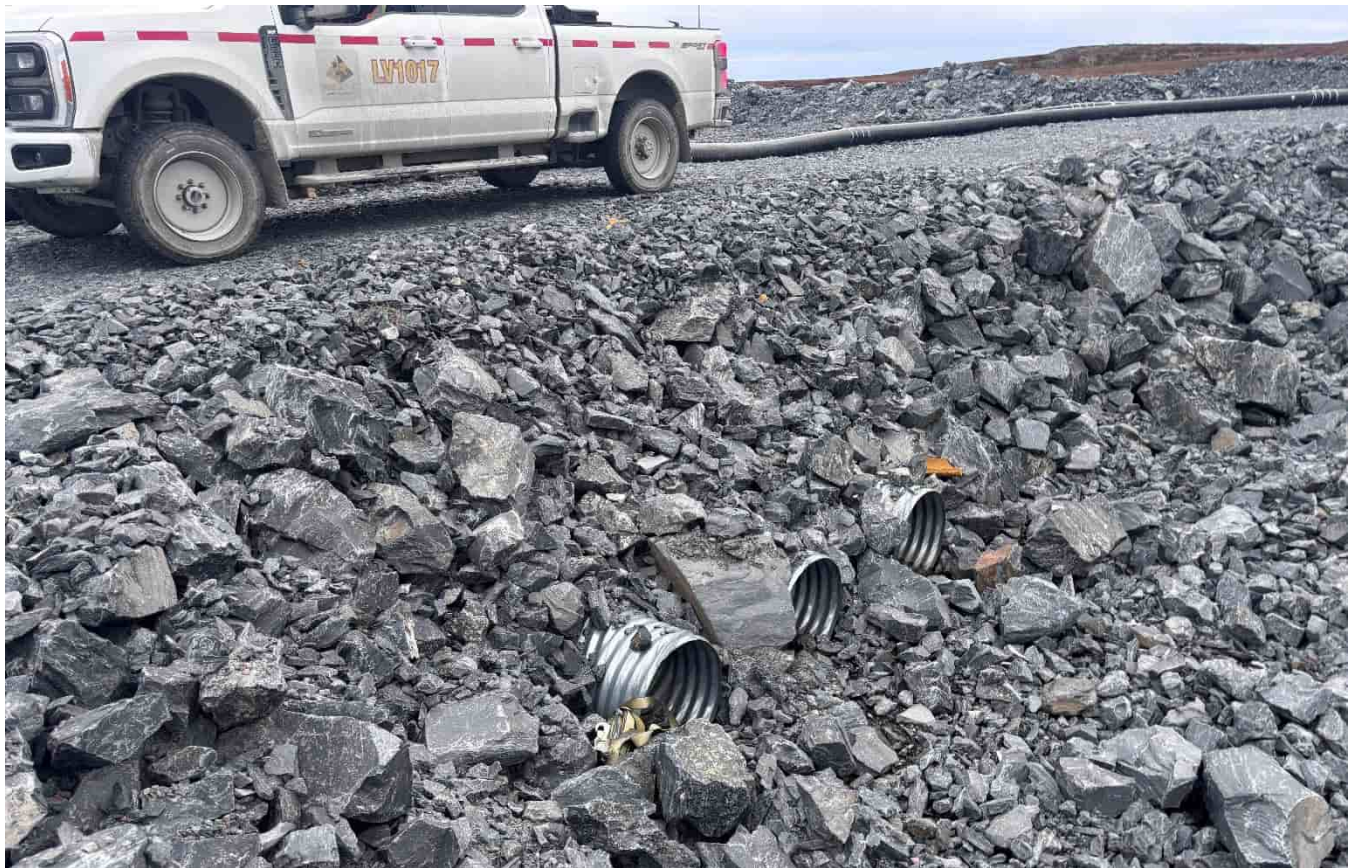
G-523: Triple culvert outlets (N side) under tailings pipeline corridor

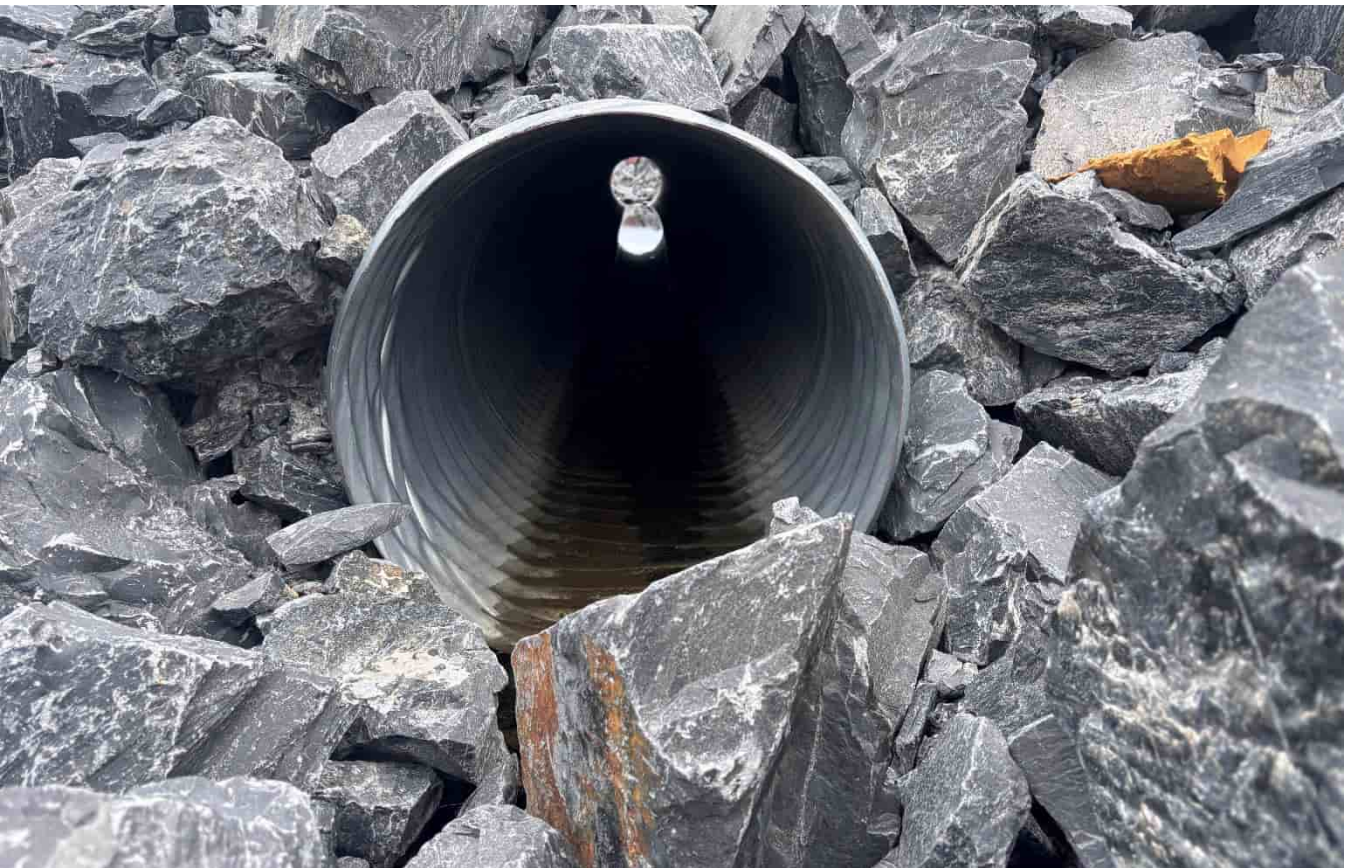
G-524: Western culvert outlet

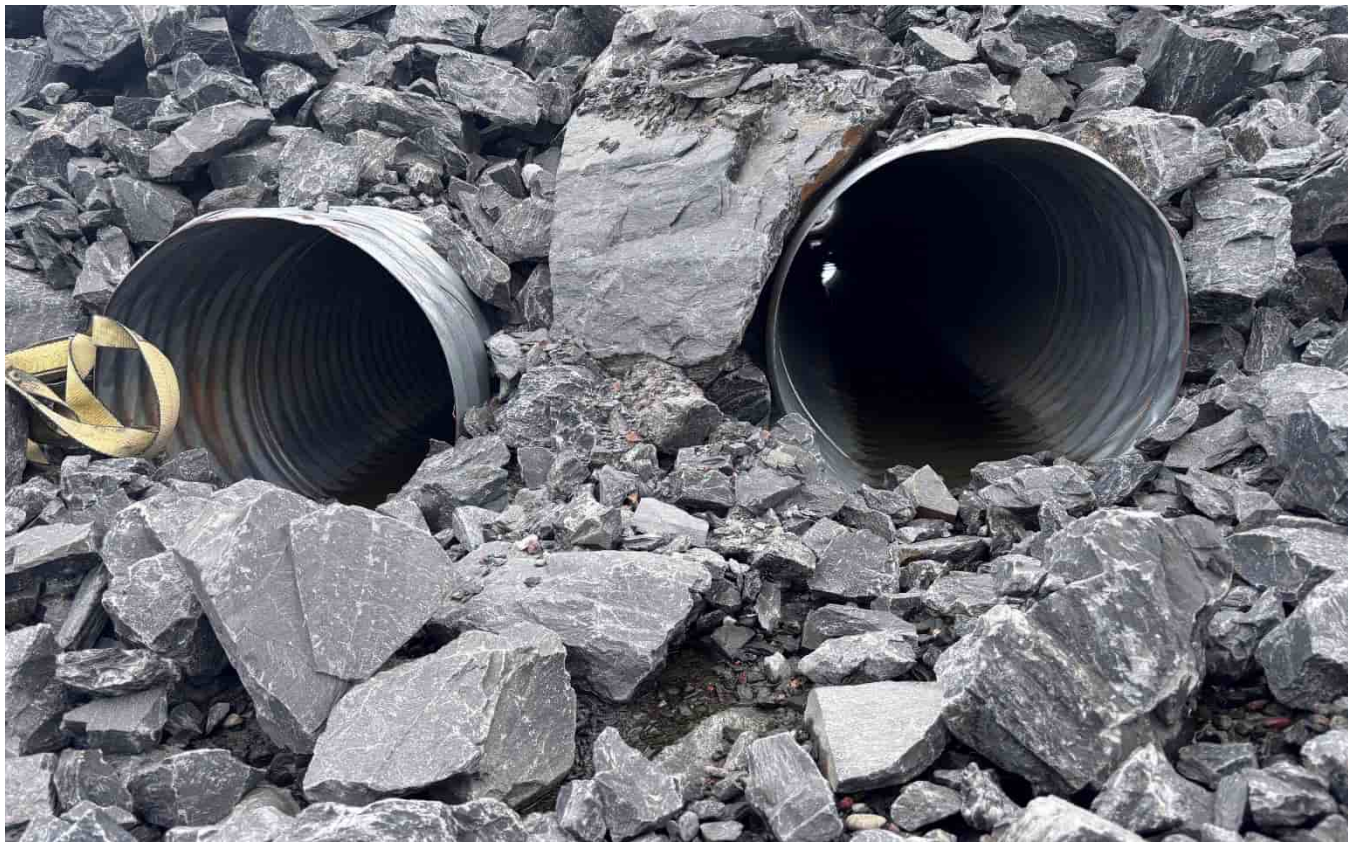
G-525: Eastern and central culvert outlets

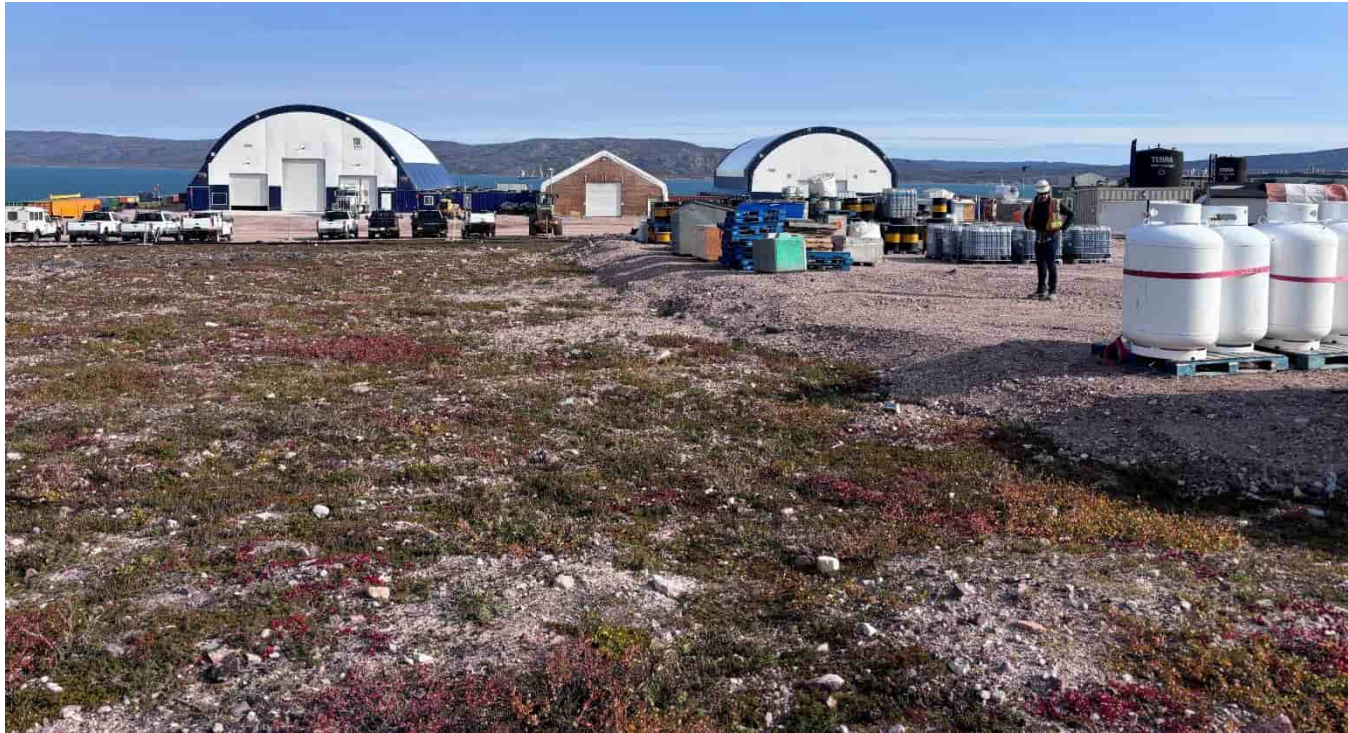
M-1: Laydown beside camp pad, looking E

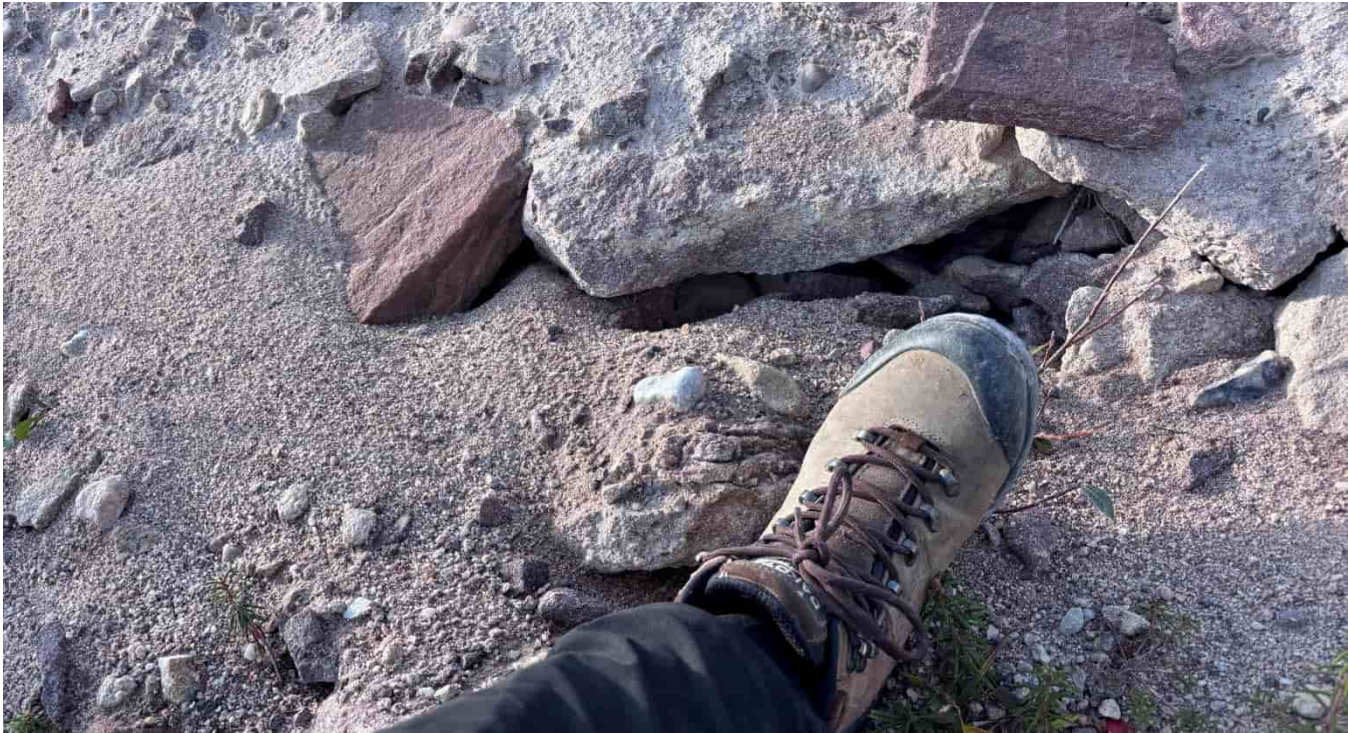
M-2: Voids in pad slope beside airstrip

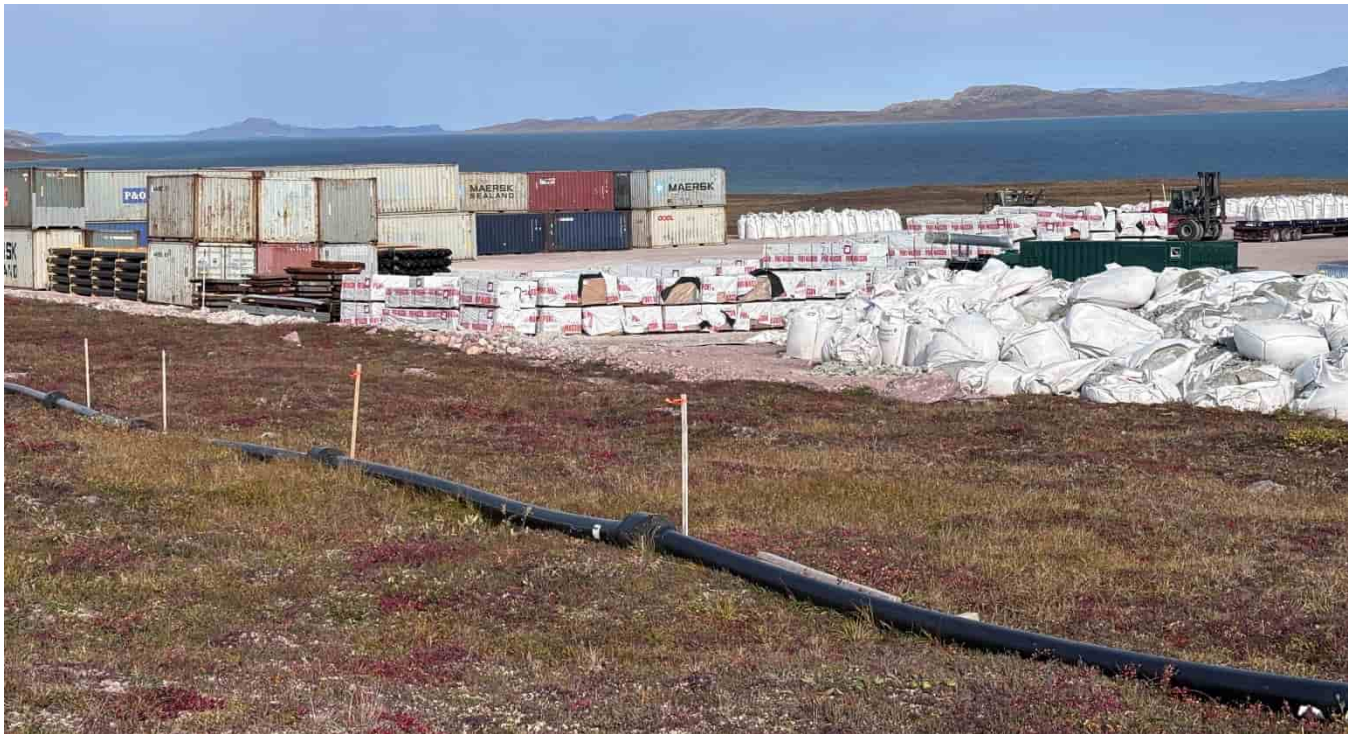
M-3: General laydown area, looking N from toe of airstrip embankment. Note pipe installed on the exposed tundra

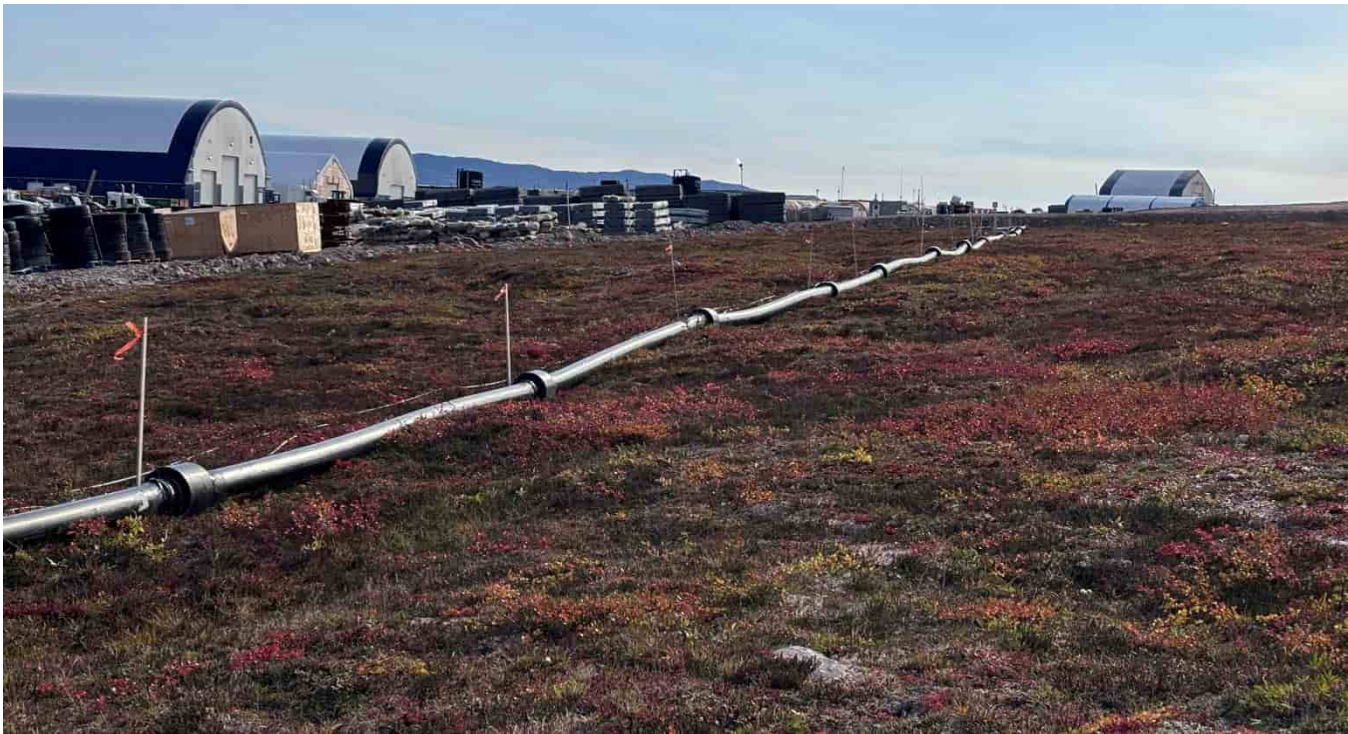
M-4: Freight storage area buildings, looking SE. Note pipe is installed on the exposed tundra

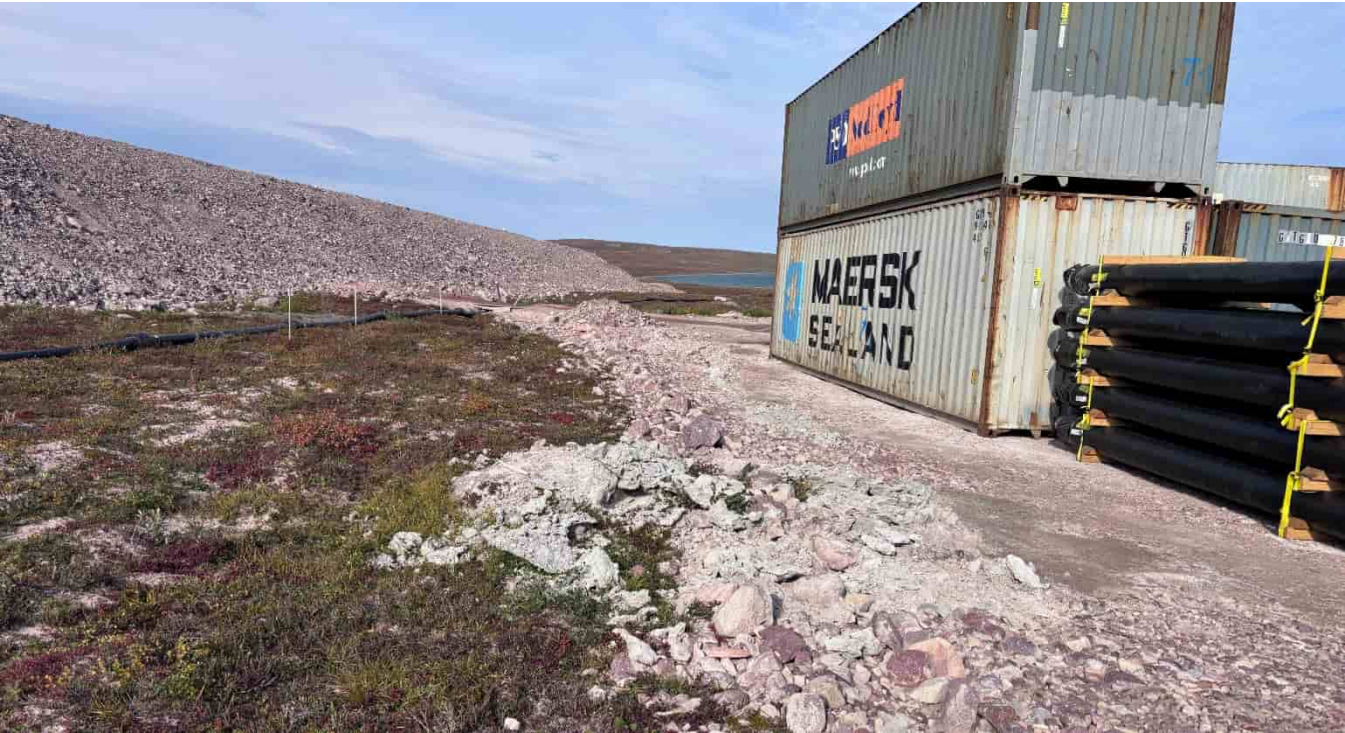
M-6: NW corner of laydown pad, beside airstrip embankment
