| | | 2025 Annual Geotechnical Inspection | | |
| | | Primary Pond Dam | | |
| Job No: CAPR004312<br>Filename: Back River_Goose_2025_AGI_PhotoLog.pdf | Back River Project | Date:<br>February 2026 | Approved:<br>JBK | Figure:<br>159 |

## **Appendix B      Photolog from 2025 Site Visit – MLA**

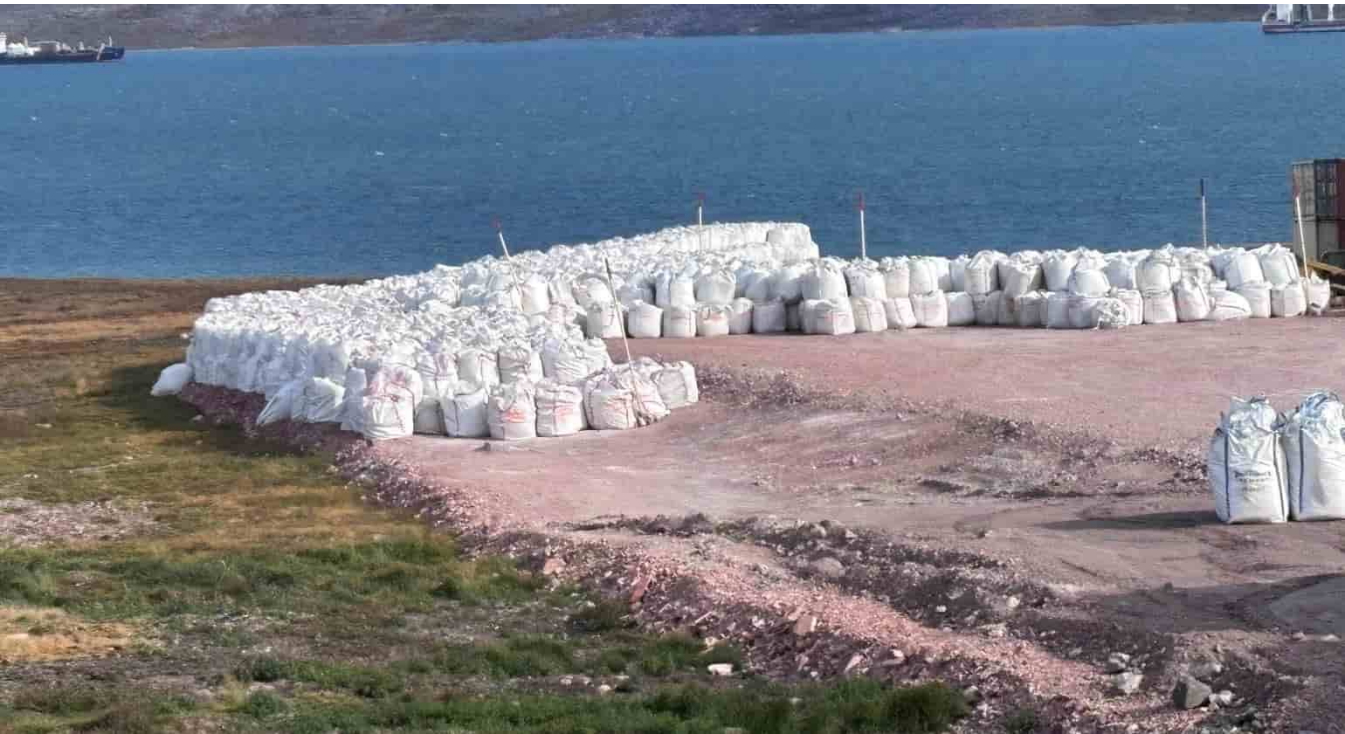
M-8: Cemented rockfill laydown at N side of pad. Temporary bag placement close to pad slope

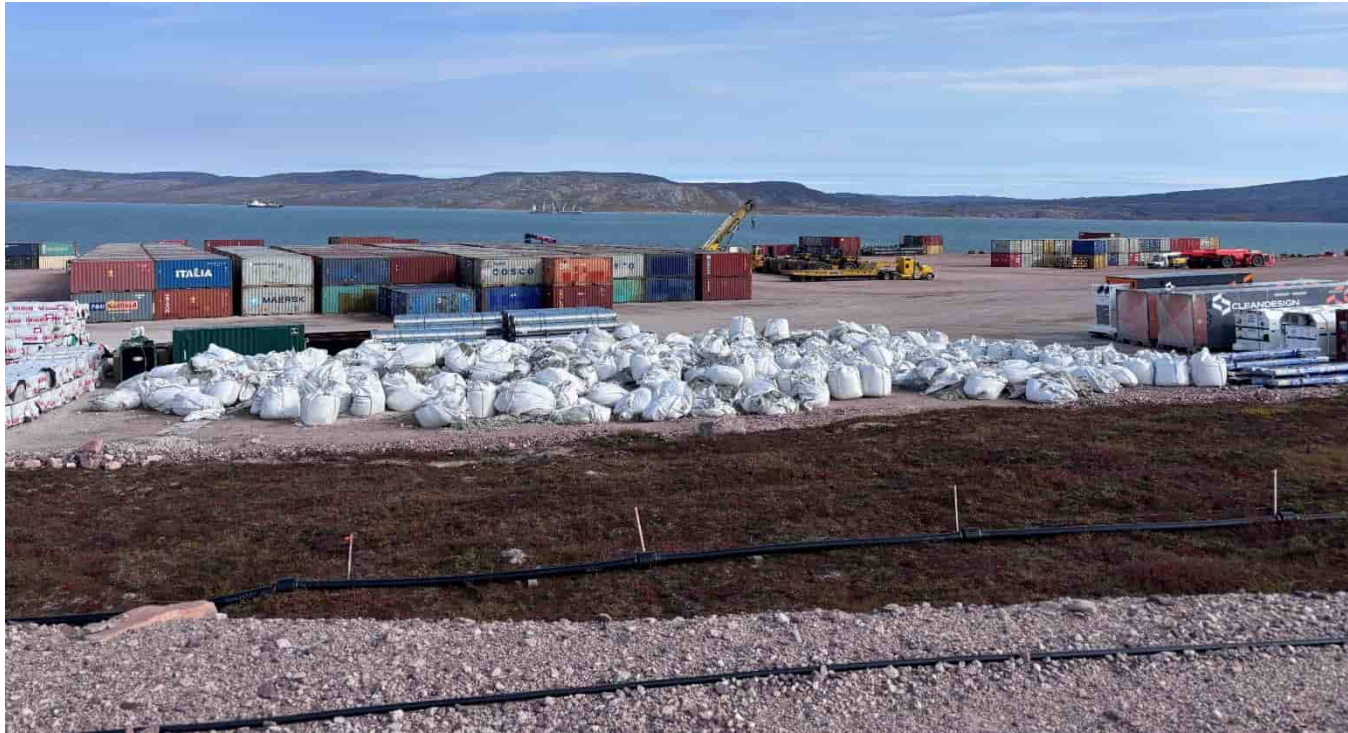
M-9: General laydown area, looking E from airstrip. Pipe placed on the exposed tundra

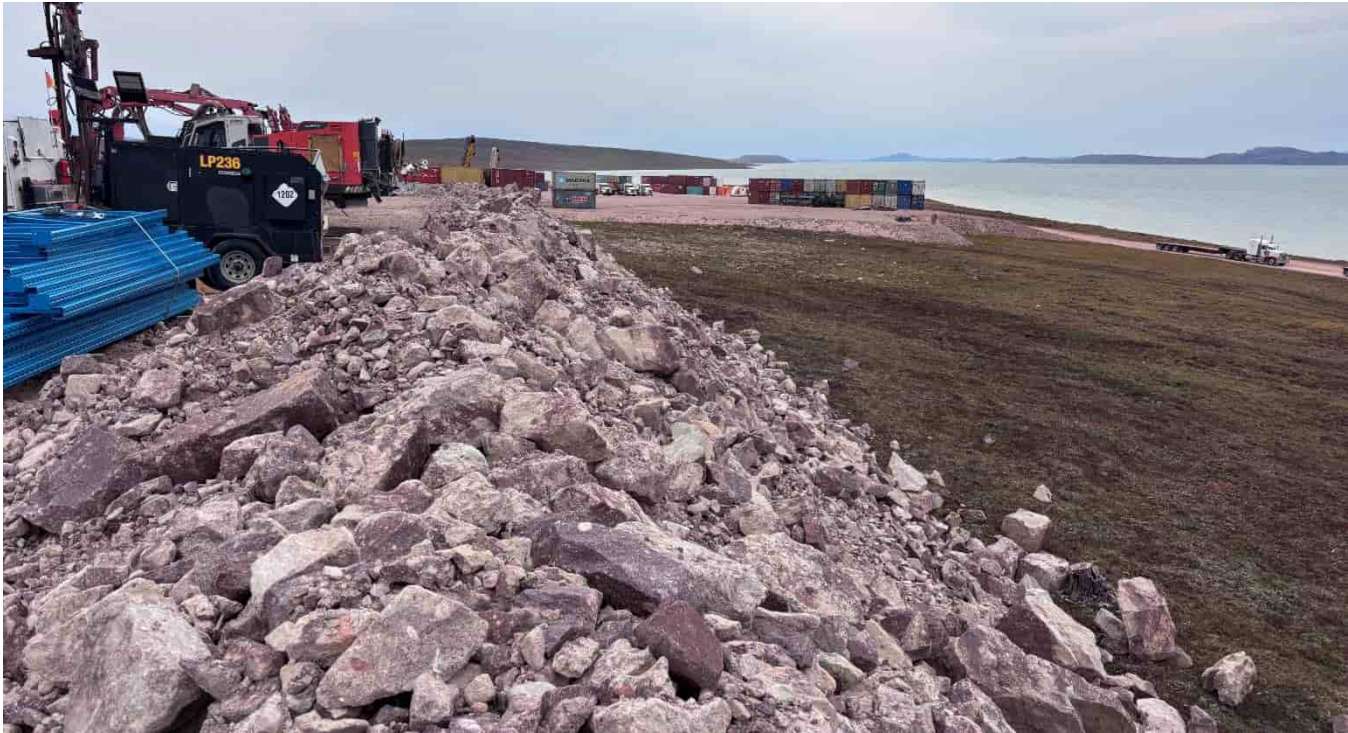
M-10: Eastern pad slope, looking N

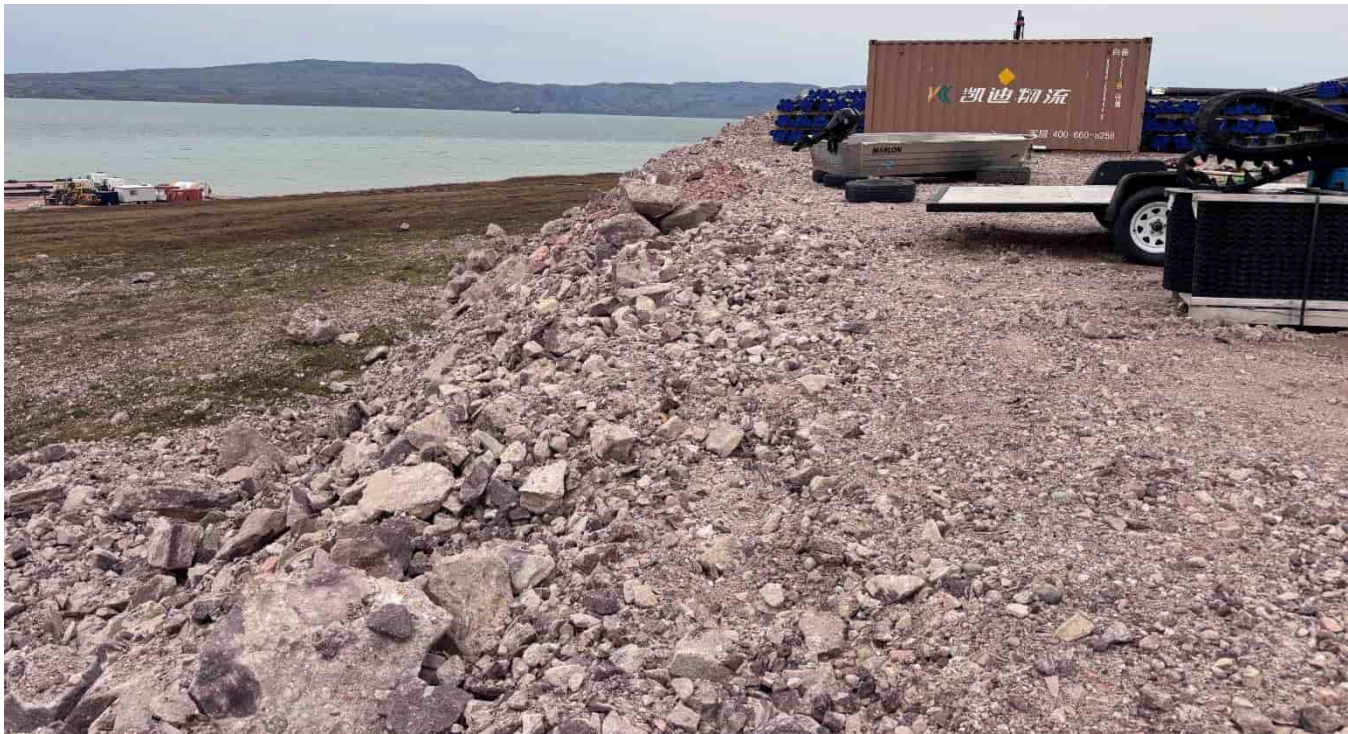
M-11: Eastern pad slope, looking SE

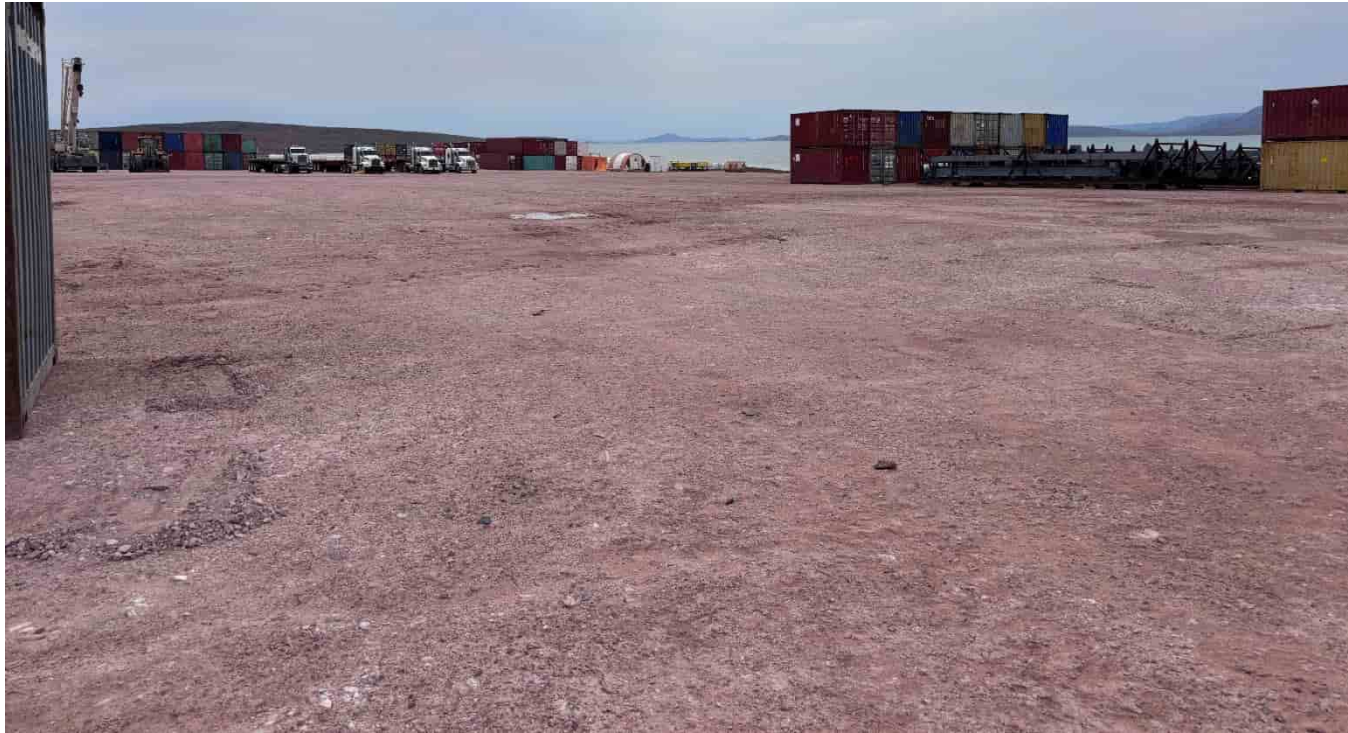
M-13: Laydown area surface conditions, looking N

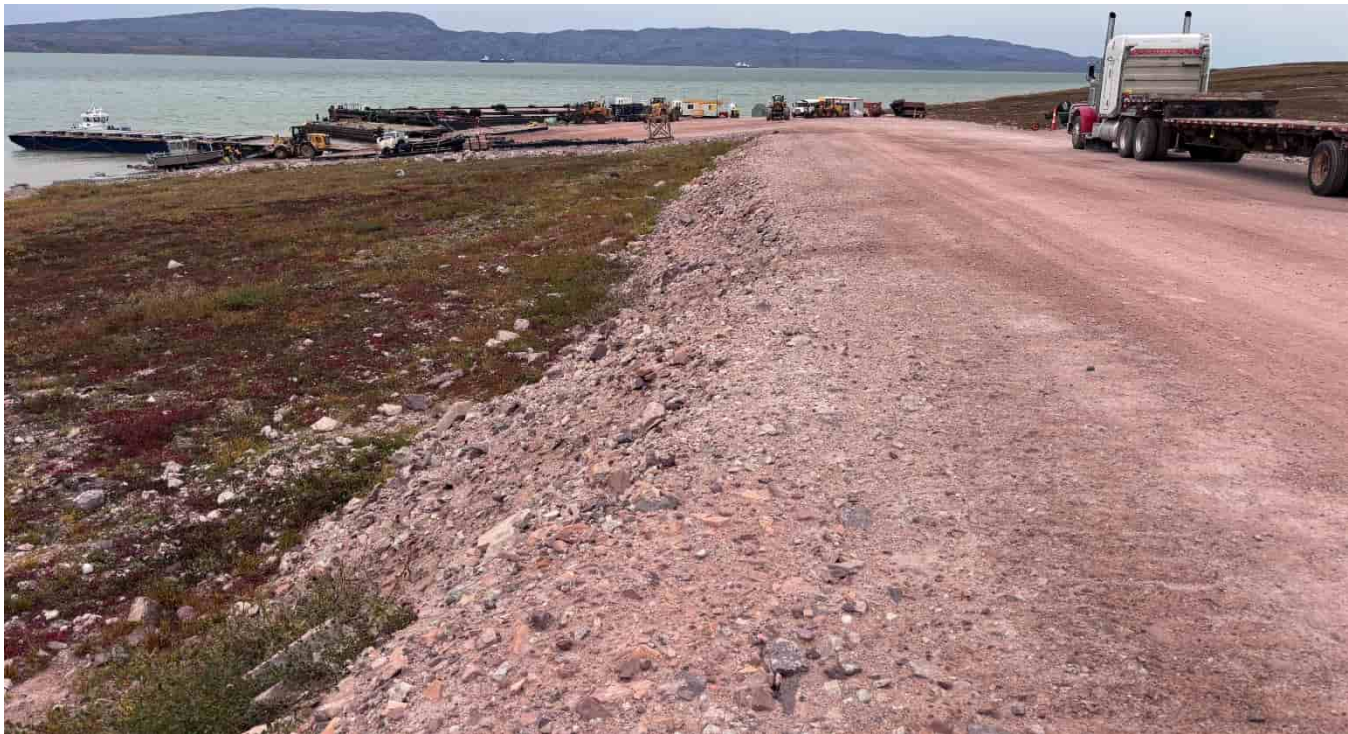
M-15: Shoreline pad access road embankment, looking SE

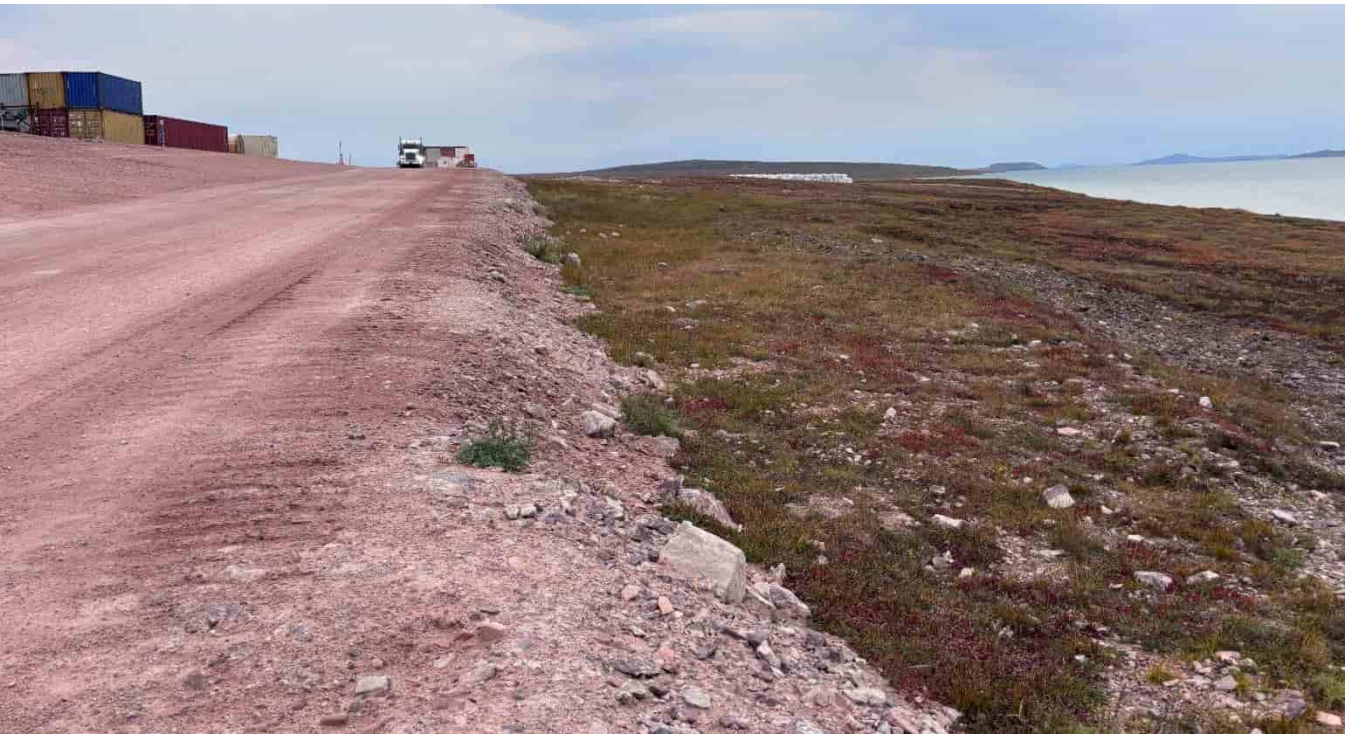
M-16: Shoreline pad access road embankment, looking NW

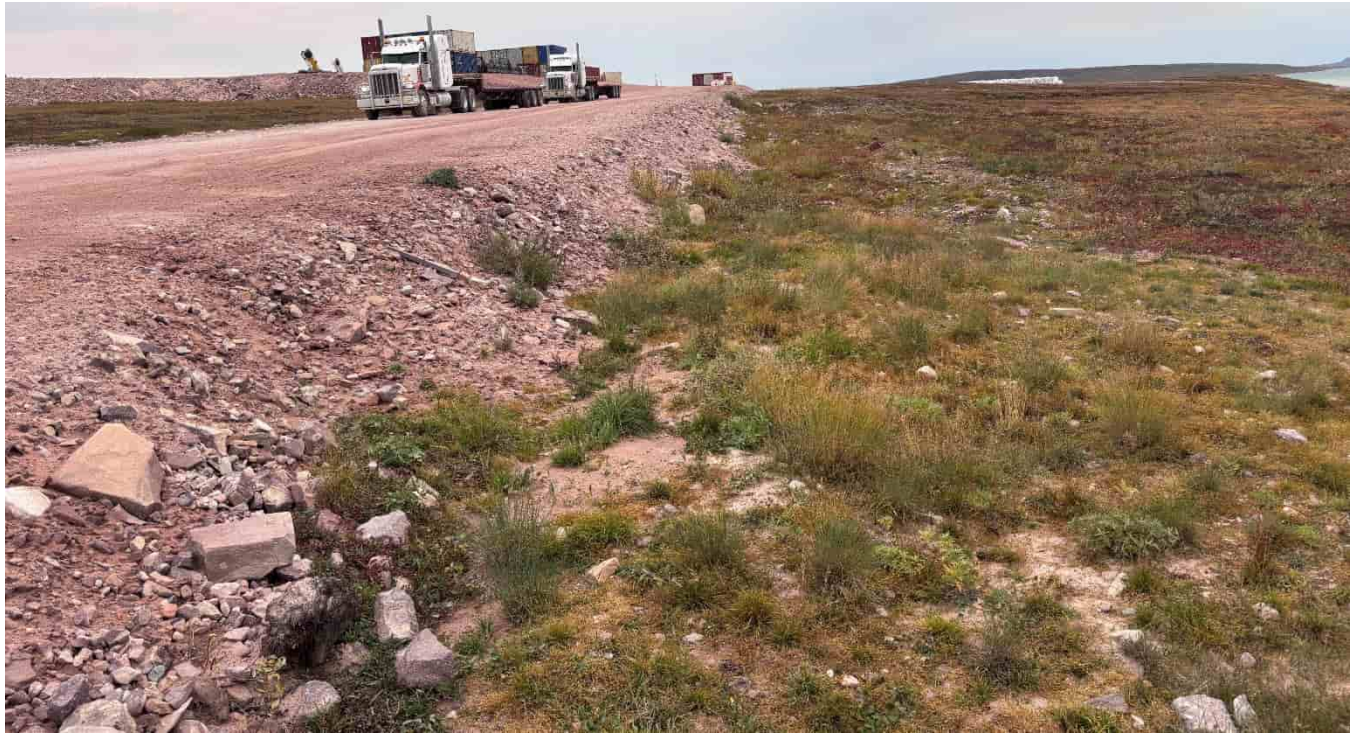
M-17: Shoreline pad access road embankment, looking NW

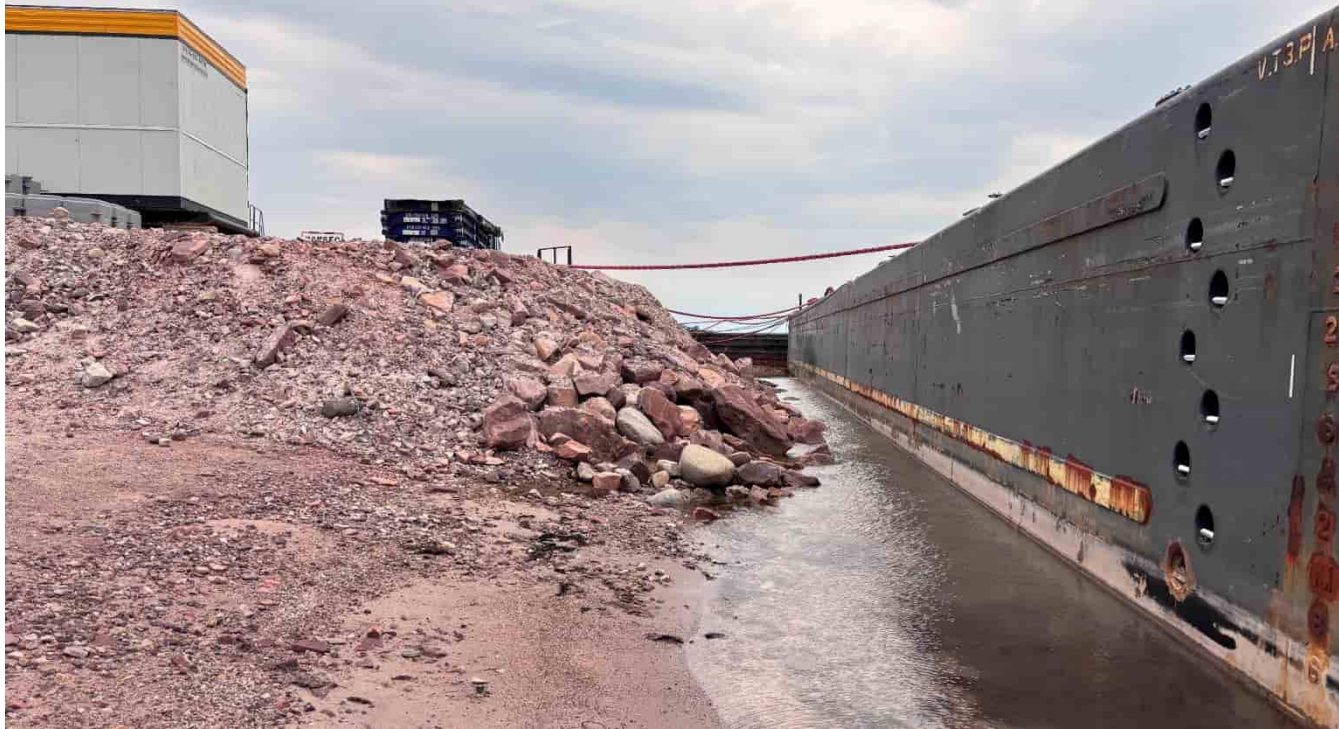
M-21: Barge access and tie off

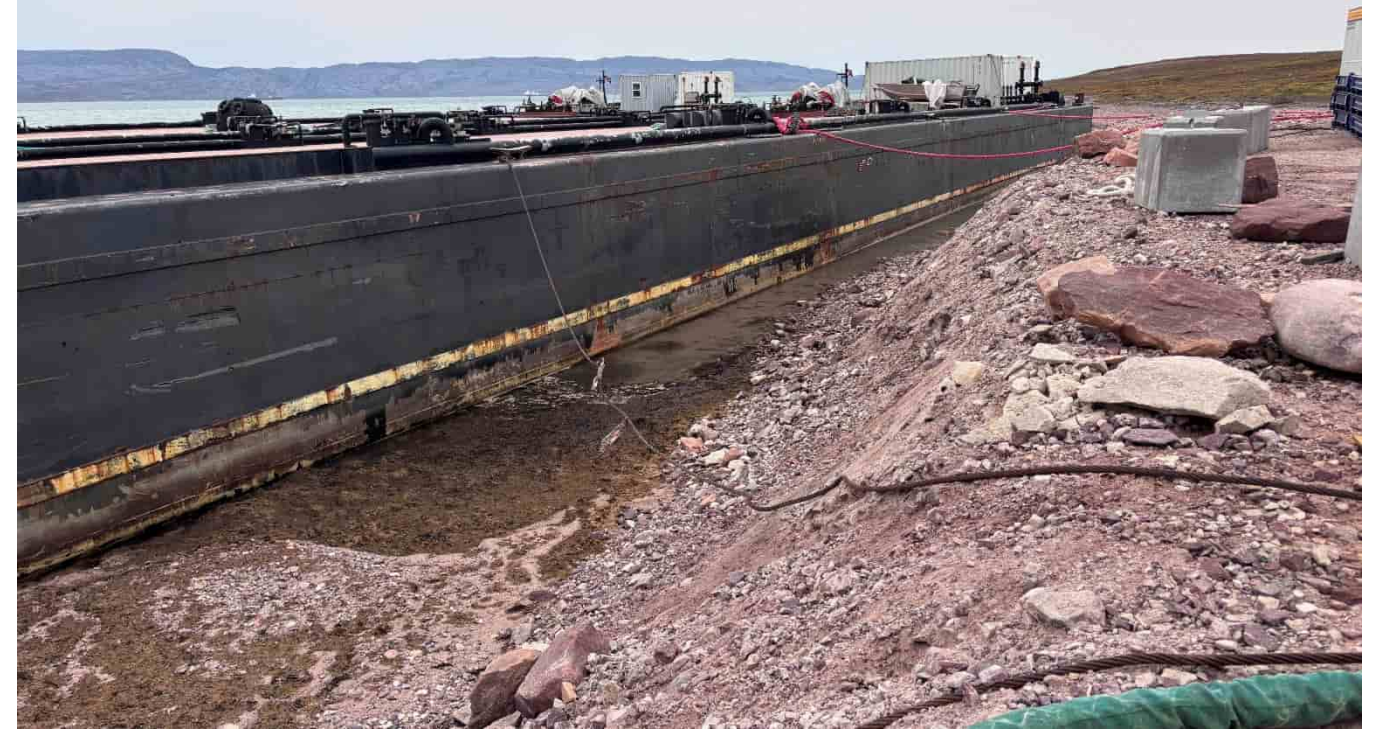
M-22: Shoreline pad slope above water

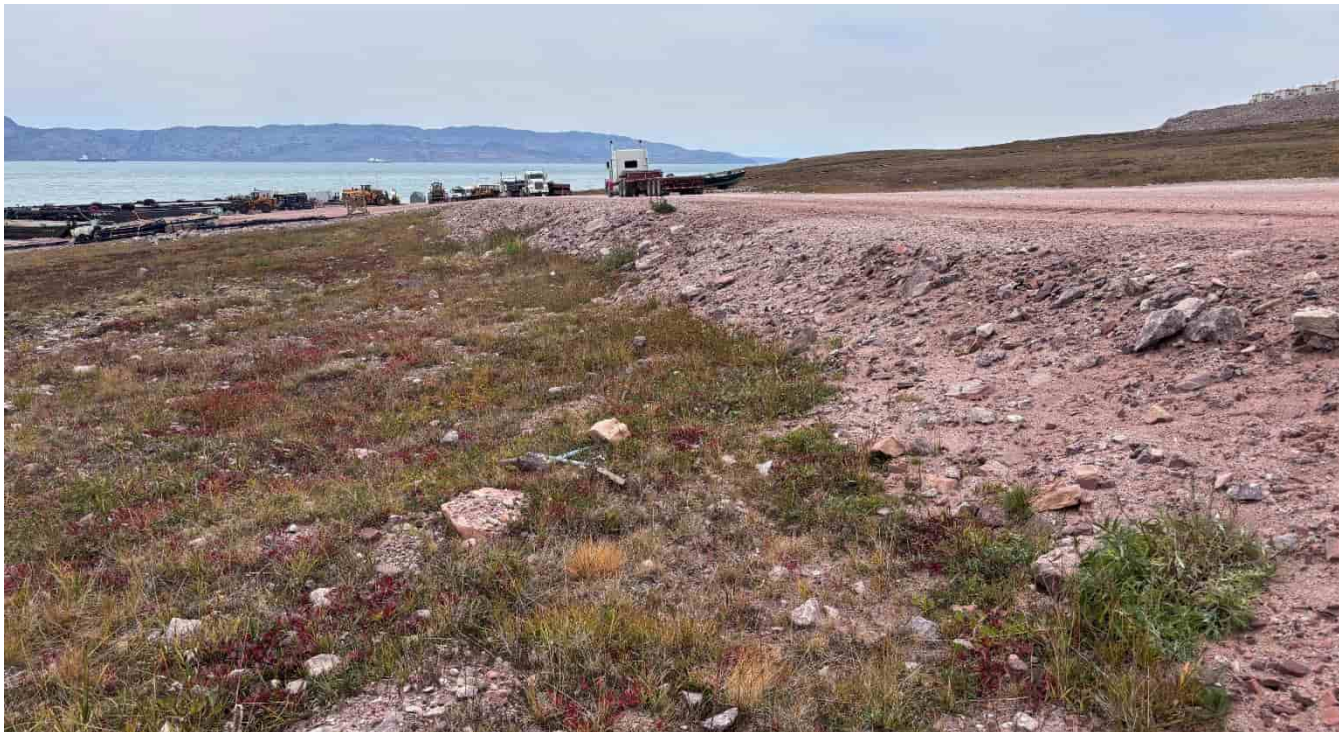
M-23: Shoreline pad access road embankment

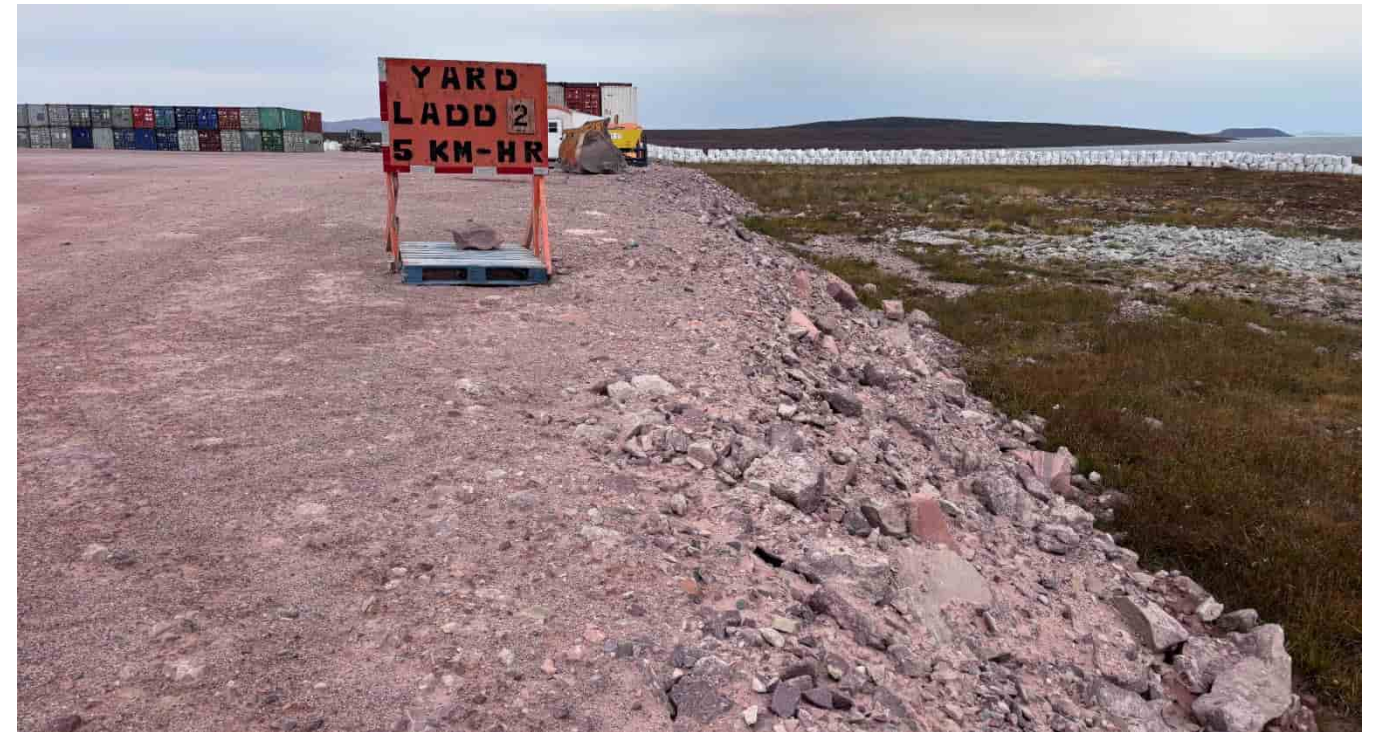
M-24: Northeastern freight storage pad slope

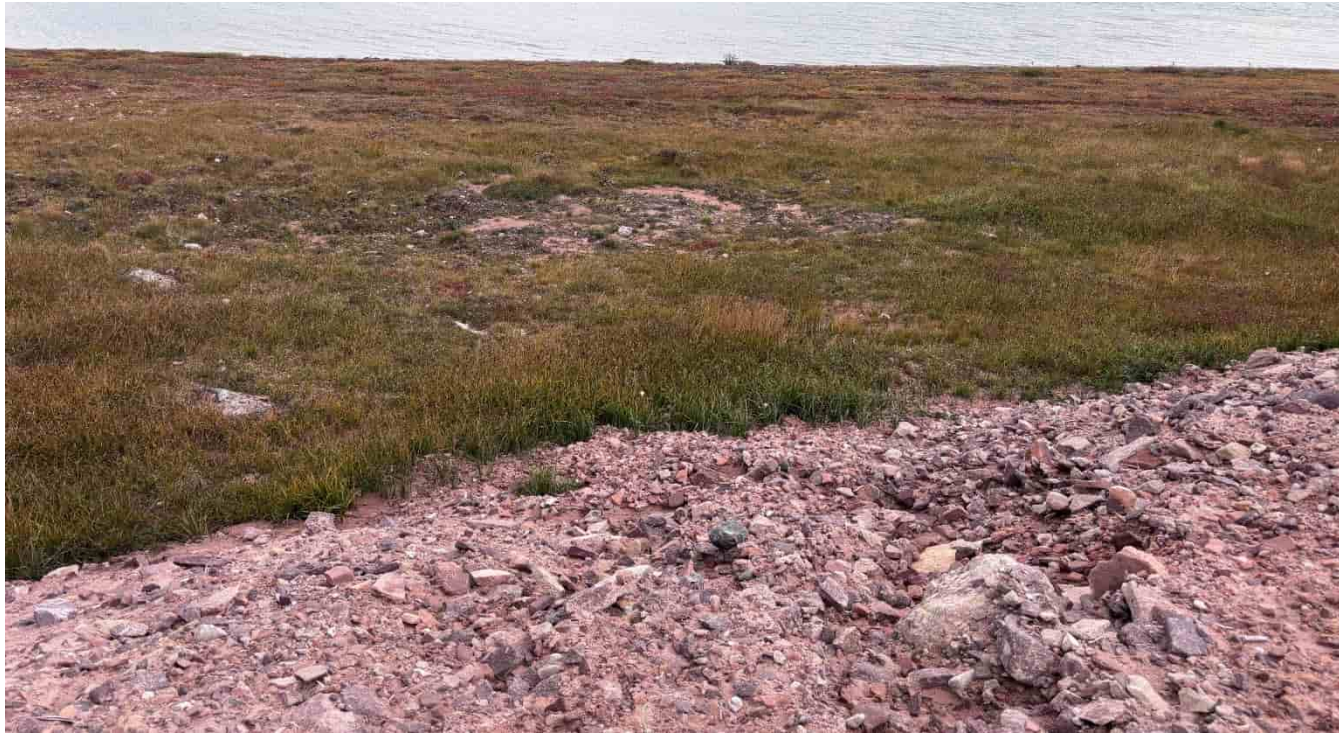
M-25: Erosion channel on NE pad slope

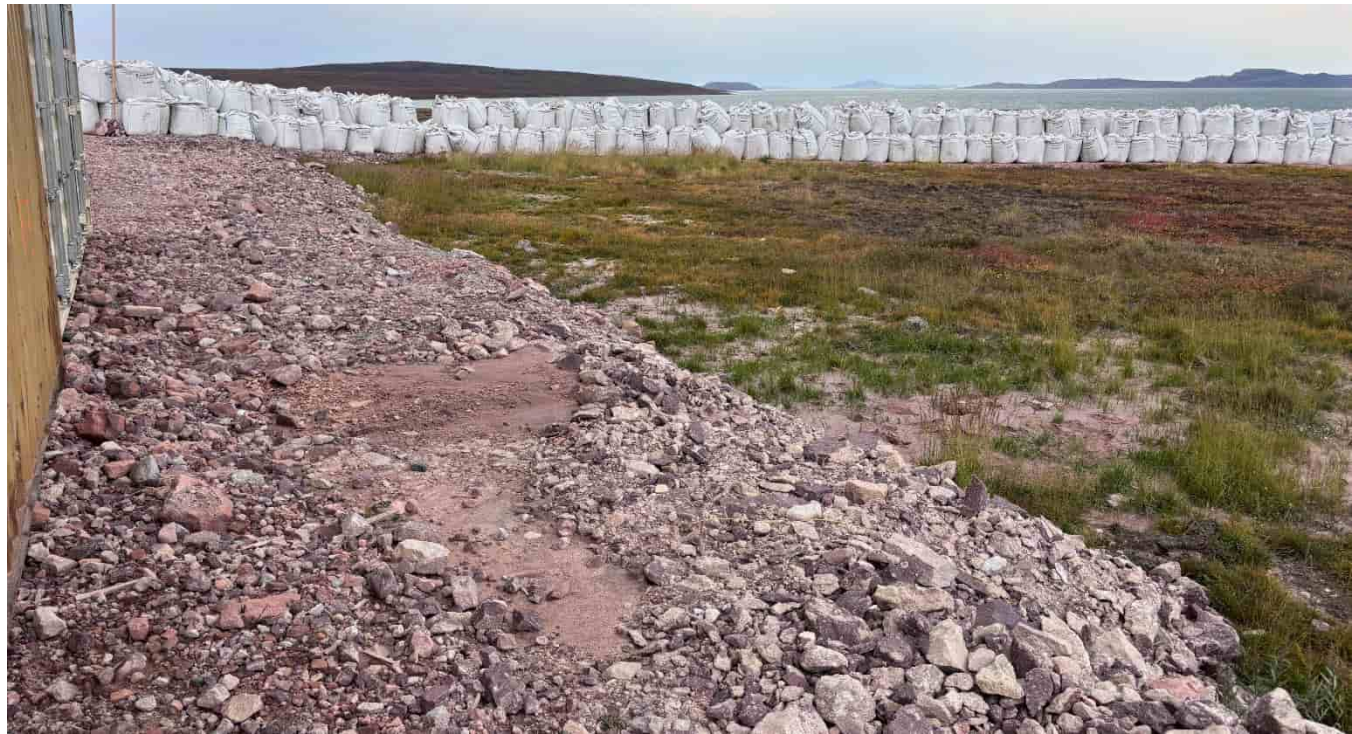
M-28: Pad slope, looking NW towards temporary cement bag storage / laydown

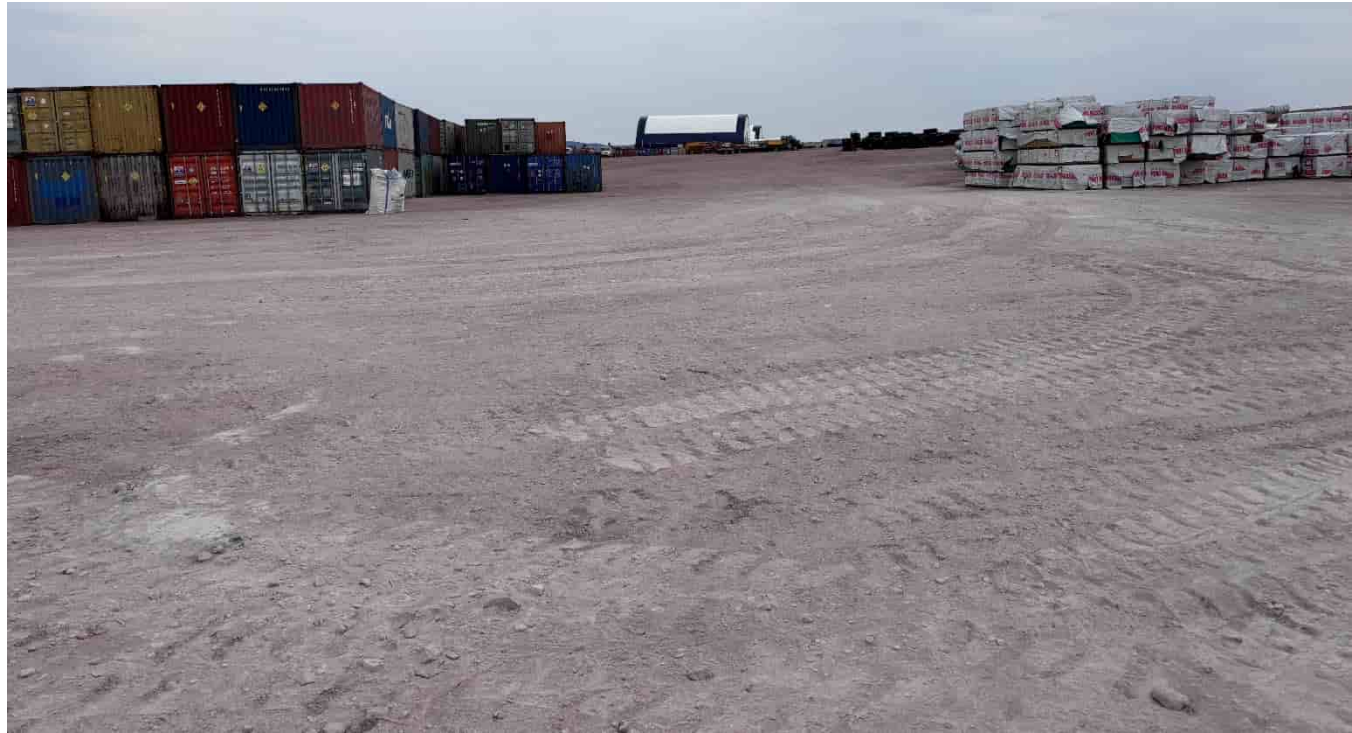
M-33: General view of pad, looking SE

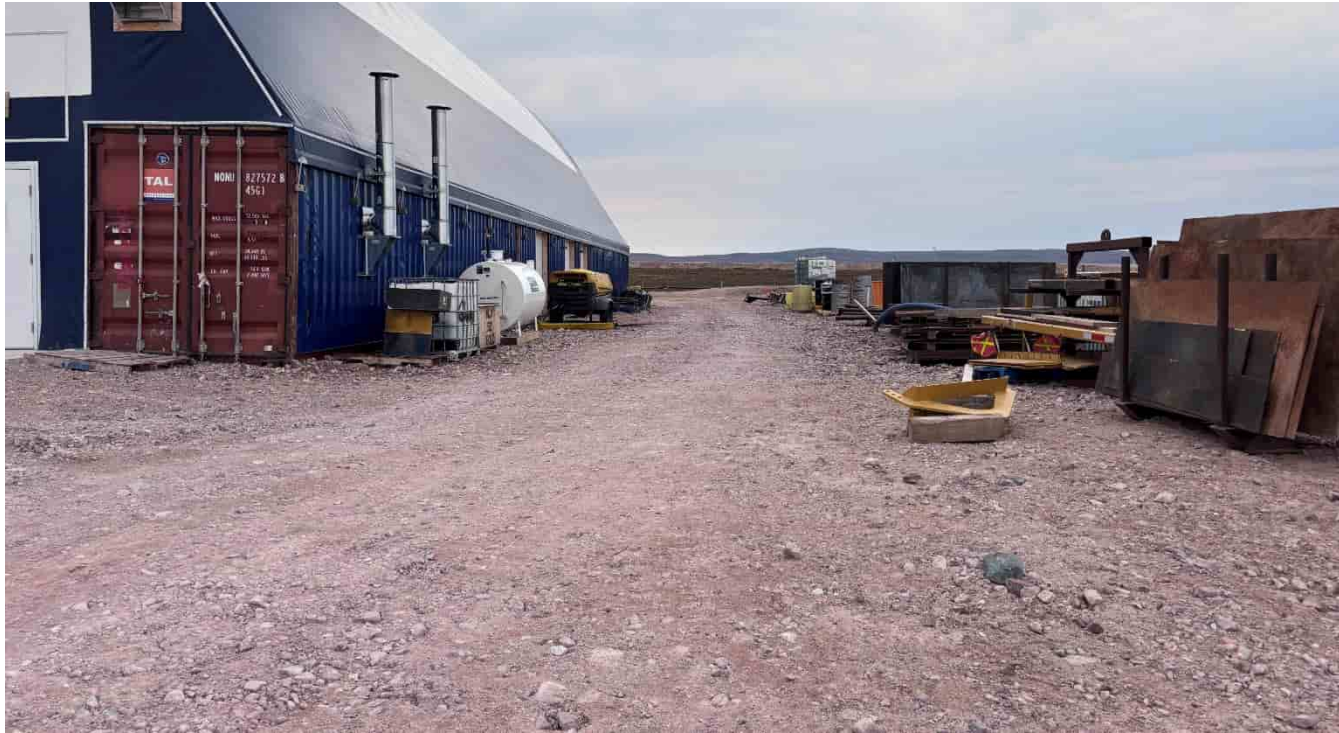
M-36: Maintenance shop area - Laydown beside building, SW

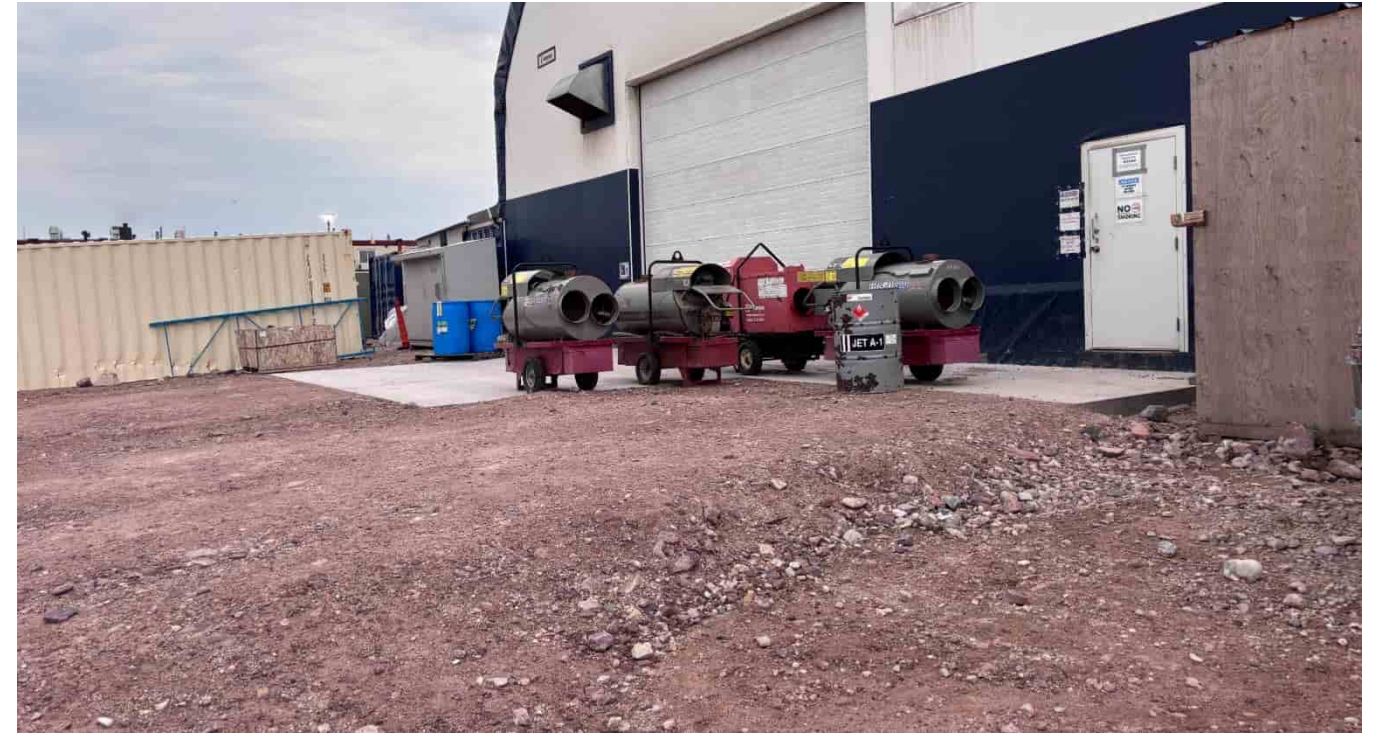
M-37: Maintenance shop area - Entrance to building and concrete pad

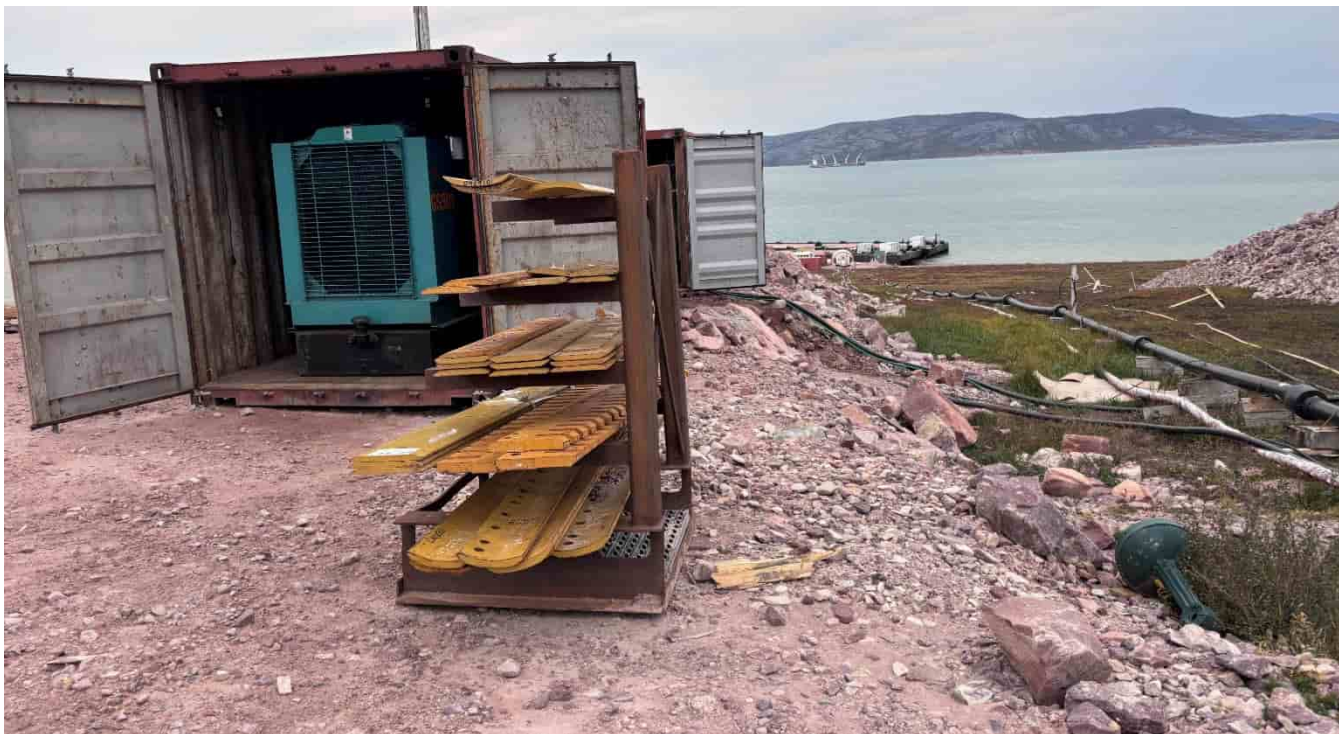
M-38: Edge of pad, looking NE – Note eroding pad slope

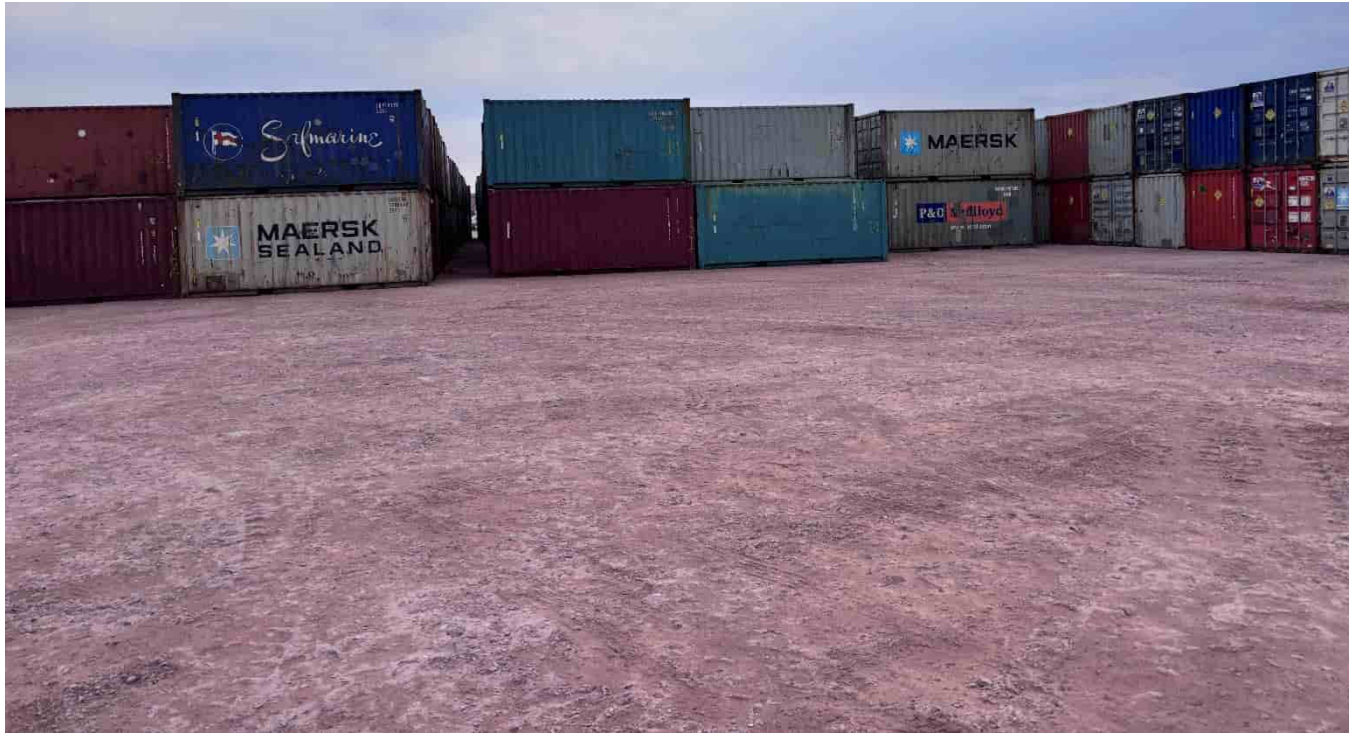
M-40: Stacked seacans in main laydown area

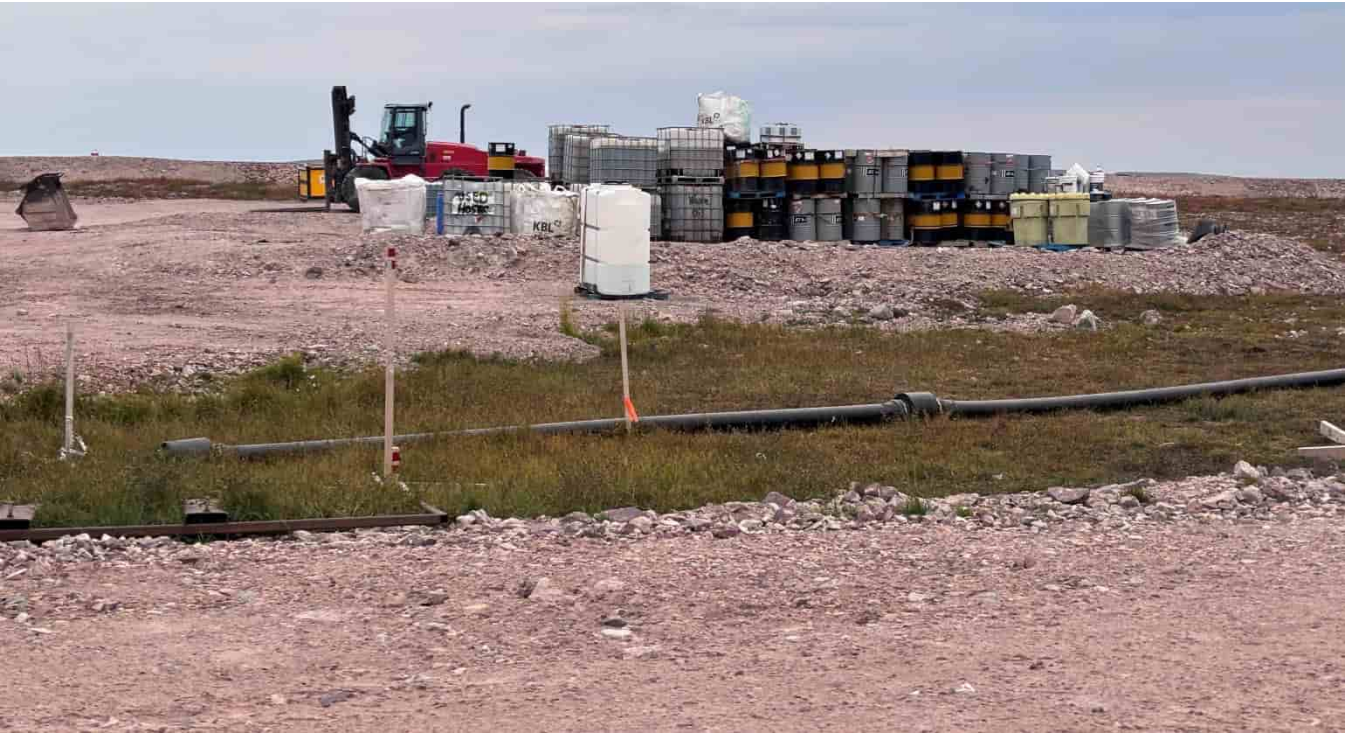
M-41: Temporary fuel storage, looking W

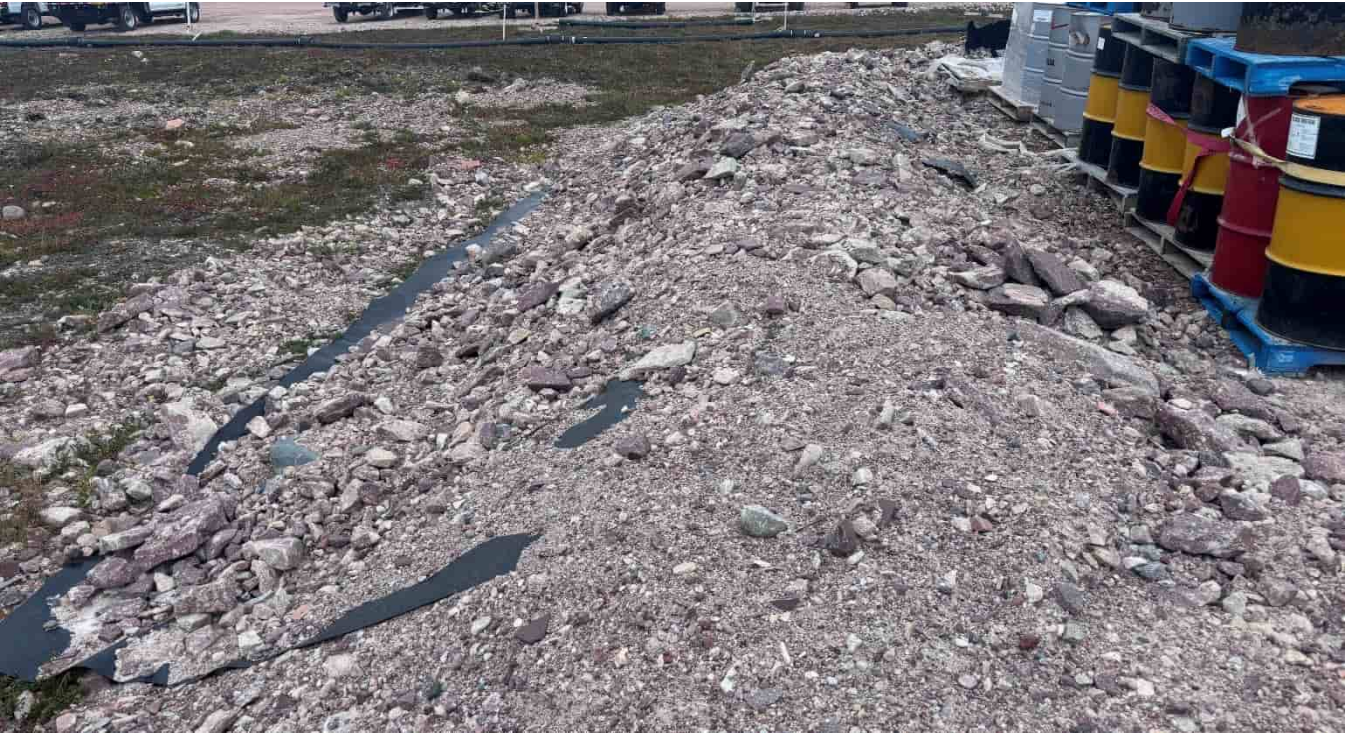
M-43: Exposed liner in pad slope beside fuel storage

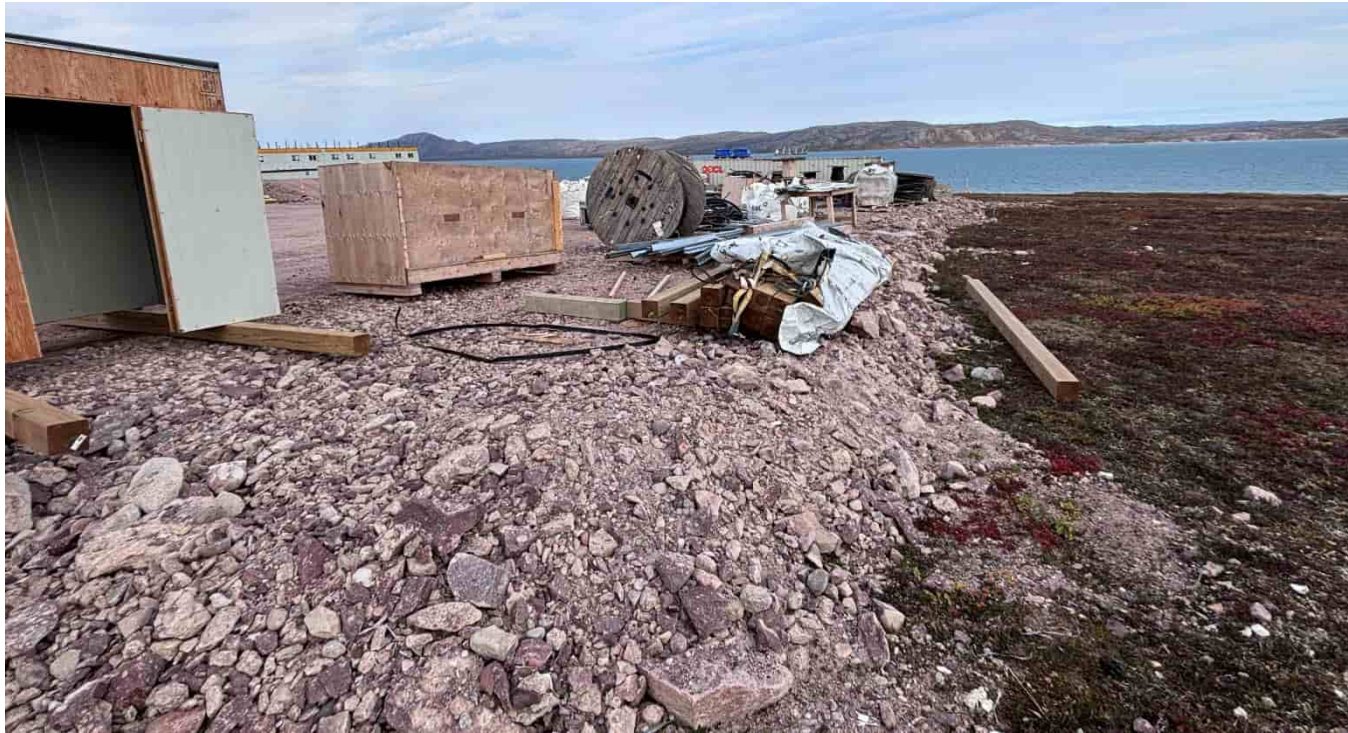
M-45: Southern pad slope – Note oversteepened slope and laydown beside edge of pad

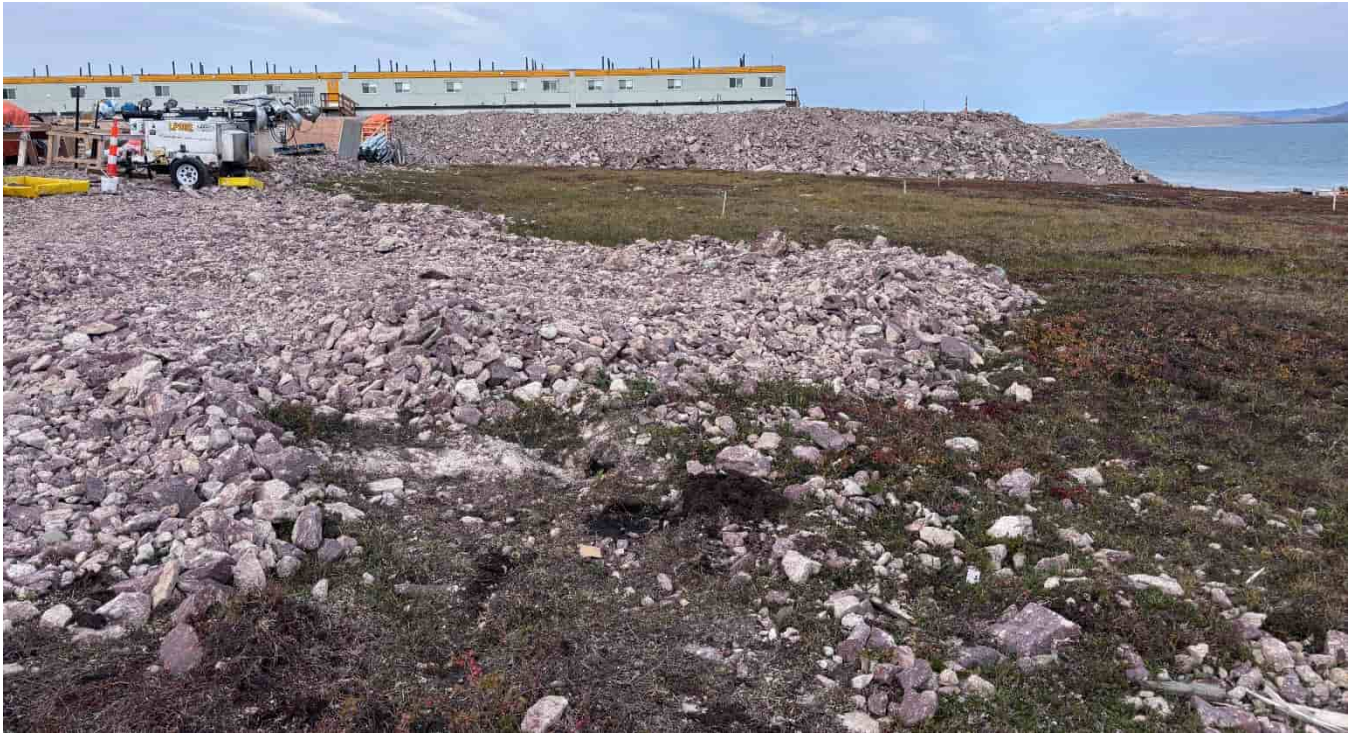
M-46: Undefined edge of pad at SE corner
