| | | 2025 Annual Geotechnical Inspection | | |
| | | Primary Pond Dam | | |
| Job No: CAPR004312<br>Filename: Back River_Goose_2025_AGI_PhotoLog.pdf | Back River Project | Date:<br>February 2026 | Approved:<br>JBK | Figure:<br>159 |

## **Appendix B      Photolog from 2025 Site Visit – MLA**

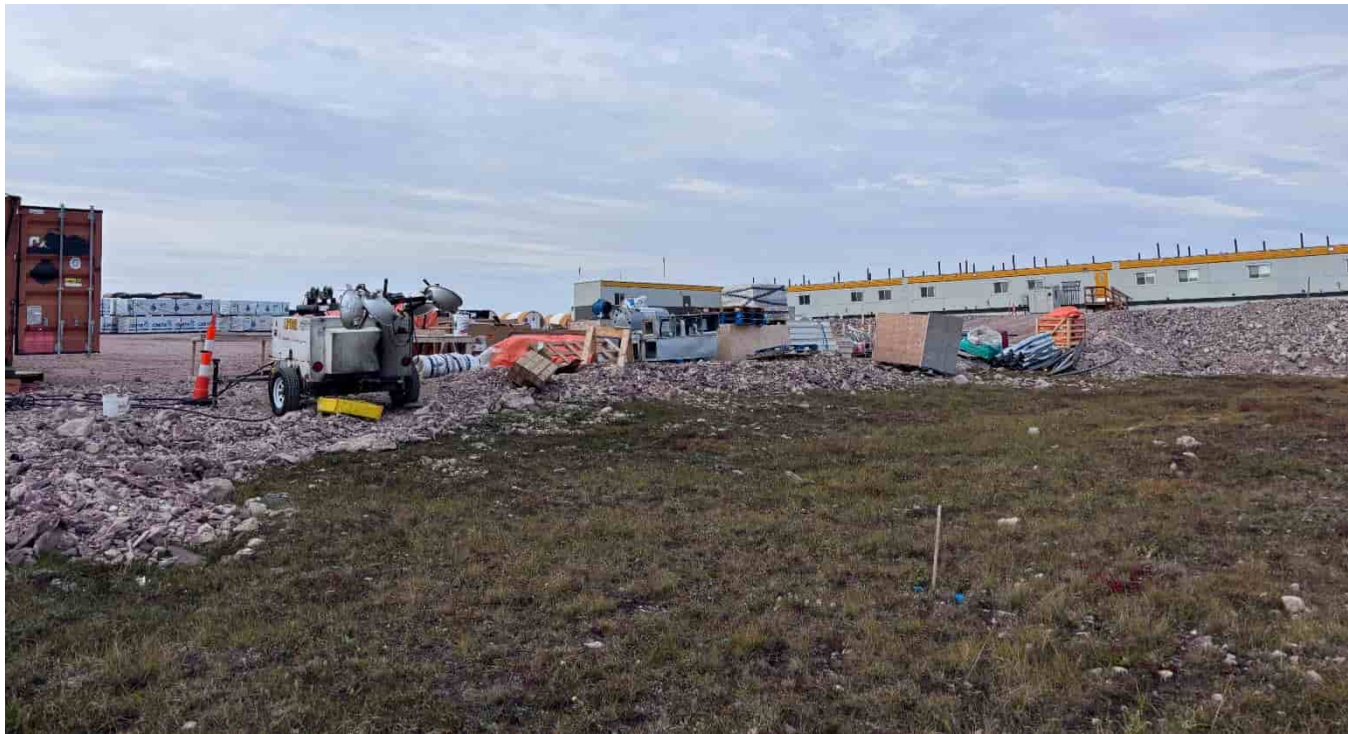
M-47: Laydown area beside pad slope at SE corner of pad

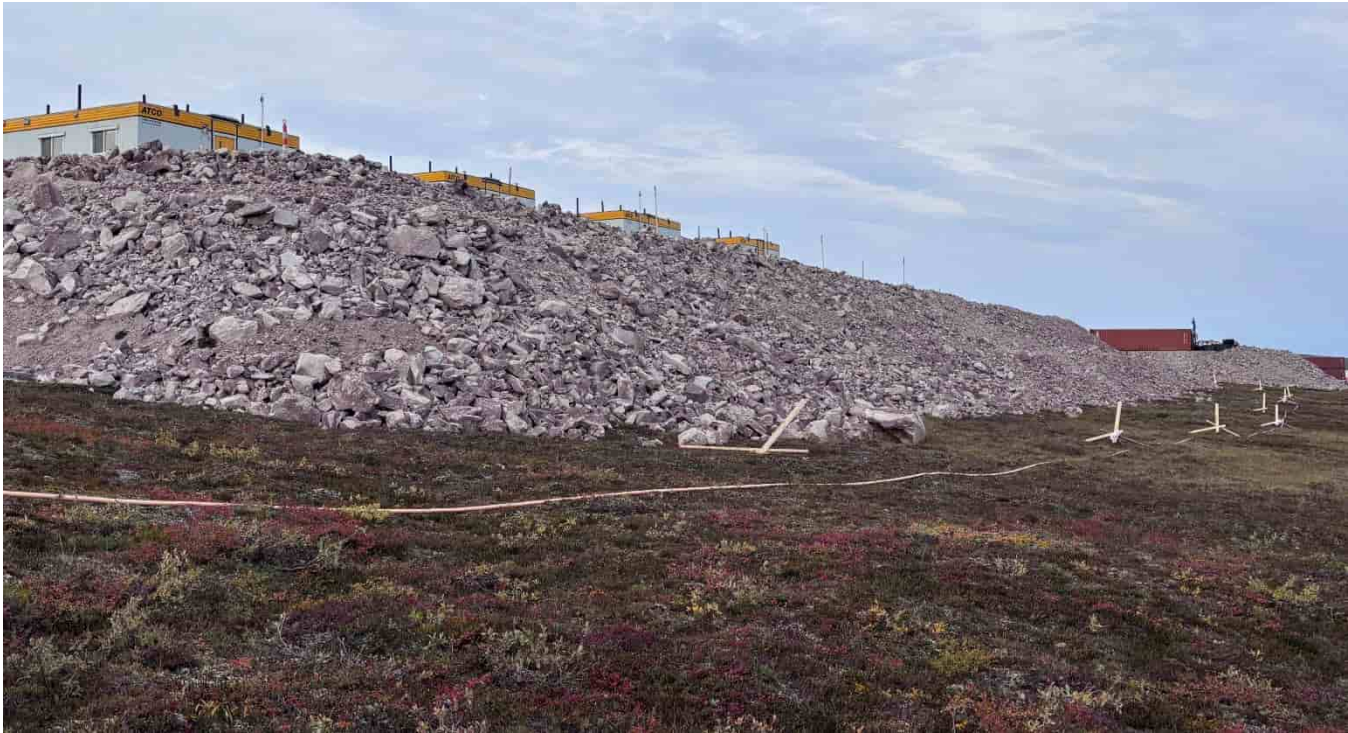
M-49: Eastern pad slope, looking NW

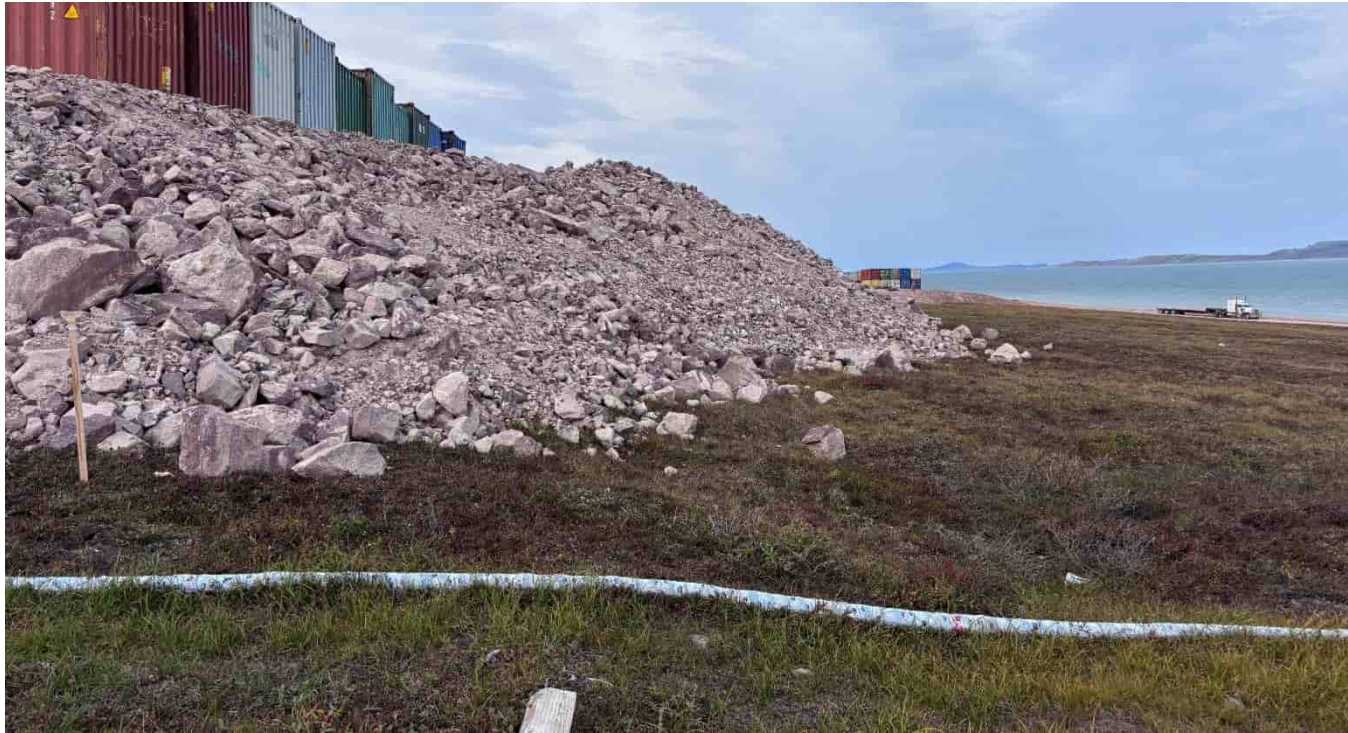
M-52: Camp pad extension, looking NW

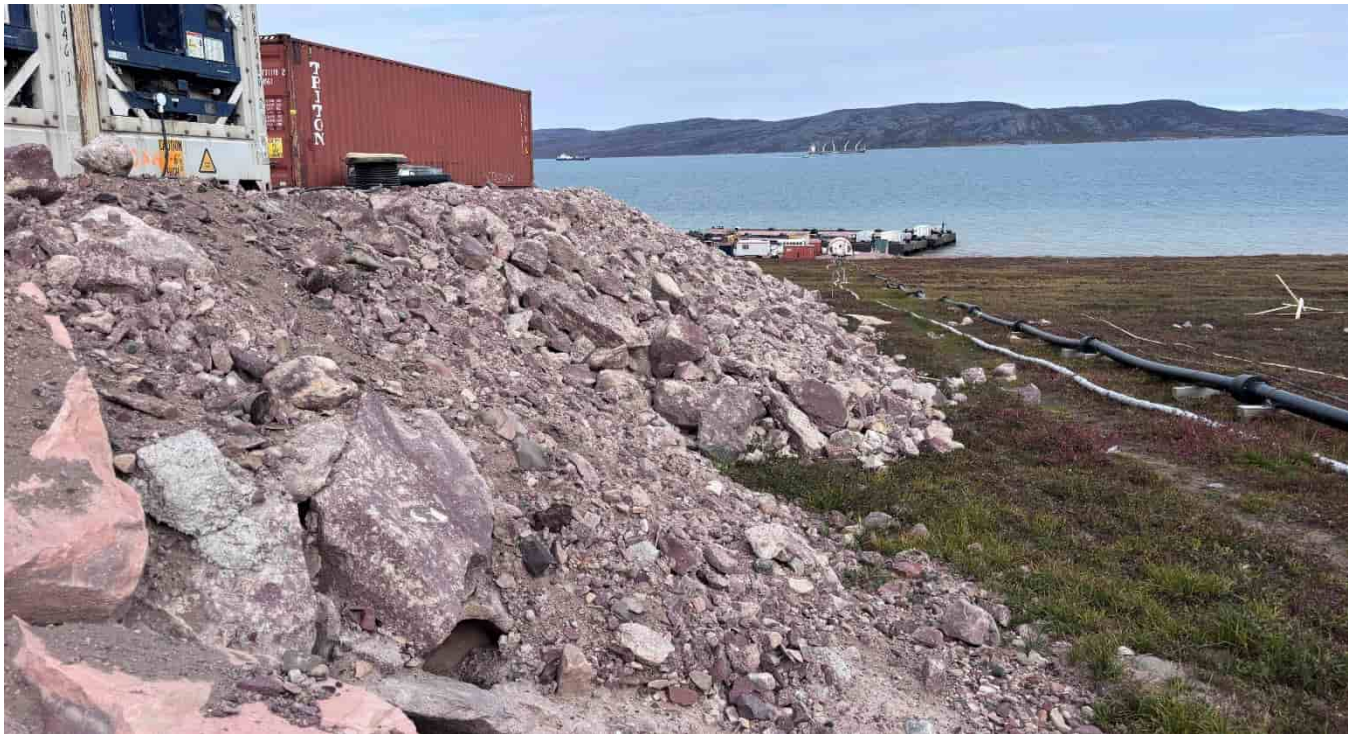
M-54: Eroding slope of camp pad extension, looking NE

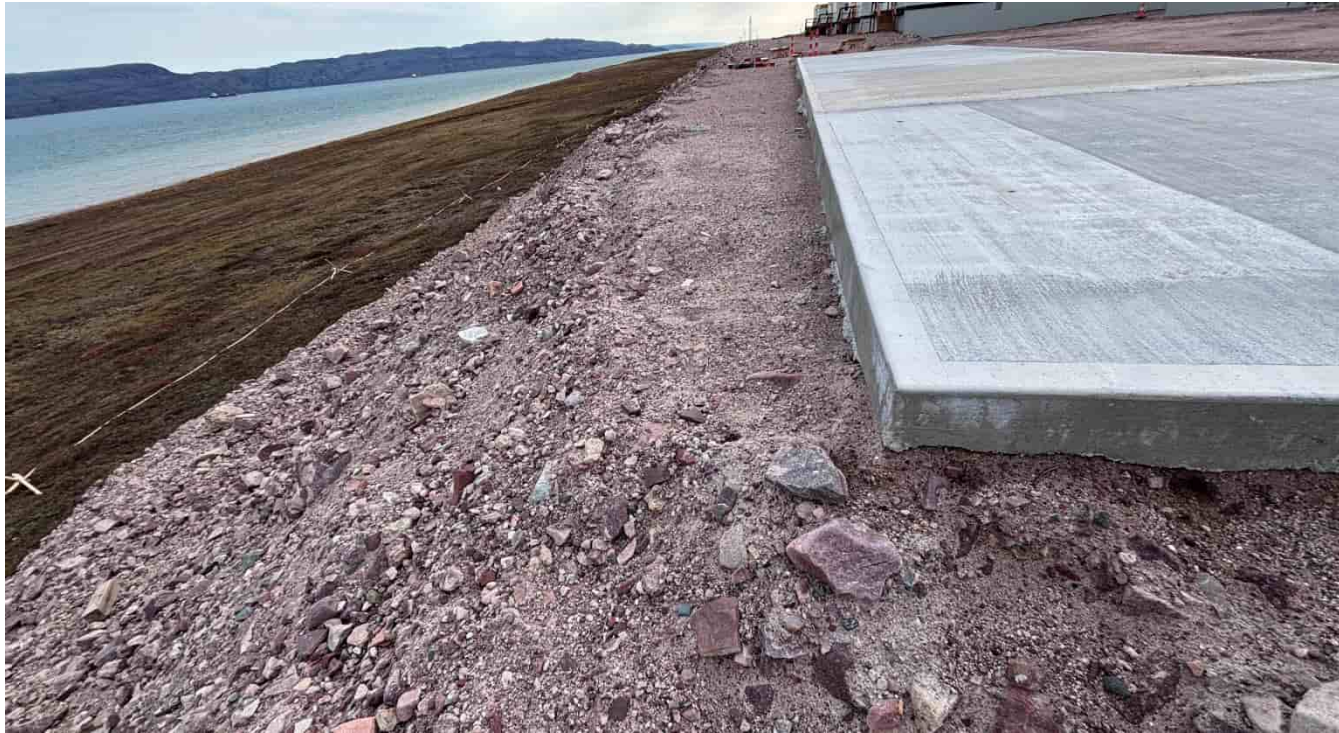
M-56: Erosion under concrete pad at N corner of camp pad, looking E

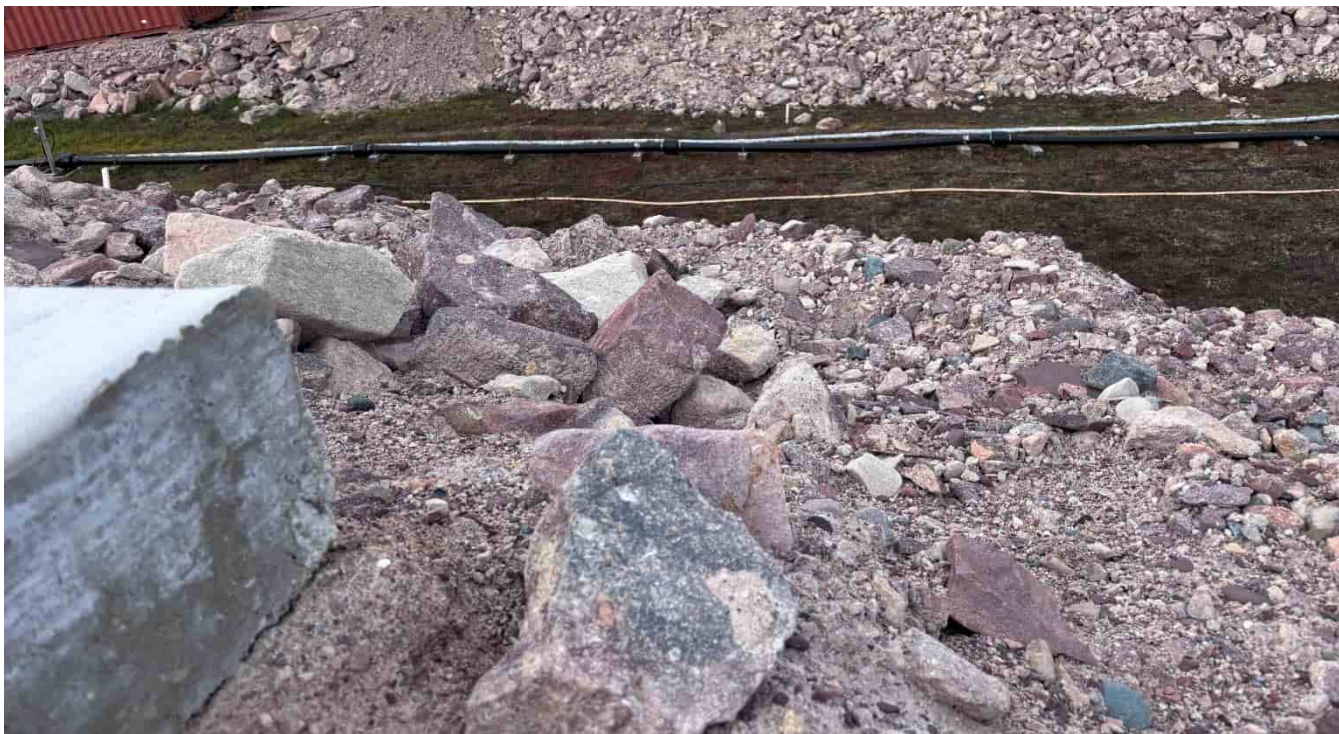
M-58: Camp pad, north corner. Note the NW corner of the concrete slab located too close to the crest of the pad

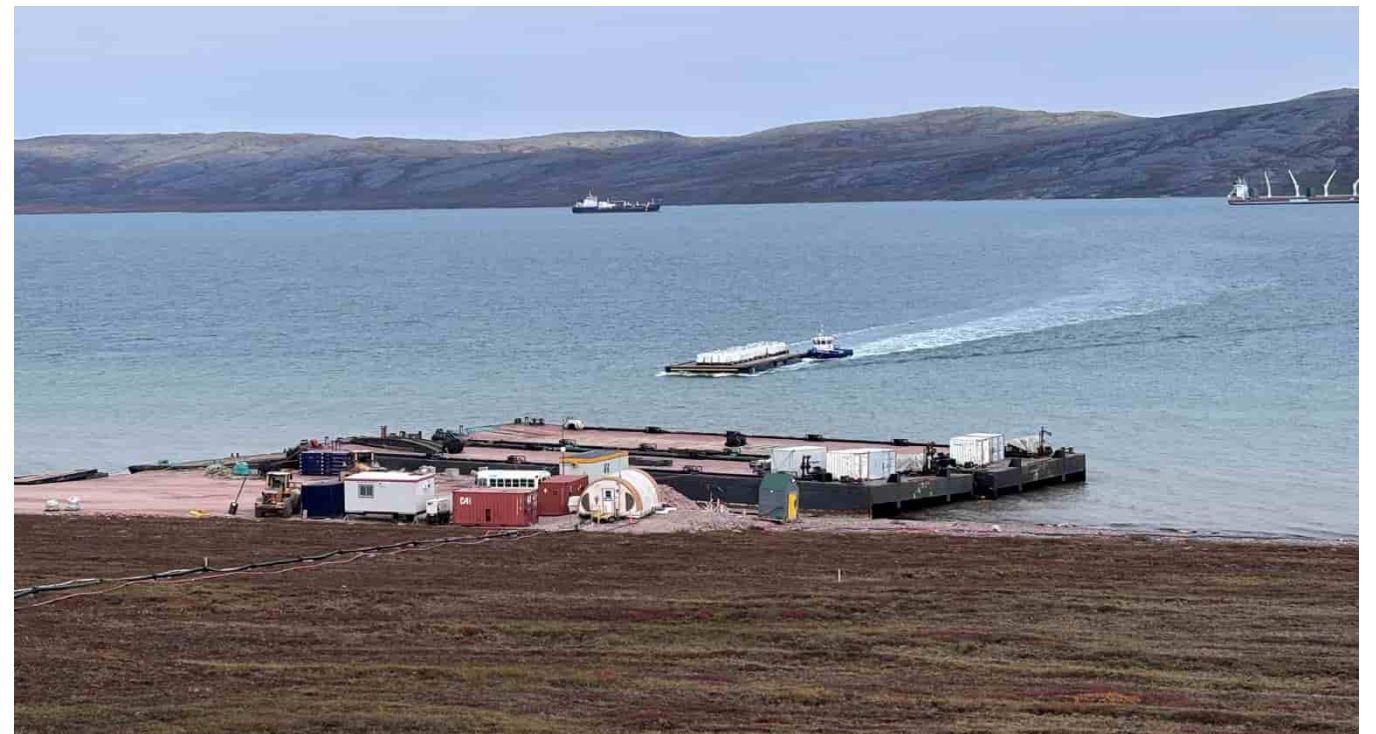
M-59: View of shoreline pad from camp pad

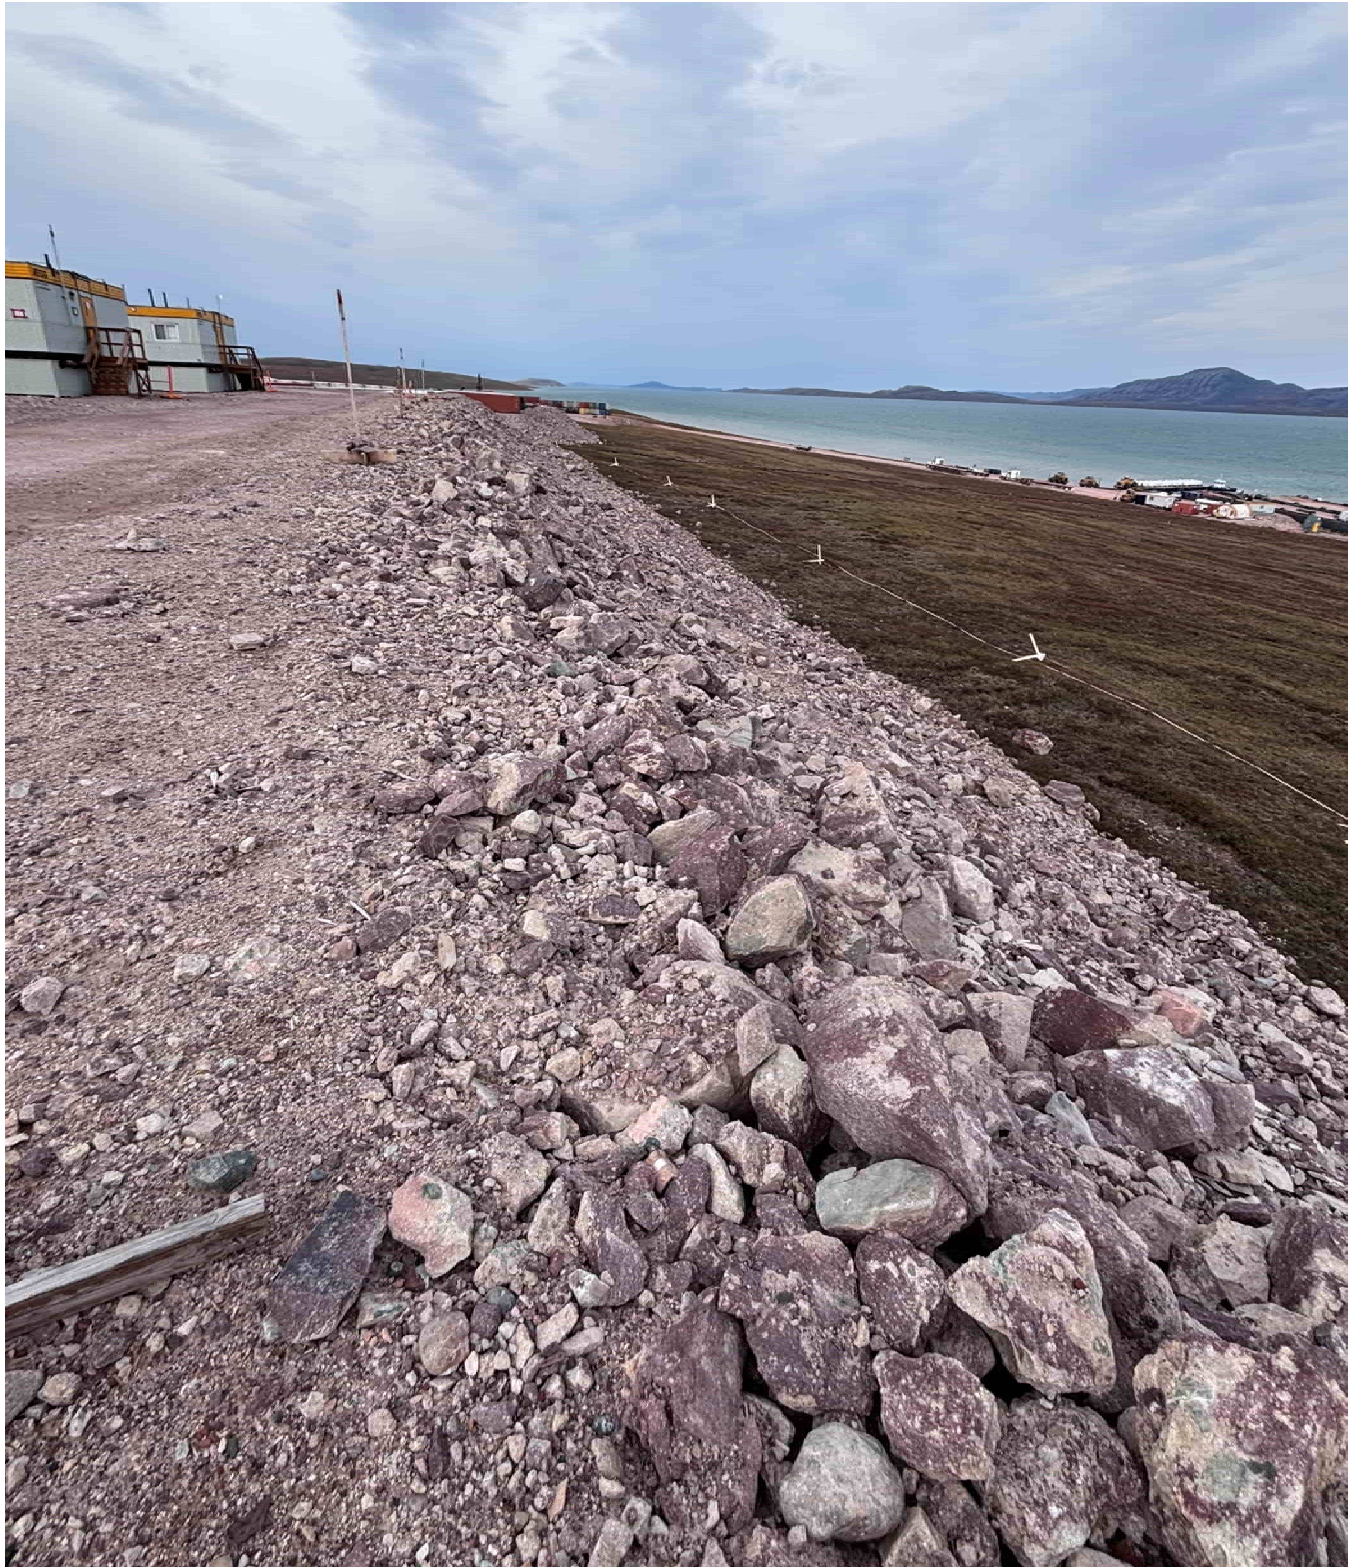
M-61: Eastern pad slope typical condition

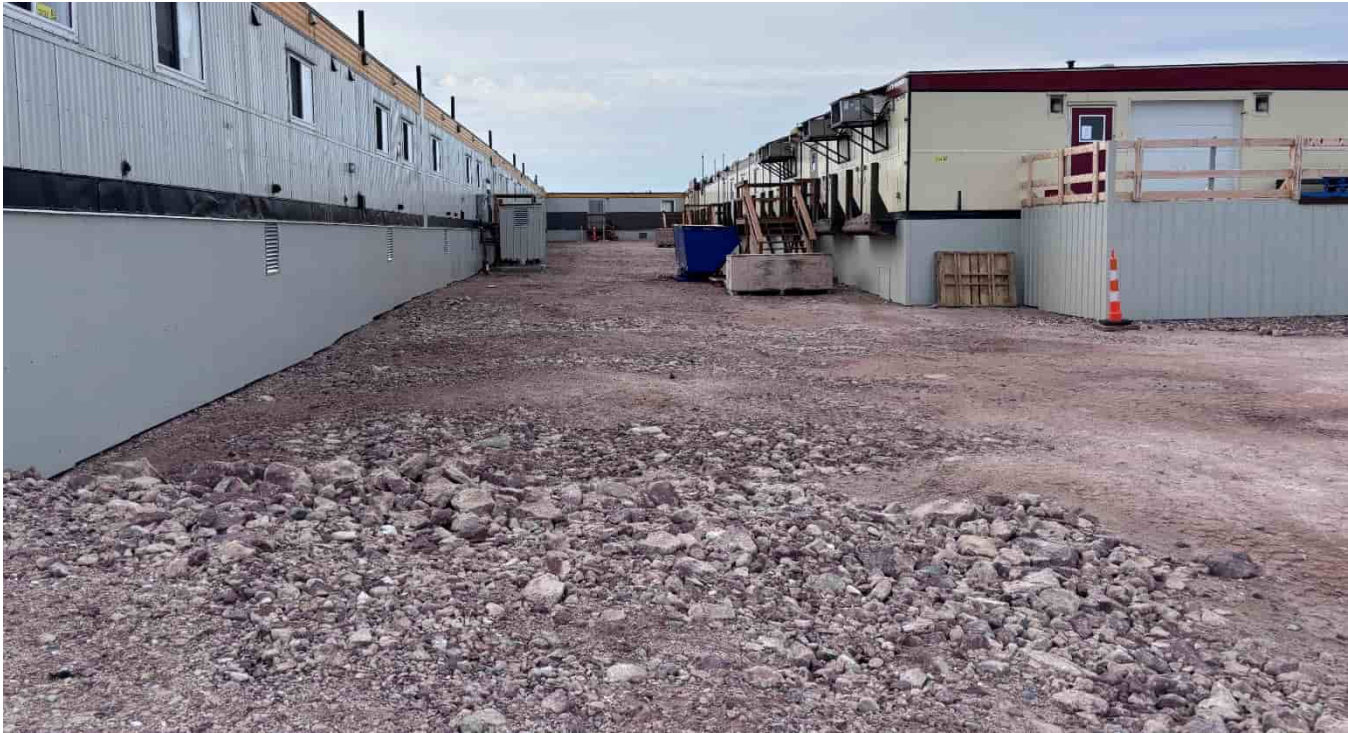
M-60: Camp pad surface conditions

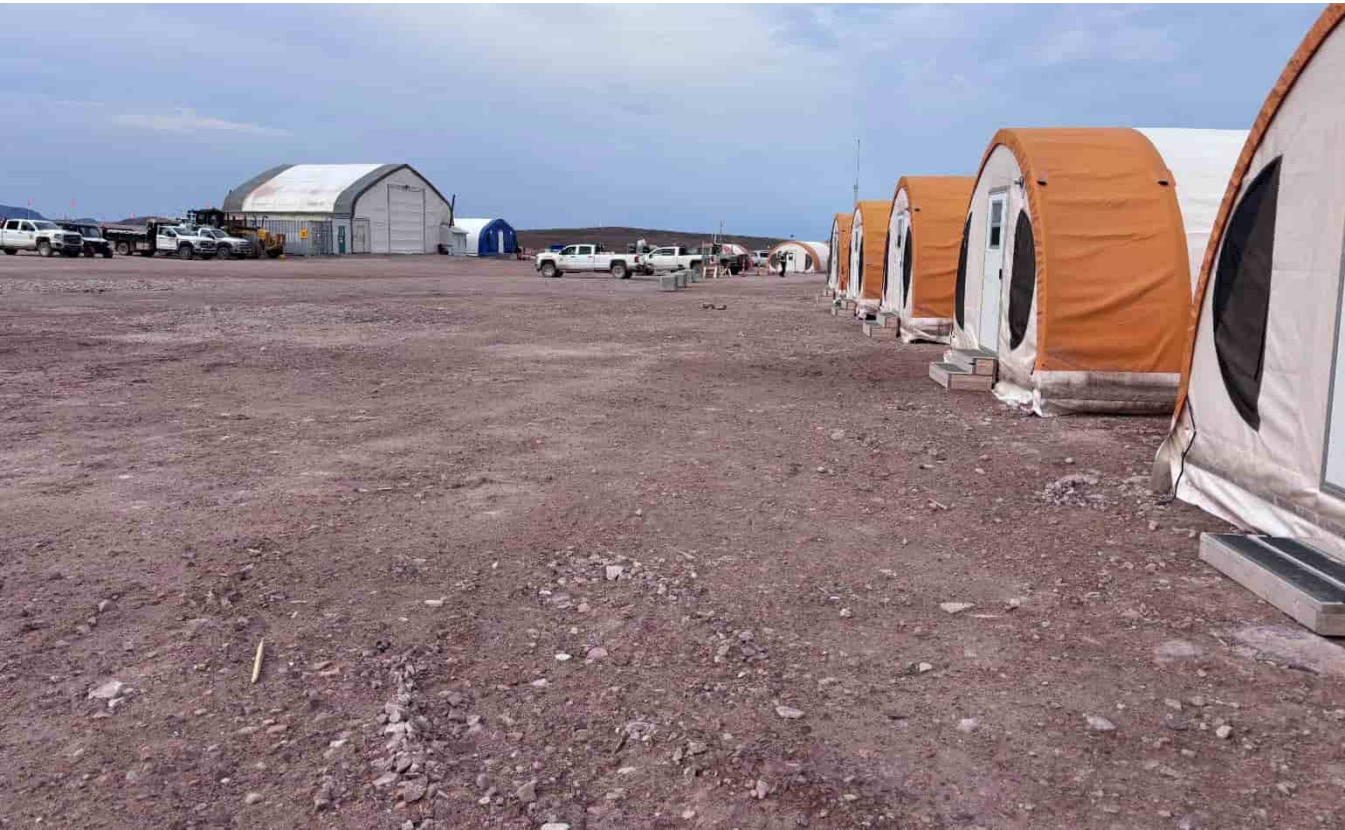
M-64: Camp pad housing and surface conditions, looking NW

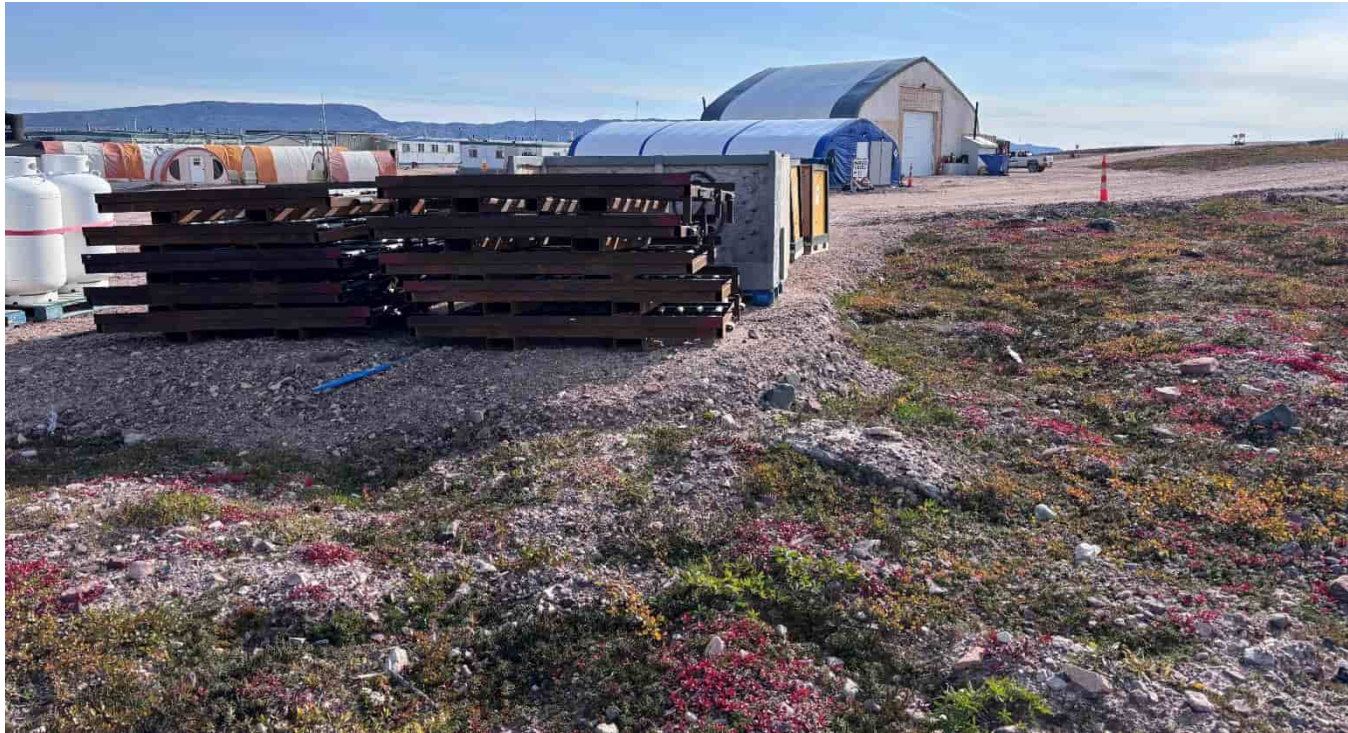
M-65: Pad between airstrip and camp pad – Note thickness of pad

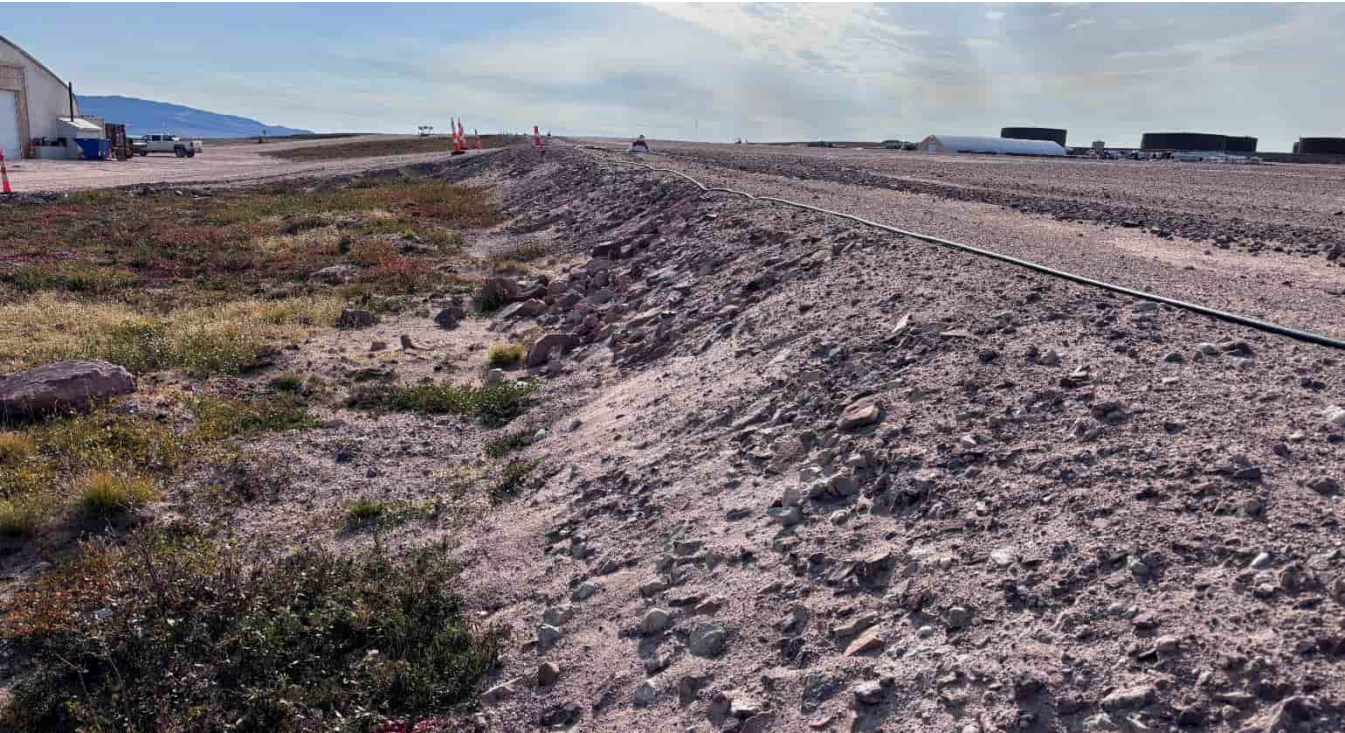
M-66: Airstrip embankment, looking SE – Note erosion

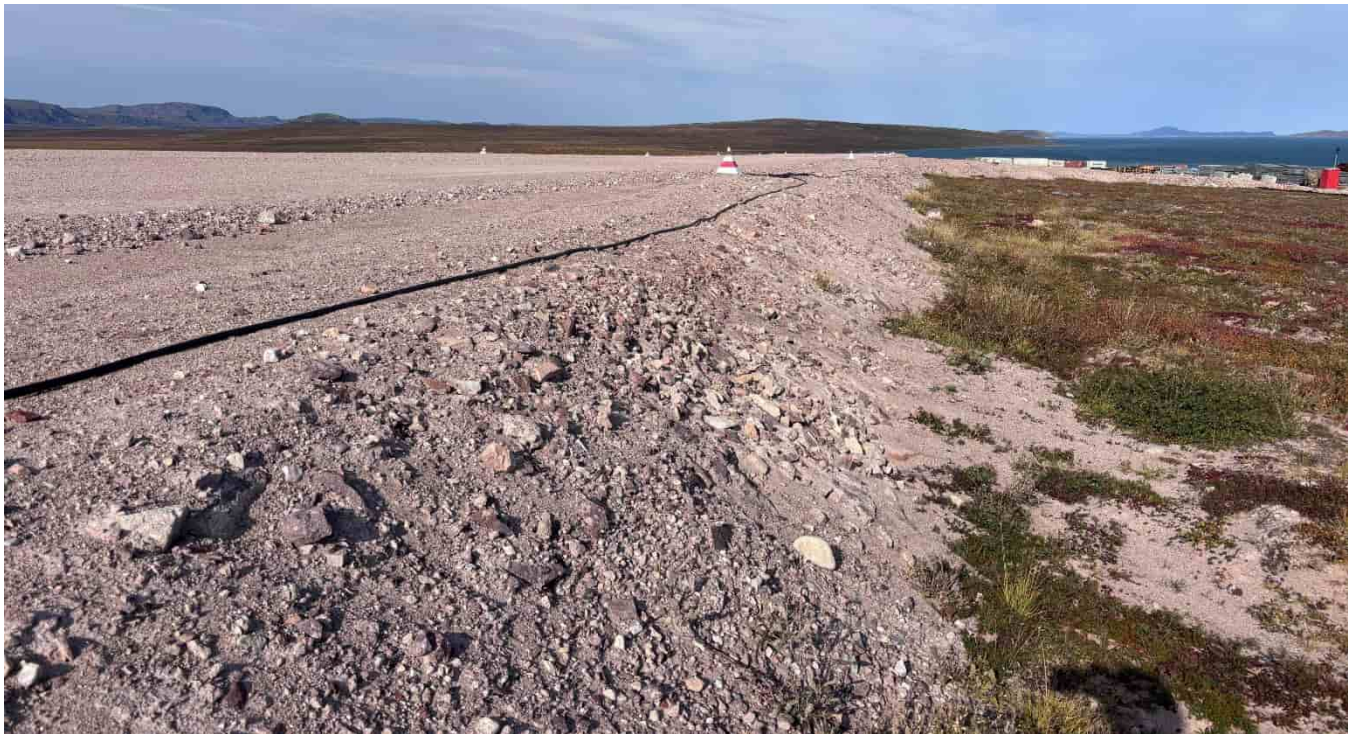
M-67: Airstrip embankment, looking NW

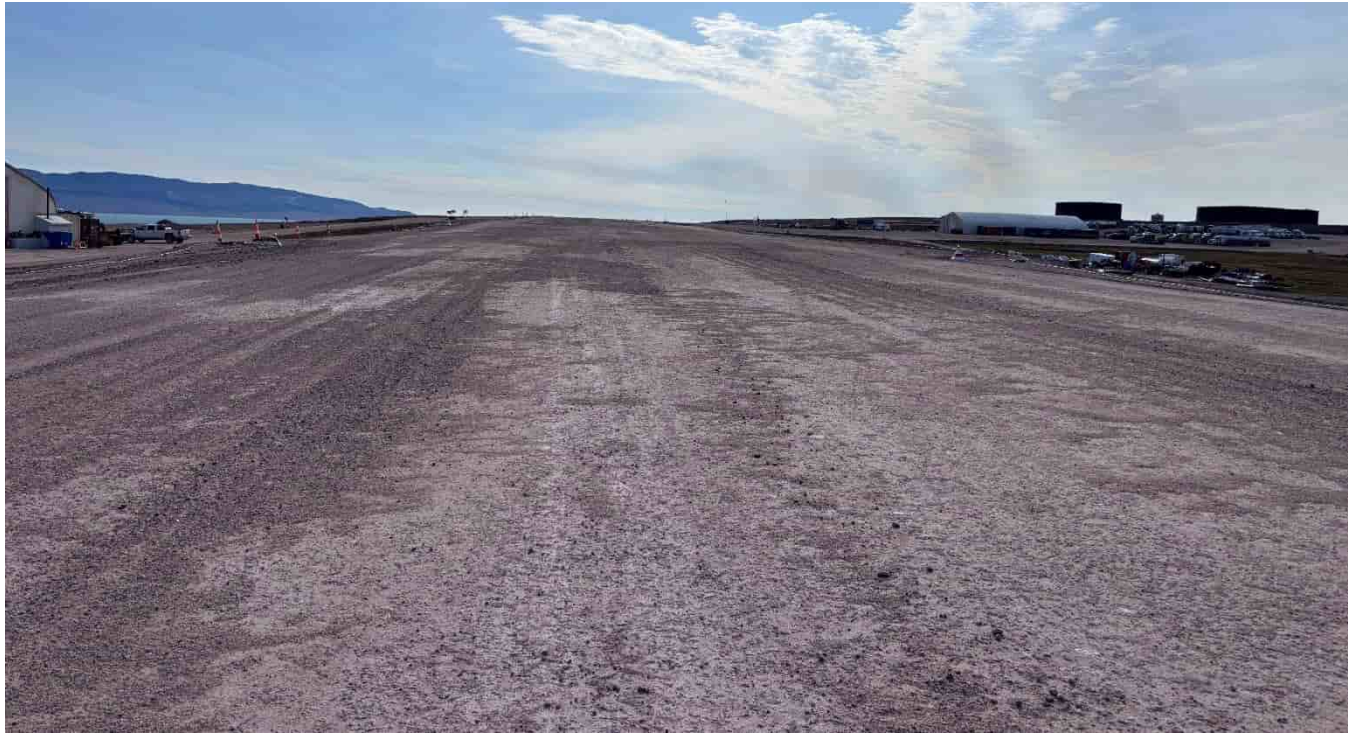
M-69: Airstrip surface conditions, looking SE

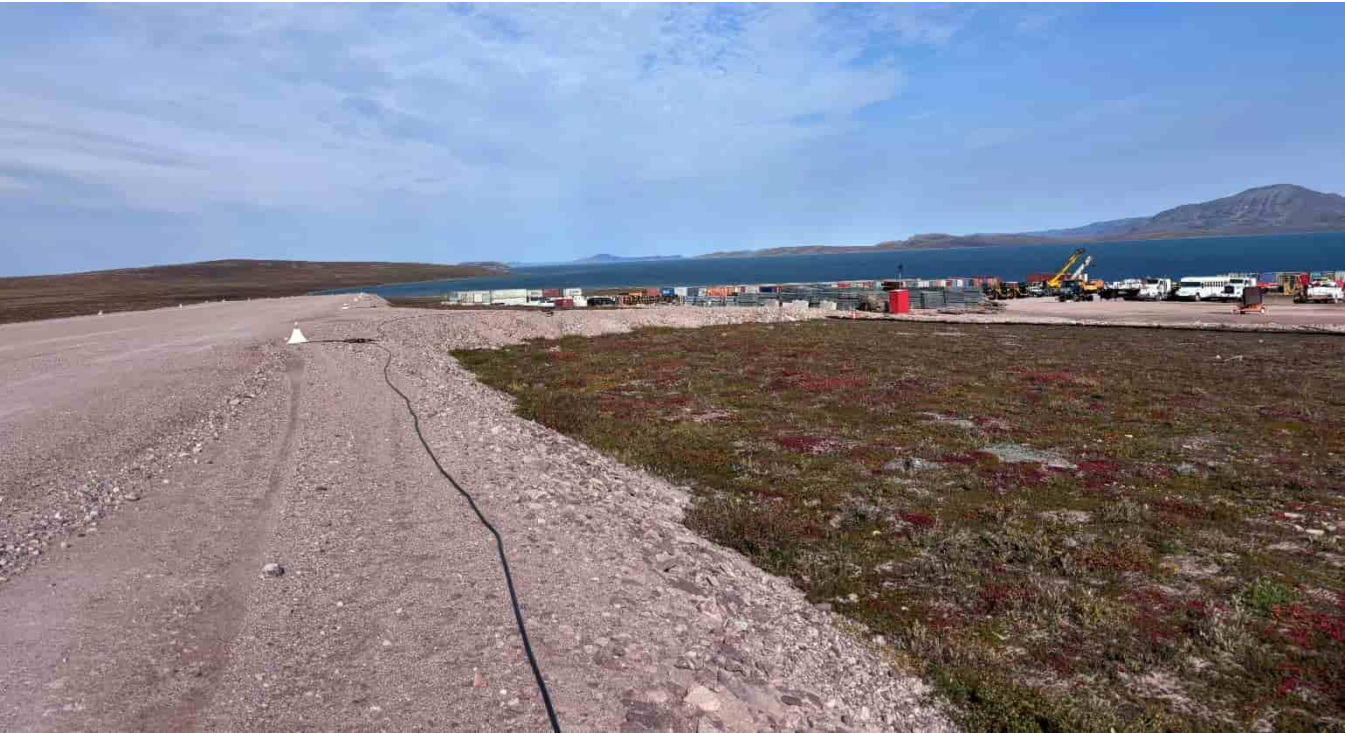
M-70: Airstrip embankment, looking NW

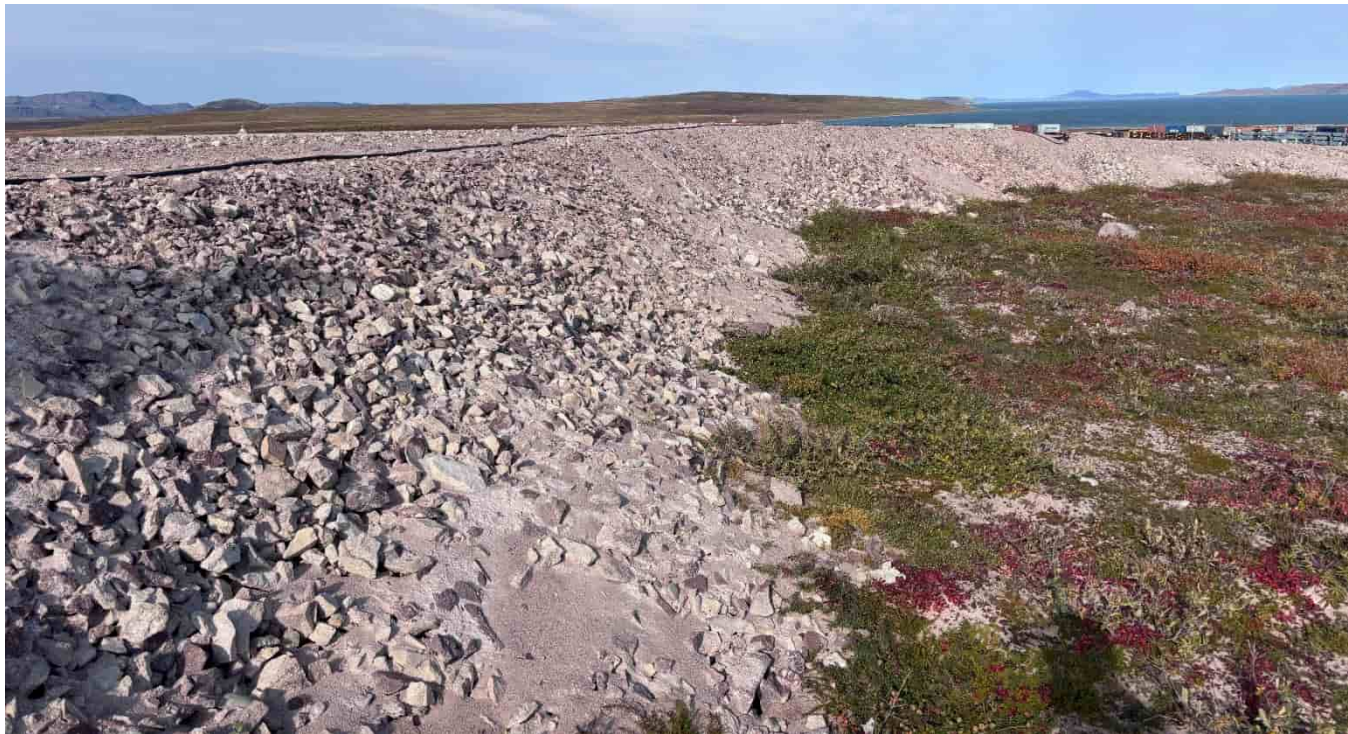
M-71: Airstrip embankment – Note erosion

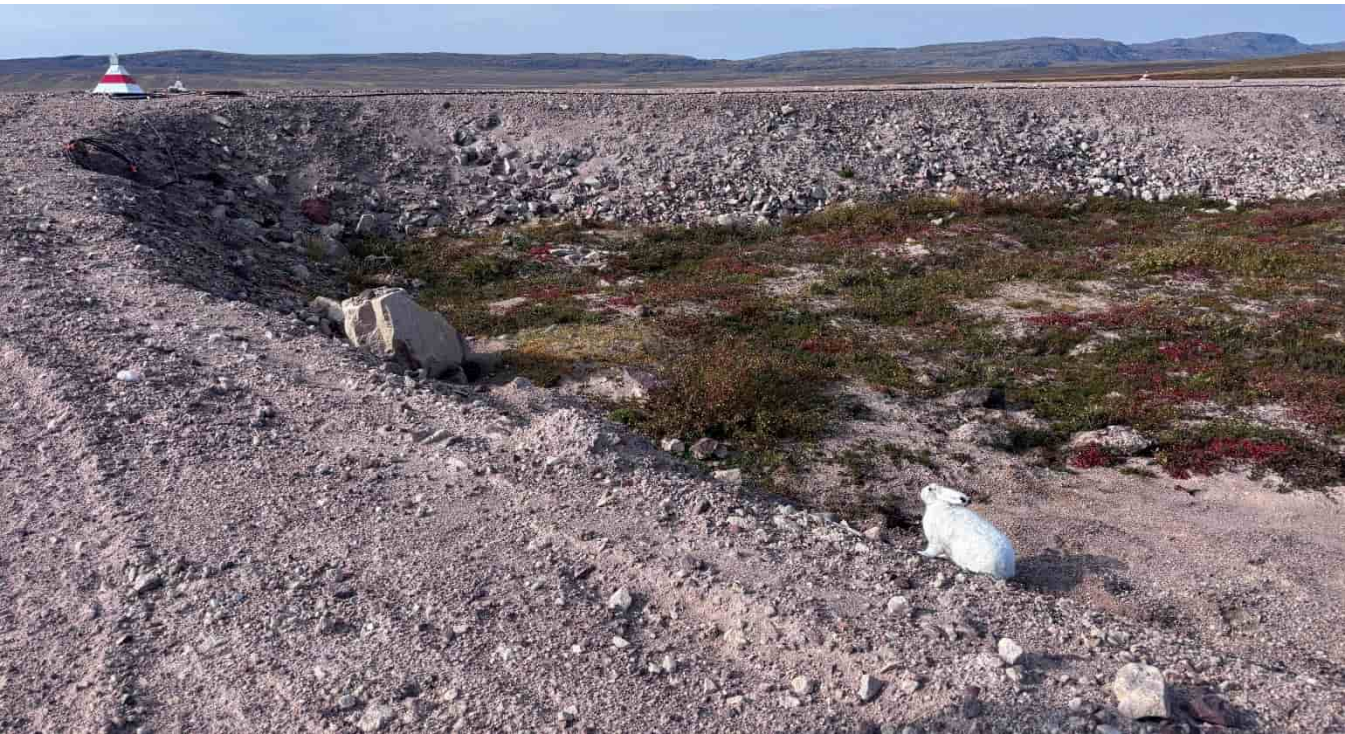
M-72: N corner of airstrip and freight storage pad access road
