| | | 2025 Annual Geotechnical Inspection | | |
| | | MLA Airstrip | | |
| Job No: CAPR004312<br>Filename: Back River_MLA_2025_AGI_Photos.pdf | Back River Project | Date:<br>February 2026 | Approved:<br>JBK | Figure:<br>36 |

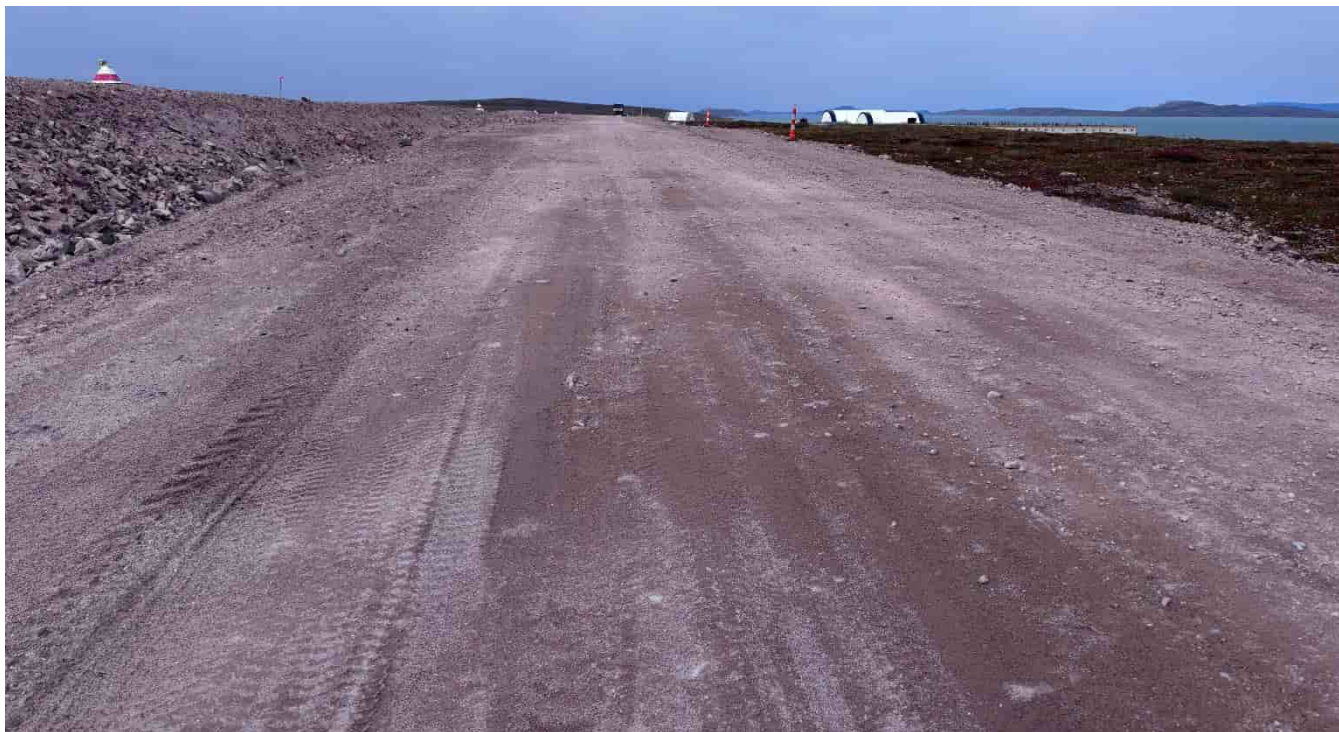
M-108: Airstrip and camp pad access road

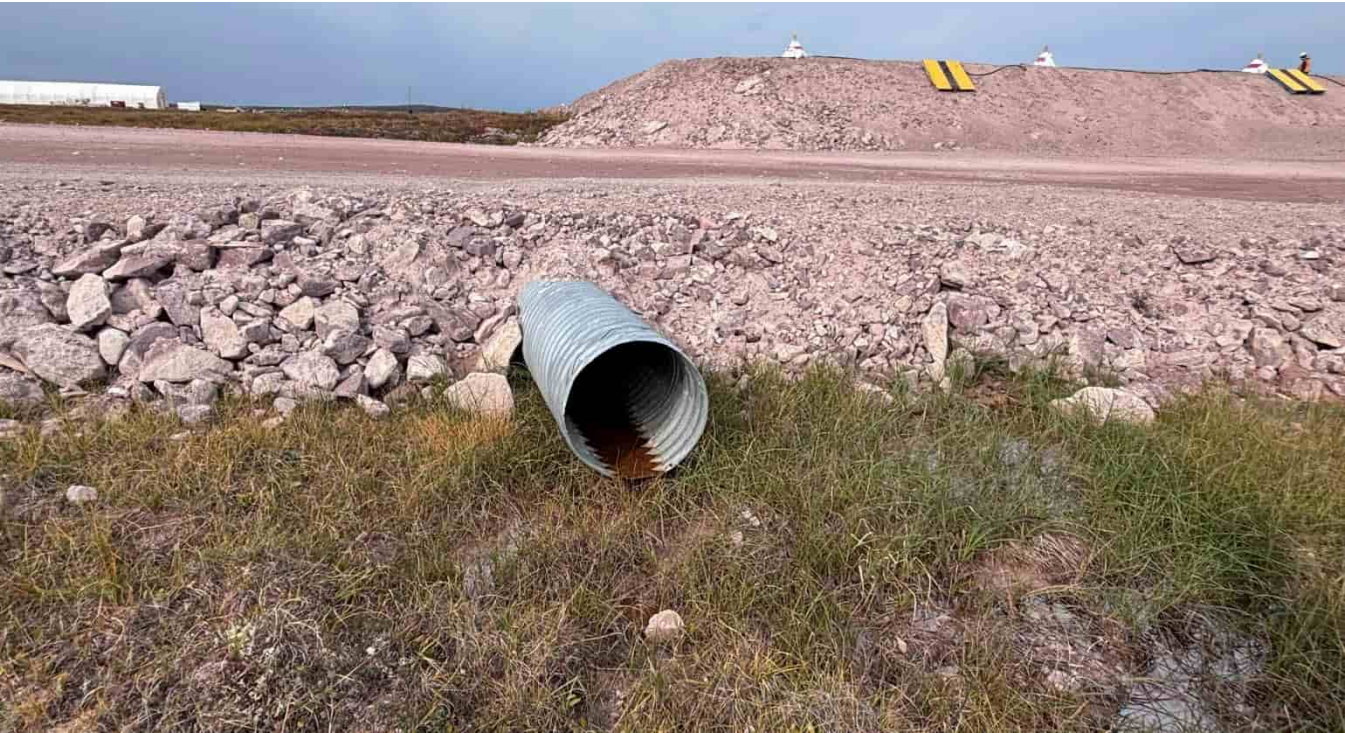
M-110: Culvert outlet under airstrip access road, beside SE end of airstrip

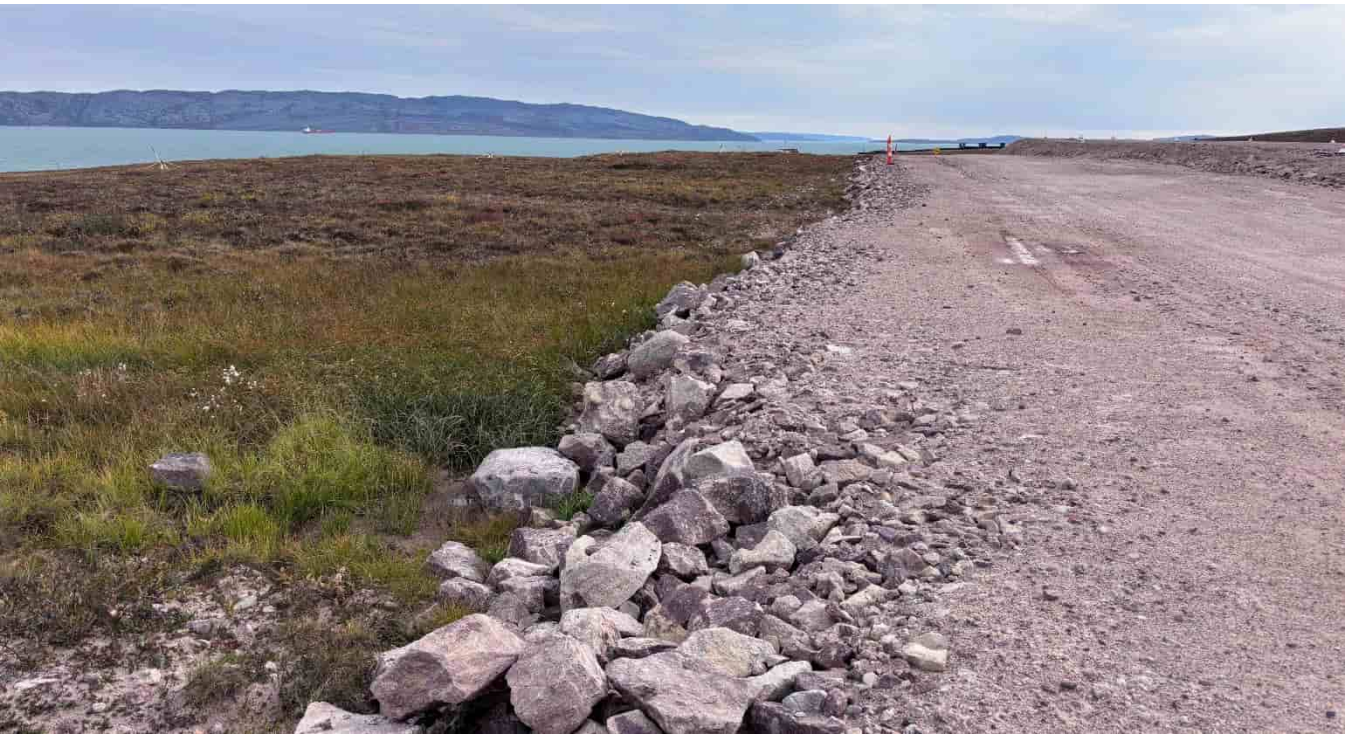
M-112: Access road embankment, looking SE

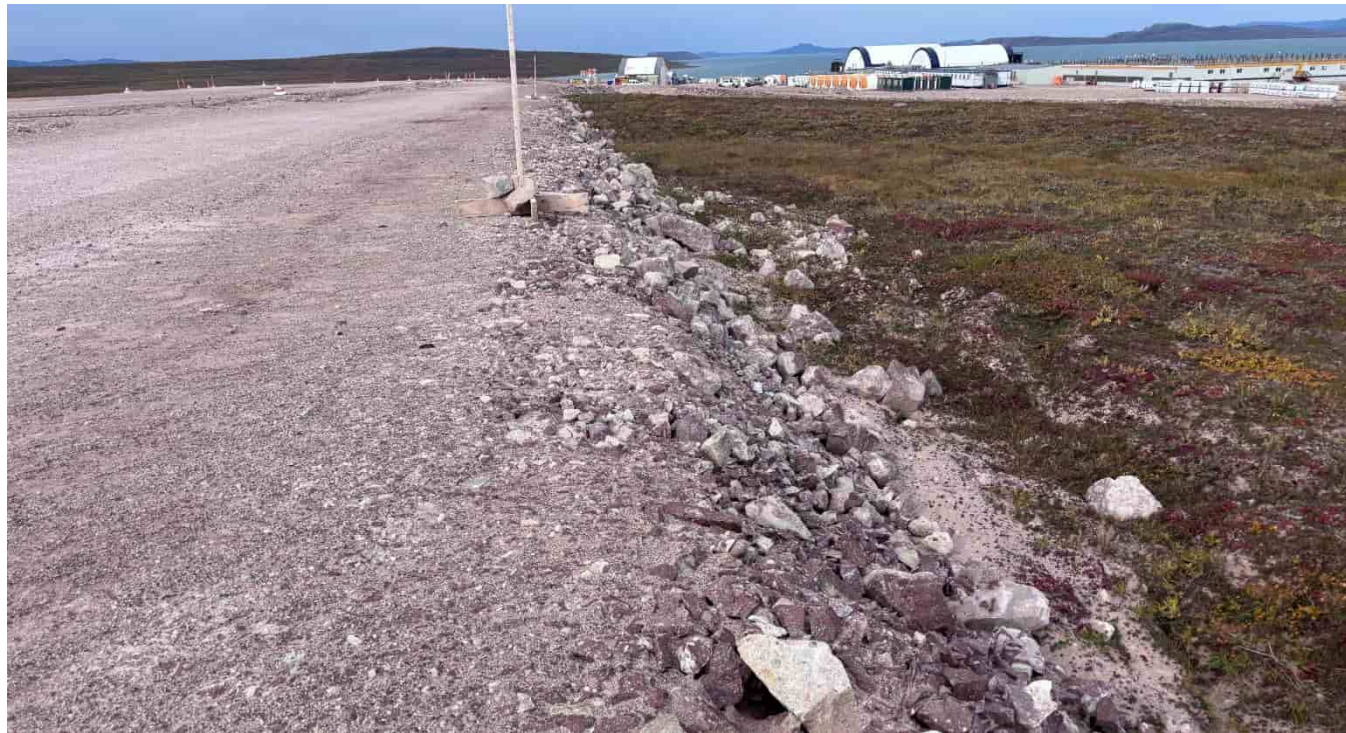
M-113: Access road embankment, looking NW

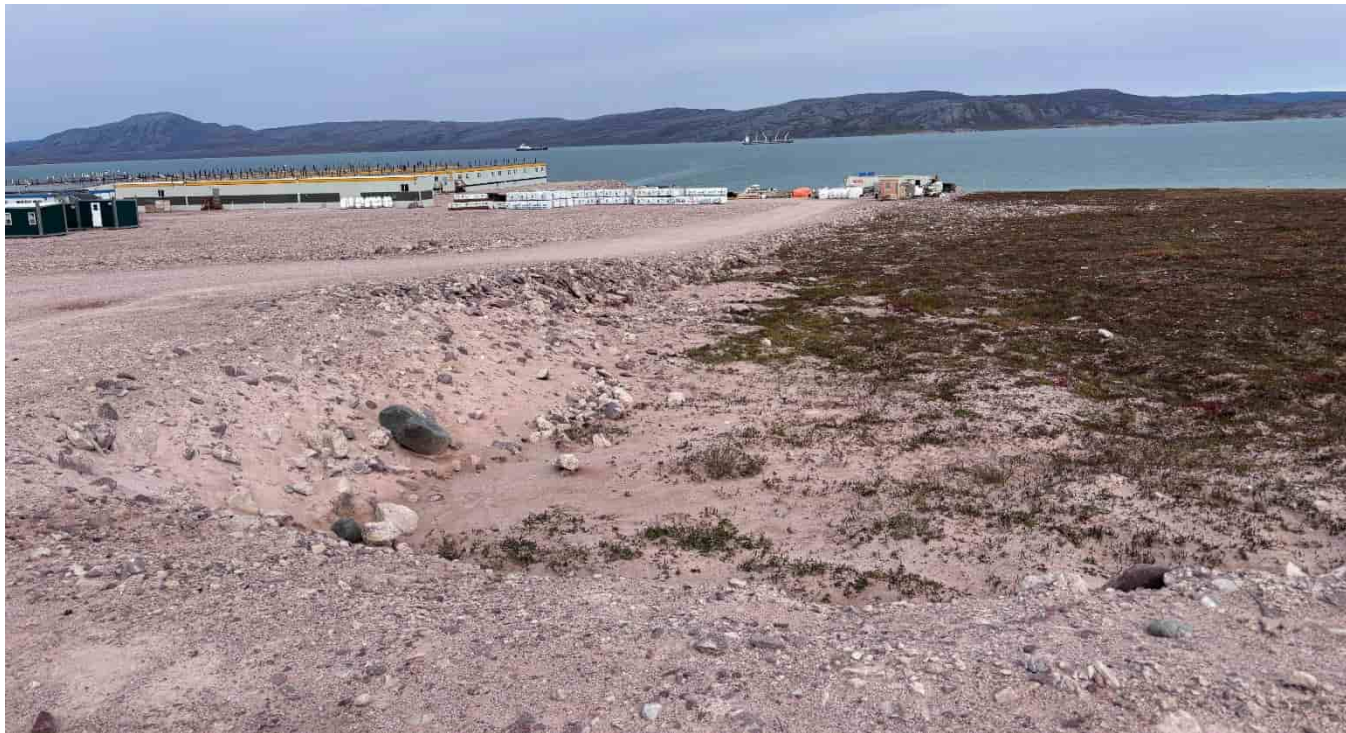
M-115: Camp pad laydown access road viewed from airstrip

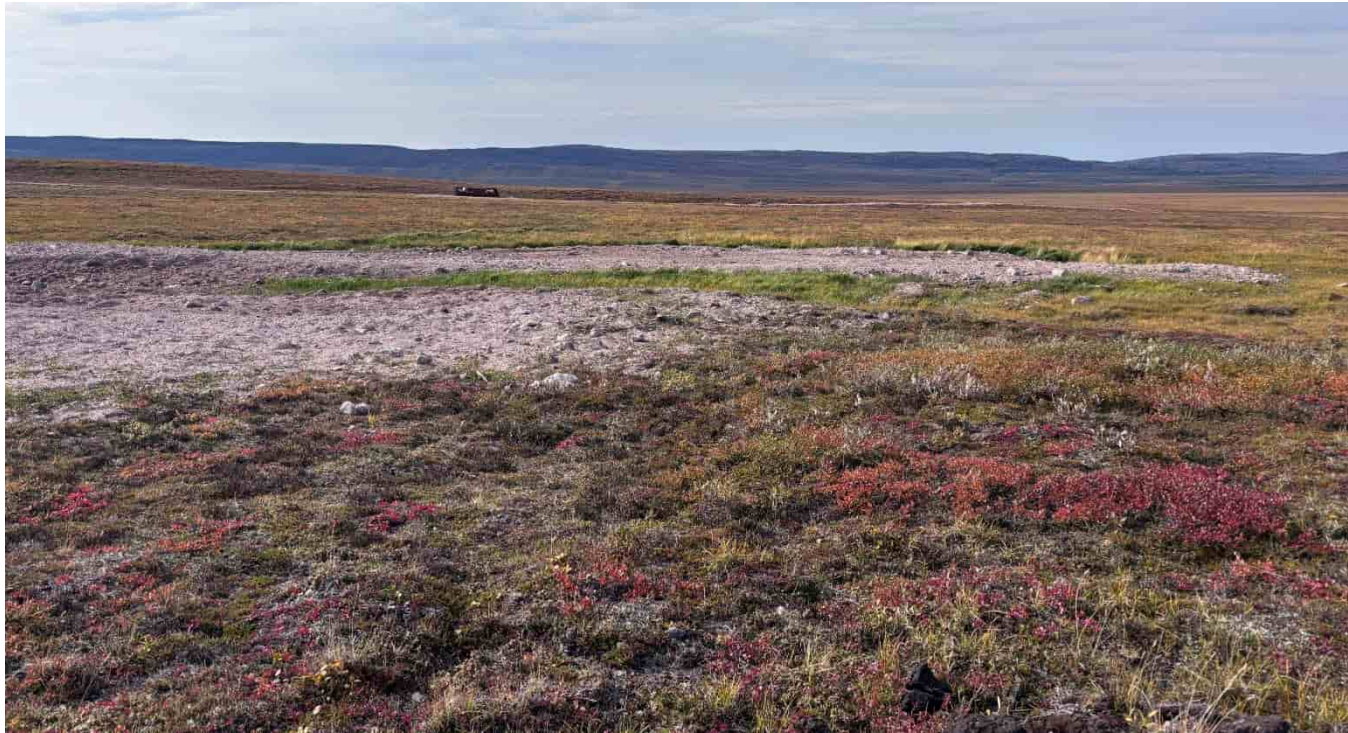
M-118: Undefined N edge of pad, looking W

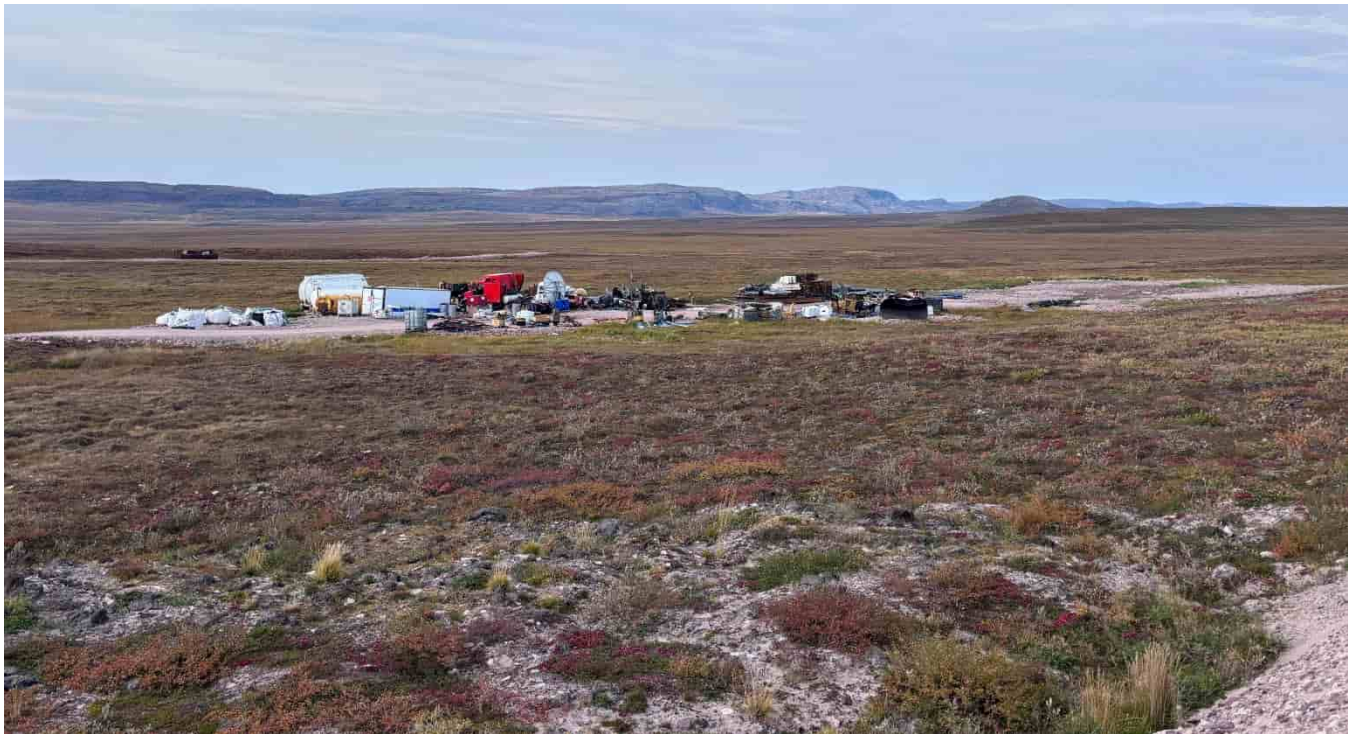
M-120: Former temporary fuel containment area, viewed from Airstrip

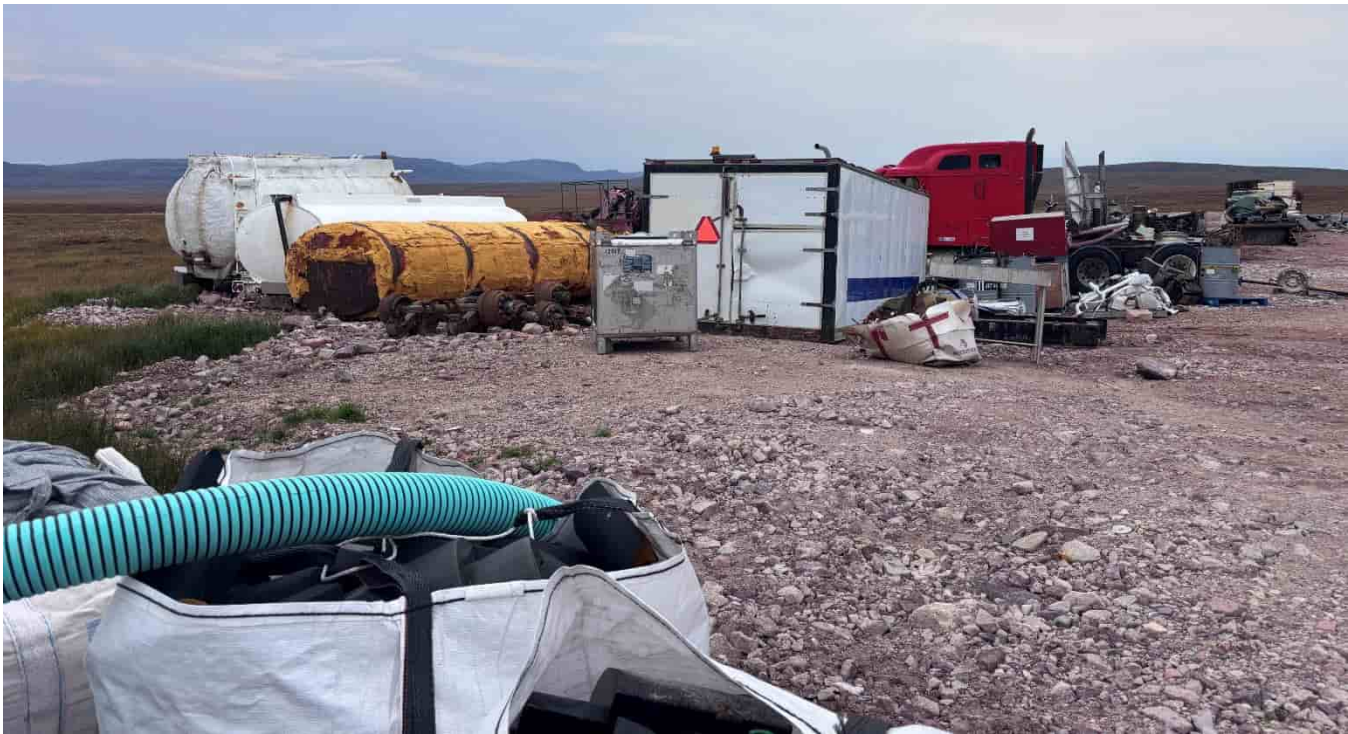
M-121: Laydown, looking NW

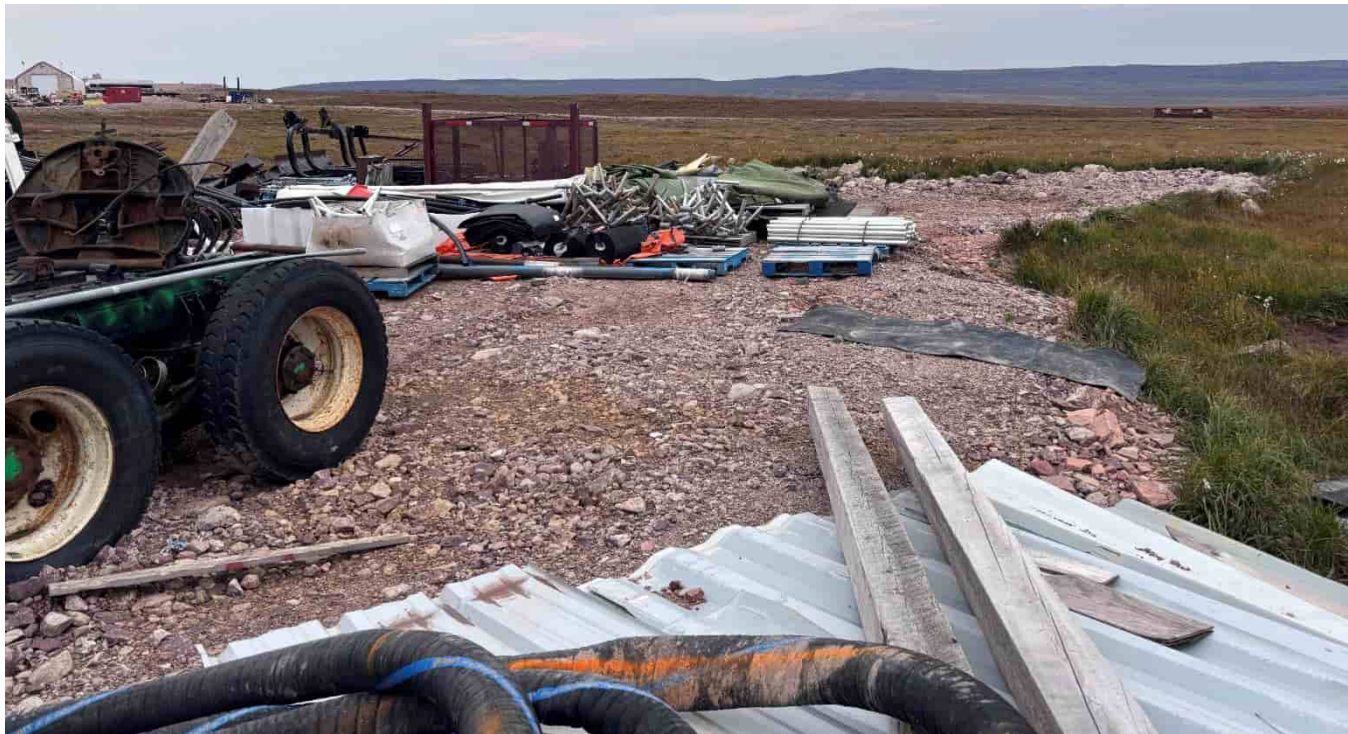
M-124: Laydown, looking SW

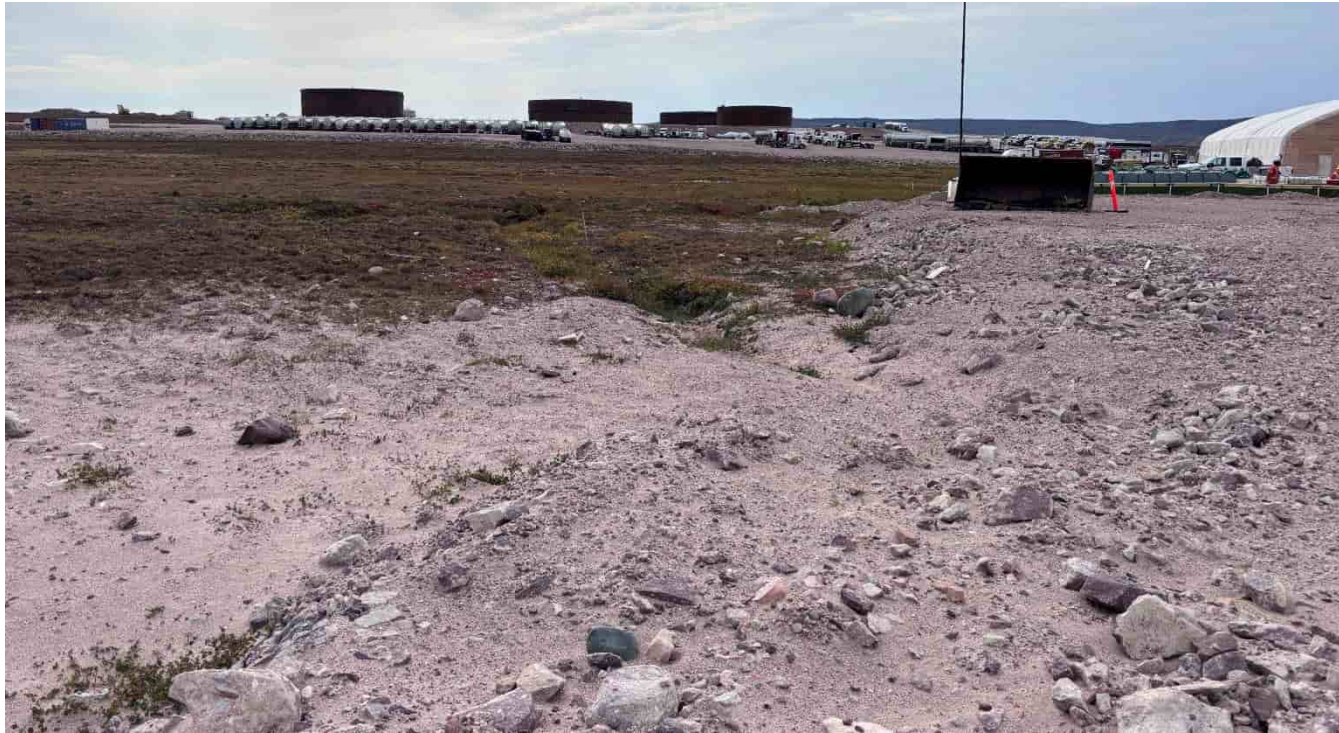
M-126: Undefined S edge of pad between airstrip and tank farm

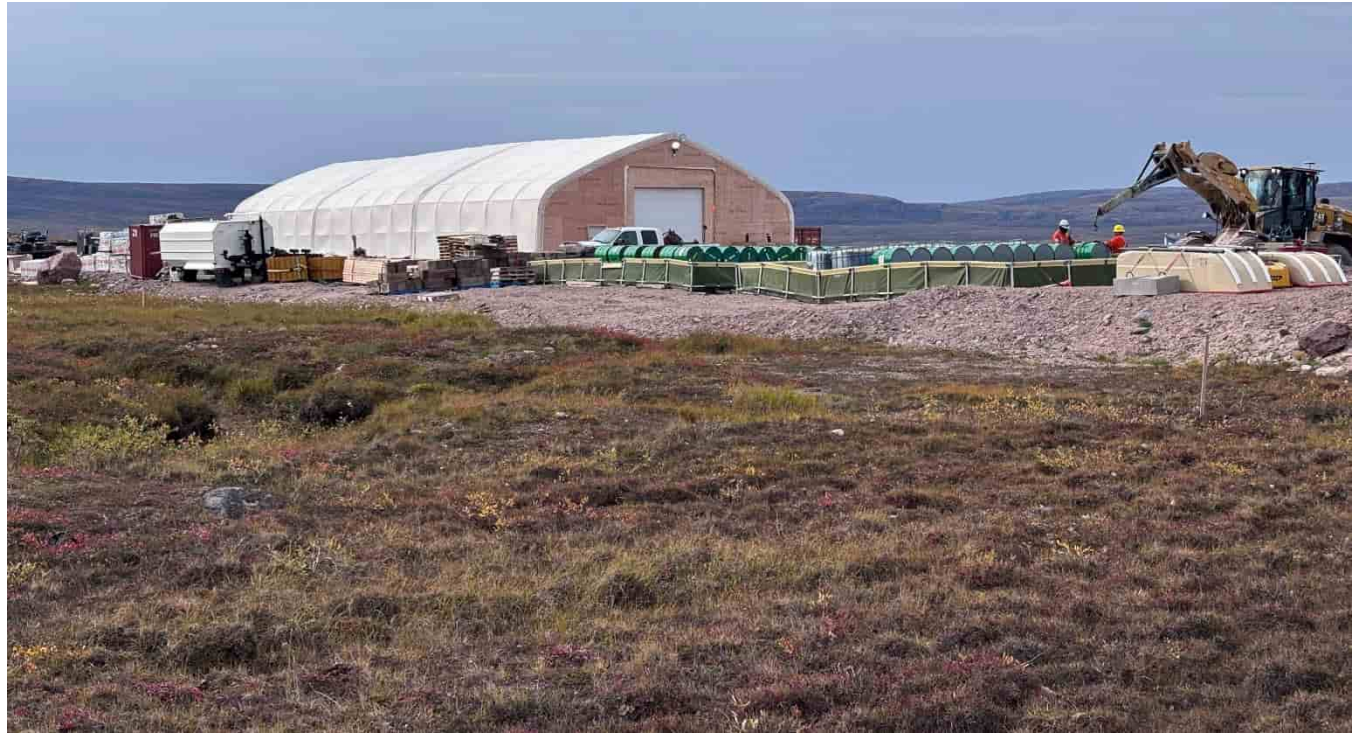
M-127: Pad between airstrip and tank farm, looking W

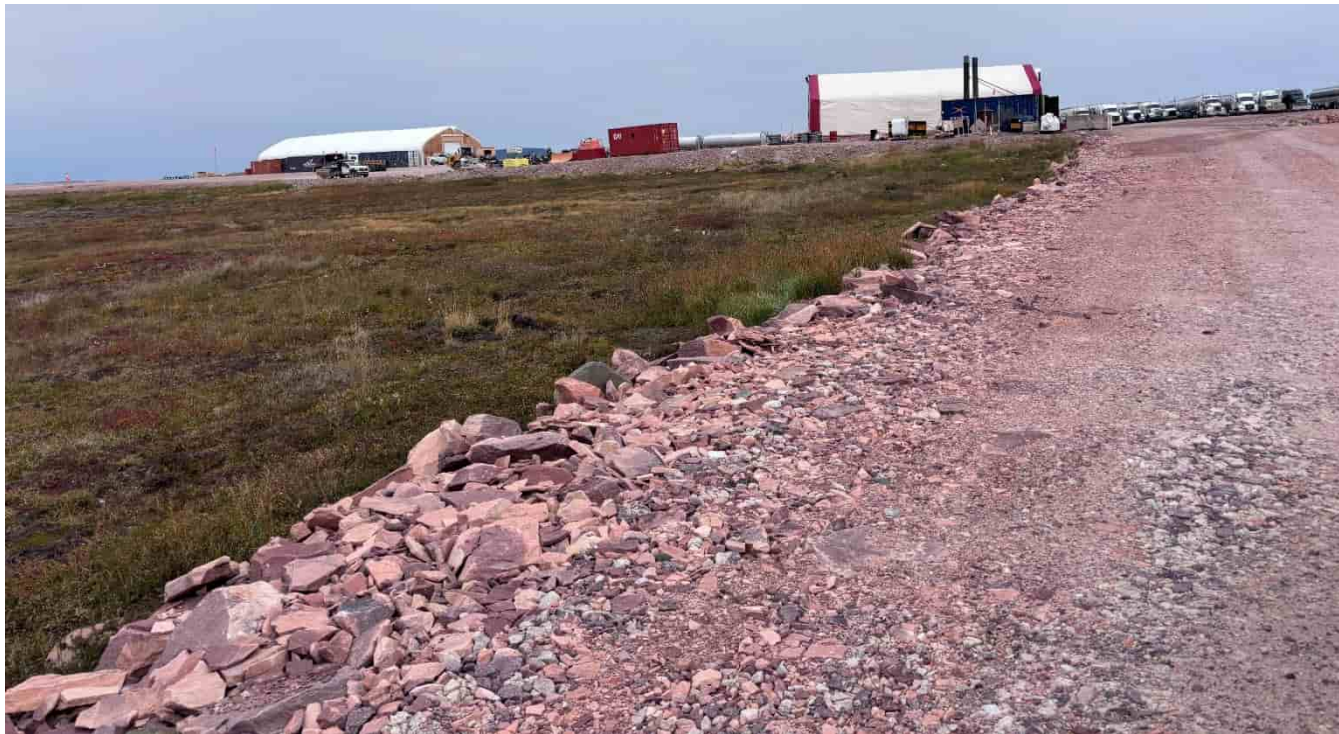
M-128: Former explosives storage access road, looking SE – Note fill is too thin

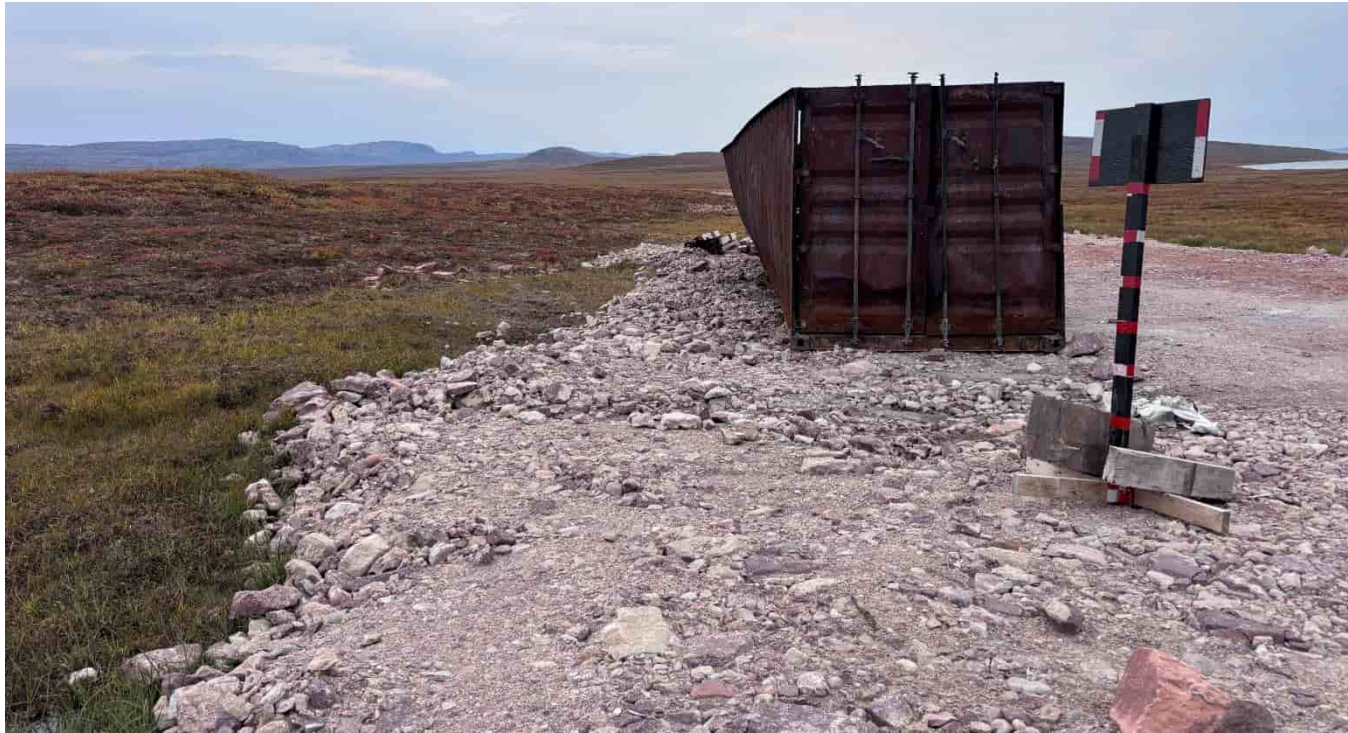
M-130: Old seacan on pad beside former explosives storage access road

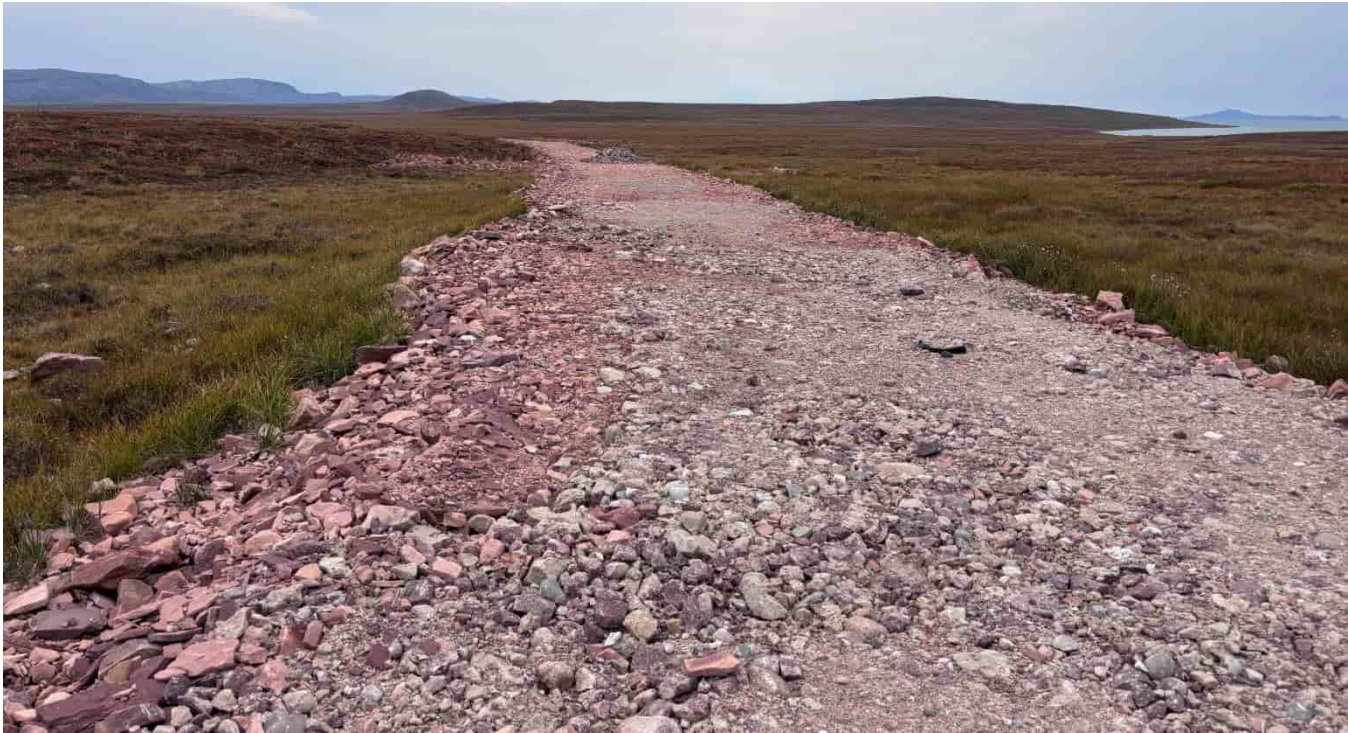
M-131: Former explosives storage access road, looking NW

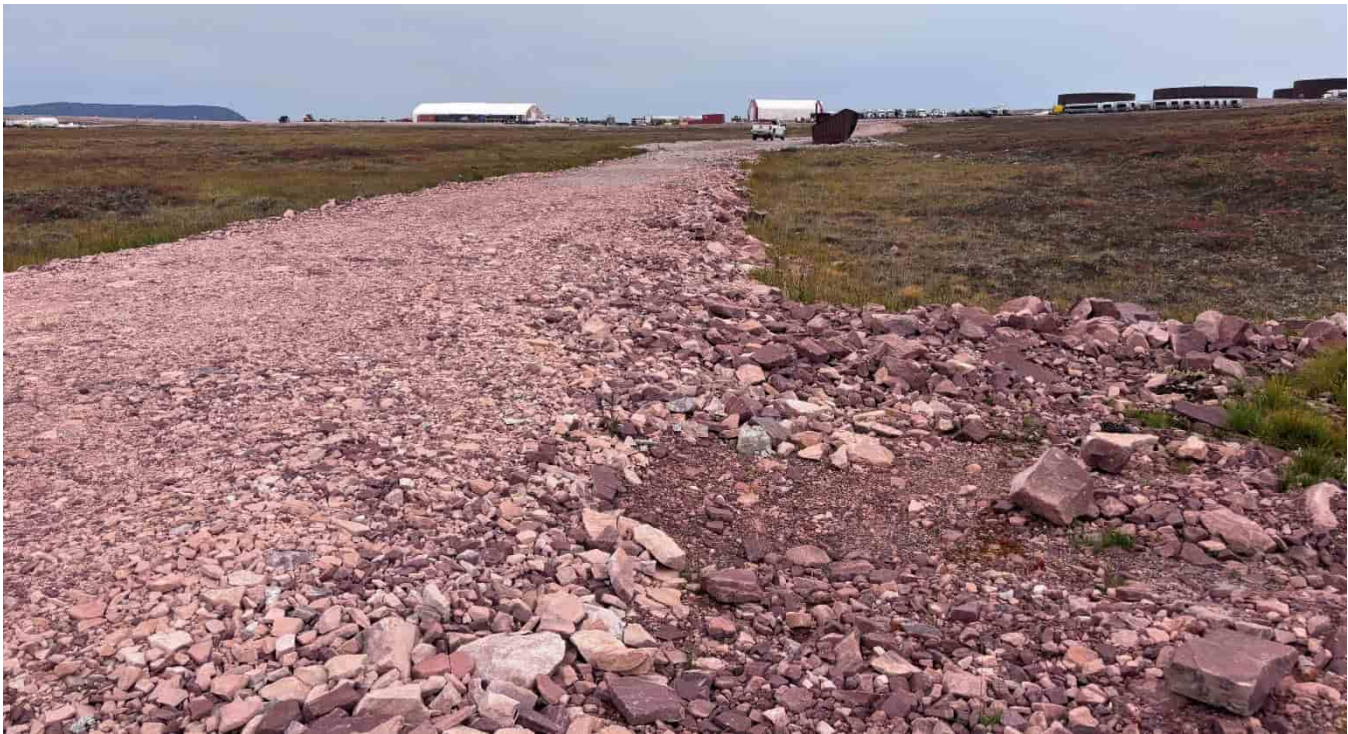
M-133: Former explosives storage access road, looking SE

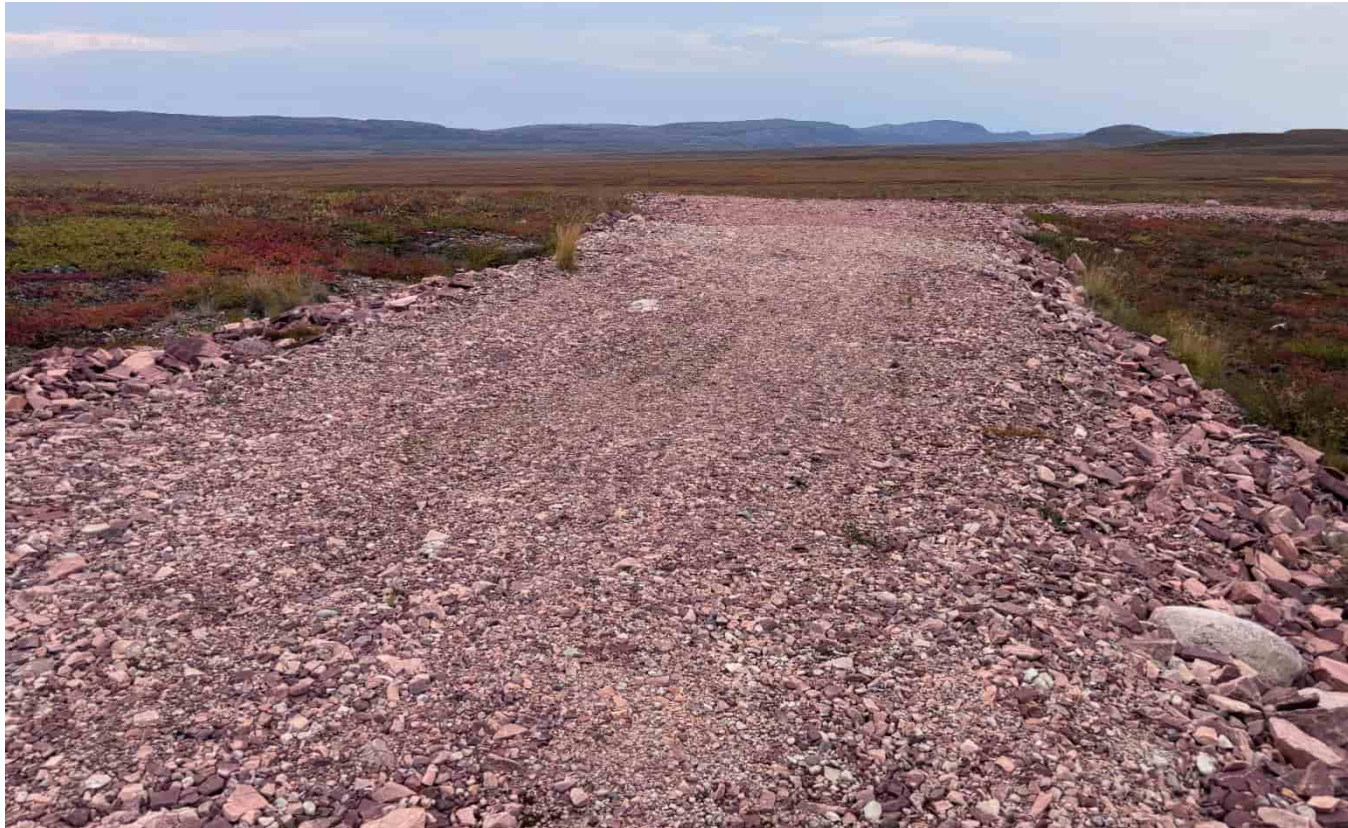
M-134: Northern end of former explosives storage access road

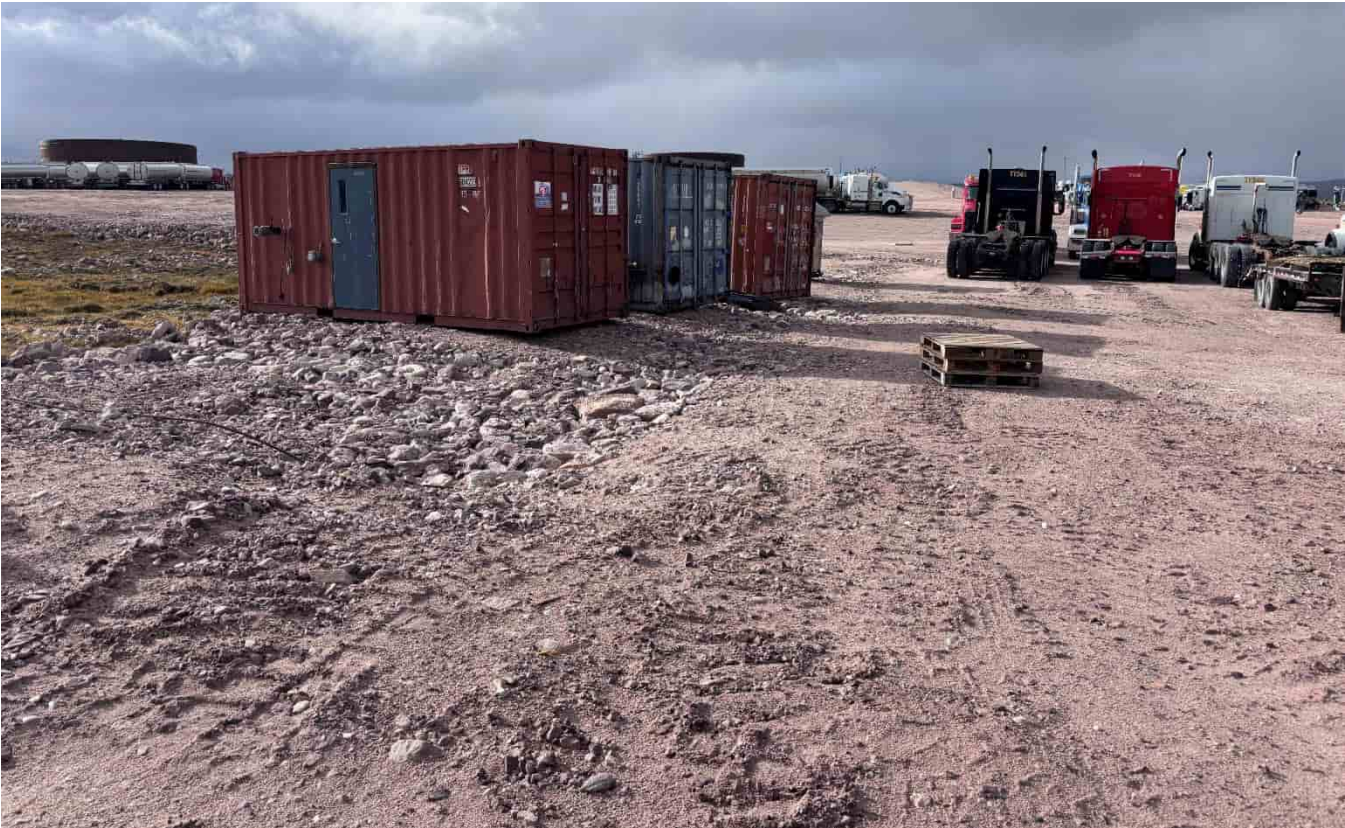
M-135: Laydown area between airstrip and tank farm

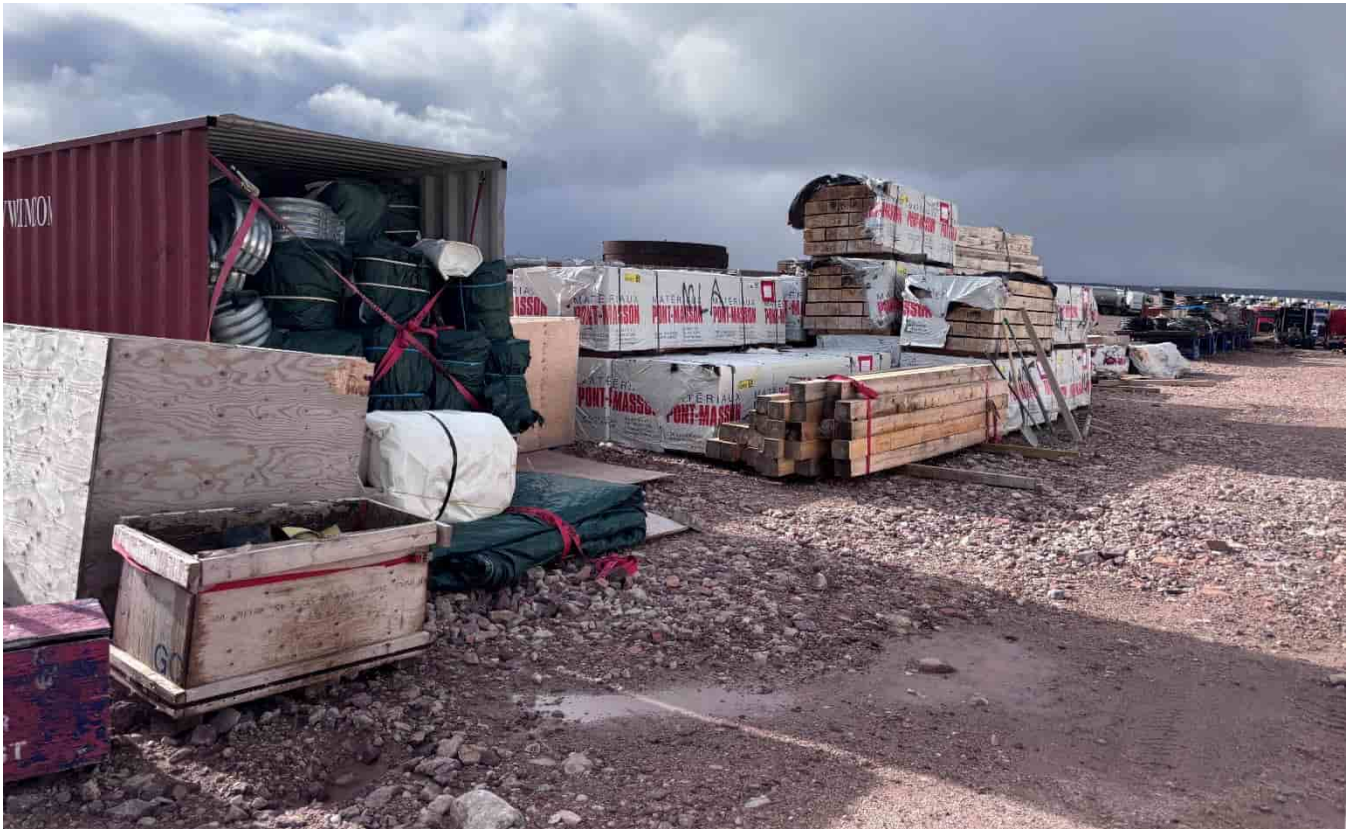
M-136: Laydown area between airstrip and tank farm

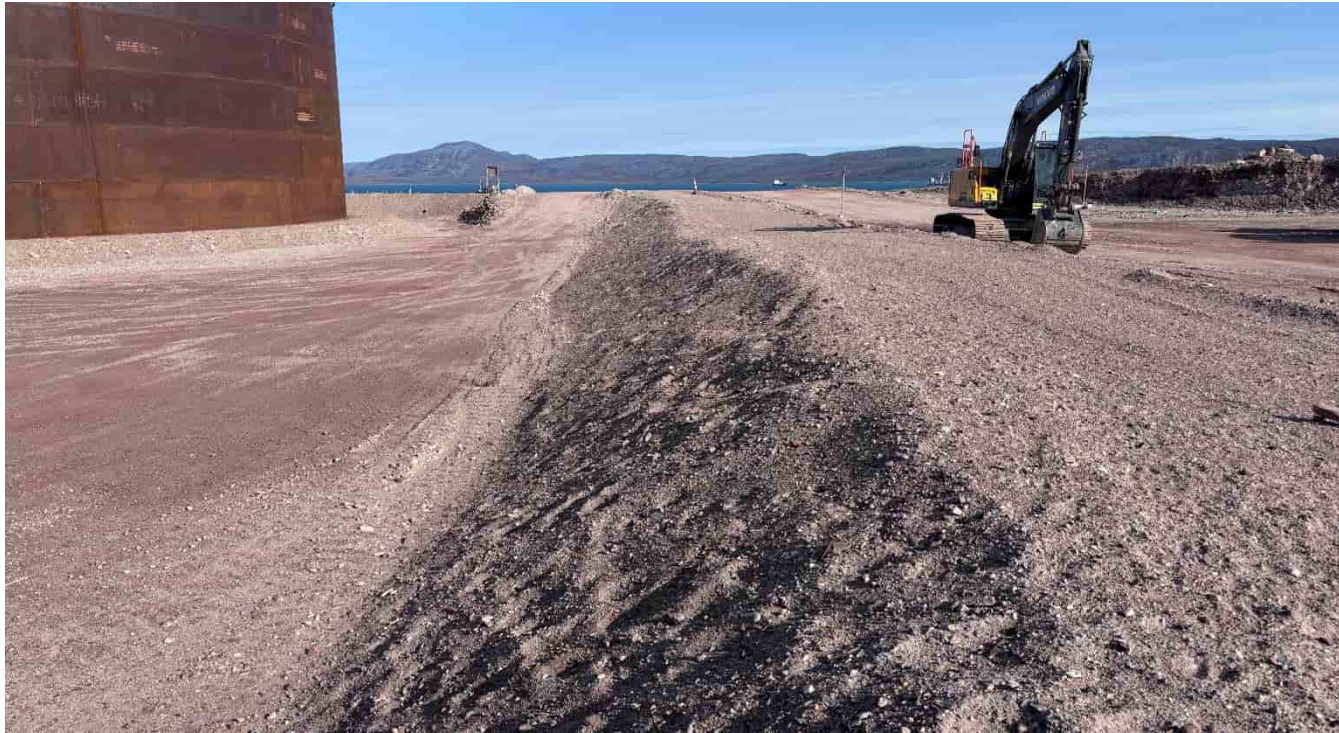
M-137: Tank farm eastern berm, looking N

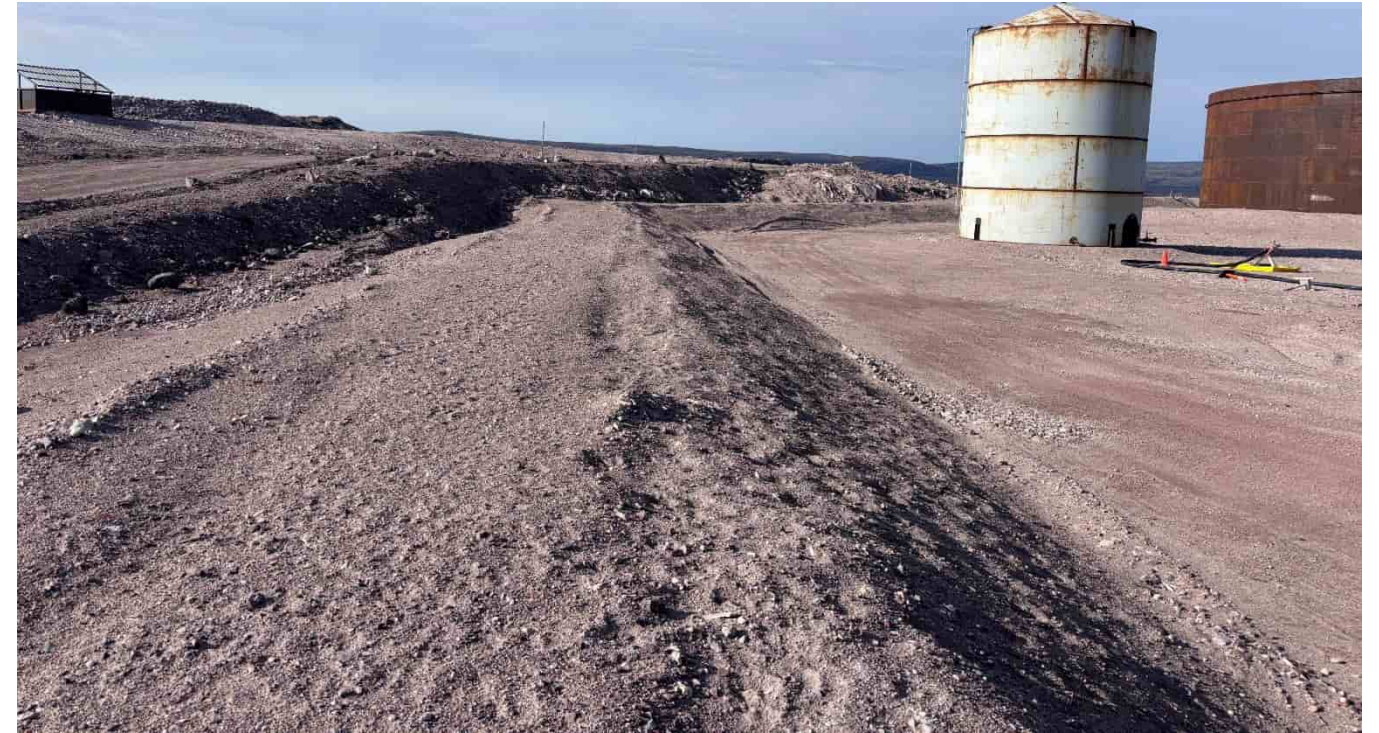
M-138: Tank farm southeastern berm, looking SW

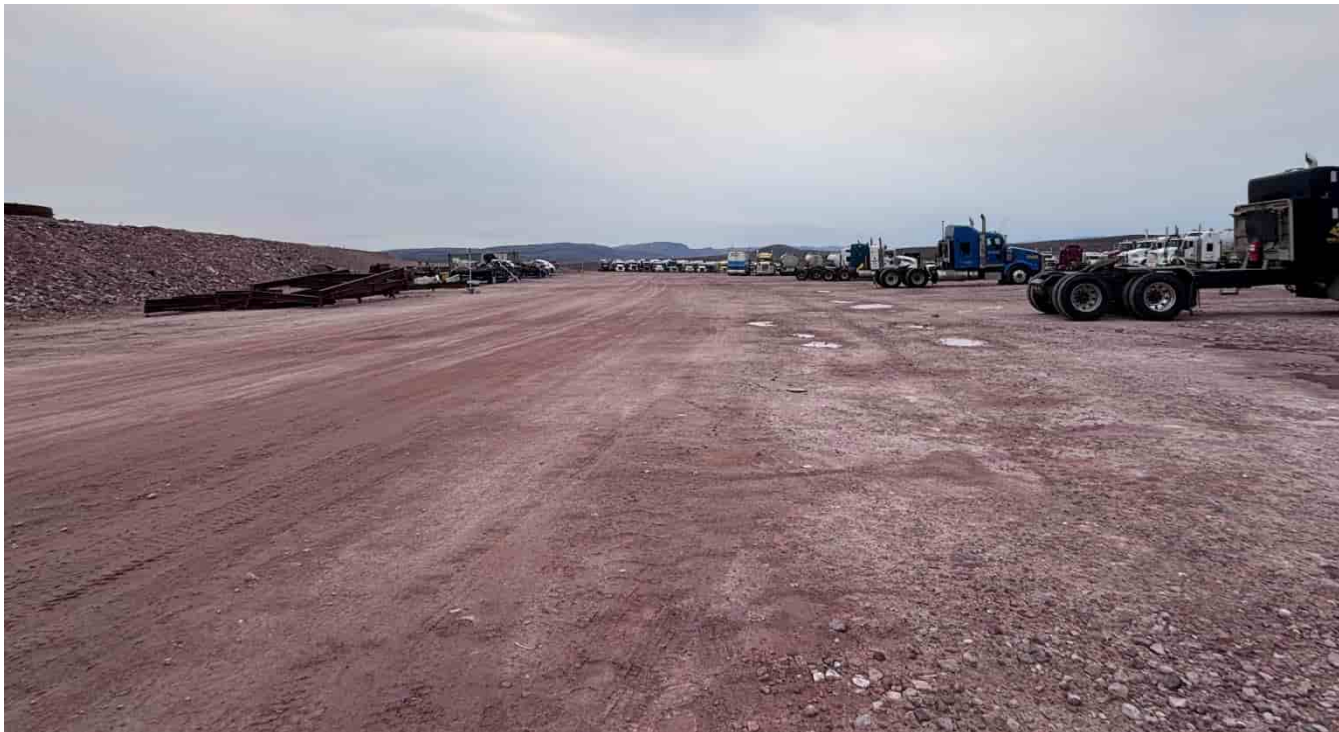
M-139: Truck laydown typical surface conditions

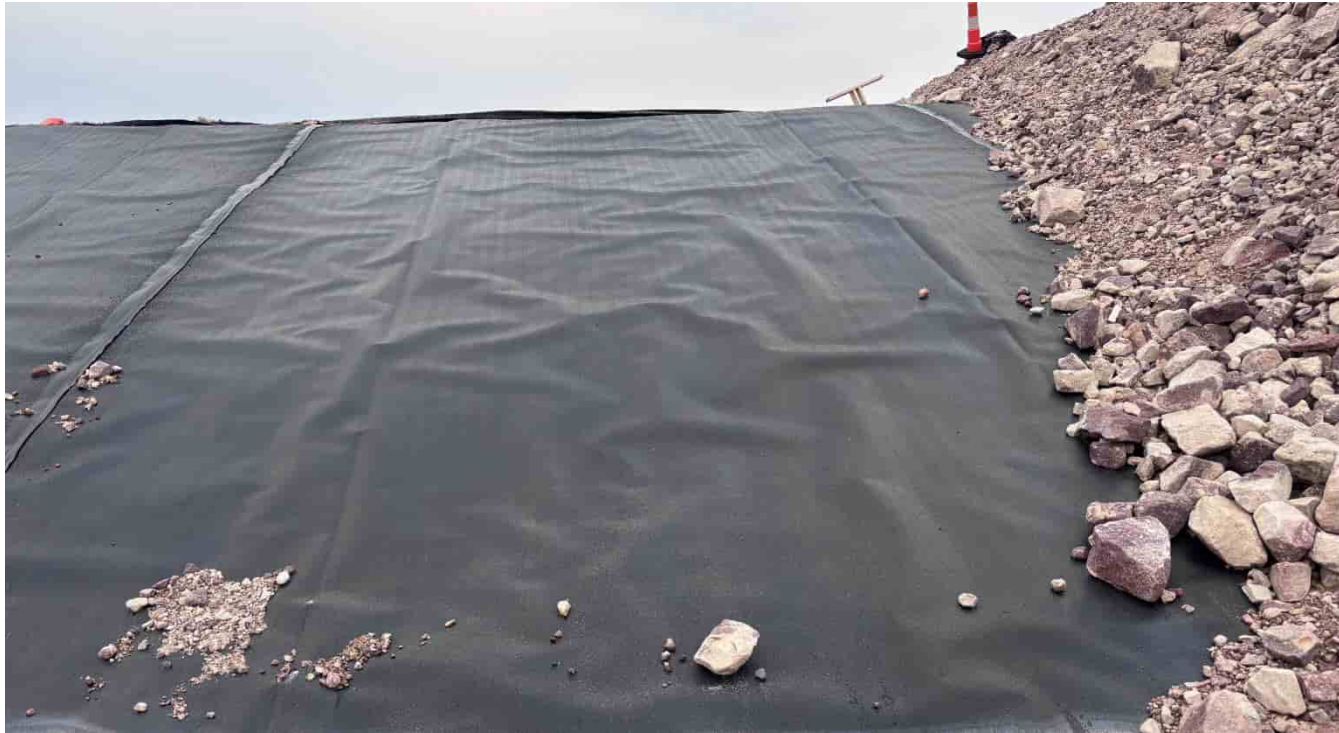
M-141: Exposed liner beside entrance to tank farm
