| | | 2025 Annual Geotechnical Inspection | | |
| | | MLA Airstrip | | |
| Job No: CAPR004312<br>Filename: Back River_MLA_2025_AGI_Photos.pdf | Back River Project | Date:<br>February 2026 | Approved:<br>JBK | Figure:<br>36 |

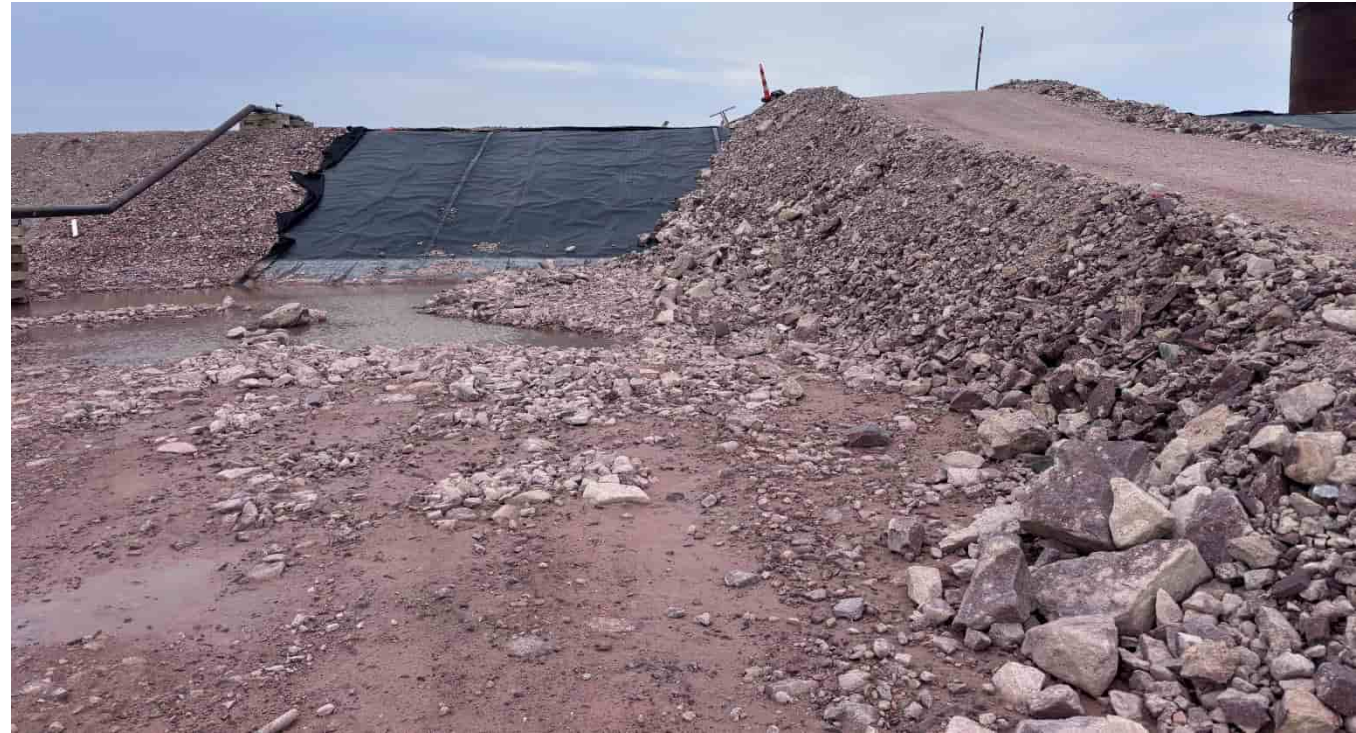
M-142: Northern embankment of entrance to tank farm

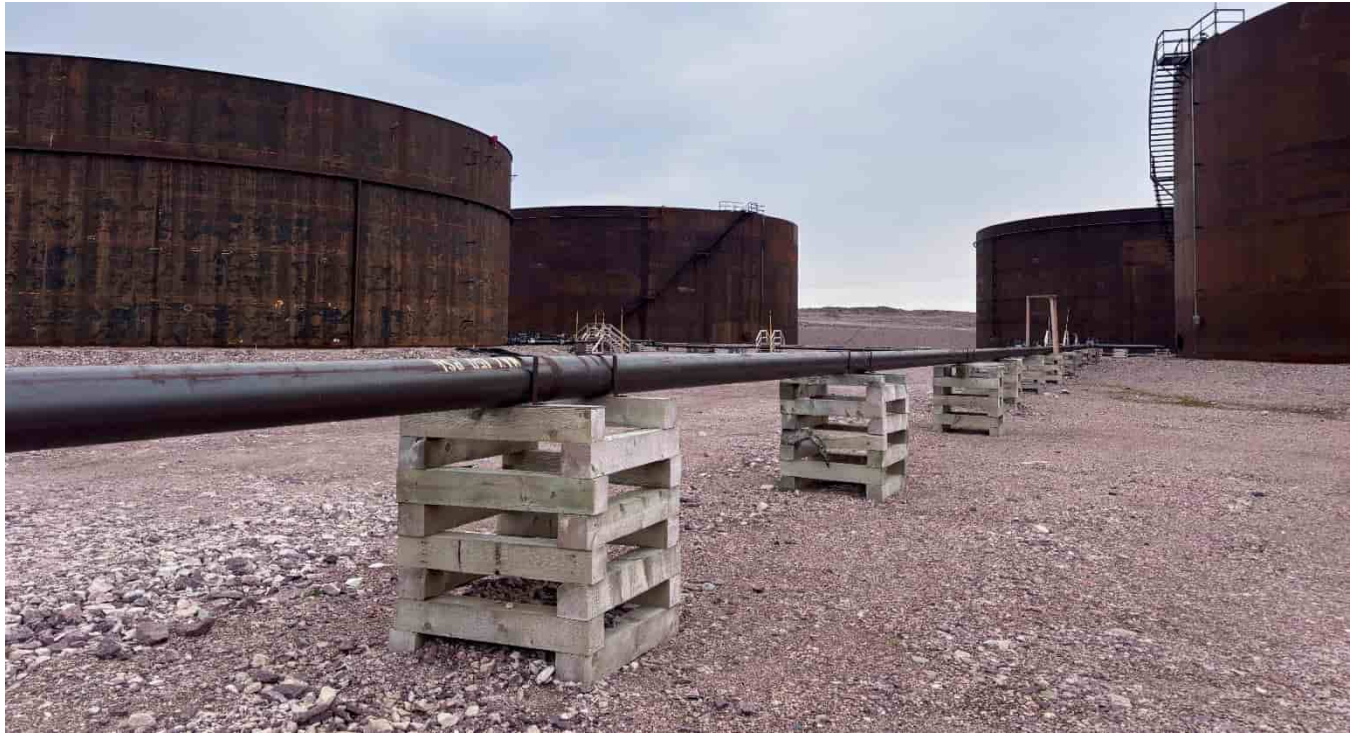
M-145: Typical pipe supports in tank farm

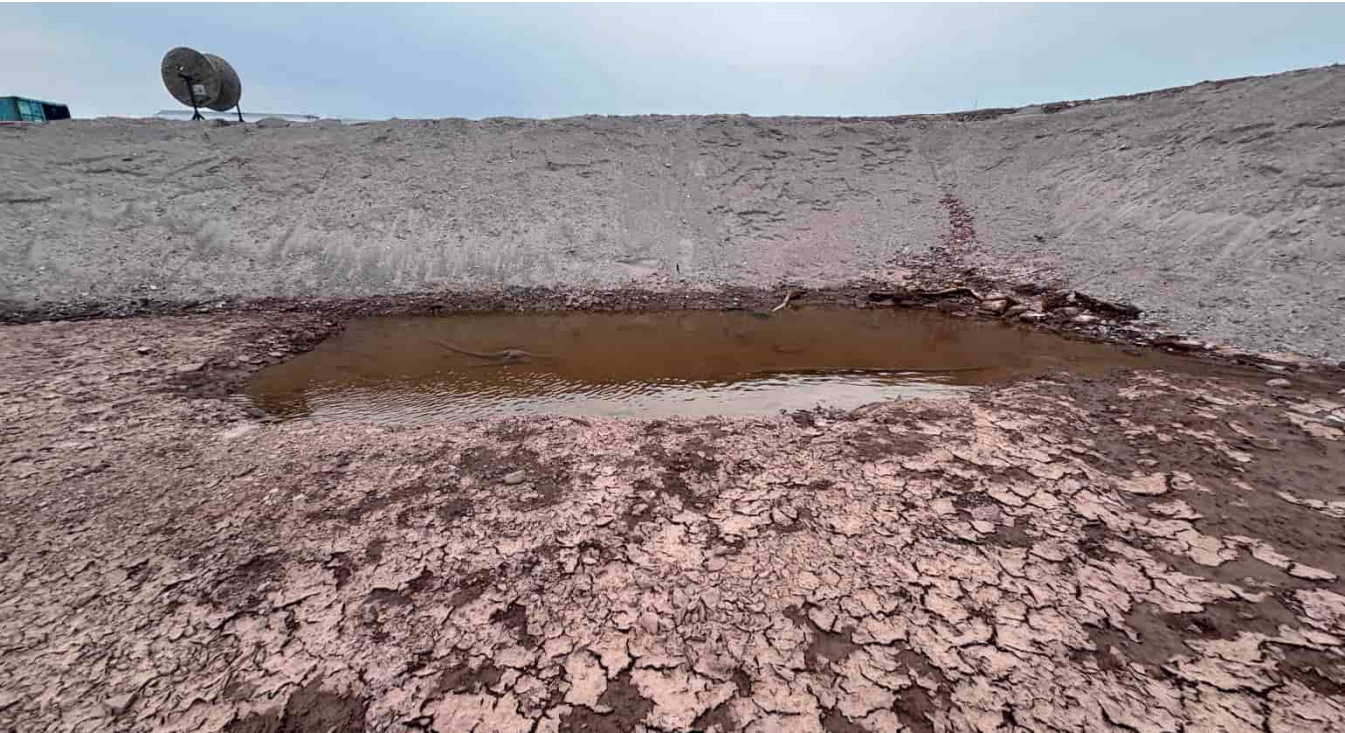
M-146: Ponding water at NW corner of tank farm

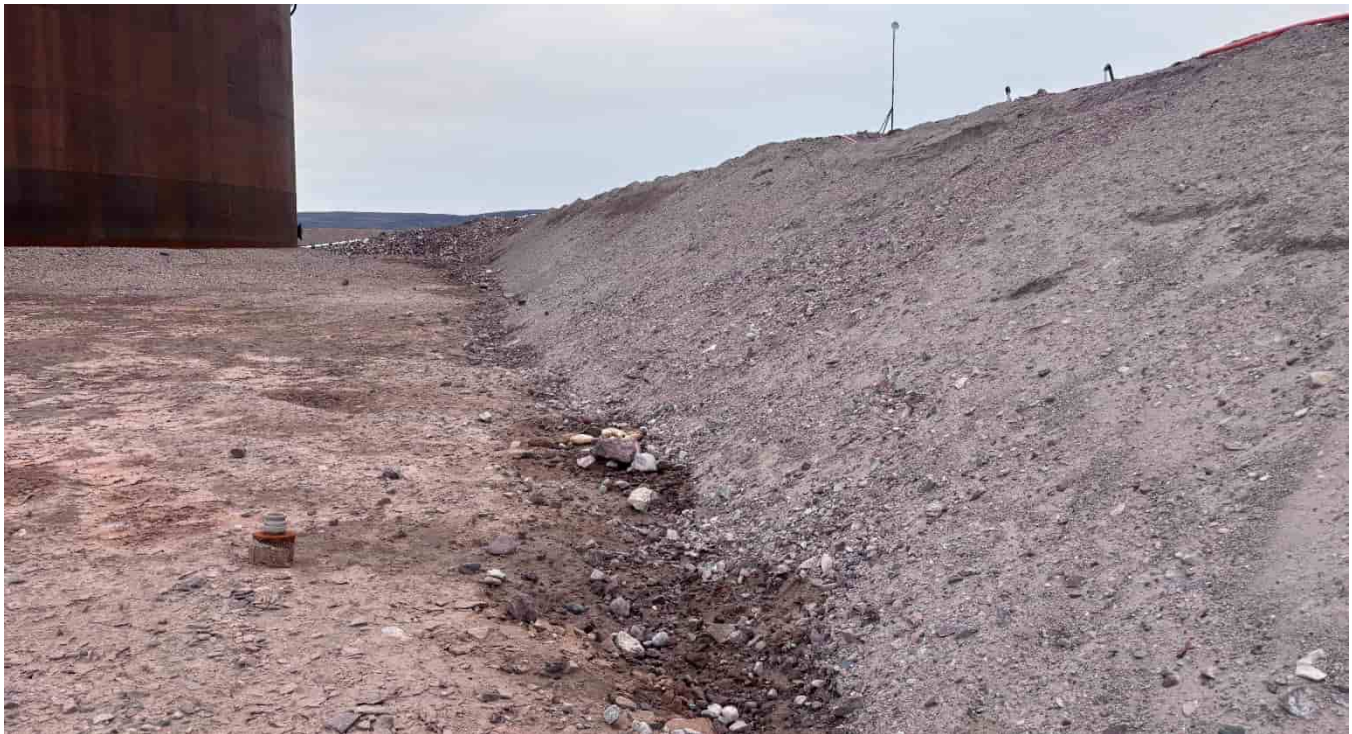
M-147: Toe of western berm, looking S

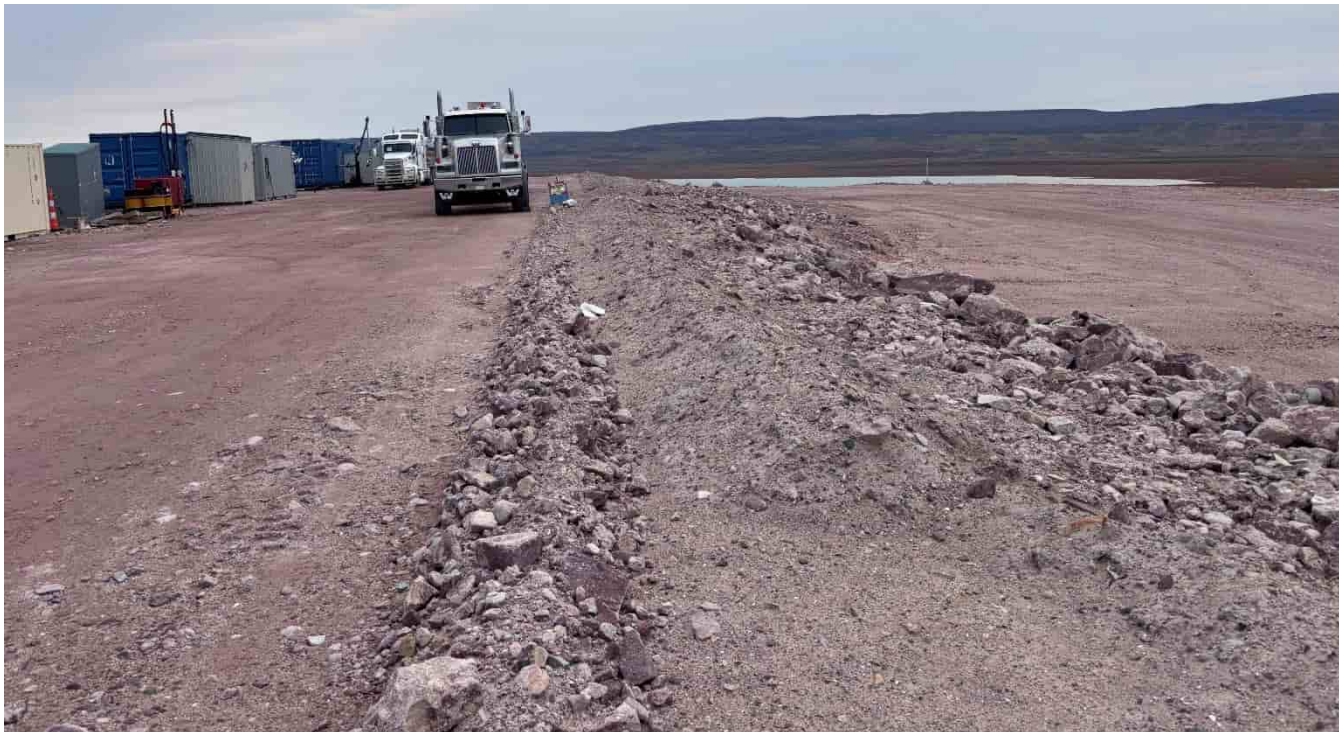
M-151: Berm at edge of fireball pad, looking S

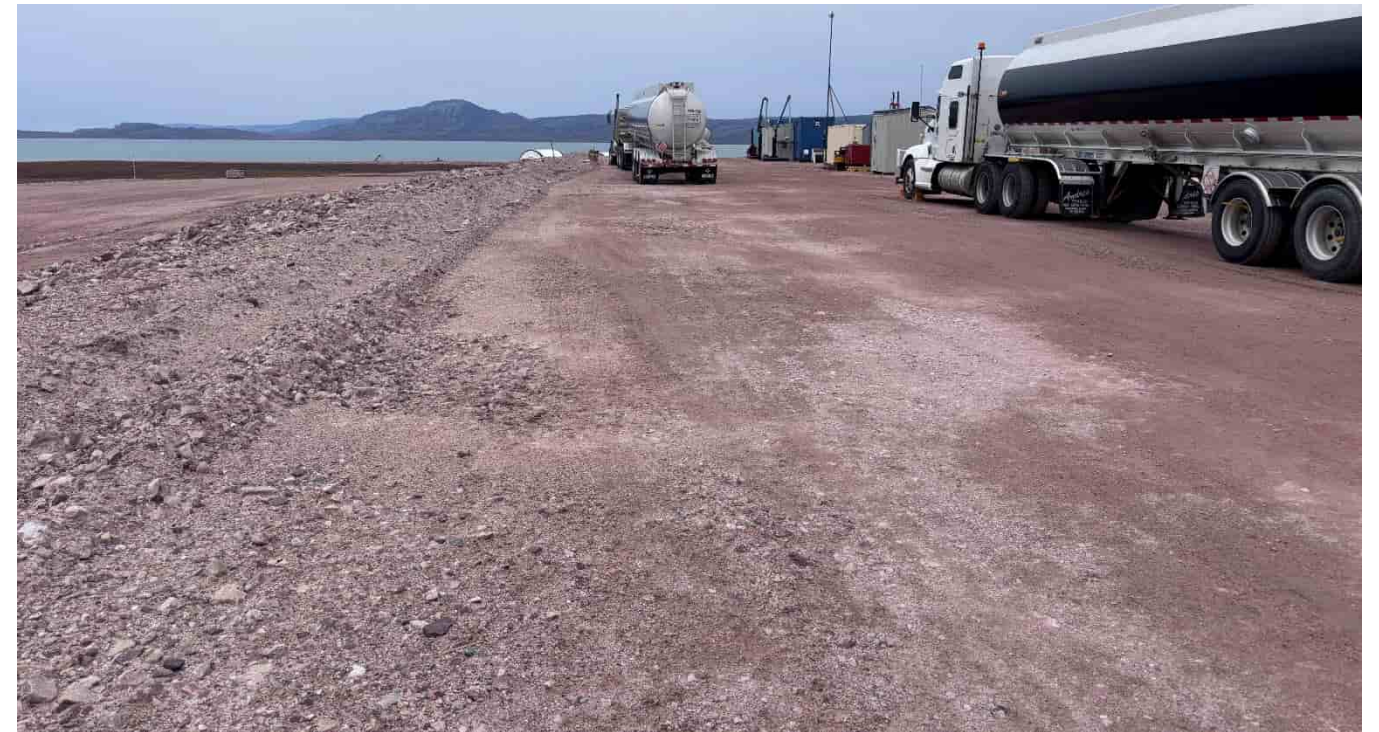
M-152: Fireball pad, looking N

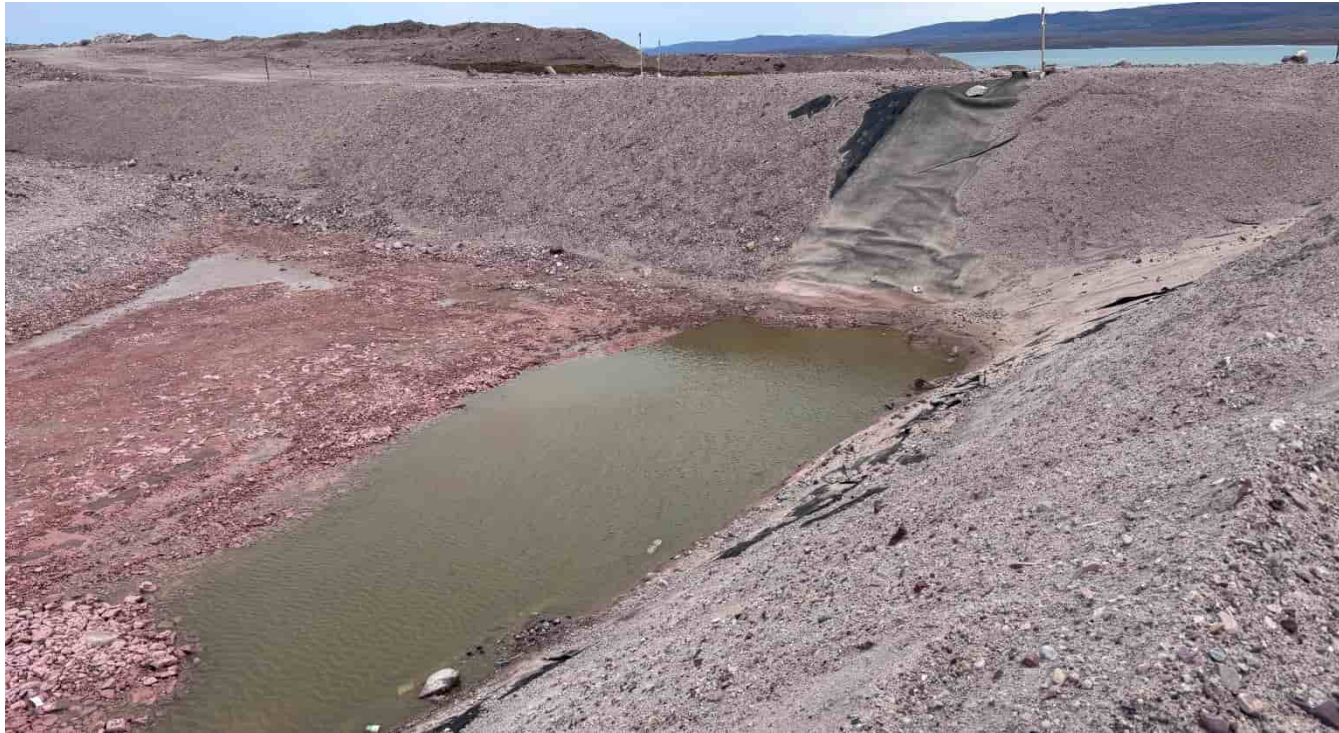
M-153: Ponding water and exposed liner at SW corner of tank farm

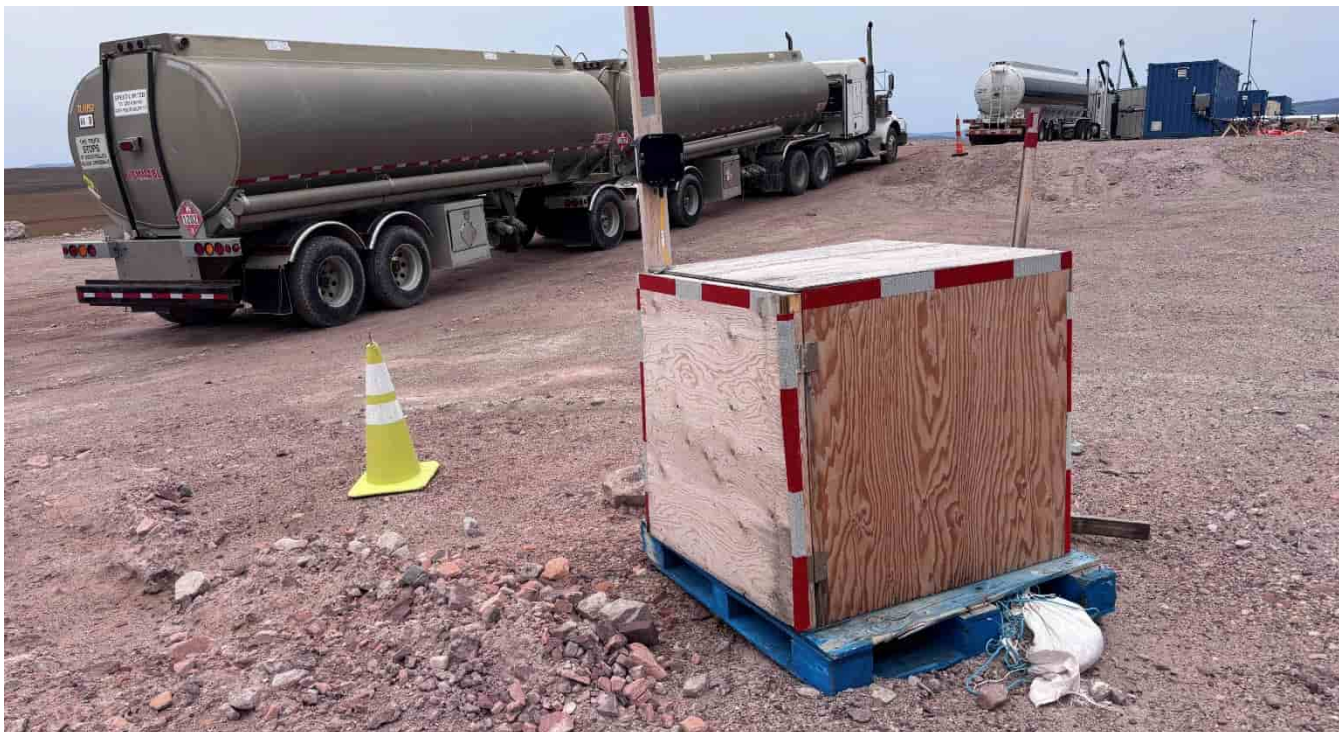
M-155: Entrance to fireball pad. Note ground temperature monitoring station installed in the area

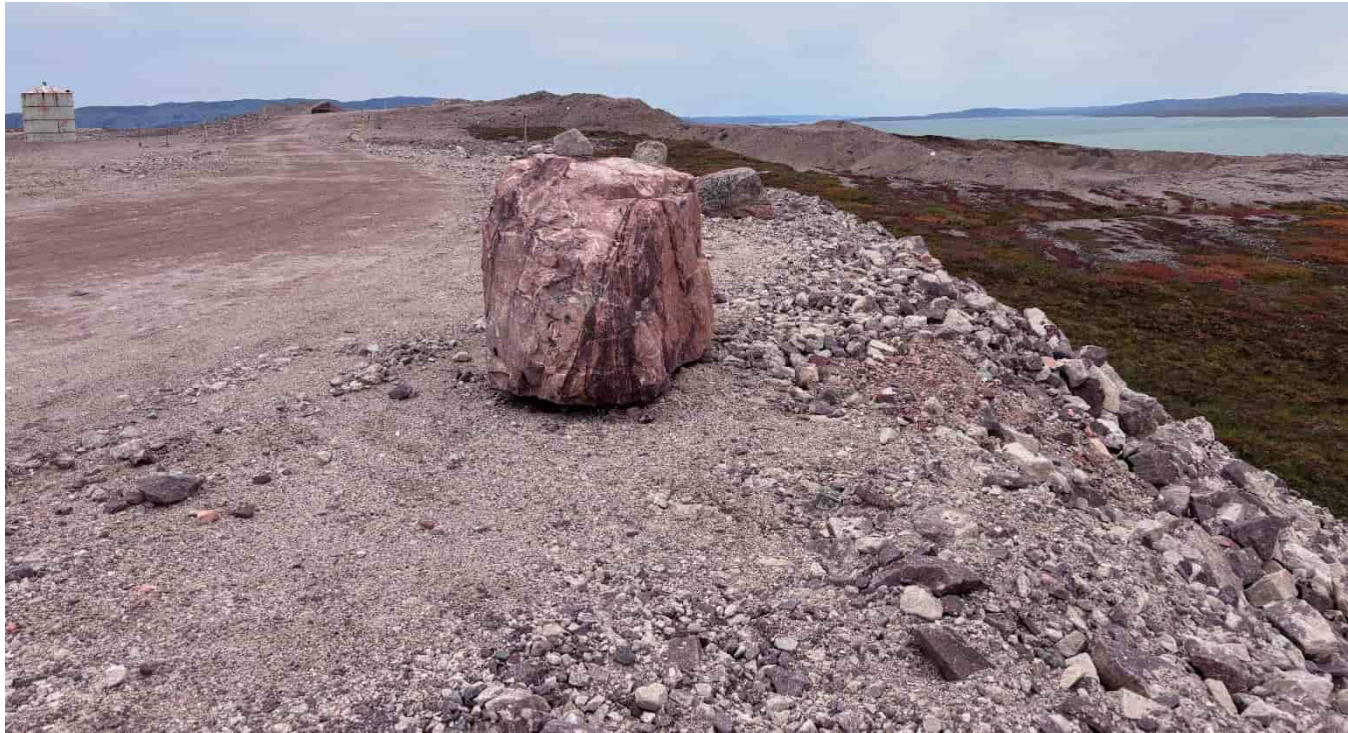
M-157: Access road for the fuel trucks at the SW corner of the tank farm, looking SE

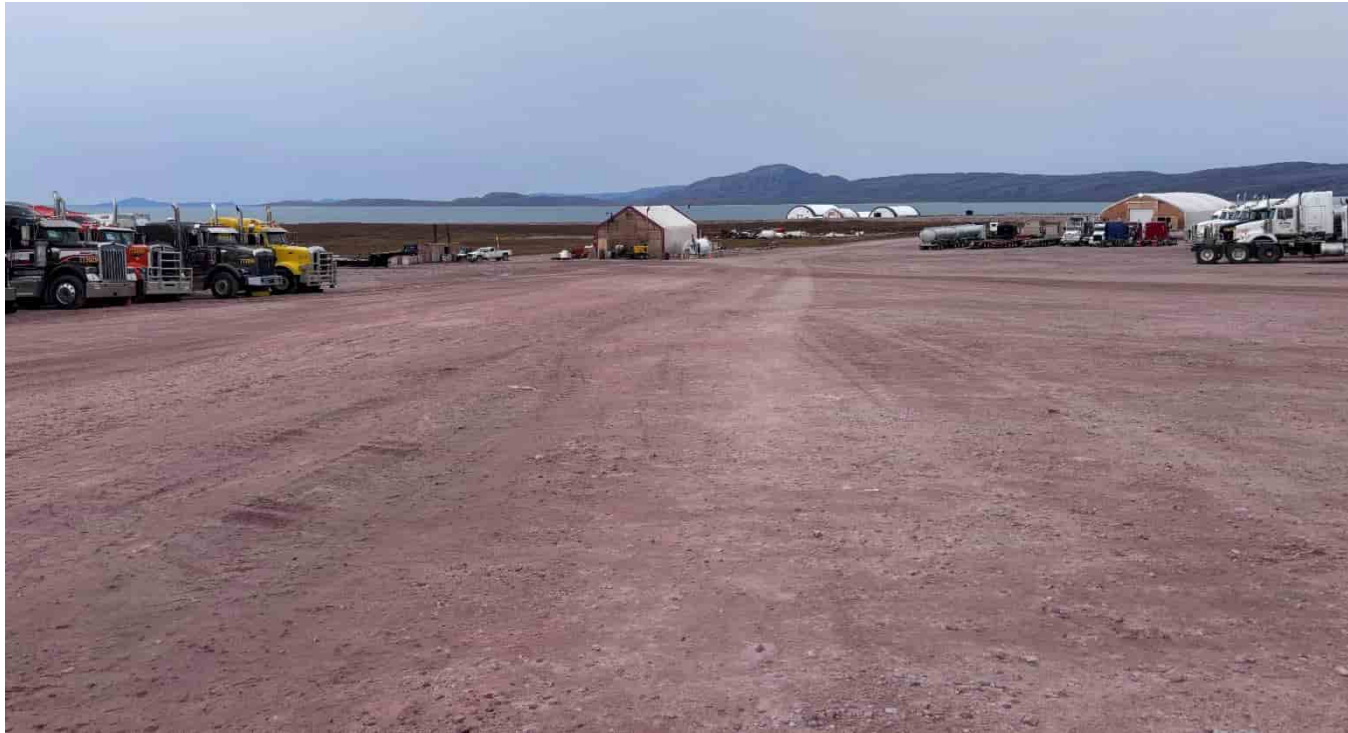
M-160: Truck laydown area north of the tank farm, looking N.

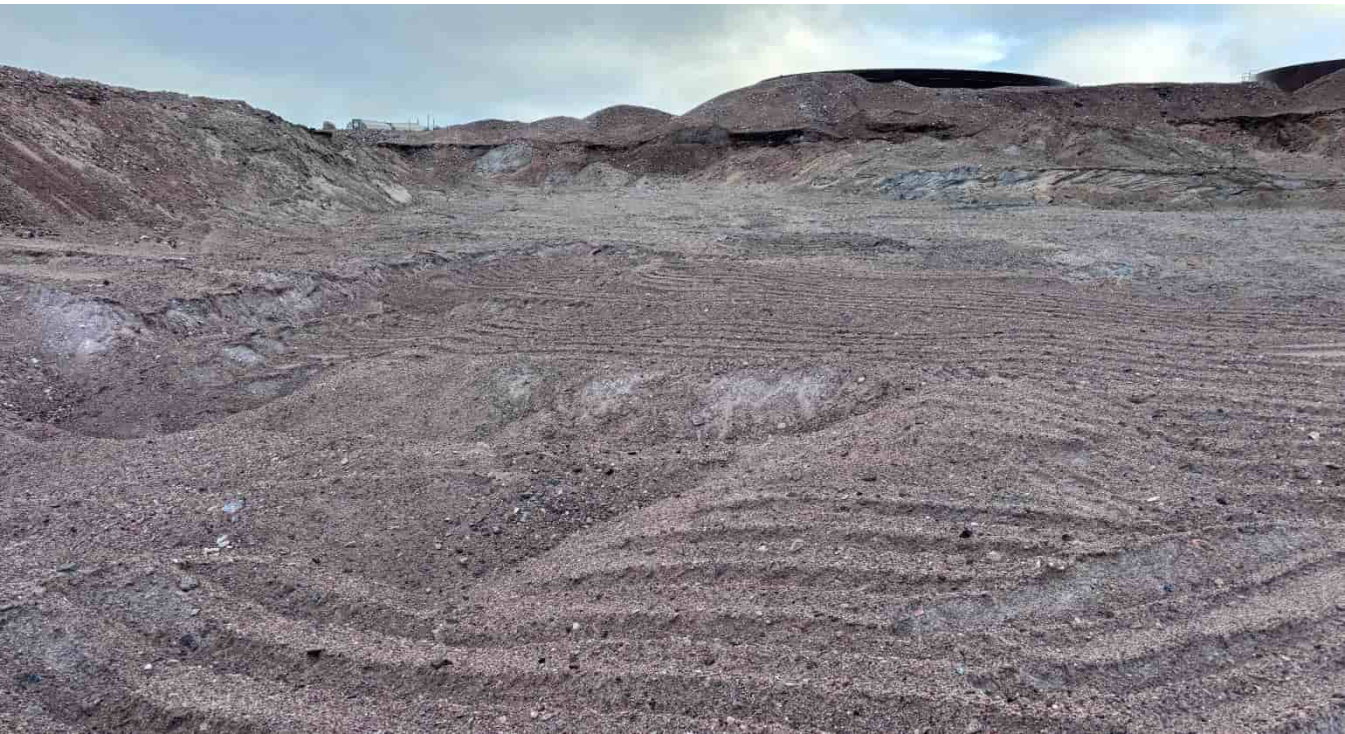
M-163: Sand borrow pit S of tank farm, looking N

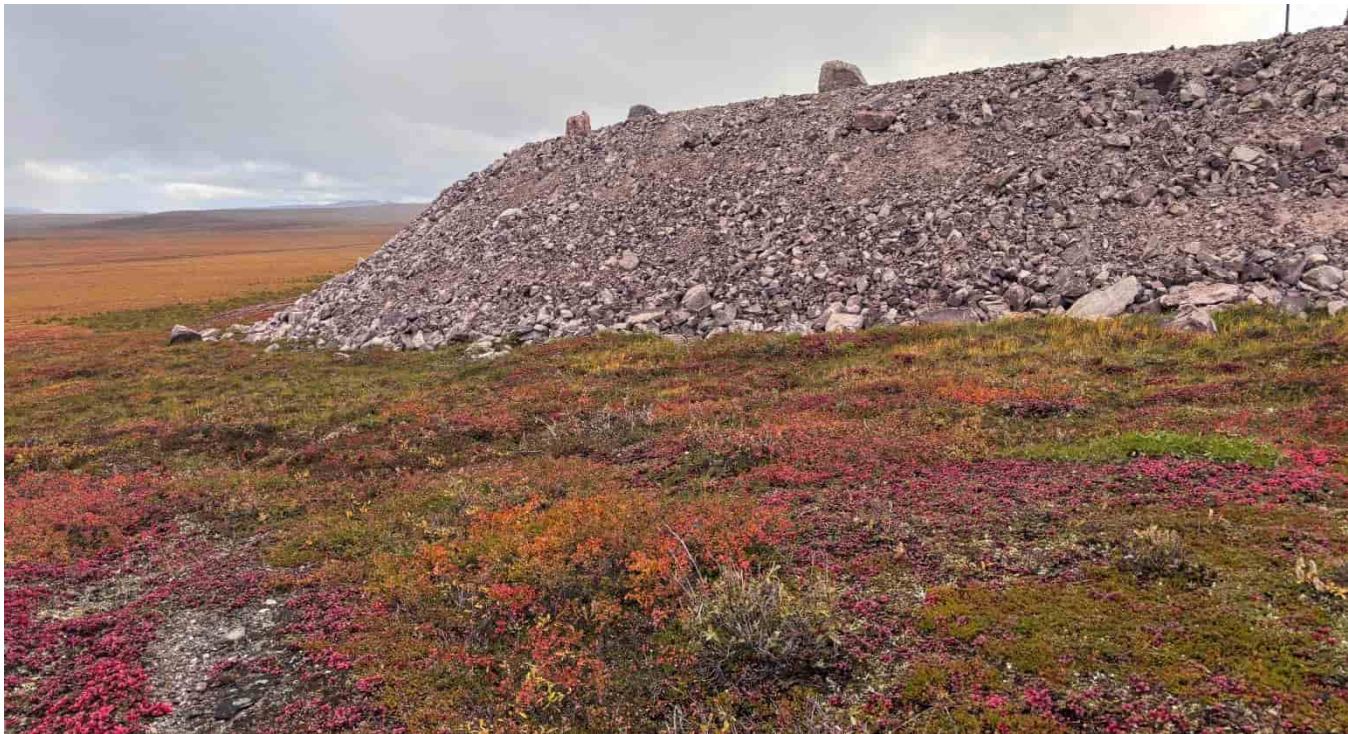
M-165: Tank farm pad NW corner, looking NE

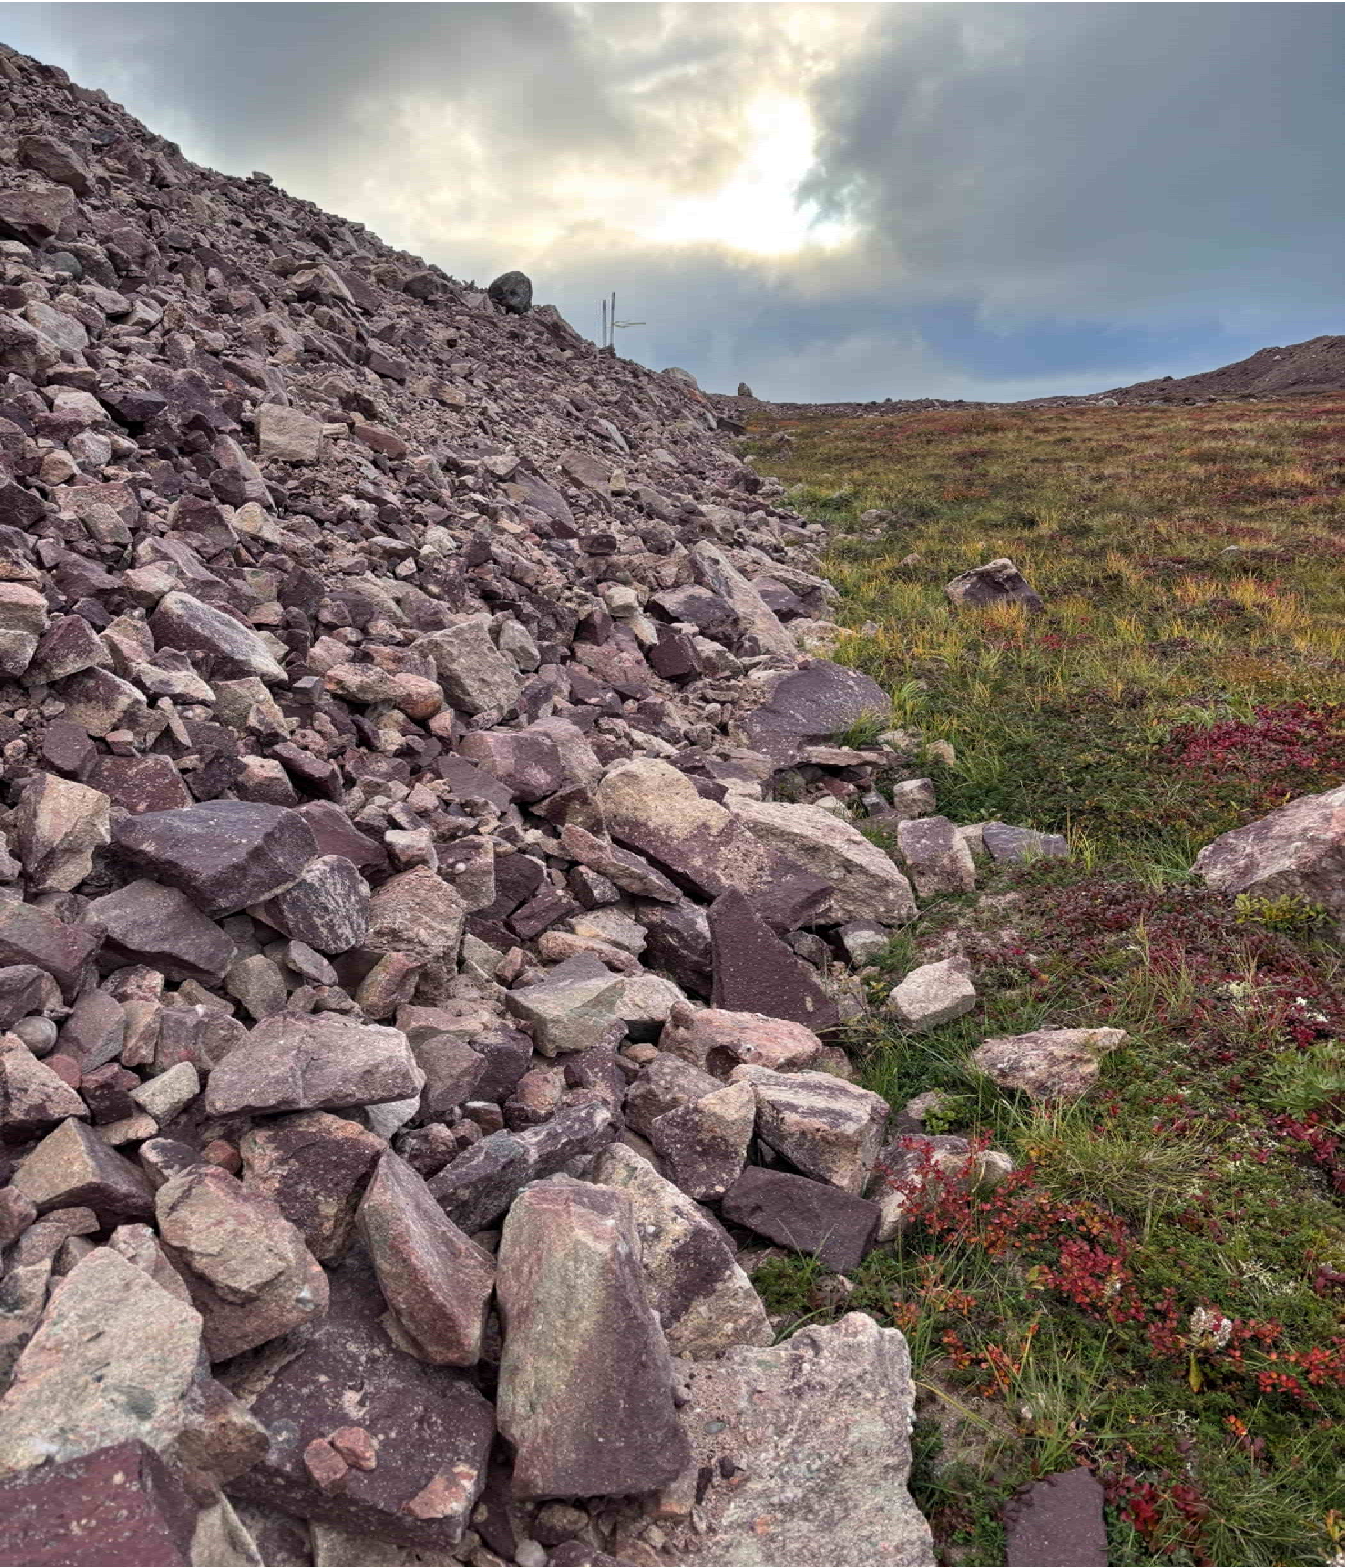
M-166: Toe of road embankment S of tank farm, looking E

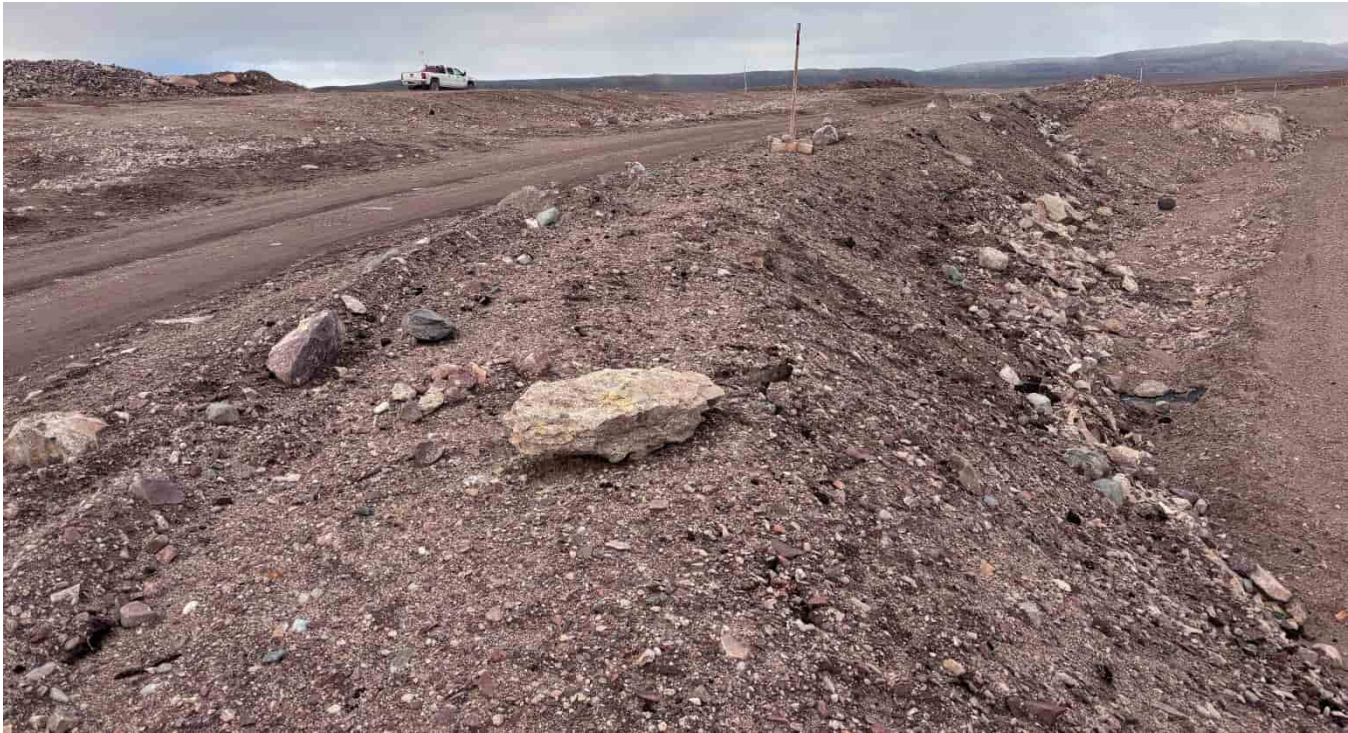
M-168: Tank farm southern berm

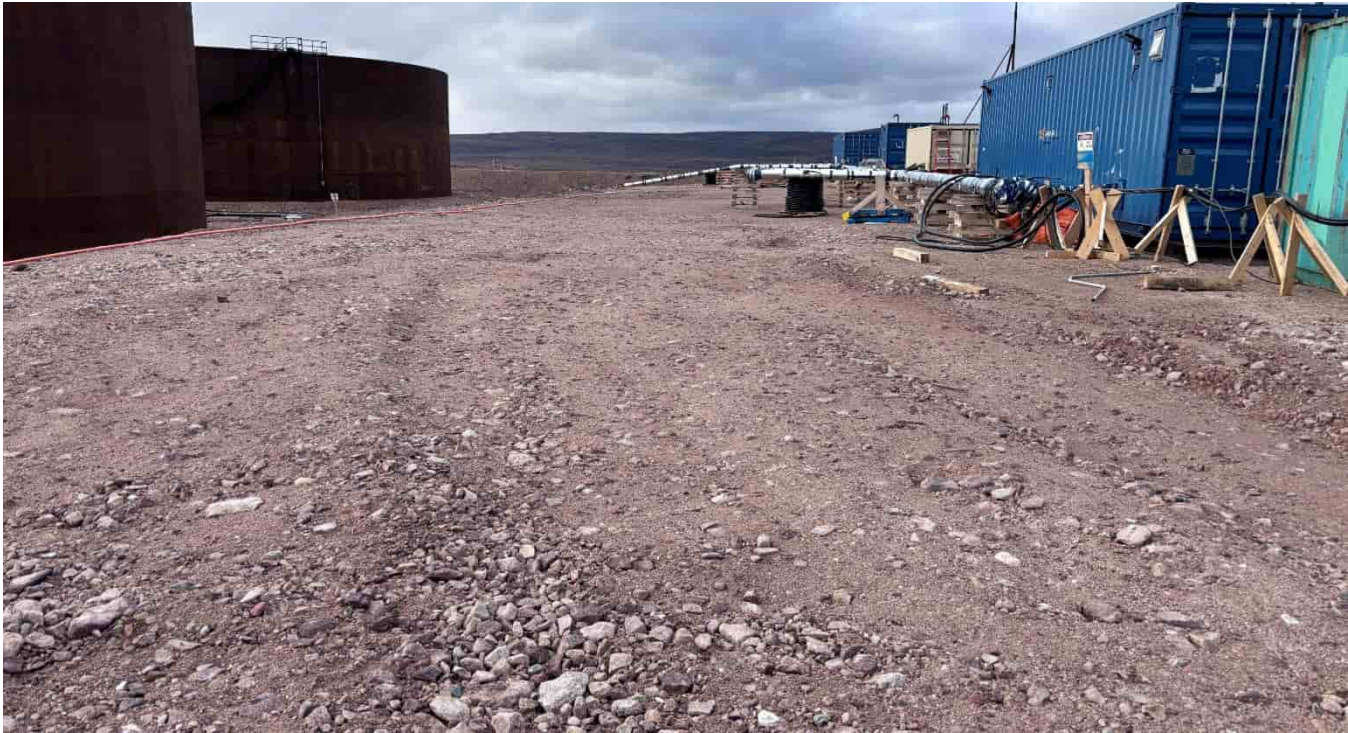
M-178: Pad between fireball and tank farm, looking SW

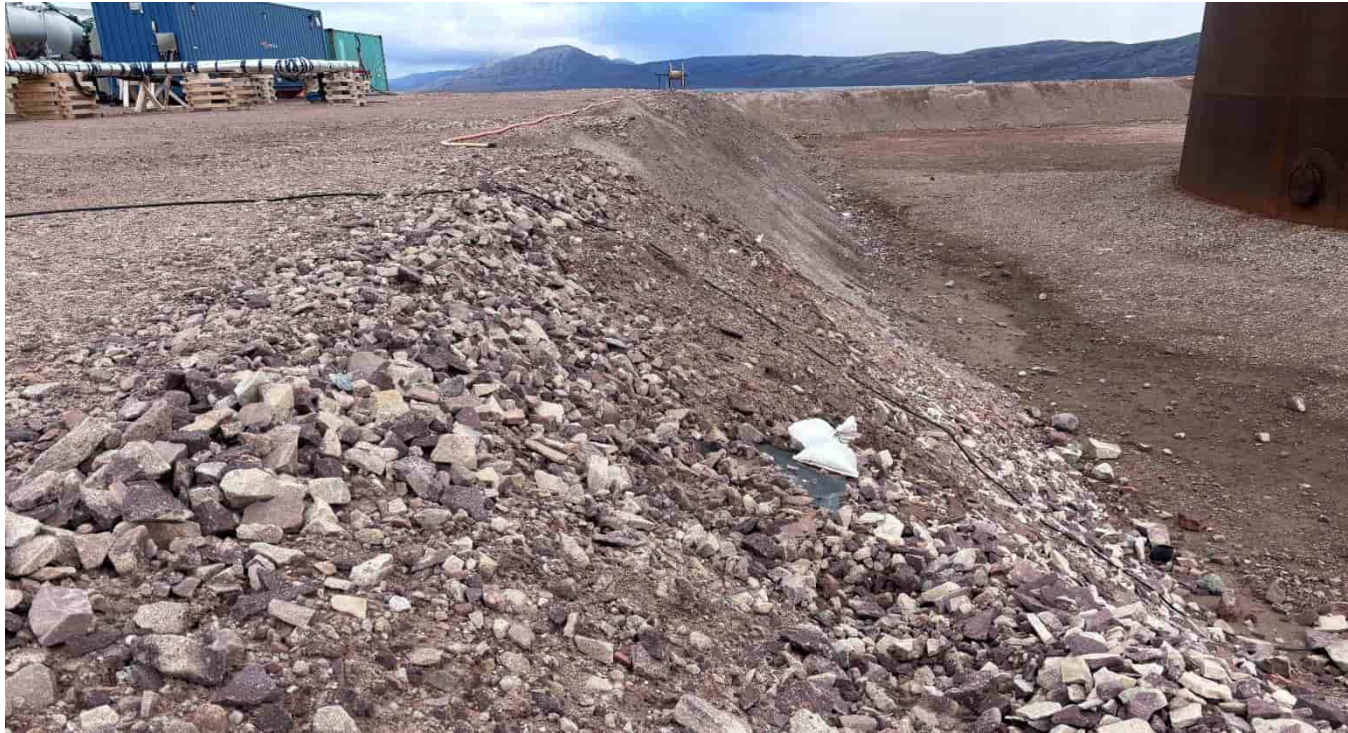
M-181: Pad slope between fireball and tank farm, looking N

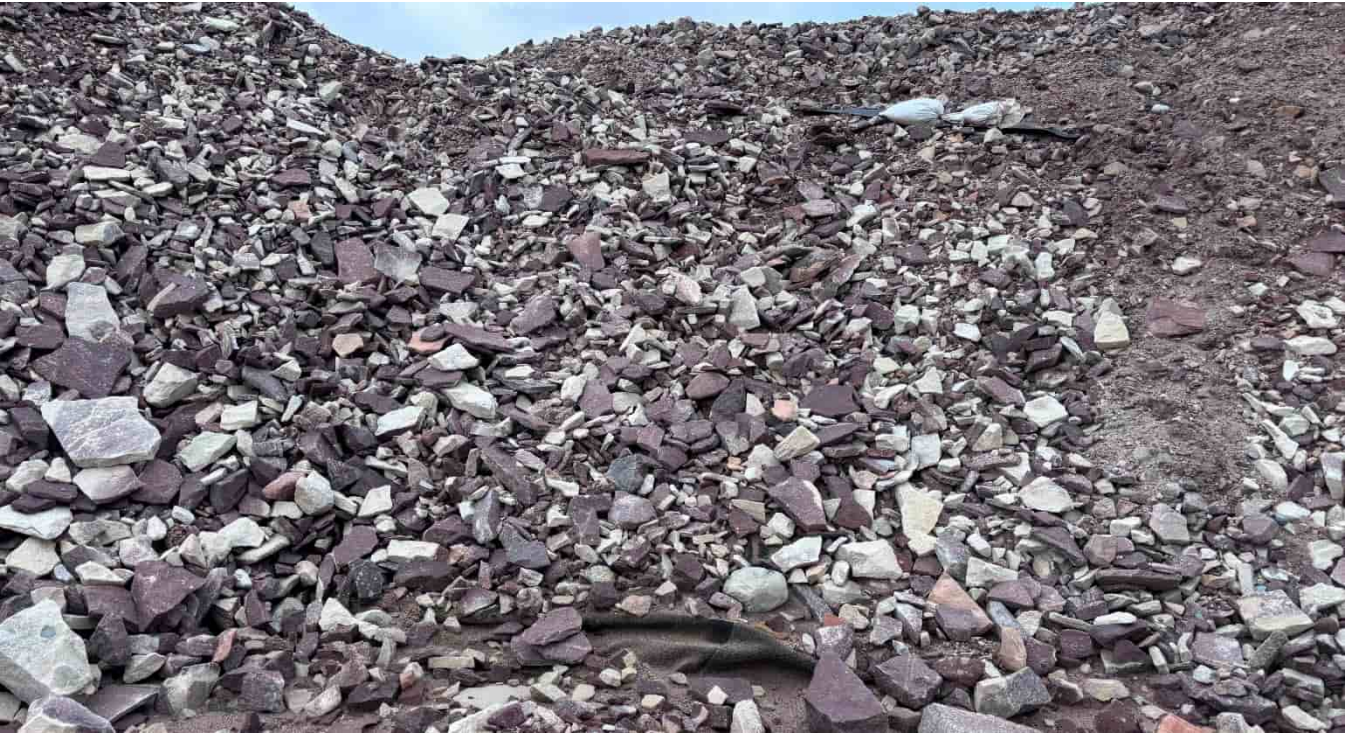
M-182: Exposed liner on slope between fireball and tank farm
