## BACK RIVER OFFSETTING OPTION

# Nulahugyuk Creek Habitat Remediation

**Submitted to:**  
Sabina Gold & Silver Corp.

Report Number: Doc 009-1545534.4000 Ver 0

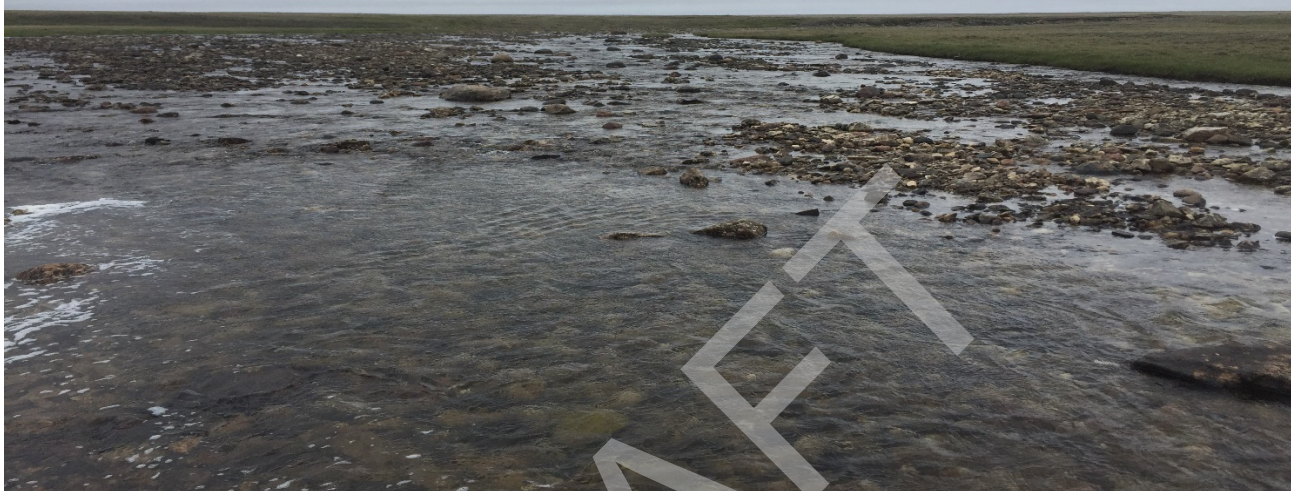
The problem area was within a stream section approximately 38 m wide, and located downstream of a sharp bend in the creek. Flows were dispersed across the creek with flow concentrated near the left downstream bank (LDB) at the upstream extent and near the right downstream bank (RDB) at the downstream extent. Shallow riffle habitat (and shallow thalweg) connected the concentrated flows between banks. Deeper water (0.4 m) along the LDB at the downstream extent of problem area provided suitable habitat as cover or refugia for fish to rest during upstream migration. Fish passage may be impeded along the RDB due to lack of depth and the presence of a boulder garden with several sections of dry streambed. Similarly, passage along the LDB was restricted due to dispersed flows through cobble and boulder substrates. Site 1 was ranked as a risk level 3-highest priority for remediation. See Photo 4-5 and Photo 11 and 12 in Appendix A.

Photo 4-5: Upstream view of thalweg from the downstream extent of Site 1 prior to remediation. 18 July 2016.

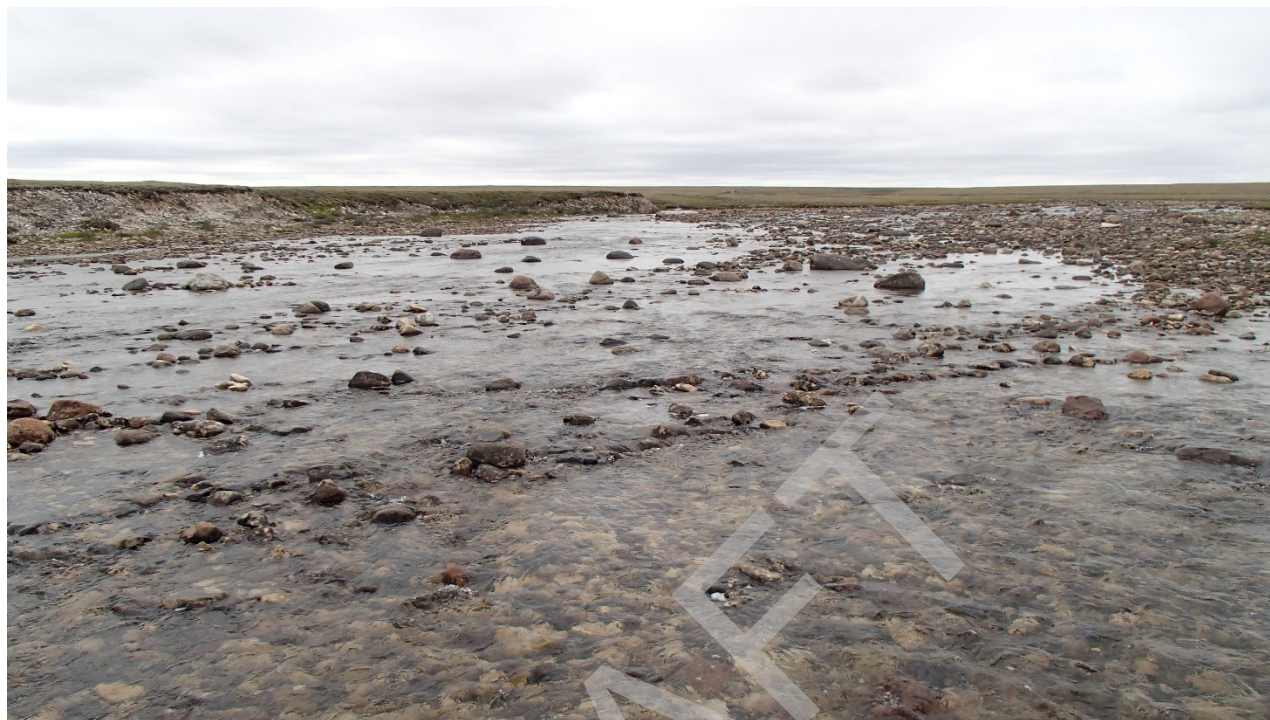
The site was within a stream section approximately 48 m wide, and was characterized by riffle habitat dominated by cobble/boulder substrate. Flows were dispersed across the creek, with most of the flow concentrated along the centre of channel at the upstream extent and near the LDB at the downstream extent. Fish passage may be impeded along the LDB at the downstream extent of problem area due to lack of water depth and presence of a boulder garden further upstream. The thalweg was difficult to locate, and there was no obvious continuous route for fish passage. Site 2 was ranked as a risk level 2 with a medium priority for remediation. See Photo 4-7 and Photo 17 and 18 in Appendix A.

*Photo 4-7: Upstream view of thalweg from the downstream extent of Site 2 prior to remediation. Note the exposed substrate along the LDB. 18 July 2016.*

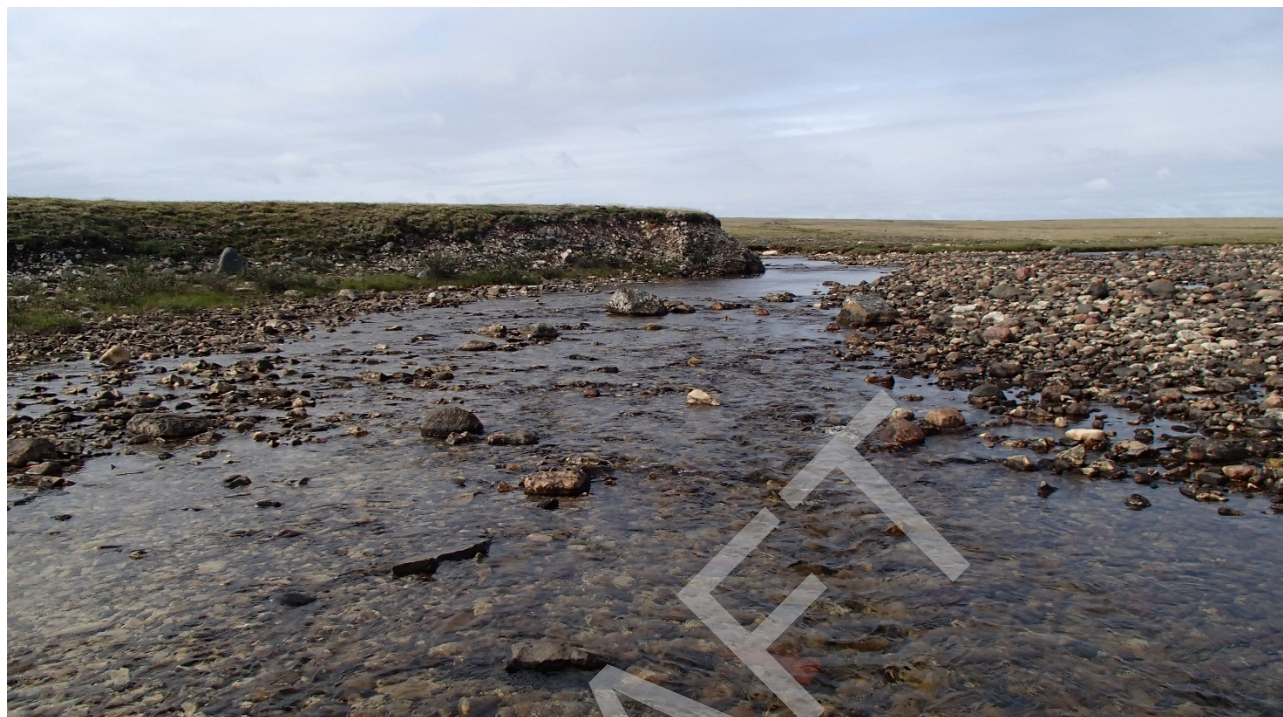
*Photo 4-9: Upstream view of thalweg from the downstream extent of Site 3 prior to remediation. Note the pool at the upstream extent along the RDB. 19 July 2016.*

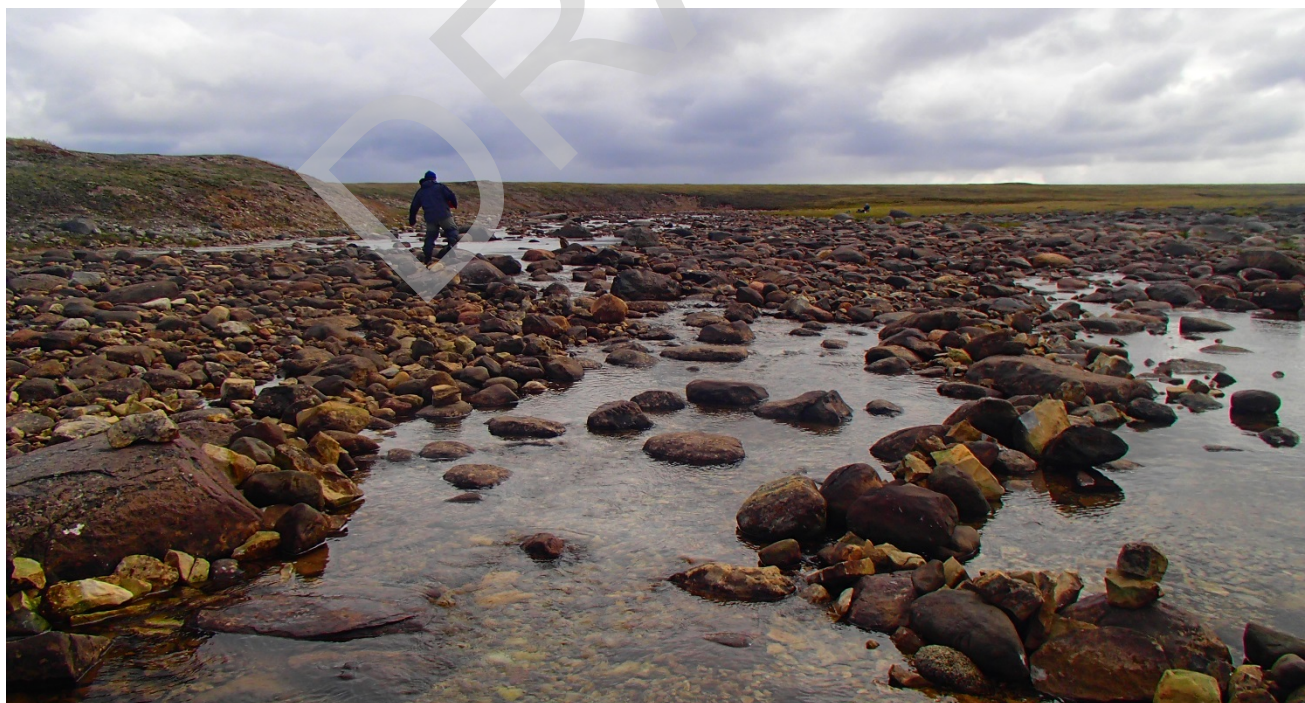
Due to the extensive boulder garden present, the low-flow channel was difficult to clear entirely of boulders. Several boulders were too large or too embedded within the streambed to be relocated (Photo 4-14; Photo 35 in Appendix A). The channel was narrowly constructed to reduce the amount of boulders to be removed. Due to the dry streambed located upstream along the LDB of the creek, a weir was constructed to deter fish passage along LDB and to direct fish towards the low-flow channel (Photo 36 in Appendix A).

*Photo 4-14: Upstream view of low-flow channel A from the downstream extent of Site 4 post-remediation. Note the large boulders left within channel. 20 July 2016.*

| Site Structures | Length (m) | Location in Creek | Photos |
|---|---|---|---|
| Low-Flow Channel A | 26 | LDB diagonally towards centre | Photo 4-14; Photo 35 in Appendix A |

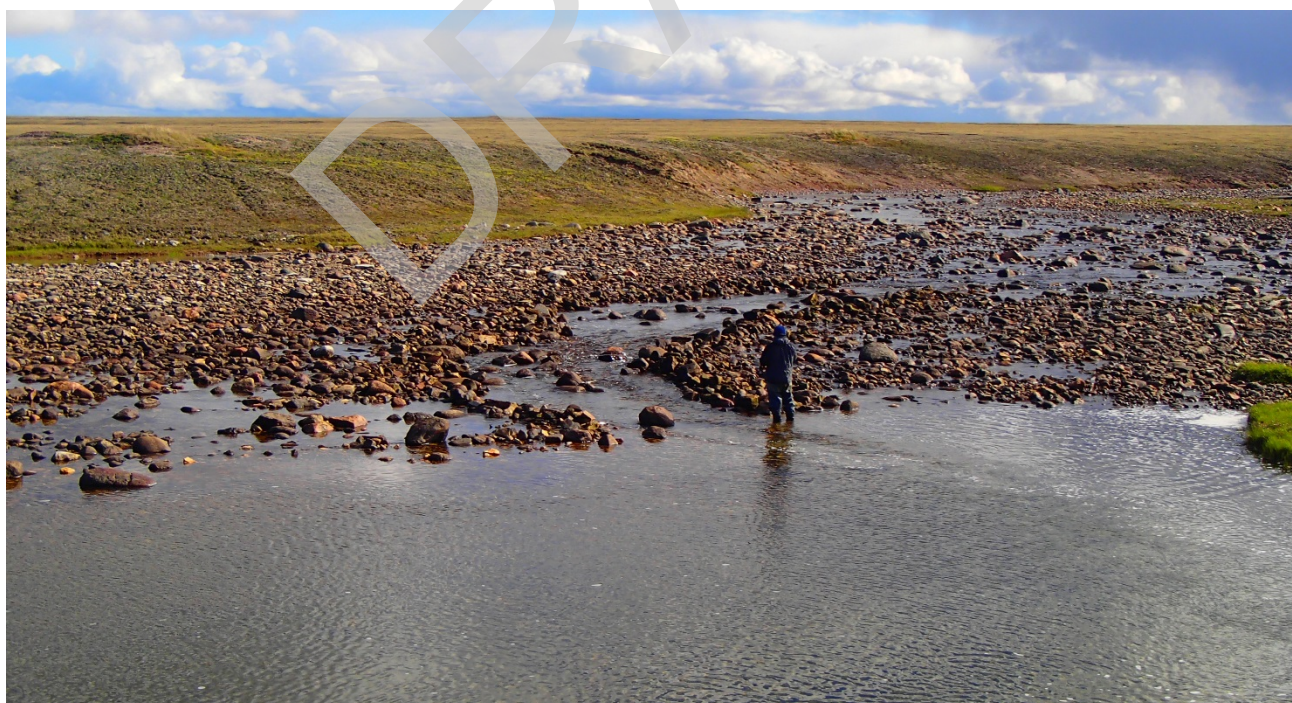
Placement of the low-flow channel at Site 6 was difficult to determine due to dispersed flows entering a large pool at the downstream extent. Flows were concentrated along the centre of channel bending sharply towards the upstream extent of pool. These flows were used to guide the angle of low-flow channel construction. Due to the curvature of the low-flow channel, extra armouring at the bend was required along the right downstream boundary in order to maintain flows within the channel. Several boulders were too large or too embedded within the streambed to be relocated (Photo 4-16, Photo 38 in Appendix A).

*Photo 4-16: Upstream view of low-flow channel as viewed from elevated LDB at Site 6 post-remediation. Note the large pool at the downstream extent of the low-flow channel. 21 July 2016.*

| Site Structures | Length (m) | Location in Creek | Photos |
|---|---|---|---|
| Low-Flow Channel A | 33 | LDB curving diagonally towards centre | Photo 4-16; Photo 38 in Appendix A |

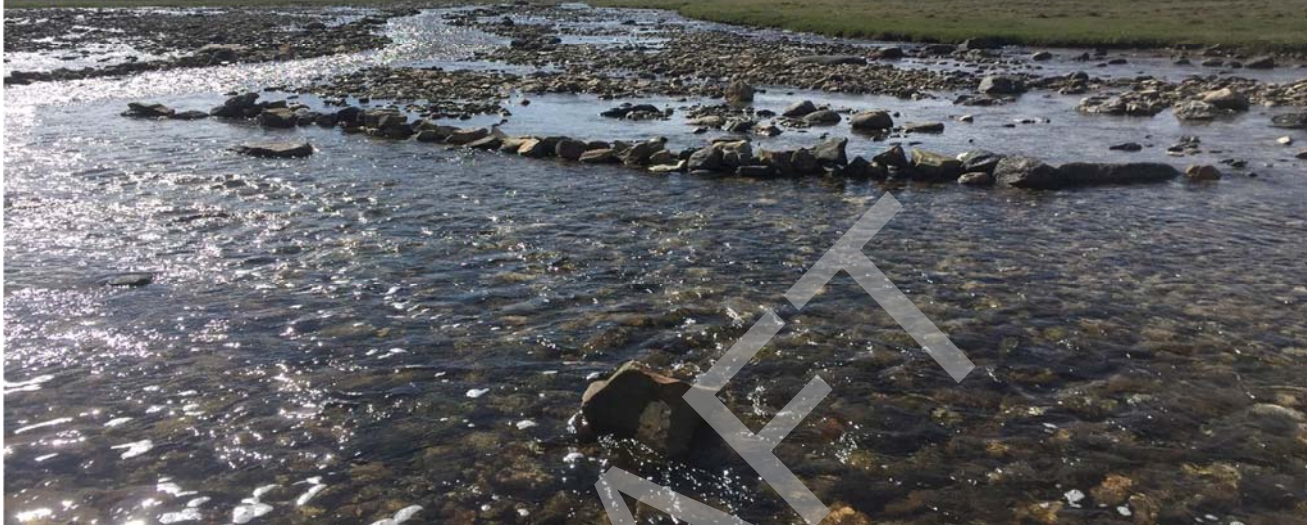
Photo 15 Upstream view of directional weir A at Site 1, guiding fish away from the area of exposed stream bed. 18 July 2016.

| Site Structures | Length (m) | Location in Creek | Photos |
|---|---|---|---|
| Weir A | 13 | Centre towards channel A | Photo 15 in Appendix A |

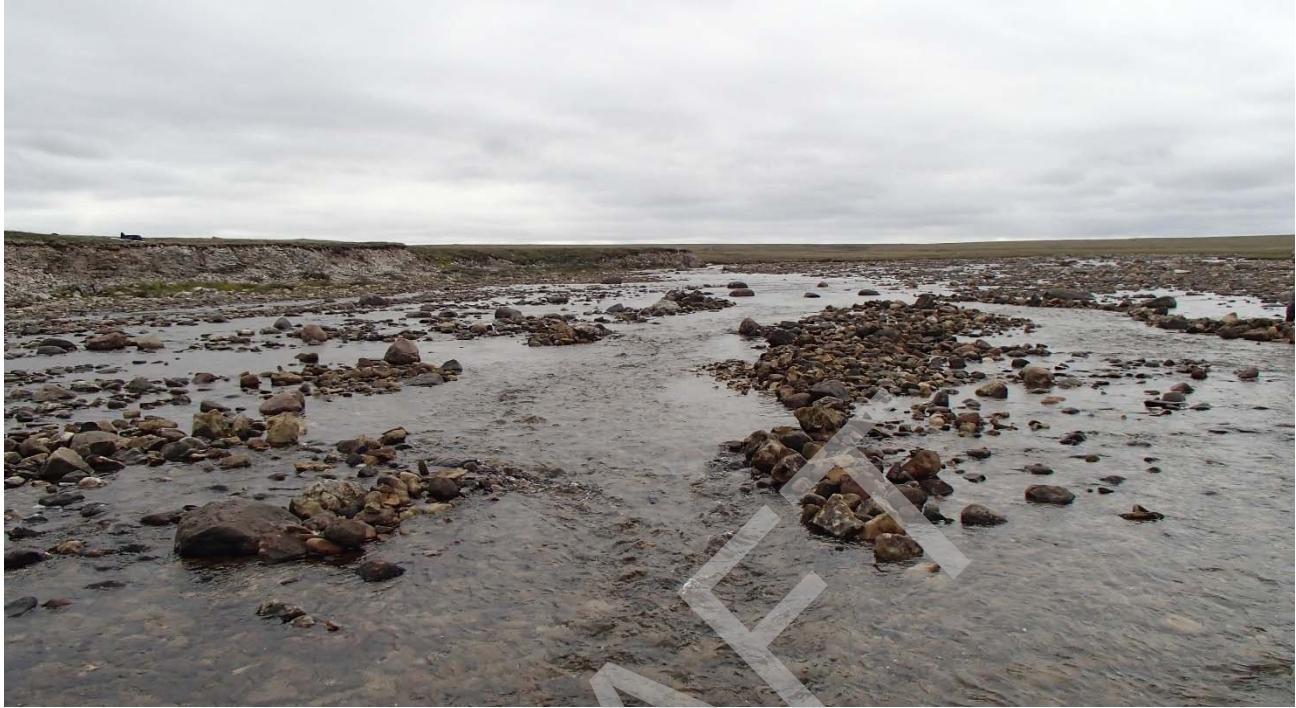
*Photo 19: Upstream view of low- flow channel B, including portions of low-flow channel A, constructed at Site 2. 18 July 2016.*

| Site Structures | Length (m) | Location in Creek | Photos |
|---|---|---|---|
| Low-Flow Channel A | 21 | LDB diagonally towards centre | Photo 4-8; Photo 19 to 20 in Appendix A |

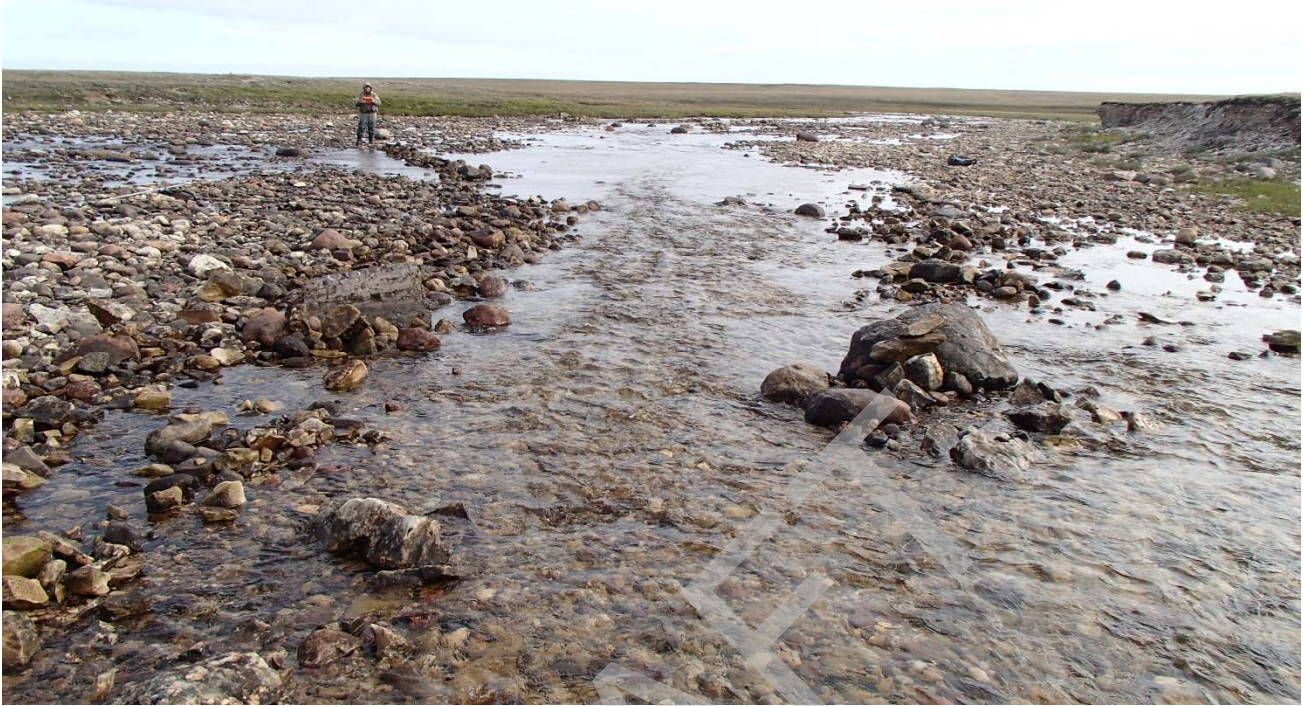
*Photo 25: Downstream view of low-flow channel A at Site 3 after remediation was completed, showing the clearly defined thalweg along the RDB. 19 July 2016*

| Site Structures | Length (m) | Location in Creek | Photos |
|---|---|---|---|
| Low-Flow Channel A | 11 | RDB | Photo 4-10; Photo 25 in Appendix A |

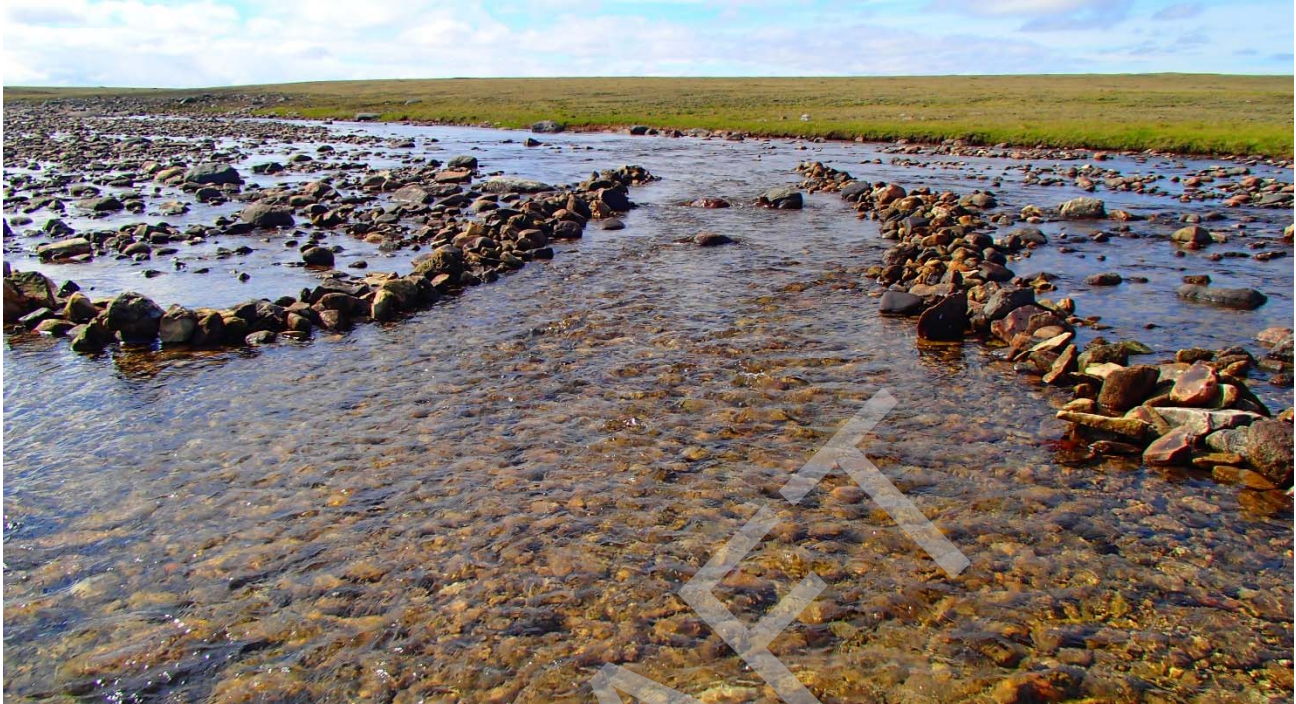
*Photo 29: Upstream view of low-flow channel B at Site 4. Note the large boulders left in the channel as cover for fish. 19 July 2016.*

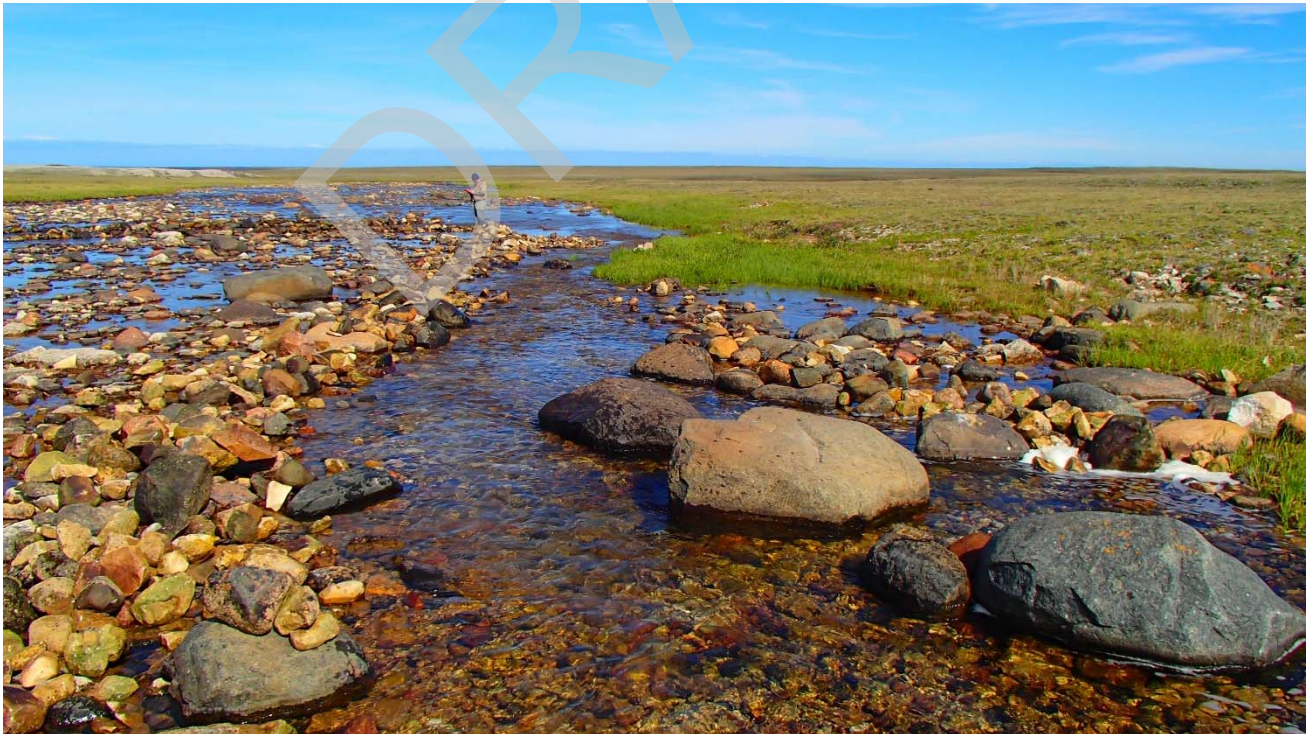
*Photo 30: Downstream view from the upstream extent of low-flow channel A at Site 4. 19 July 2016.*

| Site Structures | Length (m) | Location in Creek | Photos |
|---|---|---|---|
| Low-Flow Channel A | 33 | RDB | Photo 4-12; Photo 30 to 31 in Appendix A |

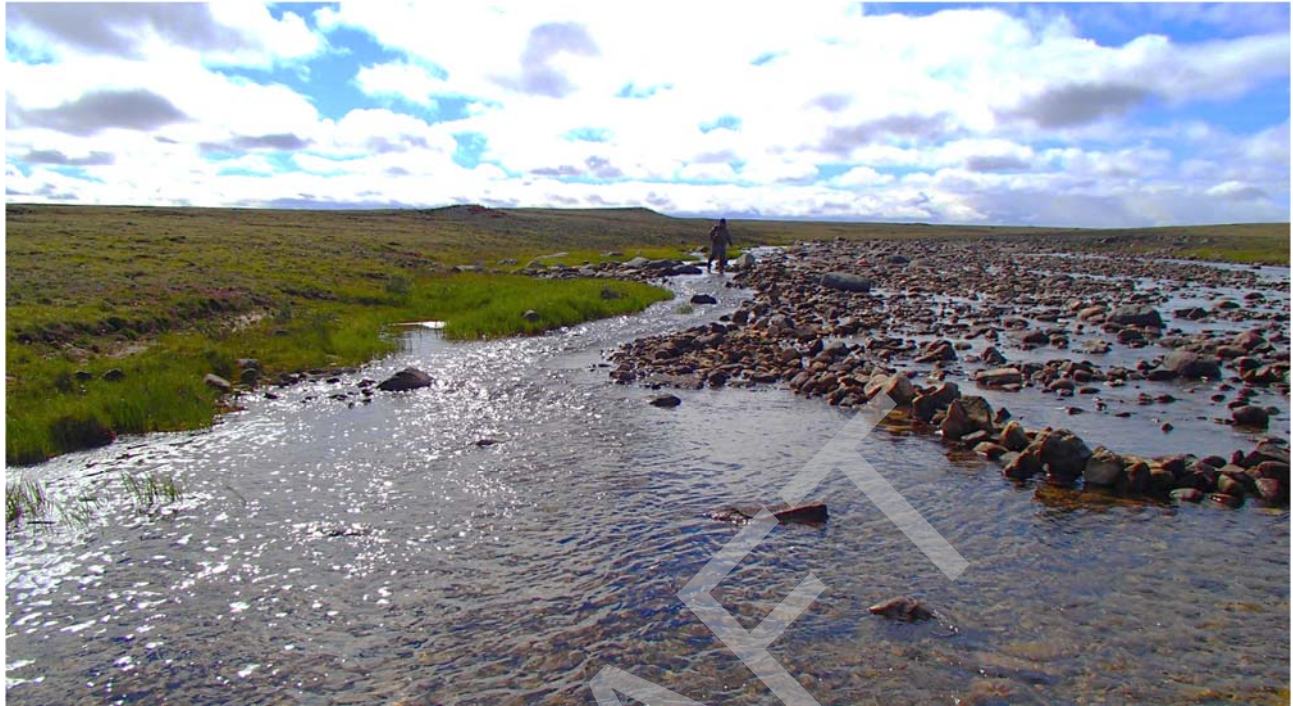
*Photo 31: Upstream view of weir A constructed at Site 4 to direct fish passage towards low-flow channel A. 19 July 2016.*

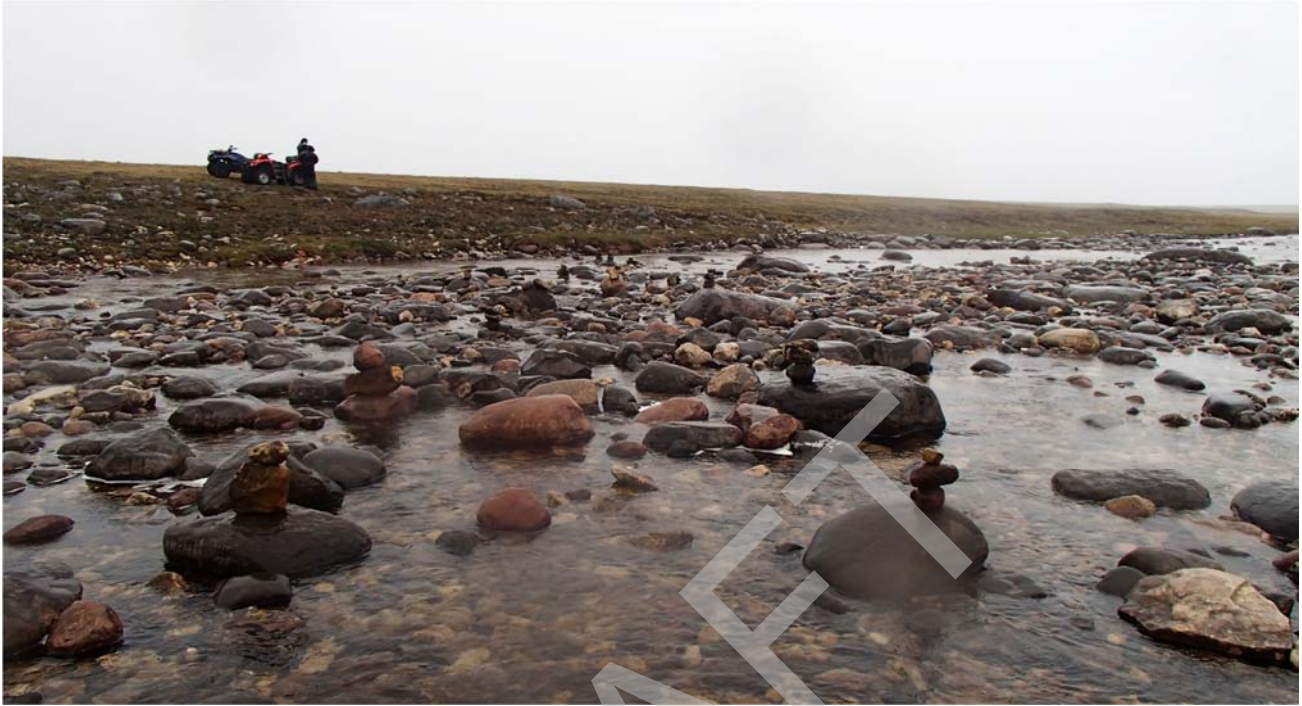
The problem area was within a stream section approximately 44 m wide and was characterized by run/riffle habitat dominated by boulder substrate. Flows dispersed across the creek, with most of the flow concentrated along the centre of channel at the upstream extent and near the LDB at the downstream extent. A continuous route for fish passage was lacking along the LDB and towards the centre of the creek due to shallow depths, no discernible thalweg, and the presence of a boulder garden with several sections of dry streambed. A large pool suitable as refugia was present at the upstream extent within the centre of the creek. Site 5 was ranked as a risk level 3-highest priority for remediation. See Photo 4-13 and Photo 33 to 34 in Appendix A.

*Photo 33: Downstream view of Site 5, viewed from the center channel prior to remediation. Note the lack of a discernible thalweg and unobstructed path for passage. 20 July 2016.*

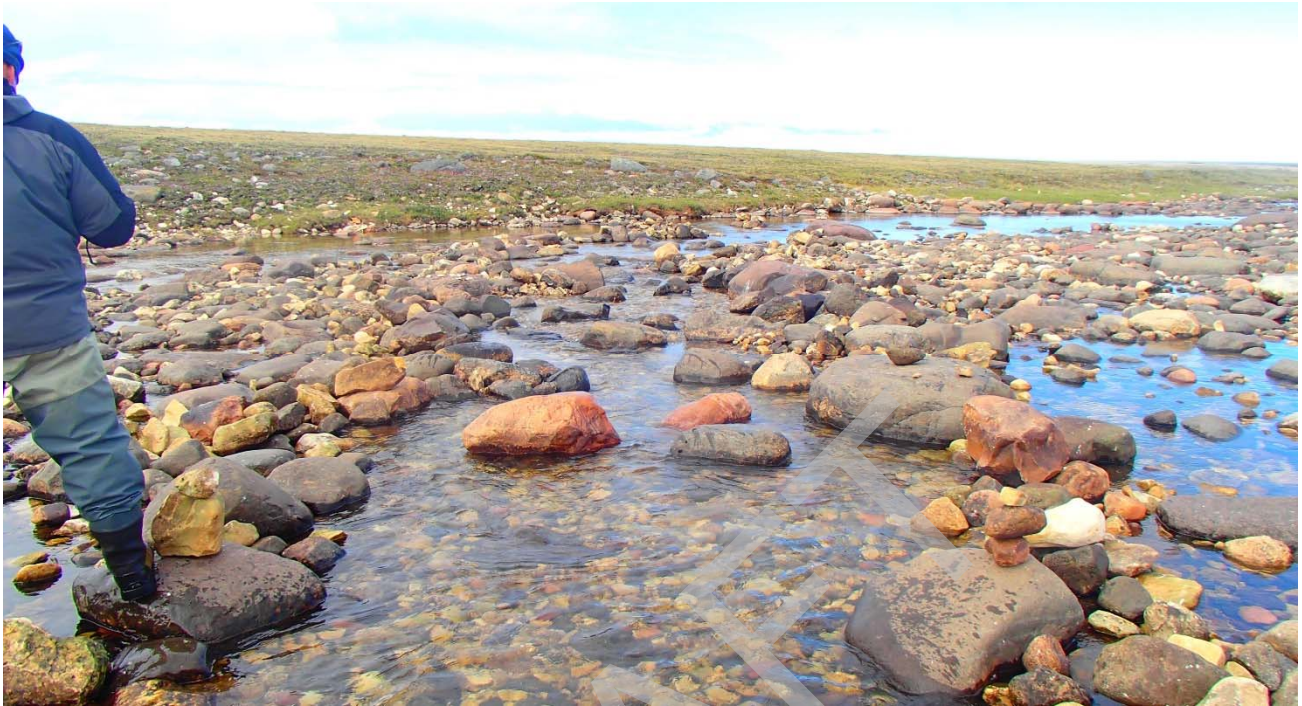
*Photo 35: Downstream view of the low-flow channel at Site 5. Boulders too large to move by hand were left within channel to provide cover for migratory fish. 20 July 2016.*

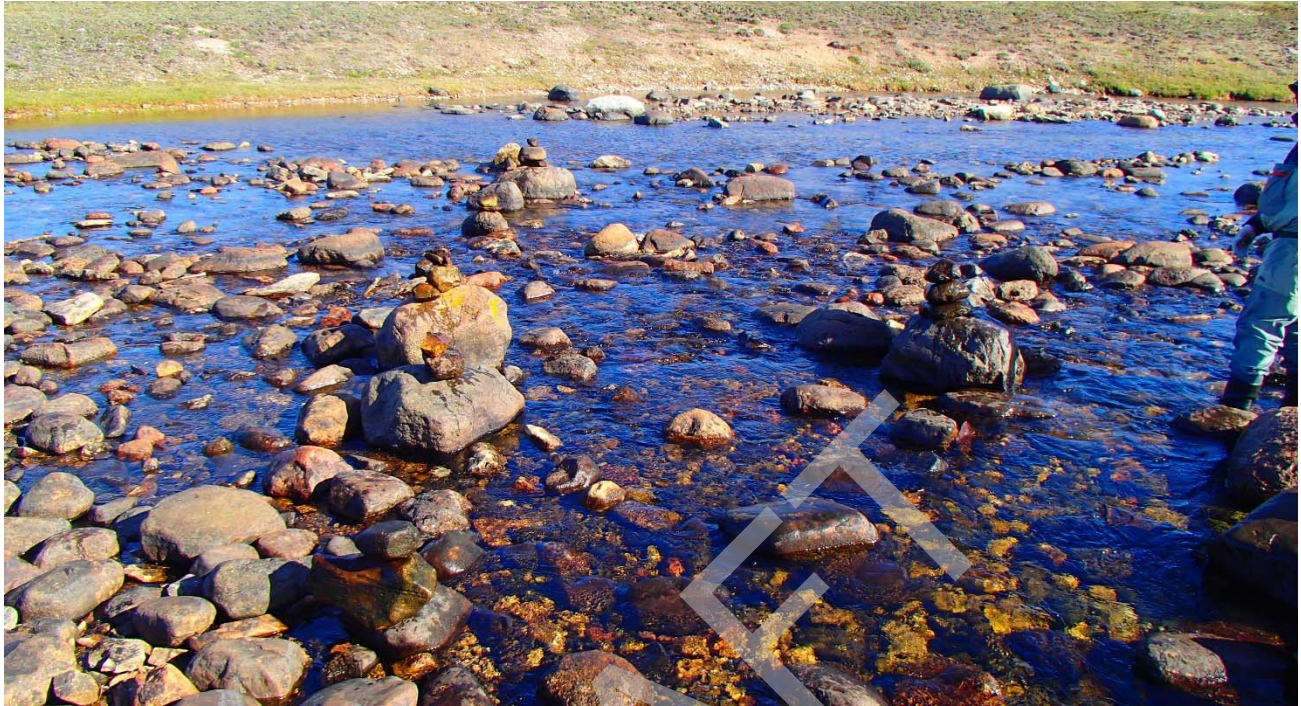
*Photo 39: Downstream view of the proposed location of low-flow channel A at the upstream extent of Site 7. Note the lack of a discernible path for fish from the large pool downstream to locations further upstream. 24 July 2016.*

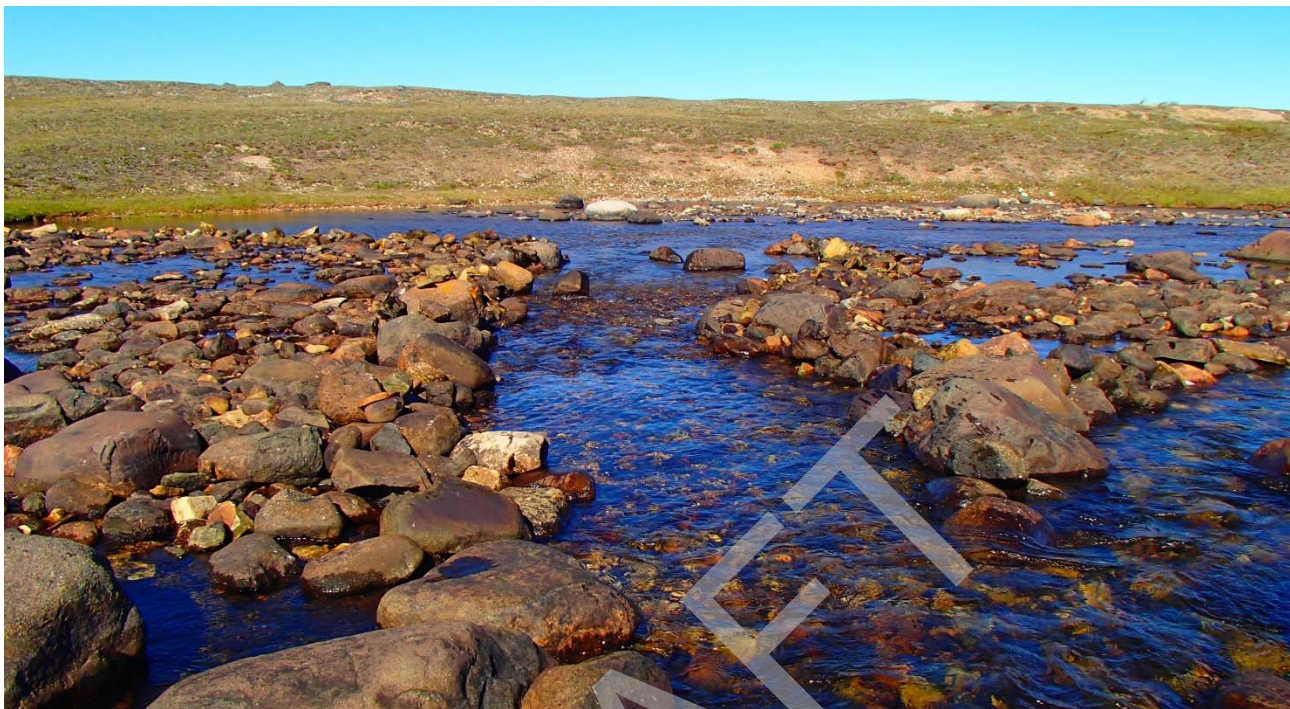
*Photo 41: Downstream view of low-flow channel A at Site 7. Note the channel connecting to the large pool at the downstream extent of Site 7. 24 July 2016.*

| Site Structures | Length (m) | Location in Creek | Photos |
|---|---|---|---|
| Low-Flow Channel A | 16 | LDB diagonally towards RDB | Photo 41 to 42 in Appendix A |

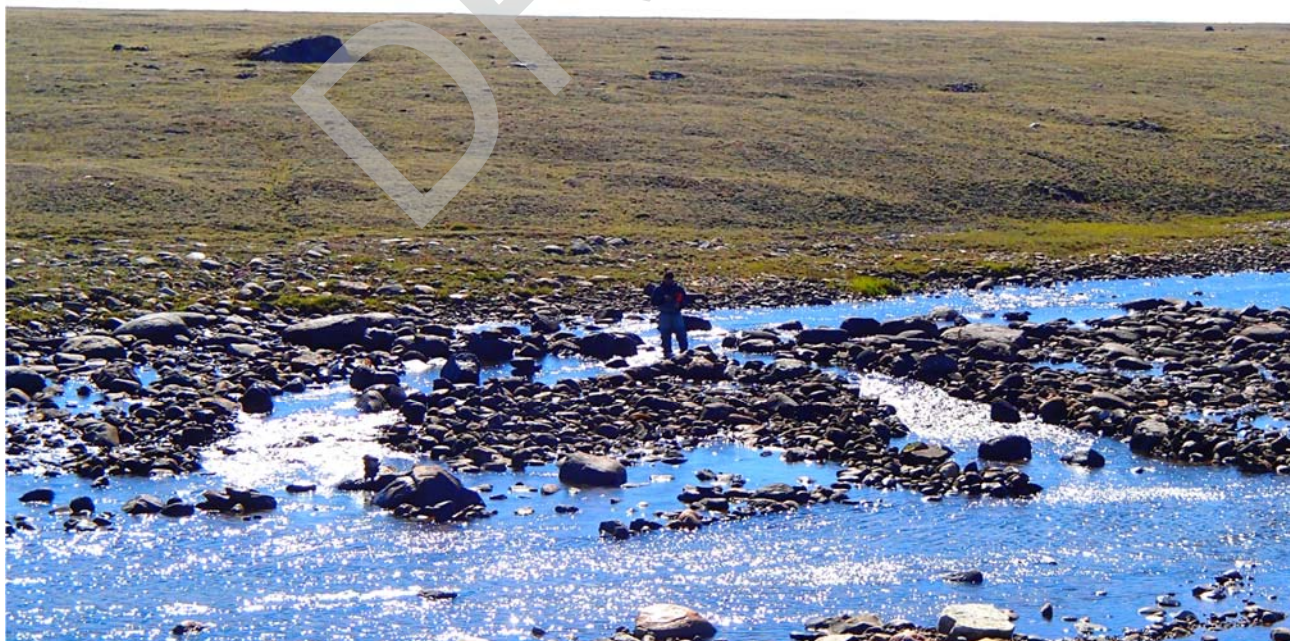
*Photo 42: Upstream view of low-flow channels A and B from above the LDB at the downstream extent of Site 7. 24 July 2016.*

| Site Structures | Length (m) | Location in Creek | Photos |
|---|---|---|---|
| Low-Flow Channel B | 18 | Centre diagonally towards RDB | Photo 4-18; Photo 42 in Appendix A |

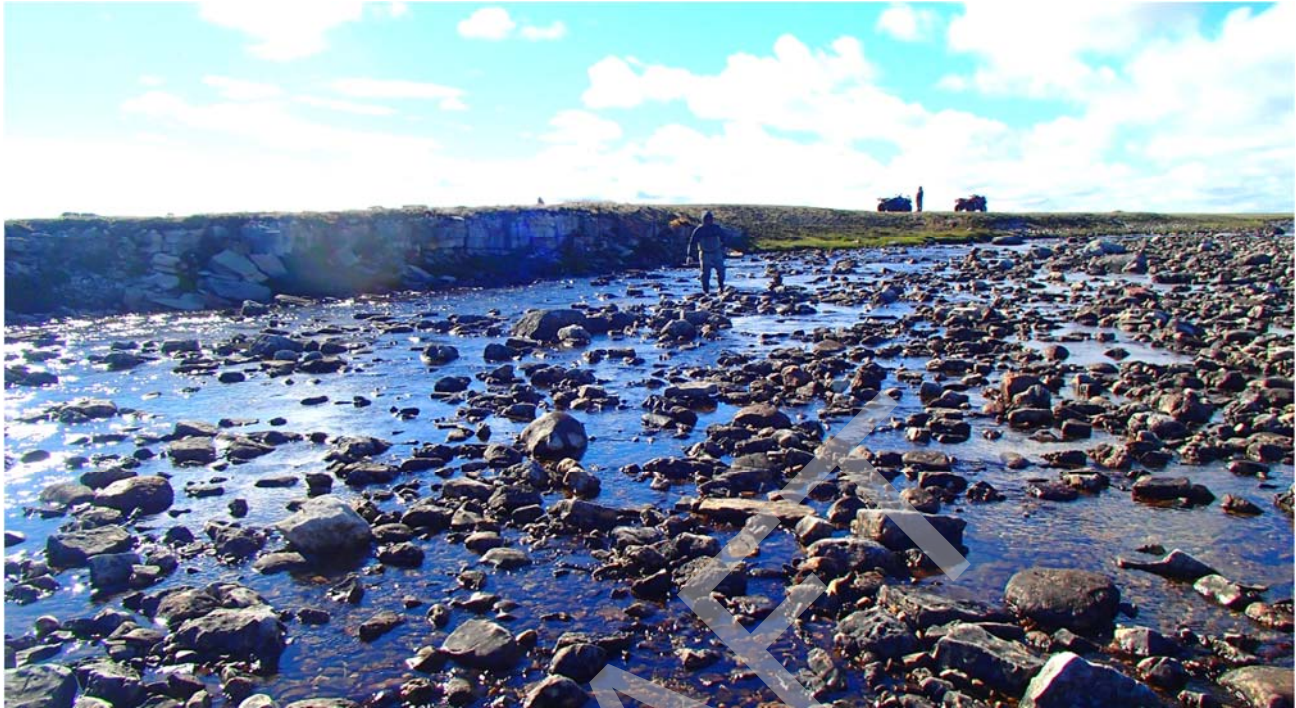
*Photo 47: Upstream view from the downstream extent of Site 9 prior to remediation. Note the absence of an obvious migratory route connecting to flows along the RDB. 23 July 2016.*

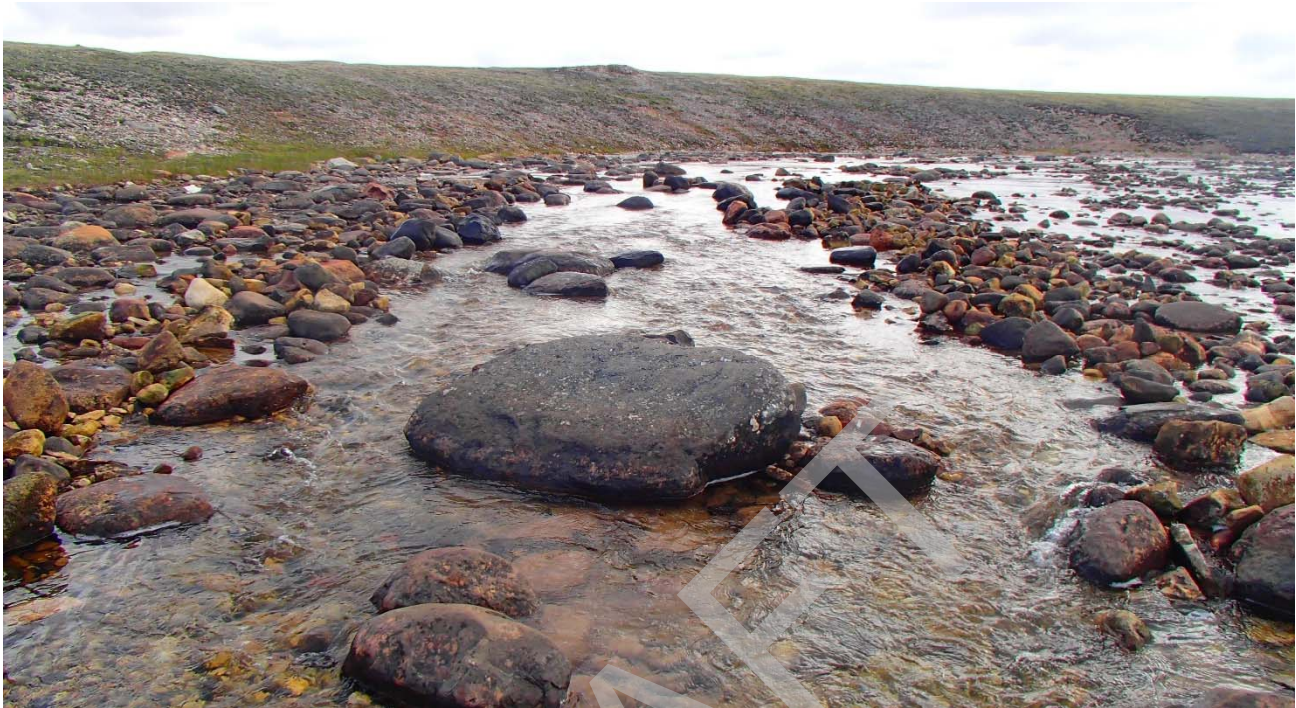
The low-flow channel at Site 11 was constructed within the centre of the creek where flows were concentrated. The channel connected a small pool at the downstream extent to a deep run habitat unit at the upstream extent (Photo 54 in Appendix A; Photo 4-26). Some boulders were too large to be relocated and were left within the constructed channel to provide refugia for migratory fish (Photo 55 in Appendix A). Due to the availability of large boulders, the boundaries of the low-flow channel are well armoured and are expected to withstand spring freshet flow conditions.

*Photo 55: Upstream view from the centre of the low-flow channel constructed at Site 11. The photograph shows large boulders left within channel to act as cover for migratory fish. 20 July 2016.*
