### 3. OBSERVATIONS AT SITE

From March 23 to 25, 2026, NIRB staff conducted a site visit to the Goose Property Area, travelled the Winter Ice Road (WIR), and visited the Marine Laydown Area (MLA) of the Back River Project, accompanied by B2Gold Nunavut's environment team. The purpose of the visit was to review construction progress, environmental management practices, and compliance with Project Certificate No. 007, Amendment 01. During the visit, NIRB staff observed ongoing construction, commissioning, and operational activities and held discussions with B2Gold Nunavut personnel regarding environmental monitoring, mitigation measures, and adherence to Project Certificate requirements ([Table 1](#))

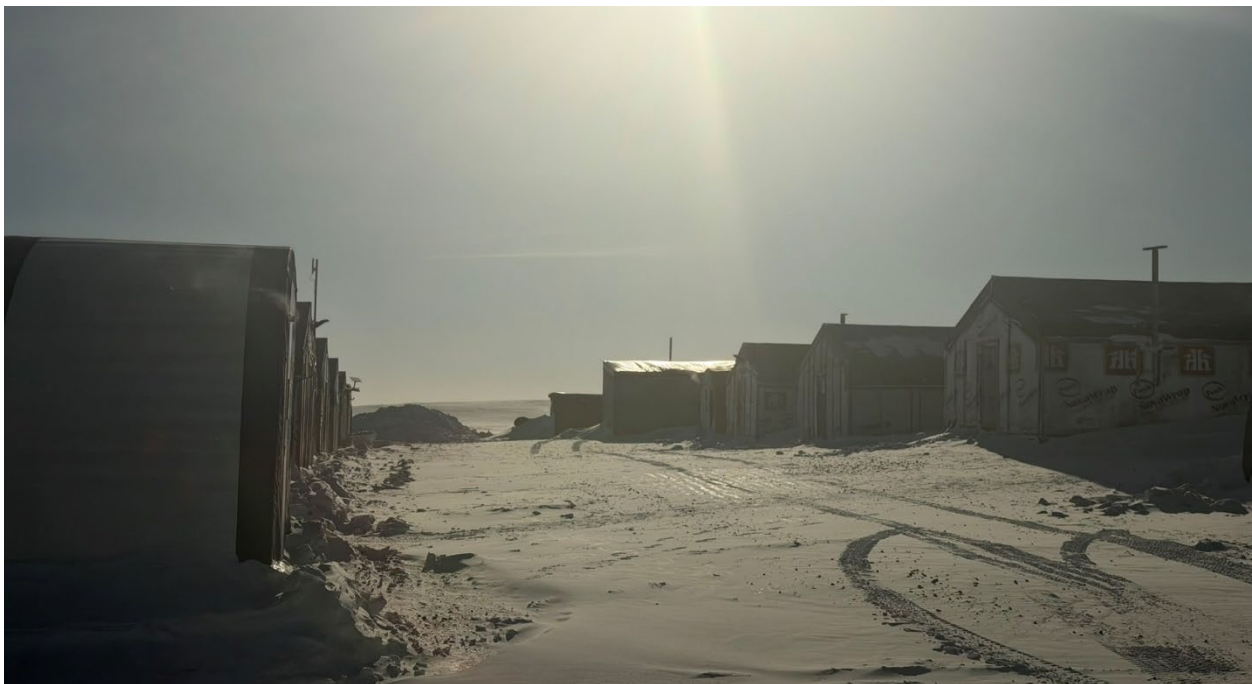
**Photo 6: Accommodation units and weather havens**

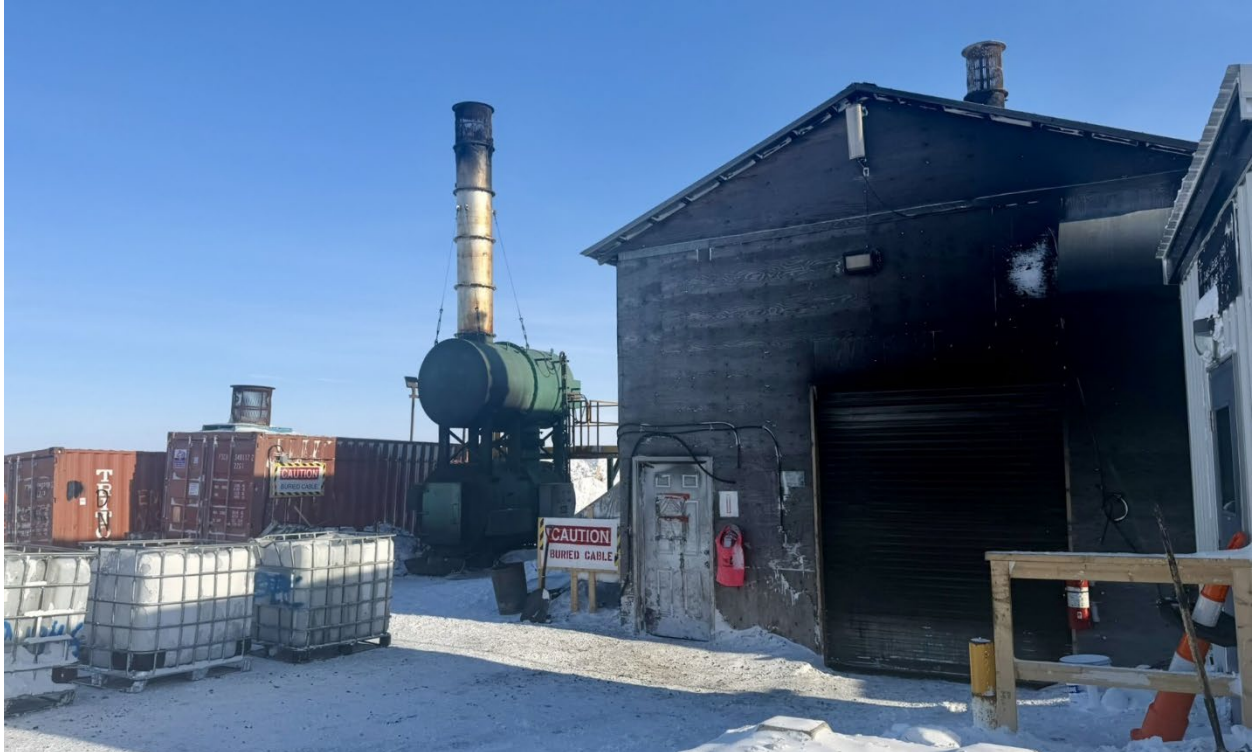
| <b>T&amp;C</b> | <b>Requirement</b> | <b>Site Observation</b> |
|---|---|---|
| 4 | Incineration Management Plan | Observed incinerators at the Goose Exploration Camp and Marine Laydown Area and associated waste management practices ( <a href="#">Photo 7</a> , <a href="#">Photo 8</a> , <a href="#">Photo 9</a> , and <a href="#">Photo 136</a> ). |

**Photo 7: Incinerators - one housed inside the shed and one outside on the left when facing east**

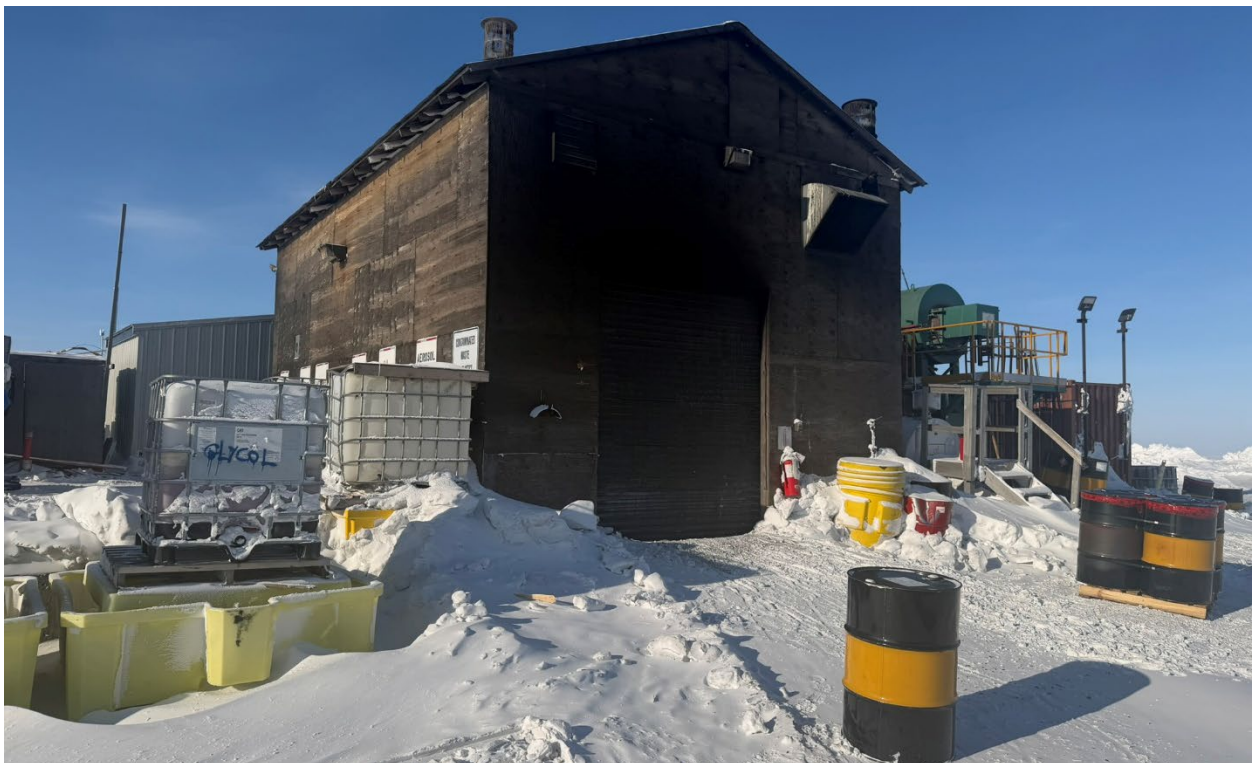
| <b>T&amp;C</b> | <b>Requirement</b> | <b>Site Observation</b> |
|---|---|---|
| 14 | Waste Management Plan | Observed waste segregation ( <a href="#">Photo 8</a> , <a href="#">Photo 9</a> , <a href="#">Photo 66</a> , and <a href="#">Photo 139</a> ), HAZMAT waste storage ( <a href="#">Photo 13</a> and <a href="#">Photo 137</a> ), burn pit ( <a href="#">Photo 26</a> ) and landfill ( <a href="#">Photo 50</a> and <a href="#">Photo 51</a> ). |

**Photo 8: Incinerators and HAZMAT waste segregation (facing west)**

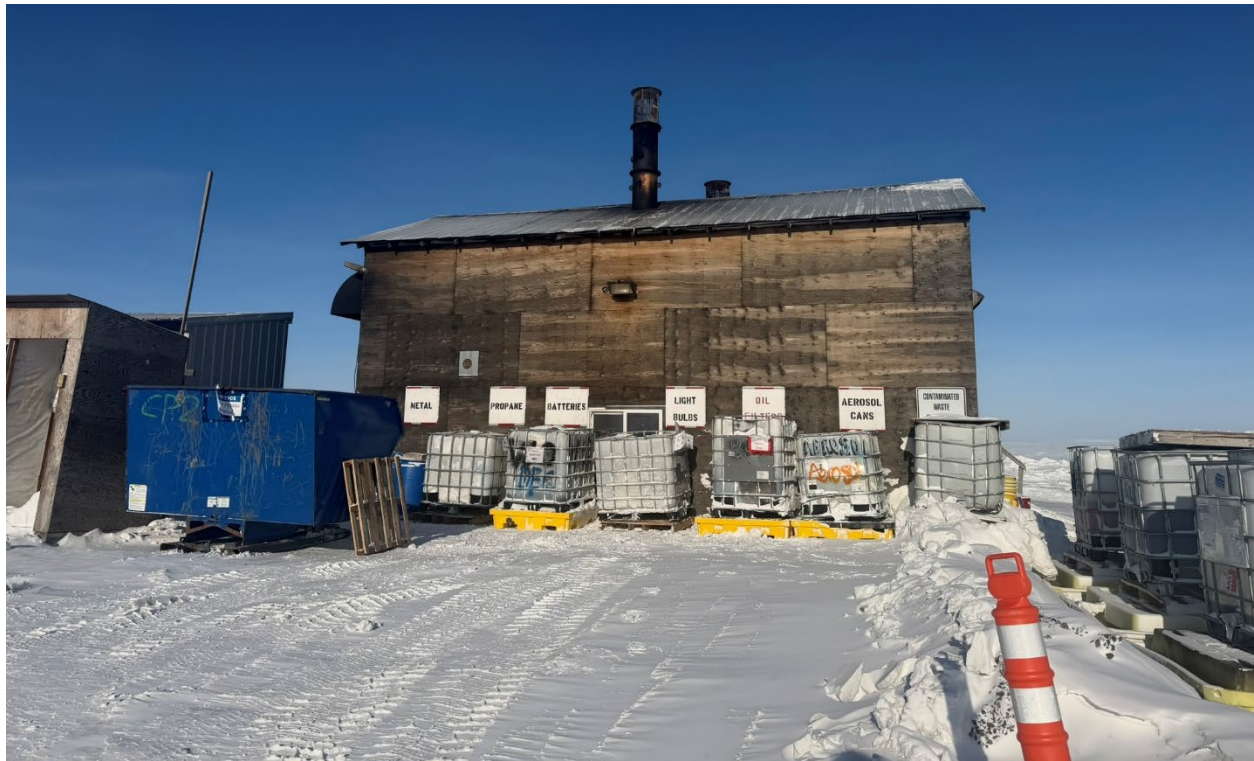
**Photo 9: Incinerators and HAZMAT waste segregation (facing north)**

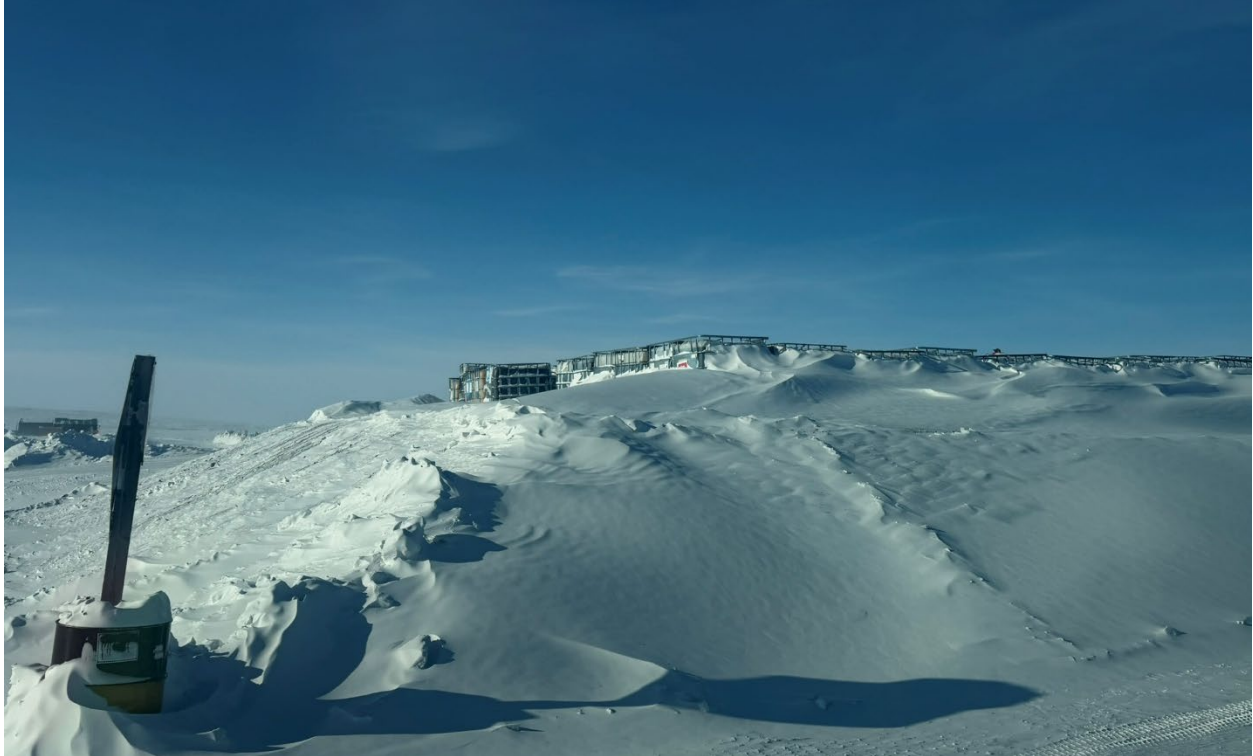
**Photo 13: HAZMAT stored in secondary containment (structure previously used for fuel tank housing)**

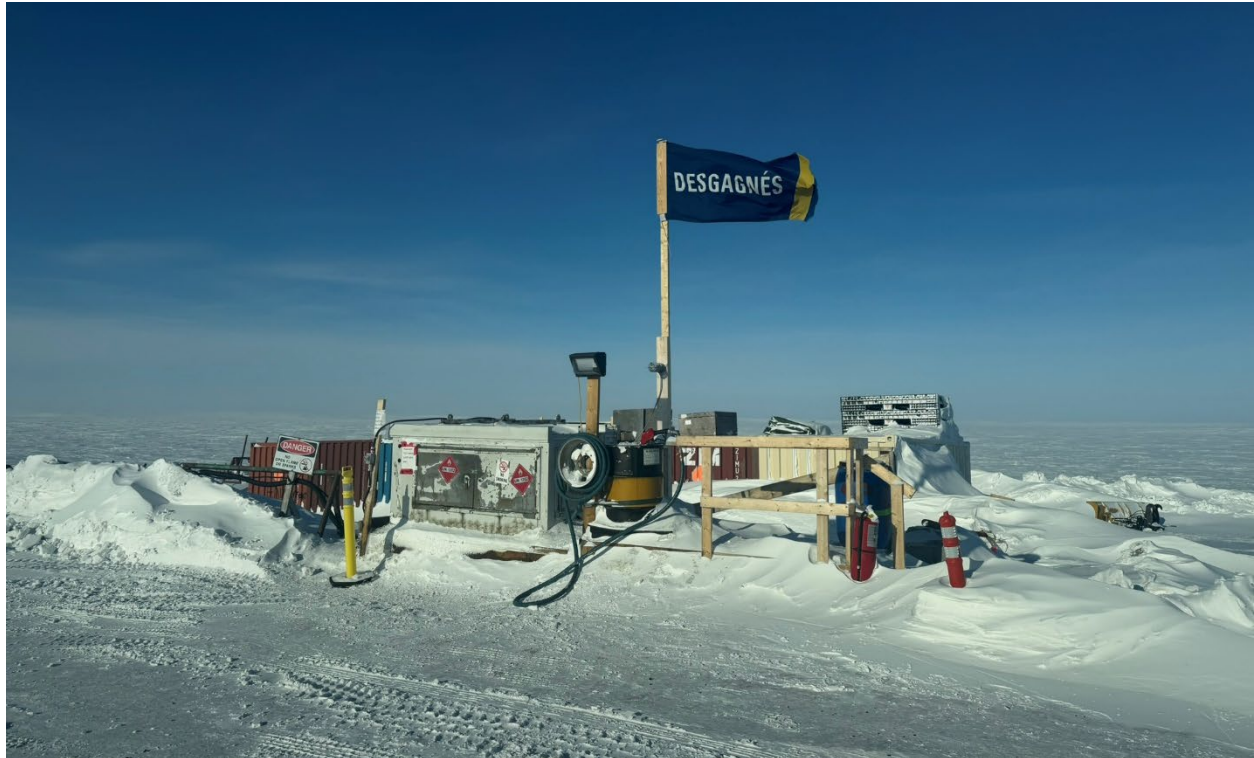
**Photo 15: Fueling station located north of the HAZMAT containment**

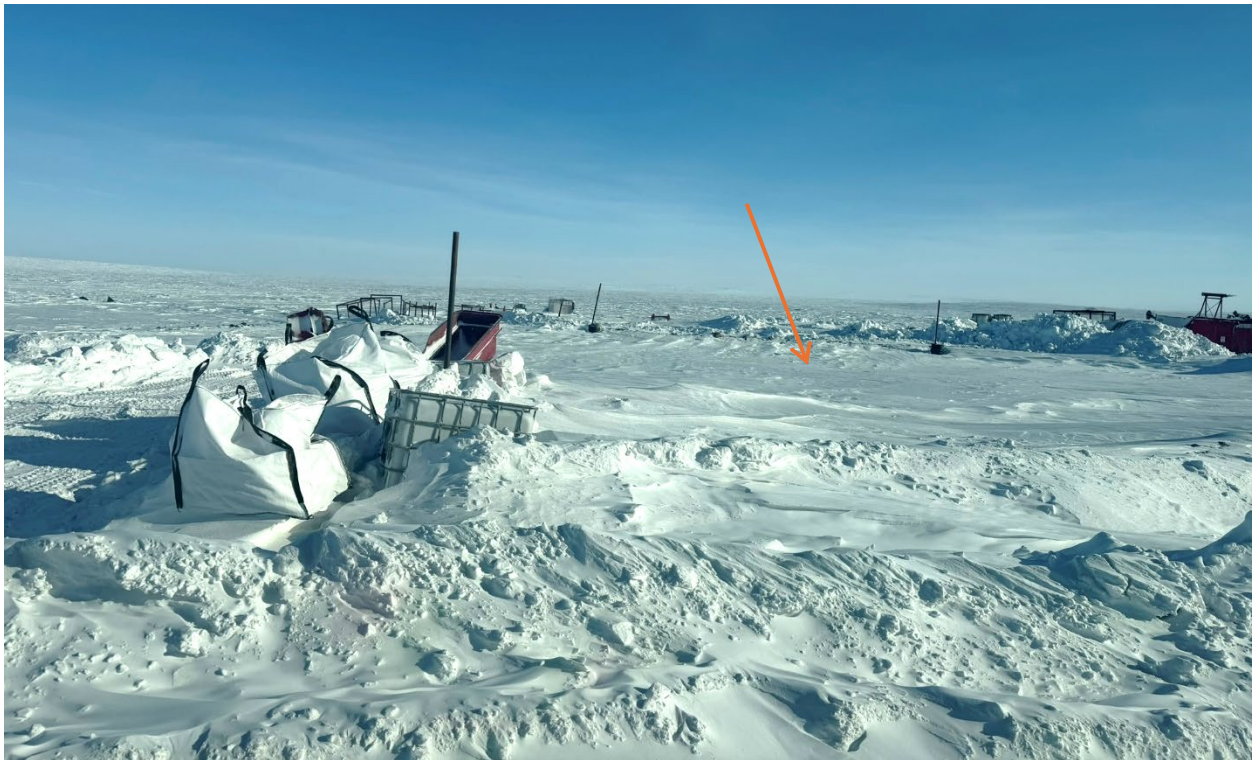
**Photo 18: Settling pond area, currently frozen and snow-covered**

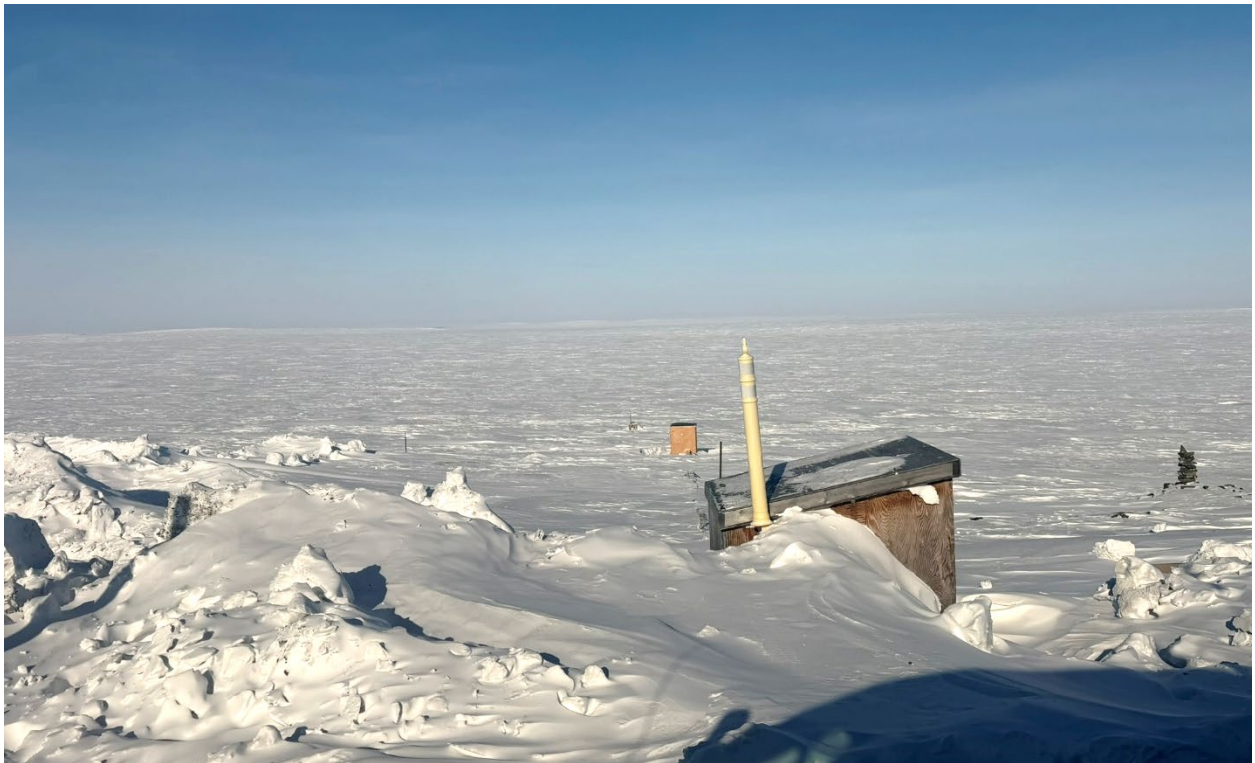
**Photo 20: Water intake facility**

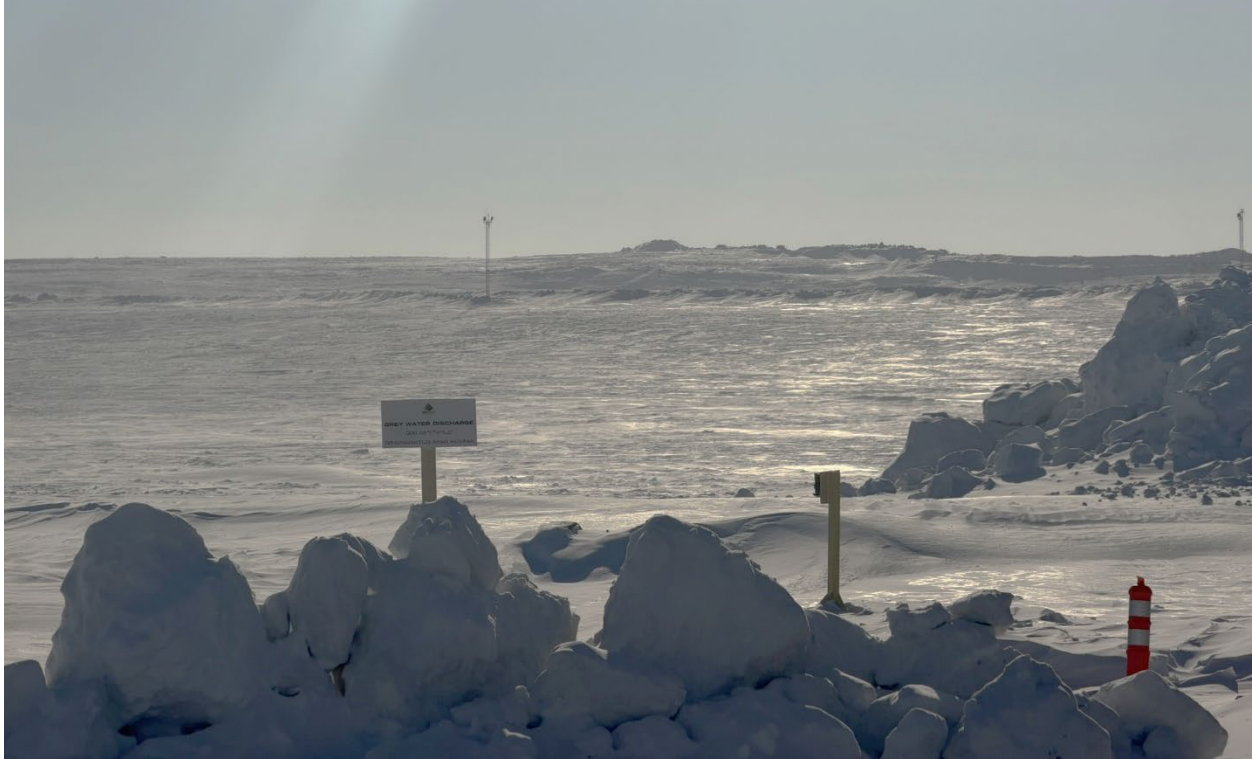
**Photo 21: Greywater discharge area; no active discharge observed**

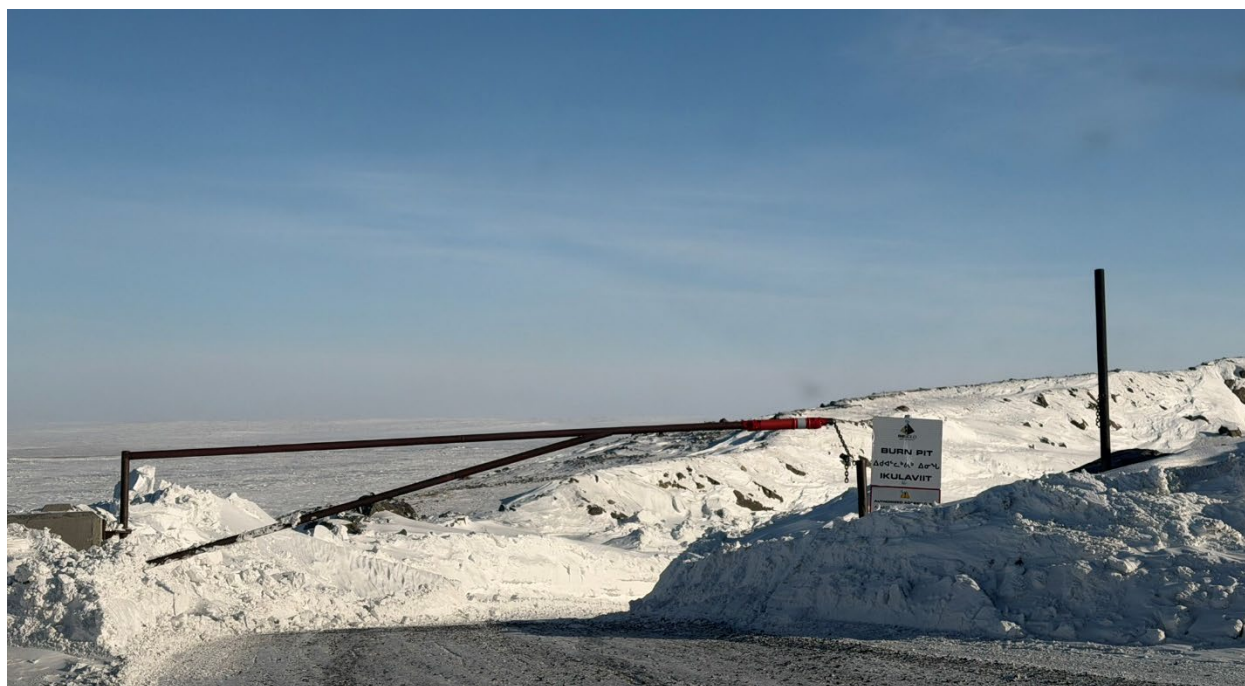
**Photo 25: Controlled access gate to the burn pit facility**

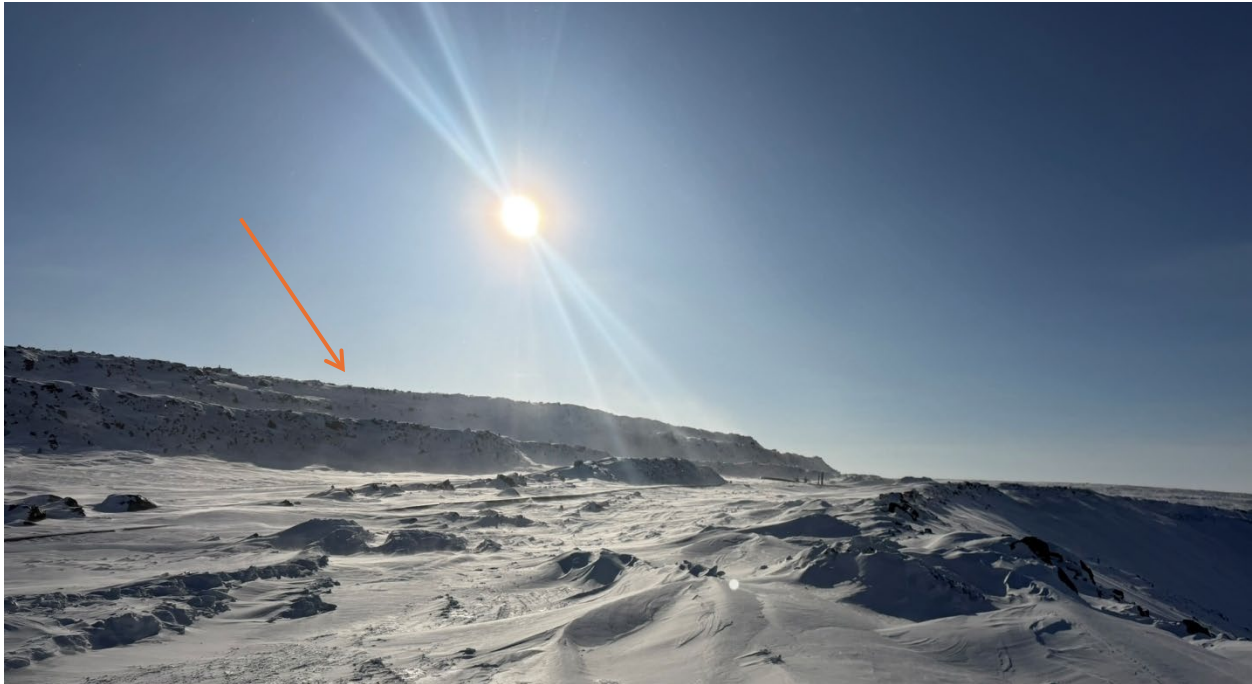
<sup>6</sup> Echo Pit has been fully mined and is currently used as a temporary tailings storage facility pending completion of a permanent facility. The Echo Pit Waste Rock Storage Area is being used to store non-hazardous materials, including tires, scrap metal, and decommissioned fuel tanks.

**Photo 29: Echo Pit waste rock storage area**

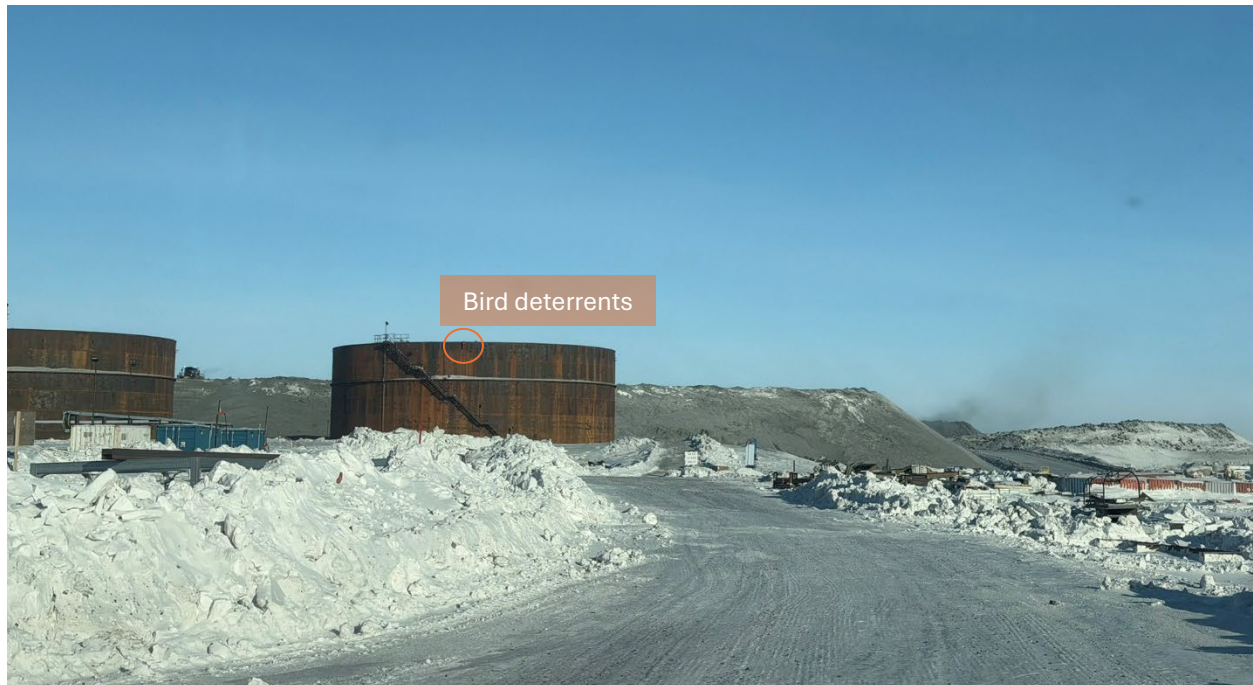
**Photo 31: Tank farm access road, looking east, with laydown areas on the right**

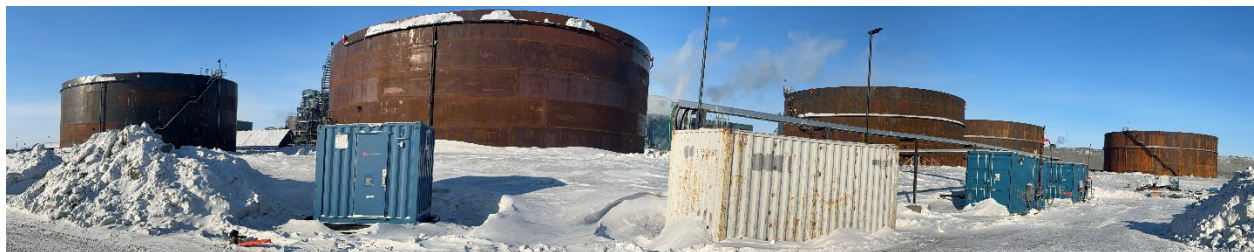
**Photo 33: Panoramic view of the Tank farm**

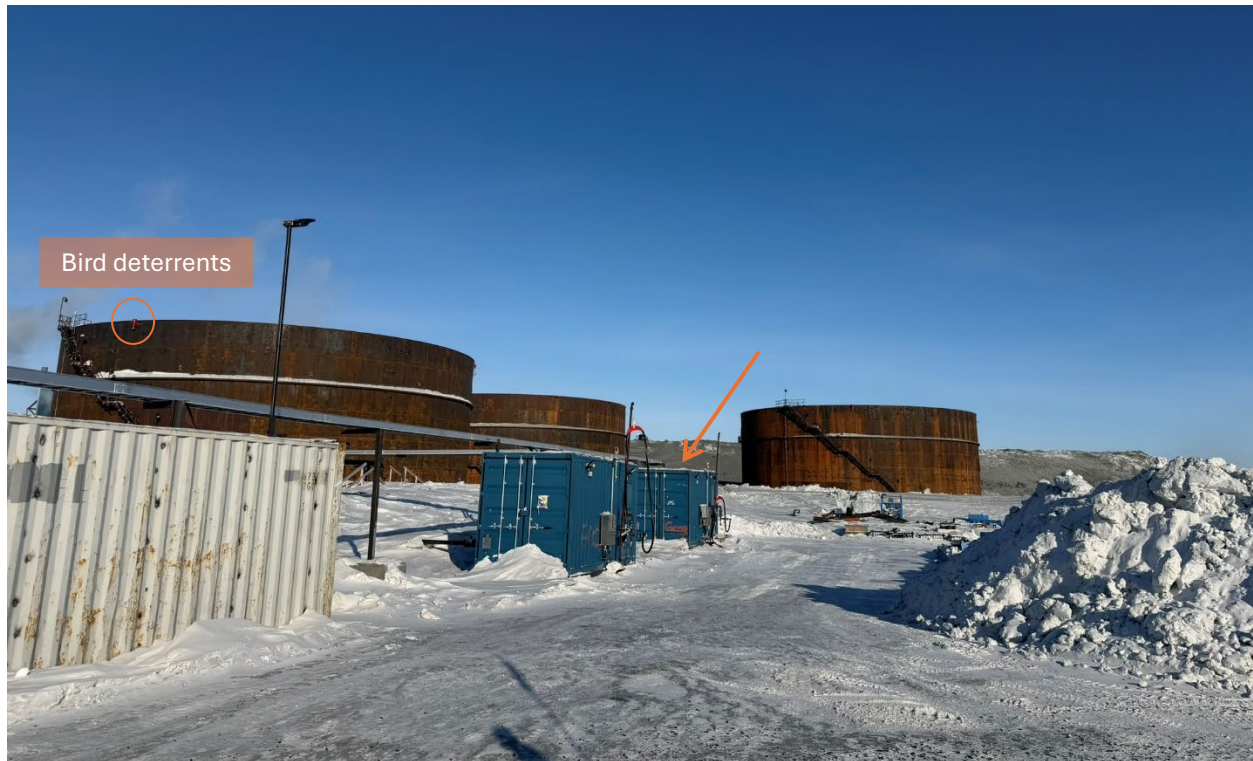
**Photo 34: Fuel truck offloading area with spill containment catchments**

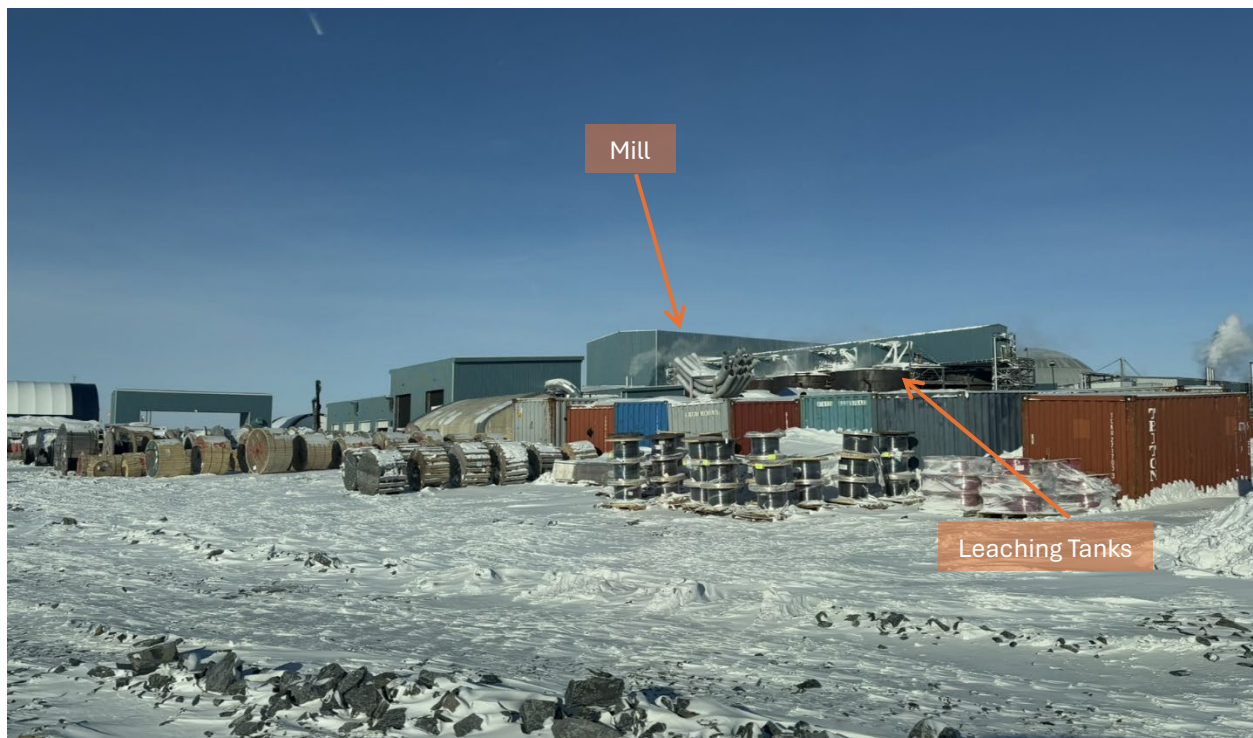
**Photo 35: Leaching tanks, mill, and laydown area located north of the Tank farm**

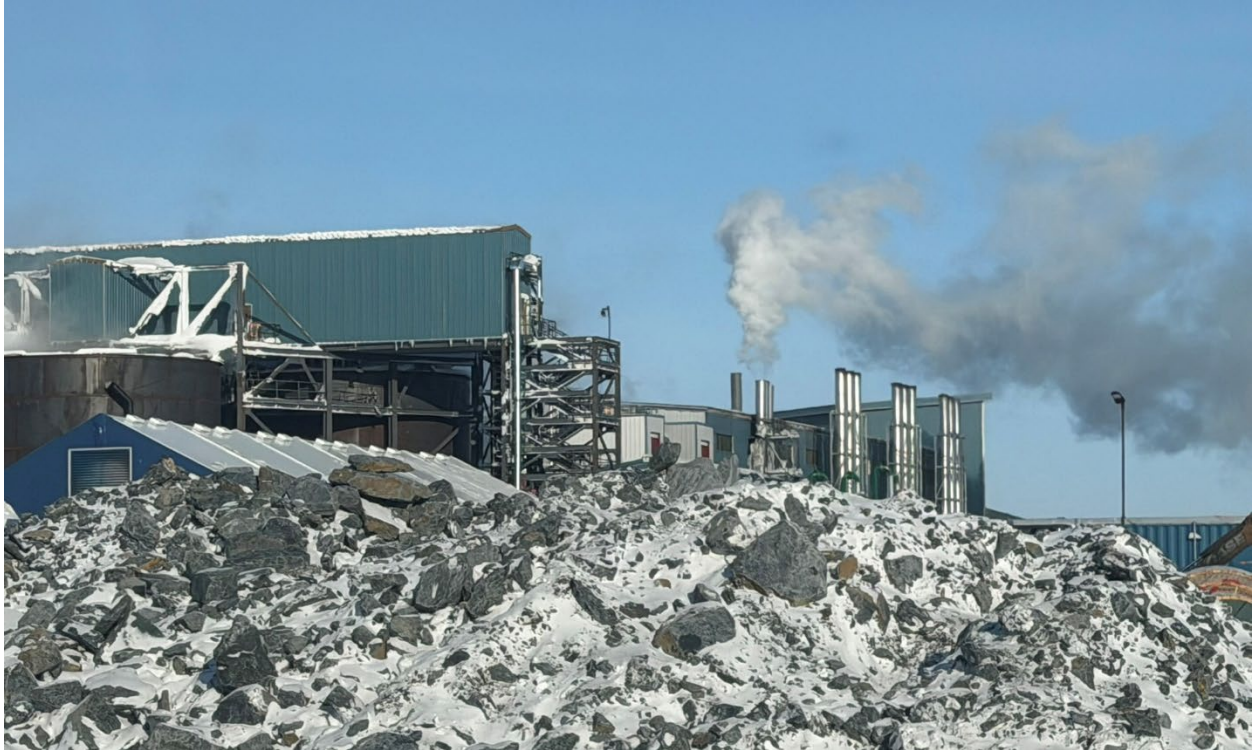
**Photo 36: Powerhouse located north of the Tank farm**

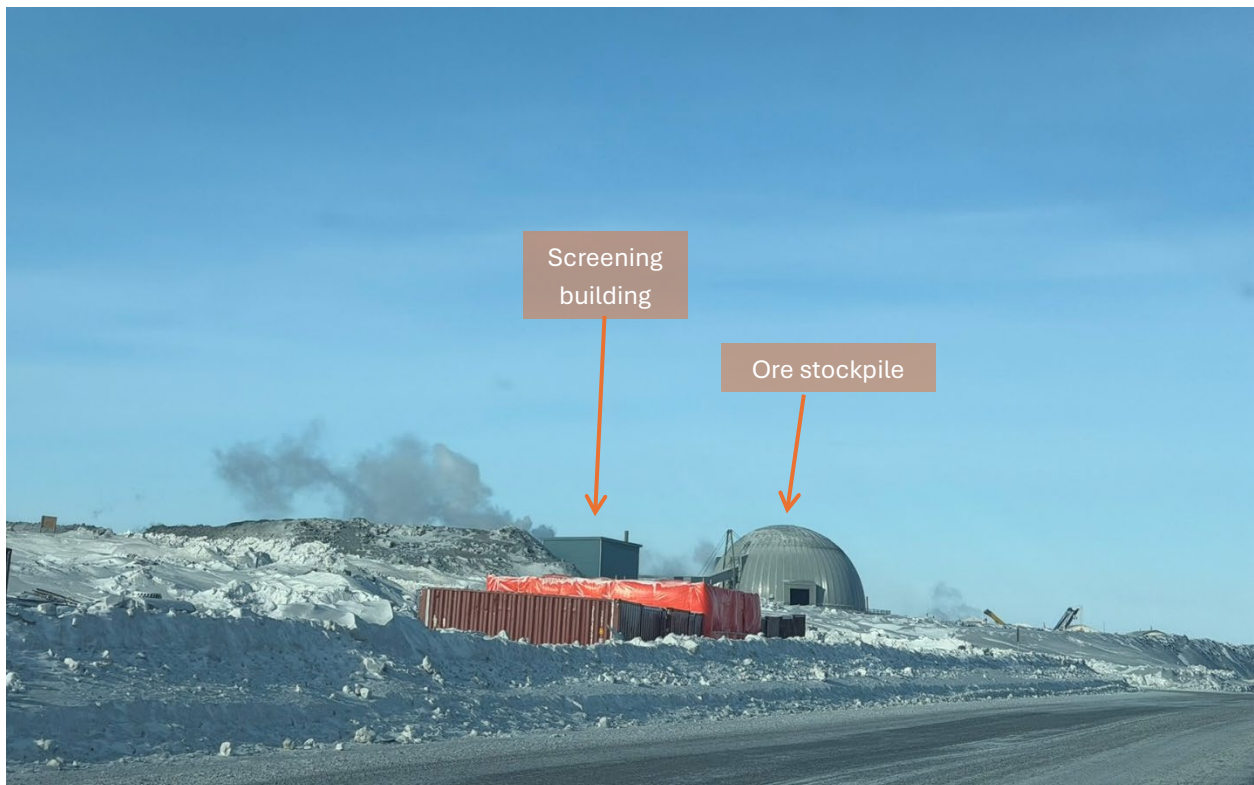
**Photo 37: Screening building and ore stockpile dome facing west from Goose Lake**

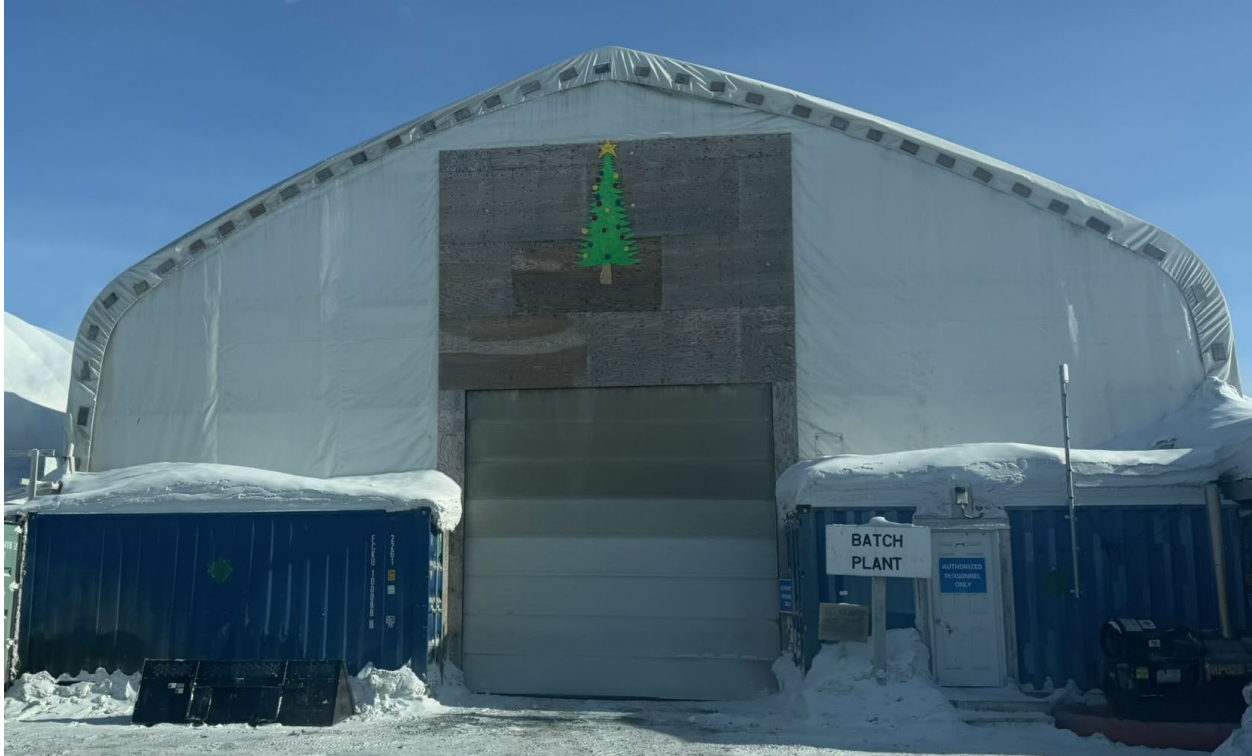
**Photo 38: Batch plant located north of the ore stockpile dome**

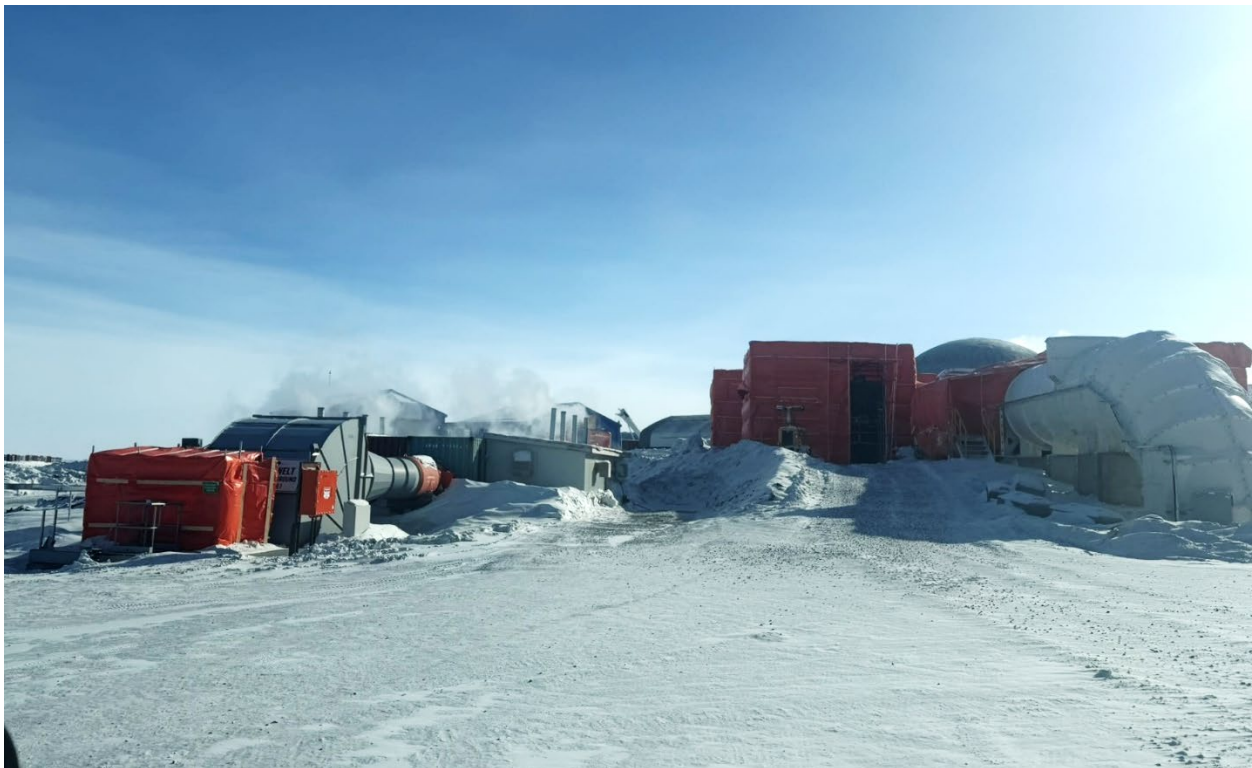
**Photo 39: Fresh air intakes 1 (left) and 2 (right) for underground ventilation located north of the ore stockpile dome**

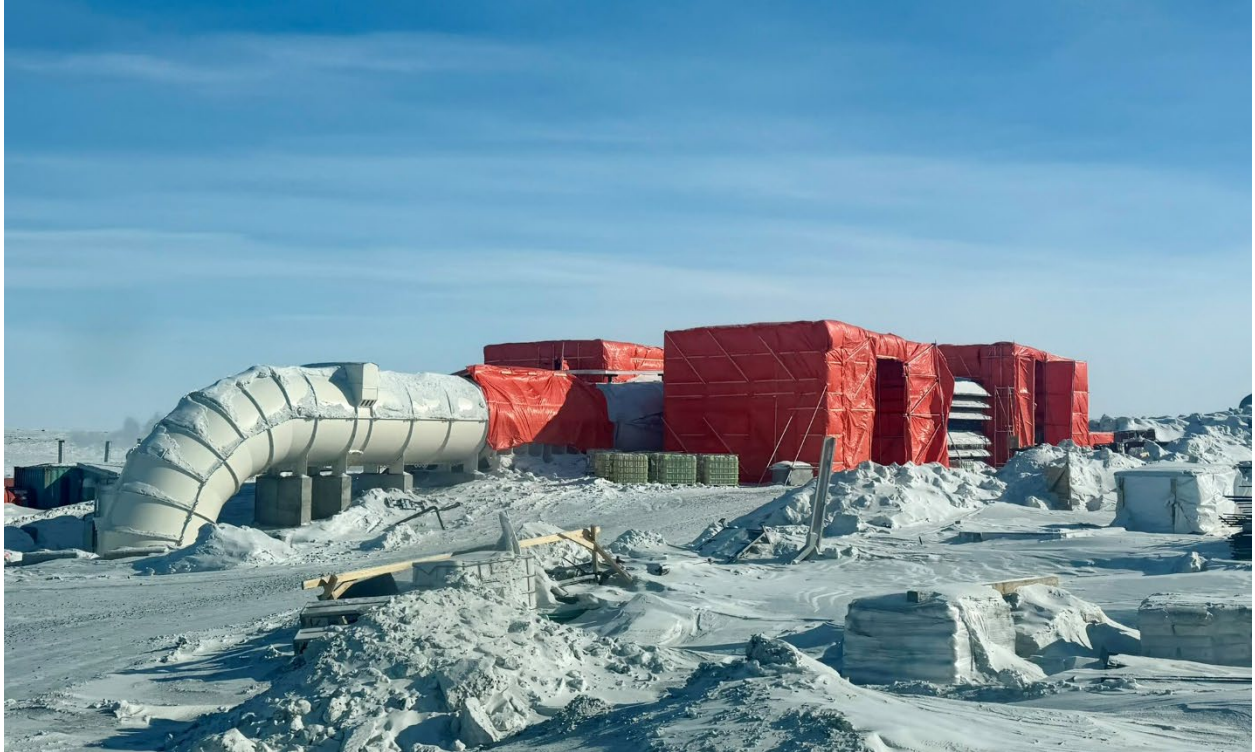
**Photo 40: Fresh air intake 2 (construction ongoing)**

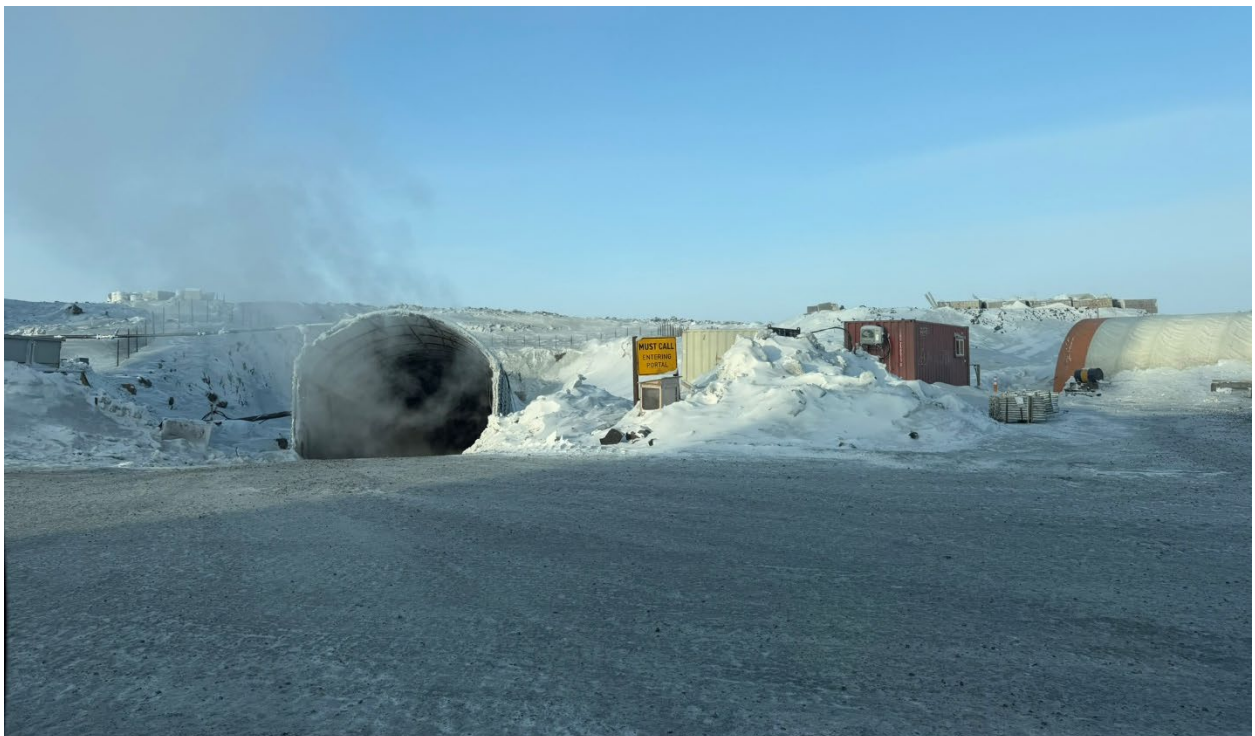
**Photo 41: Underground portal facing southwest**

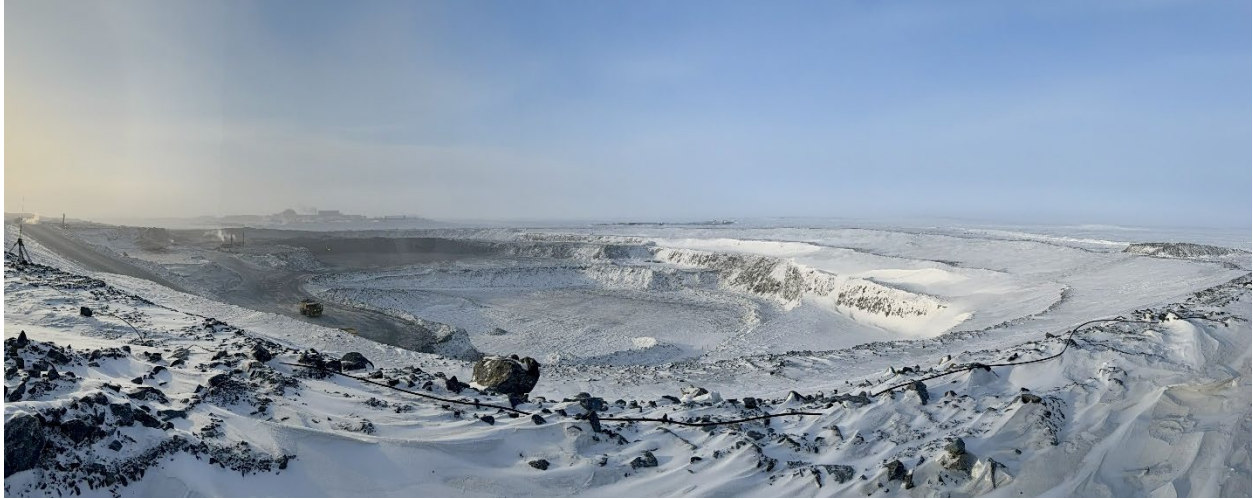
**Photo 42: Panoramic overview of the Umwelt Pit, facing south**

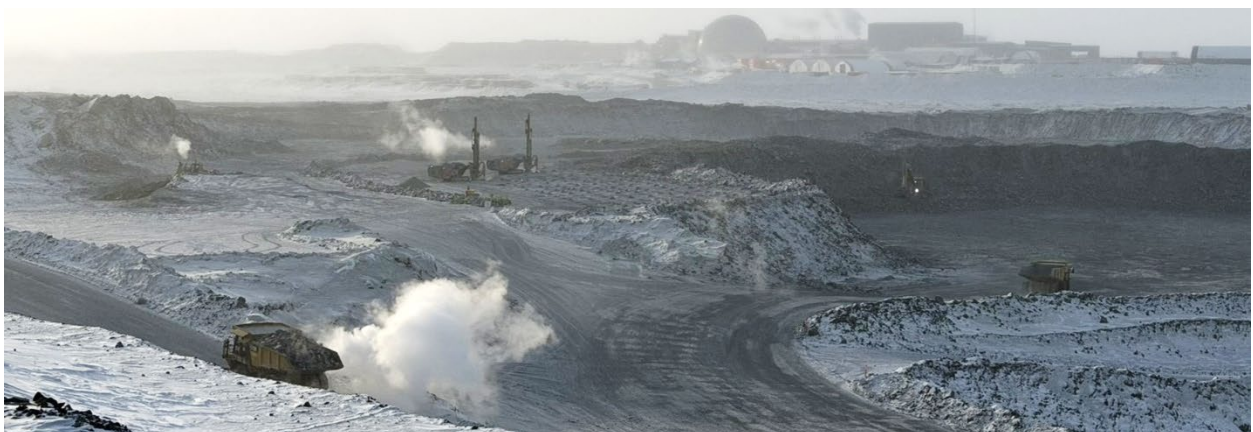
**Photo 43: Geotechnical monitoring system for pit wall stability monitoring**

<sup>8</sup> Umwelt Pit development advanced in 2025, with early-stage open-pit activities and progressing underground development. Waste rock is used for construction or placed in the Echo and Umwelt Waste Rock Storage Areas. Pit wall stability is monitored using a radar-based geotechnical monitoring system.

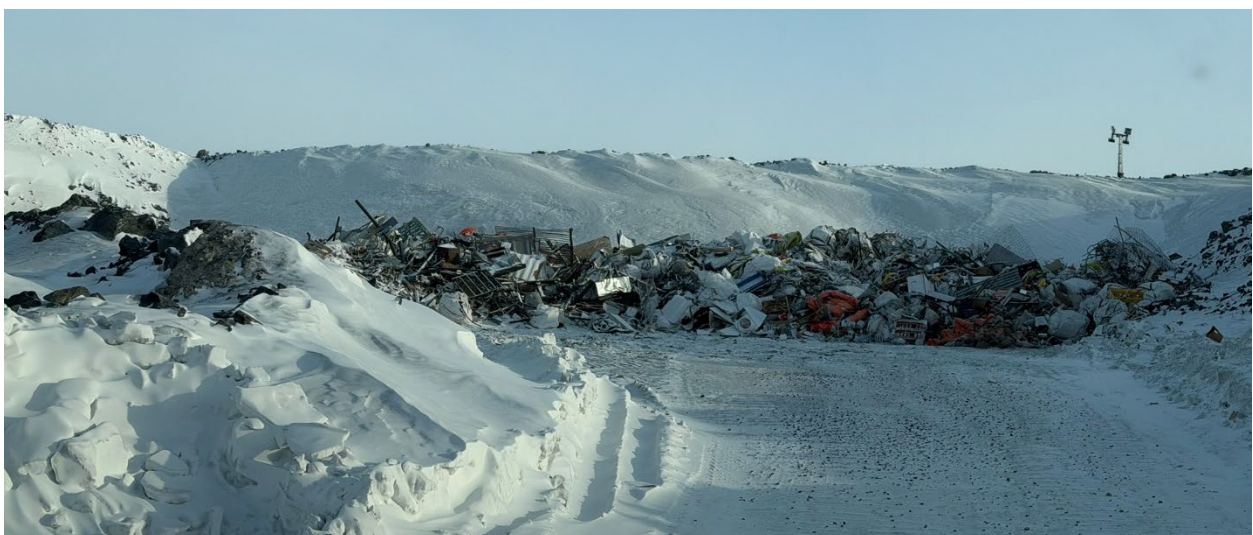
**Photo 51: Close-up view of the landfill**

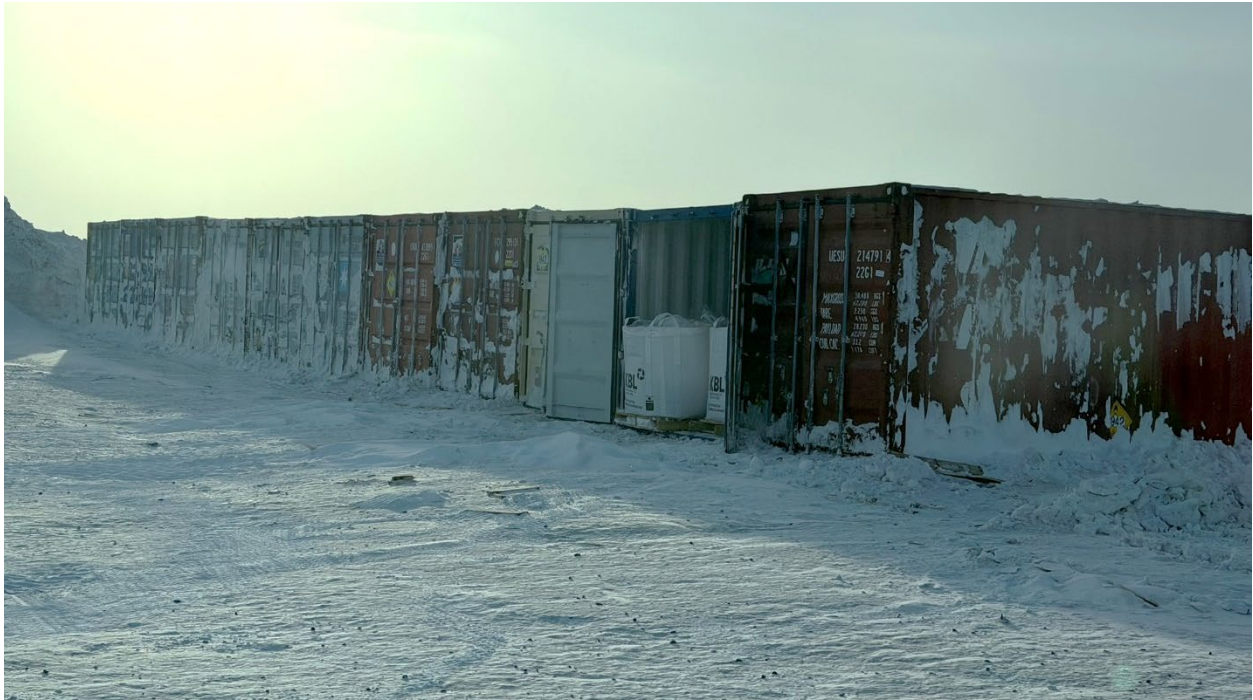
**Photo 56: Seacans east of AN storage area**
