### 3. OBSERVATIONS AT SITE

From March 23 to 25, 2026, NIRB staff conducted a site visit to the Goose Property Area, travelled the Winter Ice Road (WIR), and visited the Marine Laydown Area (MLA) of the Back River Project, accompanied by B2Gold Nunavut's environment team. The purpose of the visit was to review construction progress, environmental management practices, and compliance with Project Certificate No. 007, Amendment 01. During the visit, NIRB staff observed ongoing construction, commissioning, and operational activities and held discussions with B2Gold Nunavut personnel regarding environmental monitoring, mitigation measures, and adherence to Project Certificate requirements ([Table 1](#))

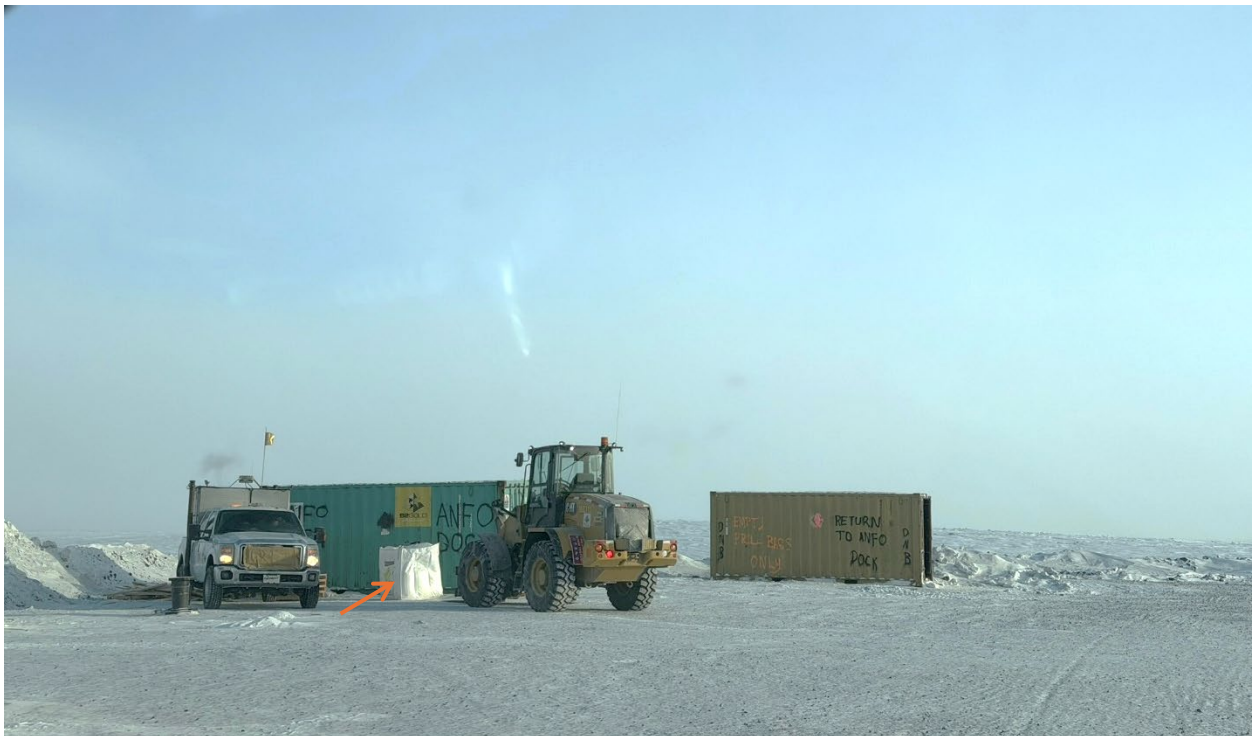
**Photo 57: Additional seacans north of AN storage area**

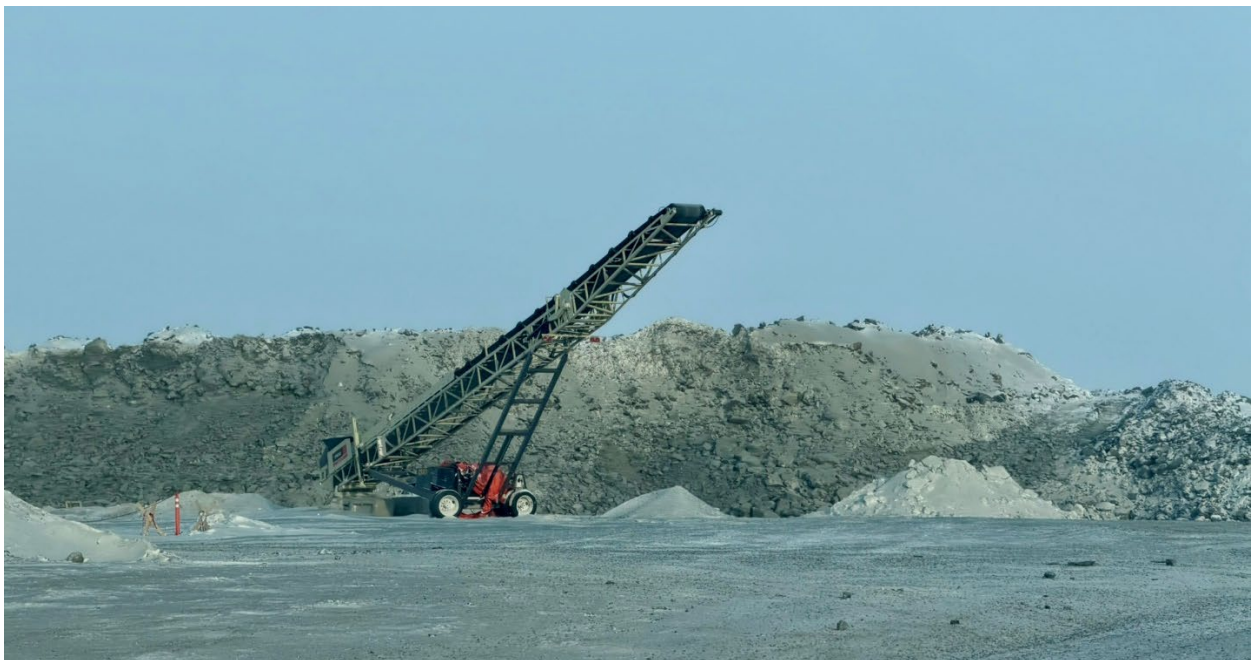
**Photo 61: Crusher pad facing west from the access road**

<sup>10</sup> The Llama crusher pad hosts mobile crusher units, with overburden and ore stockpiles present, and no active crushing observed during the site visit.

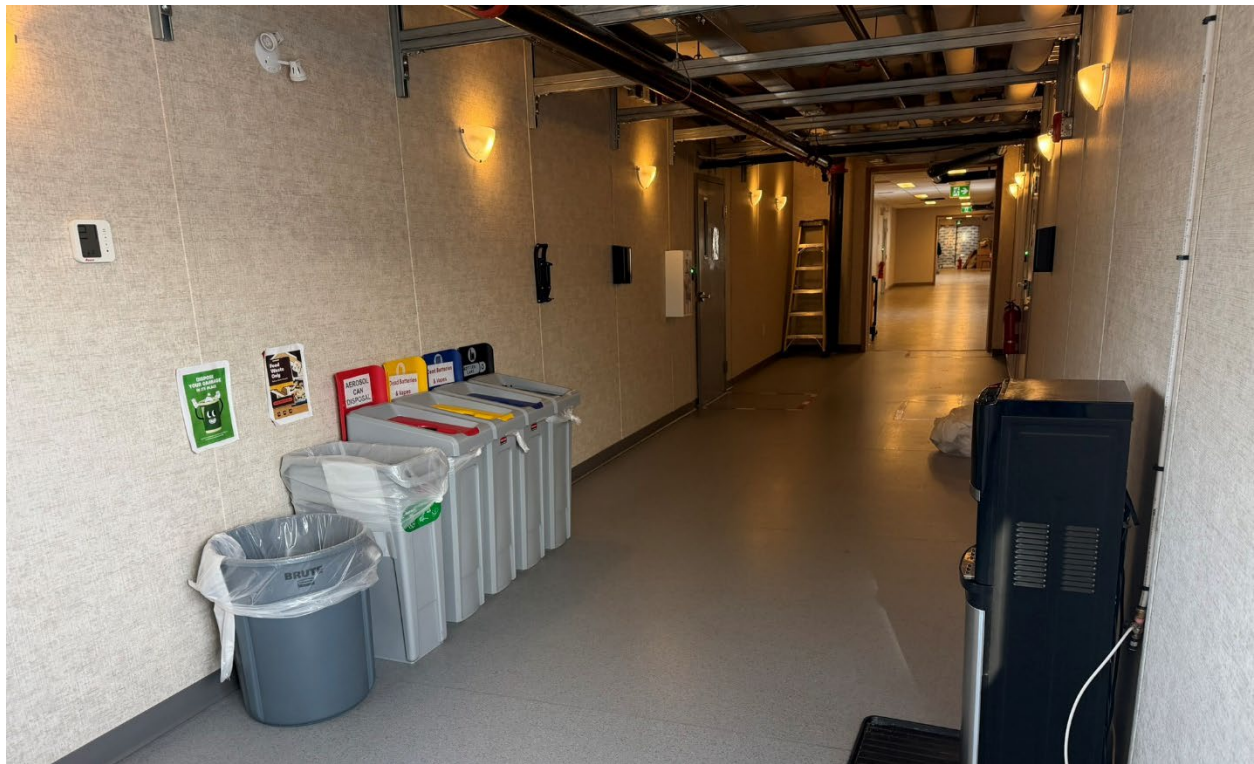
**Photo 66: Waste segregation, fire safety equipment, and water dispenser in hallway**

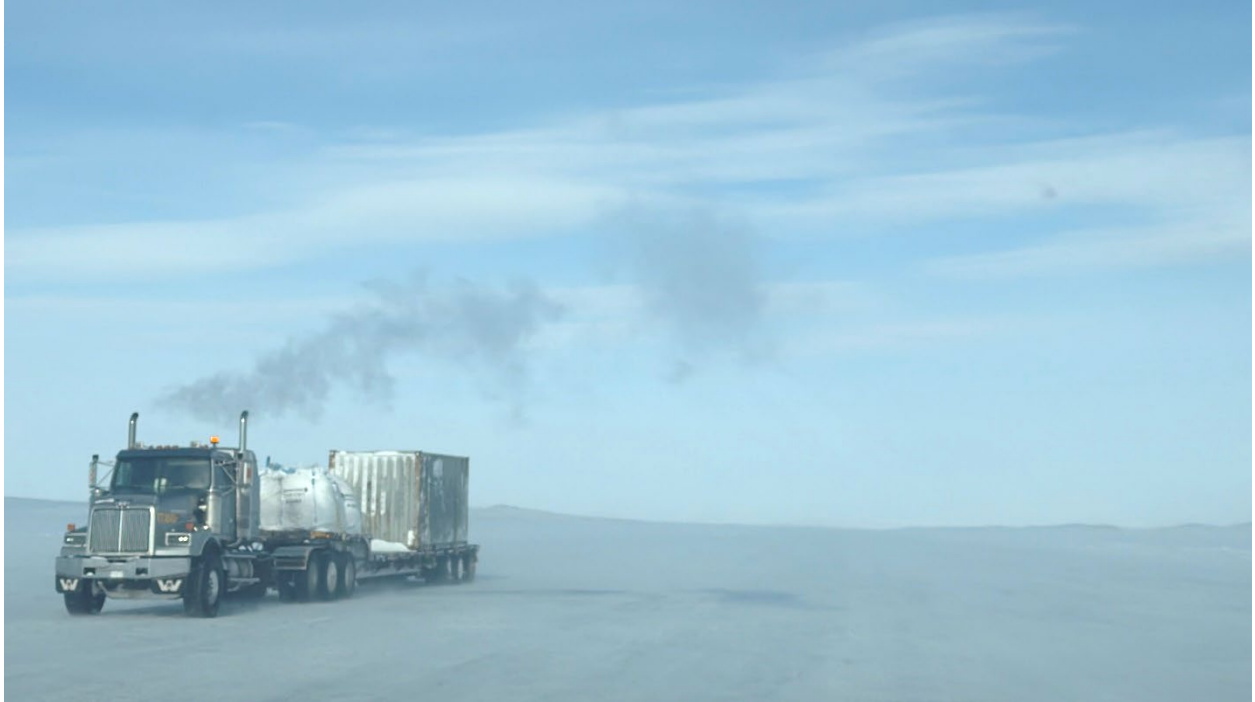
**Photo 86: Close-up: Southbound truck to Goose Site on lake between Portages 10 and 12 (~ km 30); no delineators present**

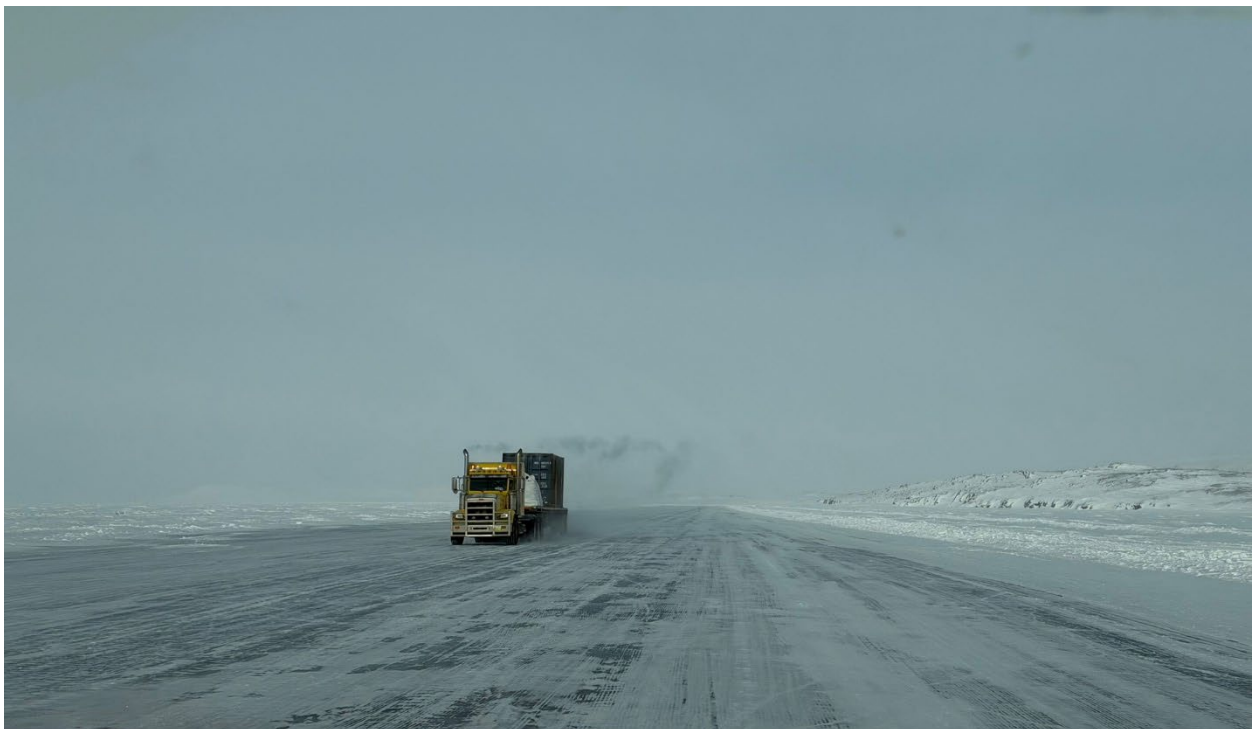
**Photo 99: southbound truck traffic to the Goose Mine site on Bathurst Lake; no delineators present**

- On wide lake sections of the Winter Ice Road, including the lakes between Portages 10 and 12 ([Photo 85 and Photo 87](#)), Portages 13 and 14, Bathurst Lake ([Photo 99](#)), and the ice road extending onto sea ice toward the Arctic Ocean at Bathurst Inlet ([Photo 106, Photo 107, Photo 110, and Photo 111](#)), clear road boundaries and delineators were not consistently observed. The installation of delineators would improve driver guidance during low visibility conditions such as nighttime travel or wind and snow events, and would help ensure vehicles remain within the designated corridor, particularly given that ice strength is greatest along the center of the road.

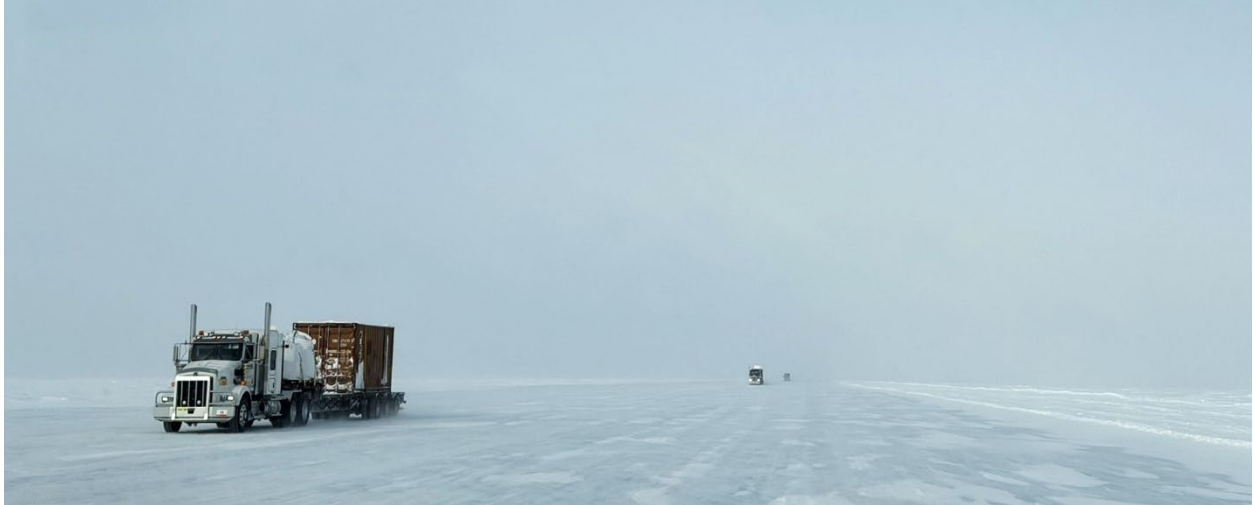
**Photo 106: Truck traffic on sea ice section of the road, northbound view**

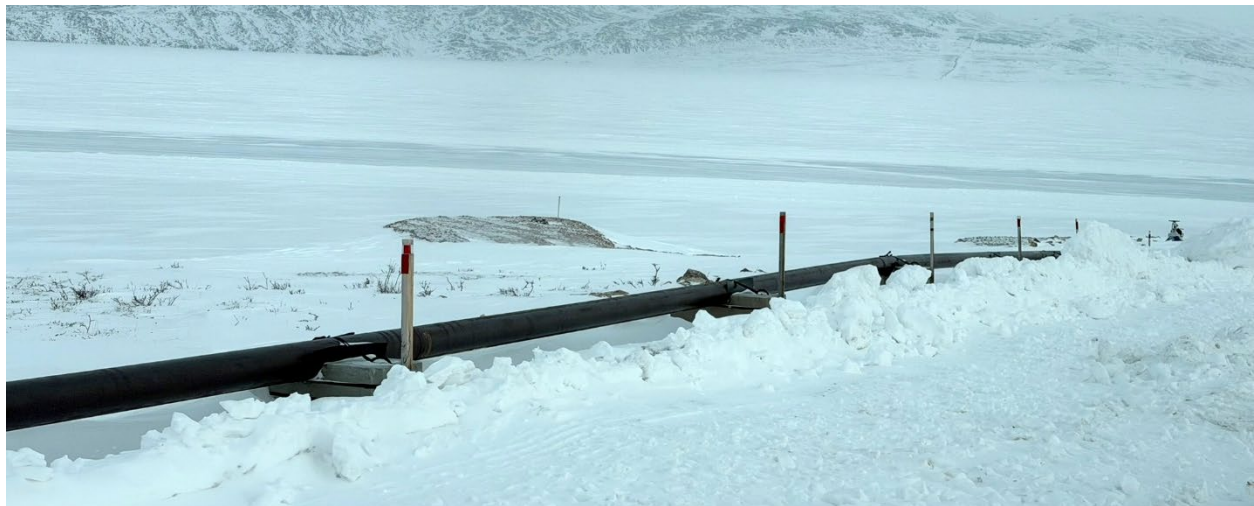
**Photo 125: Marine fuel transfer line pumphouse, facing north**

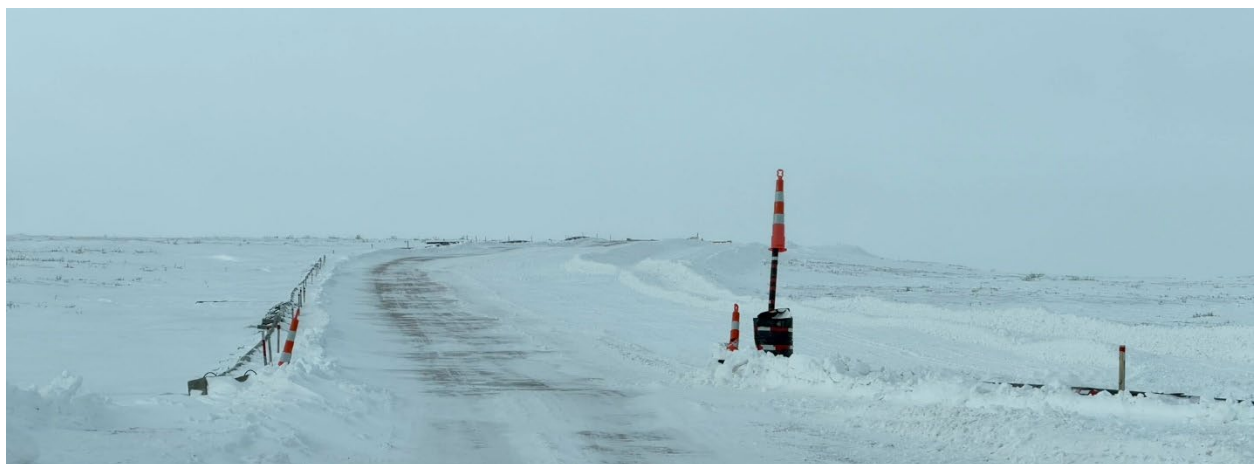
**Photo 126: Marine fuel transfer line, facing east**

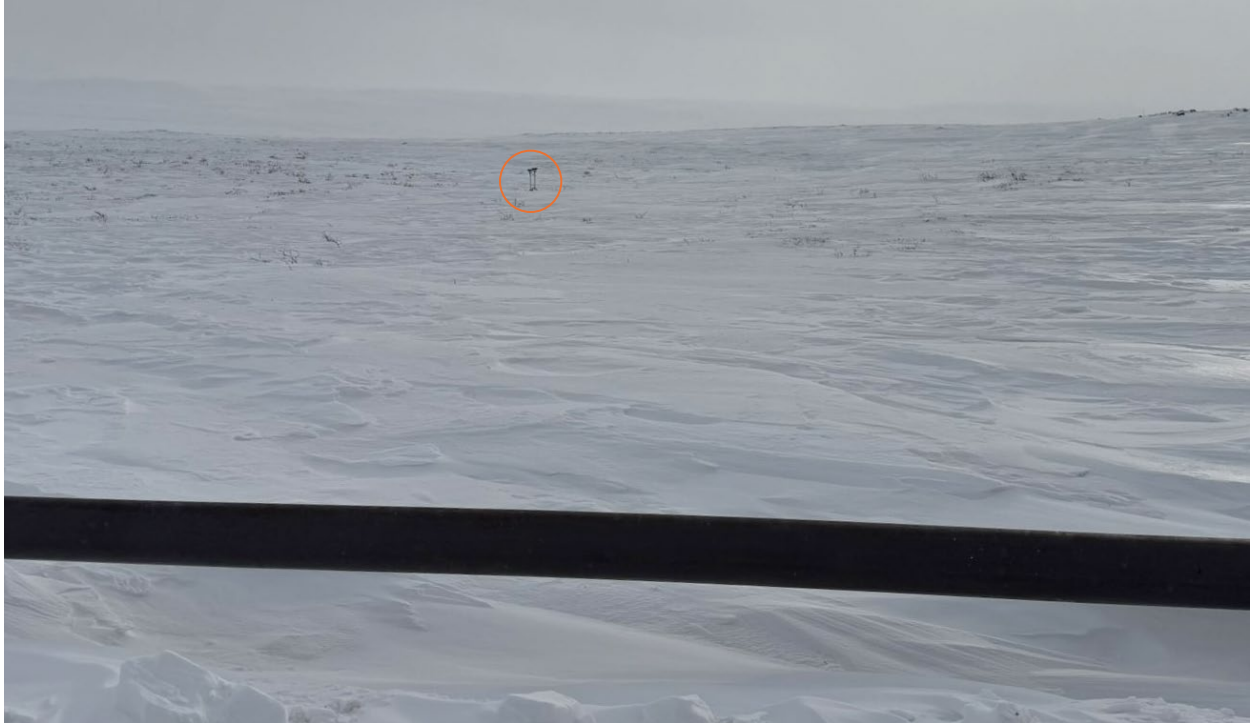
**Photo 129: Spill-at-Sea response seacans located adjacent to the Marine Fuel Transfer Area**

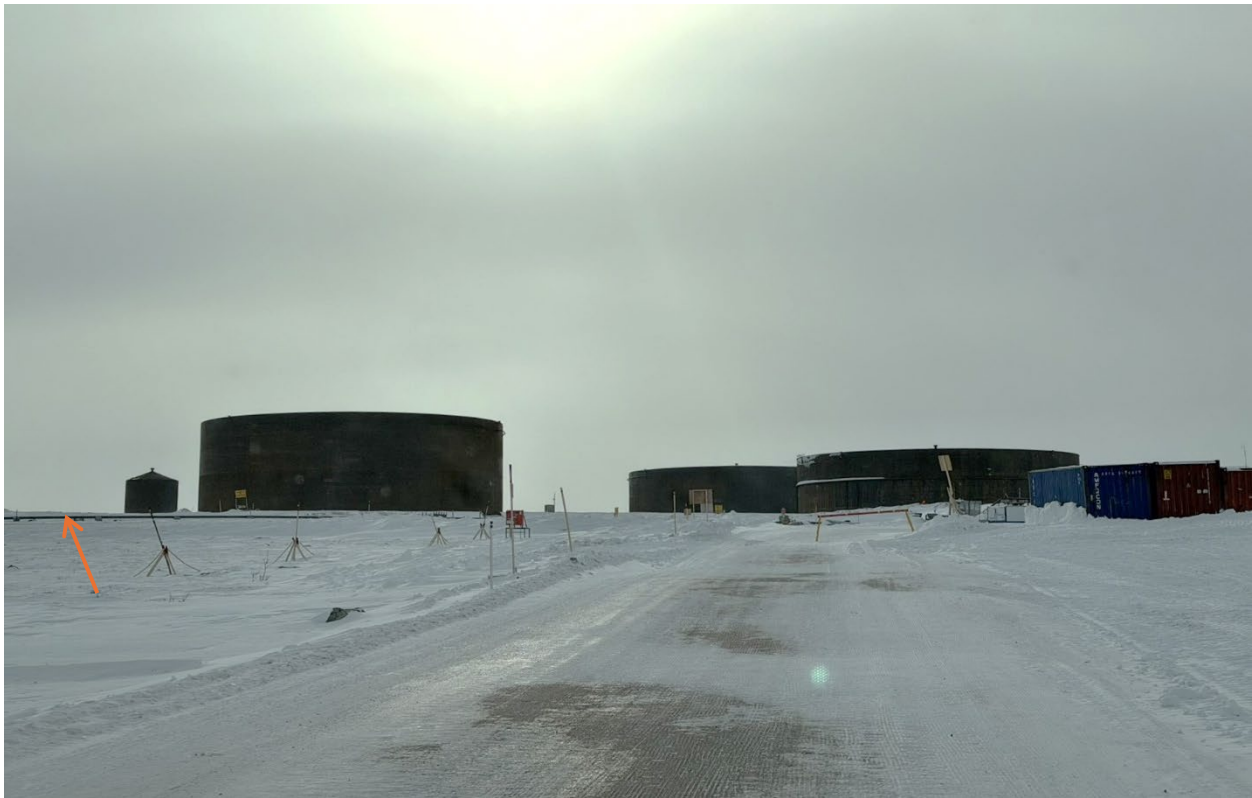
**Photo 130: Dust samplers located adjacent to the fuel transfer road**

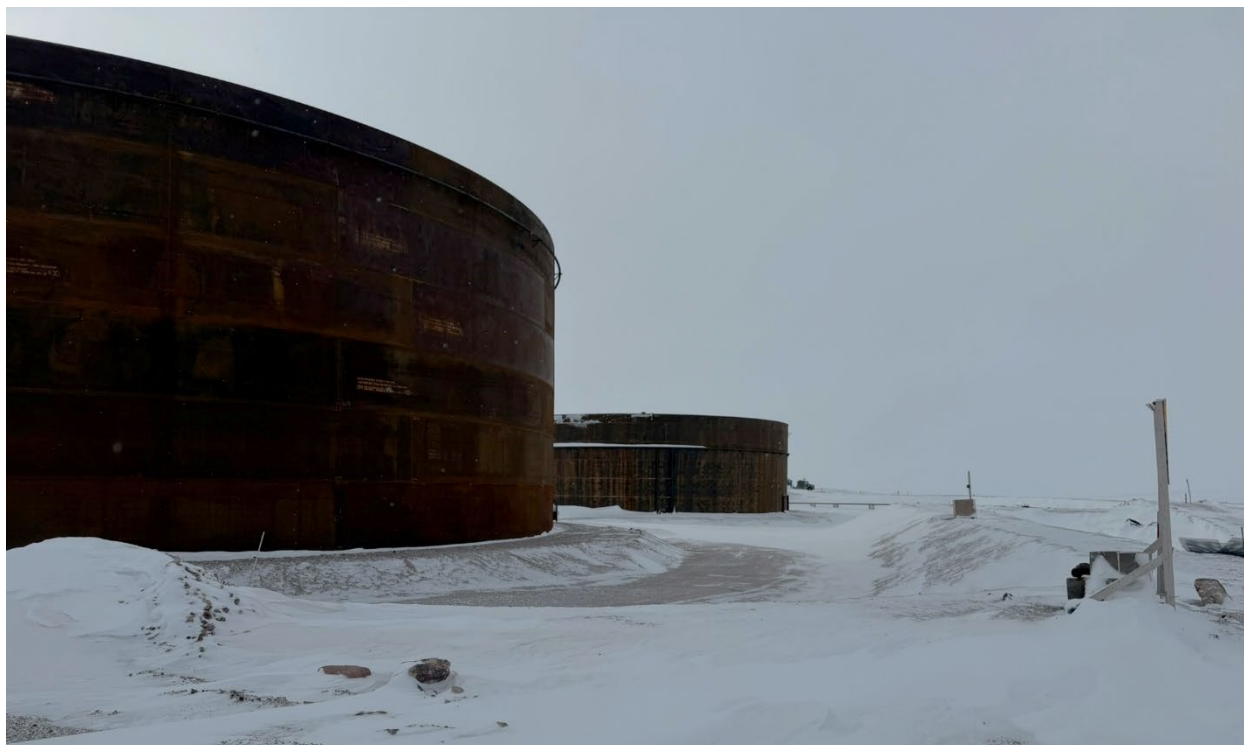
**Photo 131: Fuel transfer line and Tank Farm, facing north**

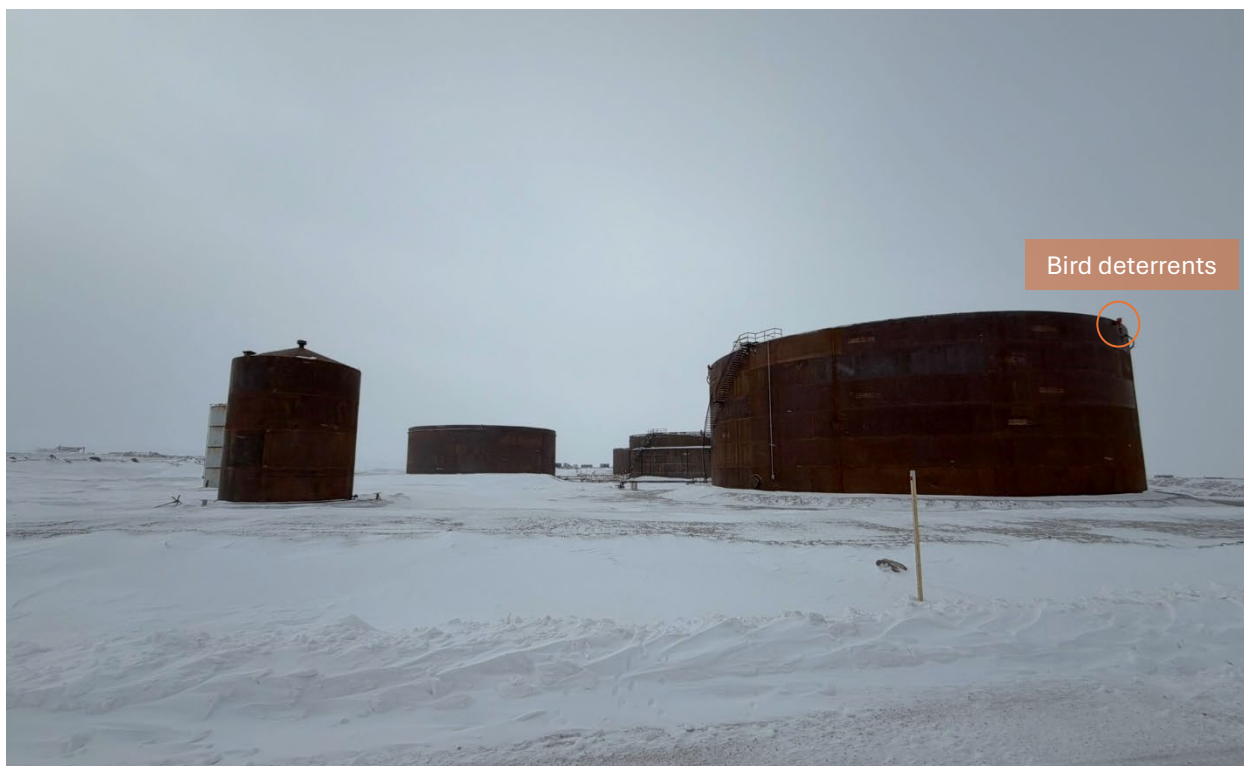
**Photo 132: Fuel tanks within secondary containment, facing west**

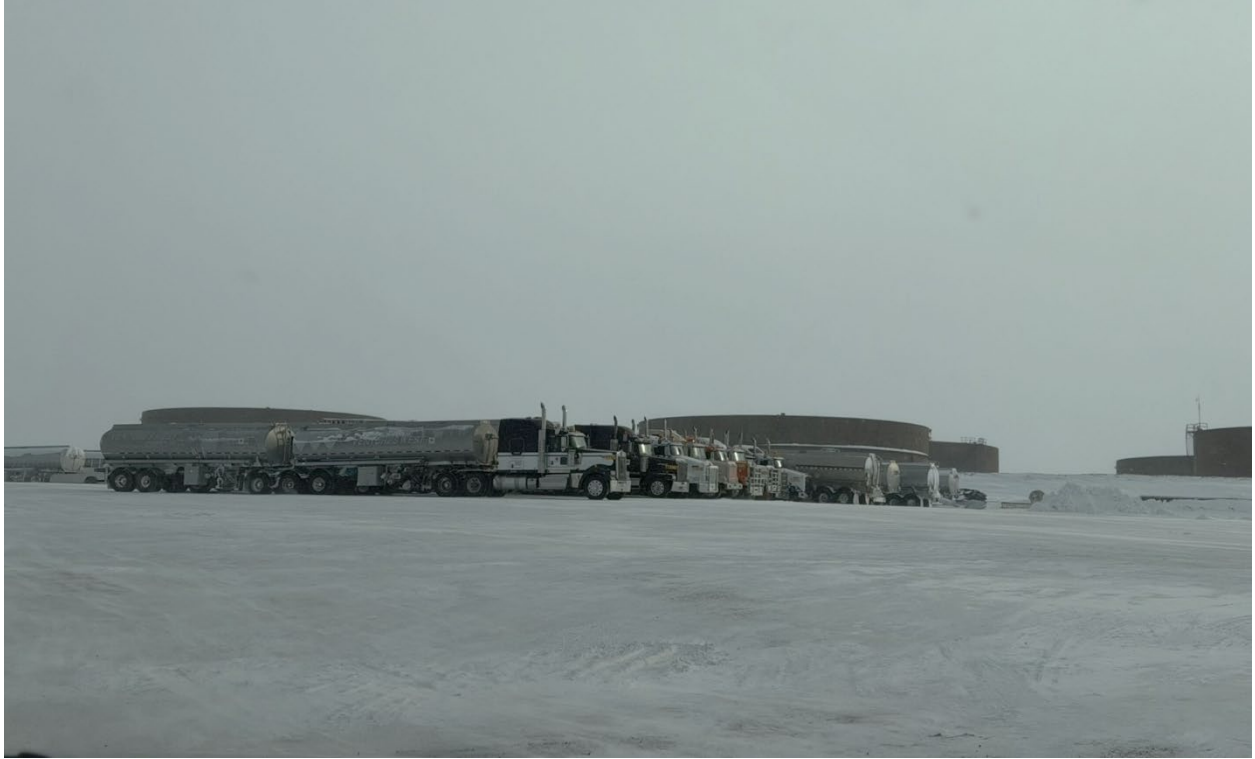
| 56 and 57 | Mitigation measures to reduce impacts on birds and raptors from construction and clearing activities | Bird deterrent devices were observed installed on each fuel tank at both the Goose Fuel Tank Farm and the MLA Fuel Tank Farm to minimize bird attraction and reduce potential wildlife interactions ( <a href="#">Photo 34</a> and <a href="#">Photo 133</a> ). |

**Photo 133: Fuel tanks within secondary containment, facing west**

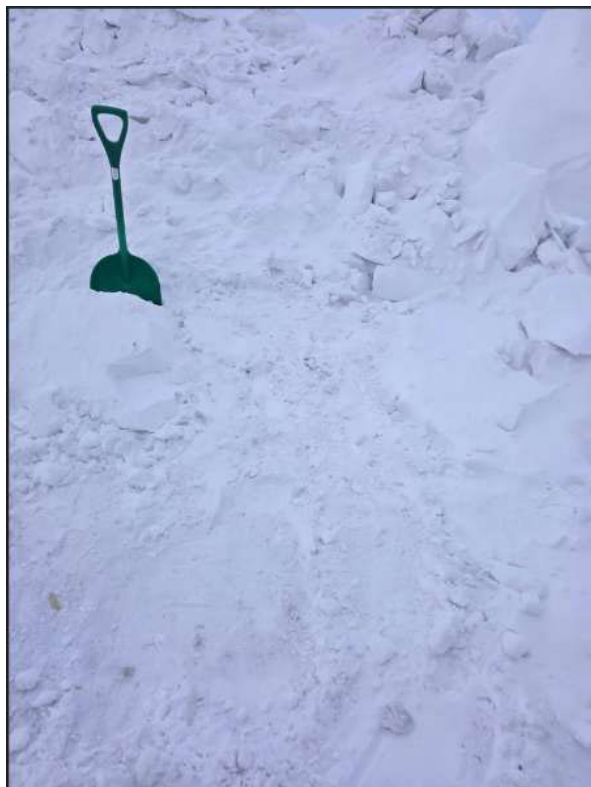
On March 28, Macoura Kone, Manager, Environment, B2Gold Nunavut, provided internal spill reports to the NIRB, including post-cleanup photographs confirming that corrective actions were completed (Photo 141 and 142).

**Photo 142: Oil spill area following cleanup, photo extracted from the internal spill report**
