# TOTE ROAD CV-225

BAFFINLAND IRON MINES  
MARY RIVER PROJECT

### **Erosion and Sediment Controls implemented in 2023**

# 2023 TOTE ROAD CULVERT EROSION AND SEDIMENTATION CONTROL IMPLEMENTATION SUMMARY

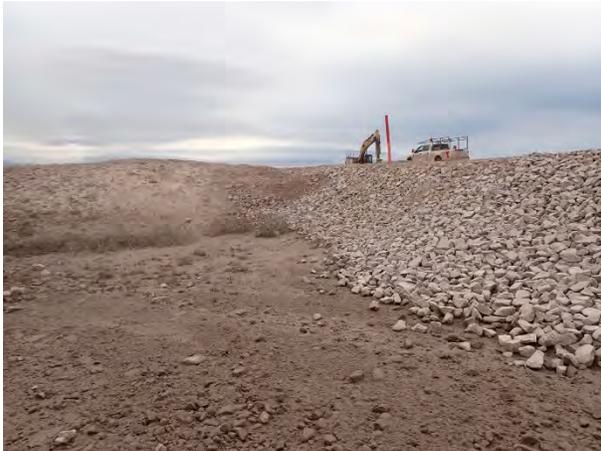
**CV-129 – KM15**

The road embankment surrounding the culvert was reinforced with rip-rap stone.

Downstream looking north (left) and south (right)

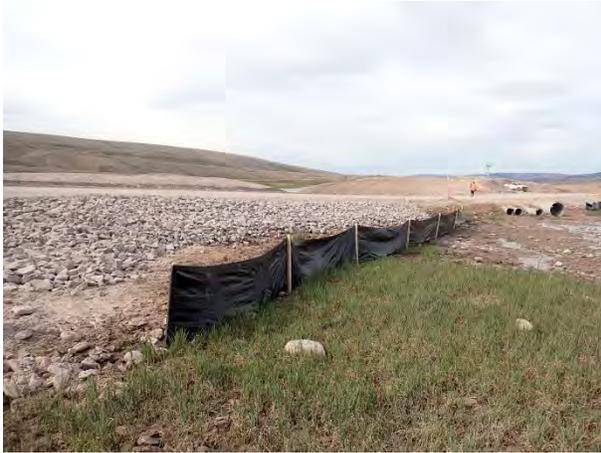
**CV-102 – KM36**

The road embankment surrounding the culvert area was reinforced with rip-rap stone. On the upstream embankments silt fences were installed.

Upstream looking north (left) and south (right)

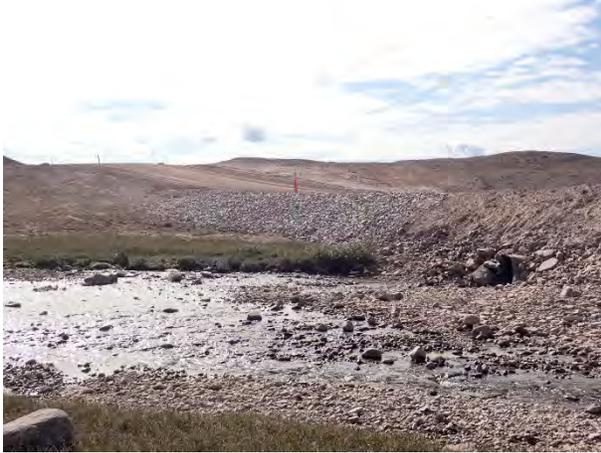
**CV-078 – KM51**

The road embankment surrounding the culvert area with rip-rap stone. The upstream north swale was lined with rip-rap stone and check-dams were added. On the upstream north and downstream south embankments silt fences were installed.

Upstream looking south (left) and west (right north embankment)

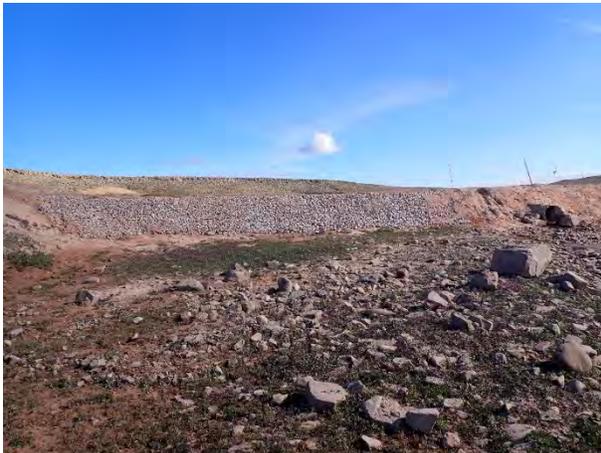
Downstream looking east (north embankment) and south (right)

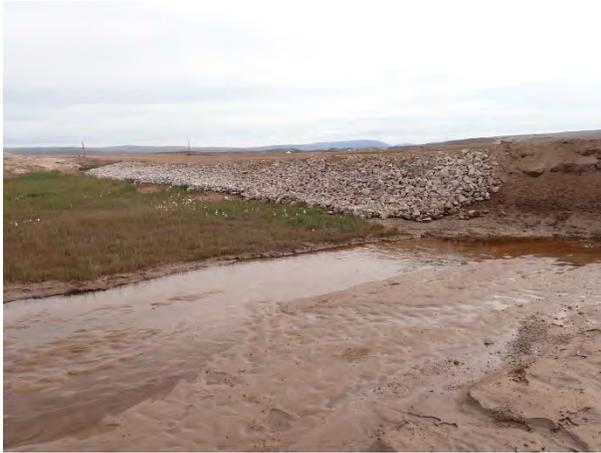
**CV-215 – KM79**

The road embankments surrounding the culvert area were reinforced with rip-rap stone. On the downstream north embankment a silt fence was installed.

Upstream looking south (left) and north (right)

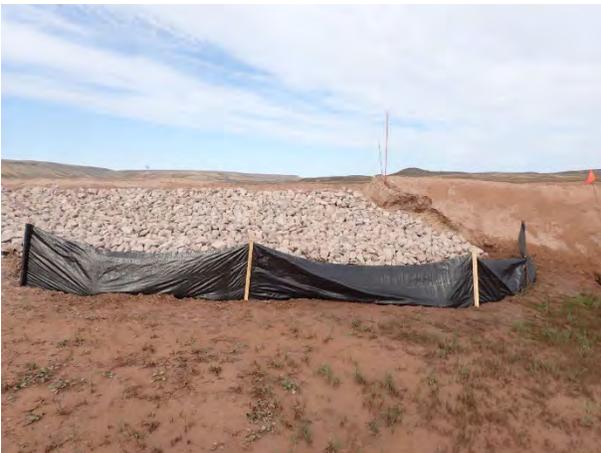
Downstream looking east (left, north embankment) and south (right)

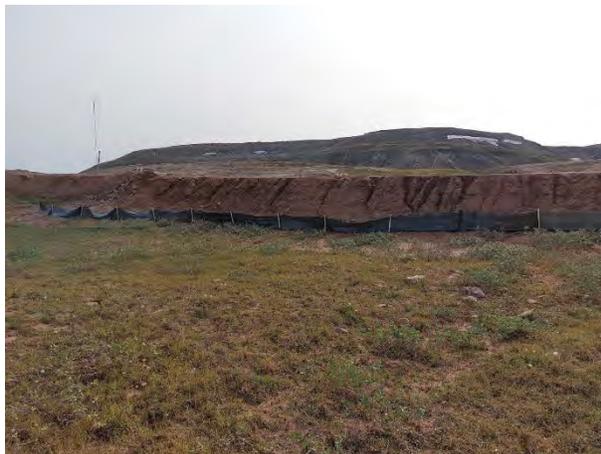
Downstream looking south (left south embankment, right culvert area)

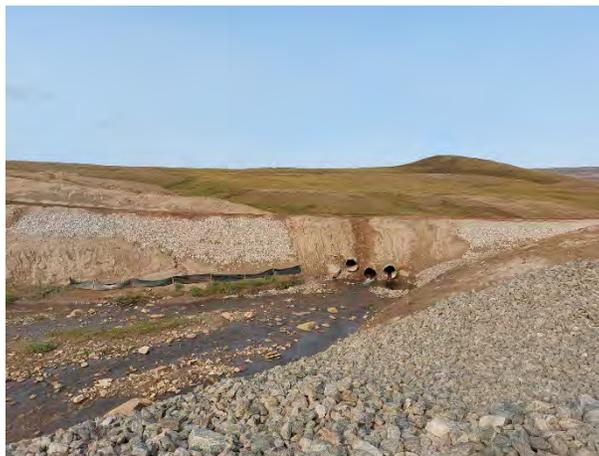
The road embankments surrounding the culvert area were reinforced with rip-rap stone. The upstream north and downstream south swales were lined with rip-rap stone and check-dams were added. On the downstream north embankment a silt fence was replaced.

Upstream looking north (left)
