Nunavut Impact Review Board

2025 Site Visit Report

Mary River Project

Report Title: 2025 Site Visit Report Mary River Project

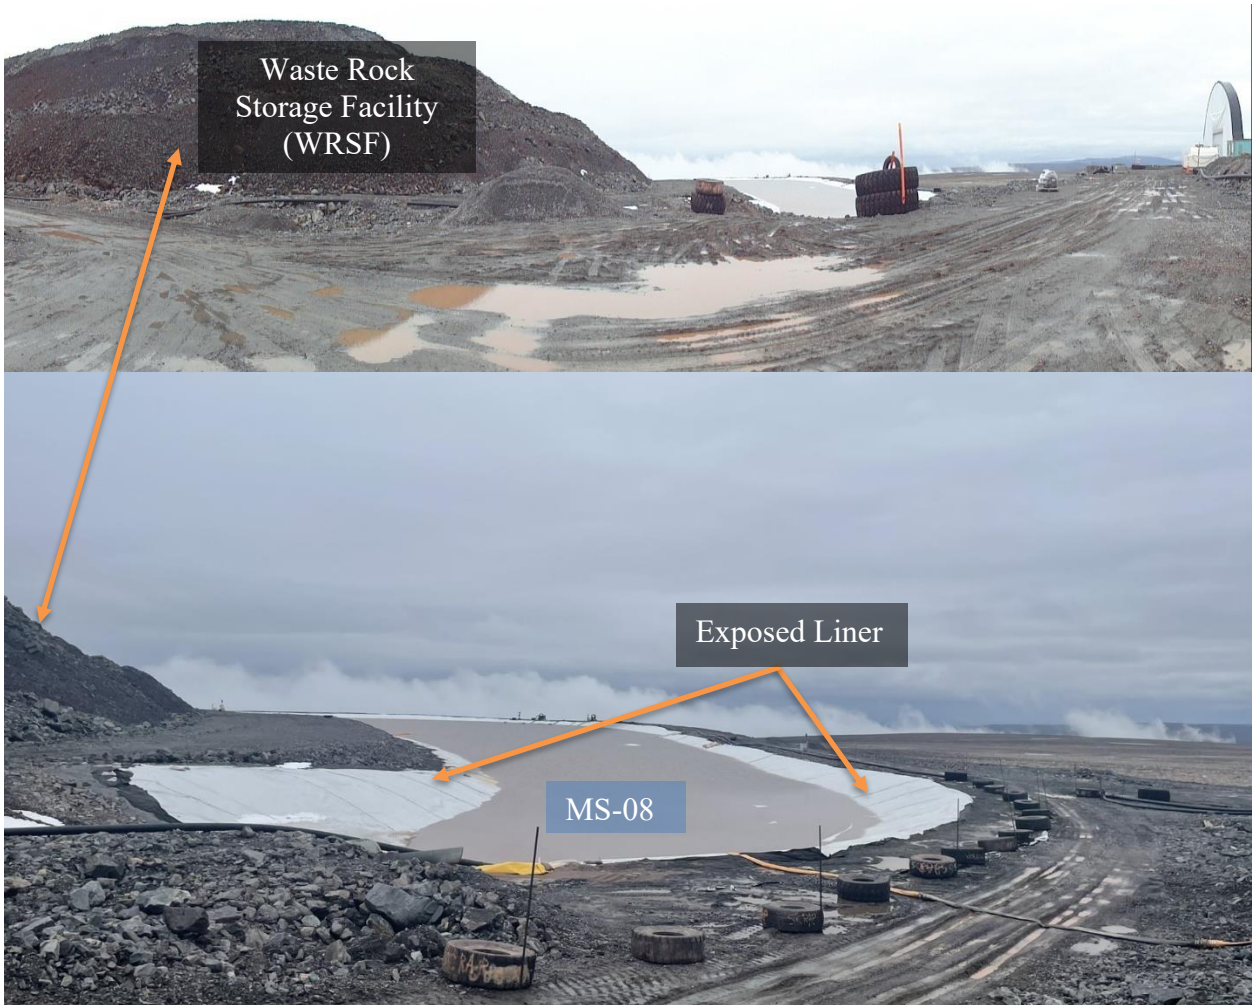
Photo 9: Lined Surface Water Management Pond (MS-08 Pond) next to Waste Rock Storage Facility

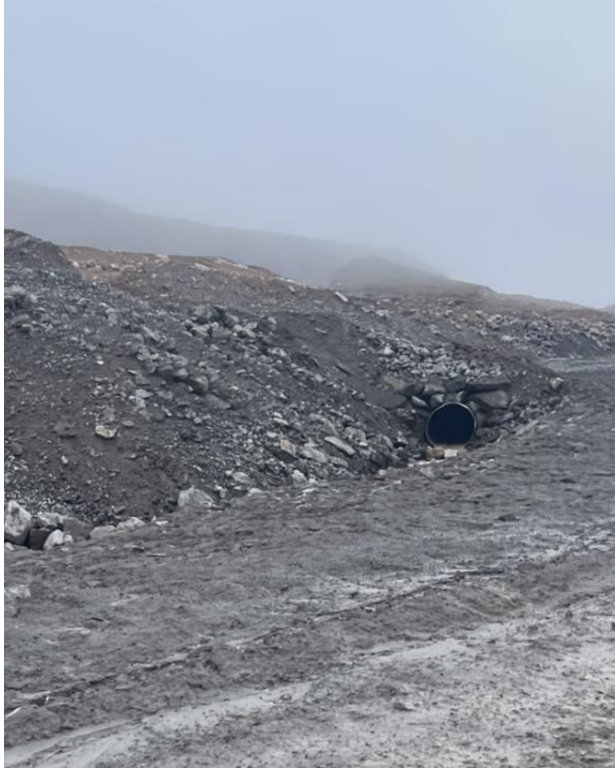
Photo 14: One (1) of the culverts along the Haul Road

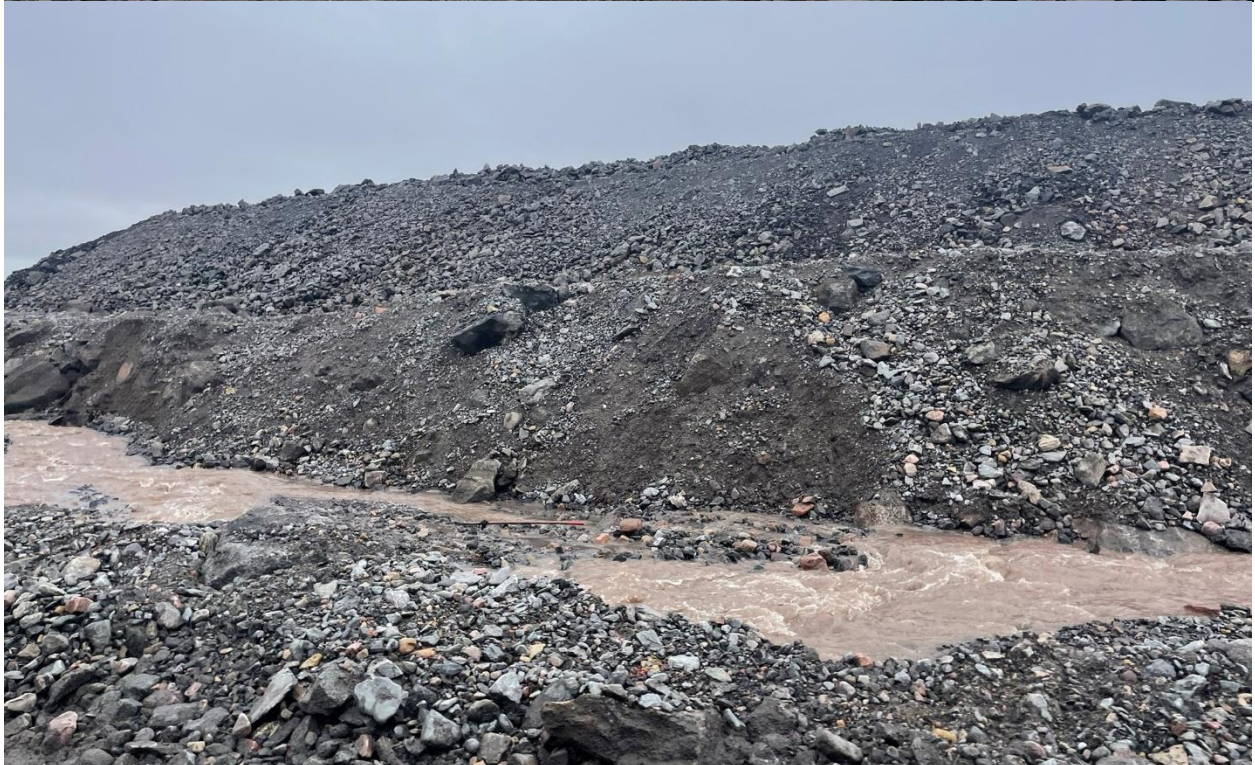
Photo 17: Drainage along the Haul Road

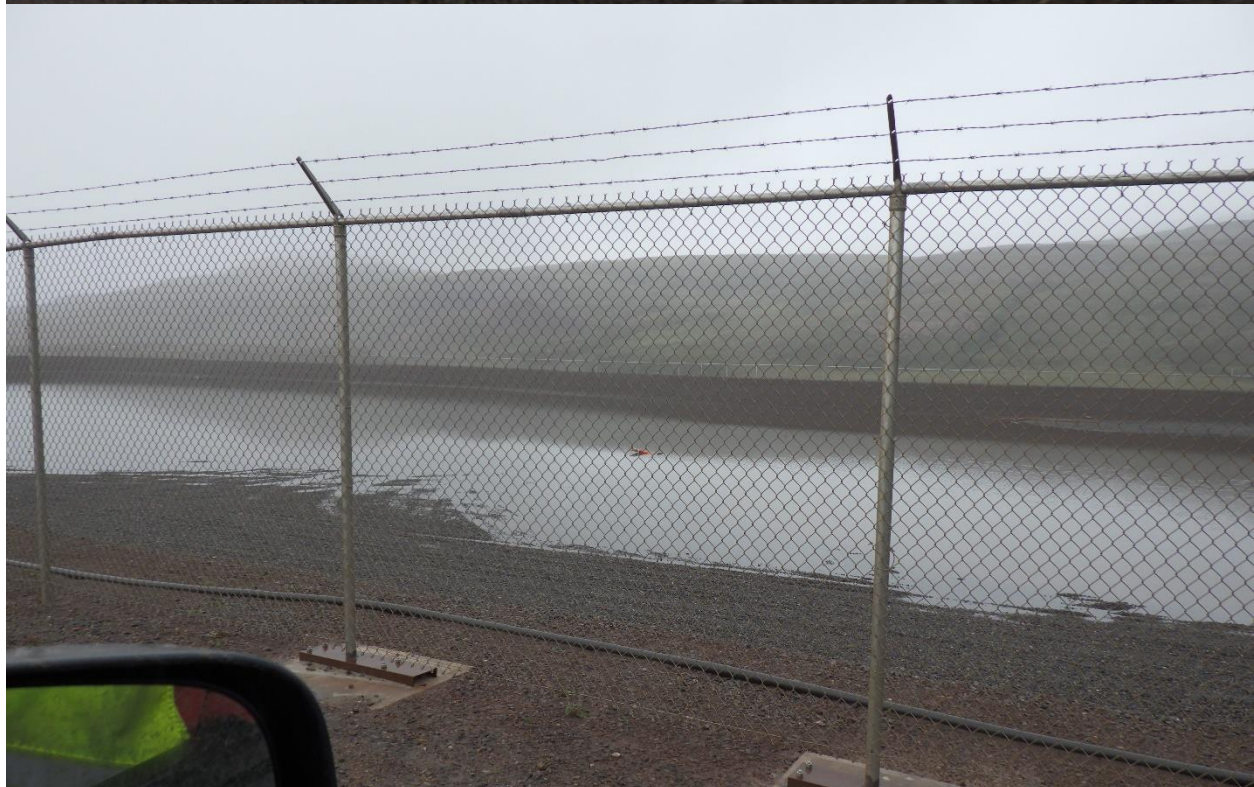
Photo 23: Chain link fence and secondary containment around Fuel tank at MS-03B

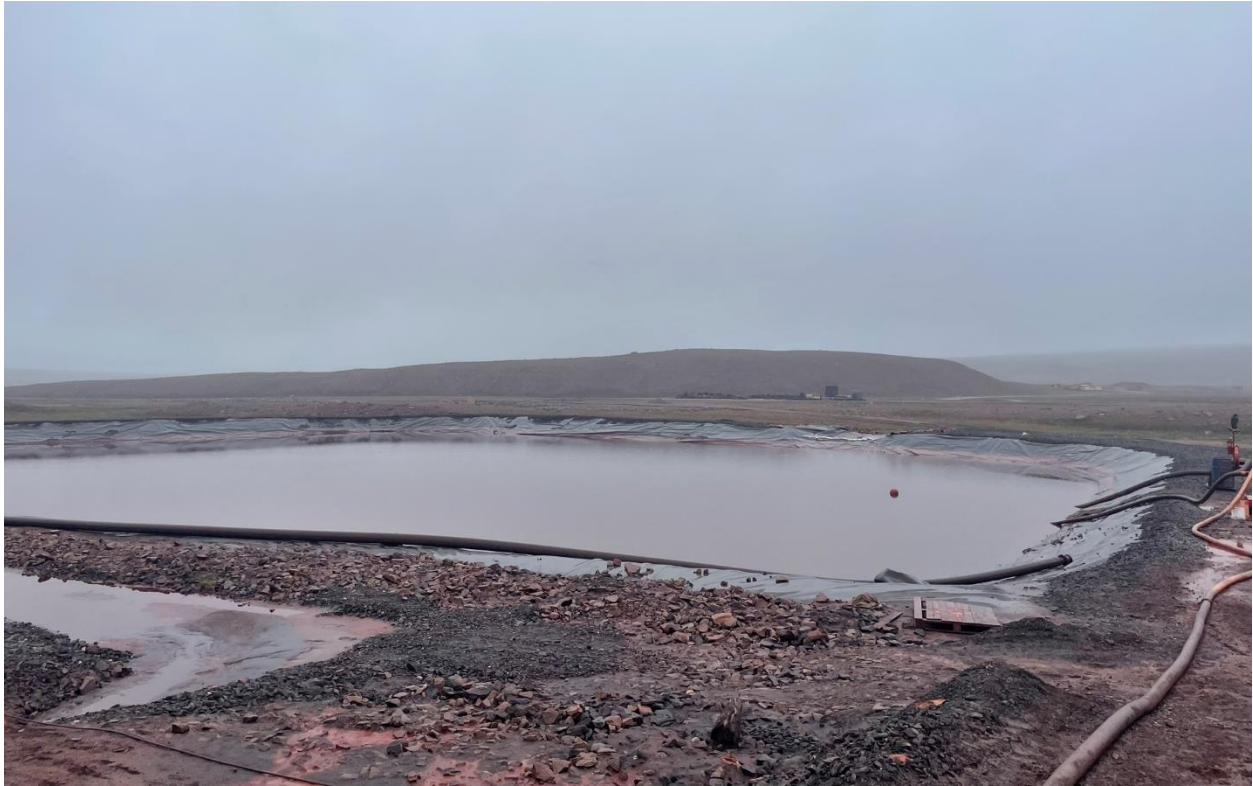
Photo 25: Surface Water Management Pond (SM-06) adjacent to the Crusher Pad

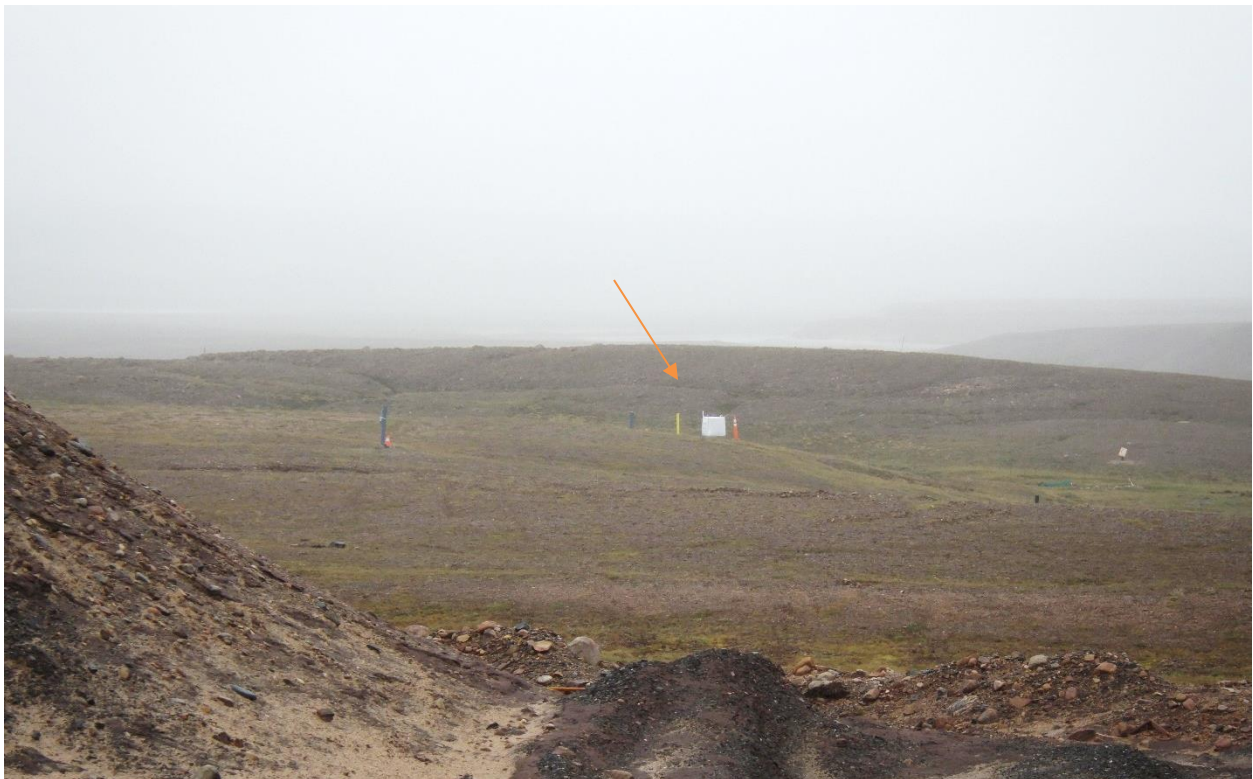
Photo 26: Water Monitoring Well (installed in April 2025)

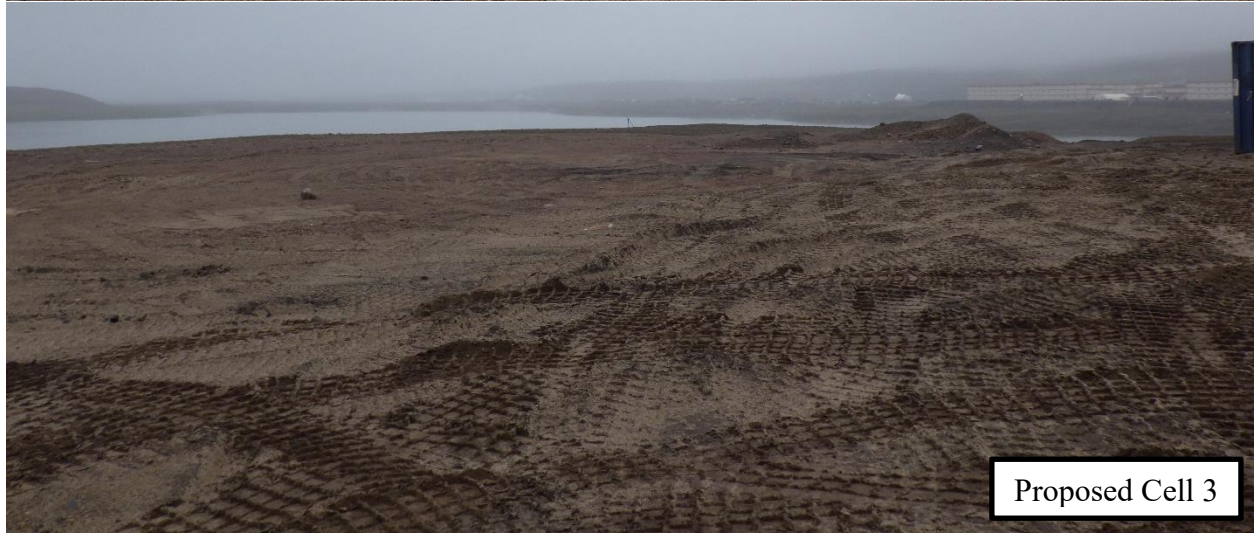
Photo 31: New landfarm cells constructed near the main Landfill Facility

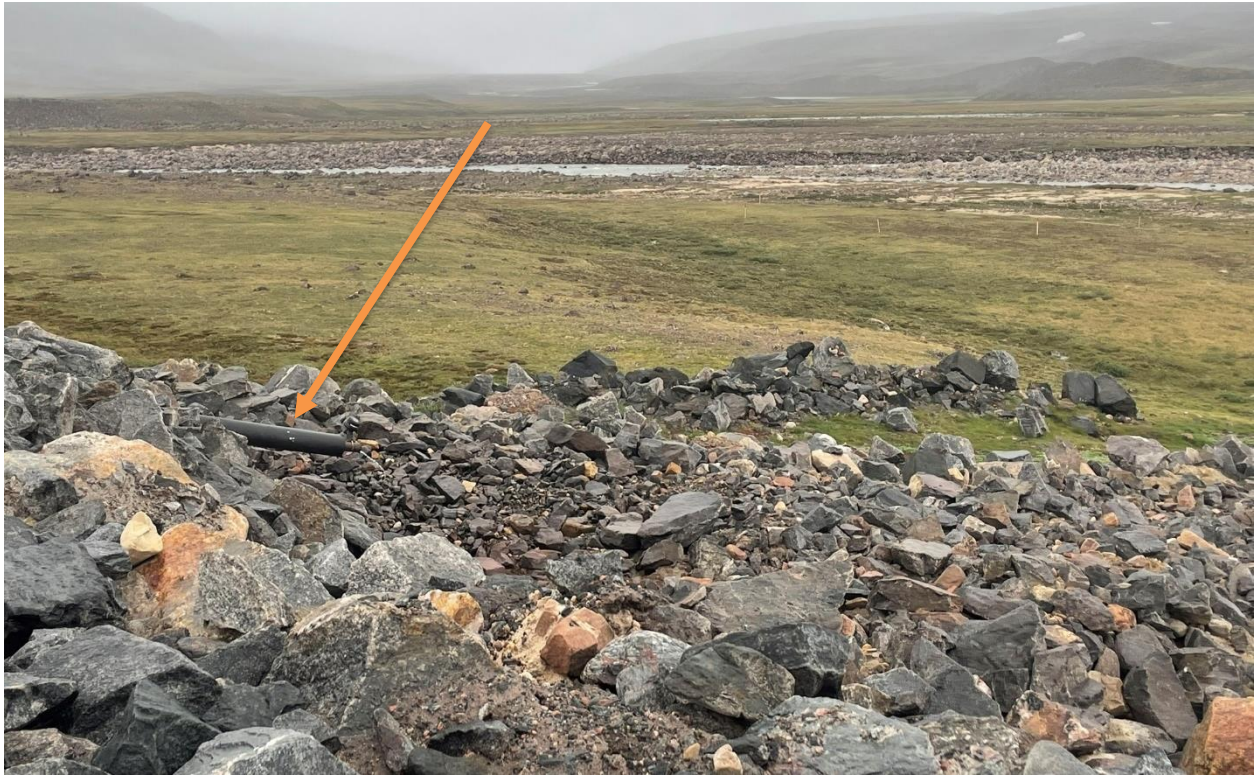
Photo 32: Treated water outlet with passive filtration at Water Discharge Area

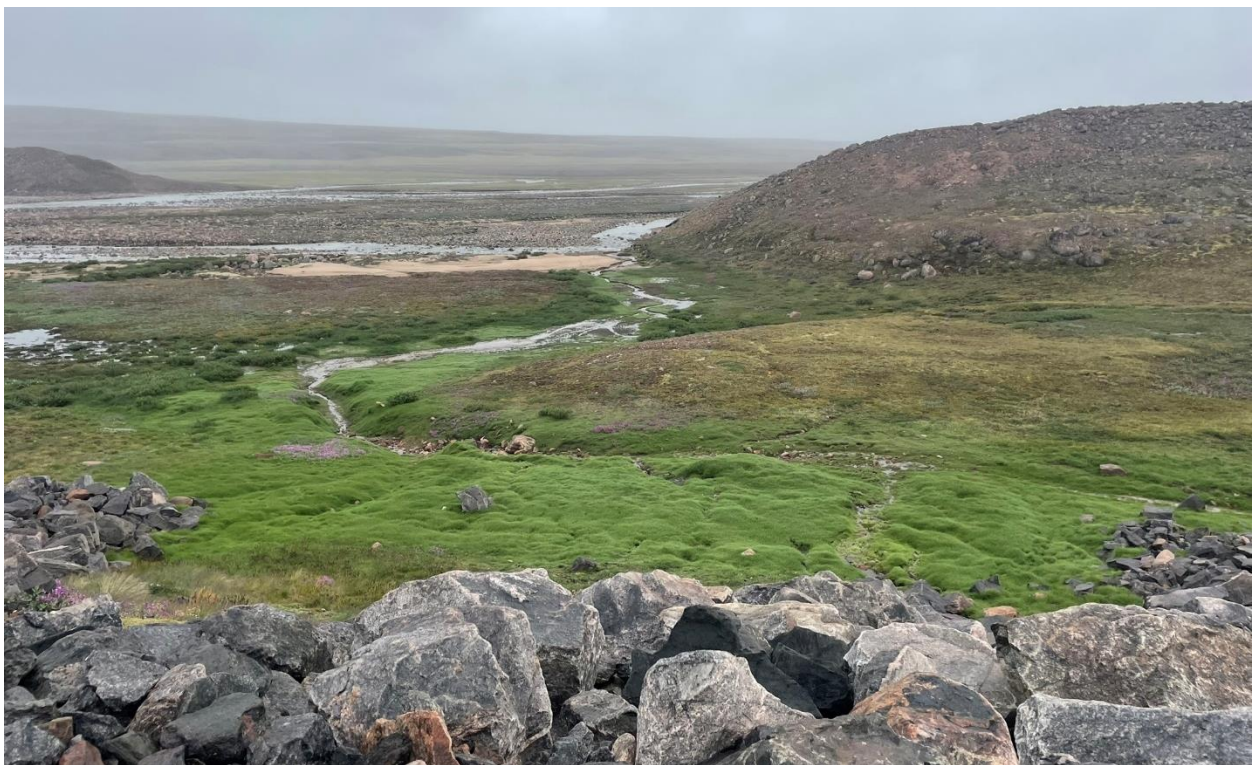
Photo 33: Former Treated Water Discharge Area beside current discharge

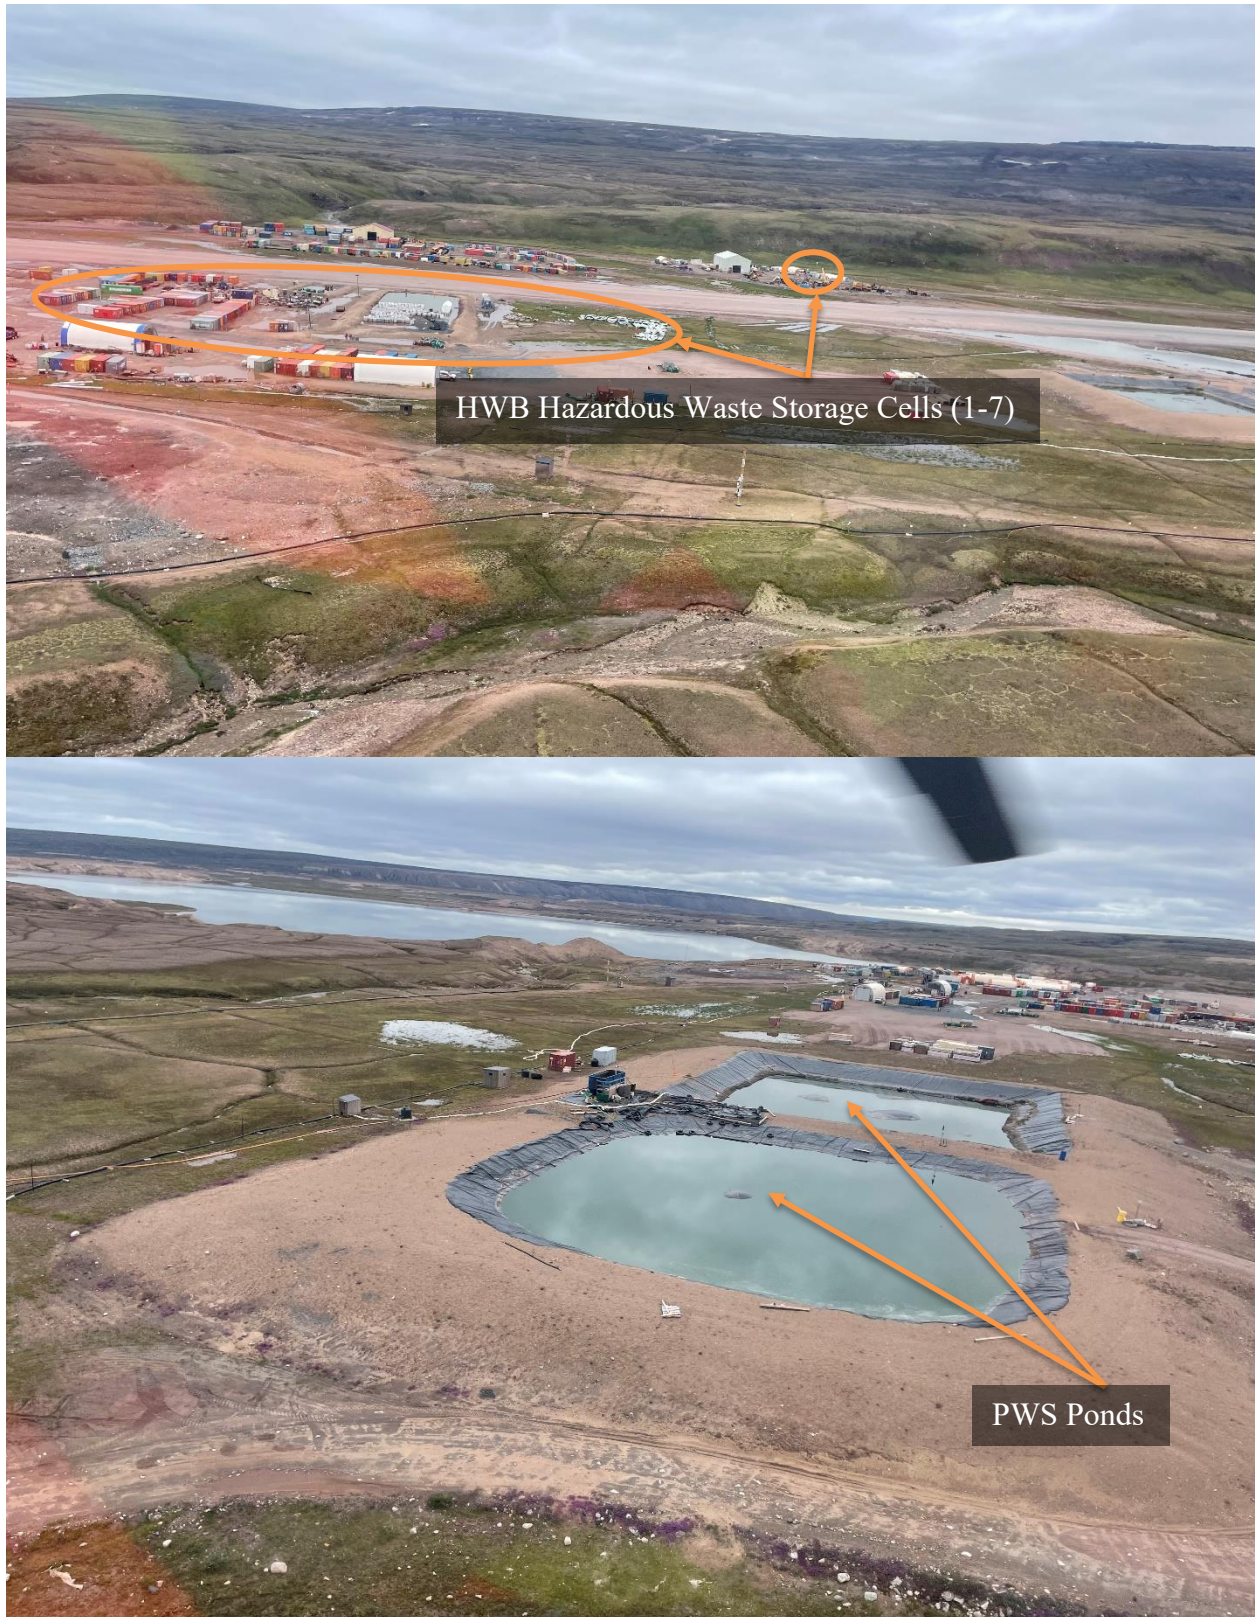
T&C	Topic	Site Observations
11	Incinerator	All food waste is incinerated from the kitchen including cardboard that stored food. NIRB Staff visited the Incinerator facility at the Mine Site; it was clean and well organized (Photo 34).
Hydrology and Hydrogeology		
17 (related to 24 and 46)	Prevent impacts to water bodies from effluent	The KM 105 Dam, Settling Pond and Effluent Testing Station was constructed in 2022 to help manage effluent from the Mine Haul Road and Deposit (Photo 18 and Photo 19).
19	Mitigate impacts to natural water flow	<p>Several culverts and ditches were observed along the Tote Road with riprap being installed in order to better control the flow of water during freshet. Some of the culverts observed were also being repaired in response to the Order from the Department of Fisheries and Oceans Canada (Photo 45, Photo 47, Photo 48, Photo 49, Photo 58, and Photo 60).</p> <p>While at the culverts at KM 80, it was noted that the road surface was spongy when walking on it, indicating a potential void. Baffinland personnel accompanying NIRB staff immediately requested site staff to investigate (Photo 50). Following the NIRB visit, it was later determined that the culvert pipes had all collapsed in the beneath the road. See the <i>CV-216 By-Pass Culvert Crossing Design Brief</i> Appendix A prepared by Nunami Stantec for Baffinland and submitted to the Nunavut Water Board (NIRB File No. 357441) for photos.</p>

Photo 34: Mary River Incinerator Building

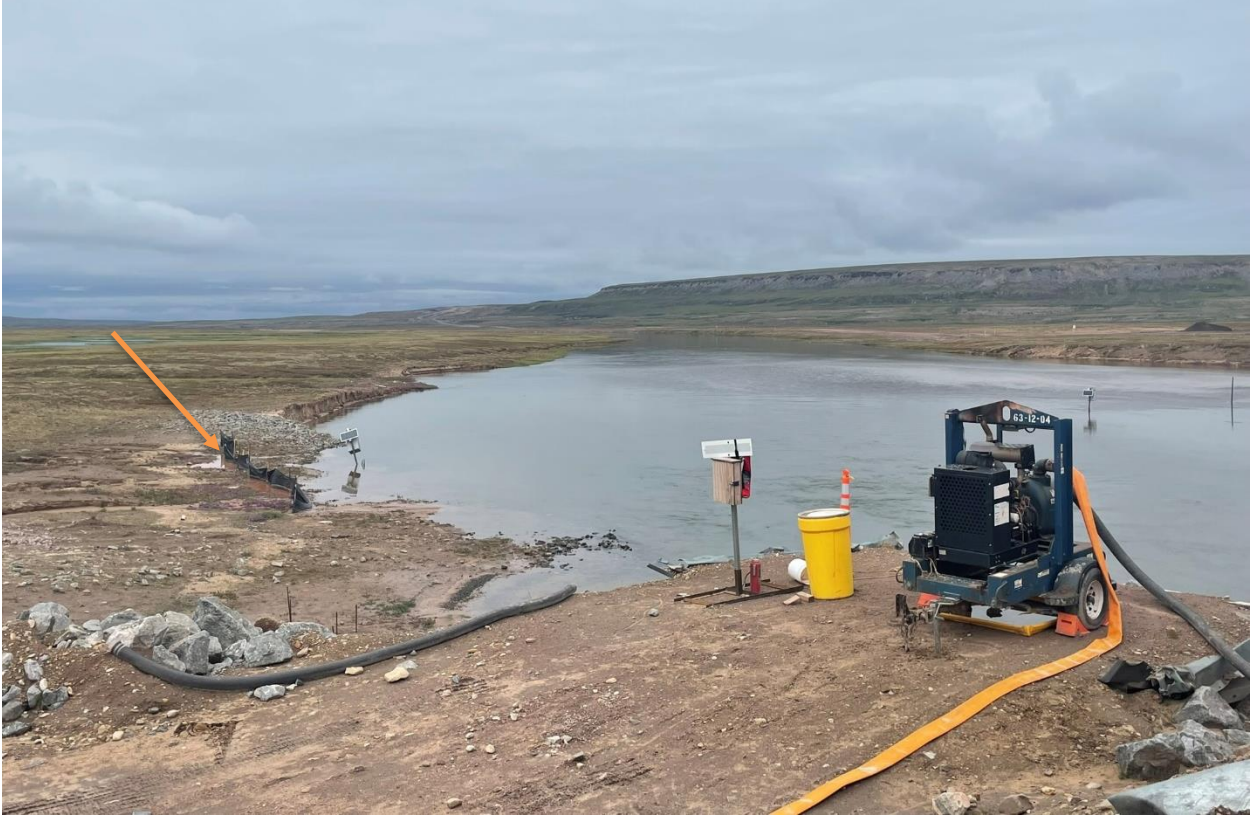
While inspecting the culvert, water levels on both sides of the road prevented NIRB staff from observing the interior of the culverts. While walking on the road above the culverts, NIRB staff noted that the road surface was soft and spongy, with air and water being forced to the surface when pressure was applied, indicating a possible void beneath the road surface. This was brought to the attention of Baffinland staff and they immediately called for the road maintenance personnel to inspect the site.

Photo 50: Road Surface at KM80 showing a soft, spongy surface

- Collapsed culverts at KM 80 of the Tote Road, which were not known at the time of the visit, require urgent, and long-term repair. This, along with ongoing road maintenance challenges following the 2024 rainfall event and soft road conditions north of the mine site, raises concerns about the long-term viability of the road for heavy ore transport.

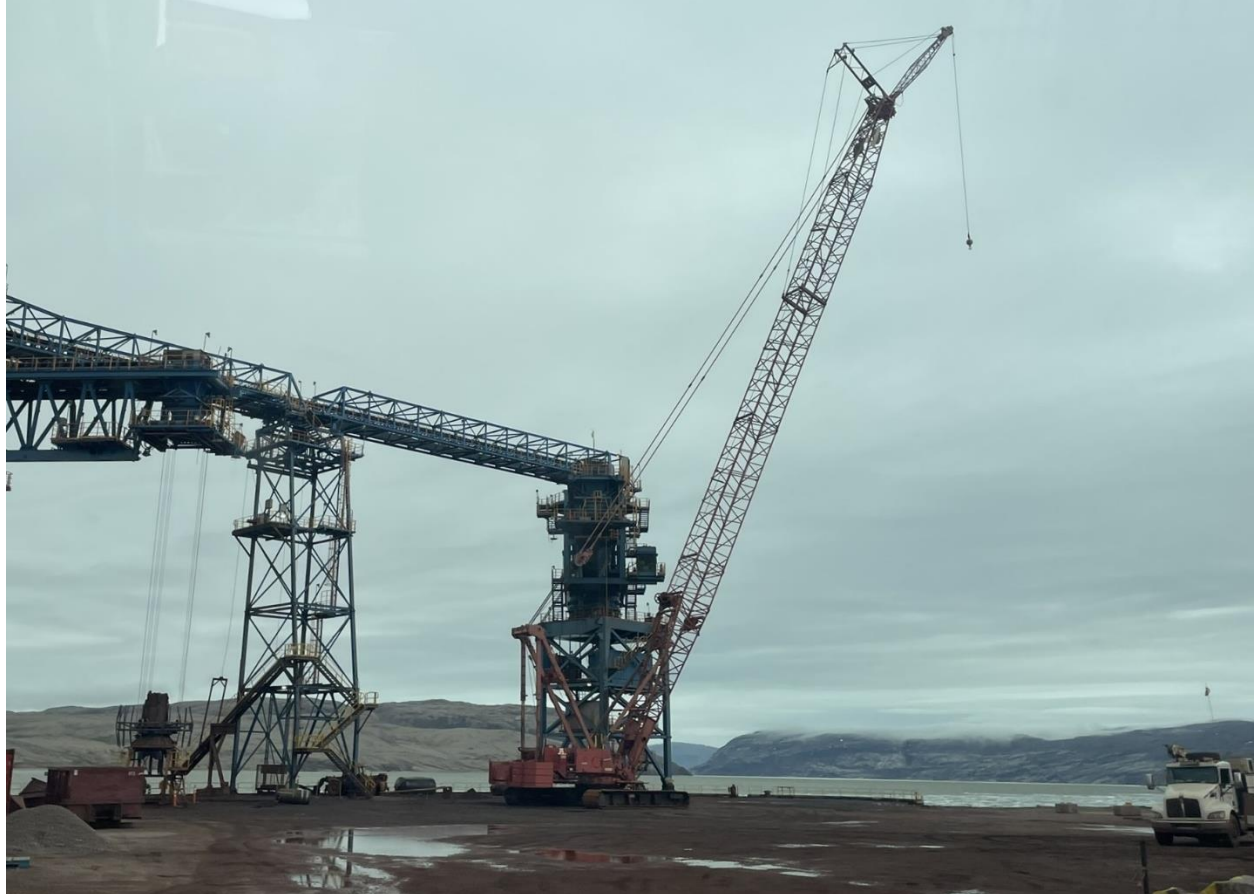
Photo 74: Ship Loader (One operational, second under construction)
