From April 30 to May 2, 2026, NIRB staff conducted a spring site visit to Baffinland Iron Mines Corporation’s Mary River Project, including the Mine Site, Tote Road, and Milne Port, accompanied by Baffinland environmental staff. The visit focused on observing site activities, environmental management practices, and implementation of Project Certificate requirements. During the visit, NIRB staff observed ongoing operational activities and held discussions with the Proponent regarding environmental monitoring, mitigation measures, and adherence to Project Certificate requirements (Table 1).

3.1. Mine Site

3.2. Tote Road

3.3. Milne Port

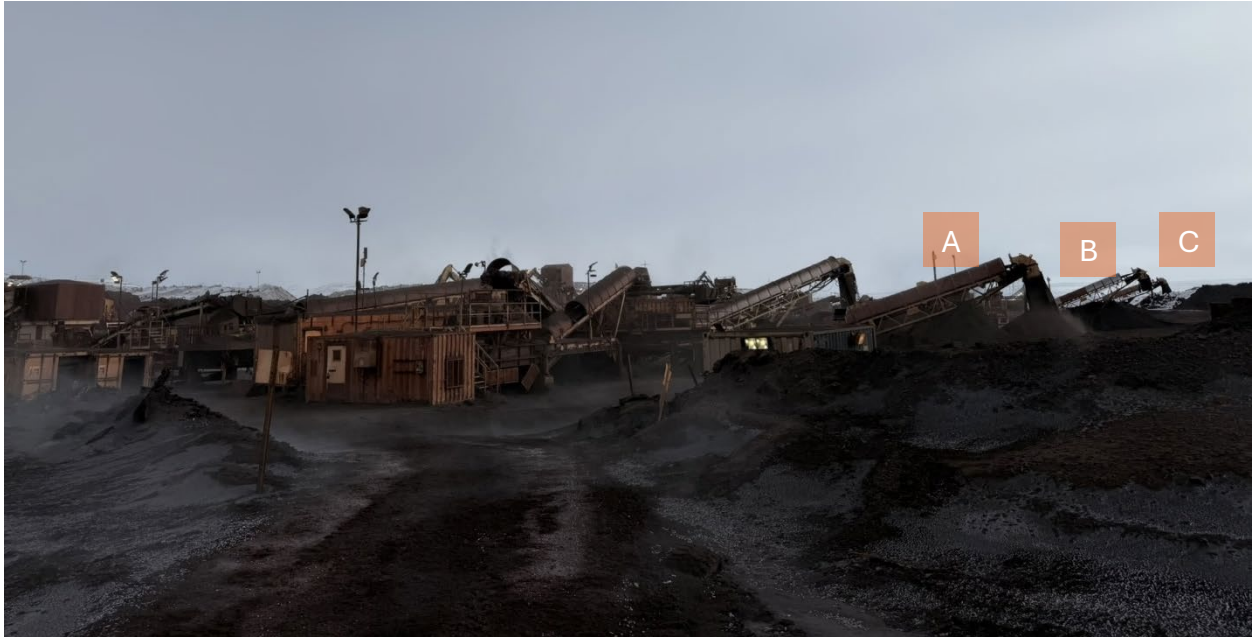
Photo 14: General overview of Crushers A, B, and C, facing south

⁴ The crusher facility consists of three (3) units (Crushers A, B, and C) used for primary ore size reduction, with conveyors transferring material to the adjacent stockpile area for temporary storage. Dust control measures, including dust suppressant application, skirting at conveyor outlets, and the use of shrouds, were observed throughout the crusher facility.

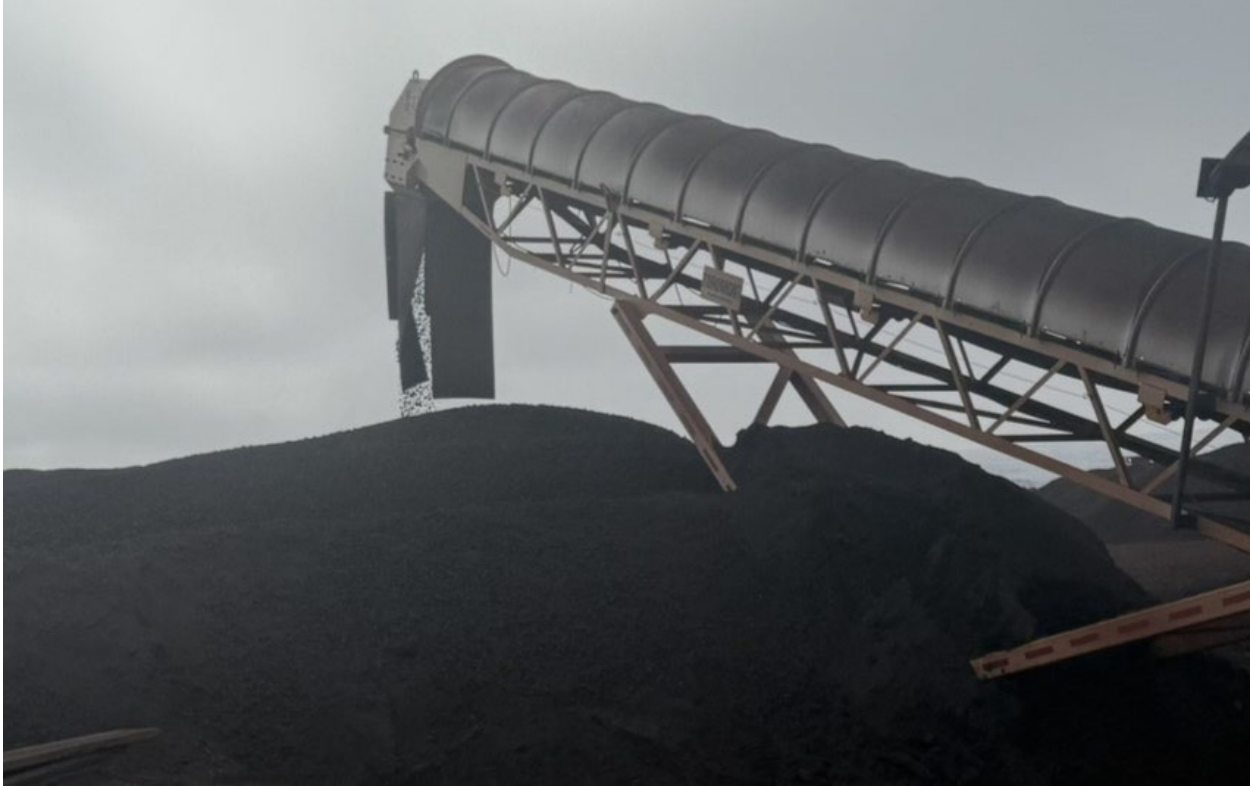
Photo 18: Crusher B outlet showing discharge of coarse, lump ore with no visible dust

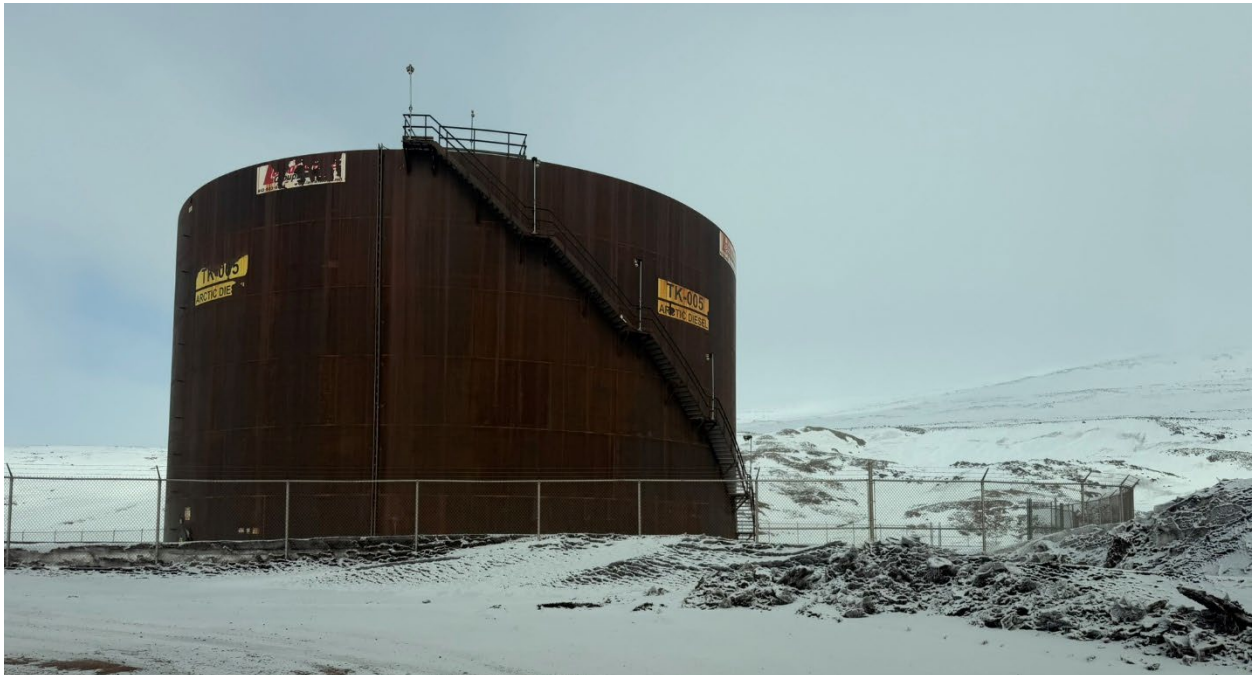
Photo 23: Chain link fence and secondary containment around Fuel tank farm (MS-03B)

⁵ Two (2) tank farms are located at the mine site: one with four (4) tanks and another with a single tank. All tanks were contained within secondary containment areas, and spill kits were available nearby.

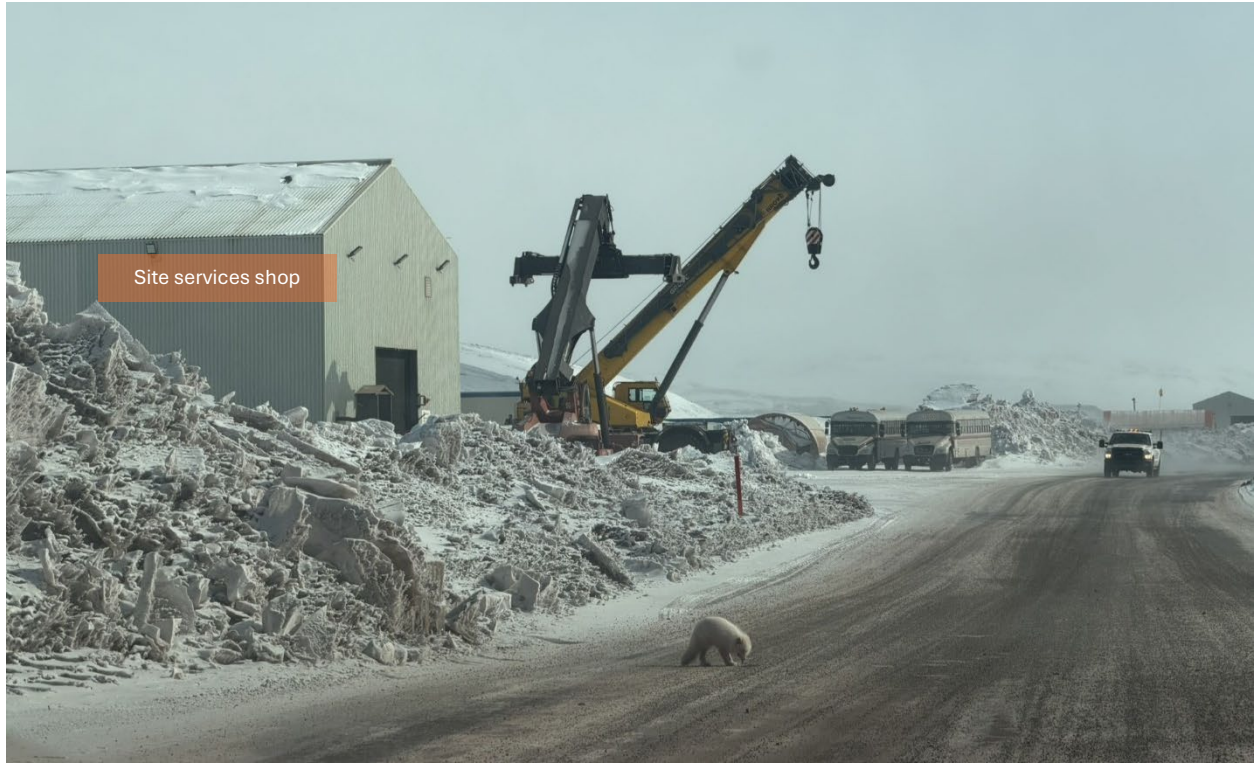
Photo 32: Arctic fox observed near the site services shop east of the incinerator building

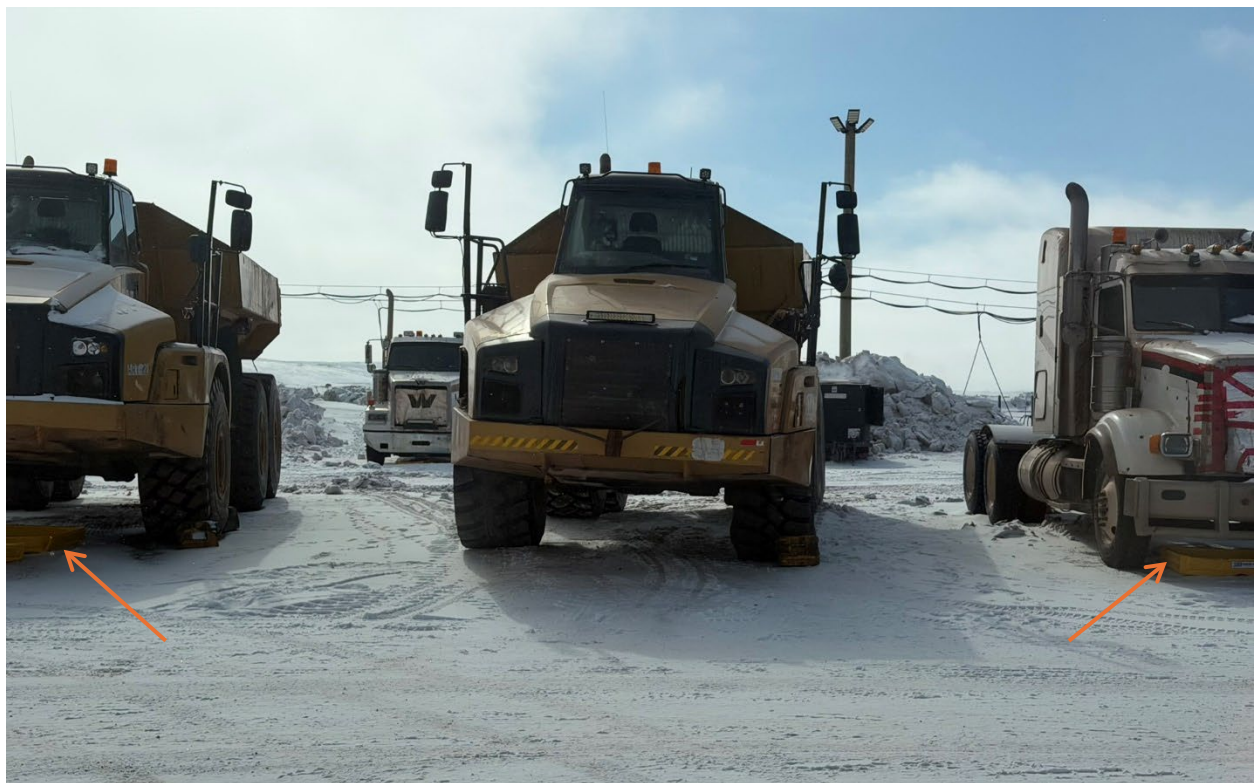
Photo 33: Vehicle and equipment laydown at site services shop, with spill trays observed

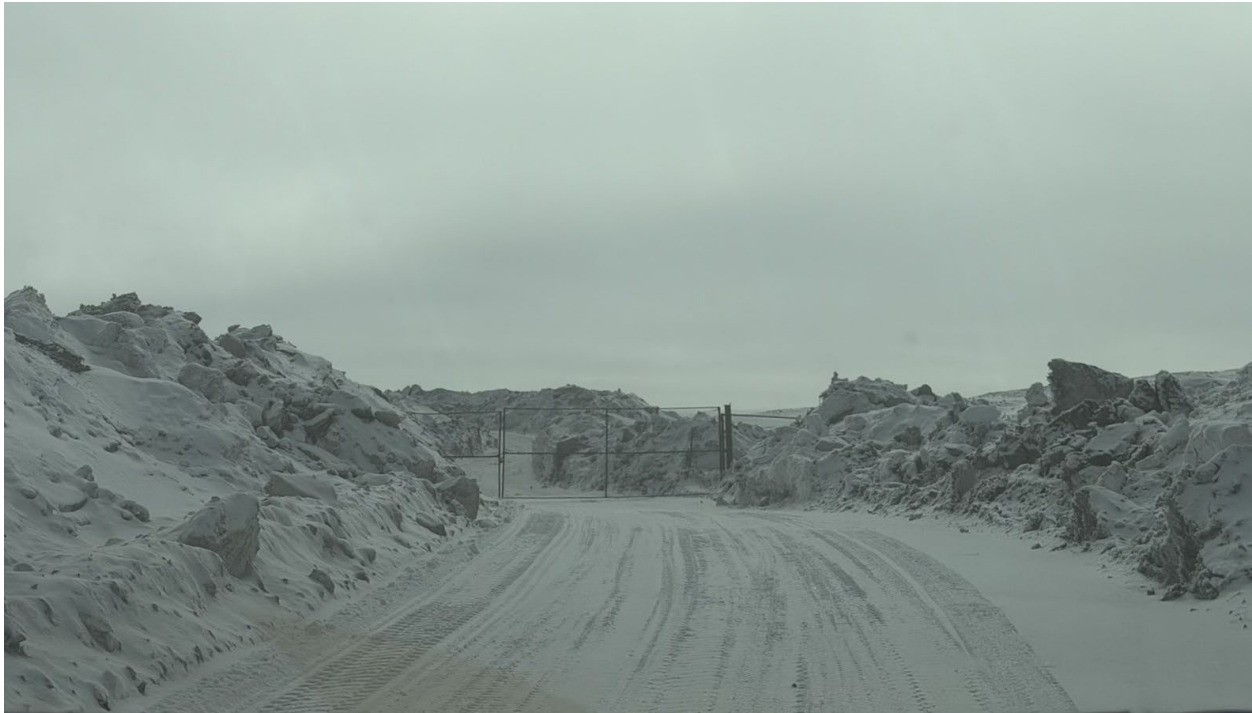
Photo 34: Fenced landfill with gated access

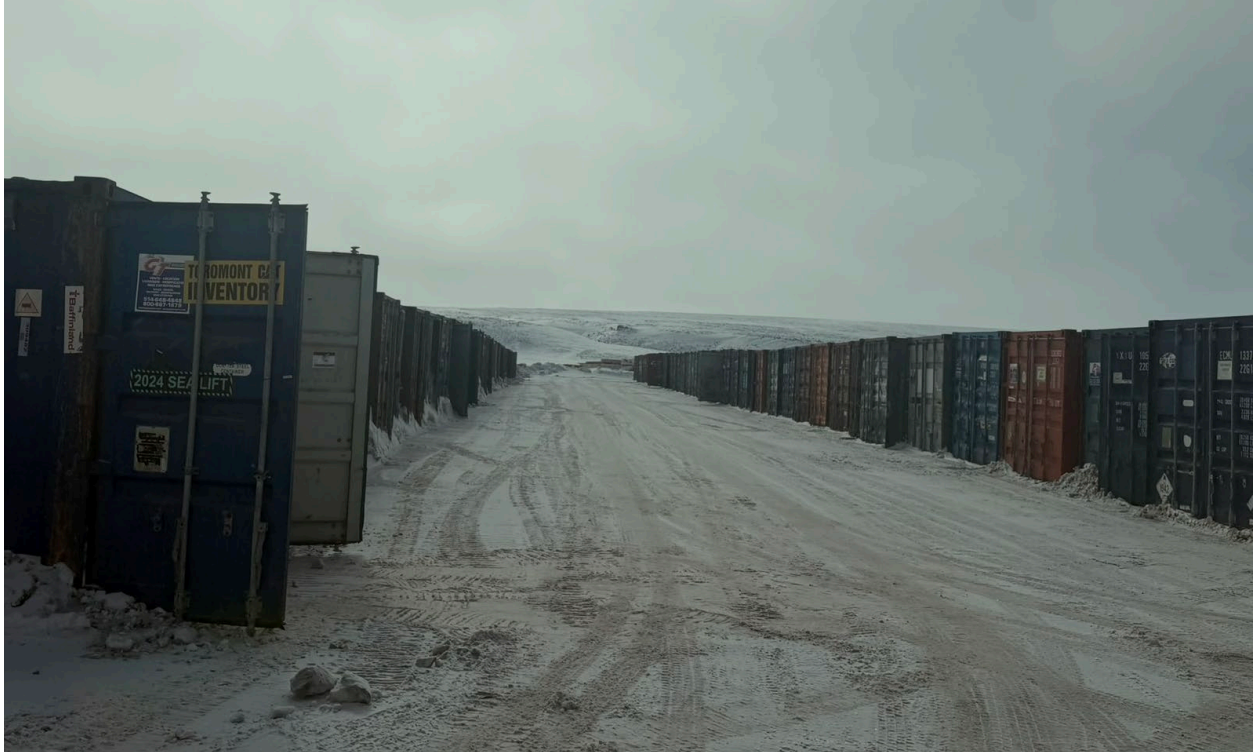
Photo 40: Additional seacans in warehouse area, with multiple units open

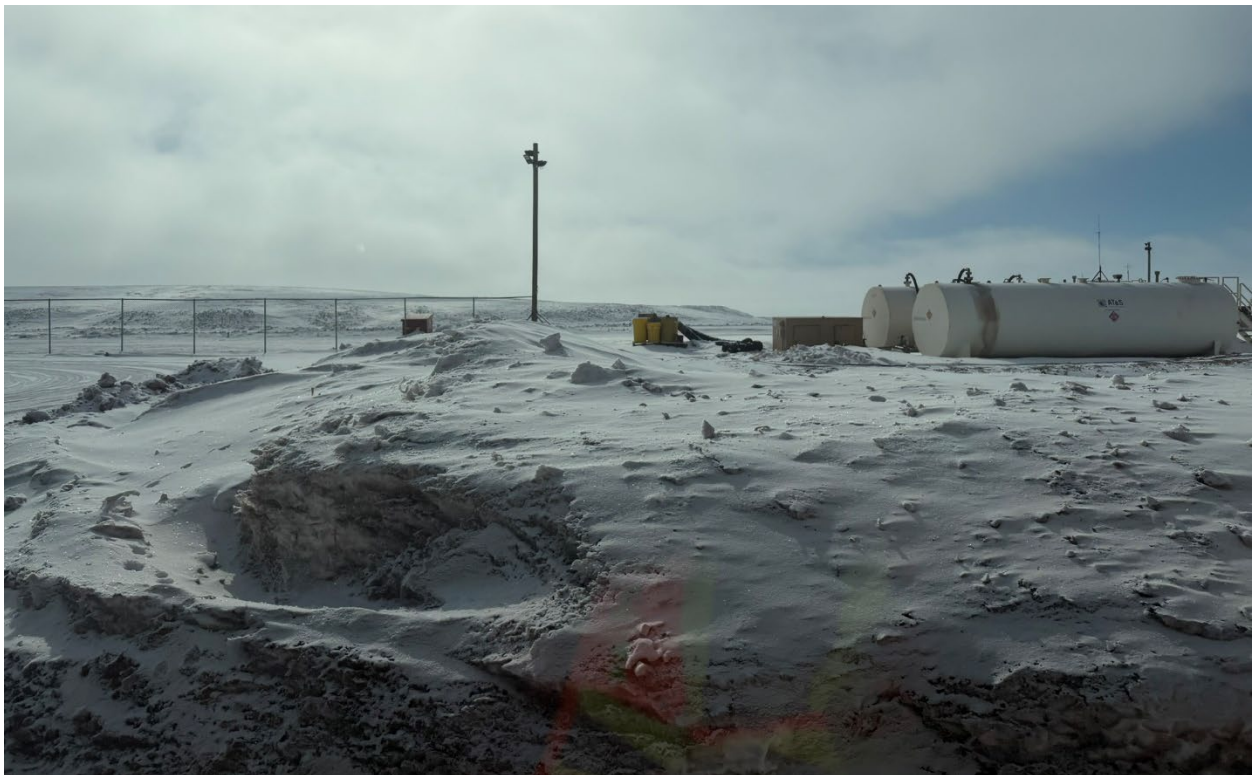
Photo 41: Fuel tanks within secondary containment at the helicopter pad (west of warehouse area); spill kits present

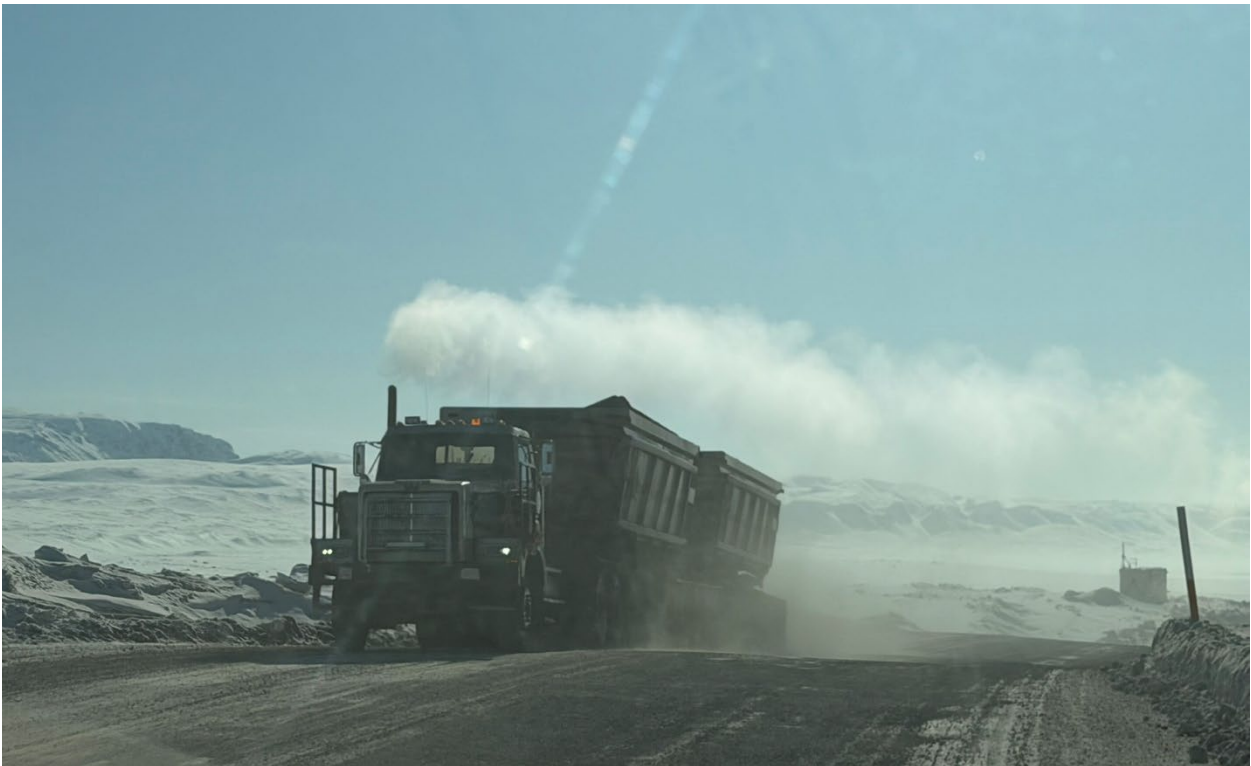
T&C No.	Topic / summary	Site Observation
5	Weather available to public	Information is made available around site as well as online. Baffinland has several weather stations installed on site.
10	Dust management and monitoring	<p>Dustfall monitoring stations were observed along the airstrip at the Mine Site and along the Tote Road (Photo 55), including near water bodies. Active air monitors were installed at multiple locations, including the crusher, to collect real-time data. Dust mitigation measures included liquid suppressant applied along the crusher conveyor and mechanical controls such as enclosures and reduced drop heights (Photo 15, Photo 17, and Photo 18).</p> <p>Snow-covered conditions allowed visual assessment of dust deposition. Dust was observed on snow adjacent to the Tote Road within a limited distance, while snow at greater distances appeared free of visible dust (Photo 48, Photo 49, and Photo 65). Haul trucks were observed in operation with no visible dust emissions from ore loads; however, dust generation from tire-road interaction was noted (Photo 50).</p>

Photo 50: Ore haul truck transporting ore to Milne Port, with fugitive dust generation from tire-road interaction

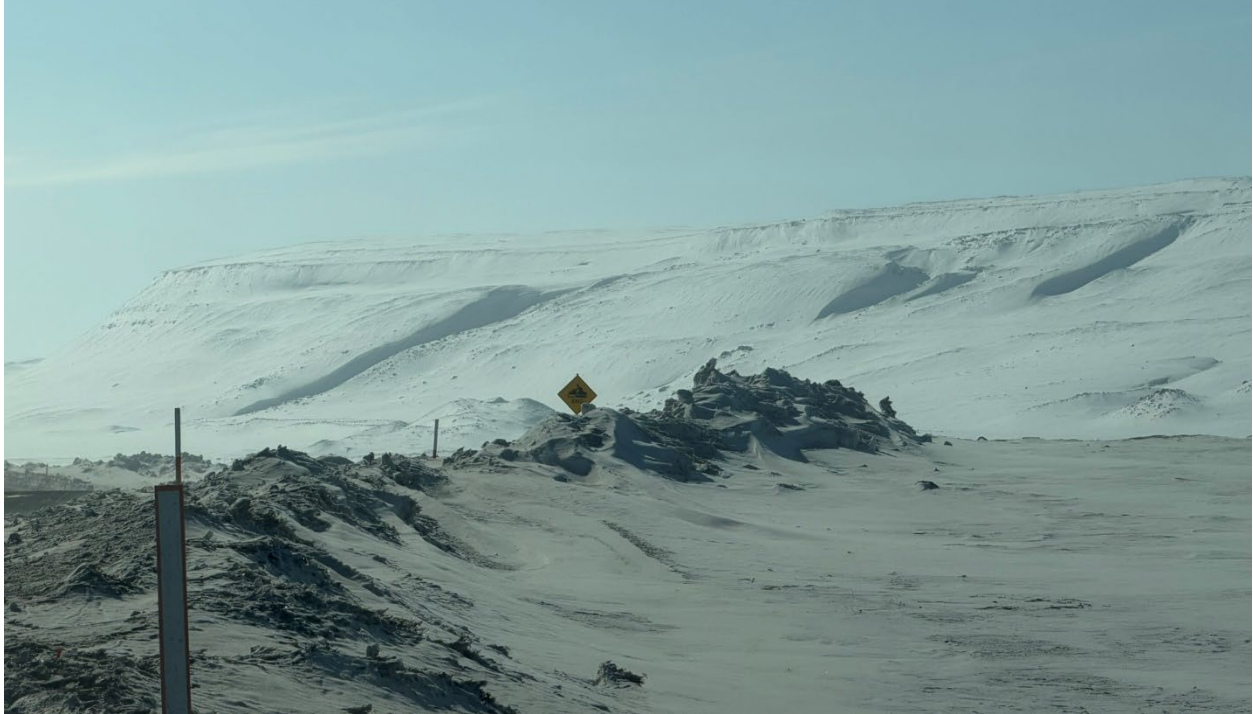
Photo 51: Distant view of snowmachine crossing located at approx. KM13, highlighting the height of the snow windrows obstructing trail access

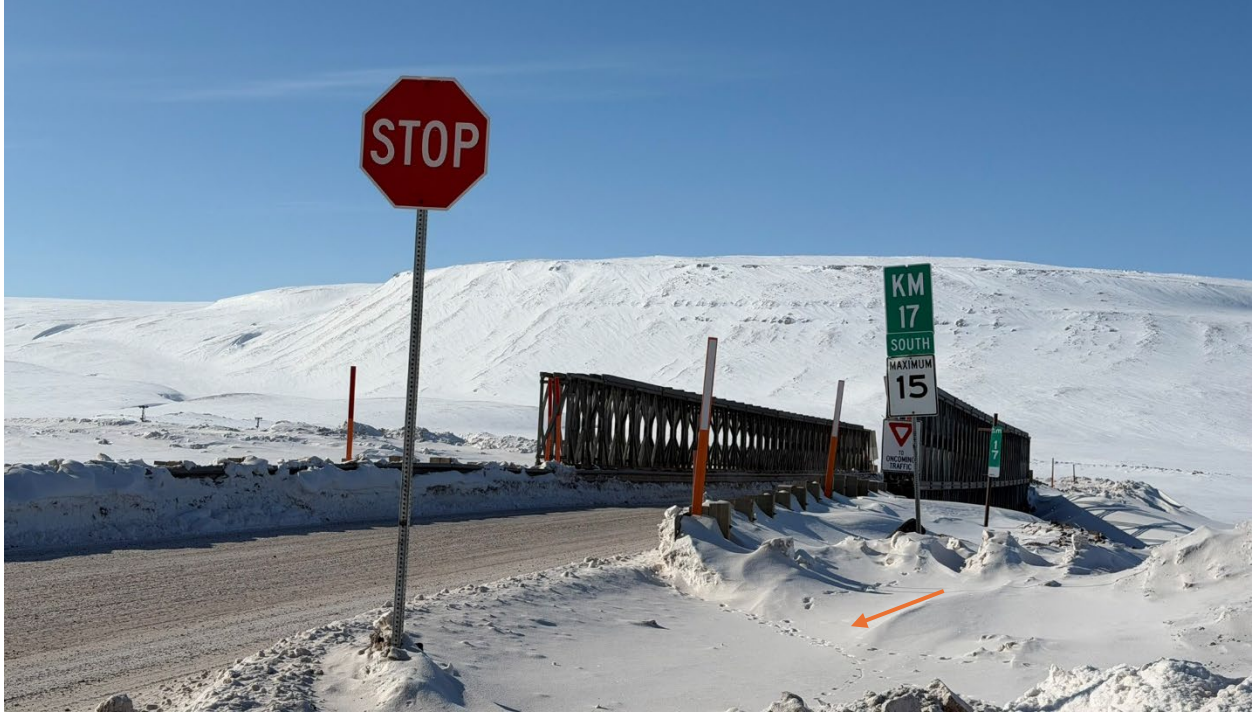
Photo 53: Bridge crossing at KM 17 over Phillips Creek, with wildlife snow tracks observed⁷

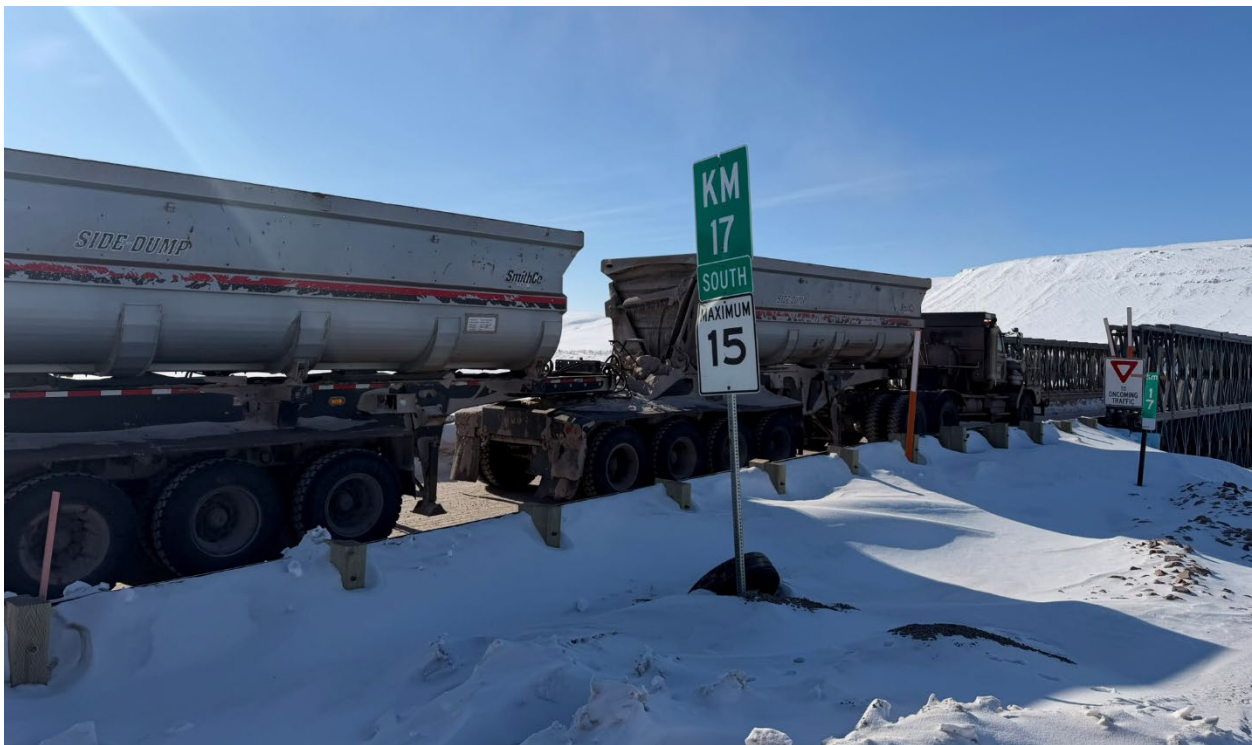
Photo 54: Ore haul truck stopped at bridge prior to crossing

⁷ Stop and reduced speed controls were observed at bridge crossings to minimize dynamic loading and vibration, thereby reducing potential structural stress and preserving underlying permafrost integrity.

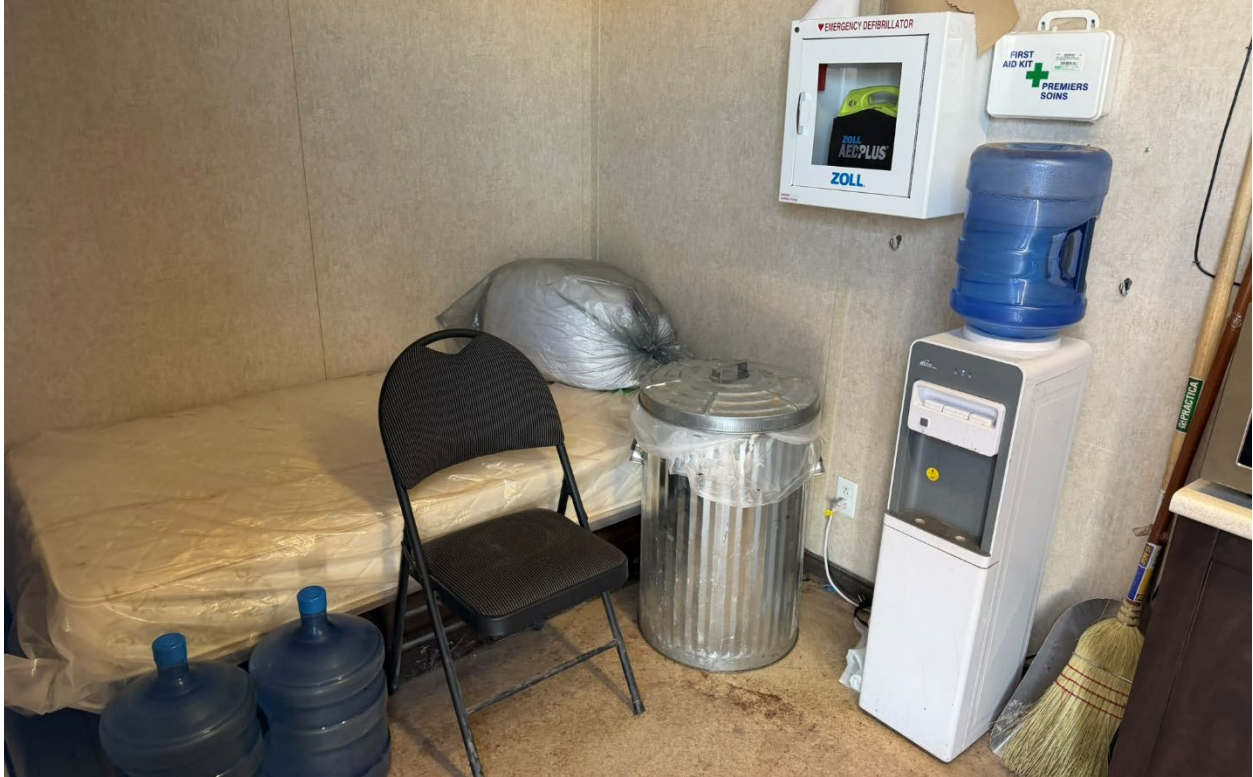
57	Wildlife reporting-incidentals	Wildlife observation logs were available at multiple locations for recording entries (Photo 45).
143	Employee family contacts	Communication facilities were observed in site accommodations, with phones available in individual rooms and internet access provided for all personnel.
165	Emergency Shelter	Emergency shelters were observed along the Tote Road (Photo 58, Photo 59, and Photo 60).

Photo 59: Interior of emergency shelter

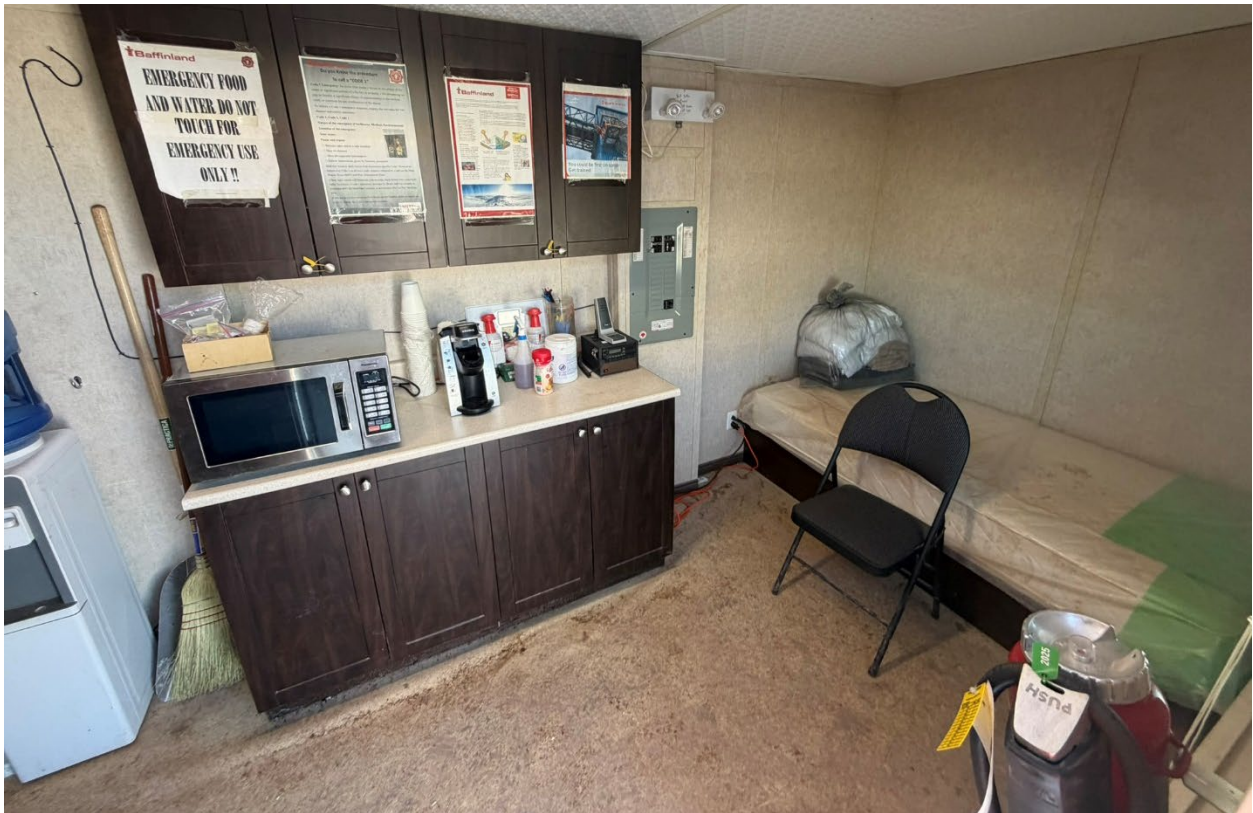
Photo 60: Interior of emergency shelter

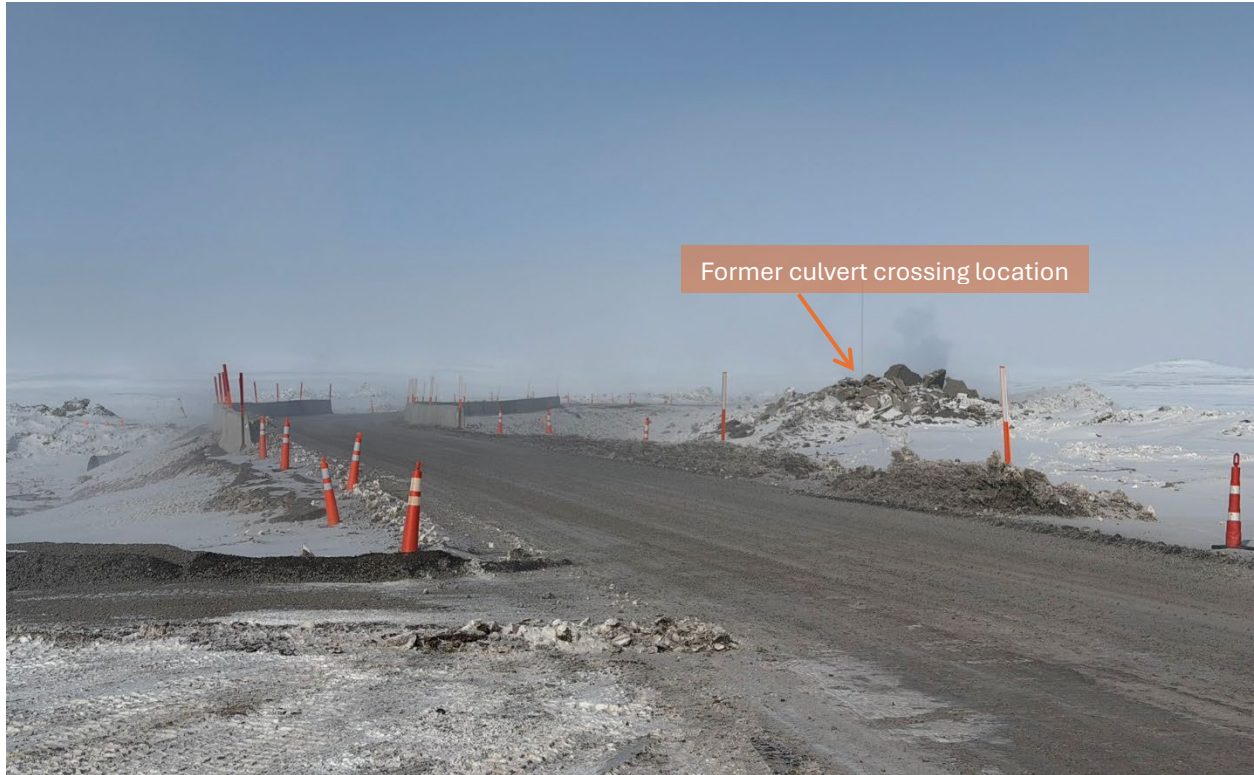
In response, Baffinland constructed a by-pass road and installed three new culverts under an Emergency Fisheries Act Authorization issued by Fisheries and Oceans Canada. At the time of the 2026 site visit, the by-pass road and new culvert installation were complete (Photo 69, Photo 70, Photo 71, and Photo 72). Concrete jersey barriers placed along the shoulder crest appear to be insufficiently supported on the sloped surface, creating a potential instability concern (Photo 72).

Photo 69: Newly constructed by-pass Road at KM 80 following culvert collapse in 2025

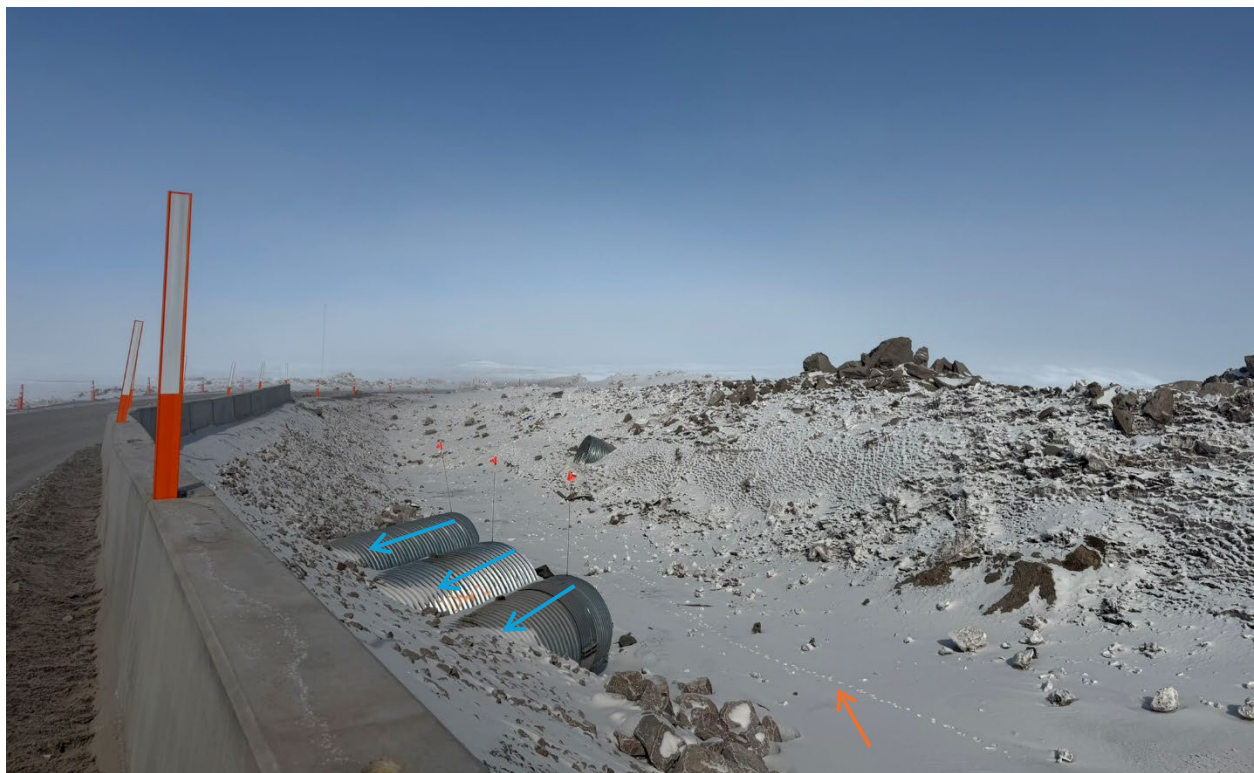
Photo 70: Newly installed three (3) culverts at KM 80

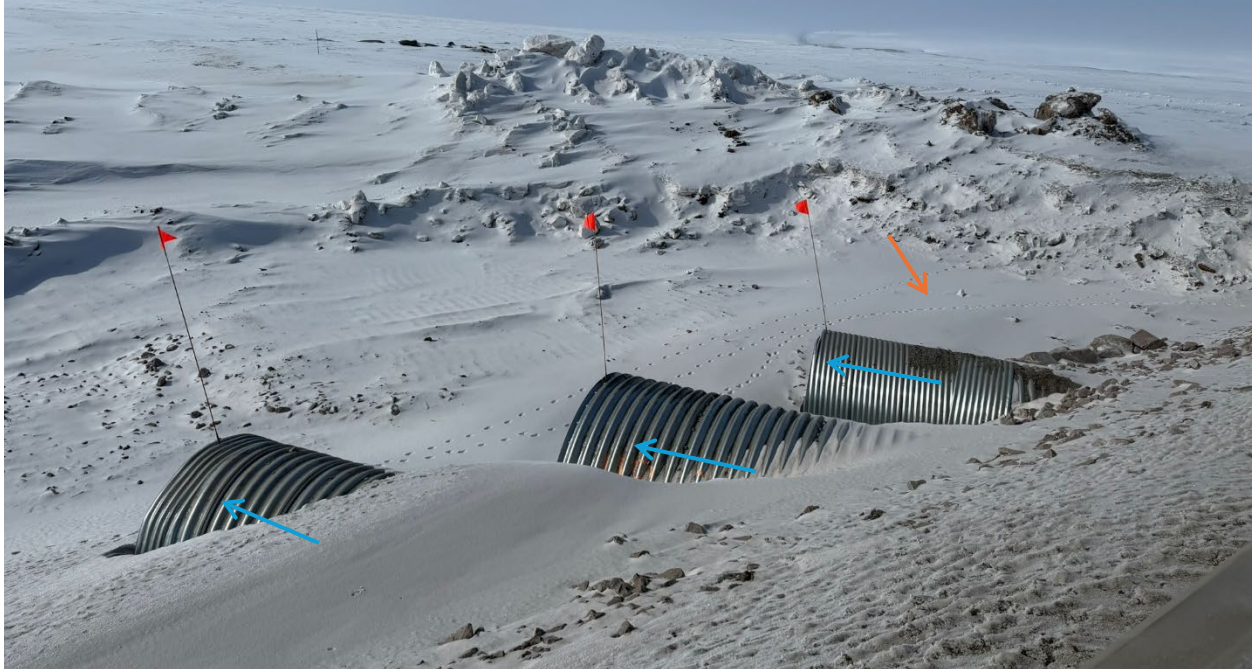
Photo 71: Newly installed three (3) culverts at KM 80

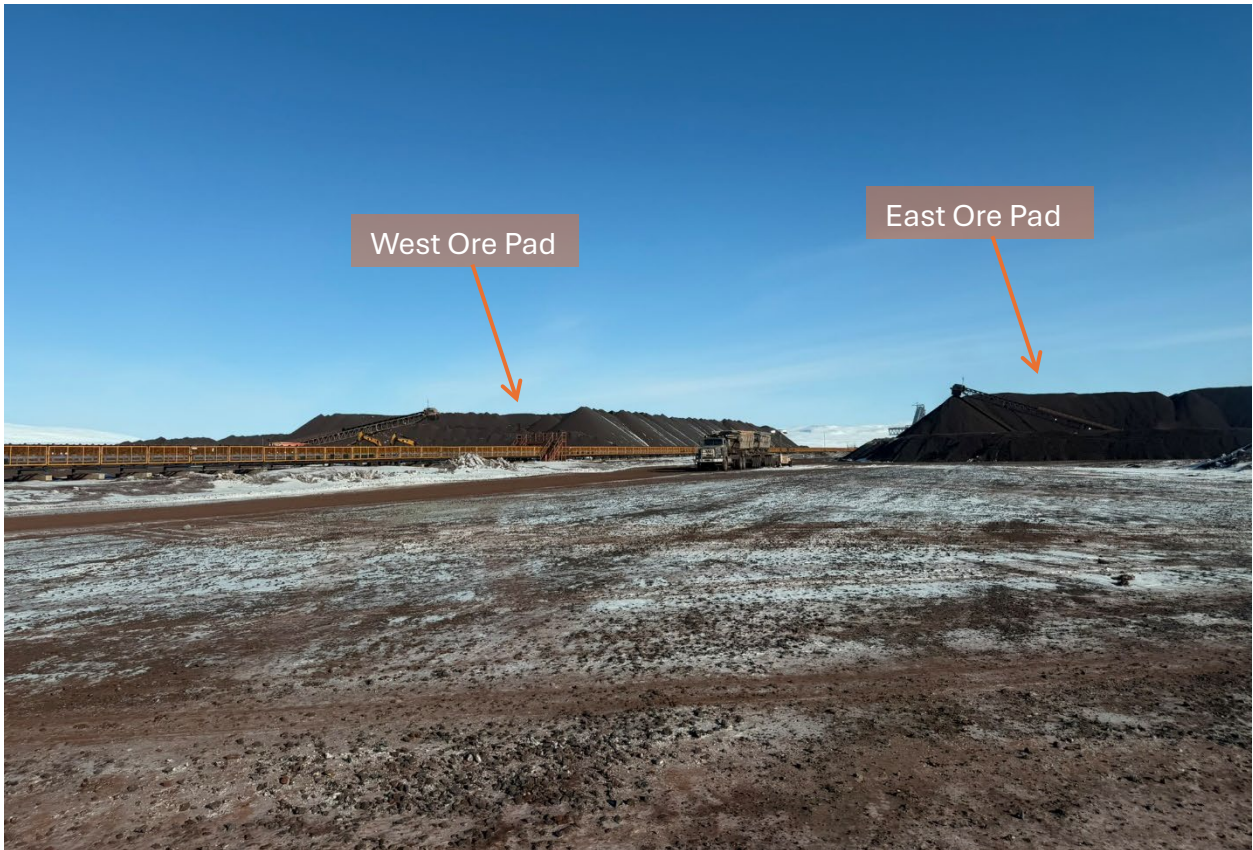
Ore stockpiles at Milne Port are identified as a source of dust emissions during stacking activities and due to wind erosion (Photo 82 and Photo 83). Baffinland applies dust suppressants to these stockpiles to manage dust generation.
11 and 64	Incineration management and Terrestrial Wildlife and Habitat - Waste Management	<p>Incinerator buildings at both the Mine Site and Milne Port were well managed, with materials clearly labeled and stored in an organized manner.</p> <p>At the Milne Port, HAZMAT storage was secured within locked seacans (Photo 91). However, domestic waste dumpsters adjacent to the incinerator building were fitted with mesh-style lids, and a raven was observed accessing waste through these openings (Photo 92).</p> <p>At the Mine Site, while the incinerator building itself was well maintained, multiple seacans containing hazardous or potentially hazardous materials were observed with missing or partially open doors, including instances of snow accumulation within containers (Photo 25 and Photo 29). Wildlife tracks were observed in the vicinity (Photo 24, Photo 28, and Photo 29). Additional tracks were observed within the hazardous waste berm east of the incinerator, where some seacans were not fully secured, and within landfarm cells adjacent to the landfill area (Photo 35, Photo 36, and Photo 37).</p>

Photo 82: Distant view of Ore Pad

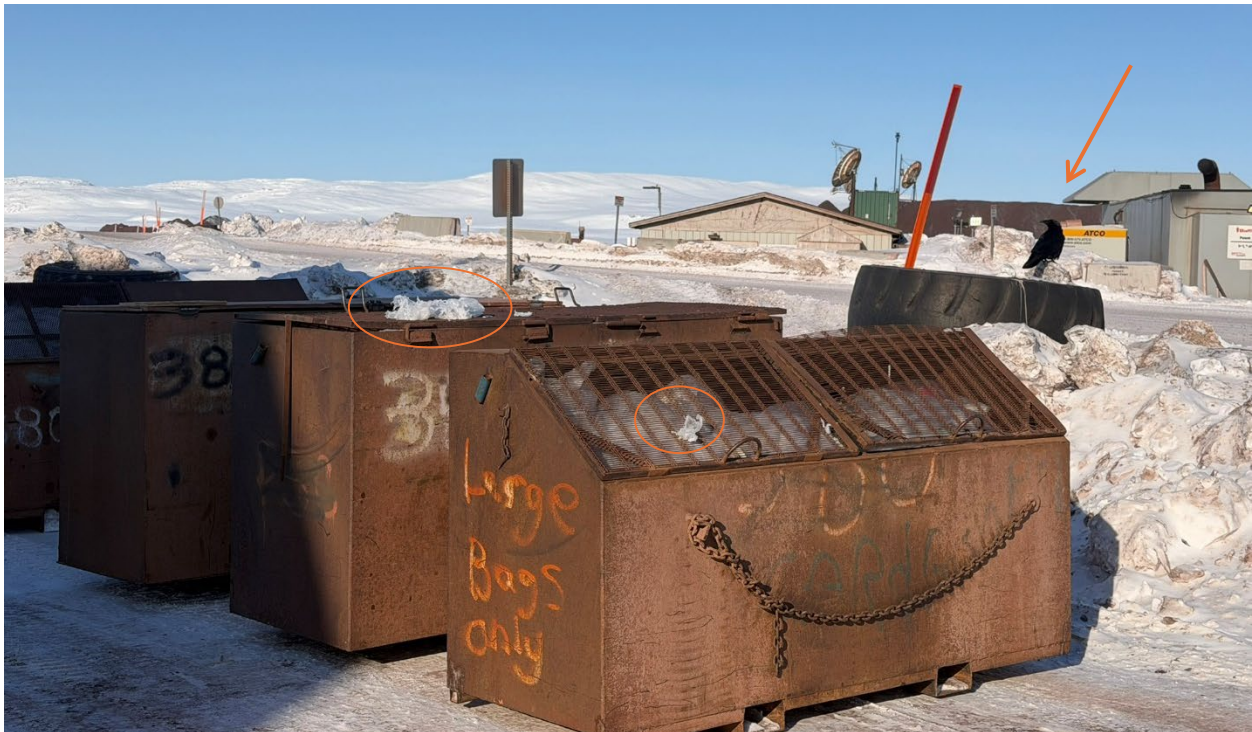
Photo 92: Domestic waste dumpsters adjacent to the incinerator building with mesh-style lids; a raven accessing waste through the openings

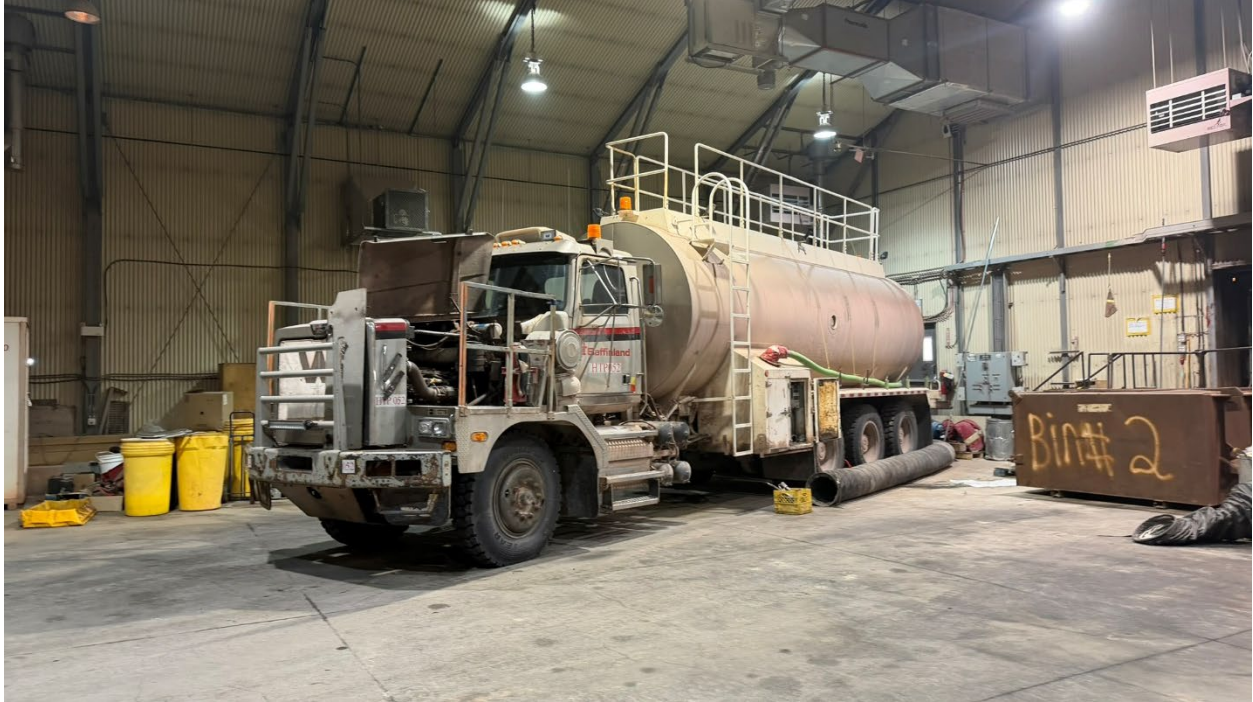
Photo 93: Interior of the incinerator building, well organized with ongoing cleaning activities and spill kits readily available

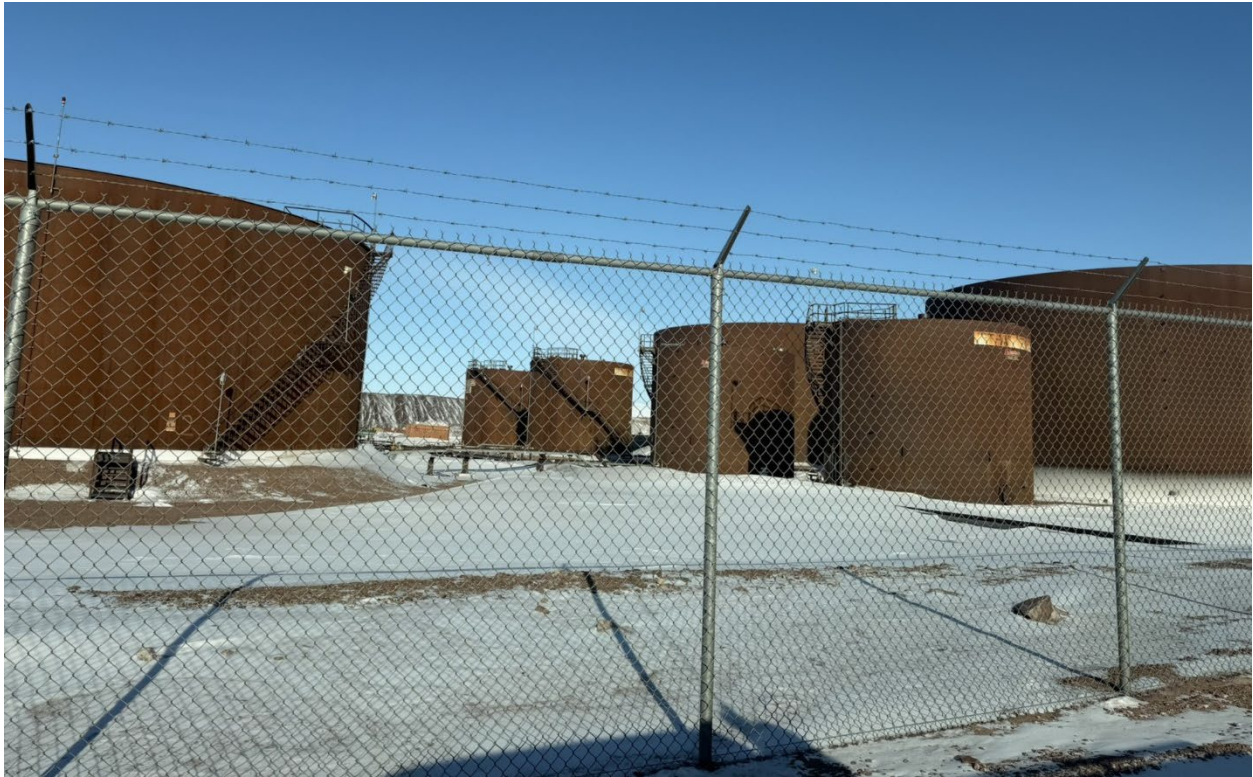
Photo 97: Fuel tanks at the fuel tank farm within secondary containment and perimeter fencing

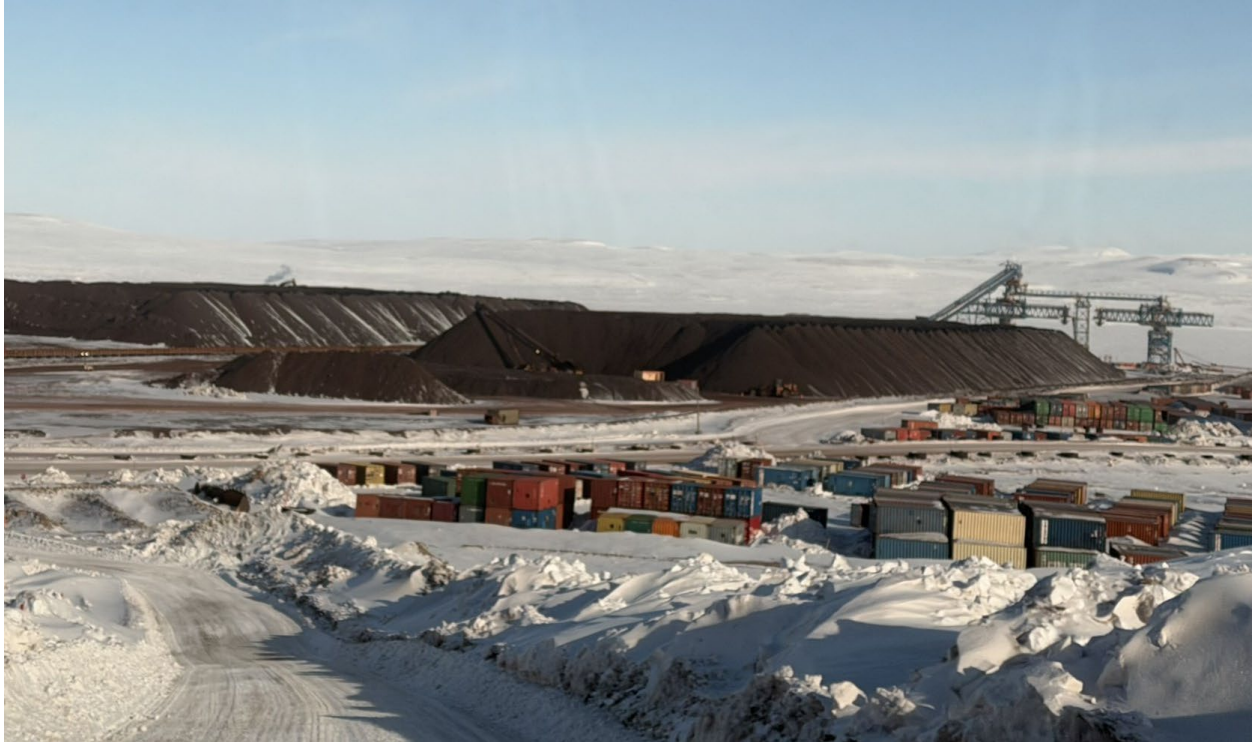
Photo 99: Laydown area east of landfarm cells, general view from the landfarm access road
