From April 30 to May 2, 2026, NIRB staff conducted a spring site visit to Baffinland Iron Mines Corporation’s Mary River Project, including the Mine Site, Tote Road, and Milne Port, accompanied by Baffinland environmental staff. The visit focused on observing site activities, environmental management practices, and implementation of Project Certificate requirements. During the visit, NIRB staff observed ongoing operational activities and held discussions with the Proponent regarding environmental monitoring, mitigation measures, and adherence to Project Certificate requirements (Table 1).

3.1. Mine Site

3.2. Tote Road

3.3. Milne Port

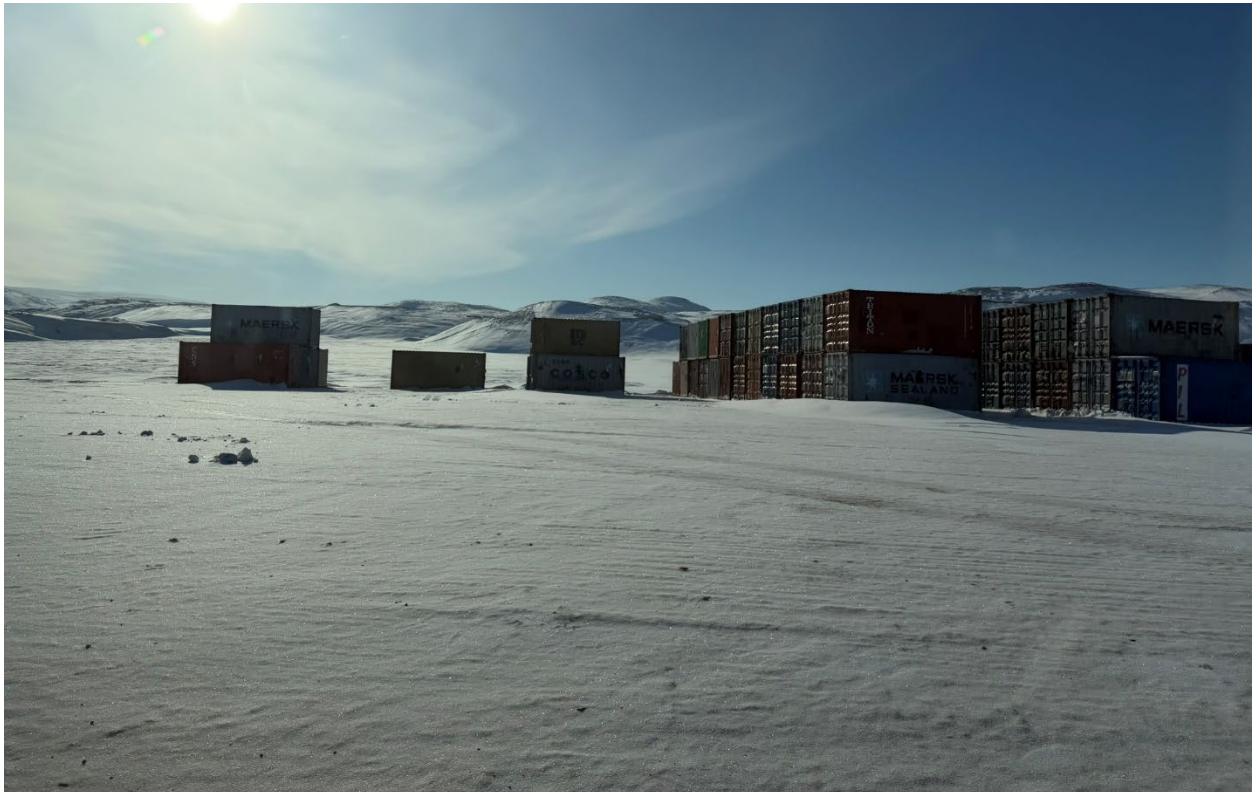
Photo 100: Laydown area adjacent to barge landing area

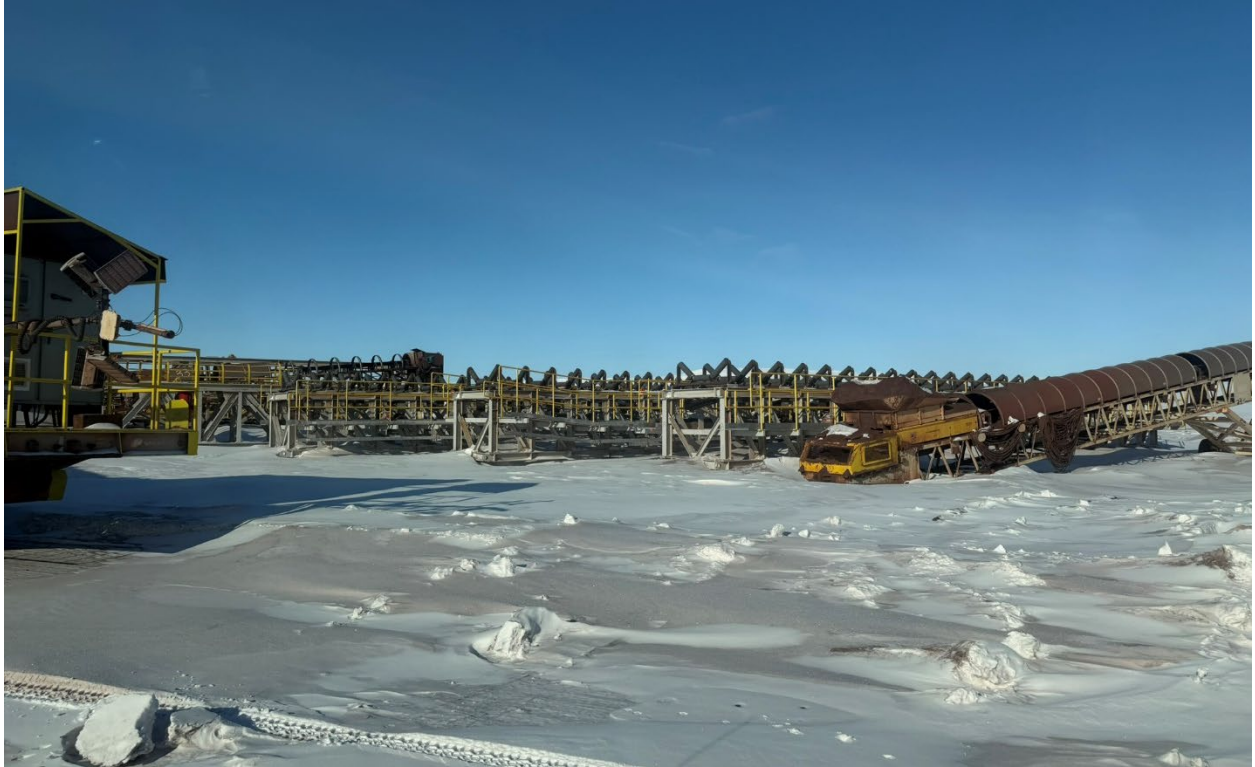
Photo 101: Phase 2 laydown area

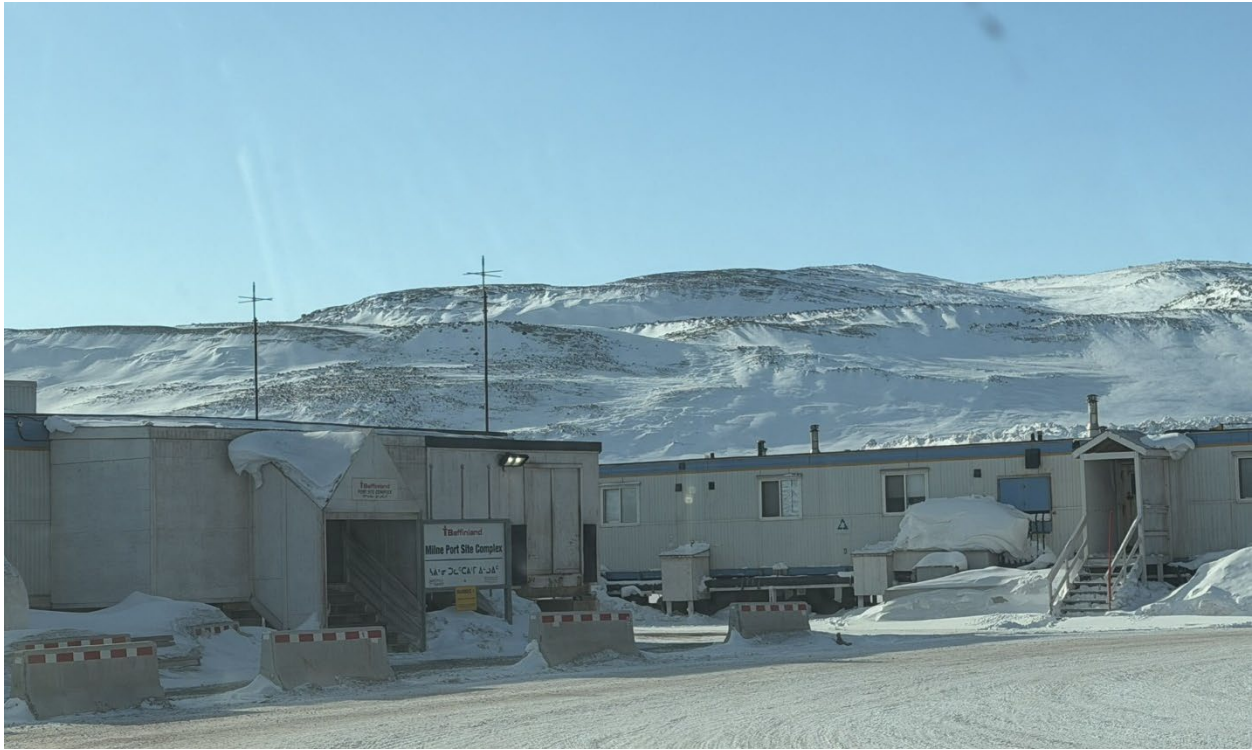
Photo 103: Milne Port Site Complex entrance

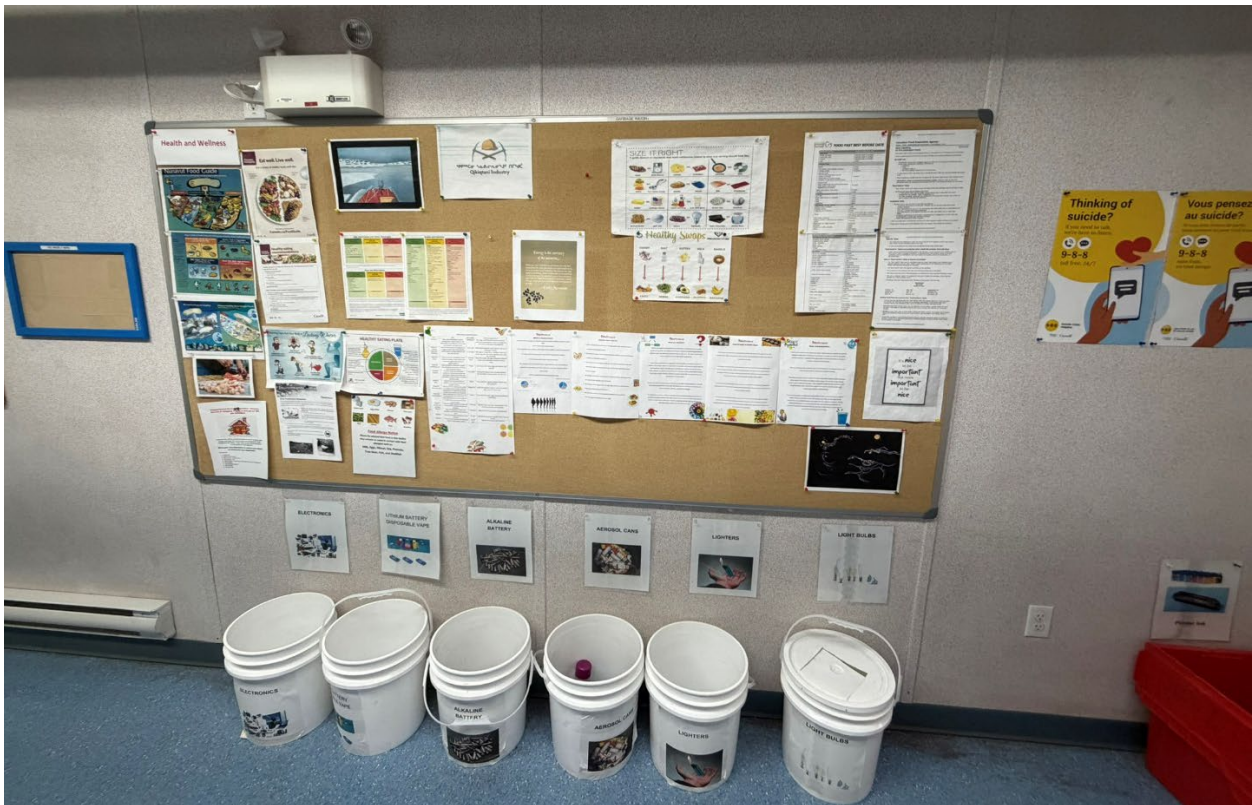
Photo 104: Waste segregation bins and an information board on health and nutrition in hallway
