## Appendix C - Material (Granular) Assessments

**Re: OTT-000254843-A0      Review of Existing Aggregate Resources  
Hamlet of Taloyoak, Nunavut - SOA 2018-77**

*Government of Nunavut  
Review of Existing Aggregate Resources  
Taloyoak Sewage Lagoon, Hamlet of Taloyoak, Nunavut  
Project: OTT-00254843-A0  
December 7, 2020*

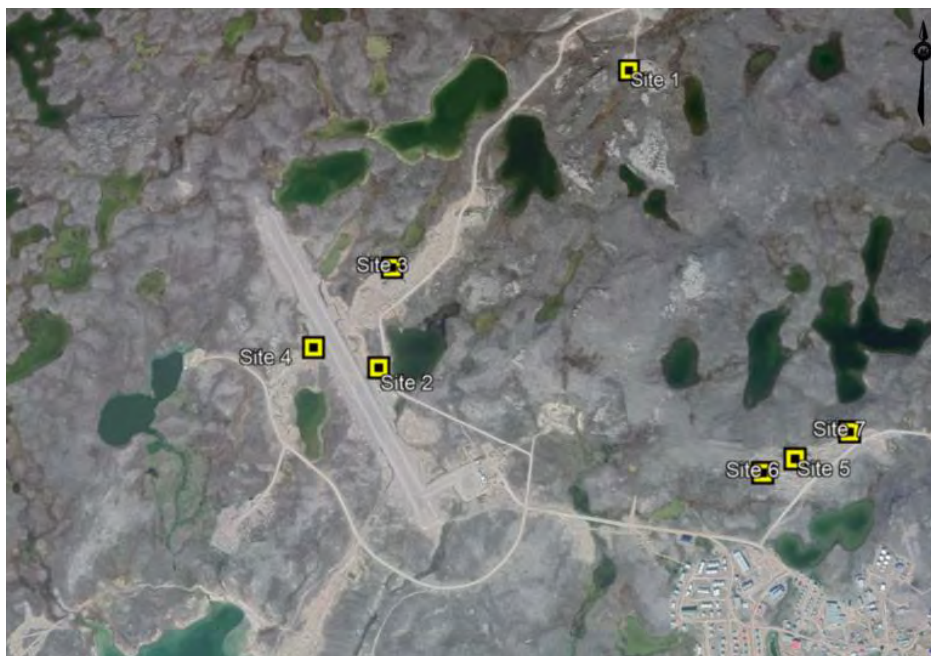
**Figure 6-1 – Aggregate sources assessment sites**

Aggregate Site 1 – Kudlik Rock Quarry – The site is a well-established quarry about 4.8 km from the existing lagoon with considerable amount of granular materials and a possibility for expansion. It has a good roadway access and a water source nearby. The quarry measures about 300 m by 300 m and has a rock face about 6 m high. The heavy equipment consists of a crusher that appears in good condition last used three years ago and trucks and loaders owned by Kudlik stored at the airport. The existing stockpiles consist of a small stockpile of 19 mm sized stone and a small stockpile of medium sized blasted bedrock. The quarry is located east of the airport on Middle Lake Road.

**Aggregate Site 2 – Airport Stockpile** – The site is a 30 m by 30 m and a couple of meters high stockpile of 19 mm sized crushed granular material that is for the airport use only and is not to be used by the Municipality. The stockpile is on the east side of the runway located 2.6 kilometers from the existing lagoon.

**Aggregate Site 3 – Middle Lake Road - Old Abandonment Pit** - The site is an abandoned pit with a possible one season left of screening and crushing of sand and gravel. The pit measures about 100 m by 1000 m and has been abandoned for almost 20 years. The equipment consists of old crushing plant and screens that seem non-functioning. The existing stockpiles include many small 1 m to 3 m high stockpiles of sand and gravel that can be screened and crushed. The site is located about 3 km from the existing lagoon. Possibly 1 season of sand and gravel available for use.

**Aggregate Site 4 – Lagoon Road between Dump and Sewage Lagoon** – The site has been occasionally used by the Municipality. The pit measures about 100 m by 400 m and is located between the dump and the sewage lagoon on the west side of the airport about 550 m east from the existing lagoon. Possibly one season of sand and gravel available for use.

**Aggregate Site 5 – Municipality Borrow Pit – Water Plant Road** – The site has been used since 1980s for sourcing granular materials for housing pads and road subgrades with a possibility to be used for another 20 years. The native material mostly consists of silty sand till with some gravel and boulders and trace of clay. The pit has 8 m to 10 m vertical banks which are being cut and the granular materials used directly around the Municipality. A screener is present on site which appears to be in use by the Municipality. The pit is southeast of the airport and west of the water reservoir about 3.1 km from the existing lagoon. Estimated 20 year plus of materials can be available for use in the eastern direction of the pit.

**Aggregate Site 6 – Clay Pit – Water Plant Road** – Clay has been sourced from this site for many years with clay being stripped and used yearly. Presently, large boulders have been scraped back to 20 m from the edge of the borrow pit to approximately 2 m below grade. The pit measures about 20 m by 100 m and is located east of the Municipality borrow pit on Water Plant Road about 3 km from the existing lagoon. Estimated available quantity for this site is unknown.

**Aggregate Site 7 – Clay Pit – Near Water Plant Road** – This site has been used for years as a clay source and has very limited resources left. The pit measures about 50 square metres and is located on the south side of the roadway before Plant Road about 3.2 km from the existing lagoon.

Sites 1 and 5 from the Material Aggregate Assessment report contain considerable granular resources and are the preferred sites for resource extraction. Sites 3 and 4 contain limited amounts of granular quantities but may also be used to supplement construction activities as required.

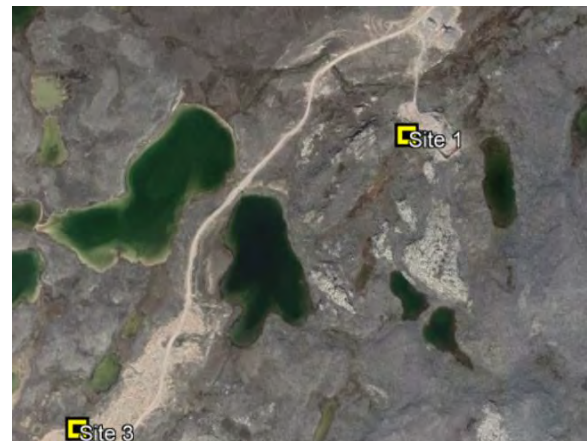
Site 1 Location

- There is an existing crusher on-site which was last used 3 years ago. The crusher appears to be in good condition. The trucks and loaders owned by Kudlik and previously used at this quarry are stored at the airport. The stockpiles and crusher coordinates are at UTM 047868 and 7716834;

- This existing rock quarry is of unlimited quantity and the rock appears to be of good quality. This quarry can be expanded in the north-south as well as in the east-west directions; and

- The site is located 4.8 kilometres approximately east from the existing lagoon.

In summary, this is a well-established quarry with considerable amount of resources and has roadway access to allow for blasting operation and the production of aggregates.

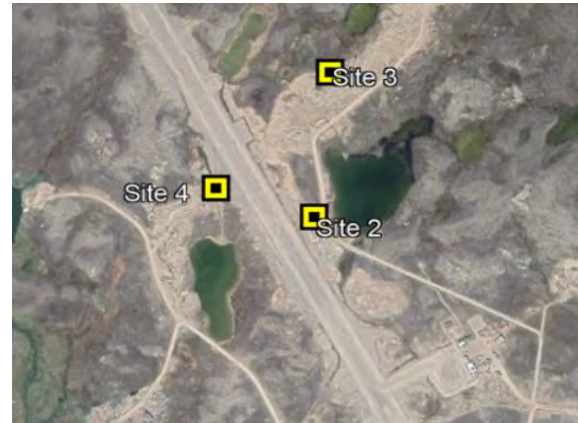
**Site 2, Site 3, & Site 4 Locations**

- This pit has been abandoned for almost 20 years; UTM location between 15W0477790 and 15W0477589 and 7715847 and 7715603;
- Approximately a 100 m to 150 m in wide and 1.0 kilometre (1,000 m) long area have been scraped to remove sand and gravel for screening and crushing purposes;
- Old crushing plant and screens are on-site and appeared to be in a non-working condition;
- Crushable sand and gravel remain available on-site for one (1) season of screening and crushing;
- There are many small 1 m to 3 m high stockpiles of sand and gravel over the site that can be screened and crushed, if needed; and
- The site is located 3.0 kilometres east approximately from the existing lagoon.

In summary, this is an abandoned pit with a possible one (1) season of sand and gravel that may be scraped, crushed and screened.

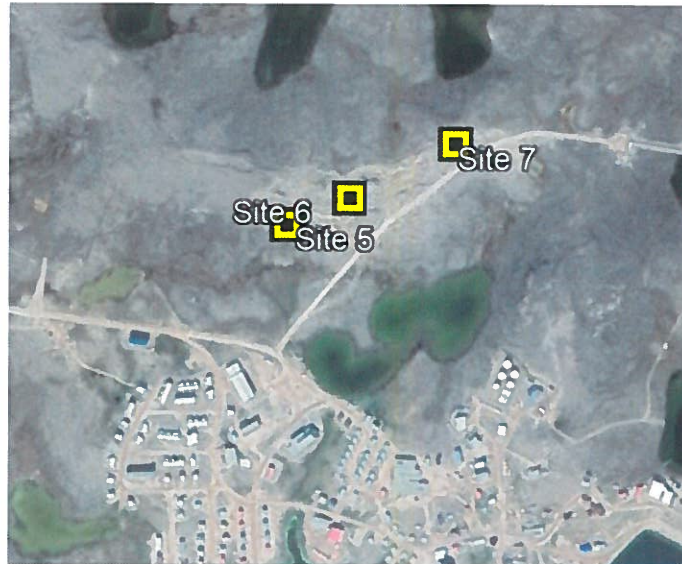
**Sites 5, 6 and 7 Locations**

This pit is located on the south side of the roadway before Plant Road and is approximately 50 square metre in area and has been used for years. The pit is located at UTM 15W04479360 and 7715133. This pit has very limited resources left; and
