GJOA HAVEN, NU

Investigation of Prospective Granular Borrow
Sources

January 2025

Prepared by:
Nunami Stantec Limited

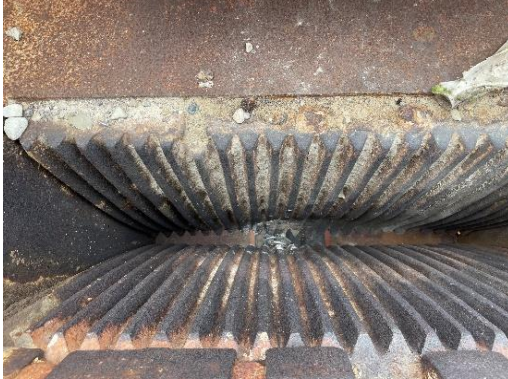
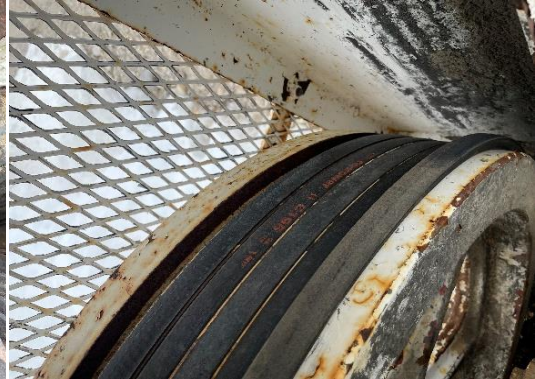
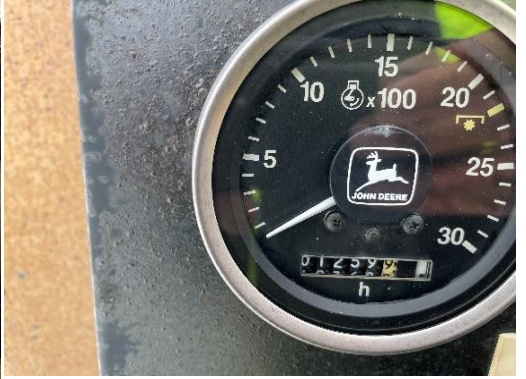
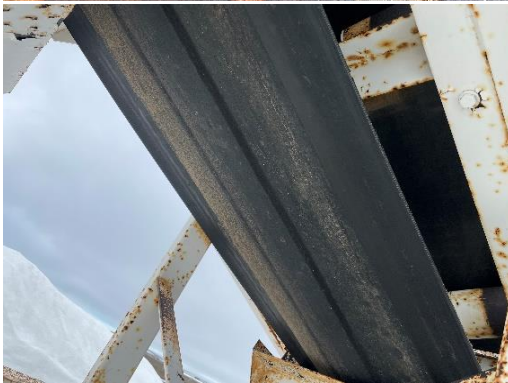
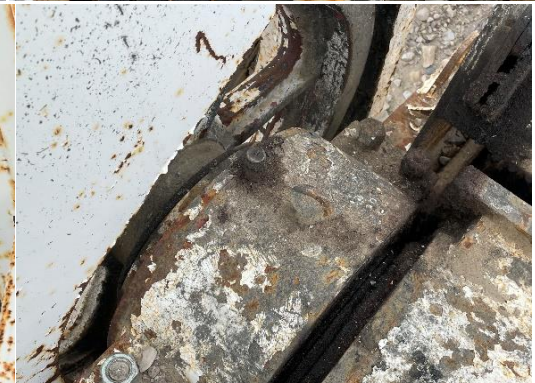
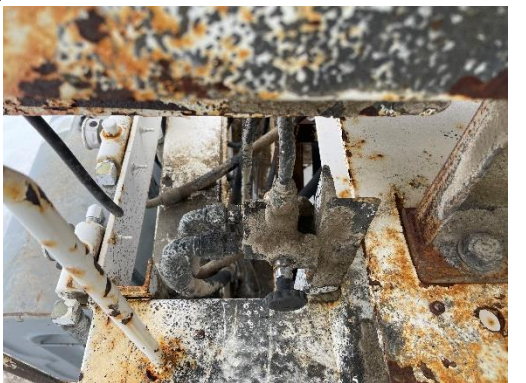
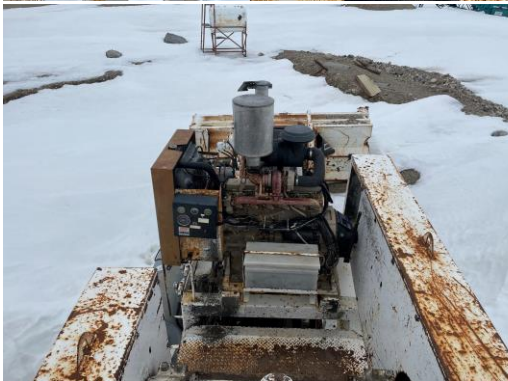
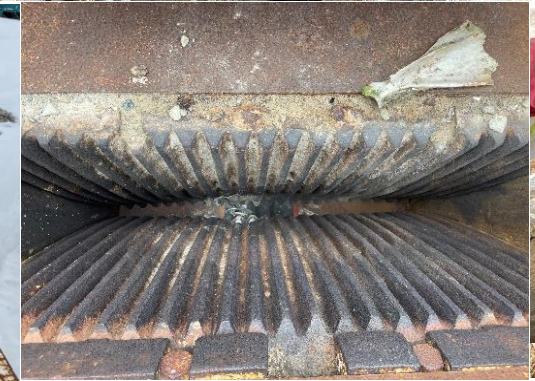
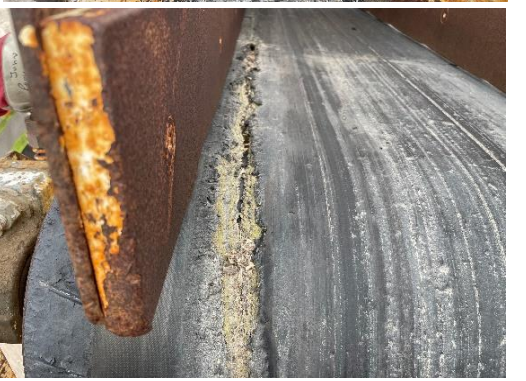
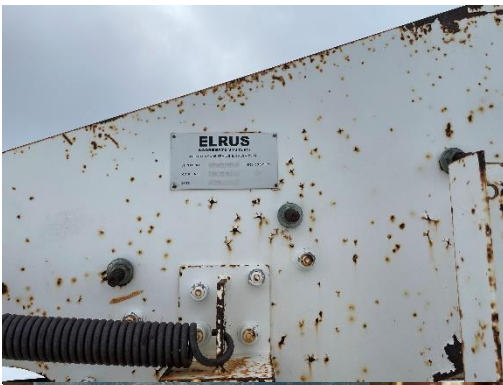
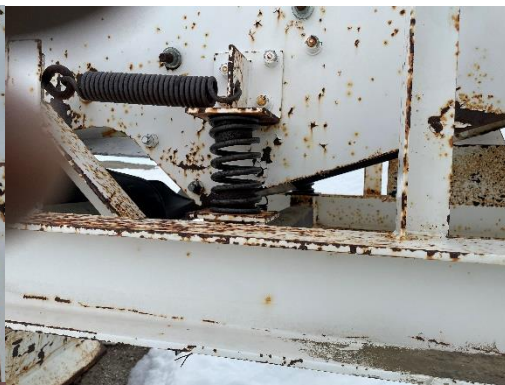
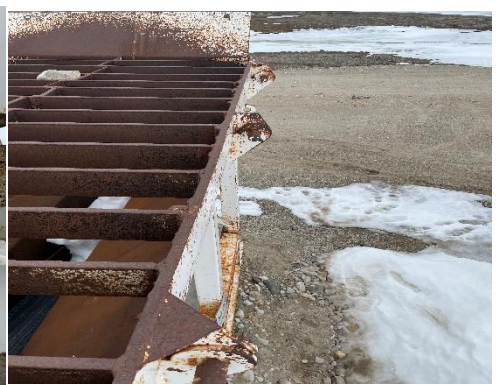
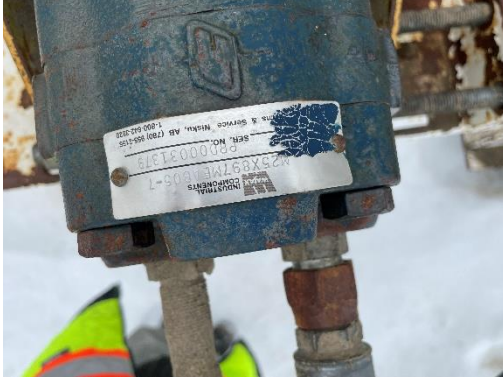
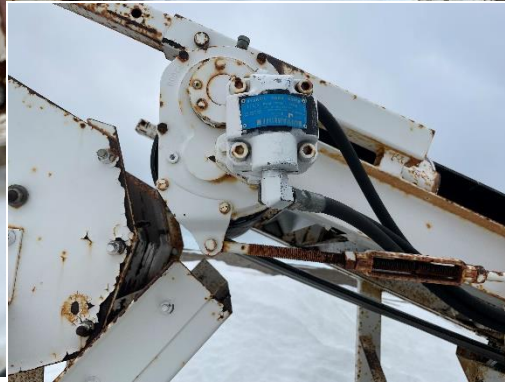
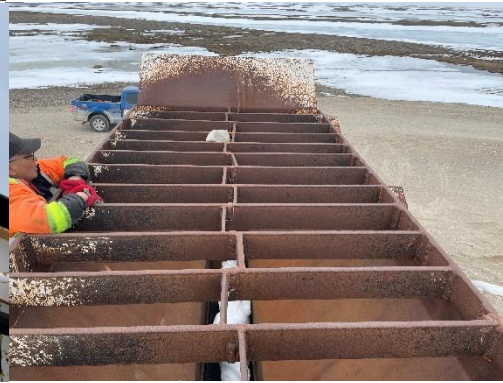
SHEET METAL	X	Good to fair					
ENGINE HOOD	X	N/A		X	CONVEYOR FRAME	Good	
STEPS, HAND RAILS	X	Good to fair		X	CONVEYOR BELTS	Feed coneyor will need to be replaced	
CATWALKS	X	Good		X	HOPPER WALLS	Fair	
PAINTWORK	X	Some surface rust		X	CHASSIS	Surface rust	
HYDRAULICS							
HYDRAULIC CYLINDERS	X	Good					
HOSES & LINES	X	Good to Fair			CONVEYOR MOTOR	Good	
CONTROLS & VALVES	X	Main push/pull valve need to be repair			VIBRATORS	Good	
FUNCTIONAL TEST	X	Worked as it should			CRUSHER ADJUSTMENT	Good	
CONVEYORS	X	Both conveyor operated as it should			DRIVE TRAIN	Good	
MAGNETIC SEPERATOR	N/A				CONVEYOR FOLDERS	N/A	
FEEDER HOPPER		Good			BREAKER CLUTCH	Good	
JAW CRUSHER		Good					
TOGGLE & MECHANICAL		Good			JAW WEAR	Will need to be flipped	
WALL LINERS		Good to Fair			PALTFORMS	Good	
SCREENER		Good to fair			VIBRATOR	Good	
Visible issues							
Discharge belt will need replacement							
Impact roller # 7,8,9 will need replacement

Tail pulley will need repair or replacement							
Stationary Jaw liner plate will need to be flipped							
Hydraulic detent control valve very stiff will need replacement							
Main drive belt should be replaced and adjusted to OEM specs							
Hydraulic cooler fan will need to repaired or replaced							
Vibrating screen drive belts cracked and worn, will need to be replaced							
Battery will need replacement							
Screen media should be replaced							
Comments							
Overall crusher in good shape, will need minor repairs and a complete service. Oil, filter and lube.

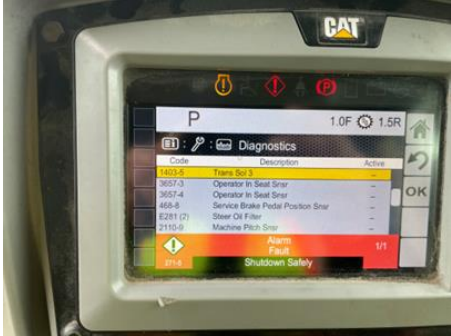
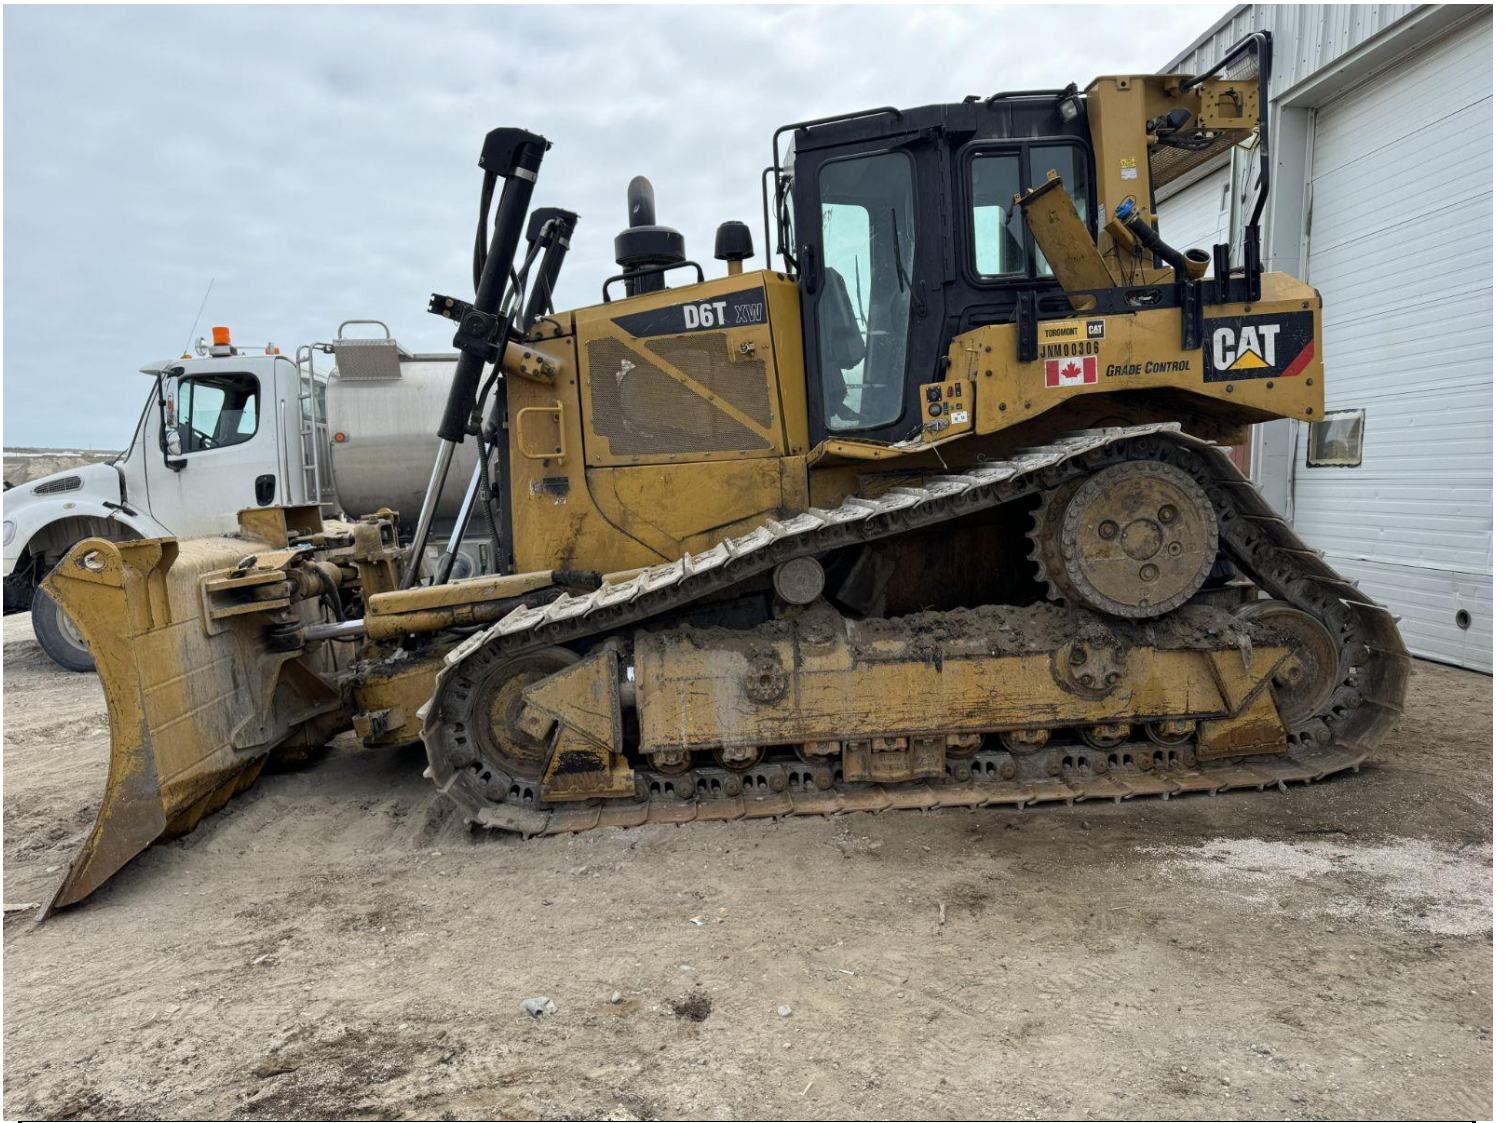
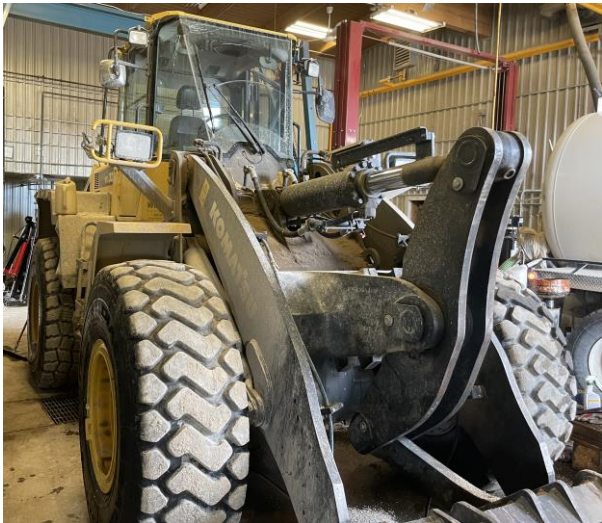
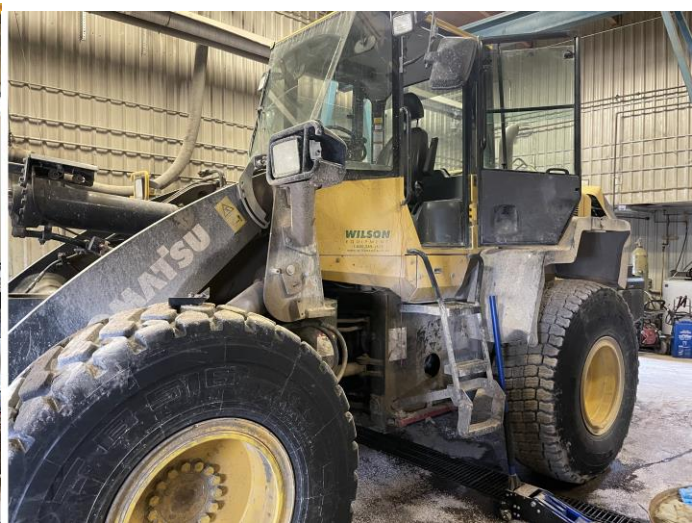
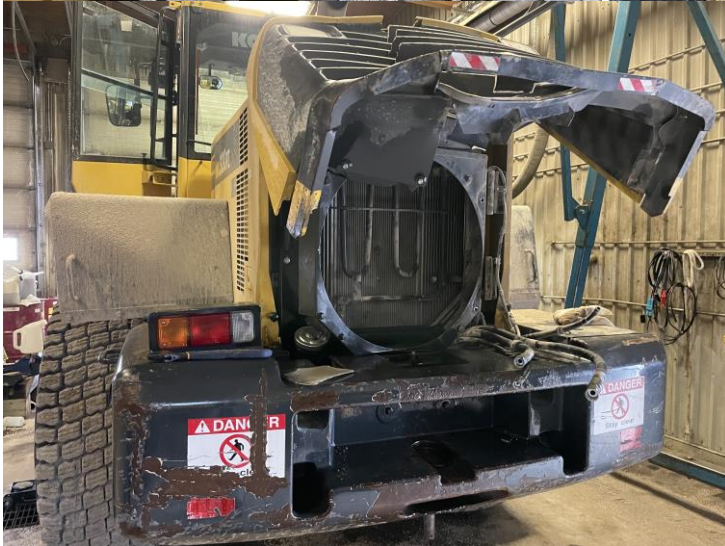
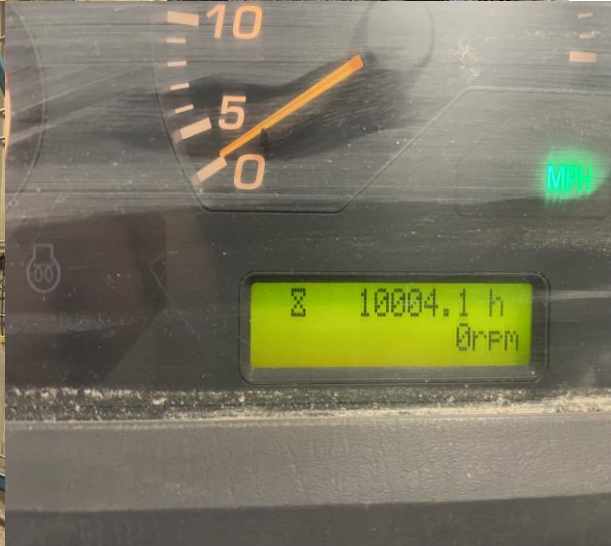
Dozer Inspection Condition Inspection

PAINTWORK		Good to fair	
HYDRAULICS							
HOSES & LINES		Fair(tube on rear of dozer is leaking)		TILT CYLINDER		Good	
LIFT CYLINDERS		Good		ANGLE CYLINDER		Good	
				RIPPER CYLINDER		N/A	
FUNCTIONAL TEST / PLAY LOCALIZATION							
PINS PUSH FRAME		Fair		PUMP NOISE		None at time of inspection	
PINS BLADE		Fair		ELECTRICS		Some repair needed	
PINS RIPPER		N/A		TRANSMISSION		Good	
EQUALIZER BAR		Further inspection required		BRAKE/CLUTCHES		Further inspection required	
STALL TEST		Failed as fuel code in system		STEERING		Fair	
BLADE CONDITION AND TYPE		STRAIGHT		ANGLE(PAT)		X	
		PIVOT PINS		TRUNIONS		U SHAPE	
		SKIN		CUTTING EDGE		X	
						SIDE ARMS	
U/C		RIGHT SIDE		LEFT SIDE			
BUSHINGS						TRACK SHOE WIDTH	
SHOES		10%		10%		ROTATING BUSHING	
REAR IDLER		40%		40%			
CARRIER ROLLER		40%		40%		CAT SYSTEM ONE	
SPROCKETS		40%		40%			
LINKS		40%		40%			
CANON CONDITION		Fair		Fair			
VISIBLE ISSUES							
Hydraulic oil tube replacement

Battery replacement							
Diagnostic code investigation							
CAT TA2 inspection							
Undercarriage needs replacement							
COMMENTS							
Overall the dozer is in fair condition, will need repair and diagnostics to bring up to standards. Has potential to be a good machine.
