Non-Hazardous Landfill, Construction Report, Ulu Gold Project Interim Report Draft

SRK Consulting (Canada) Inc.
1CB041.000
September 2022

Project No: 1CB041.000

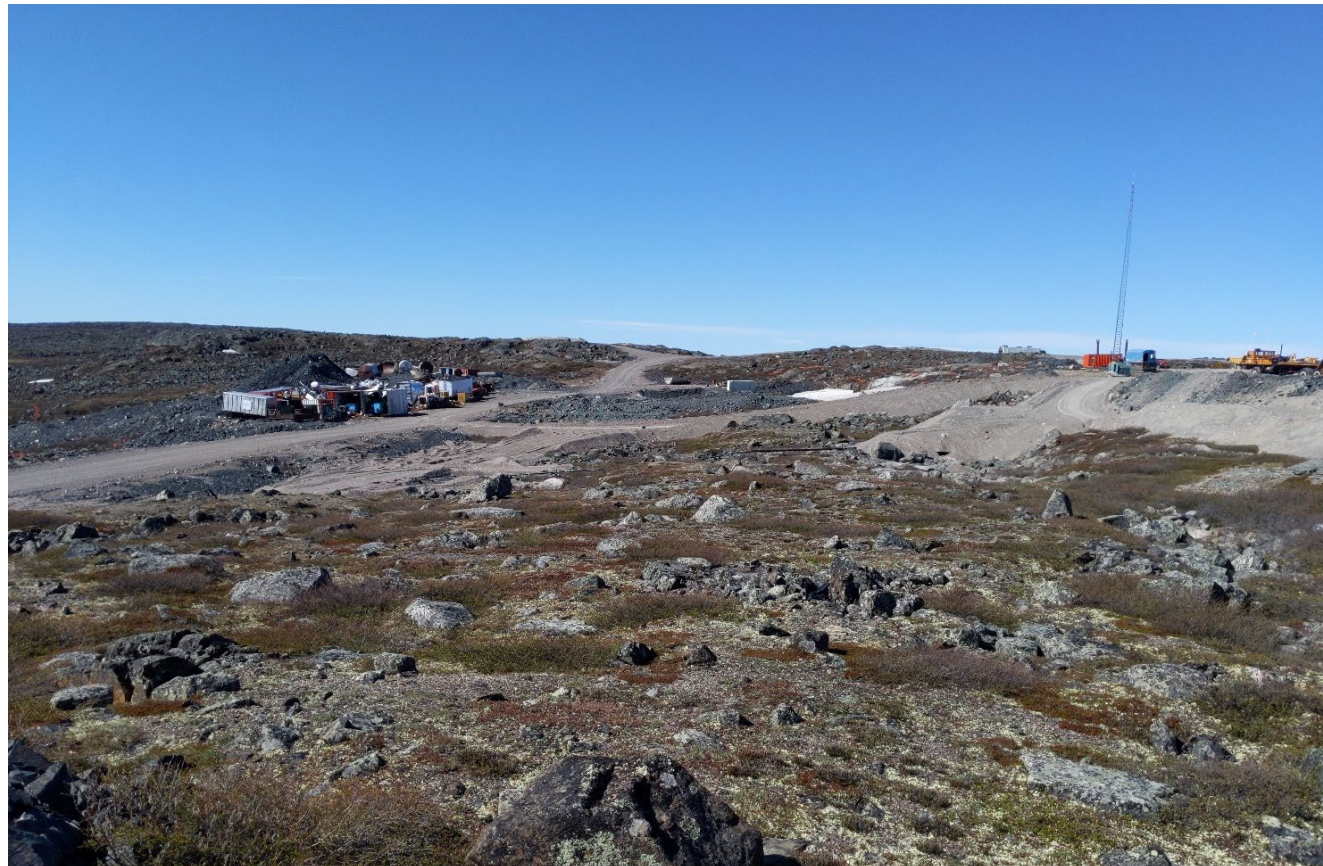
The east side of the site facing west as of June 25, 2021

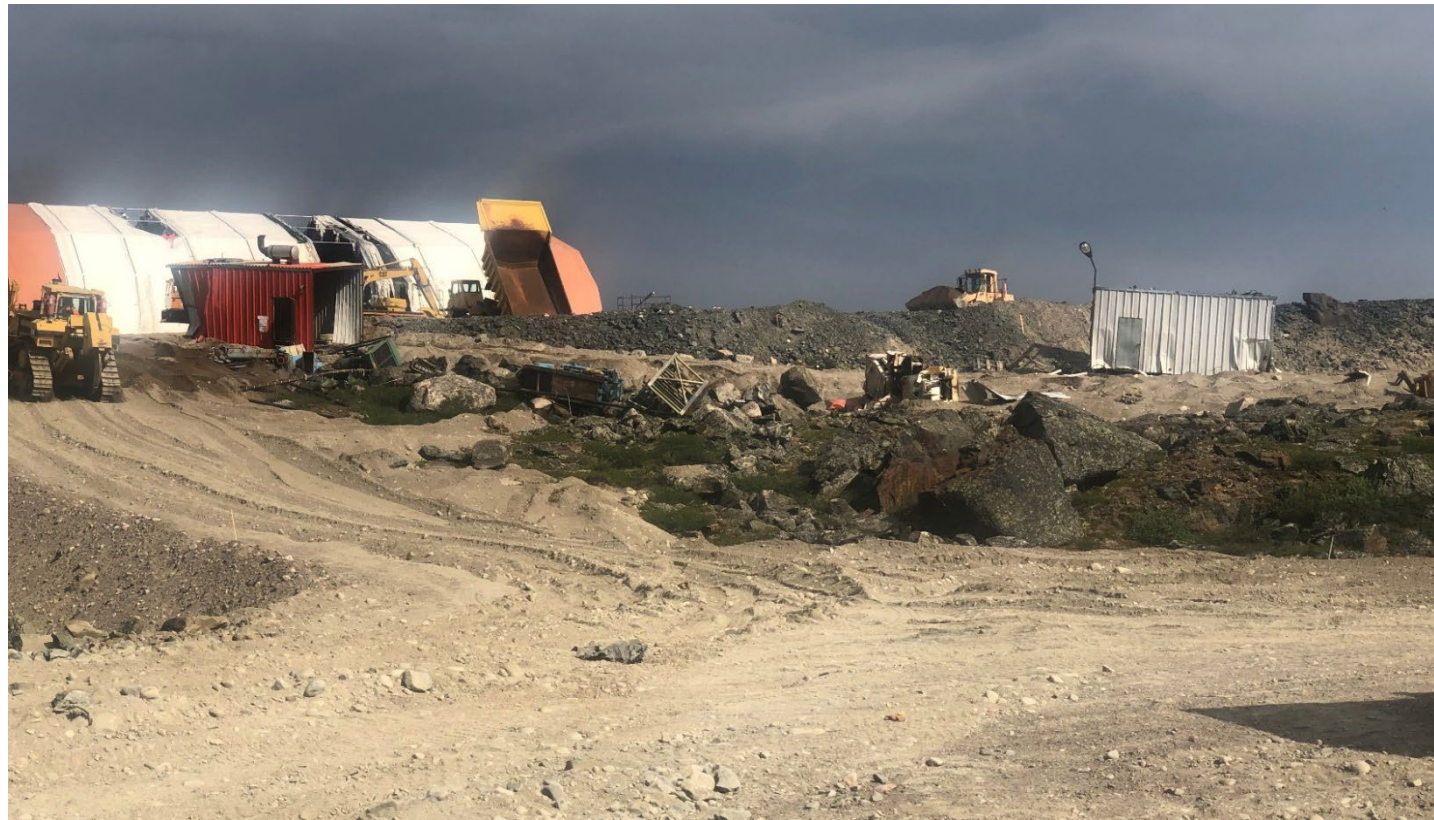
The south side of the site facing north on July 7, 2021

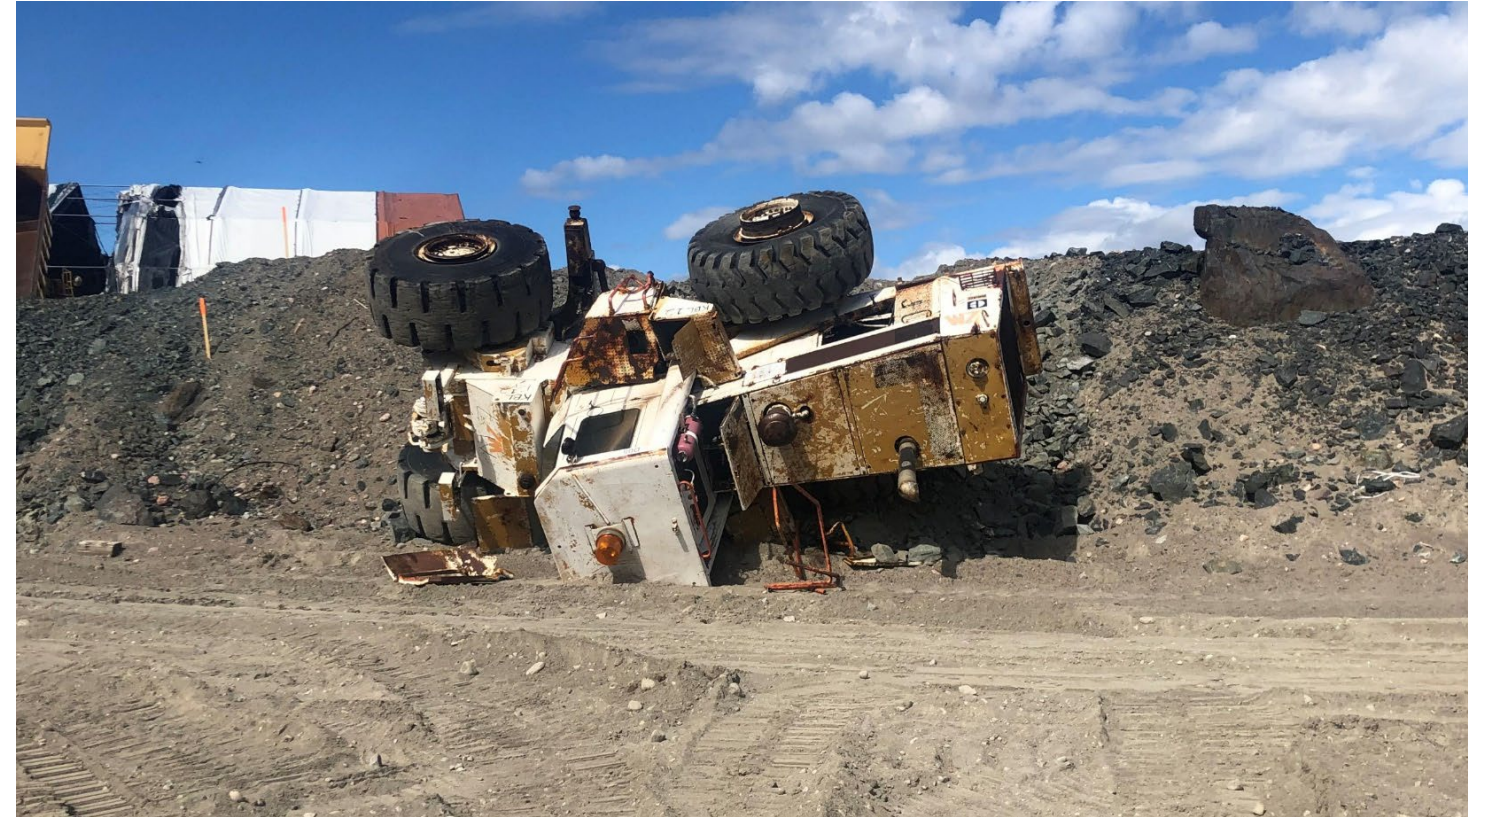
Equipment placement prior to cutting on July 7, 2021

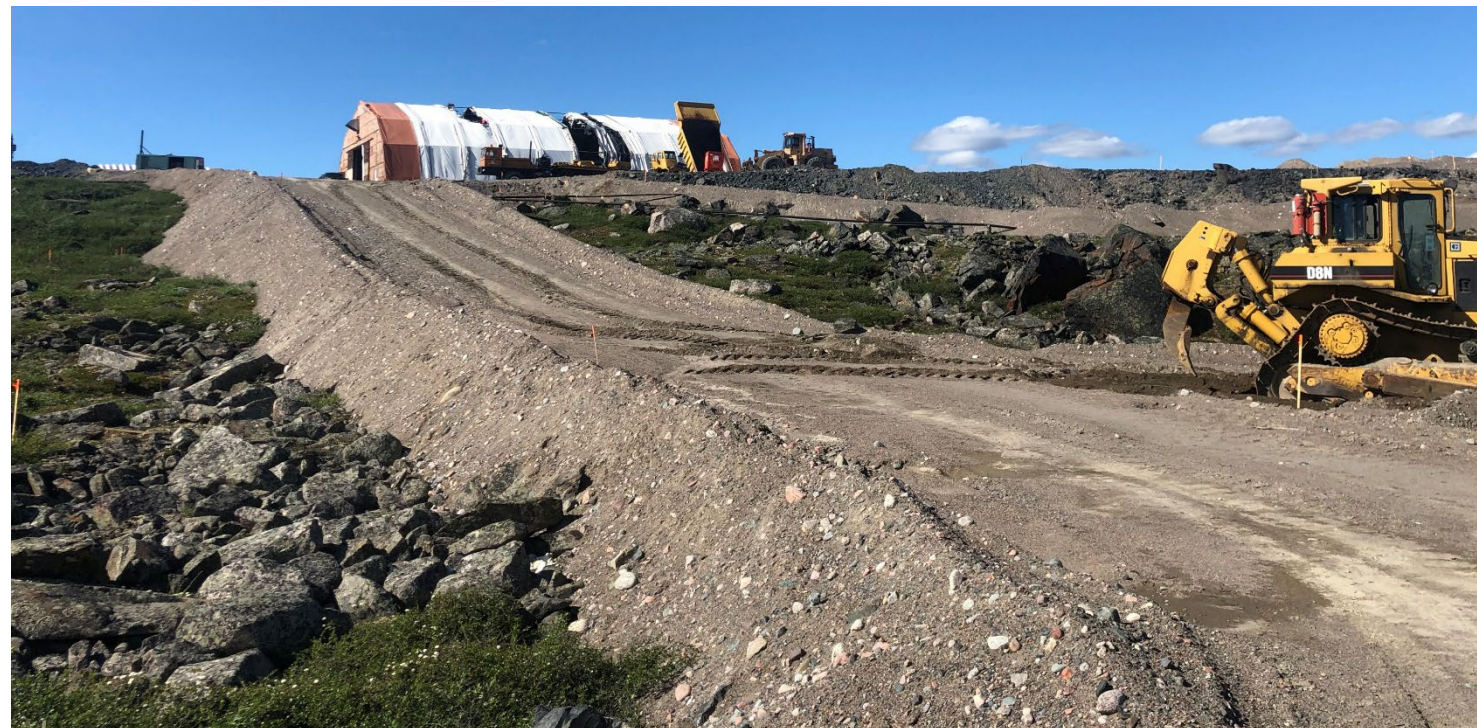
A new access road under construction on July 7, 2021

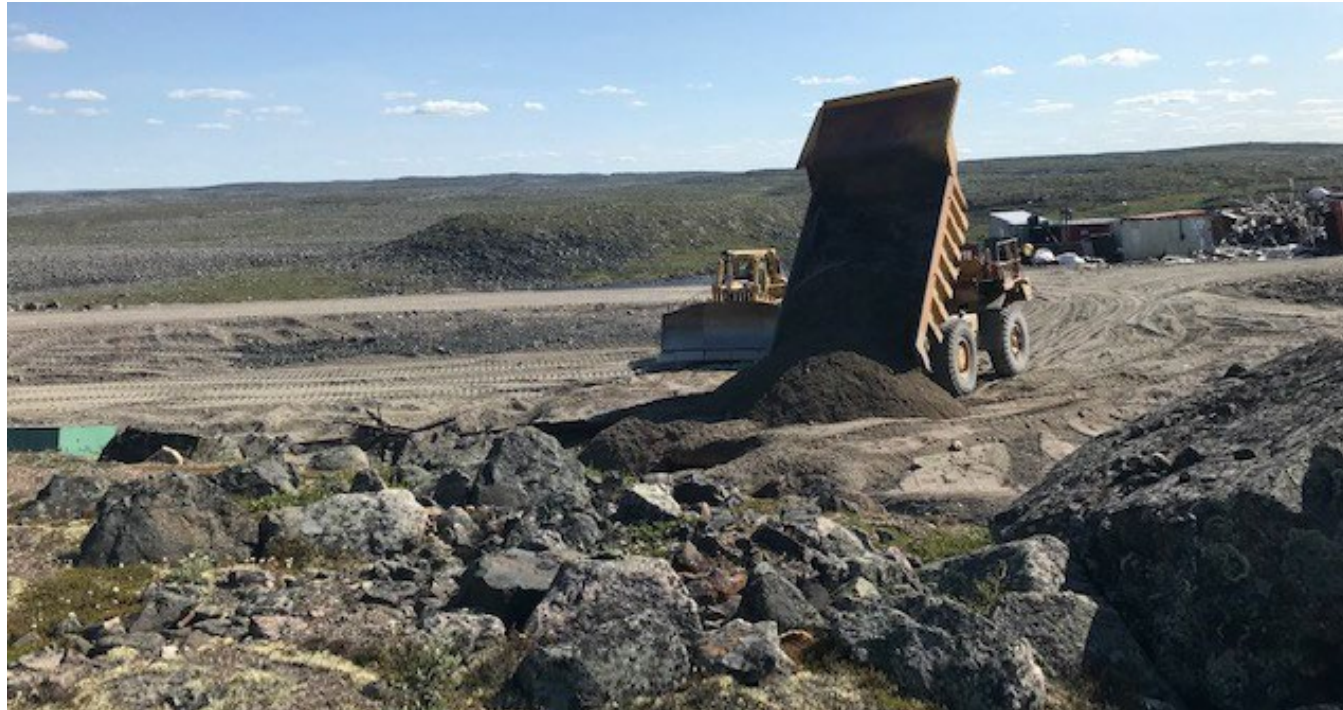
Esker sand used for access and foundation leveling on July 15, 2021

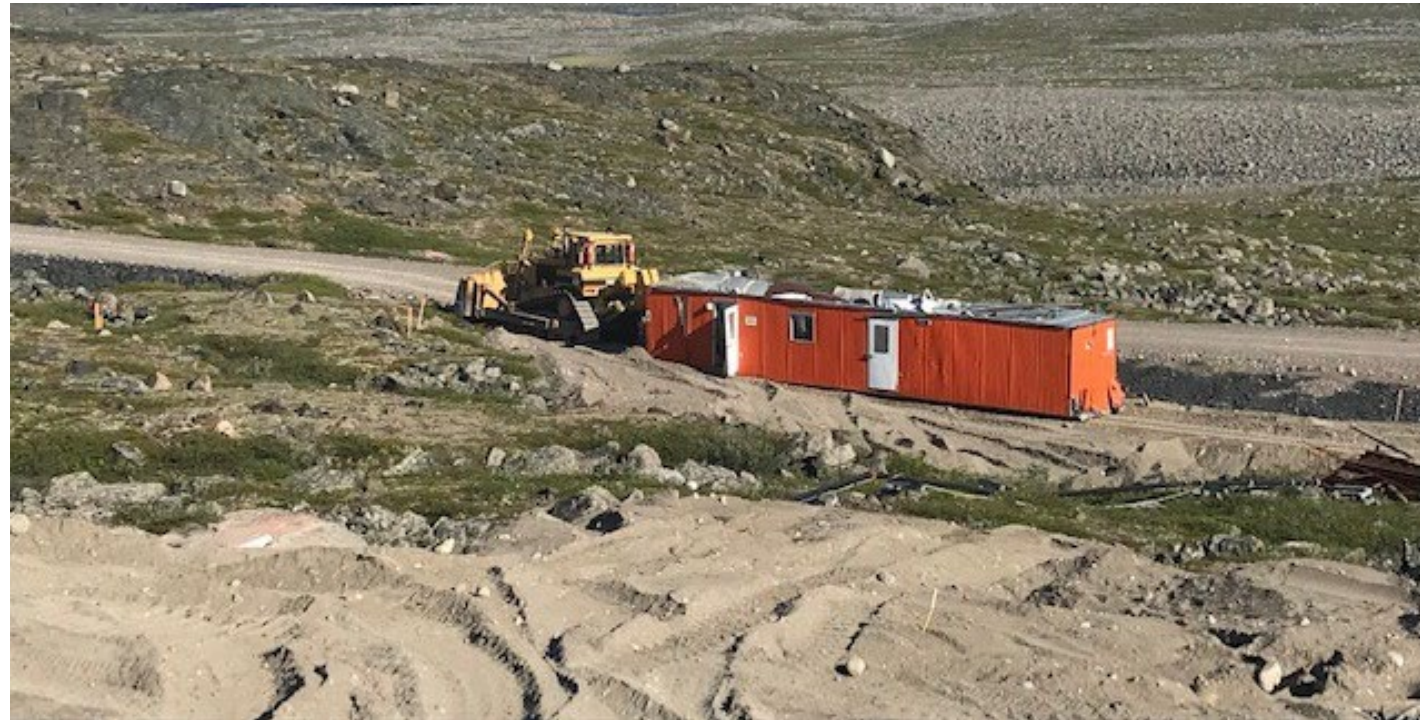
Disassembly of Bunkhouses on July 19, 2021

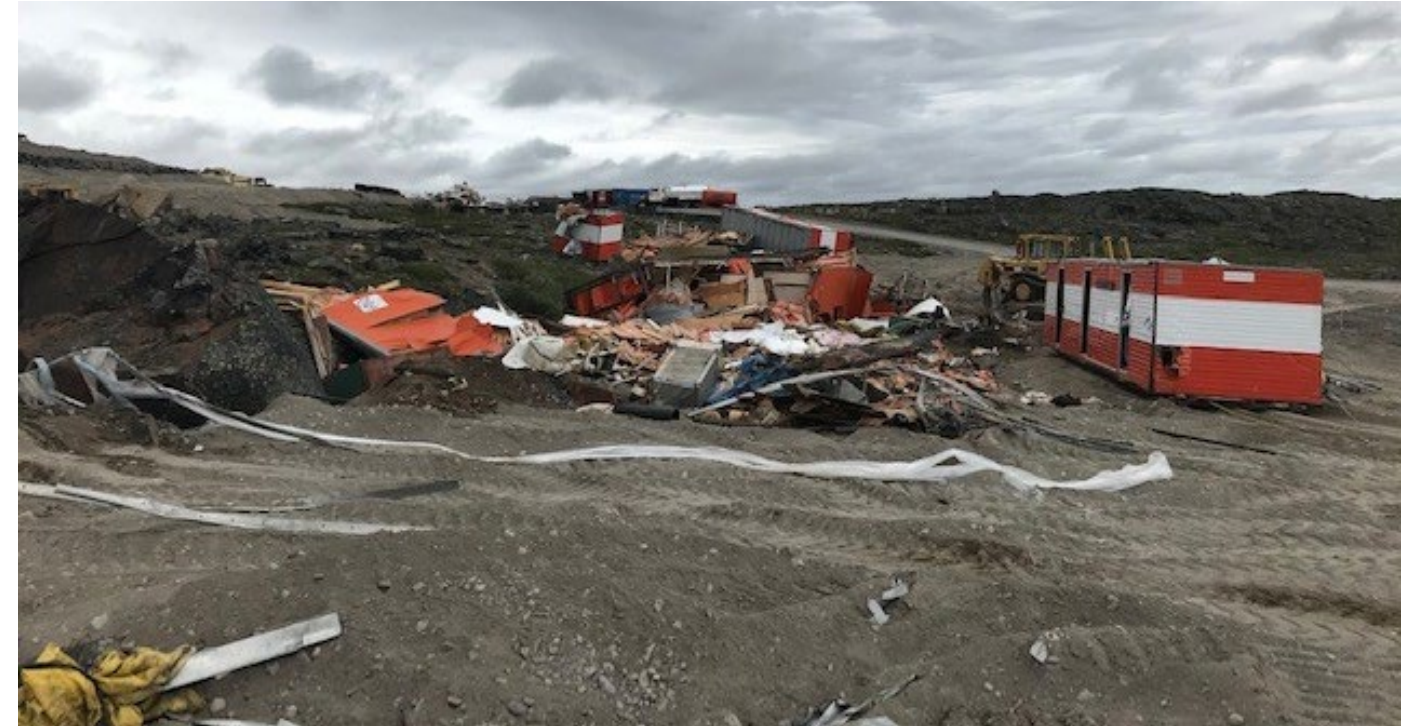
Continued bunkhouse placement and disassembly on July 19, 2021

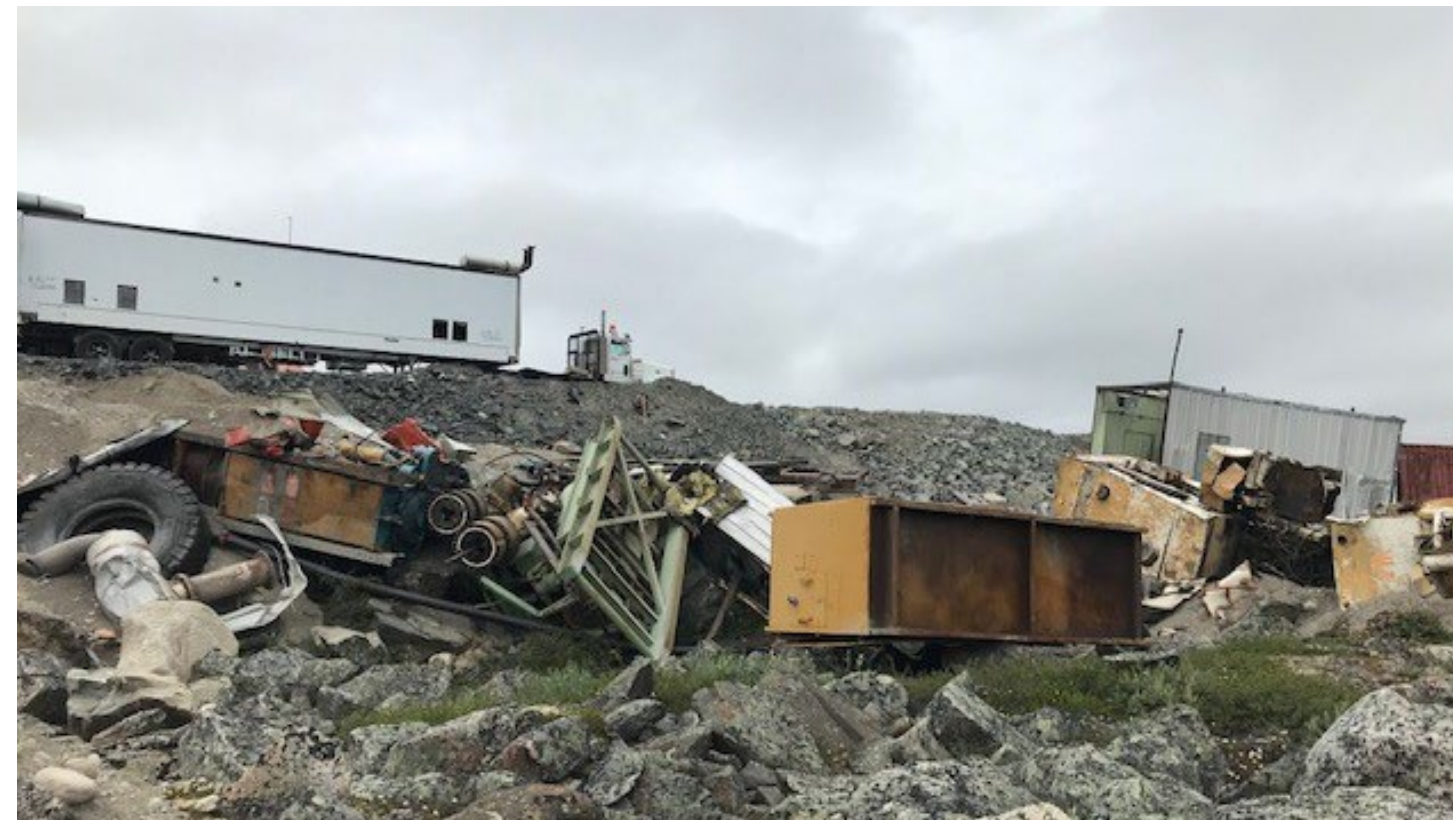
The south side of the site facing north on July 19, 2021

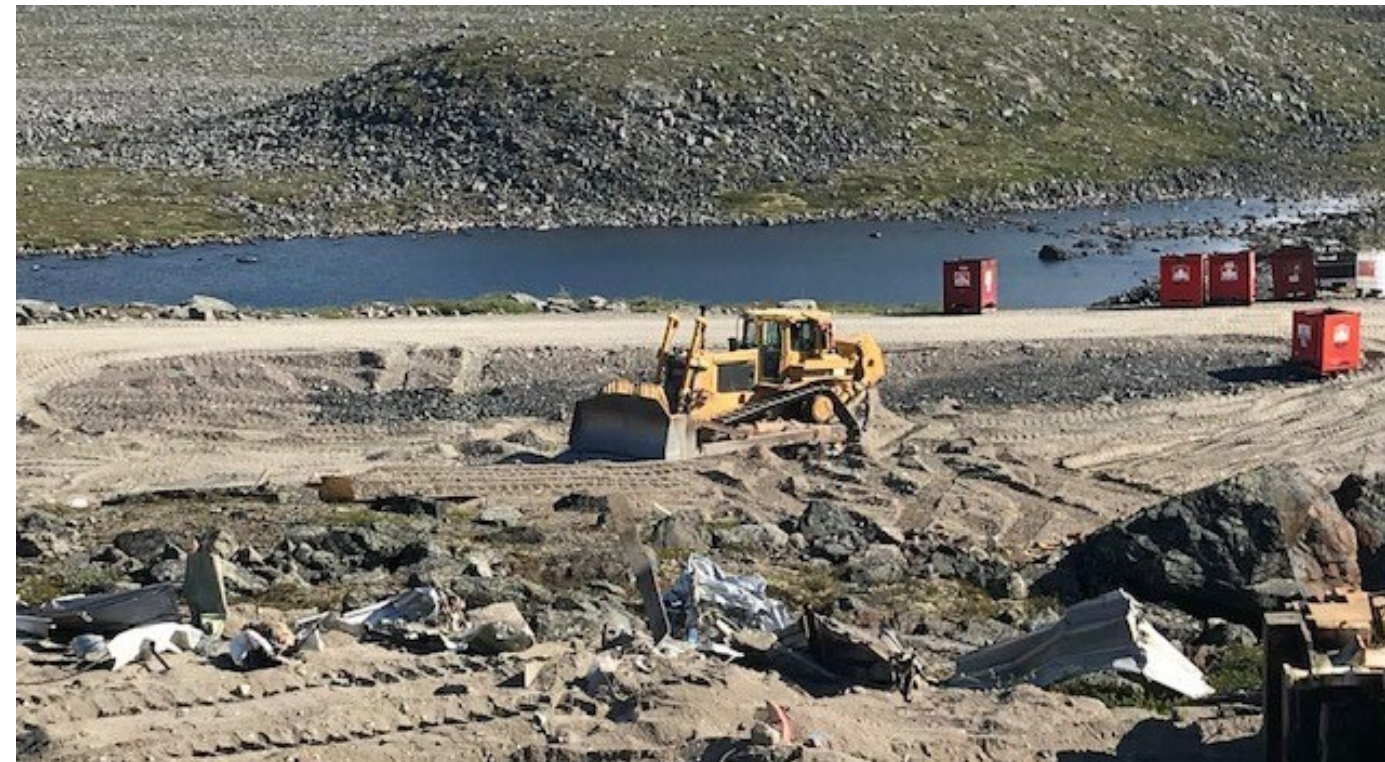
Esker sand placed over bunkhouses on July 21, 2021

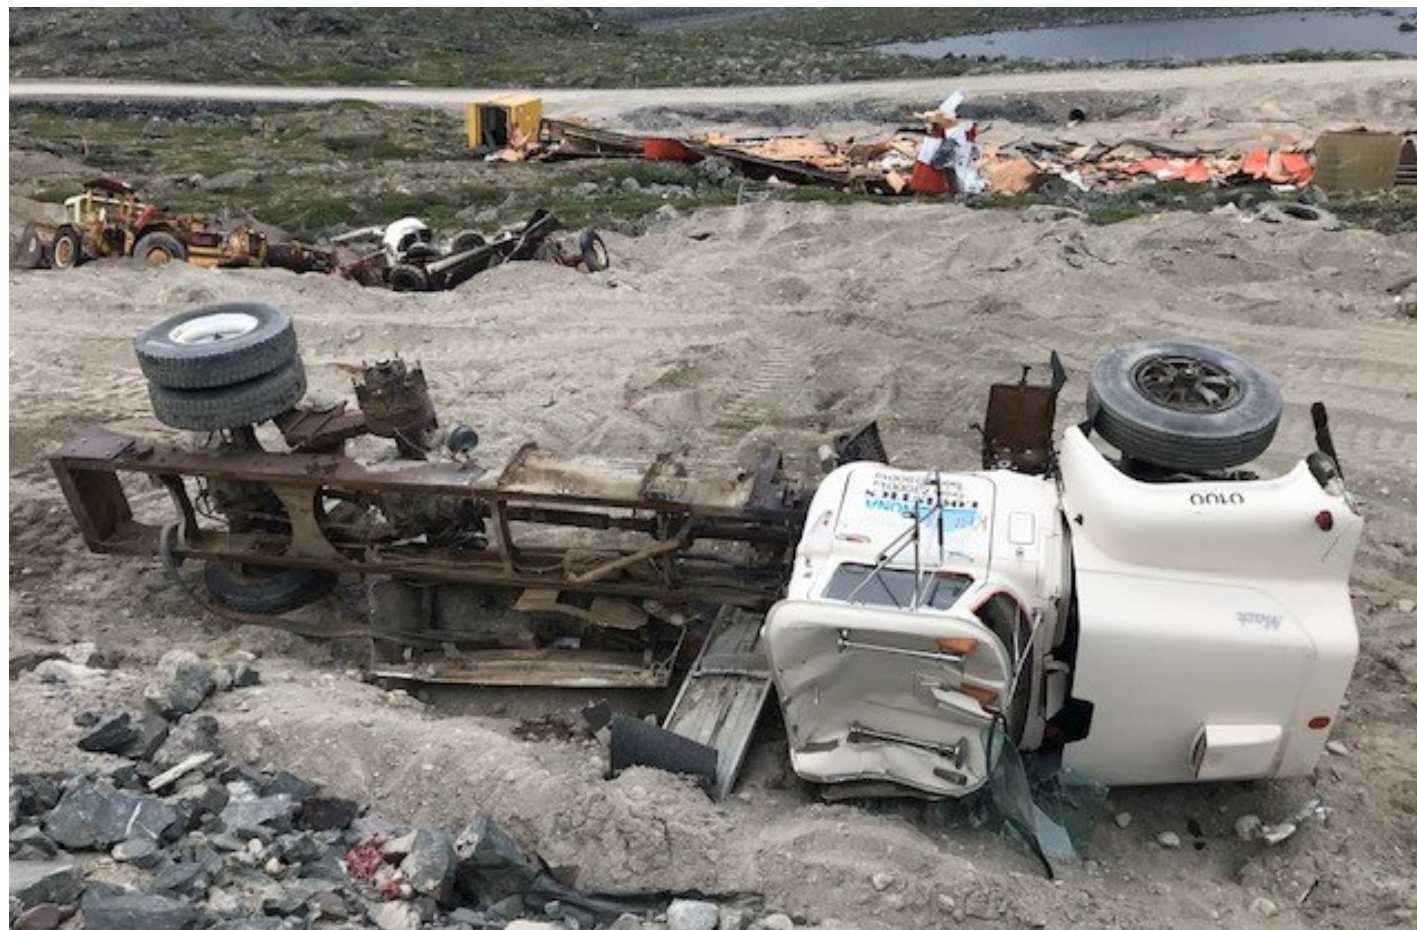
Fuel truck dismantling progress as of July 22, 2021

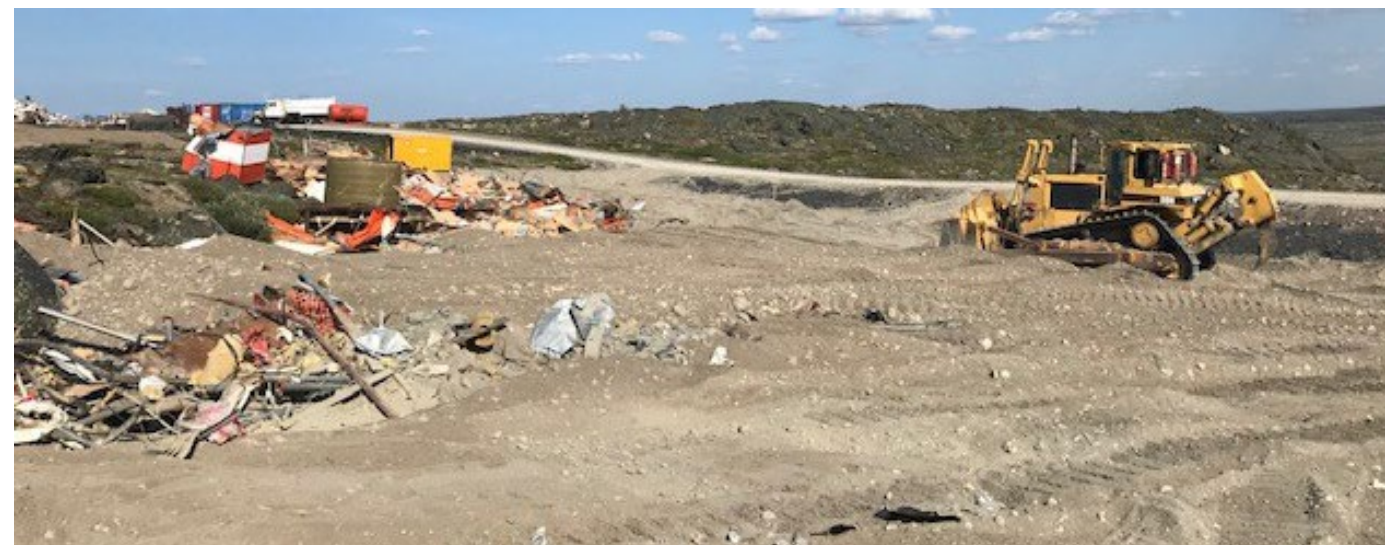
Esker sand placed over bunkhouses on July 21, 2021

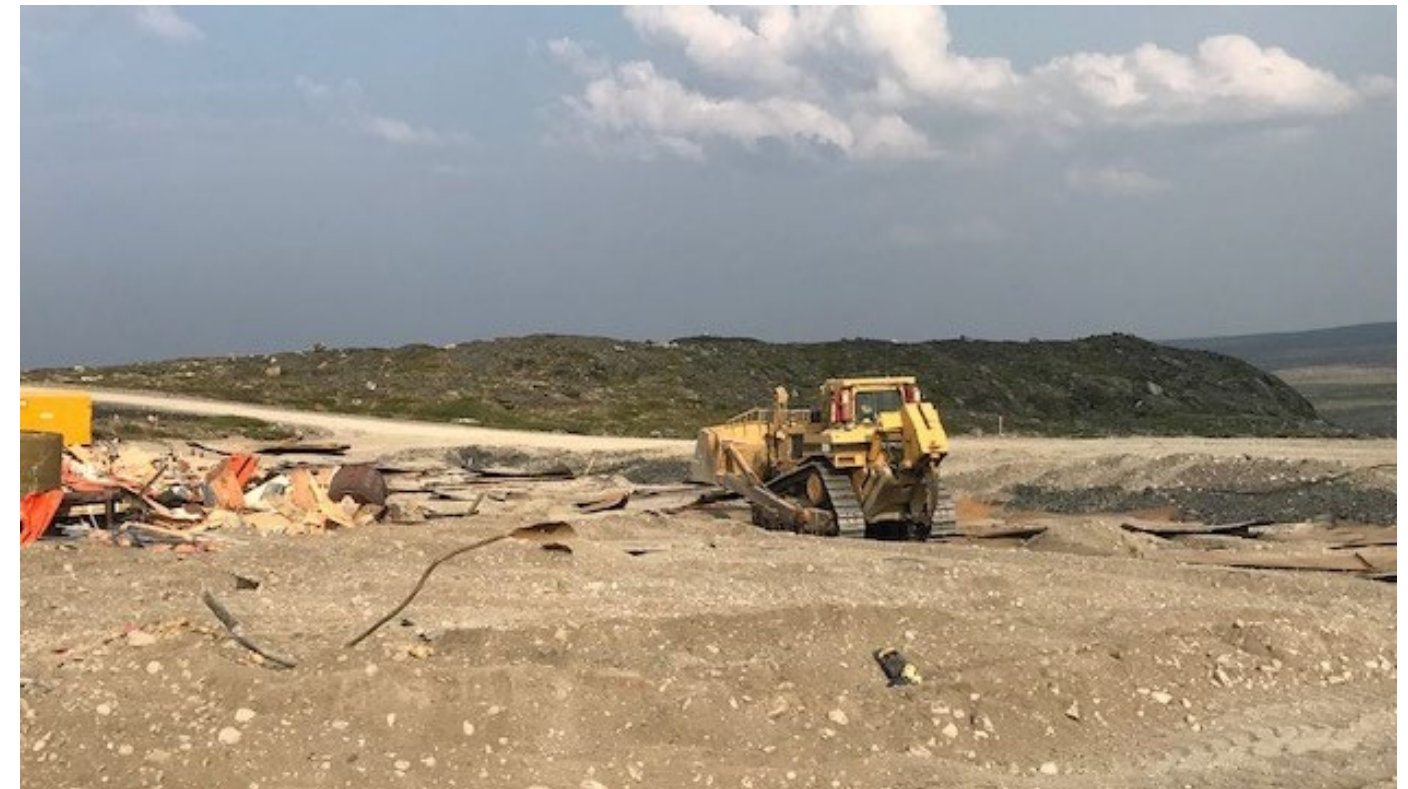
Bulldozer placing steel in the landfill. July 22, 2021

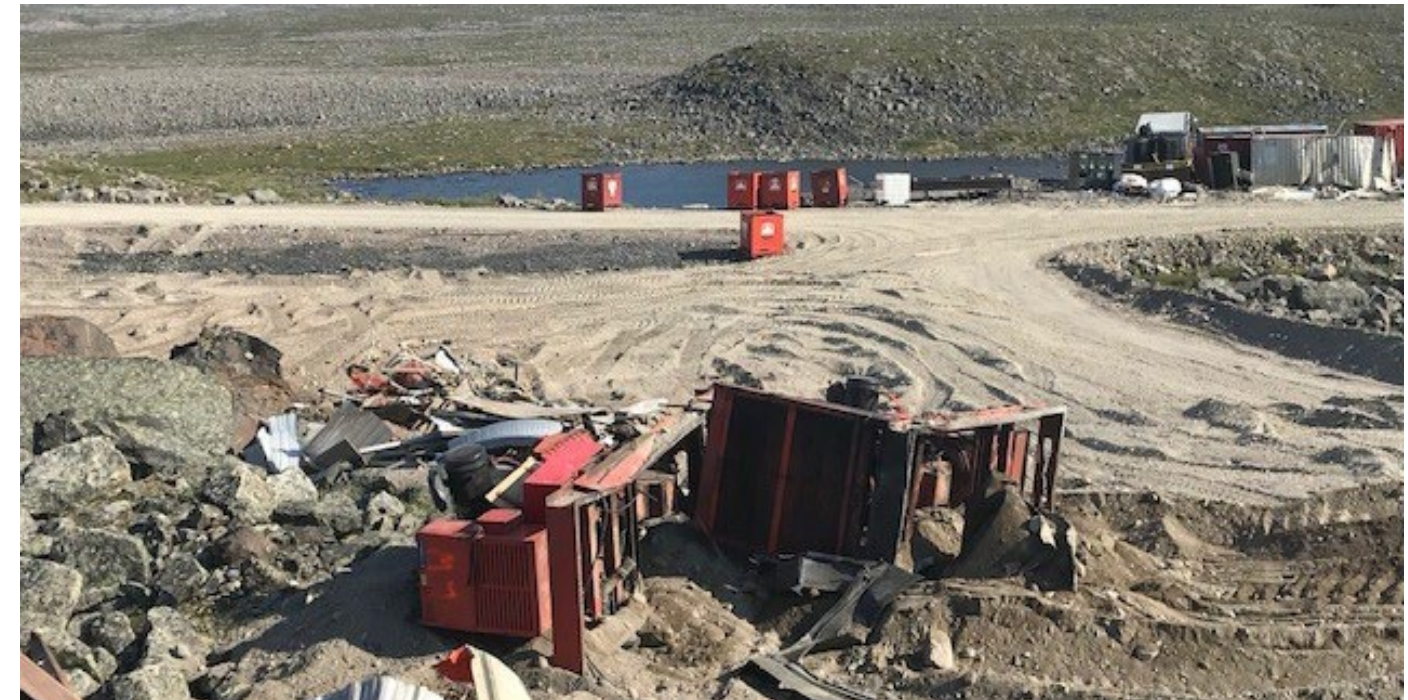
A generator placed in the landfill. July 21, 2021

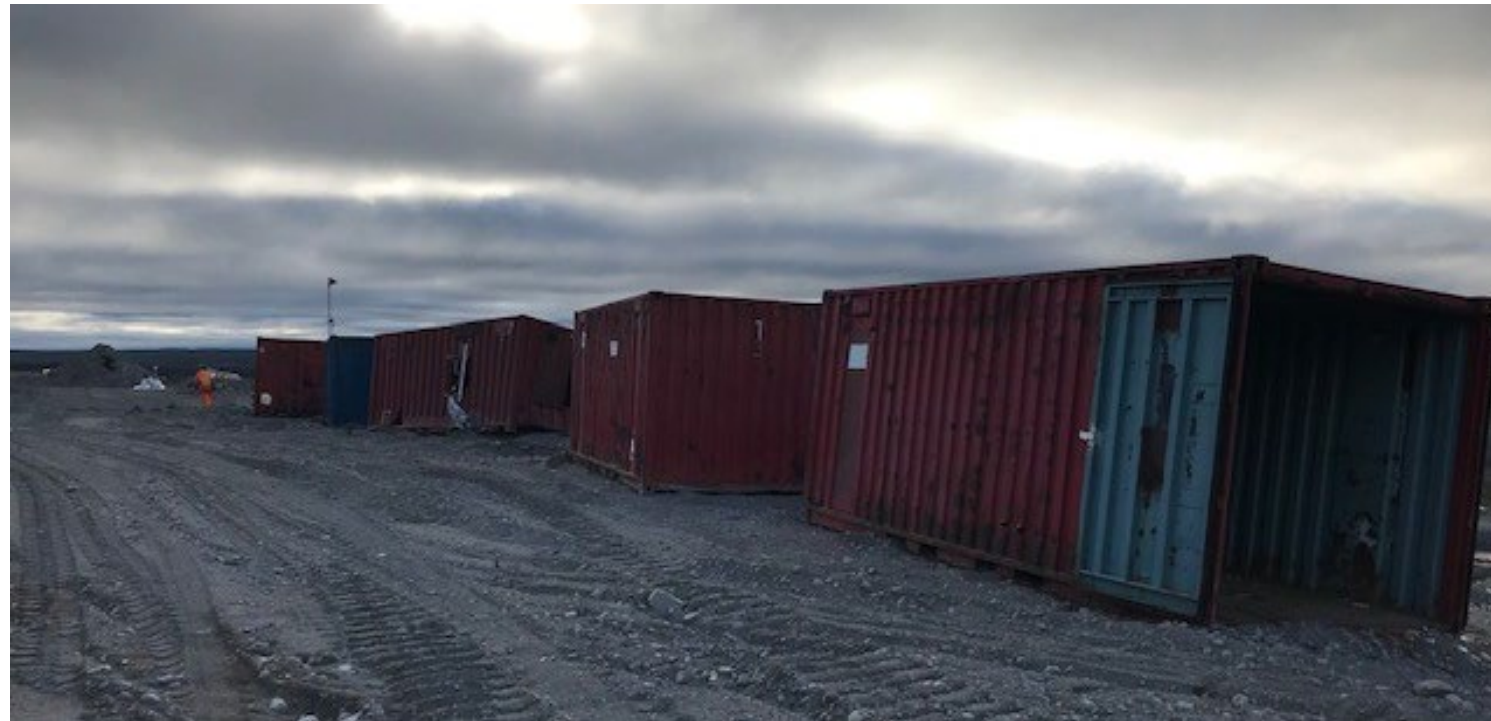
The south side of the site facing north – staging shipping containers on July 23, 2021

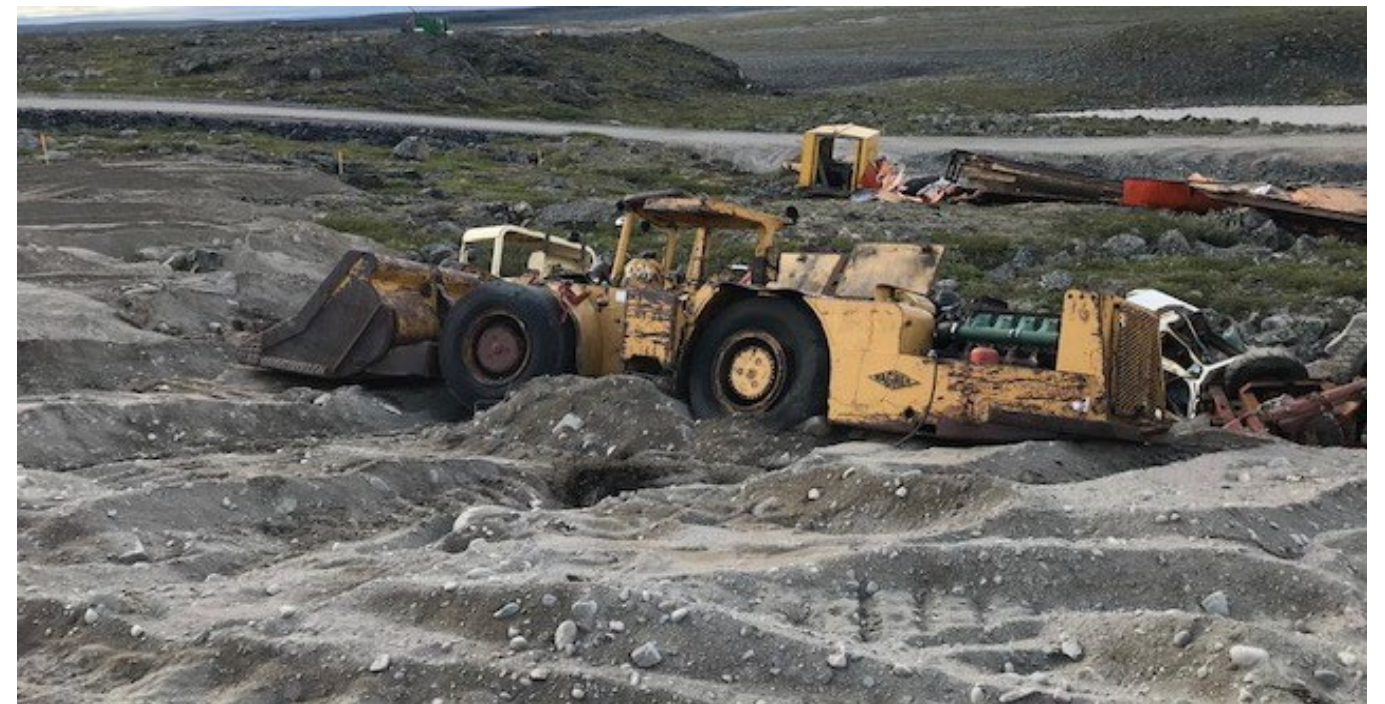
Underground equipment placement. July 23, 2021

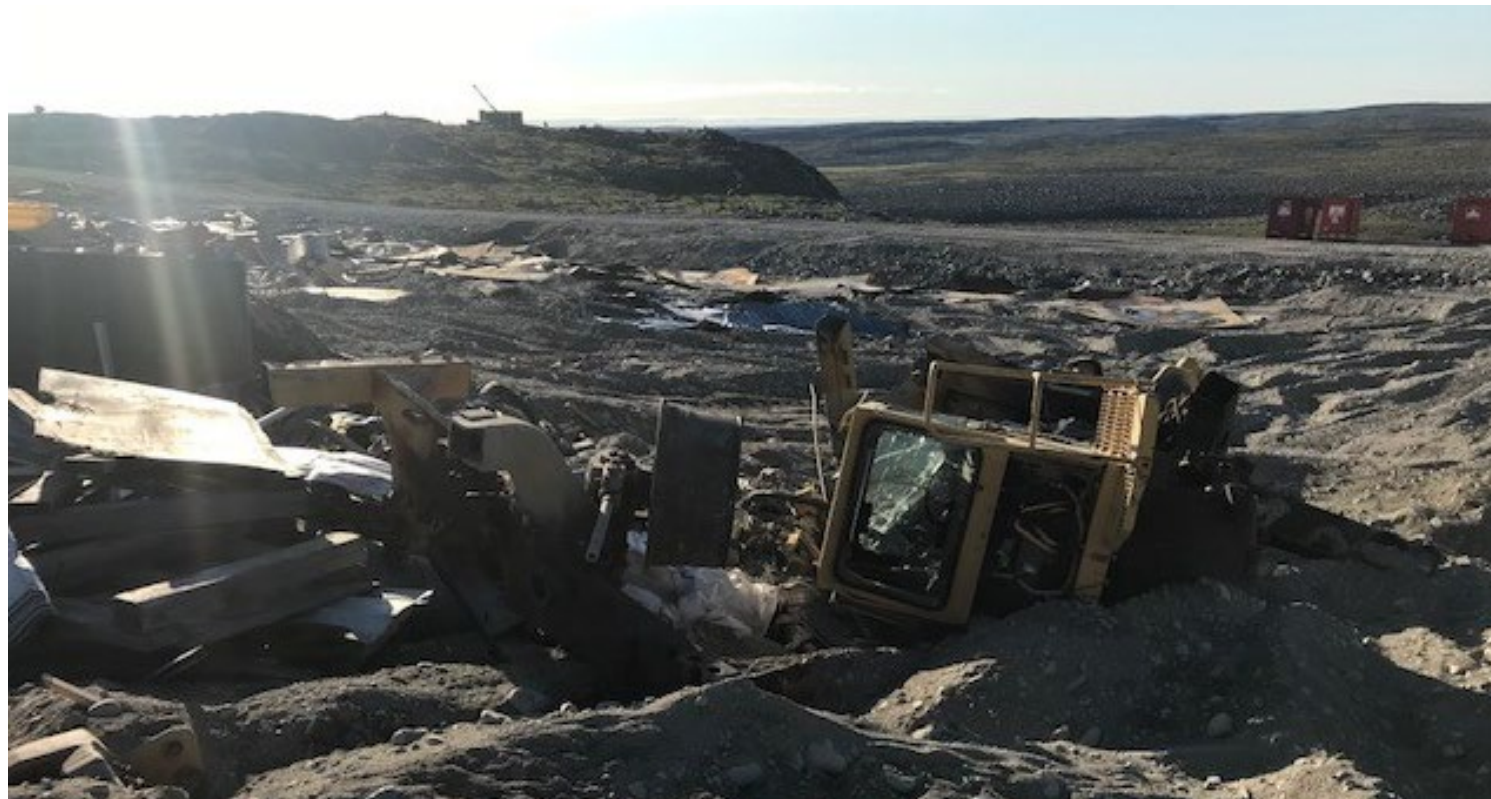
Surface haul truck placed. July 24, 2021

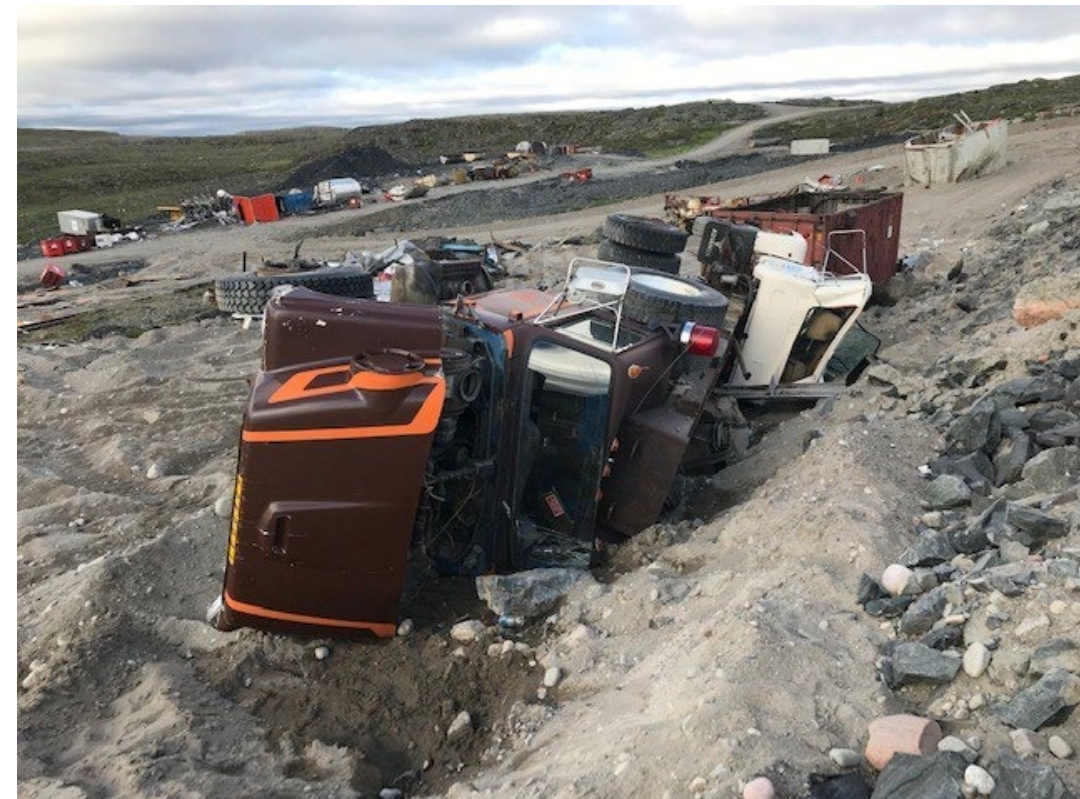
The north side of the site facing southwest on July 23, 2021

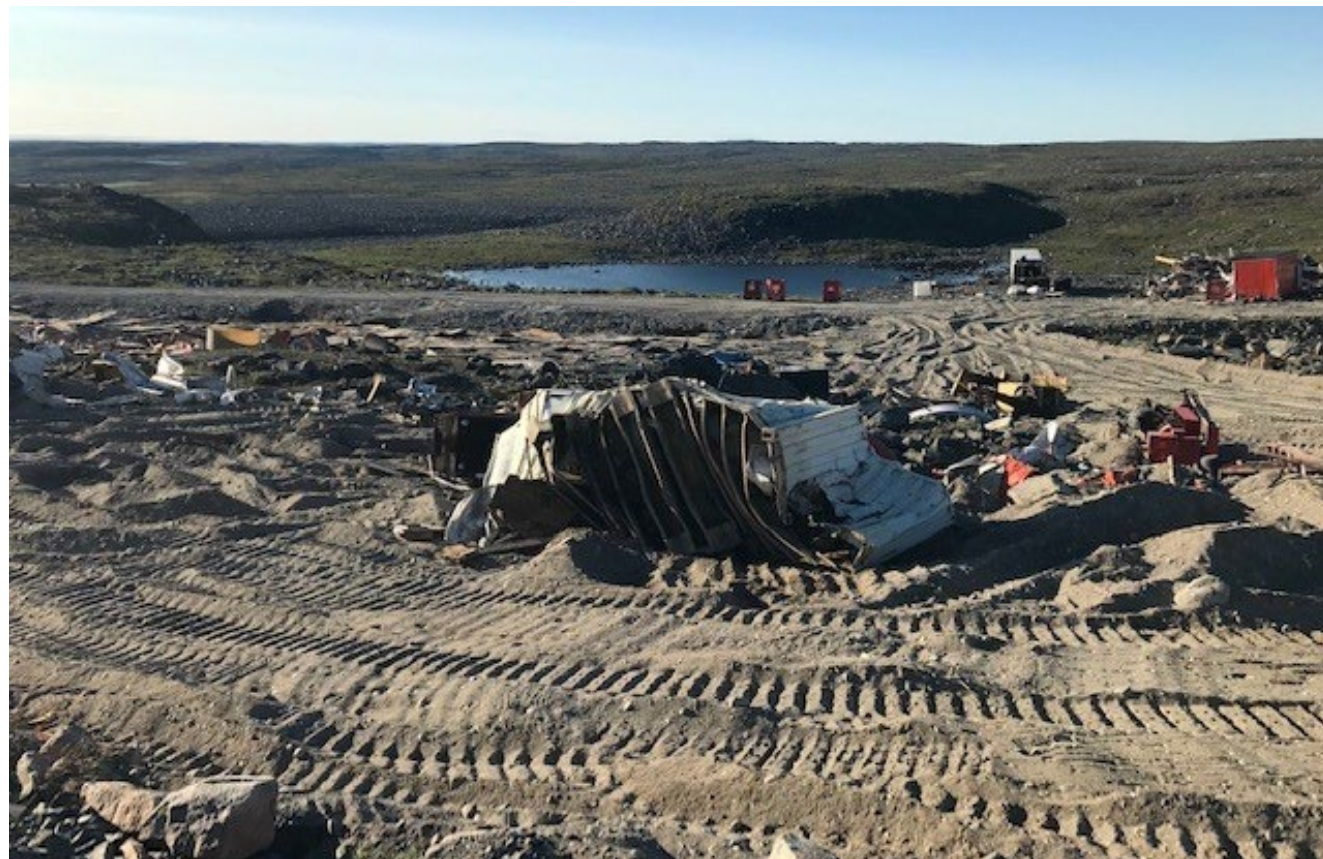
Seacan filled and compacted in landfill on July 24, 2021

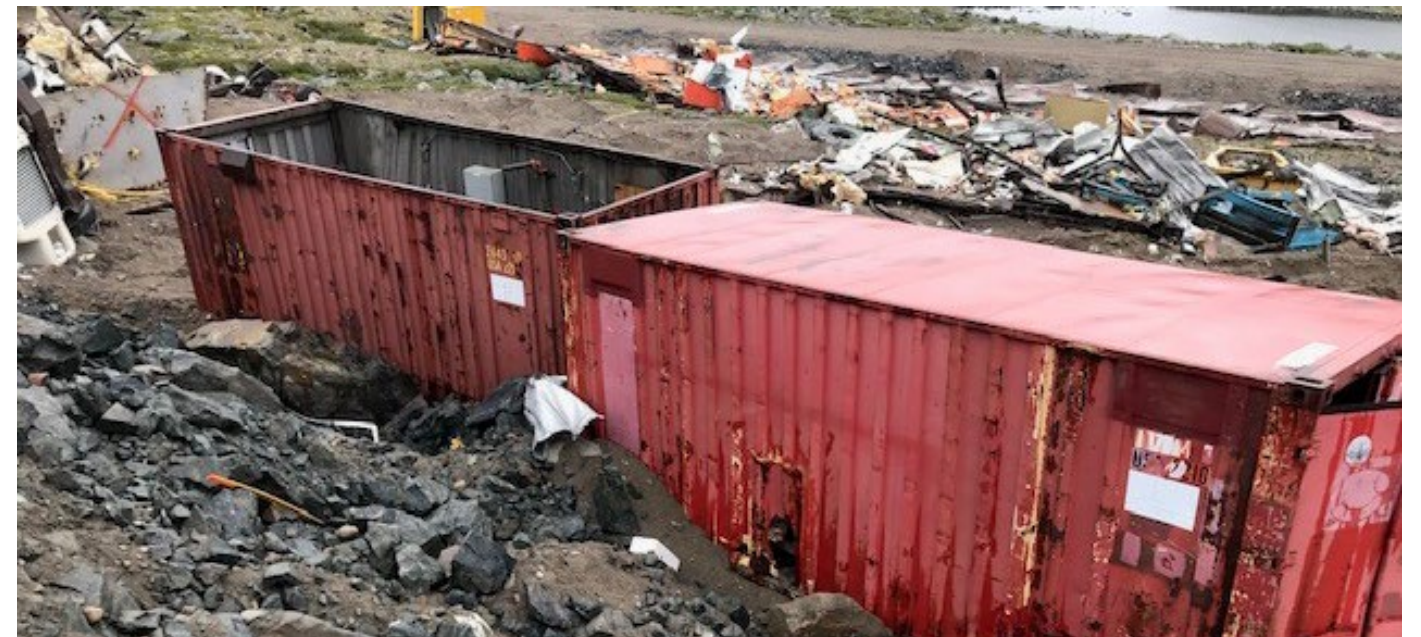
Shipping containers placed. July 25, 2021

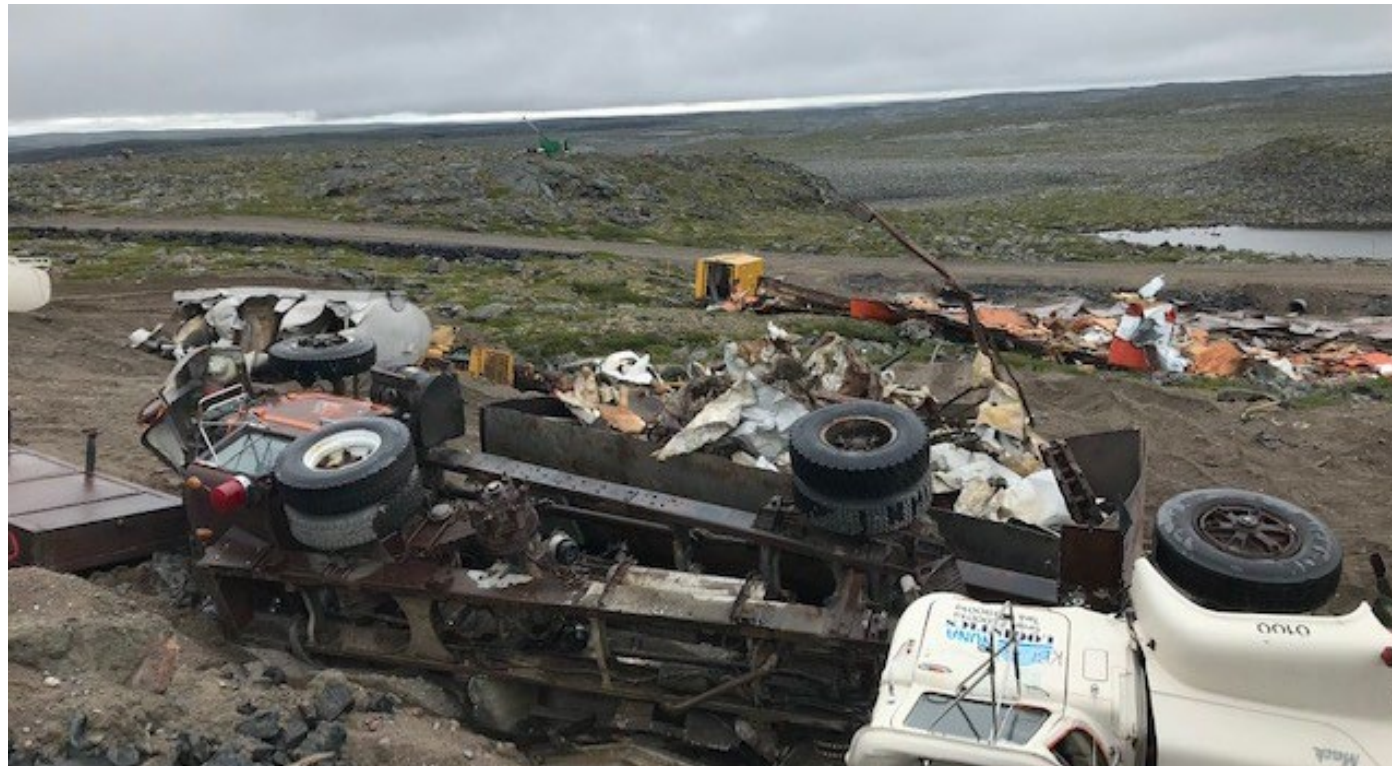
Tanks filled with waste were placed next to trucks. July 25, 2021

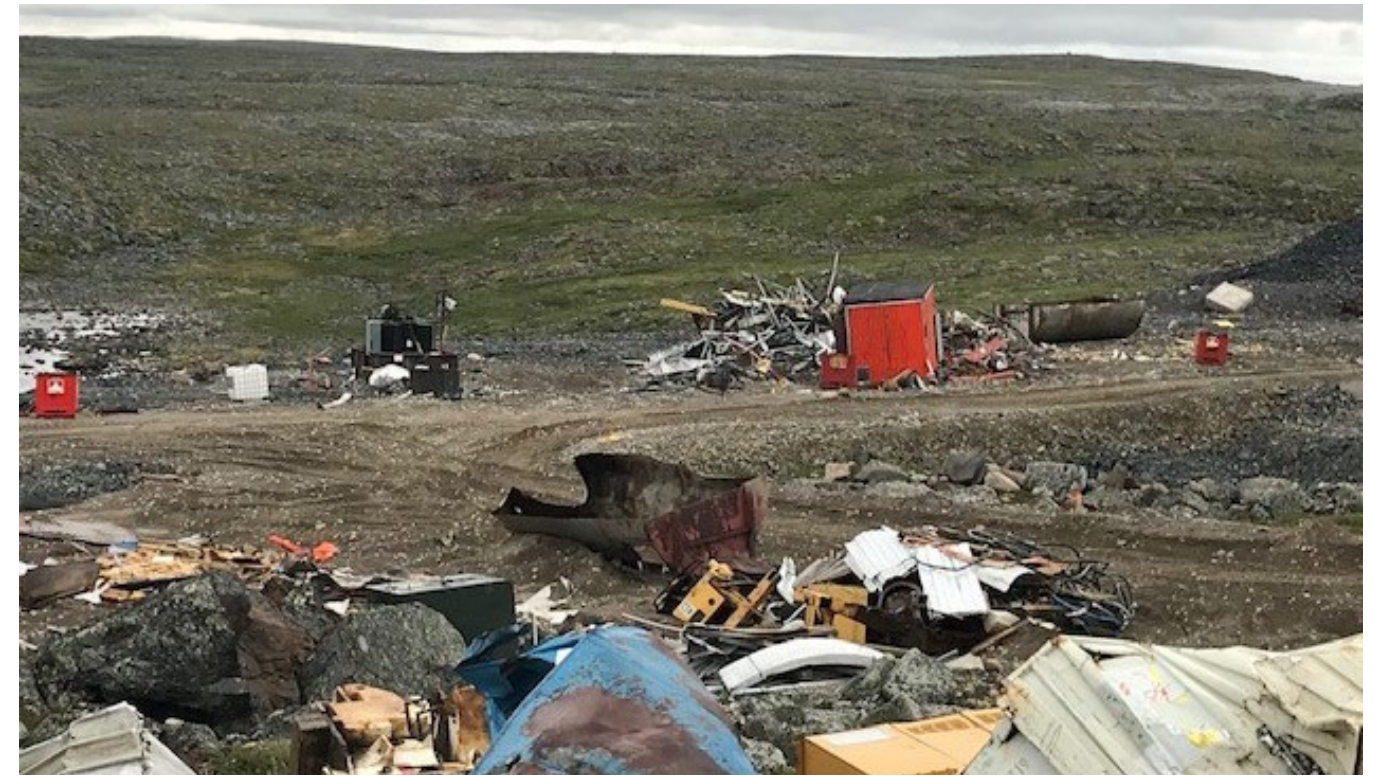
Tanks filled with waste were placed next to trucks. July 25, 2021
