Non-Hazardous Landfill, Construction Report, Ulu Gold Project Interim Report Draft

SRK Consulting (Canada) Inc.
1CB041.000
September 2022

Project No: 1CB041.000

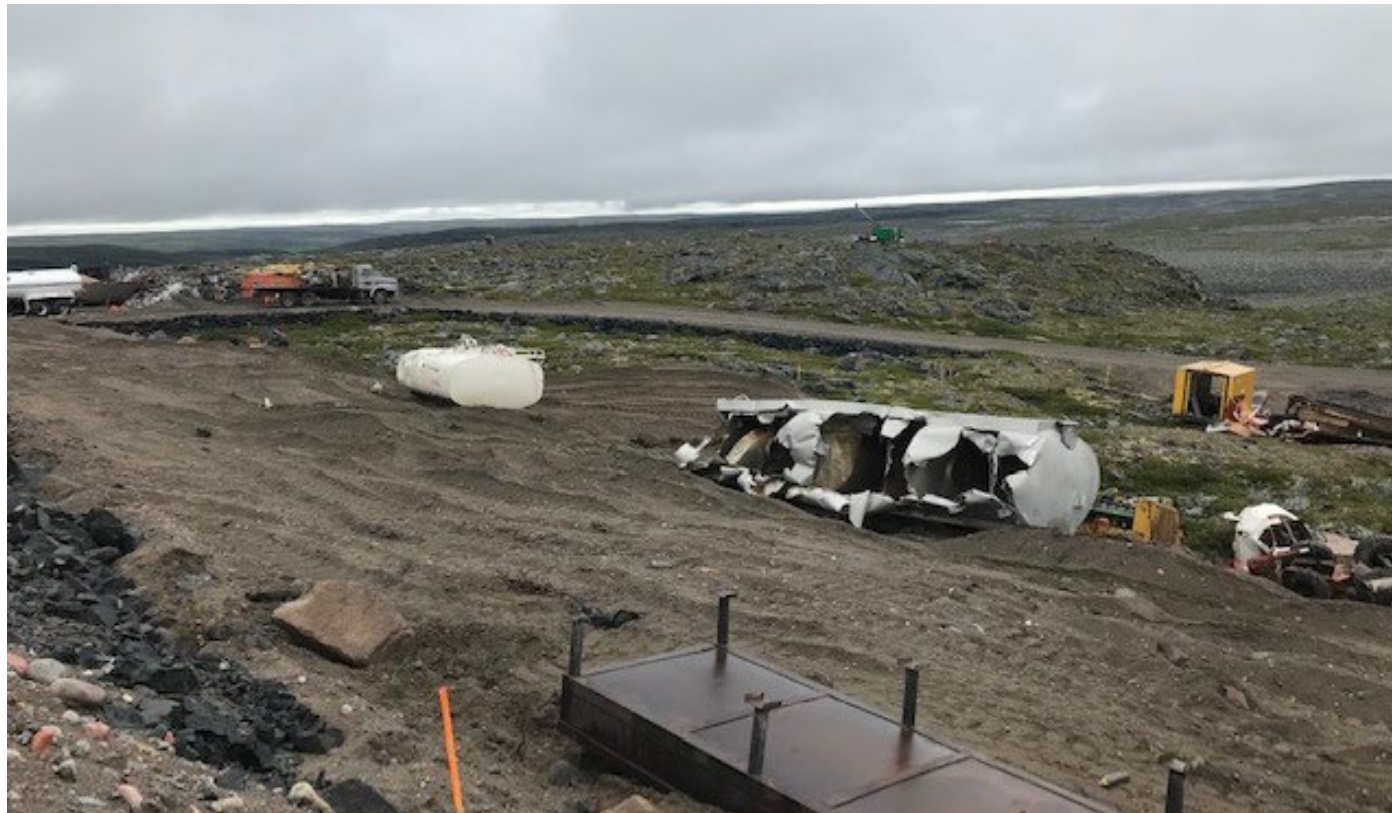
Clean tanks were staged in the landfill for cutting. July 25, 2021

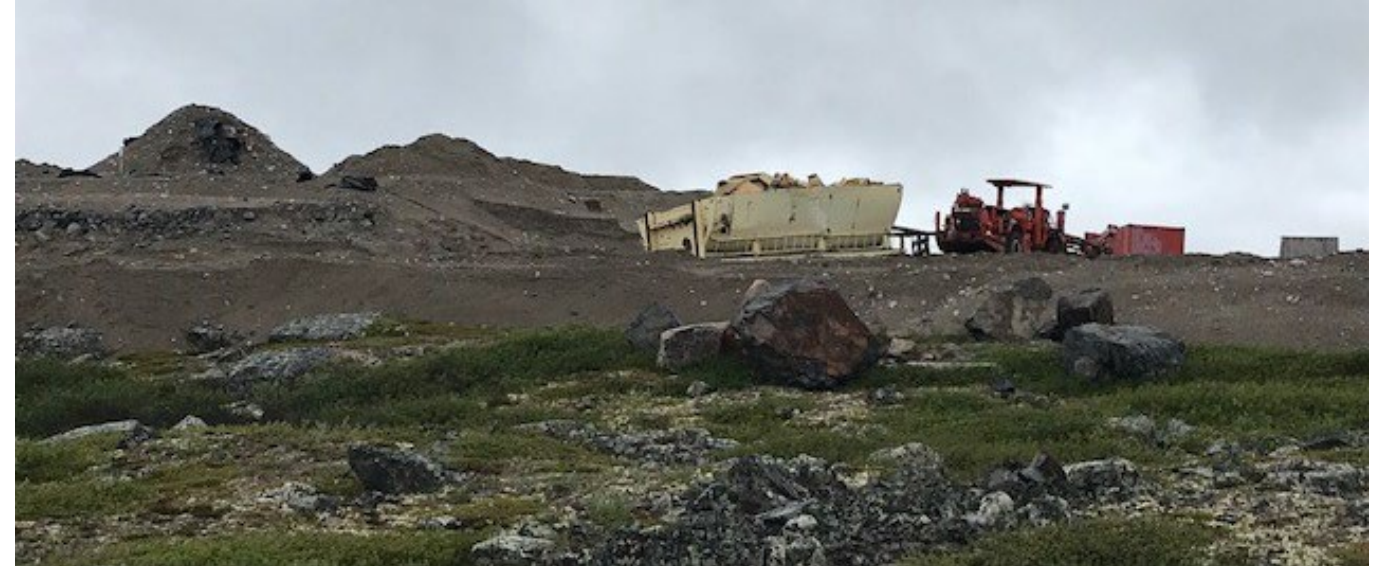
Tanks filled with waste were staged. July 25, 2021

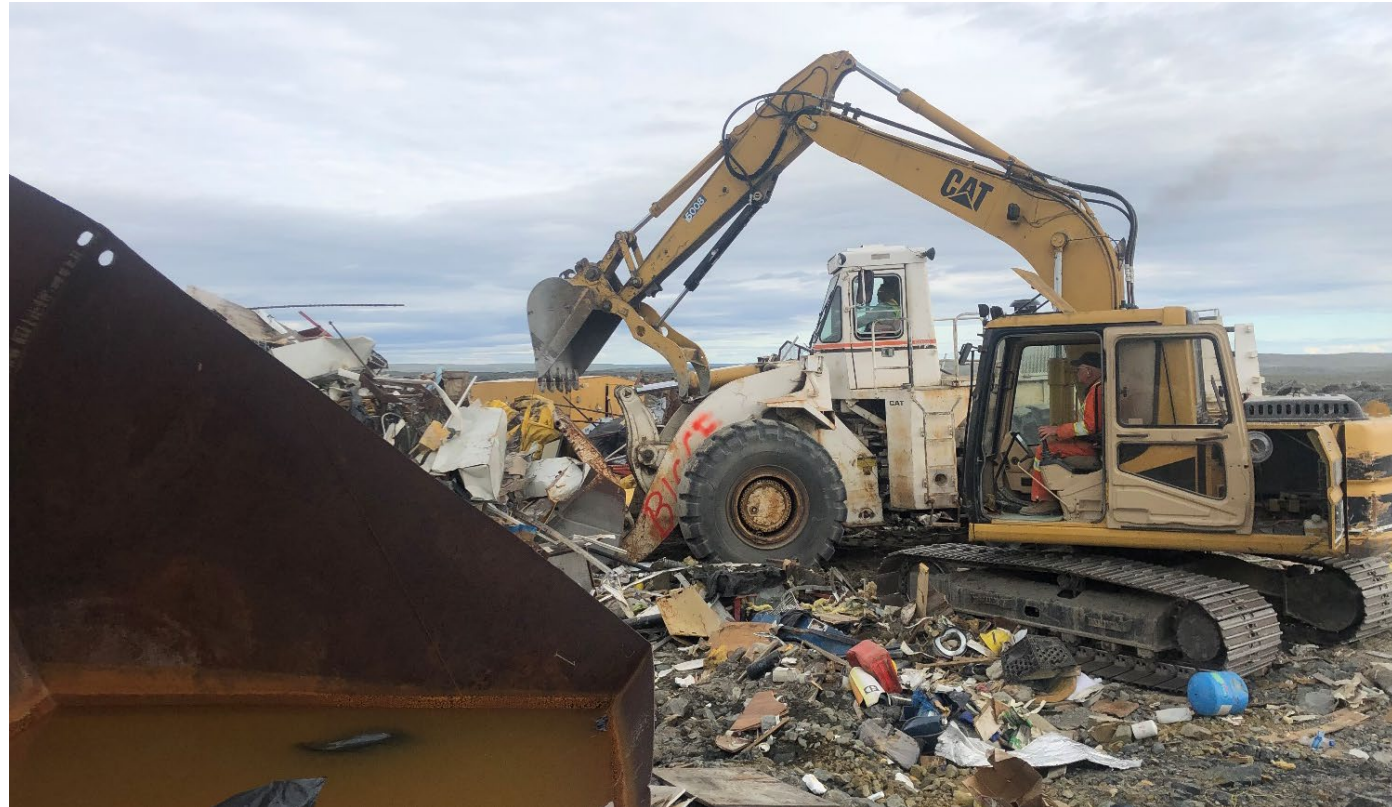
Waste placement and compaction on August 2, 2021

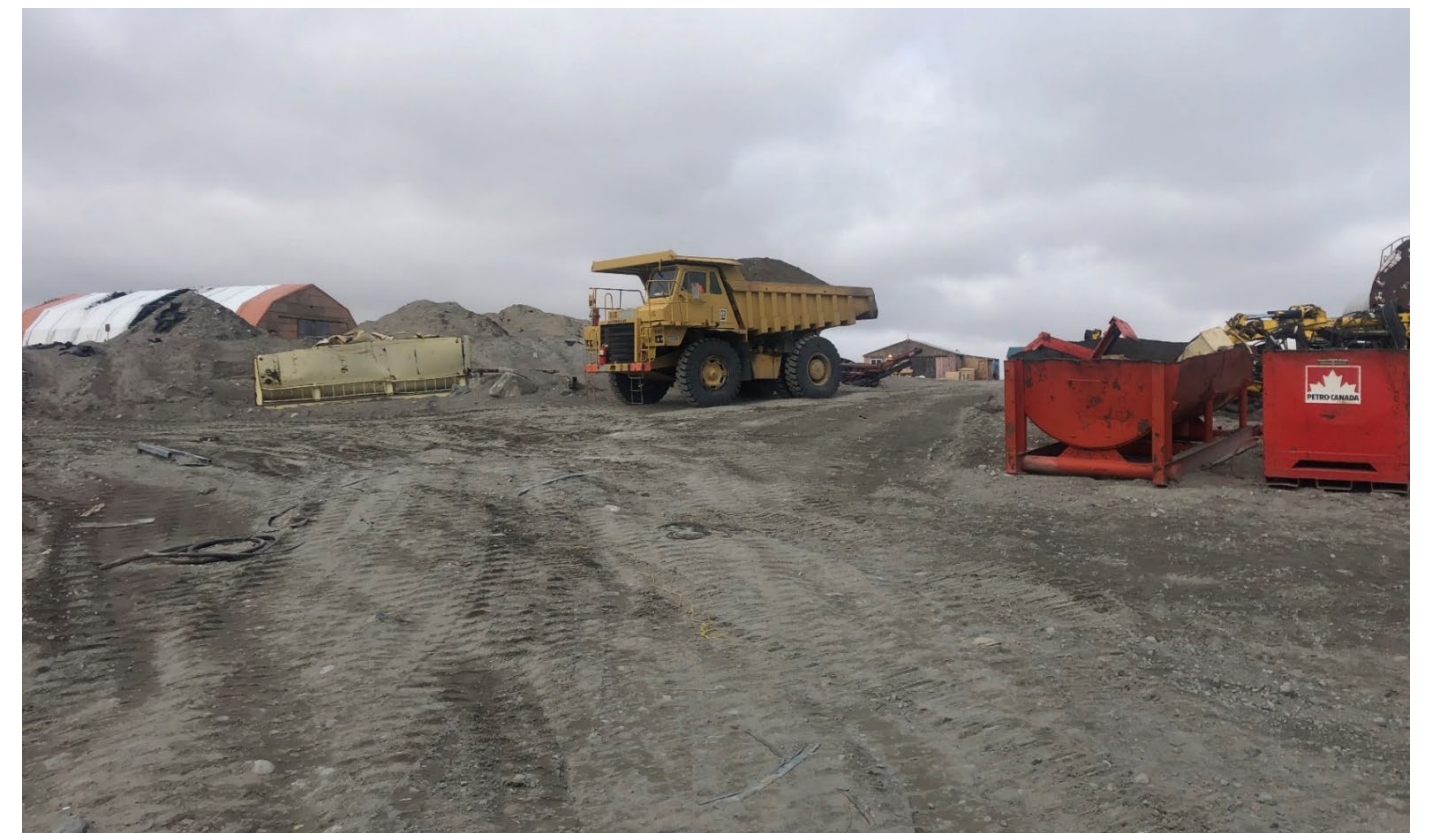
Unloading esker sand on August 3, 2021

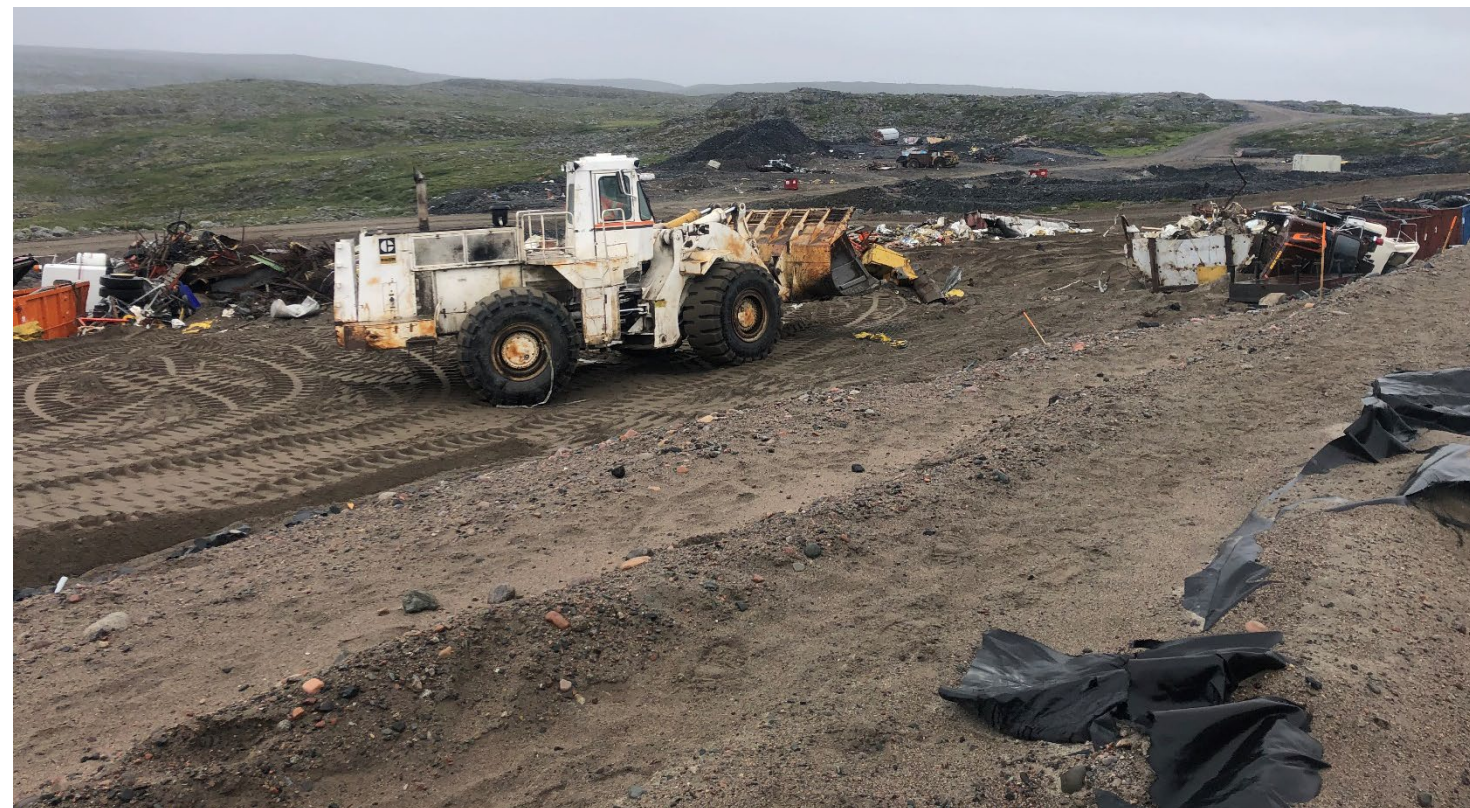
The northeast side of the site facing southwest on August 3, 2021

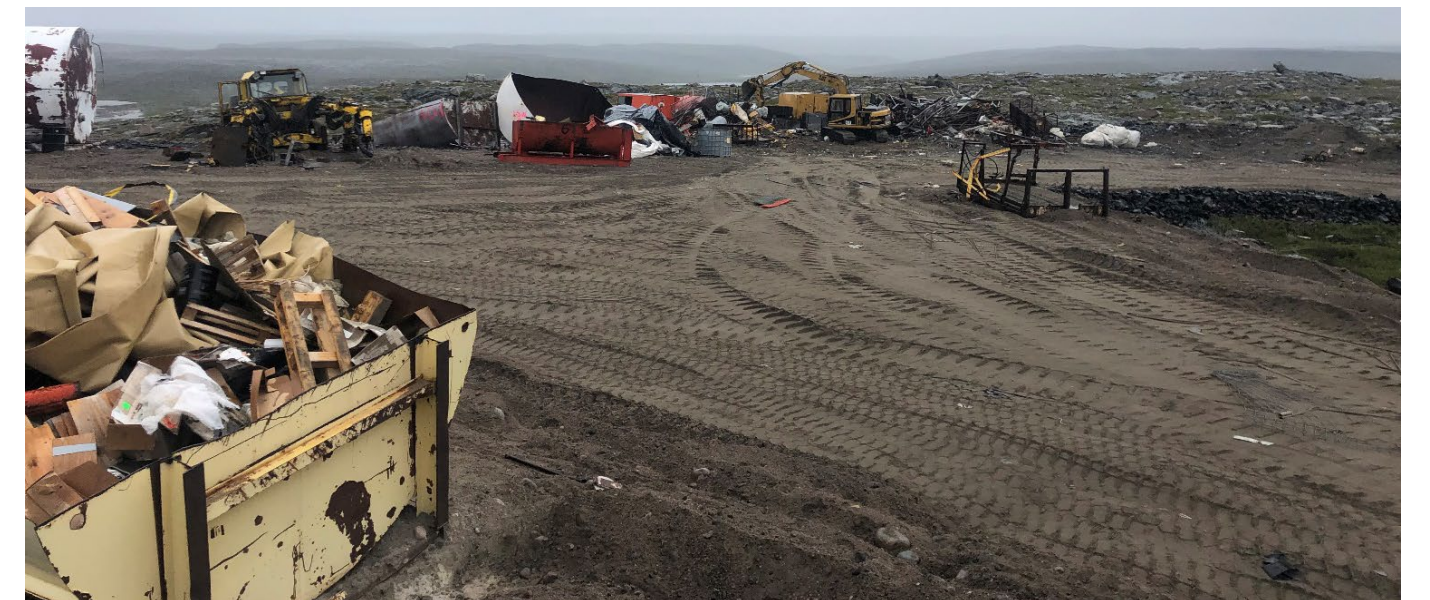
Loading waste in tanks on August 3, 2021

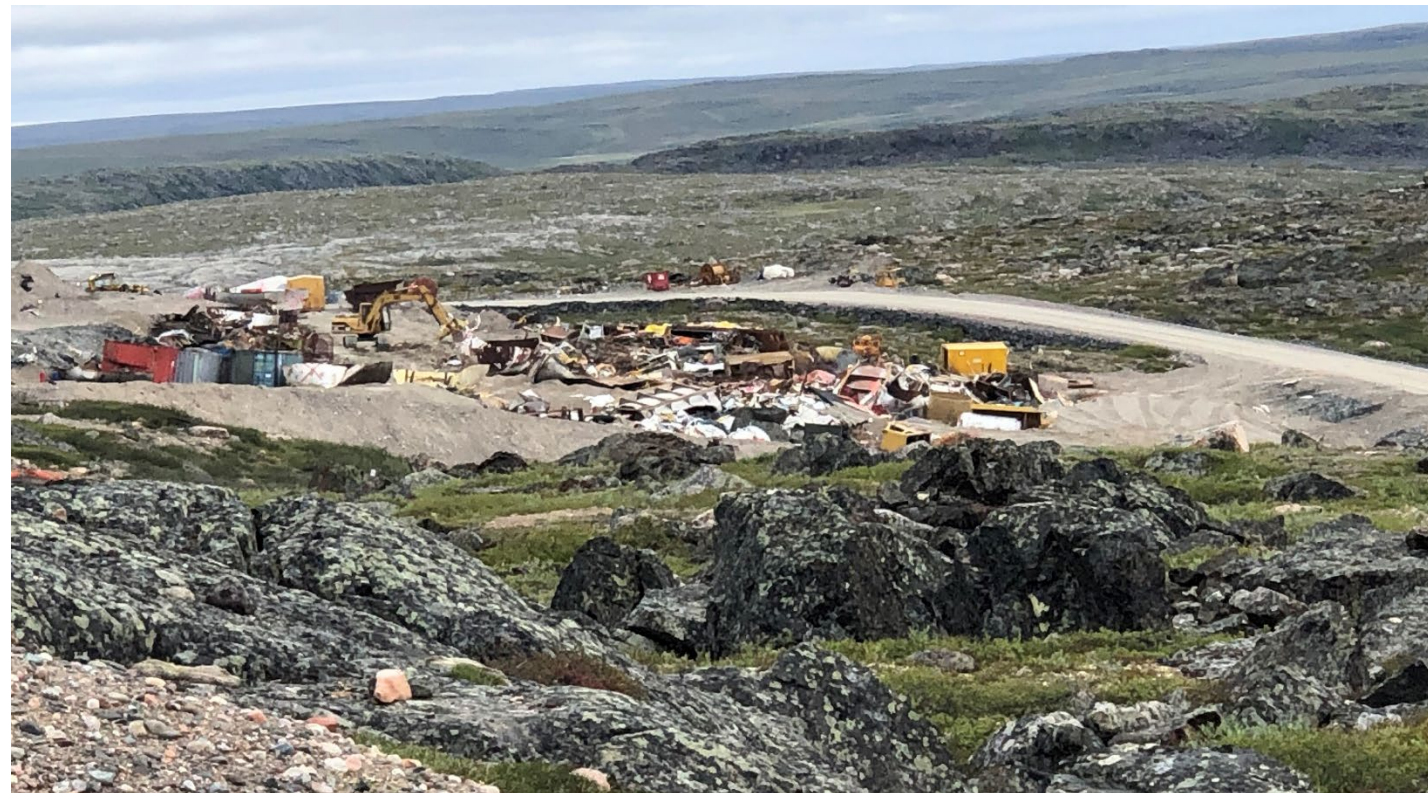
The west side of the site facing east with material placement on August 7, 2021

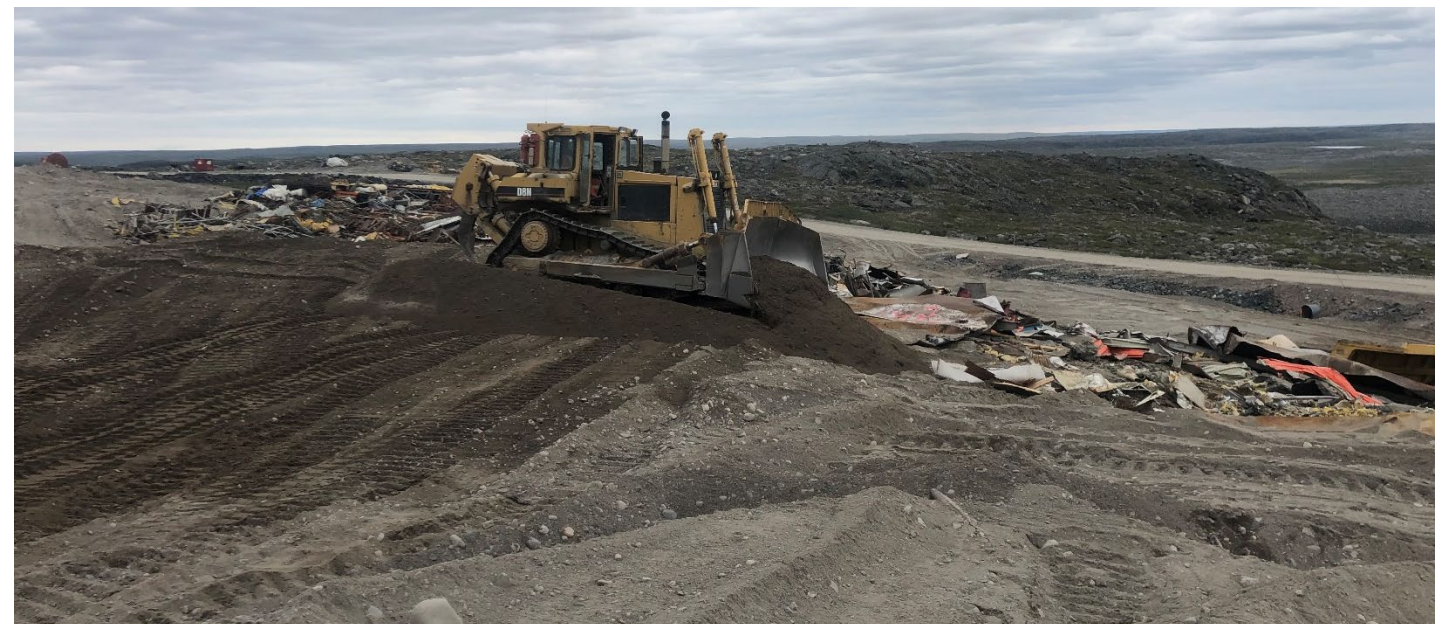
Placing esker sand on August 9, 2021

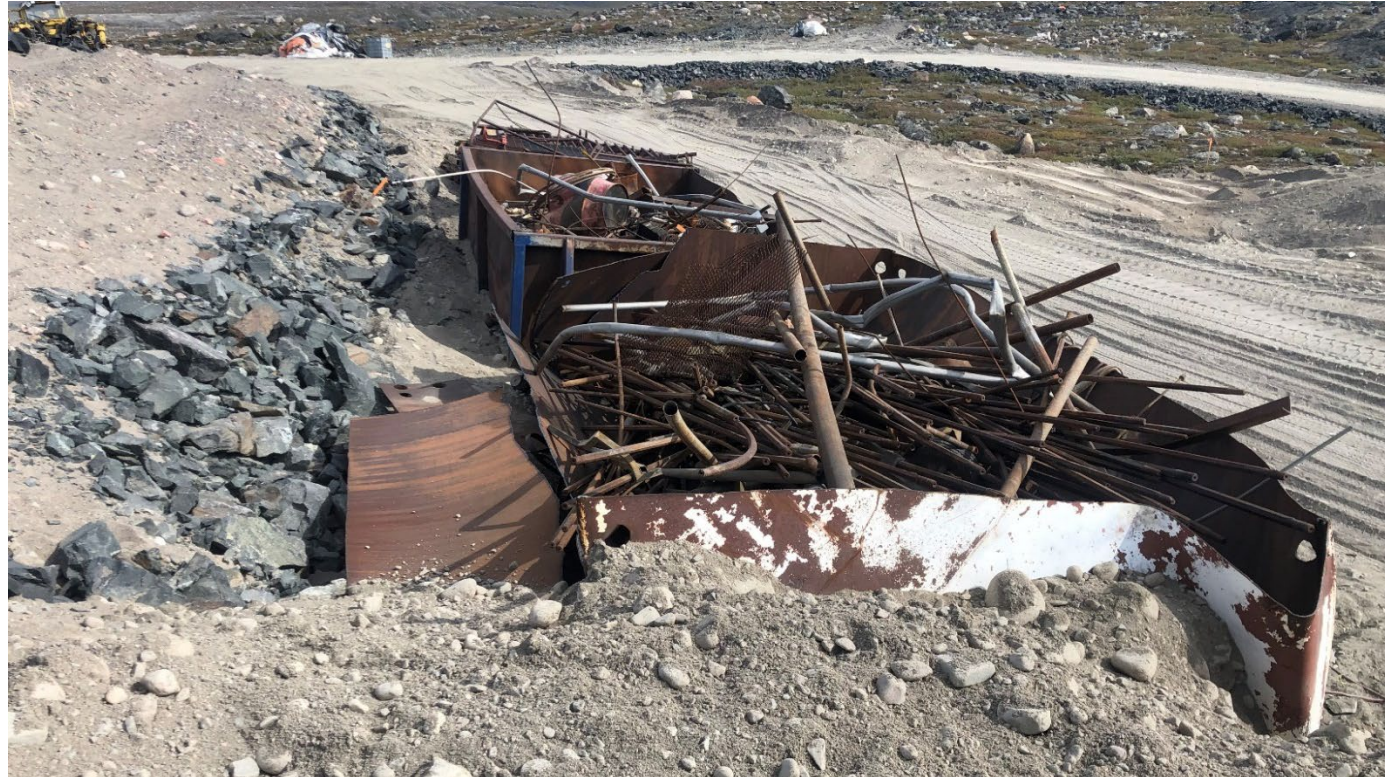
Steel in the shipping containers on August 16, 2021

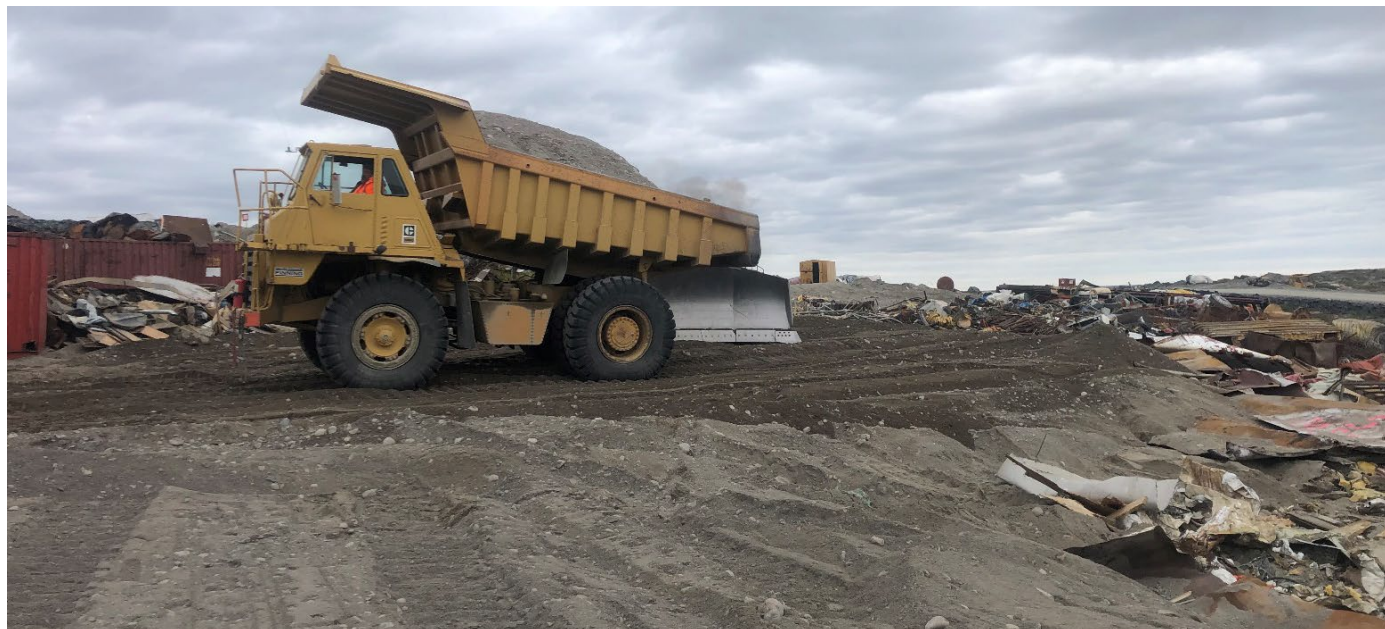
The north side of the site facing south with esker void fill and cover on August 9, 2021

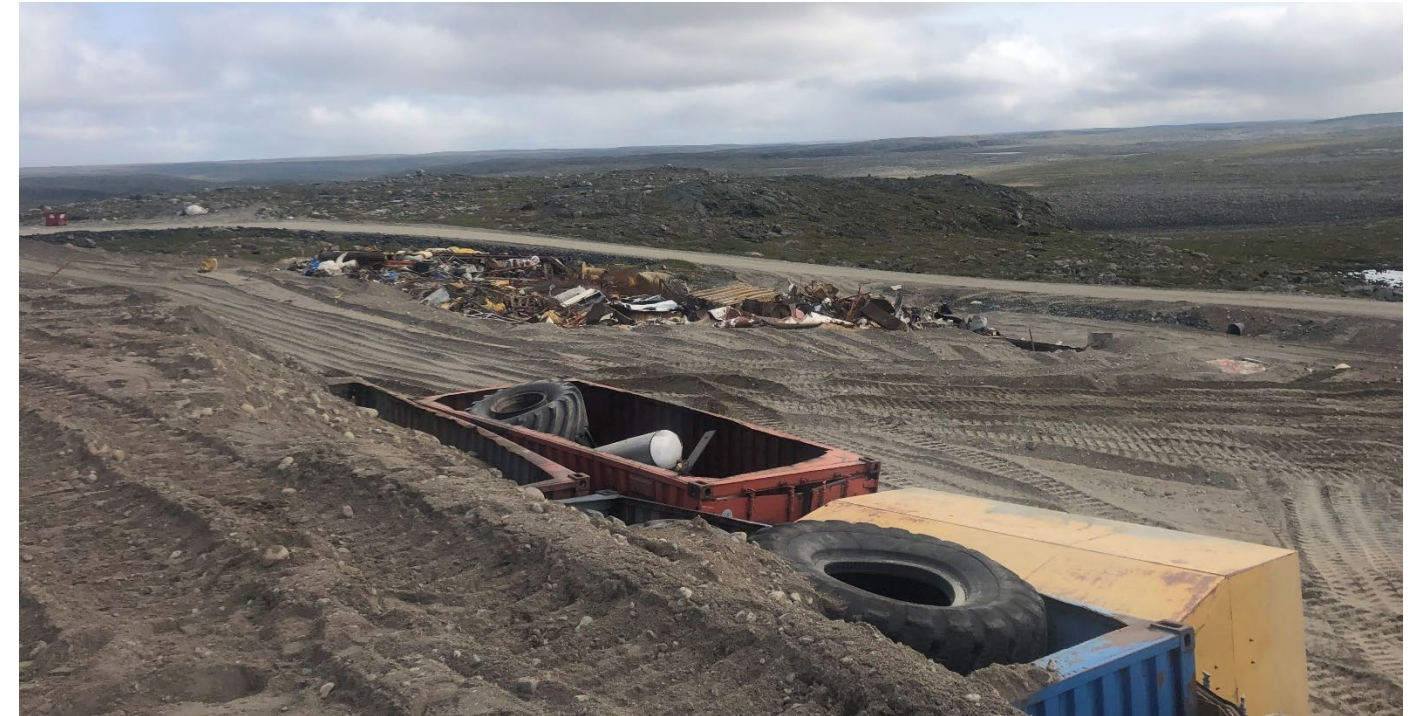
Esker sand placed over waste. August 10, 2021

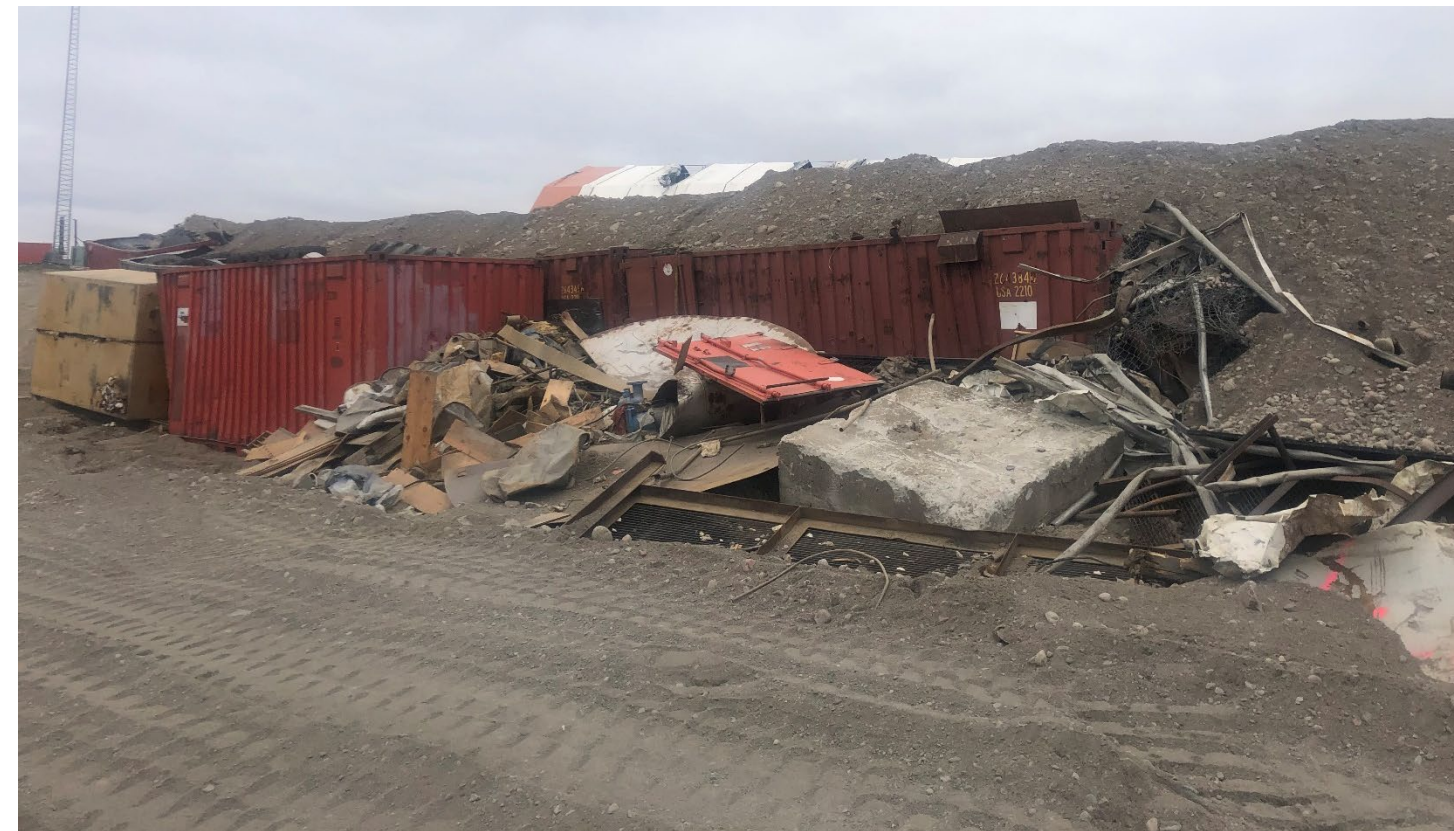
Concrete block placement on August 12, 2021

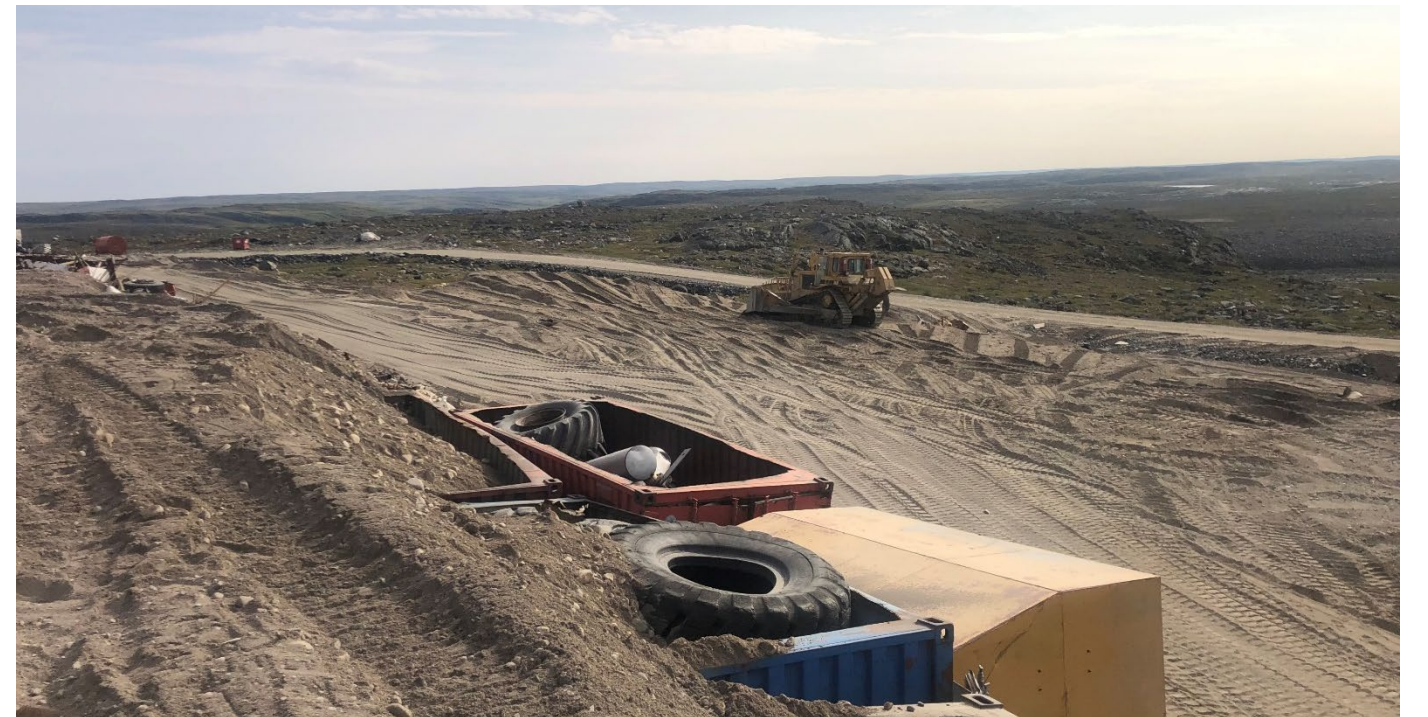
Esker sand placed over waste. August 13, 2021

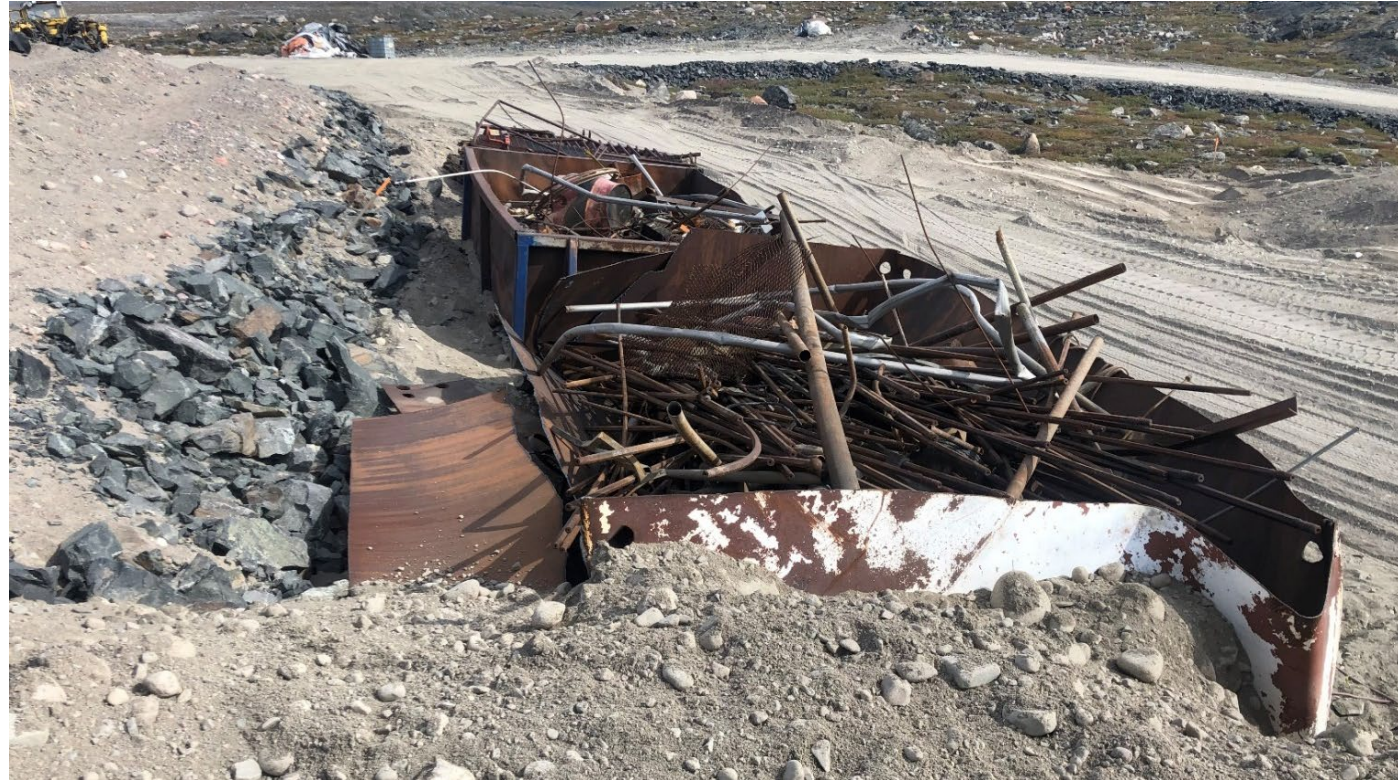
Steel in the shipping containers. August 16, 2021
