Meadowbank 2018 Annual Review of Portage and Goose Pit Slope Performance

2018 ANNUAL PIT SLOPE PERFORMANCE REVIEW

MEADOWBANK MINE, NUNAVUT

ISSUED FOR USE
704-ENG. ROCK03053-02

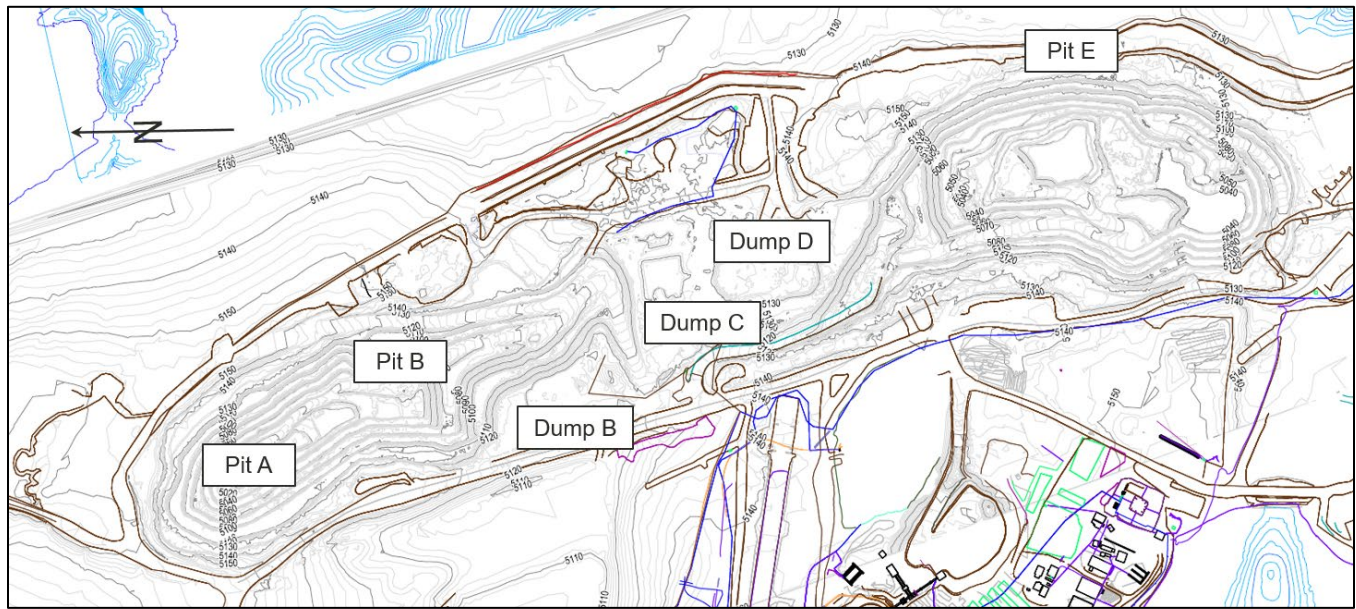
Figure 2-1: Portage Pit at the time of 2018 site visit

Pit E is the only active pit being mined in the Portage Pit and the E5 pushback area was active at the time of the site visit. Mining at Pit A was completed early in 2018. The geometry of the waste dumps in Pits B, and C have not changed substantially since the 2017 site visit. The 5126 platform of the waste dump in Pit D has been advanced further southward since 2017. The current and planned dump crest elevations are shown in the following table.

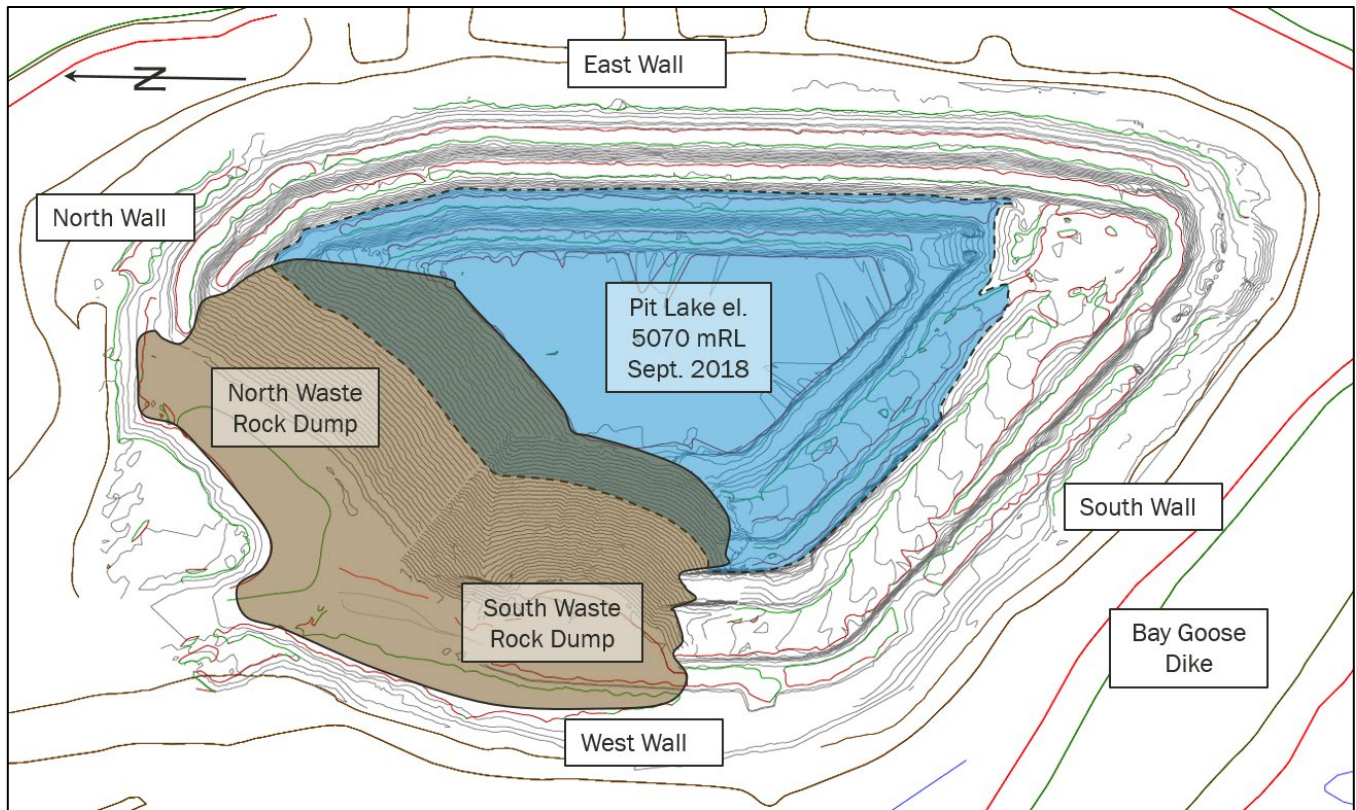
Figure 2-2: Goose Pit at time of the 2018 site visit

The Goose Pit dumps are not active. However, there are areas of significant crest sag and tension cracks which have developed further since noted in previous inspections. A full review of the dumps is beyond the scope of work for this report. The pit lake elevation has increased by approximately 3 metres from the 2017 elevation and is currently at approximately 5070 mRL.

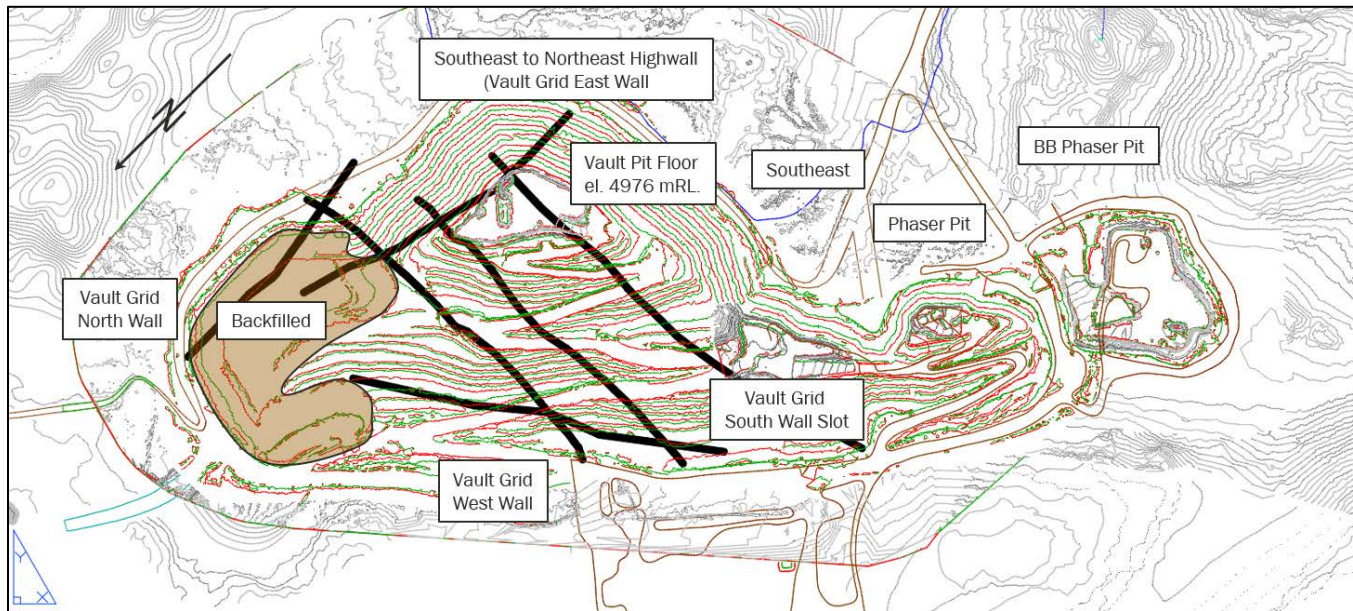
Figure 2-3: Vault Pit at time of 2018 site visit

At the time of the site visit the Vault Pit floor was excavated to approximately 4976 mRL. The extent of the Vault Pit at the time of the site visit is shown in the following Figure 2.3.

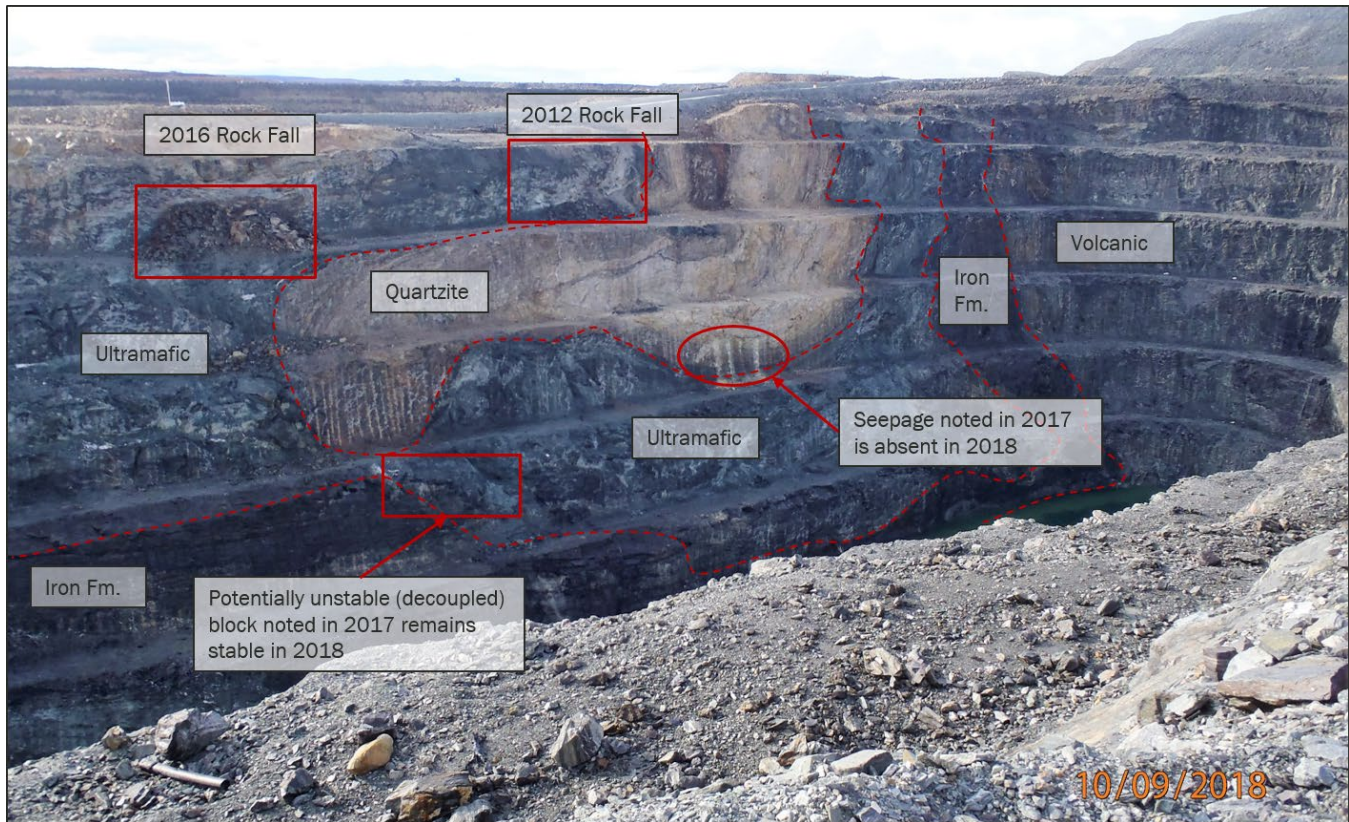
Photograph 4-3: Pit A west wall (2018)

Local areas of instability identified during previous annual inspections continued to be monitored until completion of mining of Pit A. No significant accumulation of material downslope of the 2012 and 2016 rock fall events has developed. As noted in previous reports the 2012 and 2016 rock fall events were caused by poor quality ultramafic rock in combination with toppling failure along the steep fault zone at the crest.

Groundwater seepage noted during 2017 along the axes of the synform structure within the quartzite was not observed during the 2018 inspection, suggesting the water table has been drawn down during mining.

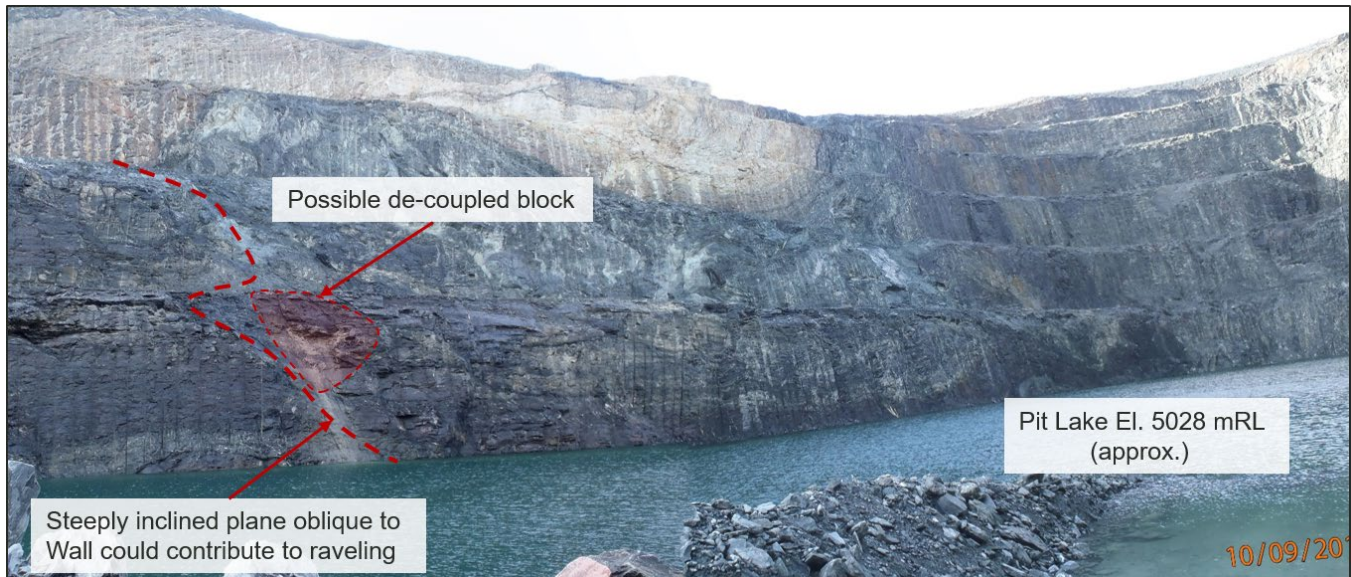
Since the completion of mining in Pit A, the lower benches continue to performing well as shown in Photograph 4-4 below. The de-coupled rock block identified during the 2017 inspection is currently stable.

Photograph 4-4: Pit A lower west wall bench performance (2018)

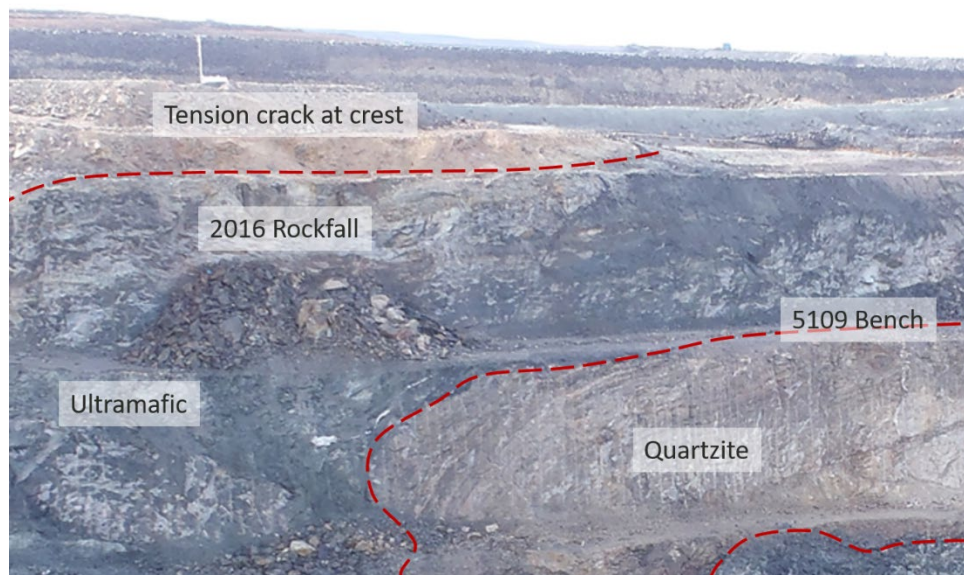
Areas of rock fall events occurring in 2012 and 2016 on the 5109 bench continue to be monitored. As described above, no significant increase in accumulation of material on the benches below these areas was noted during the 2018 site inspection.

Photograph 4-5: Pit A West Wall 2016 rock fall and tension cracks (2018)

The tension crack located at the pit crest and related to the 2016 and 2012 rockfall events continues to be visually monitored and is currently stable. These observations are documented in AEM's Quarterly Ground Control Instrumentation reports.

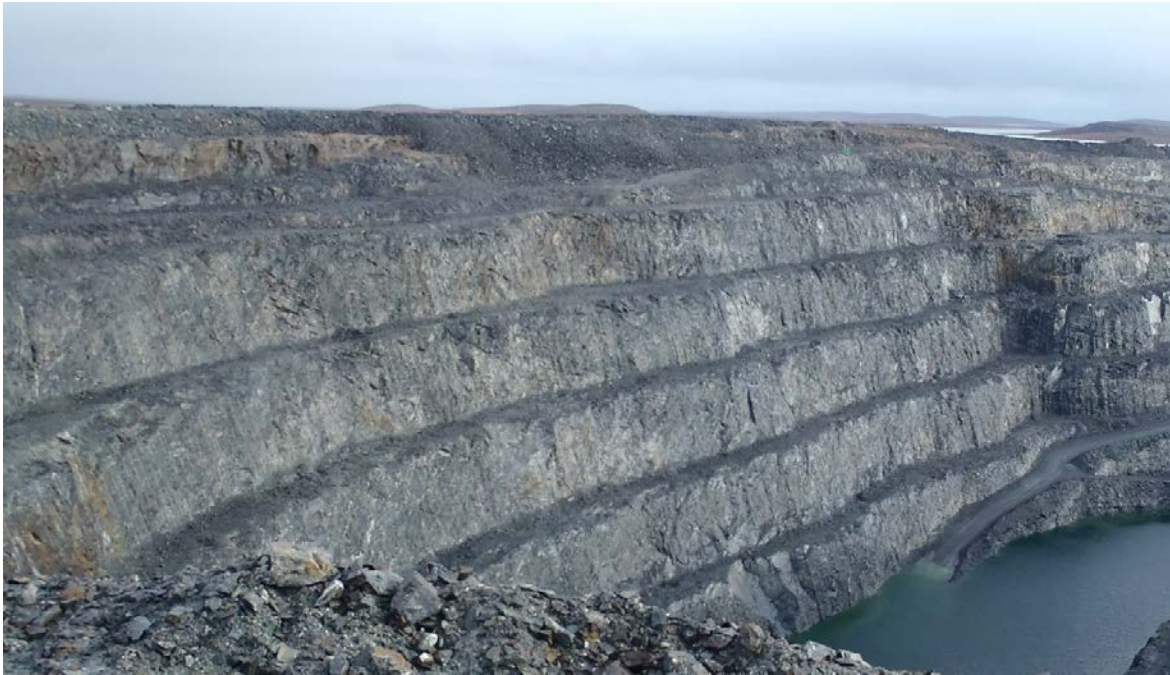
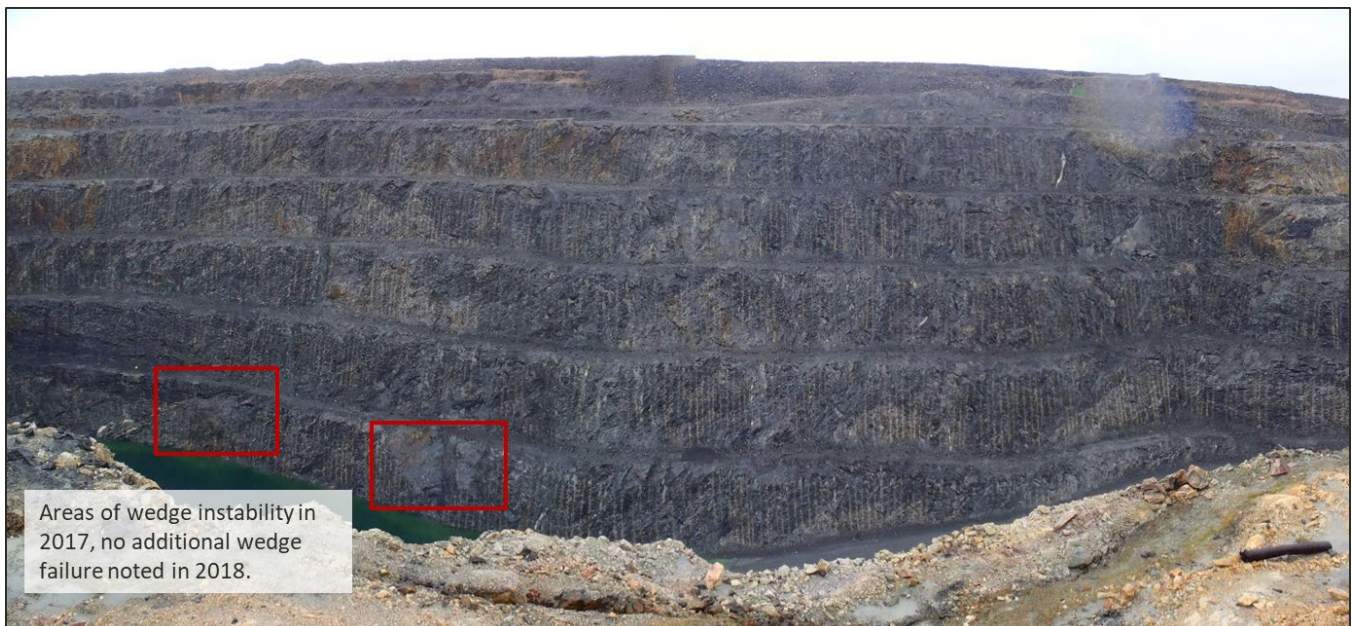
The benches of the Pit A East Wall continue to perform satisfactorily, as shown in Photographs 4-9 and 4-10.

Photograph 4-9: Pit A East wall upper benches (2018)

Photograph 4-10: Pit A east wall, north end additional wedges (2018)

No further wedge instability like that encountered during 2017 mining of the lowermost benches of the east wall of the pit was encountered, and the lower benches appear stable.

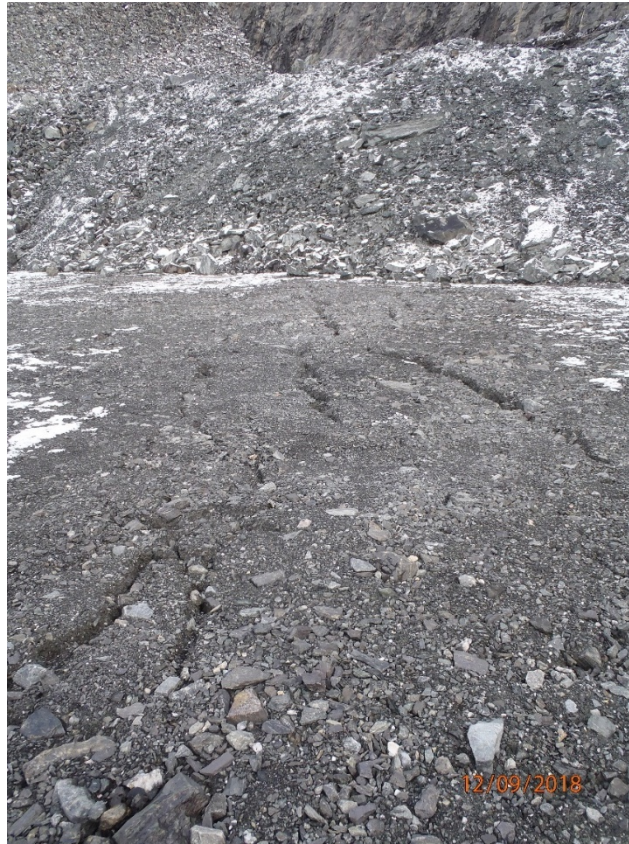
An area of tension cracks that was observed on the D Dump platforms during the 2016 and 2017 inspections has increased, and this may be a result of the advancement of the 5126 platform southward over the 5088 platform. Both radial (perpendicular to dump crest) and transverse (parallel to dump crest) were observed. Recommendations include continued visual monitoring of the dump, and prior to mining the final Pit E below the dump area, a dump inspection and review should be completed. Other recommendations include surveying the current platforms, including locations of tension crack, proper management of water in the crest areas, and the installation of simple extensometers prior to freshet to establish a baseline for any movement.

Photograph 5-4: D Dump radial tension cracks

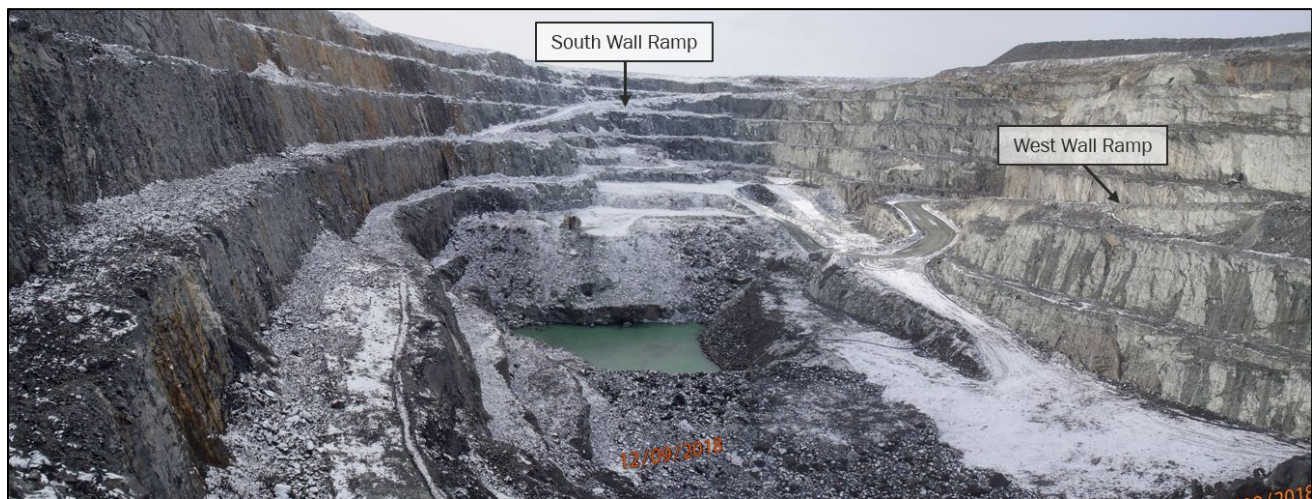
The Pit E south wall experienced a significant multi-bench failure of the ultramafic rock in September 2015. The wall is currently being mined as a pushback of the existing wall into more favourable structural and rock mass conditions for overall slope stability. Recommended slope monitoring instrumentation has been installed and an appropriate GCMP has been implemented.

Photograph 6-2: Pit E viewing south (2017)

Several bench scale instabilities have occurred during mining of the push-back as a result of undercutting of local structures. These have typically been identified during geotechnical inspections and are being managed accordingly by scaling, and using berms and candles to limit access in these areas.

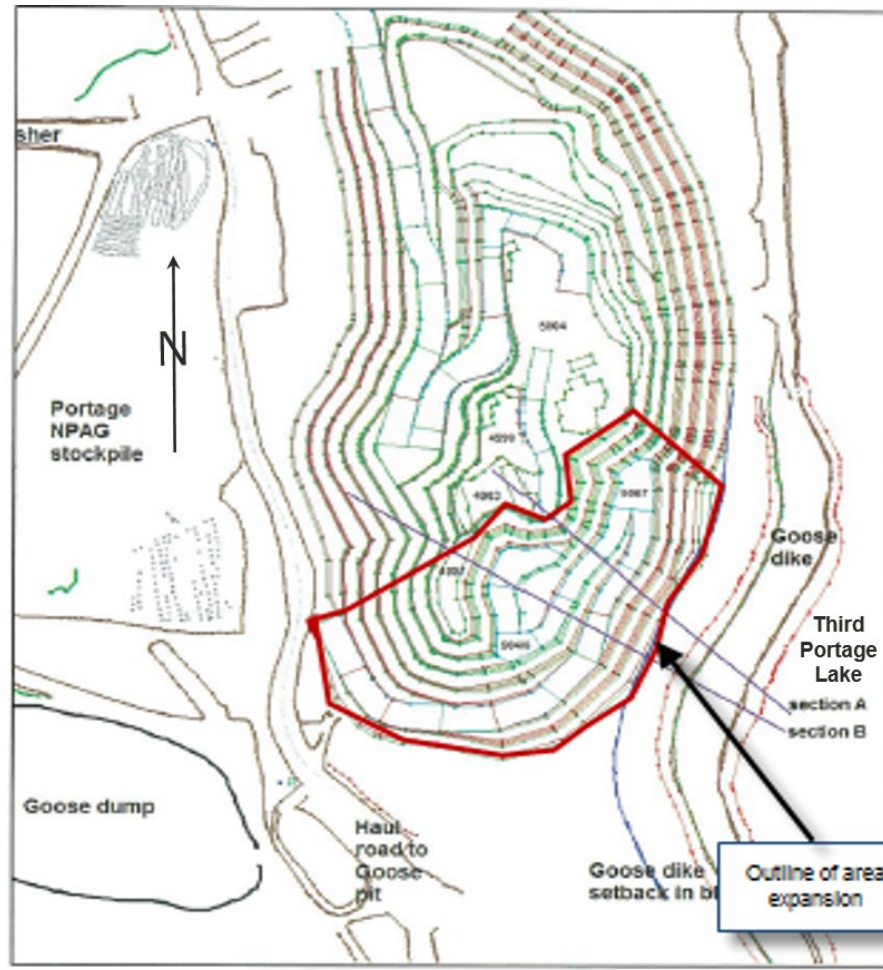
Figure 6-1: Pit E5 pushback expansion area

Pit E south wall exposes primarily ultramafic rock, with iron formation and volcanic rock on its eastern edge. The ultramafic rock is poor quality. From approximately June to September of 2015 several single and multi-bench failures within the ultramafic rock exposed in the south wall occurred. The ultramafic rock to the east and west of the failure area is in permafrost, is absent of groundwater, and is performing adequately. Additional stability analyses were carried out in 2016 to evaluate the stability of the south wall. The stability analyses concluded that there is a 'core' of potentially unstable ground through the middle of the south wall associated with increased structural complexity including folding, faulting, and hydraulic connection to the Third Portage Lake. Following the assessment AEM evaluated other options for mining of the ore, which resulted in a wall redesign to push the wall back into more favourable ground conditions and structure. The Pit E5 pushback expansion area is shown in Figure 6-1 below.

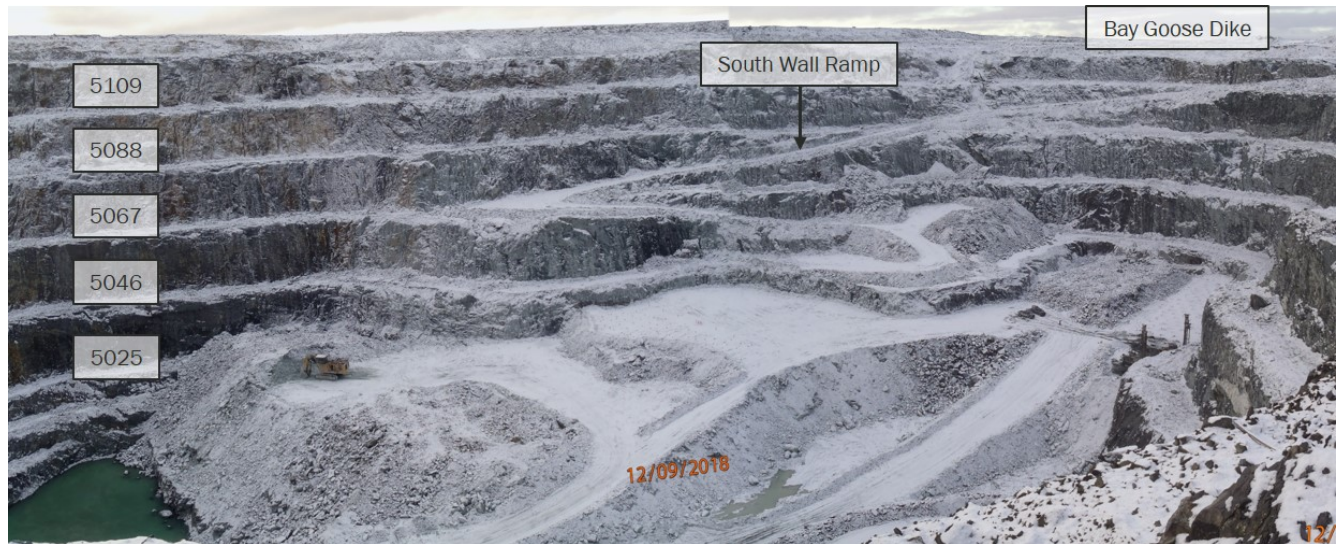
The following photograph shows the south wall at the time of the site visit. The wall has been mined down from the 5088 mRL platform in 2017, to approximately the 5025 mRL platform.

Photograph 6-4: Pit E south wall (2017)

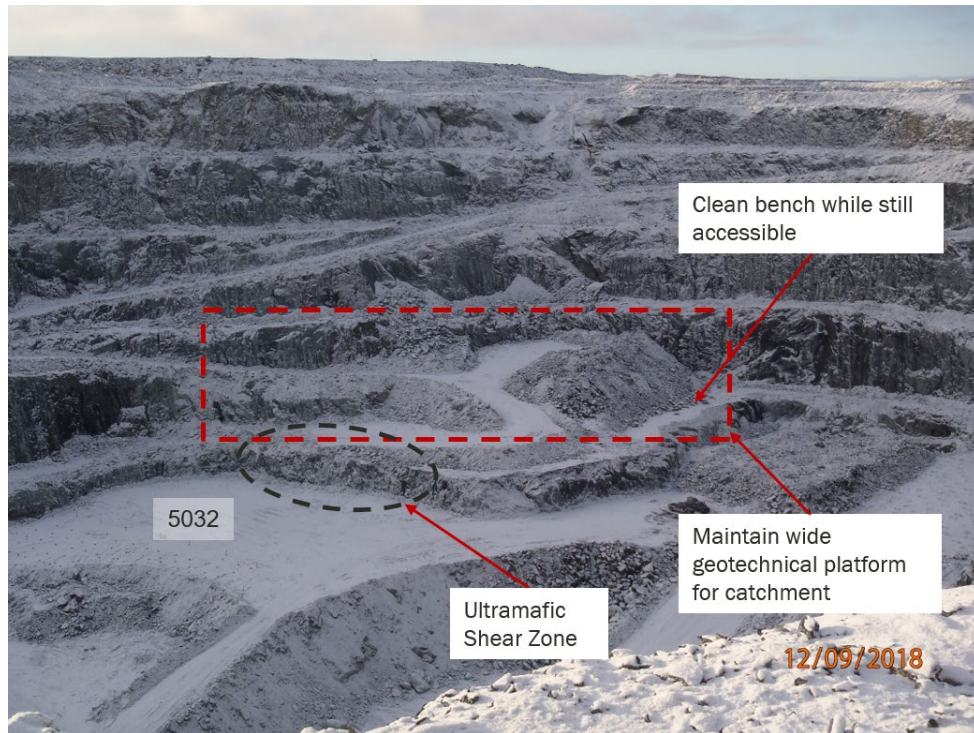
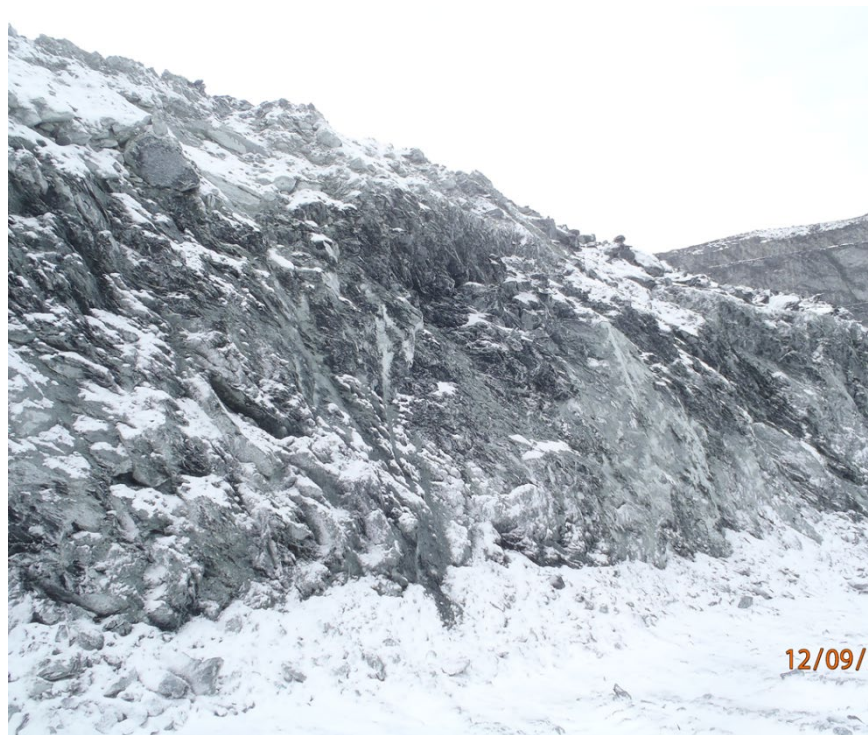
The platform at approximately 5032 mRL was visited during the inspection. Of note is the presence of a zone of strongly sheared ultramafic rock exposed along the bench face directly above the platform. The rock is very poor quality, weak, serpentinized, and wet suggesting a hydraulic conductivity up-slope. The shear zone exposed on 5032 Bench within the ultramafic rock is generally consistent in location, orientation and character with the interpreted shear zone assumed for the stability assessment during design of the pushback wall. The location of the shear zone as exposed on the 5032 mRL platform is shown on Figure 6-8 and Figure 6-9.

Photograph 6-9: Pit E5 5032 mRL platform and ultramafic shear zone

Photograph 6-8: Shear zone in ultramafic rock exposed on the 5032 mRL platform (2018)

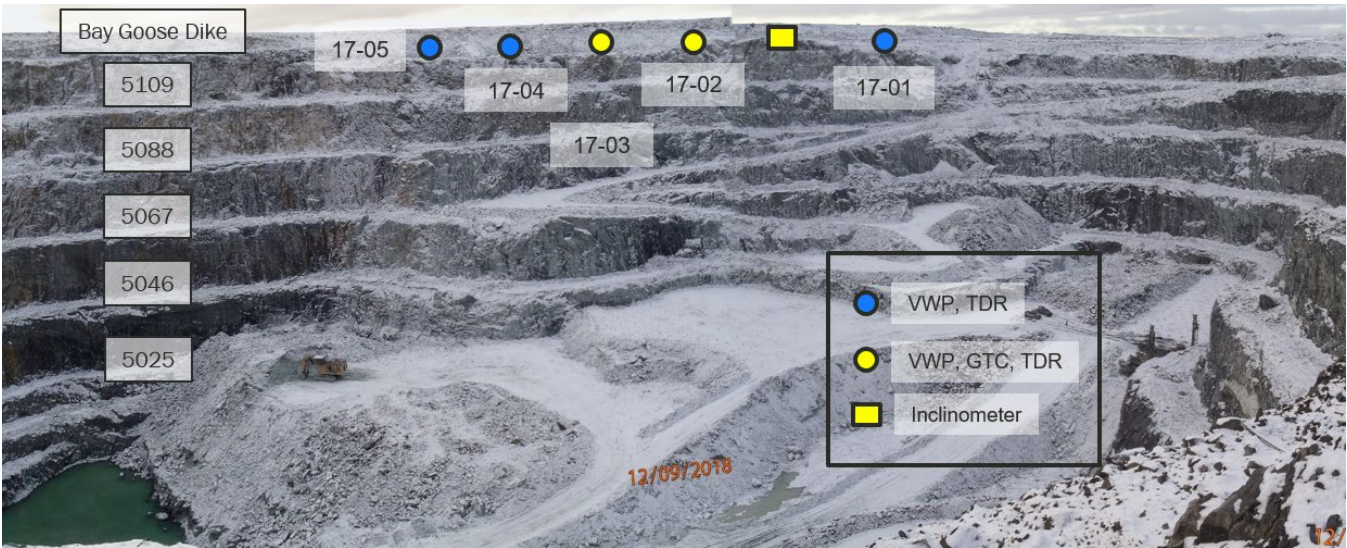
A recommendation from the Tetra Tech analysis report for the wall pushback (Tetra Tech 2017) was to install specific instrumentation in and behind the pushback area for slope monitoring purposes while the area was mined. AEM have installed instrumentation which is generally consistent with the recommendations by Tetra Tech, with the exception of prisms for monitoring surface movement. Since the GroundProbe radar is constantly monitoring the wall for movement, the current instrumentation installed is adequate in the absence of prism data. The instrumentation consists of vibrating wire piezometers, time-domain reflectometry (TDR) cables, thermistors, and an In Place (IP) inclinometer.

Photograph 6-10: Pit E south wall instrumentation locations (estimated)

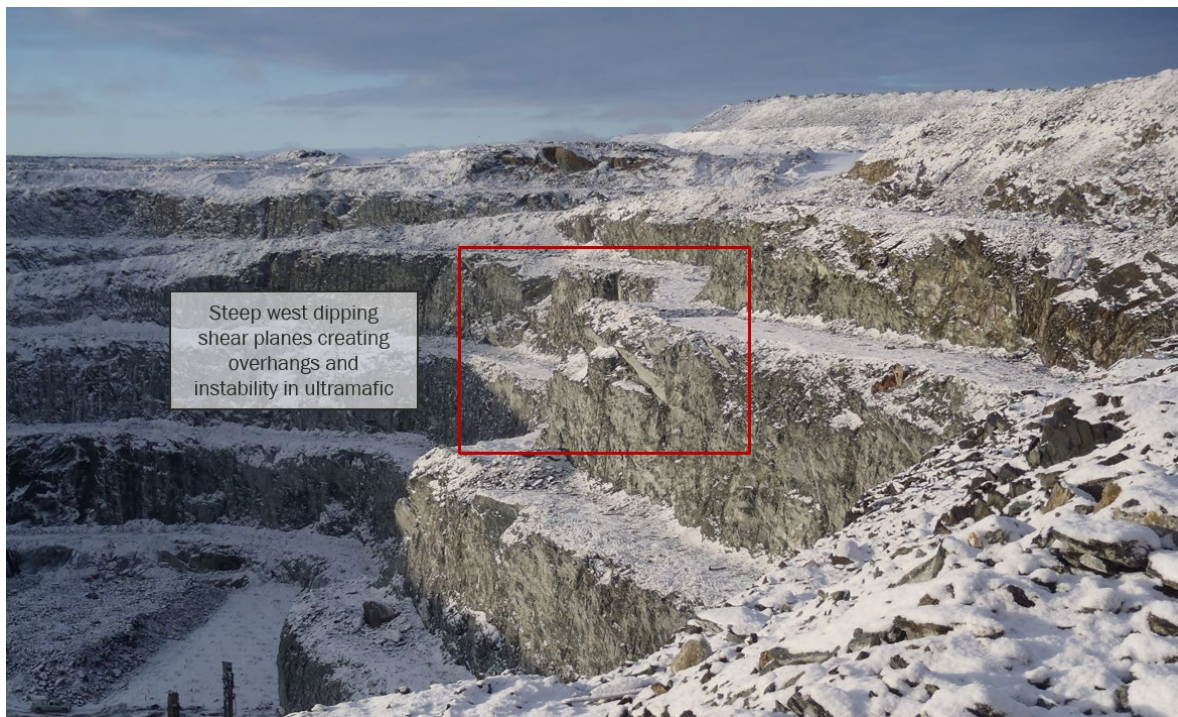
At the south end of the west wall, the contact of the ultramafic rock and overlying intermediate volcanic rock is inclined into the wall, which is beneficial for overall slope stability, but results in bench-scale instability of the underlying ultramafic rock. Local rock falls creating small overhangs have occurred as the ultramafic rock separates from the overlying volcanic contact, followed by sliding along a steeply east dipping orthogonal joint set. This potential instability is contributed to by the presence of the Bay Fault and parallel shear planes within the ultramafic rock, which are also inclined steeply into the west wall. Photograph 6-11 shows the west wall at the time of the 2018 site visit. An area of rockfall events on July 5, 7, and 11 2018, directly above seepage faces and associated with the steeply west dipping Bay Fault and associated shear planes.

Photograph 6-12: Pit E west wall south end upper benches (2018)

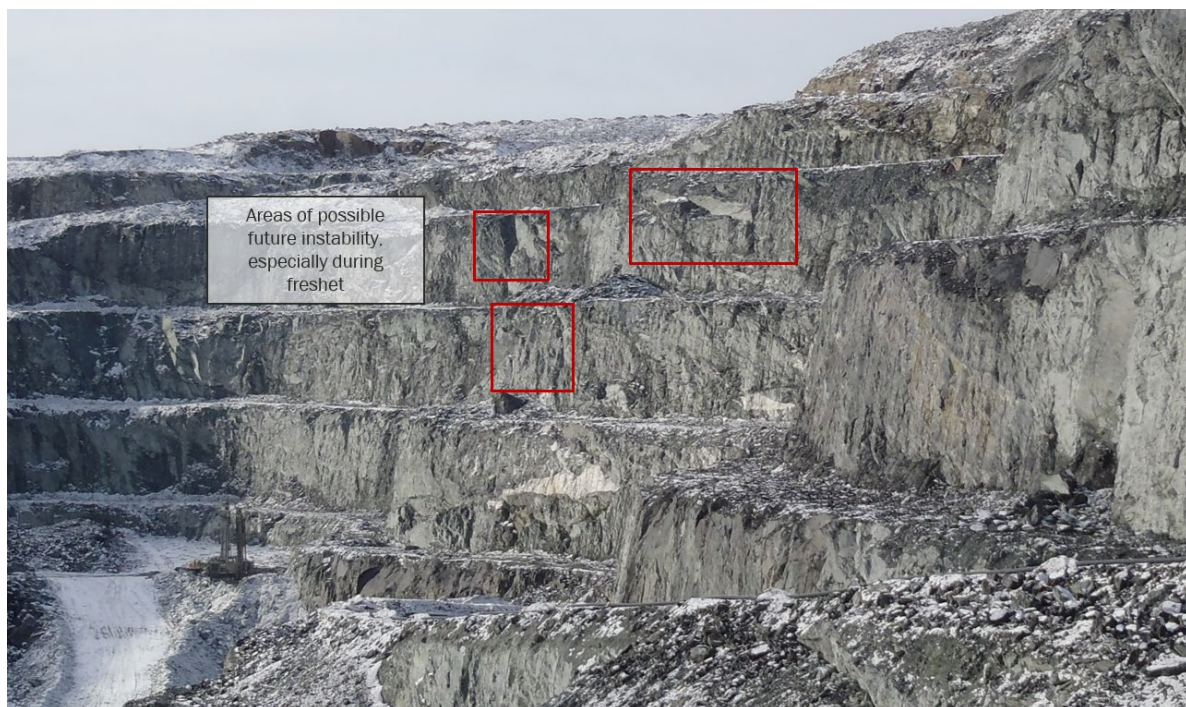
Additional possible areas of instability noted on the upper west wall above the ramp were noted, generally in association with steeply west dipping sheer planes and associated poor rock quality. These should continue to be monitored.

Photograph 6-13: Areas of potential instability along steep west dipping structure

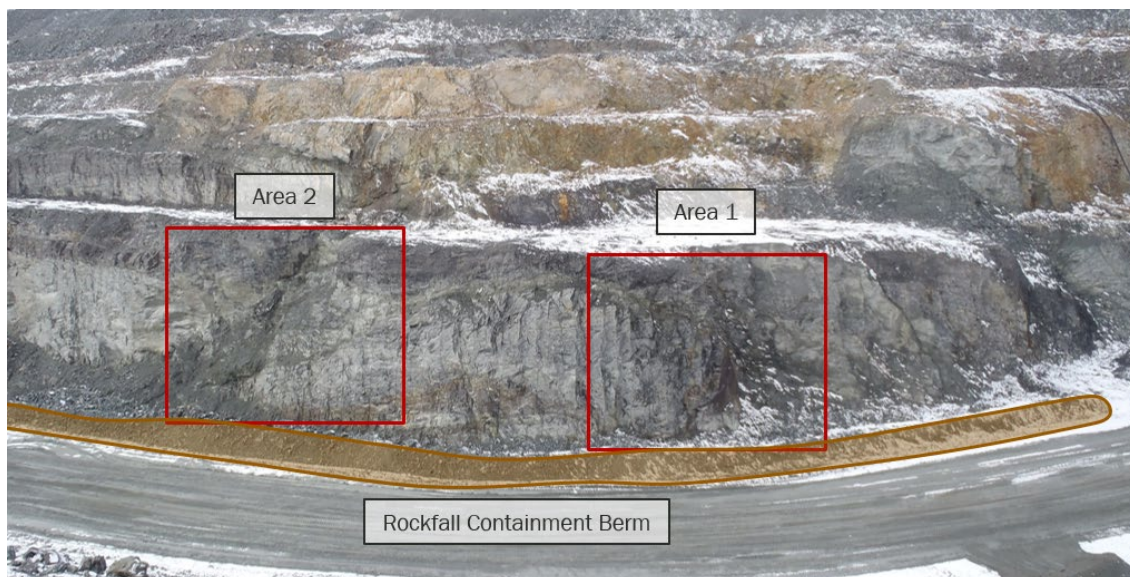
Photograph 6-17: Pit E Ramp Areas 1 and 2 - Bay Fault or splay (2018)

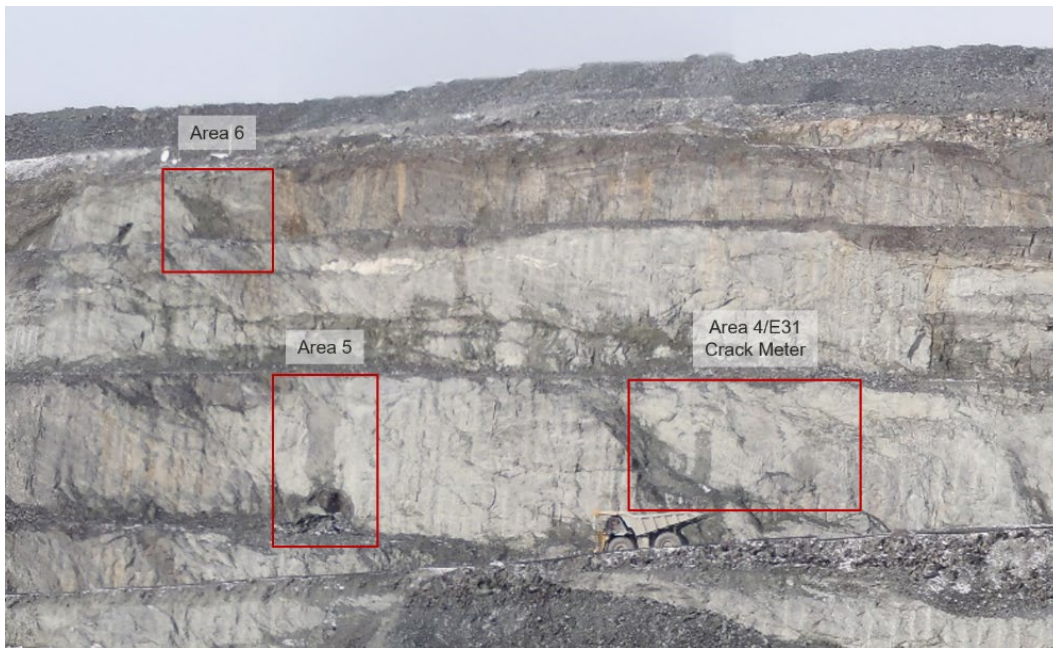
Area 6 is located above the 5088 mRL bench, and is a vertical extension of the closely spaced jointing of Area 5. These are steeply north dipping shear joints, which intersect the volcanic rock. The close spacing and continuous nature of these joints may result in increased raveling of material particularly during freshet and spring thaw.

No new material was observed to have accumulated beneath each of these areas since the 2017 inspection.

Photograph 6-20: Pit E Ramp Areas 4, 5, and 6 (2017)

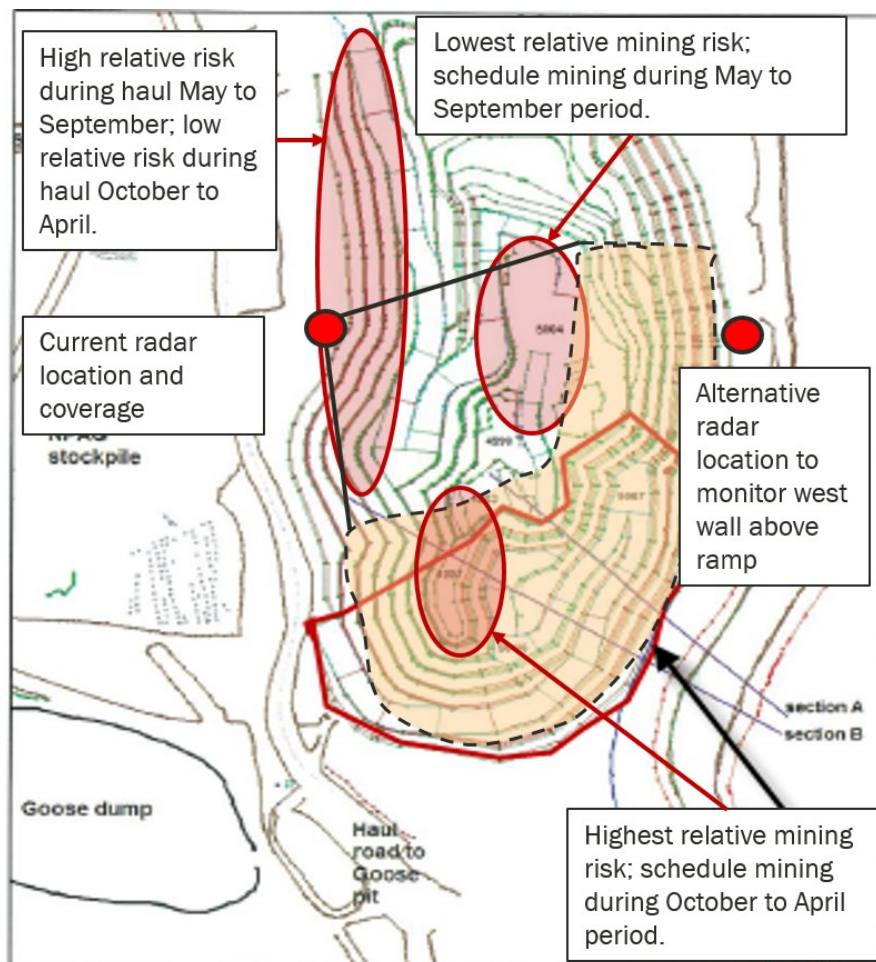
Figure 6-2: Possible mining sequence to complete Pit E3/E5 mining

Under this scenario, the slot area at the south of Pit E would be mined during winter, before mining the more central Pit E3 area where the current pit lake is located. The combination of winter mining and active monitoring using radar could be effective in managing risk during mining of the slot. In addition to the benefit that winter mining will provide for stability of the final slopes for the slot, the stability of geotechnical hazards that have been identified along the west ramp haul would also be improved during this period.

Once winter mining of the slot is complete, then this area could be retreated from, and mining of the lower risk central area of Pit E3 would be completed during spring and summer of Q3 2019. During this period, there may be an increased risk associated with the geotechnical hazards identified along the west ramp haul. AEM could consider moving the radar from its current location at the crest of the west wall to a new location at the crest of the east wall. Since the southeast wall is currently monitored by an ADAS which includes piezometer, thermistor, TDR, and inclinometer monitoring combined with a GCMP and appropriate trigger levels, risk associated with the wall is being effectively managed. Consequently, the radar could be moved to the east pit crest to monitor the south through southwest walls of the pit, as well as the west wall above the ramp area. This would provide additional risk management to the west ramp haul during final mining of the pit and hauling along the west wall ramp.

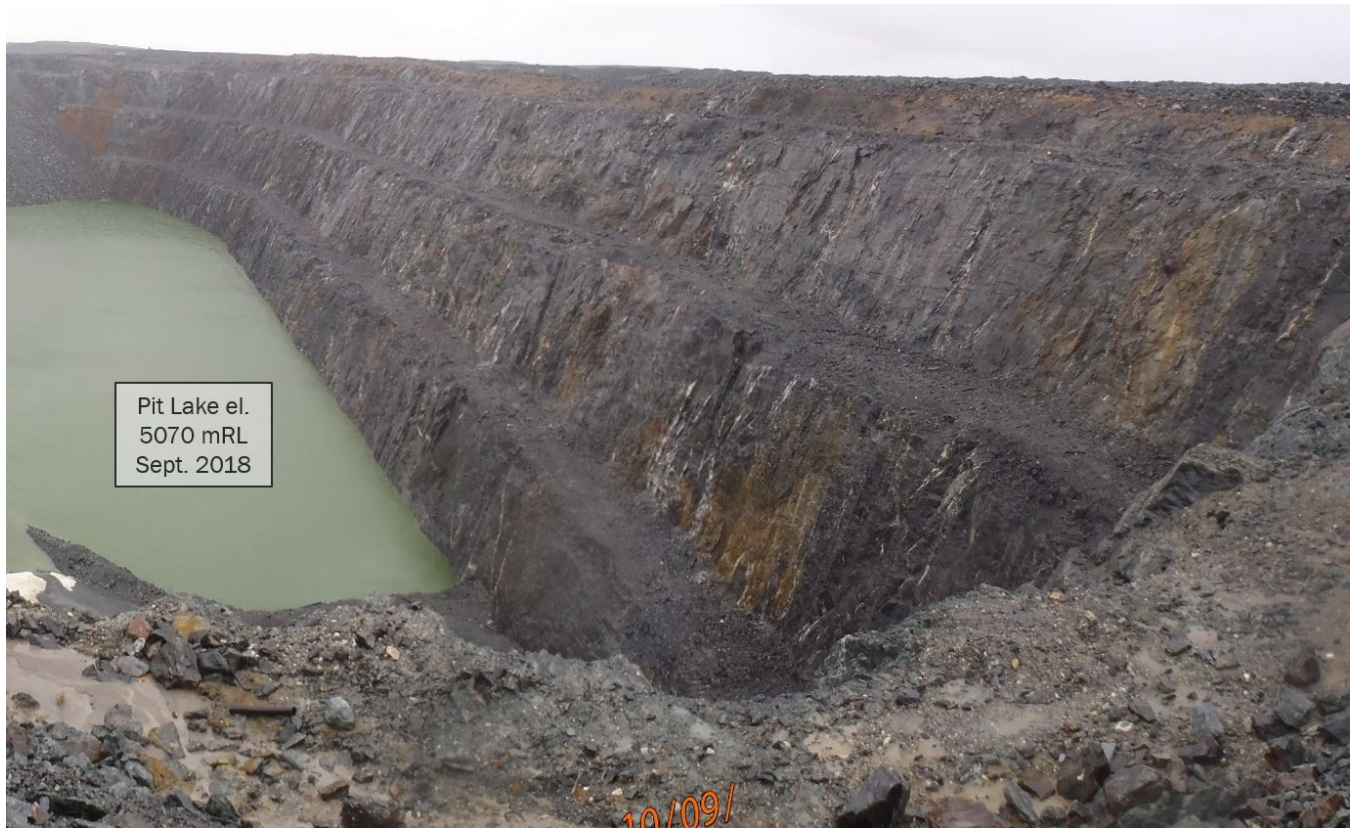
The east wall of the Goose Pit is predominantly intermediate volcanic rock and iron formation. The stratigraphy is inclined steeply at a consistent angle to the west. Steep bench faces were achieved with the use of careful pre-shear blasting. There has been very little loss of catchment, and very little accumulation of material on the benches.

Photograph 7-1: Goose Pit east wall looking north (2018)

The east wall continues to perform satisfactorily and there are no immediate geotechnical concerns.

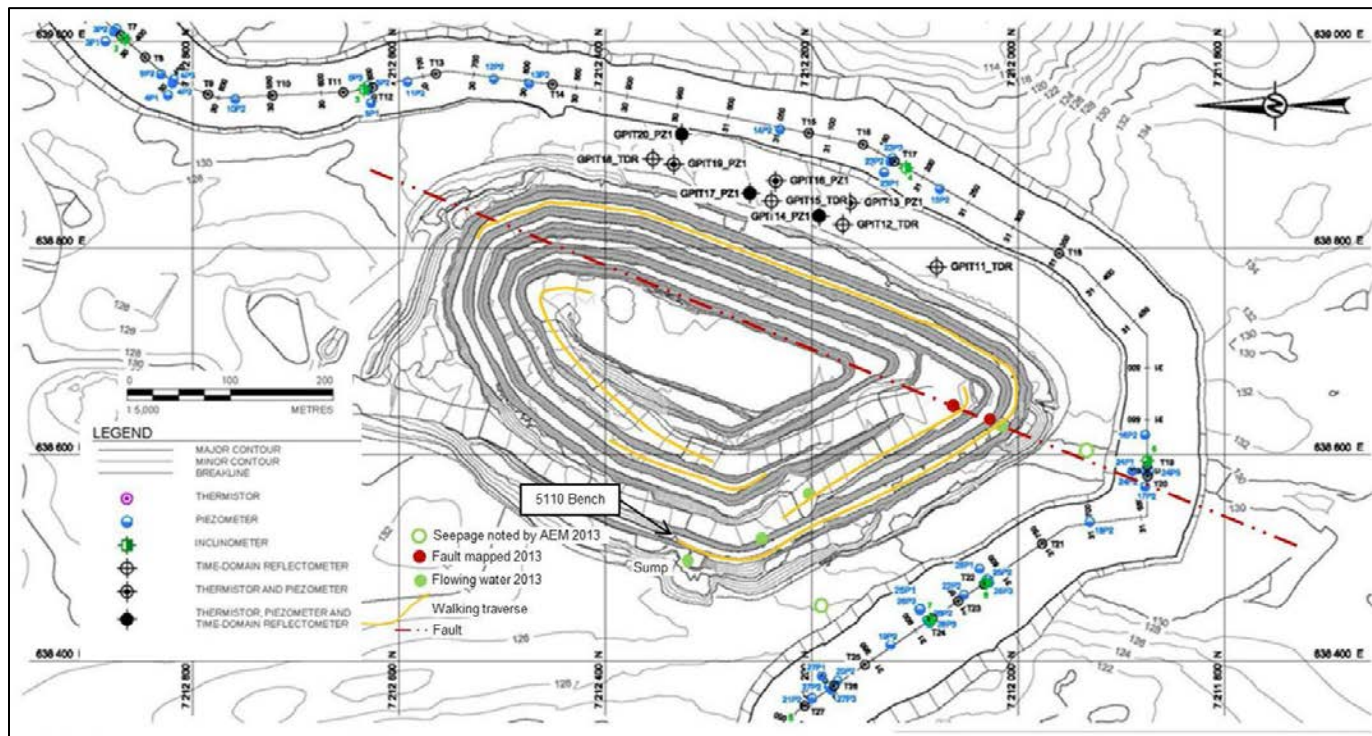
Figure 7-2: Goose Pit instrumentation plan

Thermistors were installed in 6 geotechnical boreholes drilled behind the east wall in 2013. A review of the data indicates no significant change from 2015. The data indicate generally steady-state conditions. Data from GPIT-14 continues to show a cooling trend between approximately 5090 and 5000 mRL. This trend was first visible in the August 2014 data, and has been consistent in 2015, 2016, 2017, and 2018.

GPIT-14 PZ-4 continues to record erratic pressure heads. During 2016, the piezometer recorded a constant decrease in pressure, while in 2017 the piezometer showed a constant increase in pressure. This trend has continued through 2018, from approximately 4085 m in January 2017 to approximately 5003 m in August 2018. The temperature of the PZ-4 tip is slightly above 0 degrees C. It is likely this piezometer tip is damaged. There is no significant change in ground temperatures at the piezometer tips. PZ-4 and PZ-5 show positive temperatures, while the remainder are negative so the reliability of pressure data is questionable.

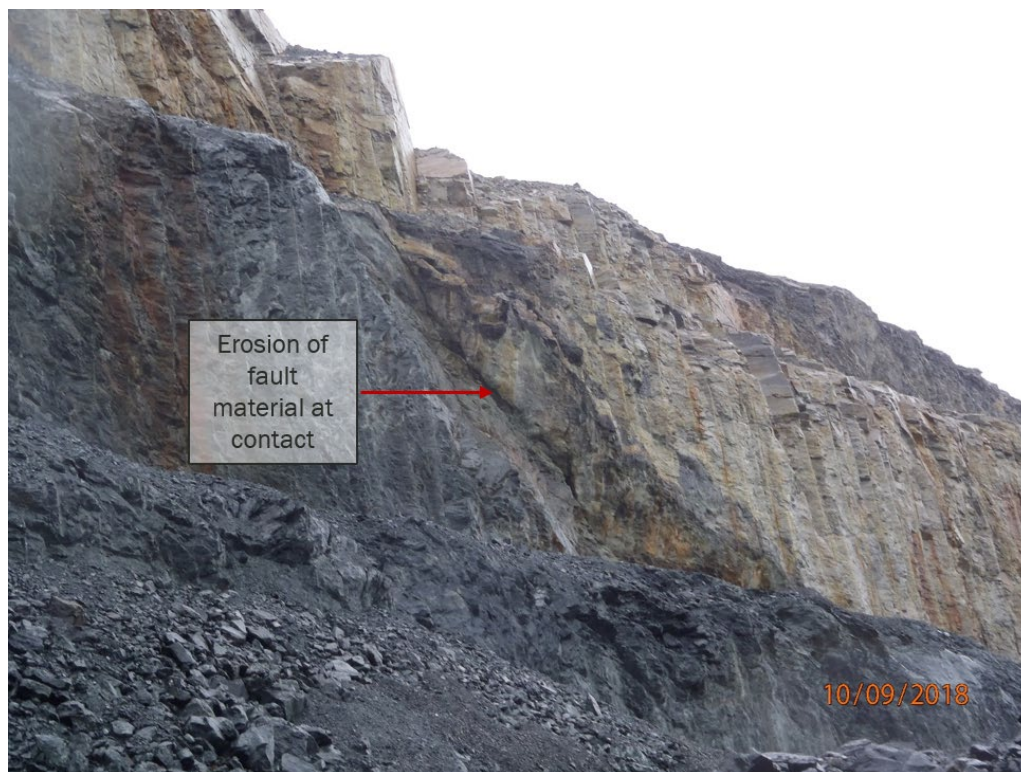
During the 2018 inspection, a fault was identified at the contact between the ultramafic and quartzite, and it was noted that the fault gouge associated with the fault was being eroded, resulting in a widening gap.

Photograph 7-3: Erosion of faulted contact Goose Pit south wall (2018)

While the risk of failure is very low due to the oblique orientation of the fault to the slope face, the potential does exist especially if erosion of the fault material continues. If the Goose Pit remains closed then the consequences of a possible bench scale instability are negligible; however, if the ramp is reactivated for use during tailings deposition, then this should be assessed further. If necessary a buttress could be placed, or the ramp could be bermed off below the fault.

- Continue visual monitoring and recording of observations as part of regular site geotechnical inspections.
- If pit ramp is reactivated, the area below the faulted contact between quartzite and ultramafic rock should be assessed further, and if necessary buttressed or bermed off below the fault. This area should be indicated on a geotechnical hazard map.
- Include the faulted contact between the quartzite and ultramafic rock in the risk register developed as part of the assessment to store tailings in Goose Pit.
