Meadowbank 2018 Annual Review of Portage and Goose Pit Slope Performance

2018 ANNUAL PIT SLOPE PERFORMANCE REVIEW

MEADOWBANK MINE, NUNAVUT

ISSUED FOR USE
704-ENG. ROCK03053-02

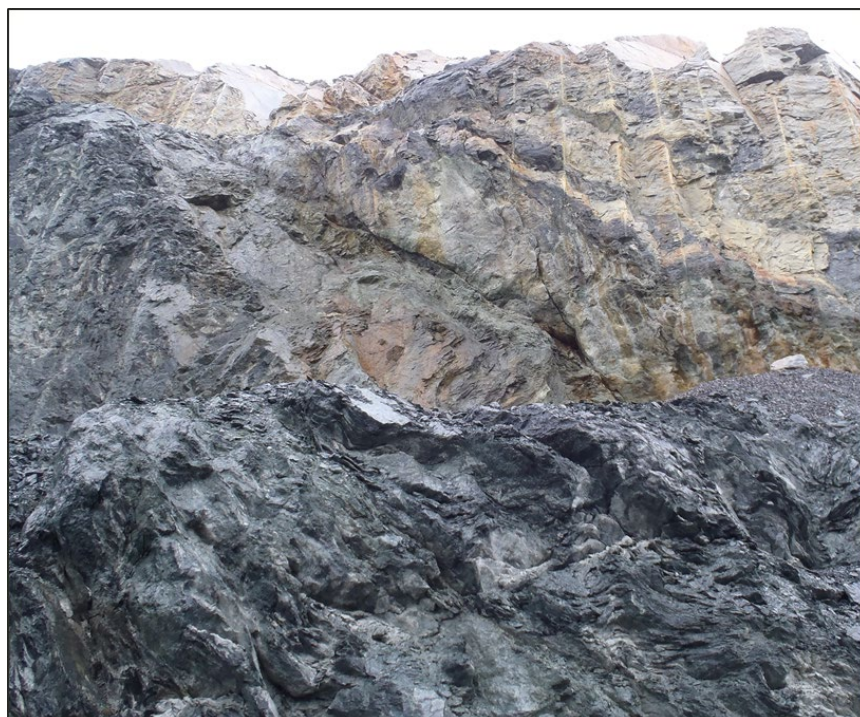
During the 2018 inspection, a fault was identified at the contact between the ultramafic and quartzite, and it was noted that the fault gouge associated with the fault was being eroded, resulting in a widening gap.

Photograph 7-4: Erosion of material along faulted contact Goose Pit south wall (2018)

While the risk of failure is very low due to the oblique orientation of the fault to the slope face, the potential does exist especially if erosion of the fault material continues. If the Goose Pit remains closed then the consequences of a possible bench scale instability are negligible; however, if the ramp is reactivated for use during tailings deposition, then this should be assessed further. If necessary a buttress could be placed, or the ramp could be bermed off below the fault.

- Continue visual monitoring and recording of observations as part of regular site geotechnical inspections.
- If pit ramp is reactivated, the area below the faulted contact between quartzite and ultramafic rock should be assessed further, and if necessary buttressed or bermed off below the fault. This area should be indicated on a geotechnical hazard map.
- Include the faulted contact between the quartzite and ultramafic rock in the risk register developed as part of the assessment to store tailings in Goose Pit.

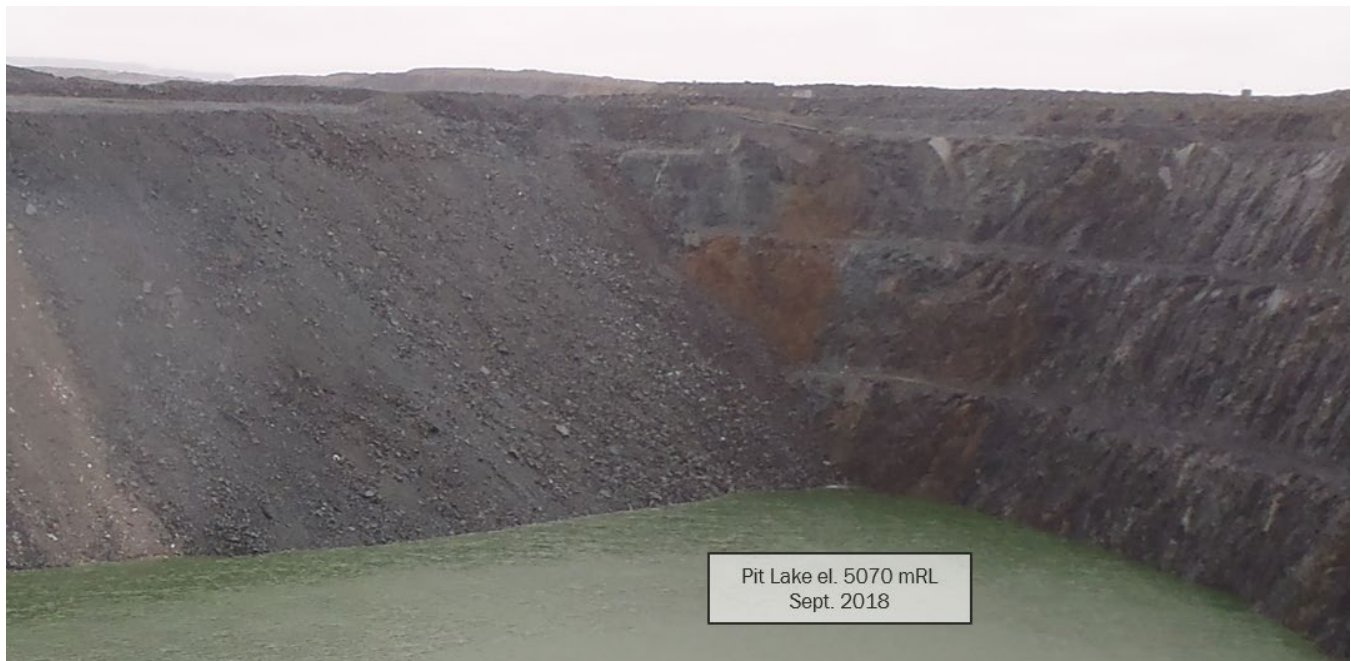
The northwest through northeast (north end-wall) walls of the Goose Pit exposes the stratigraphic sequence of the deposit, from ultramafic rock in the west, through iron formation, and then intermediate volcanic in the east. The stratigraphy and major structural features (faults and dominant foliation) strike approximately perpendicular to the wall. The wall also exposes the Bay Fault, and associated splays.

Photograph 7-9: Goose Pit northwest through northeast wall (north end wall 2018)

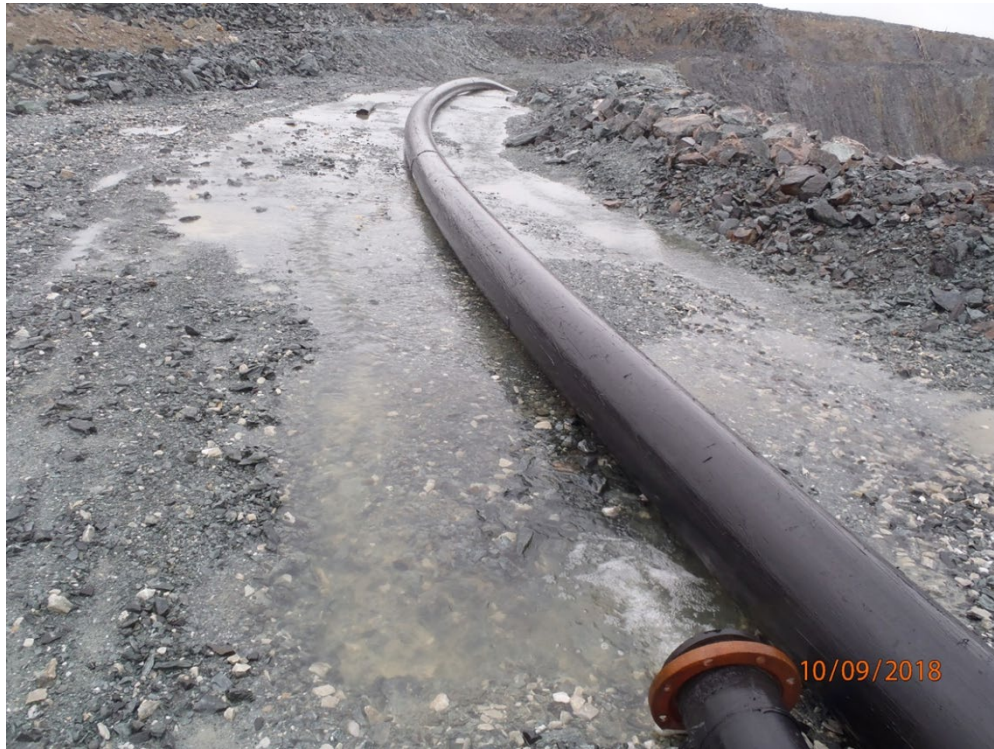
During the site inspection, it was noted that water was being discharged on to the ring road and thermal cap at the north pit crest, and flowing through the rockfill before spilling on to the rock face. Water was also flowing along the ring road to spill over the edge of the pit. The water was being pumped from a sump at the crest of Pit E. It is understood this was only a temporary discharge; however this could still affect the integrity of the ring road and should be avoided. Any water discharge should be directed on to the pit wall face, and not through the rockfill materials at the crest. During the site visit this process was stopped. The location of the water release is shown on the following figure.

Photograph 7-10: Goose Pit uncontrolled water discharge along north crest

- Do not allow uncontrolled discharge of water through fill materials at crest as this may cause unnecessary erosion of the fill materials. Direct water discharges over side on to rock face.
- When moving water discharge line at north end, do not place equipment or personnel near the crest due to potential geotechnical hazard (wedge) in rock bench below.

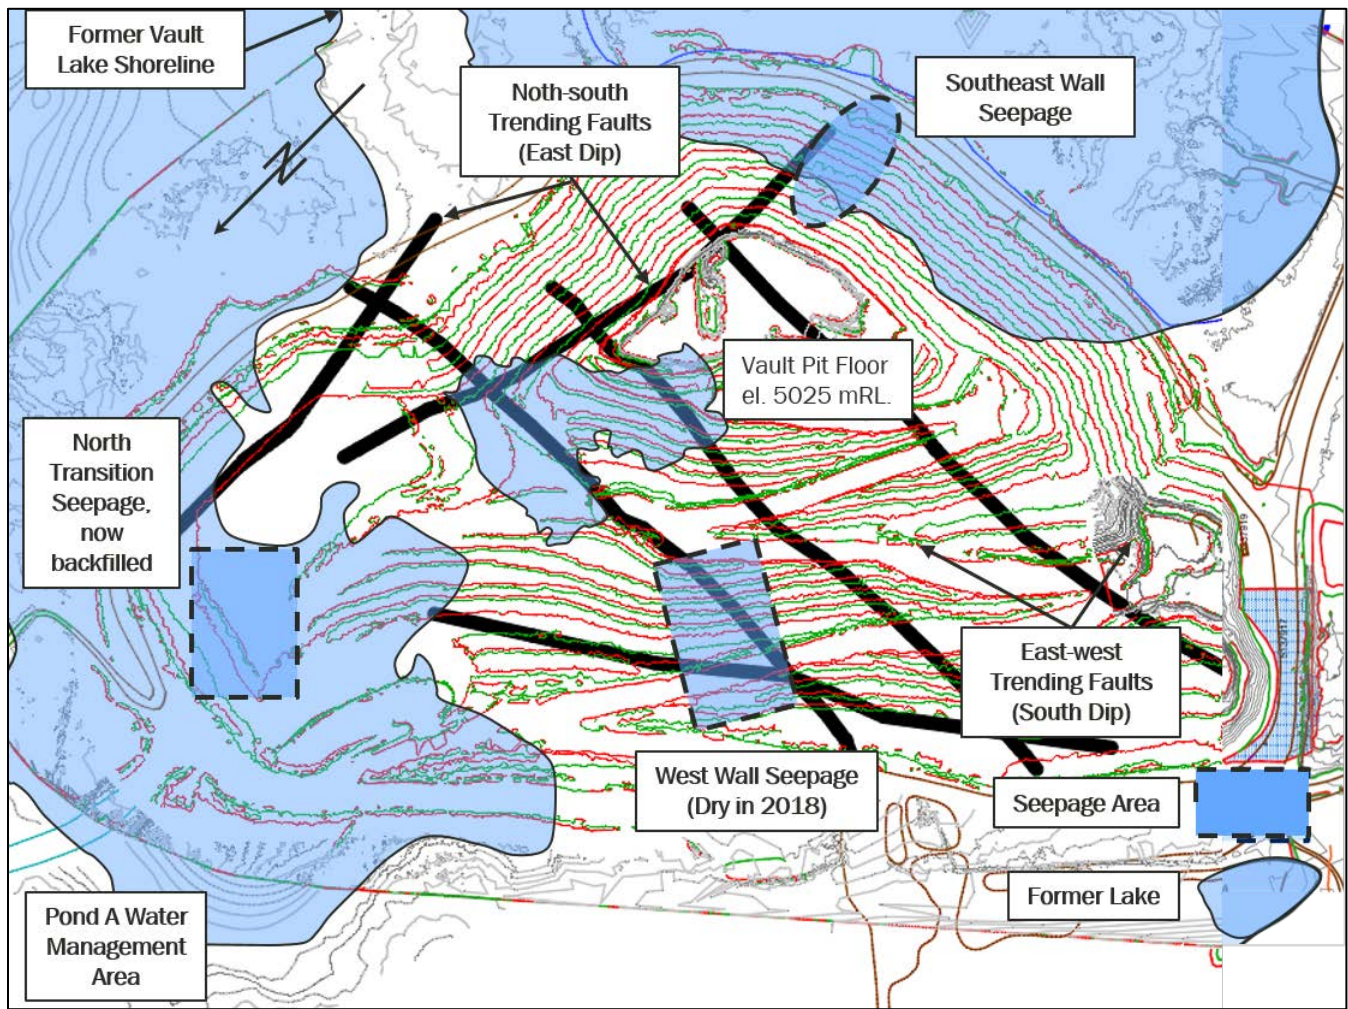
Figure 8-2: Vault Pit water inflow and seepage (2018)

The locations for water inflows and seepage noted during the 2018 inspection remain the same as for previous inspections. Two of the three main areas of the pit where water inflow or seepage have been noted during previous site visits were either dry at the time of the site visit, or were covered by waste rock backfilling of the pit. These are the west wall seepage area (dry during the 2018 site visit), and the north transition wall seepage, which has been covered by backfilling of the north end of the pit. The southeast wall seepage continues to produce water.

These are shown on the figure below and discussed in relevant sections. These are generally related to the release of water stored in the talik beneath the former lakes.

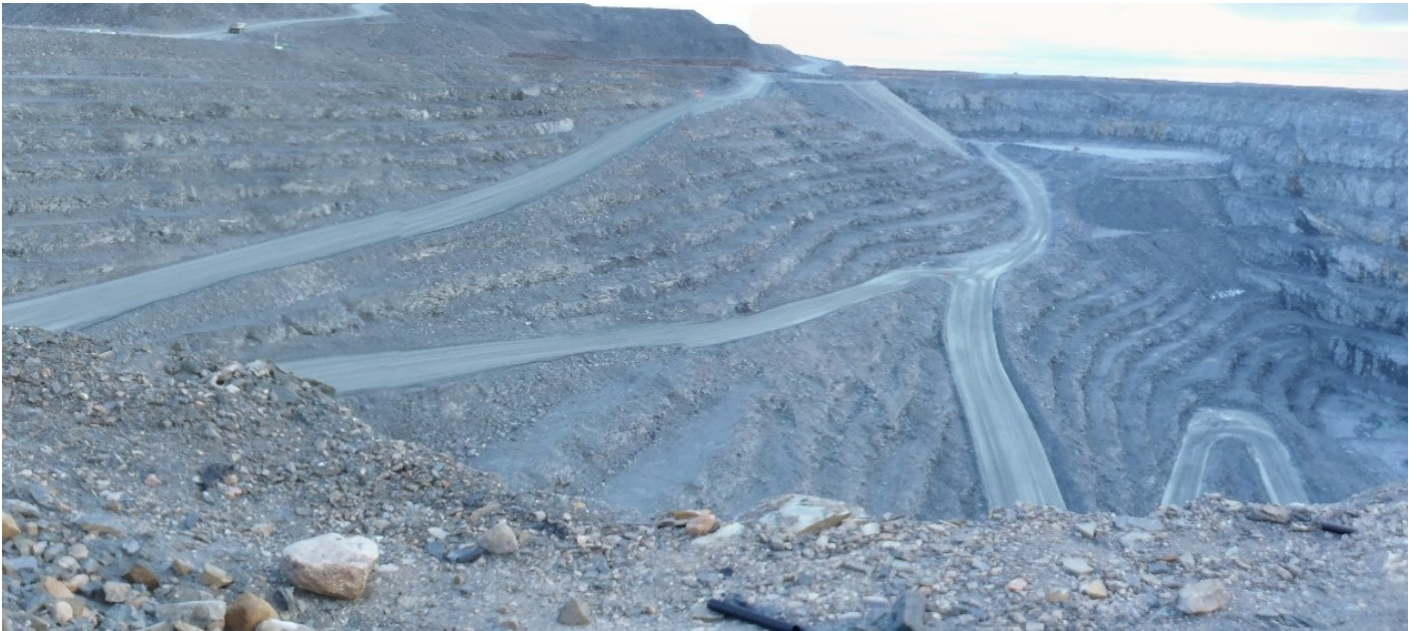
Photograph 8-1: Vault Pit west wall looking north (2018)

There are no significant geotechnical concerns noted, and no evidence of large scale (overall slope) instability for the footwall slope.

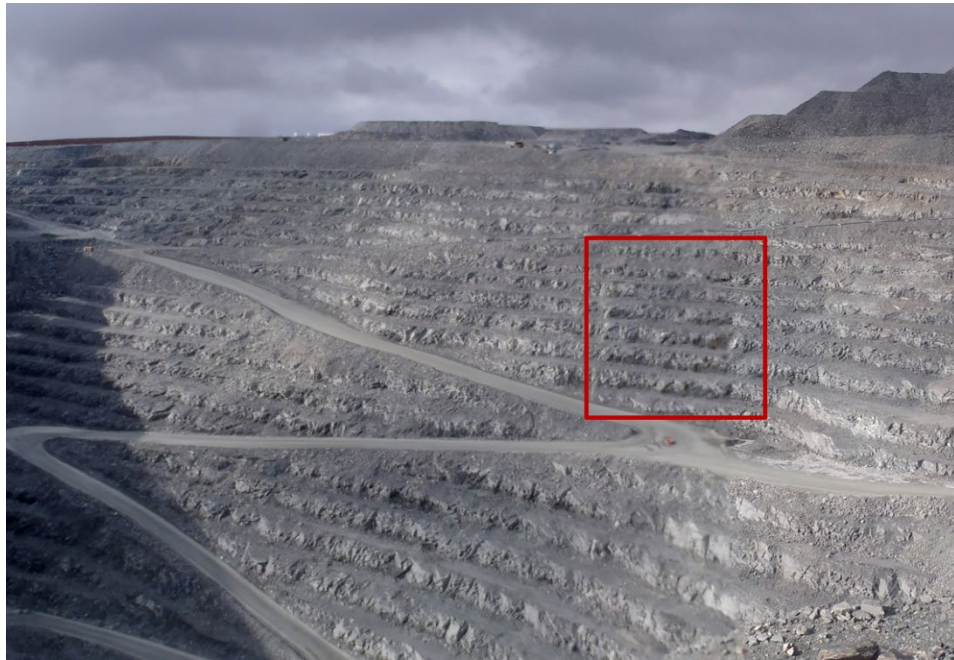
An area of seepage centrally located along the west wall appeared dry at the time of the 2018 site visit. The pit below this area has been deepened by approximately 7 single benches since 2017. Routine maintenance of the drainage ditch should continue, and monitoring of this area as part of regular geotechnical inspections should continue.

Photograph 8-3: Vault Pit west wall seepage (dry in 2018)

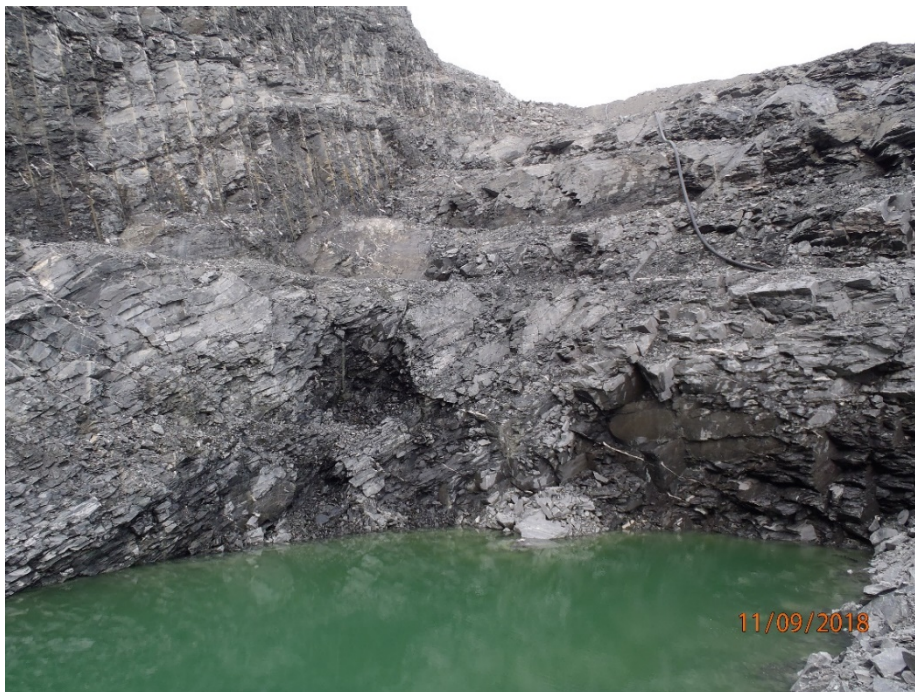
A small sump is in the southwest corner of the pit and manages water in this area. During the 2017 site visit, two outward dipping planes were noted above the sump area, forming shallow slivers of potentially unstable rock. The planes strike slightly obliquely to the wall orientation, and while they are kinematically free on their north extension, they do not appear to have any additional side release planes required for failure to occur. The area was visited again in 2018, and no observable instability associated with these planes was noted. These should continue to be monitored as recommended previously, including reminding personnel of safe work procedures relating to safe distance from rock faces, and for safety should remain to the pit-side of the equipment container.

Photograph 8-5: Vault Pit south ramp sump and out dipping planes

- Communicate the hazards in the sump area to personnel and remain on the pit-side of the equipment container for safety.
- Continue visual monitoring and recording of observations as part of regular site geotechnical inspections.

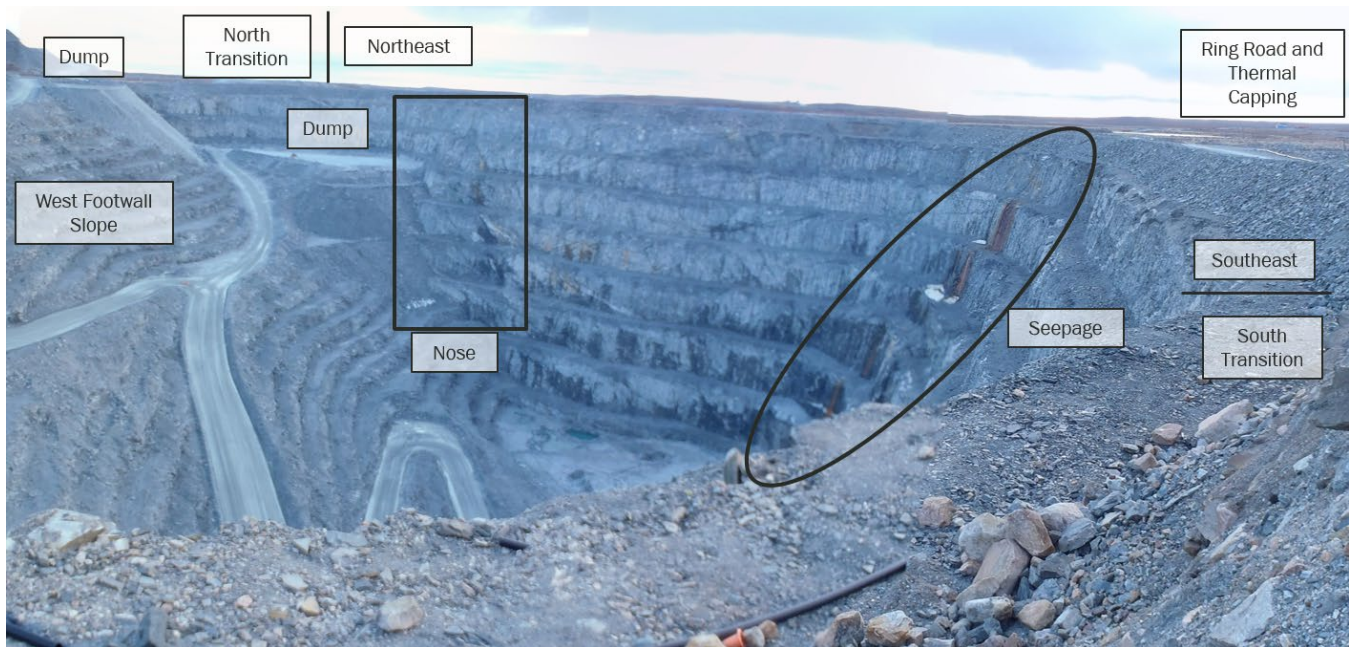
The southeast to northeast highwall (grid east wall) is being mined down to its final height. The catch benches developed for the highwall continue to perform very well. The pit floor has been deepened by approximately two triple-benches, or approximately 42 metres, to an elevation of 4976 mRL. The final benches are being mined using pre-shear blasting methods, and are being excavated to 75-degree bench face angles. Half barrels from the blast holes are clearly visible in the walls and there is very little deviation in the borehole traces.

Photograph 8-6: Vault Pit east highwall (2018)

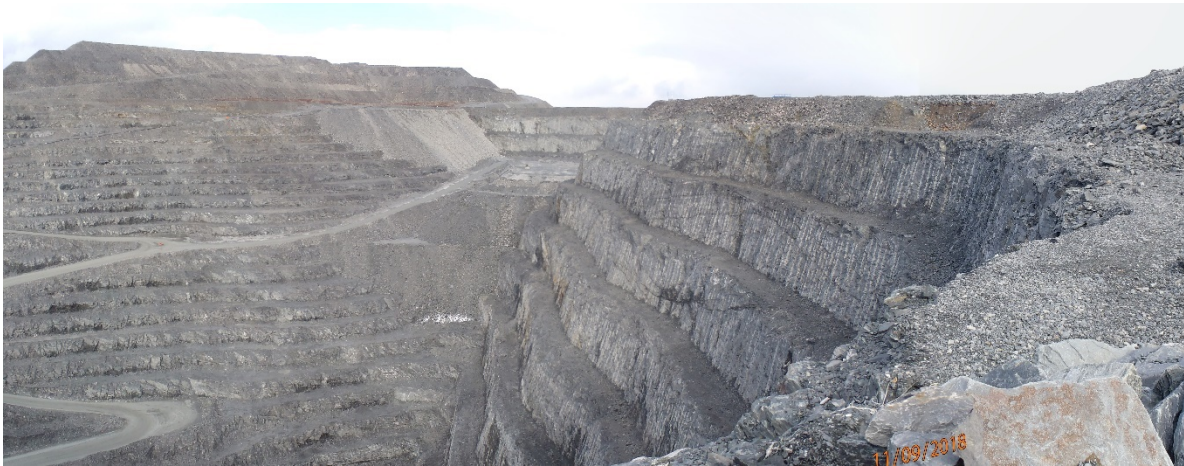
The benches are cleaned well, and there is no indication of significant raveling and no significant accumulation of material on the benches. There is some over break of bench crests due to blasting but this is not significant. In general, the toe of the thermal capping material is greater than 2 m back from the pit crest.

Photograph 8-7: Vault Pit east highwall bench performance, southeast end looking north (2018)

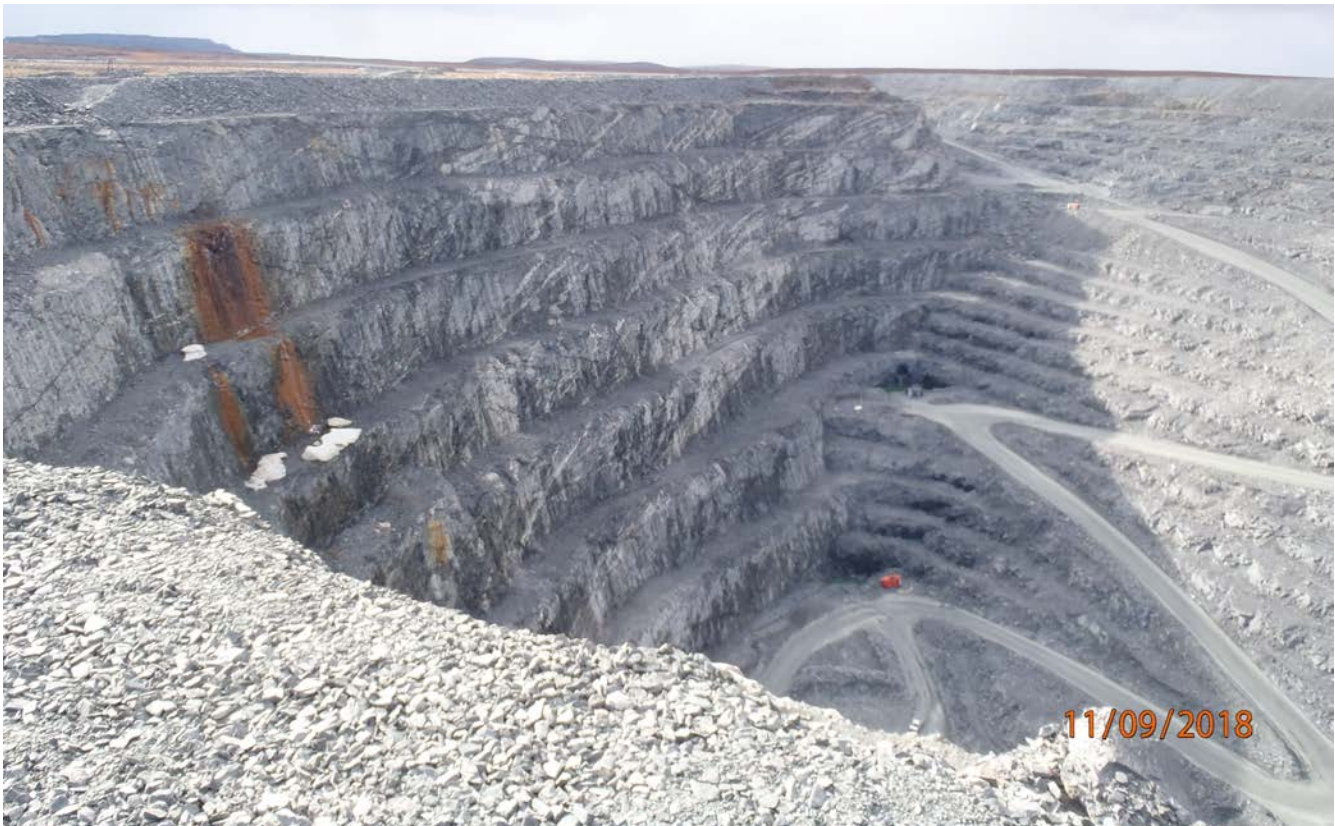
Photograph 8-8: Vault Pit east wall northeast end looking south (2018)

A minor change in wall orientation results in the formation of a 'nose' in the highwall near the northeast end of the wall. This sector of the wall has been developed within permafrost, and there are no apparent seepage faces on the wall.

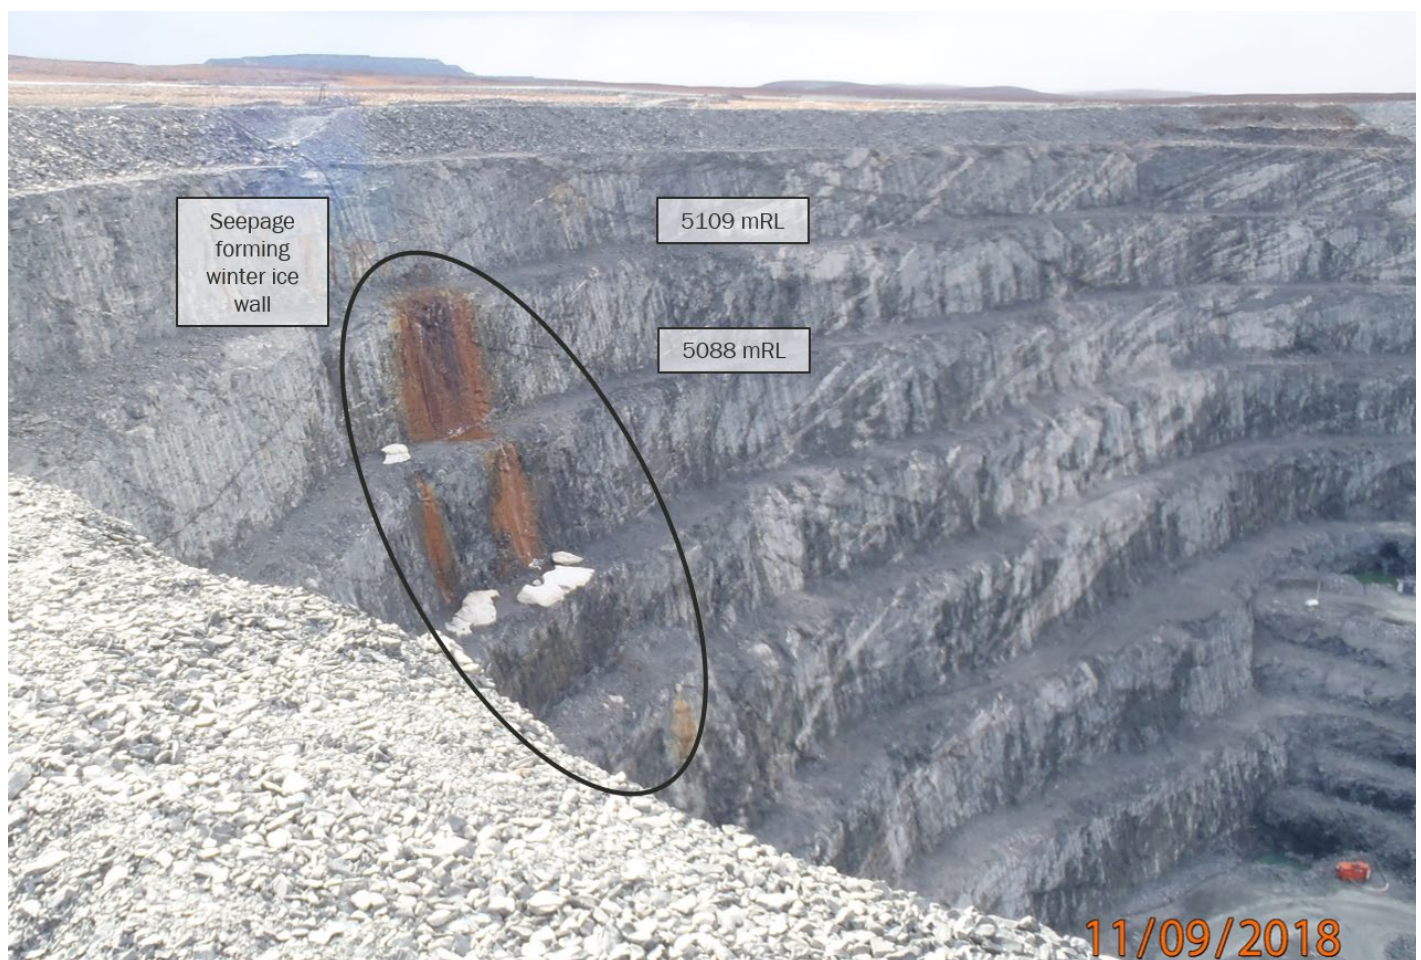
The one area of concern continues to be the south wall where seepage continues to flow from just above the 5109 mRL bench. Thermistor data suggest the area is freezing back but slowly, and there is no significant change to the non-frozen portion of the wall from which seepage flows. The formation of an ice wall can be expected for the remainder of mining in the pit. During winter mining, Agnico carry out bi-weekly inspections of the ice wall, noting any significant changes and communicating this information to operators as part of their standard management procedures. The movement and potential failure of ice is difficult to predict, but the greatest risk associated with mining adjacent to the ice wall occurs during spring freshet when ambient air temperatures are increasing. It is understood that mining of Vault Pit will be complete in January 2019, and so the risk associated with the freshet period will be avoided.

Photograph 8-9: Vault Pit seepage from southeast pit wall 5109 bench (2018)

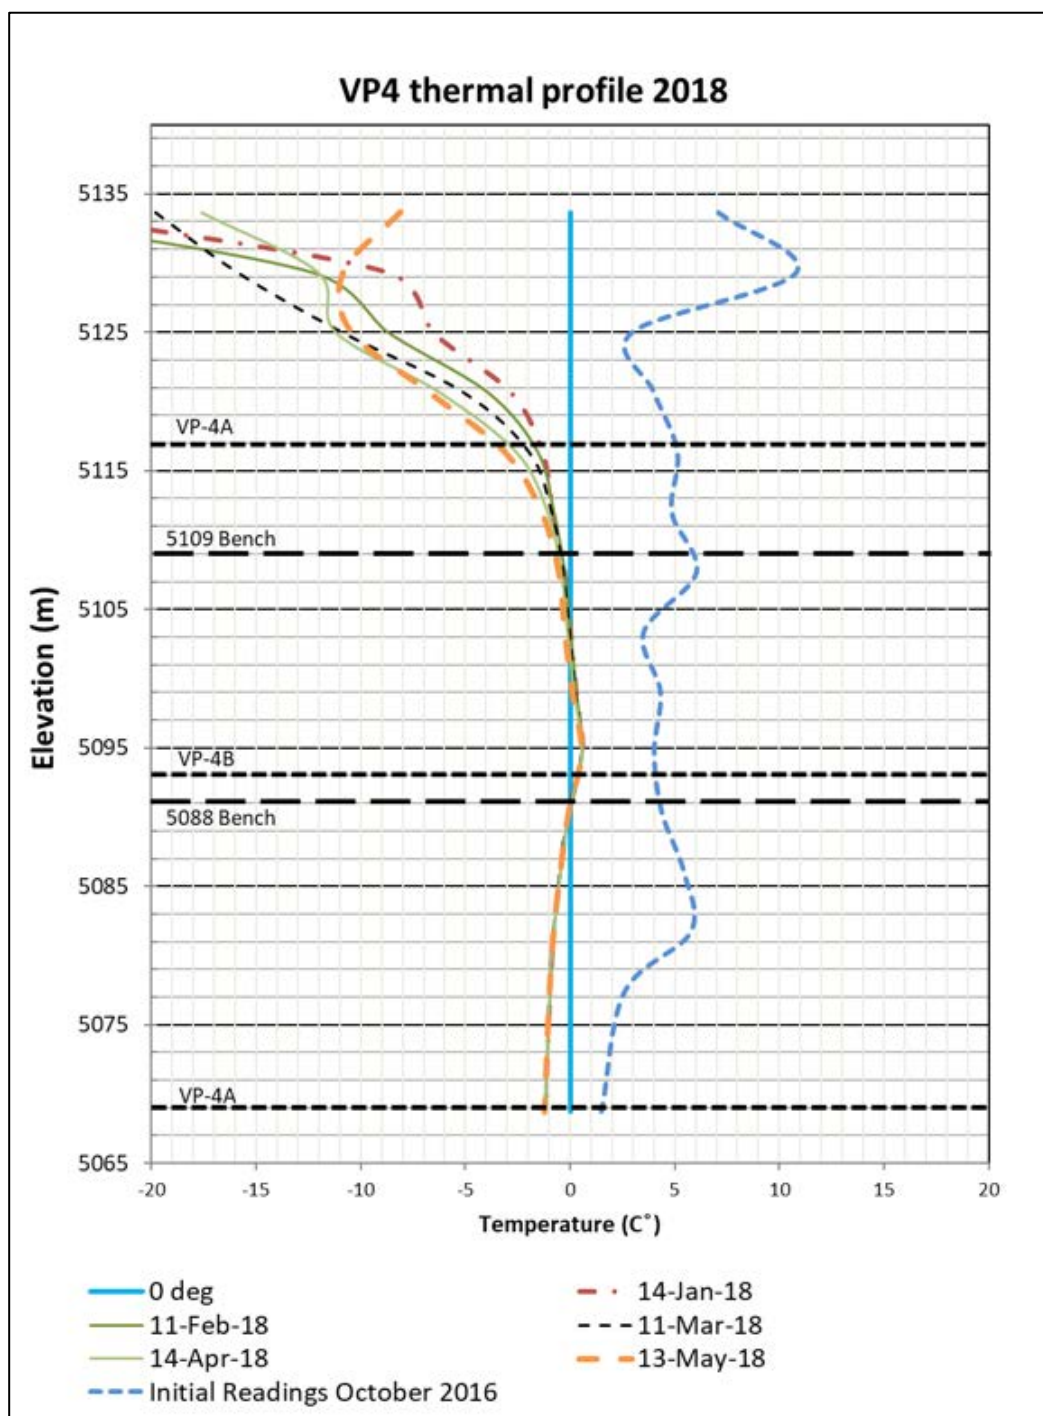
Figure 8-4: Vault Pit VP4 thermal profile

VP4 is installed behind the area of the ice wall on the southeast side of the pit. As with VP2, VP3 displays a typical permafrost 'trumpet' curve. The curve shows that the upper portion of the wall, to an elevation of approximately 5109 mRL, is within permafrost. Between 5109 mRL and 5090 mRL, ground temperatures are approximately 1 degree C in the region that seepage is noted from the wall and where the winter ice wall takes form. There is no noticeable change in the thermal profile in VP4 from 2017.

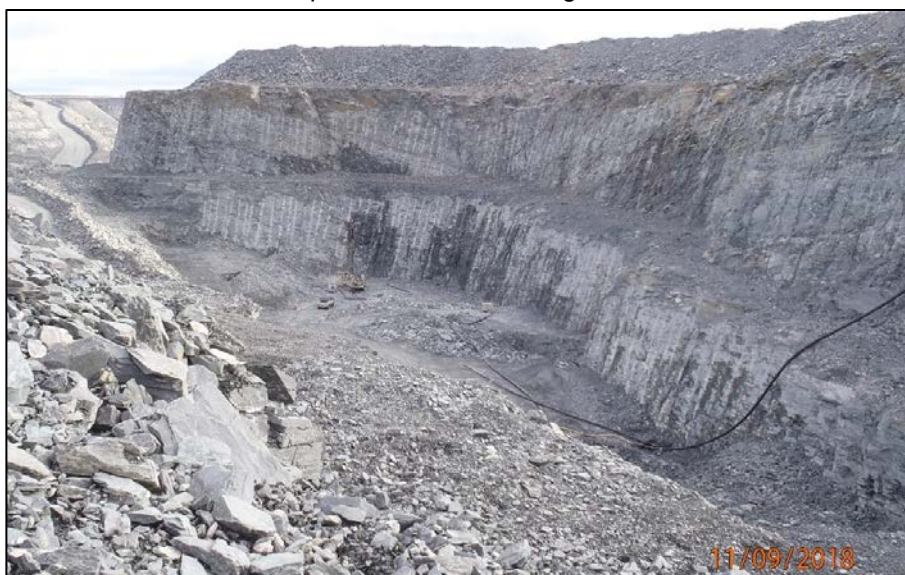
The east-southeast highwall of the pit was reviewed, and is performing well. Half-barrels from pre-shear blast holes are clearly visible, and show little deviation. The upper bench exposed during the site visit is well cleaned and allowed safe access to assess the bench-scale performance. The excavation practices are appropriately following the design criteria for the Vault Pit, and the performance of the highwall is similar to that of the Vault Pit.

Photograph 8-14: Phaser Pit east-southeast highwall performance (2018)

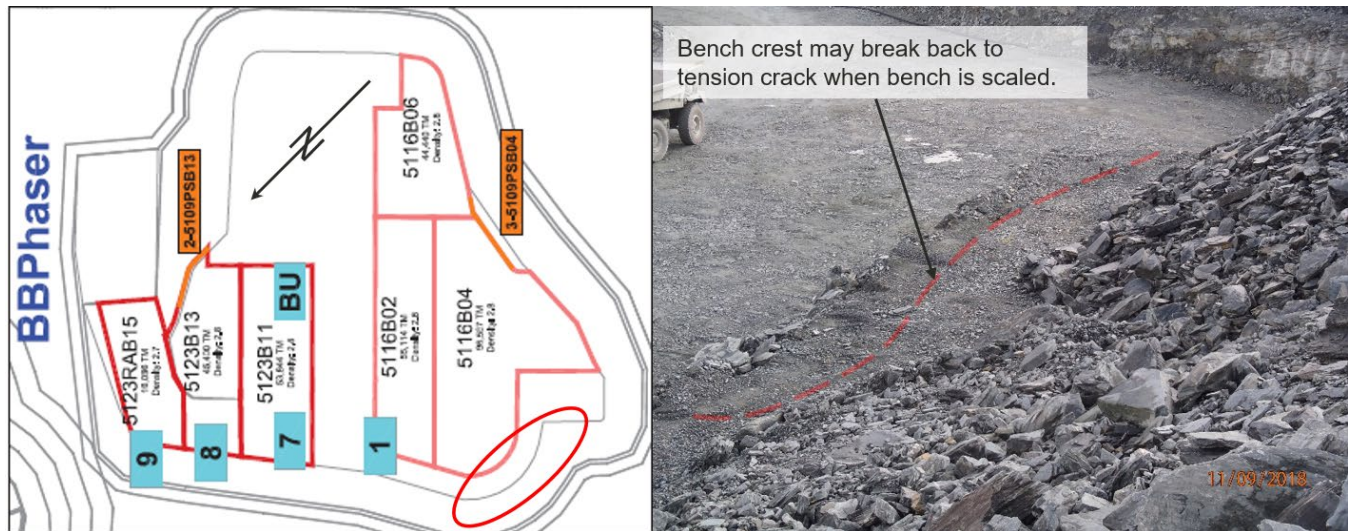
It was noted that in many areas the set back of the thermal cap toe from the crest of the pit was narrow, and less than adequate in some areas that had not yet been scaled. Furthermore, it appeared that the thermal cap was placed predominantly during winter, without proper snow and ice removal before placement. This has resulted in substantial thaw settlement and differential displacement of the thermal capping material and the development of hummocky ground, sinkholes, and tension cracks. The presence of voids may allow for water infiltration into the thermal cap, which could result in erosion. The lack of sufficient catchment at the toe of thermal cap, and above the pit, may result in spill over on to the ramp and benches.

Photograph 8-17: Tension crack at crest of first bench below thermal capping toe

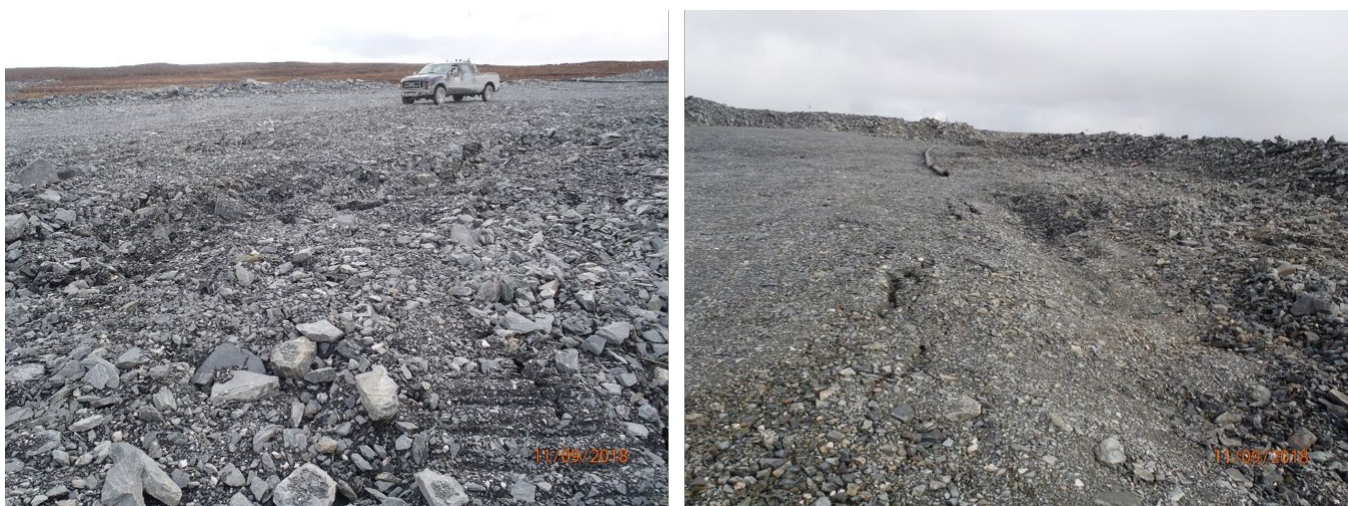
Photograph 8-18: Thermal cap showing hummocky ground, differential settlement, and voids

- Improve bench cleaning and wall scaling practices in BB Phaser Pit.
- Monitor ring road in BB Phaser Pit, and manage water accordingly. The current differential settlement is most likely due to the time of year the fill was placed, and so is not unexpected. However, the proximity of the ring road and thermal cap to the pit crests presents some potentially unsafe conditions because of this.
- Consider re-grading of the ring road/thermal cap to remove hummocky ground and promote drainage away from the crest areas.
- Consider developing a small windrow of material at the toe of the first bench to catch any material that may spill over from the thermal cap above.
- Continue visual monitoring and recording of observations as part of regular site geotechnical inspections.
- Continue mapping to confirm the orientation of stratigraphy and other important structures.

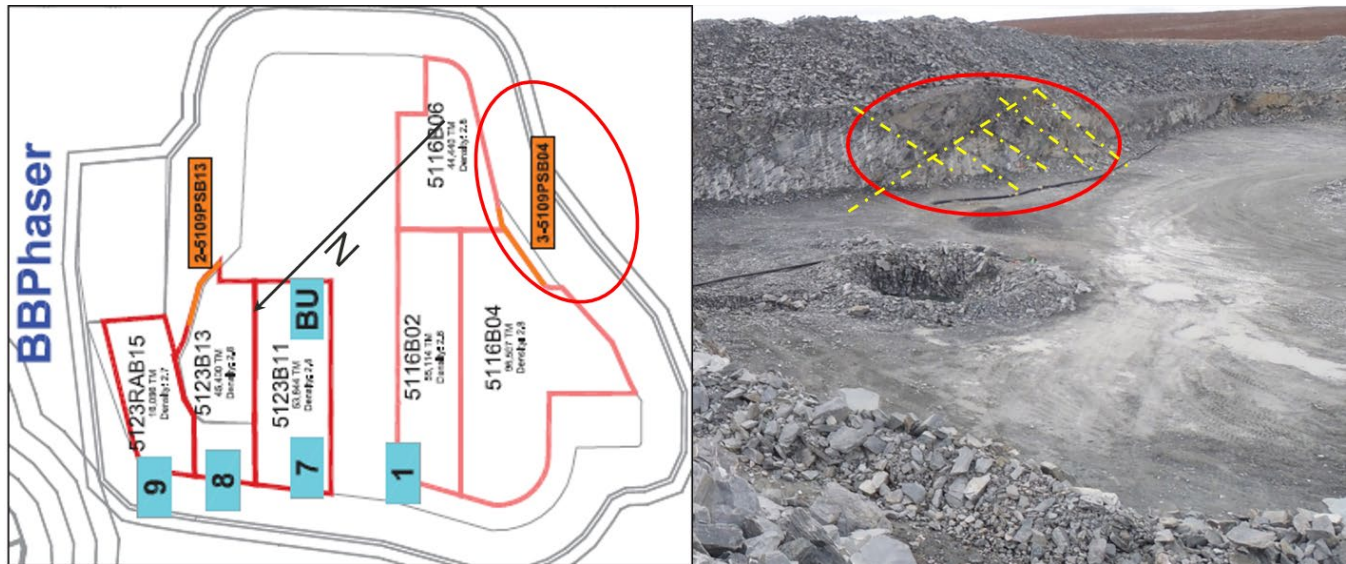
An area of the south and west wall of the pit was noted to display significant blast damage to the rock. This blast damage, combined with local faulting and continuous open jointing, has resulted in a rock mass that may be difficult to effectively scale. Over excavation during scaling could result in undercutting of the thermal cap. Consequently, it may be more effective to leave this specific area unscaled to avoid over digging of the rock mass and undercutting of the overlying materials. An alternative might be to construct a low buttress against the face if the current platform elevation is the final platform for this area. This was discussed with AEM during the site visit, and it was recommended that as a minimum, candles should be placed to restrict entry to the area until appropriately cleaned.

Photograph 8-19: BB Phaser Pit south wall blast damaged rock

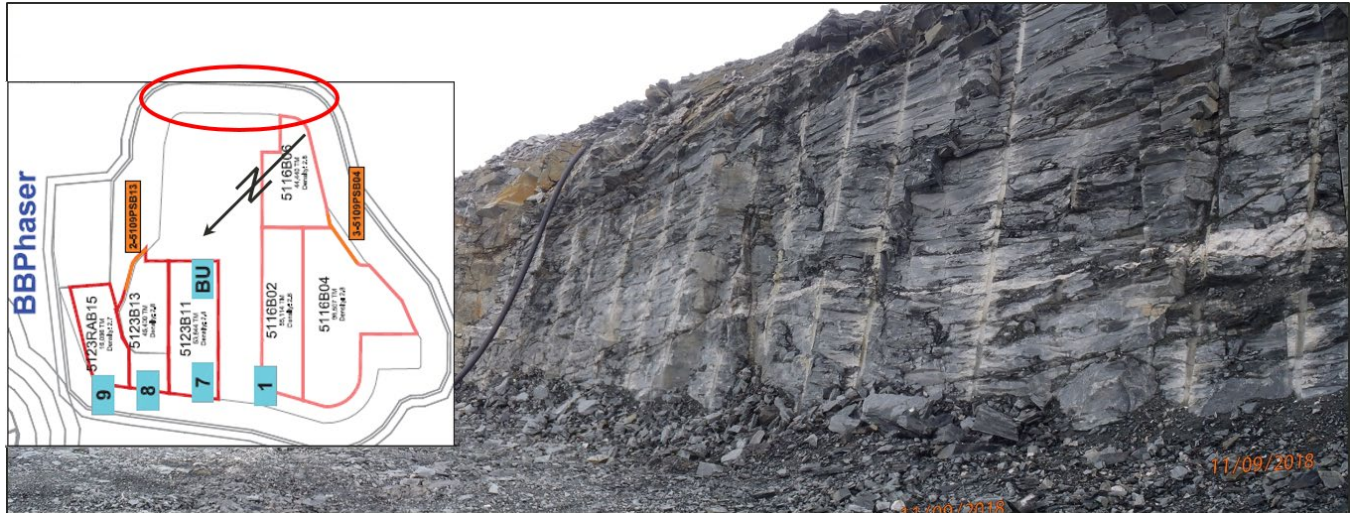
The south through east highwall of the BB Phaser Pit was inspected. This area of the pit has responded well to pre-shear blasting with half-barrels visible in the wall, and good wall performance.

Photograph 8-20: BB Phaser Pit south through east highwall showing good performance

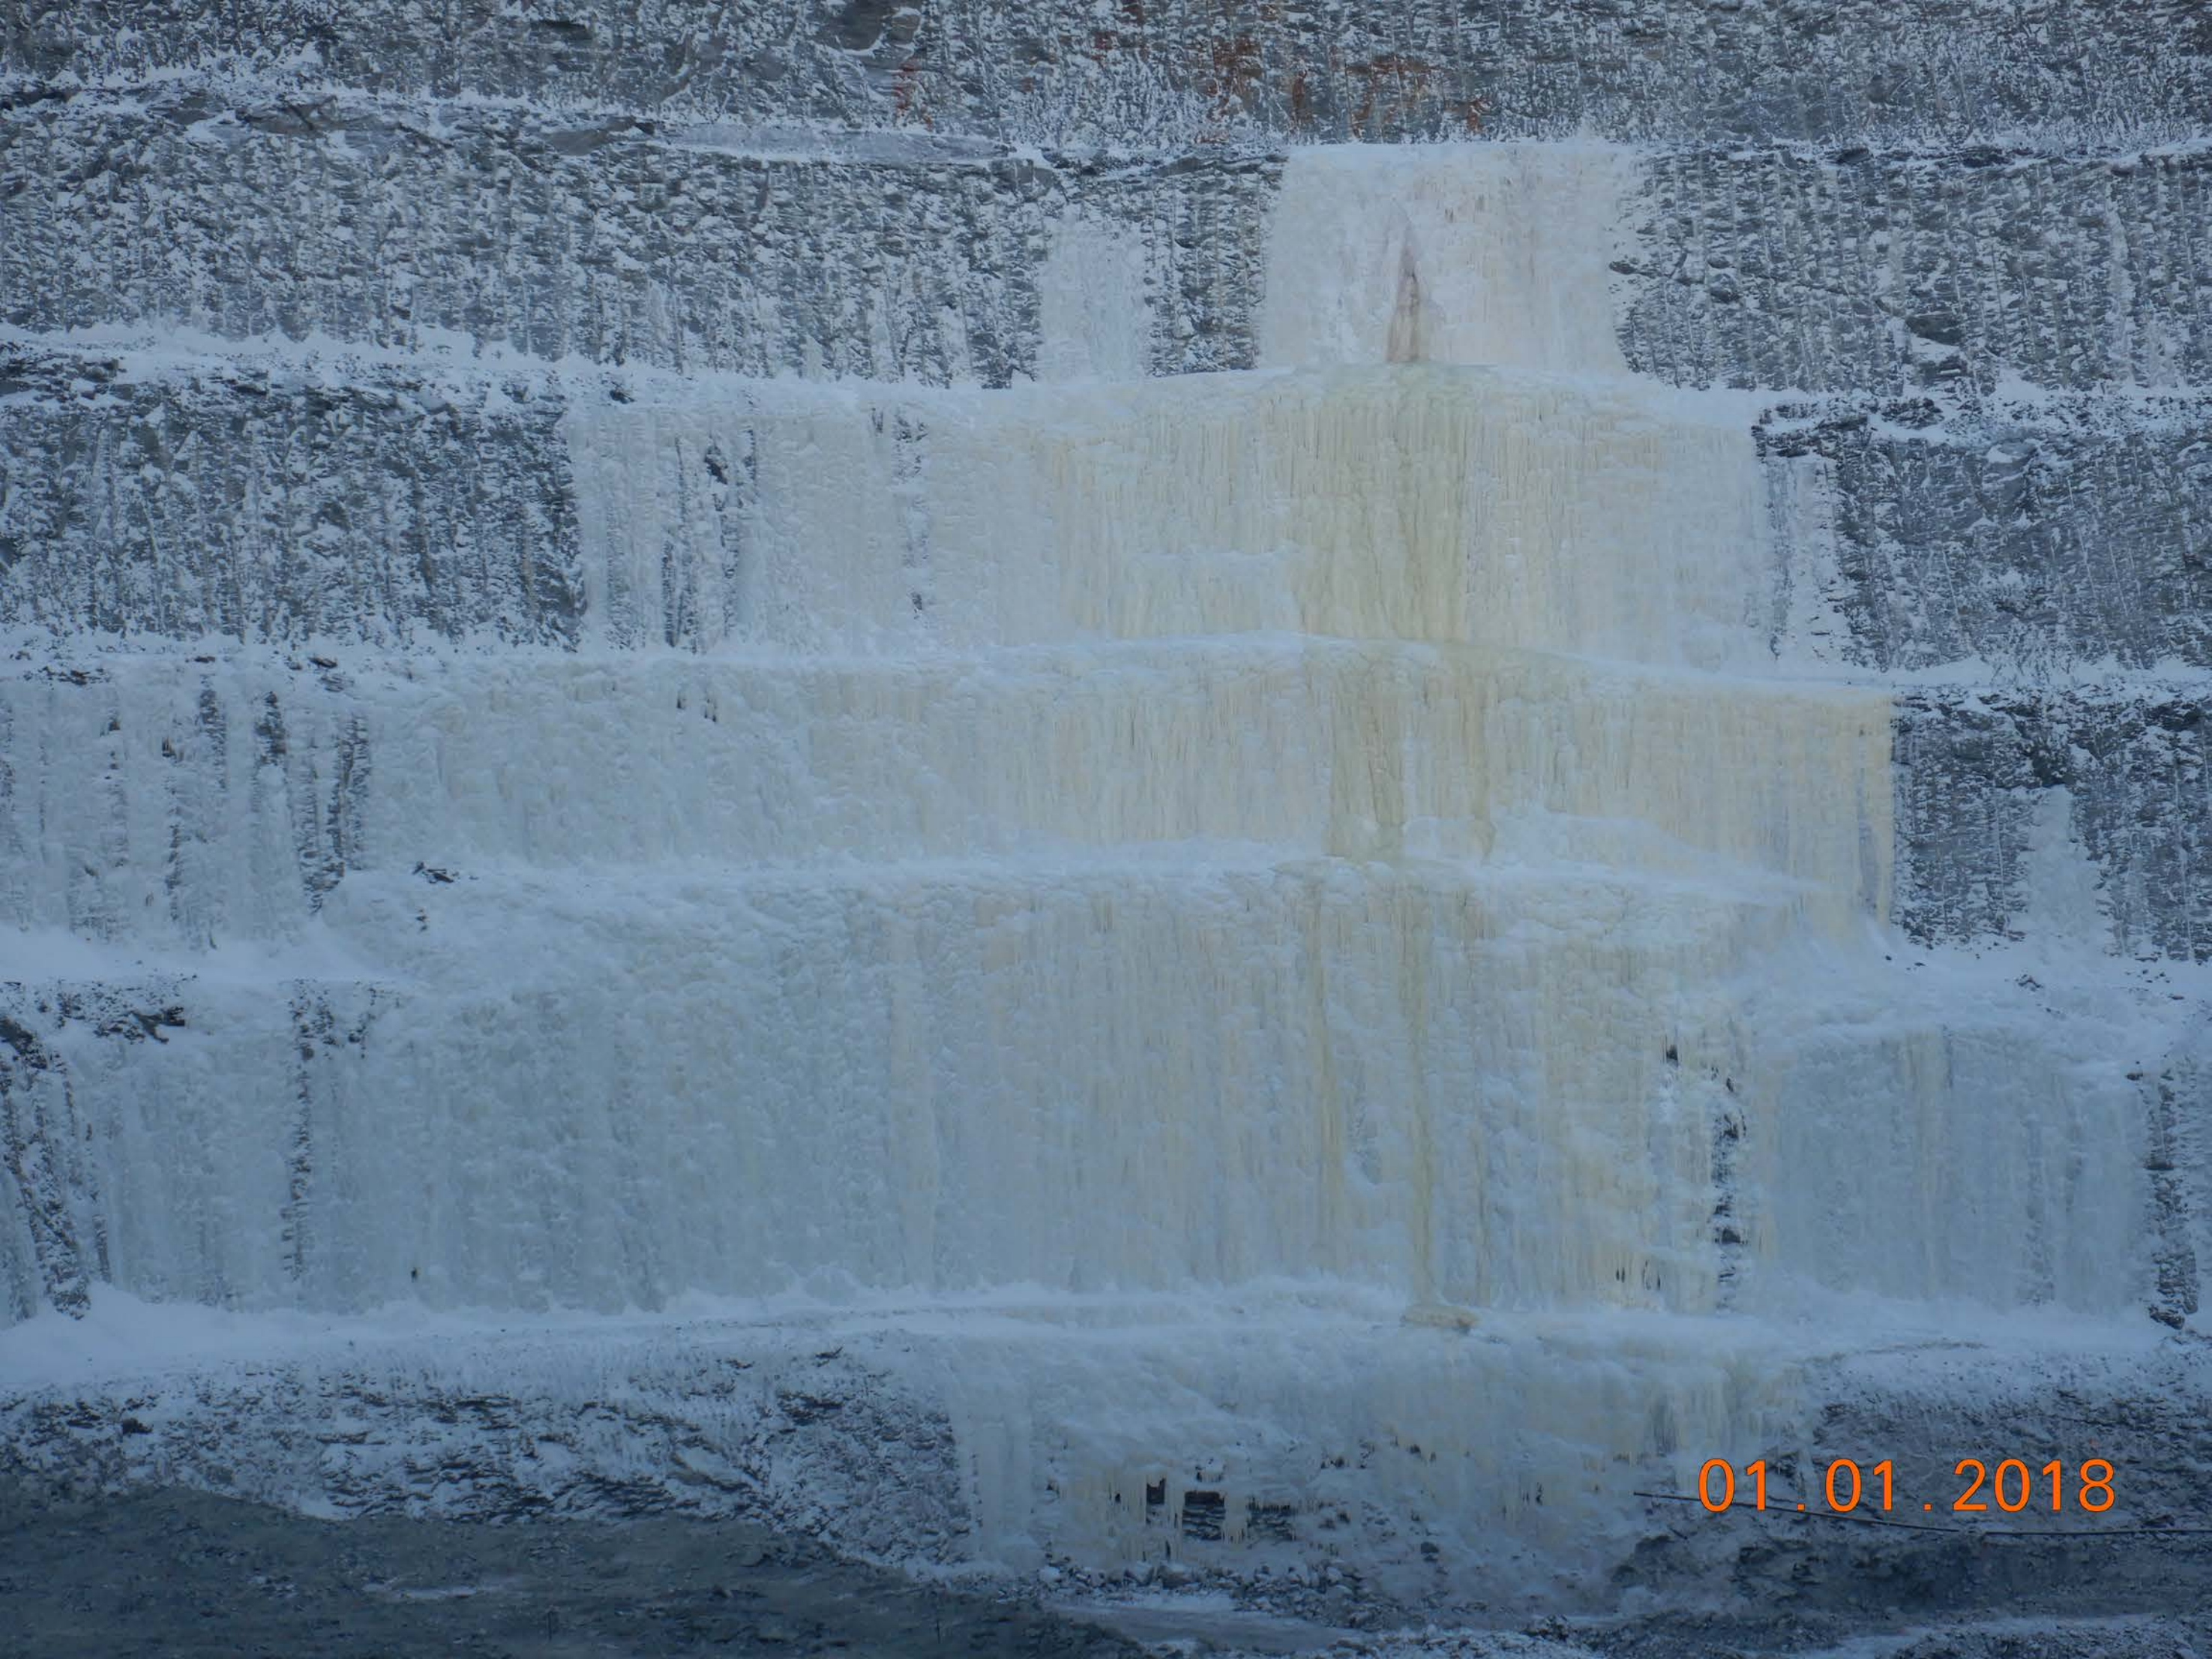
01.01.2018

Comments No defect was found so far as the wall is forming.

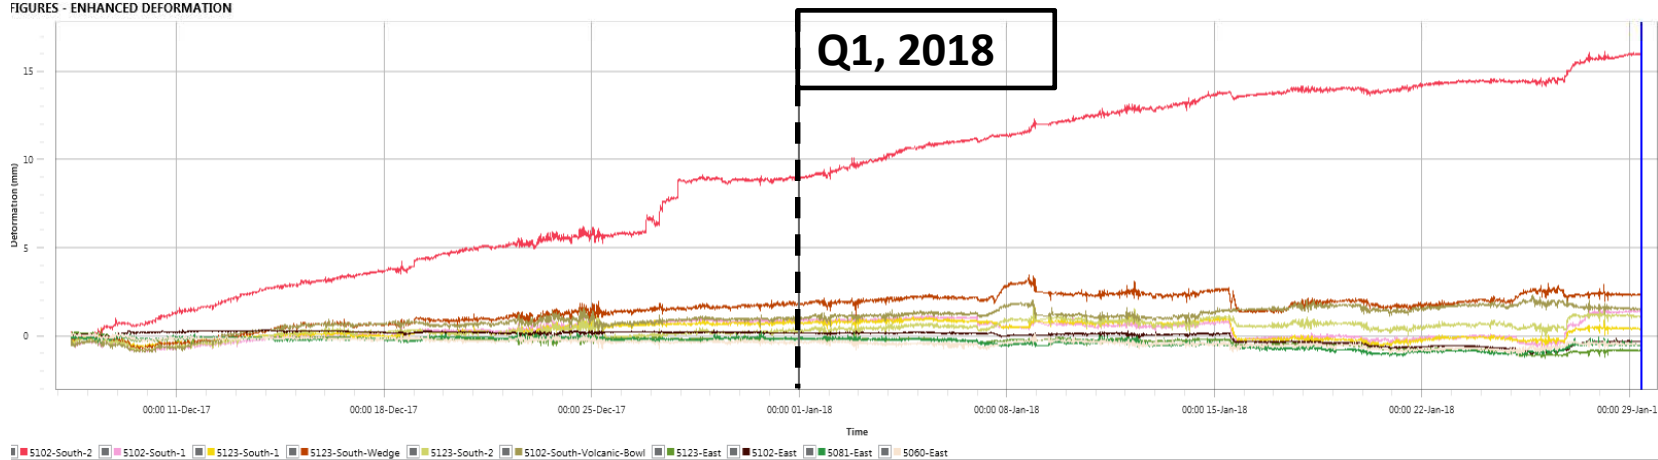
Enhanced deformation per sector (January 1st to January 29th) – Wall folder: SSR253_171207_Meadowbank_E5_SouthWall).

Comments: Most of the sectors were showing stable wall condition. The sector identify as 5102-South-2 presents a linear progression in deformation during that period(+7mm during January). The primary interpretation of this linear trend is the build-up of ice within joints behind the wall. It is assumed that this ice formation could (or not) lead to a detachment of a large block. A specific alarm setup has been implemented for this area to quickly catch any acceleration of the deformation. Usual TARP is applicable with the dispatch office for the night shift.
