Meadowbank 2018 Annual Review of Portage and Goose Pit Slope Performance

2018 ANNUAL PIT SLOPE PERFORMANCE REVIEW

MEADOWBANK MINE, NUNAVUT

ISSUED FOR USE
704-ENG. ROCK03053-02

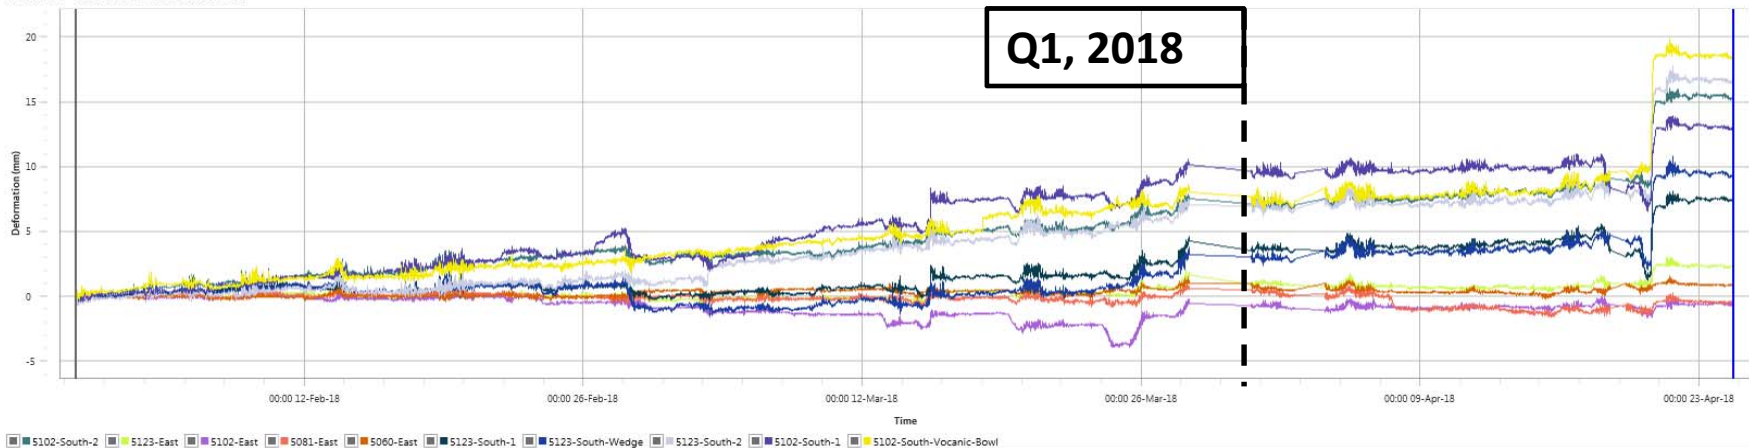
Enhanced deformation per sector (January 31st to March 31st) – Wall folder: SSR253_180131_Meadowbank_E5_South_Wall).

Comments: During the second monitoring period, the section mentioned previously (5102-South-2) gained 10mm over a 2 months period. On this second monitoring period, it is interesting to point out that out that the section does not stand out from the others like before, and it is now his close neighbour (5102-South-1) that has the strongest deformation trend. The probable cause of the small fluctuation (spikes) recorded on all the trend is the monitoring condition the Radar has to performed in.

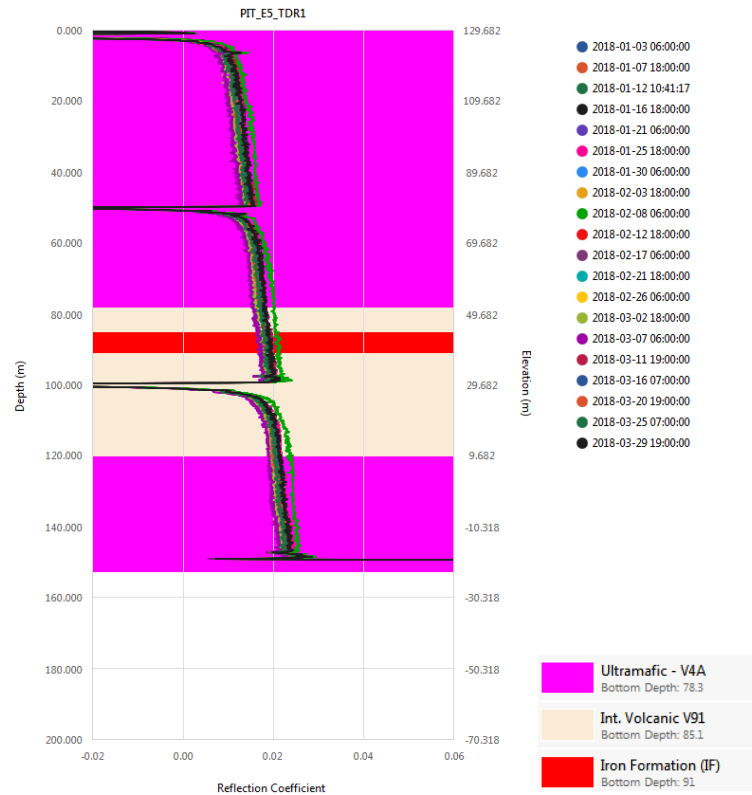
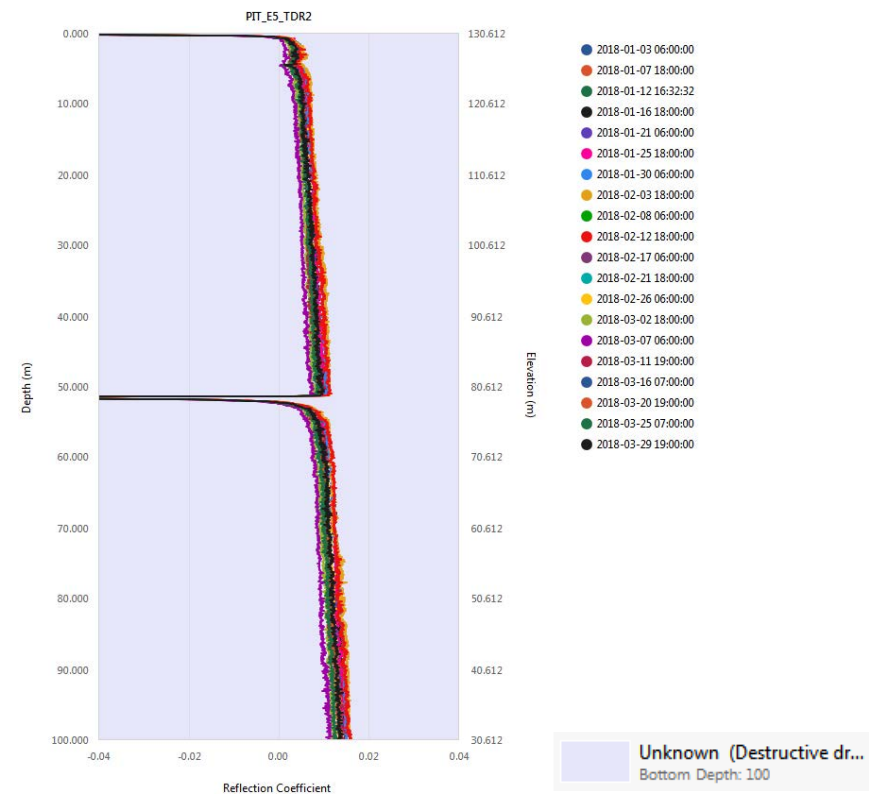
- No sign of deformation observed in TDR1 & TDR2.
- Anomalies from the TDR logger are still presents and were disregarded in the presented graphs.

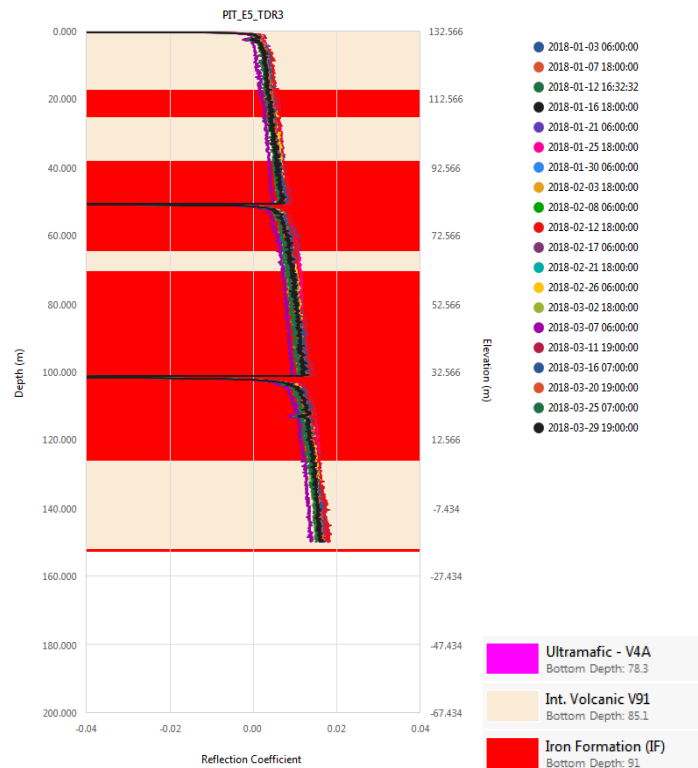
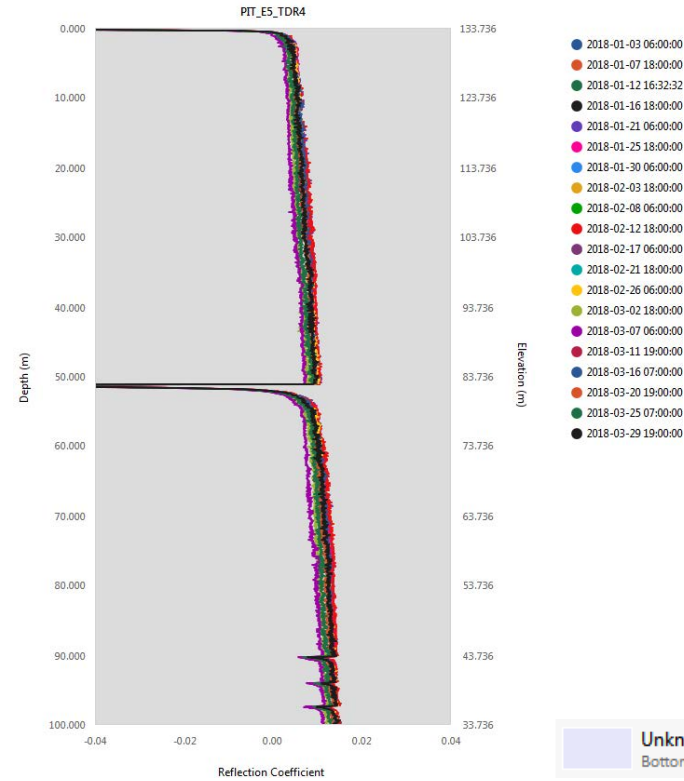
- No sign of deformation observed in TDR3.
- The small reflection coefficient spikes in between elevation 44 and 34 MASL on TDR4 are present since installation.
- Anomalies from the TDR logger are still presents and were disregarded in the presented graphs.

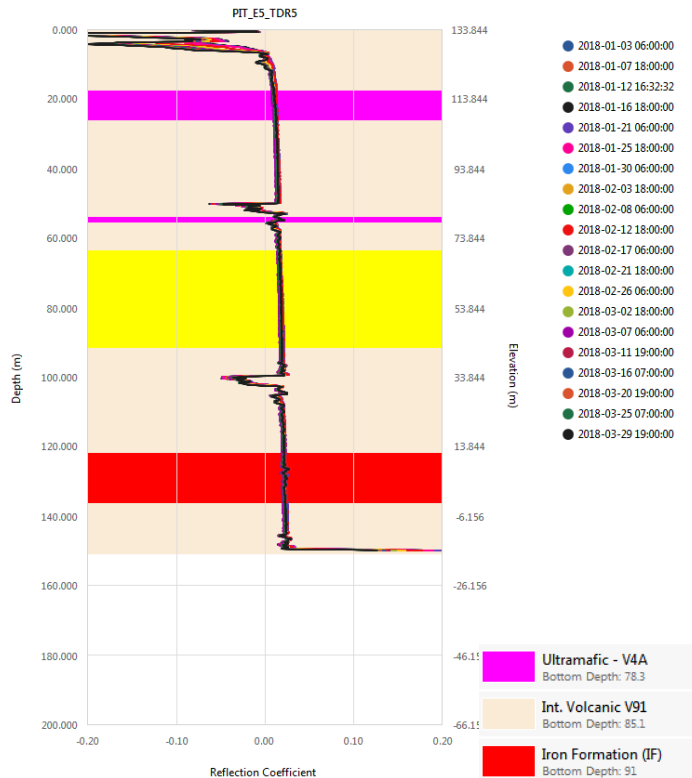
The anomalies quoted in the previous TDR results are under investigation. Basically, the defect causes the data set to be translated into the graph ($x \approx -1,500$) in the example. Even though the general aspect of the graph seems to be preserved, the Reflection Coefficient is well below the expectations.

- No sign of deformation observed in TDR5.
- The small reflection coefficient spikes in between elevation 14 and -6 MASL on TDR5 are present since the installation.
- Anomalies from the TDR logger are still presents and were disregarded in the presented graphs.

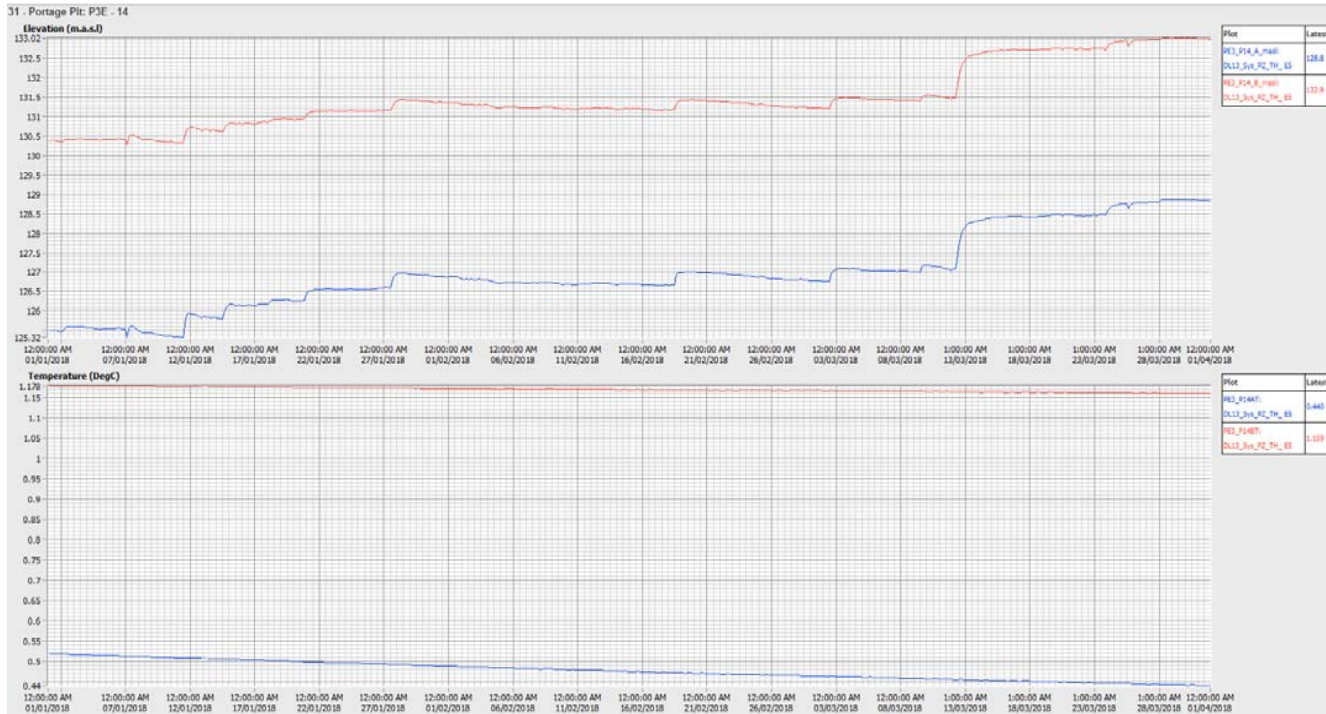
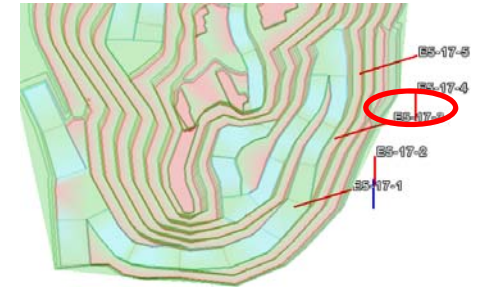
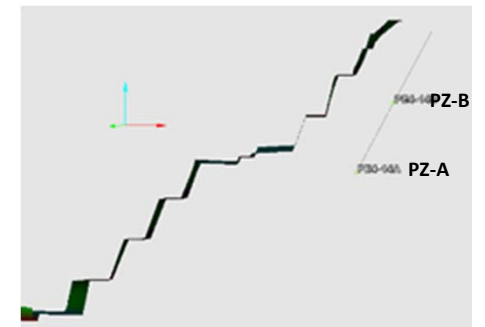
PE3-14 PZ-A,B

- Overall increase in pressure of +2.6m in the Q1, 2018. This is assumed to be related to freeze back of seepage faces.
- Smaller increase and decrease in pressure are related to mining activities (drilling/blasting).
- Overall downward trend for piezometer's temperature.

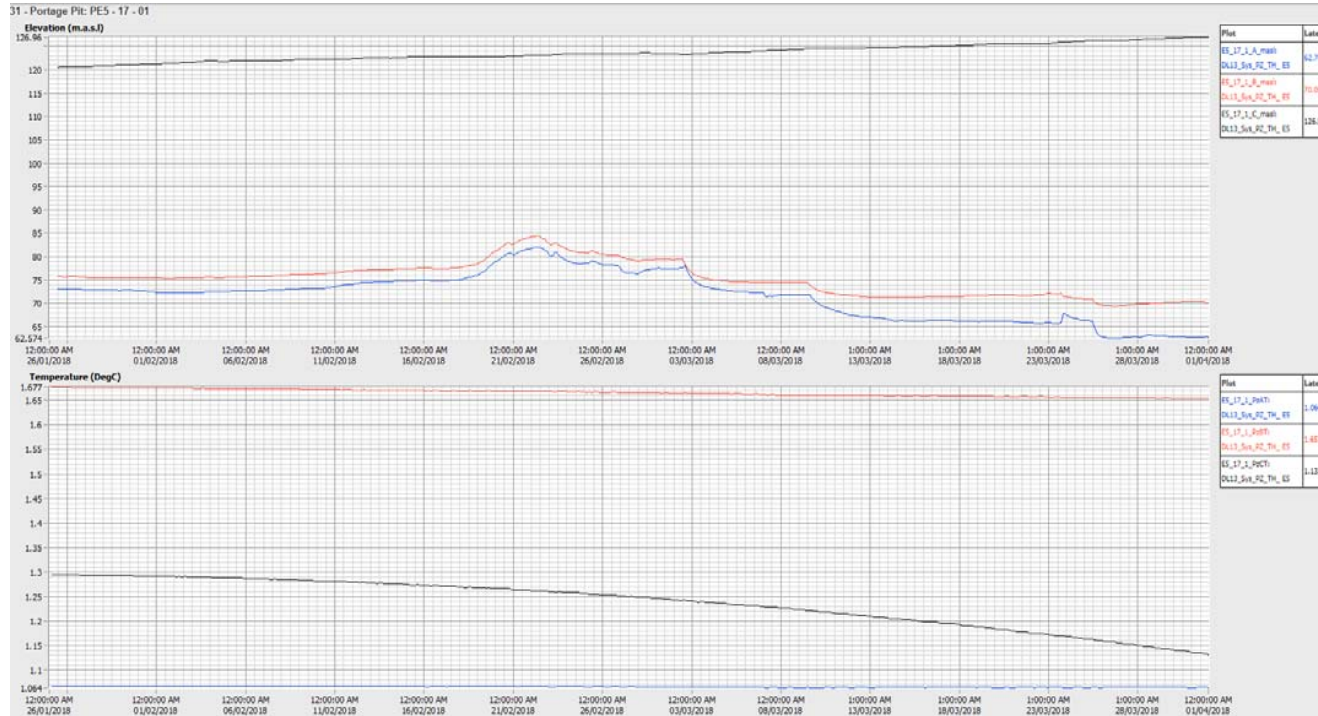
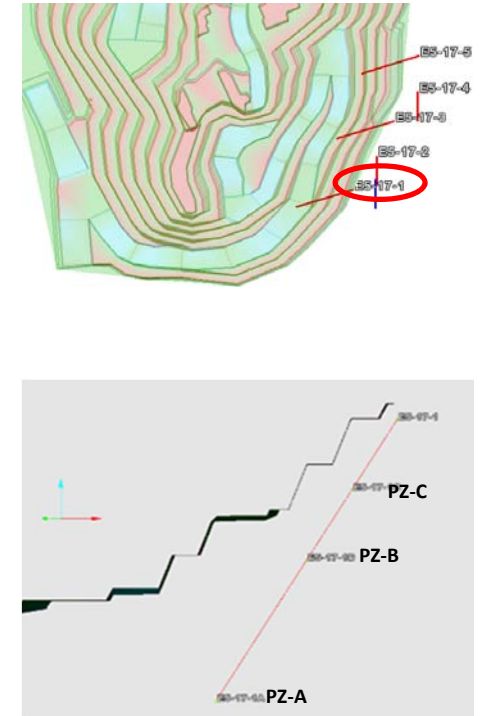
PE5-17-01 PZ-A,B,C

- PZ-A&B sharply rose 7m PWP before dropping 15m PWP from the end of February to the end of the Q1. The increasing section could be attributed to freeze back of the seepage faces while the decreasing trend could be the result of a pressure release due to the mining activities close by the hole. PZ-C has a consistent pressure increase and gained 8.7 m PWP during the Q1, 2018.
- Smaller increase and decrease in pressure are related to mining activities (drilling/blasting).
- None of the piezometers are under the freezing point.

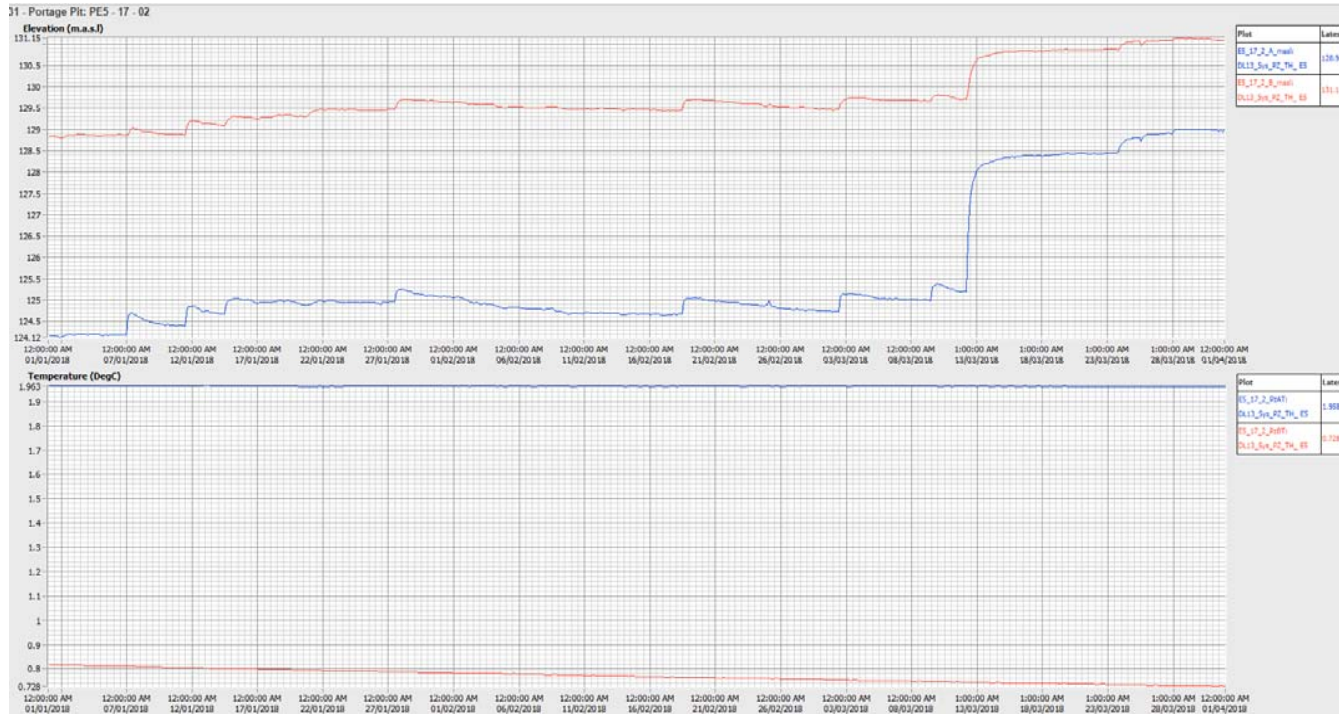
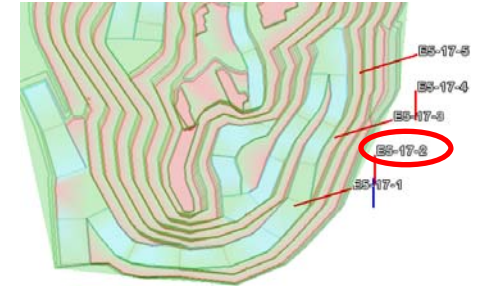
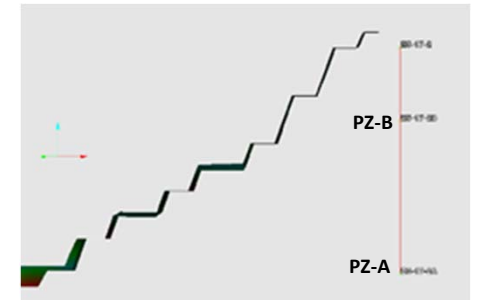
PE5-17-02 PZ-A,B

- PZ-A sharply rose 3m PWP around mid-February, while PZ-B acted the same way but on a smaller scale. This could be attributed to freeze back of the seepage faces. Indeed, PZ-A appeared to be more sensitive than PZ-B and that may be attributed to its proximity with the talik.
- None of the piezometers are under the freezing point. There is slight downward trend in PZ-B temperature's.

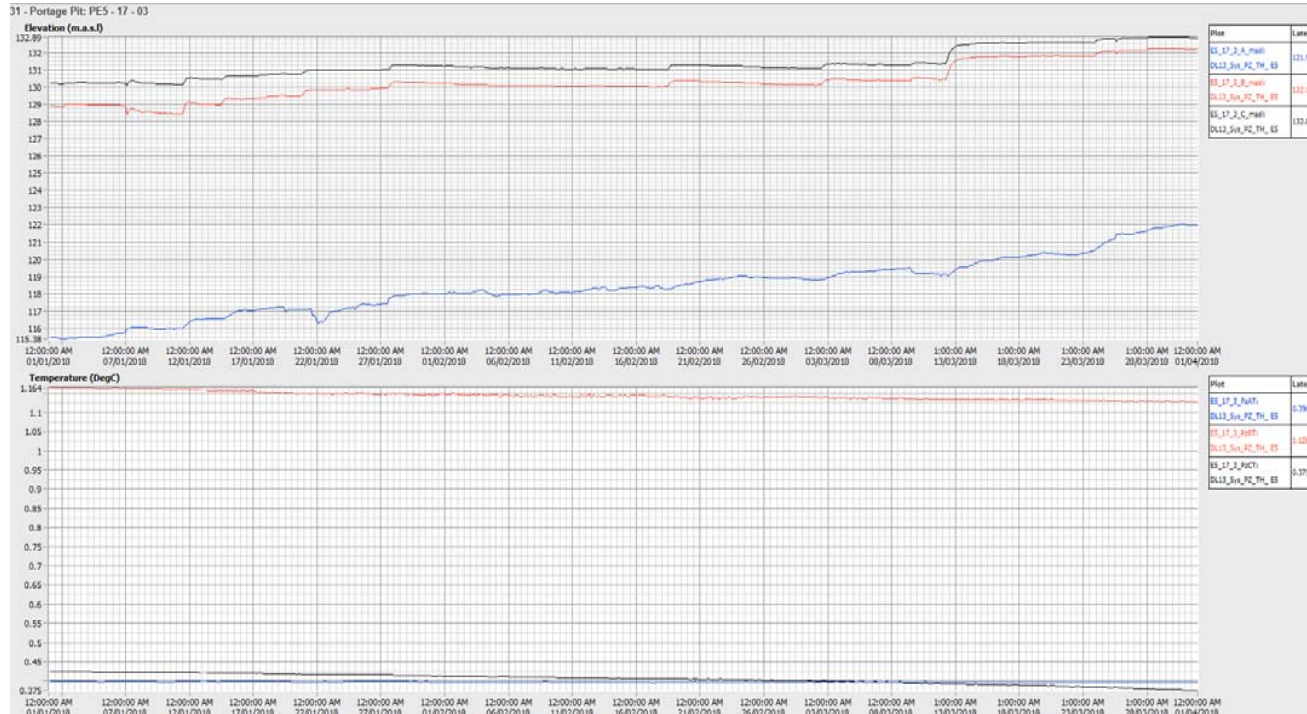
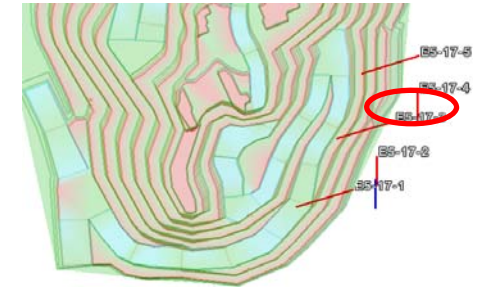
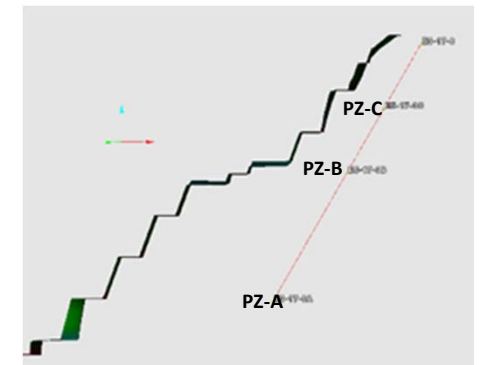
PE5-17-03 PZ-A,B,C

- PZ-A rose steadily during the Quarter Period totalizing 9 m of pore water pressure.
- PZ-B & C rose 5.3 m PWP and were subject to small sudden variations caused by the mining activities.
- All the PZs are above the freezing point and PZ-B (0.8°C) is warmer than the others.
- PZ-C is on a cooling trend and might become frozen and unreliable in the upcoming months.

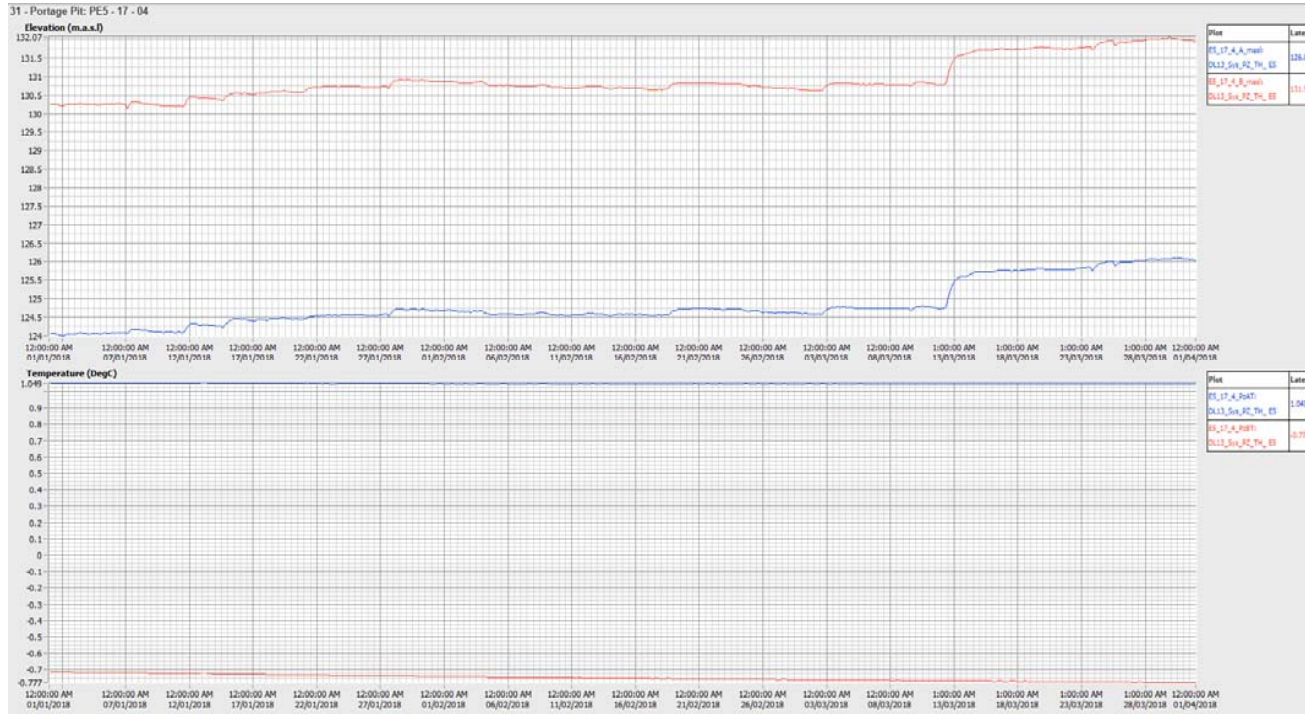
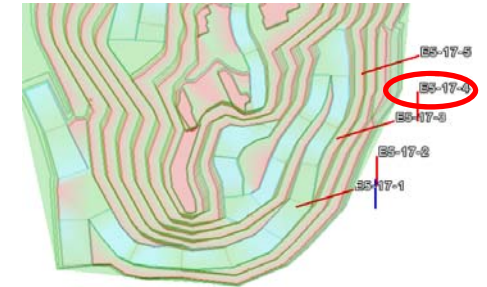
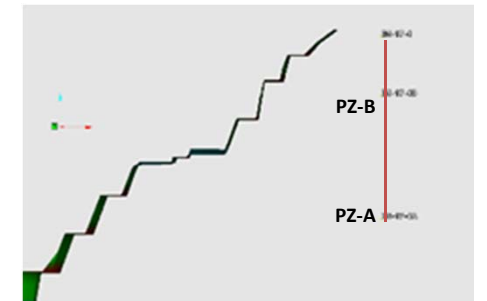
PE5-17-04 PZ-A,B

- PZ-A is on a slow increasing trend.
- PZ-B is frozen while PZ-A is at around 1°C.
- Smaller increase and decrease in pressure are related to mining activities (drilling/blasting).

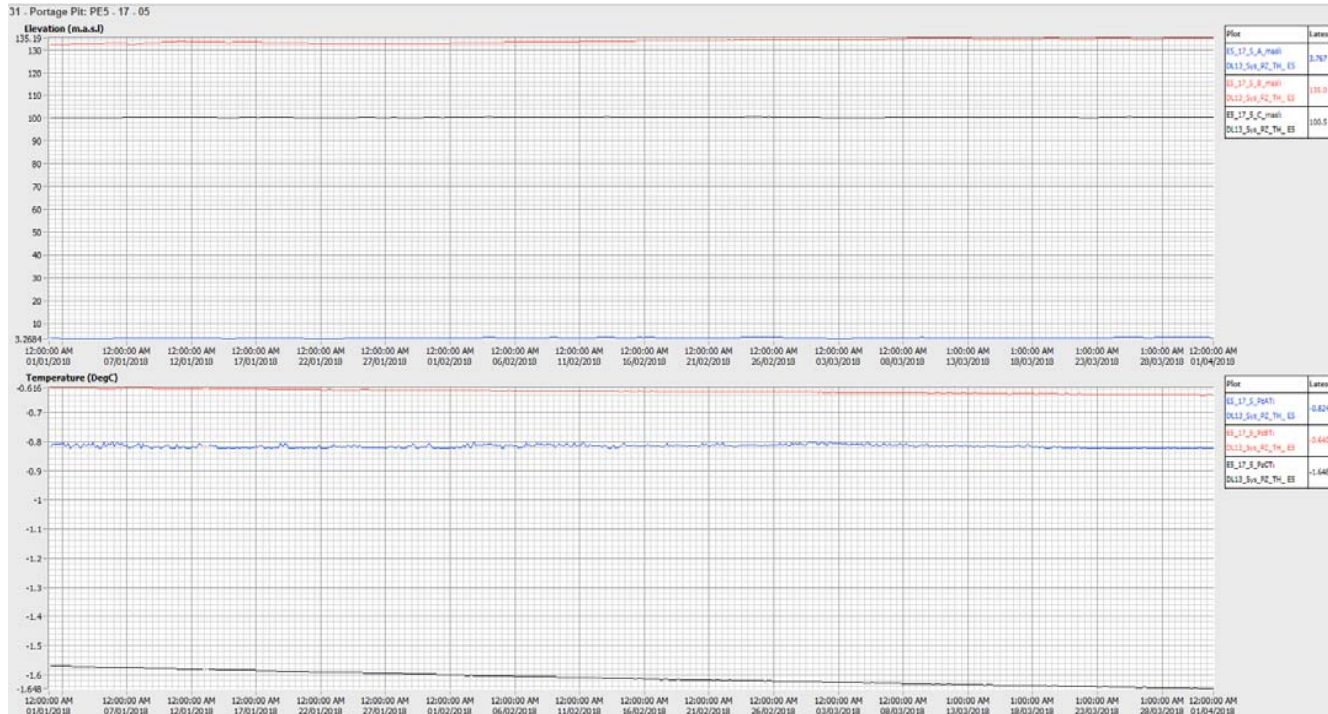
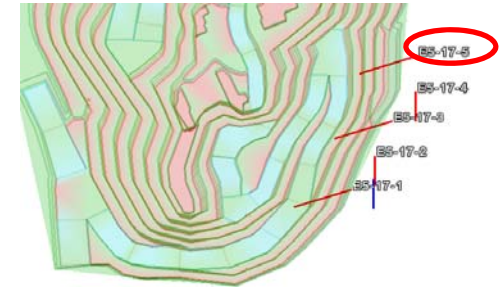
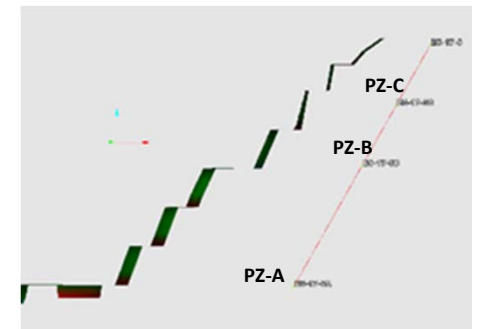
PE5-17-05 PZ-A,B,C

- PZ-A,B and C are frozen. The pressure measurements are considered unreliable.
- Temperature of PZ-C is still on a downward trend.

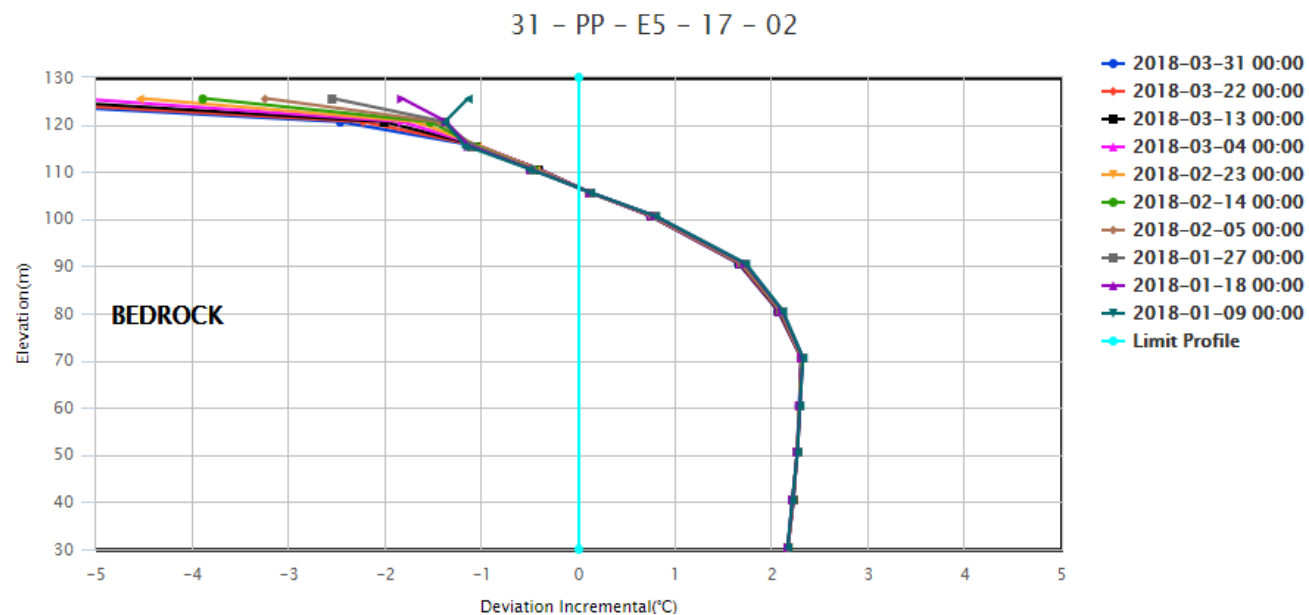
PP-E5-17-02

- There is a permafrost layer from the top of the hole at elev. 125 to the elev. 105 MASL. It suggests an aggradation of the permafrost from the surface since the dewatering of the lake in 2011.
- Apart from the 2 first beads, only minimal variations were recorded during the period.

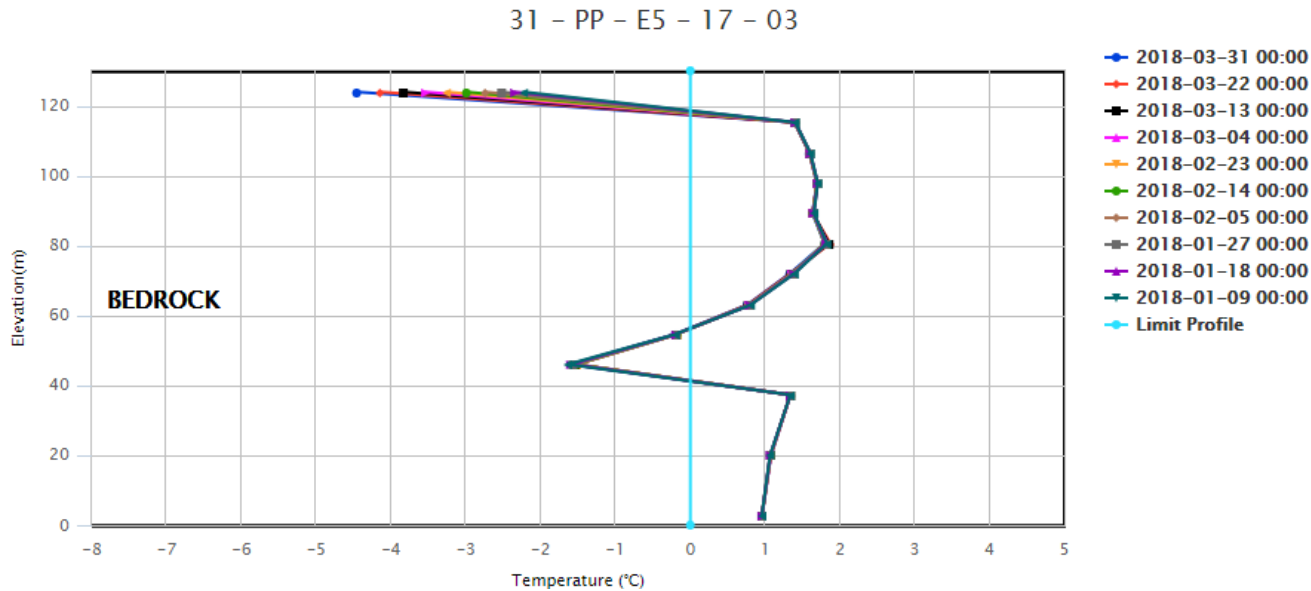
PP-E5-17-03

- Small variations occurred only on the first bead during the Q1, 2018. The rest of the thermistor remained consistent with previous data sets.
- There is a permafrost layer between elevation 40 and 55 MASL.

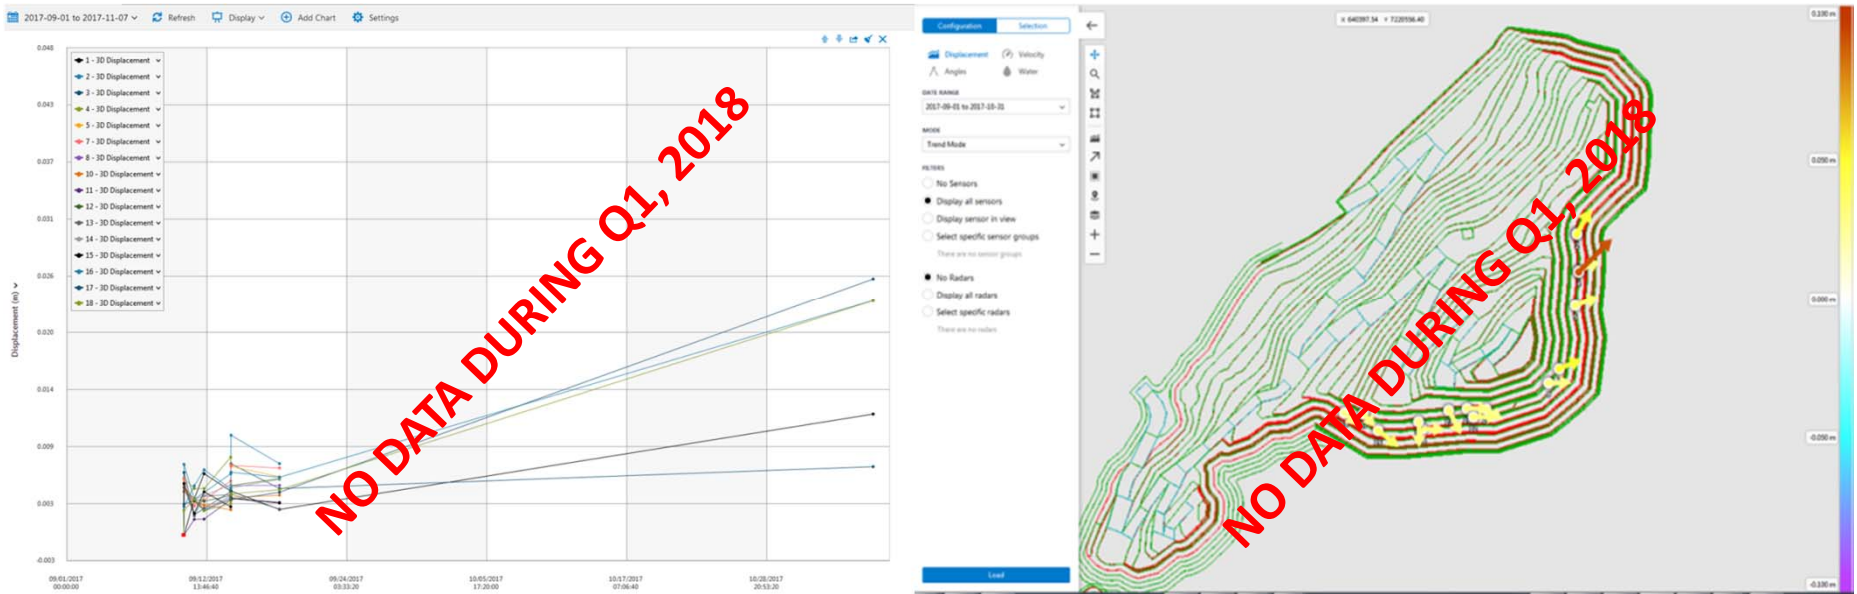
- The latest reading was taken in November.
- During the latest survey of the prisms, only few were successfully surveyed due to cold weather (frost in the lens, snow, ice wall etc.).
- The monitoring will be restarted when weather conditions will allow it (May).

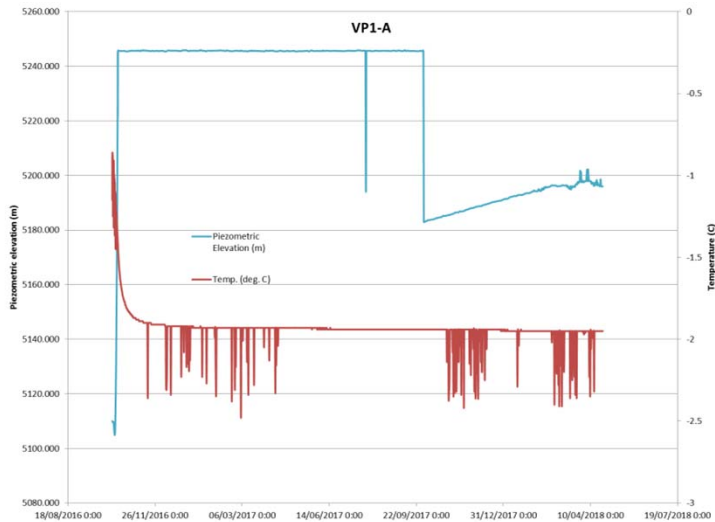
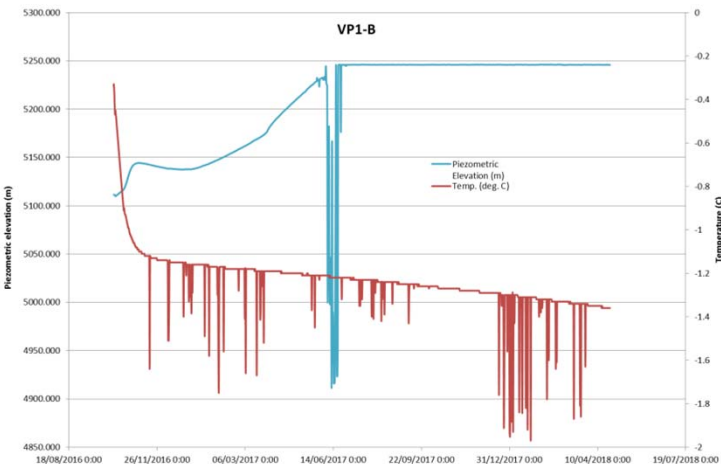
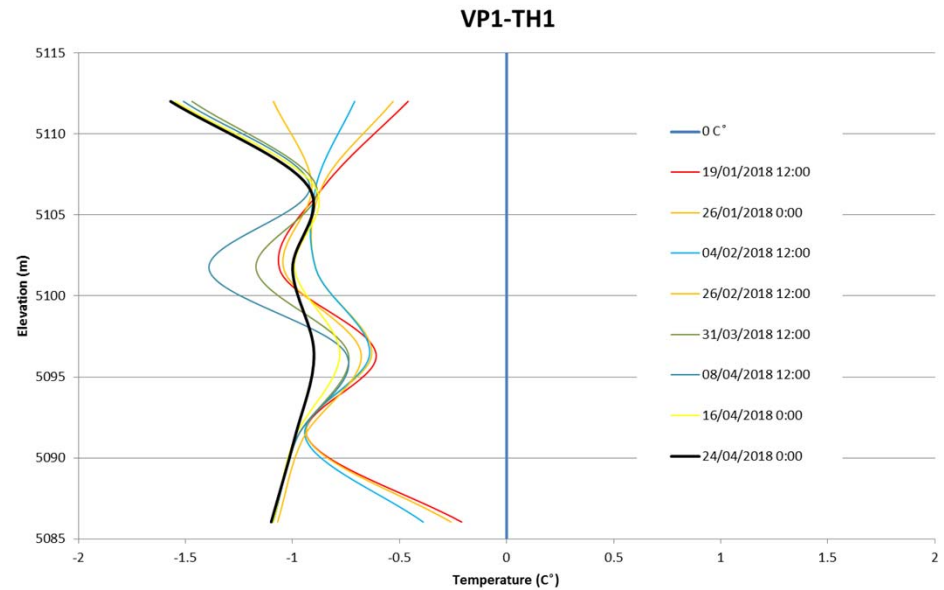
VP1-A, VP1-B, VP1-TH1

- PZ-A&B are below the freezing point. Pressure measurements are therefore considered unreliable and will not be discussed here.
- The thermistor remained frozen during Q1, 2018.

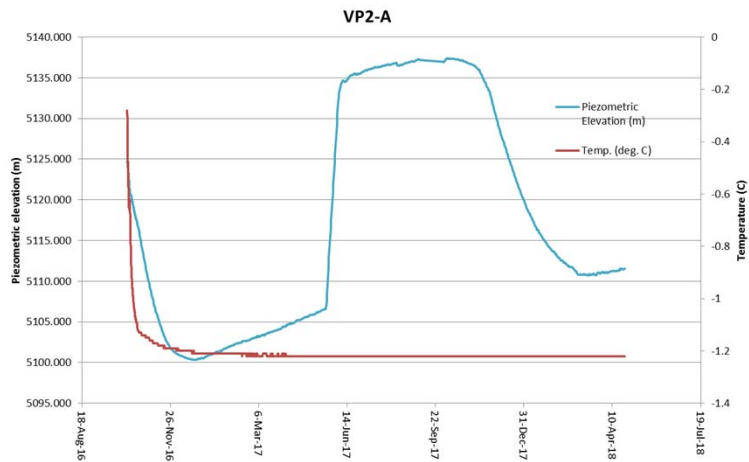
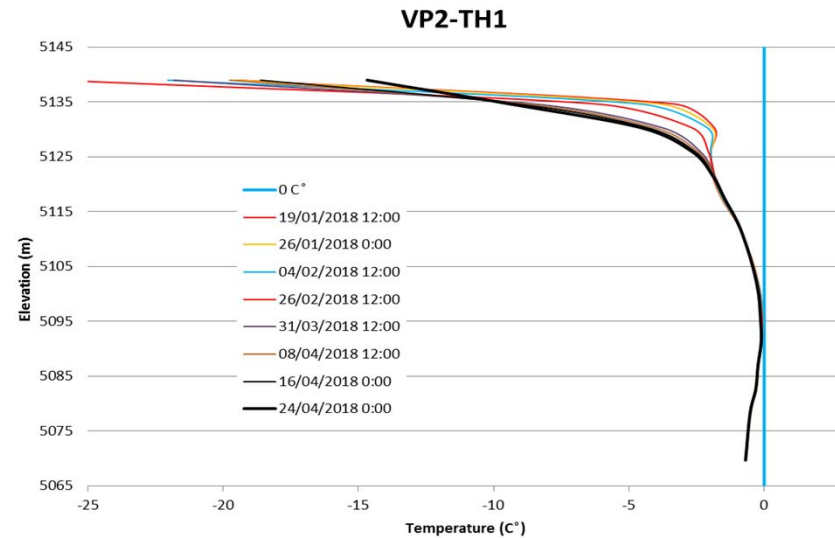
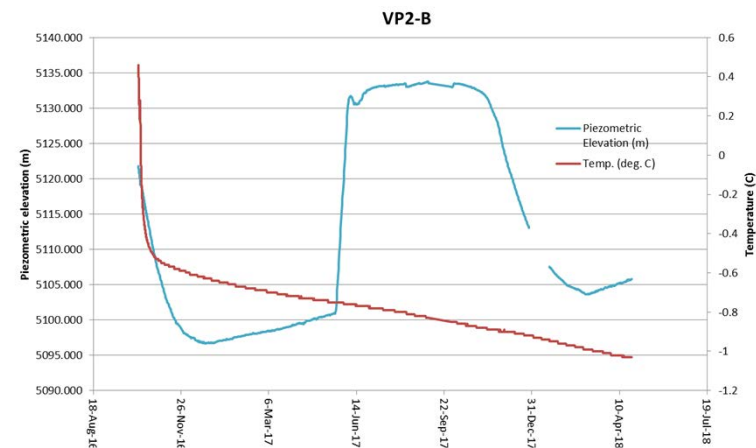
VP2-A, VP2-B, VP2-TH1

- PZ-A&B are below the freezing point since their installation and their data are considered unreliable.
- The section between 5105 and 5085 is close to the freezing but still below. Apart the top beads, minimal variations were recorded for the rest of the hole.

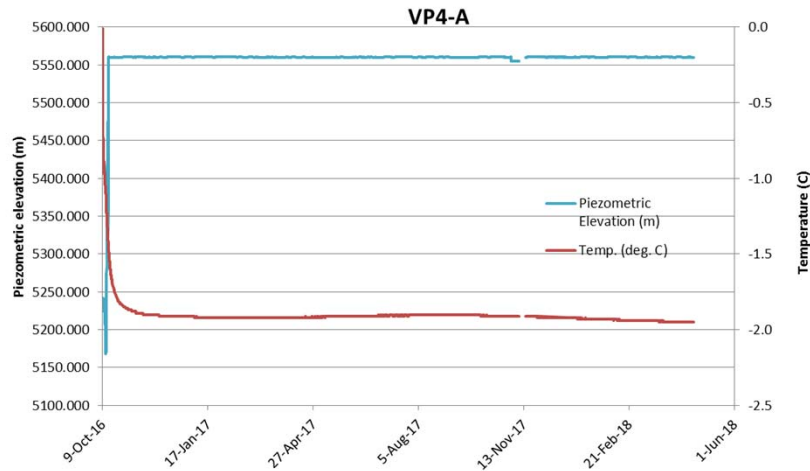
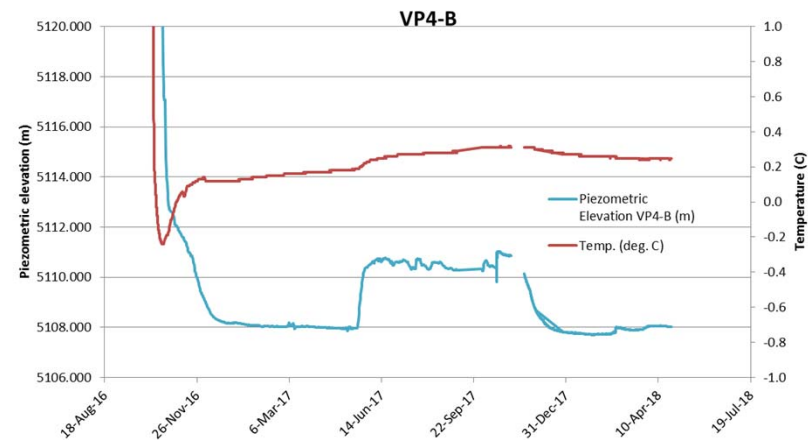
VP4-A, VP4-B

- PZ-A is under the freezing point and considered unreliable.
- PZ-B is unfrozen and since is significant pressure drop, it remained stable during Q1 ,2018. The instrument is installed in the confined layer of talik in between 5105 and 5095 at the source of the seepage causing the major ice wall in the area.
- The temperature of PZ-B is on a very slight downward trend suggesting a freeze back of the slope and aggradation of permafrost.

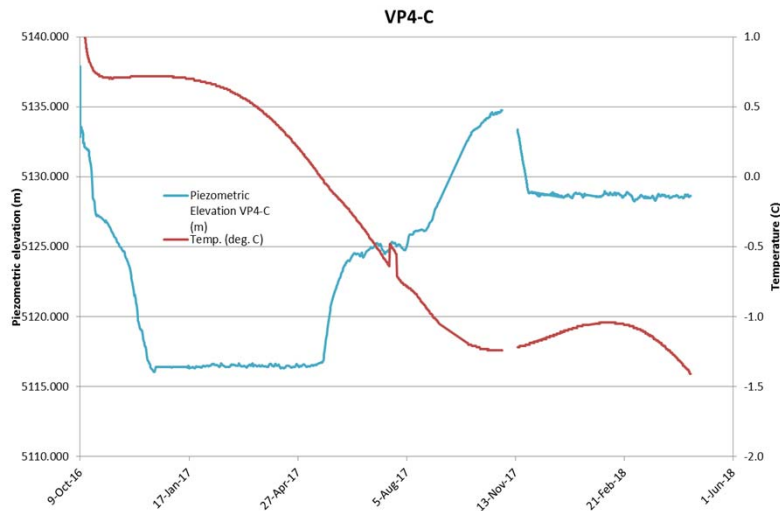
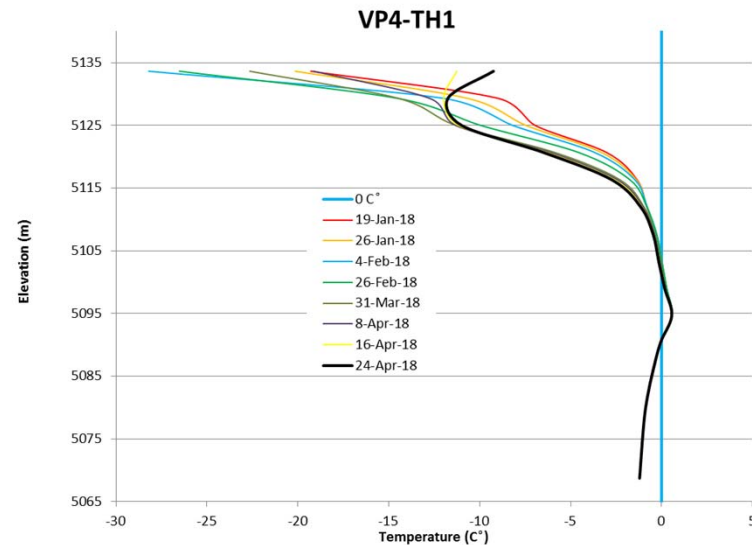
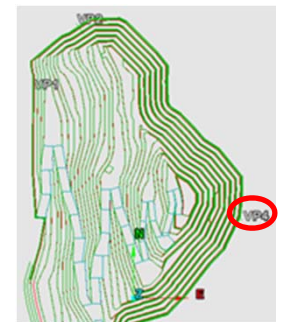
- PZ-C is frozen and data is considered unreliable.
- The thermistor show that the hole is mainly in the permafrost at the exception of the section in between 5100 and 5095 (0.56°C). This zone causes the seepage and therefore the ice wall.

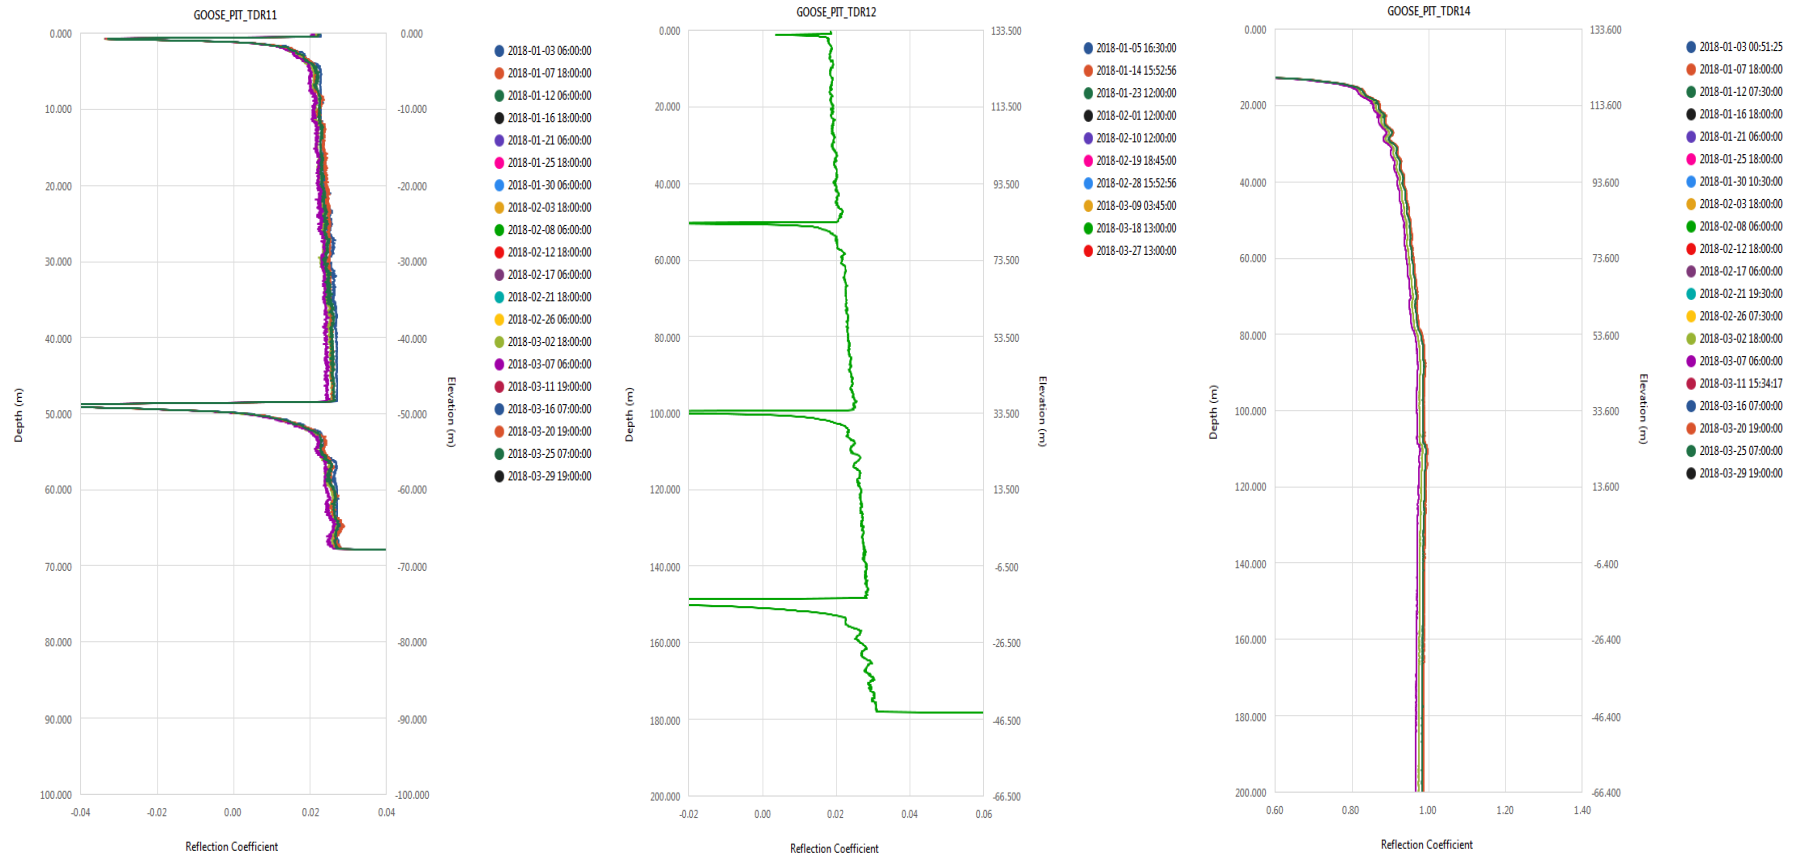
- No sign of deformation was observed in these TDRs.
- Anomalies from the TDR logger are still presents and were disregarded in the presented graphs. The issue will be addressed shortly by reprogramming the logger.

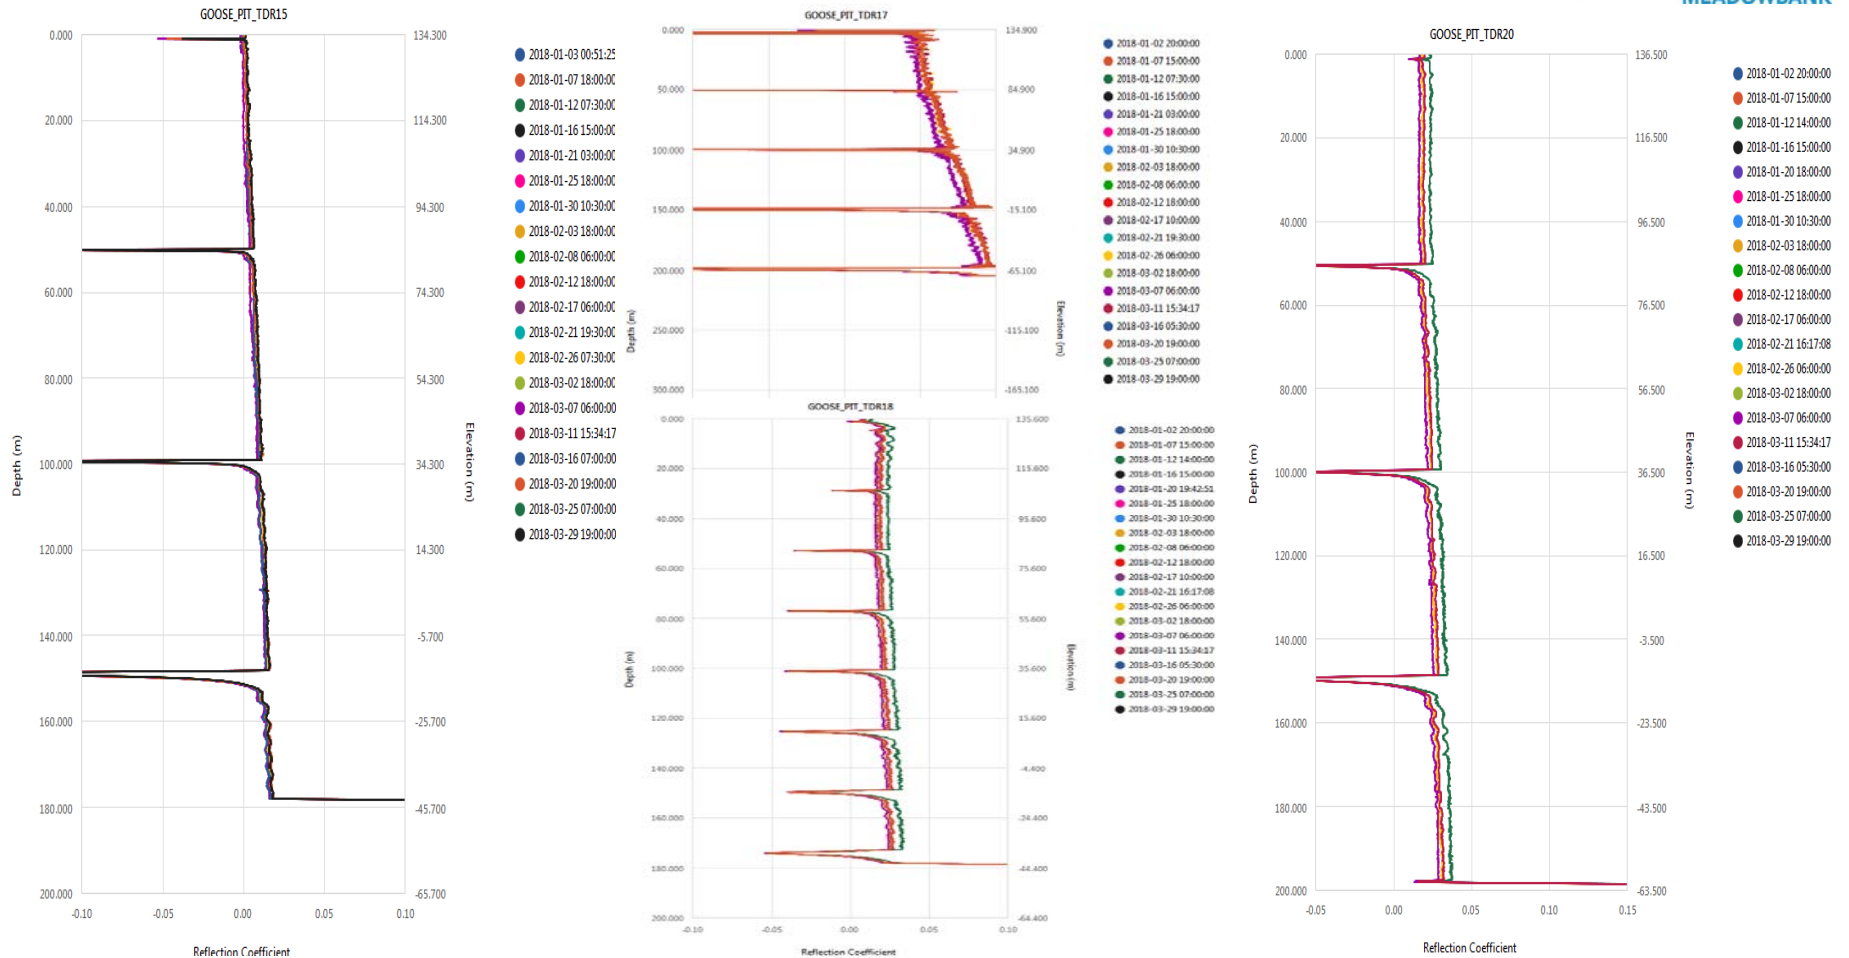
➤ No sign of deformation was observed in these TDRs.

➤ Anomalies from the TDR logger are still presents and were disregarded in the presented graphs. The issue will be addressed shortly by reprogramming the logger.
