Meadowbank 2018 Annual Review of Portage and Goose Pit Slope Performance

2018 ANNUAL PIT SLOPE PERFORMANCE REVIEW

MEADOWBANK MINE, NUNAVUT

ISSUED FOR USE
704-ENG. ROCK03053-02

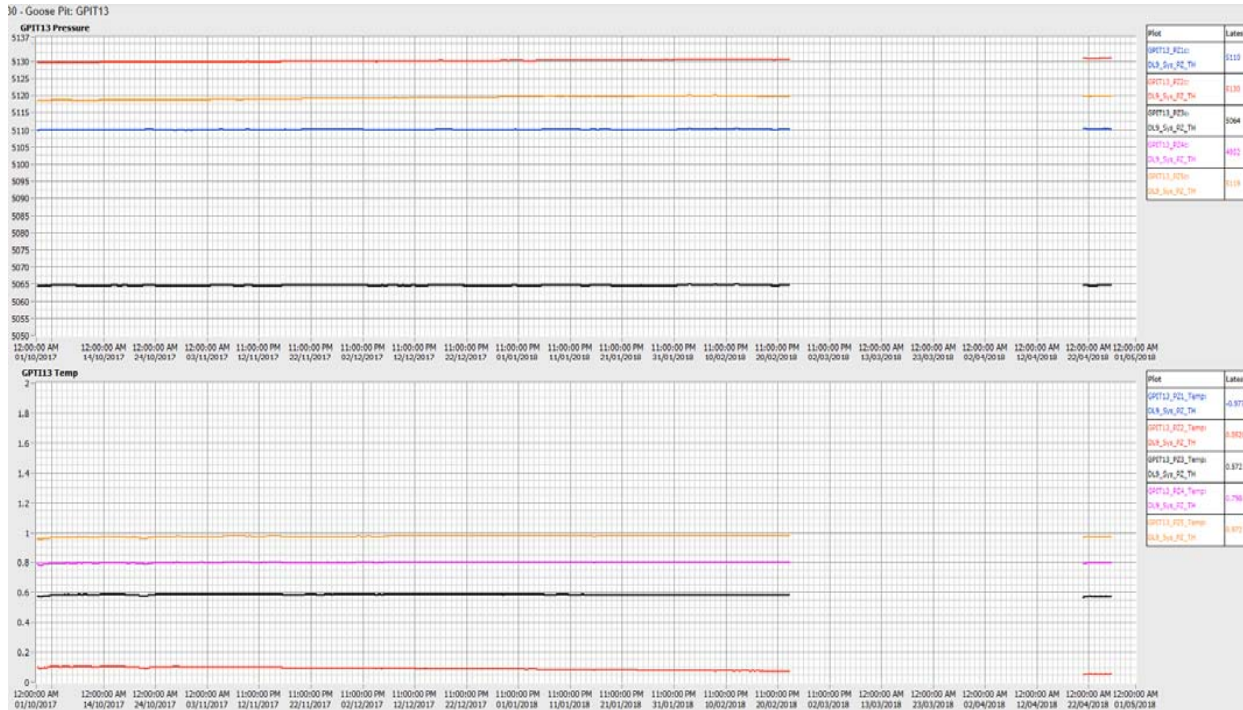
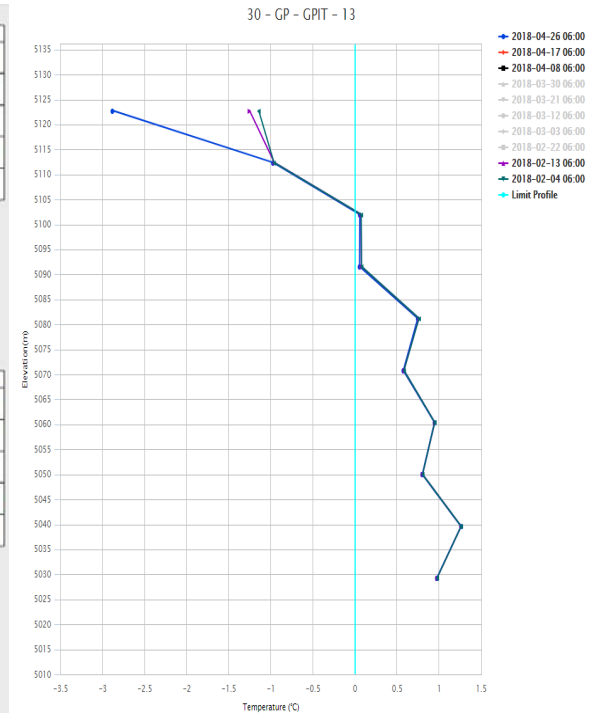
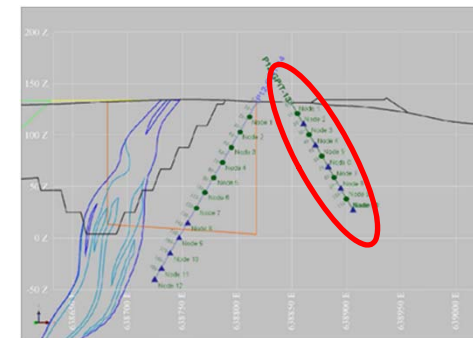
- All piezometers presents little or no variation during the Q1, 2018. All of them are above freezing point.
- A part of the data logger (DL9) was used on DL13 and no record were taken in between Feb. 23, 2018 to the end of the Quarter.
- TH-GPIT-13 was stable during Q1 compared to previous data sets. It is in the permafrost from top to elev. 5102.

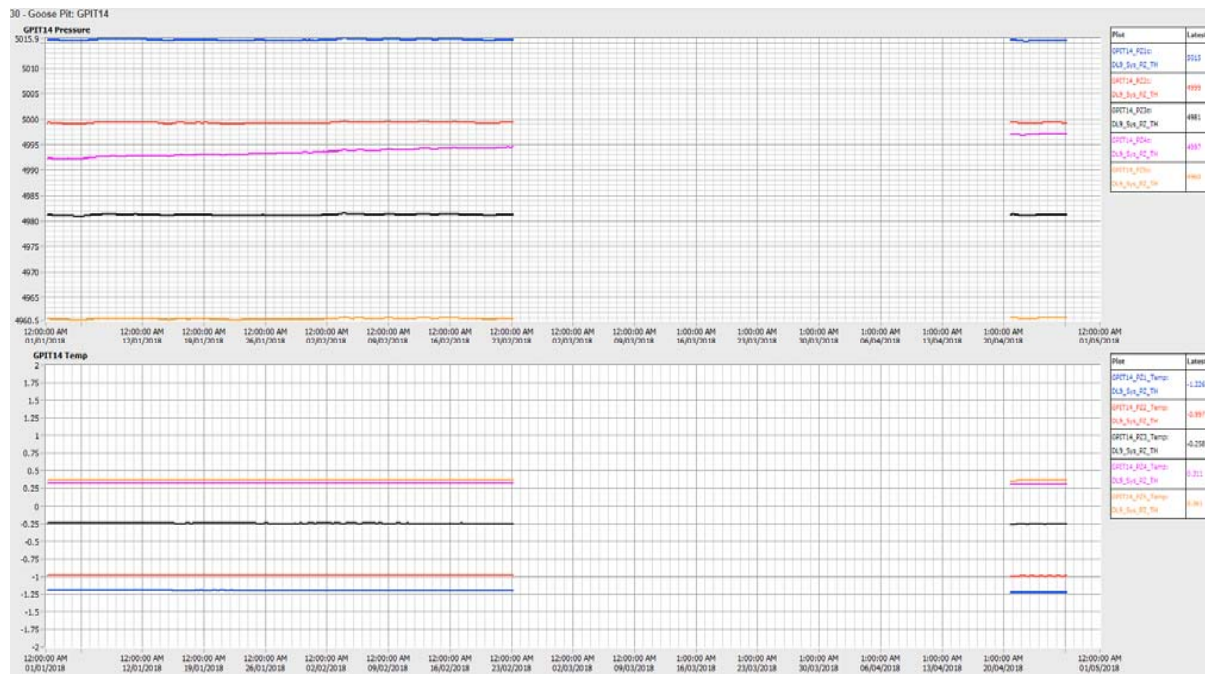
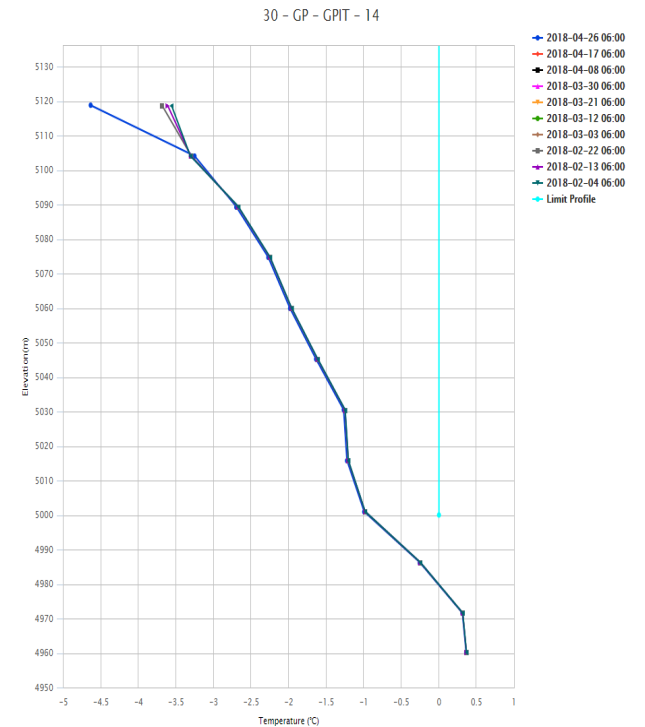
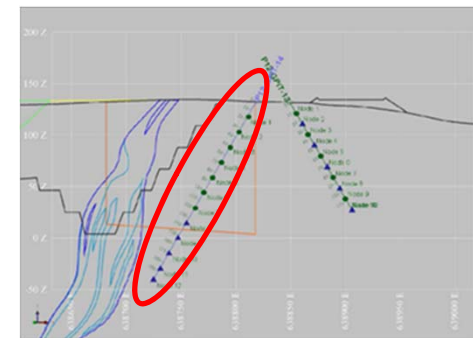
- PZ-4 is on a slow rising trend. It rose 1 m pore water pressure during the first quarter and that could be related to the water level within the Goose pit that is raising (natural flooding).
- PZ-1,2,3 are below the freezing point.
- TH-GPIT-14 is in the permafrost from top at elevation 5120 to 4980. The last 20m of the hole is above the freezing line.

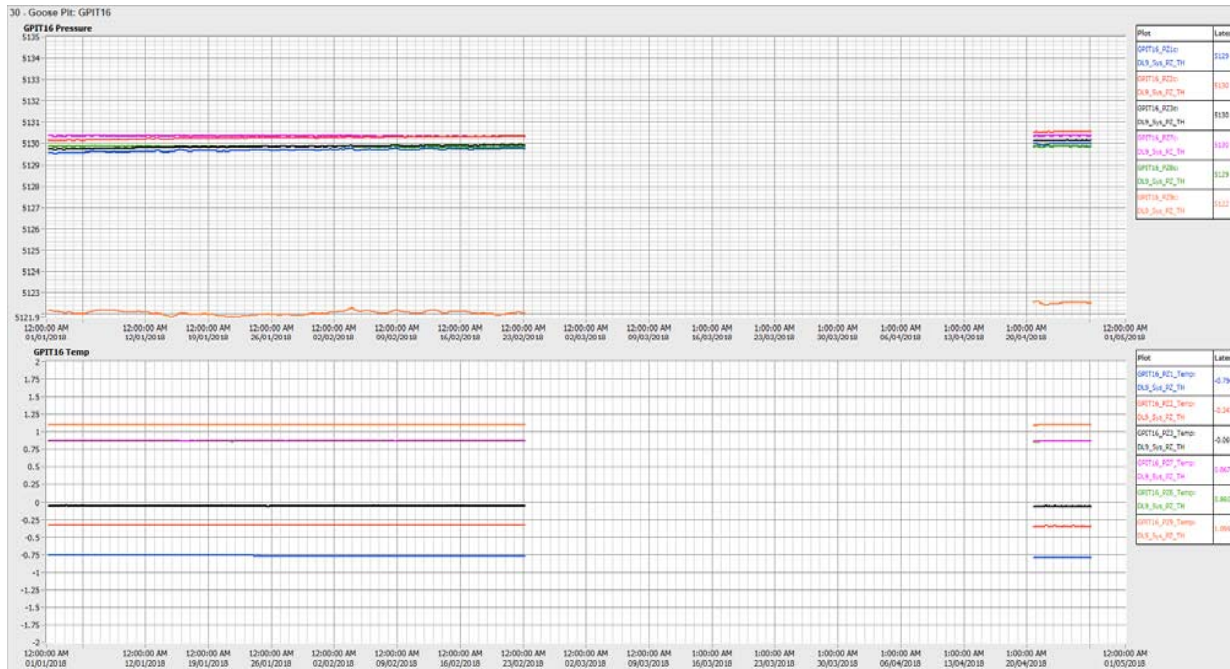
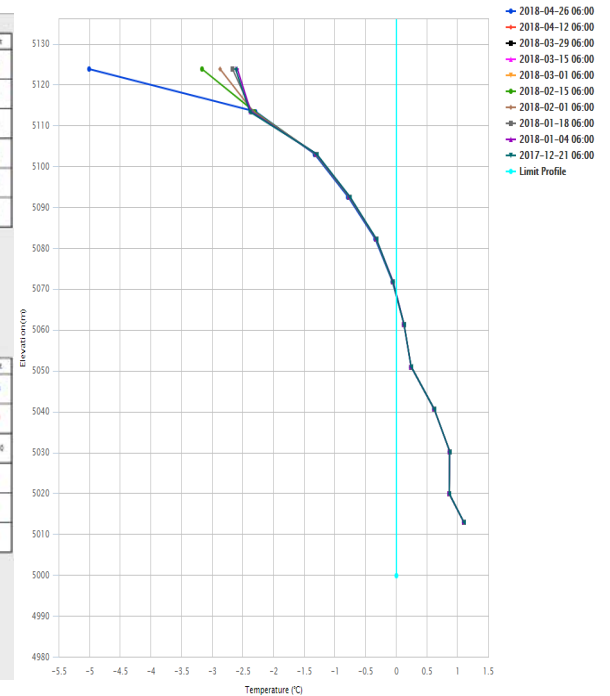
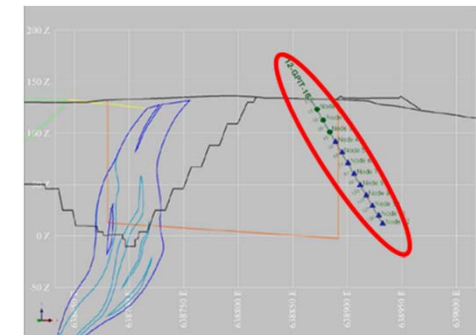
30 - GP - GPIT - 16

- All of the piezometers are on a very slow rising trend. However PZ-1,2,3 are under the freezing line and can not be considered as reliable.
- PZ-1,2,3 are below the freezing point.
- TH-GPIT-16 is in the permafrost from top at elevation 5124 to 5070. The last 57m of the hole is above the freezing line.

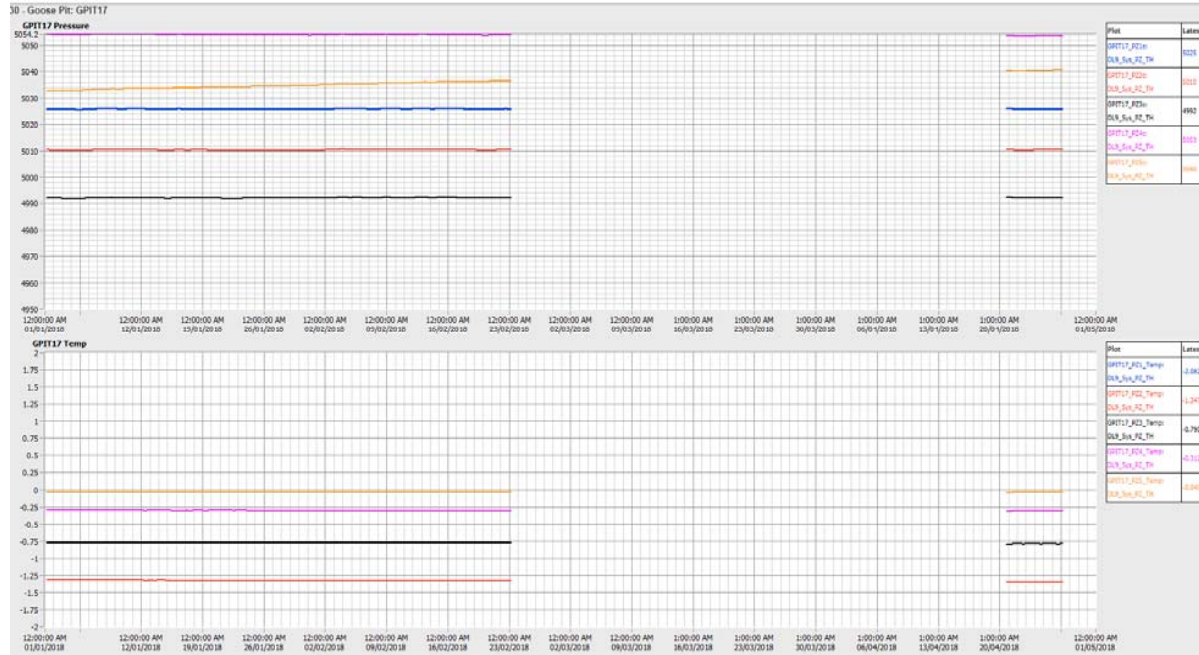
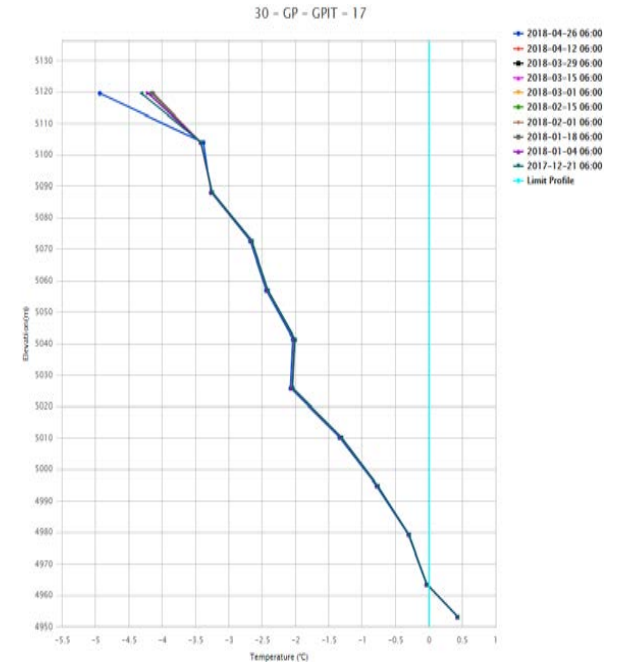
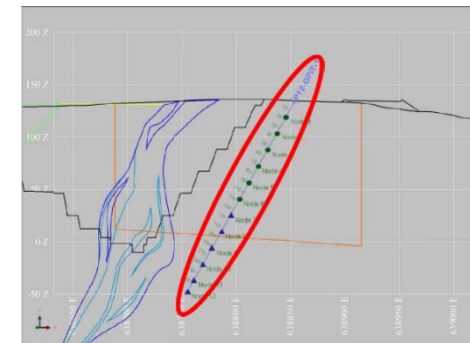
- PZ-5 has risen 6 m of pore water pressure. However, this PZ is just under the freezing line.
- PZ-1,2,3,4 are below the freezing point and can't be considered reliable.
- TH-GPIT-17 is in the permafrost from top at elevation 5119 to 4963. The last 10m of the hole is above the freezing line.

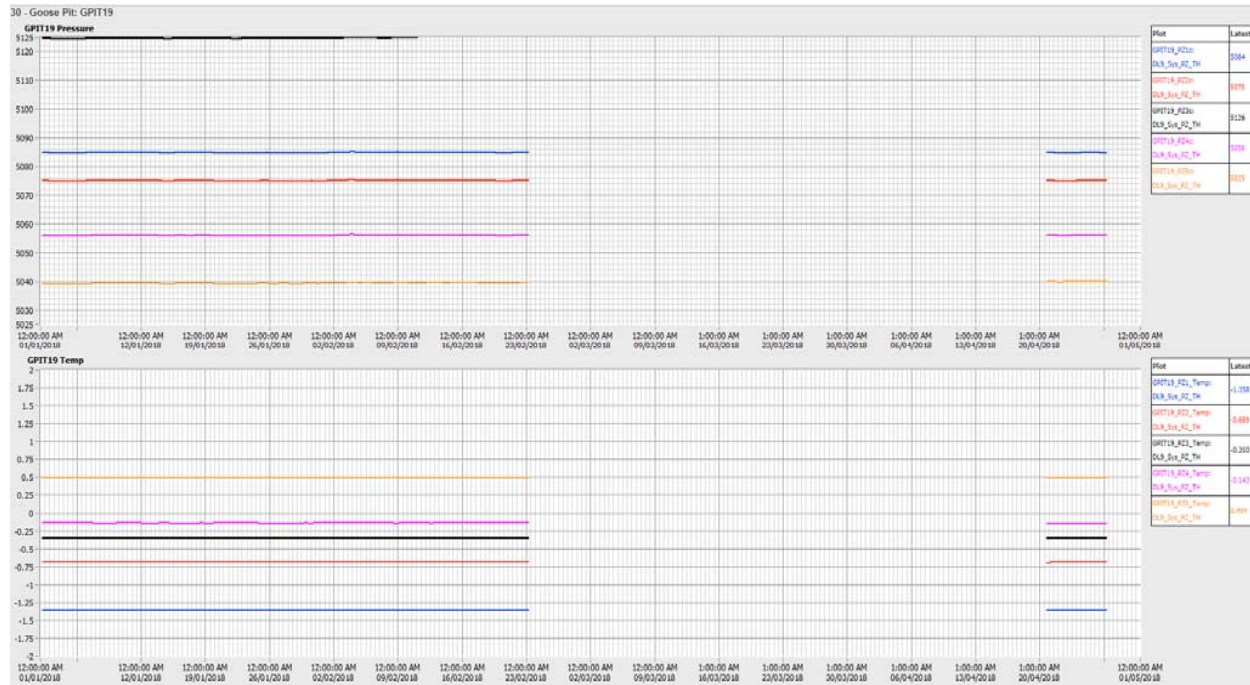
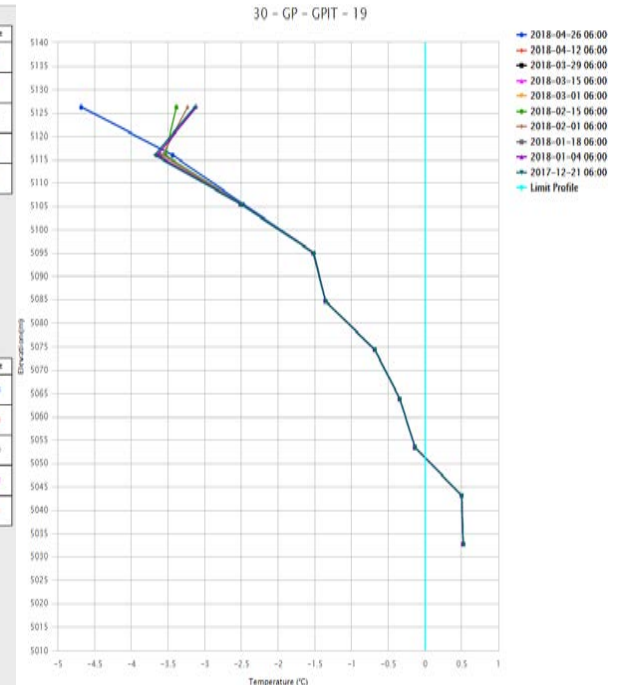
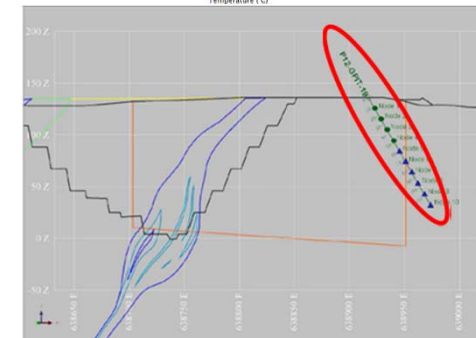
- PZ-5 is above the freezing line and it shows little or no pore water pressure variations during the quarter 1, 2018.
- PZ-1,2,3,4 are below the freezing point and can't be considered reliable.
- TH-GPIT-19 is in the permafrost from top at elevation 5126 to 5051. The first couple beads varied decimals of a degree. The last 19m of the hole is above the freezing line.

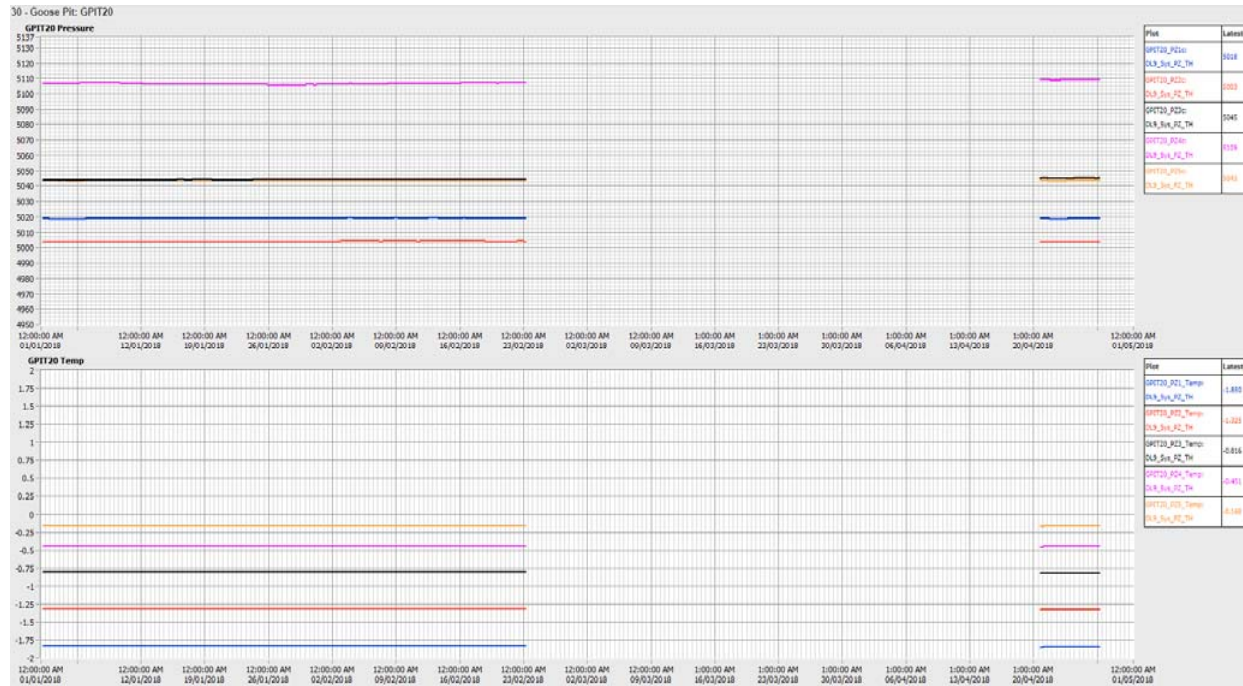
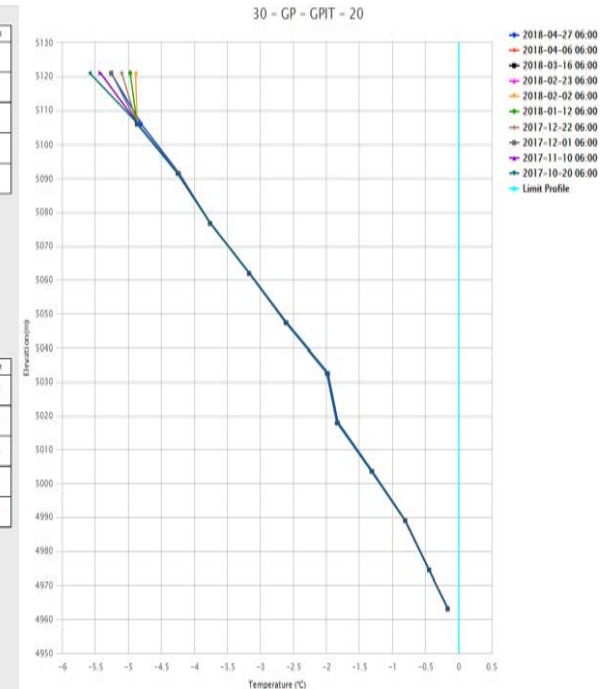
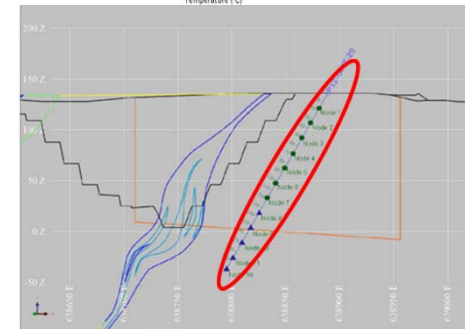
- PZ-1,2,3,4,5 are below the freezing point and can't be considered reliable.
- TH-GPIT-20 is in the permafrost on its entire length from its top at elevation 5121 to the bottom at 4963.

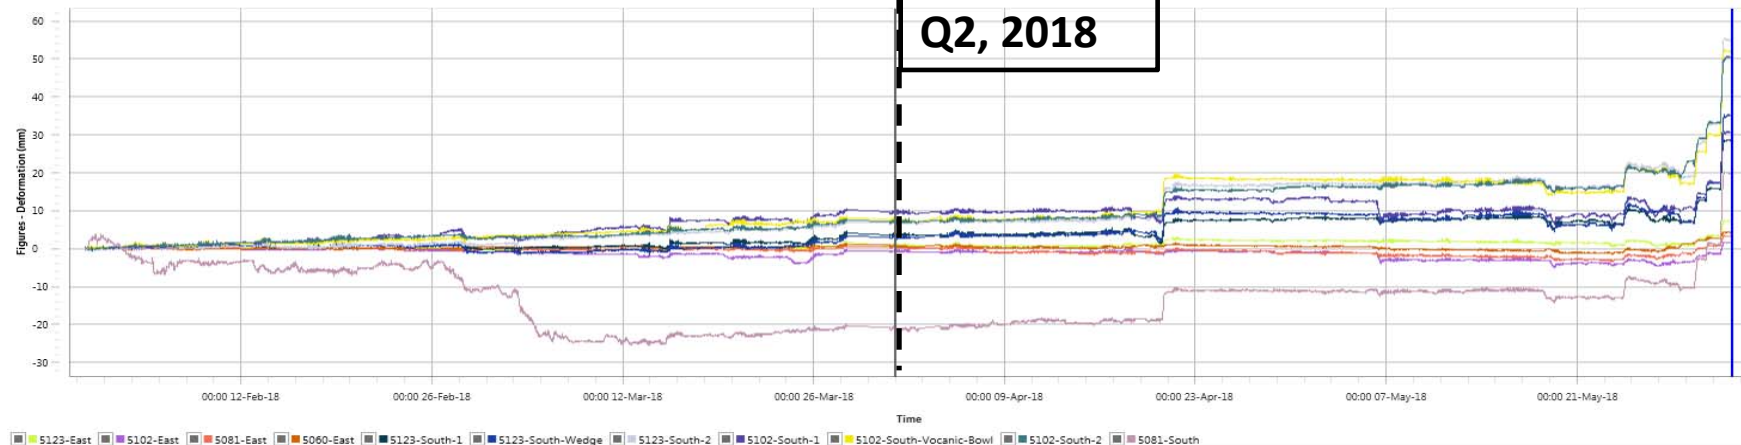
Enhanced deformation per sector (April 1st to June 1st) – Wall folder: SSR253_18031_Meadowbank_E5_SouthWall_Archive).

Comments: Most of the sectors were showing stable wall condition. A disturbance occurred on the radar around April 20 during an unknown event (wind, ice etc.), creating noise in the data. It is reflecting on every section of the wall monitored. Prior to that period the section identify as 5081 South as a small rising trend and gained 2 millimetres. Another rising trend is showed on every sections starting on May 27. This major rising trend correlates with the temperature augmentation and the possible melting at the base of the radar.

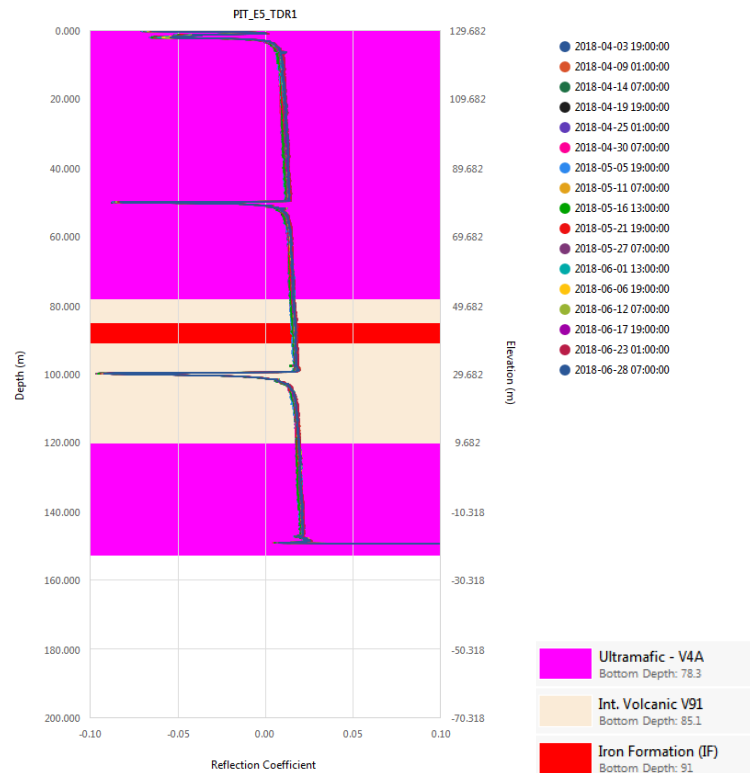
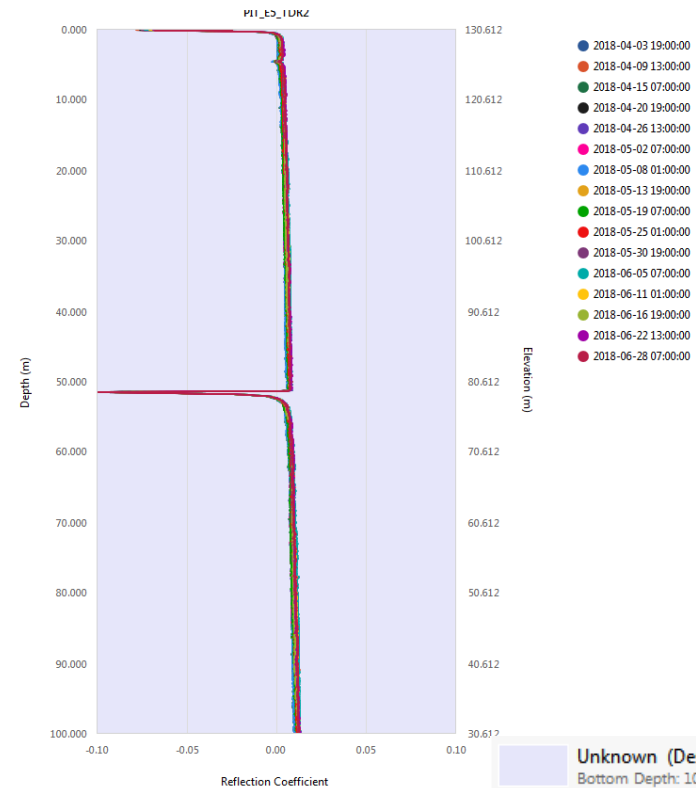
- No sign of deformation observed in TDR1 & TDR2.
- Unlike the previous period, no anomalies from the TDR logger were found in the present graphs.

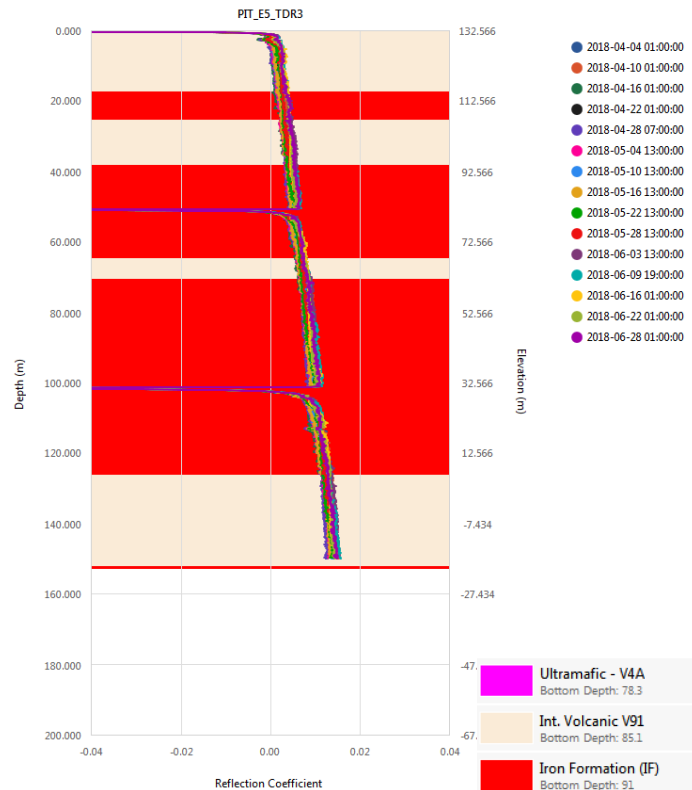
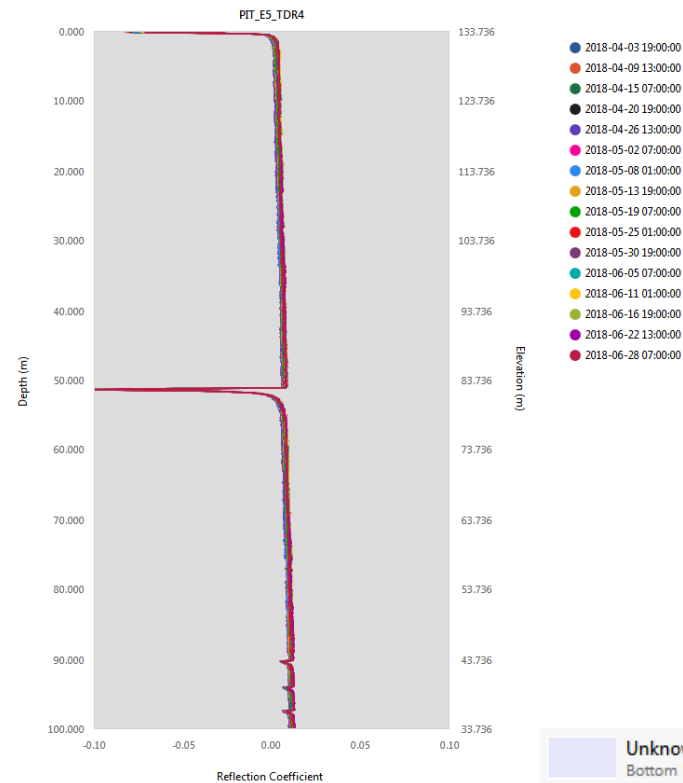
- No sign of deformation observed in TDR3.
- The small reflection coefficient spikes in between elevation 44 and 34 MASL on TDR4 are present since installation.
- No anomalies from the TDR logger were found in the presented graphs unlike the previous covered period (Q1).

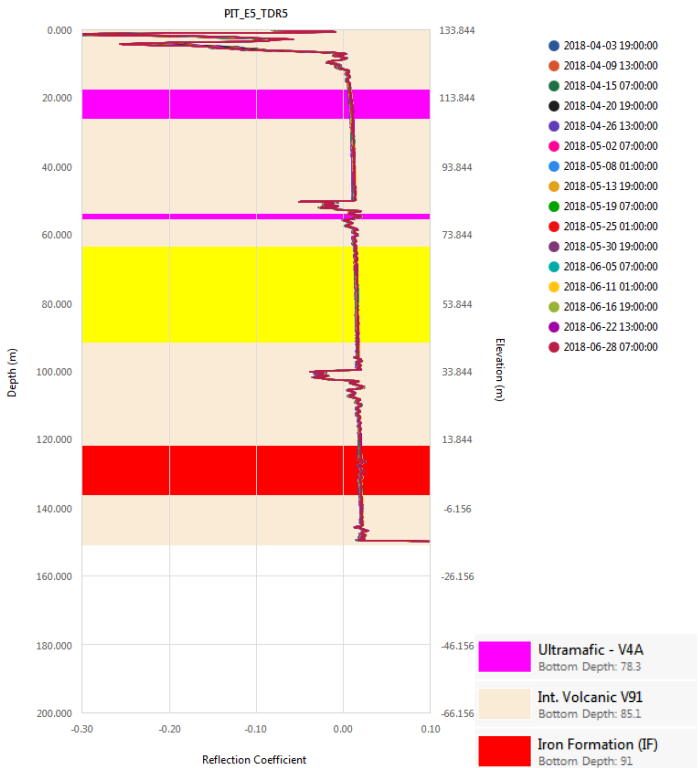
- No sign of deformation observed in TDR5.
- The small reflection coefficient spikes in between elevation 14 and -6 MASL on TDR5 are present since the installation.
- No anomalies from the TDR logger were found in the presented graphs unlike the previous covered period (Q1).

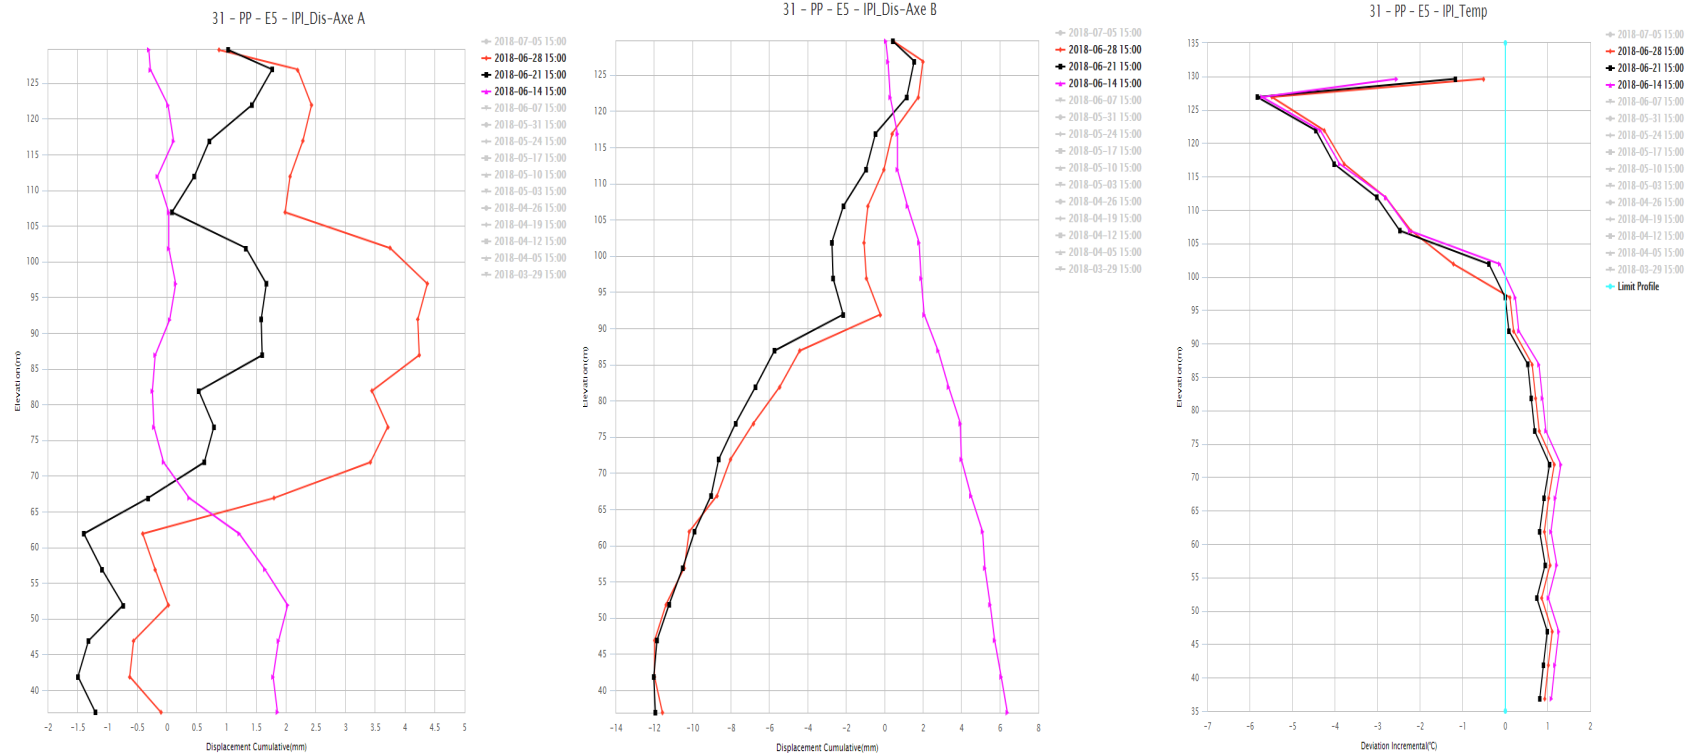
PP-E5-IPI

- The inclinometer was reinstalled on June 13, 2018.
- The two data sets after June 14, 2018 are more consistent. A cumulative displacement of -12mm is observe on the B axis.
- It is unfroze from elevation 96 MASL to 36 MASL.

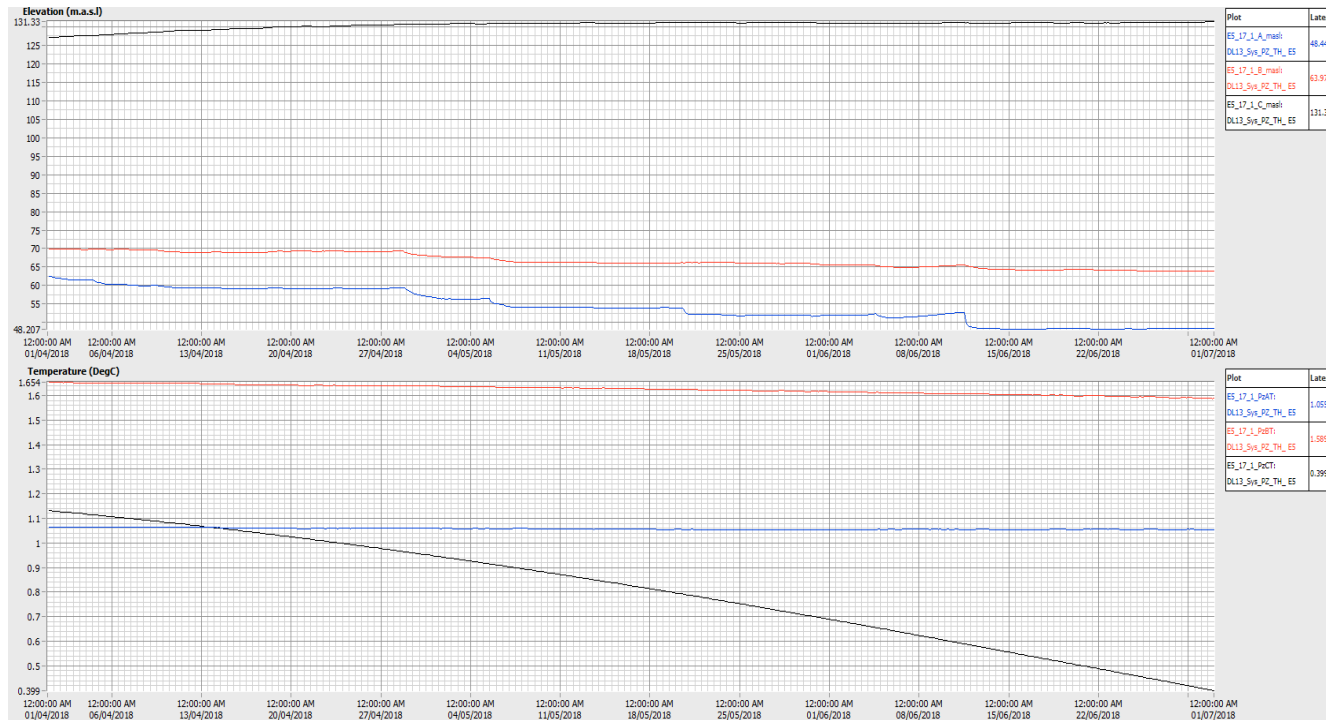
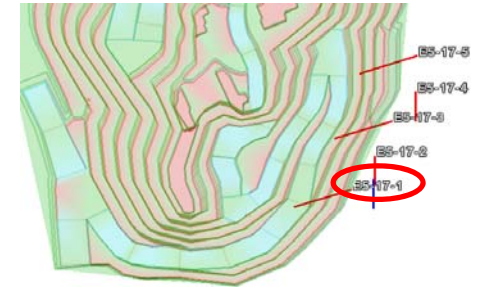
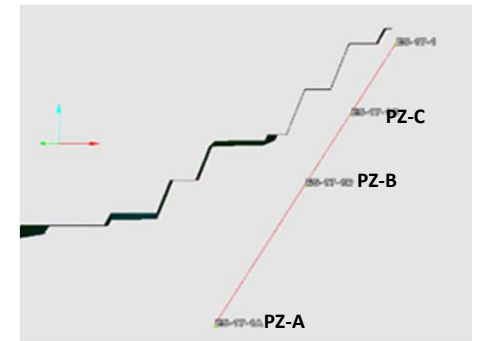
PE5-17-01 PZ-A,B,C

- PZ-A continued is downward trend during Q2, dropping another 15m PWP during the period. As for PZ-B, it dropped 6m PWP during the period. PZ-C has a consistent pressure increase and gained 8.7 m PWP during the Q1, while in Q2, it increase of 6m PWP. Instruments in this hole are very responsive and will be closely monitored.
- Smaller increase and decrease in pressure are related to mining activities (drilling/blasting).
- None of the piezometers are under the freezing point.

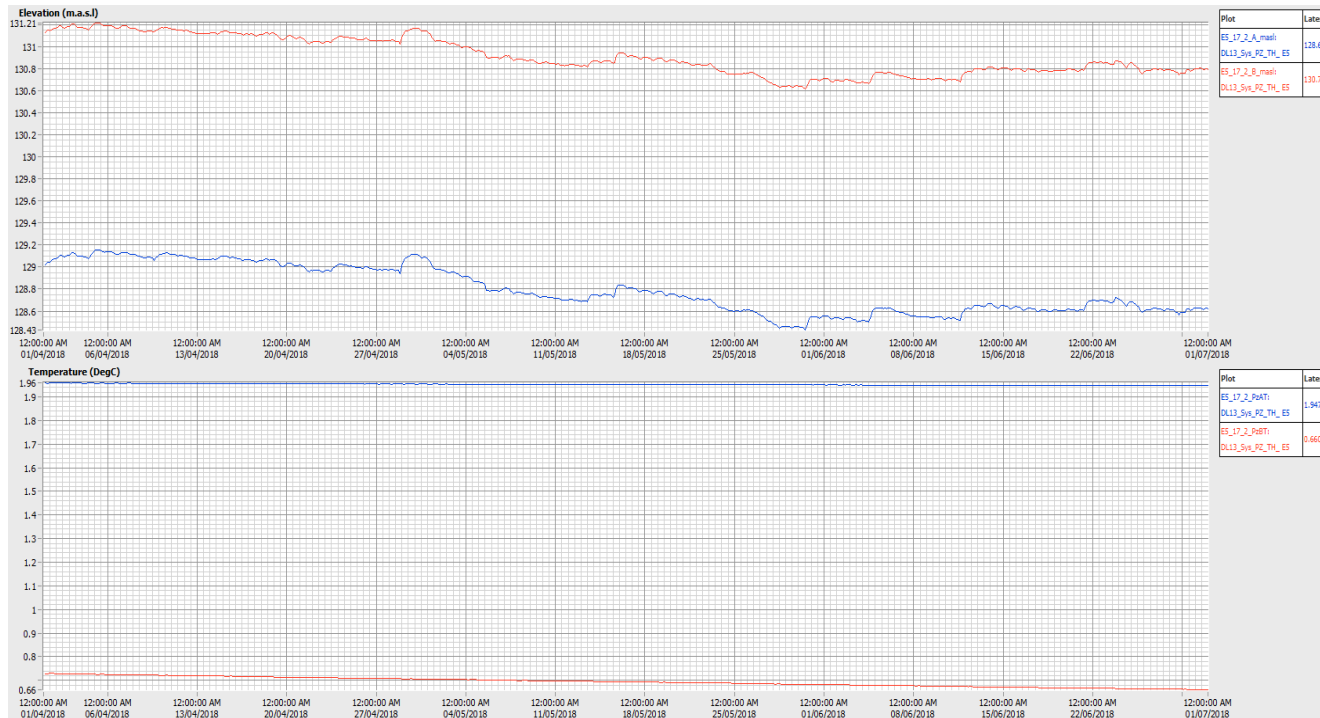
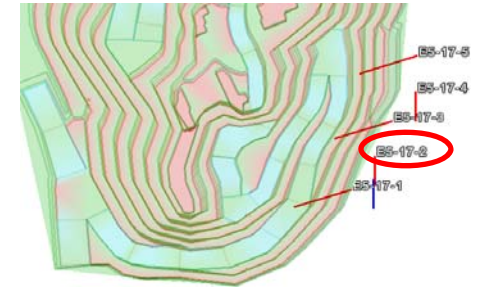
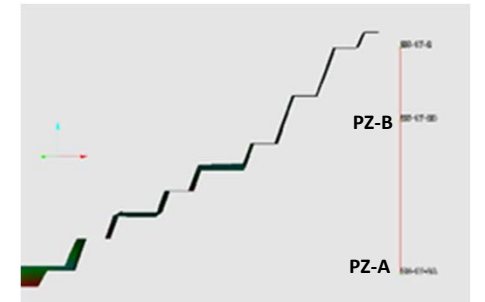
PE5-17-02 PZ-A,B

- Both piezometers are following the same kind of downward trend. A slight decrease of around 1m PWP until what appear to be a slight increase concordant with the beginning of the freshet season.
- None of the piezometers are under the freezing point. There is slight downward trend in PZ-B temperature's.

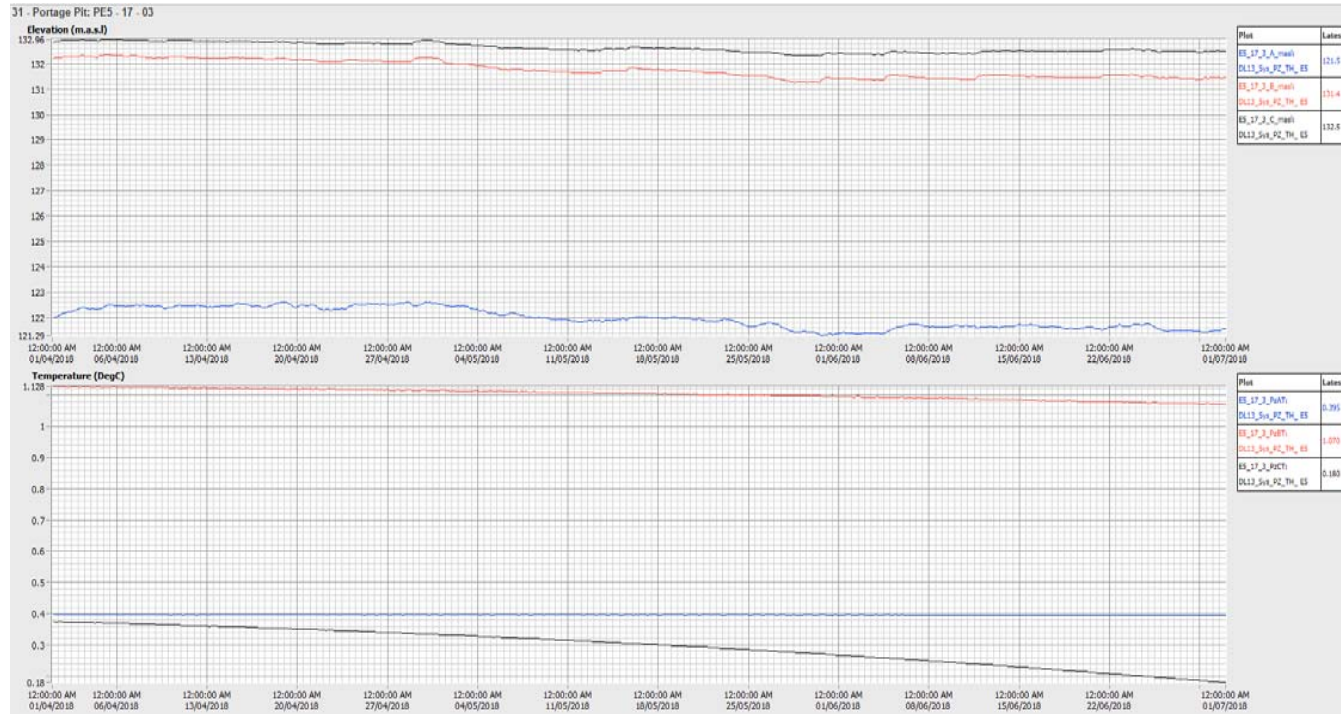
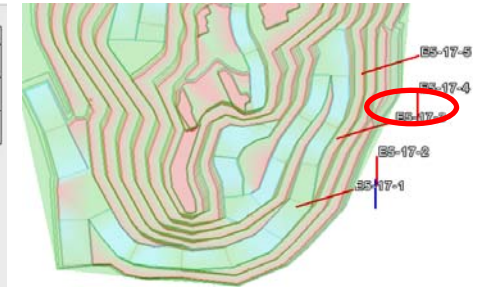
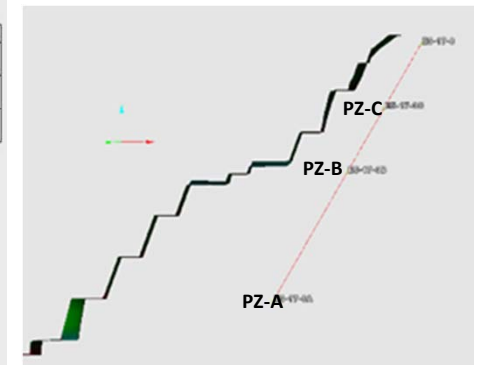
PE5-17-03 PZ-A,B,C

- PZ-A remain stable during the Q2 period with fluctuations around ± 0.5 m PWP, unlike the previous Quarter Period (Q1), where it's water pressure rose of 9m.
- PZ-B & C experienced a small decrease of -0.5m PWP and were subject to small sudden variations cause by the mining activities. Both piezometers are following the same trend with 1m PWP difference.
- All the PZs are above the freezing point and PZ-B is 0.6°C warmer than PZ-A.
- PZ-C is on a cooling trend and might become frozen and unreliable in the upcoming months (0.2°C).

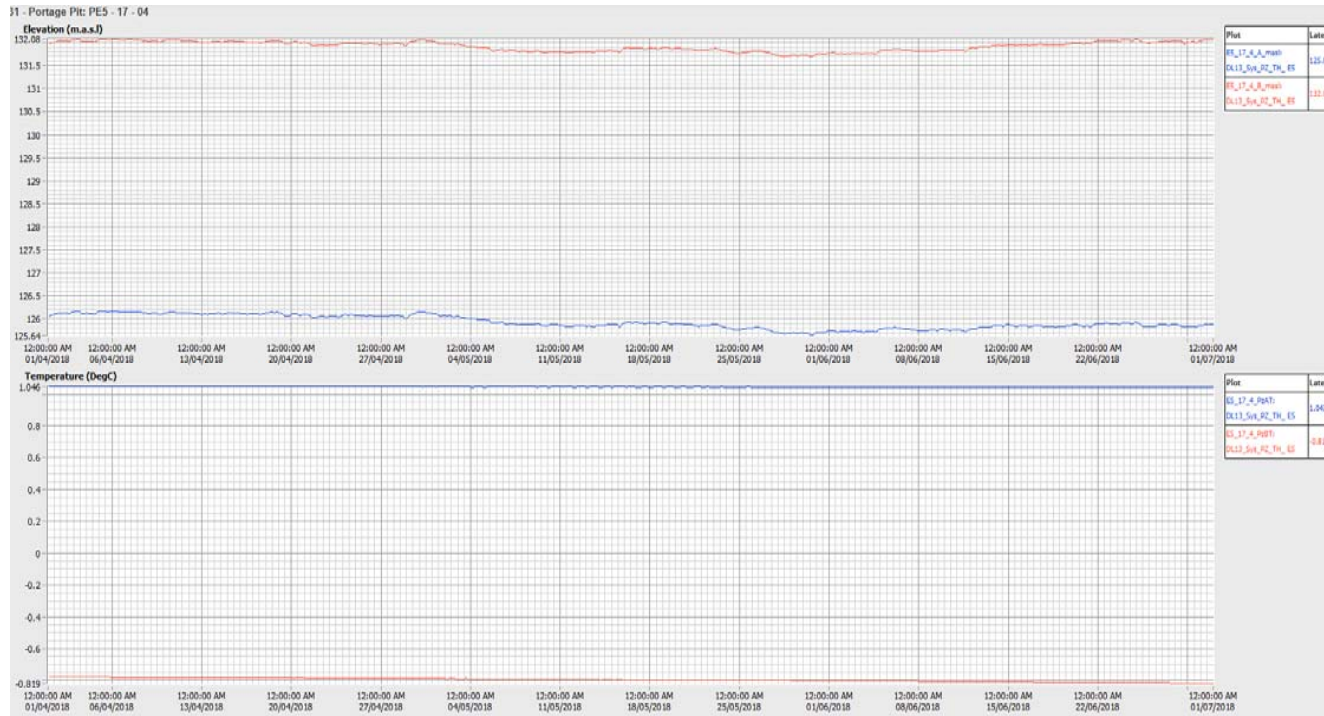
PE5-17-04 PZ-A,B

- Both piezometers remained stable during Q2 and experienced the same kind of fluctuations.
- PZ-B is frozen while PZ-A is at around 1°C.
- Smaller increase and decrease in pressure are related to mining activities (drilling/blasting).

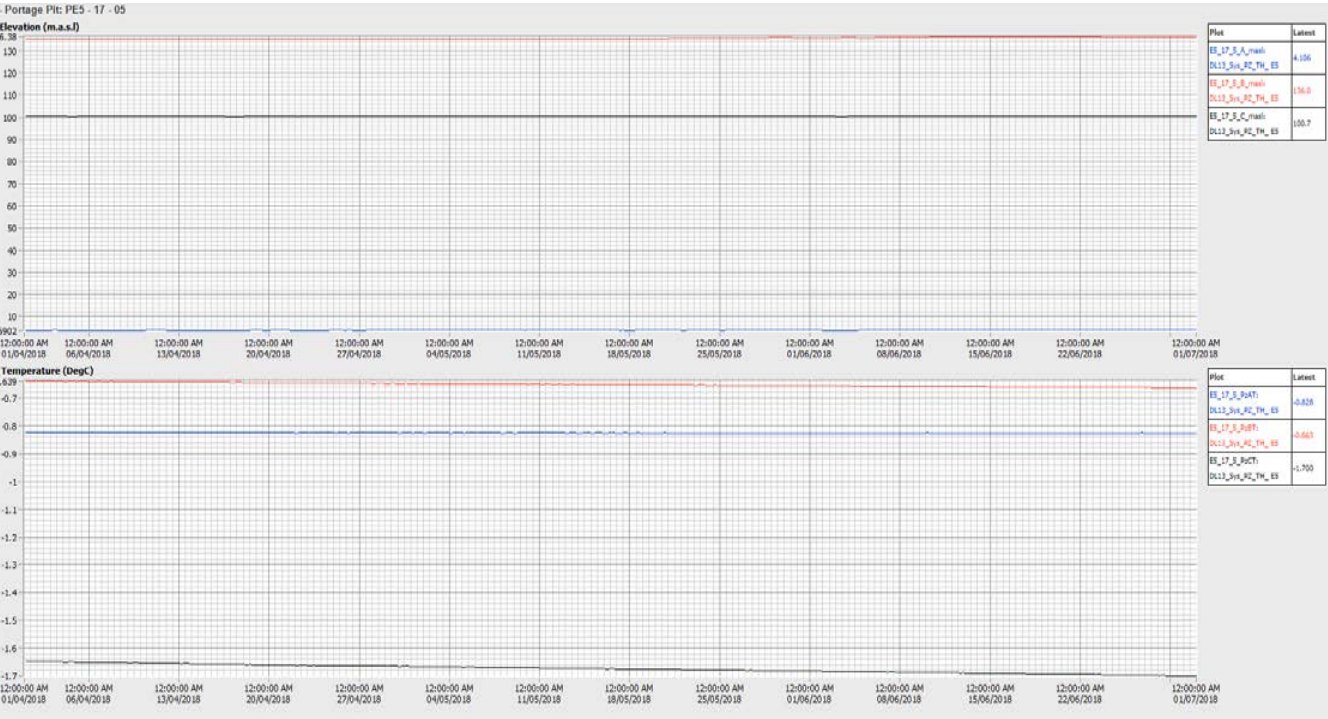
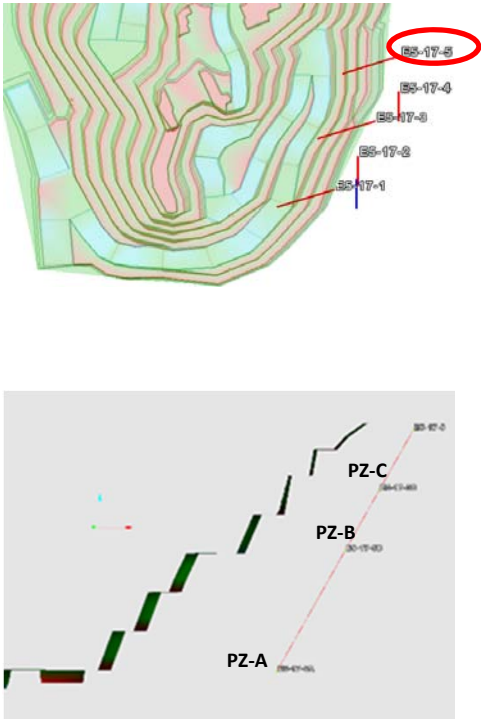
PE5-17-05 PZ-A,B,C

➤ PZ-A,B and C are frozen. The pressure measurements are considered unreliable.

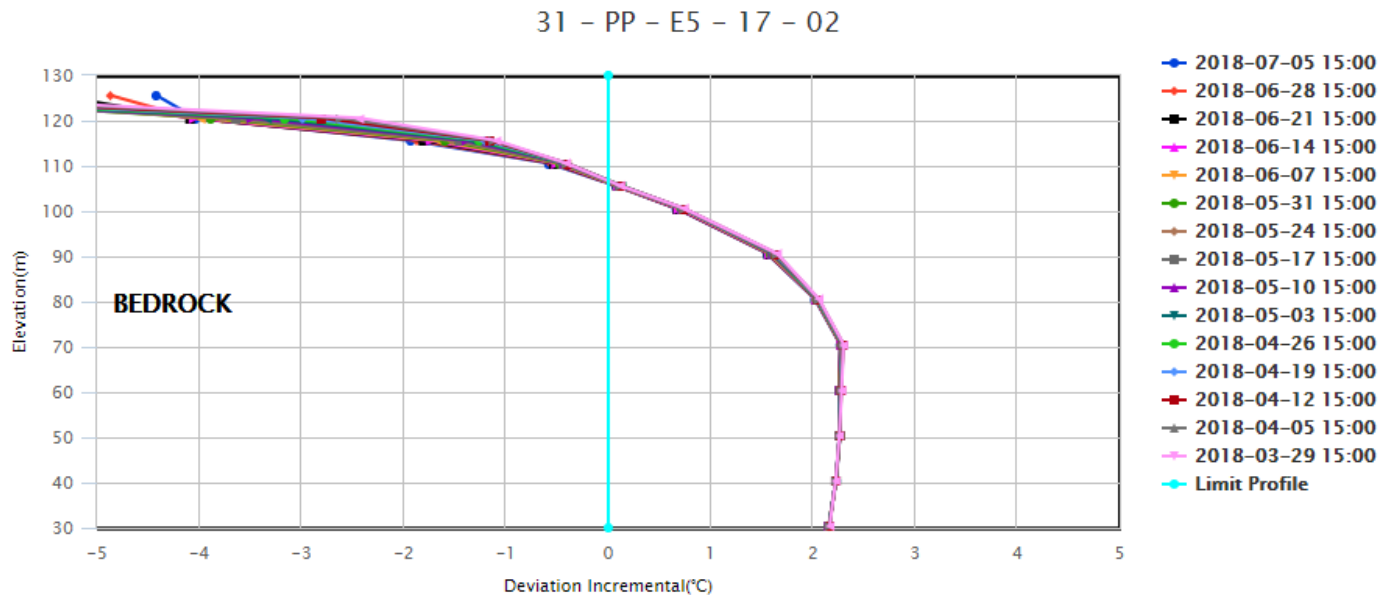
PP-E5-17-02

- There is a permafrost layer from the top of the hole at elev. 125 to the elev. 105 MASL. It suggests an aggradation of the permafrost from the surface since the dewatering of the lake in 2011.
- Apart from the 2 first beads, only minimal variations were recorded during the period.

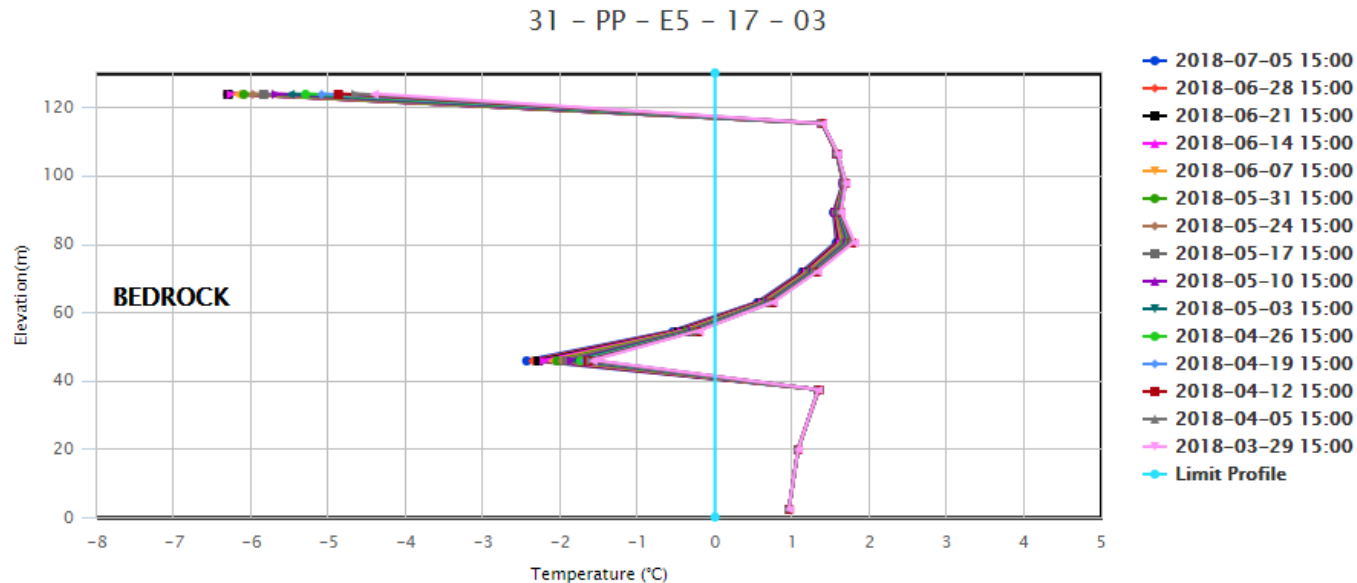
- Small variations occurred only on the first bead during the Q2, 2018. The rest of the thermistor remained consistent with previous data sets.
- There is a permafrost layer between elevation 40 and 55 MASL.
