Meadowbank 2018 Annual Review of Portage and Goose Pit Slope Performance

2018 ANNUAL PIT SLOPE PERFORMANCE REVIEW

MEADOWBANK MINE, NUNAVUT

ISSUED FOR USE
704-ENG. ROCK03053-02

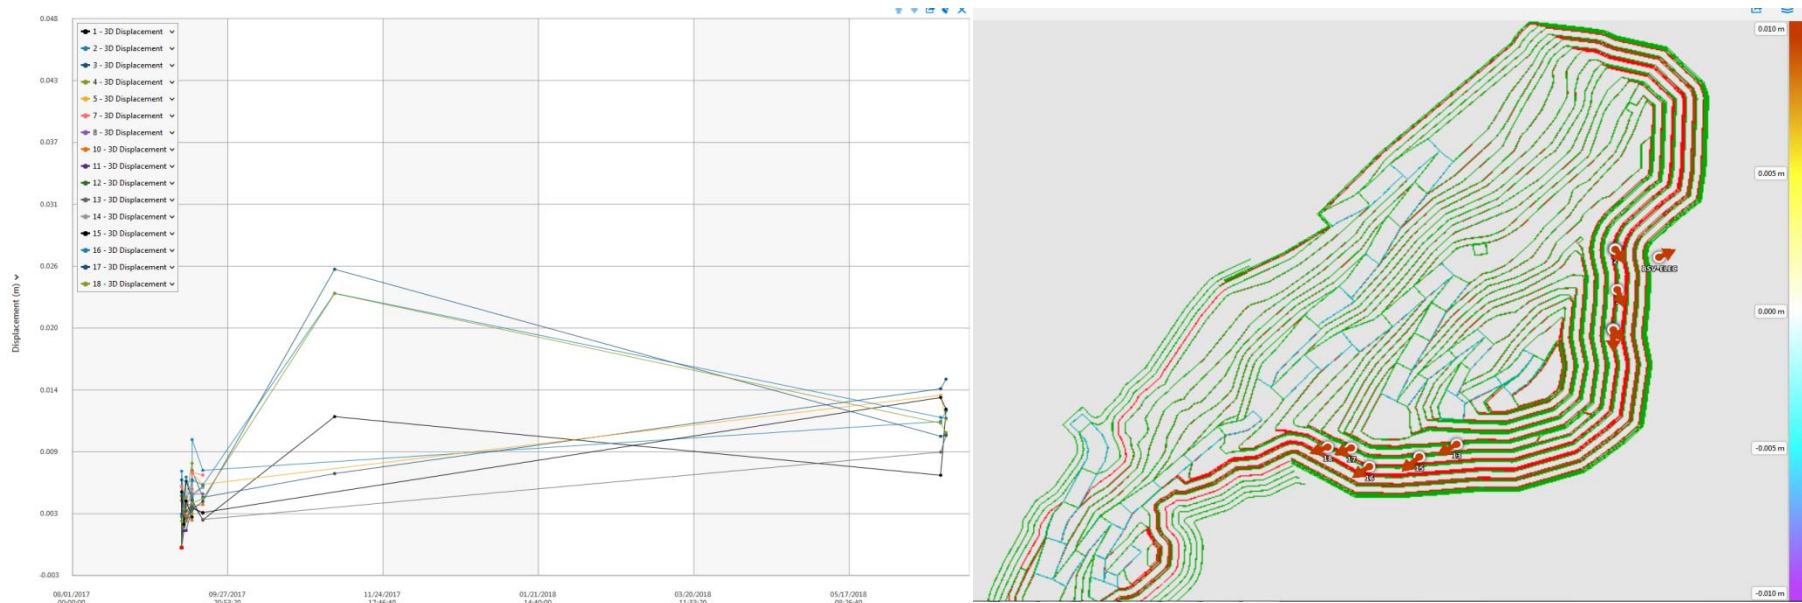
- Two sets of reading were taken in June for the Q2 Period. Prior to this period, the inside of the survey shack was not accessible due to ice accumulation.
- During the latest survey of the prisms, only 9 were successfully surveyed, the others are either gone or damage.
- More data needs to be collected to extract a trend.

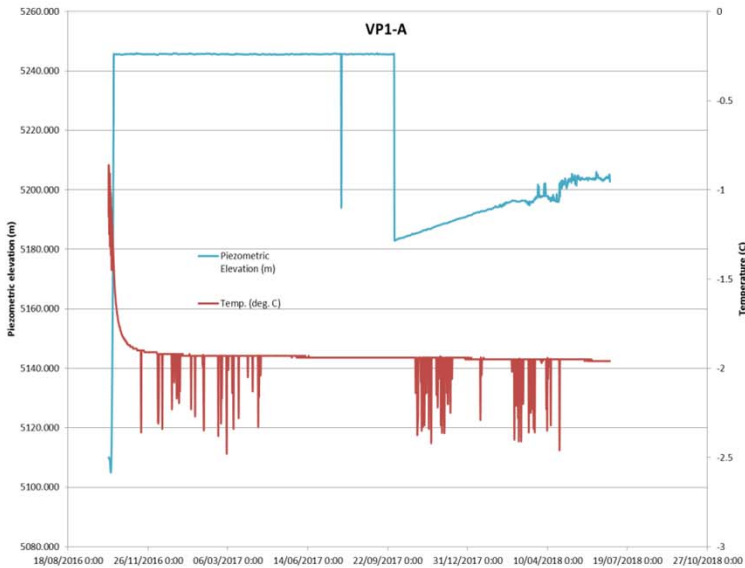
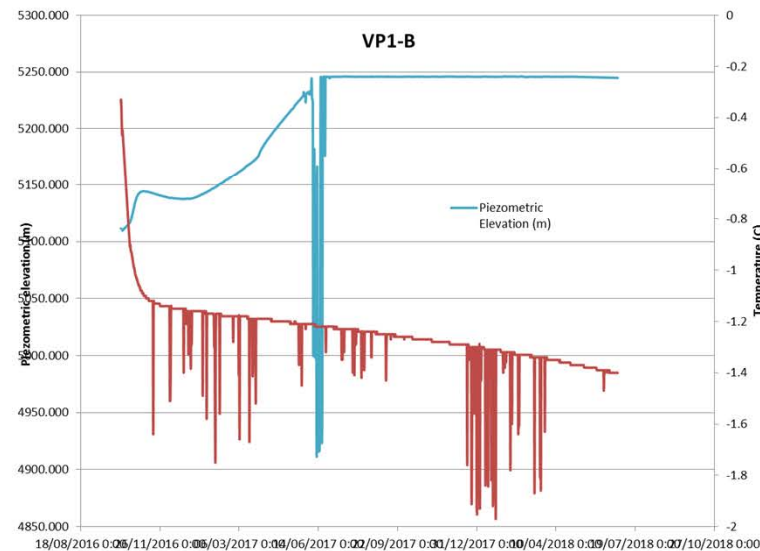
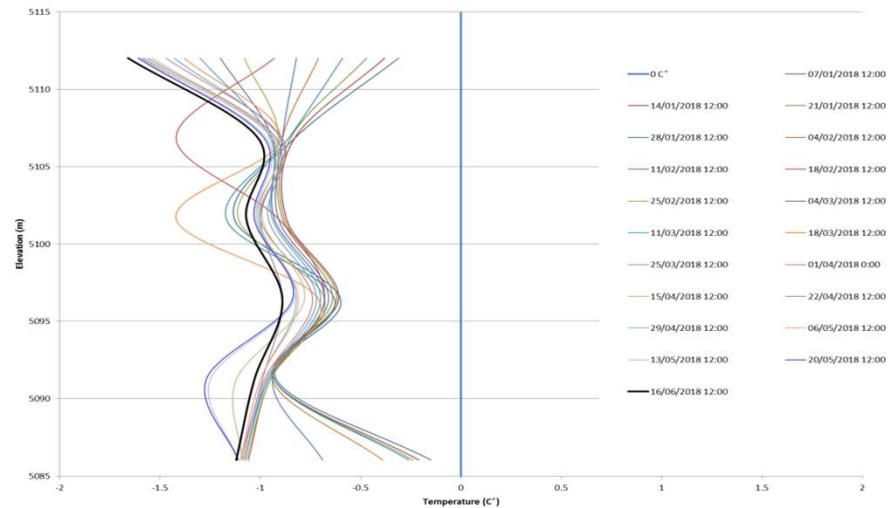
VP1-A, VP1-B, VP1-TH1

- PZ-A&B are below the freezing point. Pressure measurements are therefore considered unreliable and will not be discussed here.
- The thermistor remained frozen during Q2, 2018.

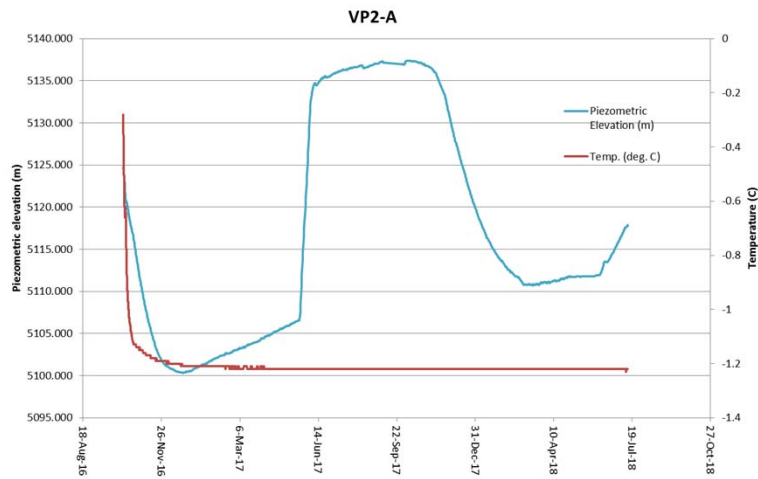
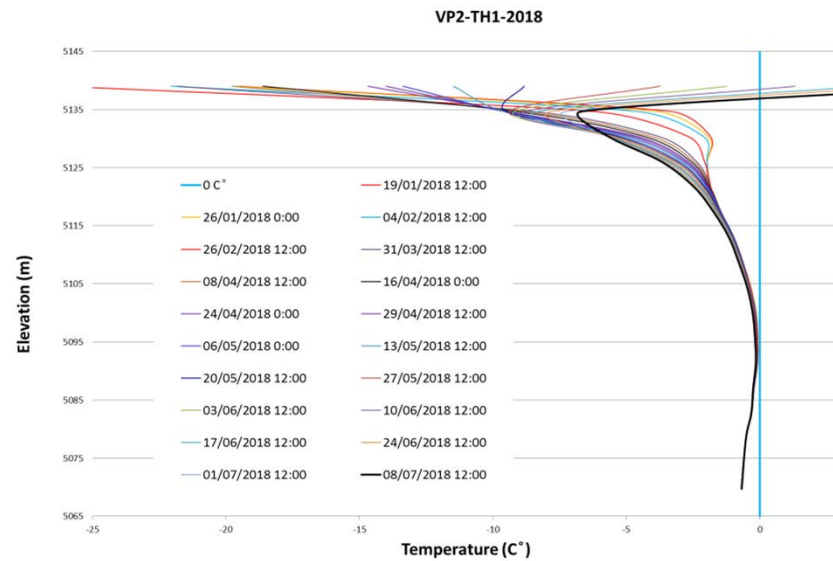
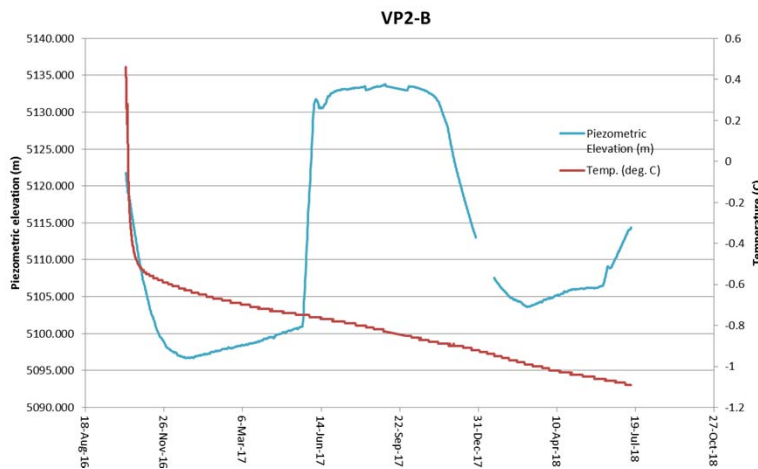
- PZ-A&B are below the freezing point since their installation and their data are considered unreliable.
- The section between 5105 and 5085 is close to the freezing but still below. Apart the top beads, minimal variations were recorded for the rest of the hole.

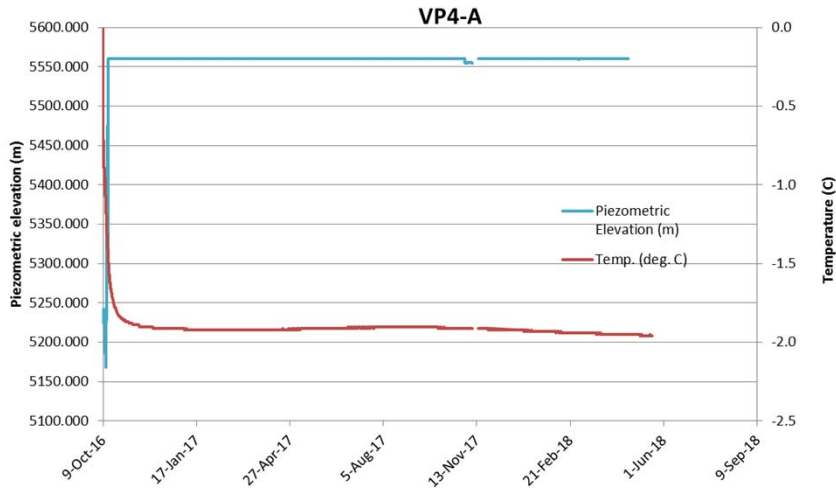
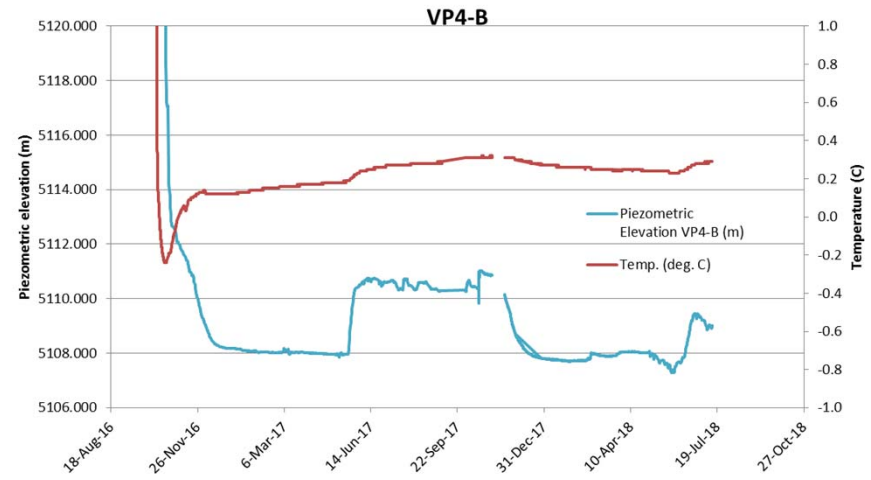
VP4-A, VP4-B

- PZ-A is under the freezing point and considered unreliable.
- PZ-B is unfrozen and since is significant pressure drop, it remained stable during Q1 ,2018. The instrument is installed in the confined layer of talik in between 5105 and 5095 at the source of the seepage causing the major ice wall in the area.
- The temperature of PZ-B is on a very slight downward trend suggesting a freeze back of the slope and aggradation of permafrost.

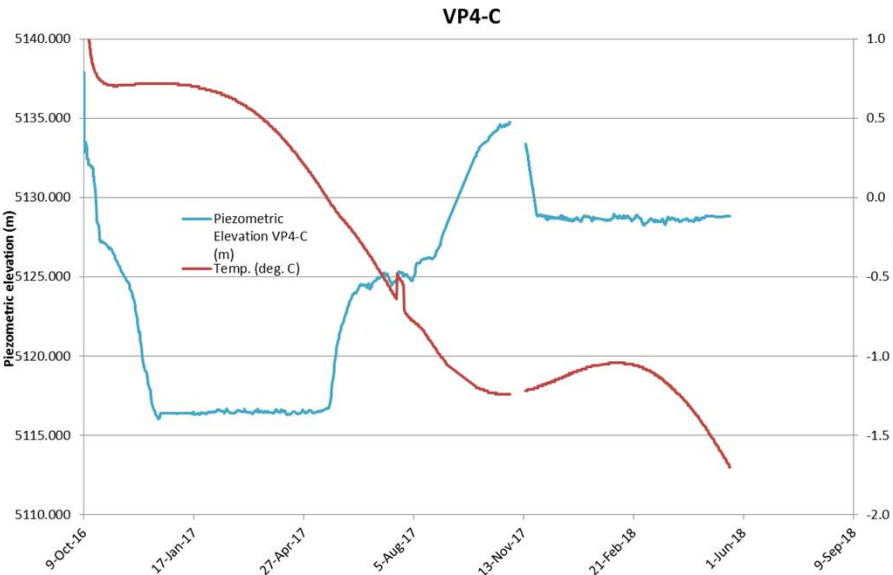
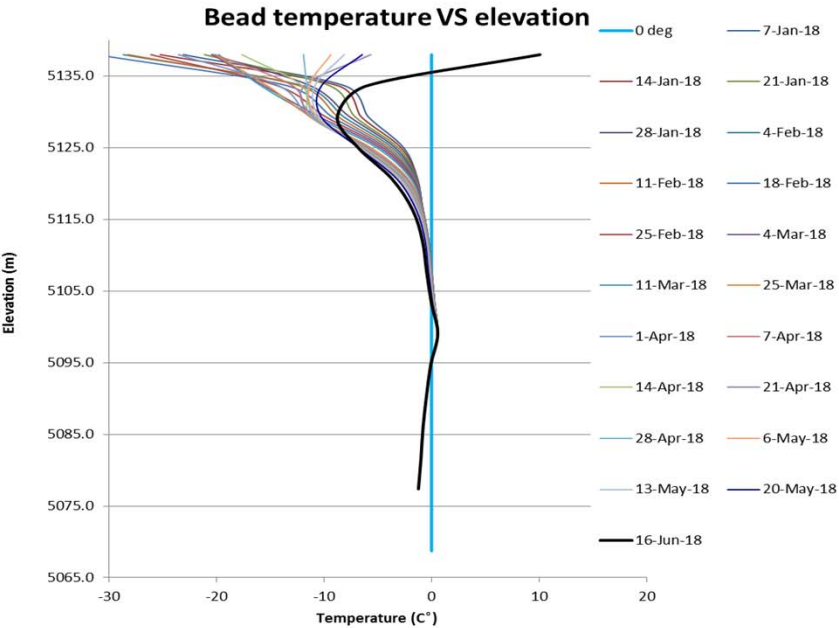
VP4-C, VP4-TH1

- PZ-C is frozen and data is considered unreliable.
- The thermistor show that the hole is mainly in the permafrost at the exception of the section in between 5100 and 5095 (0.57°C). This zone causes the seepage and therefore the ice wall.

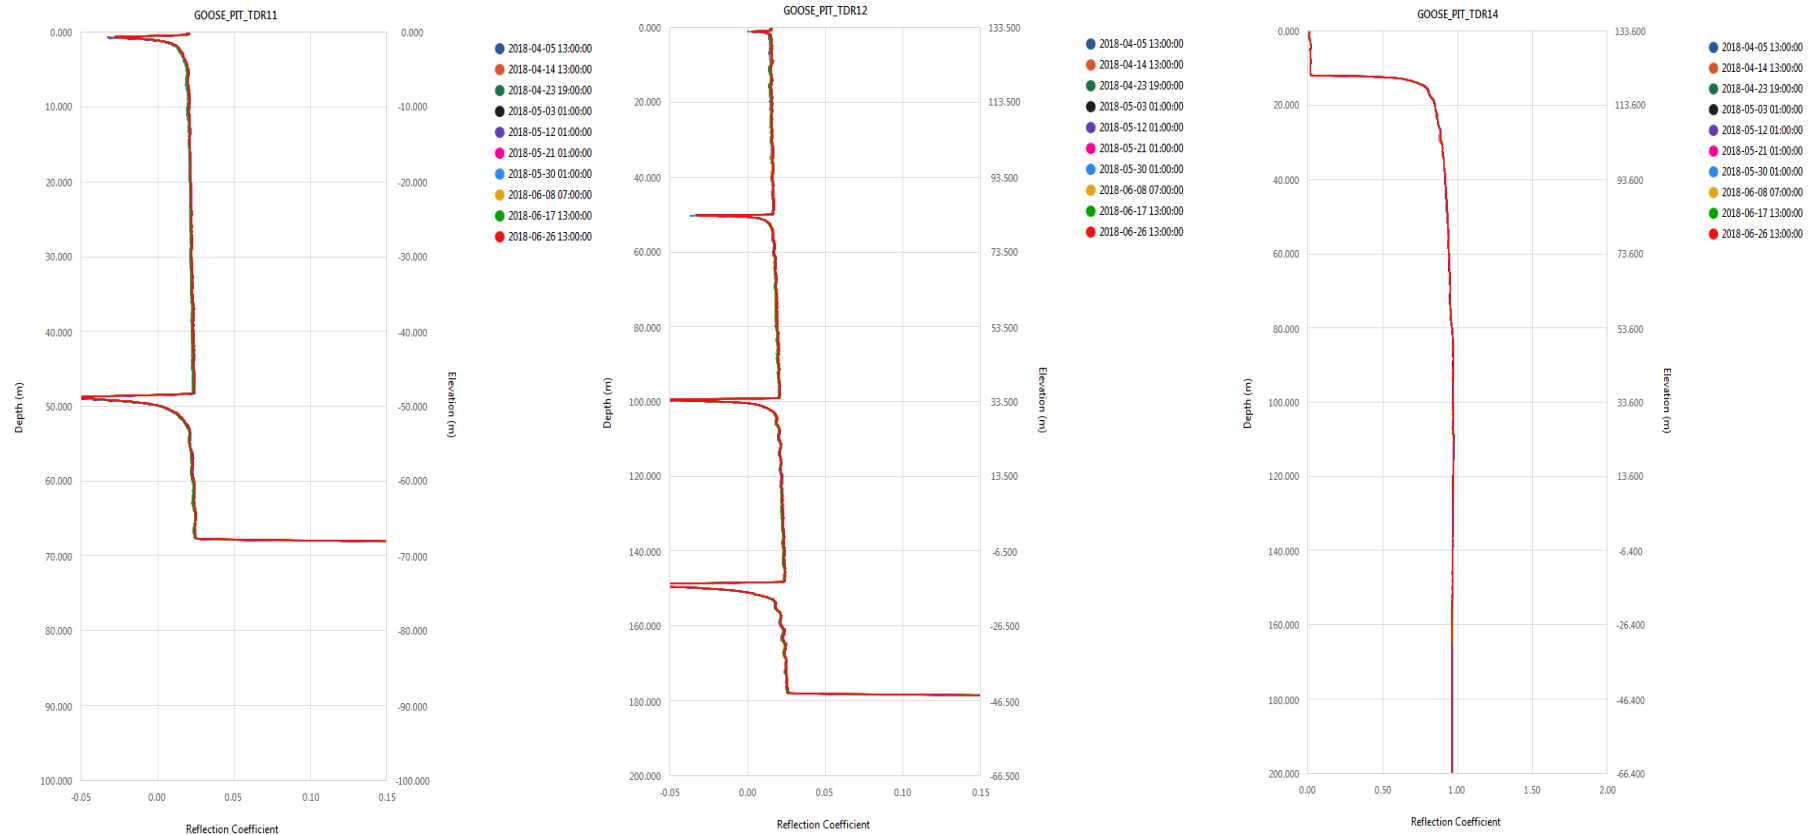
- No sign of deformation was observed in these TDRs.
- Anomalies from the TDR logger are still presents and were disregarded in the presented graphs. We are currently still trying to find a solution for this problem but it does not compromise the data integrity.
- TDR 14 was pinched at installation and therefore result might be compromise in the case of an event raising the reflection coefficient.

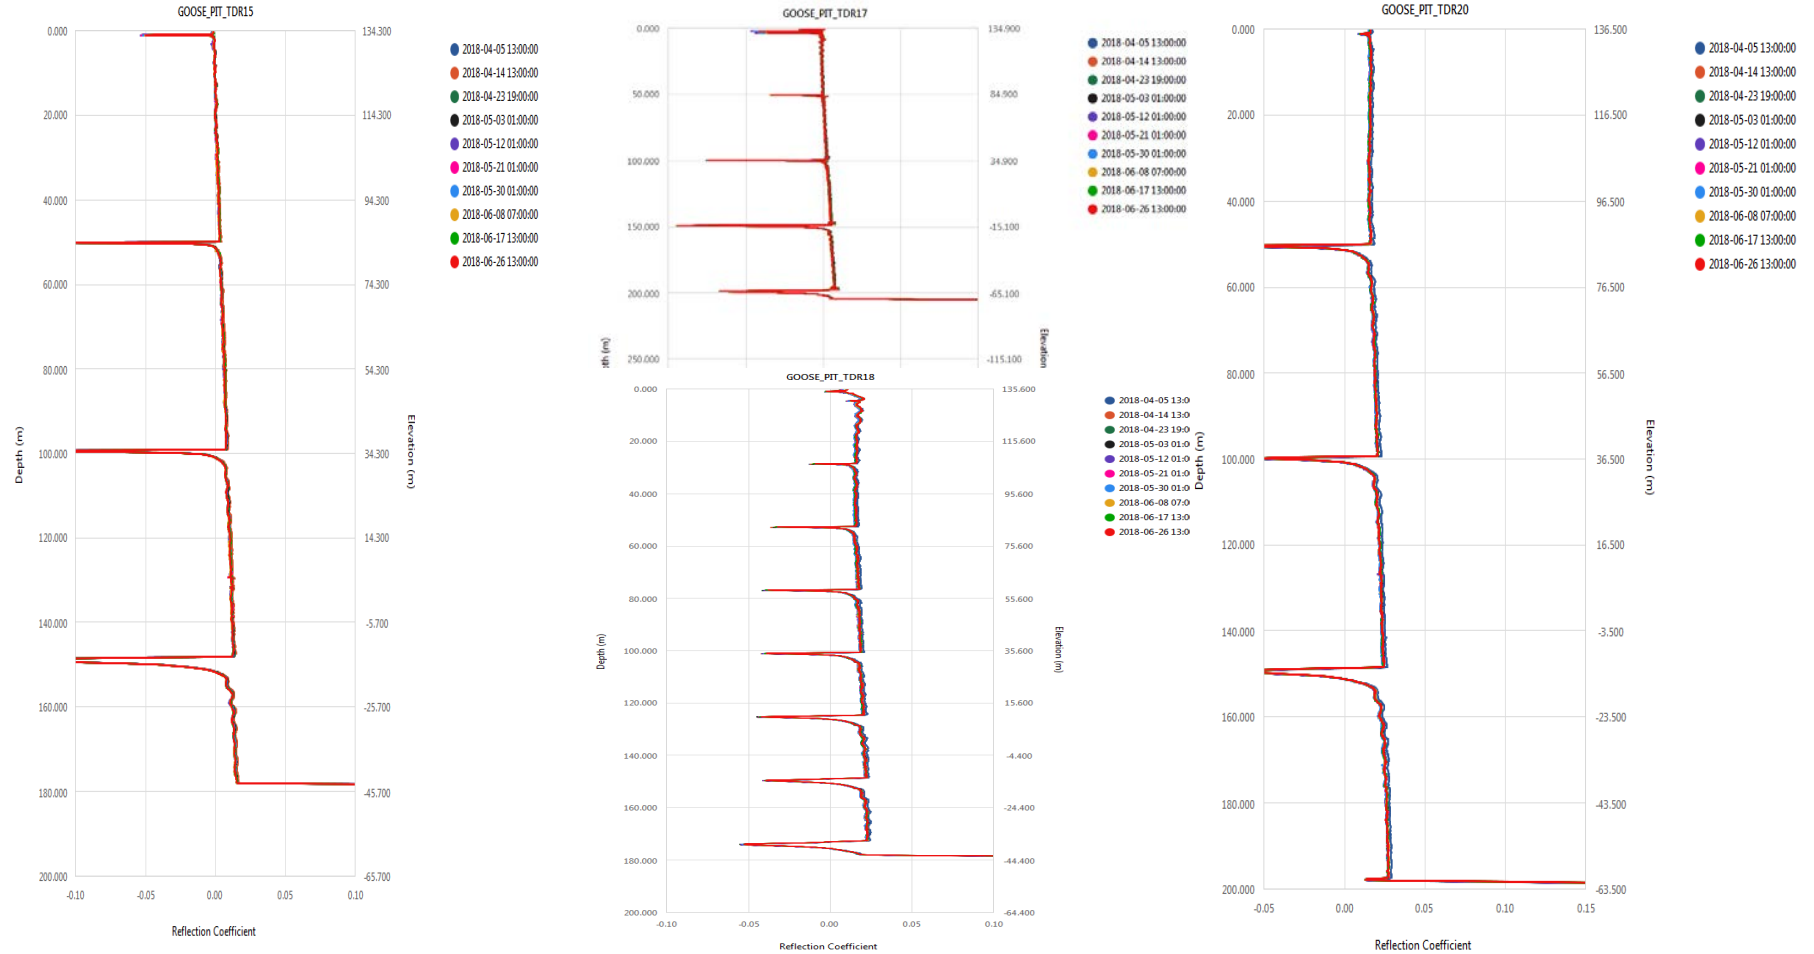
- No sign of deformation was observed in these TDRs.
- Anomalies from the TDR logger are still presents and were disregarded in the presented graphs. We are currently still trying to find a solution for this problem but it does not compromise the data integrity.

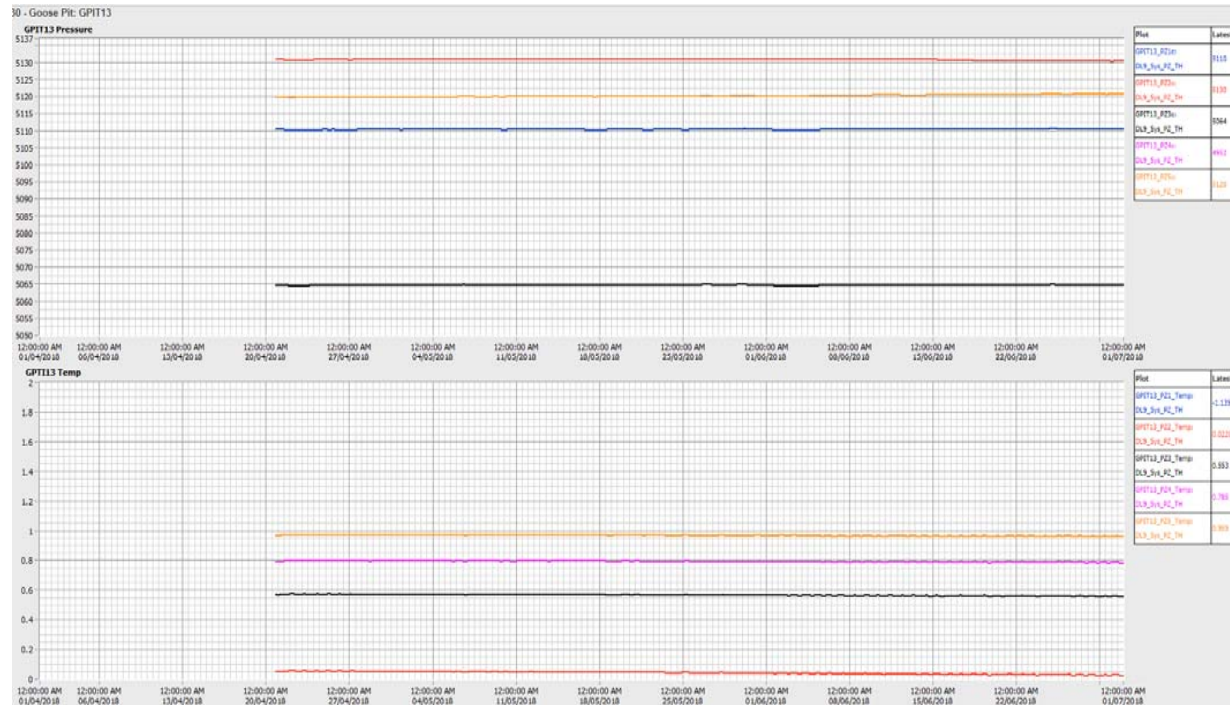
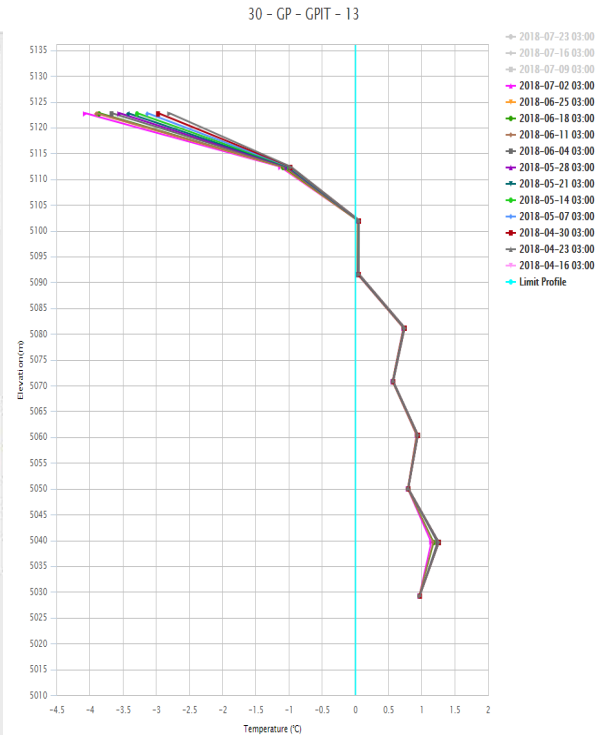
- All piezometers presents little or no variation during the Q2, 2018. All of them are above freezing point.
- A part of the data logger (DL9) was used on DL13 and no record were taken in between Feb. 23 to April 20, 2018.
- TH-GPIT-13 was stable during Q2 compared to previous data sets. It is in the permafrost from top to elev. 5102. First bead at elevation 5123 lose 1.2°C and a decimal of a degree at elevation 5039 during the Q2.

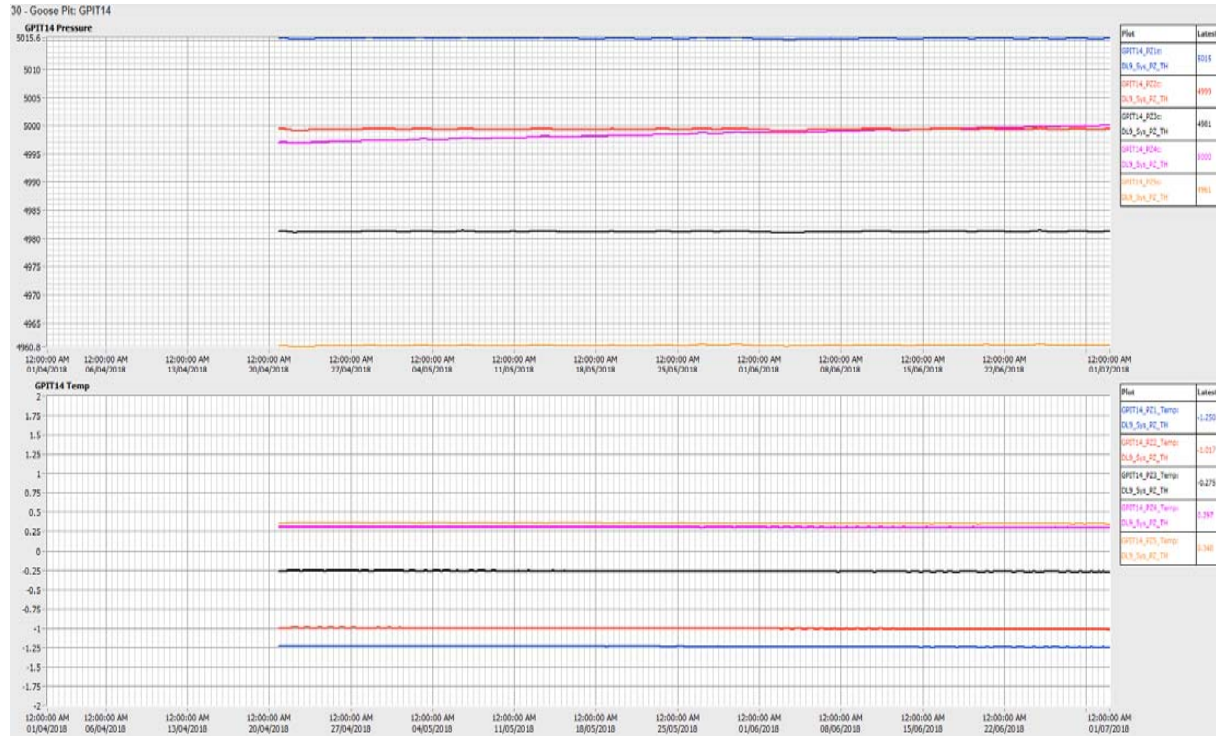
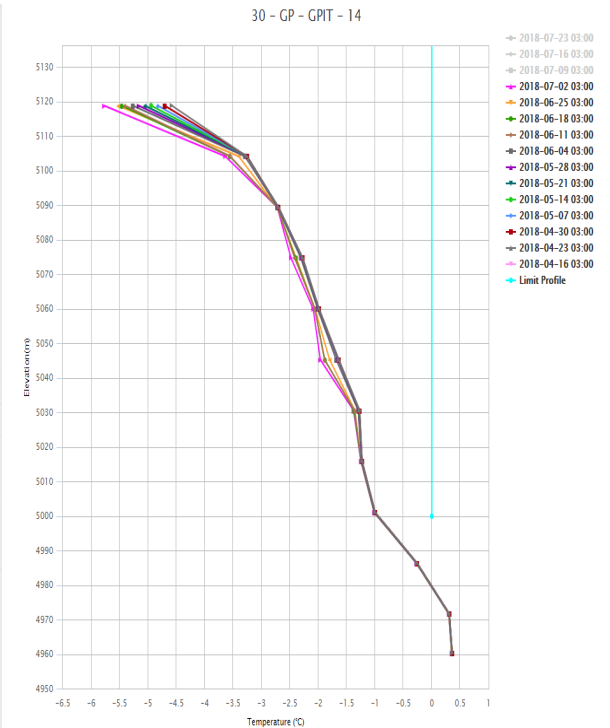
GPIT-14-PZ-1-2-3-4-5, GPIT-14-TH

- PZ-4 is on a slow rising trend. It rose 3.12 m pore water pressure during the second quarter and that could be related to the water level within the Goose pit that is raising (natural flooding).
- PZ-5 stayed constant with very few variations (0.17m).
- PZ-1,2,3 are below the freezing point.
- TH-GPIT-14 is in the permafrost from top at elevation 5120 to 4980. The last 20m of the hole is above the freezing line. From elev. 5120 to 5030, temperatures generally went down decimals of a degree. The remaining of the hole stayed the same from 5015 to 4960.

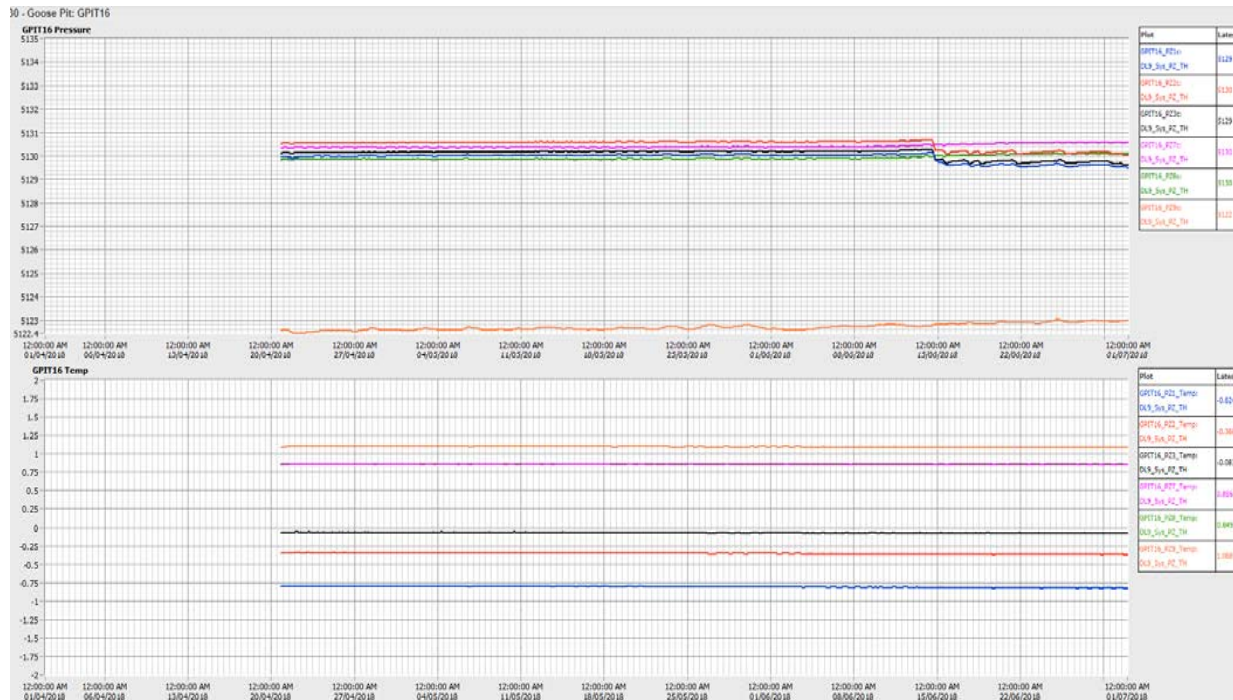
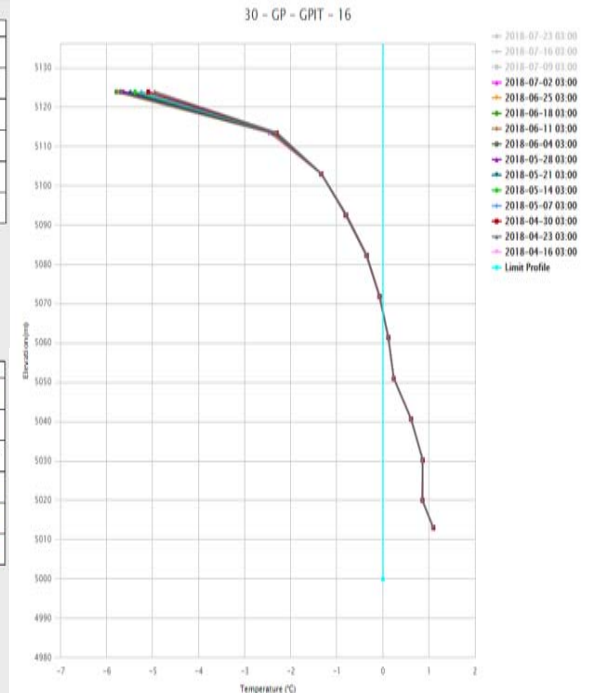
- PZ-7,8,9 are on a very slow rinsing trend.
- PZ-1,2,3 are below the freezing point and can't be considered reliable.
- TH-GPIT-16 is in the permafrost from top at elevation 5124 to 5070. The last 57m of the hole is above the freezing line. The first couple of beads loose decimals of a degree during the Q2.

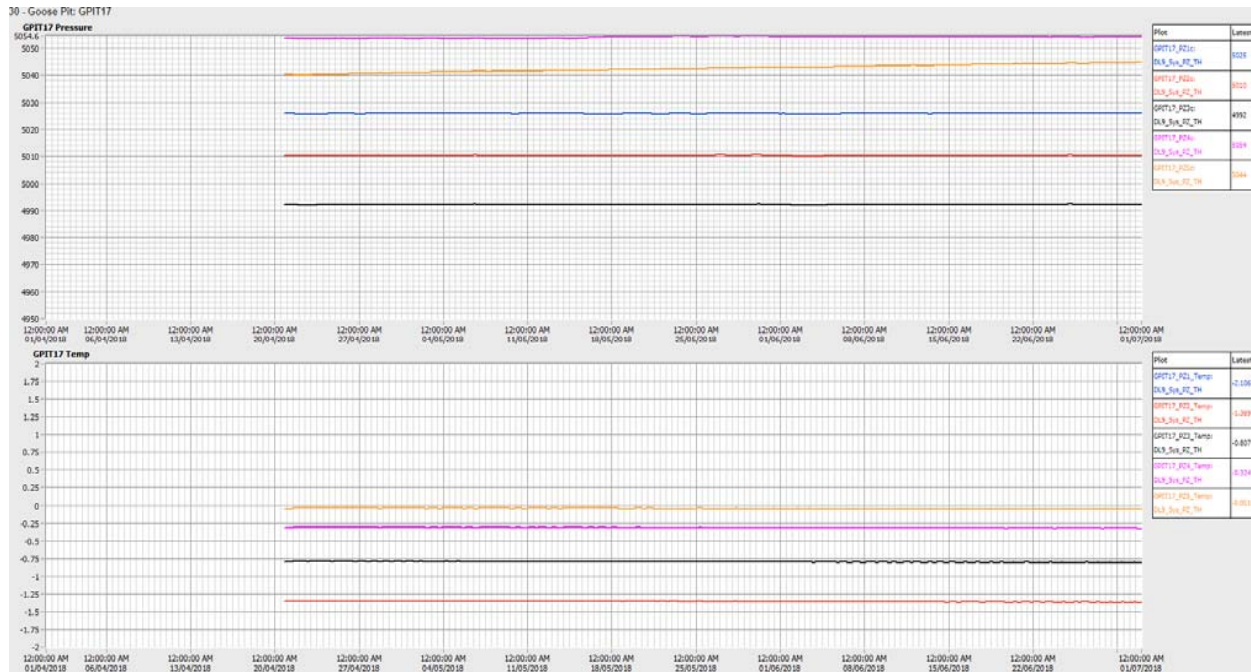
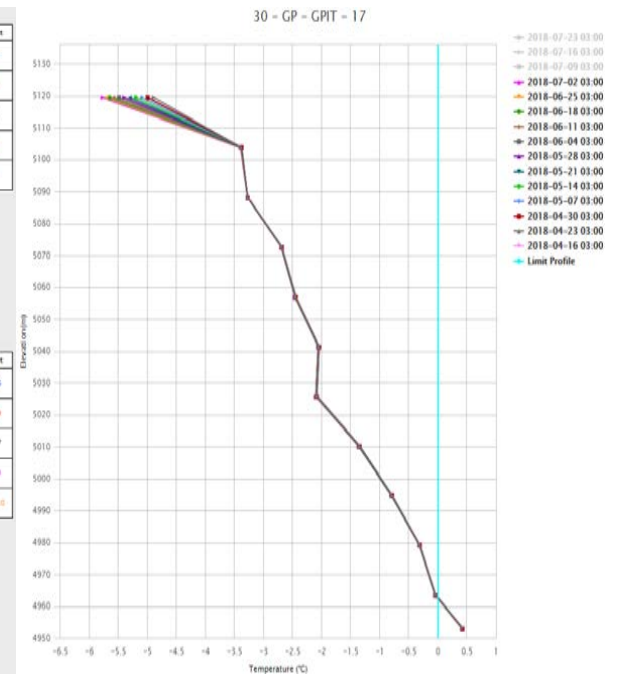
- PZ-1,2,3,4&5 are below the freezing point and can't be considered reliable.
- TH-GPIT-17 is in the permafrost from top at elevation 5119 to 4963. The first bead lost 0.7°C. The last 10m of the hole is above the freezing line.

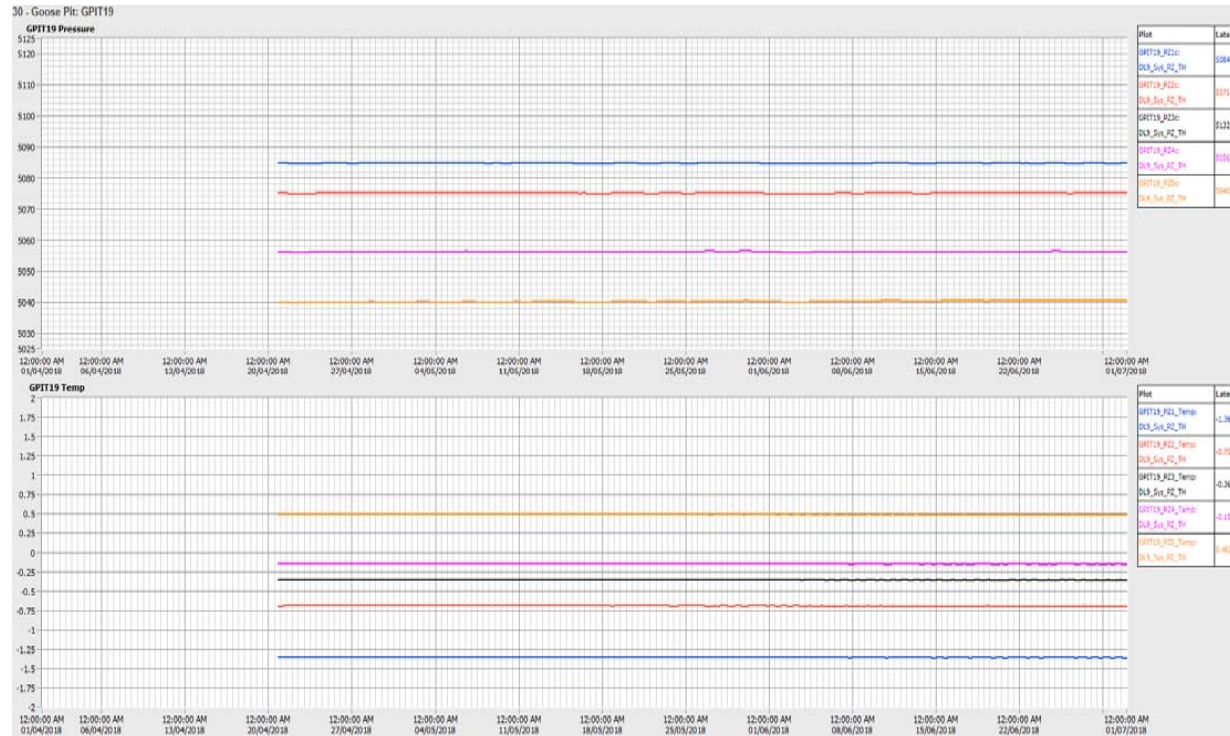
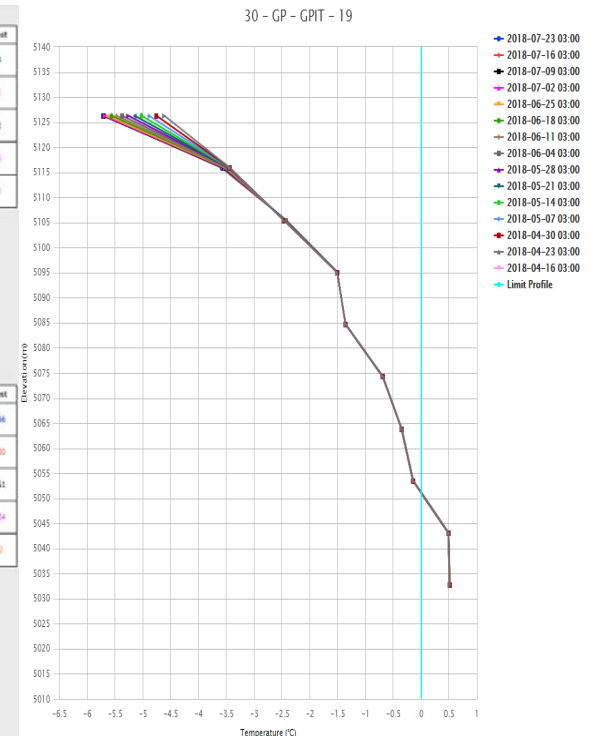
GPIT-19-PZ-1-2-3-4-5, GPIT-19-TH

- PZ-5 is above the freezing line and it shows little or no pore water pressure variations during the Q2, 2018.
- PZ-1,2,3,4 are below the freezing point and can't be considered reliable.
- TH-GPIT-19 is in the permafrost from top at elevation 5126 to 5051. The first bead lost 1°C. The last 19m of the hole is above the freezing line and didn't varied during the Q2.

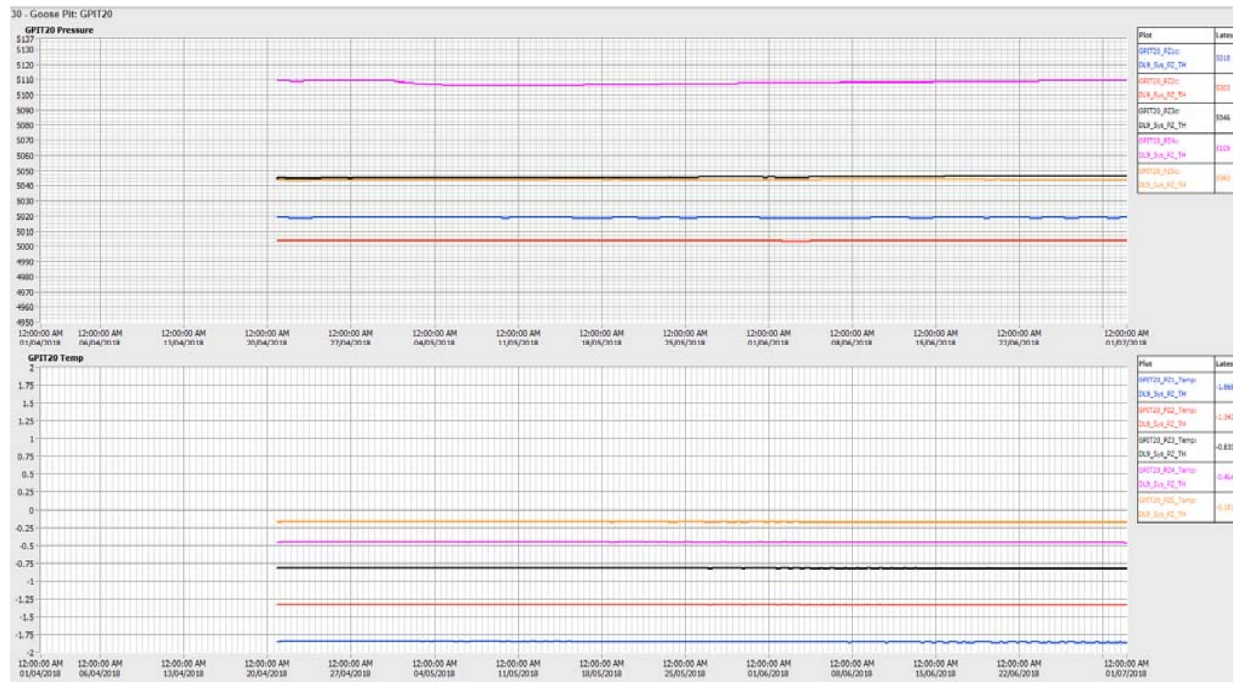
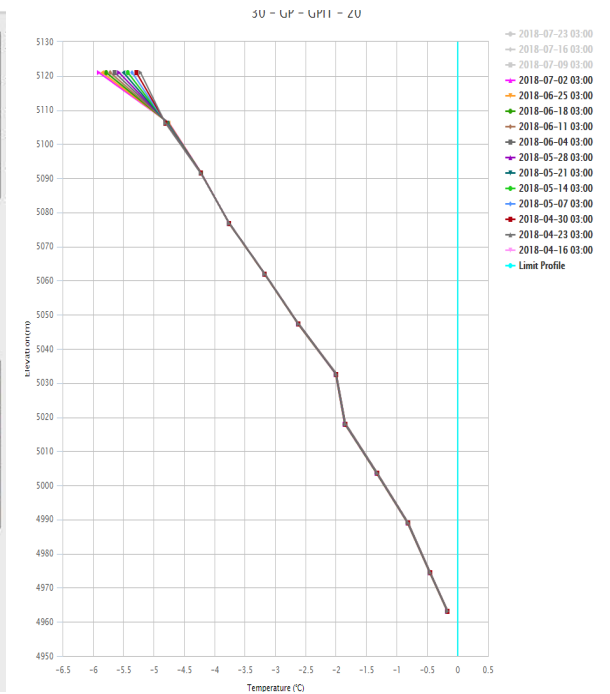
- PZ-1,2,3,4,5 are below the freezing point and can't be considered reliable.
- TH-GPIT-20 is in the permafrost on its entire length from its top at elevation 5121 to the bottom at 4963. The first bead at elevation lost 0.6°C during the Q2, 2018.

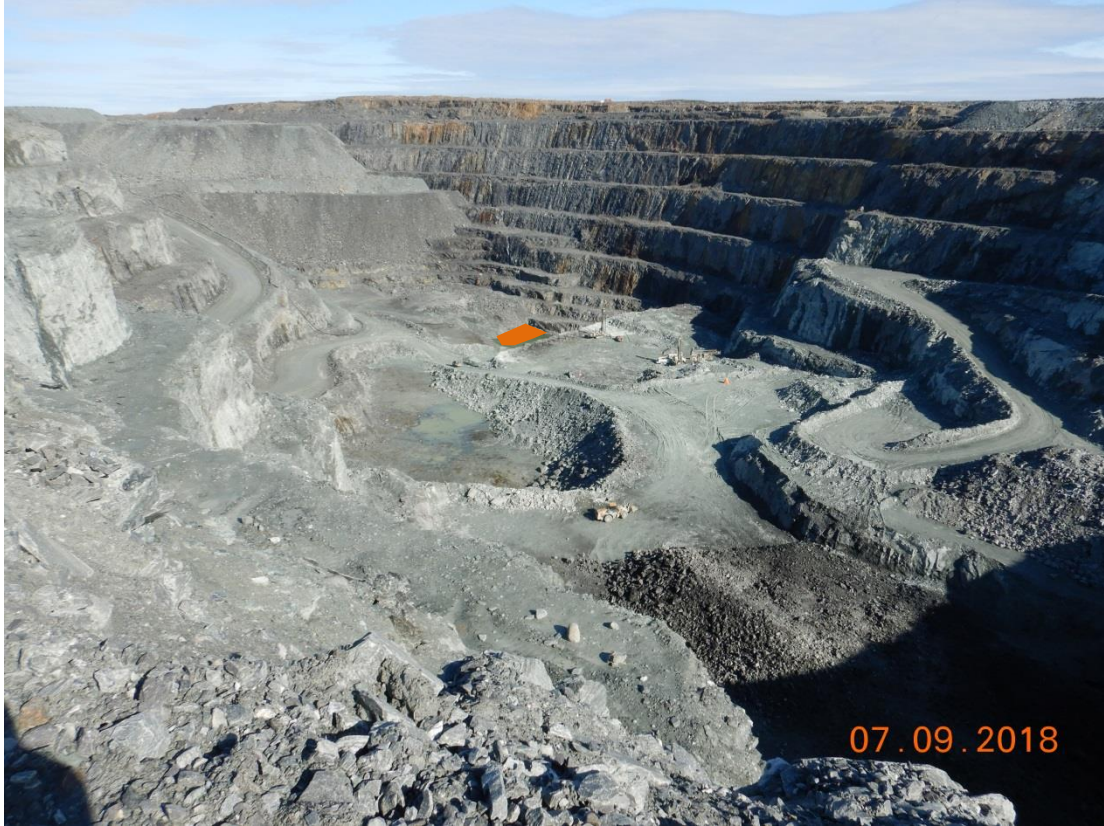
Zone E01: Pit E3: No Access Zone while in dewatering process.

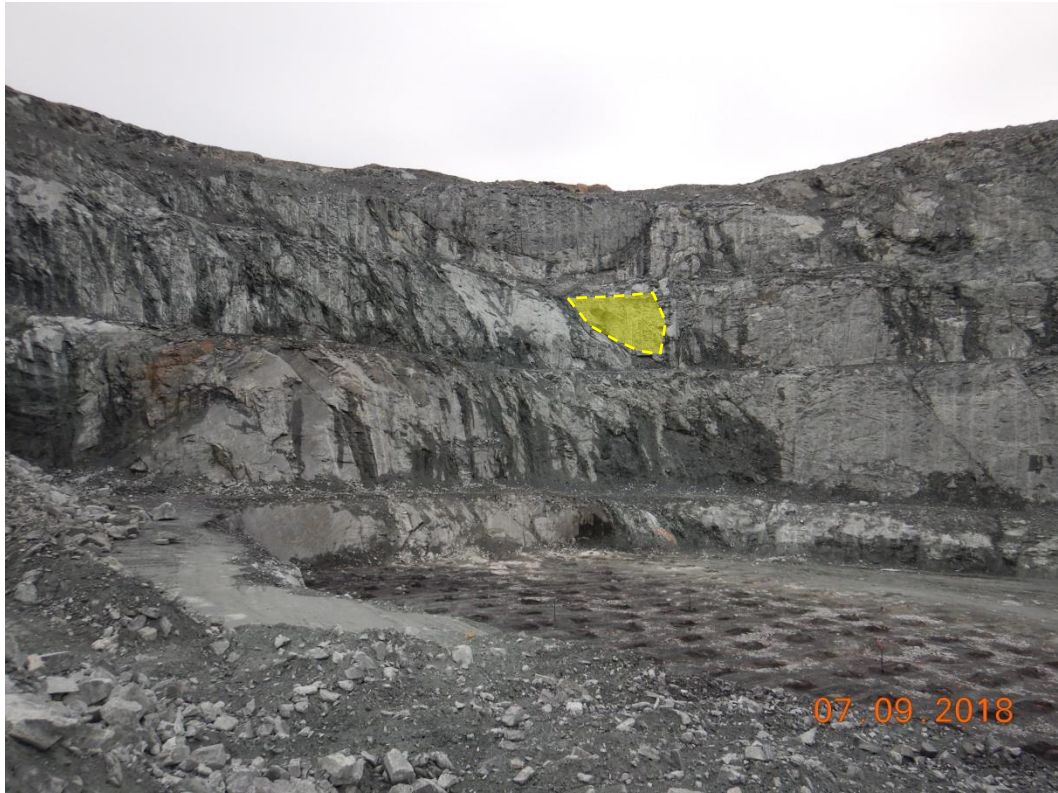
Zone E29: Pit E5, South Wall: Slab with linear progression to be monitored.

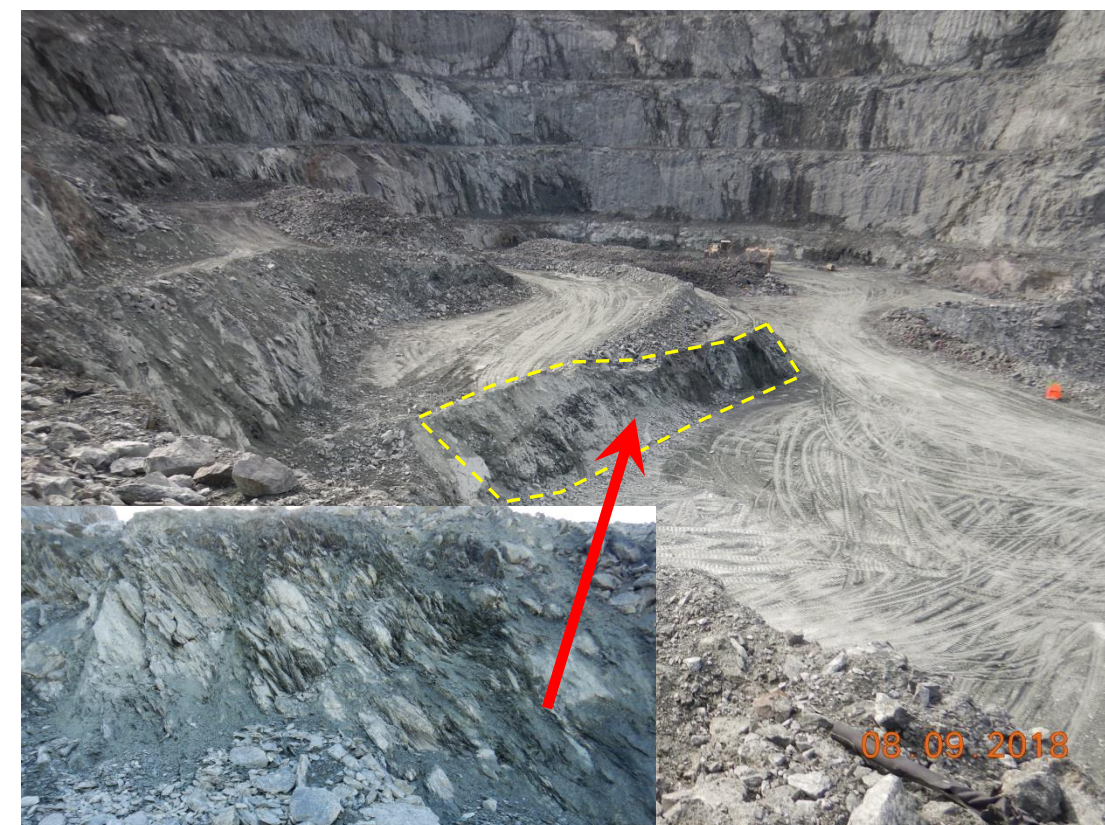
| Zone : E37 Pit : E5 Wall : South Bench:5039 <div>Status: </div> | NEW: This wall section is made of heavily foliated ultramafic rock. In addition to that, bumpers from above are too close crest. The wall is the top section of a 21 meters wall and could become a problem as we go down. | NEW: Scale and remove all loose material from the wall. Because of the large section above open space), there is a possibility to use a backhoe and slope the crest if needed. Pull back the bumpers away from the crest. | Sept. 14, 2018 | NA |

Zone E37: E5, South Wall: Scale and slope the wall. Pull back the bumpers away from the crest.

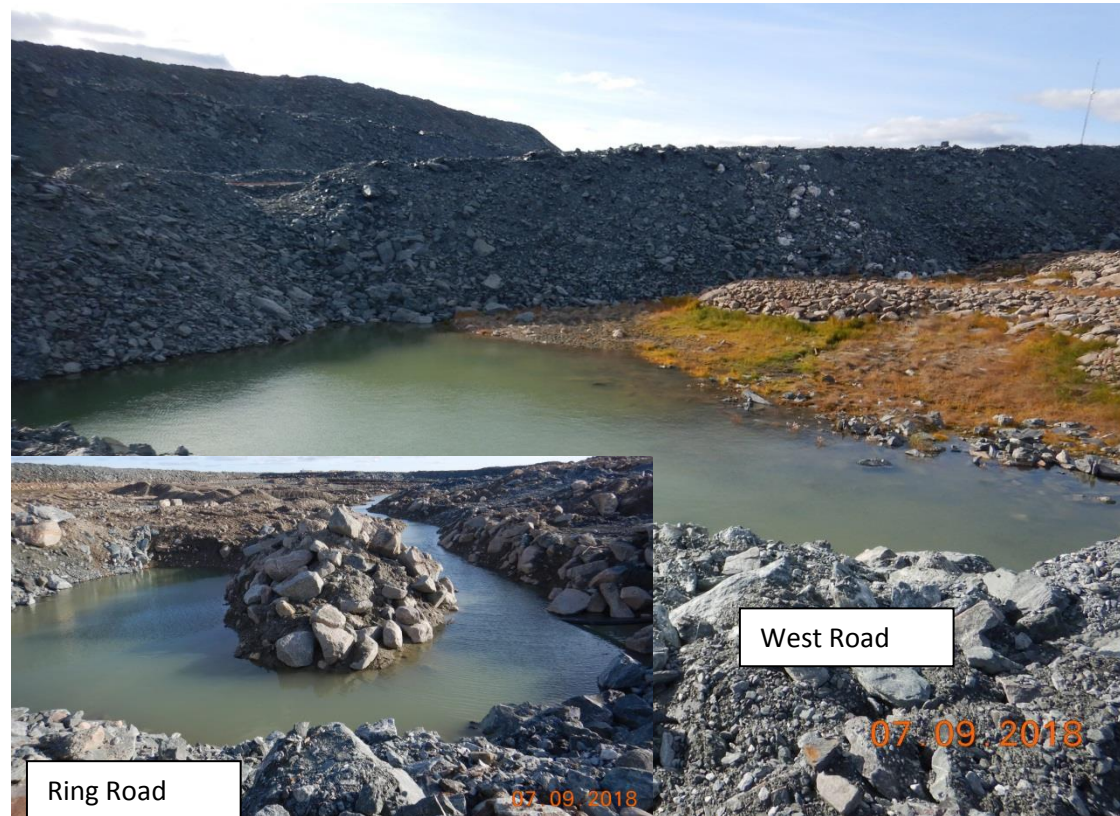
Zone E38: Top of E5 Pit: Pump the two ponds; 1 close to the old marginal on the west road and the other one on the ring road close to the till.

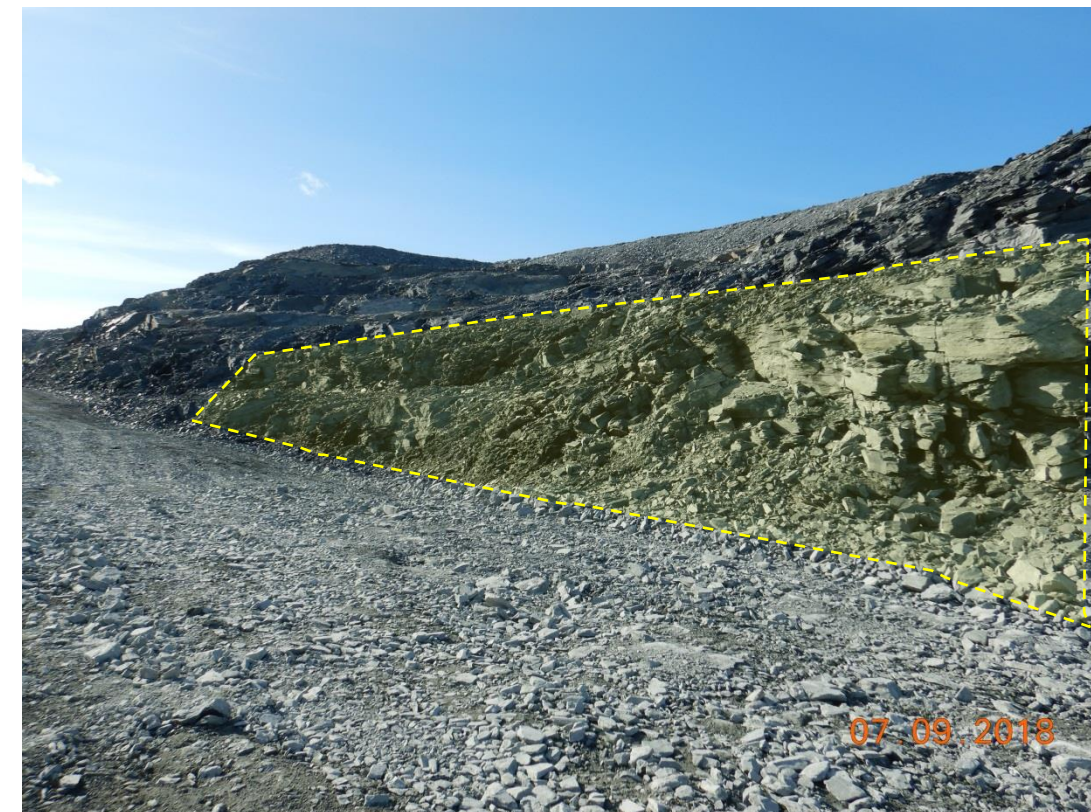
Zone P30: Phaser, West Wall: Lightly scale the wall.
