Meadowbank 2018 Annual Review of Portage and Goose Pit Slope Performance

2018 ANNUAL PIT SLOPE PERFORMANCE REVIEW

MEADOWBANK MINE, NUNAVUT

ISSUED FOR USE
704-ENG. ROCK03053-02

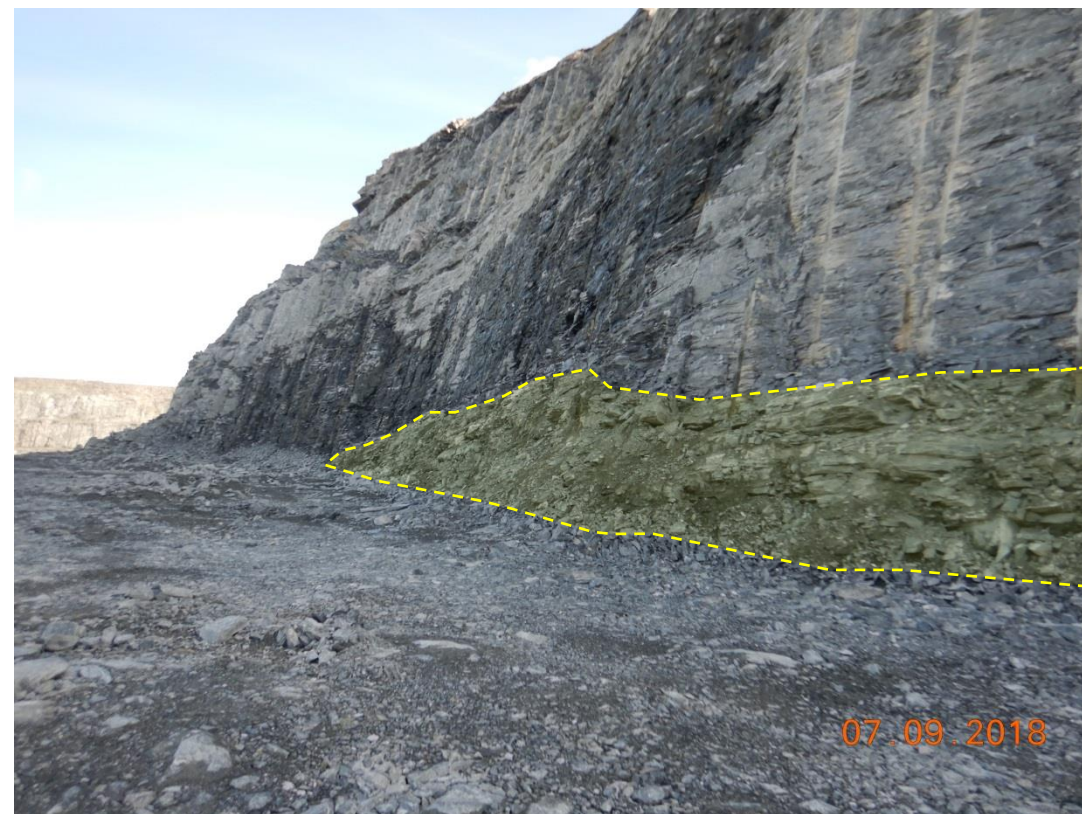
| Zone: P31 Pit: Phaser Wall: East Bench: 5088 <div>Status: </div> | NEW: A new section of the wall was exposed and presents mostly toes and loose material on its bottom despite being in general good condition. | NEW: Scale the wall and hammer the toes when required. | Sept. 21, 2018 | NA |

Zone P31: Phaser, East Wall: Scale the wall and hammer the toes when required.

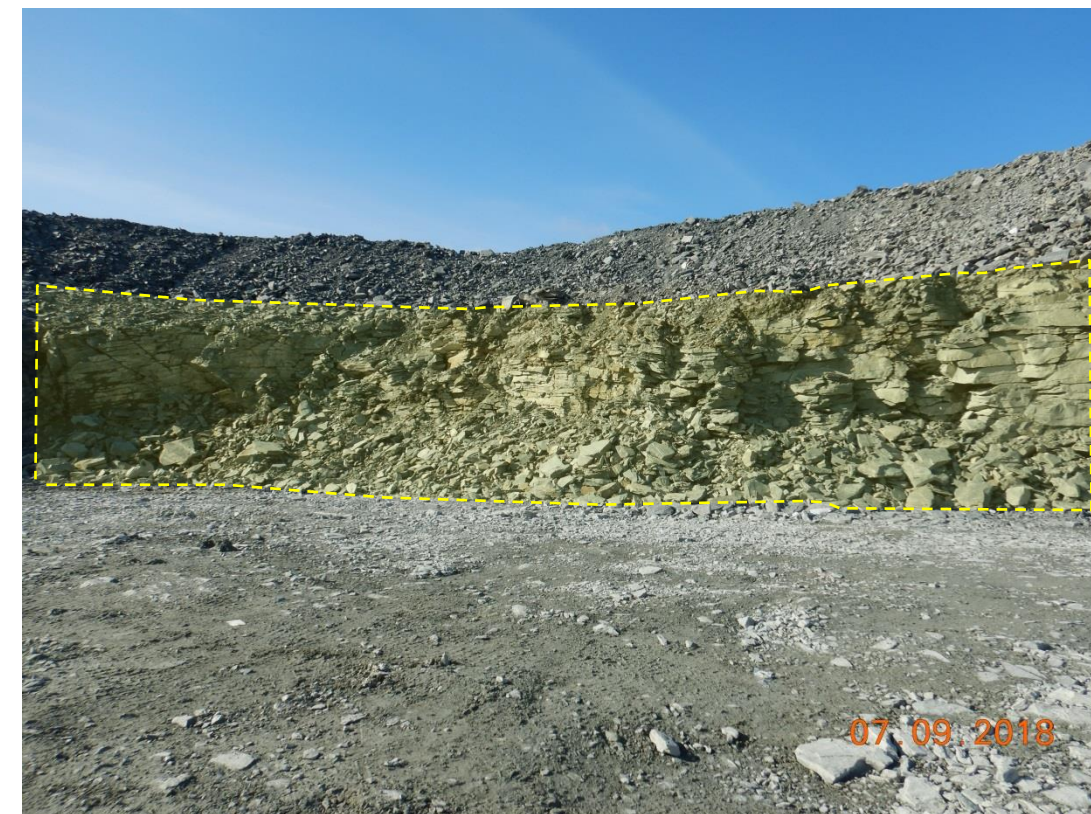
Zone BB04: E4, West Wall: Lightly scale the wall, and pick up debris.
