for the NIRB's Monitoring of
Baffinland Iron Mines Corp.'s Mary River Project

Nunavut Impact Review Board

April 2018

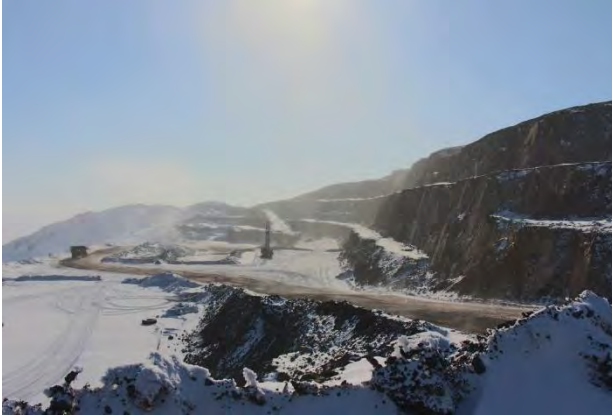
Photo 5: Deposit No.1 Pit Benches

After leaving the waste rock storage area the NIRB staff visited Deposit No.1 reserve pit. Ore extraction and mining activities within the mine pit has progressed since the last site visit in August 2017 with ore being extracted in successive layers or “benches” across the pit (Photo 5 and Photo 6). Two (2) drills were located on an upper bench with a blast scheduled for the following day (Photo 6 and Photo 8), and a loader was observed filling haul trucks with ore within the pit area (Photo 7) to be transported to the crusher facility where it is crushed and further sorted into lump or fines. Baffinland staff indicated that they plan to continue a pushback of the upper benches to access the iron ore on the benches below.

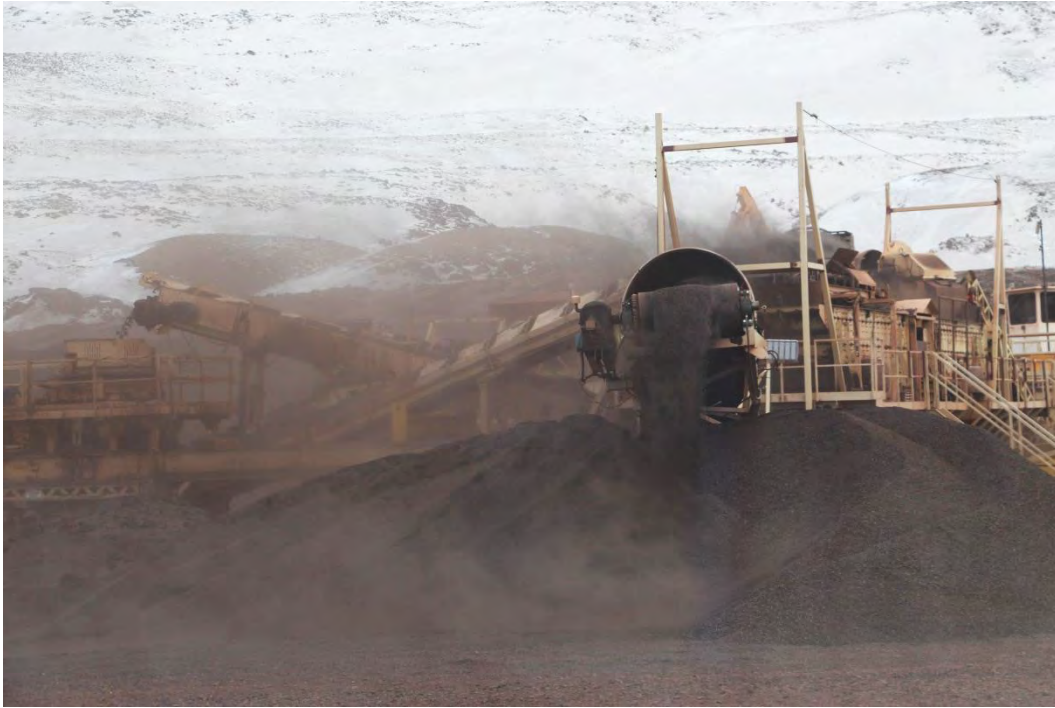
Photo 9: Crusher Plant Area

NIRB staff also took a tour around the crusher area and while at the facility observed dust emissions including large visible dust plumes from the crusher plant due to ongoing ore crushing, stacking, and loading activities (Photo 9, Photo 10). Although shrouds had been installed (Photo 11) which improved dust emissions from the plant slightly, there is still large amounts of visible dust at the transfer points along the belts. The Monitoring Officer noted that the crusher plant was generally still lacking proper dust containment controls along the conveyor belt and end of the feeder (Photo 12). In addition, dust plumes were also observed when the haul trucks dump the iron ore into the crusher plant. Overall, the dust emissions observed from the crusher plant during the current site visit do not appear to have significantly improved compared to previous site visit observations. Dust accumulation was also noted in the surface soils and snow cover adjacent to the facility and up to a minimum of one (1) km away. Baffinland staff indicated that there are plans to come up with better engineering solutions, such as ensuring the covers are re-installed along the conveyor belt and at the end of the ore feed to reduce dust emissions. However, Baffinland staff also indicated that there are no current solutions for the shaker in the crusher facility as the movement of the equipment would not support a cover and may require increased maintenance on the screens (Photo 13).

At the time of the current site visit, the Monitoring Officer noted there are no effective dust control measures at the crusher and screening plant in order to prevent dust dispersion to the surrounding environment, as such dust management continues to be an issue from the crusher plant.

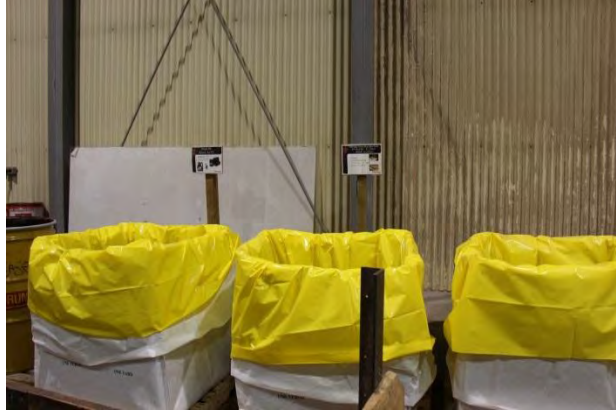
The Monitoring Officer noted that the incinerator in use at the Mary River mine site continue to remain well maintained except for presence of oily water from a tank on the floor drainage system (Photo 16). Within the incineration building, NIRB staff noted that waste materials are segregated into labelled bins for incineration (i.e., food and paper waste) or disposal off site (i.e., batteries, paint, oily rags, kitchen grease etc.) (Photo 17). NIRB staff however, observed that some of the bags containing items for incineration contained recyclable waste such as aluminum cans, aerosols, and plastics (Photo 18) and recommended that Baffinland make improvements to its waste management and waste segregation practices site wide. NIRB staff also noted that throughout the site and especially within the accommodations complex there are few bins with poor labeling to enable proper segregation of wastes, and that all staff and visitors should be provided training during their orientation on how to segregate waste, including personal waste into the appropriate bins. During this site visit, the Monitoring Officer observed the ongoing effort of Baffinland staff in relocating most of the historical tires and other used items into sea cans which were properly stacked and prepared for offsite disposal (Photo 19). Baffinland staff also noted that used tires from the maintenance shops are now automatically being put into sea cans for disposal.

Photo 17: Waste segregation in Incinerator Facility

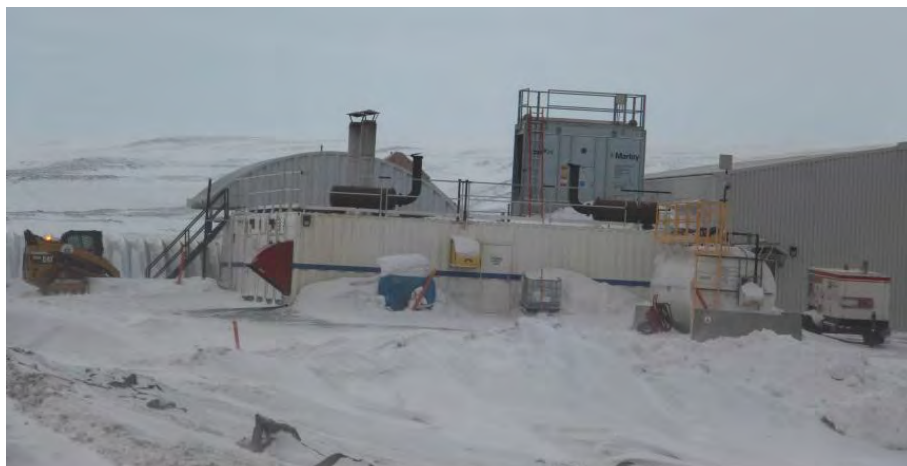
No environmental issue was identified at the effluent discharge location during the current site visit. NIRB staff also visited the emulsion plant and no issues were identified with this facility as it was very well maintained, organized and safe (Photo 20).

Photo 20: Emulsion Plant

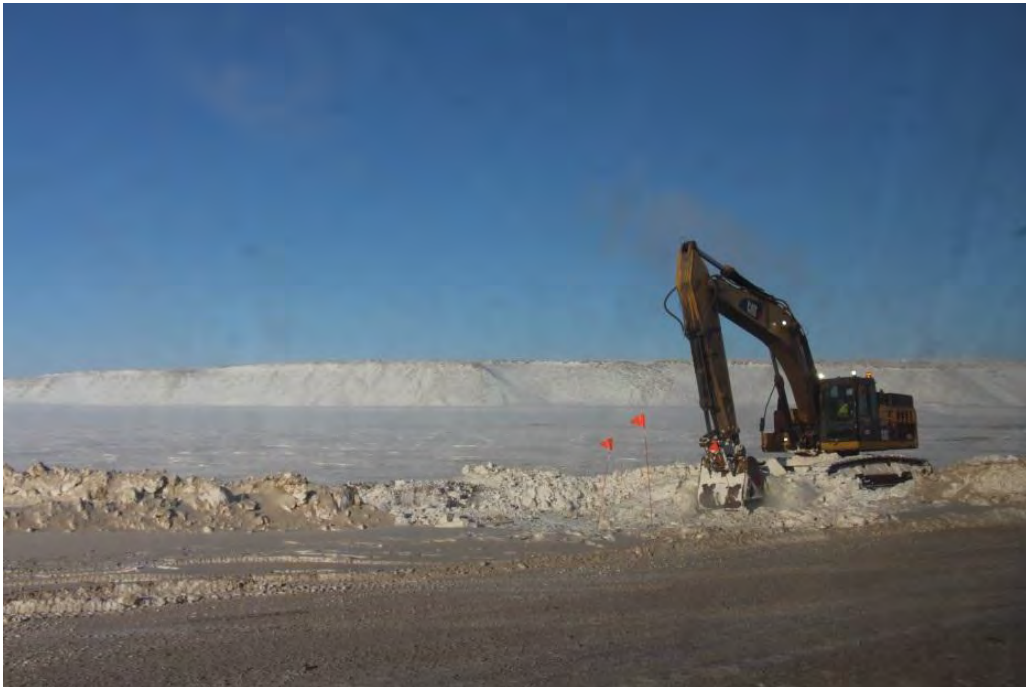
During 2018 winter site visit, the Monitoring Officer did not observe any major environmental issues along the Tote Road; the road was well maintained. Baffinland was also preparing for spring freshet by having its staff undertake steaming and clearing snow from major culverts along the Tote Road (Photo 21). Dust plumes from vehicular and B-train truck traffic was observed and dust remained air borne for long periods of time travelling away from the road and deposited on the snow cover (Photo 22 and Photo 23). Several dust fall monitoring stations at kilometre (km) 33, 34, and 69 were observed along the Tote Road. NIRB staff noted the challenges of dust control due to vehicle traffic and further discussed alternative dust suppressants options to reduce dust along the Tote Road.

Photo 21: Excavator opening culverts preparing for freshet

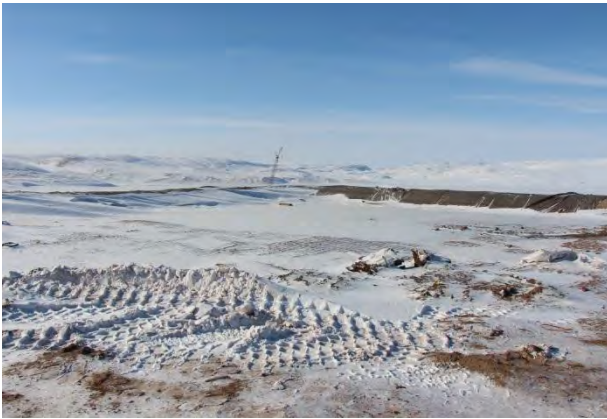
Photo 24: Landfarm

The Monitoring Officer visited the landfarm facility and followed up on progress of the facility with respect to management of contaminated snow, synthetic liners, and used tires. While the Monitoring Officer generally indicated there has been an overall improvement in the operations of the facility, there were still outstanding concerns regarding presence of several waste material items such as plastics and wood materials (Photo 24 and Photo 25). The Monitoring Officer also noted that the laydown area near the landfarm area used for salt storage had not been addressed as previously recommended during NIRB's 2017 summer site visit as many salt bags were still there and deteriorating which could increase the risk of localized salt contamination into the environment. An addition to the landfarm area was a designated area for excess snow removed from around site. Excess snow was trucked and placed on the hillside to allow for meltwater to move slowly down the hillside and remove any sediment through natural filtration before reaching Milne Inlet, or any surrounding waterbodies.

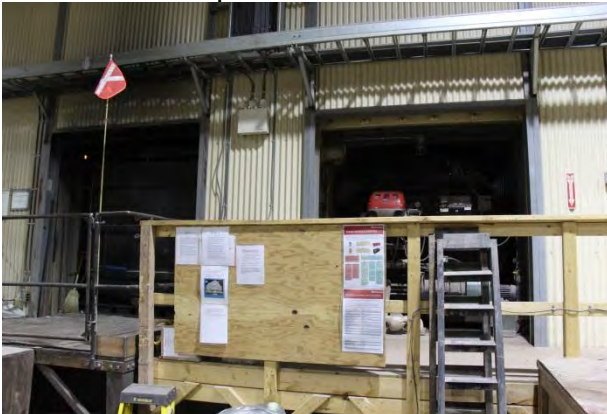
Photo 26: Incinerator

The Monitoring Officer noted that the incinerator in use at the Milne Inlet site is well maintained. Within the incineration building waste is segregated into labelled bins for disposal off site (i.e., batteries, paint, aerosols, oily rags, etc.) (Photo 26 and Photo 27); however, NIRB staff observed some areas for improvements could be made to waste management and segregation site wide.

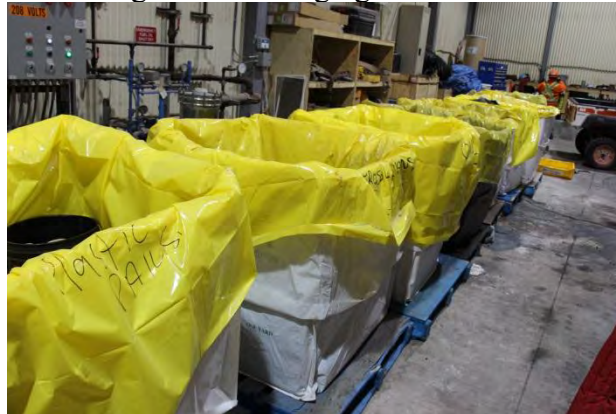
Photo 27: Segregating waste in Incinerator Building

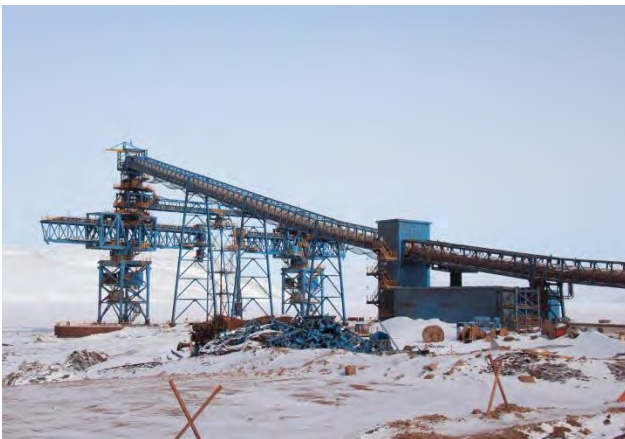
NIRB staff also took a tour to the Milne Inlet stockpile area and the ore dock and did not observe any major activities with the exception of ore stockpiling activities (Photo 28 and Photo 29). The Monitoring Officer observed that during ore stockpiling the ore transfer heights were minimized and there was minimal dust blowing from the stockpile, however, ore dust was observed on the snow and ice in Milne Inlet originating from the stockpile (Photo 30 and Photo 31). As dust fall and its potential impacts to the aquatic environment in Milne Inlet continues to be a key community concern, NIRB staff undertook discussions with Baffinland environmental staff and recommended adding additional snow and sediment studies to their monitoring program.

Photo 28: Conveyor system at Milne Inlet

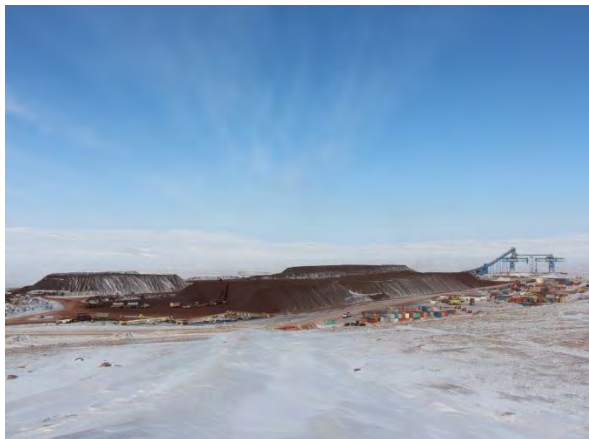
Photo 29: Ore Stockpiles at Milne Inlet

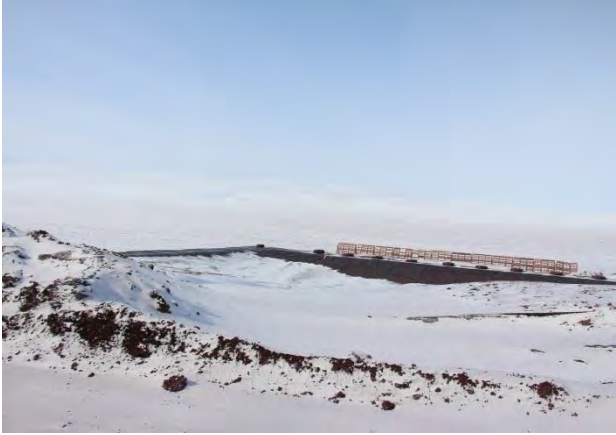
The Monitoring Officer observed that the two (2) sedimentation ponds on the east and west side of the ore stockpile pad were completed (Photo 32). The trenches to these ponds along the ore pad were filled with snow (Photo 33) which was to be removed prior to spring freshet.

Photo 32: Ore sedimentation pond Milne Inlet

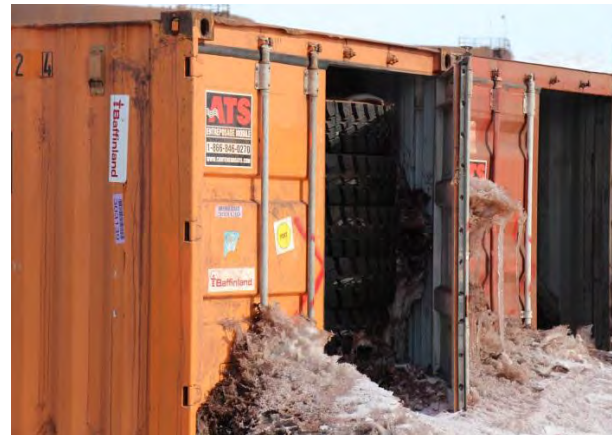
The Monitoring Officer noted that many of the designated laydown areas around Milne port contained tires piles and various scrap materials and affect the aesthetics of the area. Baffinland staff informed the Monitoring Officer that the tire stockpiles would be removed to sealift containers and that the entire clean-up of the area will be completed prior to summer sealift season (Photo 34 and Photo 35).

Photo 35: Tires containerized for shipping offsite

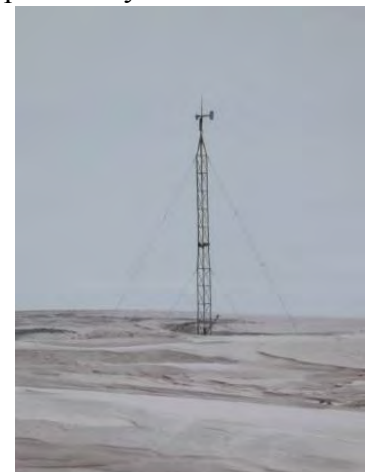
The Monitoring Officer visited the weather station in the Mary River site. **(Error! Reference source not found.)** and observed that current weather-related information is displayed on the monitors located within the main accommodation building and is available on the internet.

Photo 39: Weather monitoring station at Mary River

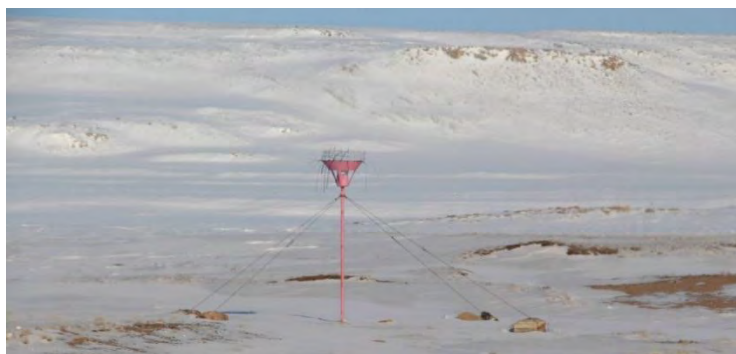
Photo 40: Dustfall Monitoring Station

During the drive along the Tote Road, the Monitoring Officer observed the increased generation of dust plumes and widespread discolouration of snow areas adjacent to the road (Photo 22 and Photo 23). Managing dust in winter is difficult as freezing conditions after application of a dust suppressant may create associated safety concerns. NIRB staff inquired about any research being done into winter dust control. None are currently being considered. Dust fall stations were observed along the Tote Road, which can be noted as being in compliance to part c of Condition 10 (Photo 40).

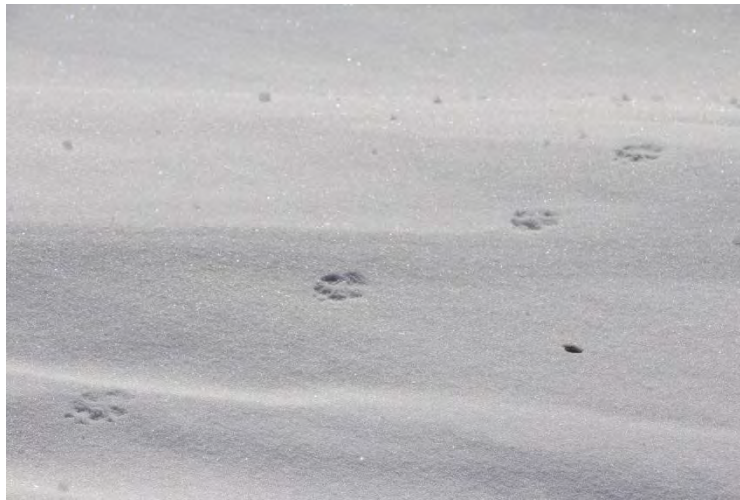
Photo 41: Fox Tracks

During the current site visit, the Monitoring Officer did not observe caribou around the Project area; however, many fox tracks were observed around the site (Photo 41). Metallic skirtings were observed around the base of all accommodations buildings to deter foxes from entry into the building. Baffinland staff indicated that no caribou has been sighted around the PDA in over 5 years and that in the event that any caribou or other wildlife are encountered on site, a right of way policy is in place that requires vehicles stop to allow wildlife pass safely. In addition, the Monitoring Officer noted that wildlife logs continue to be posted at the main camp building for staff to report on wildlife encounters or observations around Mary River, Milne Port, and along the Tote Road.

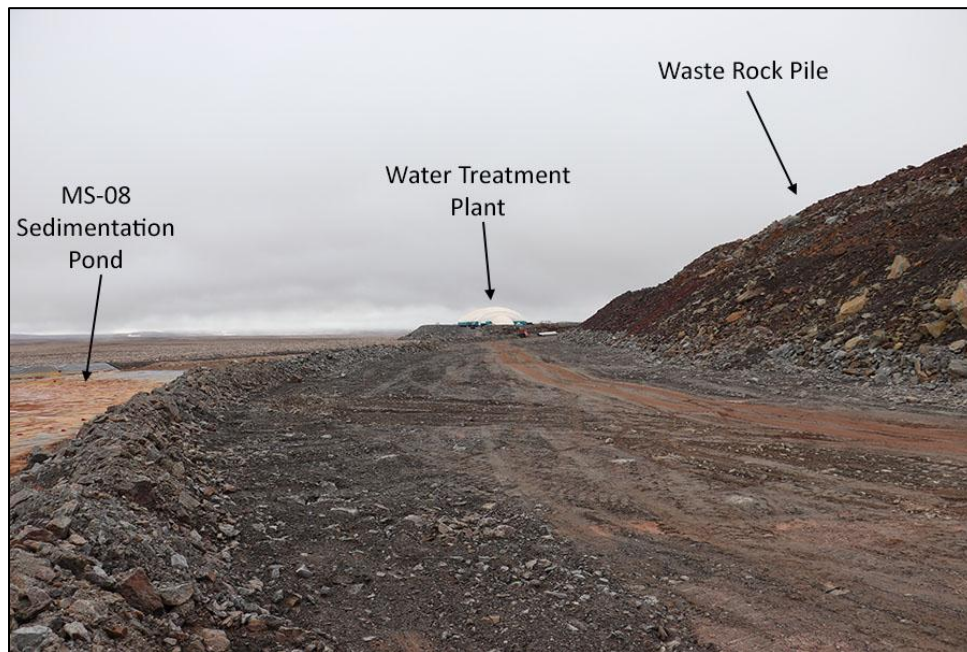
Picture 4: MS-08 Water treatment

Since the winter inspection in April 2018, Baffinland has constructed and commissioned a water treatment facility at MS-08 ([Picture 4](#)) through which all contact water from the waste rock pile is processed. Contact water pumped through geotubes and into a bladder type structure ([Picture 5](#)) in which sediments and suspended solids are captured by settlement and filtration then the water is released through holes in the bladder into a bermed area. Prior to discharge, the water is assessed to ensure it meets all parameters and Baffinland stated that it had been in operation since July and the system was working as designed.

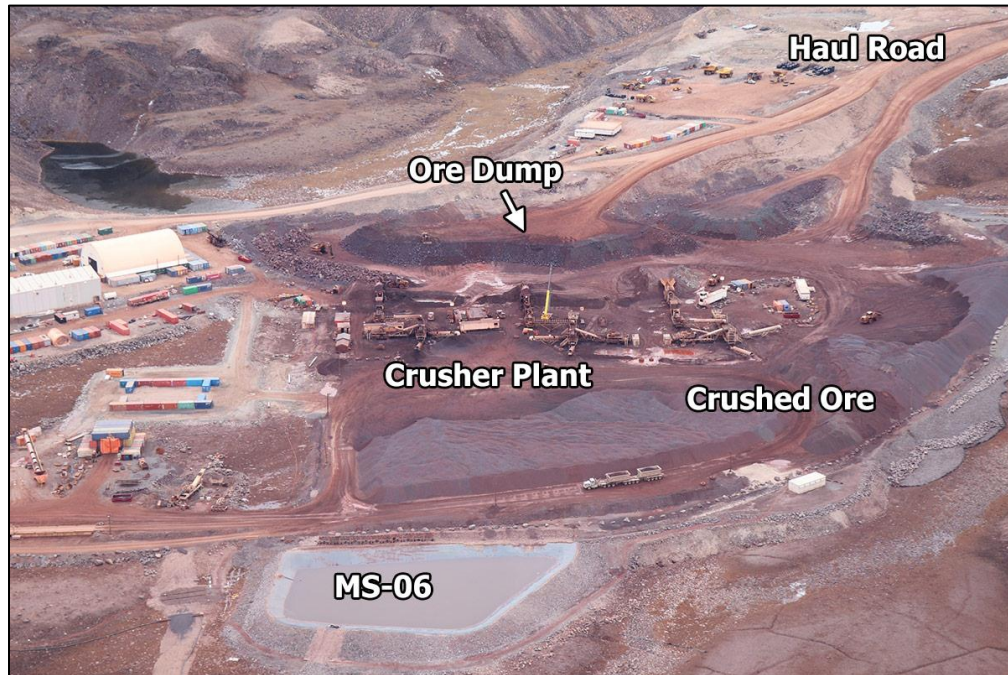
Picture 8: Crusher Plant Area Location

During the 2018 August site visit the Technical Advisor observed that the crushing operations generated minimal to no dust ([Picture 8](#) and [Picture 9](#)); however, materials were water saturated given the recent rain at site. The Technical Advisor noted that the shrouds were still in place on the crusher plant, but no other dust control was being used at the crusher site.

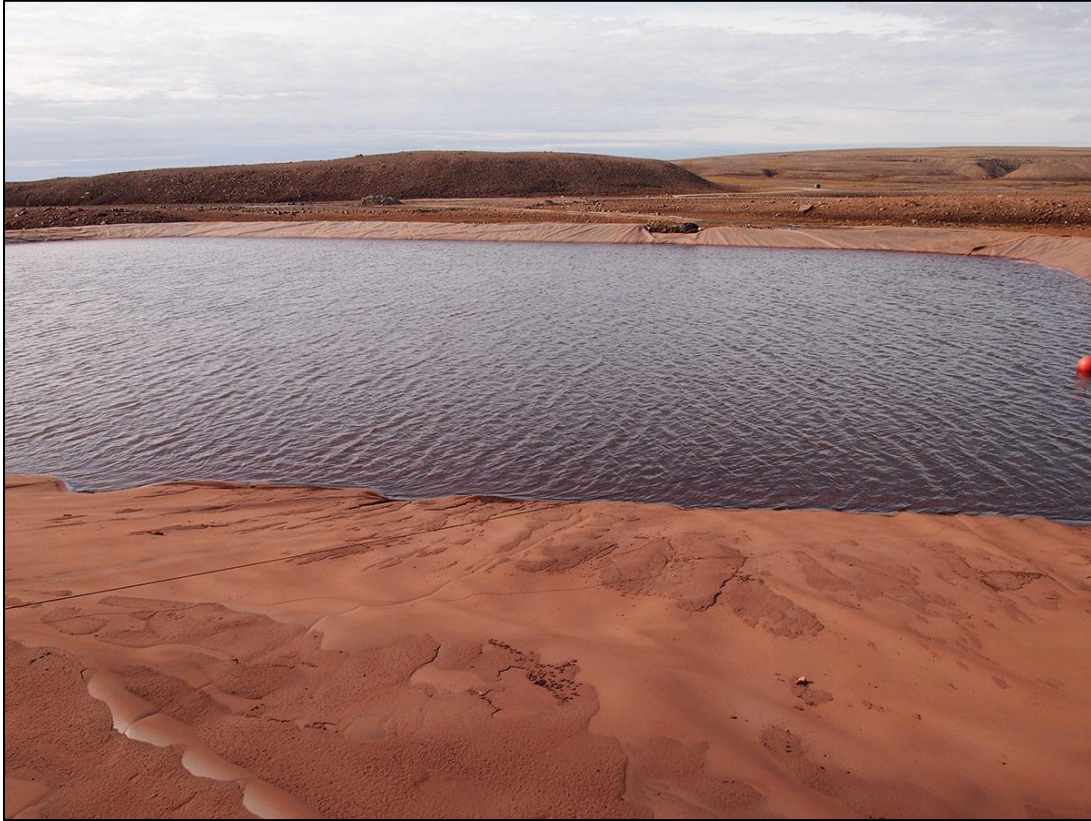
Picture 10: MS-06 Sedimentation Pond (2017)

The MS-06 sedimentation pond ([Picture 10](#)) was approved for expansion and modification prior to the 2018 August Site visit; however, construction had not started and therefore looked the same as the 2017 summer site visit. Baffinland stated that final approvals for the modifications had recently been received and modifications would begin soon.

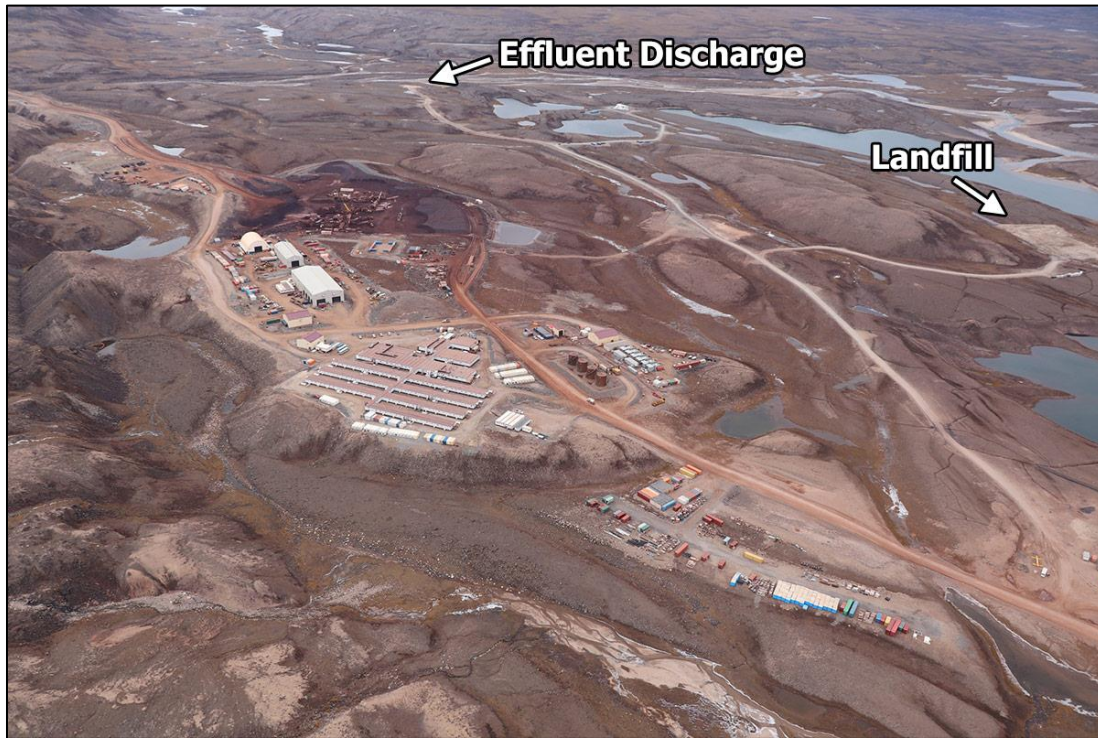
Picture 11: Landfill and Effluent Discharge Locations

In previous visits, the landfill site ([Picture 11](#)) has had issues pertaining to the fencing around the landfill. During the 2016 and March 2017 site visits, it was noted that fencing mesh was removed from the supporting poles and that Baffinland had not replaced and maintained the fencing surrounding the landfill to retain wind-blown debris. Since 2017, the landfill was lacking fencing with only a small section of wooden fencing providing any means of containing wind-blown debris ([Picture 12](#)). No improvement in the fencing in comparison to the April 2018 site visit was observed, but Baffinland indicated mesh fencing was due on sealift and would be installed once it was on site; however, Baffinland staff indicated the fencing would be limited to the north and west sides of the landfill.

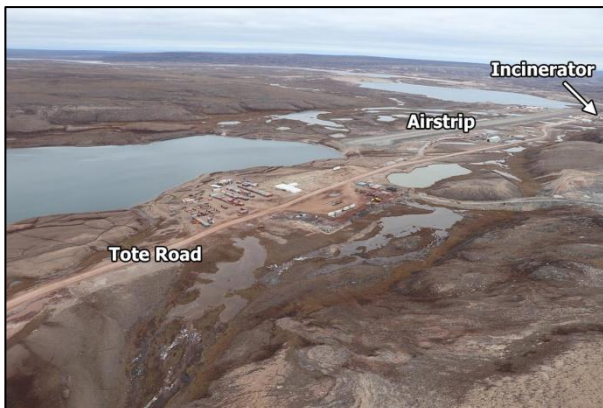
Picture 13: Location of Mary River Incinerator

Based on the previous 2017 site observations and the most recent 2018 site visit, the incinerator at the Mine site continues to be well maintained ([Picture 13](#) and [Picture 14](#)). Baffinland has been able to remove unused scrap materials, tires and synthetic materials currently stored temporarily at various Project locations, including around the immediate vicinity of the incinerator facility to improve the visual quality of the site.

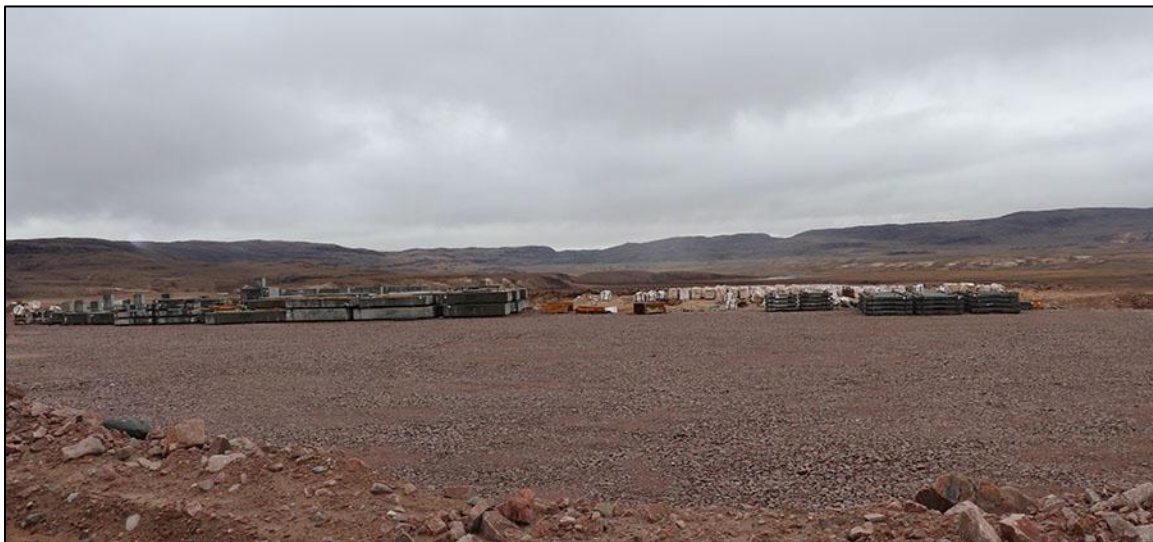
Picture 22: Salt Laydown

In the August 2018 visit, the site had been reorganized and cleaned up, with most of the salt no longer present ([Picture 22](#)). Baffinland personnel indicated the majority of the salt had been used for exploration drilling and the remaining salt was stored appropriately.

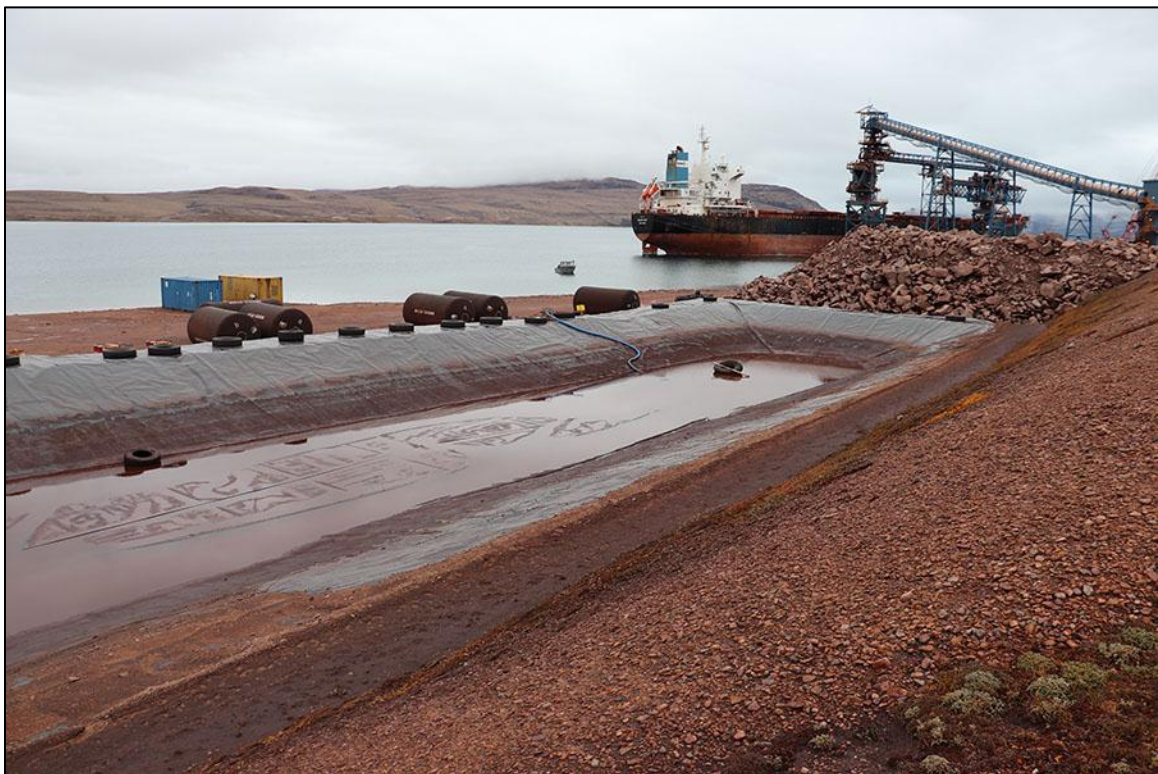
Picture 24: West Sedimentation Pond

It was noted in the August 2017 site visit that the drainage ditches surrounding the stockpile were unlined and that NIRB staff had recommended that armoring be incorporated to prevent slumping of the ditch sides. Although Baffinland did not armor the ditches, they appeared to be functioning with no significant erosion of the sides. The east and west sedimentation ponds ([Picture 24](#) and [Picture 25](#)) also appeared to be in good operating condition with no issues.

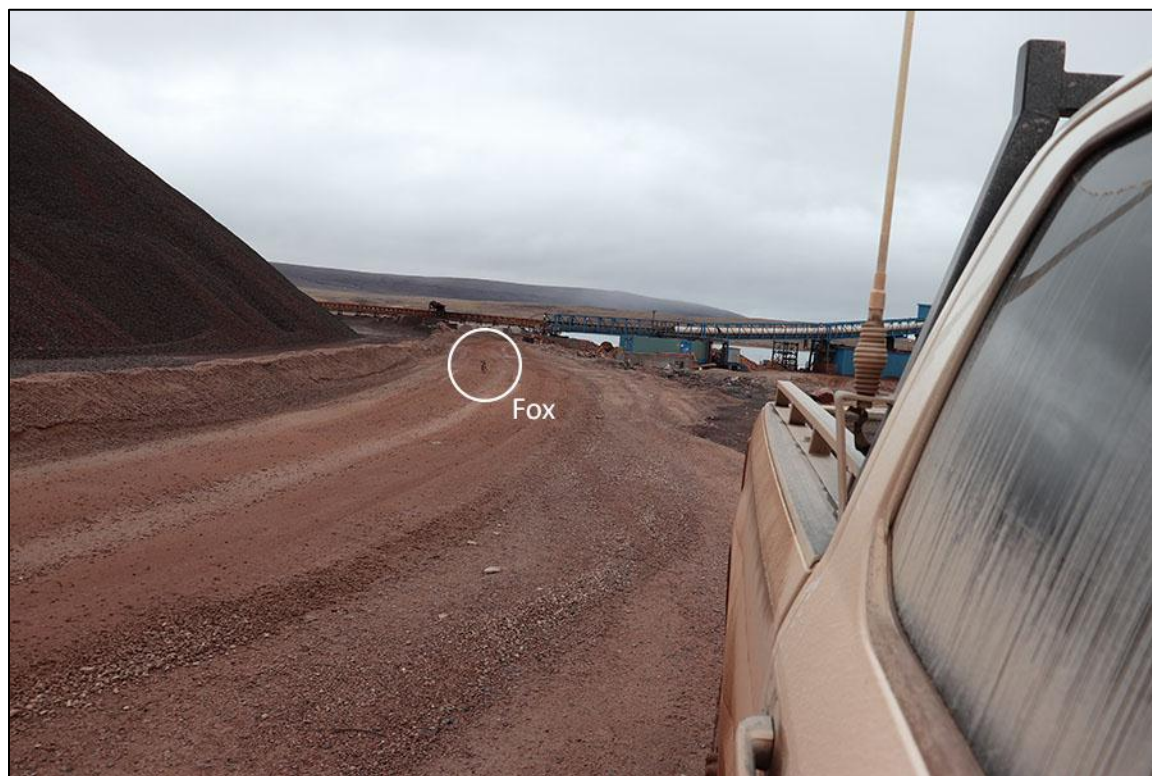
Picture 26: Fox at Port

At the time of the current site visit, three (3) foxes were seen within the project area, two (2) at Milne Inlet—one near the PSC, the other near the ore stockpile (Picture 26) and one (1) at Mary River near the MSC. On the morning of the departure from Mary River, Baffinland staff had received a report of a Polar Bear near the KM 60 Bridge approximately one (1) kilometer from the Tote Road, apparently fishing in the river.
