Site Visit Report

Meadowbank Gold Project (NIRB File No. 03MN107) and ***Whale Tail Pit Project*** (NIRB File No. 16MN056)

Agnico Eagle Mines Ltd.

October 2019

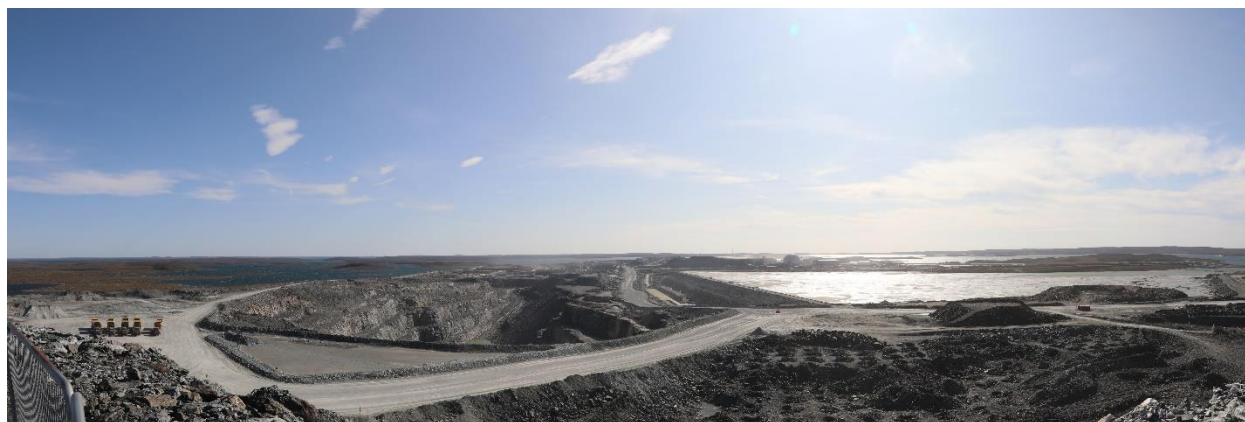
Photo 1: Overview of Meadowbank Mine Site

Supplies are shipped from locations within Canada via sealift to Baker Lake where they are offloaded at Agnico Eagle's marshalling area and transported to the Meadowbank site via truck along the AWAR. See [Photo 1](#) for an overview photo of the Meadowbank Mine Site. [Figure 1](#) through [Figure 3](#) provide a layout of the Meadowbank Mine Site, the Vault Pit Area, and the marshalling facility near Baker Lake.

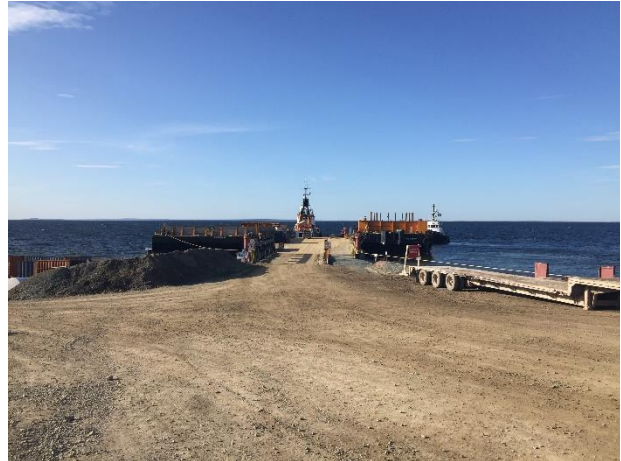
Photo 3: Barge at Baker Lake Facility

- a) The environmental emergency seacan at the barge loading facility contained booms, shovels, absorbent pads, and other miscellaneous spill response equipment (see [Photo 2](#)). At the time of the site visit, a barge was at the Baker Lake dock facility, and offloading equipment and the marshalling facility was very busy with the movement of supplies from the barge (see [Photo 3](#) through [Photo 5](#)).
- b) The lower all-terrain vehicle (ATV) trail that goes through the Baker Lake bulk fuel storage facility/marshalling area was accessible to the community members allowing members to travel to their cabins along the shoreline (see [Photo 6](#)).
- c) Arctic hare were observed at the marshalling facility and within the fuel tank storage facility (see [Photo 7](#)).

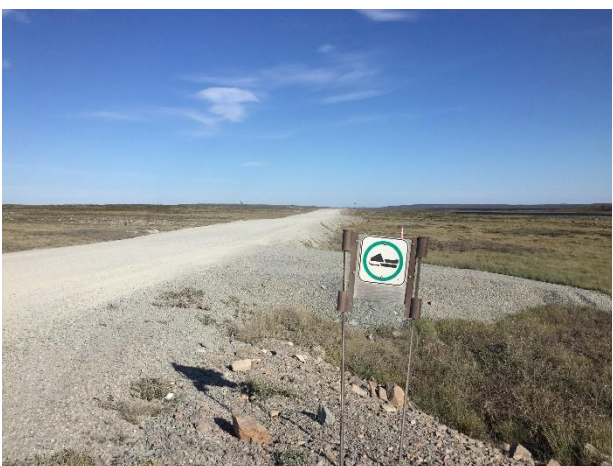
Photo 8: Snowmachine crossing near km 10

- a) Several species of wildlife were observed along the AWAR including geese, sand-hill cranes, Arctic hare, Peregrine Falcon, and siksik (ground squirrel). Agnico Eagle staff stated that caribou, muskox, and wolves were observed occasionally along the AWAR.
- b) At the snowmachine crossings, there were no signs of extreme slopes or rocks along the side of the AWAR (see [Photo 8](#)).
- c) While travelling along the AWAR towards Meadowbank on August 22, the road was not extensively used by Baker Lake community members but was extremely busy with haul trucks traveling from and to the Baker Lake facility (see [Photo 9](#)). On the way back to Baker Lake on August 24, the AWAR much of the traffic consisted of community members.

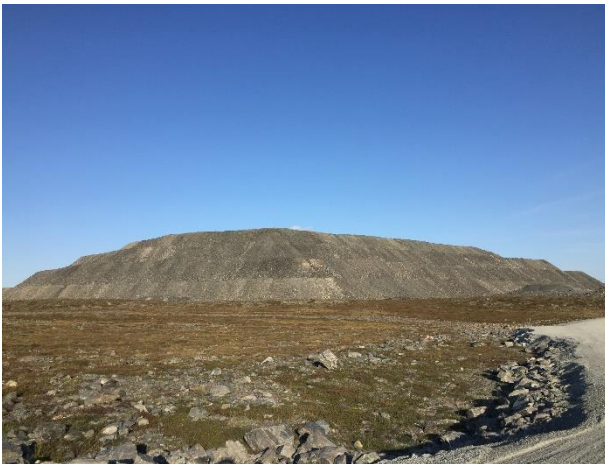
Photo 14: Vault Pit Waste Rock Pile

- a) Active drilling was ongoing at Portage Pit (see [Photo 11](#) and [Photo 12](#)), while mining ended earlier in the year at Vault Pit (see [Photo 13](#) and [Photo 14](#)) and at the Phaser and BB Pits (see [Photo 15](#) and [Photo 16](#)). Mining at the Goose Pit had ended in early 2015 and the pit has been allowed to slowly fill in naturally with water (see [Photo 17](#))
- b) As noted last year, an ice sheet was observed on the walls of the Vault Pit (see [Photo 13](#)) and it continues to be there this year.
- c) During the site visit, tailings were being disposed of into Goose Pit (see [Photo 18](#)) as one of the two (2) in-pit tailings facilities at the time of the site visit.

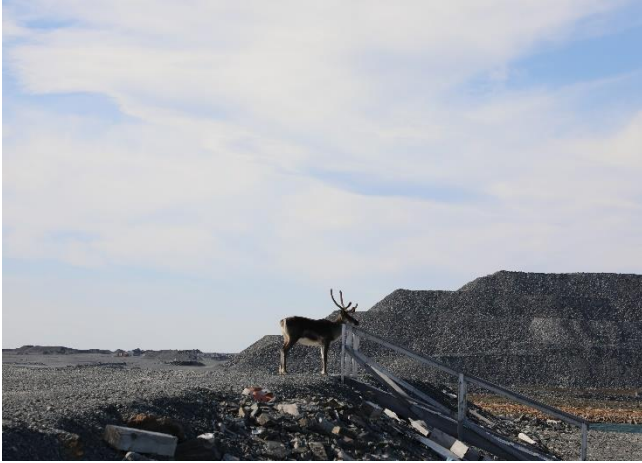
Photo 24: Caribou observed at the Vault Pit area

- i) During the site visit, a caribou was observed near the Vault Pit area (see [Photo 24](#)), while a young Arctic fox was observed at the Meadowbank site (see [Photo 25](#)).

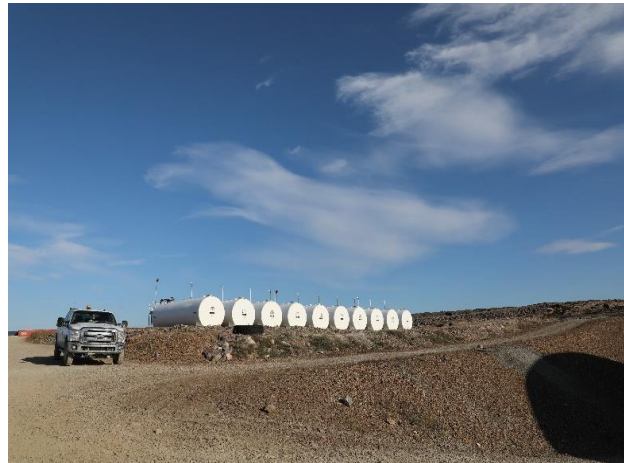
Photo 32: Aviation Fuel Tank Farm

Water was observed within the secondary storage containment facilities for the fuel tank farms but there was no visible sheen on the water or discernable hydrocarbon odours at either the Baker Lake or the Meadowbank site fuel facilities (see [Photo 29](#) to [Photo 32](#)). The liner at the Baker Lake Fuel Storage facility was exposed and it was noted by Agnico Eagle staff that this may be due to the amount of rainfall over the summer that washed away the gravel that usually covers the liner. No indication was provided on whether or not the liner would be fixed or covered with gravel.

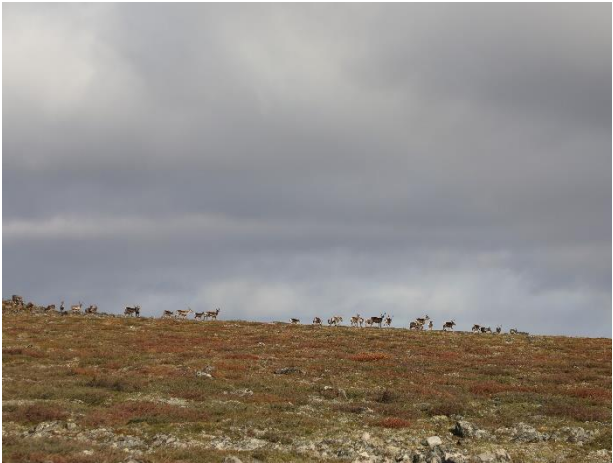
Photo 34: Caribou herd along the Haul-road

- a) During the site visit, the Haul-road to the Whale Tail site was closed to all traffic (except essential traffic) as caribou were migrating through the area between km 150 and km 175 with the majority of the caribou located on the eastern side of the road. NIRB staff joined

the Environmental Supervisor to conduct the site visit along the Haul-road and at Whale Tail Pit as the Environmental Supervisor needed to conduct monitoring of the caribou along the road (see [Photo 34](#) and [Photo 35](#)).

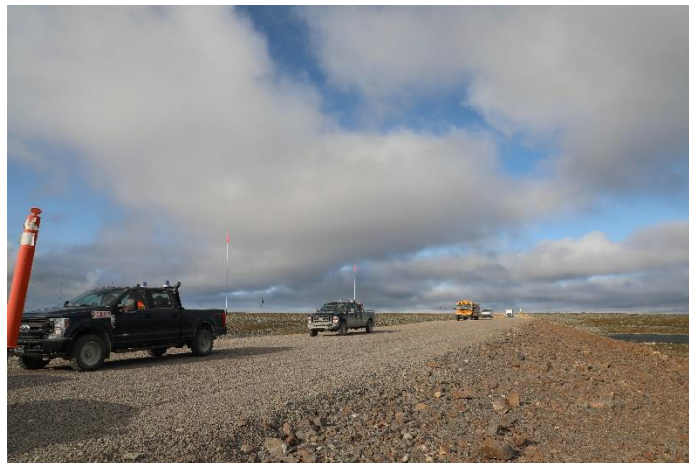
Photo 36: View of convoy travelling along the Amaruq Haul-road

- b) While travelling along the road, a convoy of essential vehicles was travelling from the Whale Tail site to the Meadowbank Mine site. The convoy is always escorted by the Environment Department and it was observed that the convoy consisted of three (3) trucks (Environment Department truck, and two (2) trucks that were being returned to Meadowbank), one (1) bus (containing employees going home for the shift change), and a food truck (see [Photo 36](#)).

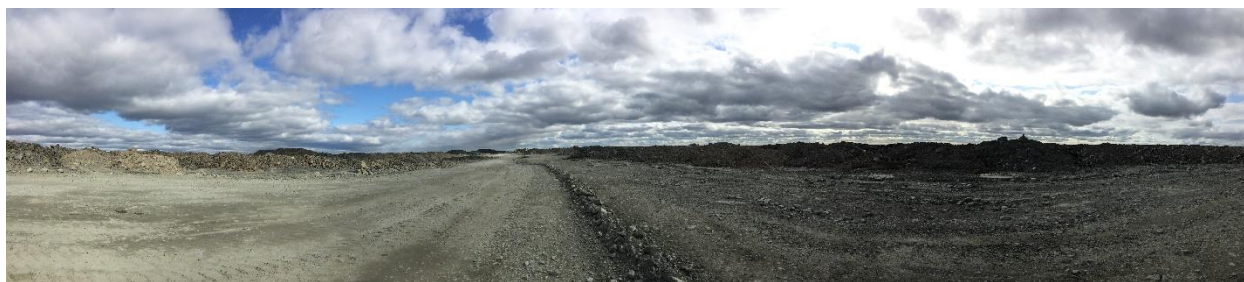
Photo 40: Overview of the Whale Tail Pit Site

- a) The Whale Tail site was extremely active with drilling occurring at the North Basin and the site moving into full operations (see [Photo 40](#) through [Photo 44](#)).
- b) Exploration activities were also ongoing with haul trucks moving rock and ore from the underground via the portal (see [Photo 45](#) and [Photo 46](#)).
