Report Title: The Nunavut Impact Review Board’s 2019 Site Visit Report for Agnico Eagle Mines Limited’s *Meliadine Gold Mine Project* (NIRB File No. 11MN034)

Project: Meliadine Gold Mine Project
Project Location: Kivalliq Region, Nunavut
Land Tenure: Inuit Owned Land

Site visit date: August 20, 2019
Last site visit: August 17, 2018

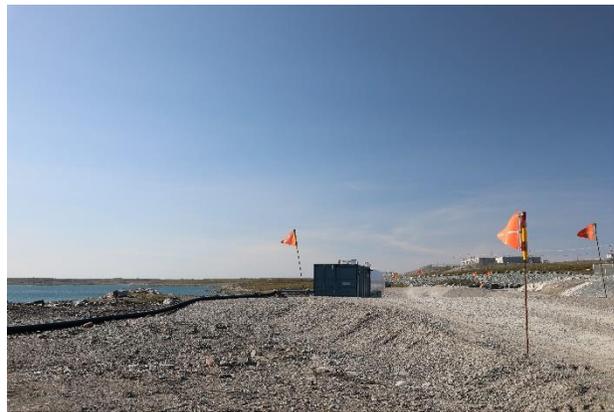
- c) It was observed that the signage on the seacan wall was updated and clearly noted to the community the public dock access and the Agnico Eagle barge area (see [Photo 5](#)).
- d) The Saline Water Discharge tank was installed at the Itivia site and appeared to be in working condition (see [Photo 6](#)).
- e) The snowmobile crossing within Agnico Eagle’s Itivia area was also inspected and appeared to be in good repair.
- f) Overall the area appeared to be maintained in good order; however, debris was observed around the Itivia site.

Photo 6: Saline Water Discharge tank

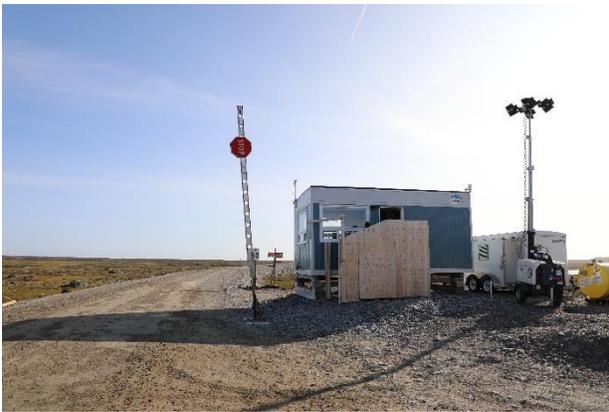
Photo 10. Gatehouse closest to the community of Rankin.

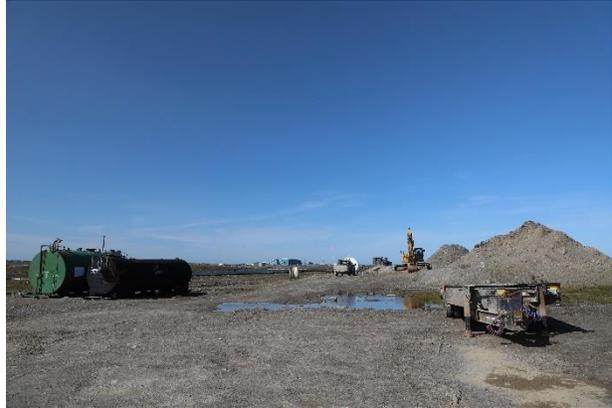
- f) The site visit also included the exploration/temporary fuel tank storage farm and temporary landfarm as following the 2017 site visit, Agnico Eagle noted that both locations would be decommissioned in the summer of 2018. During the current site visit, decommissioning work on the temporary fuel tank farm and temporary landfarm had not started and Agnico Eagle staff stated that remediation of the site had not commenced (see [Photo 27](#)).

Photo 28: Temporary landfarm

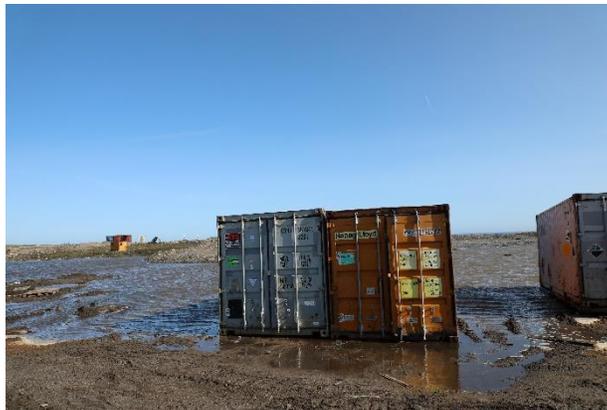
- h) Overall, the Meliadine mine site area appeared to be maintained in good order; however debris including windblown material was observed around the site (see [Photo 32](#) and [Photo 33](#)).

Photo 34: Seacans and debris observed in water

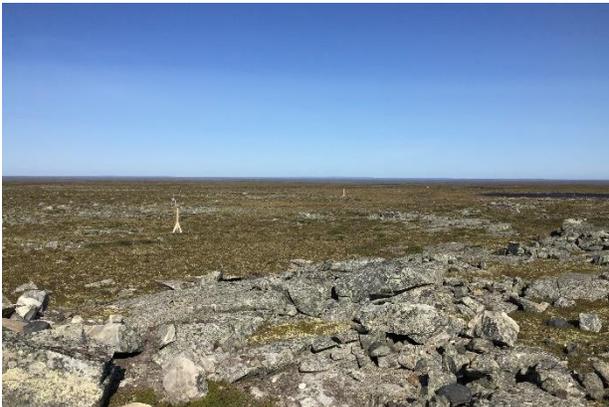
Agnico Eagle staff noted that it continues to apply TETRA flakes (calcium chloride) along the AWAR and that dust monitoring continues to be conducted along multiple stations along the AWAR (see [Photo 35](#)). In response to questioning by NIRB staff, Agnico Eagle noted that the trial using new dust suppressants on a portion of the AWAR in 2018 were not effective and the plan is to continue to use calcium chloride as a dust suppressant.

Photo 35: Dust Sampling Station along the AWAR
