NT-NU SPILL REPORT

Re: Follow-up to Spill #18-148
Mary River Project - Water Licence No. 2AM-MRY1325

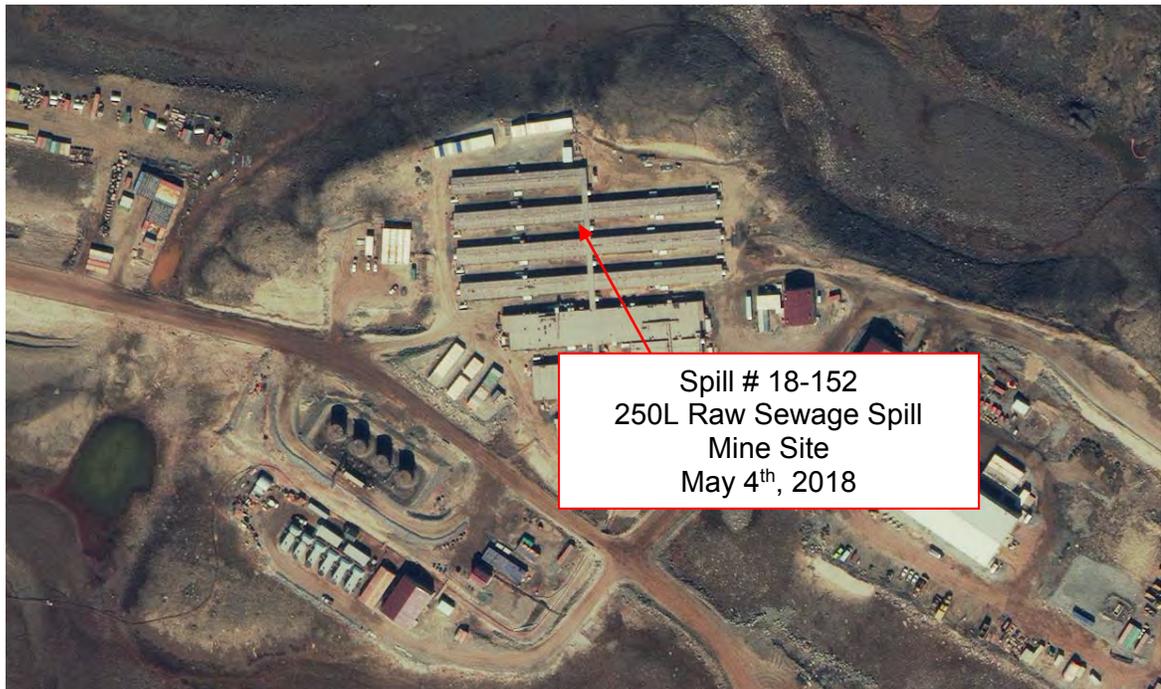
Figure 1. Map of spill location

On May 4th, 2018, 20:00 Hrs, an Environment Department employee observed discoloured water near Lift Station 5 at AE Wing North. It was determined to be sewage upon inspection. Housing Maintenance and Surface Works Supervision was notified immediately. The source of the spill was an overflow of lift station 5. The lift station was being discharged through a regular vacuum truck schedule however due to an error in the implementation of this schedule the overflow occurred. Communications and associated vacuum truck scheduling procedures are being revised to prevent an overflow reoccurrence. Approximately 250 Litres impacted the adjacent MSC pad to the lift station migrating over an area of approx. 15m². The spill is >100 m from the nearest water body which is currently frozen.

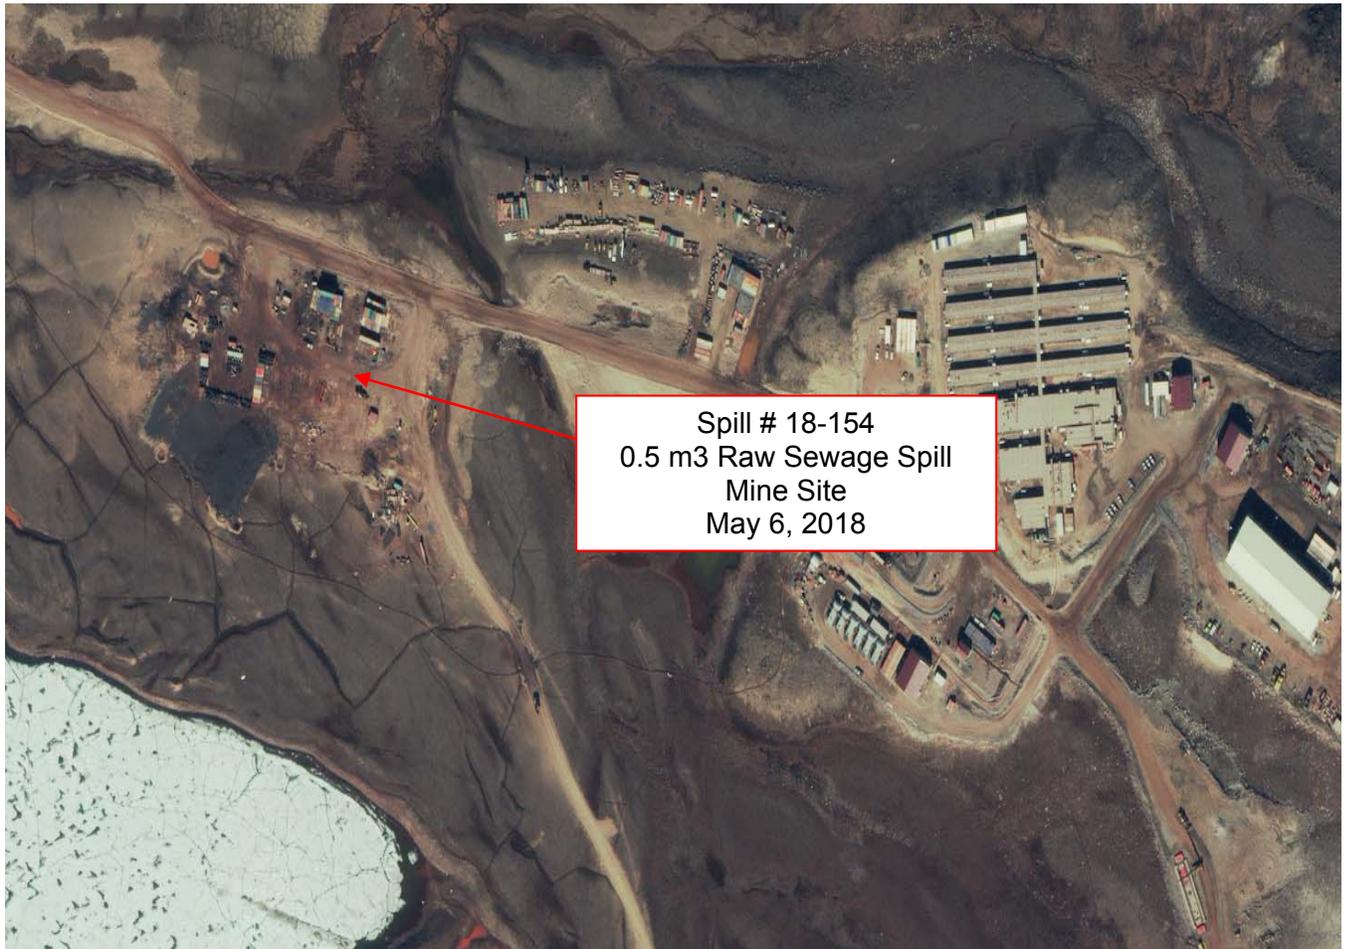
Figure 1. Map of spill location

On May 5, 2018 at 11:00 Hrs a vac truck operator was approaching the new wastewater treatment plant (WWTP) at the Mine Site and observed liquid leaking from the effluent tank door. Upon investigation, it was determined that the effluent tank had overflowed and approximately 0.5m³ of treated effluent was released to the WWTP pad, impacting an area of approximately 10m². Communications and associated vacuum truck scheduling procedures are being revised to prevent an overflow reoccurrence. The location is >100m to the nearest water course which was frozen.

It was recommended that a Standard Operating Procedure (SOP) be implemented to define operational check and balances of the plant while ensuring all communication and responsibility requirements of an operating WWTP and discharge system are clearly outlined. An audio alarm system was recommended for installation to warn of high tank levels

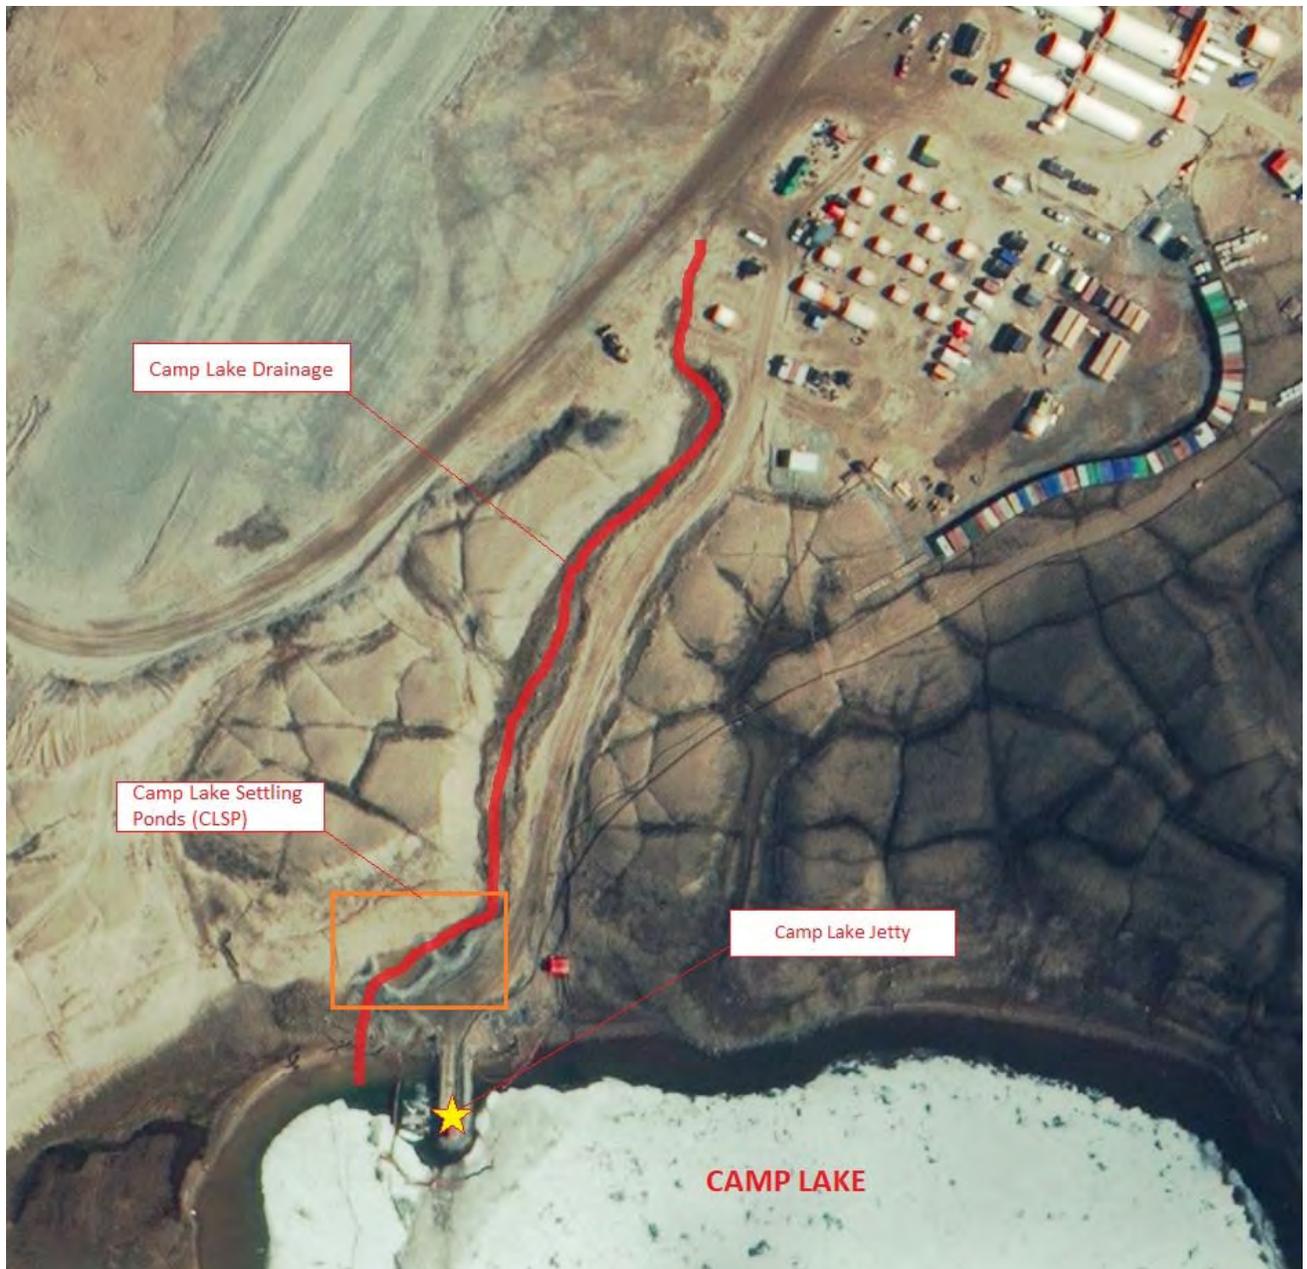
Figure 1 – Overview map of sediment release location

At approximately 13:00 HRS on May 16th, 2018, during the execution of the daily freshet monitoring program at the Mary River Mine Site, environmental technicians observed sediment-laden water to be breaching the series of sediment ponds/check dams that have been constructed along the Camp Lake Jetty access road. Elevated levels of suspended solids were observed from sediment impacted snow melt which mobilized due to the overland flow. In addition to the implementation of erosion and sediment control measures, water quality sampling was conducted of water entering Camp Lake.

Continued monitoring during freshet conditions and routine maintenance of check dams and settling ponds (i.e. excavation of material) on an as-needed basis.
