Geotechnical Investigation

Project Name
Geotechnical Investigation, Airside Surface Rehabilitation
Aggregate Search and Airside Surfaces Assessment,
Whale Cove Airport, Whale Cove, Nunavut

Project Number
OTT-00249103-A0

Date Submitted
January 16, 2019

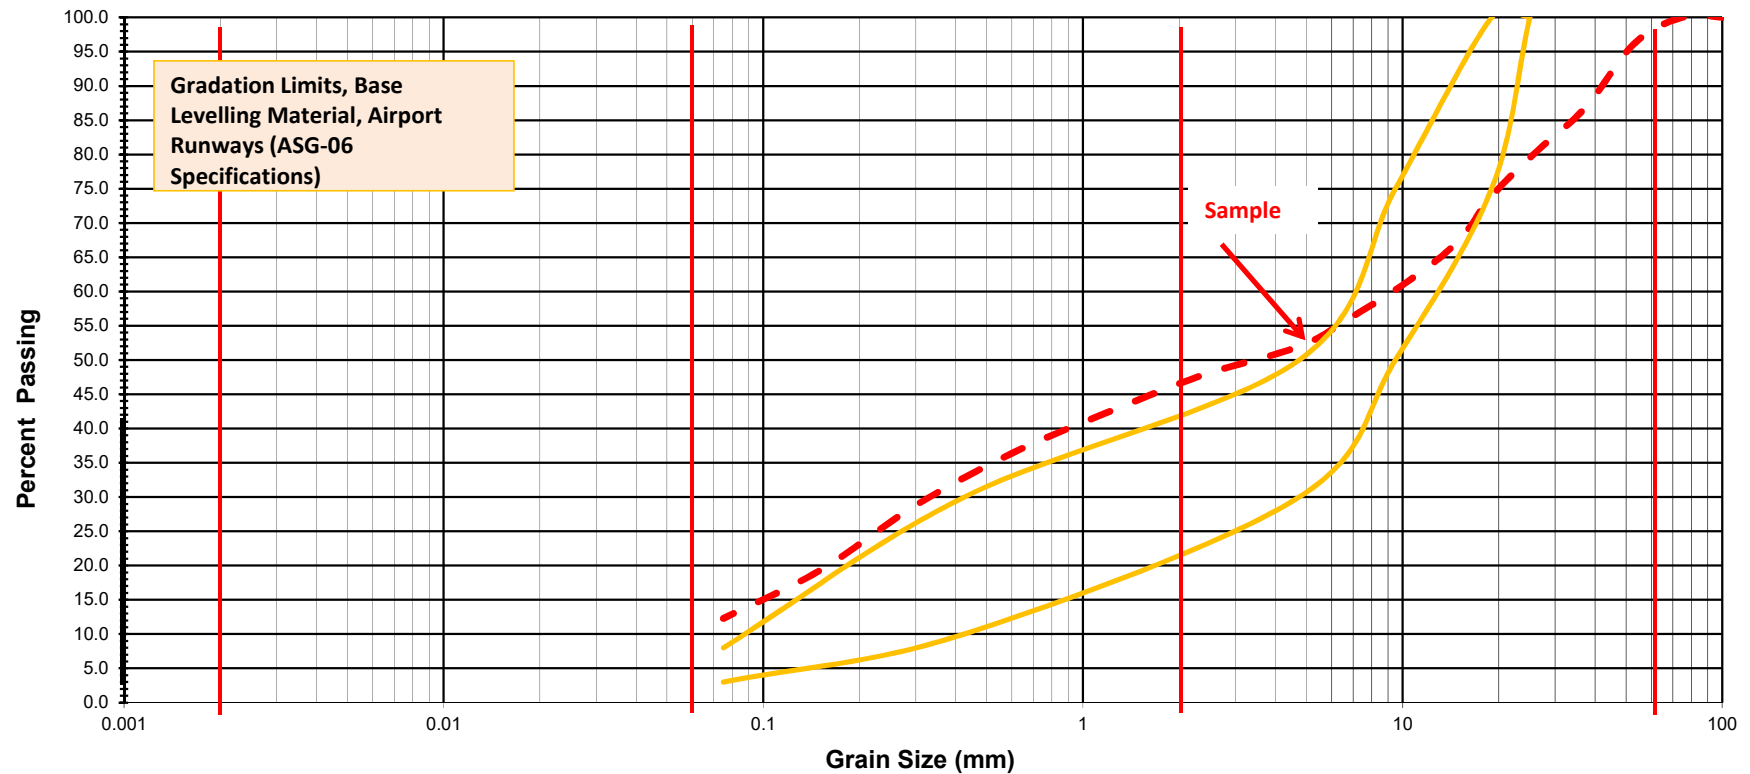
Exp Project No.:	OTT-00249103-A0	Project Name :	Airside Surfaces Rehabilitation, Condition Assessment & Aggregate Search						
Client :	Government of Nunavut	Project Location :	Whale Cove Airport, Hamlet of Whale Cove, Nunavut						
Date Sampled :	October 1, 2018	Source:	Quarry Test Pit #1	% Crushed	66	Plasticity Index:	Not Plastic		
Sample Description :	Gravelly Sand, Some Silt						Figure :	4

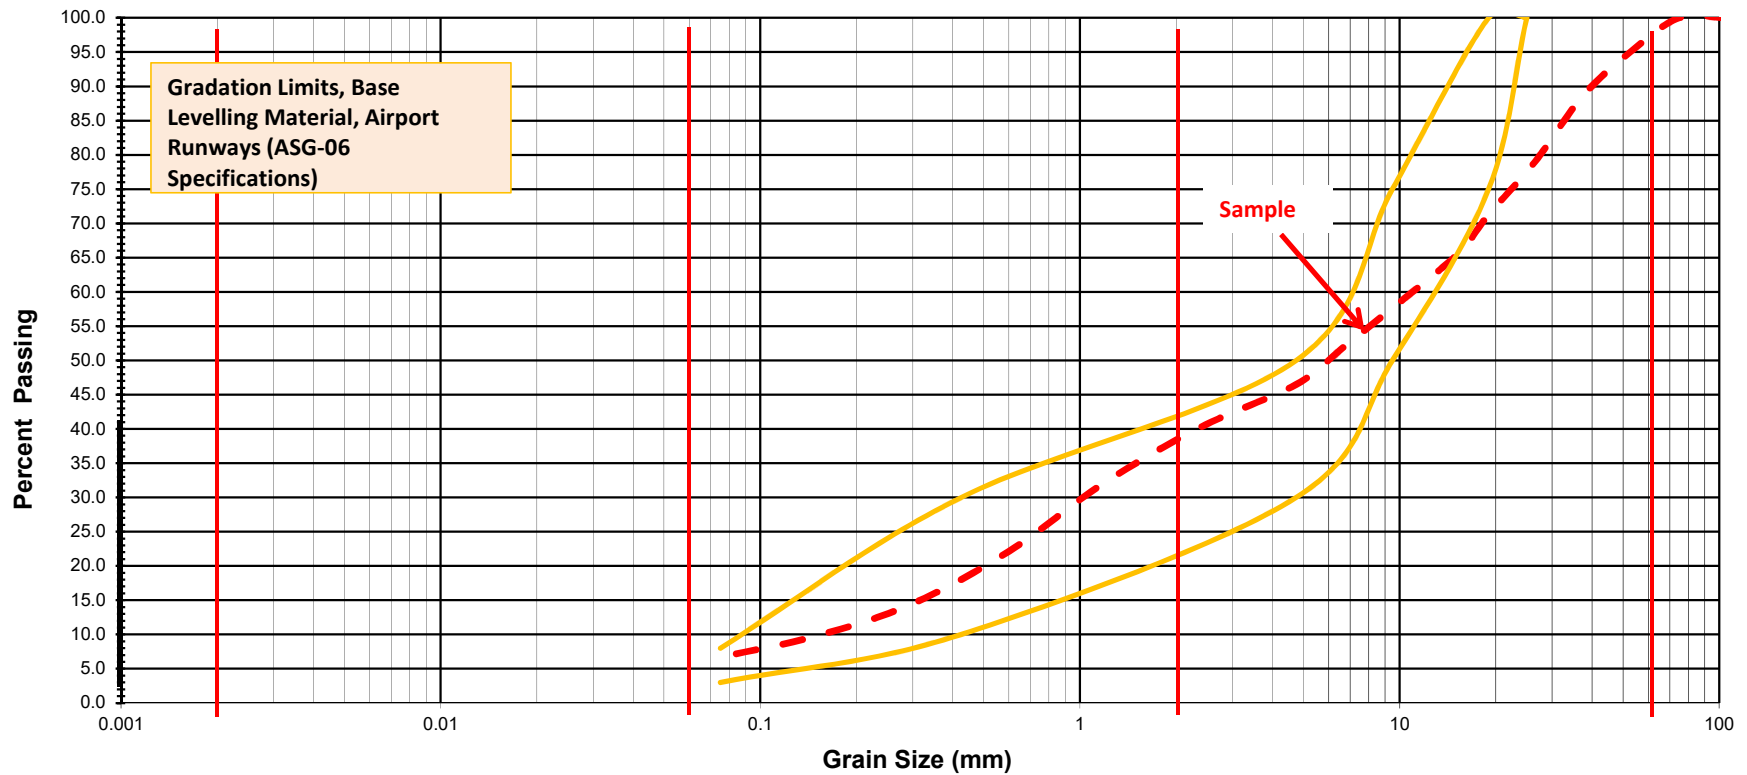
The surface deposit at this location is sand and gravel with cobbles, which extends to the entire depth investigated, i.e. 1 m (Photos A3 and A4). A grain-size analysis performed on sample of the material finer than 100 mm yielded a composition of 7 percent clay and silt, 38 percent sand and 55 percent gravel. (Figure 5). This material has 43 percent crushed particles.

Exp Project No.:	OTT-00249103-A0	Project Name :	Airside Surfaces Rehabilitation, Condition Assessment & Aggregate Search						
Client :	Government of Nunavut	Project Location :	Whale Cove Airport, Hamlet of Whale Cove, Nunavut						
Date Sampled :	October 1, 2018	Source:	Quarry Test Pit #2	% Crushed	43.2	Plasticity Index:	Not Plastic		
Sample Description :	Sandy Gravel, Trace Silt						Figure :	5

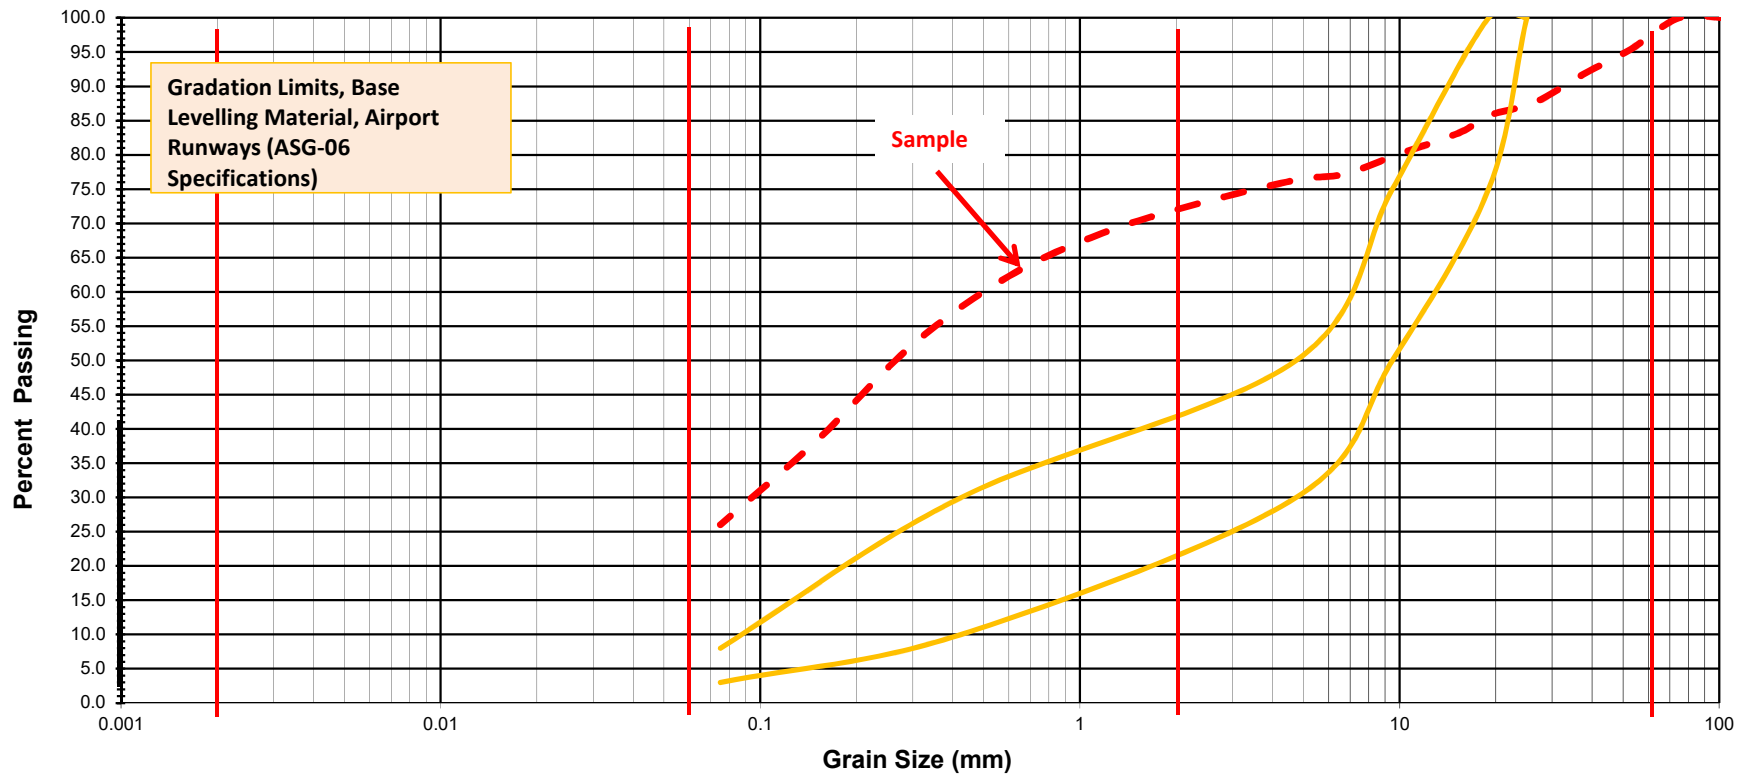
Exp Project No.:	OTT-00249103-A0	Project Name :	Airside Surfaces Rehabilitation, Condition Assessment & Aggregate Search			
Client :	Government of Nunavut	Project Location :	Whale Cove Airport, Hamlet of Whale Cove , NU			
Date Sampled :	October 1, 2018	Source:	Quarry Test Pit #3	% Crushed	79	Plasticity Index: Not Plastic
Sample Description :	Silty Gravelly Sand					Figure : 6

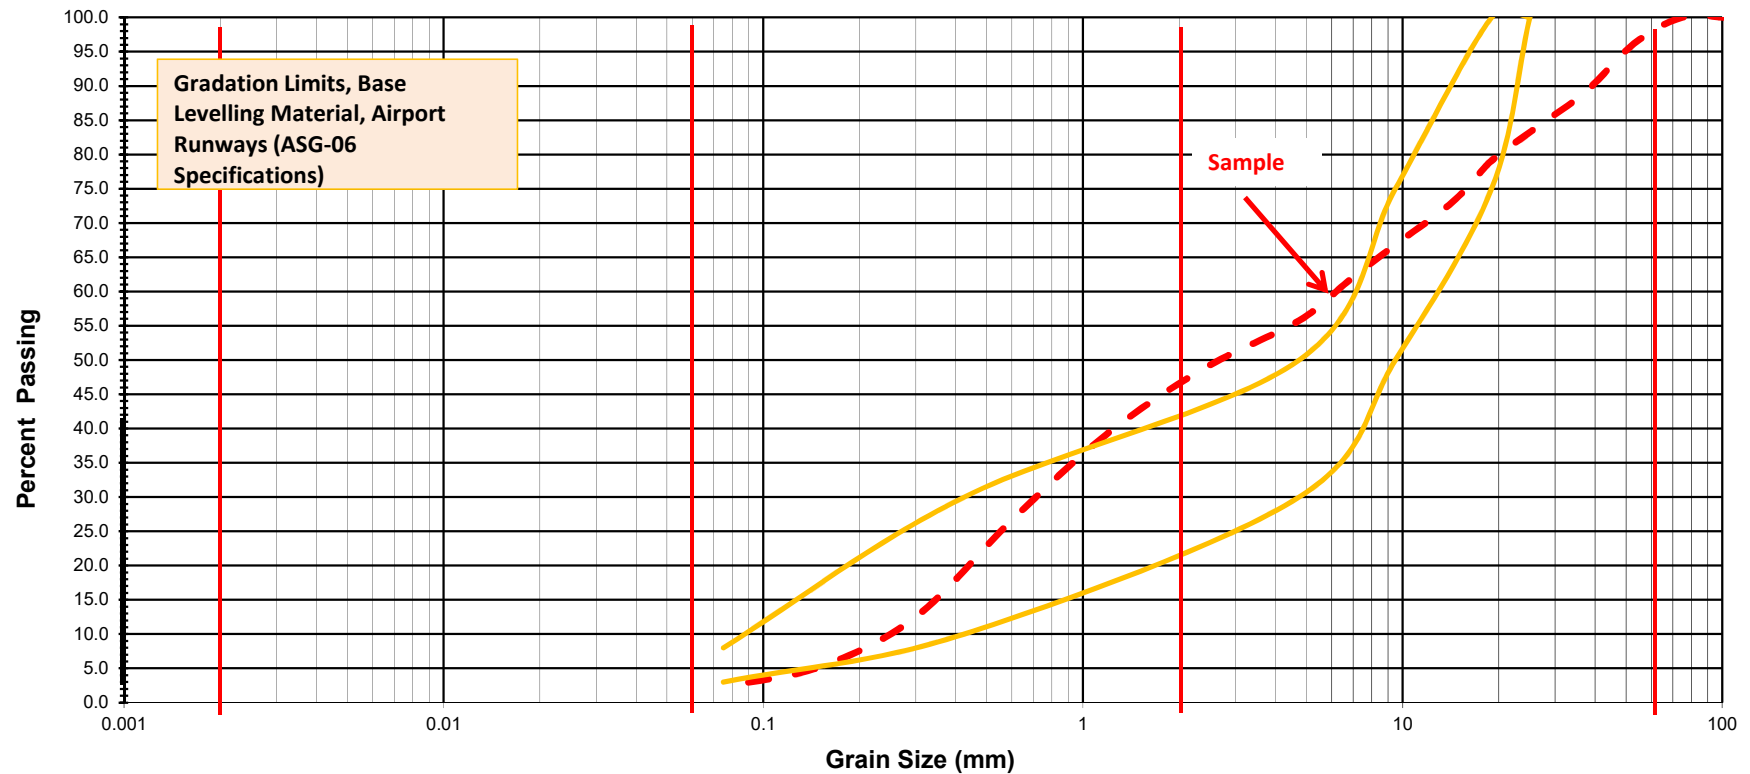
Exp Project No.:	OTT-00249103-A0	Project Name :	Airside Surfaces Rehabilitation, Condition Assessment & Aggregate Search			
Client :	Government of Nunavut	Project Location :	Whale Cove Airport, Hamlet of Whale Cove, Nunavut			
Date Sampled :	October 1, 2018	Source:	Quarry Test Pit #4	% Crushed	70.1	Plasticity Index: Not Plastic
Sample Description :	Sandy Gravel, Trace Silt					Figure : 7

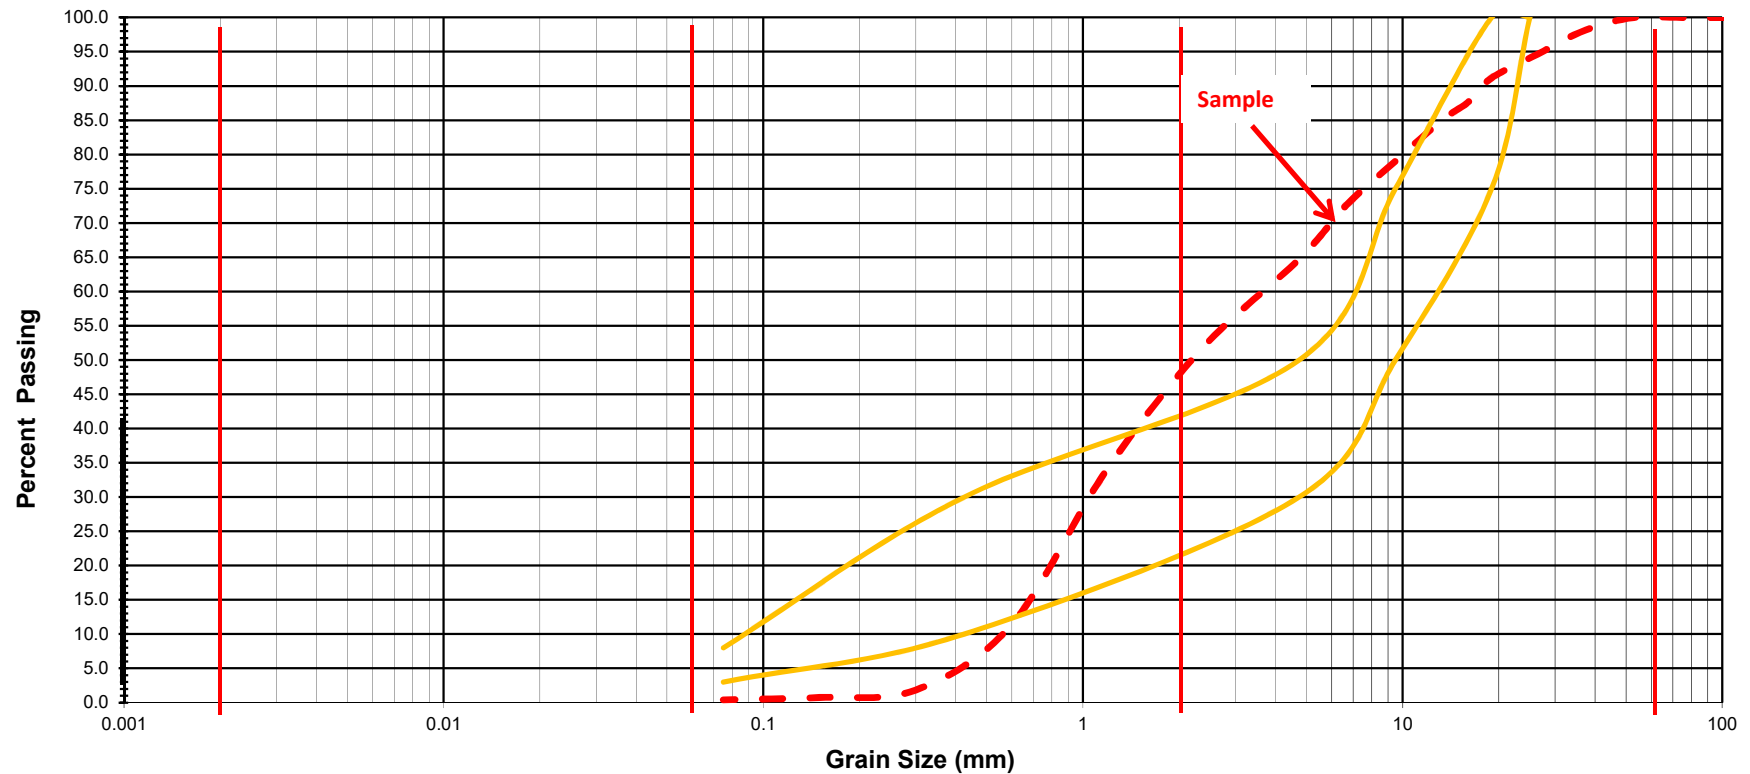
This test pit revealed that the site contains sand and gravel with cobbles and boulders, which extends to the entire depth investigating 1.0 m (Photos A9 and A10). A grain-size analysis performed on this material yielded a soil composition of 0 percent clay and silt, 63 percent sand and 37 percent gravel (Figure 8). It contains 63 percent crushed particles.

Exp Project No.:	OTT-00249103-A0	Project Name :	Airside Surfaces Rehabilitation, Condition Assessment & Aggregate Search						
Client :	Government of Nunavut	Project Location :	Whale Cove Airport, Hamlet of Whale Cove, Nunavut						
Date Sampled :	October 1, 2018	Source:	Quarry Test Pit #5	% Crushed	62.6	Plasticity Index:	Not Plastic		
Sample Description :							Figure :	8

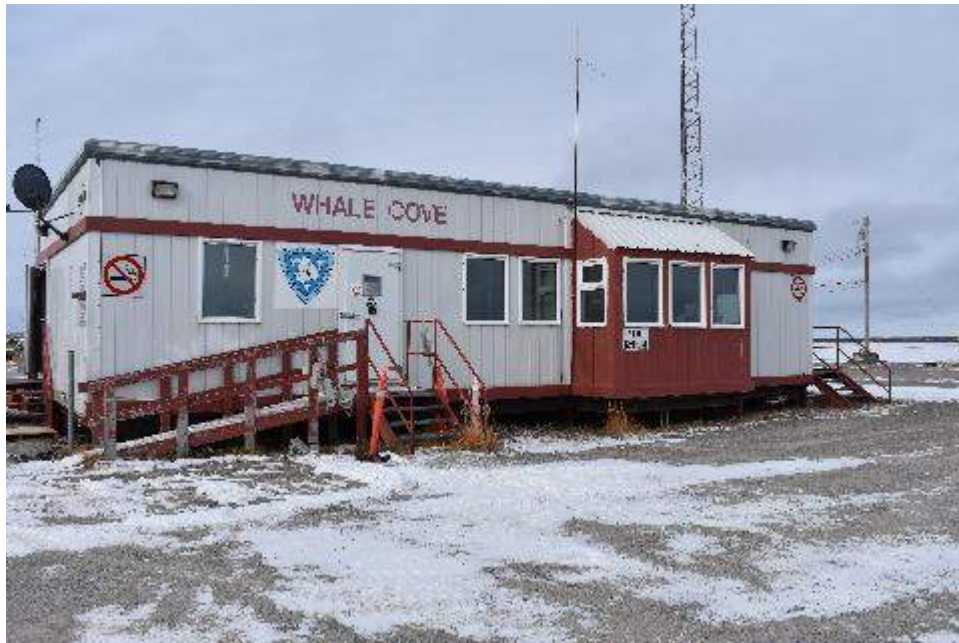
Photograph No. B1
Whale Cove Air Terminal looking northwest

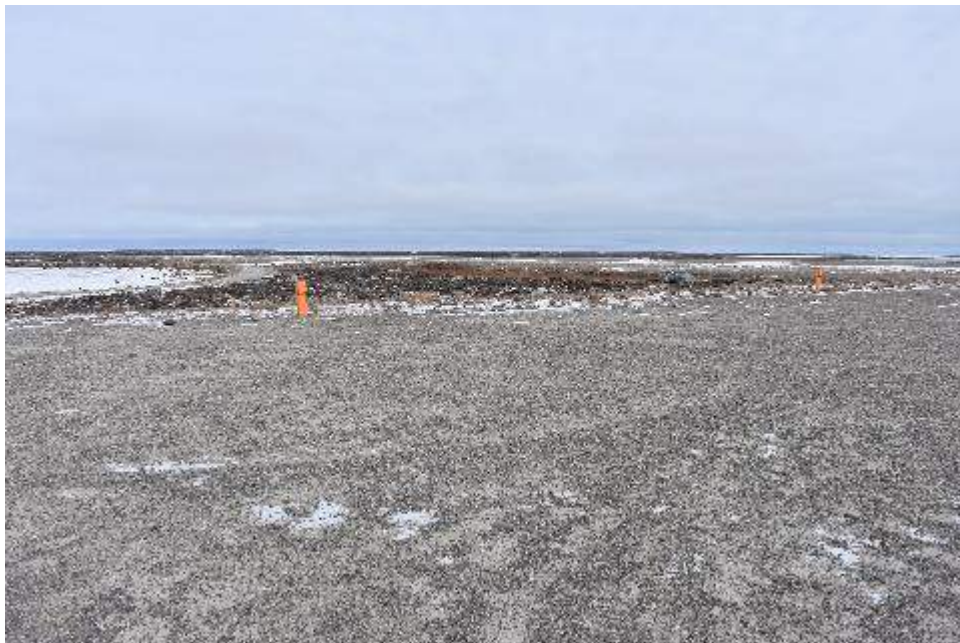
Photograph No. B4
Plug in points on the north side of the apron, looking northeast

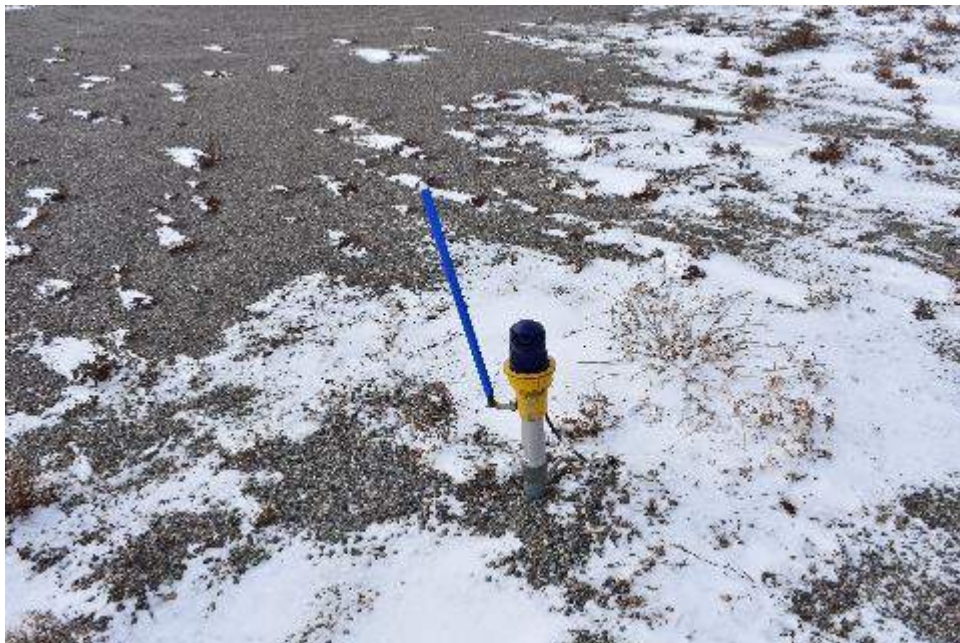
Photograph No. B6
Apron lights in good condition with snow markers attached, looking northeast

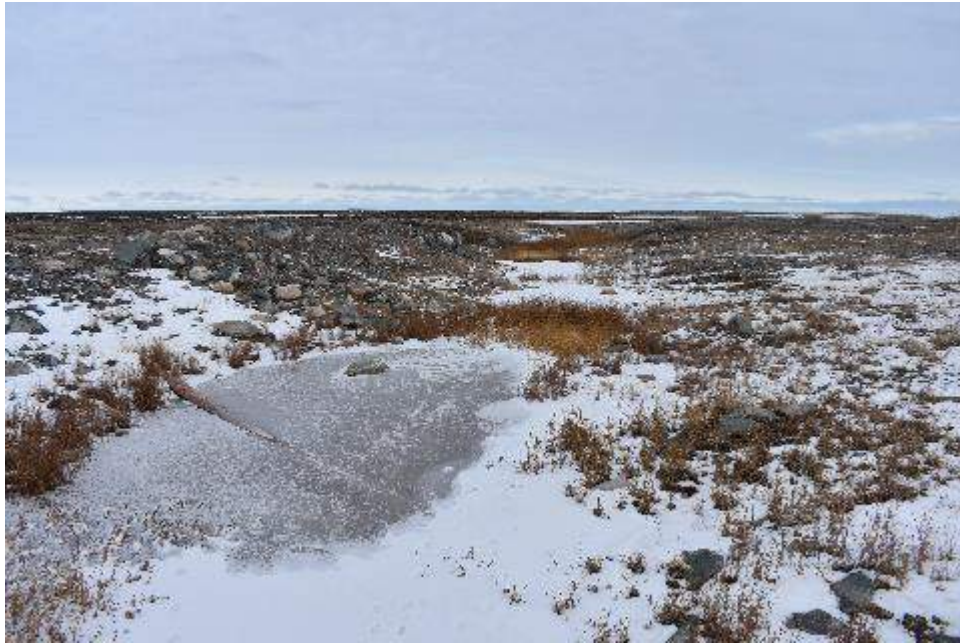
Photograph No. B15
Ditch flowing east around the north end of the runway, looking east

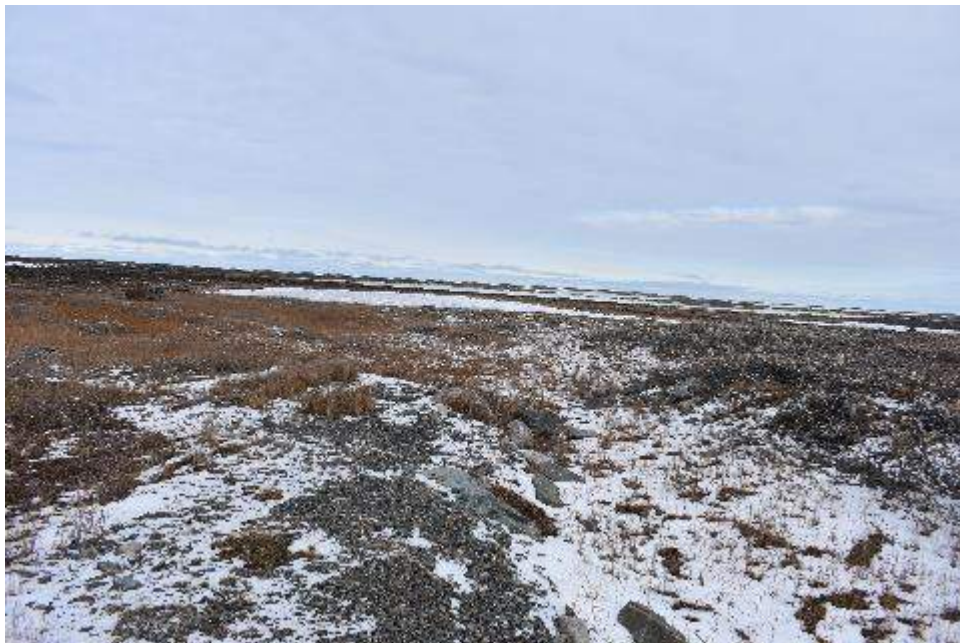
Photograph No. B16
Ditch flowing east to the ponds northeast of the runway, looking east
