Nunavut Impact Review Board

2020 Site Update Report

Meadowbank Gold Mine Project (NIRB File No. 03MN107) & *Whale Tail Pit Project* (NIRB File No. 16MN056)

Agnico Eagle Mines Limited

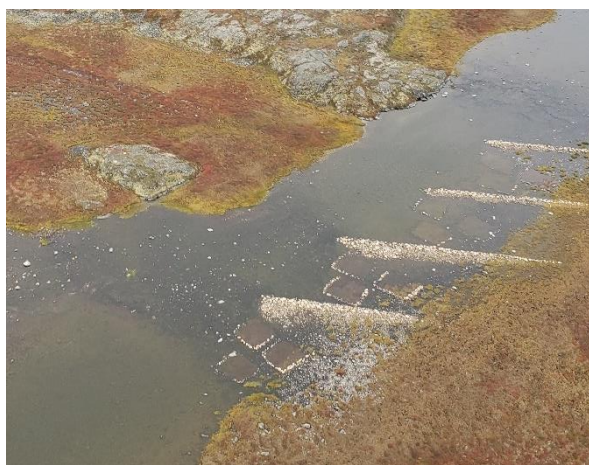
Photo 11: Spawning Pad

- a) Seacans with emergency spill response equipment are located at every bridge crossing (Photo 10).
- b) The spawning habitat rock structure located at the first bridge (Photo 11) was monitored in 2019 (see *2019 Annual Report*) with the next monitoring campaign planned for 2021.

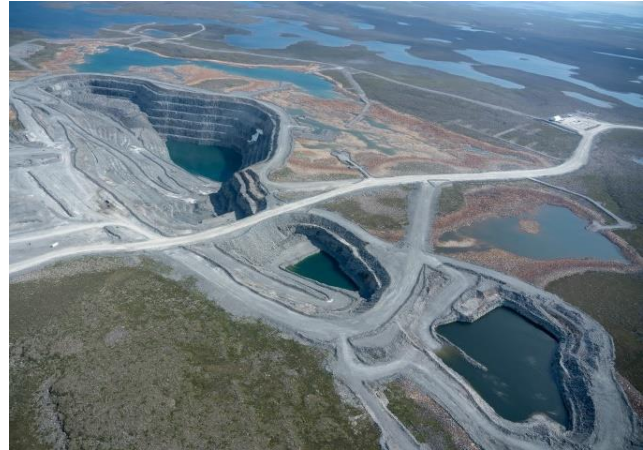
Photo 15: Vault, Phaser and BB Phaser Pits

- a) Active mining was completed at all pits by the end of fourth quarter in 2019. Some residual stockpiles are still being processed at the mill.
- b) Mining completed in Vault Pit in March 2019. As observed in previous years, an ice sheet had formed on the walls of the Vault Pit and remains present in 2020 (Photo 14 and Photo 15).

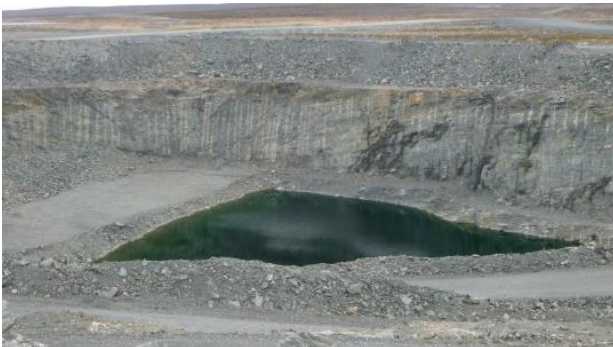
Photo 16: Phaser Pit

- c) Phaser Pit and BB Phaser Pit in October 2018 and June 2019, respectively, and are now naturally reflooding (Photo 16, Photo 17, and Photo 17).

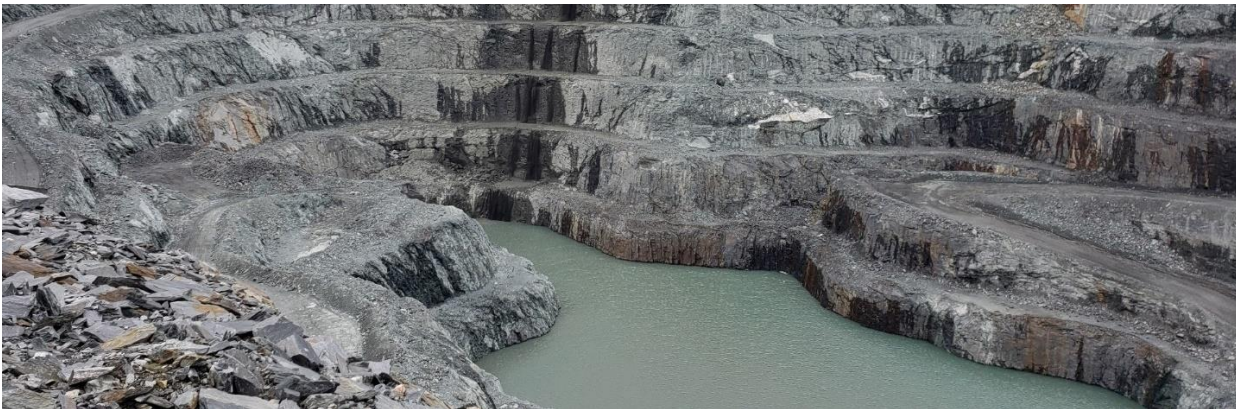
Photo 20: Portage Pit E Tailings Deposition

- e) Mining at Portage Pit A was completed in March 2018, and Portage Pit E in October 2019 (Photo 19). Tailings Deposition started in Portage Pit E in 2020 (Photo 20).

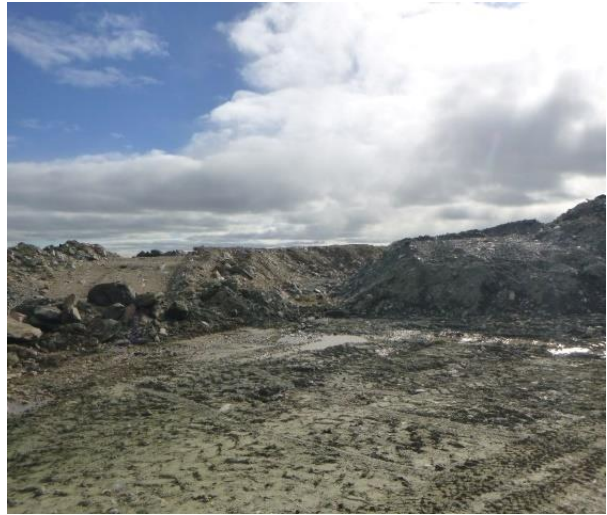
Photo 23: Landfarm 2

- g) The original landfarm, developed in 2013 and located next to the South Cell Tailings Facility, was flooded with tailings in 2017 (Photo 22). The second landfarm located to the east of landfarm 1, remains in use (Photo 23).

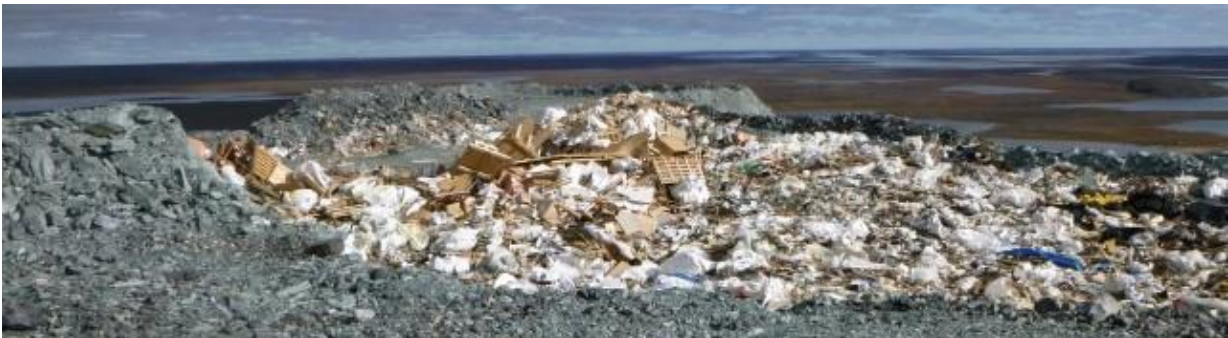
Photo 24: Landfill

- h) The Meadowbank landfill continues to be in operation ([Photo 24](#) and Photo 25) and is extending into a new area at the base of the Waste Rock Storage Facility. Previously used landfills are progressively capped (Photo 25).

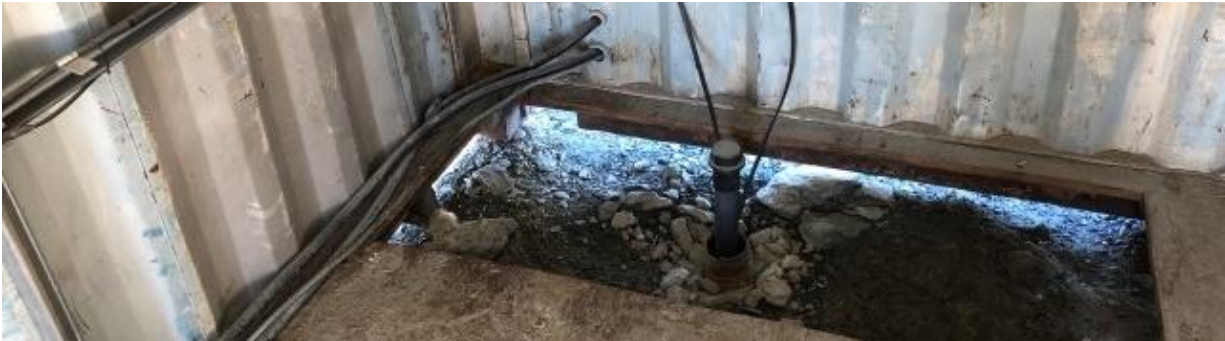
Photo 33: Groundwater Monitoring Well MW-IPD-07

Agnico Eagle confirmed that five (5) groundwater monitoring wells continue to be operational at site: MW-16-01, MW-IPD-01 (s), MW-IPD-01 (d), MW-IPD-07 (Photo 33) MW-IPD-07 2020-08-24), and MW-IPD-09. The 2020 groundwater sampling campaign was planned for September.

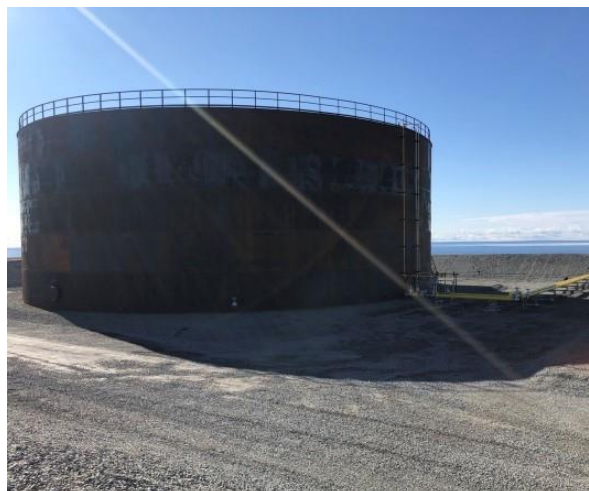
Photo 39: New Fuel Tank at Baker Lake Marshalling Facility

At the Baker Lake Marshalling Facility there is a total of 18 Jet-A tanks still in use (Photo 38). A new fuel tank (Fuel Tank 7; Photo 39) was constructed in 2019 at this facility.

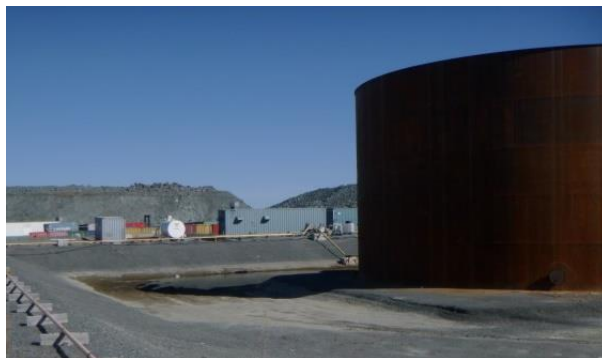
Photo 41: Water in Secondary Containment

During their 2019 site visit NIRB staff noted that the liner at the Baker Lake Fuel Storage facility was exposed and Agnico Eagle informed the NIRB that it continues to be exposed in 2020 (Photo 40). Agnico Eagle noted no liner is seen exposed at the Meadowbank Tank Farm. As with 2019, water pooled within the secondary containment facility at the Meadowbank fuel tank farm in 2020 (Photo 41). This water is discharged towards the Stormwater Management Pond which is then directed to the Tailings Storage Facility.

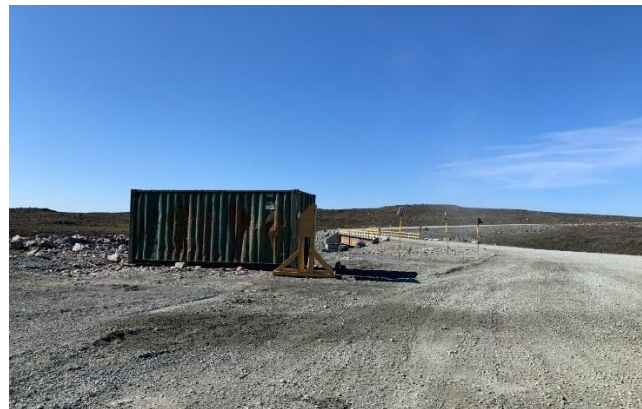
Photo 45: Emergency Seacan at Bridge

- a) Resloping was done along the Whale Tail Haul Road (WTHR).
- b) No widening of the WTHR has occurred in 2020 thus far.
- c) The one (1) snowmobile crossing is located along the Haul-road near km 127 with signage which also acts as a wildlife crossing (Photo 46).
- d) During their 2019 site visit the NIRB staff observed that environmental emergency seacans with spill kits were not available at the bridges along the WTHR. Agnico Eagle confirmed that there are now emergency seacans located at kilometre (km) 125.5 and 146 and three (3) more will be placed by the end of 2020 (Photo 45).
- e) No new road eskers or quarries were created in 2020.

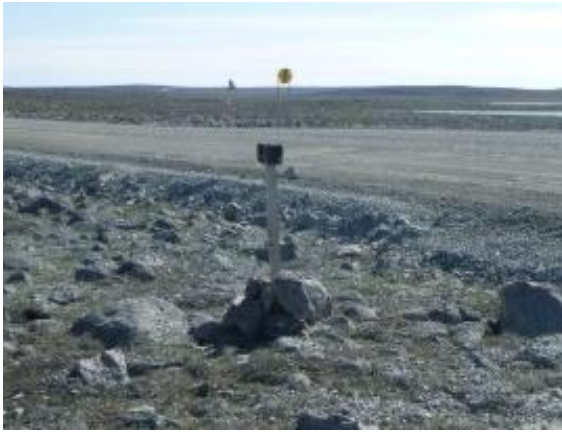
Photo 47: Wildlife Camera Along WTHR

- f) A remote wildlife camera was installed at km 158 monitoring caribou migration across the WTHR (Photo 47).
- g) There is two (2) noise monitoring stations along the WTHR that were monitored in 2020: R6 and R7 (Photo 48).

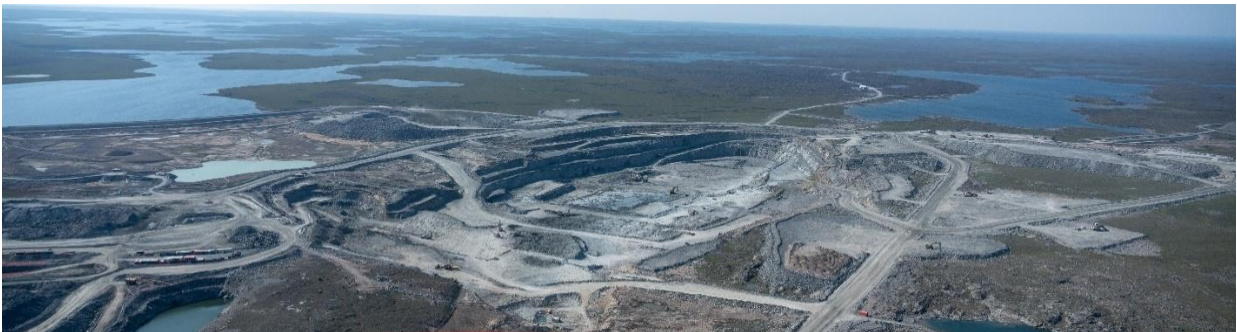
Photo 49: Whale Tail Pit Footprint

- a) Whale Tail Pit is still within the original footprint. Expansion into the increased footprint described in the Whale Tail Pit Expansion amendment has not yet occurred (Photo 49 and Photo 50).

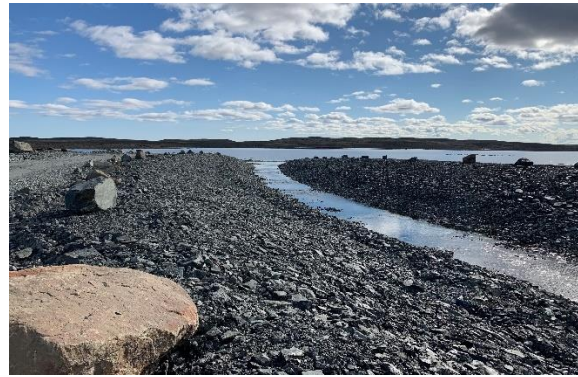
Photo 52: South Whale Tail Channel

- b) Whale Tail Dewatering was completed for the Whale Tail North Basin, and northeast pond Sector.
- c) The Whale Tail South Channel with inlet in the Whale Tail Lake South Basin is performing as designed in 2020 (Photo 52).
- d) Agnico Eagle noted that seepage is observed at the toe of Whale Tail Dike. At present, seepage water is treated as part of the Whale Tail Attenuation Pond. Grouting was completed on Whale Tail Dike to reduce the flow of seepage and a collection system is currently under construction to discharge water back to Whale Tail South (Photo 54).

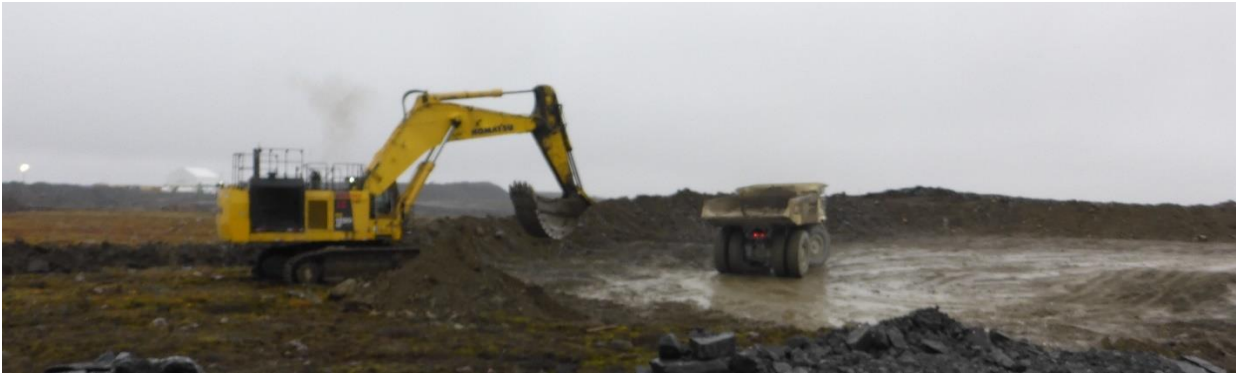
Photo 57: Prestripping of IVR Pit

- e) Prestripping of the IVR Pit began in September 2020 (Photo 57).

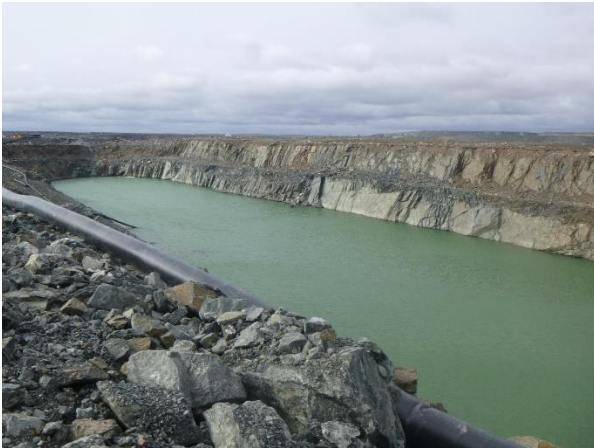
Photo 58: GSP-1

- f) Groundwater is managed in the groundwater storage pond GSP-1 (Photo 58). Additional groundwater storage ponds GSP-2 and GSP-3 have not yet been constructed.
- g) Lake A53 is not yet commissioned. Agnico Eagle noted that fish were removed and dewatering started in September 2020 (Photo 59).

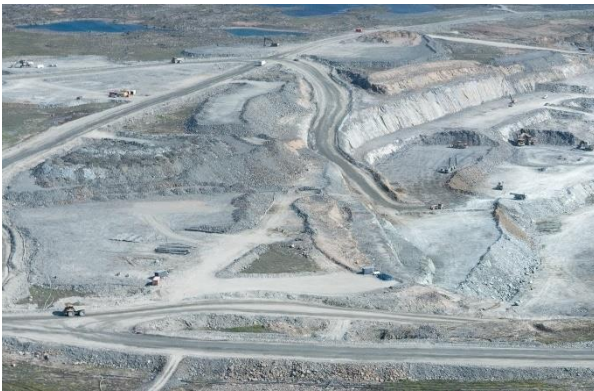
Photo 60: Ore Stockpile 4

- h) As of September 2020, no ore is currently stockpiled in Ore stockpile 4 (Photo 60).
- i) Agnico Eagle noted ore stockpiles do not have a contact water collection system as water naturally drains towards the attenuation ponds.
- j) The underground ore stockpile is currently not planned to be constructed in 2020.

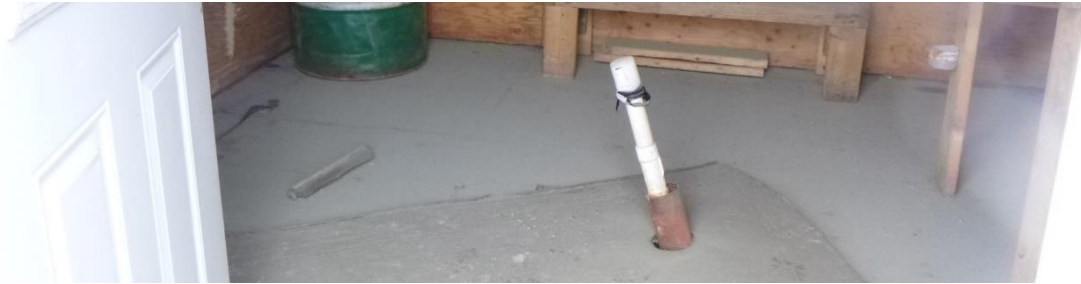
Photo 61: Groundwater Monitoring Well

- k) The IVR Waste Rock Storage Facility has not yet been constructed; however, dewatering is currently ongoing for the lake in the footprint of the future IVR Attenuation Pond and IVR Waste Rock Storage Facility.
- l) Agnico Eagle noted that the groundwater monitoring campaign is planned for October 2020 (Photo 61).

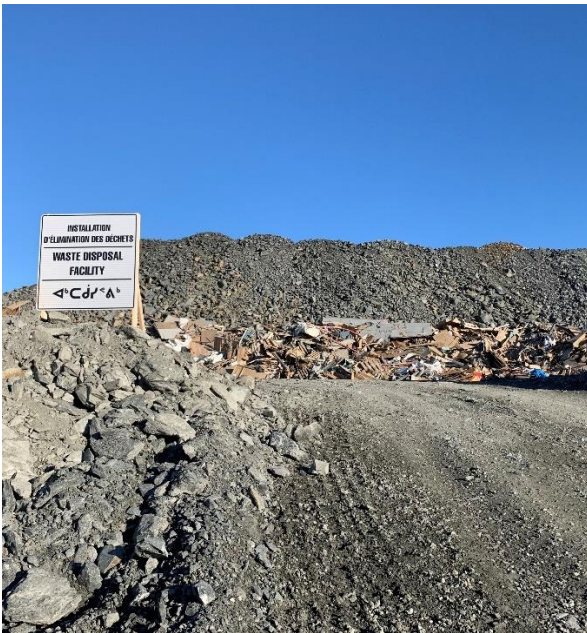
Photo 62: Landfill

- m) Agnico Eagle noted that, like Meadowbank, wastes are segregated before final disposal in the landfill (Photo 62).
- n) There is a diesel fuel tank and refueling station located on site (Photo 63).

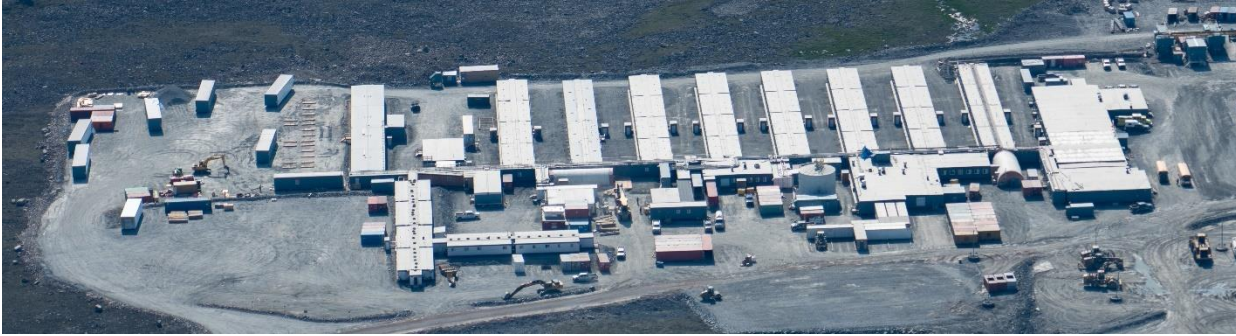
Photo 64: Permanent Camp

- o) There is currently nine (9) wings at the permanent camp and Agnico Eagle noted that the camp will be extended to 12 wings by the end of 2020 (Photo 64).
- p) Agnico Eagle noted that the exploration camp is currently being dismantled and will be decommissioned by early October (Photo 65).

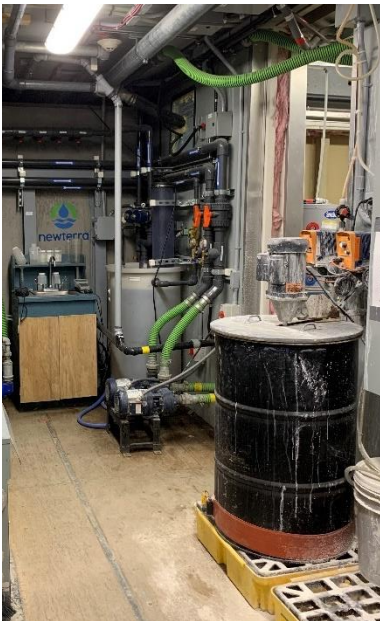
Photo 66: Sewage Treatment

- q) Onsite facilities include sewage treatment ([Photo 66](#)), potable water treatment ([Photo 67](#)) and arsenic treatment ([Photo 68](#)).

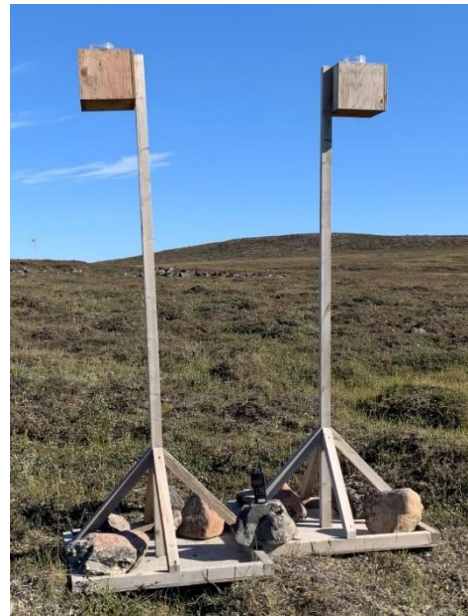
Photo 71: Dust Monitoring Stations

During their 2019 site visit, NIRB staff observed that dust suppressant was not being applied to the whole AWAR (see section 2.1.2.2), along the Whale Tail Haul Road (WTHR) nor at the Whale Tail site. In 2020 Agnico Eagle noted that calcium chloride dust suppressant was applied to the entire length of the WTHR (Photo 70). Also similar to the AWAR, dust monitoring stations have

been moved to two (2) metre (m) stands with one (1) replicate on the ground for comparison (Photo 71).
