**Report Title:** The Nunavut Impact Review Board's 2020 Site Update Report for Agnico Eagle Mines Limited's *Meliadine Gold Mine Project* (NIRB File No. 11MN034)

**Project:** Meliadine Gold Mine Project  
**Project Location:** Kivalliq Region, Nunavut  
**Land Tenure:** Inuit Owned Land

**Project Owner:** Agnico Eagle Mines Limited  
Meliadine Mine Site  
Rankin Inlet, NU  
X0C 0G0

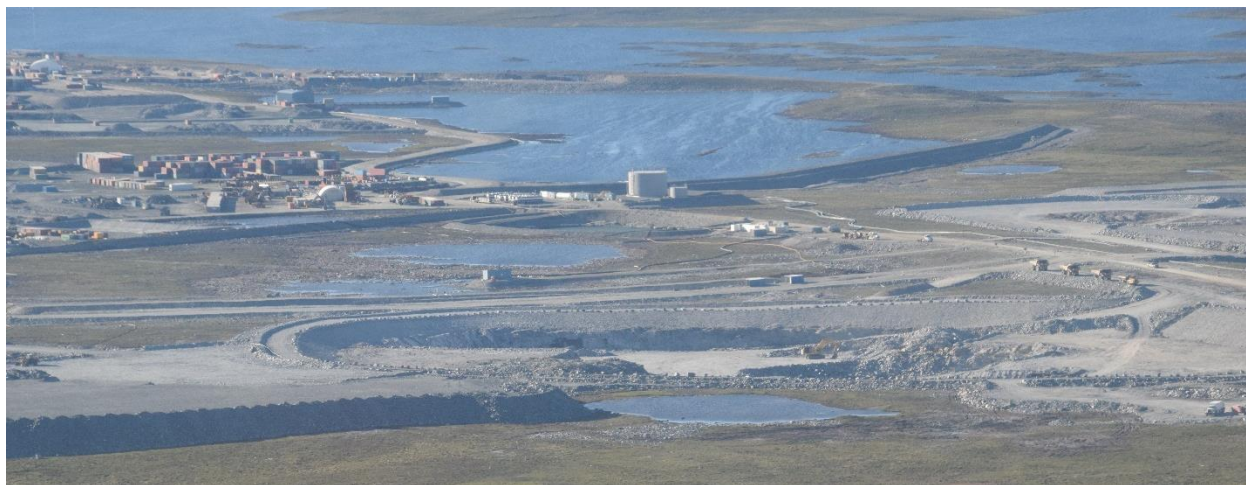
**Photo 1: Overview of Meliadine Mine Site**

See Photo 1 for an overview photo of the Meliadine Mine Site. [Figure 1](#) and [Figure 2](#) provide a layout of the Meliadine Mine Site, and the marshalling facility at Rankin Inlet.

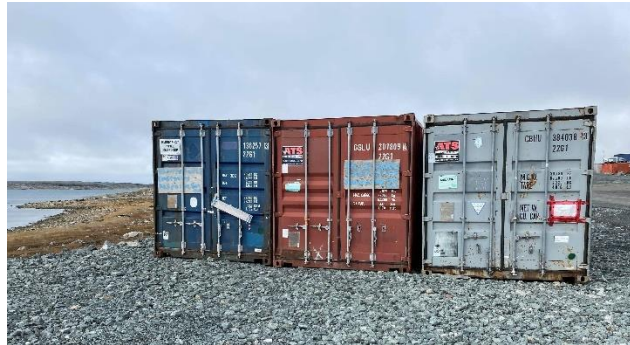
**Photo 6: Spill Response Equipment**

- c) Agnico Eagle informed NIRB that the secondary containment is functioning appropriately at the Itivia fuel farm (Photo 5).
- d) Three (3) seacans of spill response equipment are located on site (Photo 6).

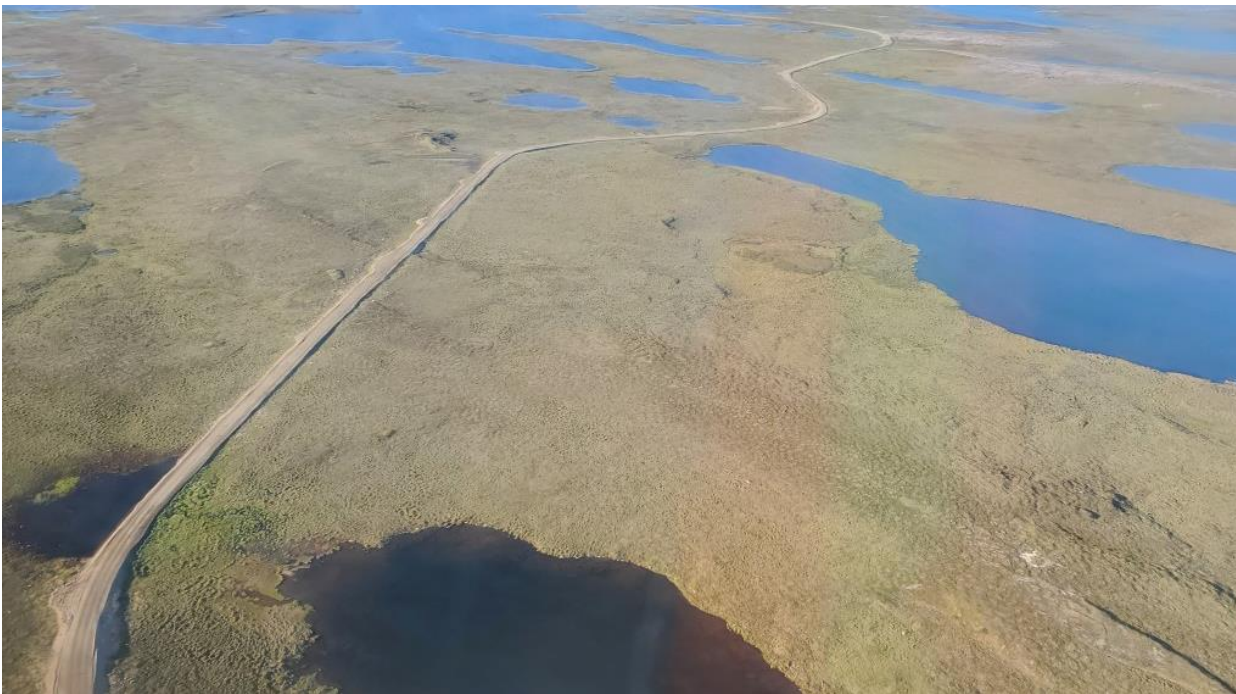
**Photo 10: AWAR**

- a) The AWAR is a 25 km long road which connects the main mine site with the bypass road (Photo 10).
- a) The gatehouse near the community of Rankin Inlet maintains a log of mine related traffic and passing all-terrain vehicles (ATVs). A sign has been put up on the gatehouse notifying community members that the mine site is currently in isolation due to Public Health restrictions. Agnico Eagle stated that a detached operations protocol is in place which requires any worker traveling south of the gatehouse to be on a list of approved workers and instructs workers to avoid interaction with community members (Photo 11, Photo 12).

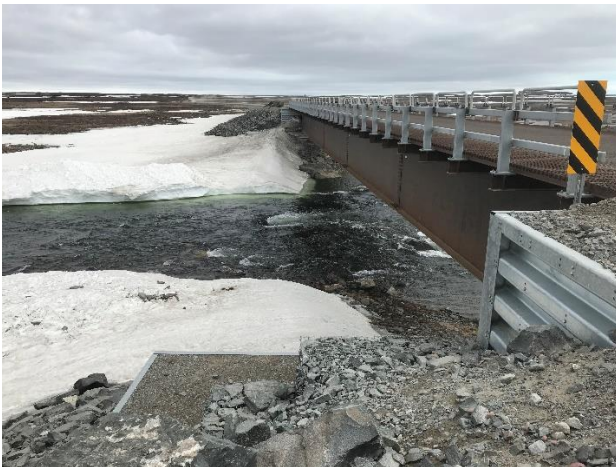
**Photo 13: Bridge Crossing**

- b) Signage marks bridge crossings and states speed limits over the bridge (Photo 13, Photo 14).
- c) Emergency spill response seacans are located at all bridge crossings (Photo 15).

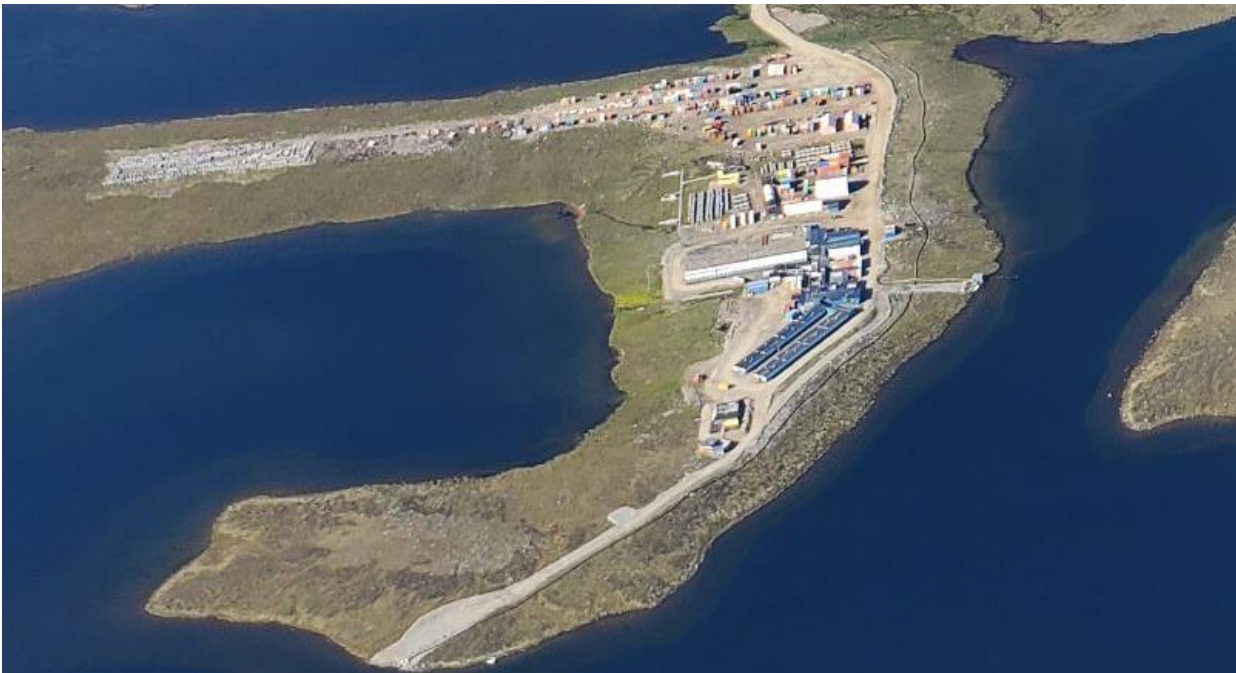
**Photo 17: Exploration Camp**

- a) Agnico Eagle noted that the exploration camp is still in use with a capacity of 144 persons (Photo 17).
- b) Screening (sorting out coarse-grained material) at the exploration camp landfarm took place during summer 2020 (Photo 18).
- c) The fuel tanks containing sewage sludge had a small berm built around them as secondary containment. Agnico Eagle indicated that they are evaluating shipping the empty fuel tanks off site (Photo 19).

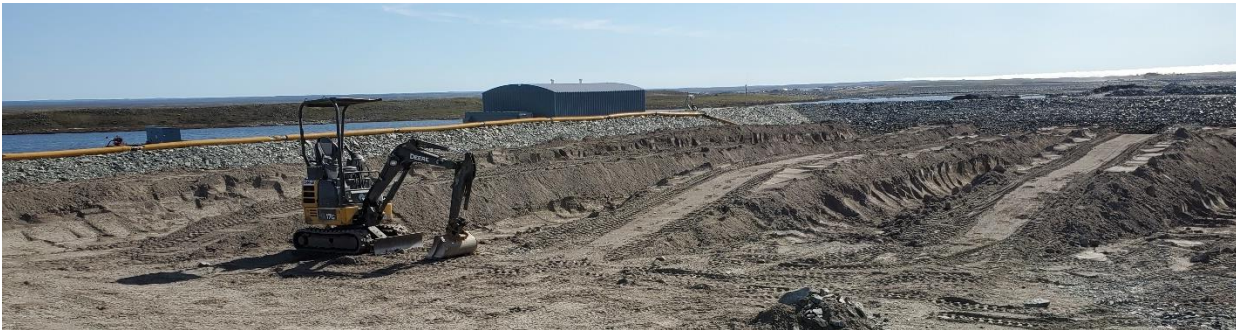
**Photo 20: Landfarm A**

- b) Waste Rock Storage Facilities have not been completed but are actively being used.
- c) Agnico Eagle noted that the temporary sorting pad at Landfarm A had not been used for soil screening in 2020; however, it was used as a temporary sorting area for hazmat material (Photo 20, Photo 21).
- d) Oil is separated from the hydrocarbon contaminated soil at the landfarm (Photo 22).
- e) The Tailings Storage Facility is dry stack tailings (Photo 23, Photo 24).

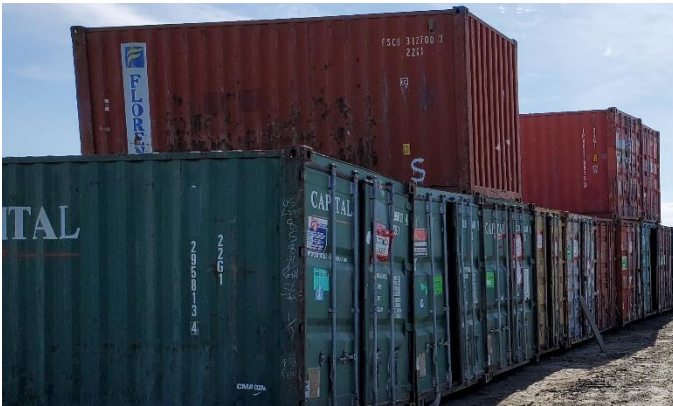
**Photo 32: Hazardous Material Storage Area**

- k) In 2019 the NIRB staff were informed that the landfill was at capacity<sup>3</sup>. In 2020 Agnico Eagle has implemented a campaign to improve wood segregation (Photo 30). Wood and steel were removed from the landfill to improve compaction. A backlog of seven (7) seacans of food waste was also shipped off site.
- l) Agnico Eagle noted that a campaign was also introduced to improve hazmat segregation with implementation of a seacan approval system. The Proponent monitors to ensure hazmat seacan doors are kept closed and are inspected regularly (Photo 32).
- m) A cyanide storage pad was constructed (Photo 33).
- n) No animal deterrents are placed at the landfill.

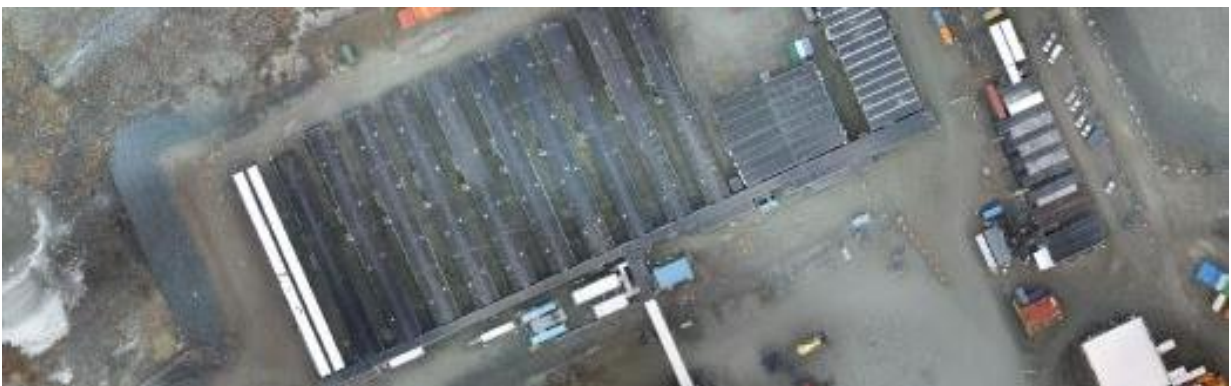
**Photo 36: Camp**

q) Two (2) accommodation wings have been added to the Meliadine camp (Photo 36).

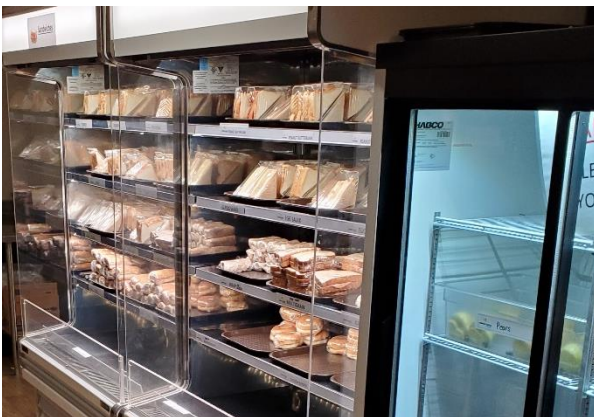
**Photo 37: Cafeteria**

r) In 2019 the NIRB staff suggested reduction of single use plastic food containers to reduce waste<sup>4</sup>. In 2020, Agnico Eagle stated that although some food is still served in single use plastic, so underground miners can take lunches, a salad bar has been installed for above ground workers (Photo 37, Photo 38). Paper cups were temporarily brought back for COVID-19 Public Health related reasons.

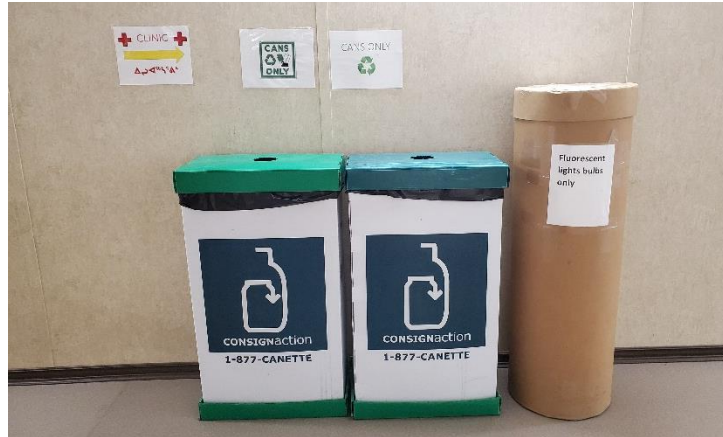
Photo 39: Indoor Waste Segregation

- s) Agnico Eagle indicated that new signage is in place for indoor waste segregation (Photo 39).

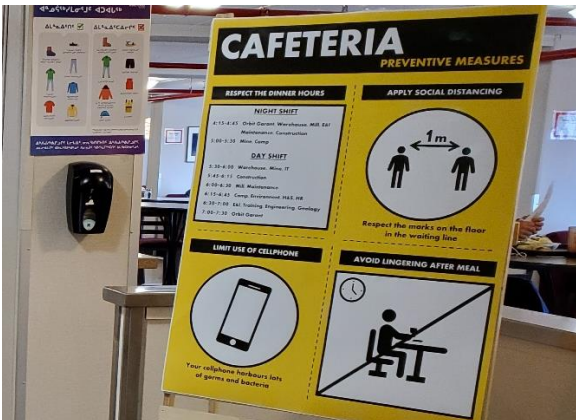
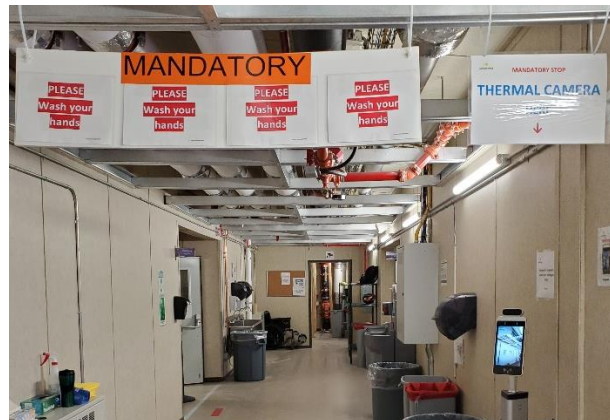
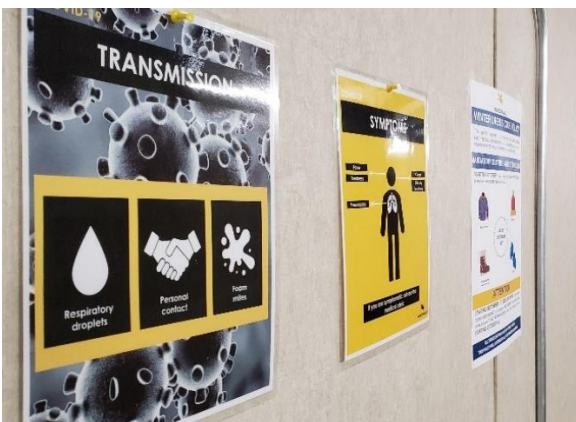
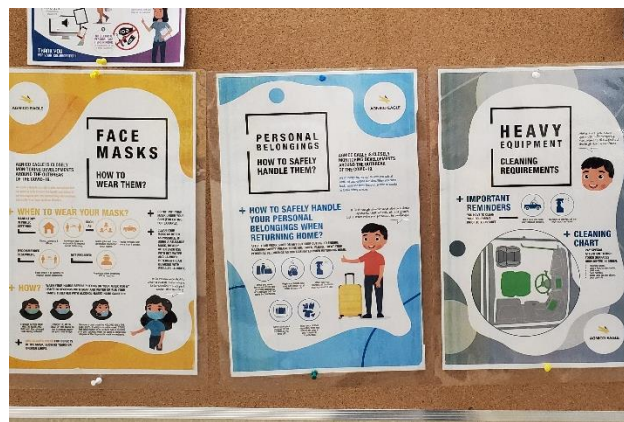
- t) Agnico Eagle has informed the NIRB that COVID-19 Public Health related updates have been implemented at site. Signage is present throughout the camp (Photo 40, Photo 41, Photo 42, and Photo 43), social distancing practices are enforced in the cafeteria (Photo 45) and a new hand washing station was installed (Photo 44), the gym has limited capacity, and high touch areas are cleaned twice daily.

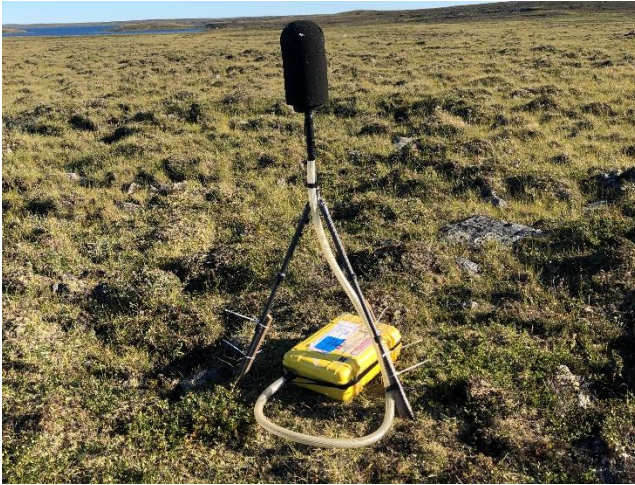
**Photo 48: Noise Monitor**

- d) There are three (3) noise monitoring stations around the mine site and AWAR (Photo 48).

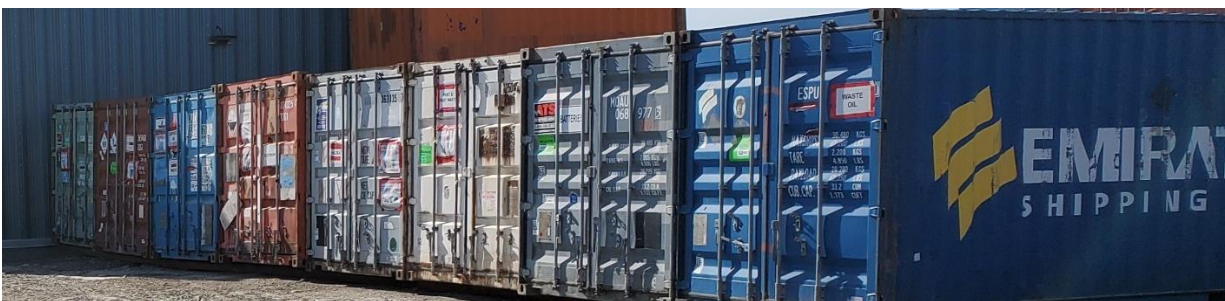
Photo 57: Waste Management

- i) In its *2019 Annual Report*<sup>5</sup> Agnico Eagle stated there were 15 fox mortalities which indicate that the Meliadine mine site continues to be an attractant for predators and scavengers. As noted above, waste management on site has improved (Photo 57). Agnico Eagle stated that they have implemented site wide Sunday site clean ups to help manage debris around site. However, there continues to be no fencing or animal deterrents used at the landfill. The NIRB is aware that the contractors with Bearwise have been unable to travel to site as COVID-19 has limited the travel of personnel into Nunavut.
