Appendix 6 : 2020 Annual Geotechnical Inspection Report

2020 Annual Geotechnical Inspection Meliadine Gold Project, Rankin Inlet, Nunavut

PRESENTED TO
Agnico Eagle Mines Limited

FEBRUARY 2021
ISSUED FOR USE
FILE: 704-ENG.EARC03140-15

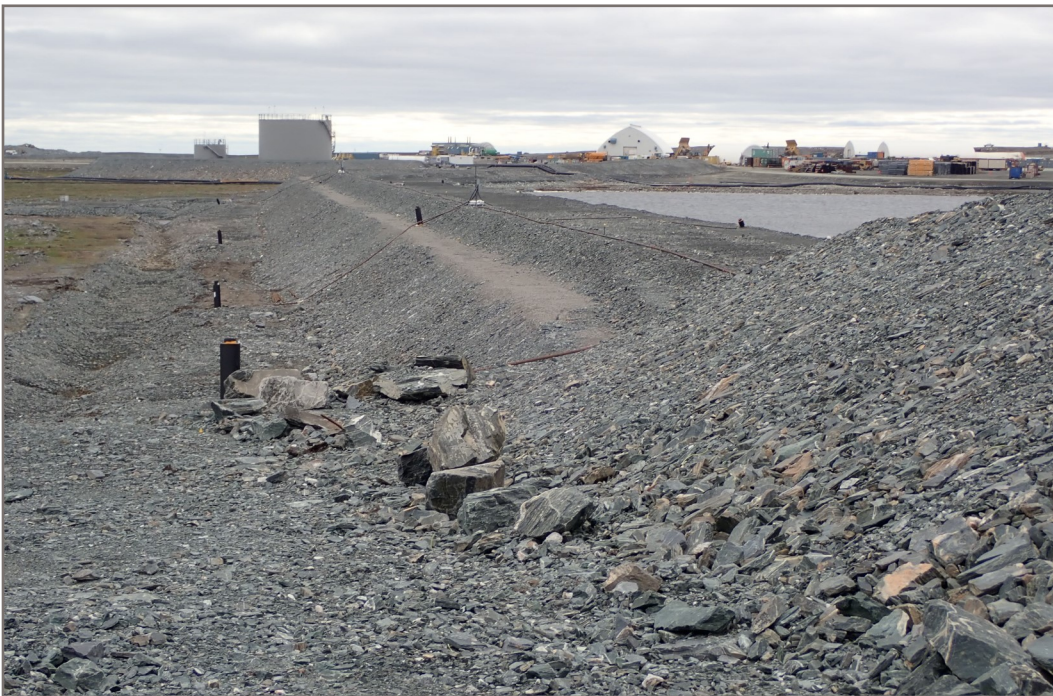
Photo 2: Dike D-CP1—Downstream face, looking south

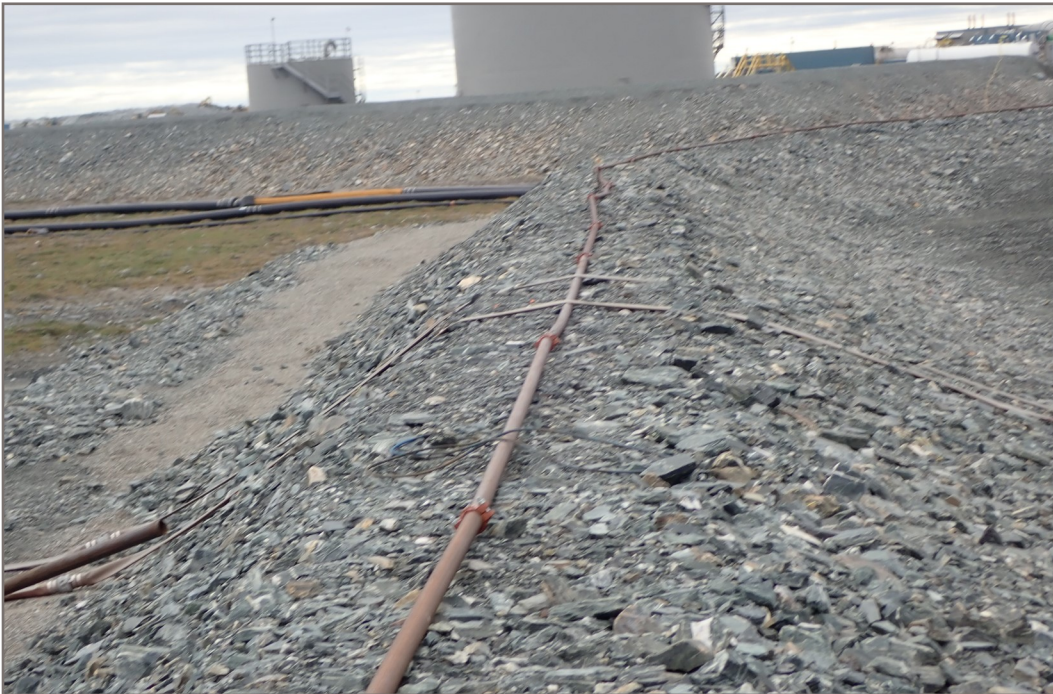
Photo 4: Dike D-CP1 - Upstream crest.

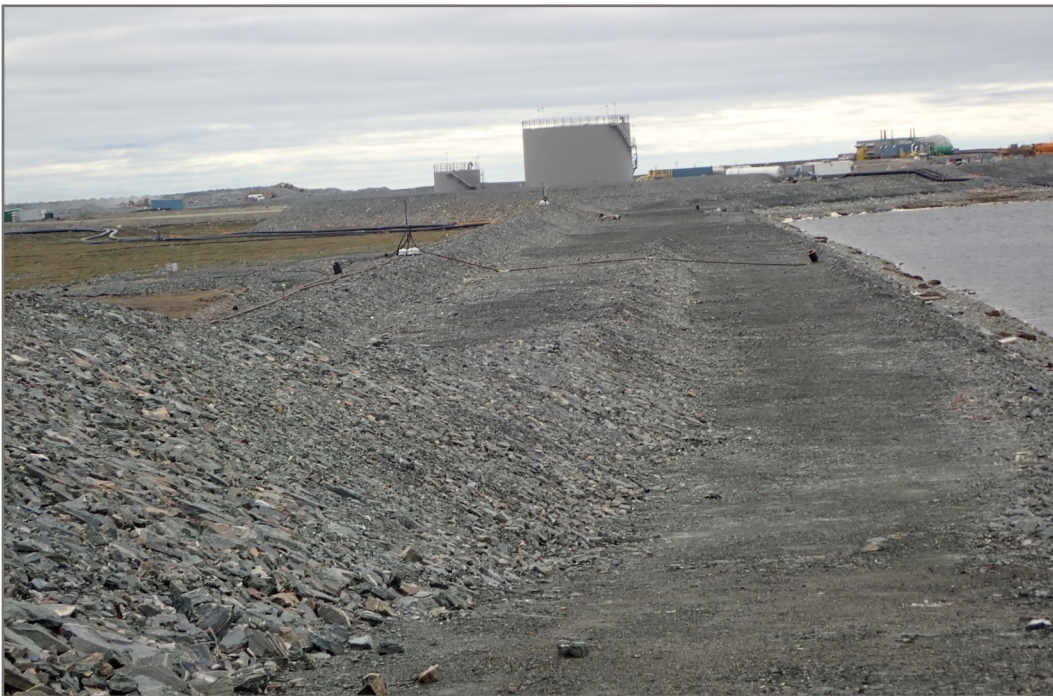
Photo 6: Dike D-CP1 - Upstream crest, looking south.

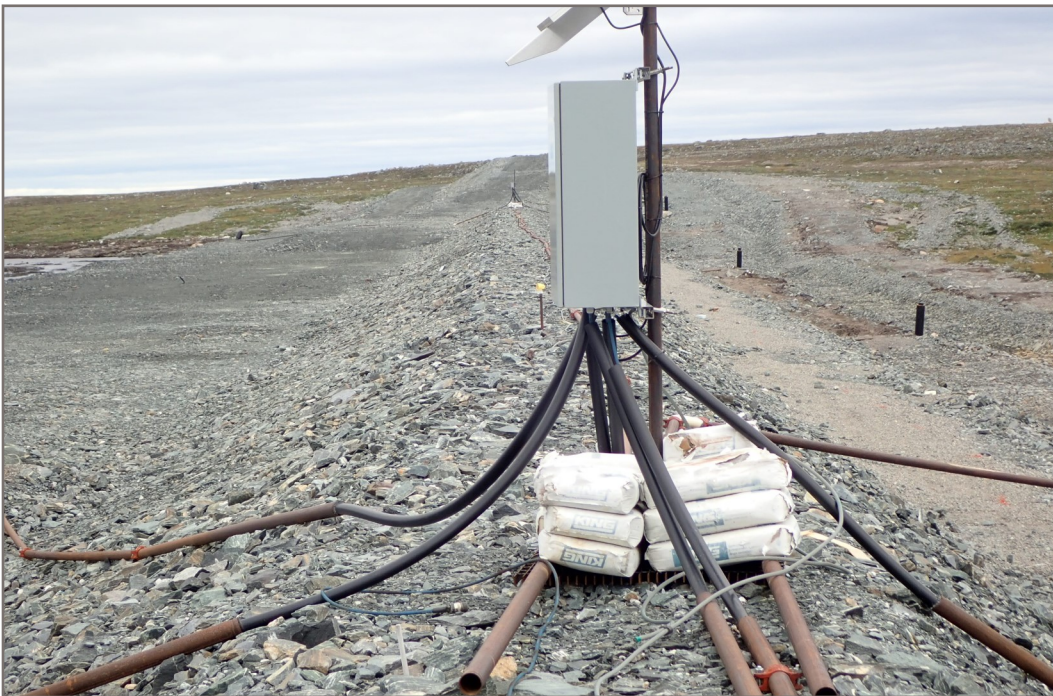
Photo 10: Dike D-CP1 - Dike crest, data acquisition terminal for GTCs

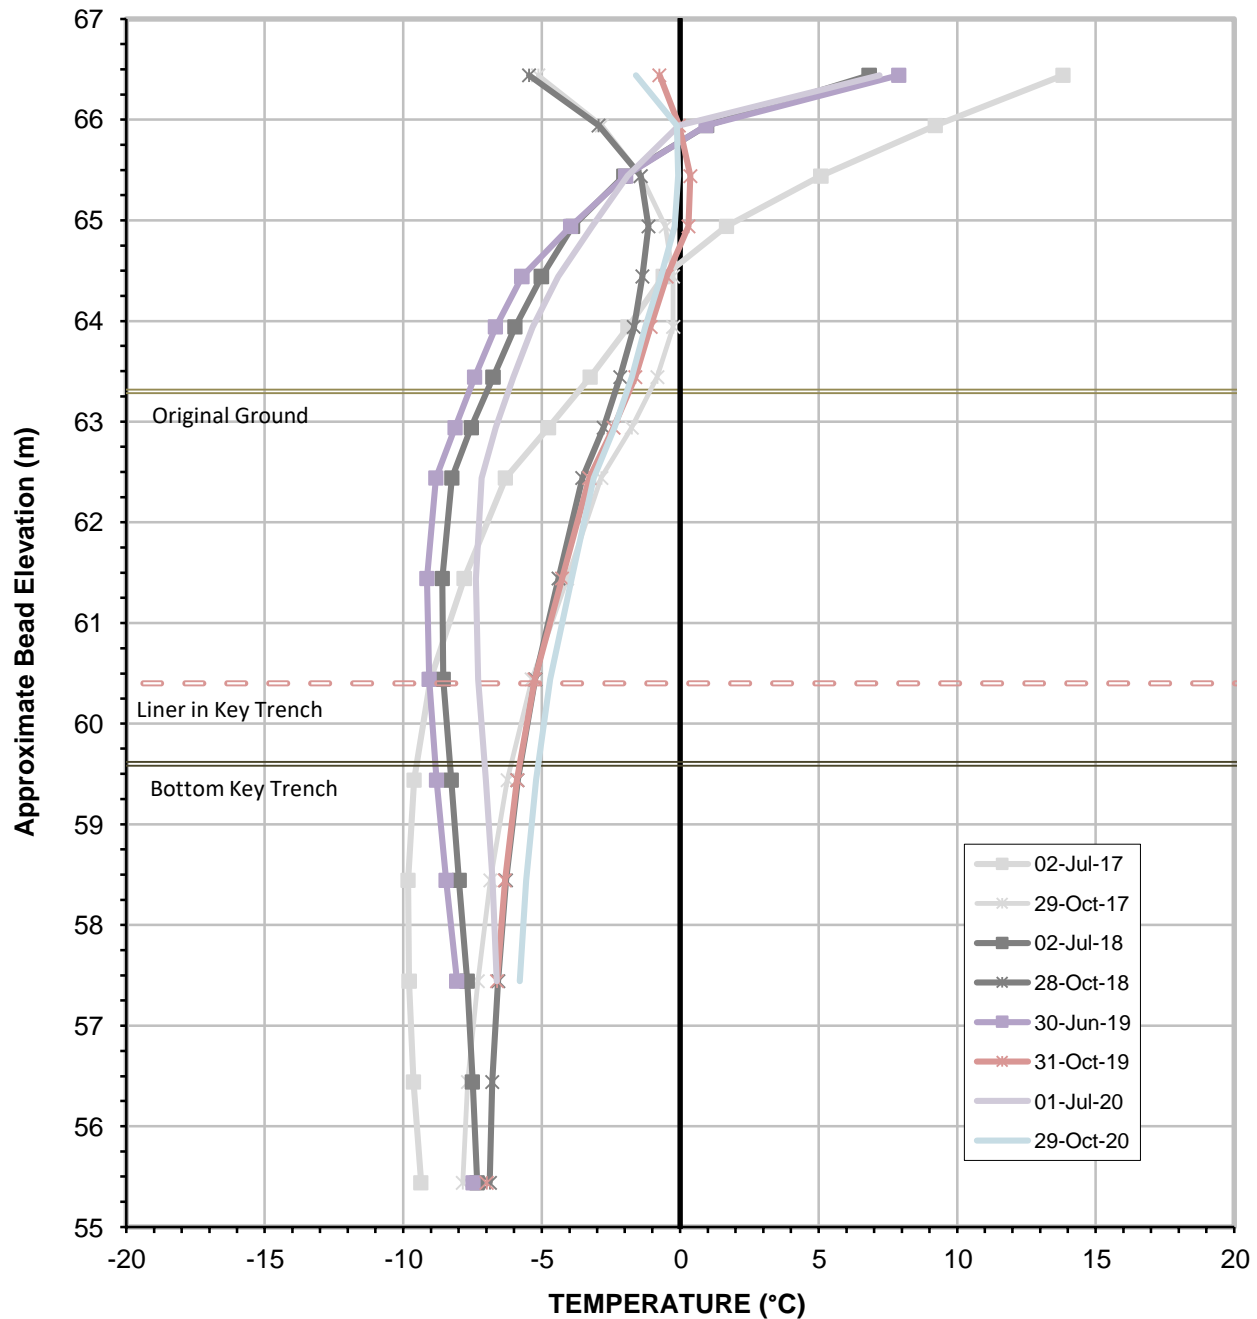
Vertical Ground Temperature Profile for Cable VGTC-03
Dike D-CP1

Average Annual Temperature at Various Elevations

November 2017 - November 2018	November 2018 - November 2019	November 2019 - November 2020
Bottom of Cable	-6.9	-6.2	-5.6
Liner Base Elevation	-6.9	-6.3	-5.3

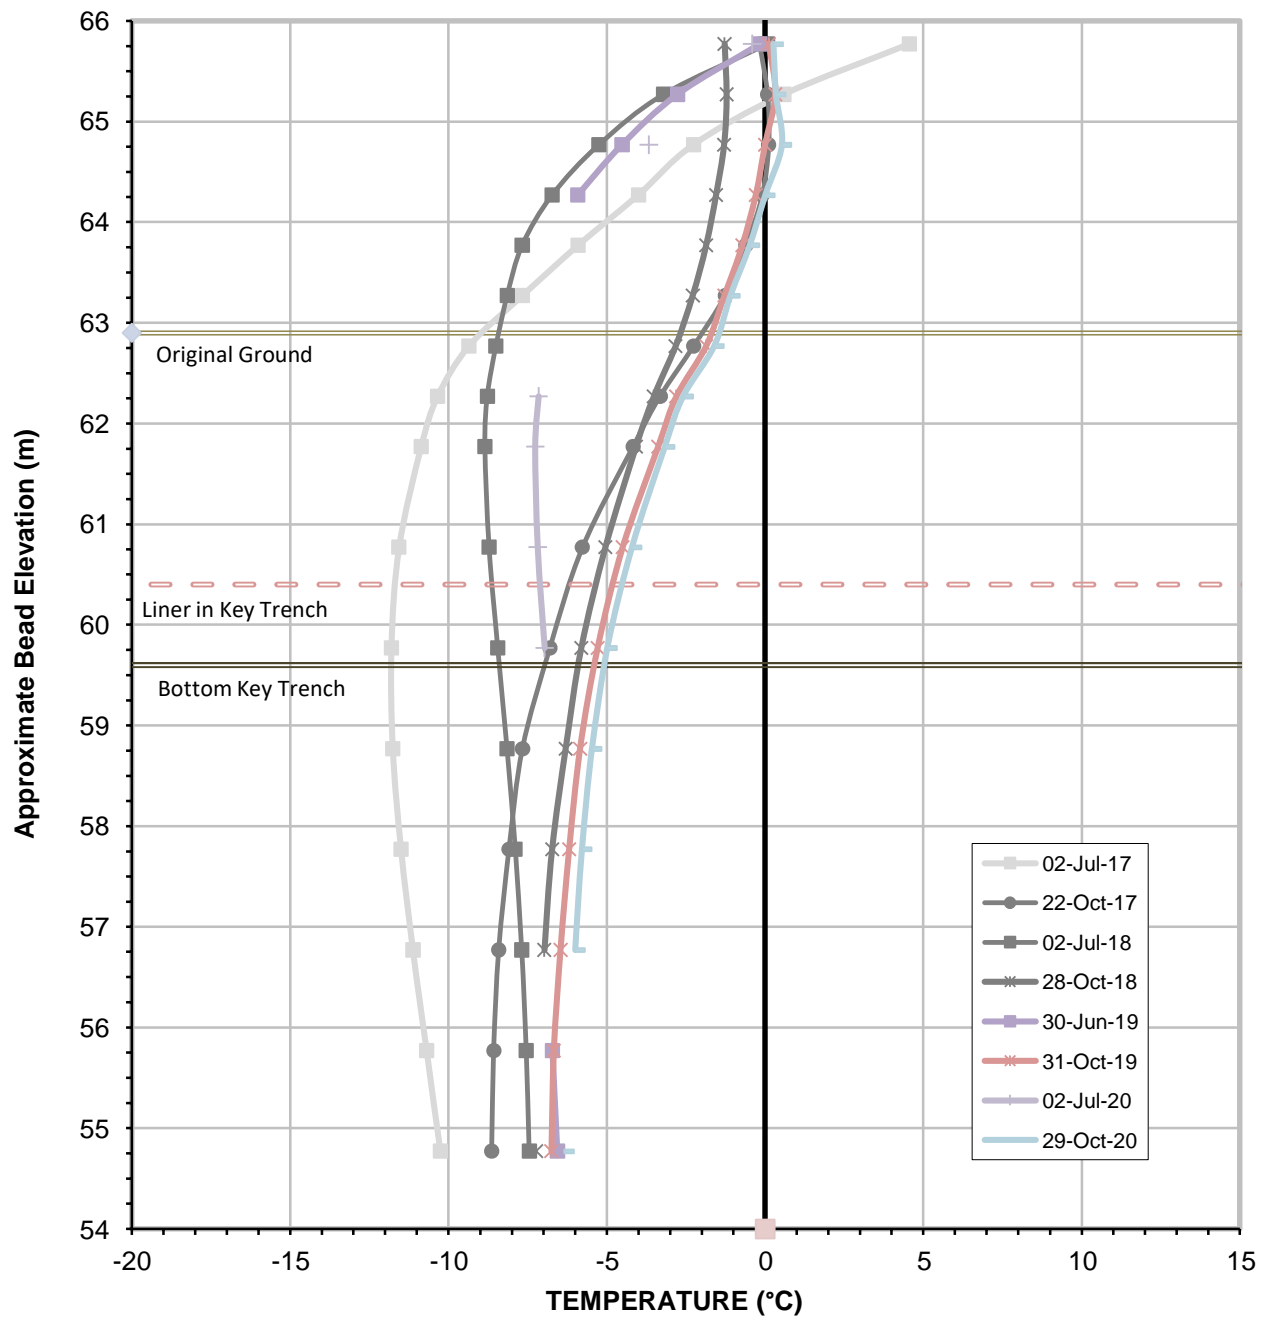
**Vertical Ground Temperature Profile for Cable VGTC-04
Dike D-CP1**

Average Annual Temperature at Various Elevations

November 2017 - November 2018	November 2018 - November 2019	November 2019 - November 2020
Bottom of Cable	-7.2	-7.0	-6.3
Liner Base Elevation	-6.9	-7.2	-5.9

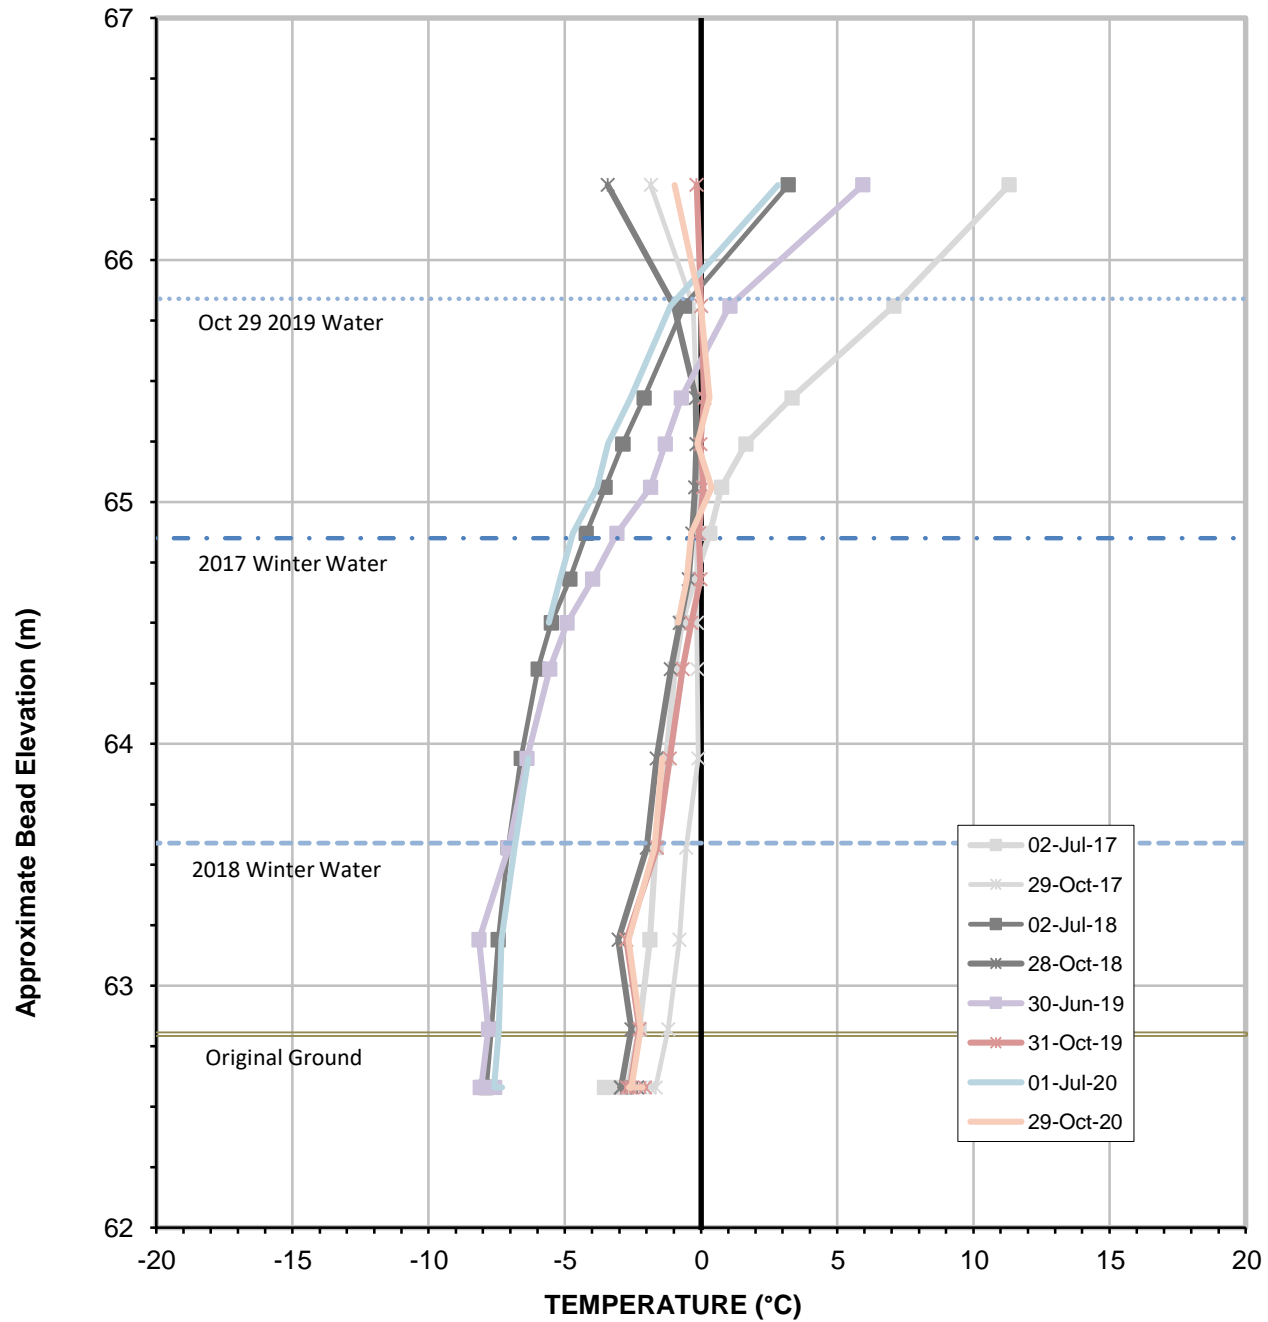
**Vertical Ground Temperature Profile for Cable VGTC-05
Dike D-CP1**

Average Annual Temperature at Various Elevations

November 2017 - November 2018	November 2018 - November 2019	November 2019 - November 2020
Bottom of Cable	-7.3	-6.7	-6.4
Liner Base Elevation	-7.0	-6.3	-5.7
