Report title: Summer 2021 Site Update Report for the Nunavut Impact Review Board's Monitoring of Baffinland Iron Mines Corporation's *Mary River Project* (NIRB File No. 08MN053)

Project: Mary River Project

Report Prepared by: Guillaume Daoust, Technical Advisor I

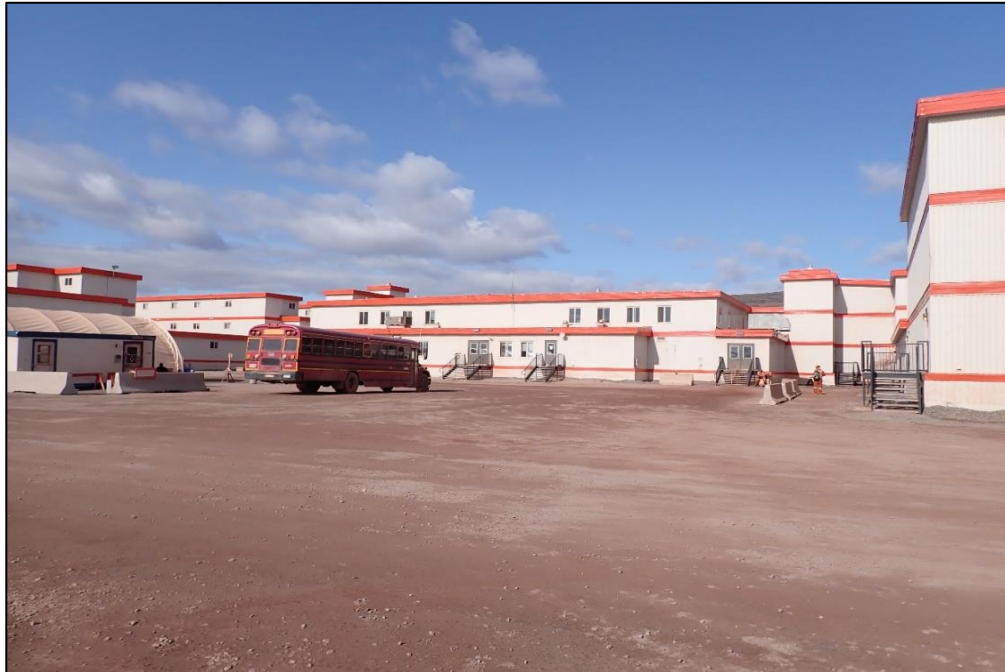
Terrestrial Wildlife Habitat and Waste Management		
54	Terrestrial Environmental Management Plan	Evidence of wildlife video-surveillance was provided in Photo 40 : Wildlife Camera at KM42 .
64	Waste Management – Carnivore Deterrents	Evidence of skirting around the Sailiivik complex in Photo 3 : Sailiivik Accommodation Complex with Metal Skirting Around the Base. The Photo 24 : Fencing at Mine Site Landfill looking North and Photo 25 : Fencing at Mine Site Landfill looking reveal fencing around the mine site landfill.
Marine Environment- Spill Prevention		
92	Spill Response Equipment	Evidence of spill response equipment located on site was provided in Photo 29 : Spill Response Equipment at the MS-03 Tank Farm and Photo 63 .
Socioeconomic Impacts

Photo 3: Sailiivik Accommodation Complex with Metal Skirting Around the Base

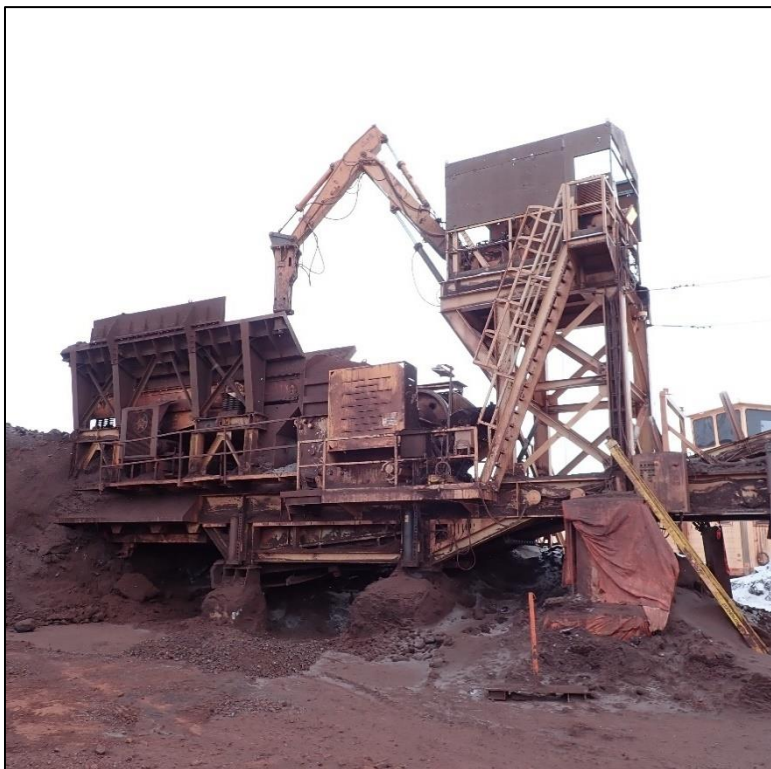
Photo 13: View of Iron Build-up at Transfer Point in the Crusher Facility

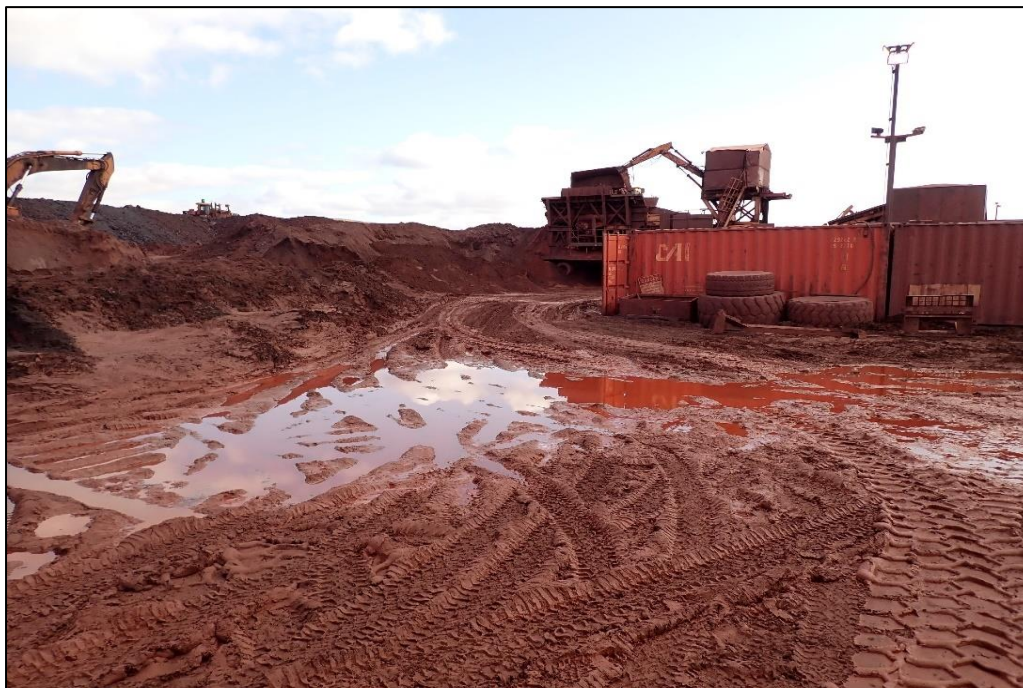
Photo 15: Standing Water at the Crusher Facility

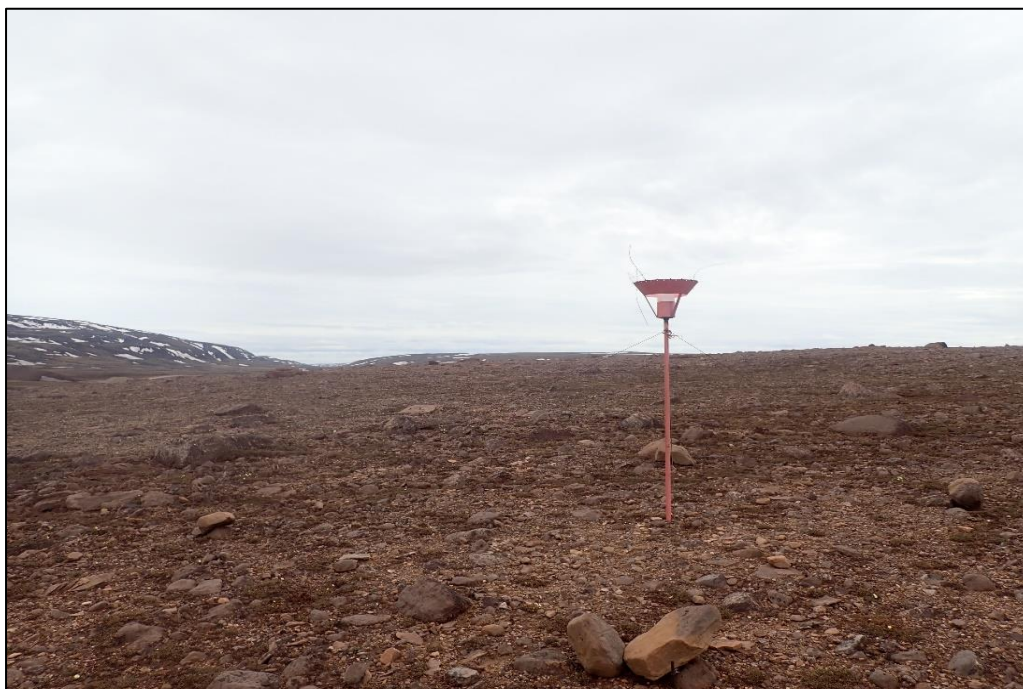
T&C No.	Category	Observation
Meteorology and Climate		
5	Weather Stations	Evidence of weather stations installed on site was provided in Photo 30 .
10	Dustfall Monitoring	Evidence of dustfall monitoring stations were provided at the Mine Site, Photo 16 : Dustfall Monitoring Station Towards Deposit 1, along the Tote Road, Photo 41 : Dustfall Monitoring Station at KM25, and at Milne Port, Photo 83 : One of the New Dust Collectors around Milne Port. Evidence of dust mitigation measures appear in Photo 42 : Truck Wetting the Tote Road for Dust Suppression and Photo 43 : Tire Drag for Dust Suppression.
11	Incinerator	Evidence of waste management practices at the incinerator facilities at both the Mine Site and Milne Port are shown in Photo 23 : Waste Segregation in the Incinerator Building and Photo 59 : Waste Sorting Bins Outside the Incinerator Facility.
Groundwater and Surface Water		
23	Groundwater Monitoring	Evidence of compliance was provided in Photo 26 : Groundwater Monitoring Wells Near the Mine Site Landfill.

Photo 16: Dustfall Monitoring Station Towards Deposit 1

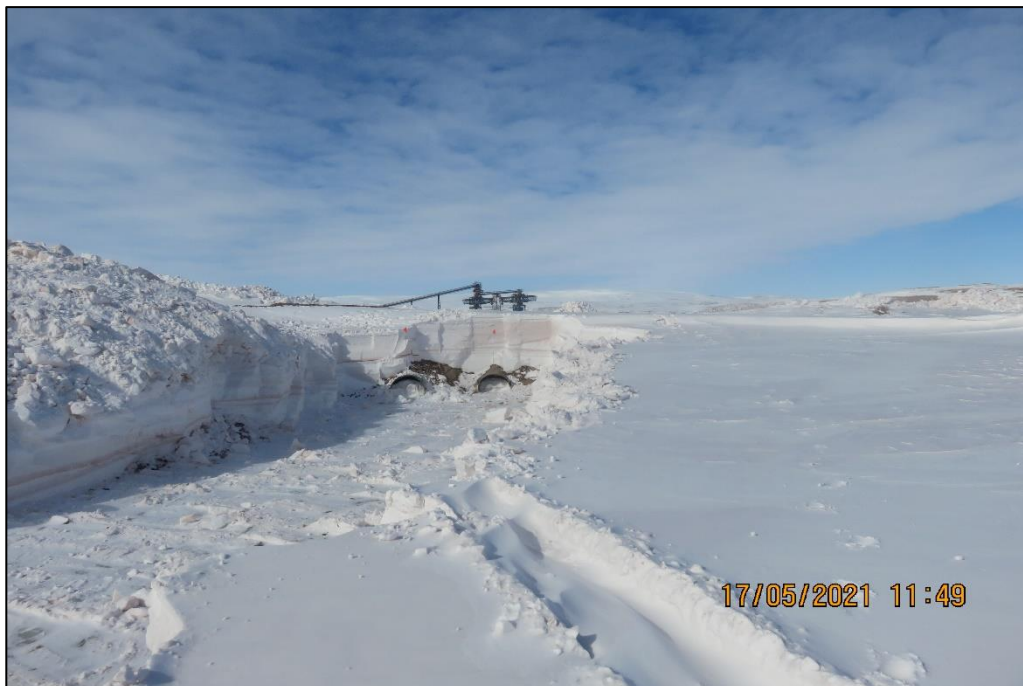
Photo 21: Freshet Monitoring Site, Surface Discharge Downstream of Construction area

Understanding that dust is a recurring concern by communities, NIRB staff appreciate Baffinland expanding the dust monitoring with an additional station ([Photo 83](#)) and conducting dust suppression mitigation ([Photo 42](#) and [Photo 43](#)). However, there are clear observations of dust deposition on the snow surface ([Photo 19](#)) and obvious dust layers in the snow cut surface from the freshet preparation ([Photo 21](#)). The NIRB will continue to track this topic.

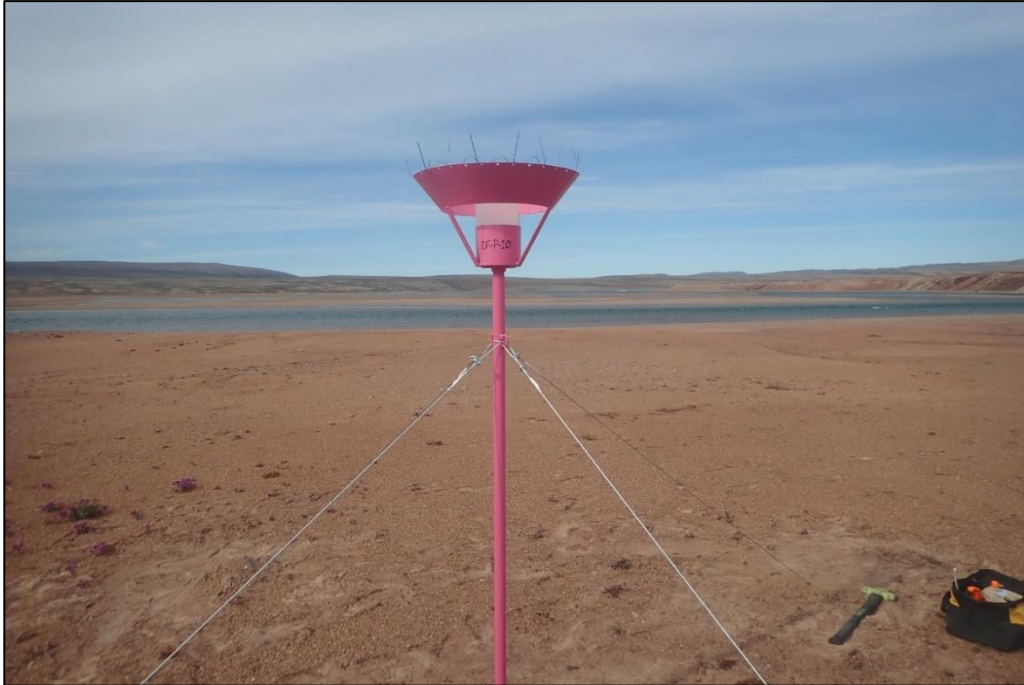
Photo 83: One of the New Dust Collectors around Milne Port

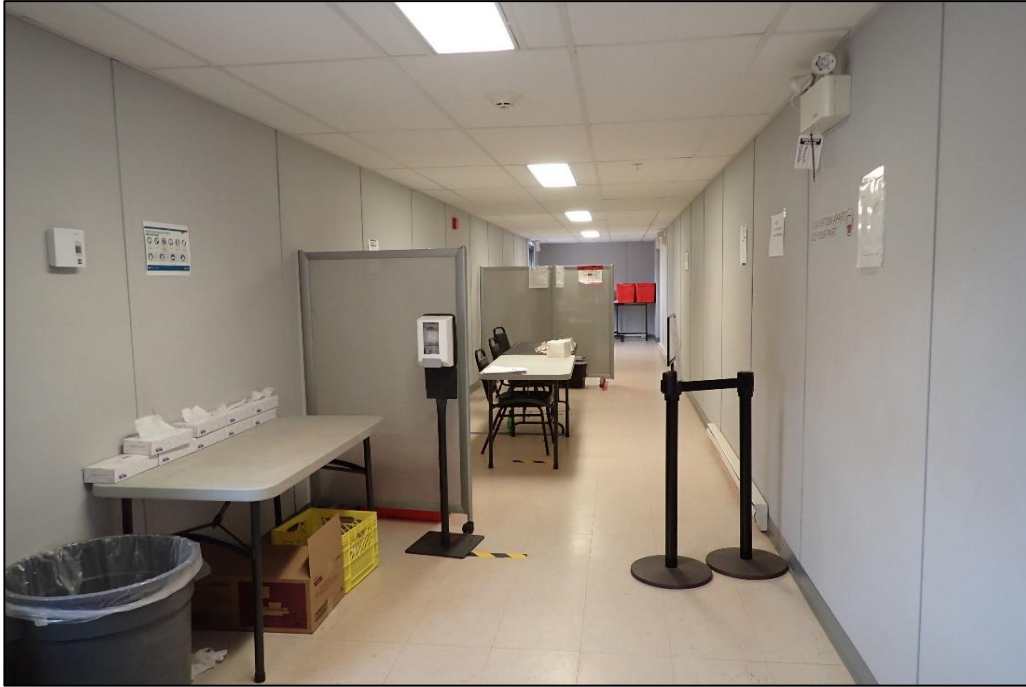
Baffinland dealt with a COVID-19 outbreak and the mine was under “Outbreak Order” from Nunavut Public Health between May and July 2021. During this period, the Proponent had reduced staff at site but maintained monitoring objectives. Additionally, Baffinland added COVID -19 testing areas outside the H Wing (Photo 86) and additional signage to highlight COVID-19 protocols.

Photo 86: COVID Testing Outside H-wing
