# Meliadine Gold Mine Project

# Agnico Eagle Mines Limited

NIRB File No. 11MN034

**Report Title:** The Nunavut Impact Review Board's 2021 Site Update Report for Agnico Eagle Mines Limited's *Meliadine Gold Mine Project* (NIRB File No. 11MN034)

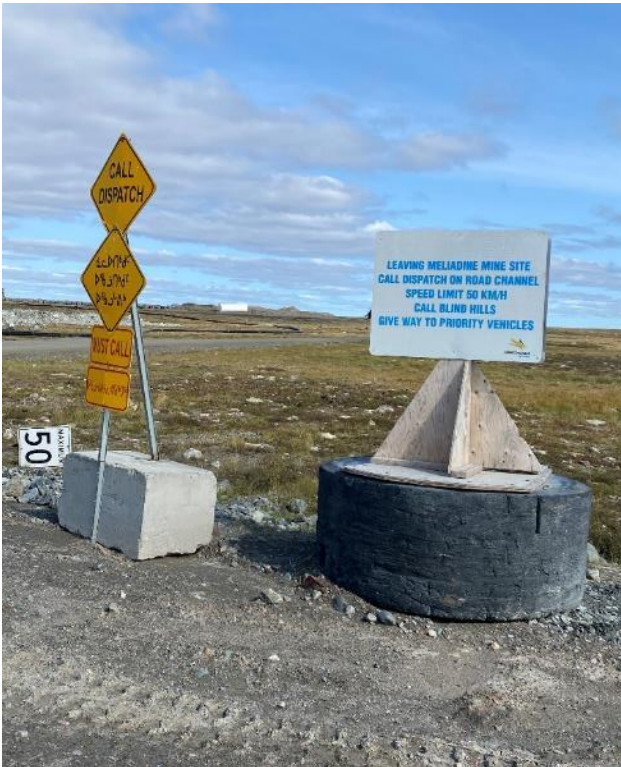
Photo 7: Call Dispatch Signage

125	Accidents and Malfunctions – All weather access road	<a href="#">Photo 6</a> shows the gatehouse at KM 8 for access to the all-weather access road. <a href="#">Photo 7</a> , <a href="#">Photo 8</a> , <a href="#">Photo 9</a> , and <a href="#">Photo 10</a> show the health and safety, and public usage signage for the all-weather access road.

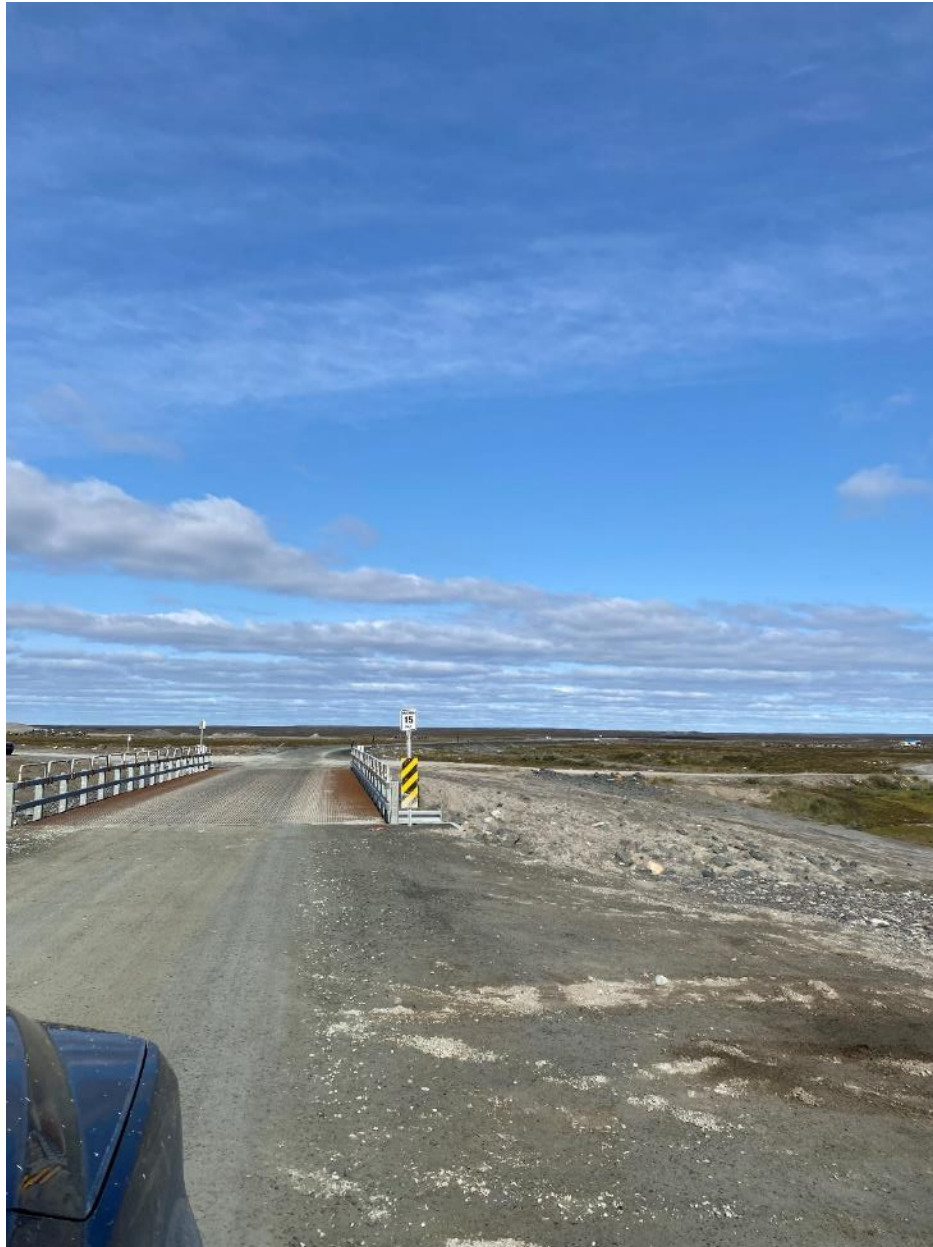
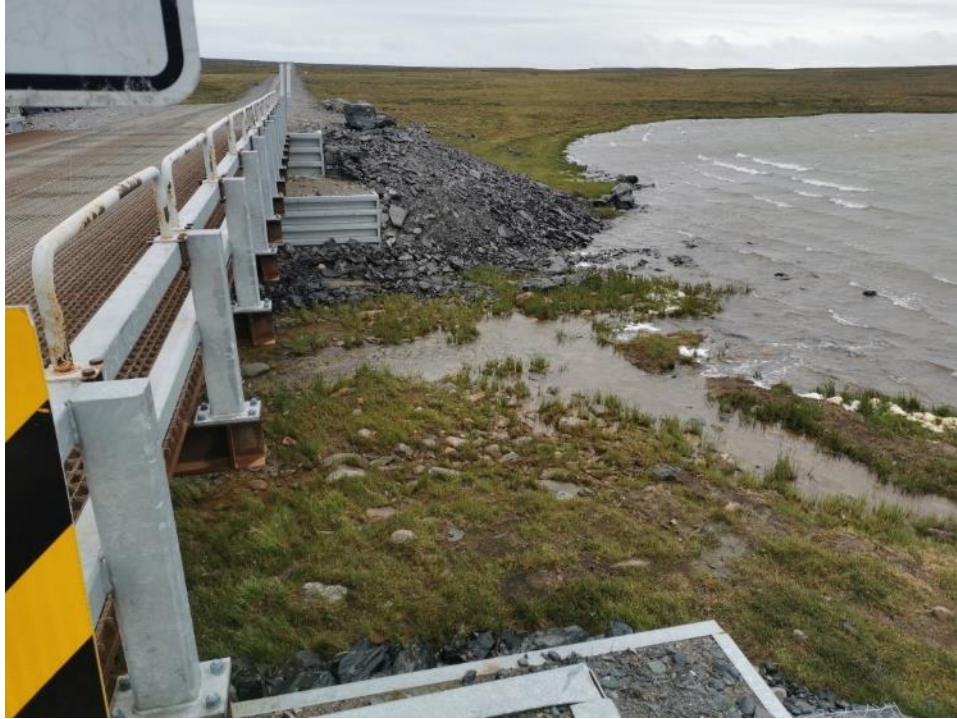
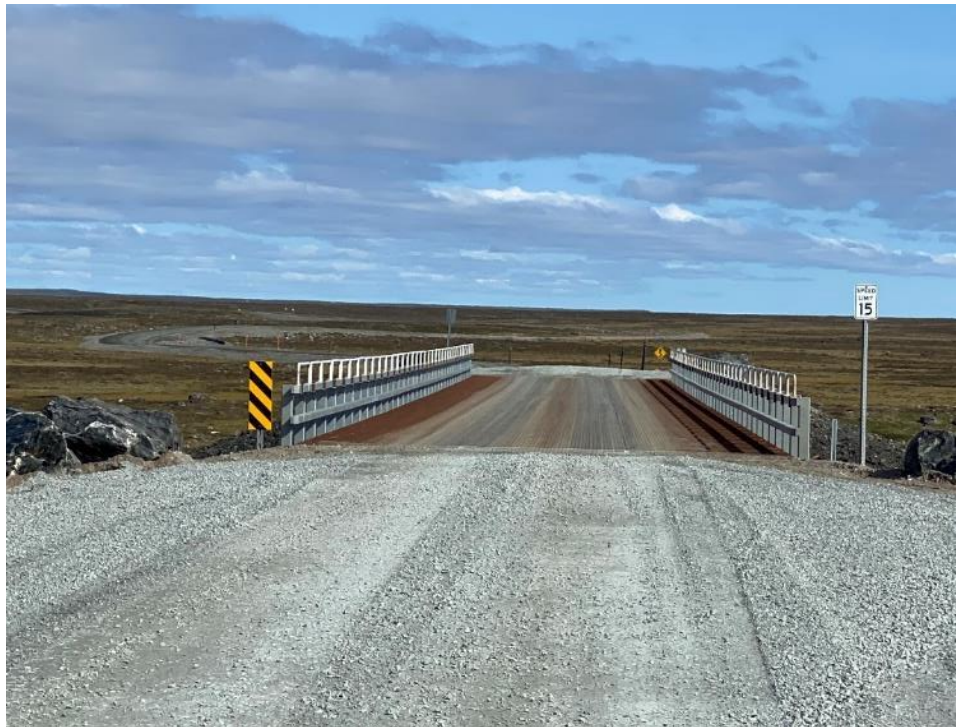
- Maintenance was performed on the bridges in August 2021.
- Bridges are inspected regularly.

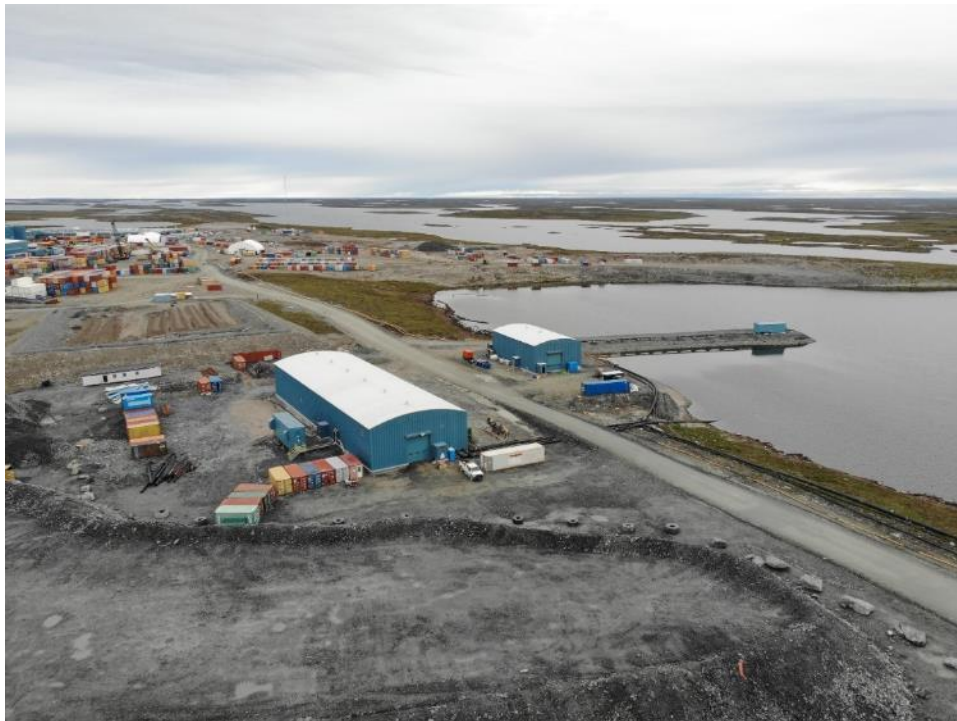
**Photo 36: Water Treatment Complex**

- In 2020-2021, Agnico Eagle built the water treatment complex, designed to provide a centralized building for contact water treatment (Photo 36).

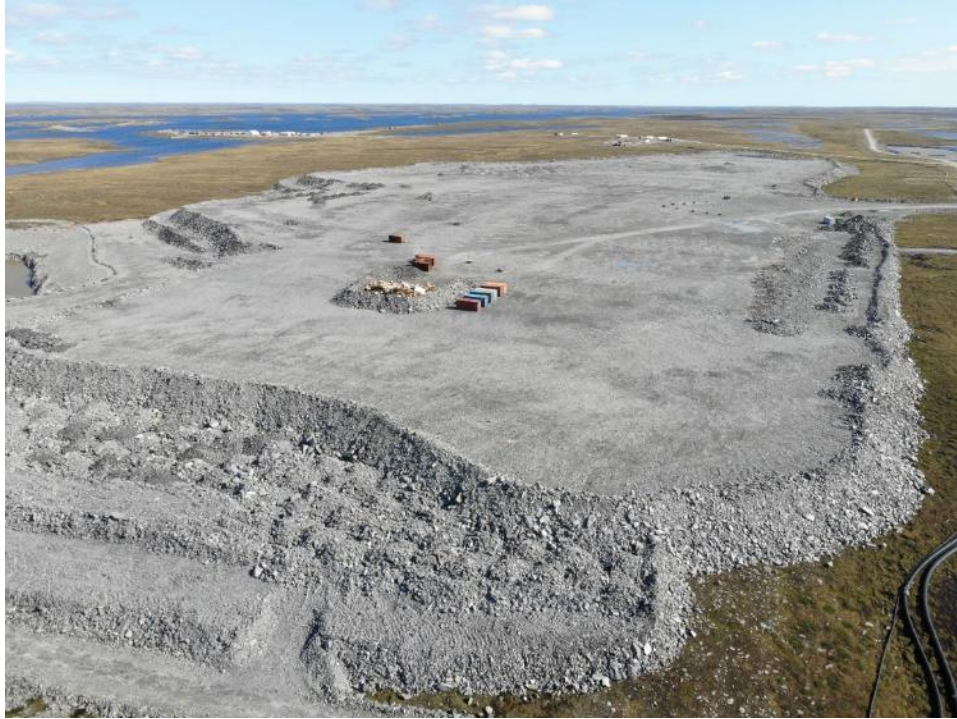
**Photo 39: Waste Rock Storage Facility 3**

- Waste Rock Storage Facility 1 is still active and expected to reach its design capacity in Year 4 (2023; Photo 38).
- Waste Rock Storage Facility 3 received all waste material from Tiriganiaq Pit 2 in 2020 and will accommodate portions of waste rock from Tiriganiaq Pit 1 in 2022 and 2023 until capacity is reached (Photo 39).

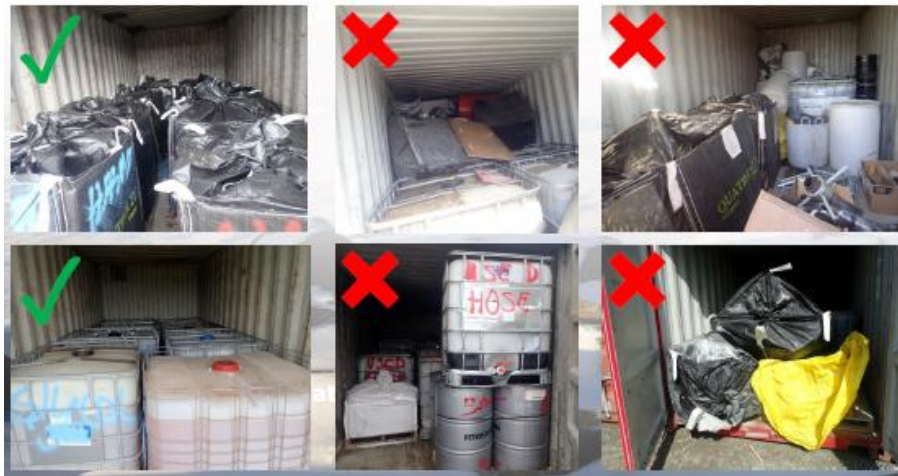
Photo 50: Waste Seacan Poster

- A site wide relaunch of waste segregation was completed in April 2021 with new signs and standardized bin labels and posters (Photo 46, Photo 47, Photo 48, and Photo 49).
- In 2020, a protocol was implemented to inspect seacans and individual items before they are moved from the users work location. This protocol is still in place in 2021 (Photo 50).

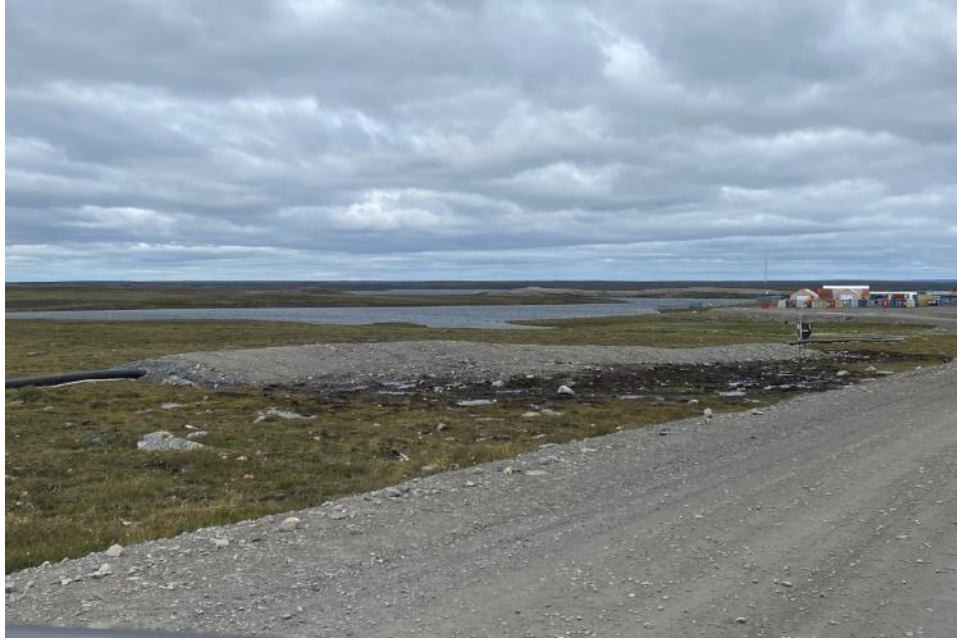
**Photo 52: Wildlife Crossing on Site**

- A waterline crossing was installed on-site in June 2021 (Photo 52). There are no wildlife crossings on the AWAR, as the embankment gradient is gradual enough not to impede crossing.
- Snowy owls, reflector tourniquets, balloons, coyotes, kites, and propane cannons were used in the 2021 breeding season in several locations to prevent birds from nesting in critical locations to the operations (Photo 53).

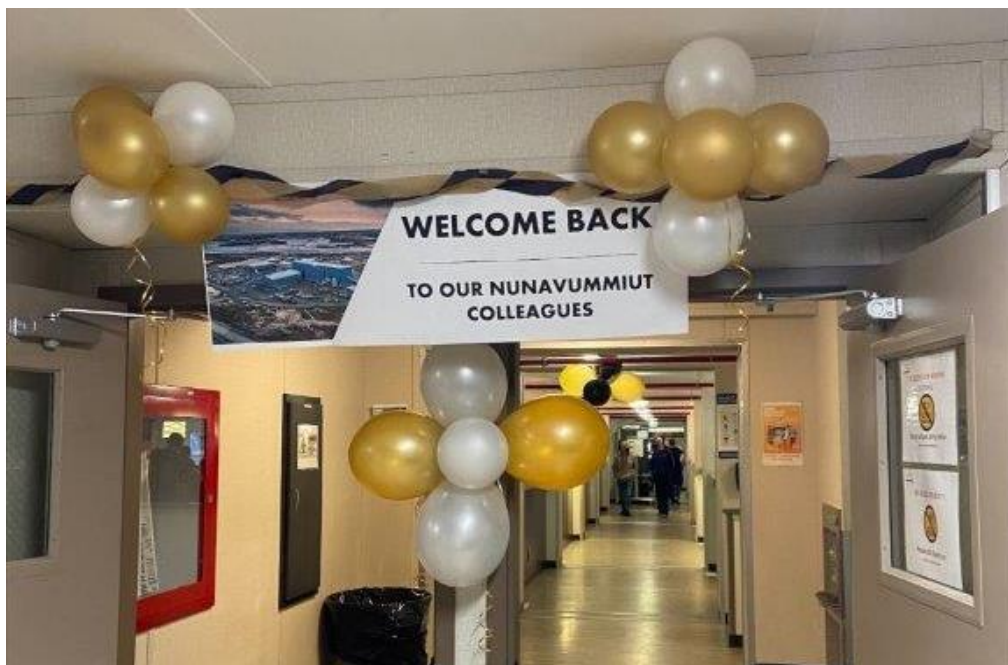
Photo 57: Nunavummiut Return to Work

- Nunavummiut from the Kivalliq region have progressively returned to work during the summer of 2021, following approval by the Chief Public Health Officer (Photo 57).

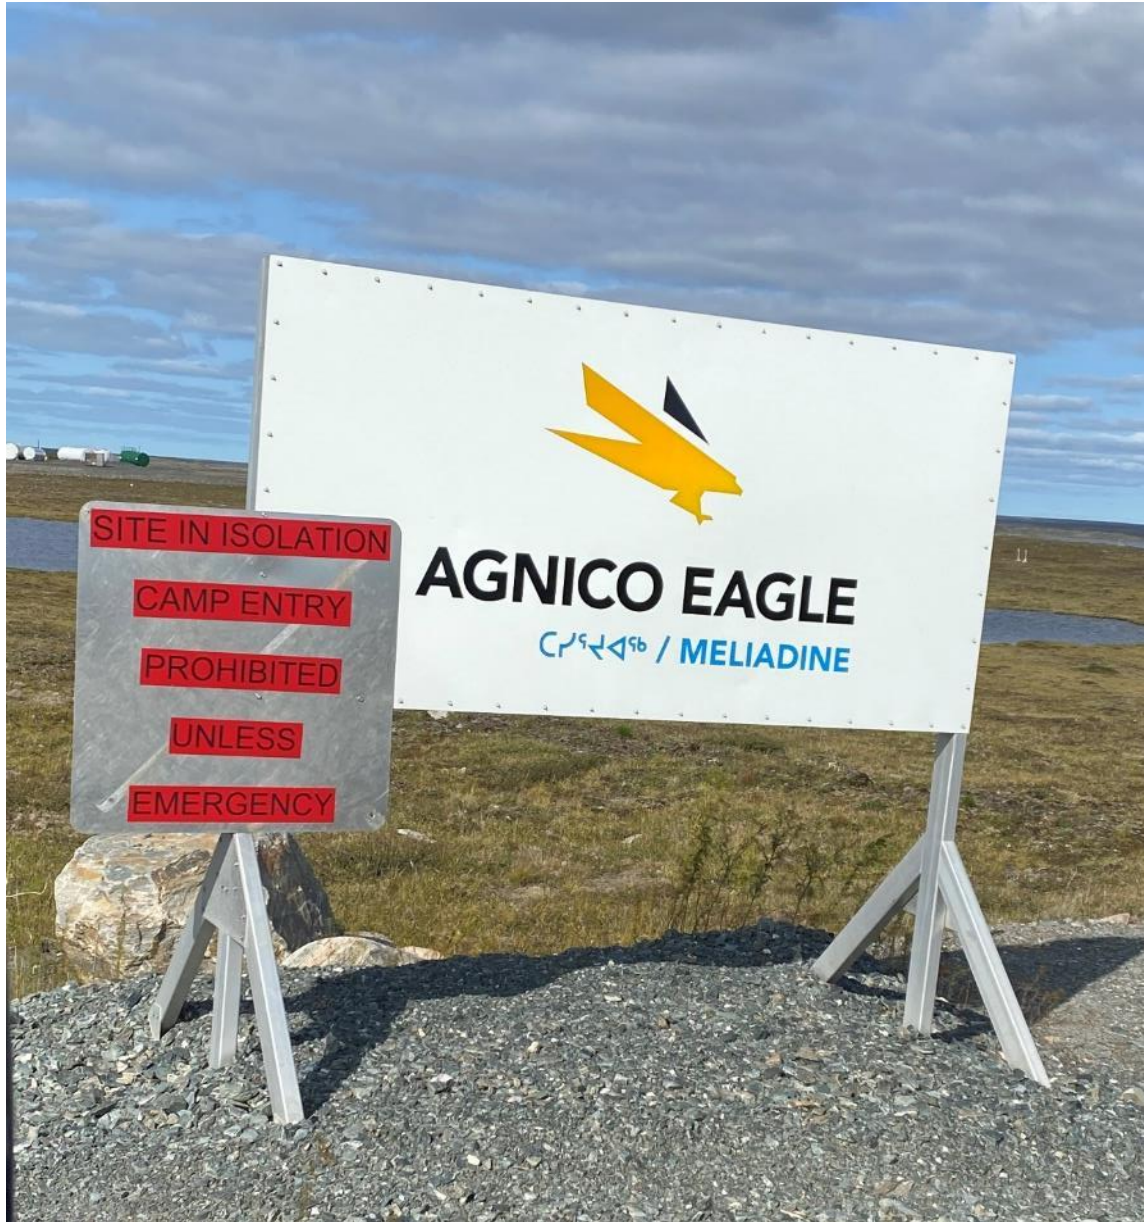
Photo 65: COVID-19 Signage Restricting Public Entry

- The Meliadine Gold Mine is still a site in isolation and a detached operation protocol and no-contact policy is in place (Photo 65).
