# Nunavut Impact Review Board 2021 Site Visit Report

## **Doris North Gold Mine and Phase 2 Hope Bay**

TMAC Resources Inc.

NIRB File No. 05MN047 and 12MN001

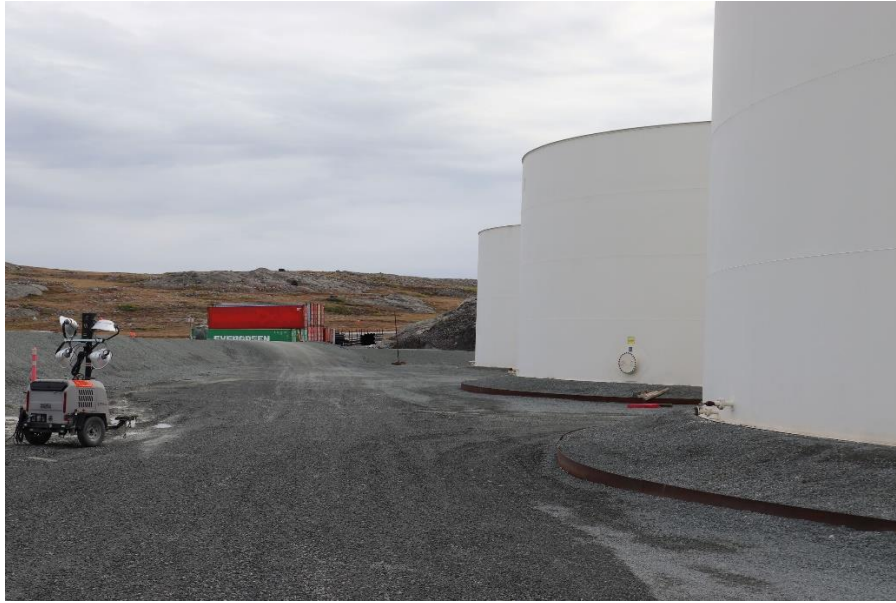
**Photo 4: Roberts Bay Tank Farm**

The Roberts Bay area ([Photo 3](#)) serves as the Project's marine access hub and is linked to the main camp and mine site by a 4.8 km all-weather road. The area is used for staging of fuel ([Photo 4](#), [Photo 5](#), [Photo 6](#)) and supplies in support of the ongoing construction and operation phases of both Projects.

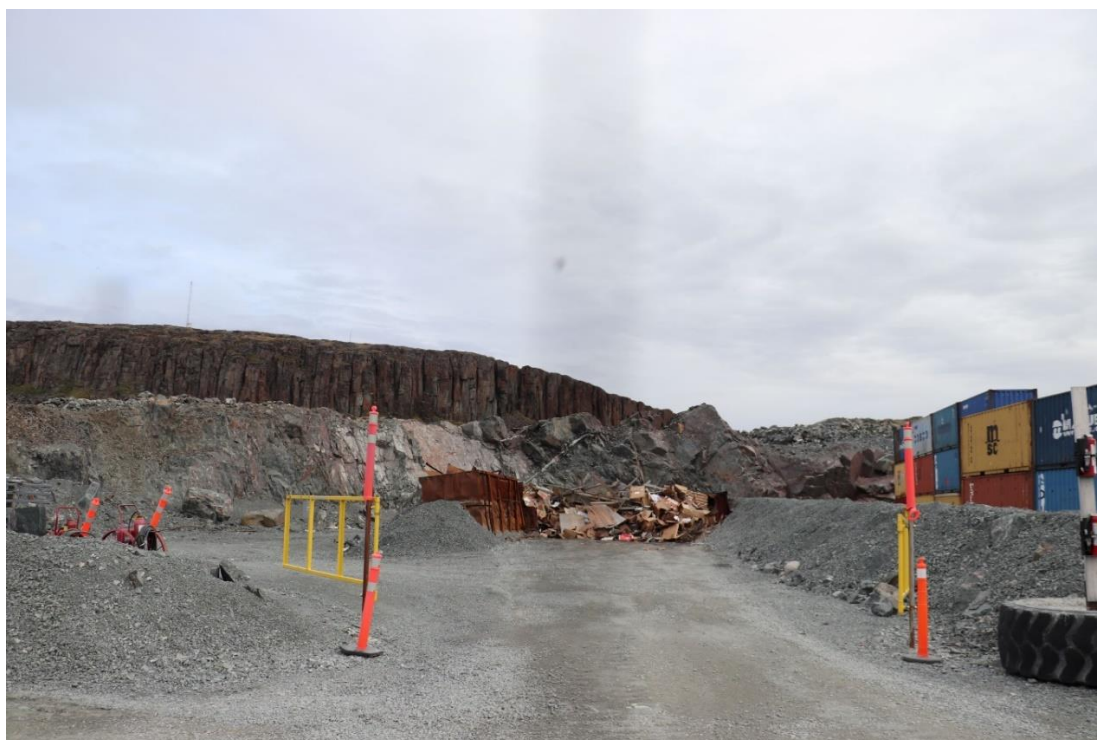
**Photo 12: Quarry 2 Burn Pan**

Quarry 2 ([Photo 11](#)) is adjacent to the all-weather road and the sewage discharge outfall is approximately 60 metres west of the all-weather road adjacent to the laydown area south of Roberts Bay. Conversion of the quarried-out area to a landfill has not yet begun, with quarry operations still ongoing. The burn pan ([Photo 12](#)) continues to be used to manage applicable solid waste such as clean wood.

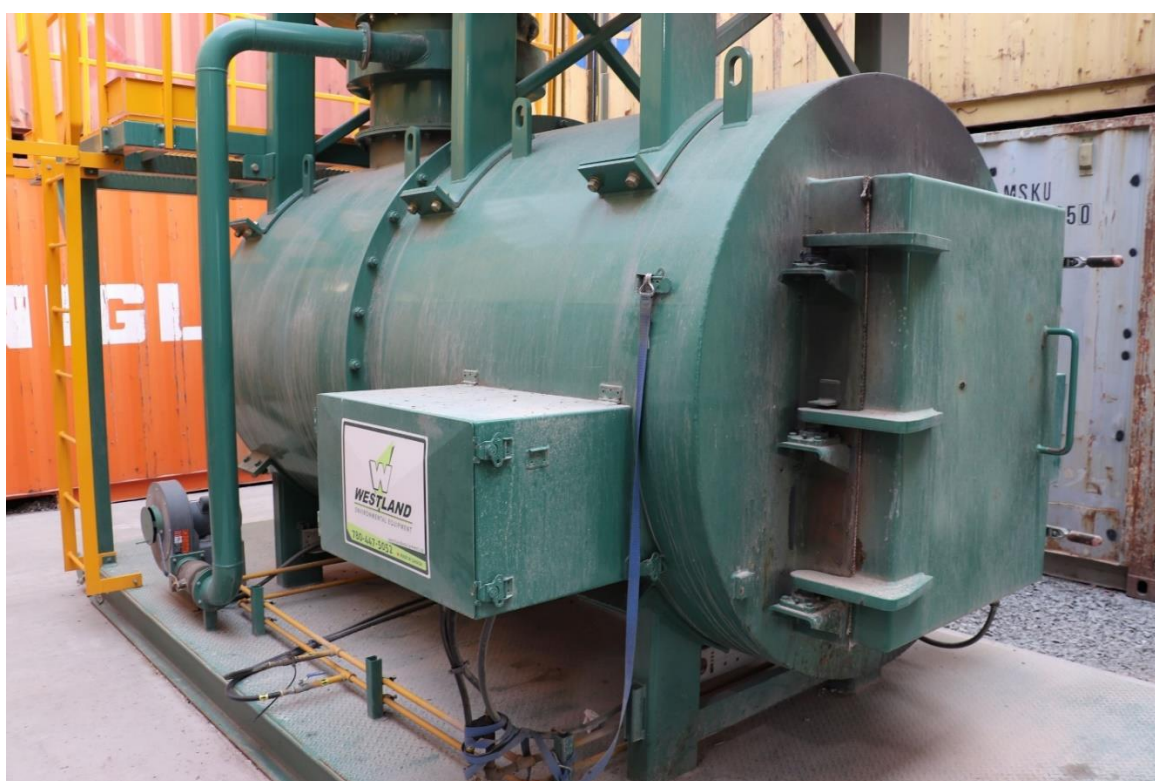
**Photo 14: Incinerator**

The incinerator which arrived in 2019 is surrounded by an enclosure made of seacans ([Photo 13](#)), as Site staff reported that operations during the winter of 2019-2020 was extremely uncomfortable for operators as the incinerator was open to the elements. The seacan wall that was constructed offered operators greater protection from wind ([Photo 14](#)), and planning is underway for the construction of a roof to provide additional protection.

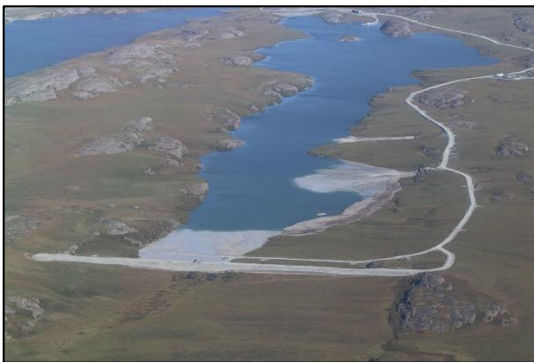
**Photo 19: Tailings August 2018**

Site and NIRB staff visited the main tailings outfalls/spigots and discharge areas within the TIA. Upon inquiry, Site staff indicated they have observed caribou that have accessed the drier part of the tailings at least once, apparently to escape flies during the summer.
