Nunavut Impact Review Board

2022 Site Visit Report

Back River Gold Mine Project

NIRB File No. 12MN036

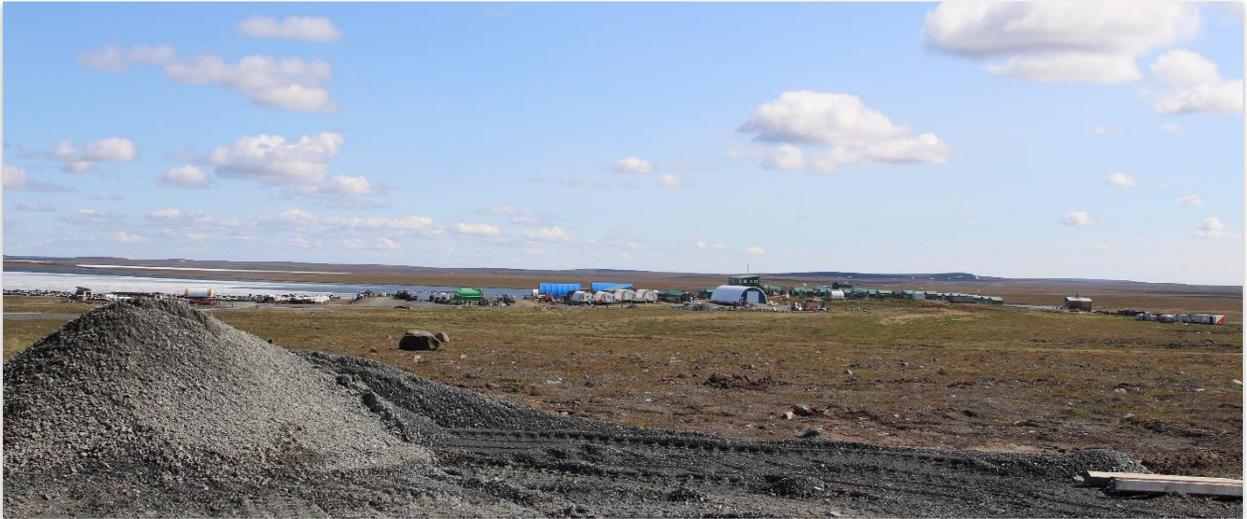
Photo 1: Goose Lake Camp

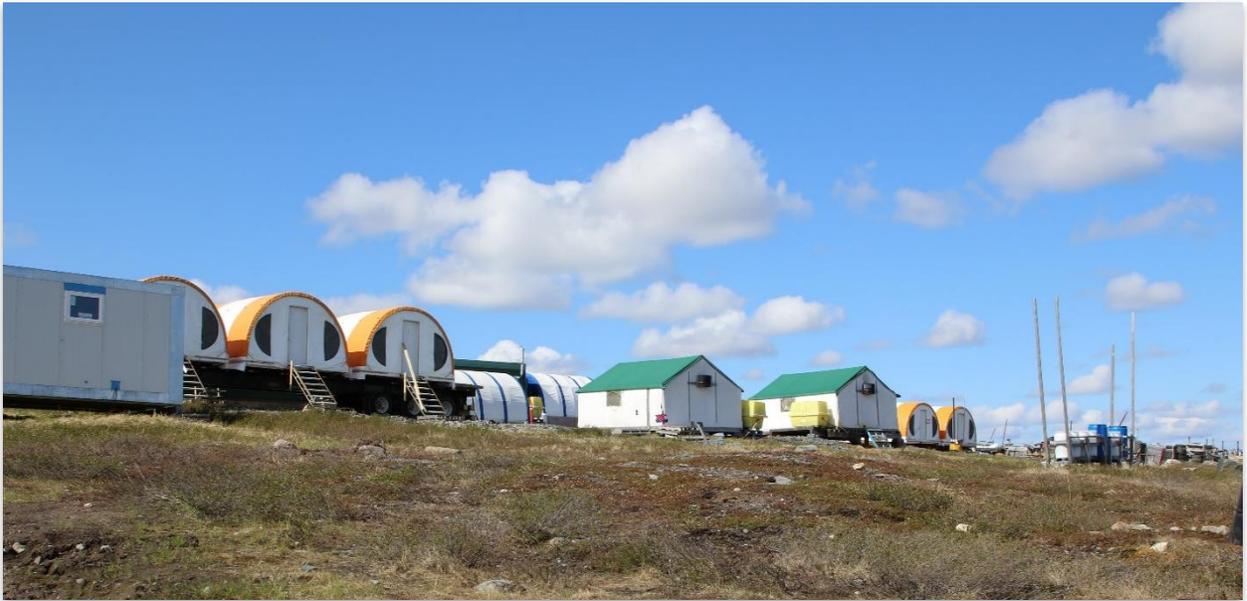
Photo 2: Goose Lake Weather Haven Accommodations

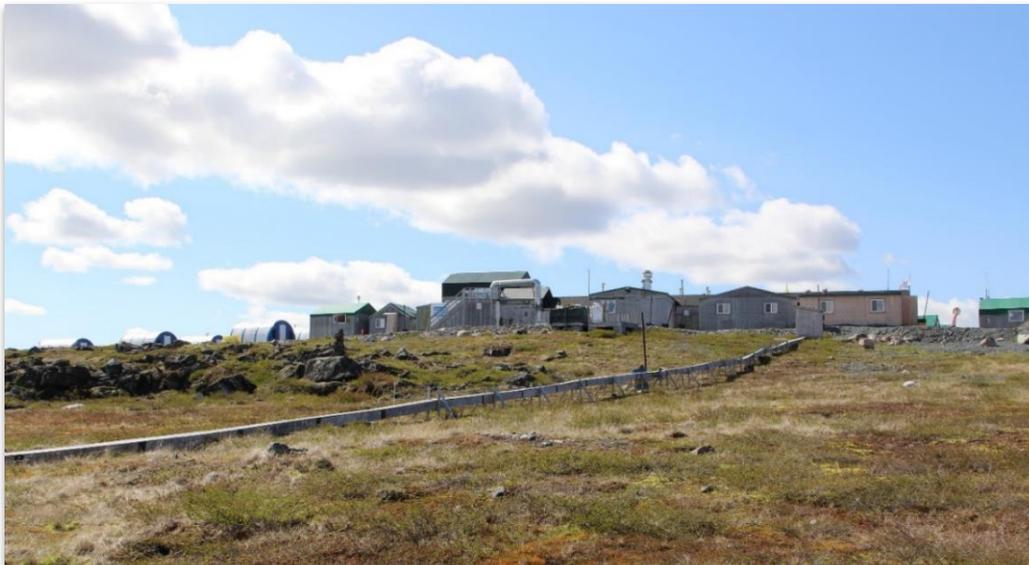
The water intake for the camp comes from the Goose Lake (Photo 3). Mr. Keefe advised the Monitoring Officers and CIRNAC that Sabina's intake of water is under the total permitted. NIRB and CIRNAC staff observed that the structure used to keep the waterline open in the winter was submerged; however, it was to be removed in the coming days as the ice had melted off Goose Lake. Sabina Staff confirmed that the water intake was covered by a screen.

Photo 4: Water Line to Goose Camp

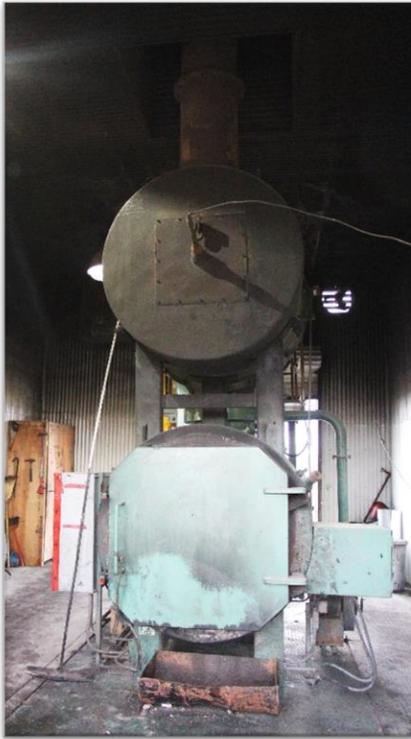
Within the Goose camp, waste is segregated as shown on Photo 8 with combustible and non-hazardous waste sent to the incinerator (Photo 9), and clean wood and cardboard to the burn box (Photo 10). Outside

Photo 9: Incinerator at Goose Camp

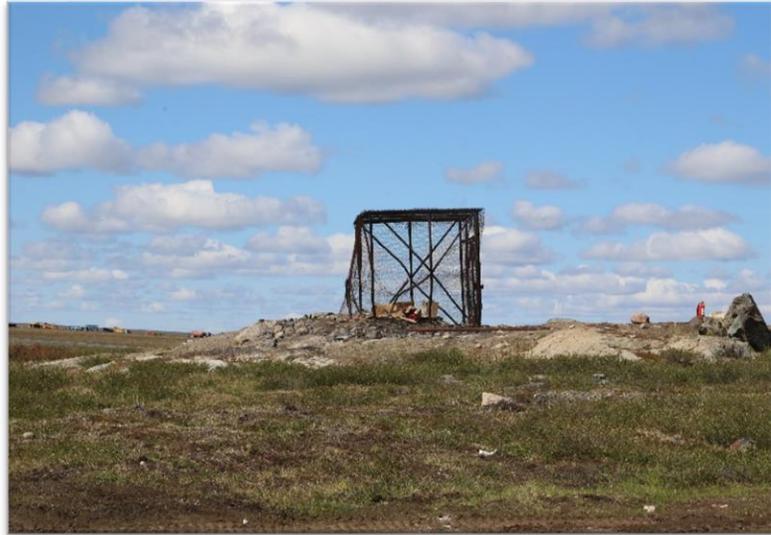
Photo 10: Burn Box at Goose Camp

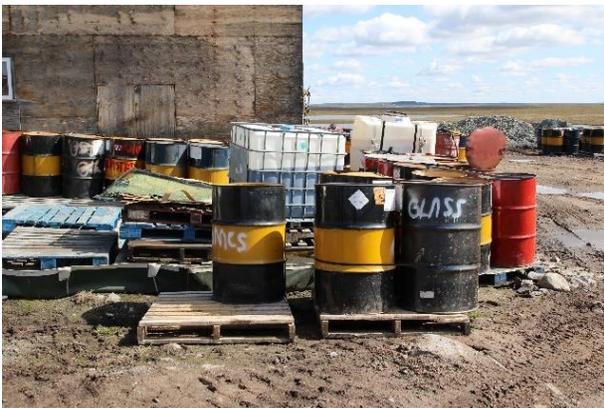
the incinerator, other waste segregation containers were placed for non-combustible waste (Photo 11). Currently the ash from the incinerator is stored (Photo 12) and will be tested when Sabina has its permanent landfill where it will be disposed if it meets criteria.

Photo 11: Non-combustible Waste Segregation

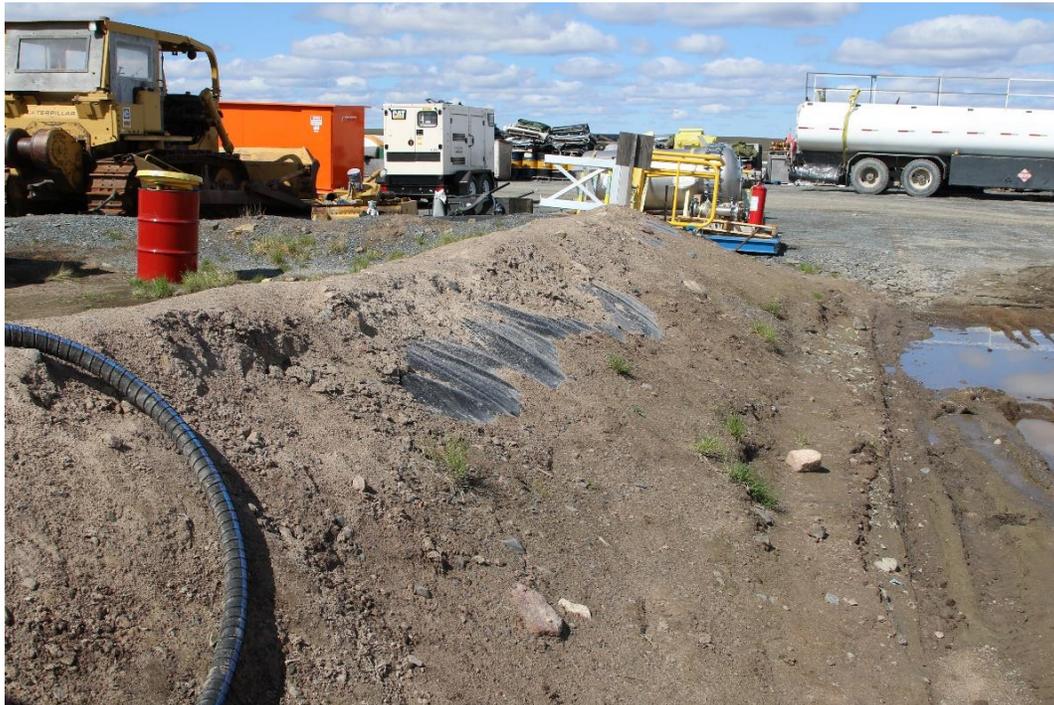
Overall, the bulk diesel fuel and hazardous materials were well managed at Goose Camp. Bulk diesel fuel was contained in double walled tanks within a containment (Photo 14). Some ponding was observed as there had been rains in the days prior to the site visit. Should the water become an issue (*i.e.*, will not dry up or continue to build up throughout the summer) it will be tested prior to pumping and release. Heating fuel was also contained to prevent spills at the accommodation's buildings (Photo 15) with Sabina heating some facilities with used oil (Photo 16).

Photo 15: Tankfarm at Goose Camp Refueling Area with Spill Kit

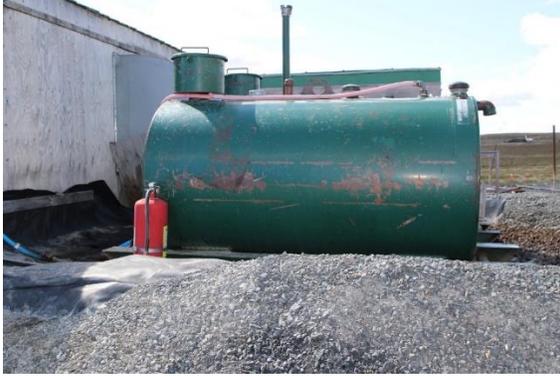
Photo 16: Heating Fuel Tank and Berm

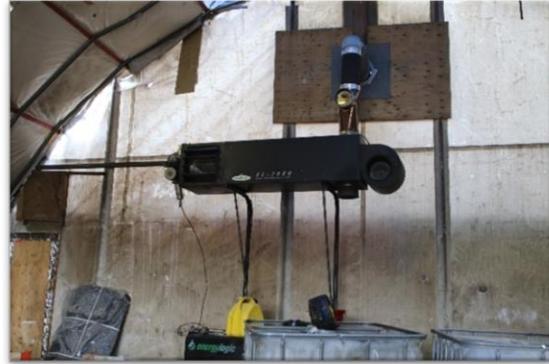
Photo 17: Oil Heater Supplied by Used Oil

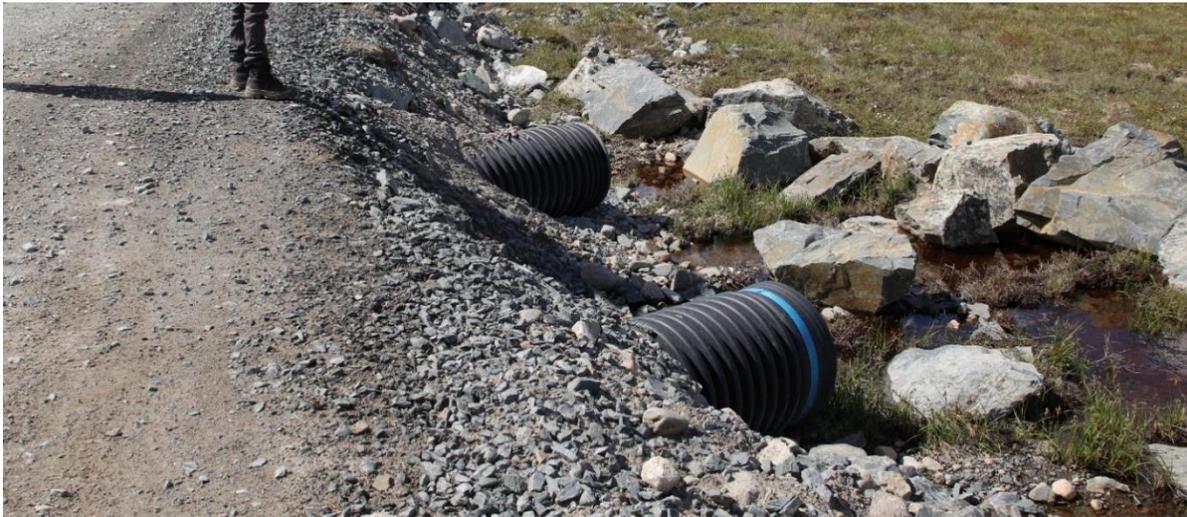
Sabina showed Monitoring Officers an area being monitored monitoring next to the road (Photo 20) and Sabina said it was watching the area to ensure that the tundra recovered and would undertake active remediation as necessary (Photo 21). On the connecting road to Goose camp, all culverts were well managed, and no water management was noted by the Monitoring Officers (Photo 22) and the road appeared well-managed. Sabina observed that it would be replacing two (2) of its bridges in this summer (Photos 23 and 24).

Photo 21: Culvert on the Road Towards the New Goose Camp Pad

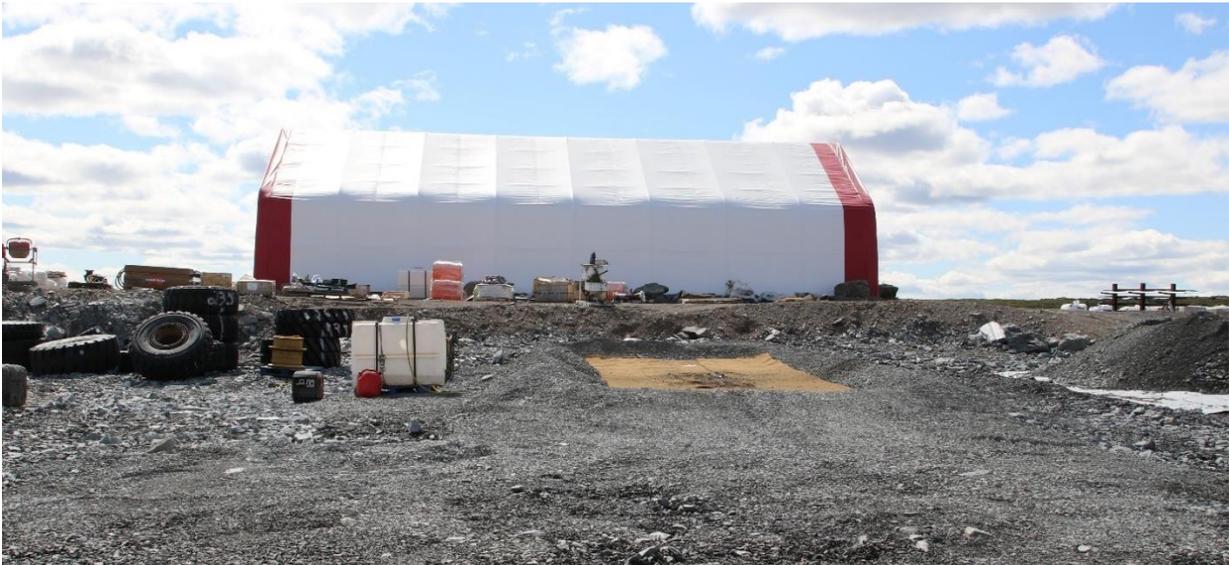
Sabina is preparing the pad for its new camp located northwest of its existing Exploration Camp. Currently at the entrance a maintenance shop is established along with a Laydown Area and Wash Area (Photo 24). Additionally in this area, the Monitoring Officers observed active construction (Photo 25) which mostly consisted of earth work and construction of a tank at the future Tankfarm (Photo 26). During the visit, Sabina stated that it is planning to move accommodations from the MLA to here during the next ice road season.

Photo 24: Wash Area with Berm and a Maintenance Shop in the Background

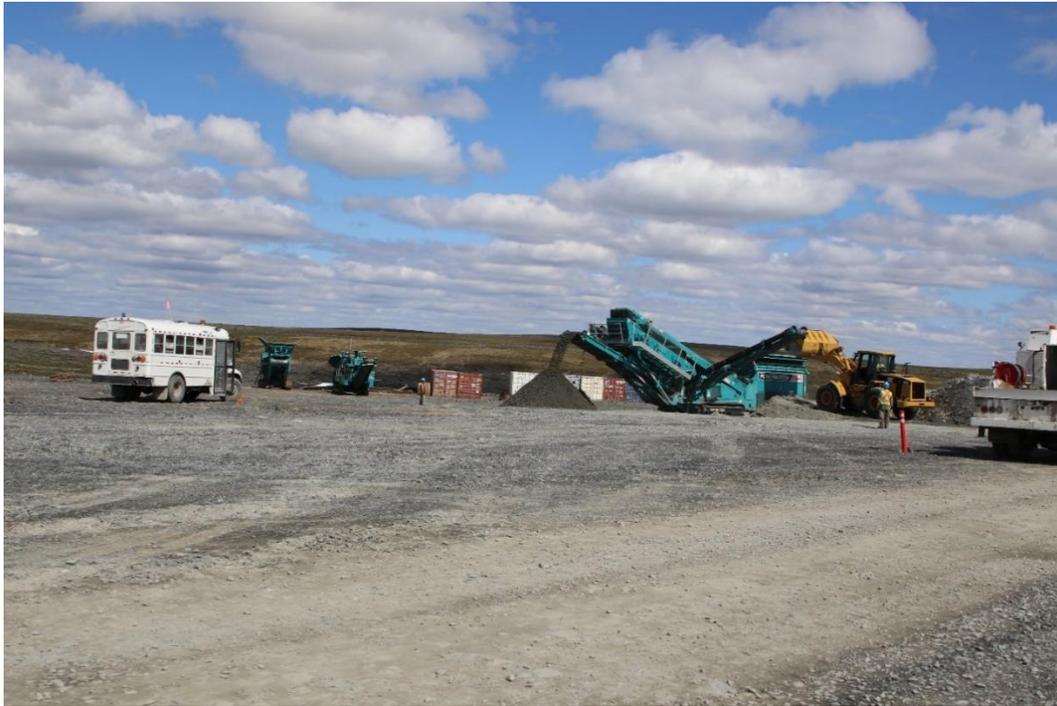
Photo 25: Crusher for Construction Material

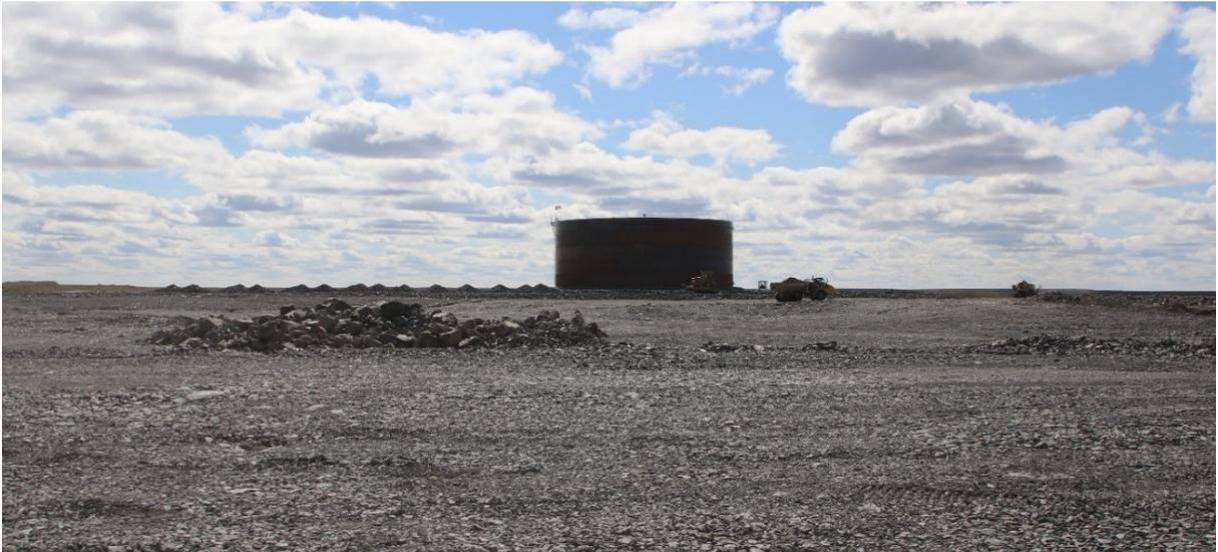
Photo 26: New Tankfarm and Ongoing Groundwork for the New Goose Camp

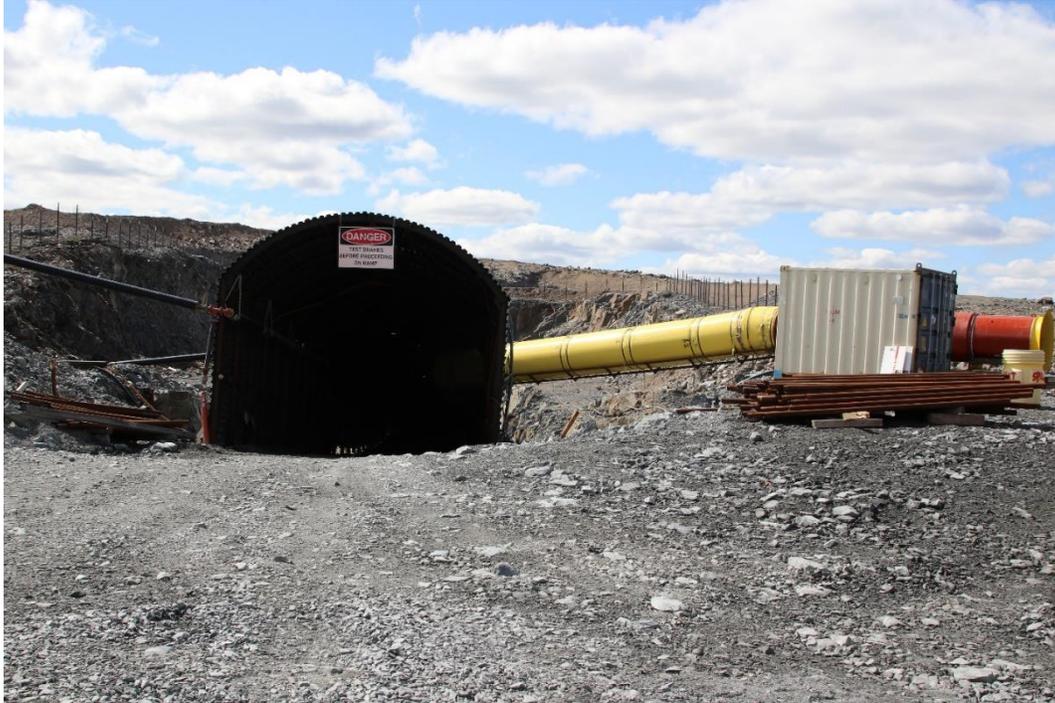
Sabina has also constructed a portal at the Umwelt deposit (Photo 27) and underground development is occurring.

Photo 27: Portal for Umwelt Deposit

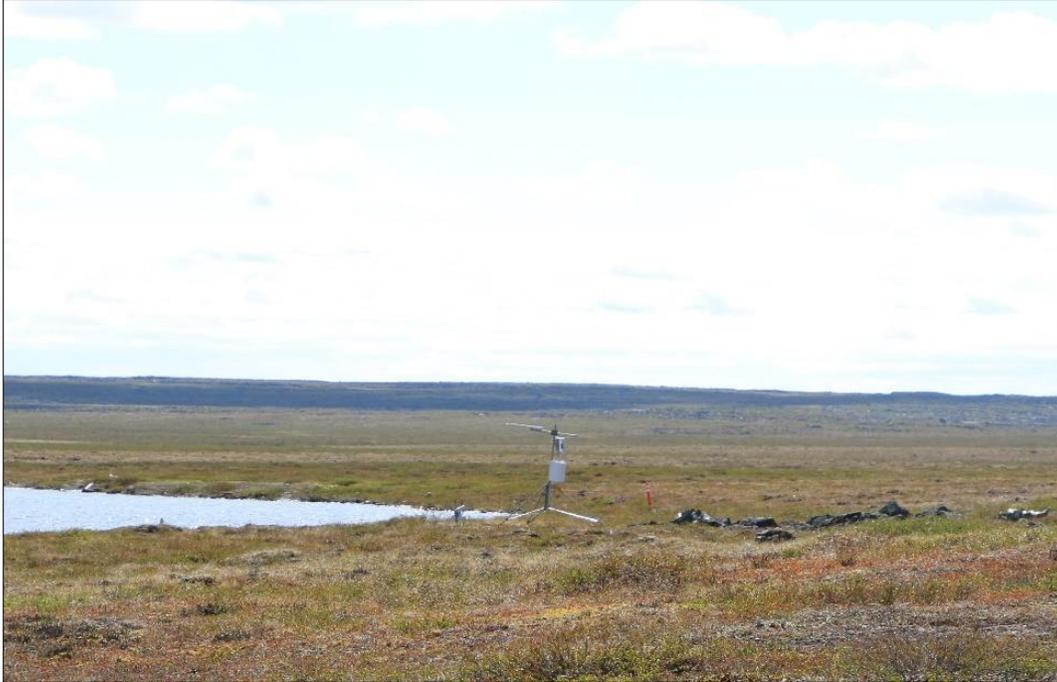
On site, the Monitoring Officers had the opportunity to observe different environmental monitoring stations. As part of the Project Certificate, Sabina maintains a hydrology monitoring station (Photo 28) to measure the water level of Goose Lake. Staff were able to confirm the presence of weather-related monitoring stations (Photo 29) as part of the Term and Condition #8. To ensure the drilled rock does not have the potential of acid generation, Mr. Keefe showed NIRB and CIRNAC staff the acid rock test barrel station (Photo 30) where the rock is stored in barrels without lid and water is collected and tested. If the rock presents a risk for metal leaching the Proponent is expected to prevent drainage of that material to the environment as part of the Term and Condition #23.

Photo 28: Hydrology Monitoring Station Near Goose Lake

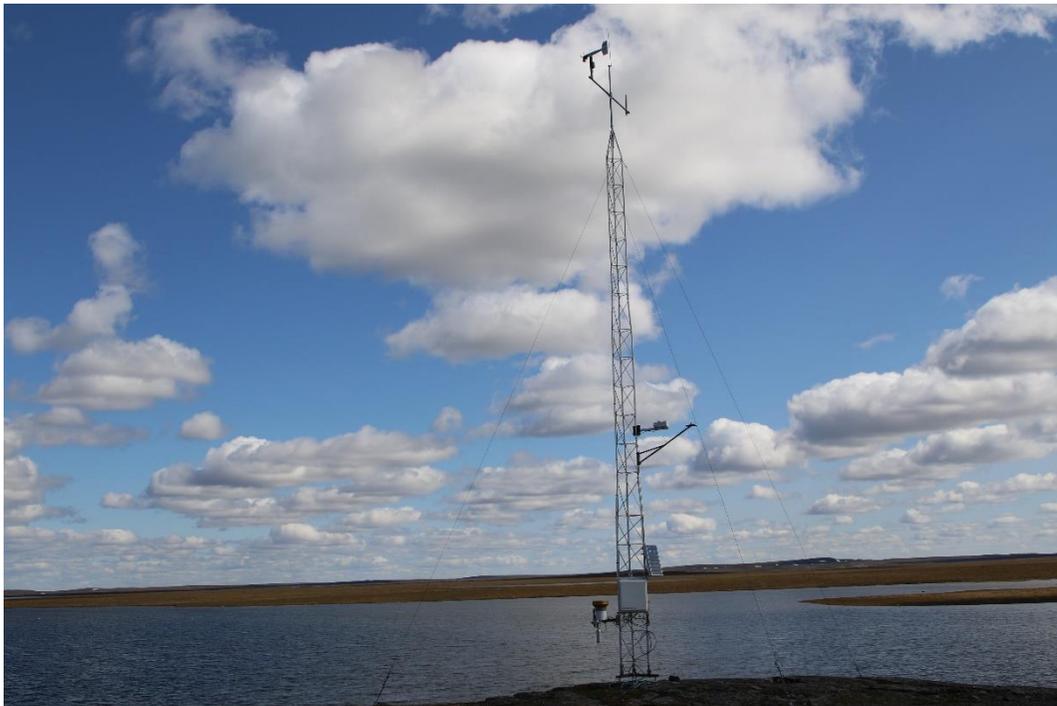
Photo 29: Weather Station at Goose Camp

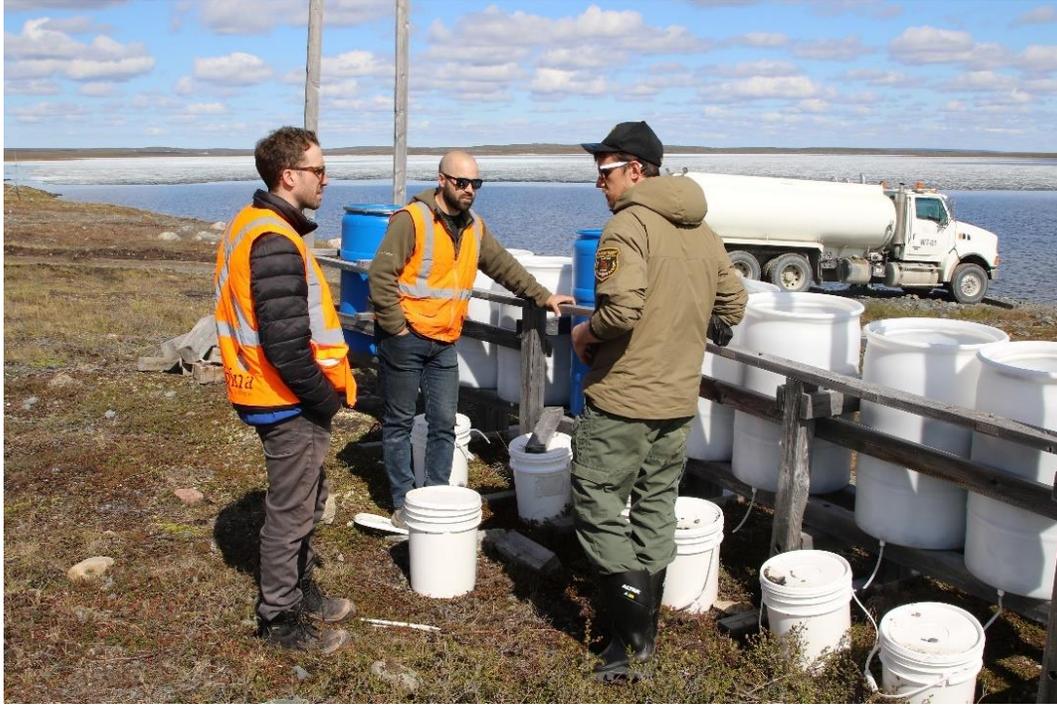
Photo 30: On Site Acid Rock Testing Station at Goose Camp

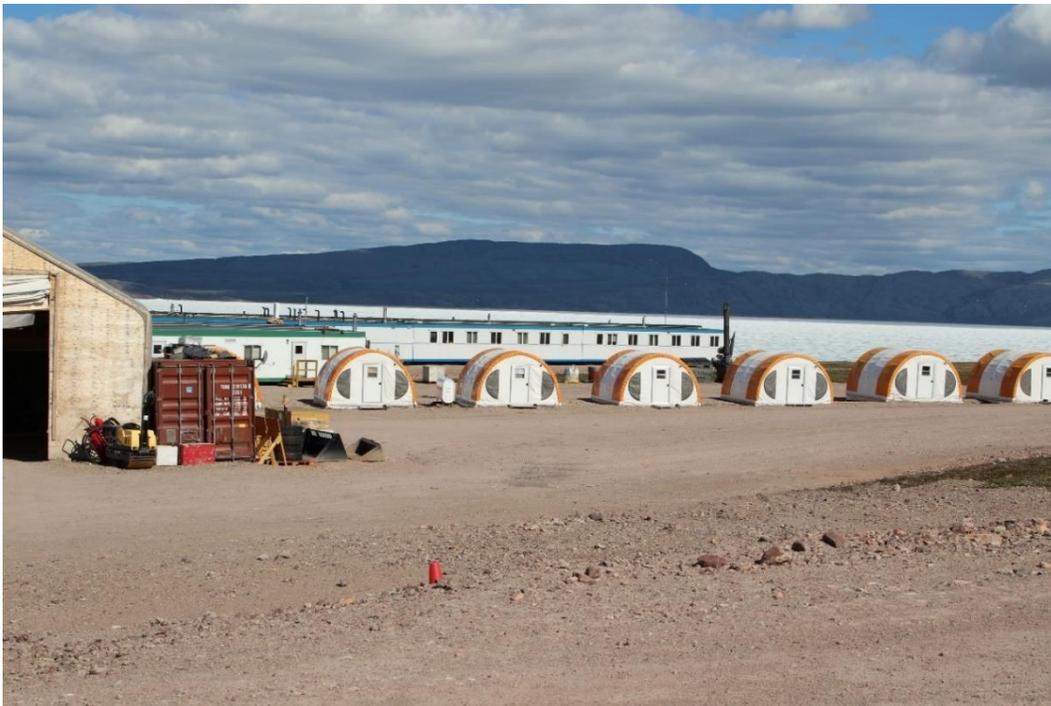
Overall, the camp appears to be well organized and clean (Photo 31). The MLA Landing off Bathurst Inlet is expected to be modified in the summer of 2022 (Photo 32) and be built out to about where the person is standing.

Photo 31: MLA New Accommodations and Weatherhaven Camp

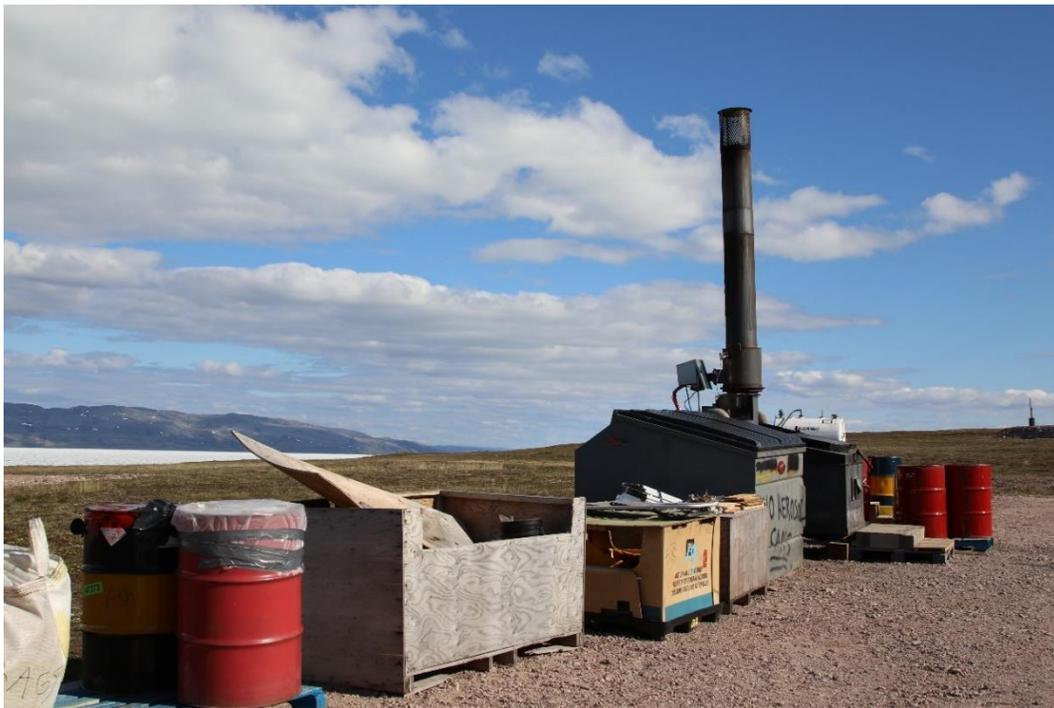
The Monitoring Officers observed the incinerator with waste segregation on its side (Photo 33). To supply the Camp with water, Sabina pumps water directly from the inlet (Photo 34) and run it through a desalination process (Photo 35) which is tested on a regular basis and results are posted at Camp as they are received.

Photo 33: Incinerator with Waste Segregation

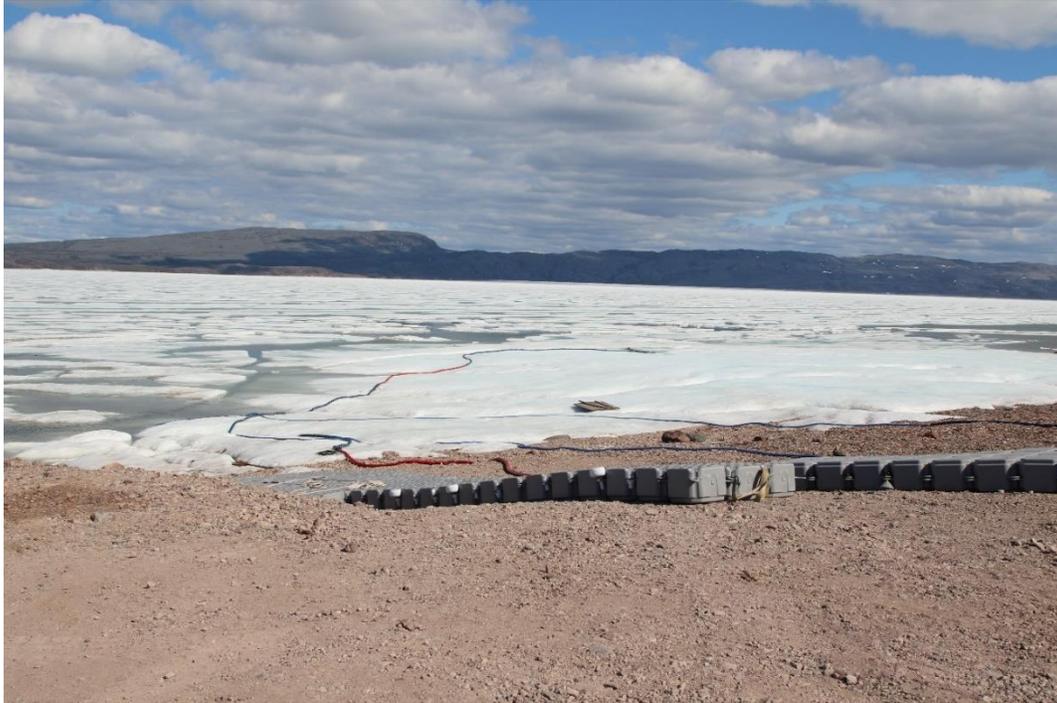
Photo 34: Waterline to the Desalination Facility (Red and Black Pipeline) Beside Temporary Dock

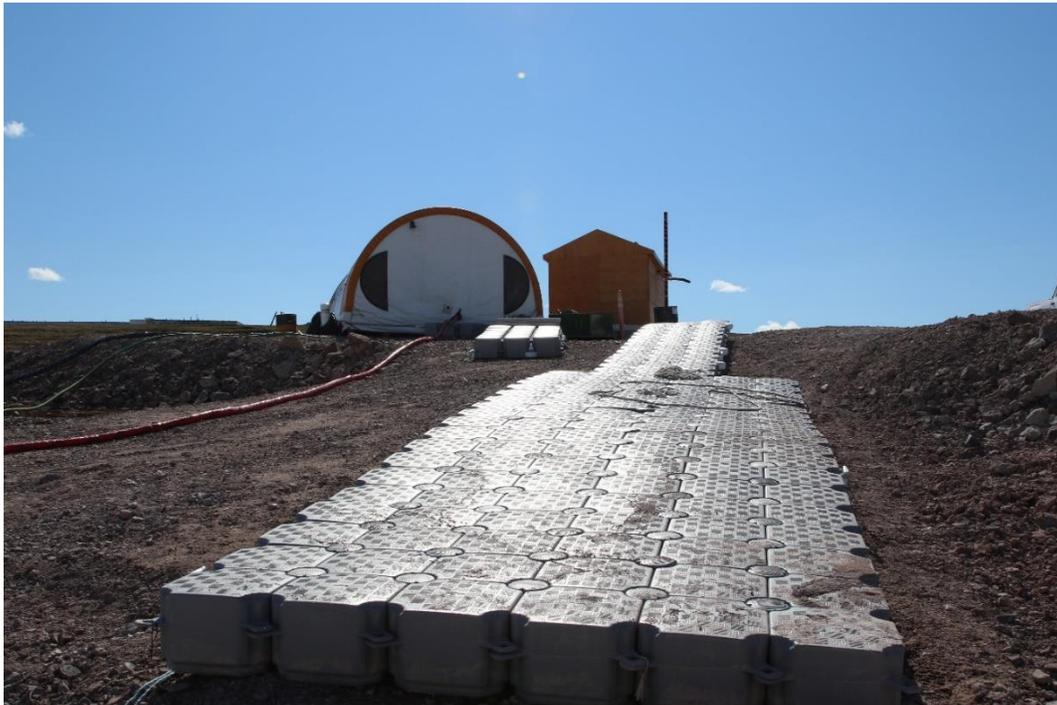
Photo 35: Water Desalination Facility Background and Floating Dock Foreground

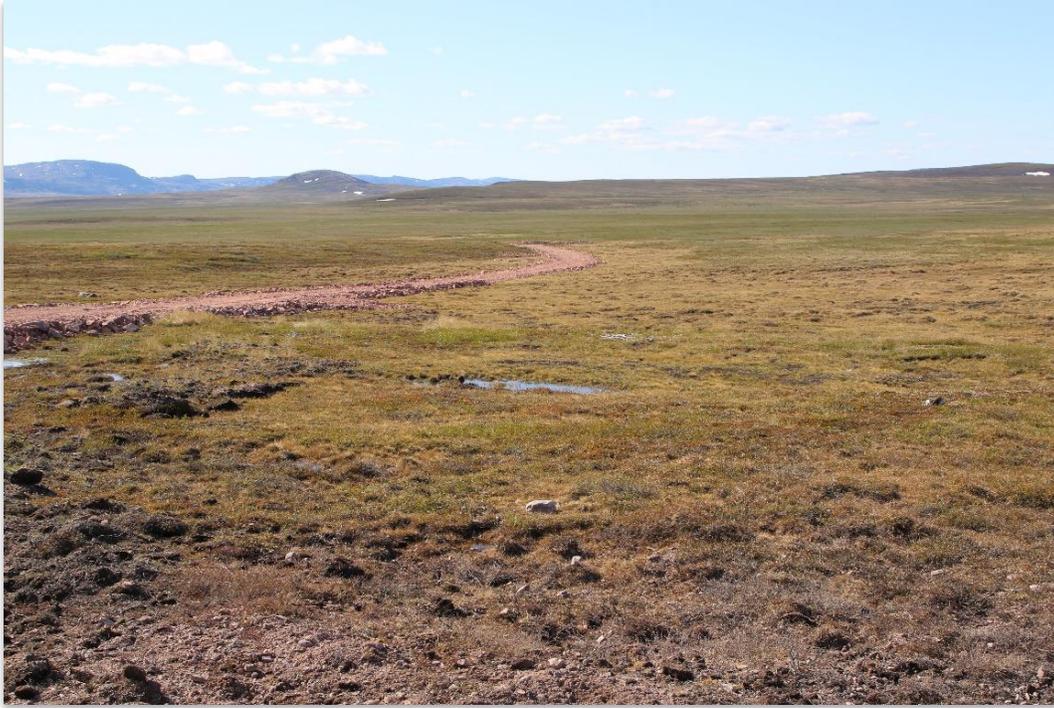
Permanent roads had been constructed around the MLA, including two (2) trails to access the Explosives Magazine and Ammonium Nitrate Storage (Photo 41). The road is still present, but the facilities were removed.

Photo 41: Road to Previous Explosive Storage Area

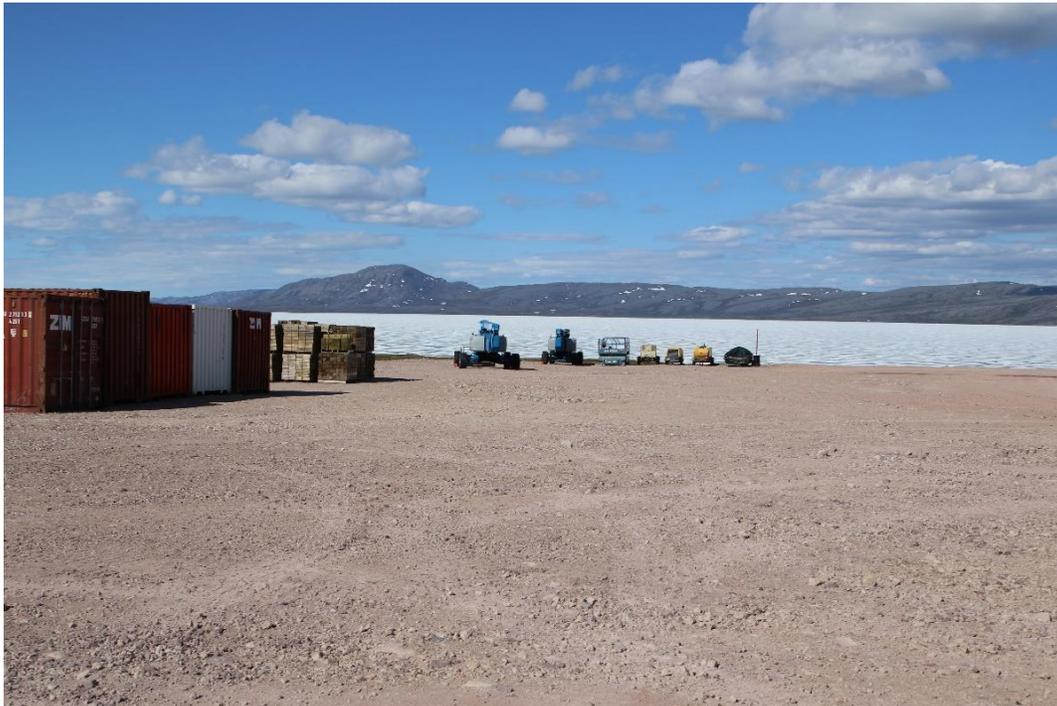
Laydown Pads, a Freight Storage Pad, and the Shoreline Pad for the receipt of sealift barges were constructed. During the site visit the Monitoring Officers noted the Laydowns are well organized and clean (Photo 42 & 43). The Spill Containment materials were located in seacans beside the Barge Landing Area in Photo 42.

Photo 43: Laydown Area Up Slope from to the Port

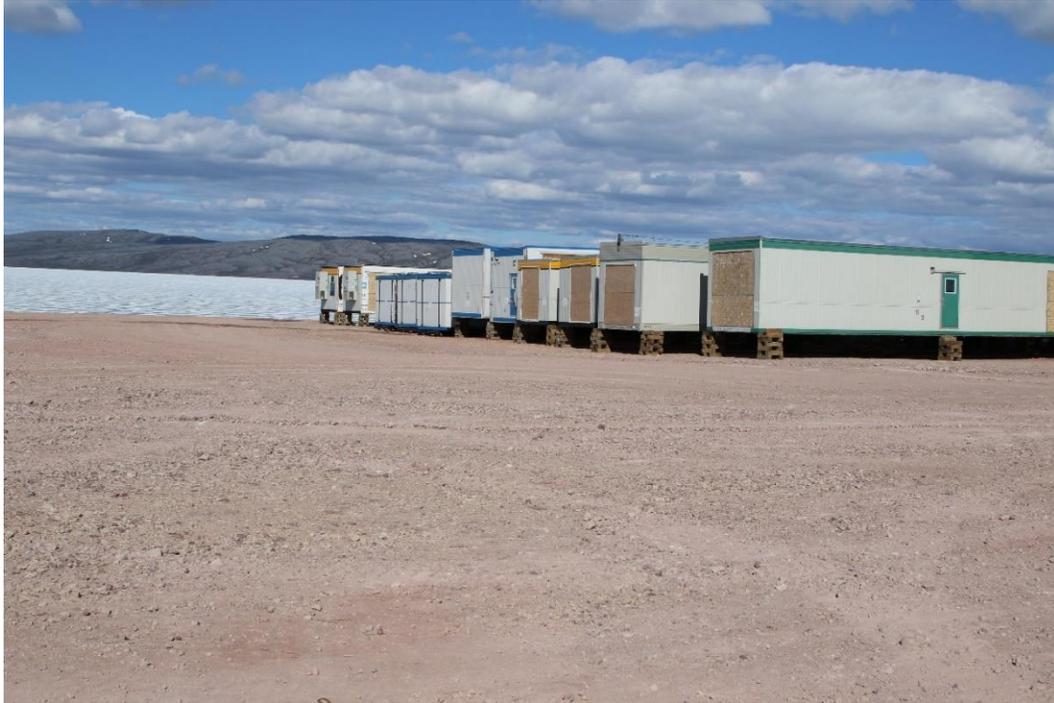
NIRB and CIRNAC staff also noted the trailers for the future Goose Camp were stored at the MLA (Photo 44) and waiting to be transported on the Winter Ice Road. All oil and/or fuel containers were contained in berms (Photo 45). The area is large enough to contain materials from both the 2021 and 2022 shipping season.

Photo 44: Laydown Area New Goose Camp to be Moved on the Ice Road

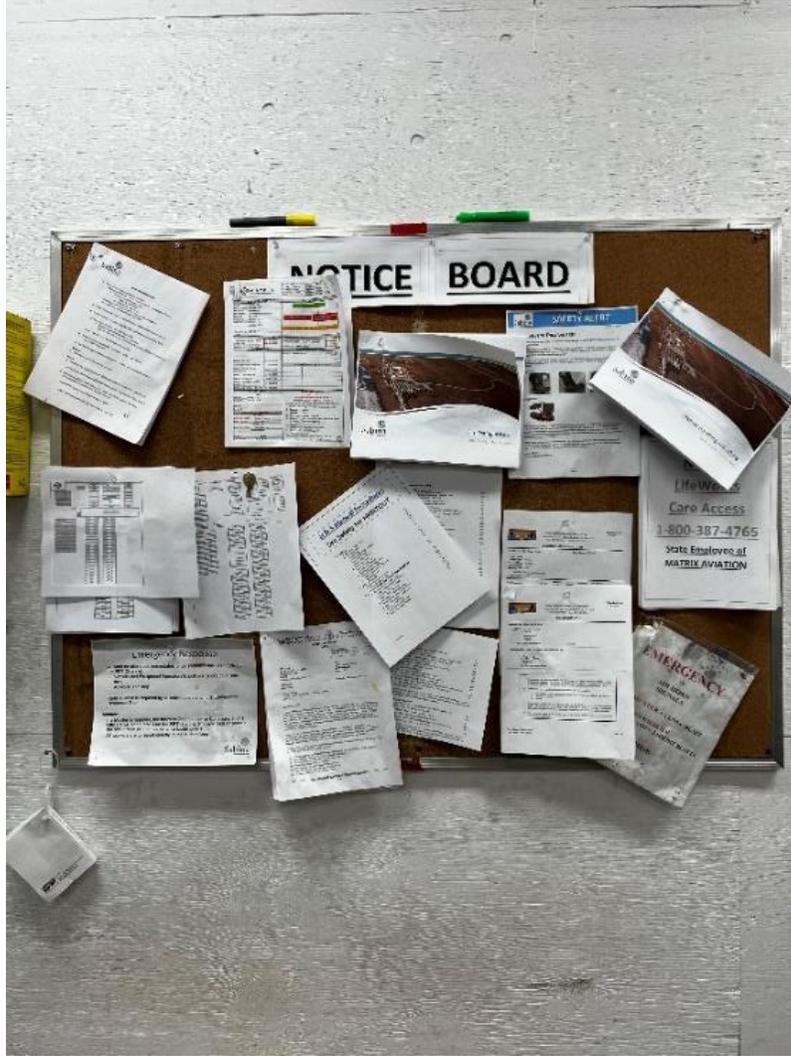
NIRB Staff viewed the wildlife log binder (Photo 46) by Sabina and other appropriate project licenses and other procedures (Photo 47) in the office area and around MLA. To date no wildlife incidences were noted.

Photo 47: Board at MLA with Procedures and Documentations

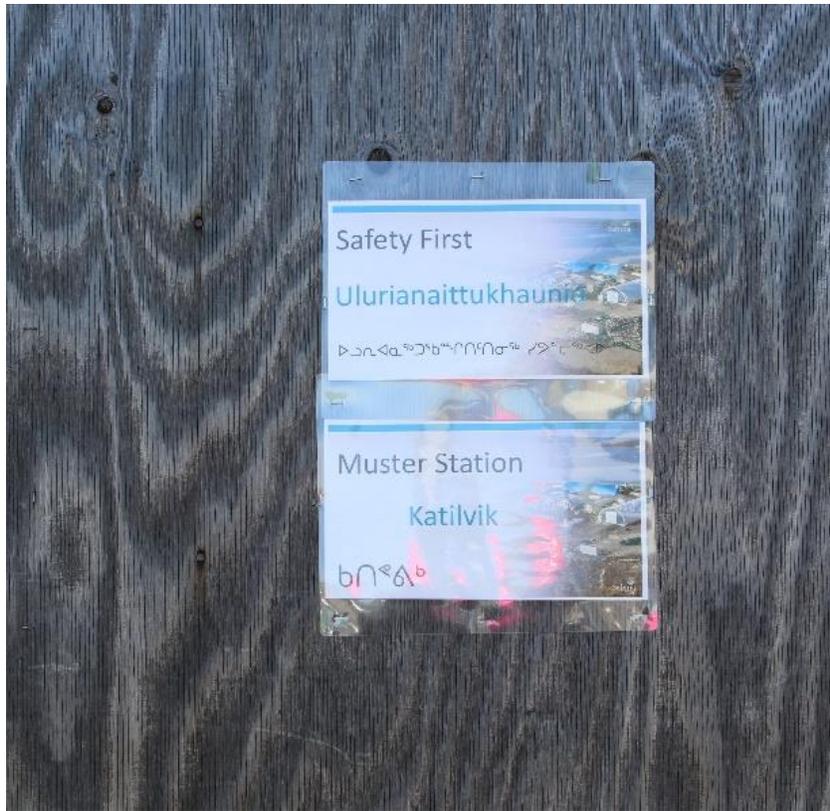
NIRB staff also observed that signs (Photos 48 & 49) and many materials were translated both at Goose and the MLA.

Photo 48: Signs at Goose Camp

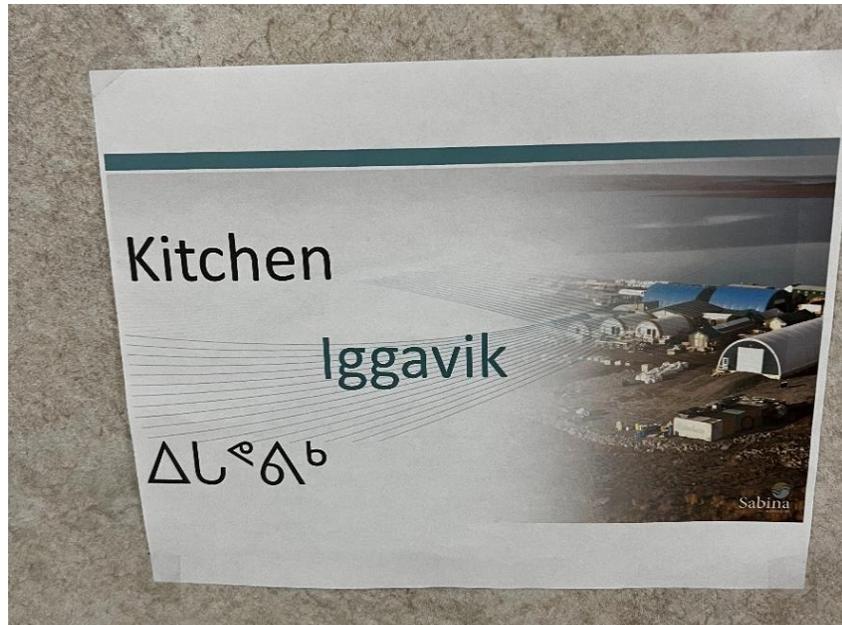
Photo 49: Sign at MLA

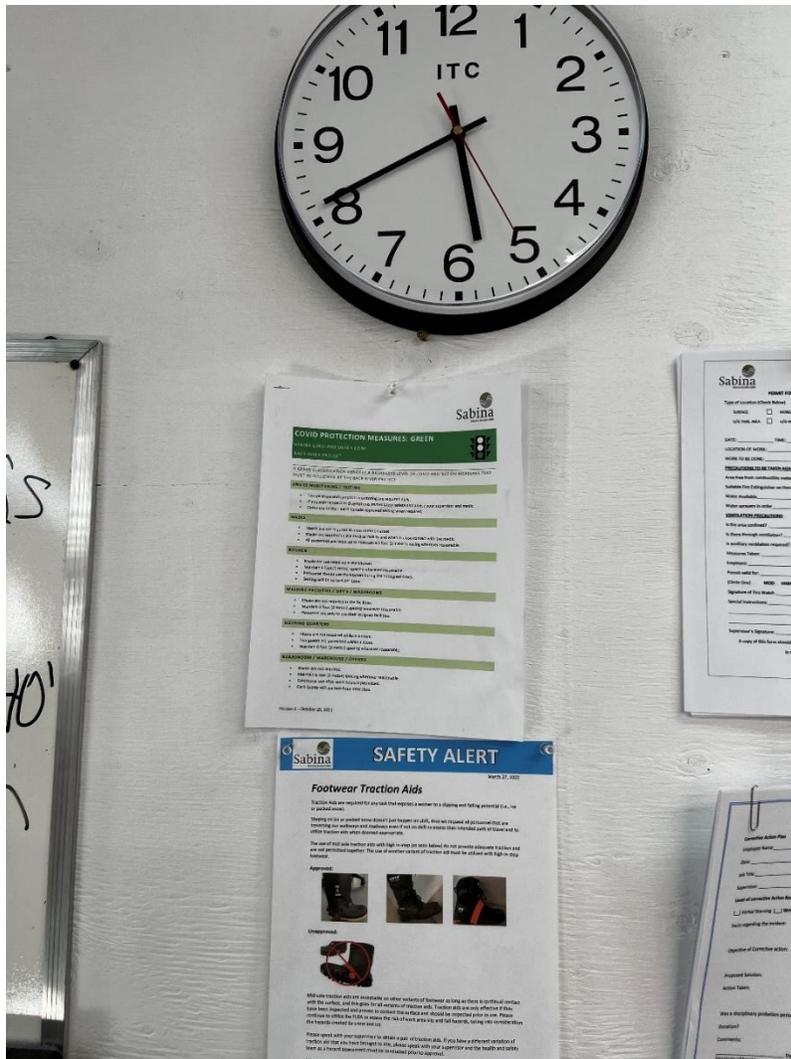
Sabina also continues to have COVID-19 measures in place and has materials up for people to follow and/or use if there is a breakout (Photo 50).

Photo 50: COVID-19 and Safety Notices MLA

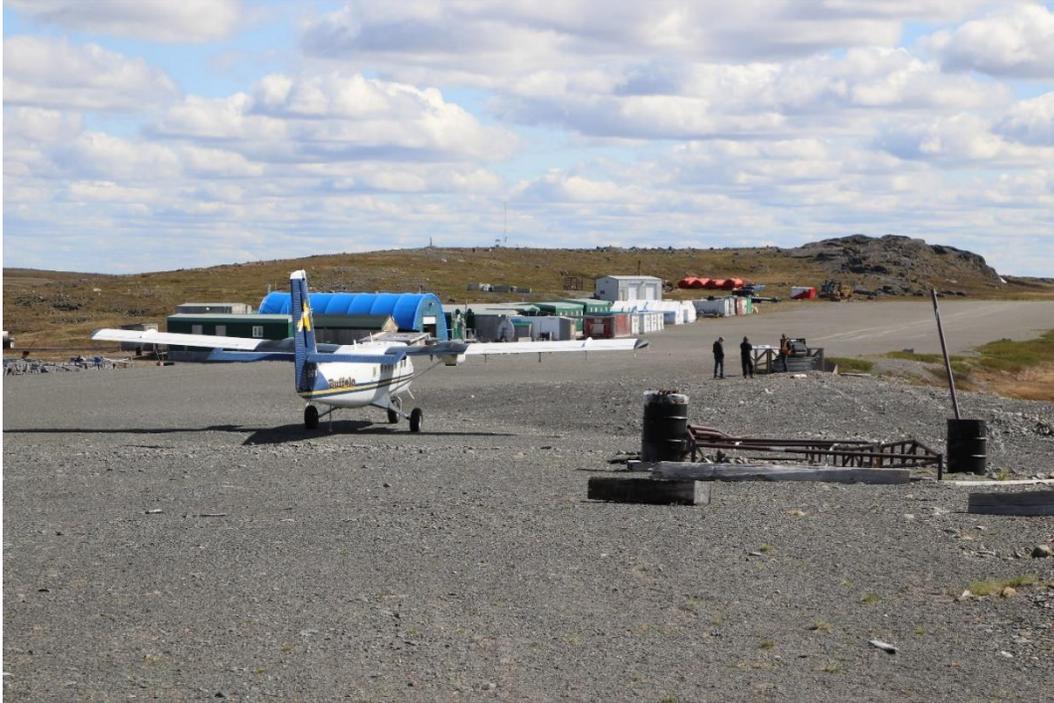
The George Lake Property is an advanced exploration camp located approximately 50 km northwest of Goose Property, and currently has four (4) mineral deposits identified for potential future development. During the NIRB and CIRNAC site visit Sabina had just started to reopen the camp and make it functional for further explorations in the area. During the visit, Sabina was bringing fuel barrels by plane and stored them into a berm in the George Exploration Camp (Photo 51).

Photo 51: George Lake Exploration Camp
